Evaluation of Service Life of Noise Barrier Walls in Illinois

Project IIB-H1, FY 1997

Report No. ITRC FR 97-3

November 1999

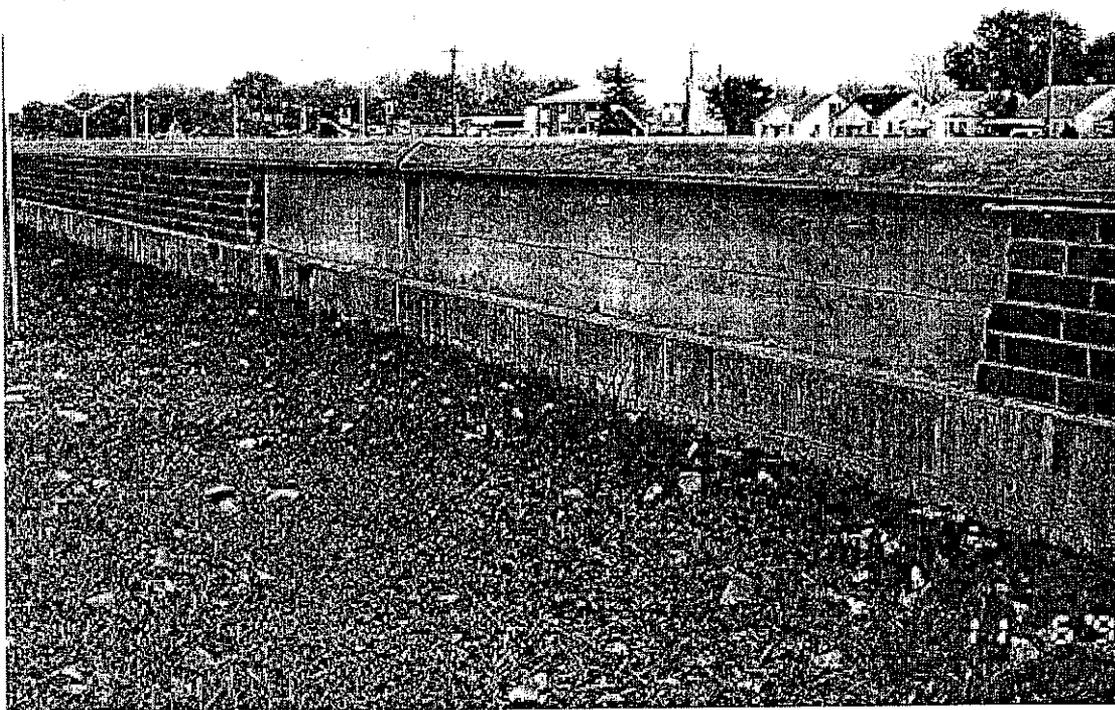
The visit to Michigan was instructive, however. In particular, several sections of brick and brick/concrete noise barrier constructed in the late 1980s on I-696 were observed to have failed. In both cases, the cause of the observed distress was not a failure of the materials used to construct the barrier (brick and cast-in-place concrete), but rather a failure of the connection of these two materials. In all the observed cases of distress or failure, control joints in the poured concrete footing and in the brick were not aligned with each other. Differential movement at the joints in the concrete wall supporting the brick could not be transferred to corresponding joints in the brick. The resulting differential movement appears to have caused stresses in the brick resulting in cracking, spalling of the brick facing, and in one case complete failure of the barrier (Figures 5-1 and 5-2).

Figure 5-1. Spalling of brick-faced barrier. I-696, Detroit MI.

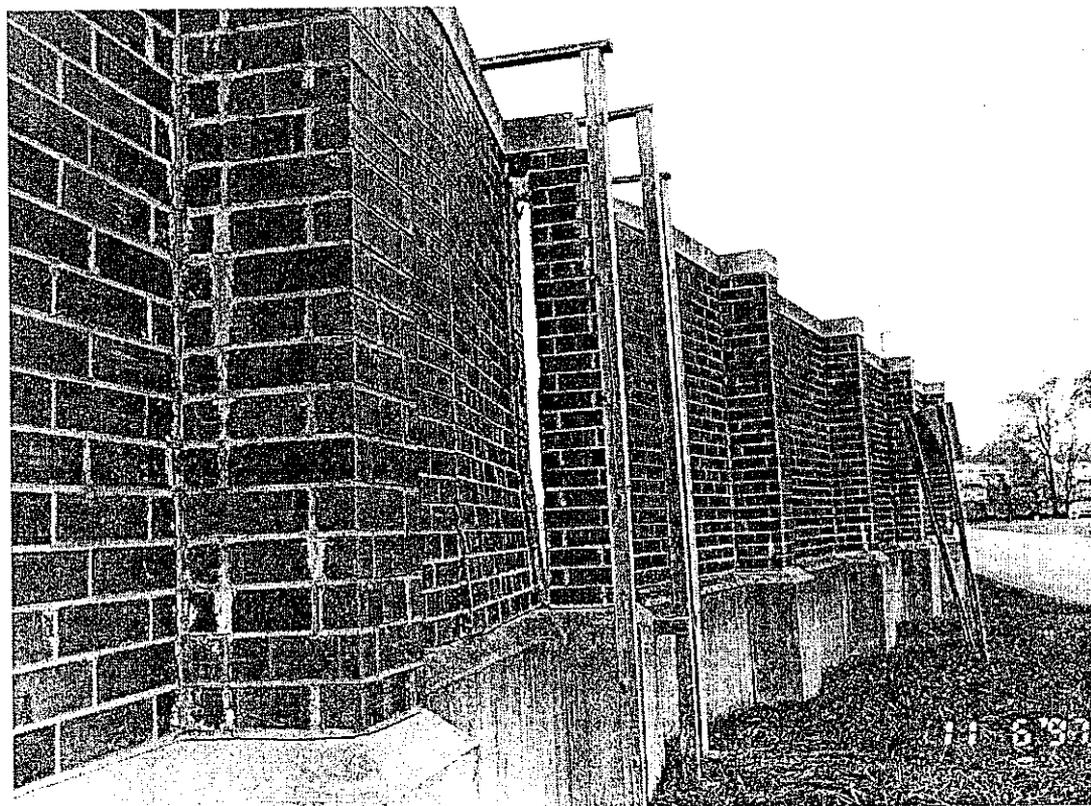
Figure 5-2. Failure of brick barrier, I-696, Detroit, MI.

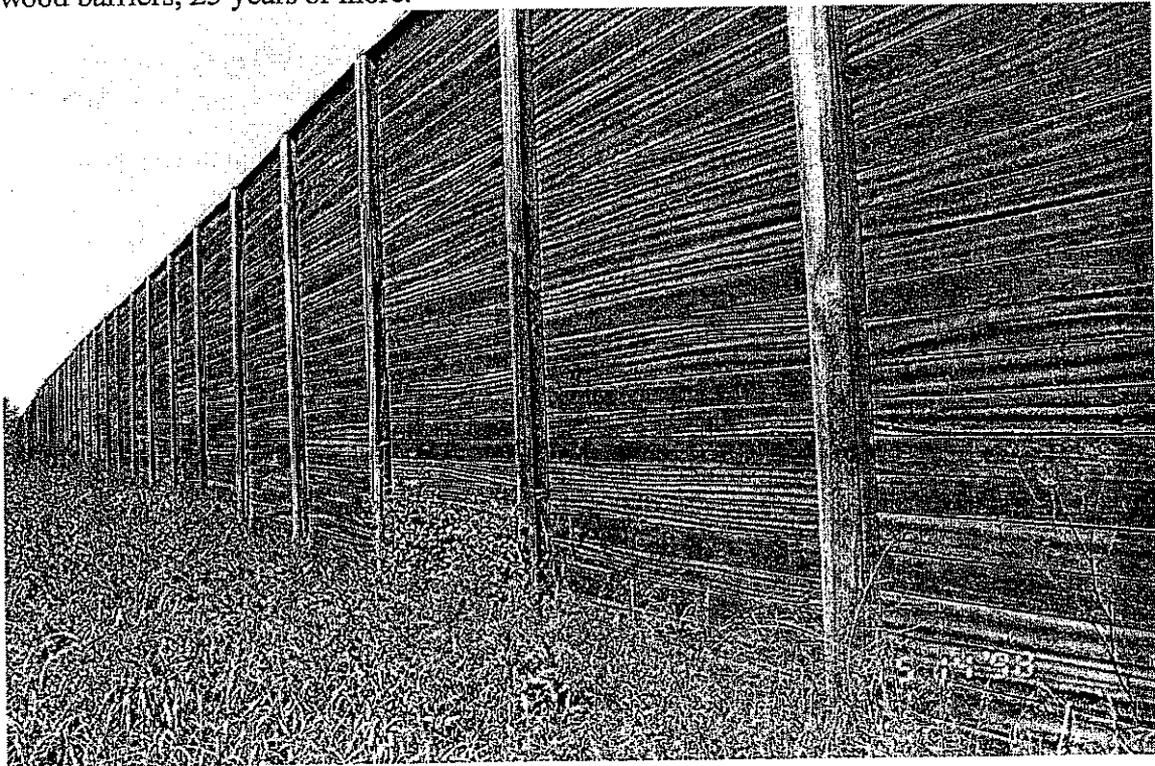
The remaining life of this type of barrier is difficult to speculate upon. Sections of barrier at Lake/Cook appear to be currently unserviceable after approximately 8 years. Numerous panels appear unsafe, and the barrier is unsightly. It is likely that given the inherent density and rot-resistance of this wood, and the massive cross section of the posts, the material itself will last beyond the time this barrier must be removed for structural or aesthetic reasons. Some of the redesigned barriers on IL 53 are performing well after 8 years, and should have a service life at least equal to that of glue-laminated wood barriers, 25 years or more.

Figure 5-7. Tropical hardwood barrier IL 53 near Army Trail Road.

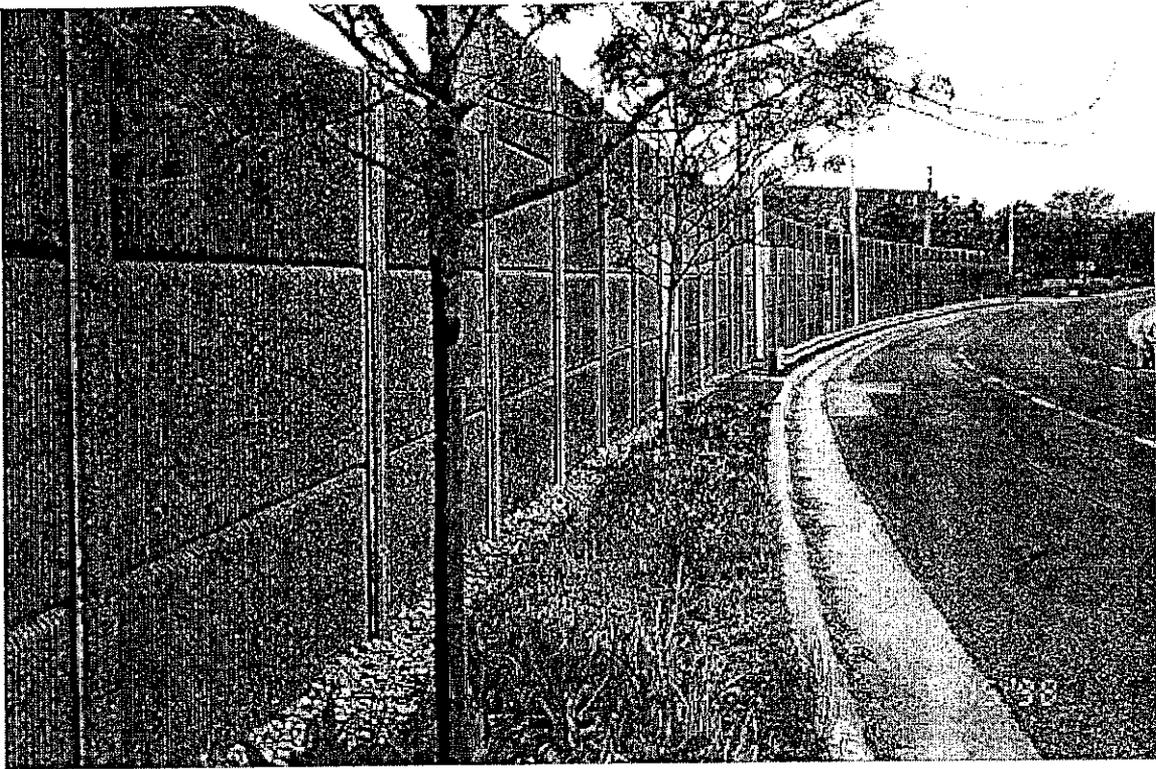
The earliest Durisol noise barrier in Illinois was constructed in 1993. The condition of the Durisol barriers was found to be generally good. On several sections, the fluted surface has been marred by vehicle or snowplow strikes. Although the coloration of the panels is continuous through the outer layer, damage to the surface of individual panels creates a visible gash that is not reparable in the field. Correction of panels damaged by vehicle strikes would most likely require replacement of the affected panel.

Figure 5-11 Durisol barrier, IL 19 Schaumburg 1993-1998.

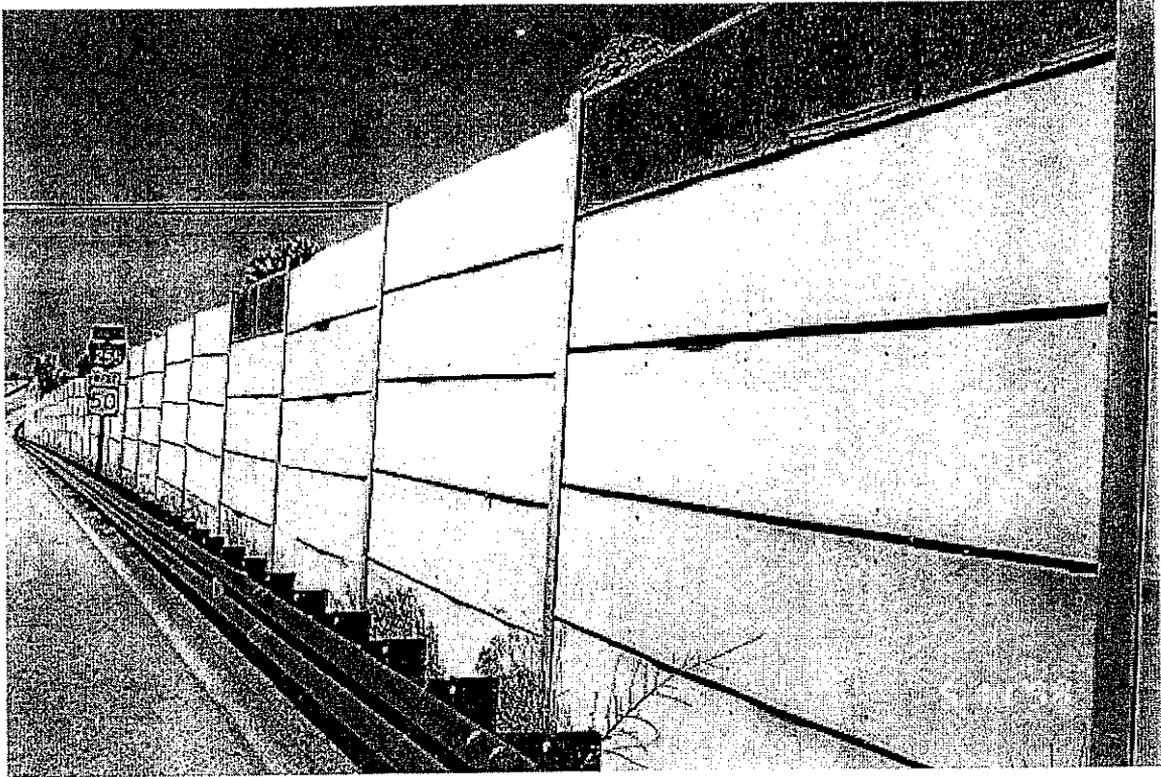
A second metal wall, also supplied by Industrial Acoustics Company, Inc., is located on I-255 near the town of Centreville. This barrier is constructed of a perforated stainless steel face, a solid galvanized steel back, with a mineral wool filling. The panels are coated with an epoxy-based primer and are oriented horizontally. Each panel is 2 feet high and 12 feet long; individual panels are stacked to reach the required barrier height. The panels are held in place by galvanized steel wide flange beams (W 5 X 16) acting as posts. According to IDOT District 8 personnel, the barrier began to deteriorate soon after installation in 1984. The supplier determined that the "detail of the panel allowed entrapment of water in a pocket which was intended to drain out at the end of the panel. The presence of water which acted as an electrolyte created a corrosive environment which destroyed the integrity of the barrier" (Figallo 1998). The painted coating on the face (highway side) of the panels peeled off, and the steel corroded. IDOT maintenance personnel later covered the perforated surface with solid fiberglass panels (Fig. 5-23). On the back side, the solid steel panels also corroded and buckled, with some panels bowing out of the plane of the wall by more than 2 inches in the 12 foot length of the panel (Fig. 5-24).

Figure 5-23. Noishield® steel, I-255, Centreville.

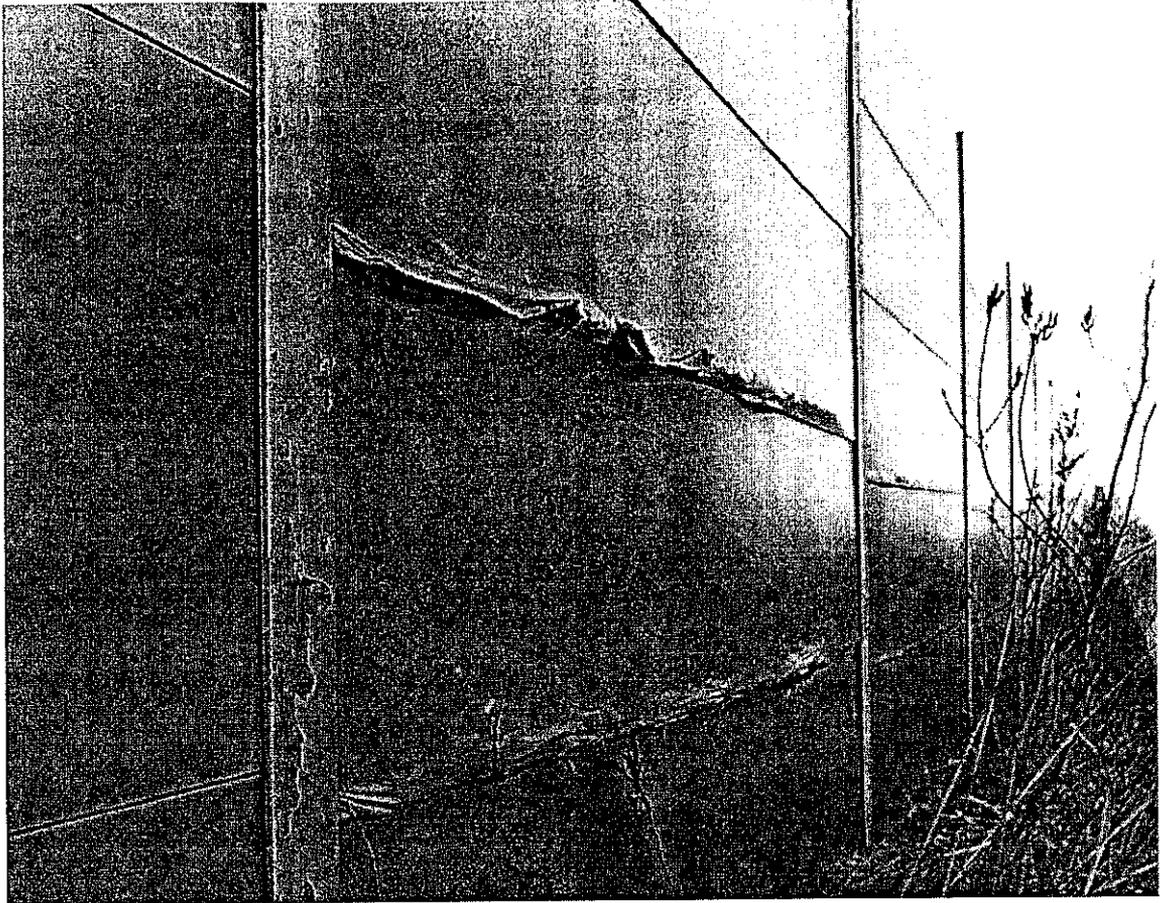
Figure 5-24. Noishield® steel, corrosion visible on residents' side.

IDOT District 8 is currently considering the replacement of the steel noise barrier. Because this barrier has been determined by the district to be at the end of its useful life, the researchers requested permission to study this barrier in some detail in an effort to quantify some of the physical characteristics that define service life. The researchers met to discuss the proposed field work at IDOT District 8 headquarters on April 20, 1998 with Allan Guttman, John Dhermy, Paul Bauer, and Bernie Fahey of District 8 and TRP members Michelle Mahoney and Michael Bruns. The district gave permission for the work, provided access to the site, and coordinated the necessary traffic control when the researchers were on IDOT right-of-way. The field work was performed on May 11, 1998. Measurements were taken along a 500-foot section of barrier on the south-bound lanes of I-255, beginning at the northern end of the barrier.

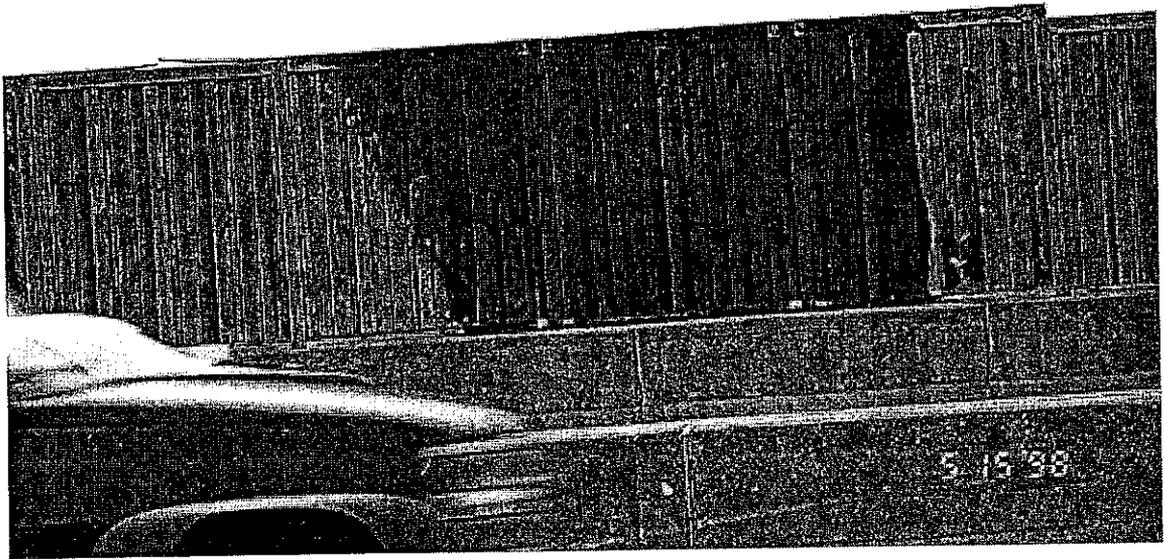
reportedly knocked down by a vehicle impact shortly after the construction of the barrier in 1980. No photographs or exact description of the extent of damage were available. One glue-laminated wood barrier was observed to have survived a fire (Fig. 6-1). Another section of glue-laminated wood wall on I-290 was recently damaged by a vehicle strike according to reports by IDOT personnel. While a section of the wall appears to have been sheared at ground level, the barrier remains standing, apparently supported by adjacent sections. No report on the proposed method or date of repairs to this section was available.

Figure 6-1 Glue-laminated wood wall damaged by fire, I-290 at St. Charles Road.

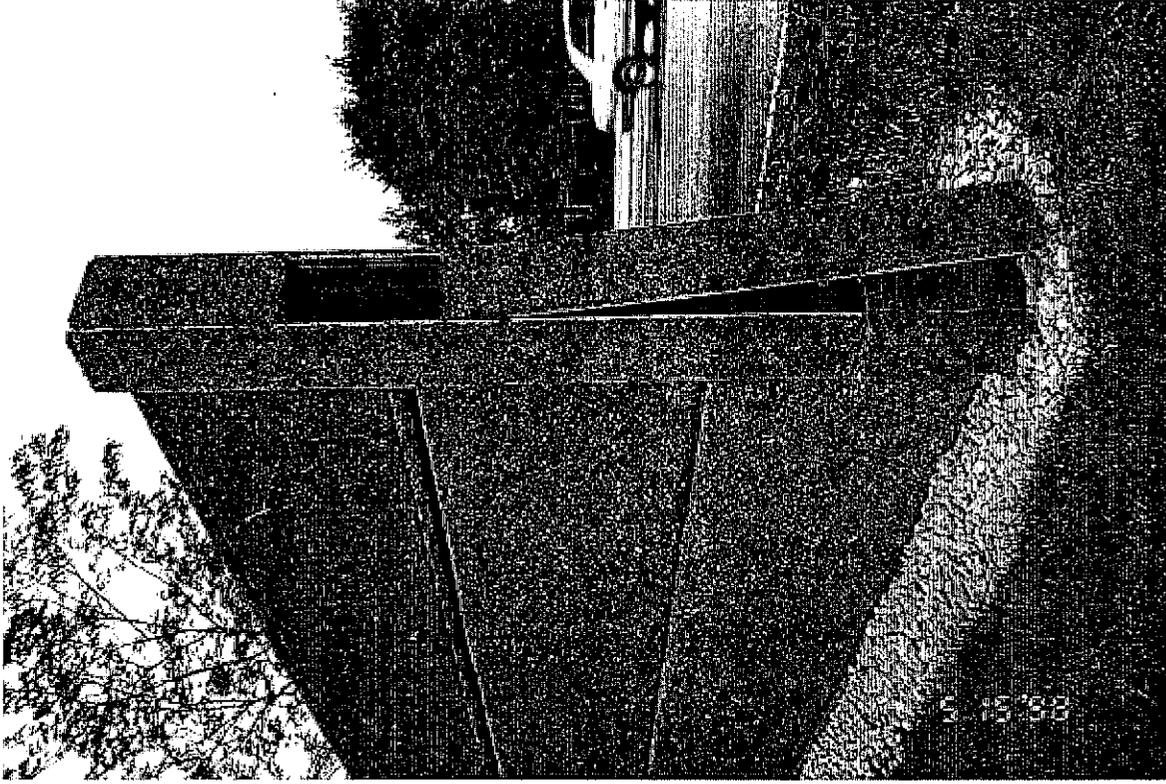
6. Durisol, fracture of covering for steel H-post, IL 19, Schaumburg

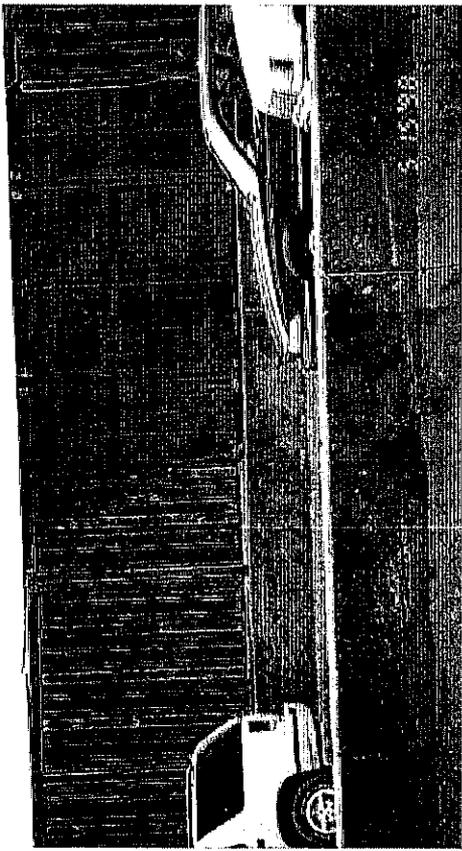
19. Wood glue-laminated, fire damaged, I-290

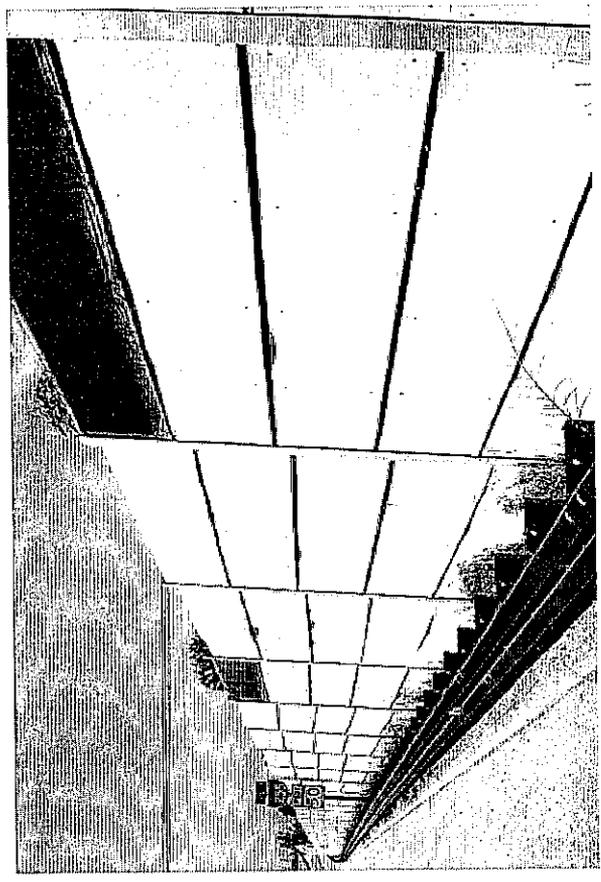
8. Corroded steel wall panels (visible at top right) covered with fiberglass panels for remediation, I-255 Centerville built 1984

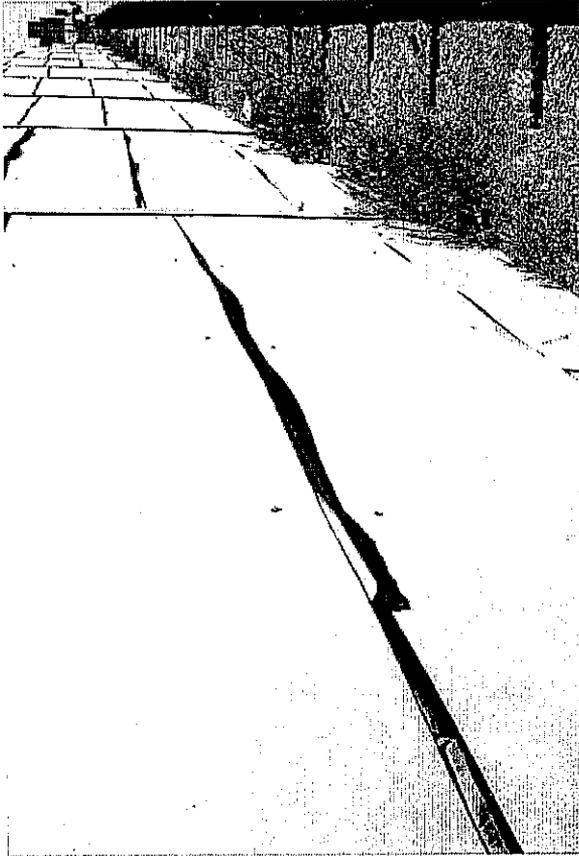
9. Corroded steel panel's original paint protruding from fiberglass covering I-255, Centerville built 1984

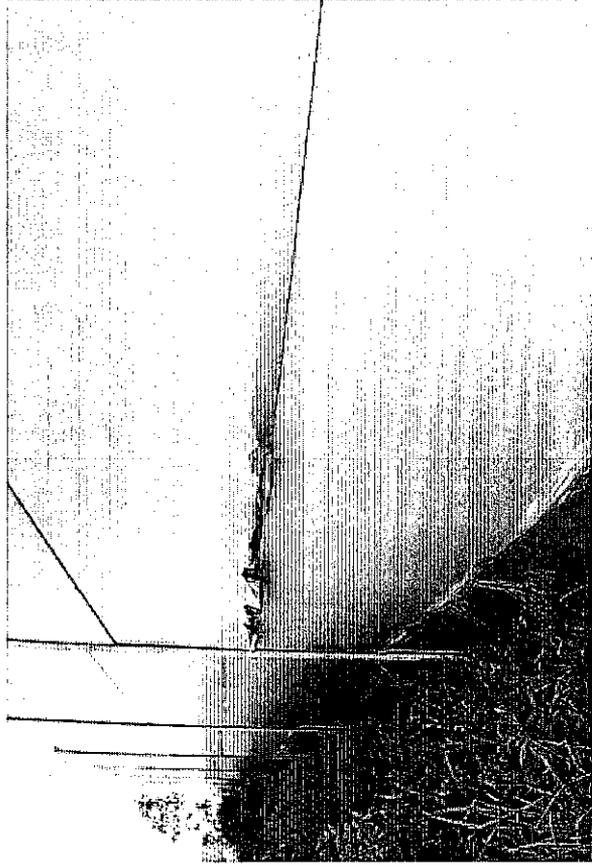
15. I-255, Centerville, corrosion damage on backside of wall built 1984

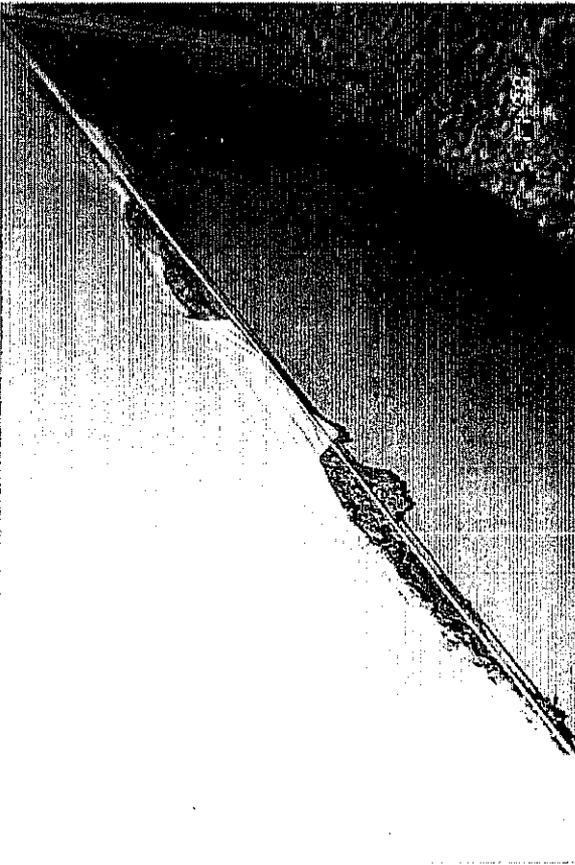
16. I-255, Centerville, corrosion damage on backside of wall

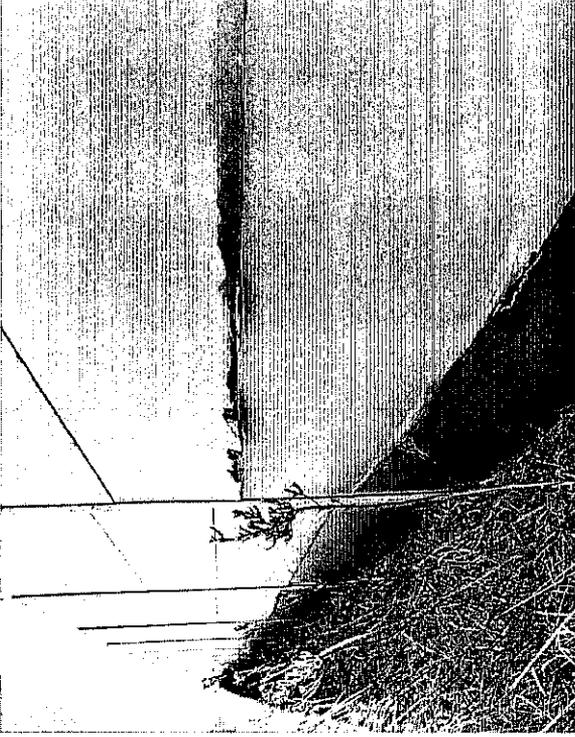
17. I-255, Centerville, corrosion damage on backside of wall

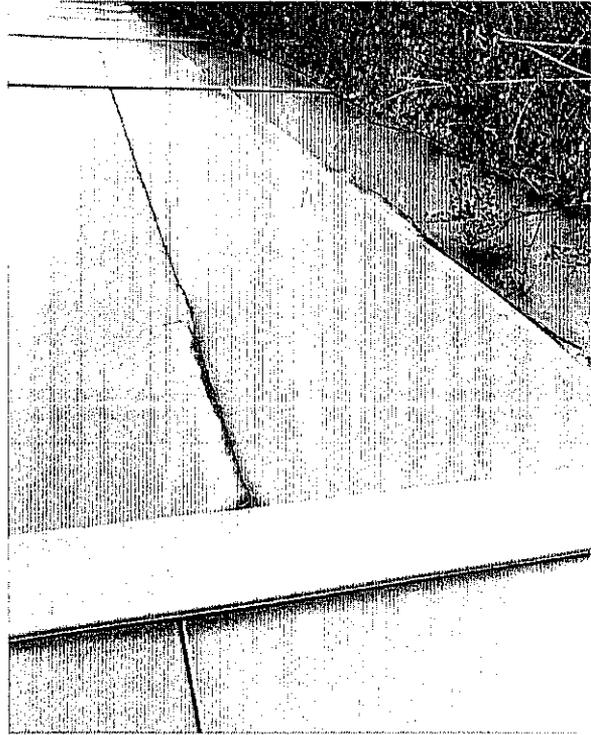
18. I-255, Centerville, corrosion damage on backside of wall

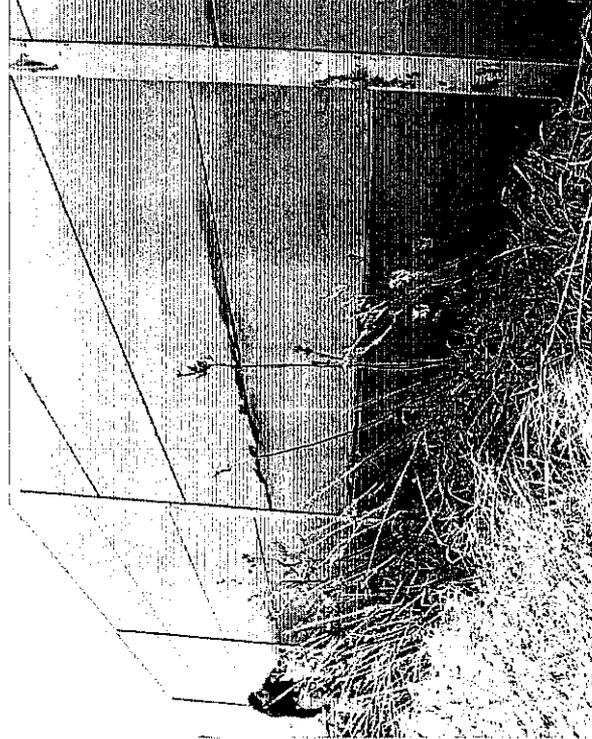
22. I-255, Centerville, corrosion damage on backside of wall
built 1984

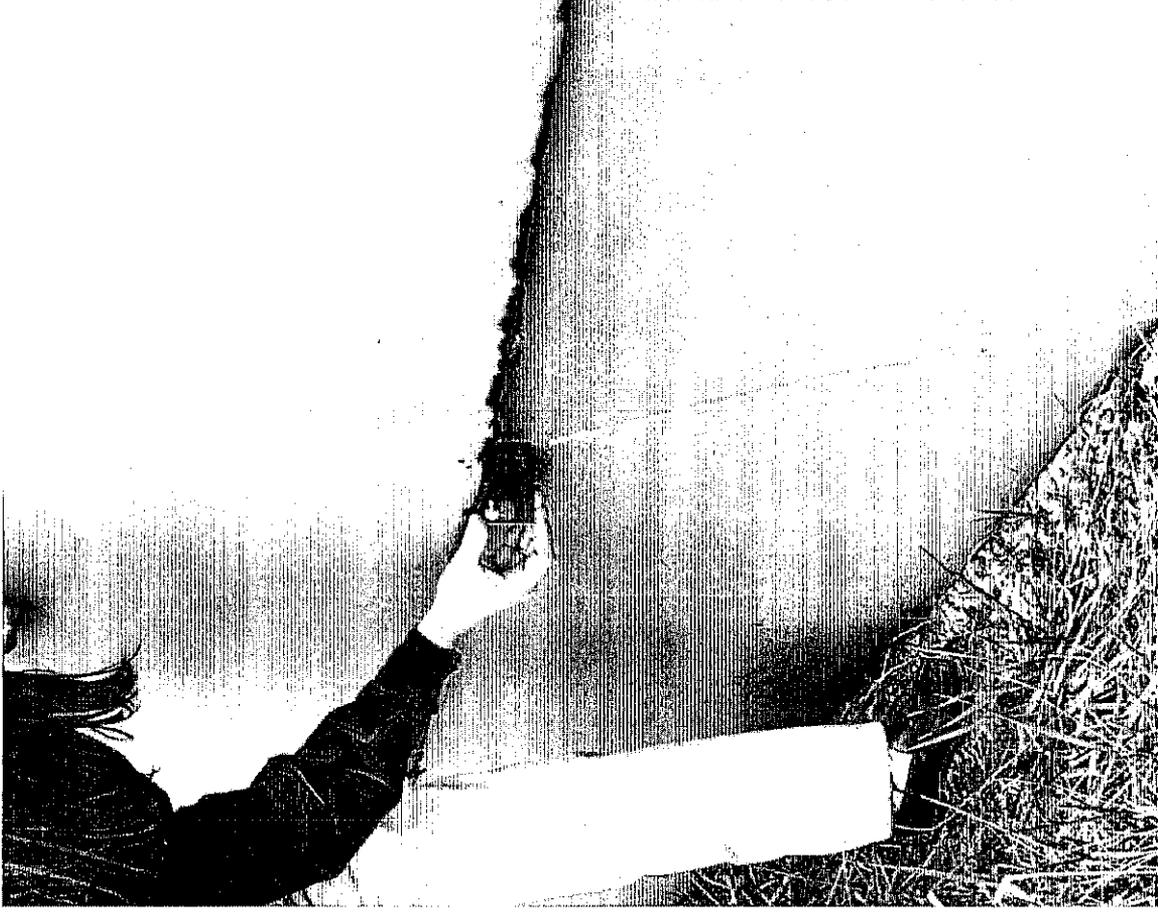
21. I-255, Centerville, bulging of backside of panels
built 1984

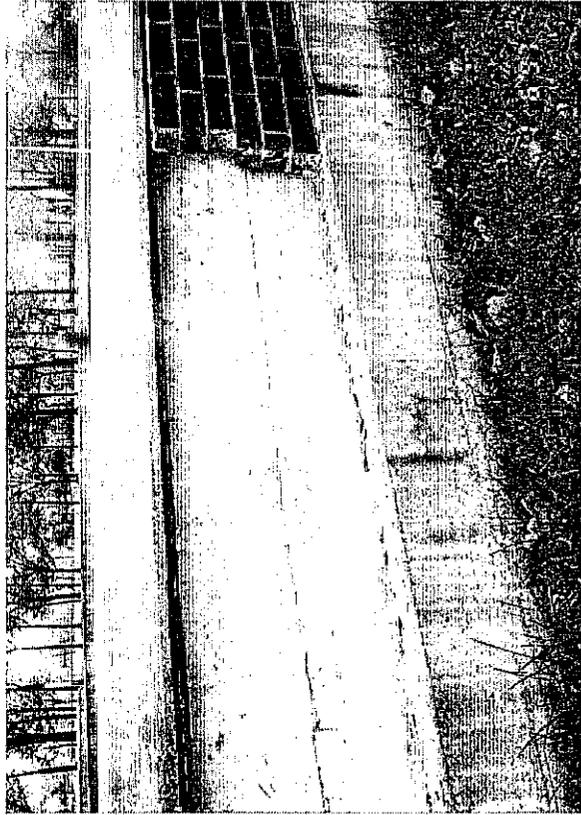
3. Parapet wall along depressed freeway section, I-696, Detroit suburbs, with brick spalling

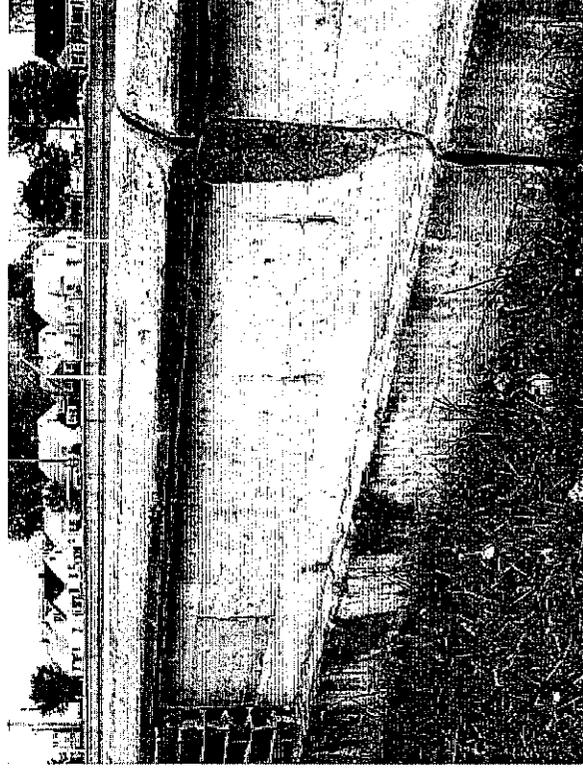
4. Parapet wall along depressed freeway section, I-696, Detroit suburbs, with brick and concrete spalling, movement at expansion joint

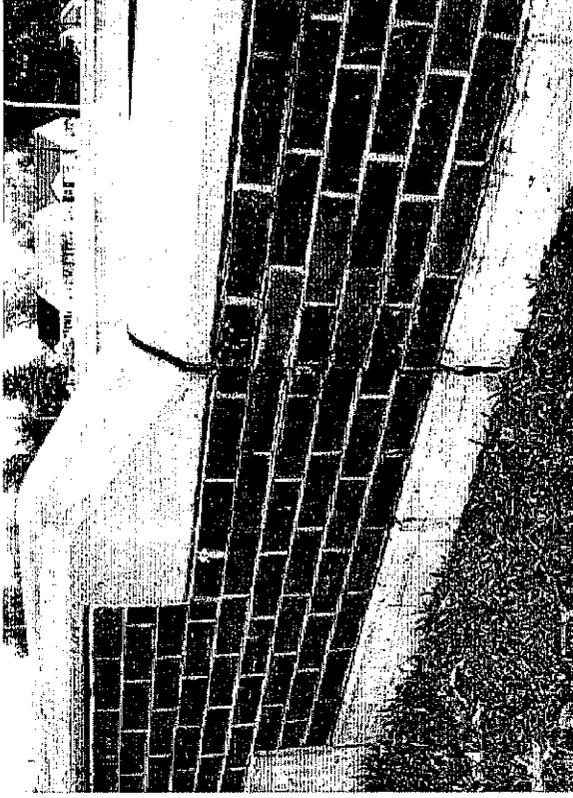
6. Parapet wall along depressed freeway section, I-696, Detroit suburbs, with movement at expansion joint 1986-1997

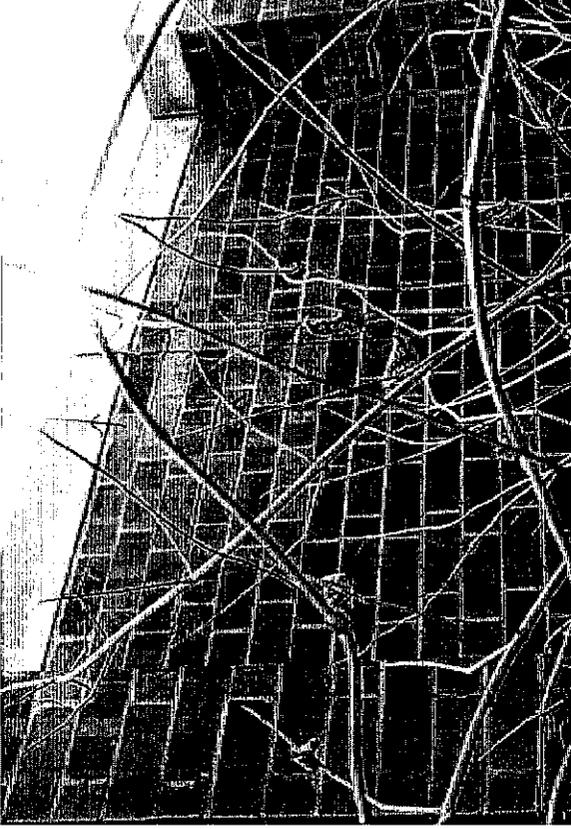
10. Brick noise barrier, I-696, Detroit suburbs, residents' side, cracking along joints near top of wall

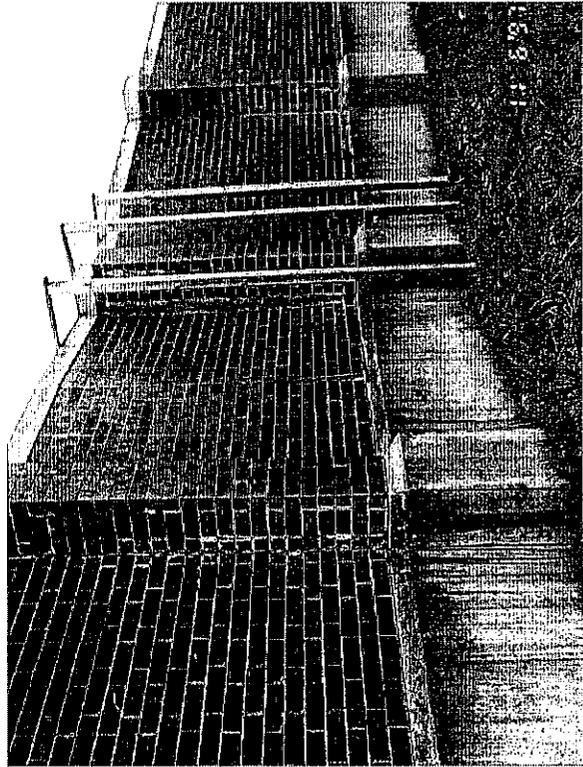
11. Brick noise barrier, I-696, Detroit suburbs, with temporary 2 X 4 braces at failed wall panel

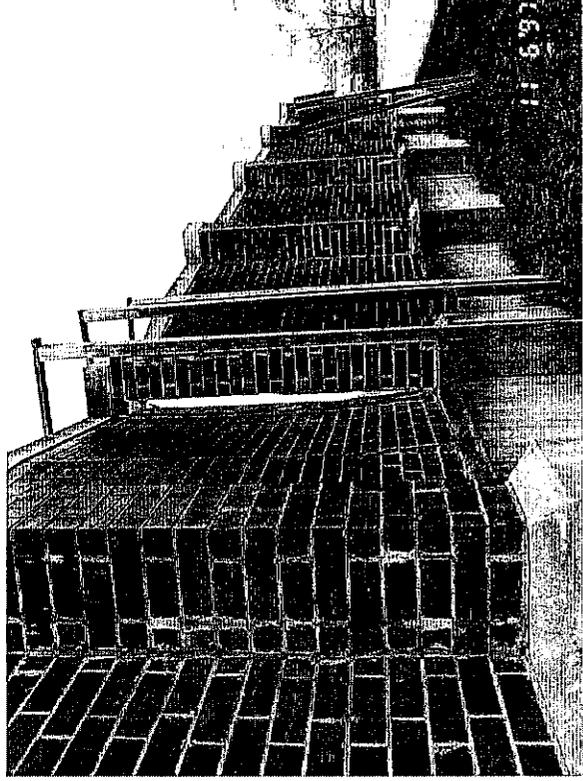
12. Brick noise barrier, I-696, Detroit suburbs, with temporary 2 X 4 braces at failed wall panel

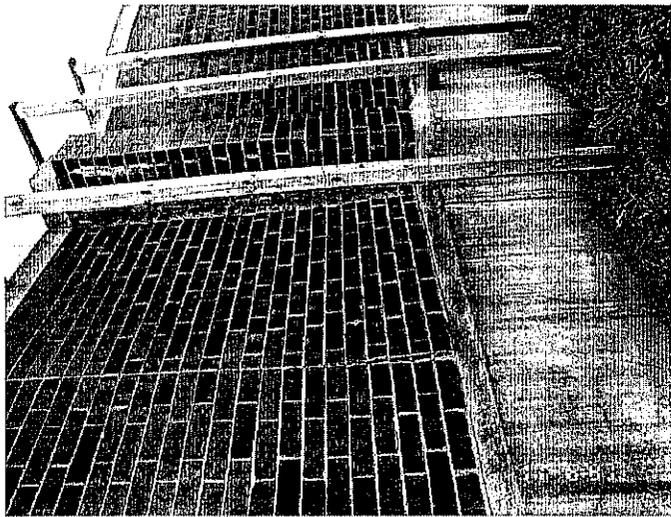
13. Brick noise barrier, I-696, Detroit suburbs, with temporary 2 X 4 braces at failed wall panel 1986-1997
