Bridge Deck Condition Survey

Final Report
IHR 306

Bridge Deck Condition Survey
Phase V Long Term Performance Evaluation

by
J. E. LaCroix
Surface Properties Engineer
Physical Research Section

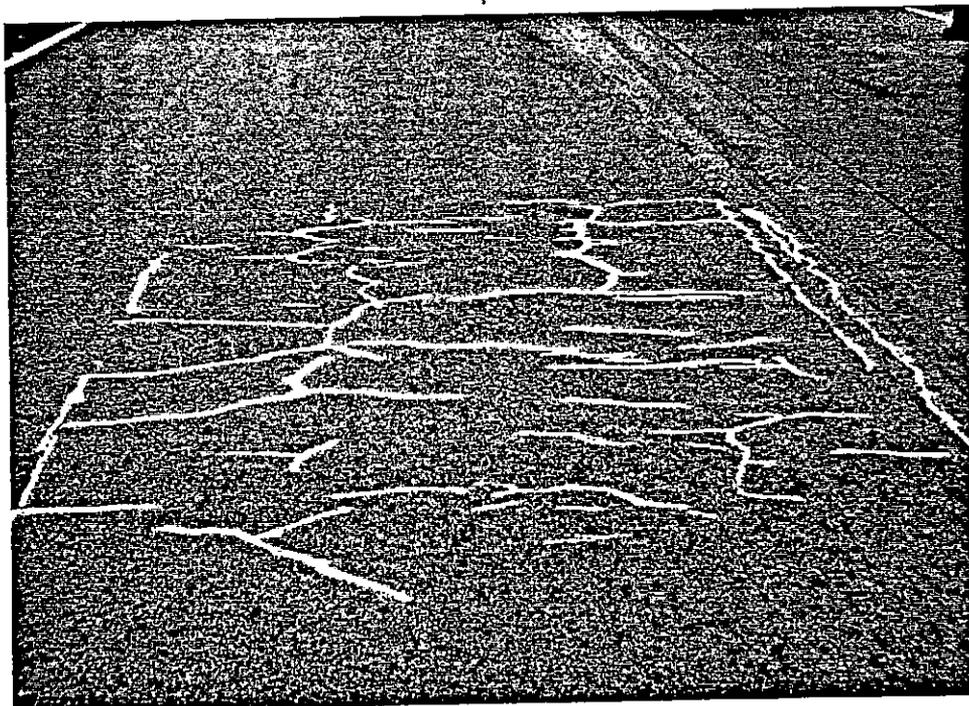
a). Typical cracking on structures 10-0009, -0010, -0018, -0019 during 1982 survey (randomly selected area on 010-0018).

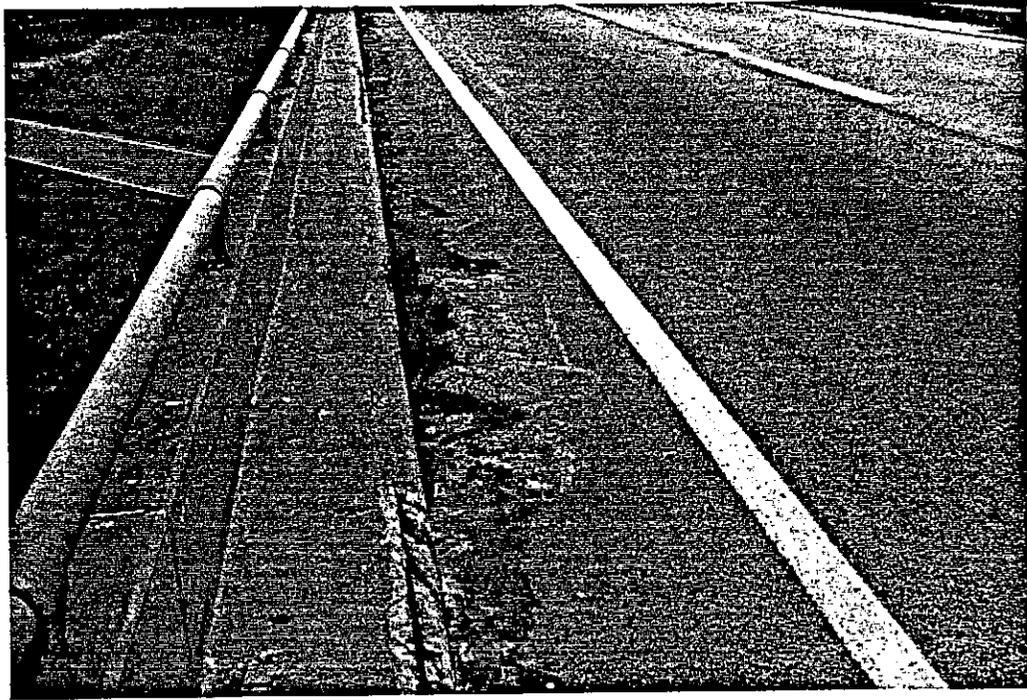
a). Patch failure (1984 photo) structure 57-0018.

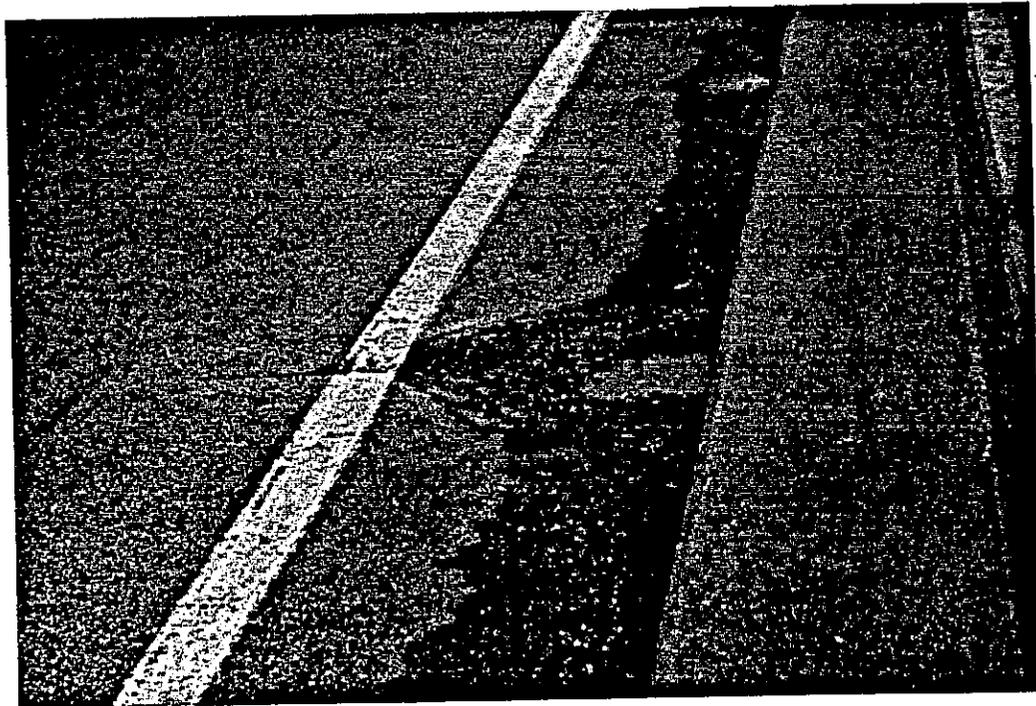
b). Patch failure removed by snowplow (1984 photo) structure 57-0019.

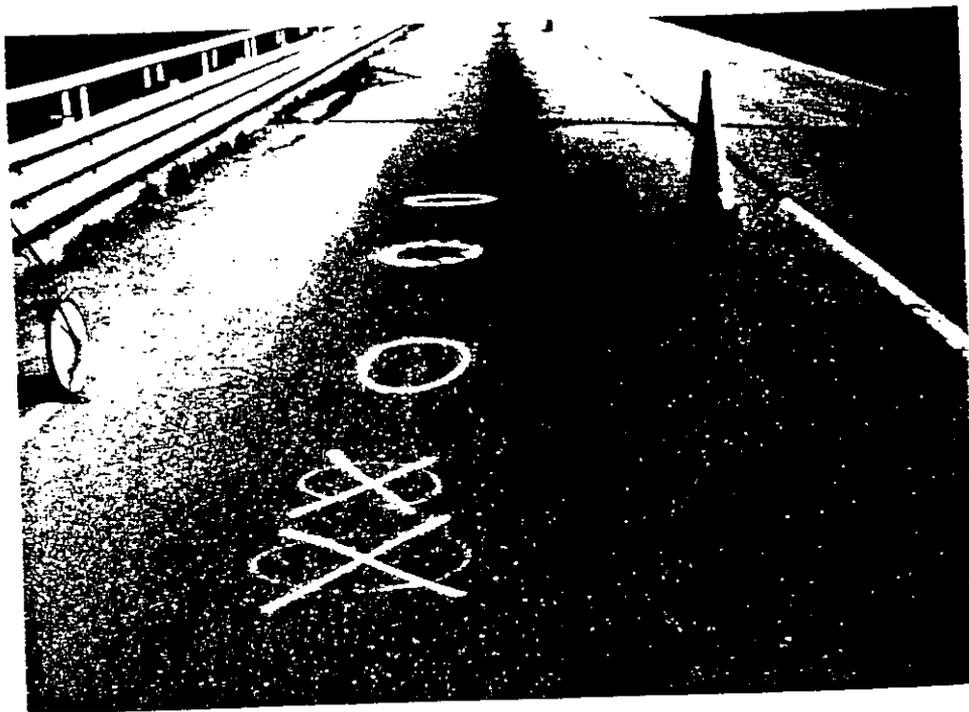
The 1984 survey was modified significantly. Delamination results from past surveys had been confounded by the formation then healing of hollow-sounding bubble-like locations or blisters as shown in Figure 5a. Furthermore, none of the waterproofing appeared to be in need of replacement. Therefore, it was decided to limit the final survey to a visual inspection of the surface. Unusual surface problems were mapped and previously marked delaminations were inspected for "obvious" signs of a need for repairs in the near future.

a). 1983 survey, upstream on 10-0032.

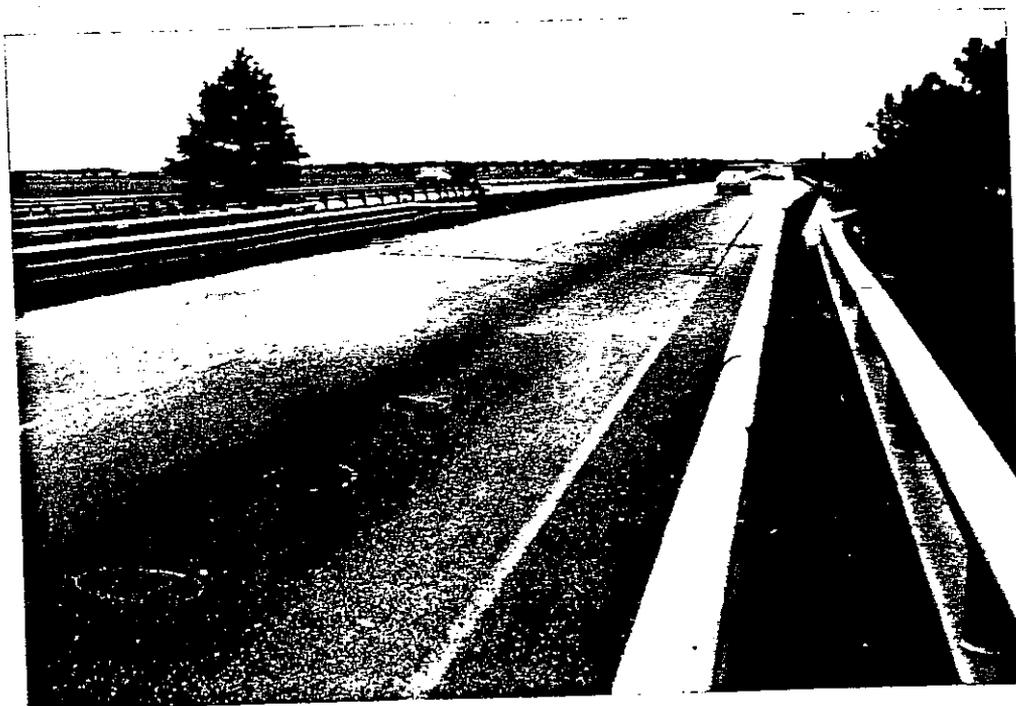
Light-colored dust size material is being flushed from the crack. (Photo taken after a rainshower). The presence of a crack with ejected material indicates that aggregates or cement have been broken and probably have been crushed. This suggests that a delamination has formed and the marked area becomes one with "obvious" signs of a need for repairs in the near future. The dotted oval has sounded hollow every year since 1980, but has shown no apparent distress.

Figure 5b is a photograph of structure 010-0032 looking with the flow of traffic during the 1984 survey. The three suspected delaminations marked in 1983 are still visible. The suspected delamination nearer the end of the deck has developed a "Y" crack.

b). 1984 survey, downstream on 10-0032.

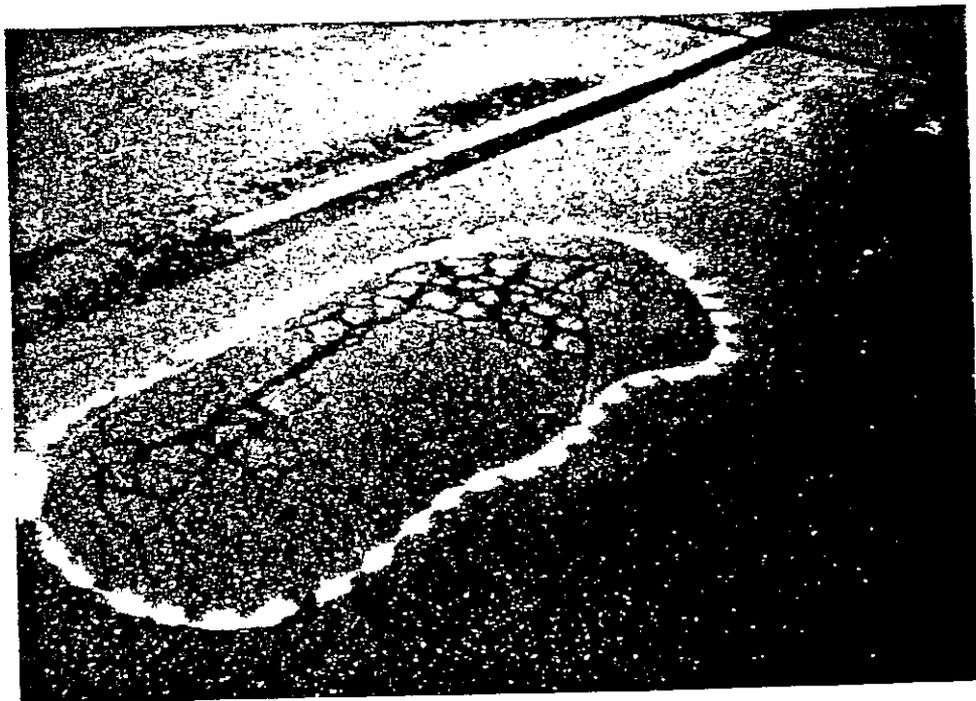
Another example of an area with "obvious" signs of needed repairs is shown in Figure 6. The surface has advance stages of alligator type cracking, material is being ejected from the cracks, and broken deck concrete is visible at the bottom of the largest cracks on the right hand side of the area. This area will receive maintenance attention before that shown in Figure 5b.

Figure 6. Delaminated area on structure 010-0029.

As can be seen in Table 4, the author rated the surfacing as five or better. Repair of delaminated area such as shown in Figure 6 or humps such as shown in Figure 8 is rated minor maintenance (7 rating) or major maintenance (6 rating) depending upon the total area of delaminations or humps observed. Repair of the cracking condition shown in Figure 7 is considered minor rehabilitation (5 rating). The top surface and sand cushion could be removed and replaced leaving the waterproofing intact.

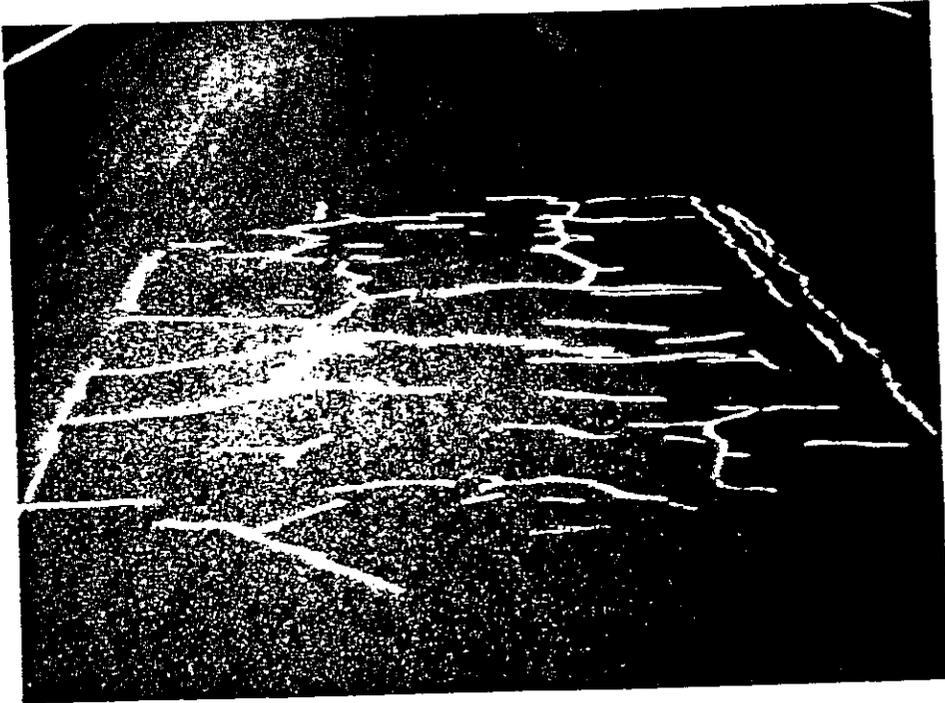
The 1982 and 1983 surveys show increases in the amounts of transverse and longitudinal cracking on most structures. On structures 010-0018, 010-0019, 010-0009 and 010-0010 a severe cracking problem appeared to be developing in the bituminous surface.

Figure 7a contains a 1982 photograph of a typical, randomly selected area of the severe cracking problems (structure 010-0018). The hairline cracks were tight and barely visible. The cracks shown were highlighted with paint to show the number of cracks per unit area. This type of cracking was observed on only the four structures mentioned.

a). Typical cracking on structures 10-0009, -0010, -0018, -0019 during 1982 survey (randomly selected area on 010-0018).

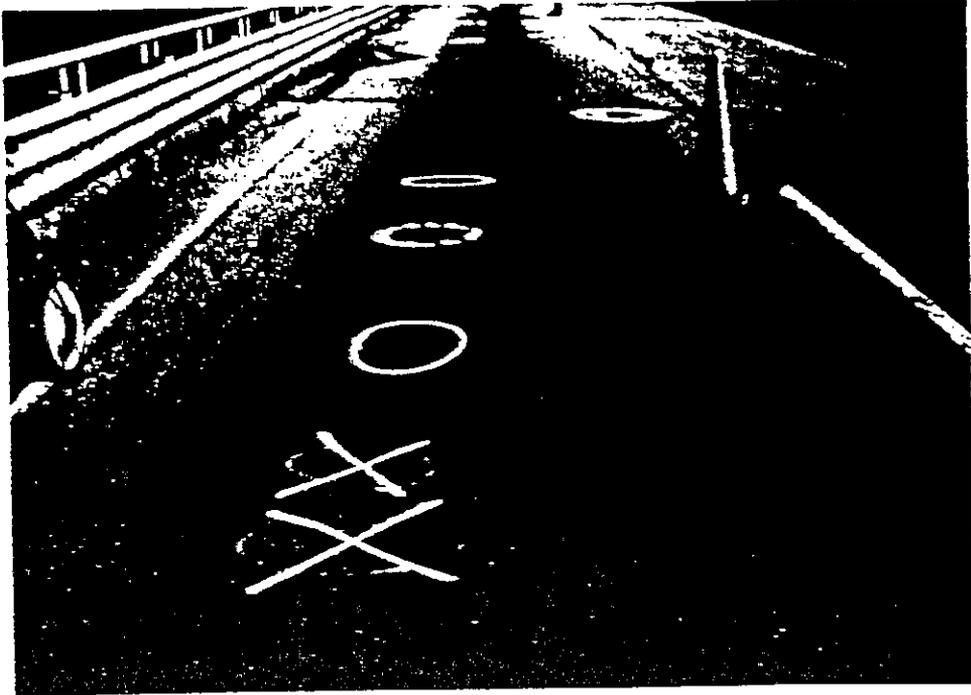
a). 1983 survey, upstream on 10-0032.

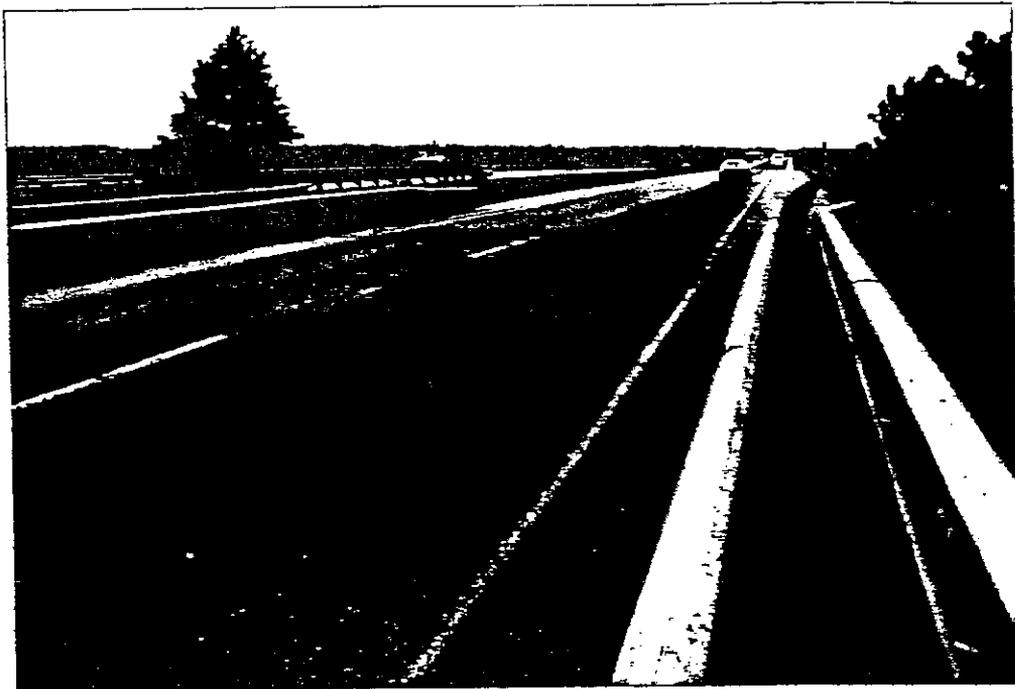
Figure 5b is a photograph of structure 010-0032 looking down stream during the 1984 survey. The three suspected delaminations marked in 1983 are still visible. The delamination furthest downstream has developed a "Y" crack.

b). 1984 survey, downstream on 10-0032.

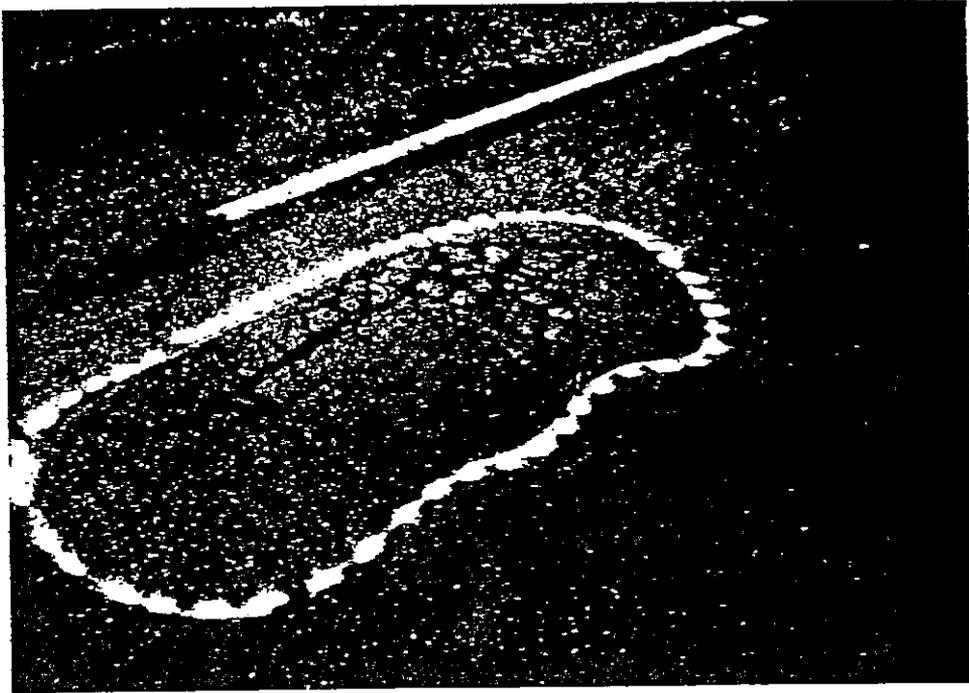
Figure 6. Delaminated area on structure 010-0029.

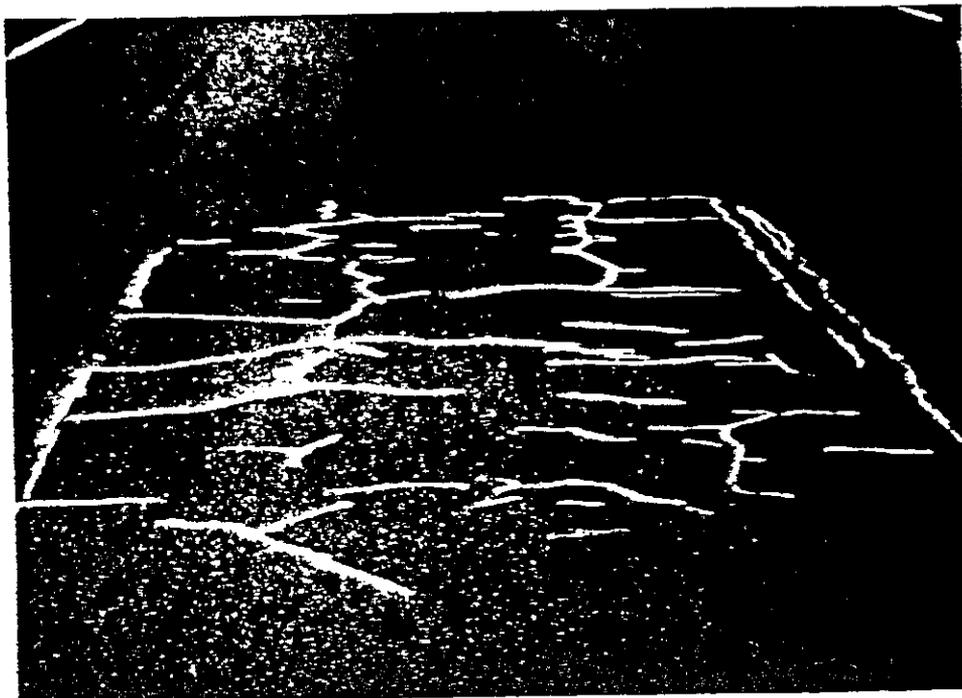
Figure 7a contains a 1982 photograph of a typical, randomly selected area of the severe cracking problems (structure 010-0018). The hairline cracks were tight and barely visible. The cracks shown were highlighted with paint to show the number of cracks per unit area. This type of cracking was observed on only the four structures mentioned.

a). Typical cracking on structures 10-0009, -0010, -0018, -0019 during 1982 survey (randomly selected area on 010-0018).

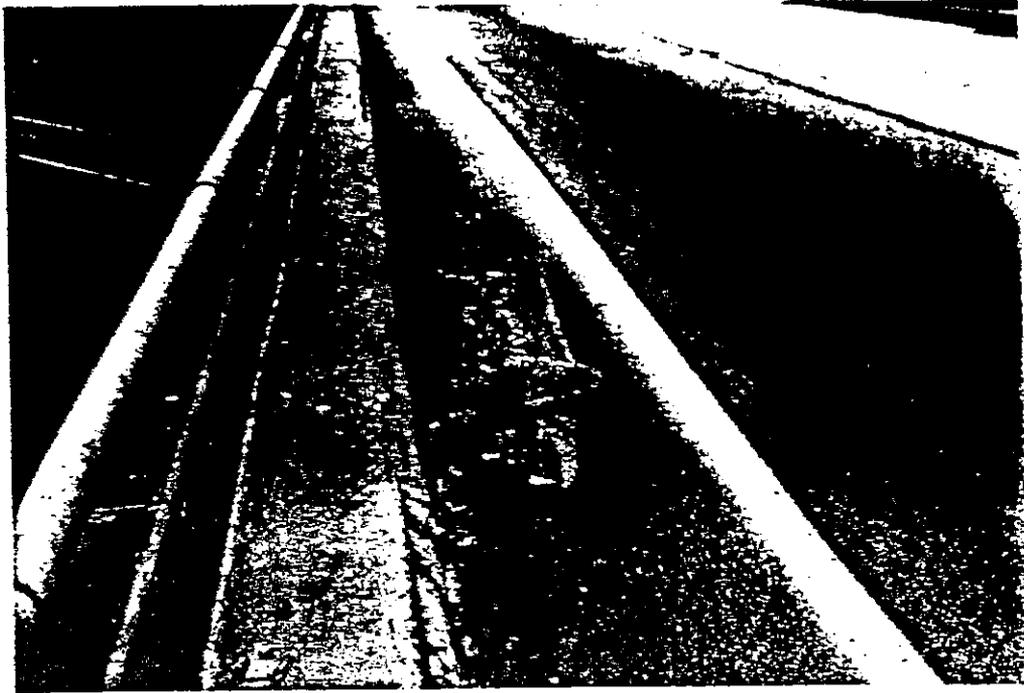
a). Patch failure (1984 photo) structure 57-0018.

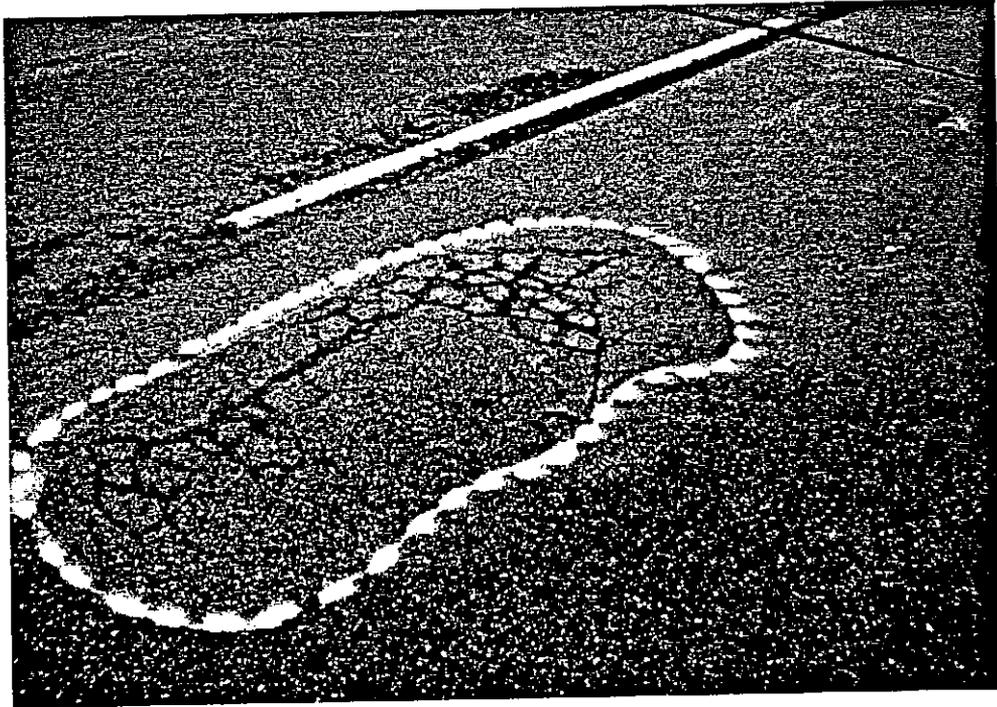
Figure 6. Delaminated area on structure 010-0029.

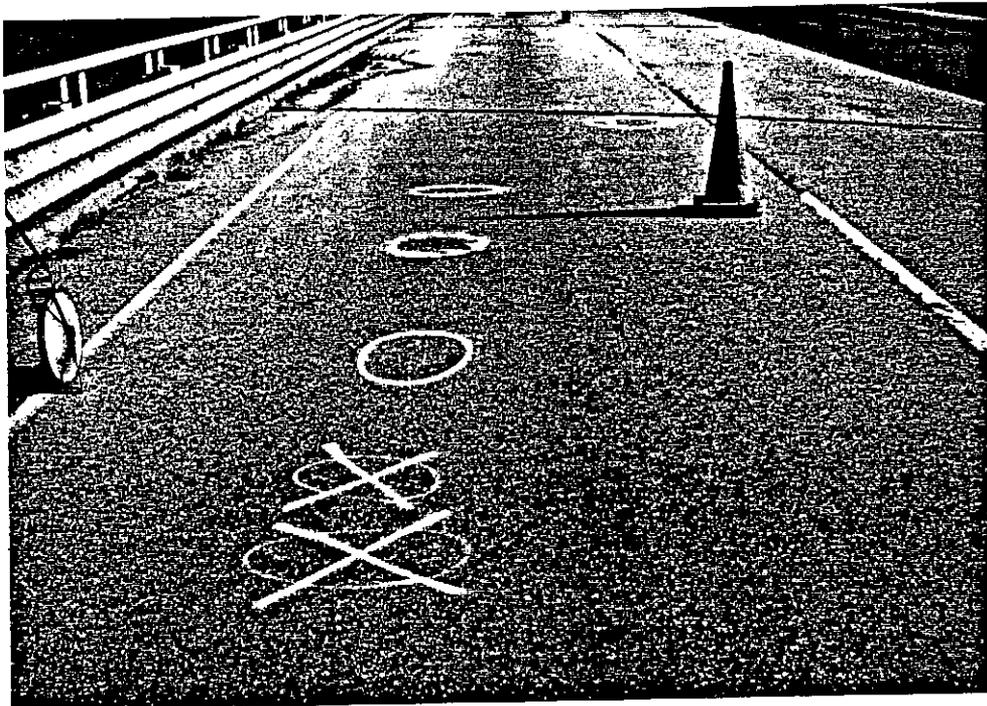
a). 1983 survey, upstream on 10-0032.

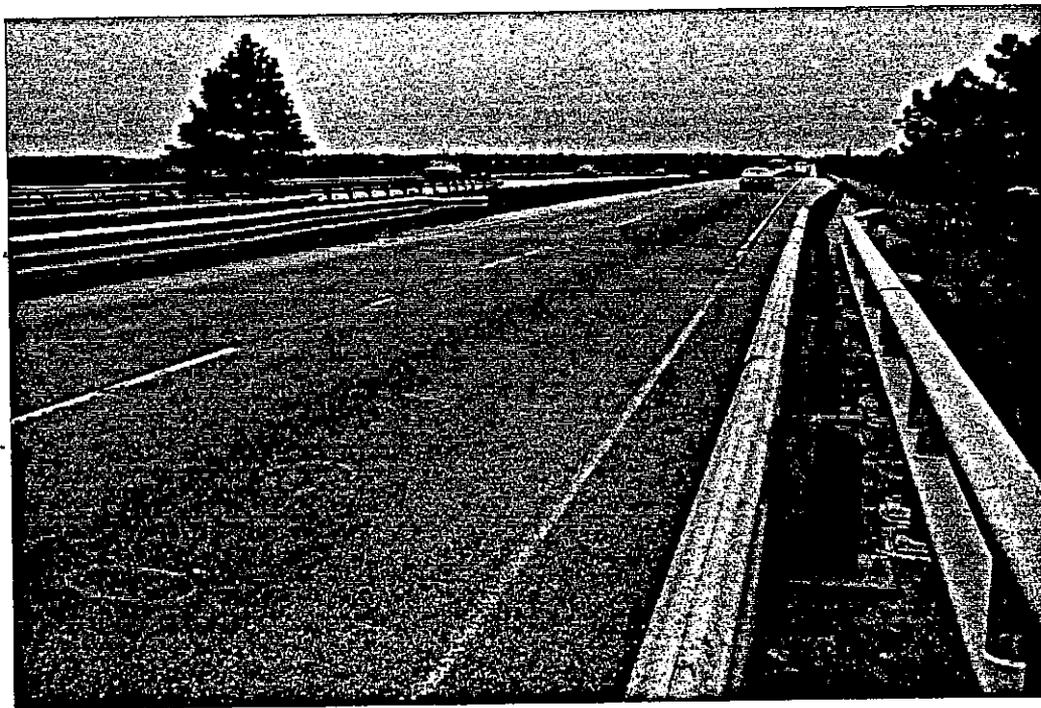
b). 1984 survey, downstream on 10-0032.
