Performance Evaluation of Jointed Concrete Pavement Rehabilitation Without Resurfacing

Final Report

Physical Research Report No. 102 / August 1986

Illinois Department of Transportation
Bureau of Materials and Physical Research

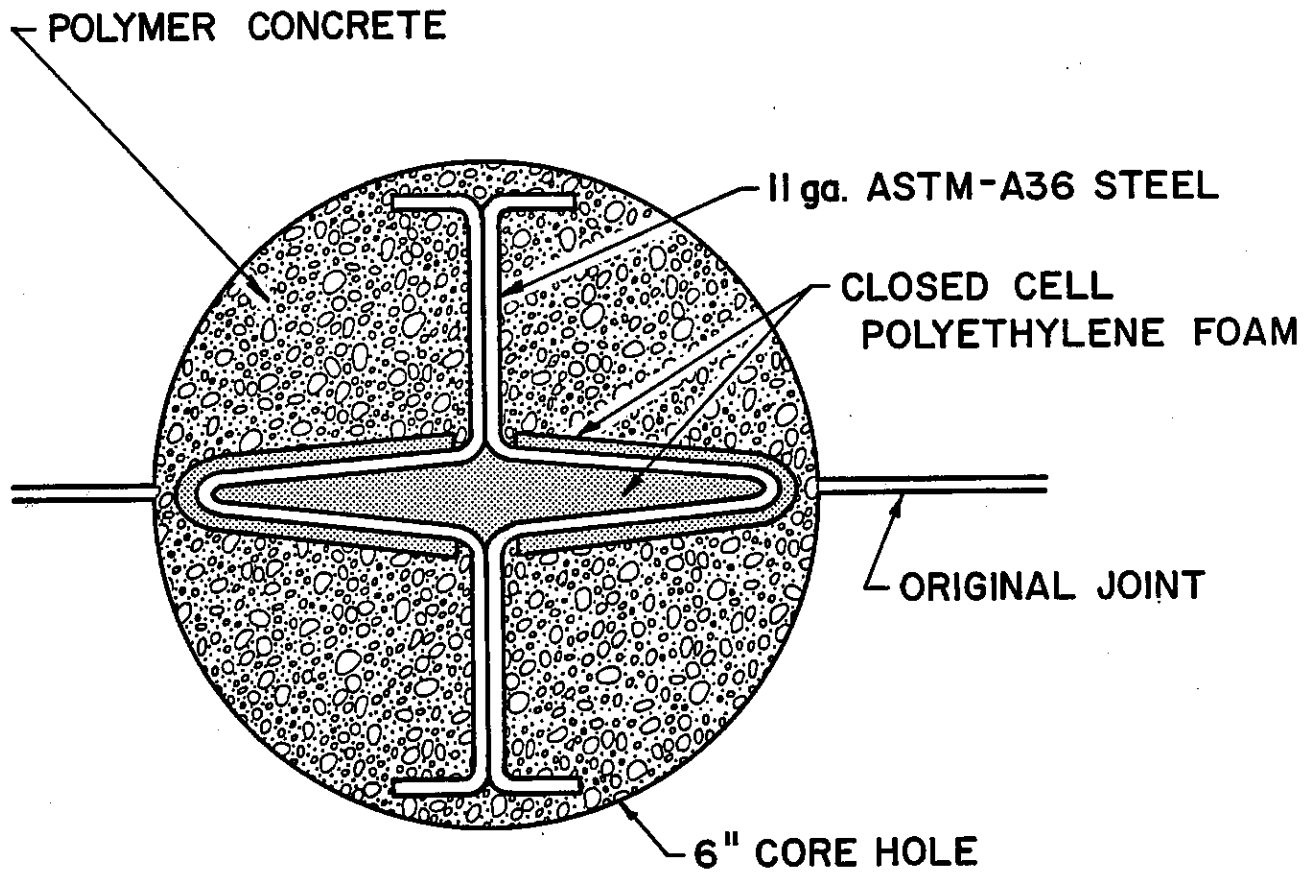
Figure 2. Double Vee Load Transfer Device

Project Number 4 was the only project to use retro-fit load transfer devices shown in Figure 2. Several problems were encountered in the installation of these devices. First, the contract did not call for grooving or roughing the inside of the core hole before installing the device. The manufacturer of the load transfer device provided a tool which applied several grooves to the inside of the core hole. Grooving of the holes provided more surface area for the polymer concrete to bond. Since the contract did not require the grooving, only a small number of the core holes were grooved. These locations were noted for comparison.

The second problem was the polymer concrete used. Improper mixing resulted in a mixture which did not take a final set for several days. When mixed properly, the polymer concrete was almost unworkable. Adjustments in the mixing procedures by pre-wetting the course aggregate resulted in an acceptable product.

Within a few months of installation, over 50% of the devices debonded at the pavement-polymer concrete interface. There seemed to be no pattern to the debonding in that it occurred on either or both sides of the joint or crack. The grooving of the core hole had no influence upon the debonding. By 1985, all 671 devices installed have failed by debonding.

- Spalled, rocking and pumping patches should be replaced rather than undersealed.
- Future use of Double Vee or similar load transfer devices should be on a limited experimental basis to determine performance.
- More research is needed to determine the effectiveness of underdrains.
- Joint sealant reservoirs should be designed to provide the proper shape factors for the sealant and movement needs.

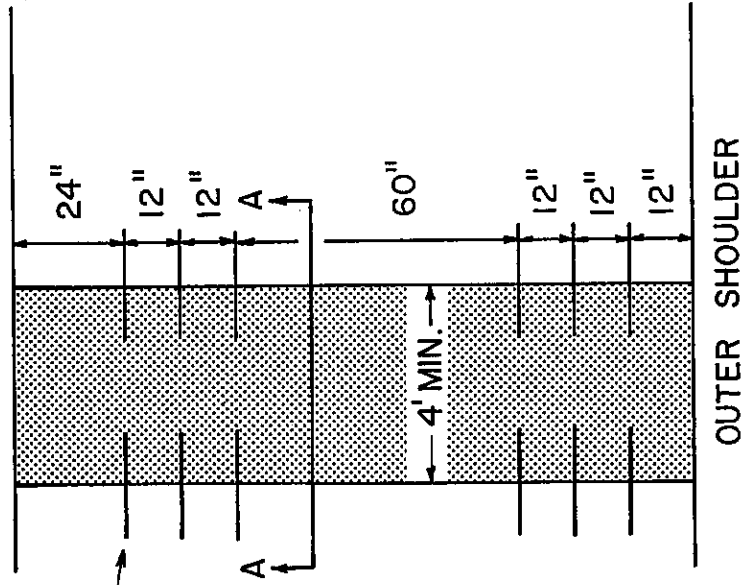
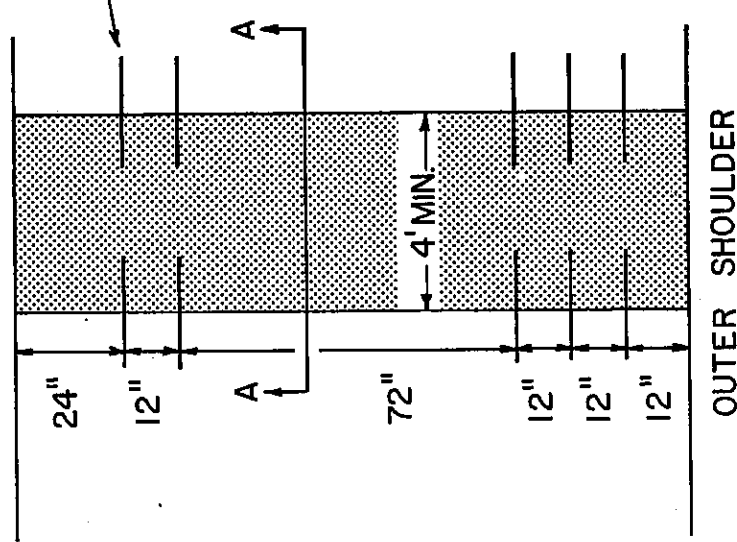
Figure 3. Patch Design Details of 3-2 and 3-3 Patches

All projects included full-depth patching with the percentage of patching ranging from 0.2% to 4.5% of the total pavement area. Projects 1, 2, 3 and 4 were patched in 1983 using a 3-2 patch design as detailed in Figure 3. The following Spring (1984), Projects 1 and 3 experienced severe spalling of a number of patches. Along with the spalling, evidence of pumping could be seen. When heavy trucks passed over the patches, a rocking motion could be visually detected.

As a result of problems with the 1983 3-2 patches, an extra dowel bar was placed in the inner wheelpath for 1984 construction as detailed by the 3-3 patch design in Figure 3. Project Number 5 used a 3-3 patch design and also included a joint seal at all joints. Also using the 3-3 patch design was Project 1 (southbound lanes only) in 1984 when a few badly distressed patches were replaced.

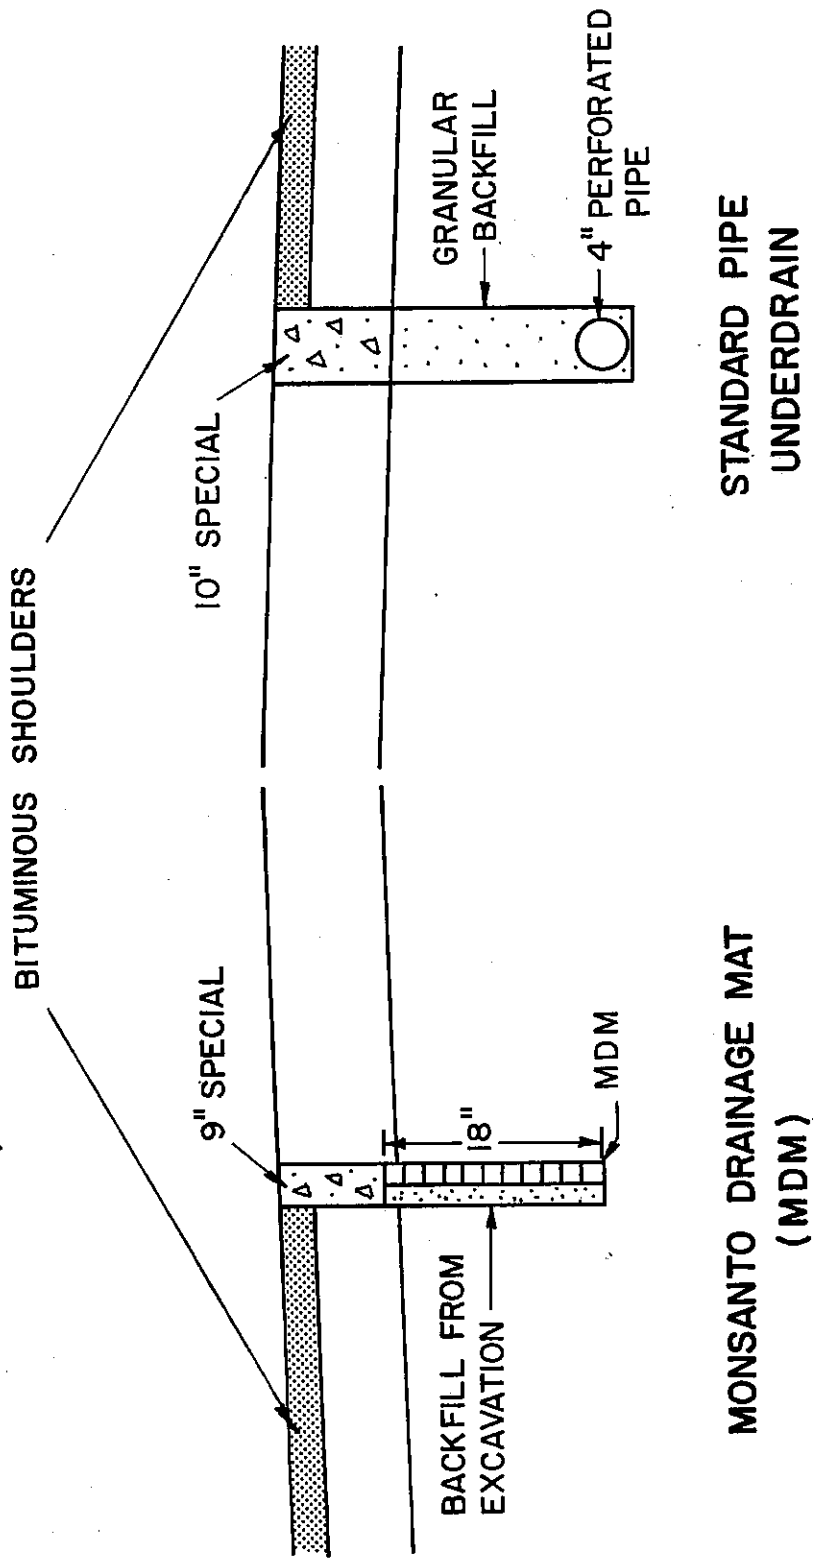
Figure 5. Details of Monsanto Drainage Mat and Standard Pipe Underdrains

On Project Number 4, a new drainage product was included, the Monsanto Drainage Mat (MDM). Figure 5 compares the design of standard pipe underdrains and the MDM. Sections of the pipe underdrains and MDM were monitored by use of a tipping bucket device which measures outflow with time. Figure 6 shows the typical outflow characteristics of the two underdrains.

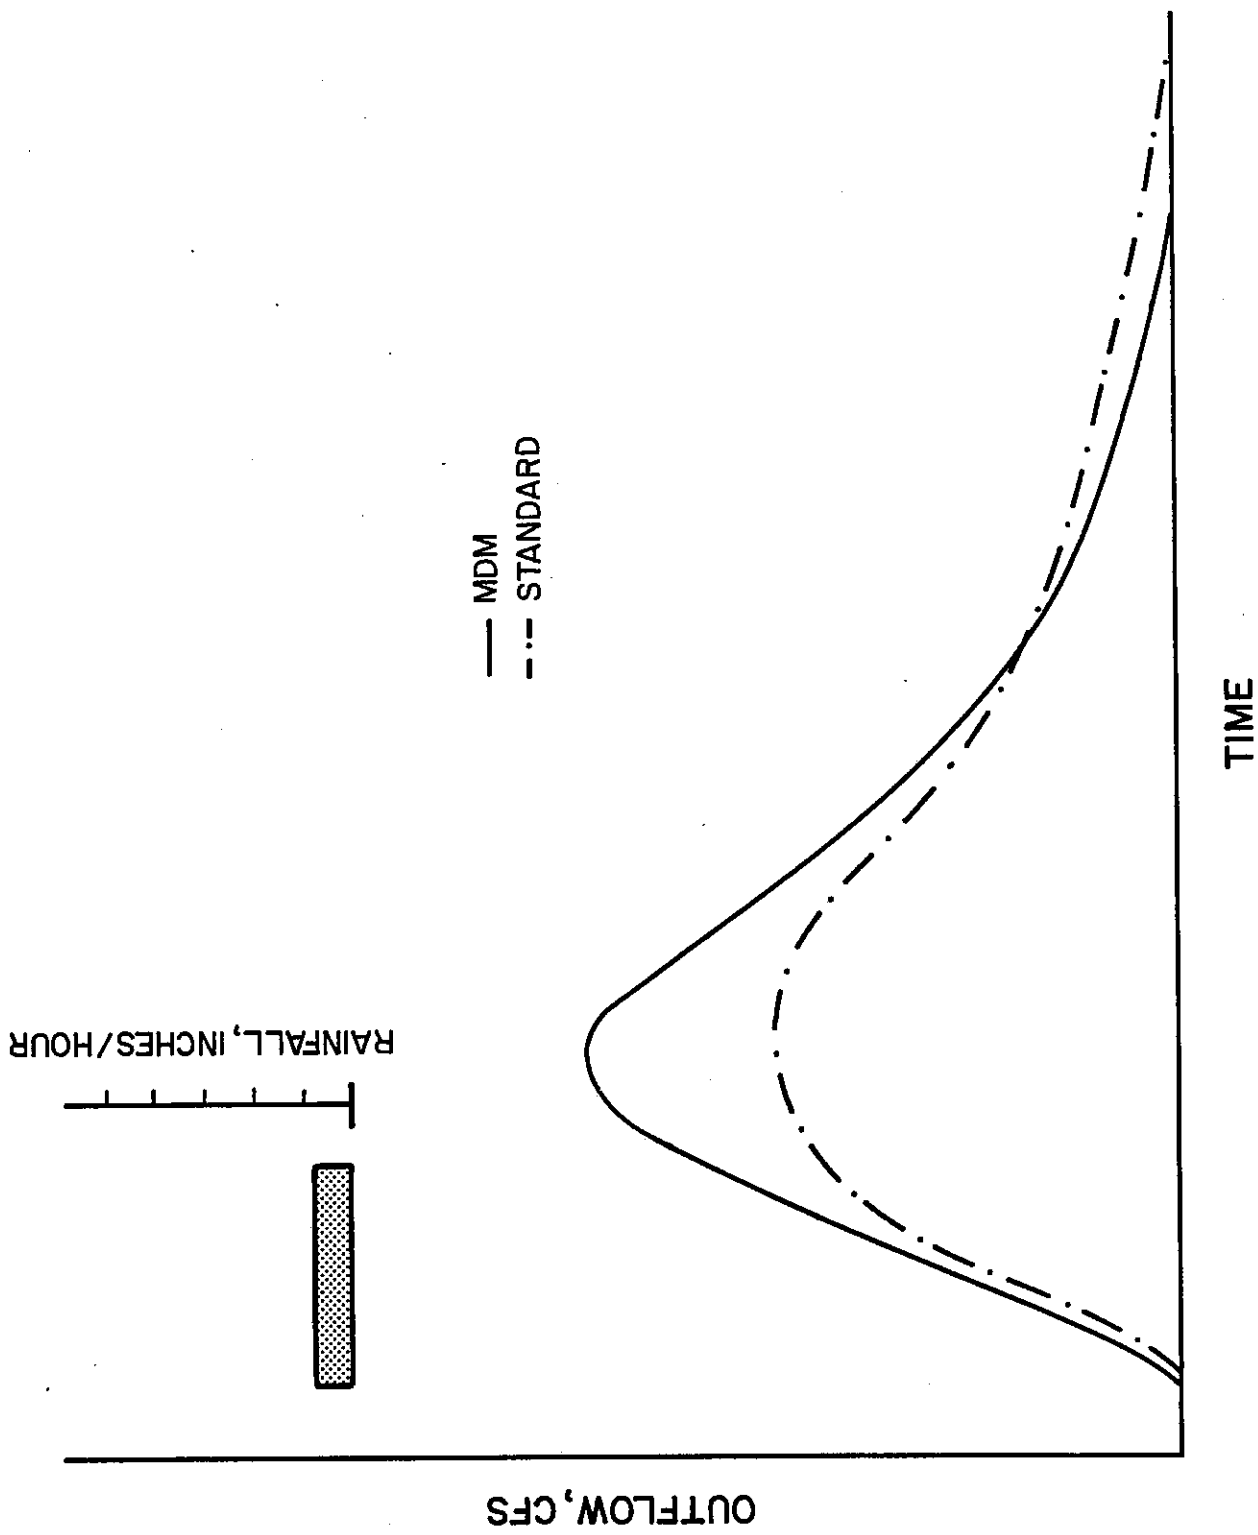
Figure 6. Typical Outflow Characteristics of Monsanto Drainage Mat and Standard Pipe Underdrains

The outflow characteristics of the MDM drain showed a desirable improvement in two areas. First, the MDM removed 1.11 to 1.87 times the water of the standard pipe underdrain. Second, the MDM removed the water from the pavement faster, while the standard drain continued to flow for several days.

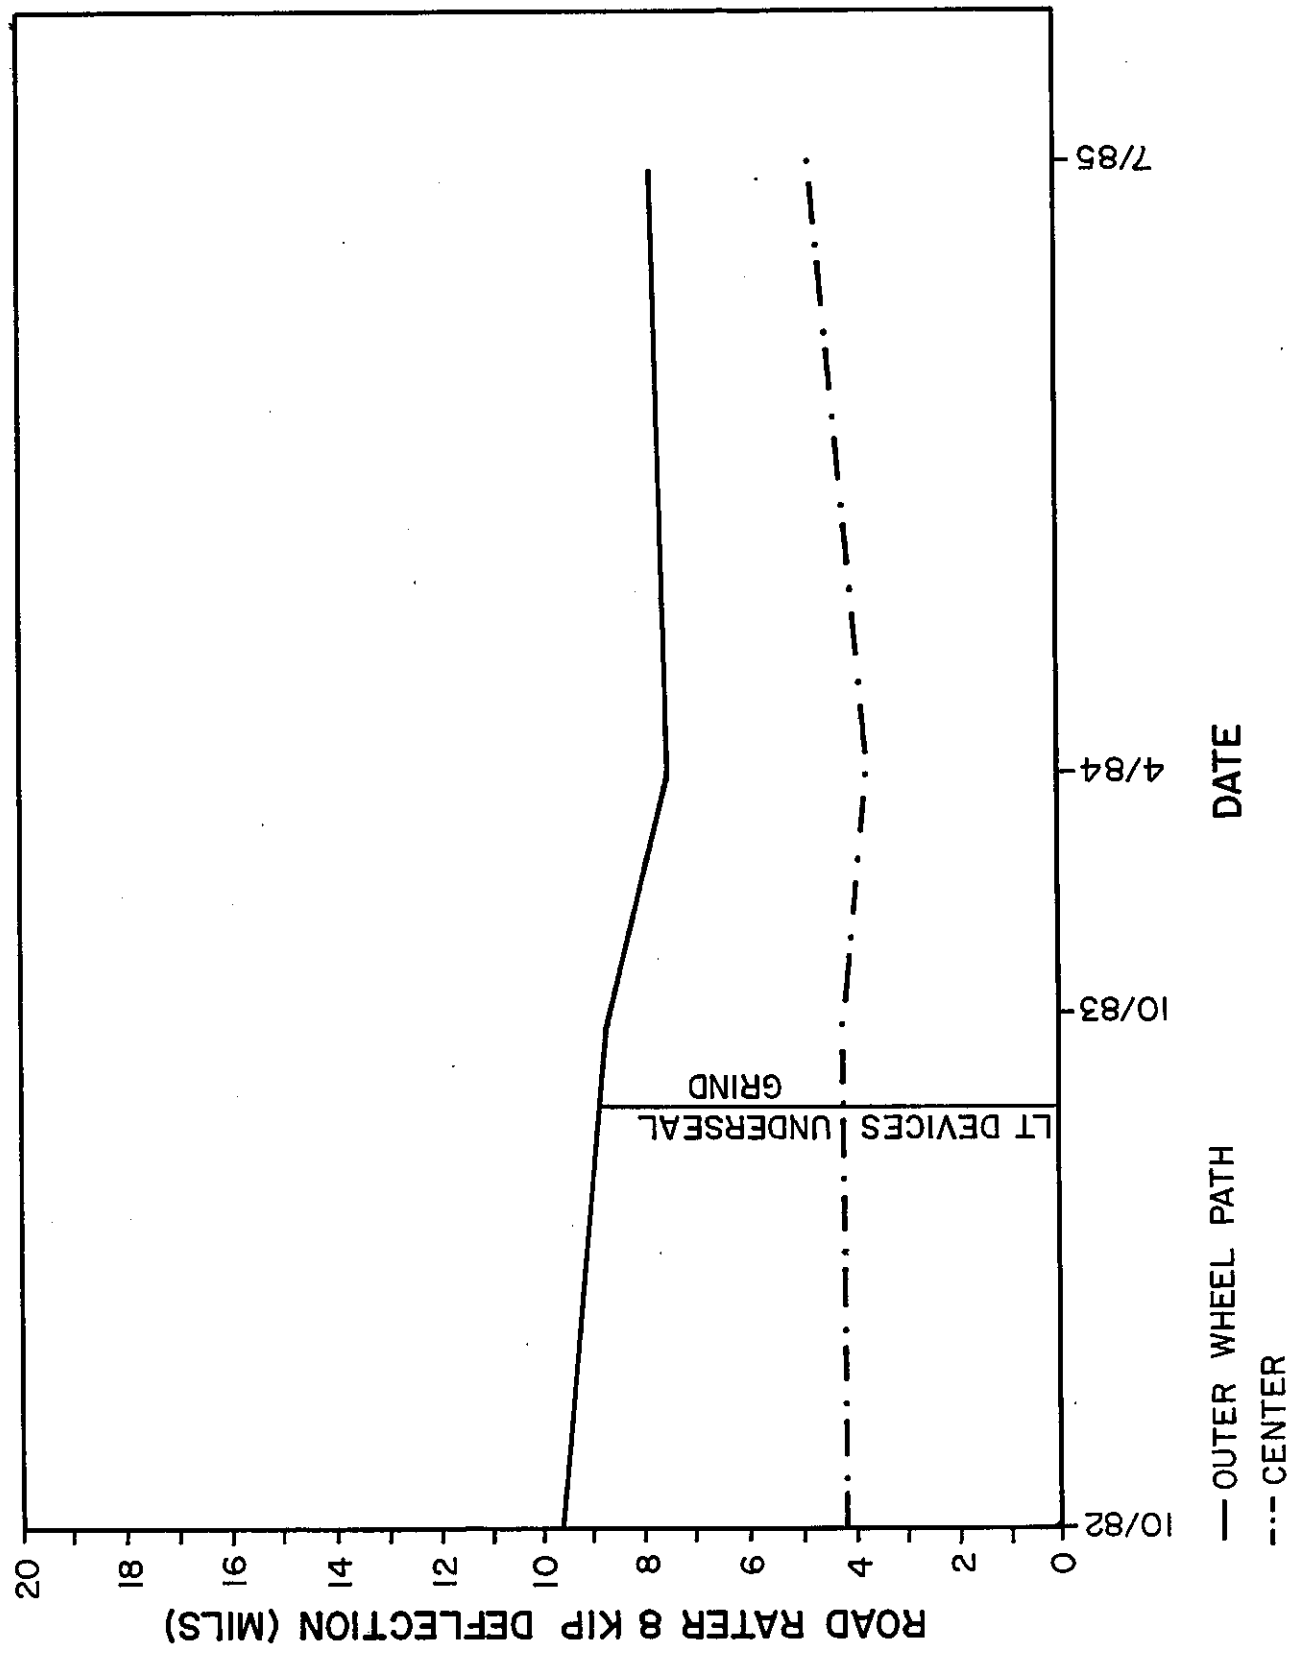
Figure 12. Deflection History of Undersealing on Project Number 4

Blanket undersealing on Projects 4 and 5 were monitored by deflection testing before undersealing, after undersealing and then periodically. On Project 4, the Department's Road Rater 2008 was used to apply an oscillating 8 kip peak to peak load at a frequency of 15 Hertz to the pavement. The deflection histories of outer wheelpath deflection and center of slab deflection of Project 4 are given in Figure 12. The figure shows a reduction in deflection after undersealing, but the reduction is so small that it is doubtful whether the undersealing produced any benefits. The effects of subgrade support, which are reflected in the center deflection, seem to have more influence on deflections than undersealing in this case.

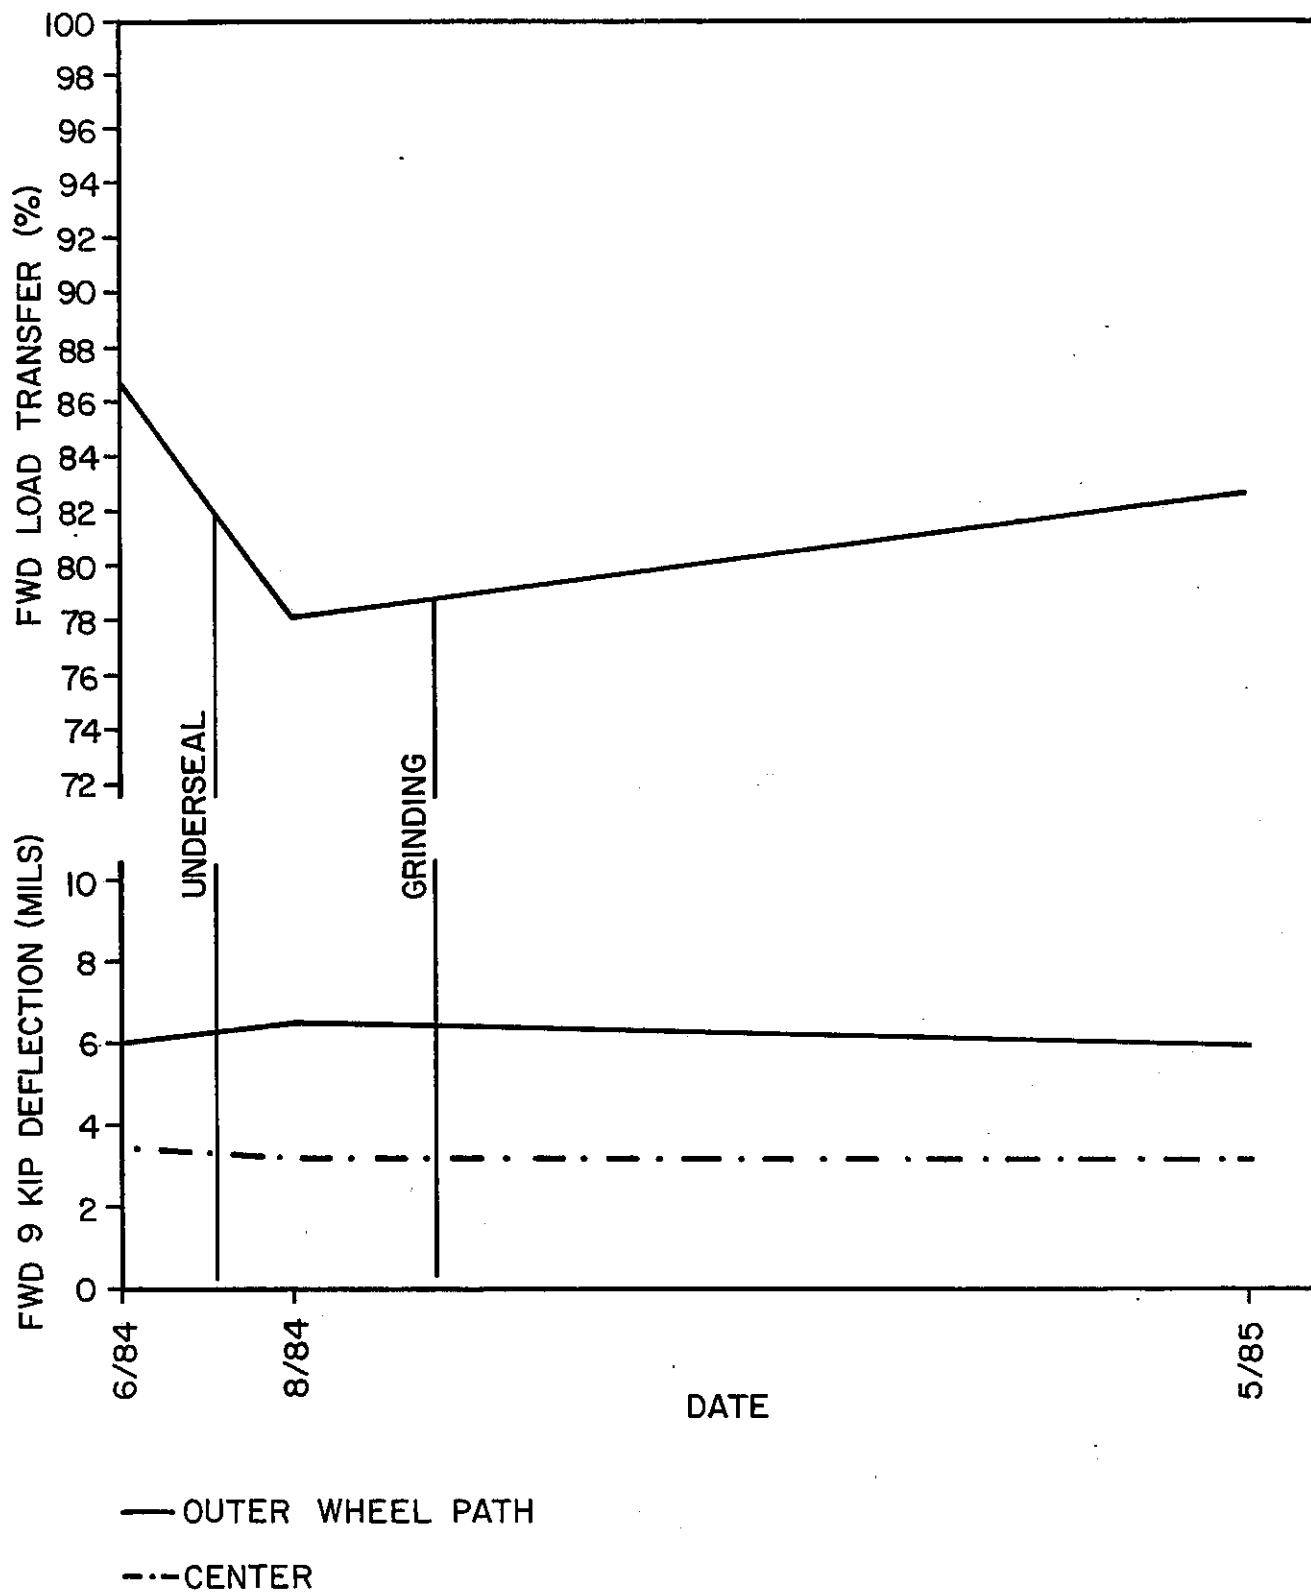
Figure 13. Deflection and Load Transfer History of Undersealing on Project Number 5

Also compared in the procedure are load transfer efficiency, 9 kip deflection and center of slab deflections. By using these procedures, only 2 voids were found in the 53 joints and cracks tested before undersealing. Tests after undersealing and the following year showed the voids were filled and remained stable. The deflection and load transfer histories are given in Figure 13.

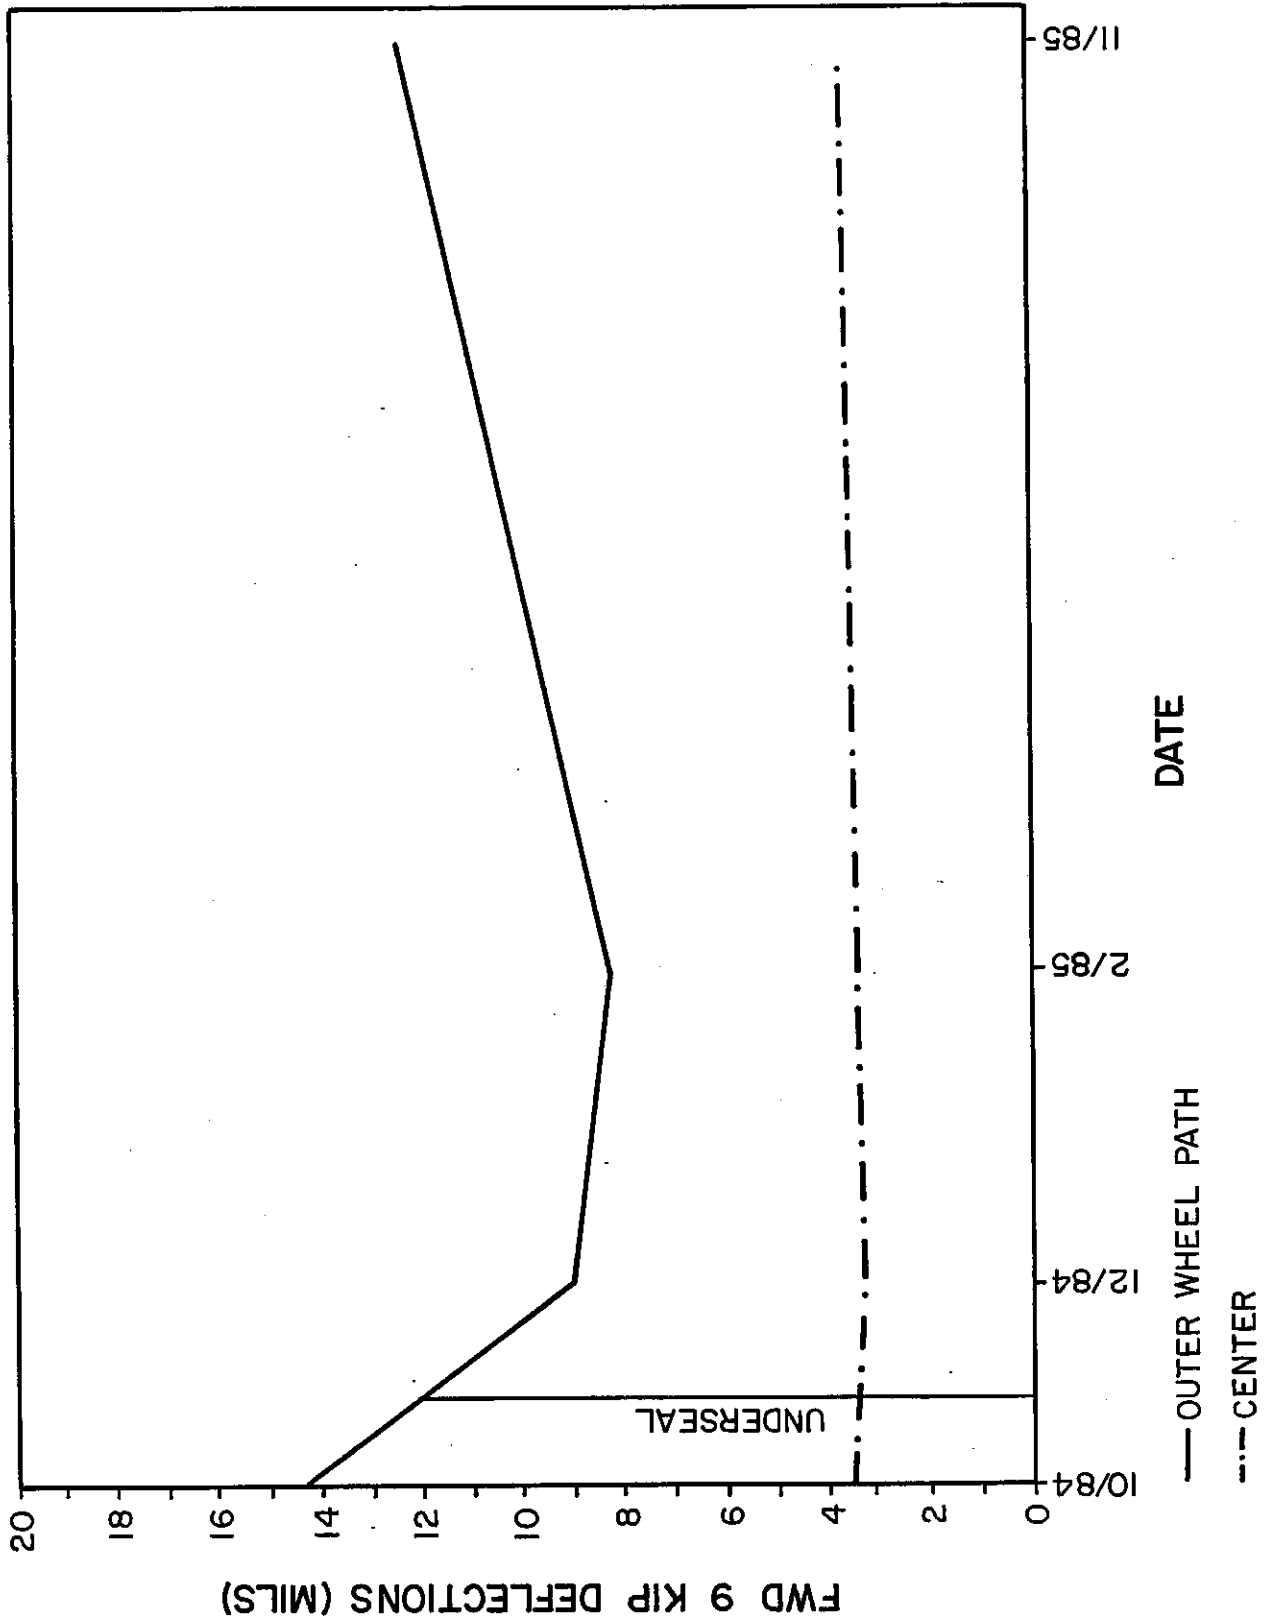
Figure 15. Deflection History of Patch Undersealing on Project Number 3

Project 3 was also undersealed in the Fall of 1984 at all patch locations to arrest pumping and spalling of the patches. Before undersealing, a group of 21 patches were selected for evaluation. Deflection testing results using the FWD are given in Figure 16, which again shows that patch undersealing was effective for about one year.
