State of Illinois
Department of Transportation
Bureau of Materials and Physical Research

EVALUATION OF POZZOLANIC MIXTURE
CONTAINING
CEMENT KILN DUST (CKD)
(IL 83-11)

Jagat S. Dhamrait

December 1988

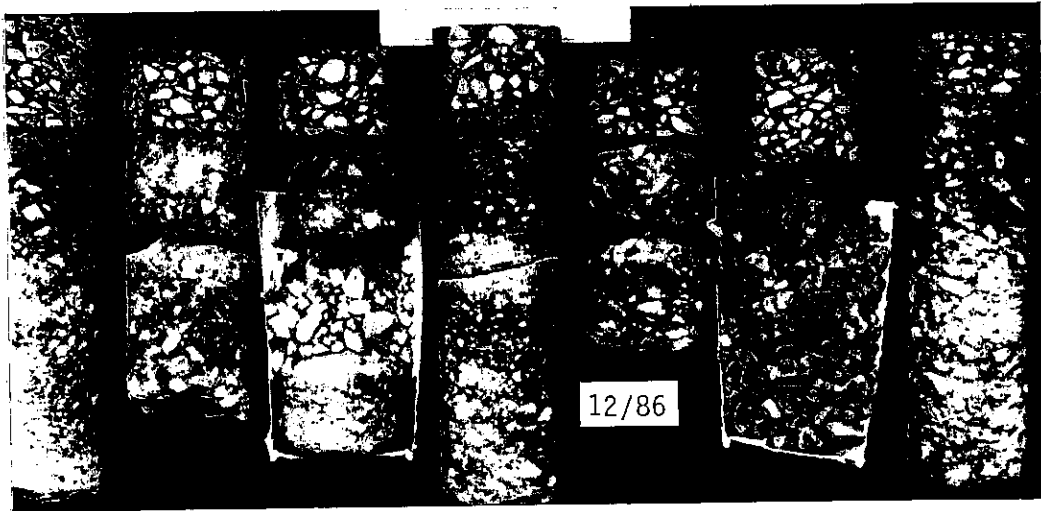
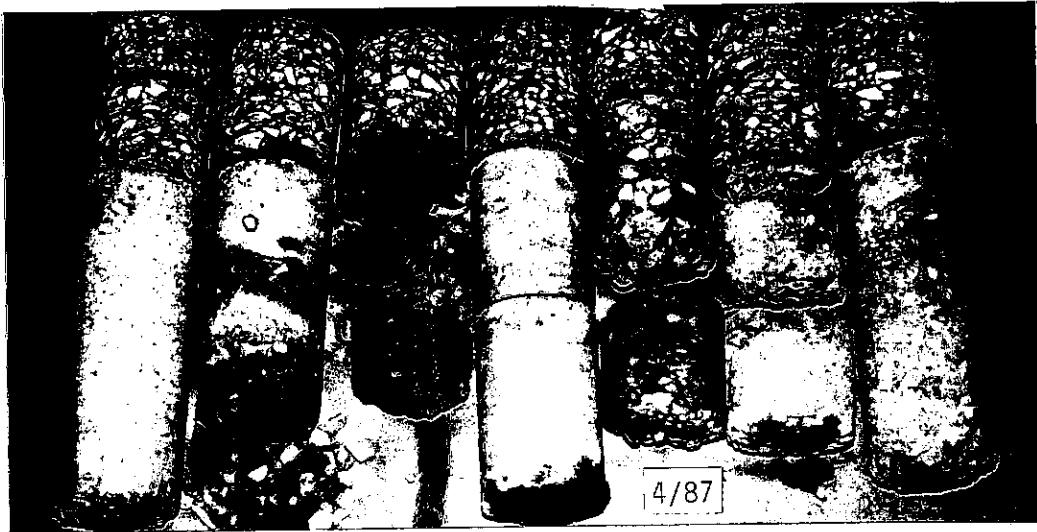
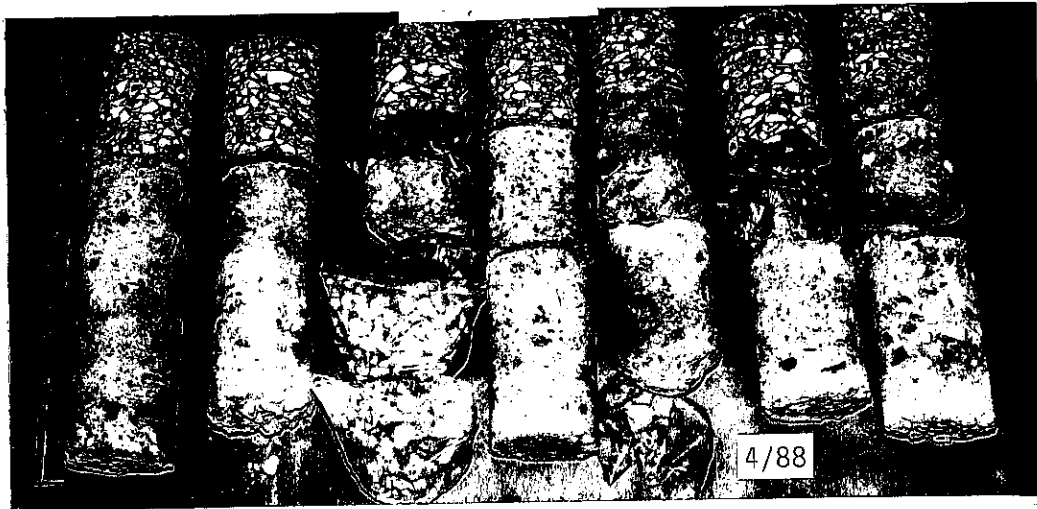
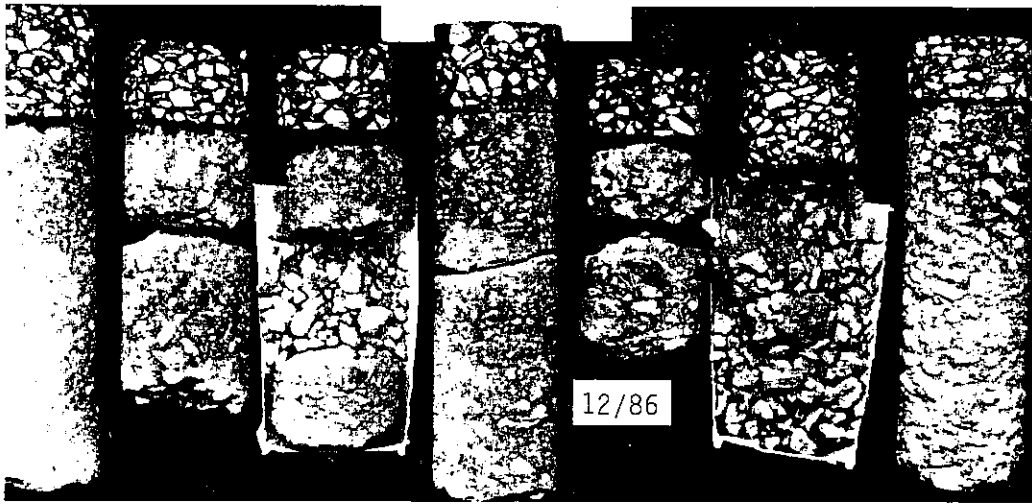
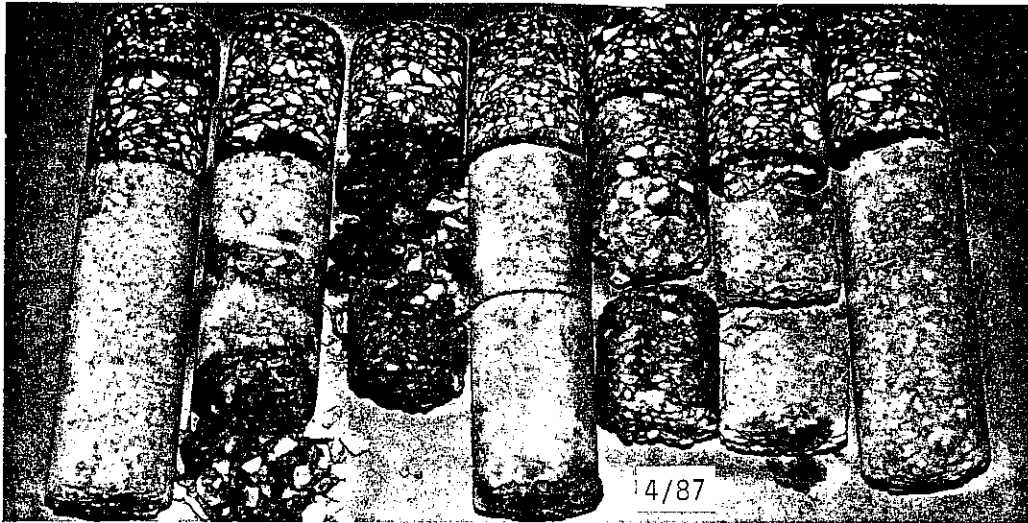
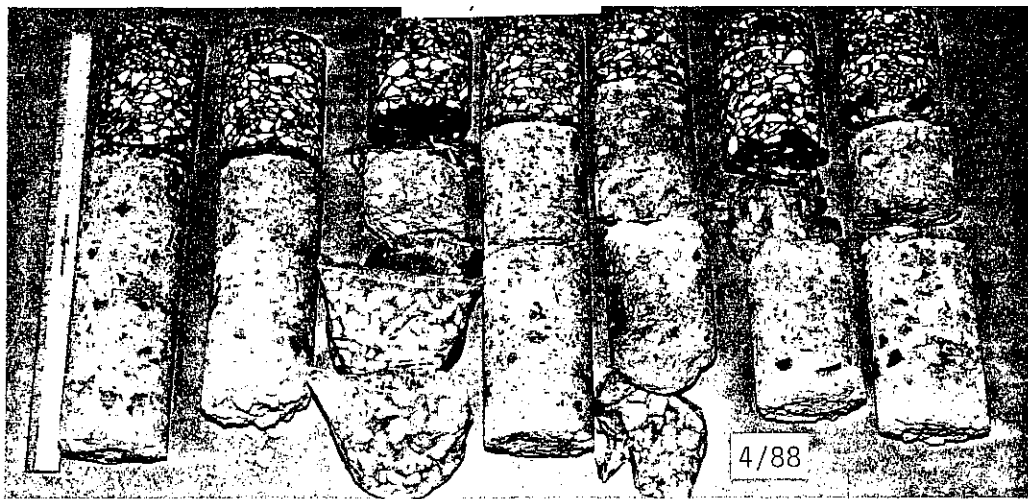
Figure 2. Photographs showing the conditions of the cores.

As can be observed from the photographs, favorable climatic conditions (above average temperatures and below normal precipitation) over the two winters following the PAM base construction contributed to an improvement in its durability/cementation characteristics and a reduction in the damaging effects of freeze-thaw cycling. The condition of the cores ranged from a good solid

homogenous (core #1 deflection 3.2 mils) to loose gravel (core #3, deflection 19.4 mils.) A majority of the core samples did, however, reveal construction related problems specifically: lack of cementation and compaction, inadequate mixing, and segregation. At most core locations loose material was encountered between the top and bottom lift, a condition previously described as being created by the toothed roller used for compaction.

As expected, the compressive strength development has continued with age. It should be kept in mind that the compressive strengths presented above and in Tables 3, 4, and 5 represent only the portion from which test samples could be obtained. Therefore, due to the presence of the uncemented material between the lifts or segregation, the strength results are not representative of the total PAM base layer. This loose material will collect water and cause further deterioration. These conditions are now adversely effecting the PAM performance.

4. Loose and uncemented material between the bottom and top lift was observed in a majority of cores when they were cut after construction. Water will collect in this loose material and will cause premature deterioration. To avoid these construction-related problems, it is recommended that the PAM should be constructed in one lift.
