# An Evaluation of IDOT's Current Underdrain Systems

Physical Research Report No. 120  
December 1995

**Illinois Department of Transportation**  
Bureau of Materials and Physical Research

AN EVALUATION  
OF  
IDOT'S CURRENT UNDERDRAIN SYSTEMS

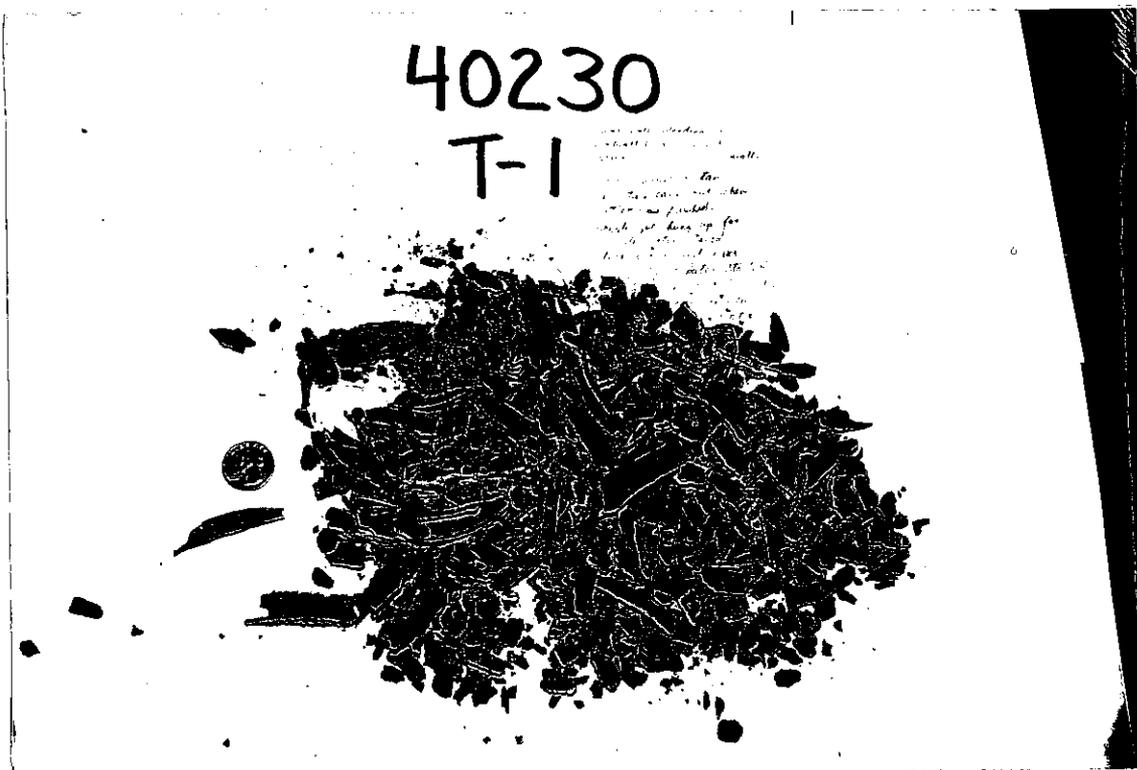
In general, the outlet pipes contained only small amounts of debris that were congregated in the corrugations of the pipe. Several headwalls contained silt and/or plant matter, but this did not appear to extend past the headwall. Two outlets contained a large quantity of calcite deposits that had formed in the pipe corrugations (see Figure 2).

Figure 2. Calcite deposits formed in outlet pipe.

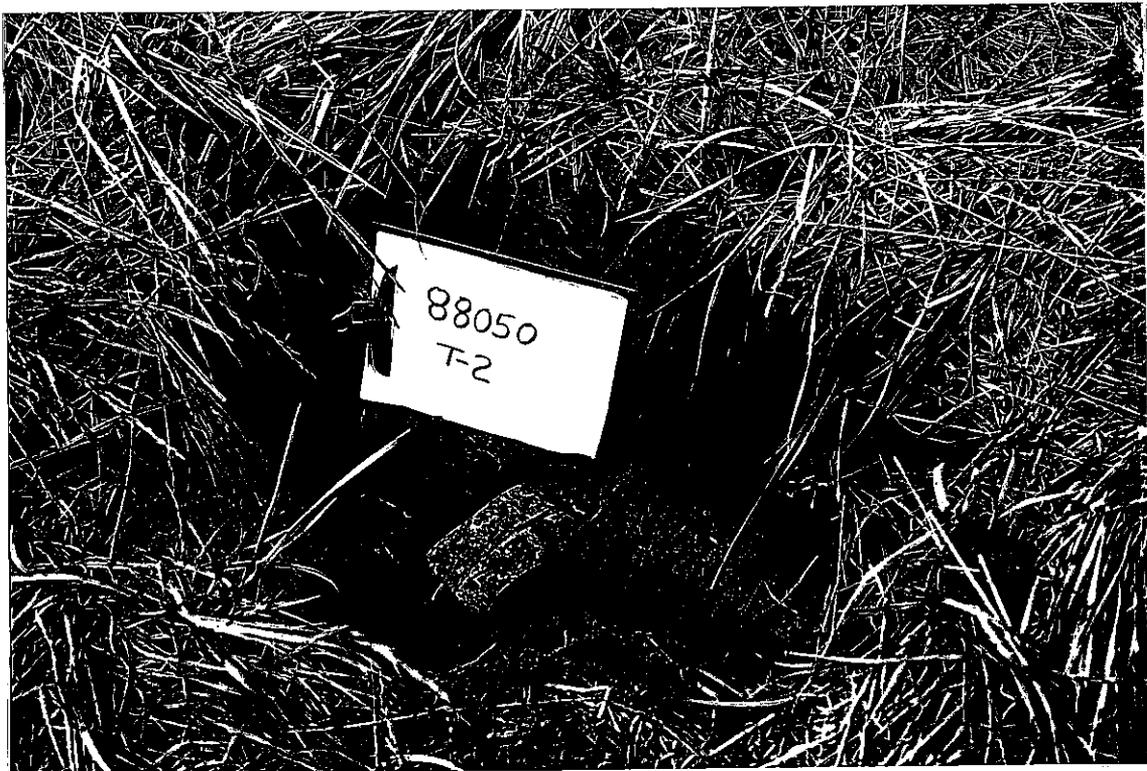
Many outlets were constructed using perforated rather than solid pipes. One outlet was found to be collapsed at a joint a few feet upstream from the headwall (see Figure 3). The type of pipe coupler used was short and dependent on the connecting pipes for structural strength. As the headwall moved and pulled away from the coupler, the strength of the joint was lost and the entire joint collapsed. In addition, one outlet

**Figure 3. Outlet pipe collapsed at joint.**

pipe was partially collapsed due to improper construction.

- IDOT's 15 foot mowing policy should be relaxed at least enough to insure that the area around underdrain headwalls is mowed.
- The districts should continue to backflush outlets at their current frequency and should repair all bad joints found in the outlet pipe.

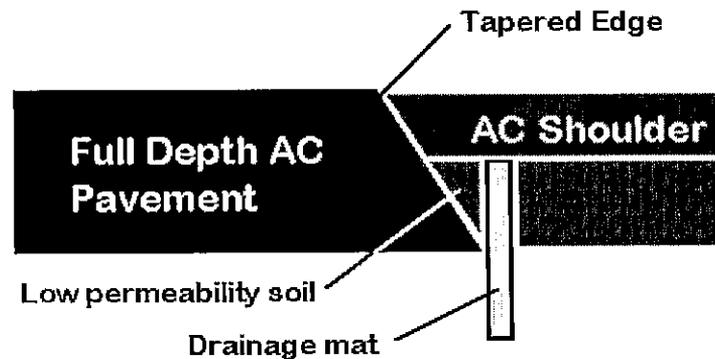
Five of the six 14" mat underdrain samples were eight inches or more from the pavement edge. These drains were only used on full depth asphalt pavement. The wide drain placement was attributed to the trapezoidal shape of the pavement which narrows from bottom to top. In other words, the drain may have been in contact at the base of the pavement, but the tapering of the edge resulted in the top being 8-18 inches away. A major downside of this detail is that it was common for low permeability material to be backfilled in the triangular-shaped area adjacent to the 14" mat underdrain (see figure 4). No sagging or depth control problems were noted for the 14" mat underdrains.

Figure 4. Observed 14" mat installation adjacent to full depth asphalt pavement.

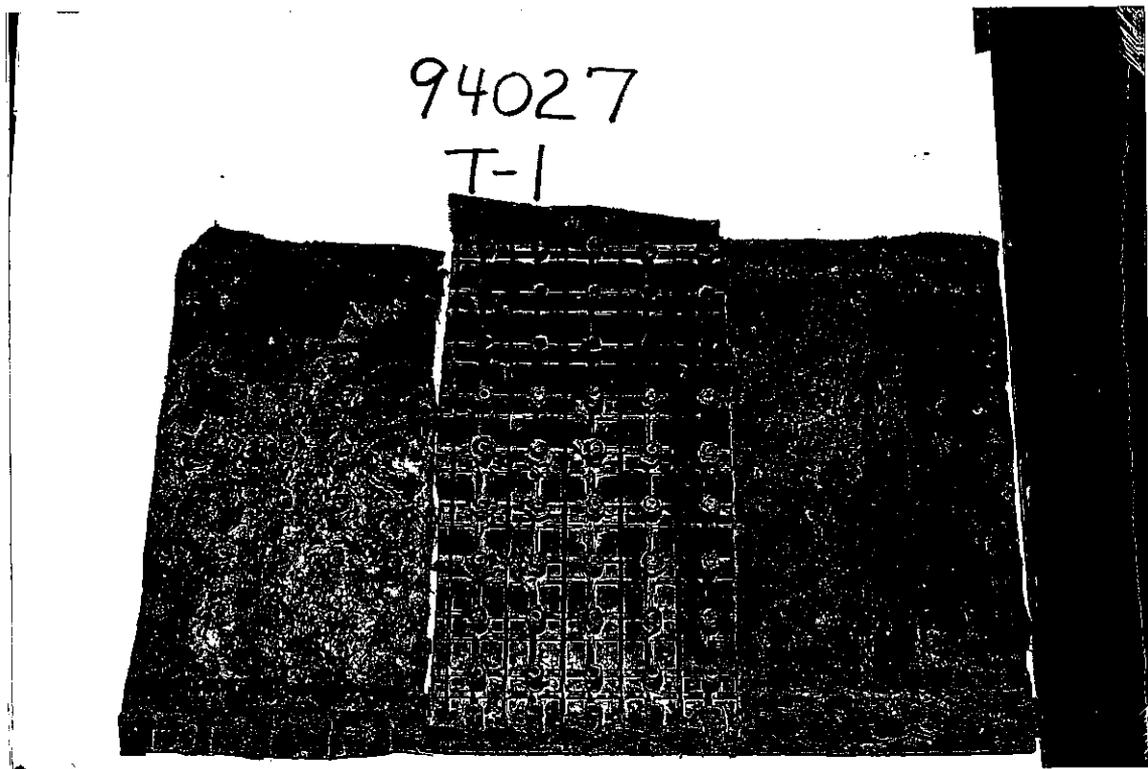
addition, a few underdrains contained a very sticky, brown silty clay. Other solids found in small amounts included sand and root-like material. Deposits found in the bottom of the drain only told half the story. It was common for fines to coat the walls of the mat underdrains, well above the level of solids. Depending on the composition of these fines, they could have a very detrimental effect on the underdrain performance. Low permeability fines, such as clay, can almost completely cut off the inflow of water (see Figure 11). The pipe underdrains showed less of a tendency to collect solids than

**Figure 11. Mat underdrain geotextile coated with clay.**

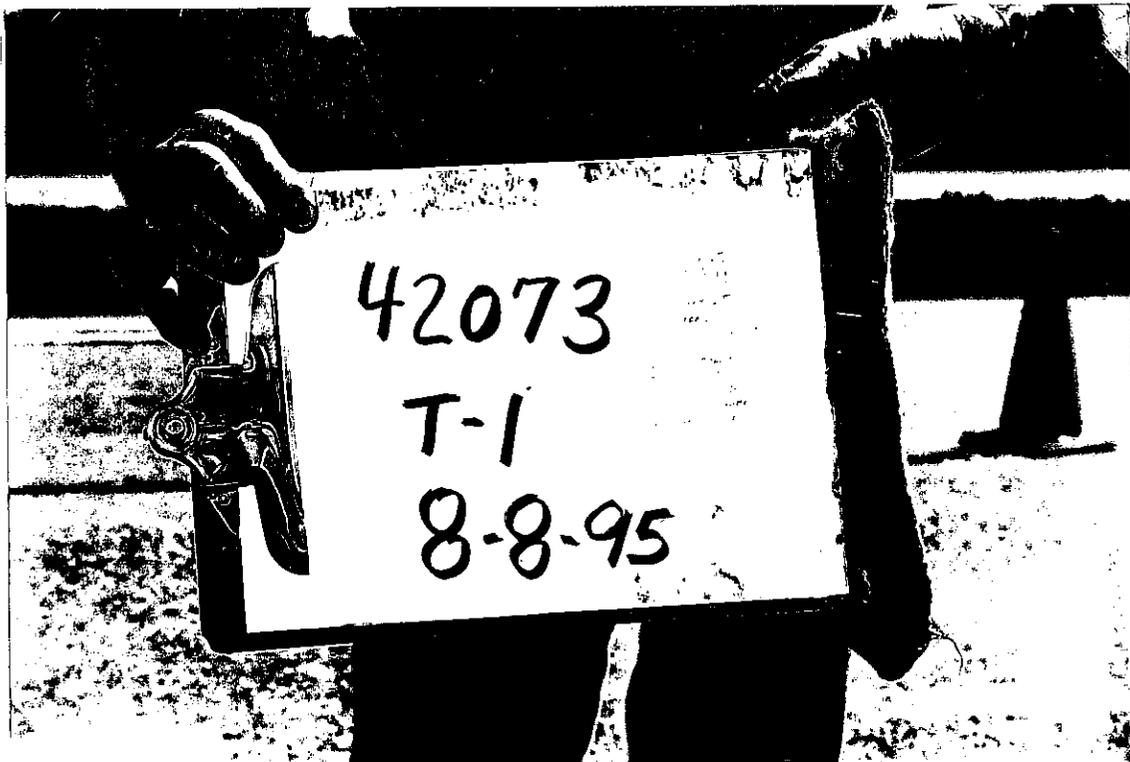
Figure 15. Example of J-ed drainage mat.

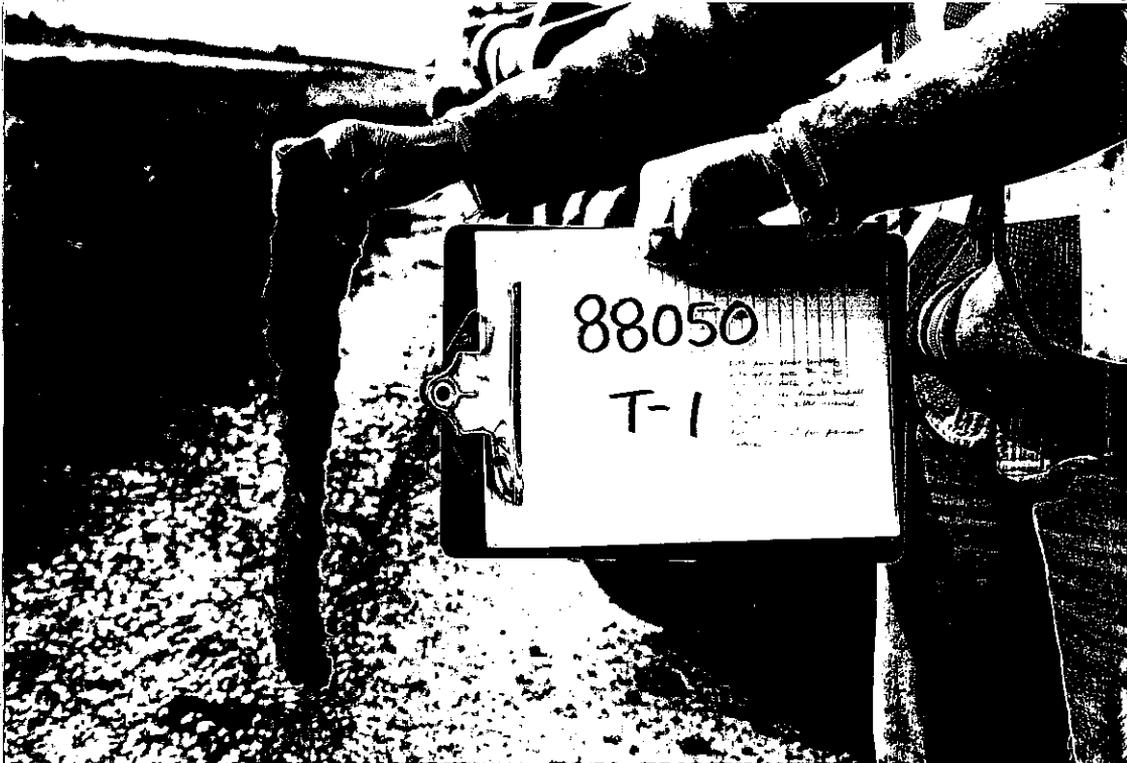
being compacted against the tapered edge of the asphalt pavement (see Figure 4) and it also appears that the contractors attempted to fit the 14" mats into 12 inch holes. A severe case of crushing is illustrated in Figure 16.

**Figure 16. Example of crushing.**

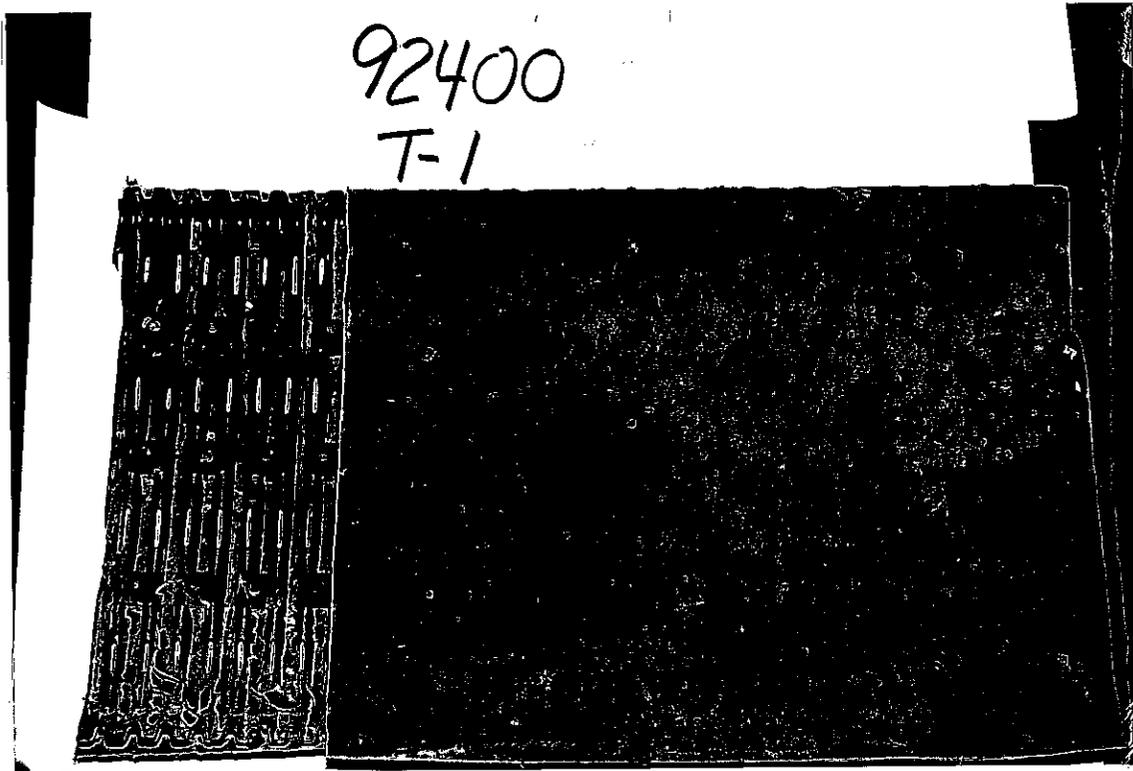
The Advanedge brand drainage mat manufactured by ADS is constructed of the same material as their 4" PE pipe underdrains. In concept, the design resembles an oval-shaped pipe. No cracks or other distresses were found in the Advanedge samples (see Figure 17).

**Figure 17. Intact core of Advanedge drainage mat.**

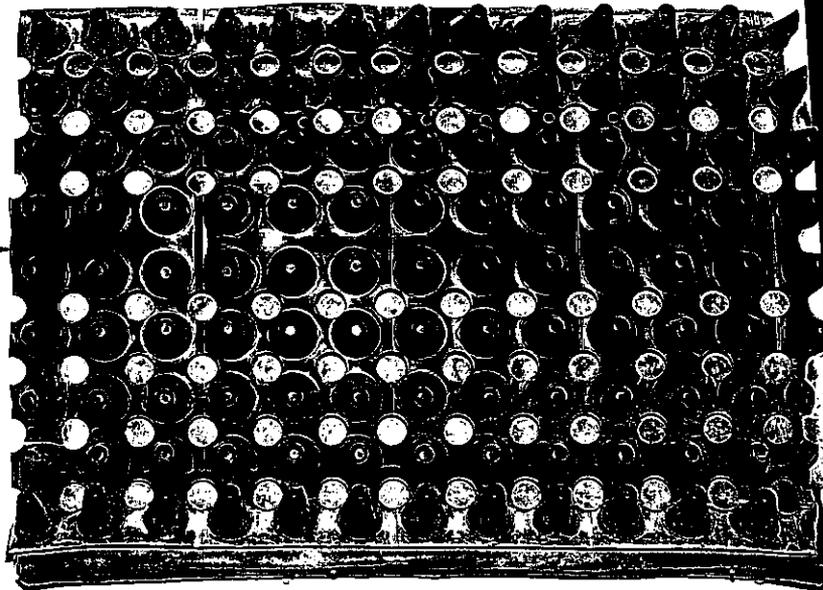
84384  
T-2  
6-13-95

The core of Contech's Stripdrain consists of conical sections protruding from a flat backing with circular openings. Stripdrain was found to be very brittle and both samples contained cracking. One sample (Contract 84384 T-2) had been bent considerably in the field and was nearly broken into four sections (see Figure 18). The structural performance of Stripdrain was deemed unacceptable.

**Figure 18. Highly distressed Stripdrain core.**

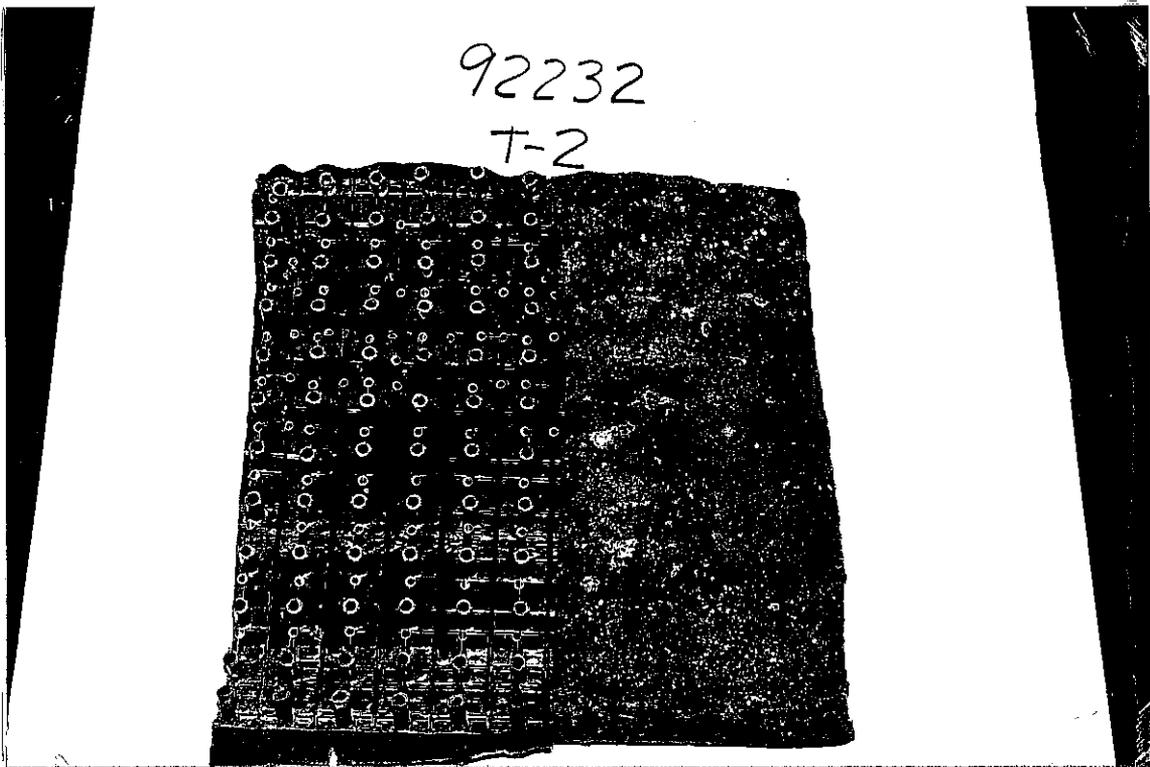
The resin used in the newer design was found to be much more brittle than the resin used in the older design (see Figure 19). Cracks were hard to see in the older mats because their cores naturally tended to have a wrinkled appearance, whereas the newer mats had a smooth texture. It was also difficult to see cracks in mats that had

**Figure 19. Brittle cracking of newer Monsanto mat. Dots indicate cracks.**

appreciable silt accumulations. About half of the older design Monsanto mats appeared to contain cracks. By contrast, all of the newer design Monsanto mats contained cracks. Cracking was especially prevalent in the 14" mats. The 14" mats were all constructed using the newer design and were found to contain, on average, four times as many cracks as the 12" mats constructed with the same design. Table 5 summarizes the distresses found in the drainage mats.
