State of Illinois
DEPARTMENT OF PUBLIC WORKS AND BUILDINGS
Division of Highways
Bureau of Research and Development

EVALUATION OF SA-1 (STABILIZING AGENT-1) IN THE RECONSTRUCTION
OF A TOWNSHIP ROAD BY ADAMS COUNTY

June 1, 1967

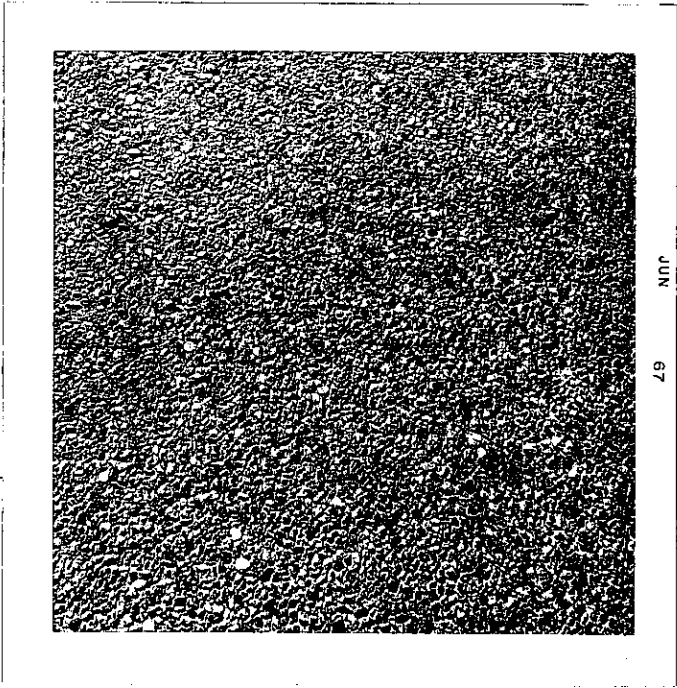
A second inspection was made of the treated section on October 25, 1966. The SA-1 treated material had been covered with a seal coat, which had improved the appearance and riding quality of the road. However, there were still some rough spots and uneven ridges on the surface. The SA-1 treated material still felt solid when struck with a hammer. The appearance of the seal coated road is shown in Figures 16, 17, 18, and 19.

Figure 16. October 25, 1967. The appearance of the seal coated surface. Figure 17.

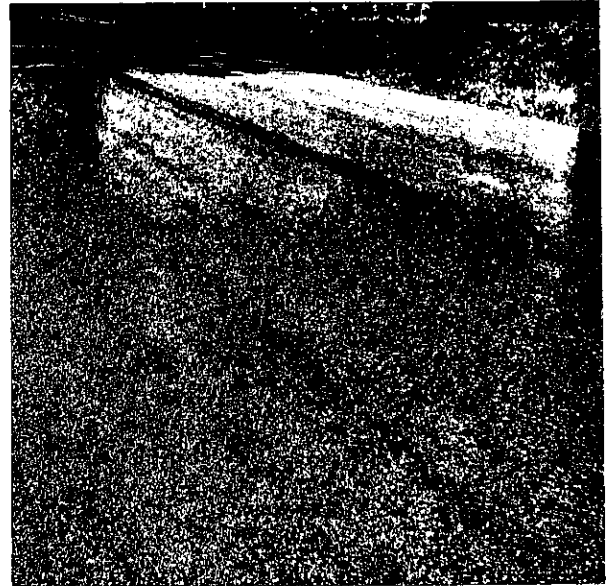
Figure 18.
October 25, 1967. The appearance of the seal coated surface.

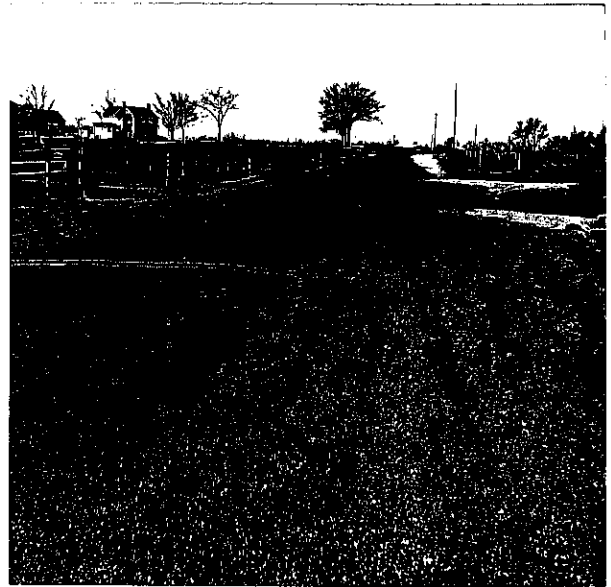
Again on February 14, 1967, an inspection was made of the SA-1 treated section at which time the surfacing was found to be deteriorating severely in the form of raveling along the edges of the road. The main reason for this raveling seemed to be the poor continuity of the treated layer. The particles of material that were not broken down during treatment have little bond to each other and, consequently, are subject to being shoved around with subsequent cracking and raveling under the action of traffic. Also, the layer of treated material had no bond to the underlying subgrade. Large areas of surfacing could easily be lifted by hand. The condition of the road surface at this time is shown in Figures 20, 21, 22, 23, 24, and 25.

Figure 20.
February 14, 1967. Raveling along the edges of the road.
