State of Illinois
DEPARTMENT OF PUBLIC WORKS AND BUILDINGS
Division of Highways
Bureau of Research and Development

EVALUATION OF SA-1 (STABILIZING AGENT-1) IN THE RECONSTRUCTION
OF A TOWNSHIP ROAD BY ADAMS COUNTY

June 1, 1967

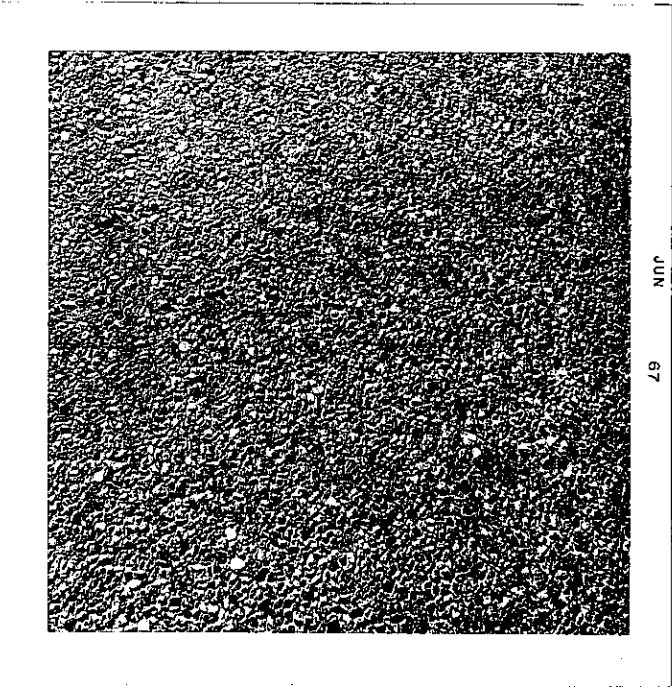
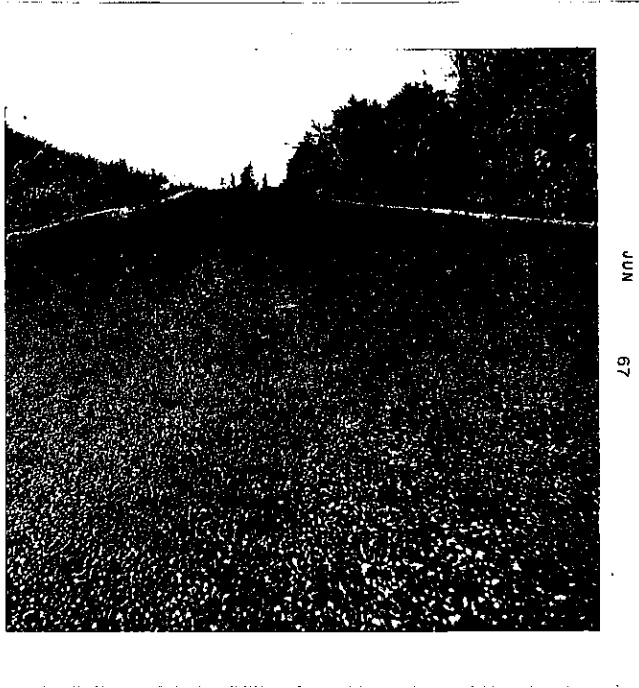
A second inspection was made of the treated section on October 25, 1966. The SA-1 treated material had been covered with a seal coat, which had improved the appearance and riding quality of the road. However, there were still some rough spots and uneven ridges on the surface. The SA-1 treated material still felt solid when struck with a hammer. The appearance of the seal coated road is shown in Figures 16, 17, 18, and 19.

Figure 16. October 25, 1967. The appearance of the seal coated surface. Figure 17.

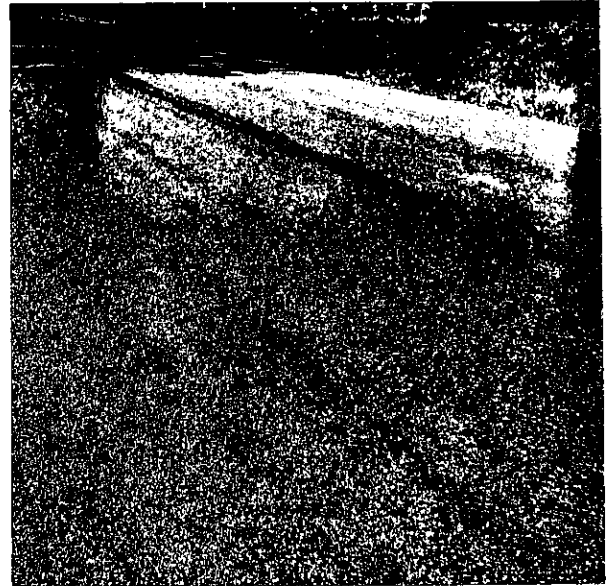
Figure 19.

Figure 18.
October 25, 1967. The appearance of the seal coated surface.

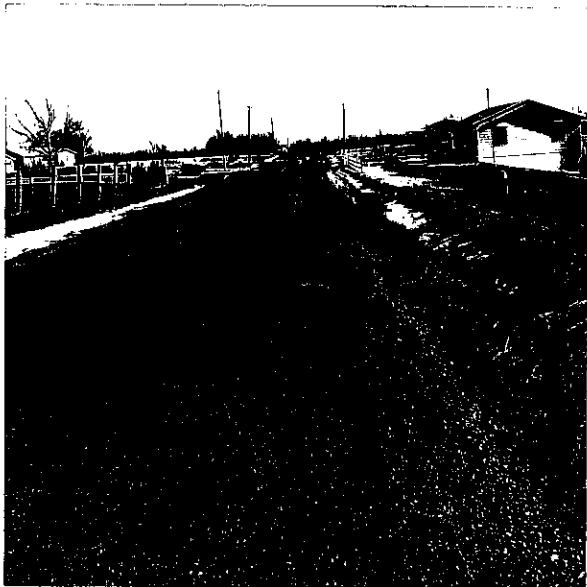
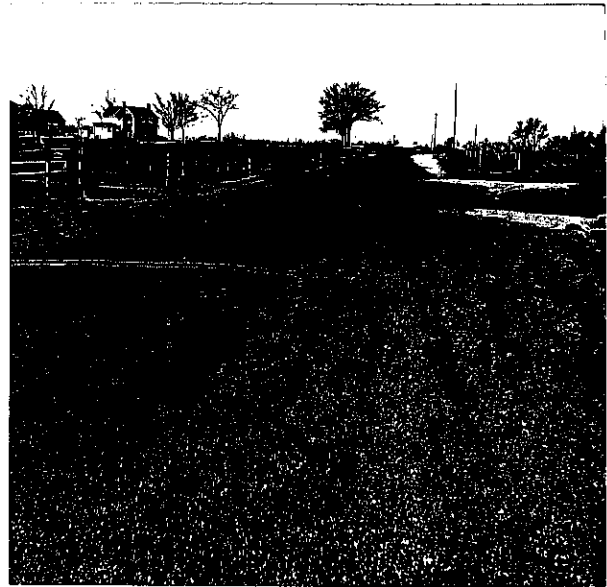
Figure 21

Again on February 14, 1967, an inspection was made of the SA-1 treated section at which time the surfacing was found to be deteriorating severely in the form of raveling along the edges of the road. The main reason for this raveling seemed to be the poor continuity of the treated layer. The particles of material that were not broken down during treatment have little bond to each other and, consequently, are subject to being shoved around with subsequent cracking and raveling under the action of traffic. Also, the layer of treated material had no bond to the underlying subgrade. Large areas of surfacing could easily be lifted by hand. The condition of the road surface at this time is shown in Figures 20, 21, 22, 23, 24, and 25.

Figure 20.
February 14, 1967. Raveling along the edges of the road.

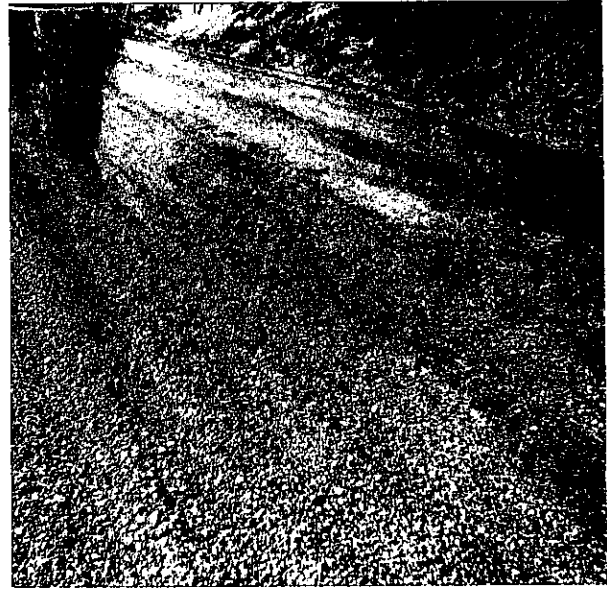
Figure 23.

Figure 22. February 14, 1967. Raveling along the edges of the road.

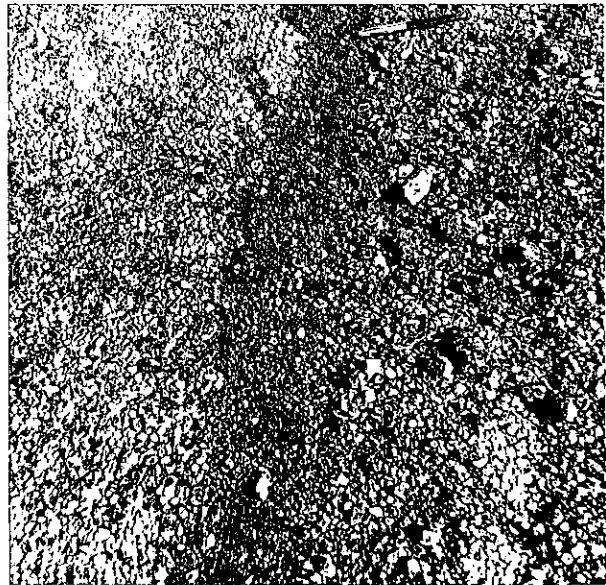
Figure 25.

It is concluded that the use of SA-1 in the reconstruction of the Adams County road covered by this investigation has been unsuccessful. The primary reason for the failure appears to be the inability of the SA-1 to adequately break down the scarified material. In recompacting this partially broken down material, a layer of material of nonuniform characteristics and weak spots was formed, which

Figure 24. February 14, 1967. Closeup photographs of the condition of the SA-1 treated material where raveling has occurred.

On the basis of the results of this investigation, it is recommended that no further consideration be given to the use of SA-1 in this type of construction.
