RESEARCH AND DEVELOPMENT REPORT NO. 21

FINAL REPORT OF EXPERIMENTAL USE OF URETHANE
FOAM INSULATION TO CONTROL BRIDGE DECK ICING
(JHR - 79)

Project No. IHR-79

June 1969

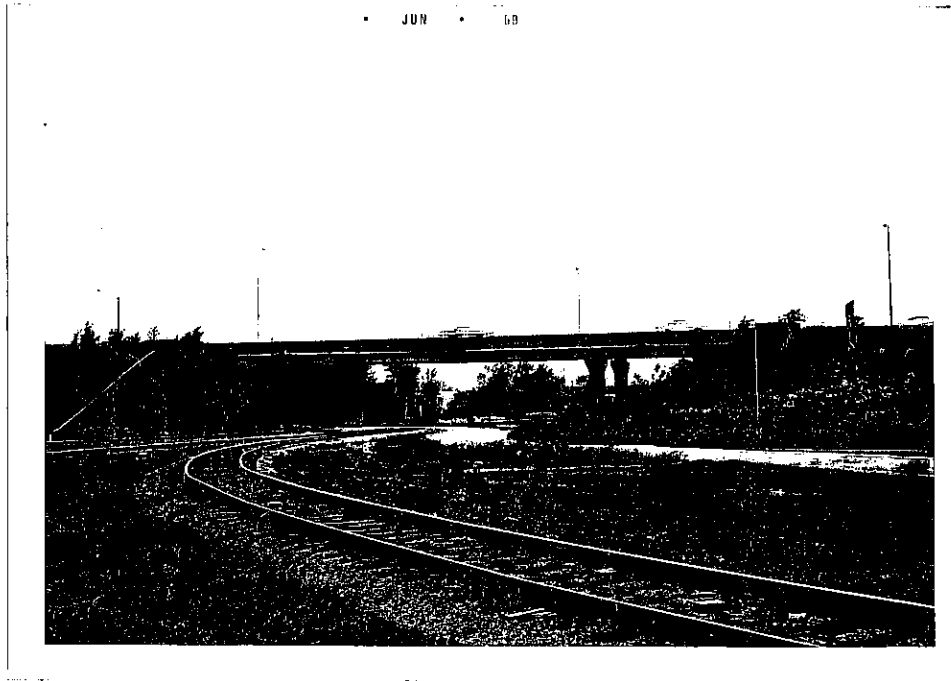
Figure 1. TP&W RR overpass with insulated bridge deck

After the first heavy rain following application, an area of localized deflection in the foam insulation was found near an open joint, and an opening in the material had to be provided for draining the trapped water. Except for this one area, the insulation was in excellent condition within the first year after the application. Inspections made five and six years later revealed the insulating material in good condition, except for excessive peeling near the transverse deck joints. There also was evidence at location near the deck drains that water had become entrapped at the interface of the insulation between the steel stringers and concrete deck. Close examination of the insulated surfaces near the drains and random inspection of other areas failed to disclose any significant deterioration of the concrete or rusting of the structural steel that could be attributed to the presence of the insulation.

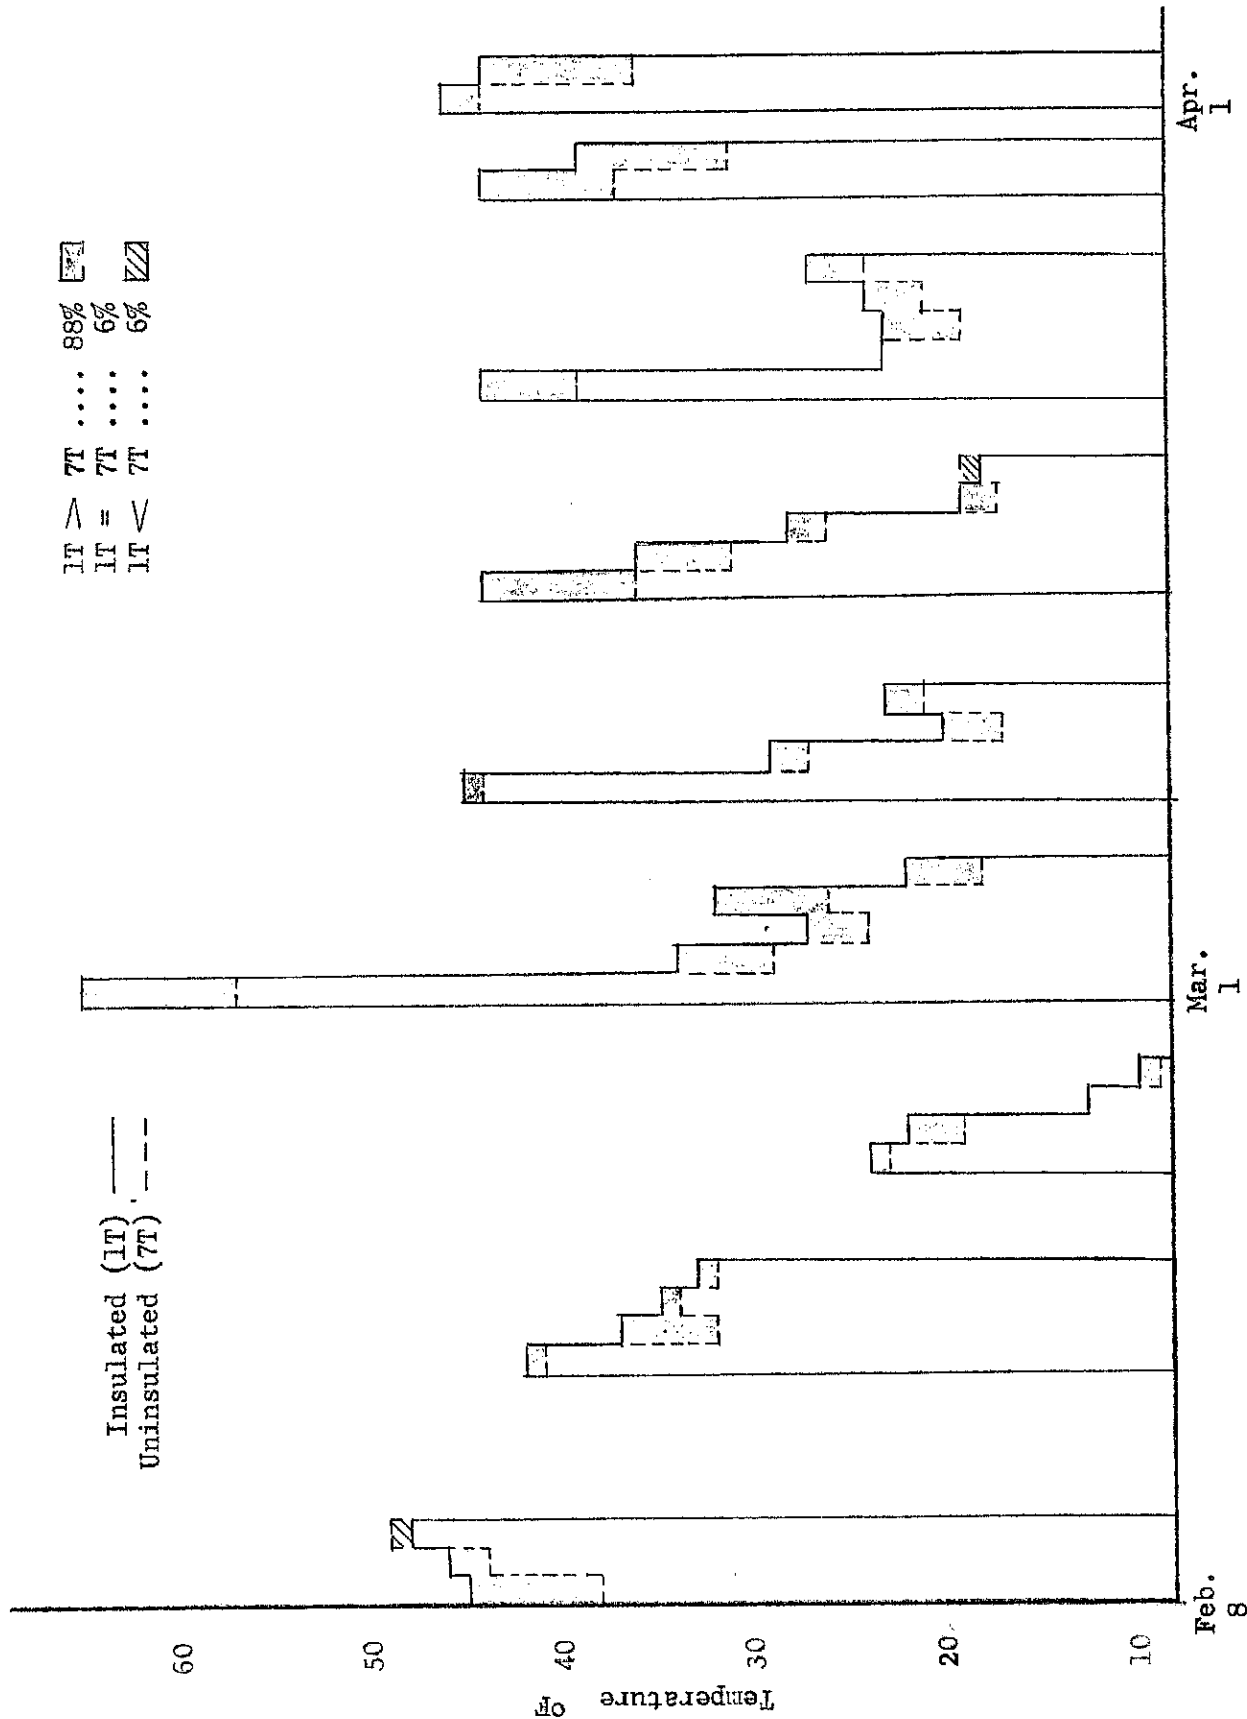
CHART 1

in the concrete slabs in the early morning before sunrise. During these low temperature periods when conditions were most conducive for frosting, the insulated deck was found to have a tendency to remain somewhat warmer than the uninsulated deck. This phenomenon occurred approximately 78 percent of the time within the scope of the recorded readings. Details of this analysis are presented in Charts 1-16 included as an Appendix to this report.

Minimum Daily Temperatures - 1T vs 7T

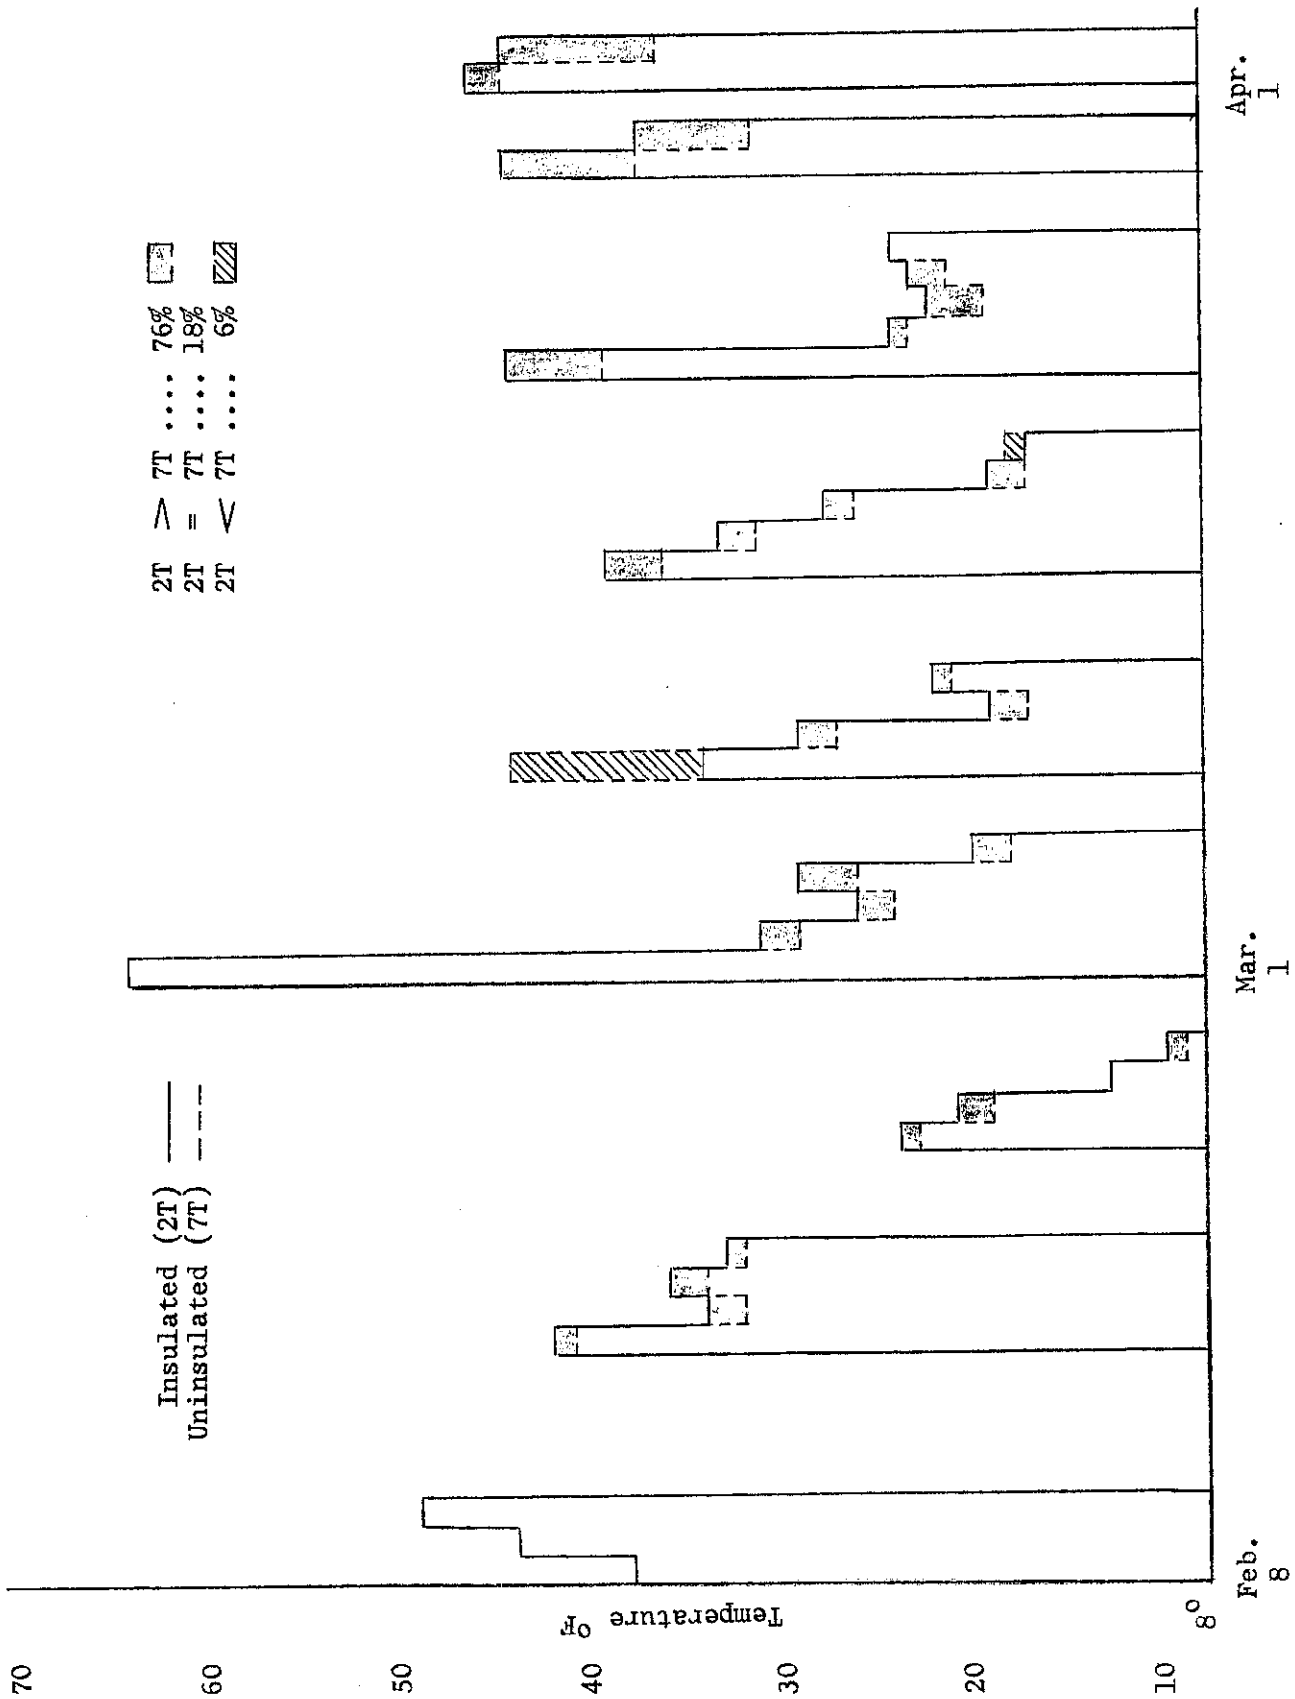
CHART 2

Minimum Daily Temperatures - 2T vs 7T

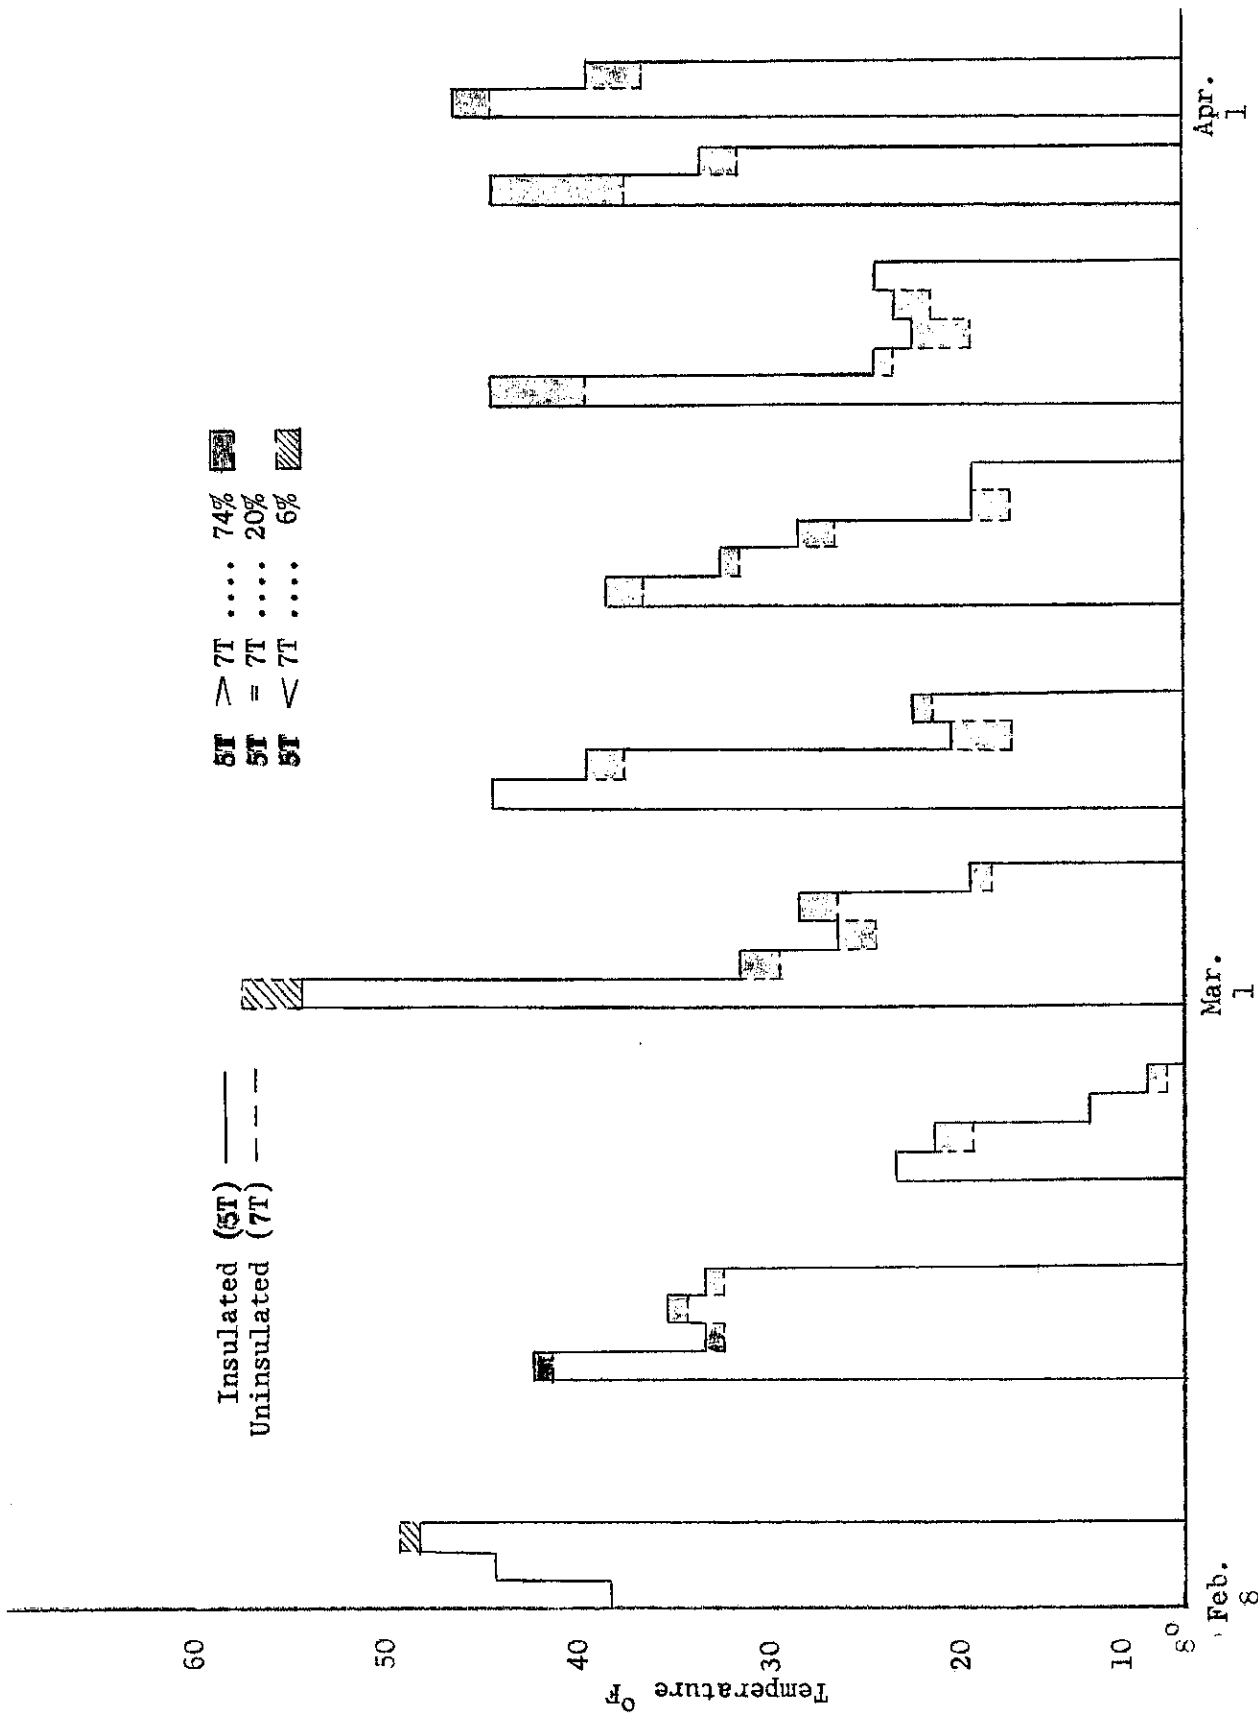
CHART 3

A similar trend, however, was not apparent for the approach pavement and the uninsulated deck. A comparison of temperatures on the basis of percentage of one above or below the other indicated a close similarity in the behavior of the two slabs.

Minimum Daily Temperature - 5T vs 7T

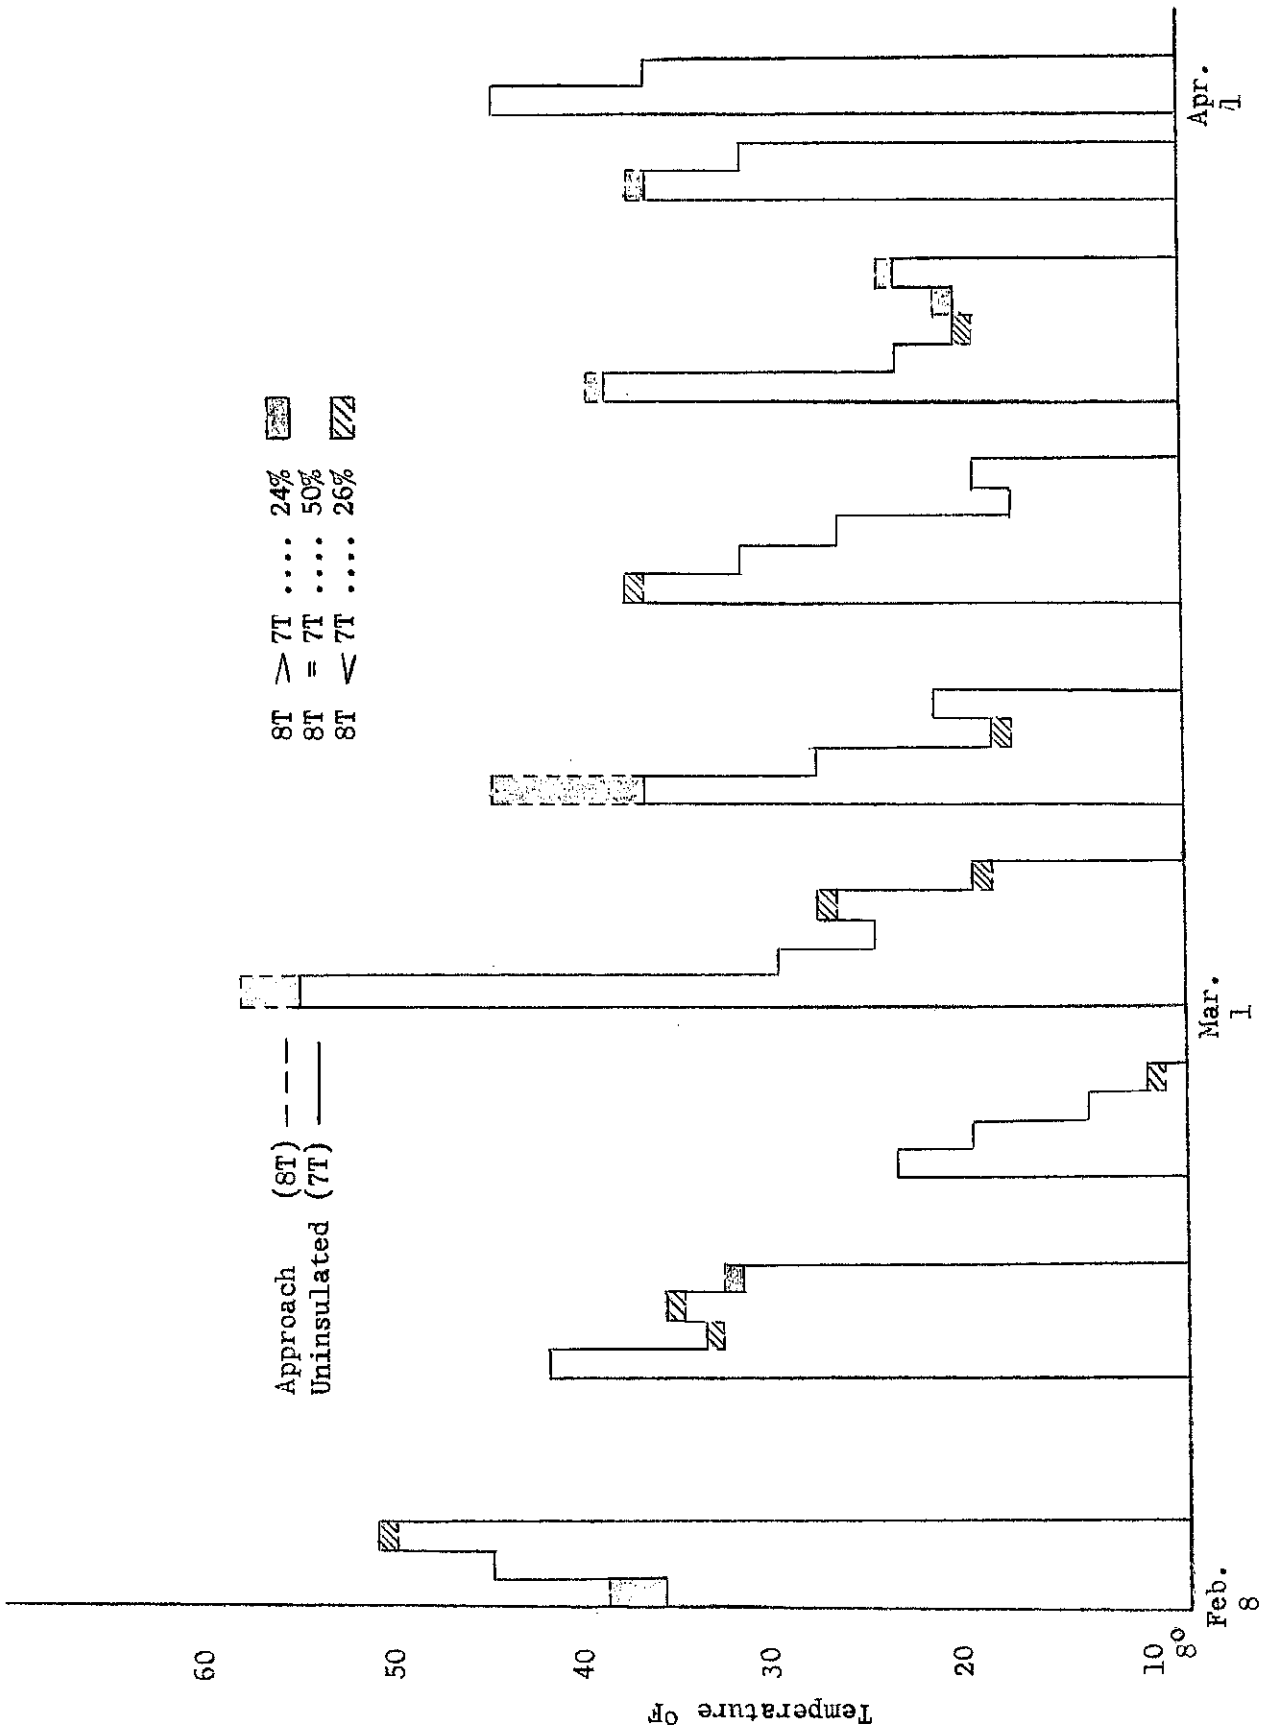
CHART 4

Minimum Daily Temperature - 8T vs 7T
