RESULTS OF BRIDGE DECK CONDITION SURVEYS AND  
CORROSION RATE DETERMINATION

Interim Report

Bridge Deck Condition Survey

June 1979

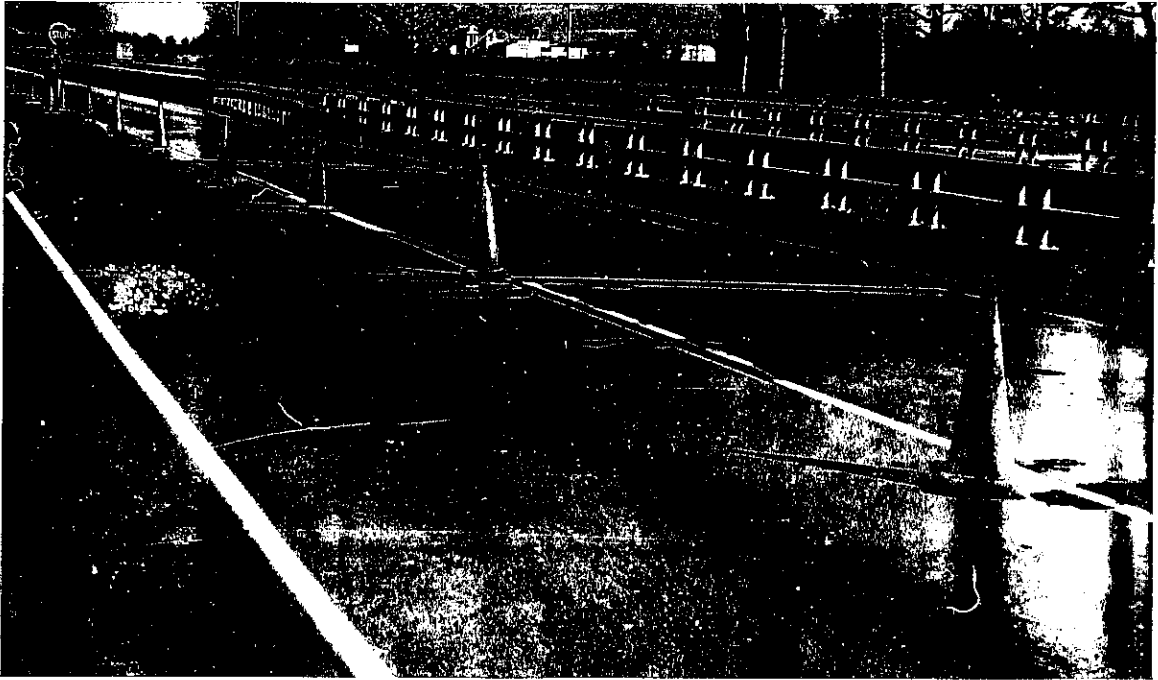
a). Typical Category II deck.

Results of the preconstruction survey show that the actively corroding area on the Category II decks is very near the upper limit (40 percent for the category (Table 1). The results also show that more than 50 percent of the surface area of each Category II deck is contaminated with chloride contents greater than the corrosion threshold.

Visual observations indicate that the amount of surface distress, mostly spalling and patching, was considerably less on the Category II decks than on most of the Category I decks (Figure 3a and 3b). In three instances, adjacent structures were in different categories.

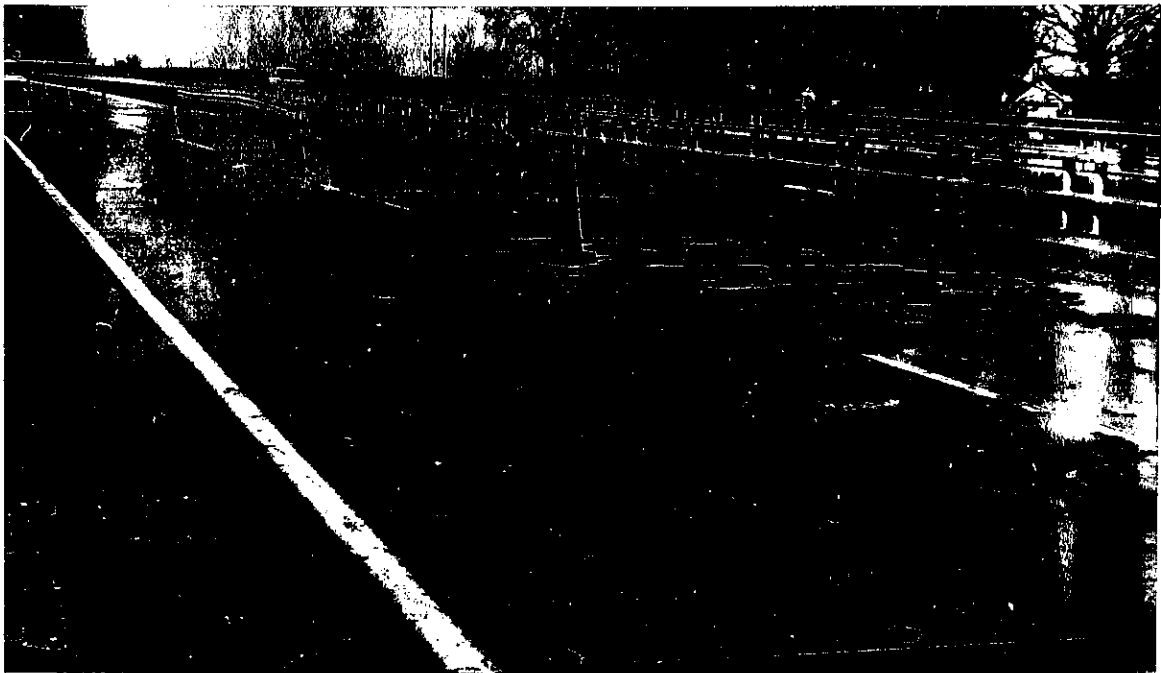
b). Typical Category I deck.
