INVESTIGATION OF TRUNNION FAILURES INVOLVING MOVABLE
VERTICAL LIFT BRIDGES

Special Report

IHR-104

A Research Study Conducted by
Illinois Department of Transportation

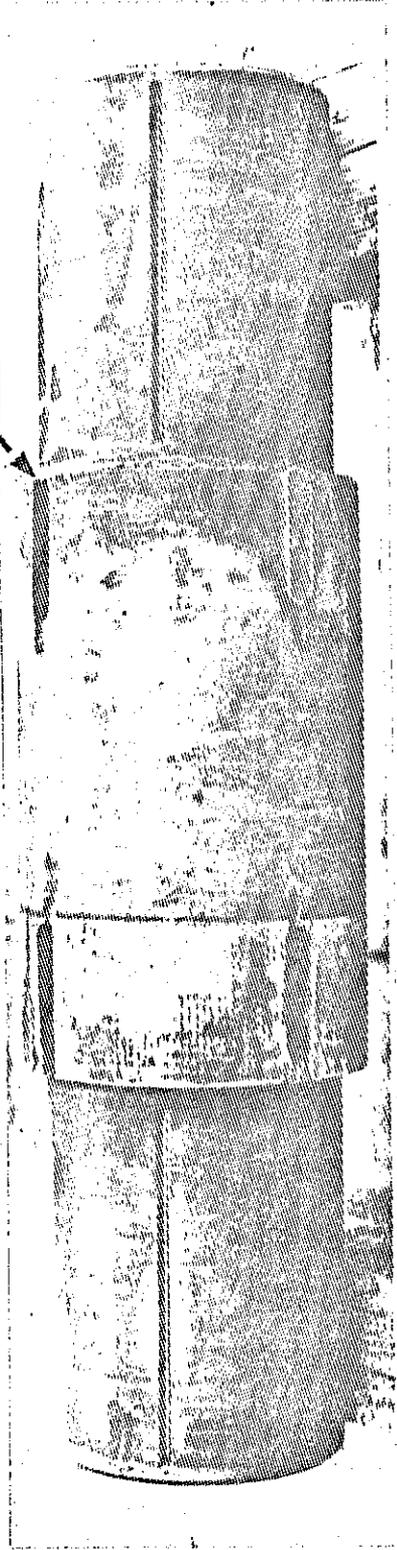
Fatigue crack growth in fillet area.

Figure 6. View of 10 1/2- to 11 3/4-inch trunnion.

bearing, and shear stresses based on the nominal section at the bearing journal. Except for a 1/2-inch (12.7 mm) fillet, little or no consideration is given to the abrupt change in section of the shaft from the sheave to the journal box. This feature was also commonly used in the design of trunnions for bascule bridges.

modifications that would extend the service life of the trunnion. Past studies of fracture mechanics indicate that a substantial improvement in fatigue life could be achieved by increasing the size of the fillet and by incorporating a higher strength steel.

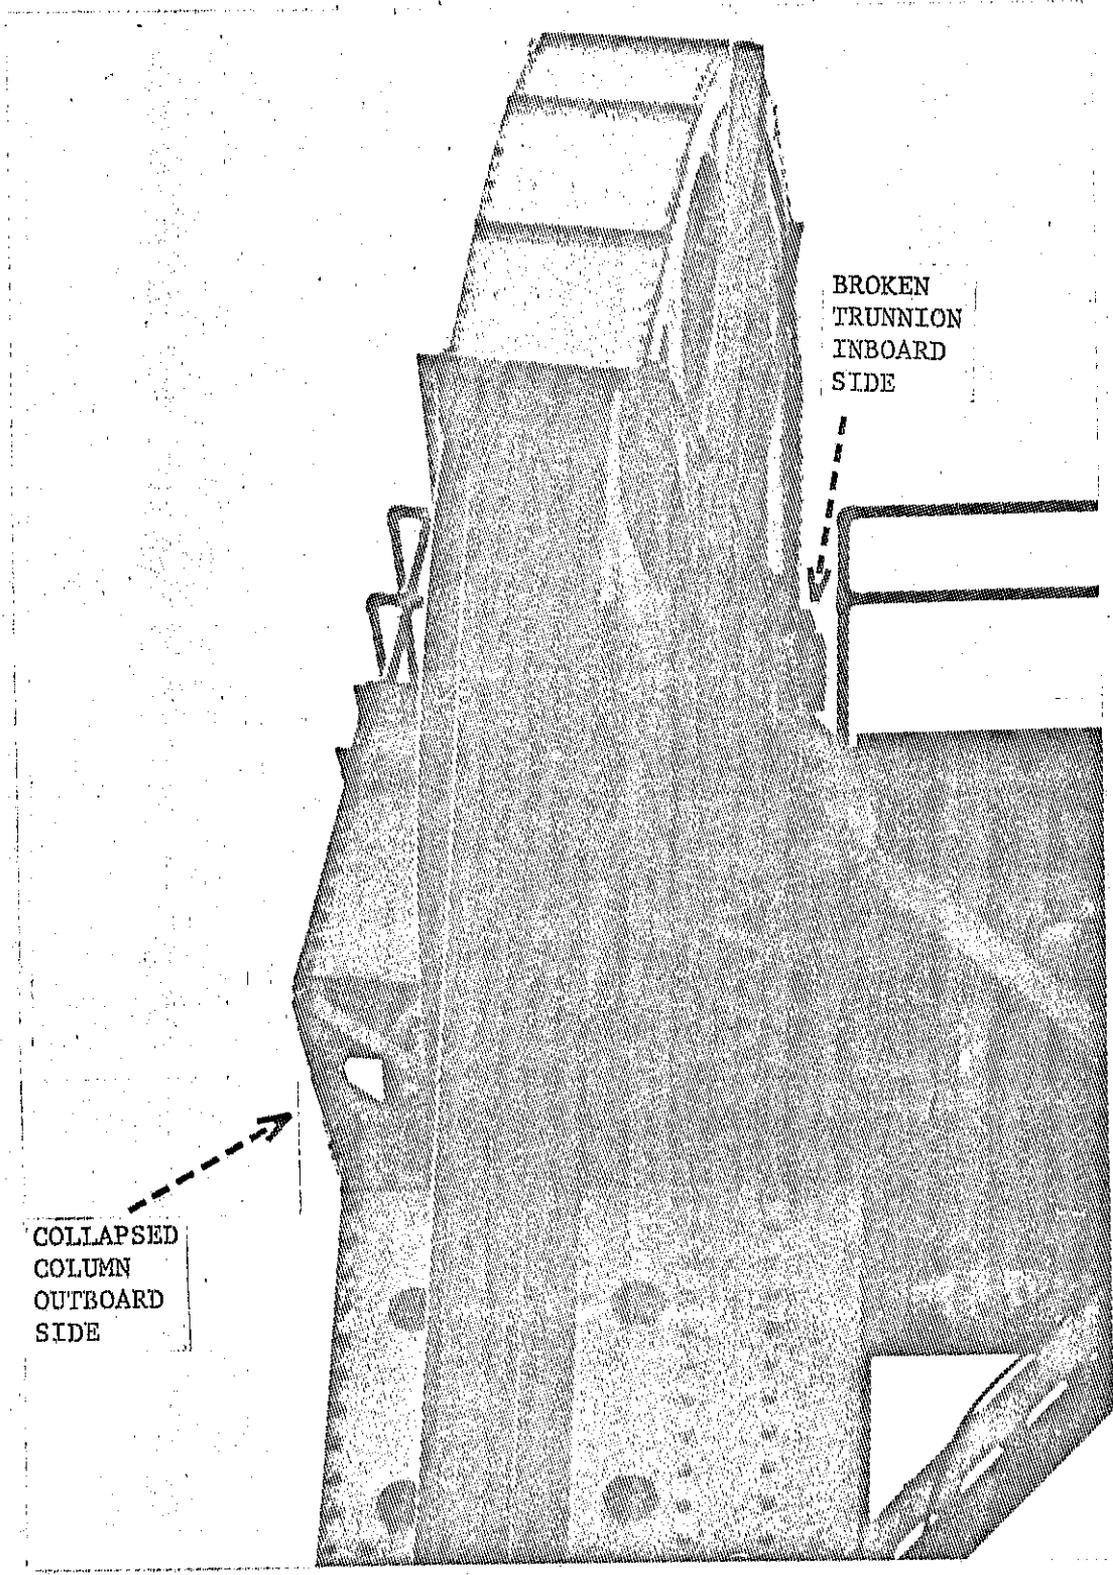
The failure was induced by a fractured trunnion that broke on the inboard side of the subposts that fasten the sheave to the tower (Figure 7). Immediately after failure, the inboard side of the sheave dropped about 5 inches (127.0 mm) (Figure 8) and came to rest with the inner rim of the sheave being supported by the crossframe at the top of the tower. The outboard subpost was partially collapsed (Figure 9) and the inner portion of the broken trunnion came in contact with the bottom saddle of the bearing block. The main restraining elements preventing a total collapse appeared to be the anchor bolts that fasten the inboard bearing journal to the inner subpost (Figure 10) and the severely damaged channels at the base of the outer subpost.

Figure 7. Overall view of trunnion failure.

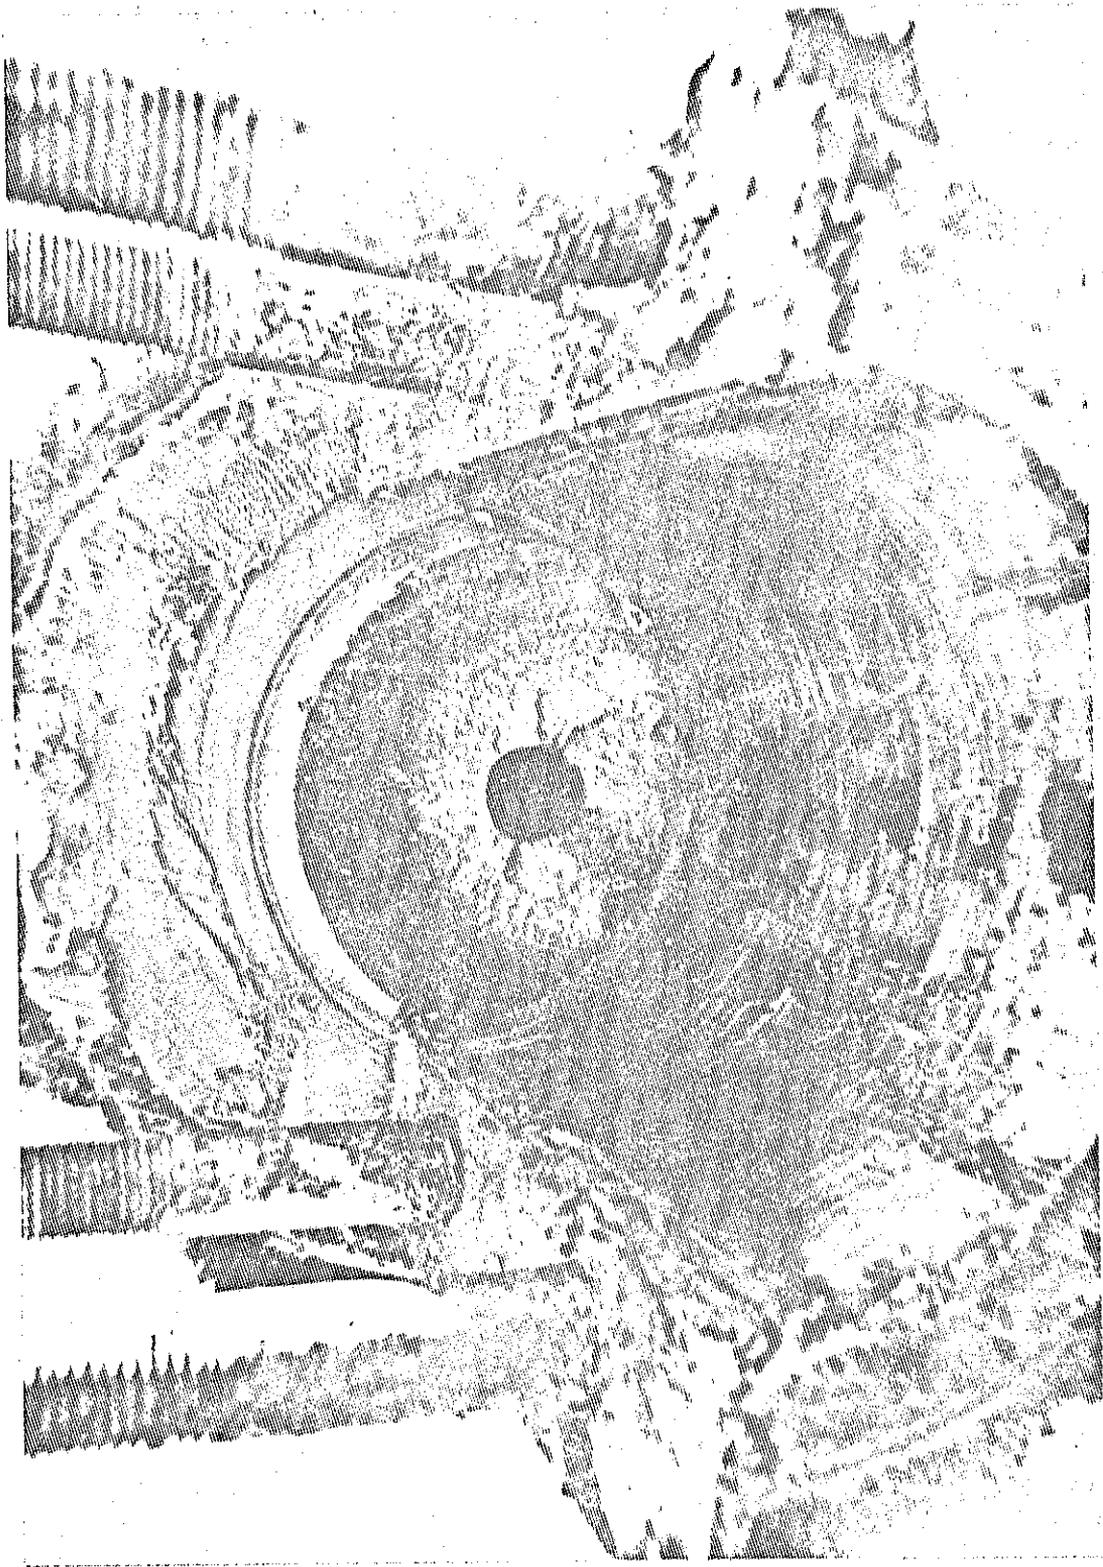
Figure 8. View of fractured trunnion on inboard side of sheave.

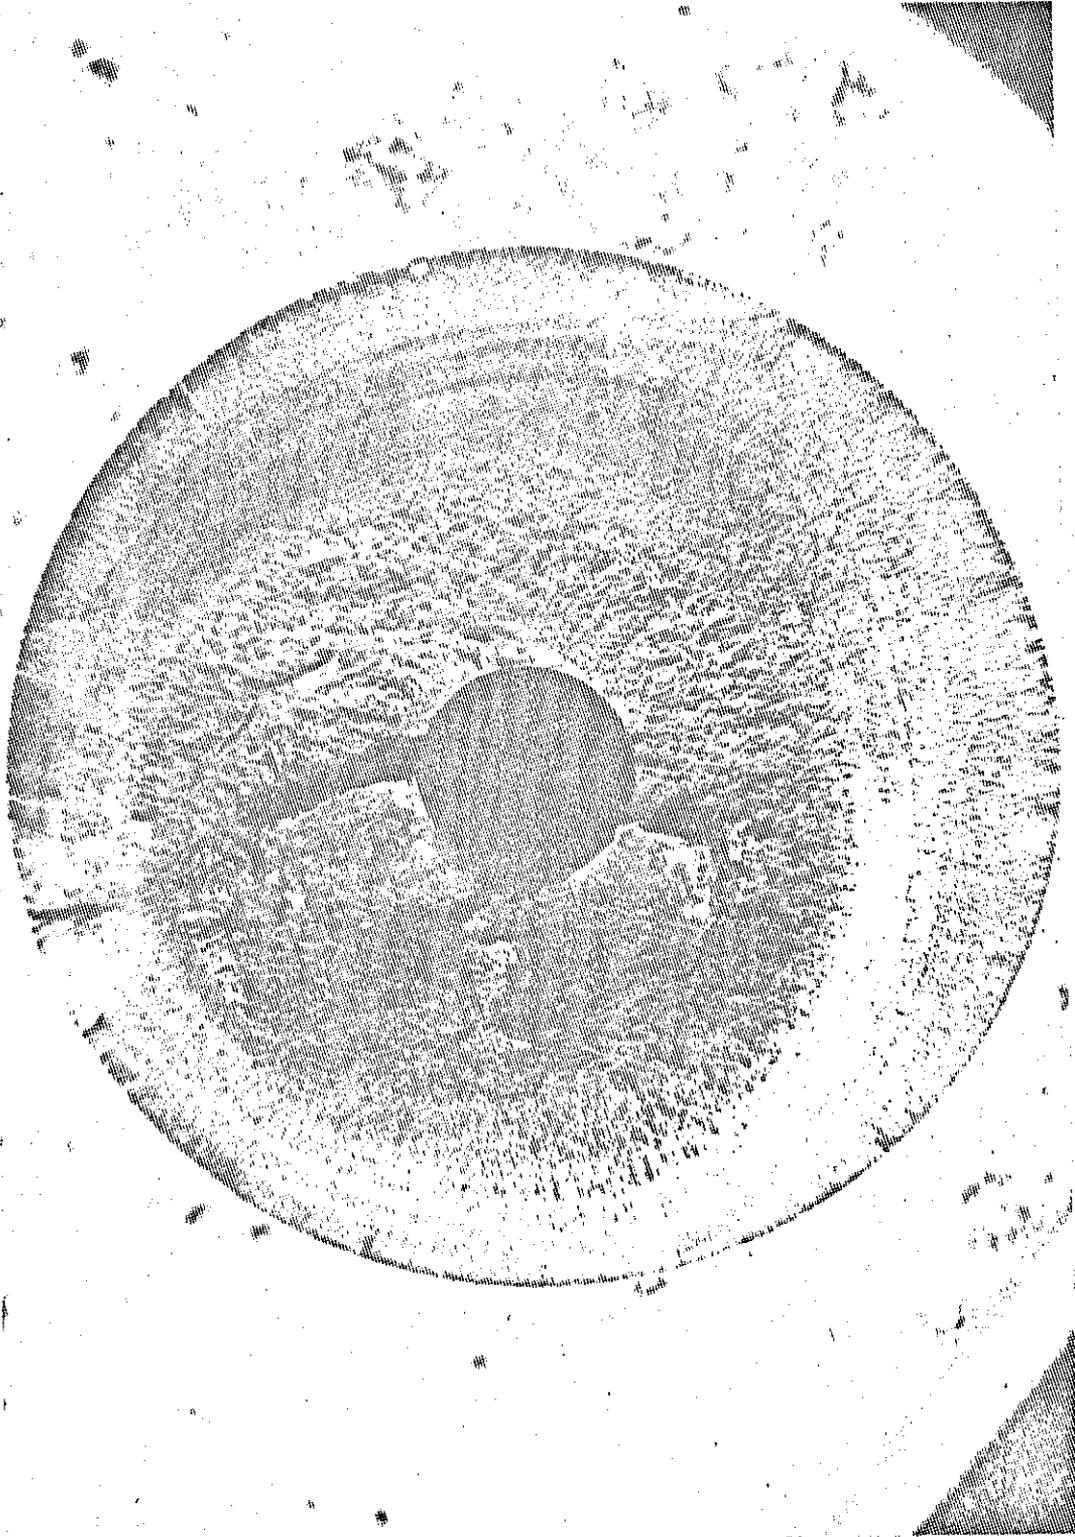
The type of failure encountered with the broken trunnion of the Shippingsport Bridge is a typical fatigue failure resulting from the member being subjected to repeated cycles of complete stress reversal (Figure 11). It is classical failure associated with progressive fracturing as induced by repeated loads. The failure starts with a minute crack and continually progresses until a final break suddenly occurs. The crack, which may occur at one or more points in a member, grows with repeated cycles of high stress at the edges of the crack (Figures 12 and 13). The crack is often induced at a point of high localized or concentrated stress such as in this case at an abrupt change in section (Figure 14).

Figure 11. View of fractured trunnion.

The mechanics of failure associated with the fractured trunnion on the Shippingsport Bridge were induced by propagated fatigue cracking which became critical after about 600,000 cycles of complete stress reversal. The major contributing factor initiating the failure was the development of high concentration of stresses in the critical fillet areas resulting from an abrupt change in section in the configuration of the trunnion.

Two approaches were considered in the redesign of the trunnions. One approach involved refitting the trunnion supports with new bearing blocks and saddles that would accommodate a straight shaft with no change in section. However, to economize the repair cost and to minimize the time required for the remedial work, a decision was made to use the present configuration with

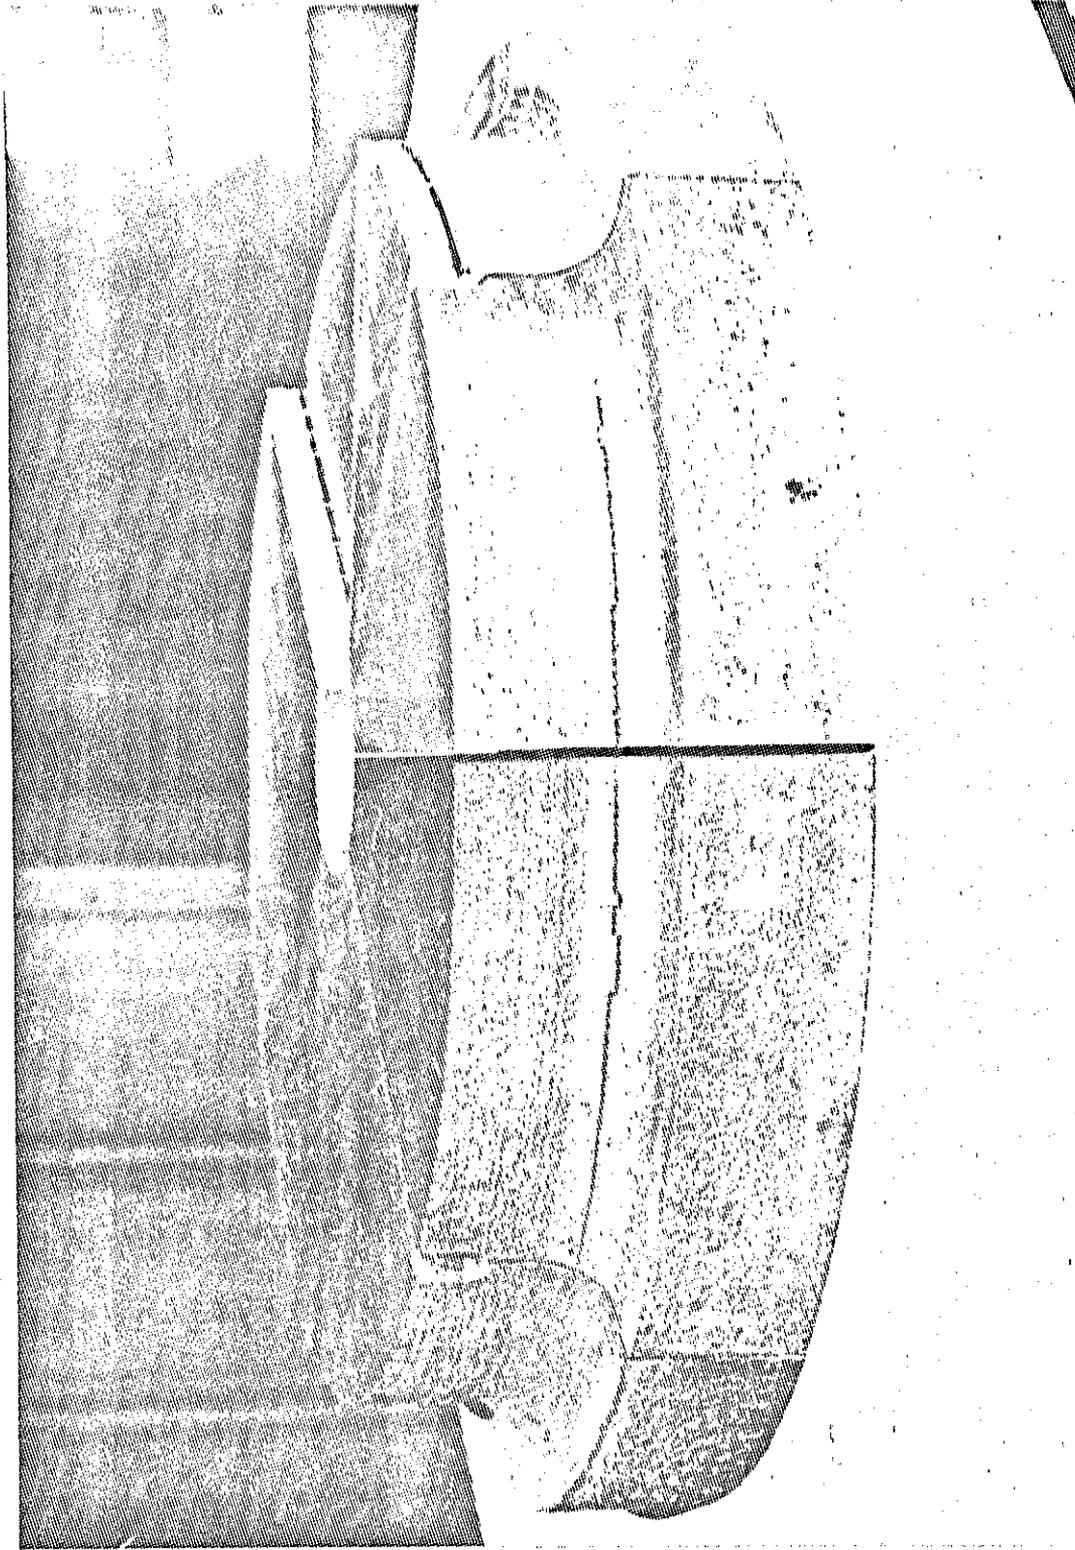
Figure 12. Cut sections of trunnion showing fatigue crack at opposite end of trunnion.

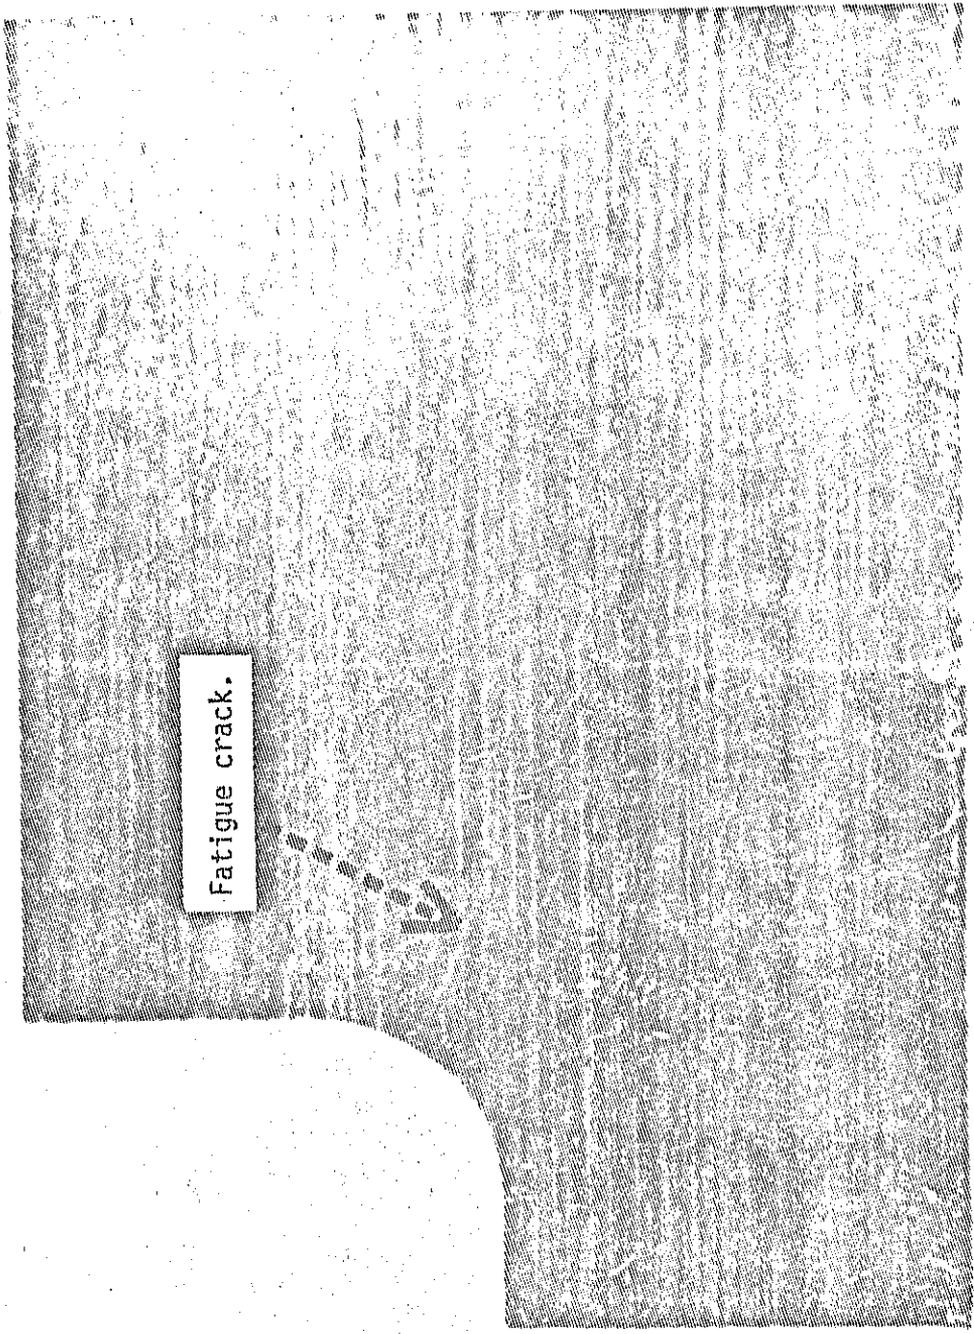
Figure 14. Side view of cut section showing penetration of fatigue crack.

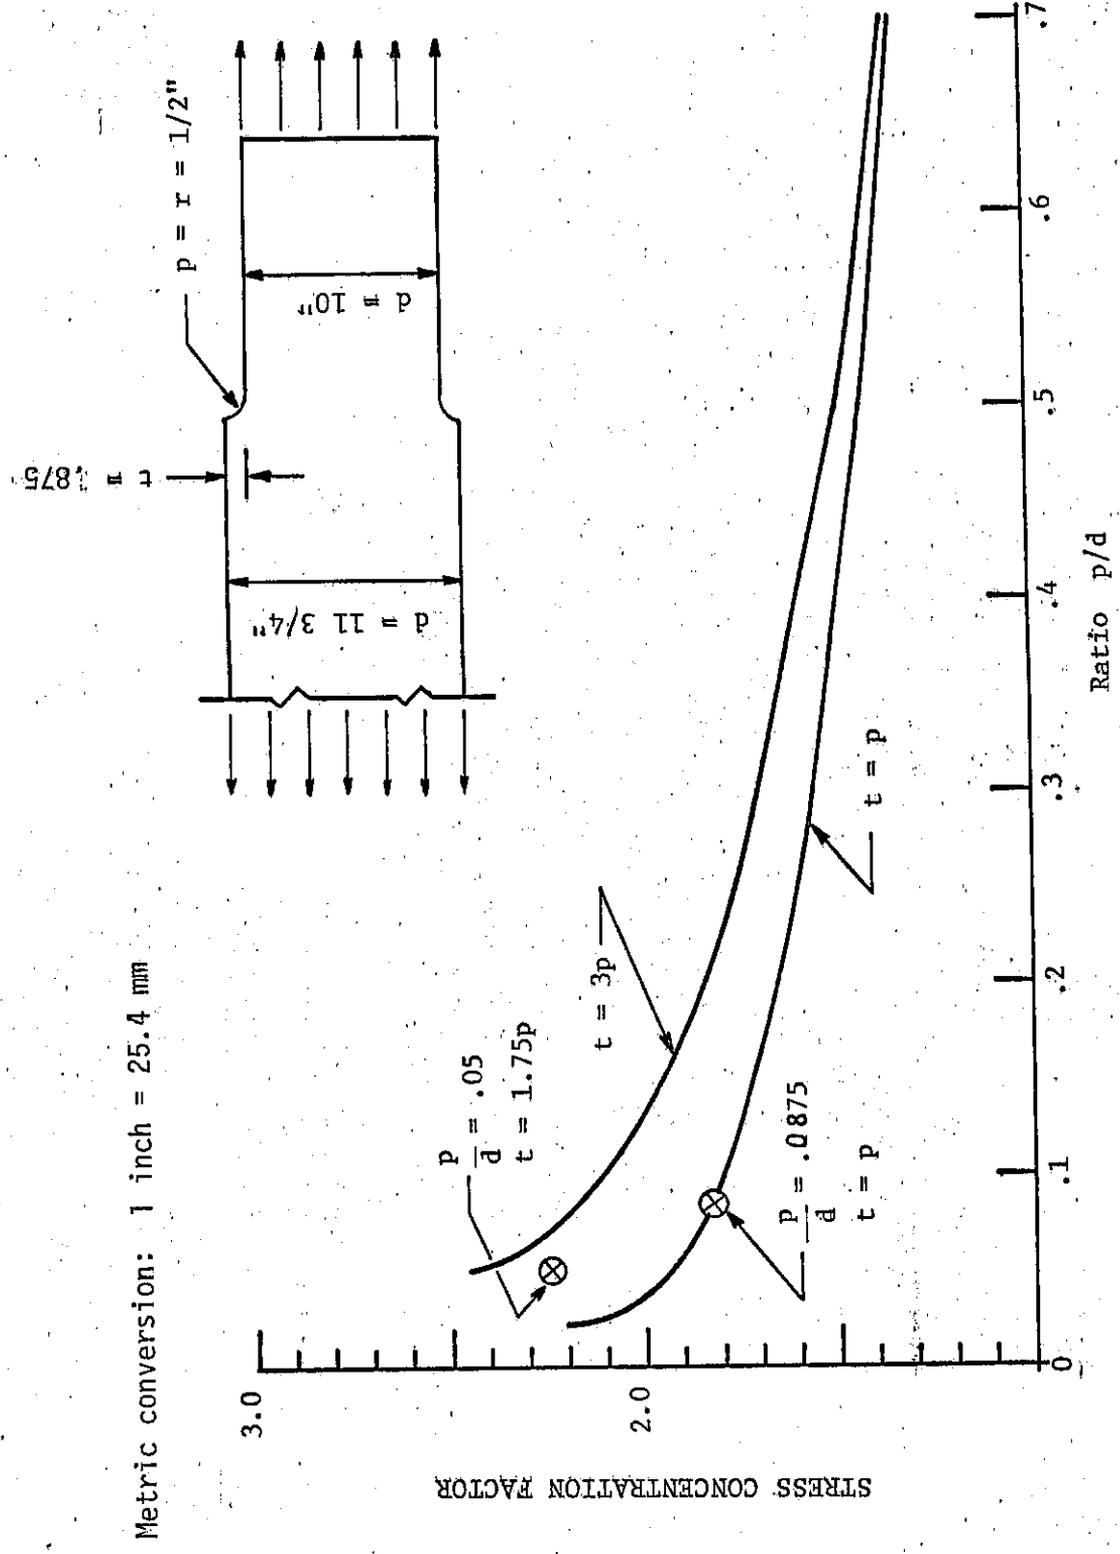
A typical plot of stress concentration factors based on flat sections with uniform stress distribution is shown in Figure 15. The data are based on photoelastic studies reported by Frocht. Although the data used for plotting the curves may not be entirely representative of the true stresses developed across the fillet, they are somewhat indicative of the high localized stress conditions that are probably occurring within trunnions that are designed with an abrupt change in section. The curves show that the stress concentration factor also becomes highly critical when the p/d ratio is less than 0.1. For a fillet radius p equal to 1/2 inch (12.7 mm) the p/d ratio for the trunnion that failed is 0.05, which could result in a stress greater than twice the nominal stress across the reduced section. The plot also shows the effect of increasing the fillet radius to 7/8 inch (22.2 mm) where $t = p$ and $p/d = .0875$. By increasing the fillet radius to the

Figure 15. Theoretical stress concentration factors for fillets.

maximum that could be accommodated by the original configuration, the localized stresses within the fillet could be reduced by as much as 30 percent.

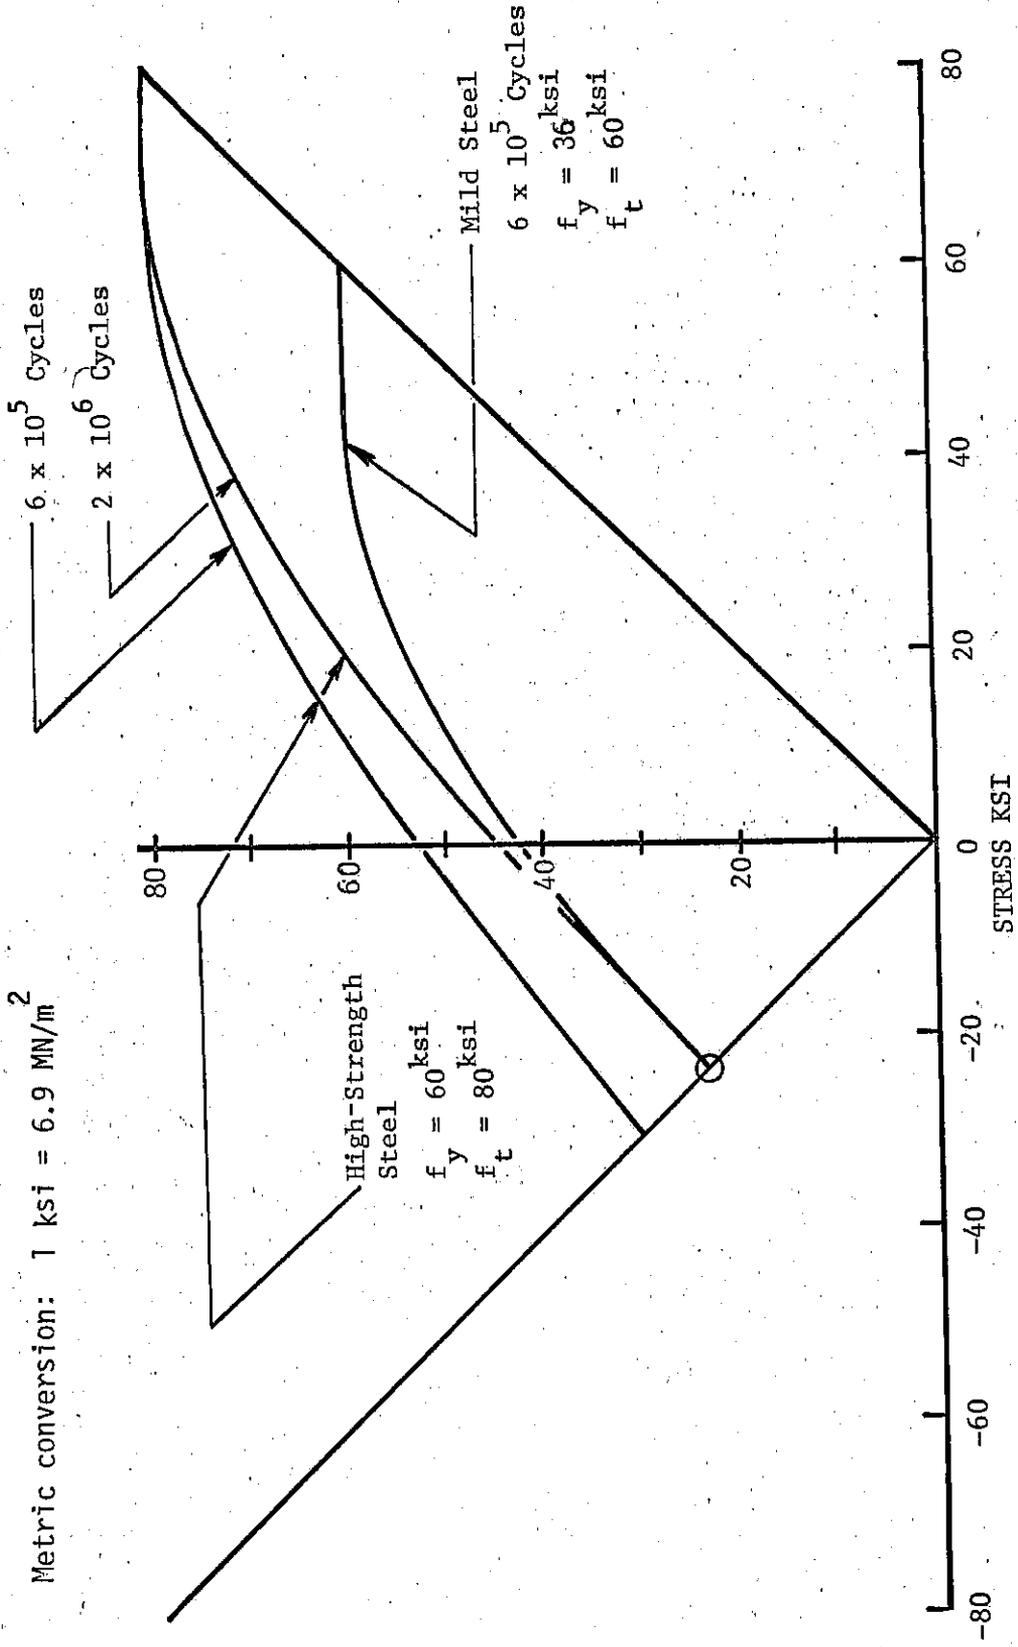
The effect of high stress reversals in relation to the fatigue life of mild steel is shown in Figure 16. Considering that the pulley is 12 1/2 ft (3.8 m) in diameter and that 55 ft (16.8 m) of vertical travel is encountered during a lift, the pulley would rotate 1 1/2 revolutions each time the span is either raised or lowered. Assuming that the lift span has been raised and lowered on an average of 15 times per day with 3 complete cycles of rotation occurring for each lift, over 600,000 cycles of complete stress reversal could have been accumulated over the past service life of 45 years.

The curve relating to the mild steel indicates that cumulative fatigue damage would occur with stress levels near 20 ksi (137.9 MN/m^2). With the stress concentration induced by the abrupt change in section, stresses well above the 20 ksi (137.9 MN/m^2) could be expected. The predicted fatigue life of high-strength steel is shown also in Figure 16. The curve for the higher strength steel shows a fatigue life of 2,000,000 cycles at stress levels between 20 ksi (137.9 MN/m^2) and 30 ksi (206.8 MN/m^2), whereas for the mild steel the fatigue life is about 600,000 cycles at the same level of stress. This relationship indicates that substantial increase in fatigue life at a ratio of about 3 to 1 could be achieved by utilizing a high-strength steel in the design of the trunnion.

Figure 16. Fatigue strength of mild and high-strength steel.

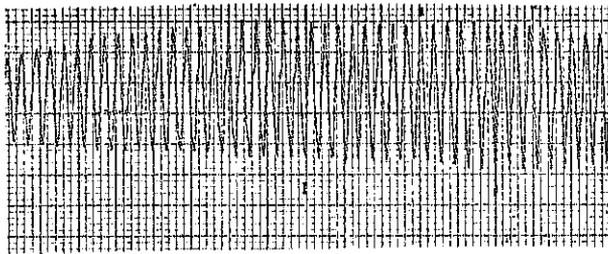
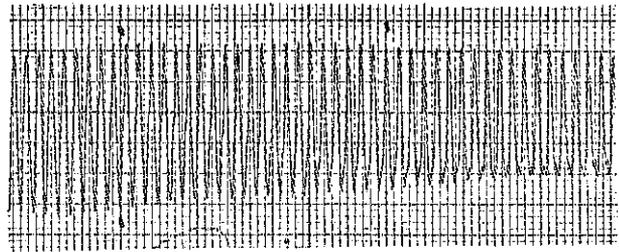
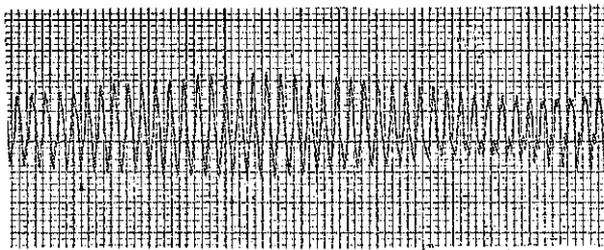
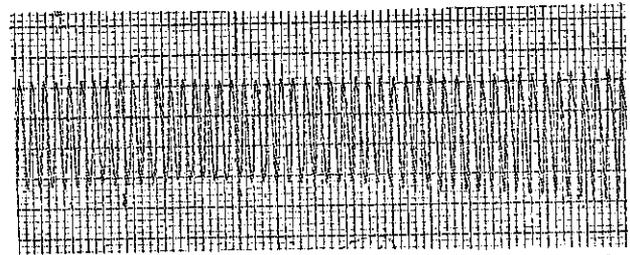
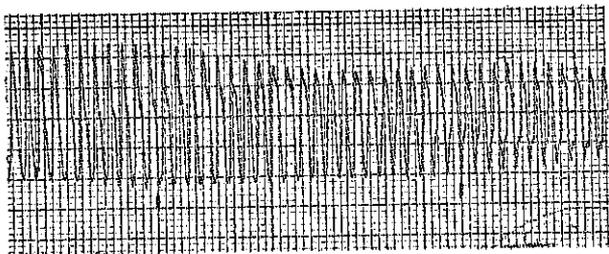
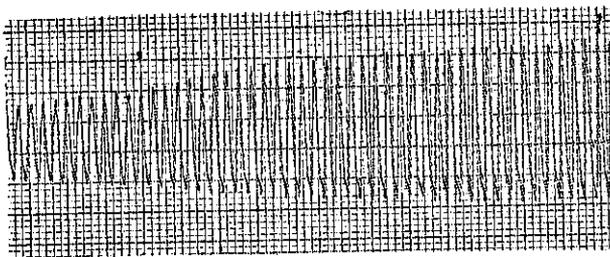
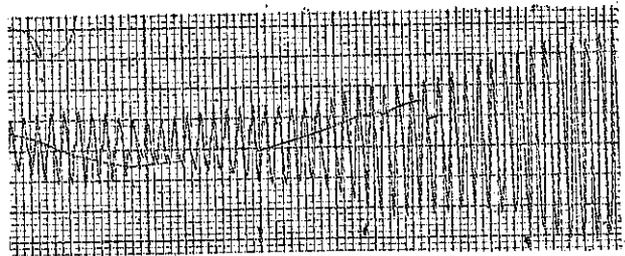
Verification of the loads in the cable suspenders was determined by the theory of harmonic motion. With the length, geometry, and unit weight identical for each cable, the relative load level per cable is directly related to the square of the natural frequency of each cable. An accelerometer (Figure 17) with auxiliary electronic signal-conditioning equipment was used to determine the natural frequency of each cable at one of the four support locations. Strip chart recordings of the accelerometer readings and the corresponding natural frequencies are shown in Figure 18. A summary of cable load factors based on differences in natural frequency is shown in Table 1. The maximum variation in load for a given cable was 18 percent. The data also indicate a slight unbalance in load across the pulley, which may have a slight effect in the bending stresses induced in the trunnion. An analysis of the load factors indicates about ± 6 percent variation in stress due to the unbalanced loading.

Figure 18. Strip chart record showing accelerometer measurements of cables at northwest tower.

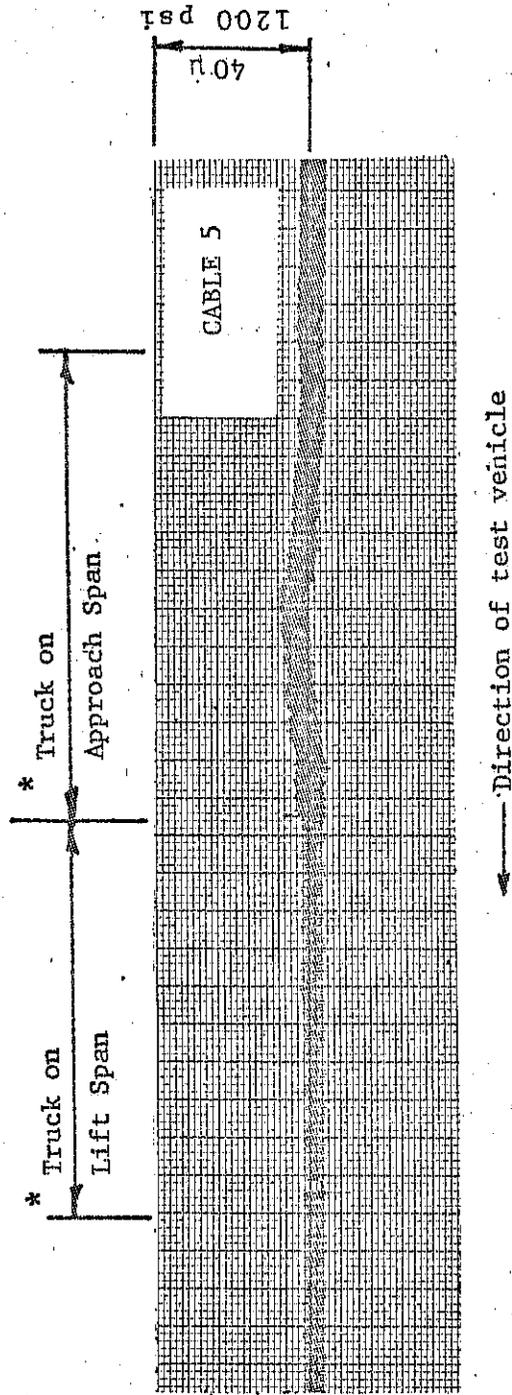
Strain gages were applied on two cables (Figure 19) at the same support location where the accelerometer measurements were taken. These gages were used to study the effect of live loads and loads induced while raising and lowering the lift span. A loaded truck with a gross weight of 72 kips (320.3 kN) was used as a test vehicle to evaluate the effect of live loads due to truck traffic. The test vehicle was operated at various speeds from a crawl to 30 mph. A typical strip chart recording of strain measurements at a test speed of 30 mph is shown in Figure 20. Analysis of the recording indicates about a 3 percent increase in load through the suspender cables

Figure 20. Strip chart record showing strain measurements during live load test.

while the test vehicle crossed the approach span which supports the lifting towers. The recording also shows little or no effect with the test vehicle on the lift span.

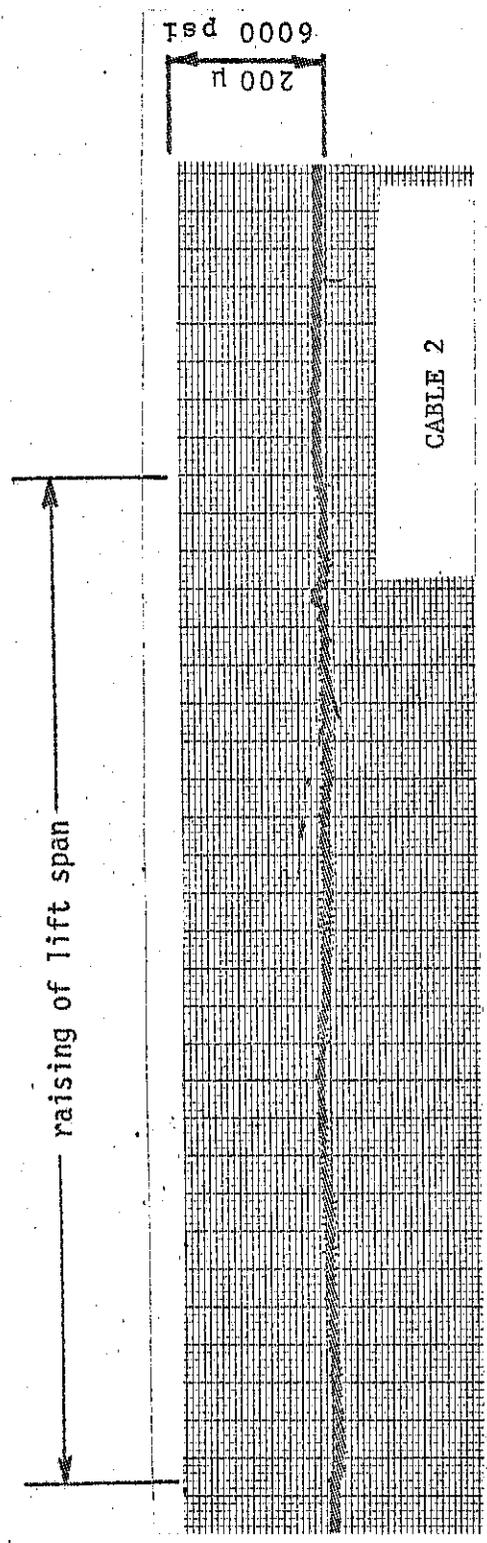
Strain measurements were taken during the normal operation of raising and lowering the lift span. Figure 21 shows a typical strip chart recording of measured strains induced while raising the lift span. The data indicate about a 4 percent increase in load under normal operation of raising or lowering the lift span.

Figure 21. Strip chart record showing strain measurements when raising the lift span.
