State of Illinois
DEPARTMENT OF TRANSPORTATION
Bureau of Materials and Physical Research

Bridge Deck Condition Survey

Final Report

IHR-306

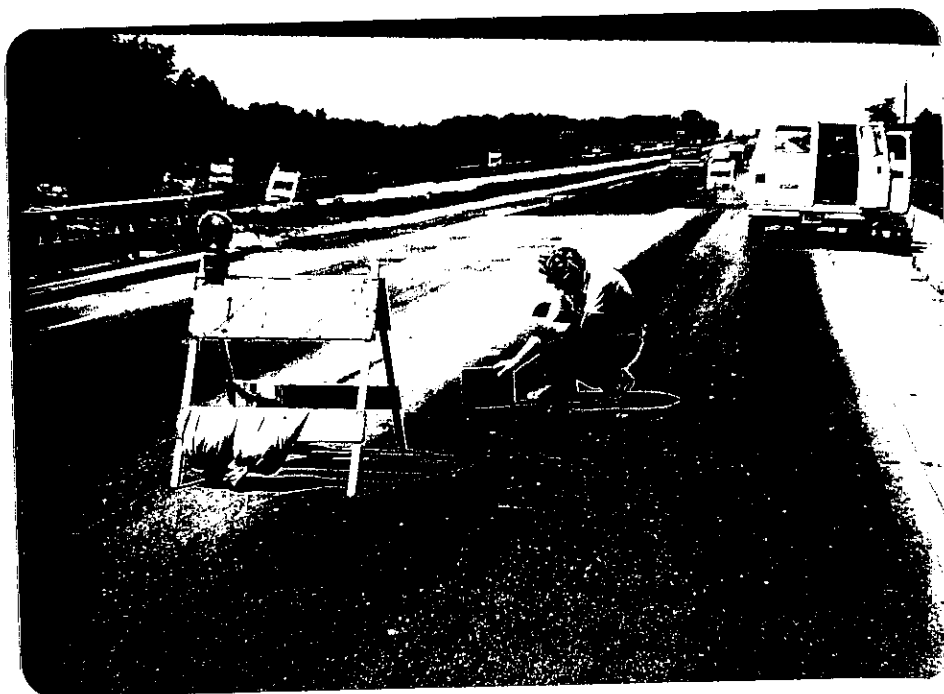
Figure 4. Dish-shaped depression

Dish-shaped depressions were observed to some extent in the surfaces of 15 of the 20 structures (Figures 4a and 4b). Although they detracted from the riding quality of the new surface, the author failed to see the significance of the depression during the 1979 survey. They were not quantified, tabulated, or mapped.

The "Y" cracks were in dish-shaped depressions. The length of each leg of the "Y" was about equal and was proportioned to the size of the dish. The junction of legs is located in roughly the center of the dish.

4a. General location of depression

4b. Close-up view of depression

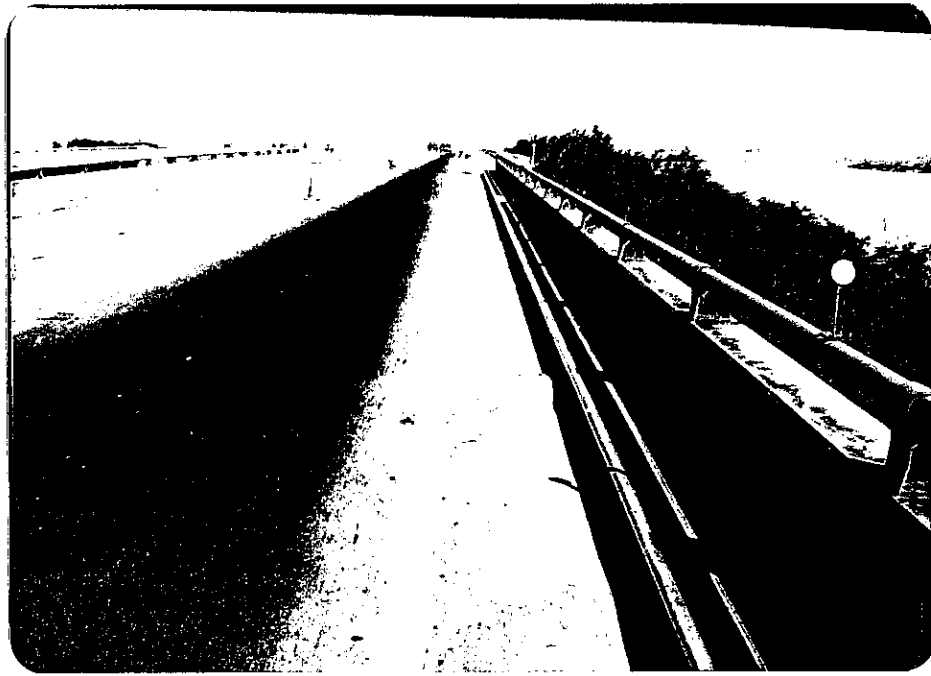
Figure 6. Patch failures, 1980

On structure 57-0018 a new hump had formed about 20 feet south of the original hump, and the original hump had grown in size (Figure 6).

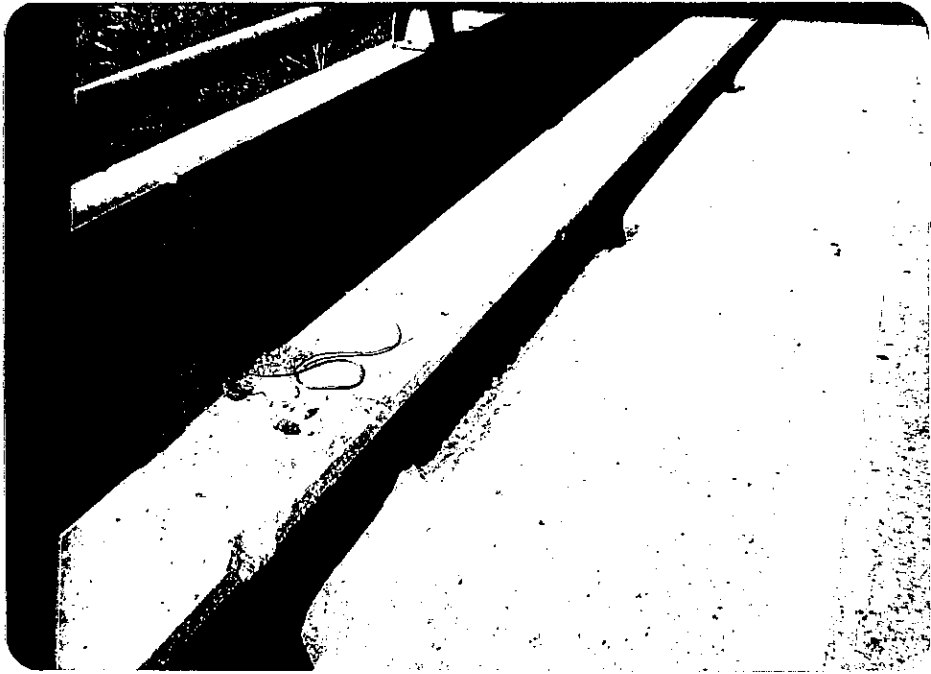
Figure 7. Snowplow damage to hump, 1980

On structure 57-0019, sometime during the winter of 1979 a hump had formed and had been partially cut away by a snowplow along with a strip of surface about 4 inches wide by 5 feet long (Figure 7).

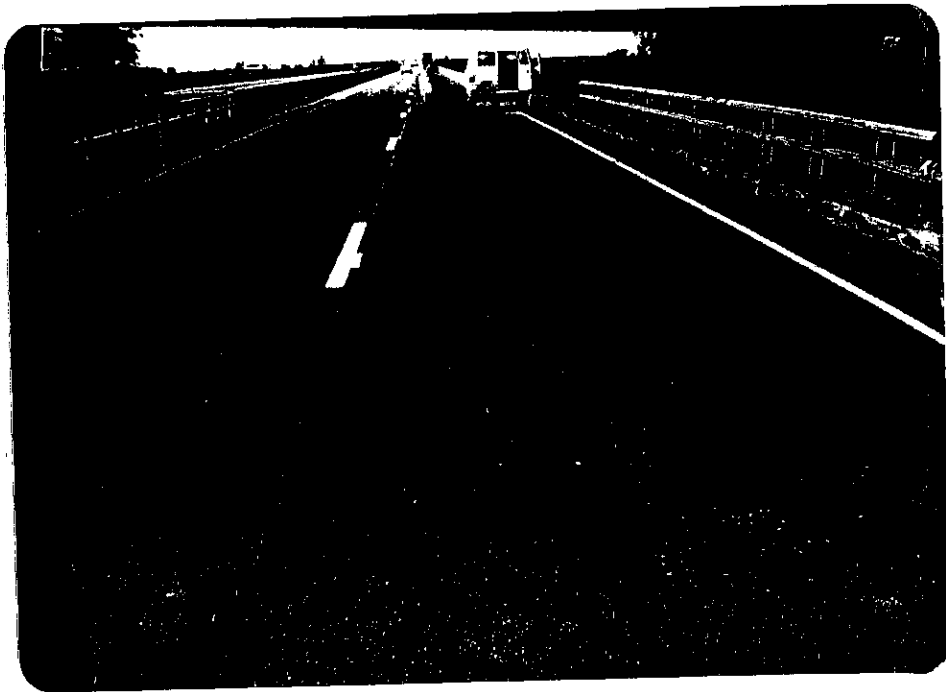
Figure 10. Delaminated area of Structure 10-0002 in 1979

On structure 10-0002, the delaminated area was nearly 3% initially and increased to nearly 5% over one winter. Large areas of the east and center spans apparently were delaminated. Figures 10a and 10b show the delaminated area outlined. A slurry mix was used to fill the numerous aggregate popouts in the original PCC surface. During 1978 and 1979 it was thought that the slurry had become disbonded and that large areas of the waterproofing and bituminous surface would soon strip off.

The photographs in Figures 11a and 11b were taken in 1980 and are of the same area shown in the 1979 photographs shown in Figures 10a and 10b. Delaminated area is outlined in lumber crayon on the deck surface. The entire area of each span was sounded extensively using delamtect and manually with a hammer (evidenced by the white specks on the surface). Over 4.5% of the delaminated area apparently has rebonded.

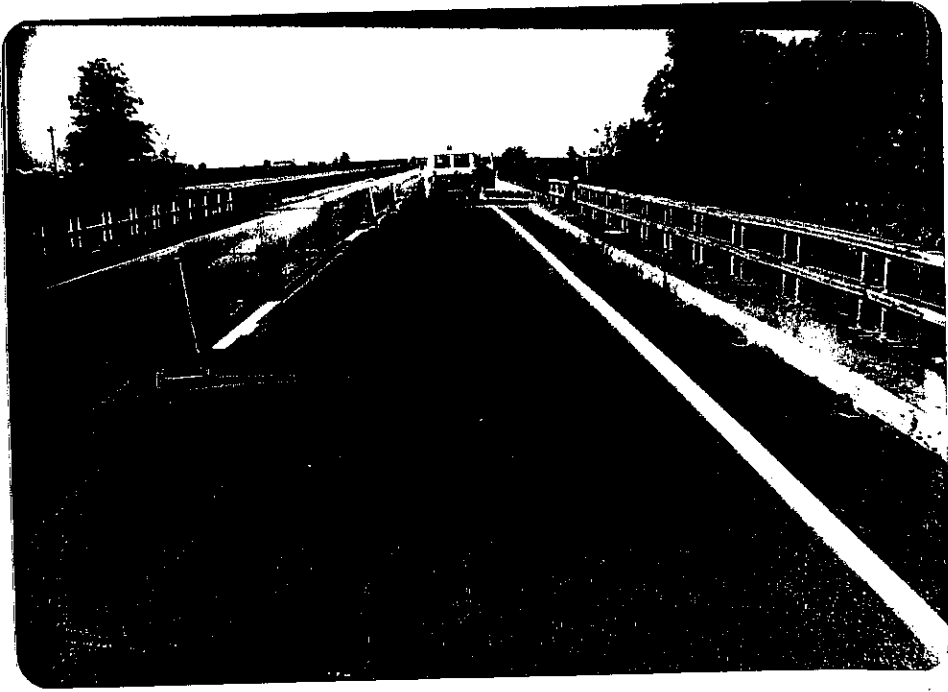
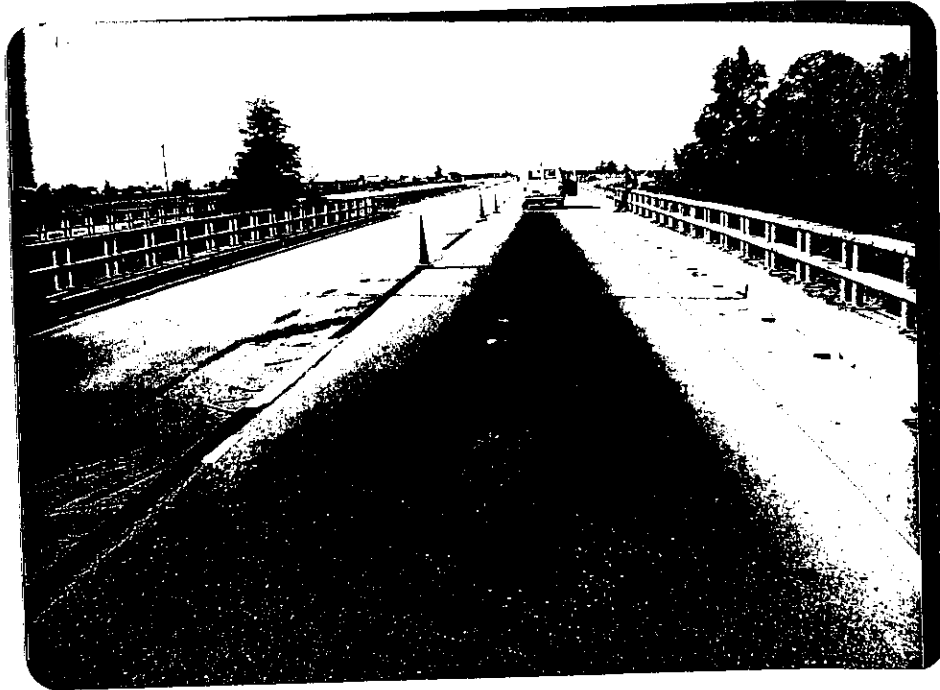
Figure 11. Delaminated area of Structure 10-0002 in 1980

The 1980 delamination survey results show that 18 of the 20 decks had less delaminations than the previous year. Seven decks had no delaminations. The average area was about 0.3%. The average decrease in area was 0.3% on the 7 decks with no delaminations. On 10-0002 the delaminated area dropped from 4.8% to 0.3%.
