From November 29, 2016 FHWA Event Report: Ohio Steel H-Pile Failure

Event Report

Subject: Closure of SR 14 Bridge - Due to H-pile Failure

Location: Streetsboro, OH

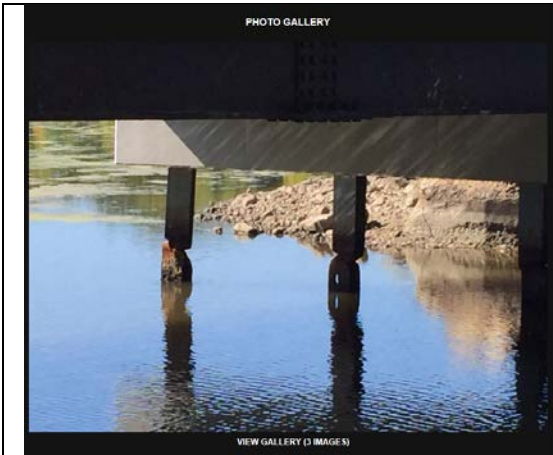
1. News Photo – October 2016 - West pile bent

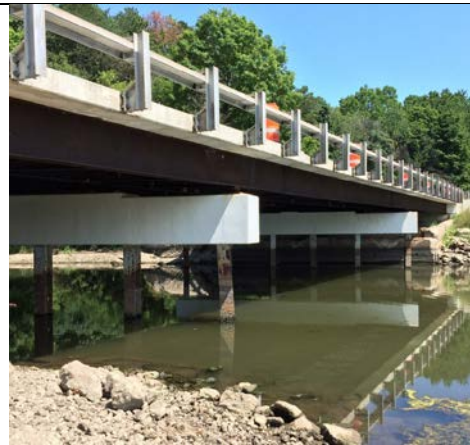
2. ODOT Photo - July 2016 - Facing east

OH Division Office contacted Tim Keller, ODOT Bridge Engineer, who indicated they believe the 12 buckled steel H-piles were likely the result of an overloaded vehicle crossing the structure illegally. ODOT provided a photo from July 2016 showing the piles in rusty but seemingly good condition. As previously stated, the most recent NBI substructure condition rating was "7". The April 2016 bridge inspection report also indicated that 6 of the 12 steel H-piles had "rust at waterline," although there was no indication of section loss or extent of rust. As a follow-up, Mr. Keller contacted the District inspection staff to understand the level of inspection procedures performed. Through his discussions, he believes the previous bridge inspections were conducted appropriately in relation to ODOT inspection guidance but he is taking immediate actions to mitigate a similar future event.
