From February 24, 2017, Closure of I-276 Delaware River Bridge Event Report

Event Report

Subject: Closure of I-276 Delaware River Bridge (PA Turnpike and NJ Turnpike)

Date of Event: January 20, 2017

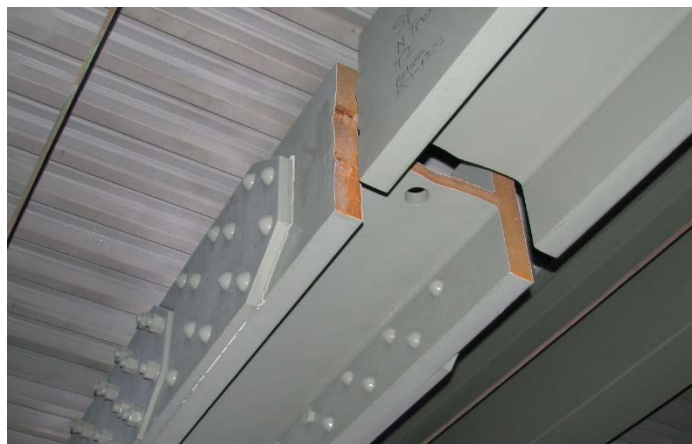
The fracture occurred on the north truss face, on the 16th span, just prior to panel point 19'. The member is designated U19-19' and is a rolled 14WF314 that is weak axis oriented. Figure 3 shows the fracture in the field.

Figure 3 Fracture of U19-19', North Truss, Looking South and East at Panel Point 19', prior to any material sampling. (HNTB)

The only definitive conclusion so far is that this was a brittle fracture, which initiated in the heat affected steel around the partially weld-filled holes.

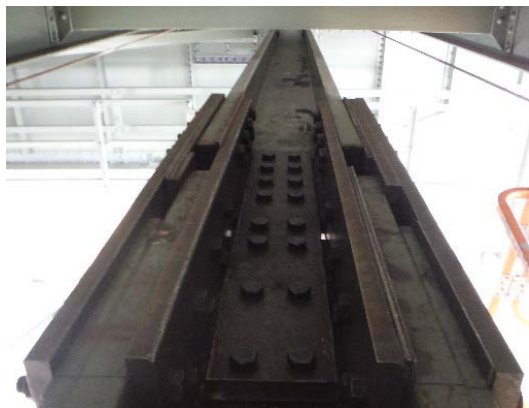
Figure 4 Splice plates on U19-19', looking west from panel point 19'. (HNTB)

At the site of the fracture, the consultant measured approximately 1" of lateral misalignment, 0.75" of vertical misalignment and 2.5" of longitudinal displacement. The contractor shimmed the splice plate to make a flush connection, not attempting to bend the member or otherwise restore geometry. Samples were torch cut from each fracture face for metallurgical analysis by Lehigh University.

The bridge and the local roads running under the damaged 4-span unit on the PA approach were immediately closed. The consultant's immediate concern was the continued stability of the bridge. With weather forecasts for Monday, January 23rd calling for high winds (30-40 mph sustained with 60 mph gusts), the painting contractor was directed to remove the paint tarps, suspended platforms, and any stored materials from this and adjacent spans, to reduce potential wind loading. In order to provide some member continuity and establish a comfort level with safe worker access, the consultant designed and fitted temporary web and flange splice plates over the fractured member. The splicing operation was completed early Sunday morning. The splice is shown in Figure 4.

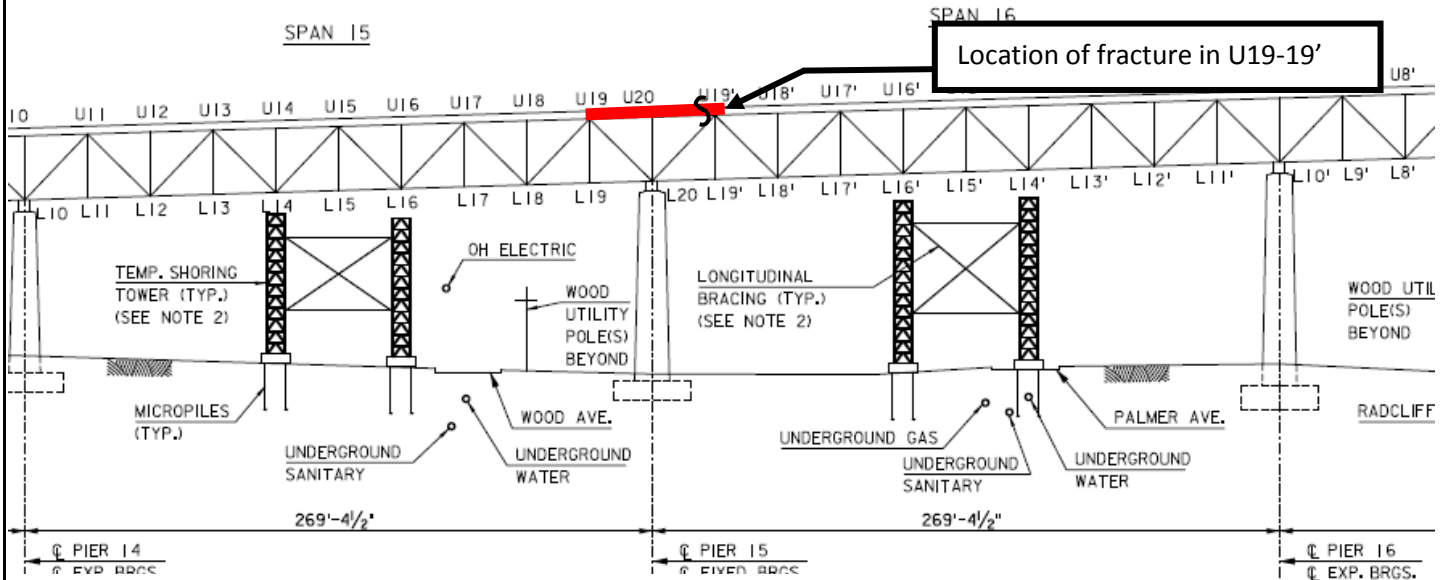
Figure 5 Shoring Tower locations, elevation looking north (HNTB)

The consultants also began designing shoring towers, to be placed in positive moment locations on either side of the pier, as shown in Figure 5. The lower chord of the truss is about 80' off the ground at this pier. They were designed to serve as a catch should the truss fail, but also provide a platform for potential jacking during the repair. A typical section is shown in Figure 6.

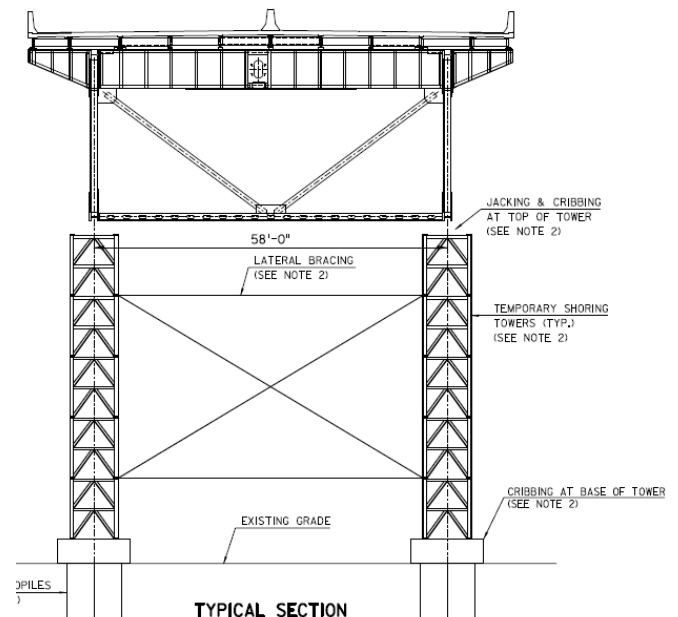
Figure 6 Shoring Tower typical section, looking east

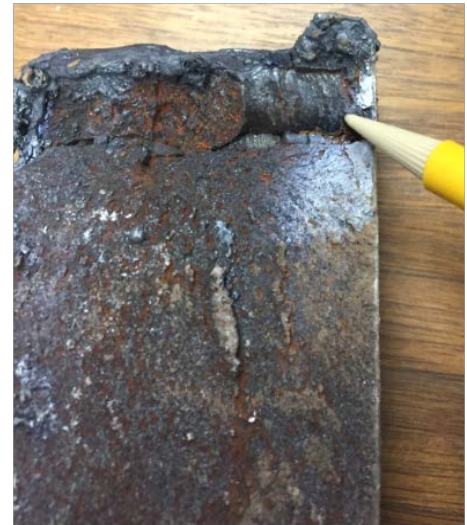
Initial visual assessment by Lehigh University indicated that the north flange of the failed member has two additional shop-reamed holes that are not present in the south flange, just past the edge of the adjacent cover plate. The holes line up with the cover plate rivet lines, so the current thought is that these holes are a fabrication error. It appears the holes had weld material placed in them and ground smooth at the surface. The weld material inside the hole did not really penetrate the surrounding steel, but is likely that the steel properties around the holes were affected by the heat of the weld material. The fracture initiated at the site of these holes and was brittle in nature, with no indication of fatigue. These holes have been called plug welds, but we note a more accurate descriptor would be weld-filled holes.

Figure 7 Sample taken from North Flange fracture surface. (HNTB)

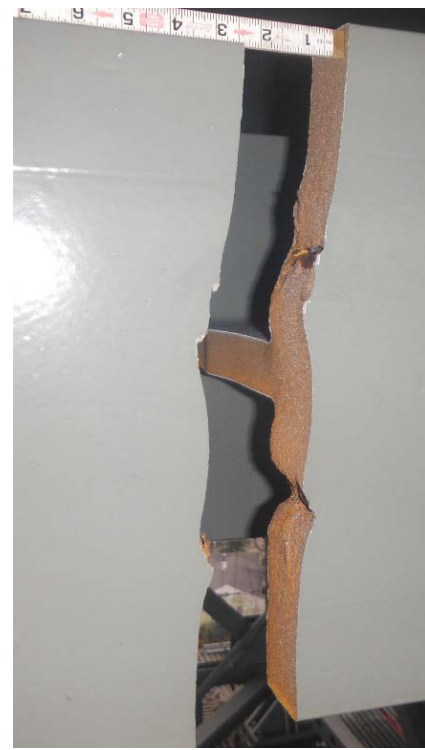
Figure 8 Close-up of north flange fracture face. (HNTB)

Charpy v-notch tests were run at 40 degrees and 0 degrees F, with 40 degree results averaging 21 ft-lbs and 0 degree results averaging 7 ft-lbs. These results are low compared to modern steel; however, there was no specification for Charpy toughness at the time the bridge was constructed. Yield strength was

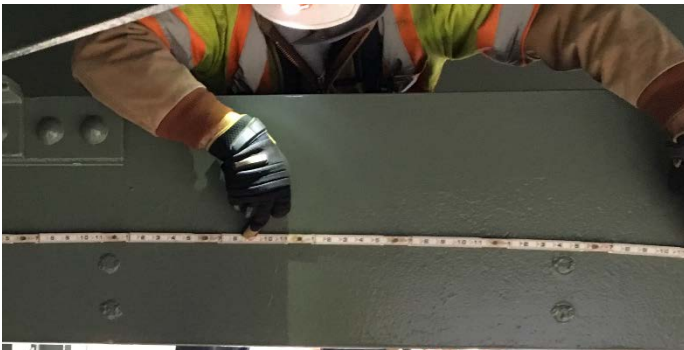
Figure 9 Tack-welded rivet shanks, member U19-19', near PP20 (HNTB)

both approaches where there are holes in the inside flange with rivet shanks filling the holes, as shown in Figure 9. The rivet heads have been removed and the top of the rivet tack welded over. It's unknown what the purpose was of these holes, if they are further fabrication errors or erection holes, or something else. These defects were not noted on the 2014 FC inspection, despite being in the FC top chord. These locations will be repaired prior to opening the bridge, by drilling out the rivet shanks, overdrilling the hole to remove the heat affected steel, then painting.

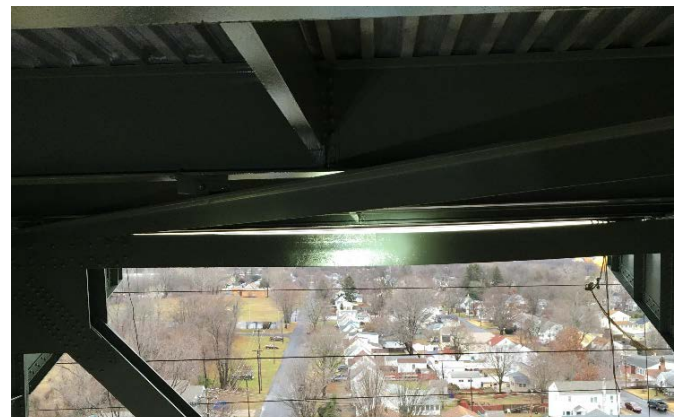
In the next span beyond the fractured member, the top chord U19'-17' has an elastic buckle or bow, as shown in Figure 10. This is not unexpected since the member is relatively small (14WF87) and went into compression after the fracture. Some of the stringers have lateral displacements, and several of the stringer/floorbeam connections in these spans were broken but do not appear to have been designed structural connections.

Figure 10 Elastic bowing in U19'-17', between panel points U19' and U18'. (HNTB)
