Illinois Department of Transportation

CIRCULAR LETTER 2010-09

BRIDGES WITH GUSSET PLATES, FRACTURE CRITICAL MEMBERS OR HOAN DETAILS

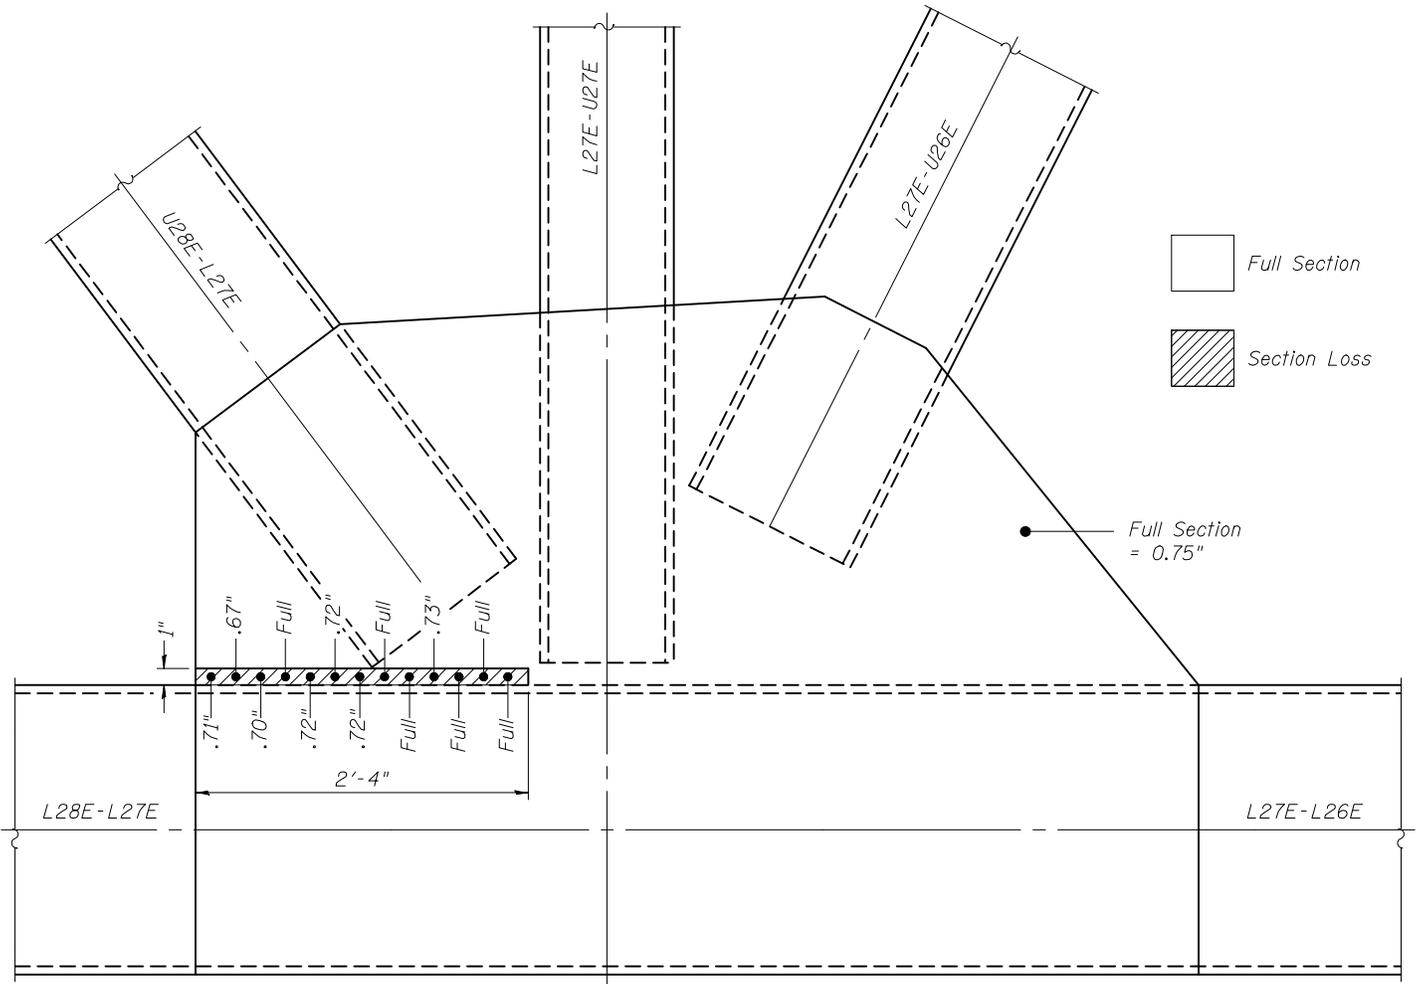
SECTION LOSS EXAMPLE 2
OUTSIDE GUSSET PLATE

Attached are examples of gusset plate section loss documentation. A photo should be taken of both sides of all gusset plates, i.e. typically both sides of both gusset plates (minimum 4 photos) at each panel point location. Photos of the interior face of the gusset plates may be difficult to take and/or may not show the entire interior surface, but they should still be taken.

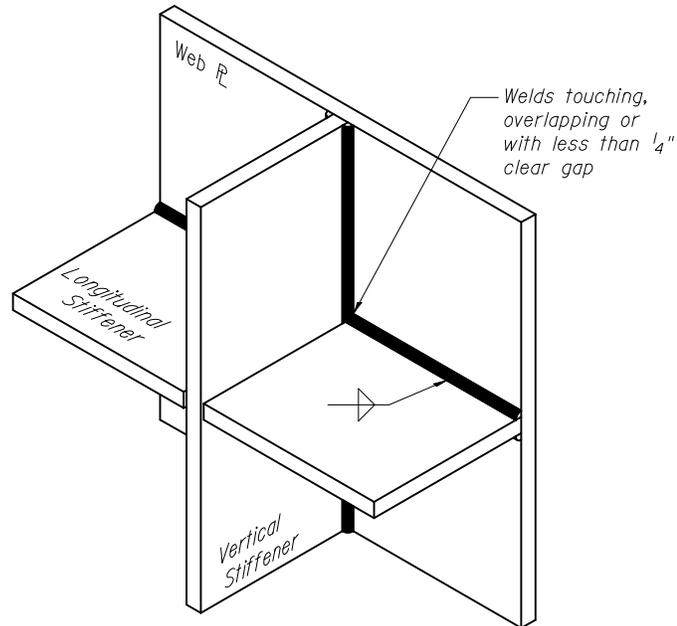
Research shows the gap between the longitudinal and transverse welds is the most important parameter in determining the vulnerability of this type of detail. Details with less than ¼-inch separation between welds create a condition of high constraint. When the gap is greater than ¼-inch, the constraint of the web plate is relieved, and the risk of constraint-induced fracture is much less of a concern.

Longitudinal stiffener terminations in areas of the web subject to tension are vulnerable to constraint-induced fracture if there is insufficient weld clearance.

in the attached examples on future NBIS inspections. Typically, these details will be found on structures with main spans exceeding 120-feet in length, which may require longitudinal web stiffeners and/or wind bracing. If found, information should be provided to the Bureau of Bridges and Structures for assistance and determination of course of action. Depending on the configuration, web gap and condition of the detail, a special feature inspection may be initiated or a retrofit may be recommended.

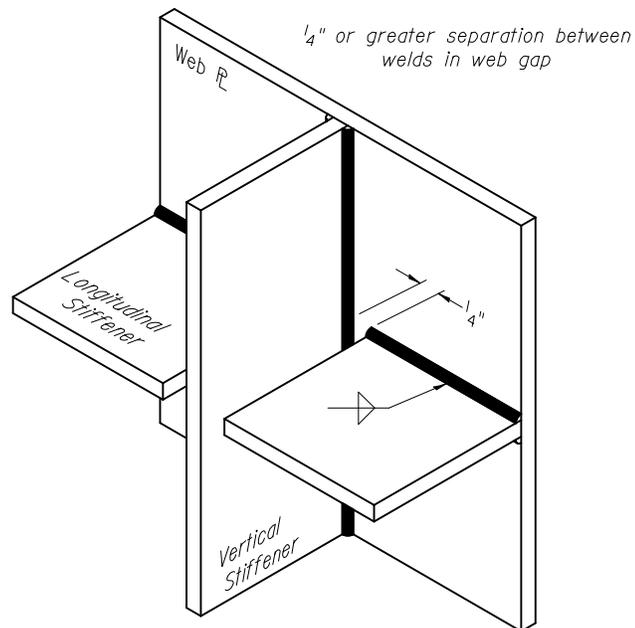
Longitudinal stiffener terminations with 1/4" or greater clear gap between welds present a low risk for constraint-induced fracture.

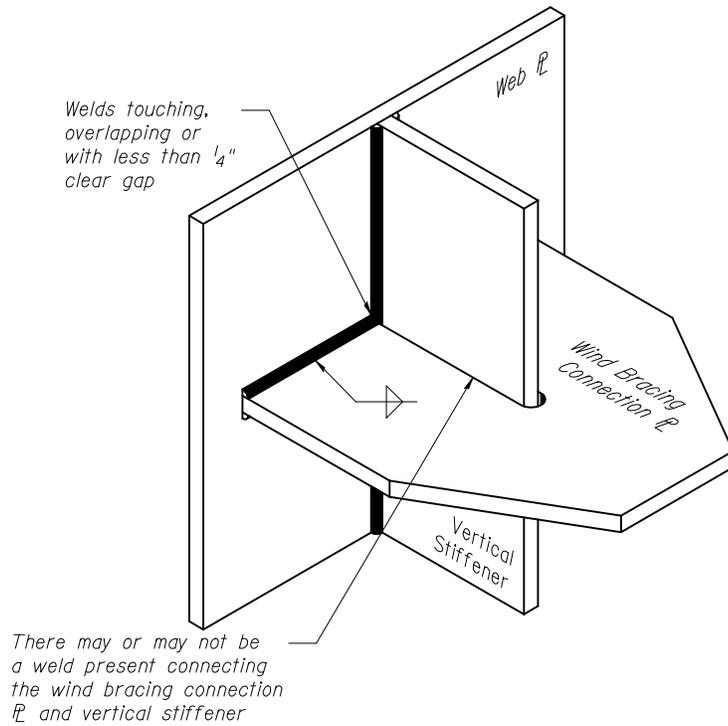
Wind bracing connection \mathcal{F} 's in areas of the web subject to tension are vulnerable to constraint-induced fracture if there is insufficient weld clearance.

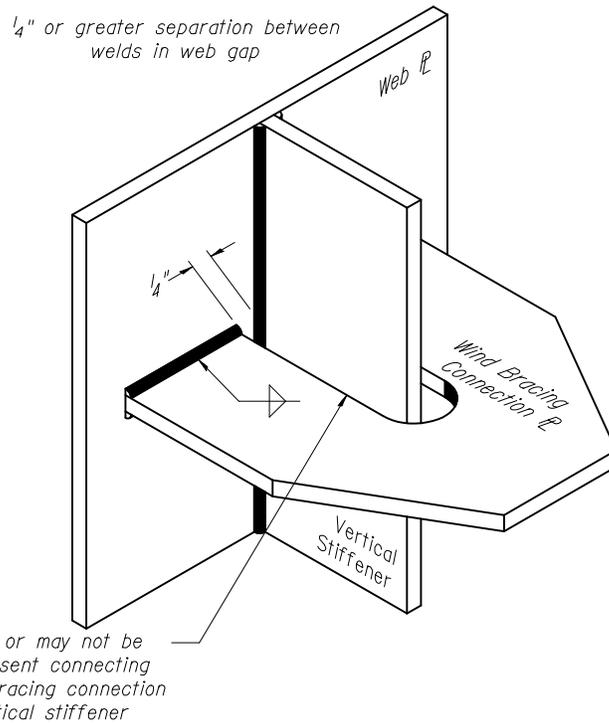
Wind bracing connection \mathcal{F} 's with $\frac{1}{4}$ " or greater clear gap between welds has a low risk of constraint-induced fracture.
