Open Graded Drainage Layer Performance in Illinois

**FINAL REPORT
PHYSICAL RESEARCH REPORT NO. 147
AUGUST 2004**

Illinois Department of Transportation

Final Report

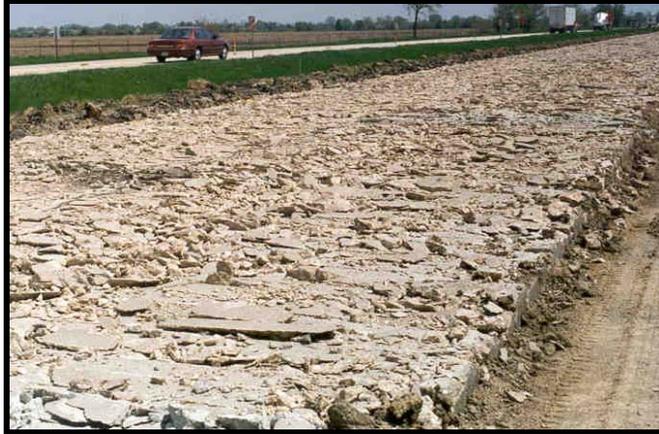
Figure 3

Broken Pavement Prior to Removal

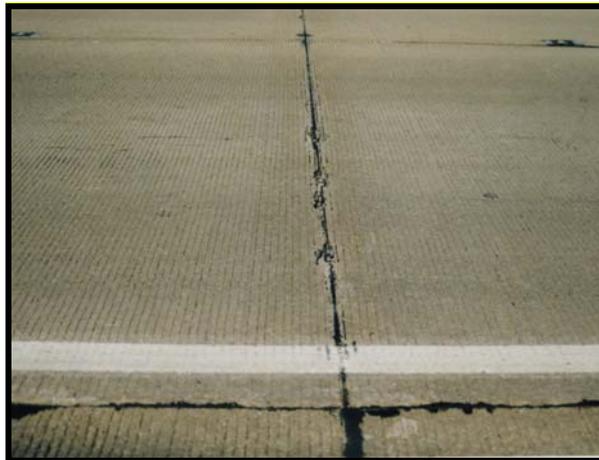
The project on Interstate 39 at Bloomington is a 10.75-inch hinge jointed plain concrete pavement on a 6.0-inch CTOGDL built in 1989. This project has performed very well to date. The 2003 visual distress survey indicated that three joints showed some minor spalling, as shown in Figure 9, and two joints indicated an adjacent crack. Approximately 50 percent of the joints also exhibited a fault of 0.13 inch, or less. There are a total of 81 pavement joints in the test section.

Figure 9
Minor Joint Spalling

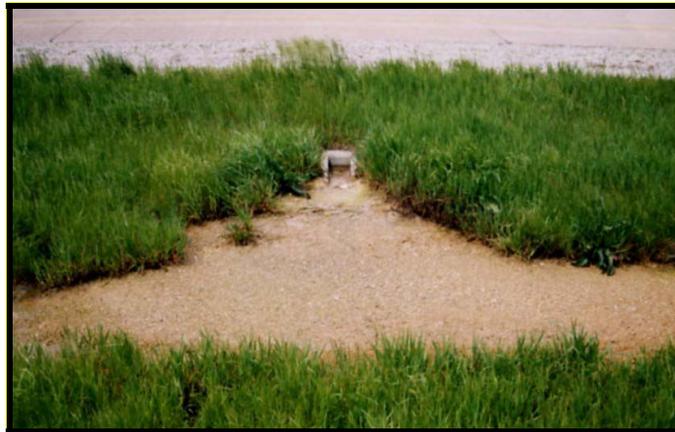
Figure 22

In 1999 a large portion of the southbound lanes in the area of CTOGDL placed directly on lime modified subgrade was undersealed. The undersealing process was aimed at filling the voids of the OGDG to prevent further intrusion of the subgrade fines. At the same time, the undersealing was used to lift the pavement and correct the lane to shoulder settlement which had occurred in several areas. In all, nearly 2,300 square yards of pavement were undersealed in the southbound lanes, and 150 square yards in the northbound lanes. The pavement was raised an average of 0.80 inch, and as much as 1.75 inches in one location, to correct the settlement. One side effect to undersealing the pavement was the filling of the underdrain system and the outlets. Several of the median underdrain outlets of the southbound lanes were filled as shown in Figure 22. Ironically, the outside shoulder underdrain outlets at the same locations were not filled.

Sealed Median Underdrain Outlet on I-39 at El Paso

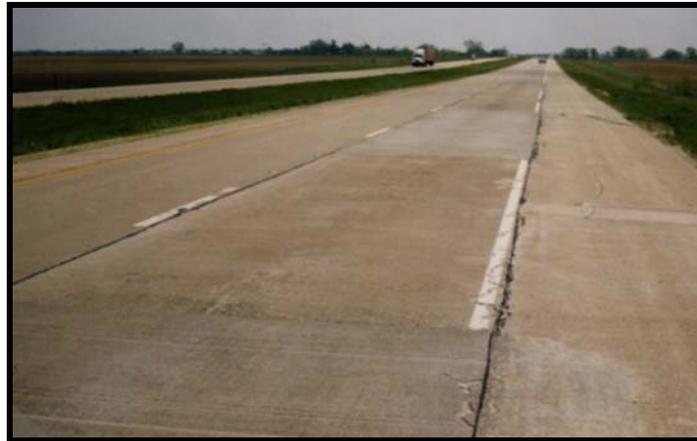
In addition to the undersealing, numerous full-depth concrete patches have been placed throughout the project in the driving lane. All of the patches for the entire project length were recorded as part of the 2003 visual distress survey. These patches were placed between the years of 1994 and 2002, with the majority of the patches placed in 2001. Figure 23 illustrates an area of the southbound lanes that has been patched several times.

Figure 23
Patching on I-39 at El Paso

The OGDL section placed on the 3-inch aggregate separation layer has had approximately 468 square yards patched, or roughly 0.42 percent of the total pavement area. The OGDL section placed directly on the lime modified subgrade has had approximately 2,240 square yards patched, or roughly 1.43 percent of the total pavement area. There are several areas within this OGDL section that have been patched and re-patched several times over the last eight years.

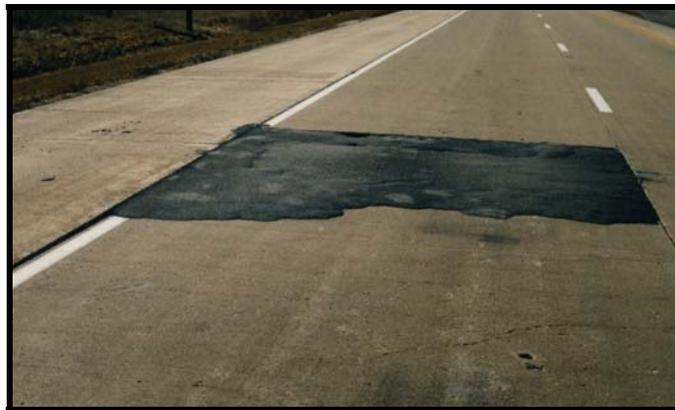
In addition to the undersealing, several full-depth concrete patches have been placed throughout the project. All of the patches for the entire project length were recorded as part of the 2003 visual distress survey. The westbound lanes have had approximately 35 square yards patched, or merely 0.04 percent of the total westbound pavement area. The eastbound lanes have had approximately 309 square yards patched, or roughly 0.35 percent of the total eastbound pavement area. Figure 24 illustrates a bituminous patch that has been placed within an area of depression in the eastbound driving lane. Lane-to-shoulder and lane-to-lane settlement was noted at this area during the final distress survey.

Figure 24
Bituminous Patch on I-80
