**EVALUATION OF HIGH PERFORMANCE  
CONCRETE BRIDGE DECKS  
AND  
OTHER EXPERIMENTAL BRIDGE  
DECKS THROUGHOUT ILLINOIS**

**PHYSICAL RESEARCH REPORT NO. 166  
December 2017**

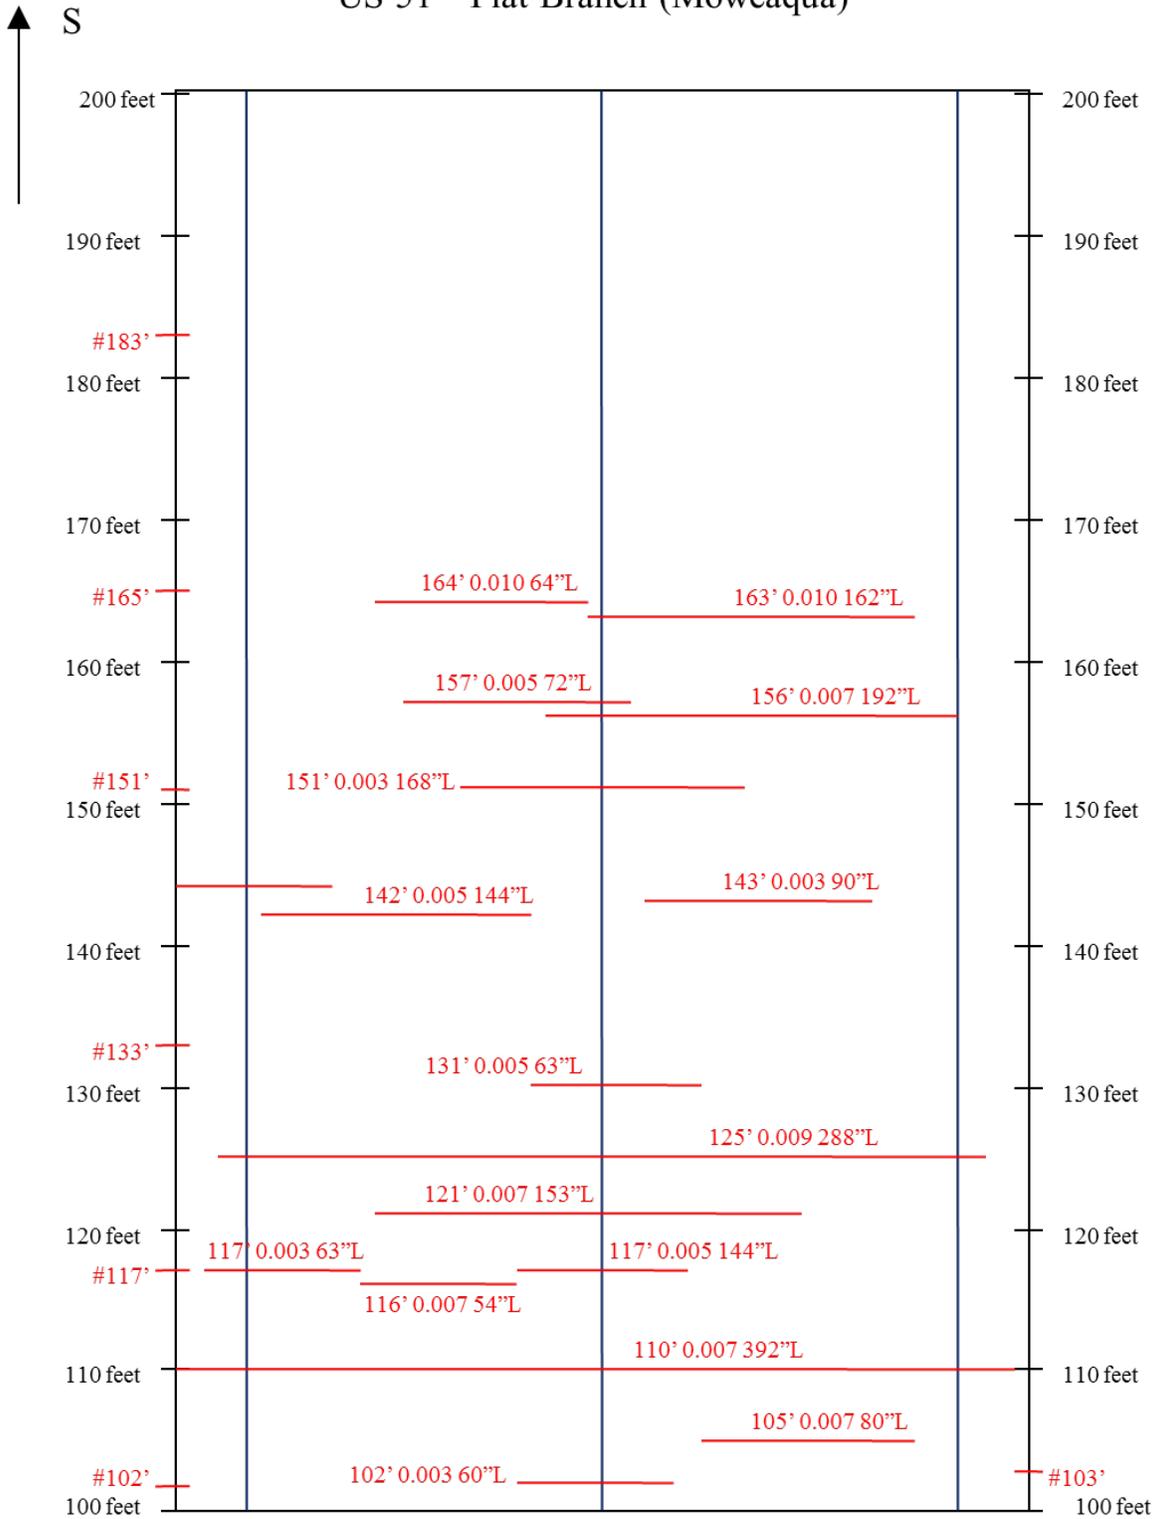
Figure 2.1-2

Average Transverse Crack Distance: Transverse cracking was observed every 6' on average between beams. On top of the bridge deck, transverse cracking was observed every 4' – 5'.

Longitudinal Cracking: More longitudinal cracking observed on this deck than 011-0035.

Bridge Joint Cracking / Integral Abutment Cracking: "Integral Abutment" restraint cracking observed with more pronounced cracking near the approach slab.

Christian County – SN#011-0036 – surveyed 9/19/2003  
 The “#” symbol represents cracks in the parapet only.

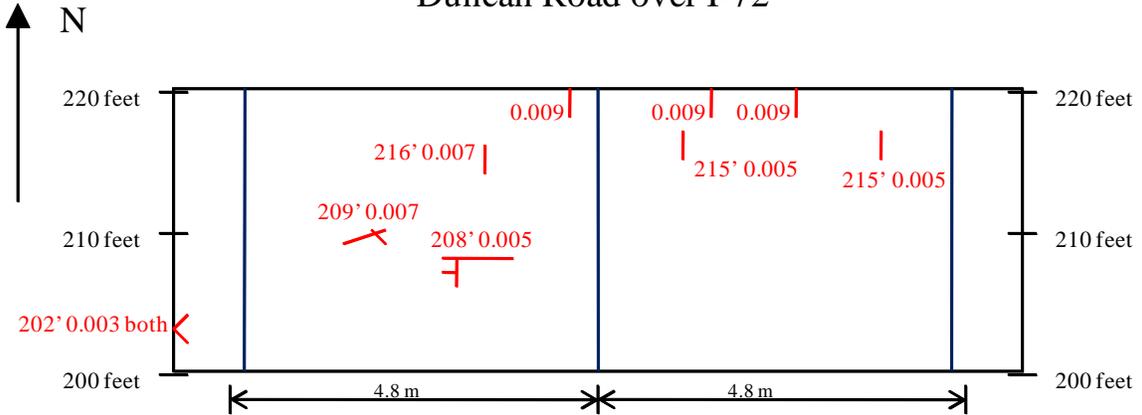
Champaign County – SN# 010-0170 – Surveyed 10/6/2003

\* Denotes areas showing map cracking.

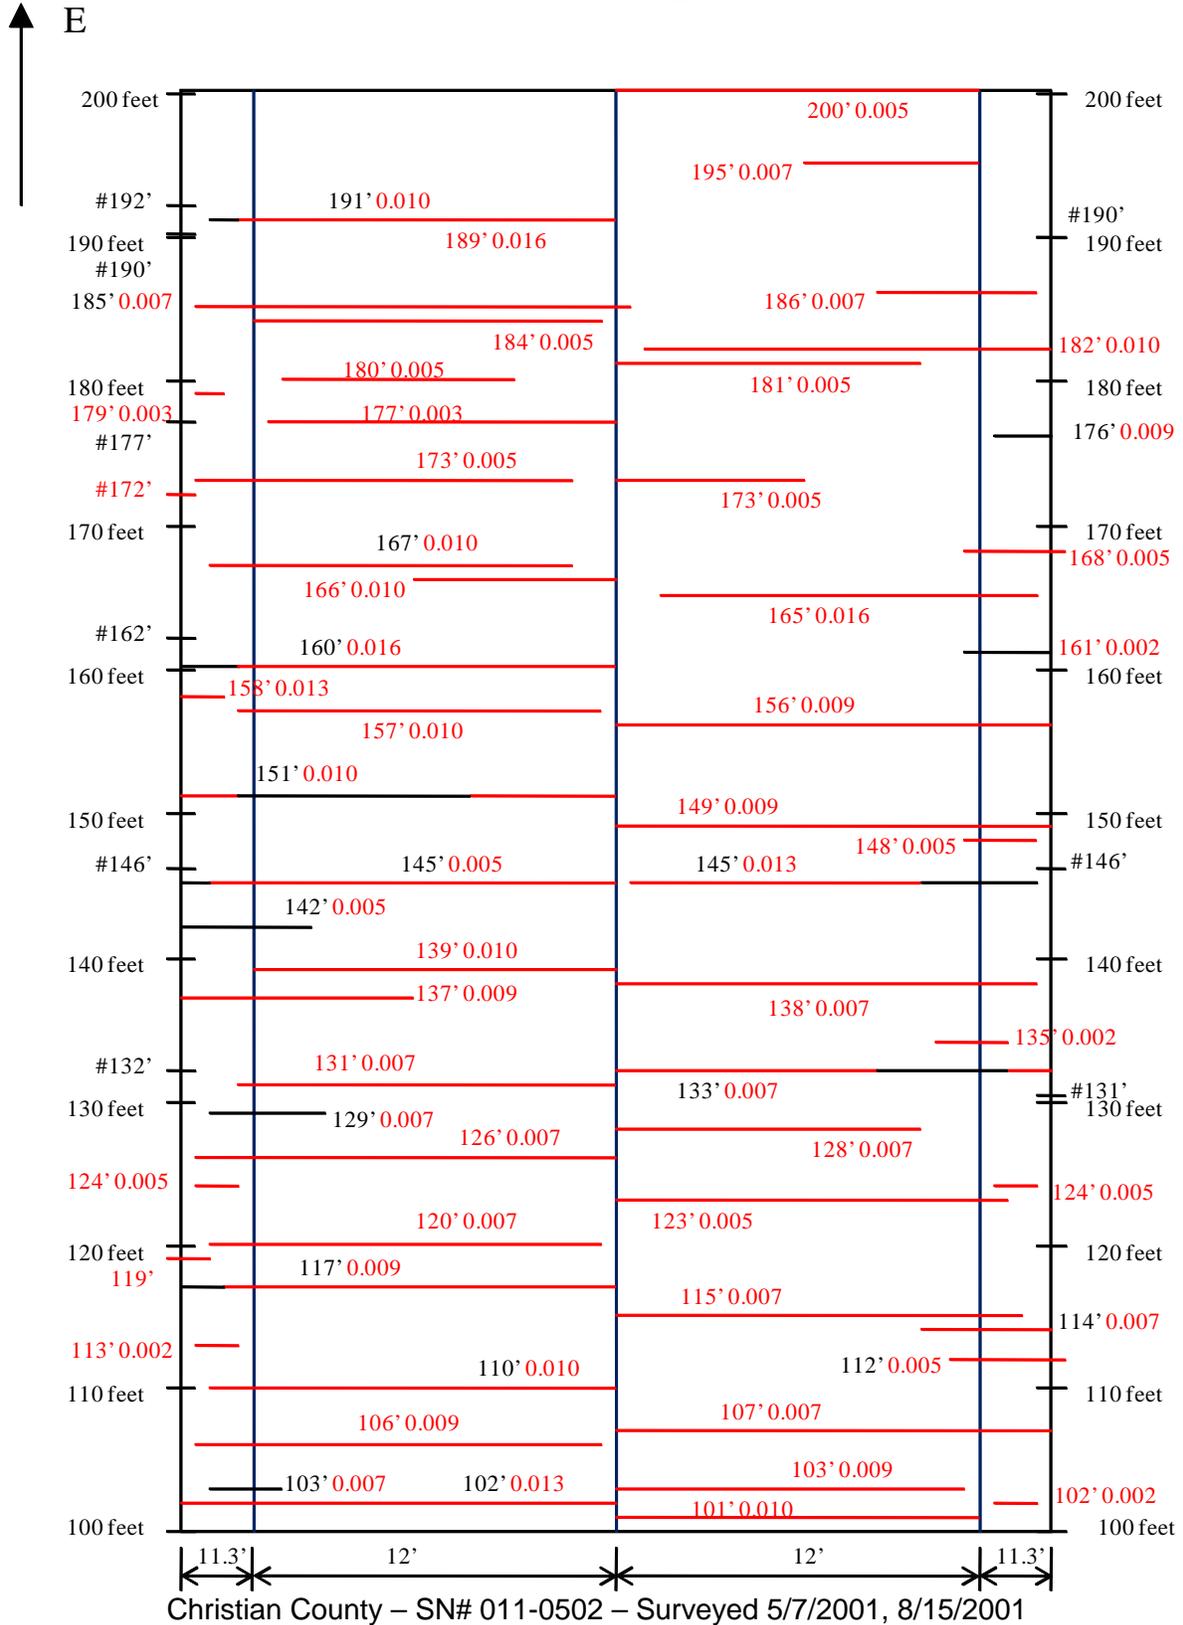
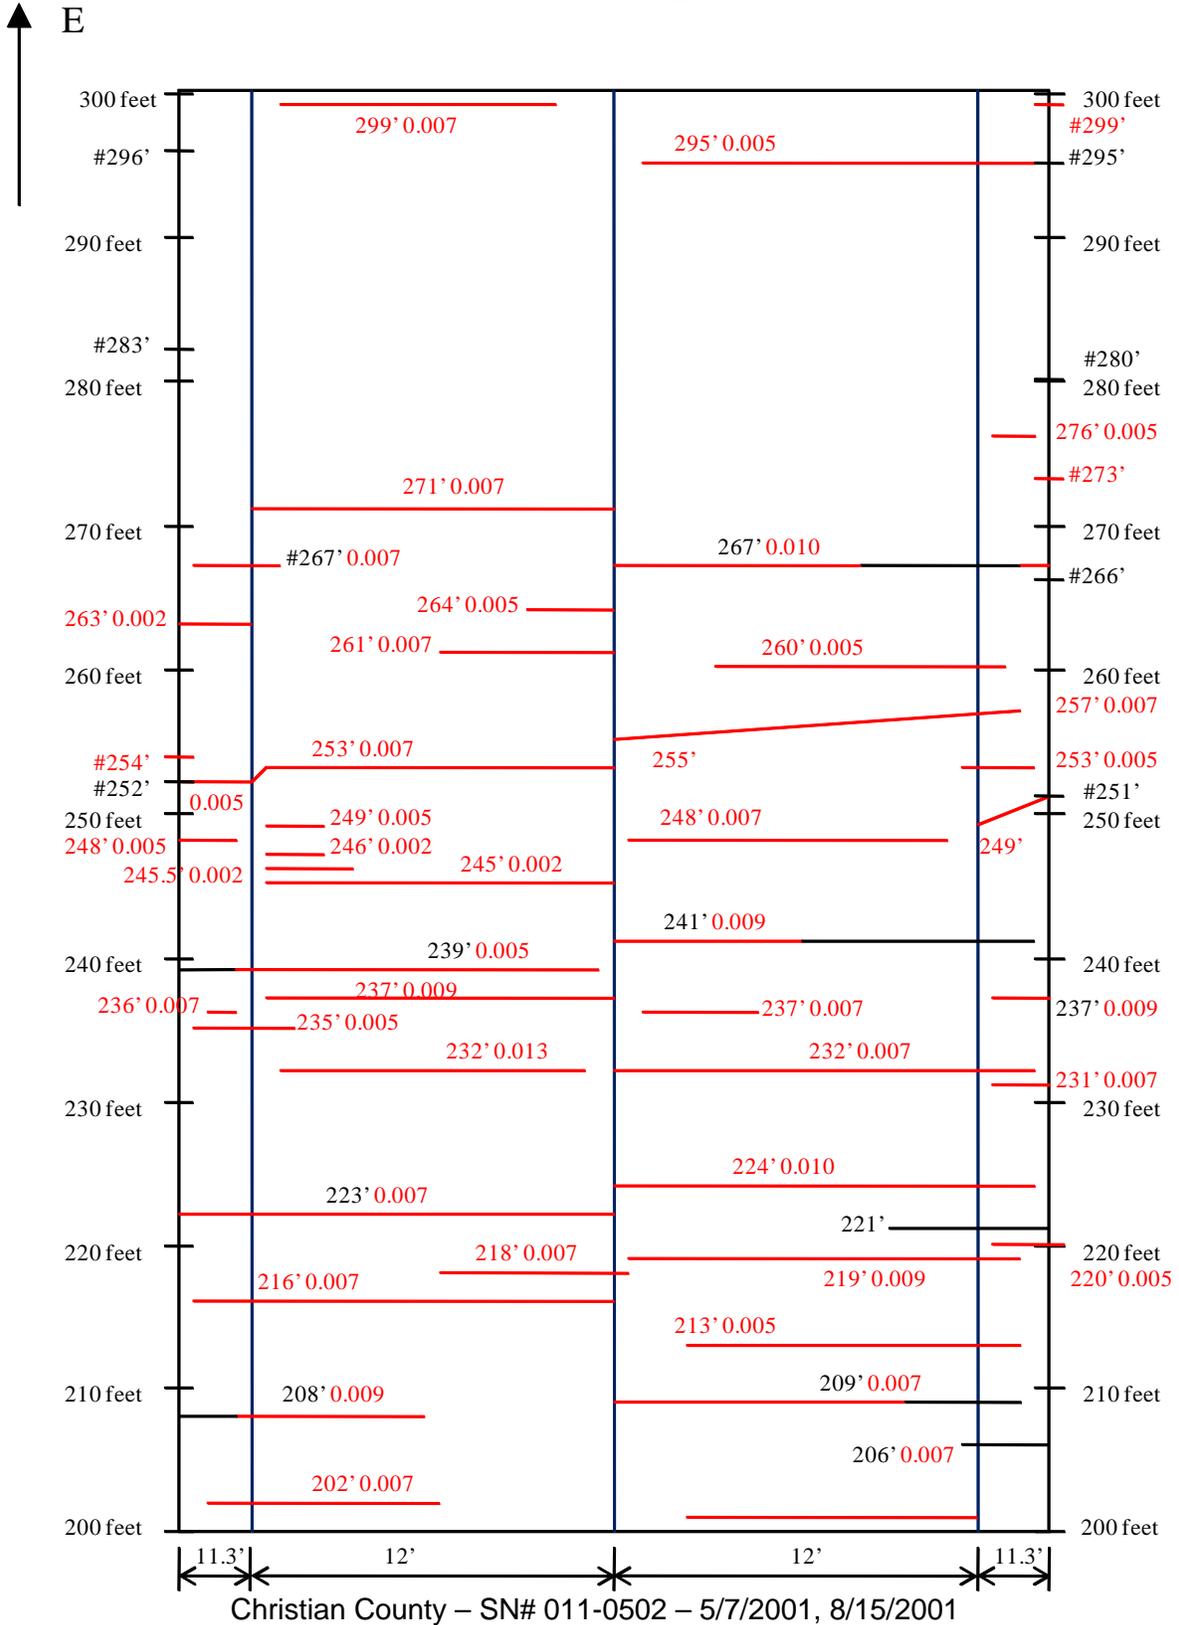
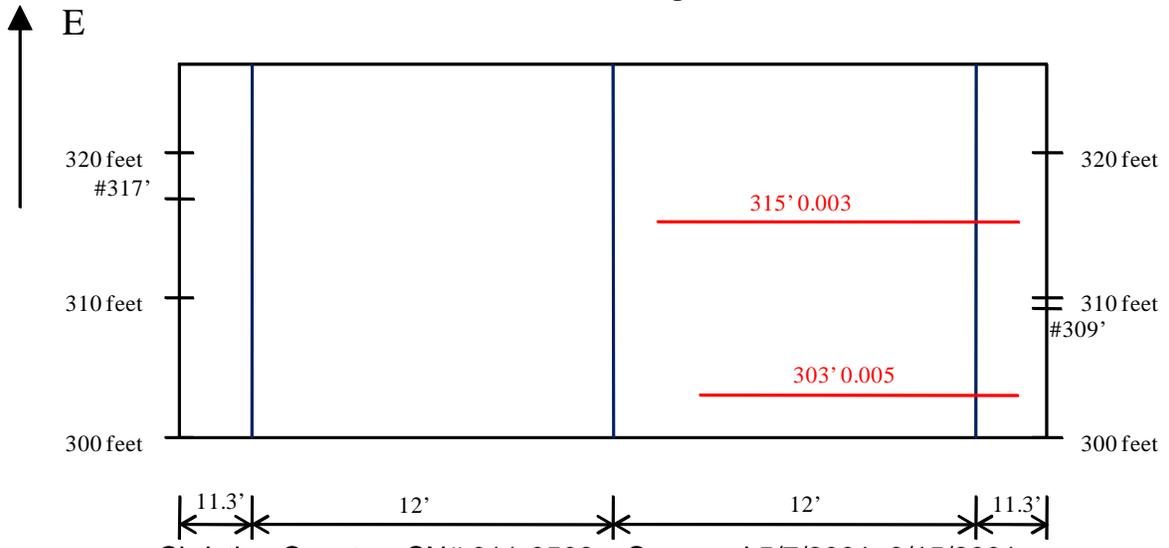
Christian County – SN# 011-0502 – Surveyed 5/7/2001, 8/15/2001

SN# 011-0502 was poured 10/12/2000 and the initial survey showed three hairline cracks.  
The “#” symbol represents cracks in the parapet only.

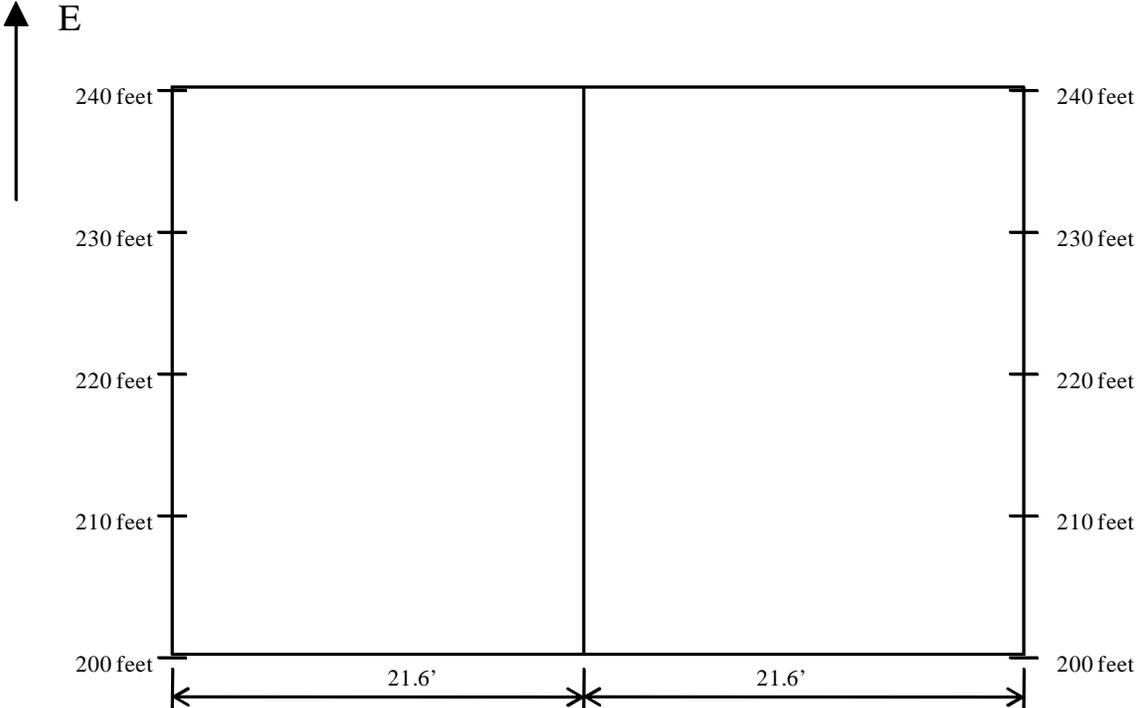
Clark County – SN# 012-0053 – Surveyed 10/1/2003

\* Crack traversed through deck drain.

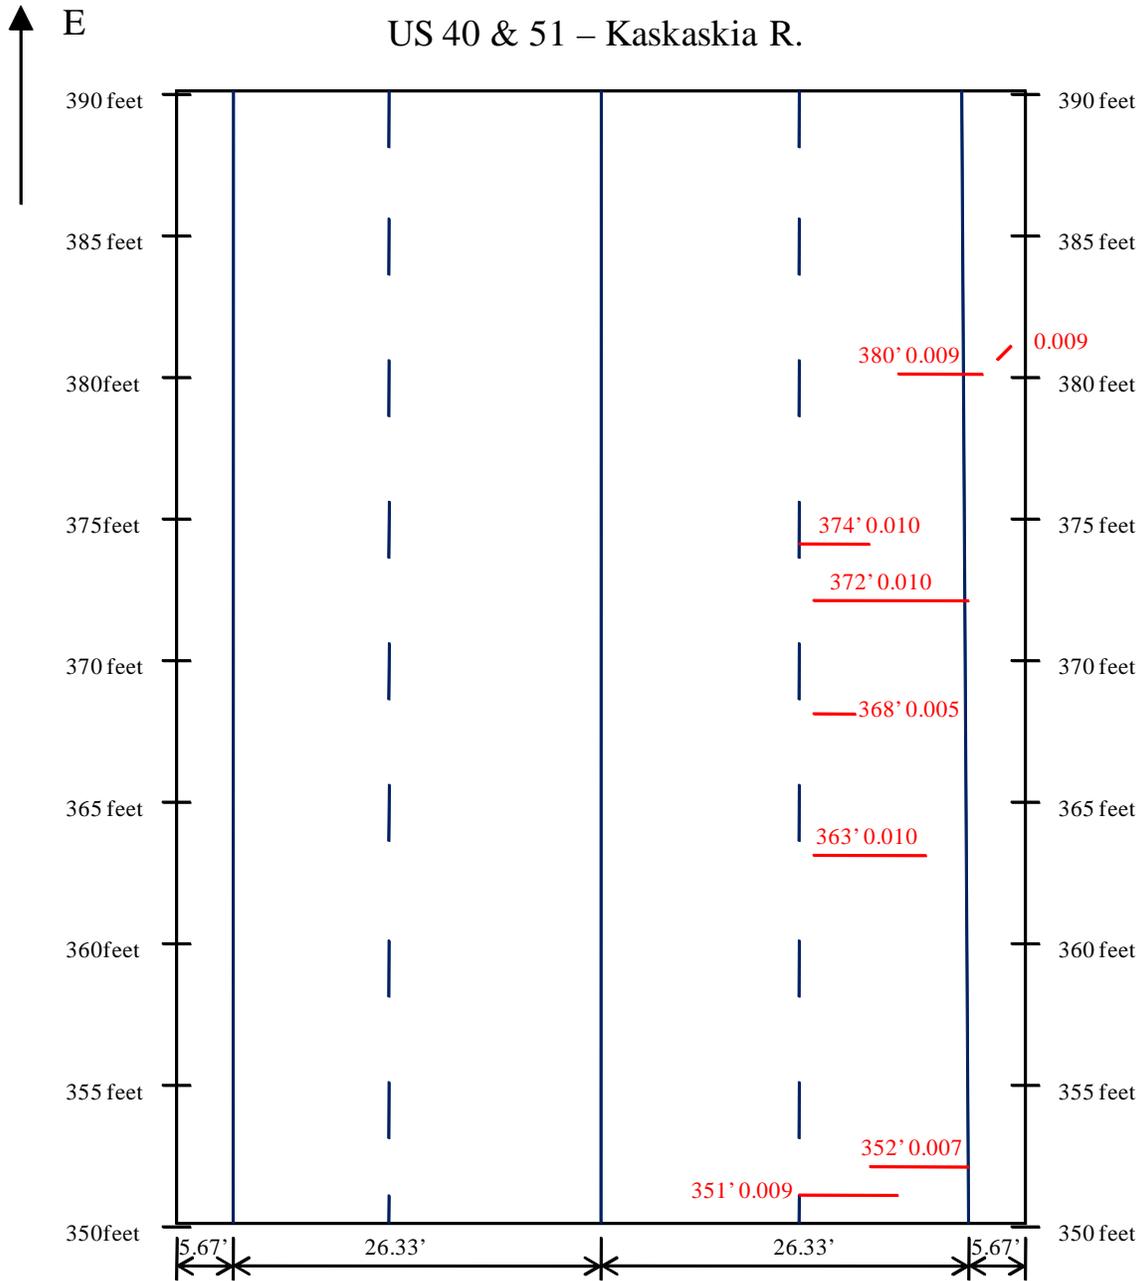
Fayette County – SN# 026-0034 – Surveyed 2003

The structure numbered 026-0034 showed transverse and longitudinal cracking on the bottom of the bridge deck. Severe transverse cracking was visible at 2' - 3' spacing in the eastbound lanes with a low temperature differential and faint transverse cracking was visible at 7' - 8' spacing with a high temperature differential in the westbound lanes. Both the eastbound and westbound lanes exhibited longitudinal cracking at 4' or more spacing on the bottom of the deck. On top of the deck, cracking was observed at 3' - 5' spacing near the middle of the bridge.

Only the driving lanes of this bridge deck were surveyed because of time constraints and traffic safety concerns. Numerous cracks extended from the driving lanes into the passing lanes.

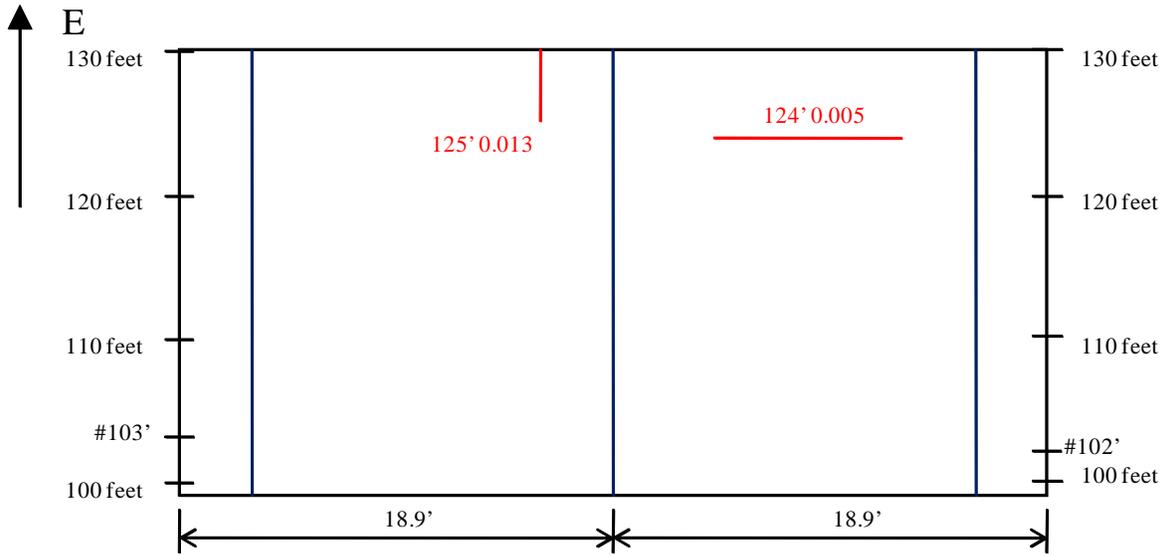
Iroquois County – SN# 038-0207 – Surveyed 5/9/2001, 11/5/2001

Deck poured on November 03, 2000. The initial survey of this structure showed little to no cracking.

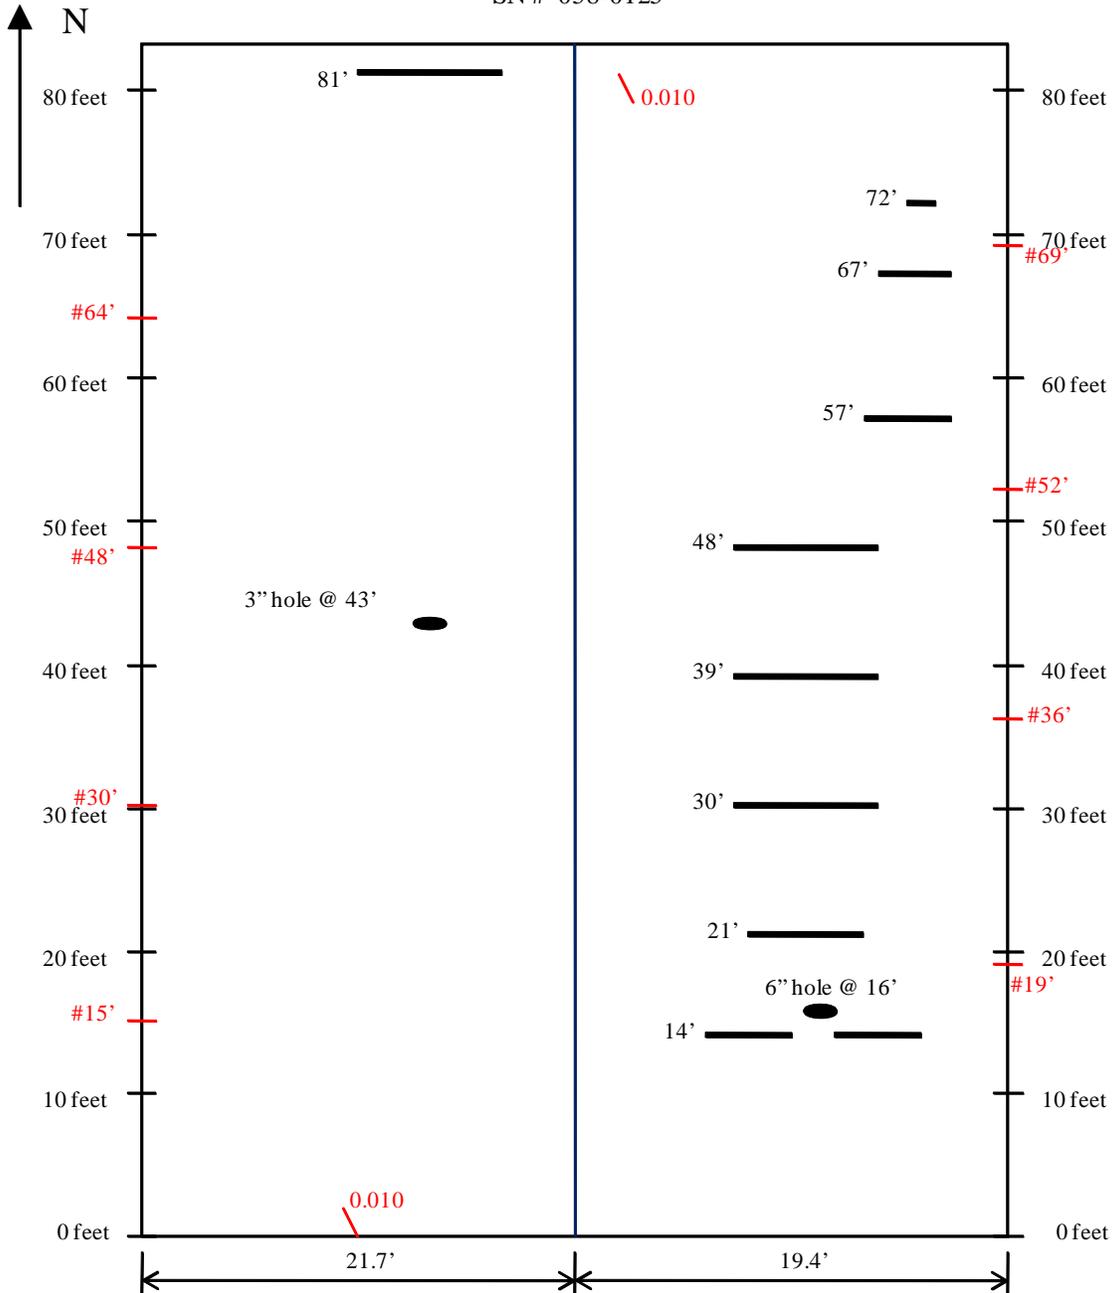
Macon County – SN# 058-0125 – Surveyed 5/7/2001, 10/19/2001

This bridge deck was poured on October 12, 2000. The initial survey showed no cracking. The thicker lines represent areas of popped out aggregate. The “#” symbol represents cracks in the parapet only.

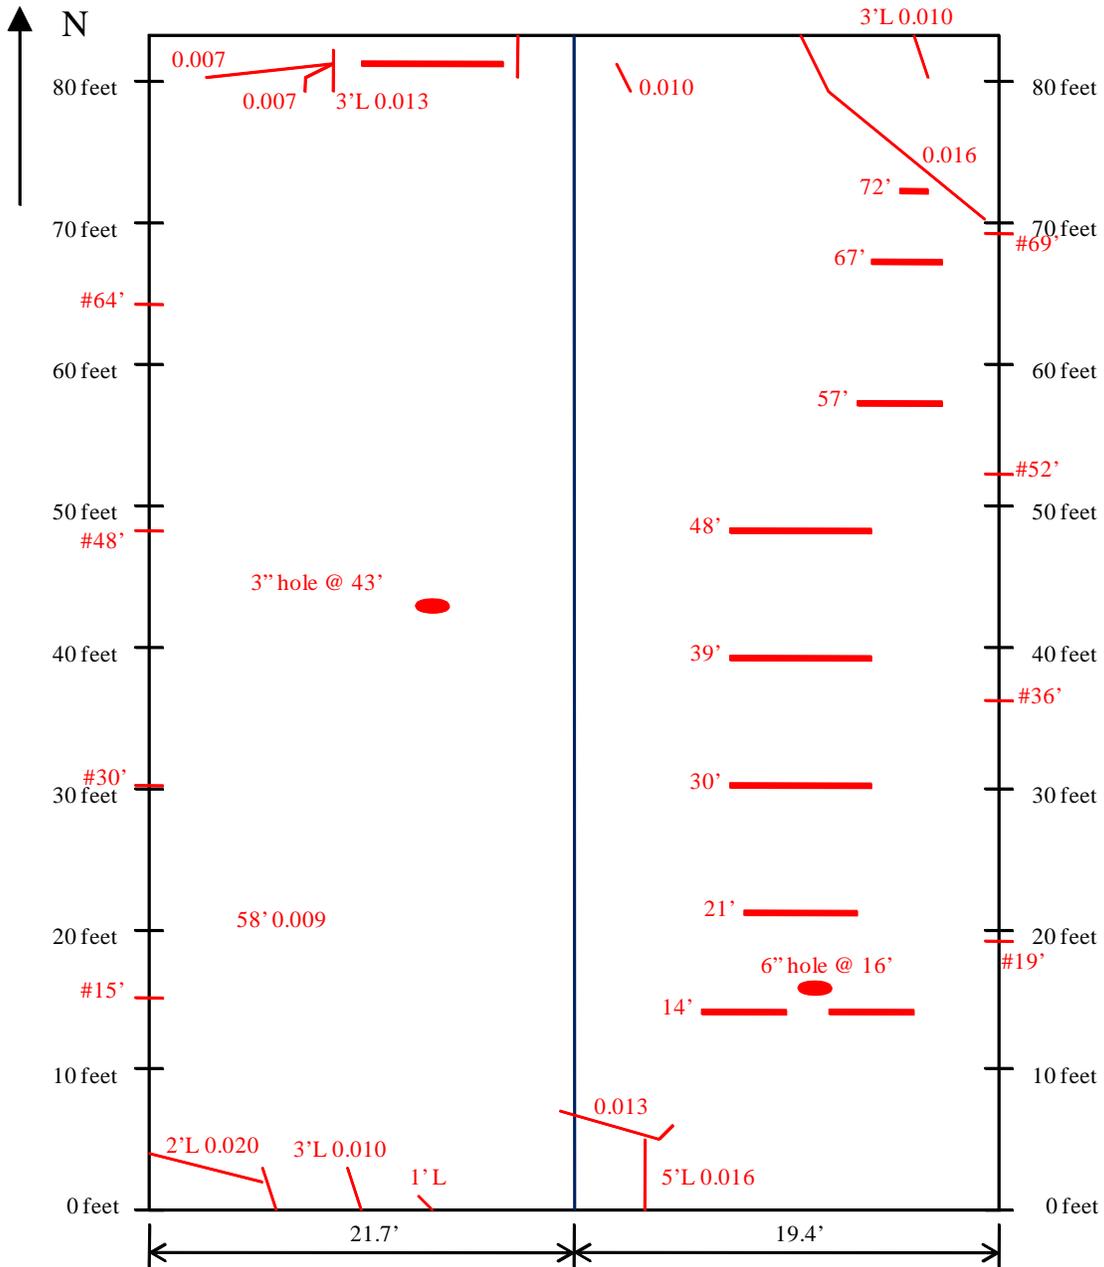
Macon County – SN# 058-0125 – Surveyed 10/31/2002

The “#” symbol represents cracks in the parapet only. The thicker lines represent areas of popped out aggregate.

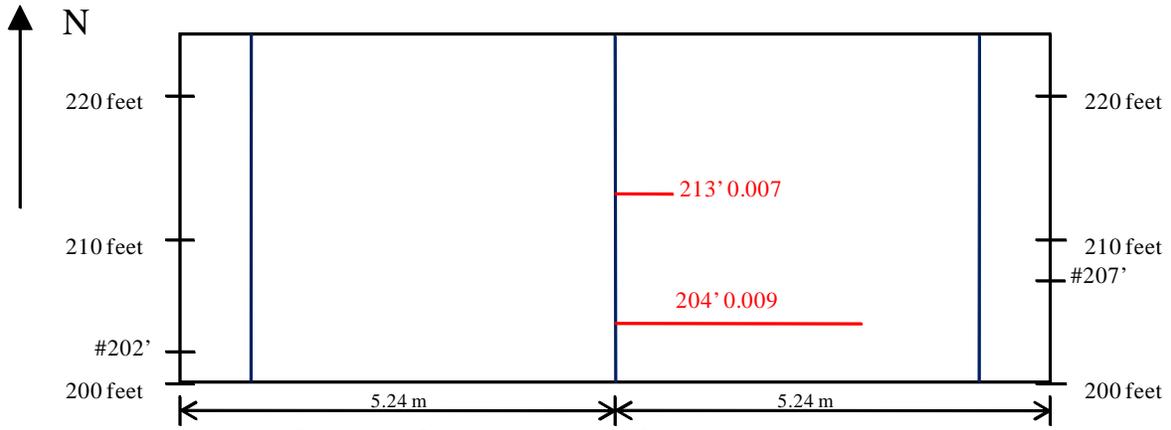
Madison County – SN# 060-0108 – Surveyed 5/8/2001, 8/2/2001

The initial survey of the southbound lane showed only one transverse crack.  
The initial survey of the northbound lane showed five hairline transverse cracks.

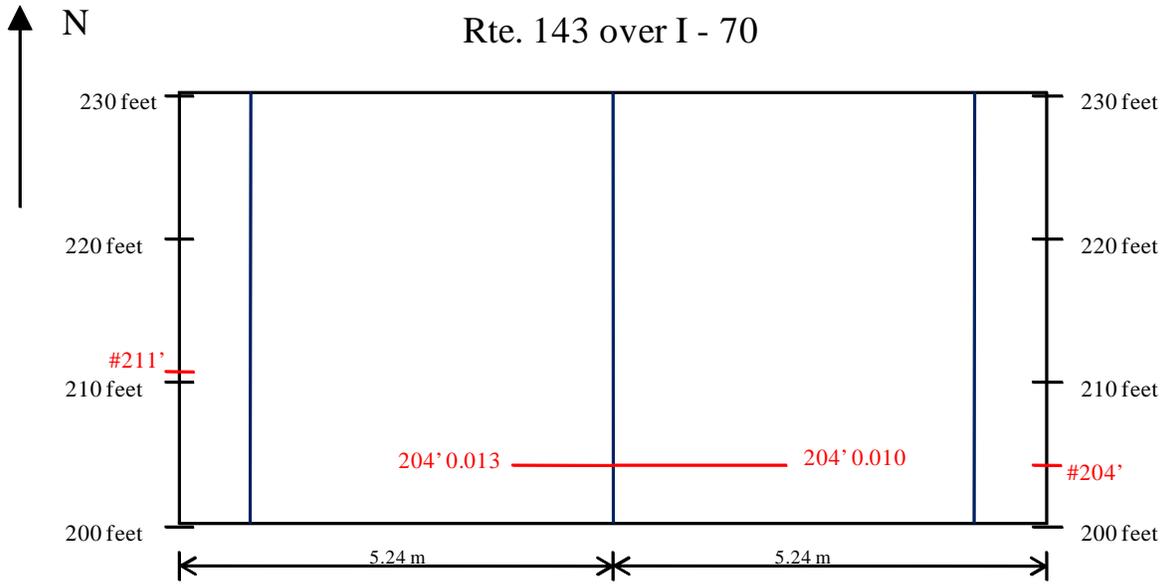
Madison County – SN# 060-0151 – Surveyed 5/8/2001, 8/2/2001  
 The initial bridge deck survey showed five hairline transverse cracks.  
 The “#” symbol represents cracks in the parapet only.

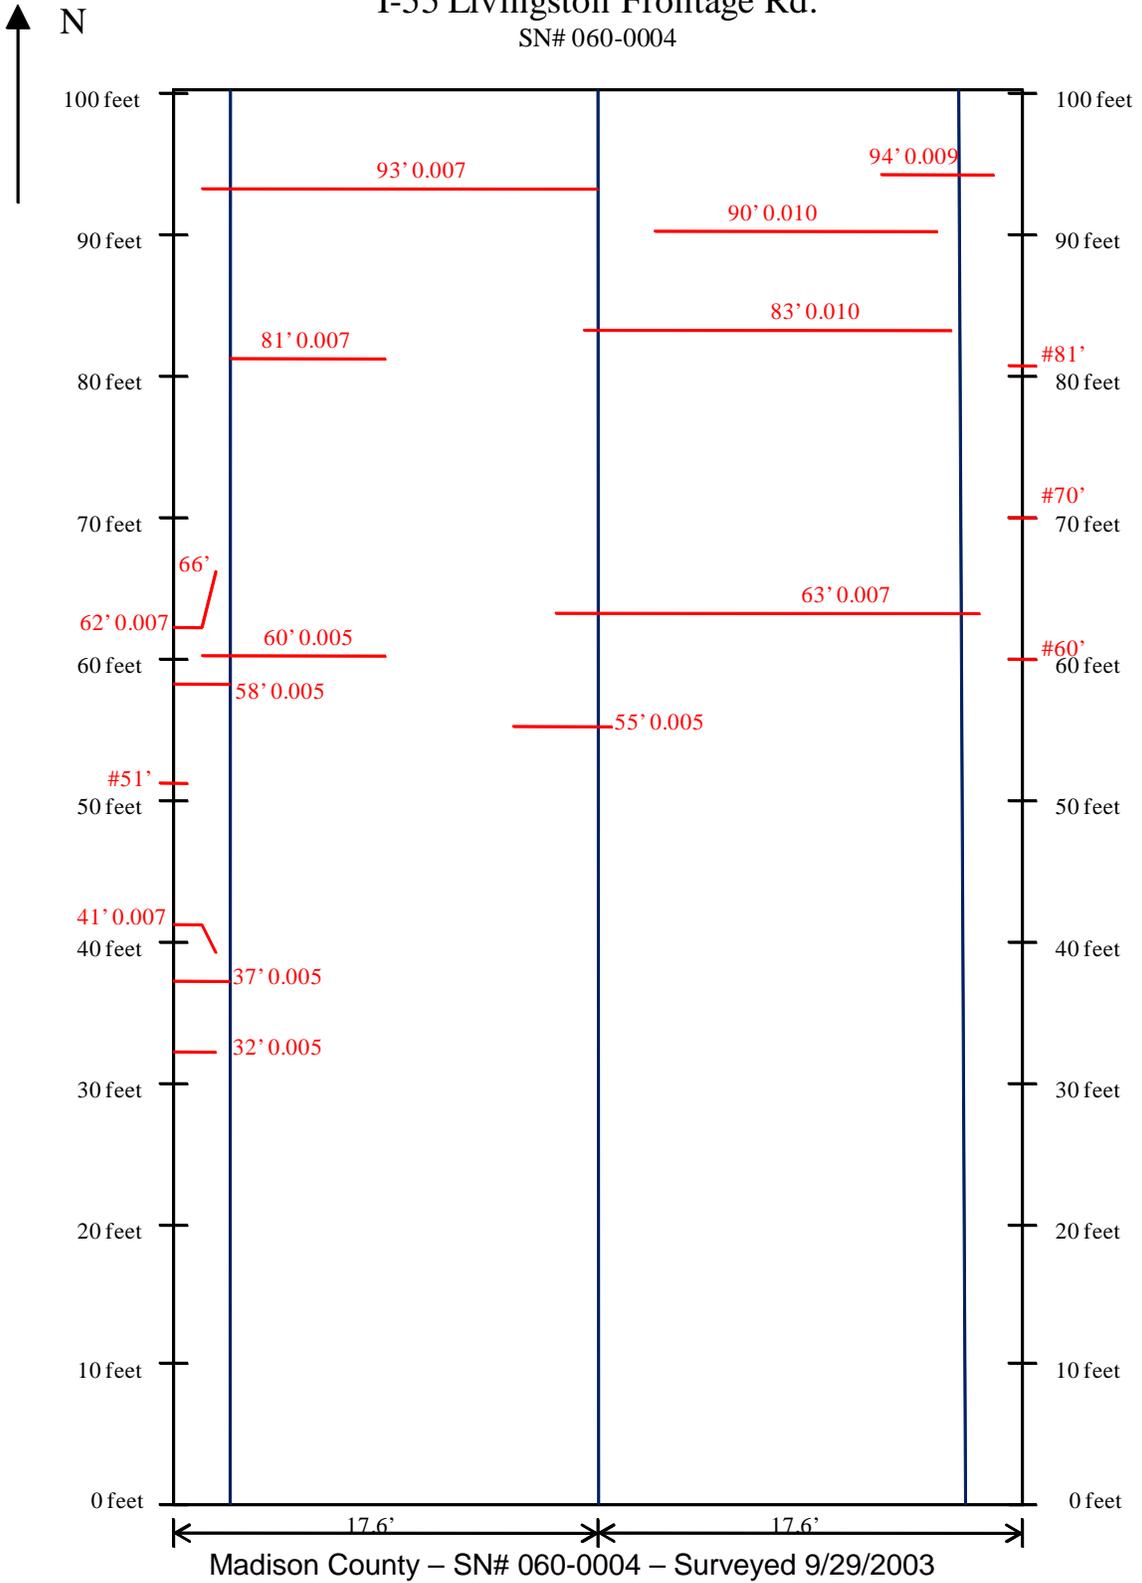
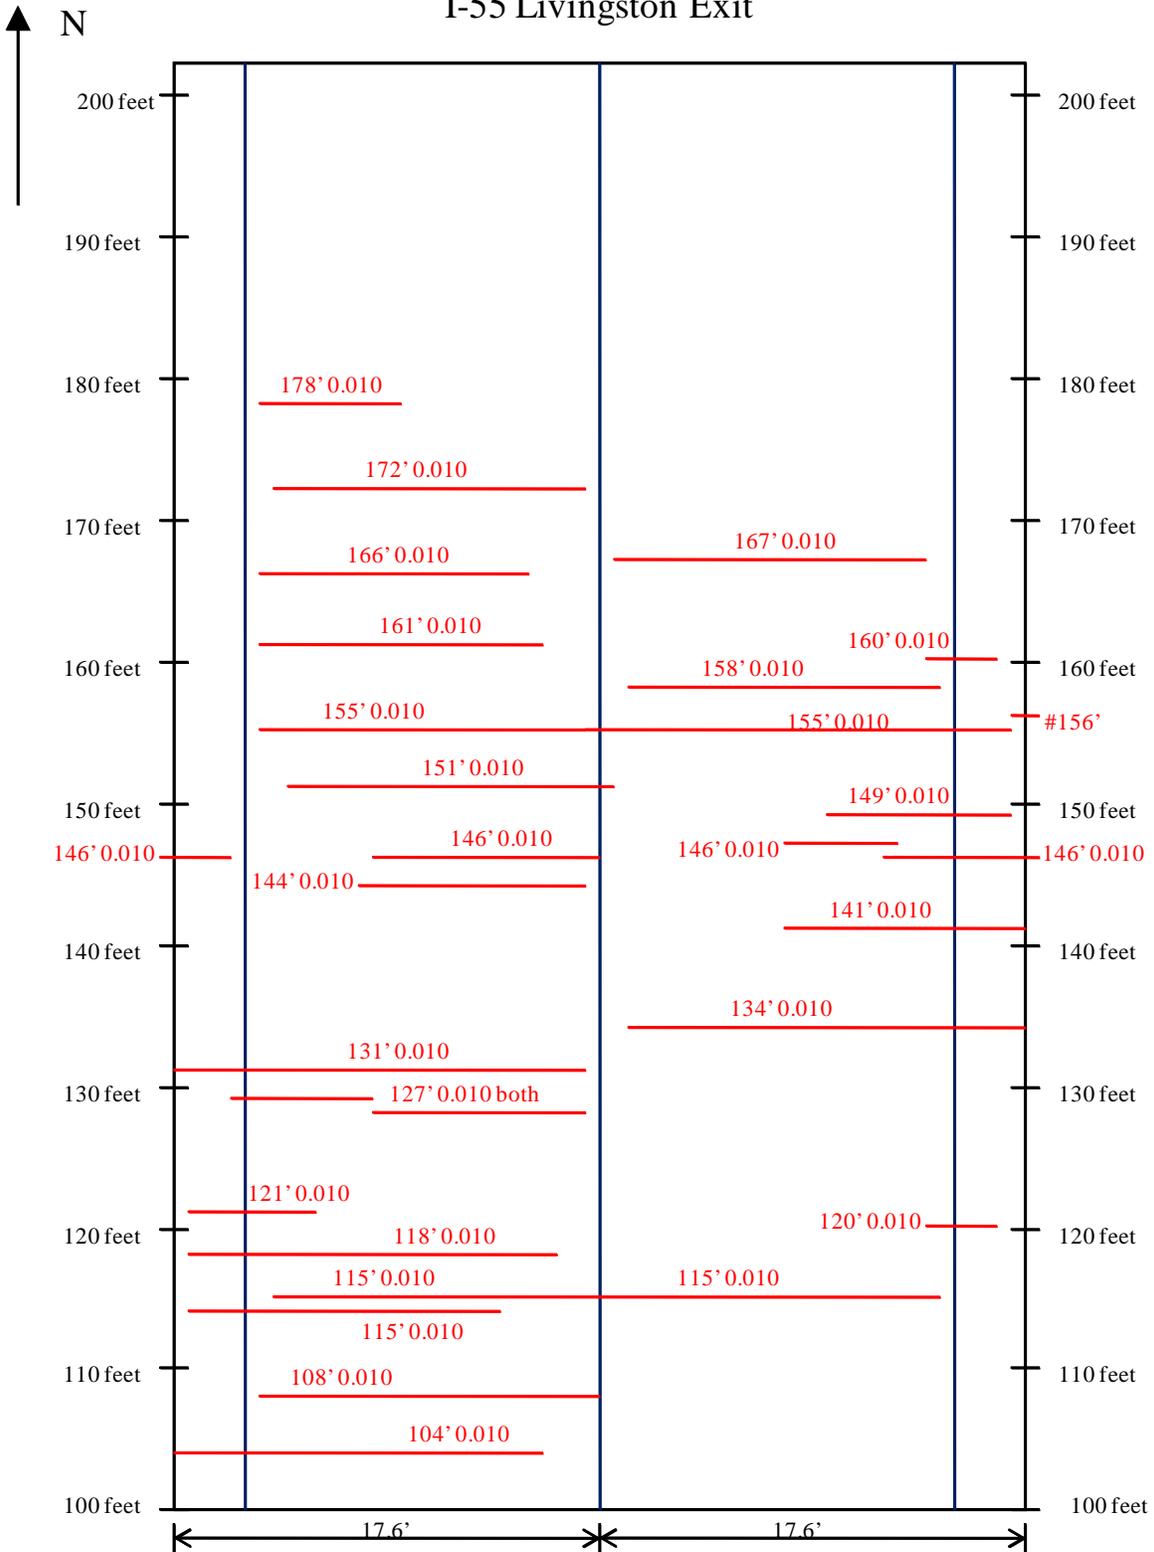
Madison County – SN# 060-0004 – Surveyed 9/28/2005  
 The “#” symbol represents cracks in the parapet only.

The structure numbered 060-0004 exhibited transverse cracking on the top of the deck at 1' - 3' spacing, and on the bottom of the deck at 3' - 5' spacing in the middle and northern spans despite a mild temperature differential. The HPC structure numbered 060-0004 has a low ADT of 126.

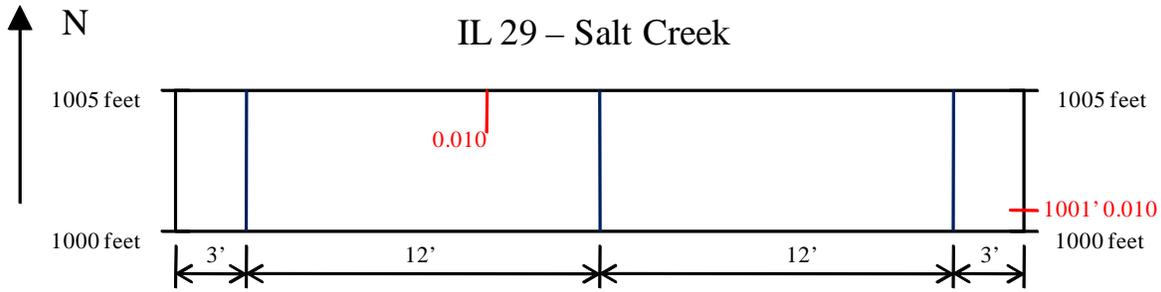
Mason/Menard County – SN# 065-0501 – Surveyed 10/2/2008, 10/20/2008

- \* Unless otherwise noted, the areas marked with this symbol contained exposed aggregate.
- A Northbound lane, from 402’ – 403’, the cracks measured from 0.013 – 0.016

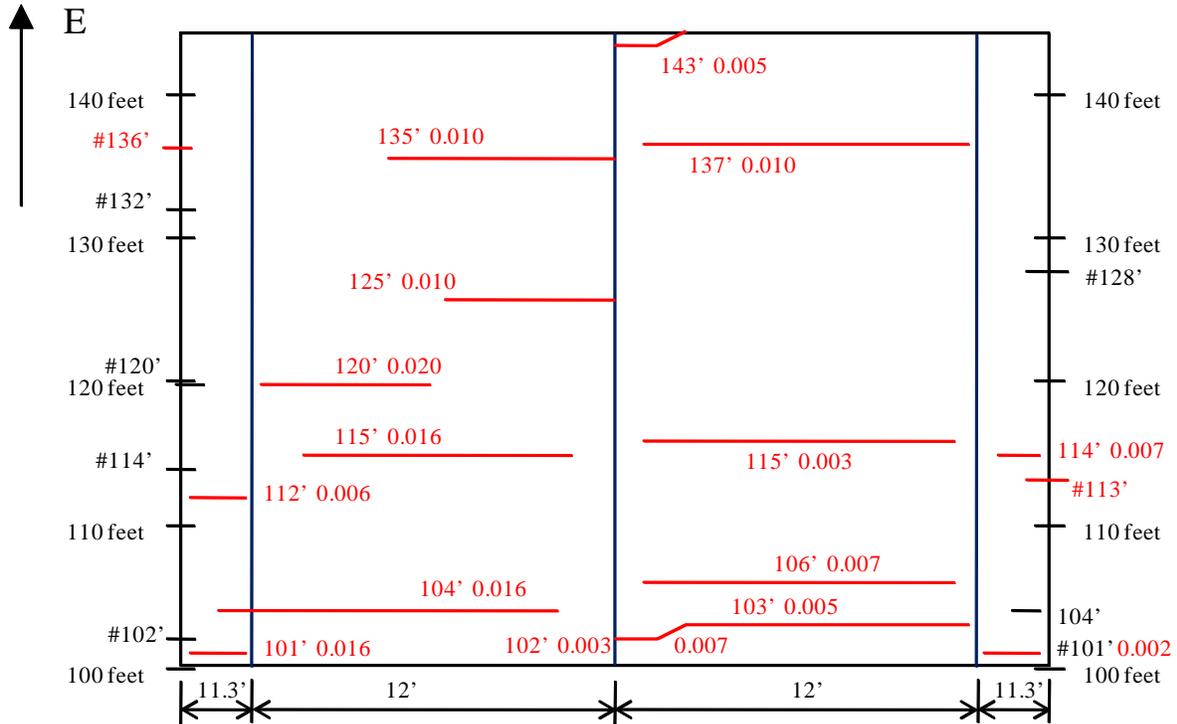
Sangamon County – SN# 084-065 – Surveyed 5/7/2001, 8/15/2001

The initial survey of the westbound lane showed 33 hairline transverse cracks.

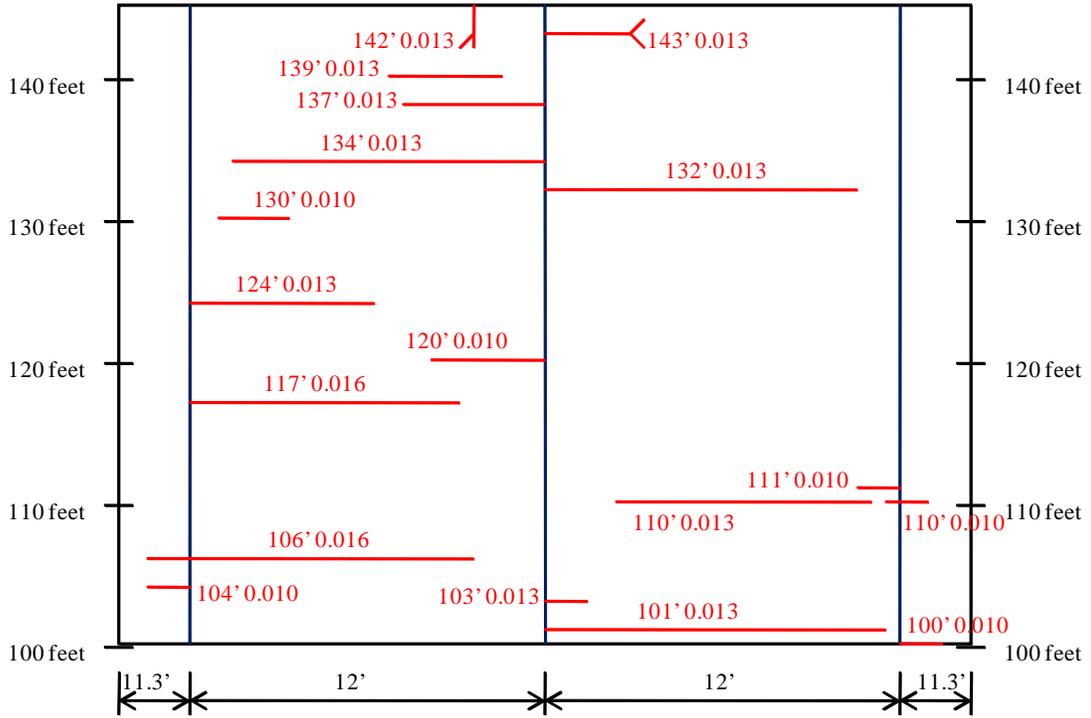
Sangamon County – SN# 084-0065 – Surveyed 12/30/2003

\* Denotes areas of interconnected hairline cracks, sometimes resembling a spider web.

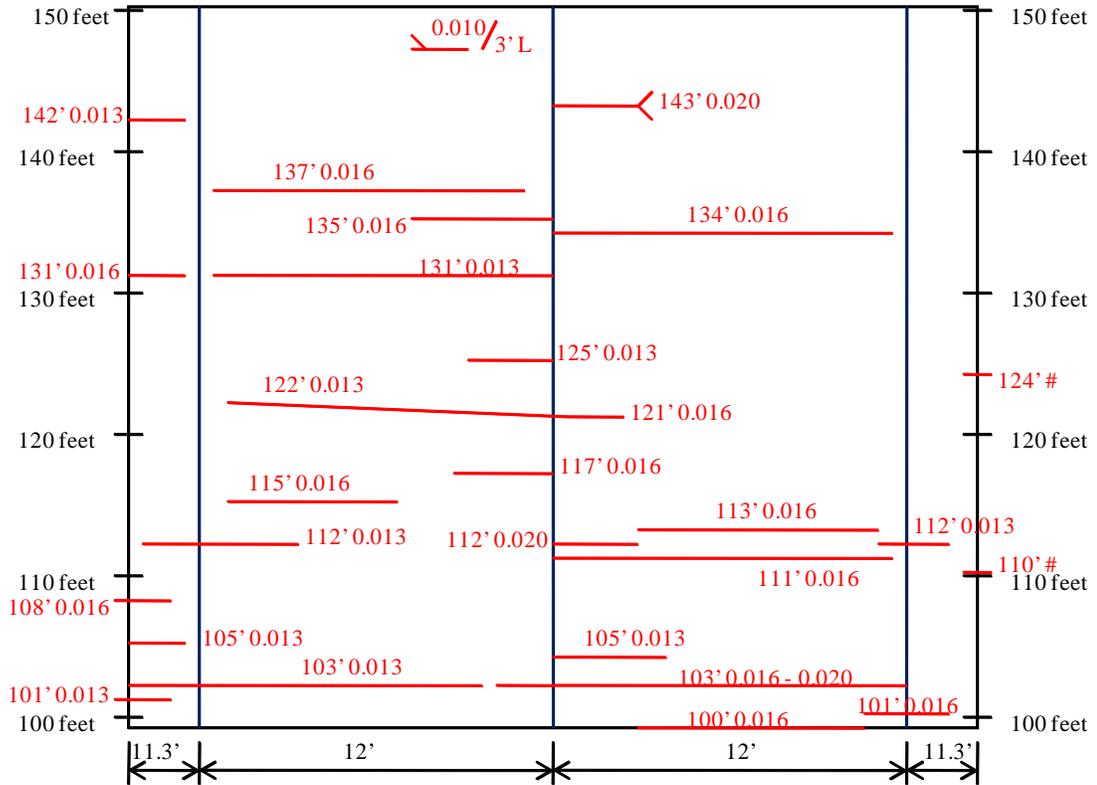
Sangamon County – SN# 084-0065 – Surveyed 9/26/2005

Map cracking was observed in the eastbound lane near the centerline from 9' to 89'.

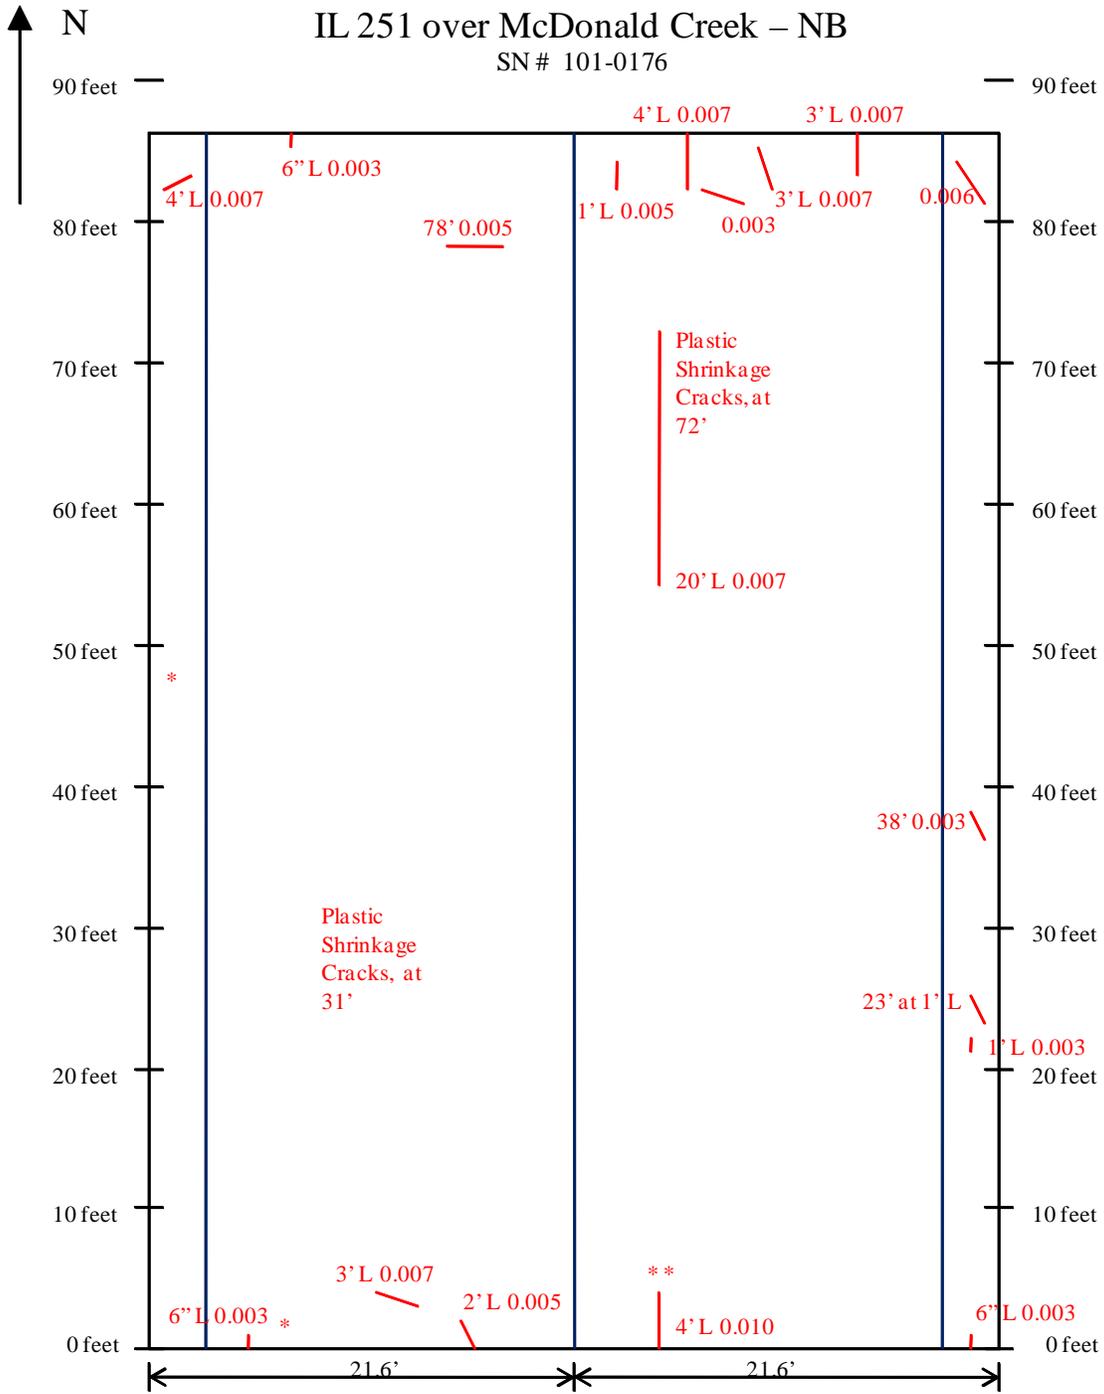
Winnebago County – SN# 101-0176 – Surveyed 9/30/2003

\* Denotes areas of plastic shrinkage cracking
