EVALUATION OF WELDED WIRE FABRIC IN
BITUMINOUS CONCRETE RESURFACING

W. Emmitt Chastain, Sr., Engineer of Research and Development
R. H. Mitchell, Research Engineer

Illinois Division of Highways

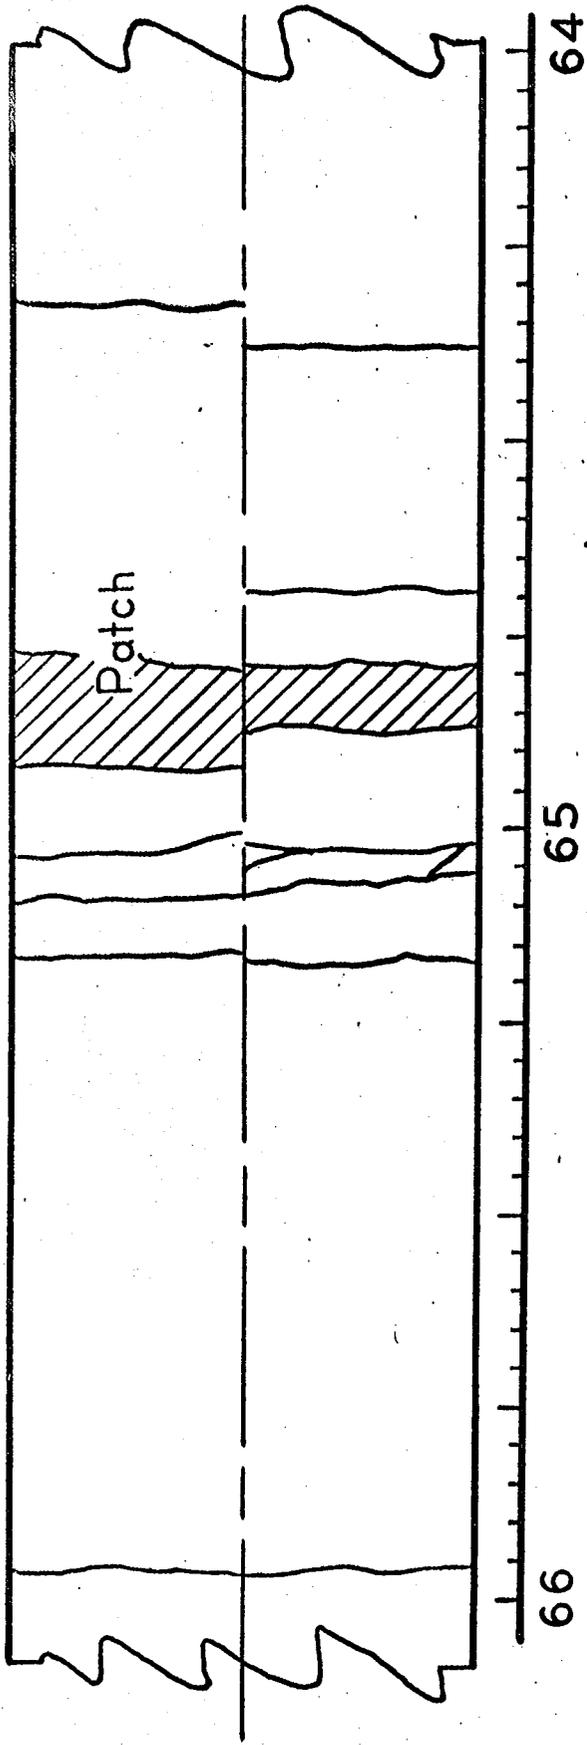
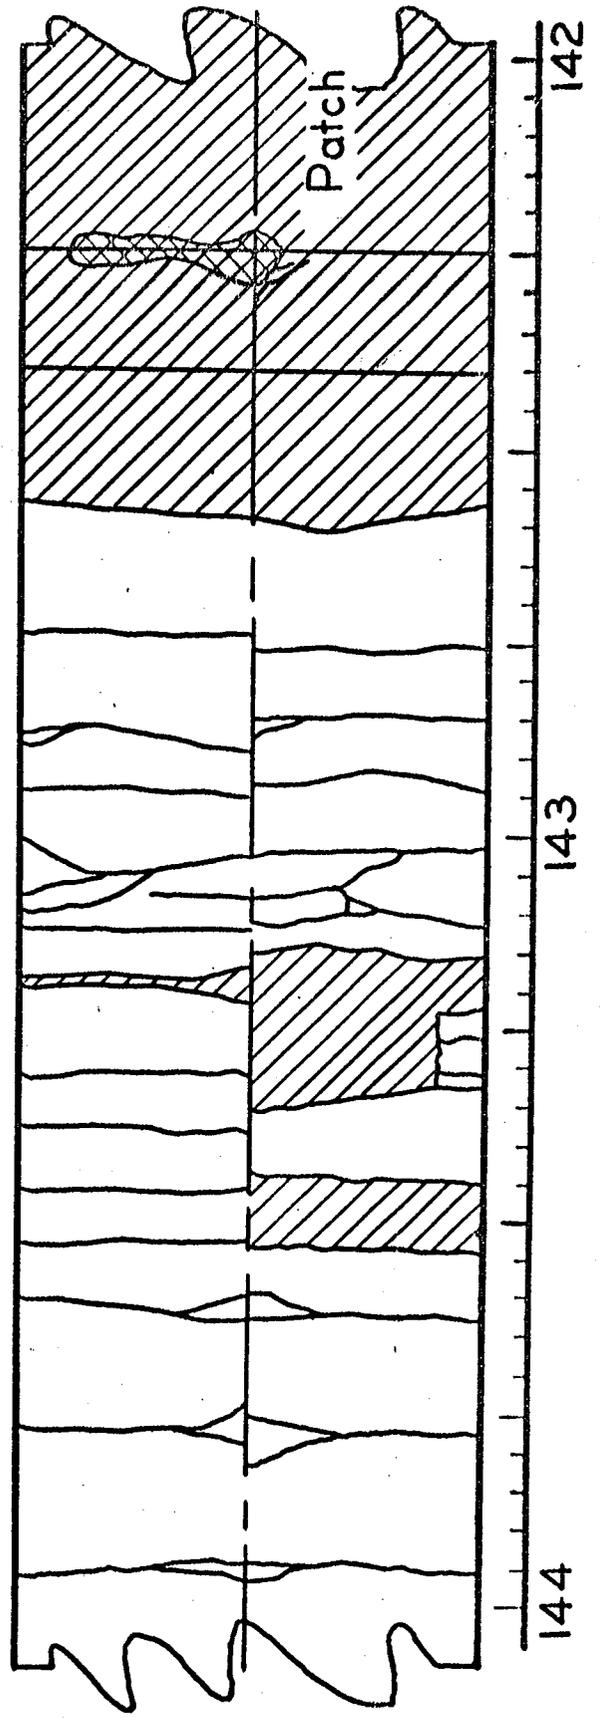
Figure 2 Typical Condition of Old Concrete Pavement

A comprehensive condition survey of the existing pavement was made prior to resurfacing. A representative field survey sheet that is typical of the condition of the old concrete pavement is shown in Figure 2.

The condition survey of the old portland cement concrete pavement prior to resurfacing revealed numerous wide transverse cracks and associated spalling and faulting. There were two general transverse crack-intervals, one at nearly 50 feet, between Stations 51 and 86, and the other at approximately 10 to 15 feet, between Stations 86 and 230 (see Figure 4). No reason was found for the wide difference in crack interval between the two locations.

The existing pavement had required extensive full-depth patches during the 1940's. Many of these patches, all of which were of portland cement concrete, showed distress with wide areas of raveling. Intermittent areas of scaling were present throughout the entire length of the project.

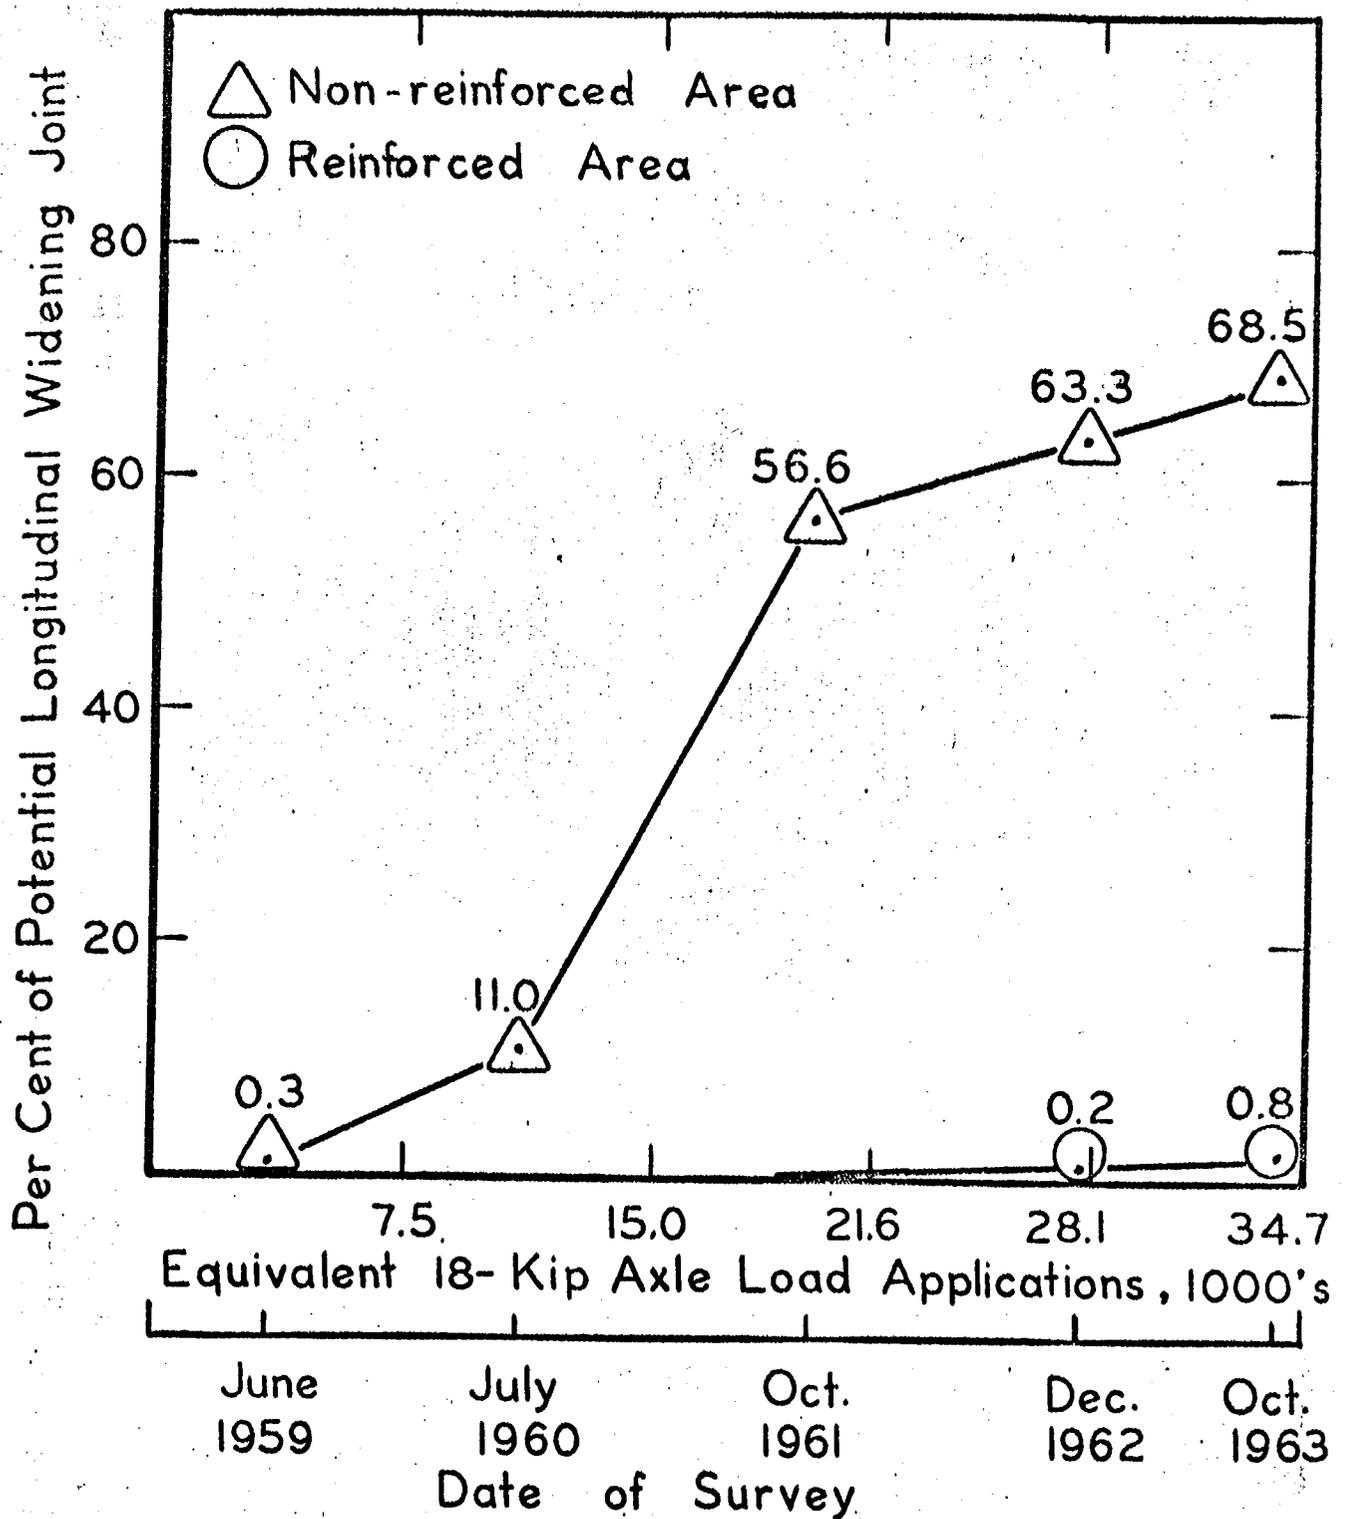
Figure 5. Progression of Longitudinal Reflection Cracking over Widening Joint.

The survey data on longitudinal reflection cracking over the longitudinal widening joints were summarized and analyzed for the two sections with fabric and for the two sections without fabric reinforcement. The progression of longitudinal reflection cracking over the widening joint for both the reinforced and nonreinforced sections is shown graphically in Figure 5.

Reflection cracking over the longitudinal widening joint in the areas containing the welded wire fabric was not apparent until the fourth survey in 1962, at which time 0.2 per cent of the total possible length had reflected. In 1963, after five years of service, the reflected amount was still less than one per cent. Reflection cracking over the widening joint in areas outside the fabric reinforcement, recorded in 1959 after one year service, amounted to 0.3 per cent of the total possible length. In 1960, the recorded value was approximately 10 per cent. This cracking distress progressed to 57 per cent in the third year of service, to 63 per cent in the fourth year, and to nearly 70 per cent by the fifth year (1963). During these years, single-axle loads accumulated at the rate of about 7,500 per year.

All widths of fabric reinforcement, varying from $3\frac{1}{2}$ to $10\frac{1}{2}$ feet, and placed 3 to 6 inches from the outer edge of the 2-ft. wide base widening, appear to be about equally effective in controlling cracking over the widening joint.

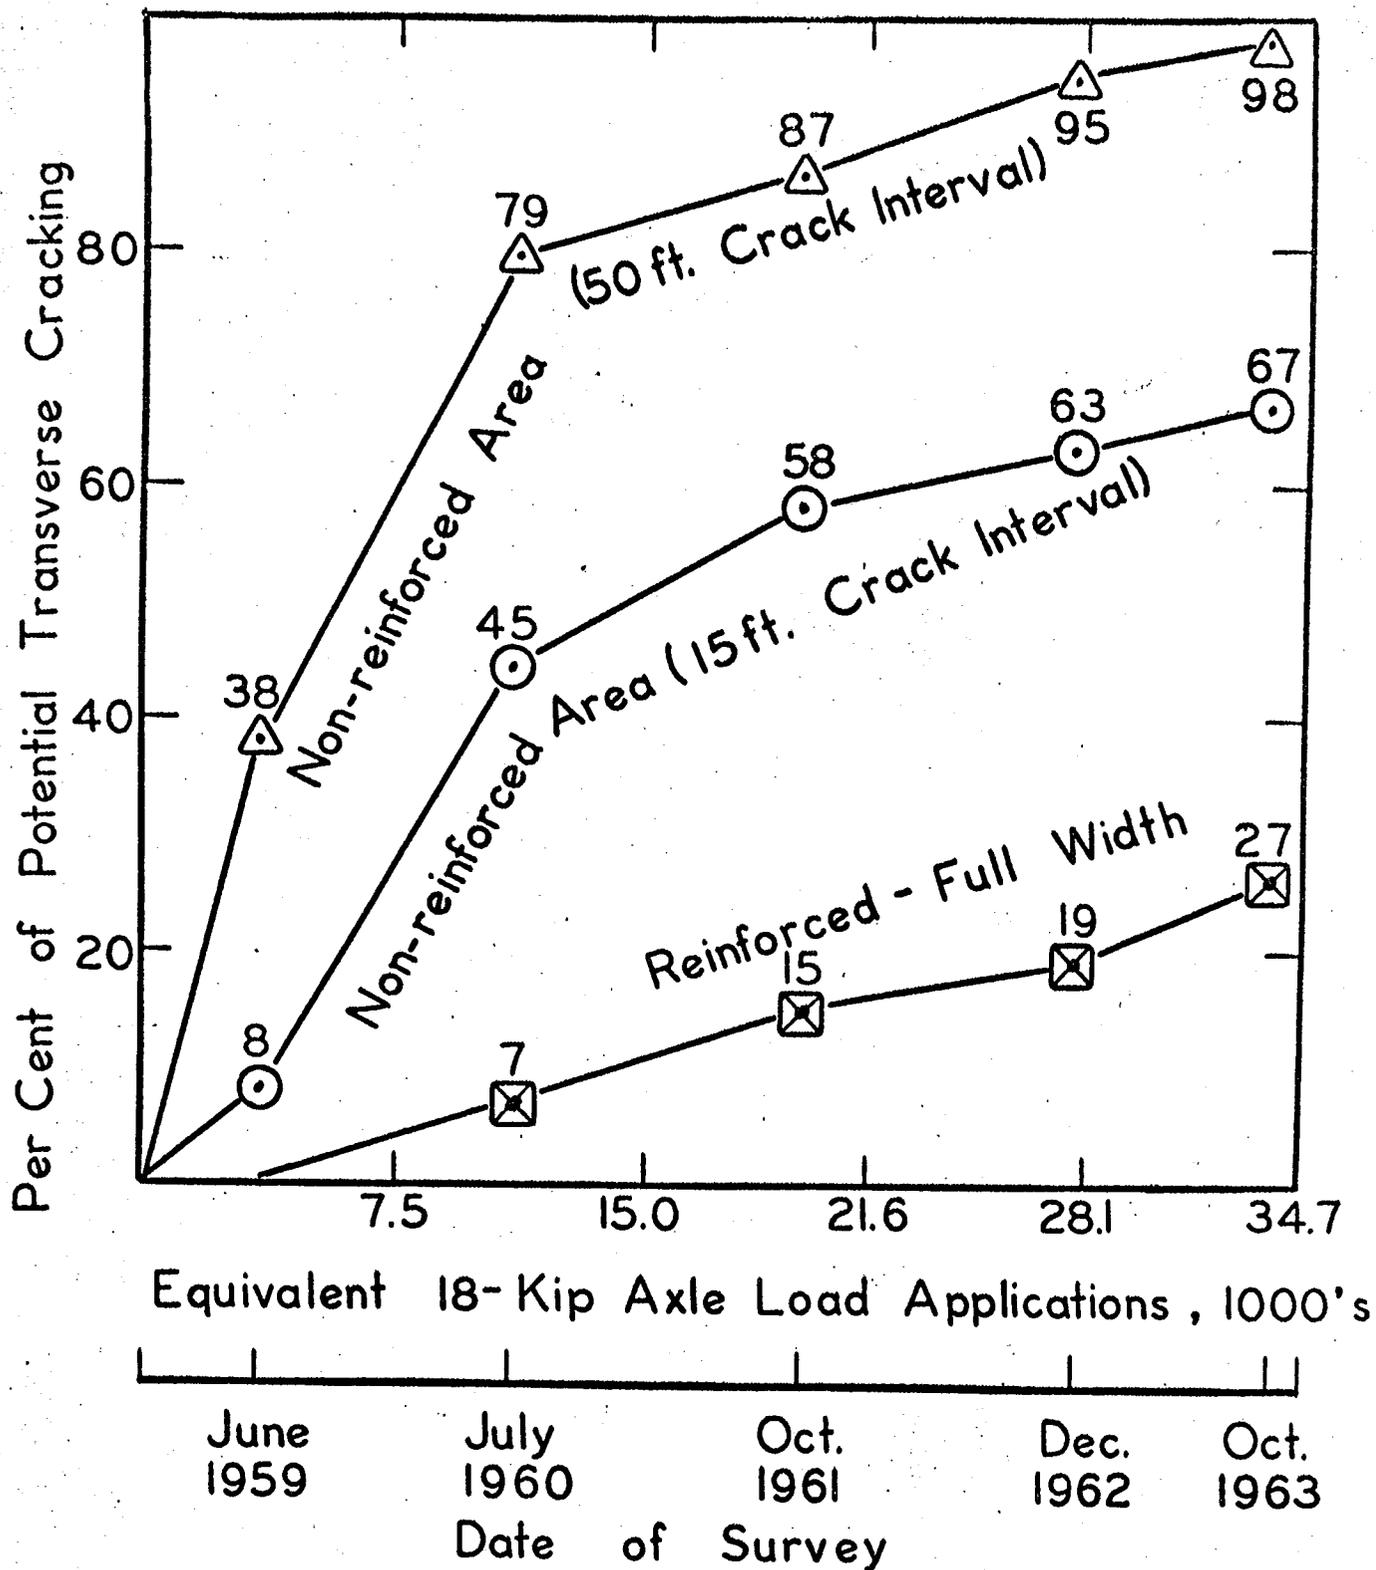
Figure 6. Progression of Transverse Reflection Cracking

The analysis of transverse reflection cracking was limited to the two sections of pavement of initial long and short average joint and crack interval when no reinforcement was used, and to the reinforced sections having near-full-lane-width ($10\frac{1}{2}$ ft.) fabric. It will be recalled that the nonreinforced section of shorter joint and crack interval and the fabric-reinforced section initially had about the same average interval (13 ft.). The other nonreinforced section initially had an average joint and crack interval of about 50 feet. It did not seem appropriate to include the sections in which the shorter widths of fabric covered the original transverse joints and cracks only partially in this analysis. The progression of transverse reflection cracks, expressed as a per cent of the original number of transverse joints and cracks, with time and the accumulation of 18-kip equivalent axle loads is shown in Figure 6. Fig. 6

Referring to Figure 6, it will be seen that there has been a sharp growth of transverse reflection cracking where welded wire fabric was not used as compared with where it was used. The 50-foot crack-interval section data show 38 per cent had reflected the first year, with a steady increase to 98 per cent in the fifth year of service. The 13-foot crack-interval control section demonstrated a similar growth of 8 per cent the first year to 67 per cent by the fifth year. In the full-lane-width reinforced sections no appreciable amount of transverse reflected cracks was evident in the first year, and only 27 per cent reflected after the fifth year of service. As stated previously, 18-kip equivalent single-axle loads representative of mixed traffic accumulated at the rate of about 7,500 per year.

It is apparent that the welded wire fabric has been beneficial in reducing the growth of transverse reflection cracking up to the fifth year of service, with the per cent reflected being about one-fourth that in the 50-foot crack interval section, and less than one-half the value of the 13-foot crack interval control section.
