# AN EVALUATION OF INTERLAYER STRESS ABSORBING COMPOSITE (ISAC) REFLECTIVE CRACK RELIEF SYSTEM

**FINAL REPORT  
PHYSICAL RESEARCH REPORT NO. 150  
MARCH 2005**

**Illinois Department of Transportation**

# Final Report

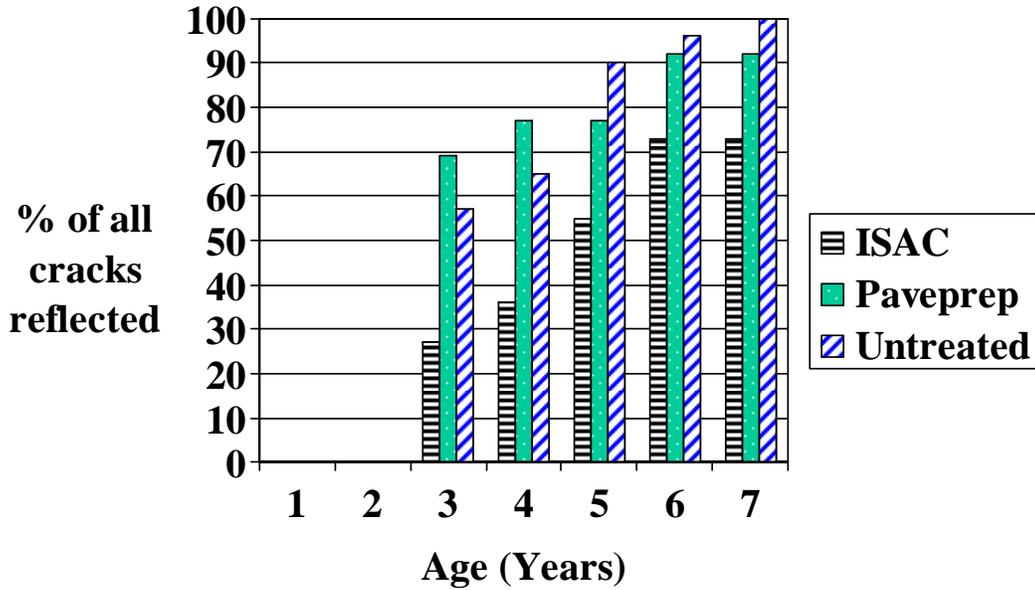
Figure 1

After three years, nine of the 13 (69%) PavePrep locations had reflective cracks, while only three of the 11 (27%) ISAC locations had reflective cracks. At this time, 28 of the 49 (57%) other reflective cracks at untreated locations had reflected through the overlay. All cracks were low severity. After seven years, 12 of the 13 (92%) PavePrep locations had reflective cracks with seven high severity cracks, while eight of the 11 (73%) ISAC locations had reflective cracks with one high severity crack. After this survey, eight of the 49 (16%) reflective cracks at untreated locations were high severity and 24 (49%) were medium severity.

Many of the PavePrep locations and some of the ISAC locations contained two or more cracks that were one to two feet apart. Some of these double cracks extended across the entire lane and sometimes the cracks formed “Y’s”. The cracks in the adjacent lanes were usually single cracks and much straighter. Crack control fabric was exposed in some of the high severity cracks in the outer and middle lanes.

Since there was no pre-overlay survey, the number of untreated cracks and joints is unknown. However, only five new cracks were recorded in the 2003 and 2004 surveys. The ISAC strips delayed the reflective crack by about two years (see Appendix A Figure 1). The crack severity progression was also delayed by about two years. The PavePrep locations had the quickest formation of reflective cracks and the highest severity progression.

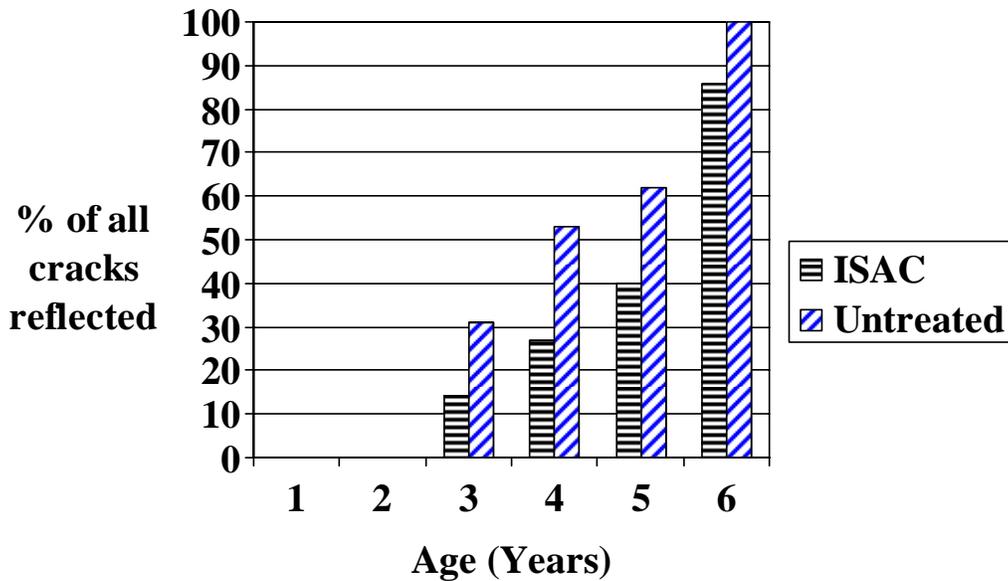
Figure 2

After three years, 14 of the 103 (14%) ISAC locations had reflective cracks. At this same time, 40 of the 131 (31%) untreated cracks had reflected through the overlay. After four years, 28 of 103 (27%) ISAC locations had reflective cracks. At this same time 70 of the 131 (53%) untreated cracks had reflected through the overlay. After five years, 41 of the 103 (40%) ISAC and 81 of the 131 (62%) untreated cracks had reflected through the overlay.

A large increase in reflective cracks at ISAC locations occurred between the 2003 and 2004 survey. The reflective cracks increased from 31 to 89. The reflective cracks at the untreated sections increased from 81 to 131. It was also between these surveys that the cracks were routed and sealed.

Before the cracks were sealed between the 2003 and 2004 surveys, there were 15 medium and high severity cracks at the untreated locations and only two medium severity reflective cracks at ISAC locations. The severity levels of the sealed cracks were rated at the previous severity level unless they had deteriorated further. The ISAC

strips delayed the reflective cracks between one and two years (see Appendix A Figure 2).

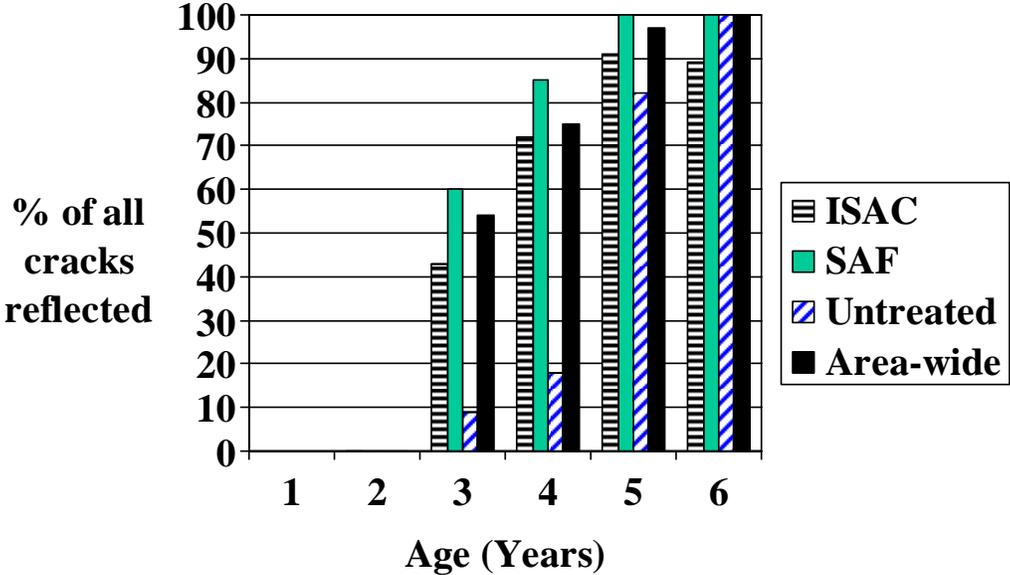
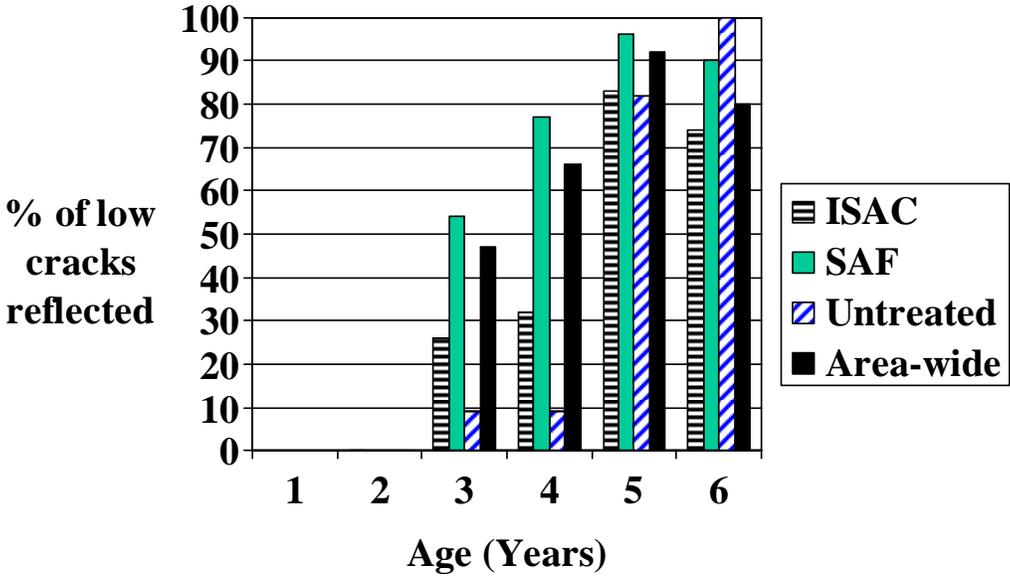
Figure 3

The ISAC section was compared to the SAF section that was in the adjacent lane. The lengths of these sections were the same. The SAF section had 20 more reflective cracks, in the 2002 survey, than the ISAC section. Only one low severity crack in the ISAC section was not at an ISAC strip. Seams were forming at 18 of the 47 ISAC locations and four SAF locations. The ISAC strips were more effective at delaying the reflective cracks than the SAF layer. The formation of reflective cracks in the ISAC section was delayed about two years (See Appendix A Figures 3 and 4).

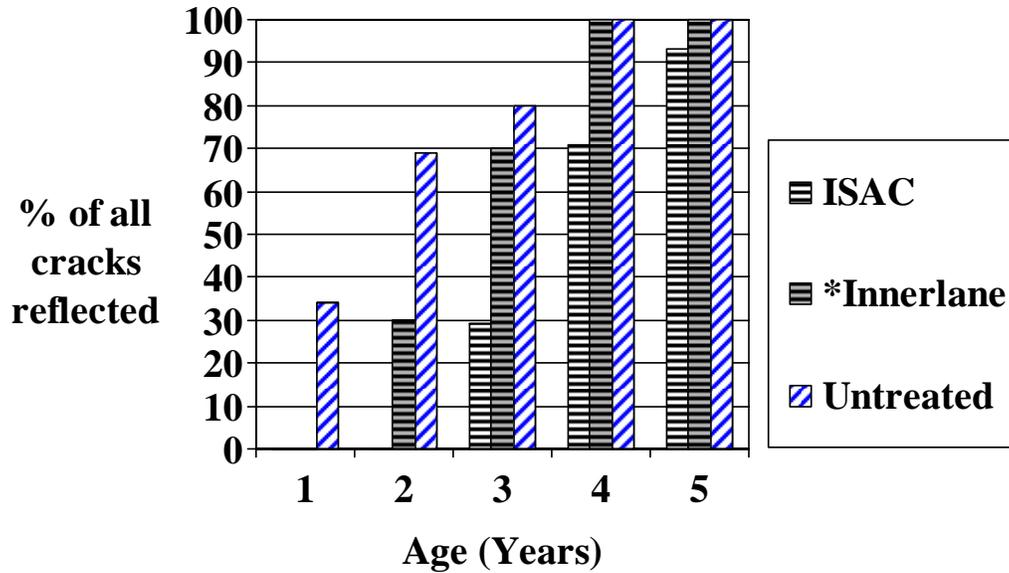
Figure 5

The percentage of reflective cracks at the ISAC locations after three years, 29%, was slightly less than the percentage at the untreated locations after one year, 34%. This

percentage was almost identical to the percentage of reflective cracks in the lane adjacent to the ISAC patches, 30%, after two years. There was a similar comparison of the ISAC locations after four years, 71%, to the untreated after three years, 69%, and with the adjacent lane after two years, 70% (See Appendix A Figure 5).

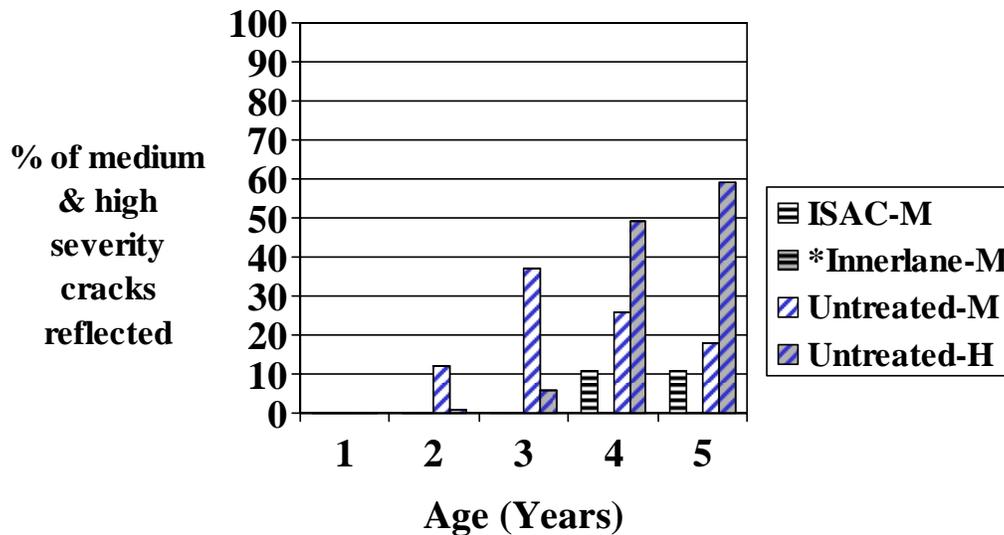
Figure 6

One patch was placed before the 2003 survey and two patches were placed before the 2004 survey in outer lane. The reflective cracks in the outer lane were rapidly deteriorating. There were 93 high severity cracks in 2004 and many of these cracks had been treated with spray injection patches. All of these cracks were at untreated locations. There were 17 low severity and three medium severity reflective cracks at the ISAC locations (See Appendix A Figure 6).

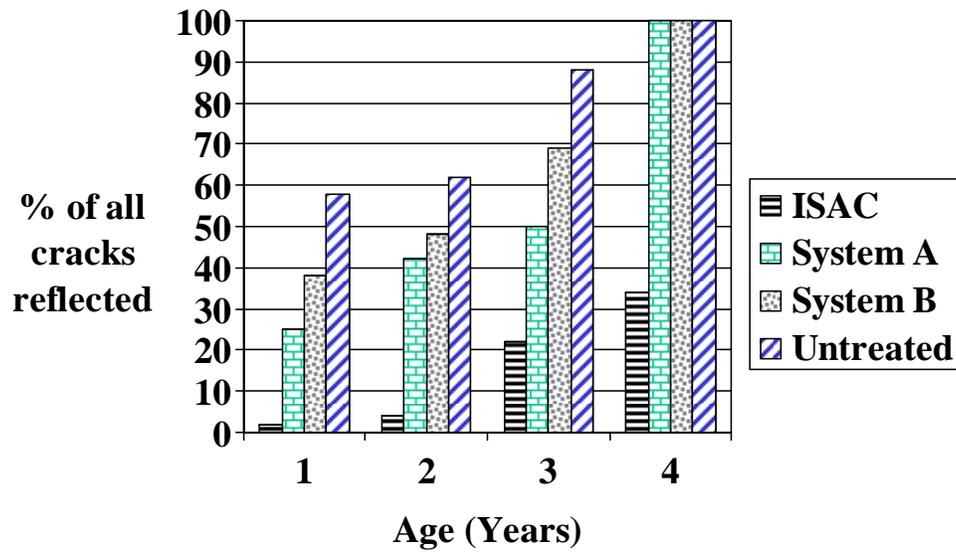
Figure 7

After one year, nine of 455 (2%) ISAC locations had reflective cracks. At this same time, three of 12 (25%) System A (non-woven fabric), 32 of 84 (38%) System B (Roadtac), and 15 of 26 (58%) untreated locations had reflective cracks. After three years, 102 of 455 (22%) of the ISAC locations had reflective cracks. At this same time, six of 12 (50%) of System A (non-woven fabric), 58 of 85 (68%) System B (Roadtac), and 23 of 26 (88%) untreated locations had reflective cracks (See Appendix A Figure 7).

The greatest increase in reflective cracks at the ISAC locations, from 18 to 102, occurred between year two and three. There was an increase to 153 in year four. When compared with "System A", the reflective cracks were delayed by about two years with ISAC. When compared with "System B", the reflective cracks were delayed almost three years. When compared with the untreated locations, the reflective cracks were delayed over three years.

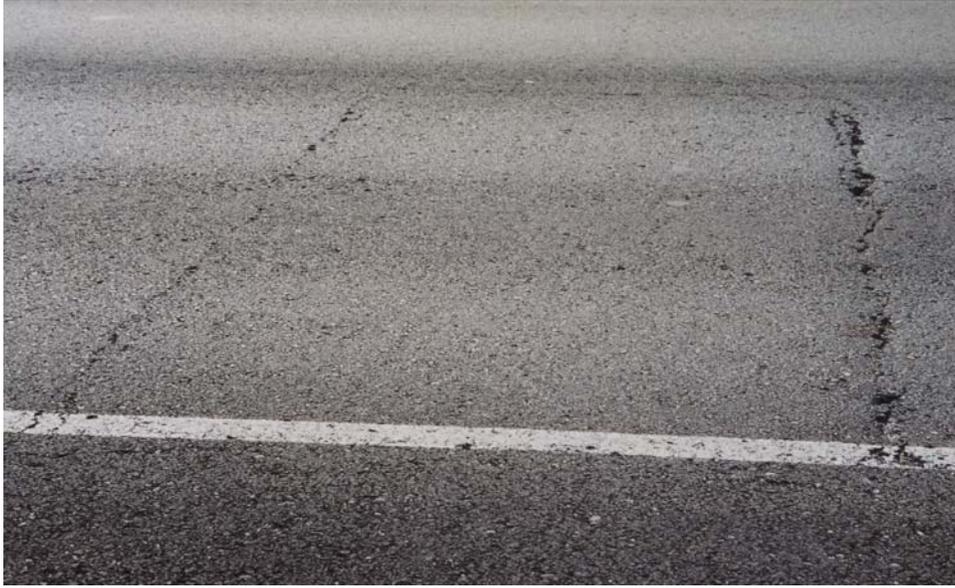
This section was patched in the Fall of 1998 and overlaid with an asphalt concrete binder course. Traffic was allowed on the binder throughout the winter. Reflective cracks formed in the binder and needed repair before the surface was placed. The district wanted to use the ISAC strips at these locations to deter the reflective cracks. It should be noted that only the reflective cracks that were visible were repaired. There may have been other locations where the reflective cracks had begun, but had yet to reach the surface. Appendix C contains photos from this project. Formal control (untreated) sections were not established during the installation.

Interstate 55 reflective cracks in binder layer June 1999.

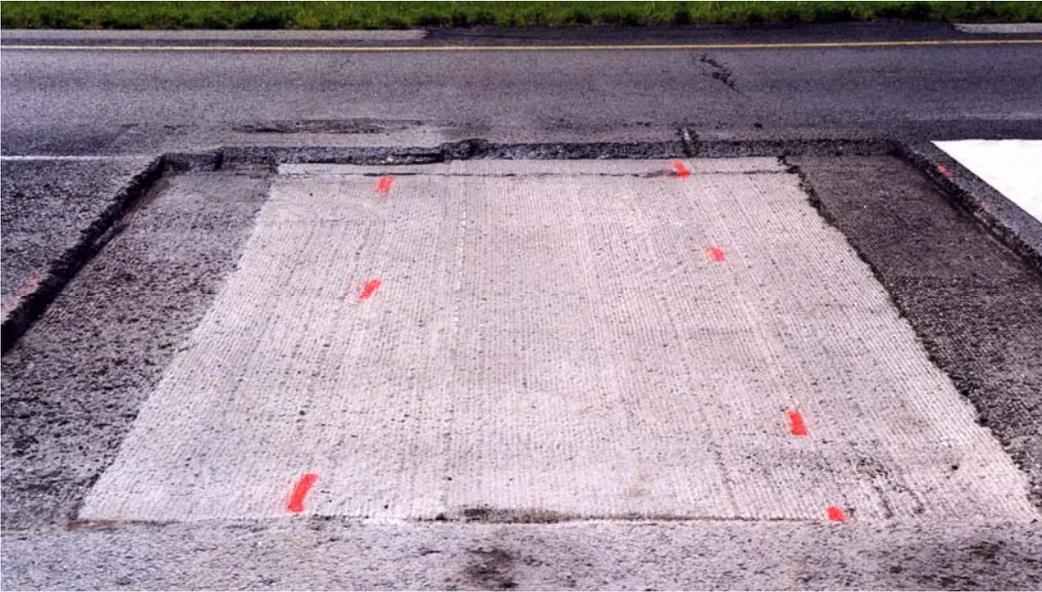
Binder layer removed June 1999.

The binder around the reflective cracks was milled 2.5 inches to expose the concrete patch. A rubberized asphalt (D-6690 Type II) tack coat at 400 °F was used to provide a bond between the fabric and the pavement. The plastic backing remained on the ISAC while a hand roller was used to seat the ISAC. A rubber-tired vehicle was used for final seating.

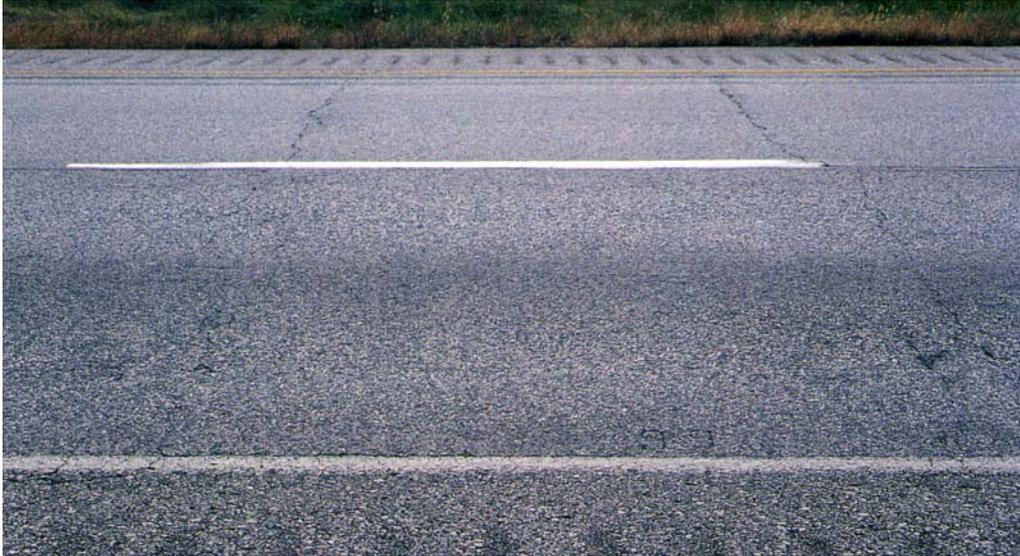
10/07/04 ISAC treated patch in bottom lane ("99" stamped near the edge stripe).  
All reflective cracks are low severity.

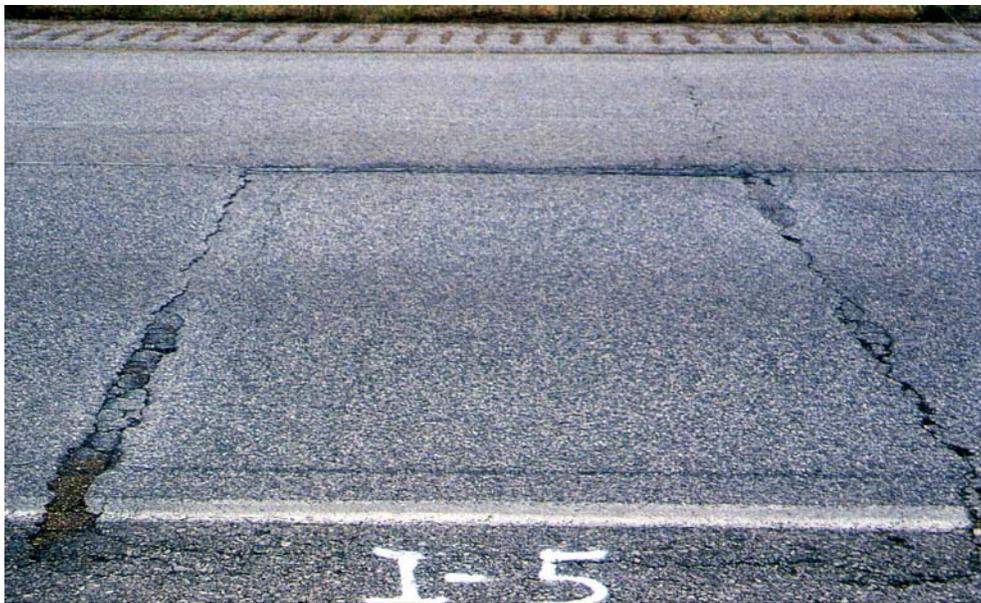
10/07/04 untreated patches. Low severity reflective cracks in top lane.  
High severity reflective cracks in the bottom lane.
