Tech Brief

Maintenance of Damaged Guardrail Systems

Illinois Department
of Transportation

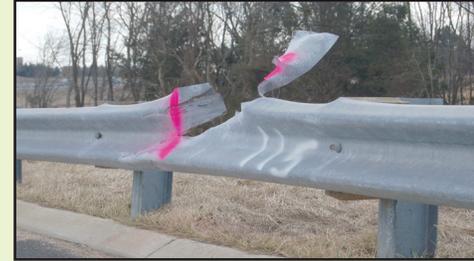
A

- Vertical tears in the W-beam (Photo A) that extend to the top or bottom of the rail greatly reduce the capacity of the rail and create areas of high stress concentrations, both of which can cause the rail to tear completely through and allow vehicular penetration upon impact.
- Non-manufactured holes (e.g., those caused by crash damage, lug nut damage, or corrosion) in the rail element that intersect the top or bottom edges of the W-beam
- Rail flattening may increase the chances that an impacting vehicle will overturn upon contact as well as increase the deflection distance. Any flattened panel that increases the W-beam section width to more than 18 inches (normal height is 12 inches) should be replaced.
- Damage at the splice where more than 1 bolt is missing or damaged, or the rail is torn can also compromise the continuity of the system. (Photo B).

Perhaps the most catastrophic failure of a guardrail is vehicle penetration allowed by physical separation (rupture) of the rail element or over-riding the guardrail. Therefore, any damage that significantly decreases the tensile strength of the w-beam rail or reduces its height to less than 26" should be considered a high-priority repair.

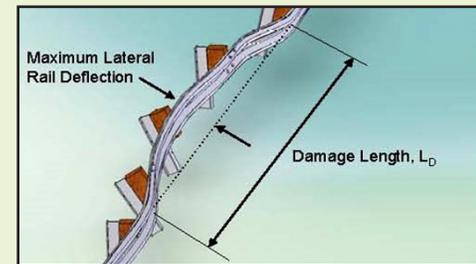
C

If the barrier has been deflected more than 9 inches over a 25-foot length, (Photo C), or if any posts are missing or ineffective due to tears, rot, broken or detached, prompt repairs should be made (the 31" can function with one missing post if no curb is present). These types of damage can result in greater vehicle instability in a crash, possibly leading to rollover, barrier rupture, or barrier override.

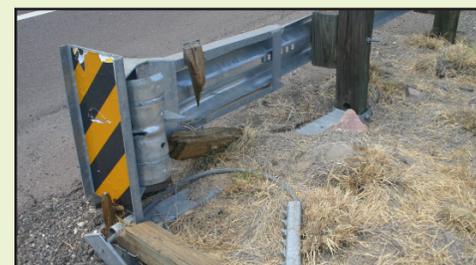
D

- If the end post is broken or if either the cable is not attached or the steel bearing plate is missing (Photo D), the anchorage is lost and any motorist striking the rail just downstream from the treatment end would likely penetrate the system rather than be redirected.
- For those terminal designs that incorporate a compression-based, energy-absorbing head, the head should be properly aligned and in position with the W-beam rail element so the rail is fully embedded and will "feed" into it in any head-on crash (Photo E), absorbing the vehicle's energy. Missing lag screws at the impact head can result in misalignment of the head. It is critical that the axial strength of the rail be maintained (i.e., on a straight line with no kinks or bends).
