I-55 Managed Lanes Combined Design Report

Appendix A.3 – Structures

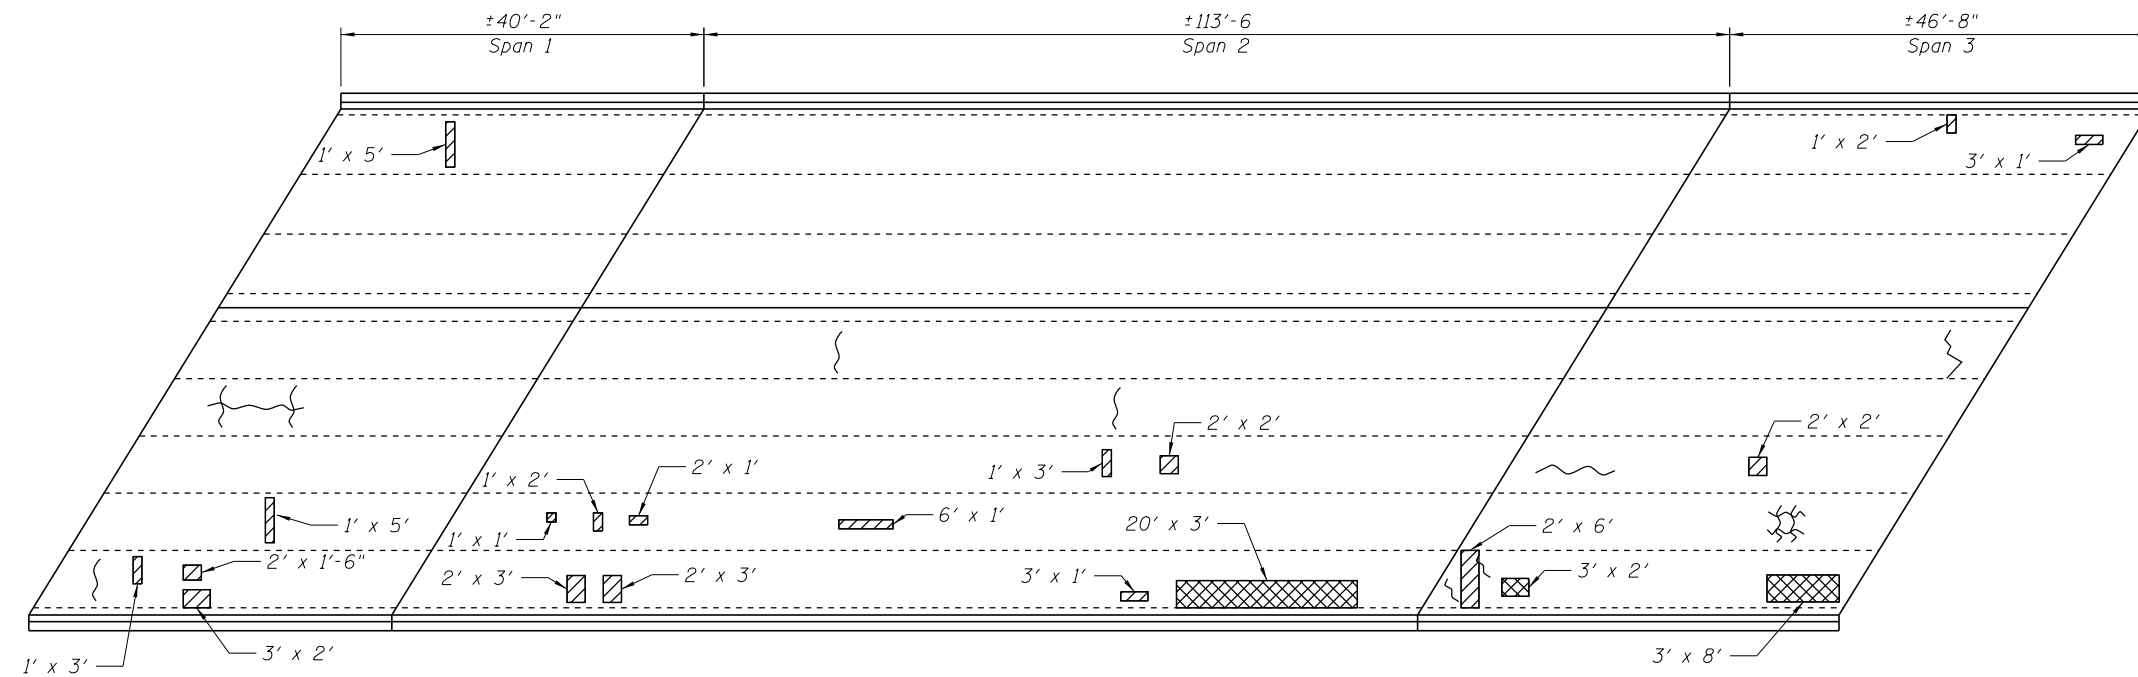
UNDERSIDE OF DECK
(Eastbound Bridge)

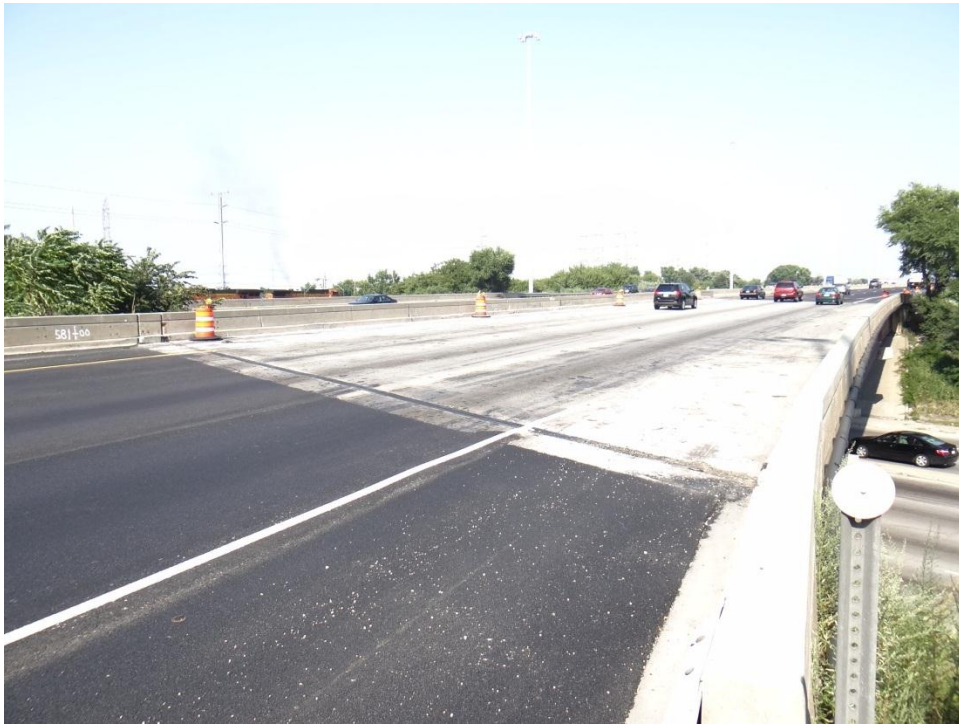
Figure 4. Typical view, deck top surface, looking northeast

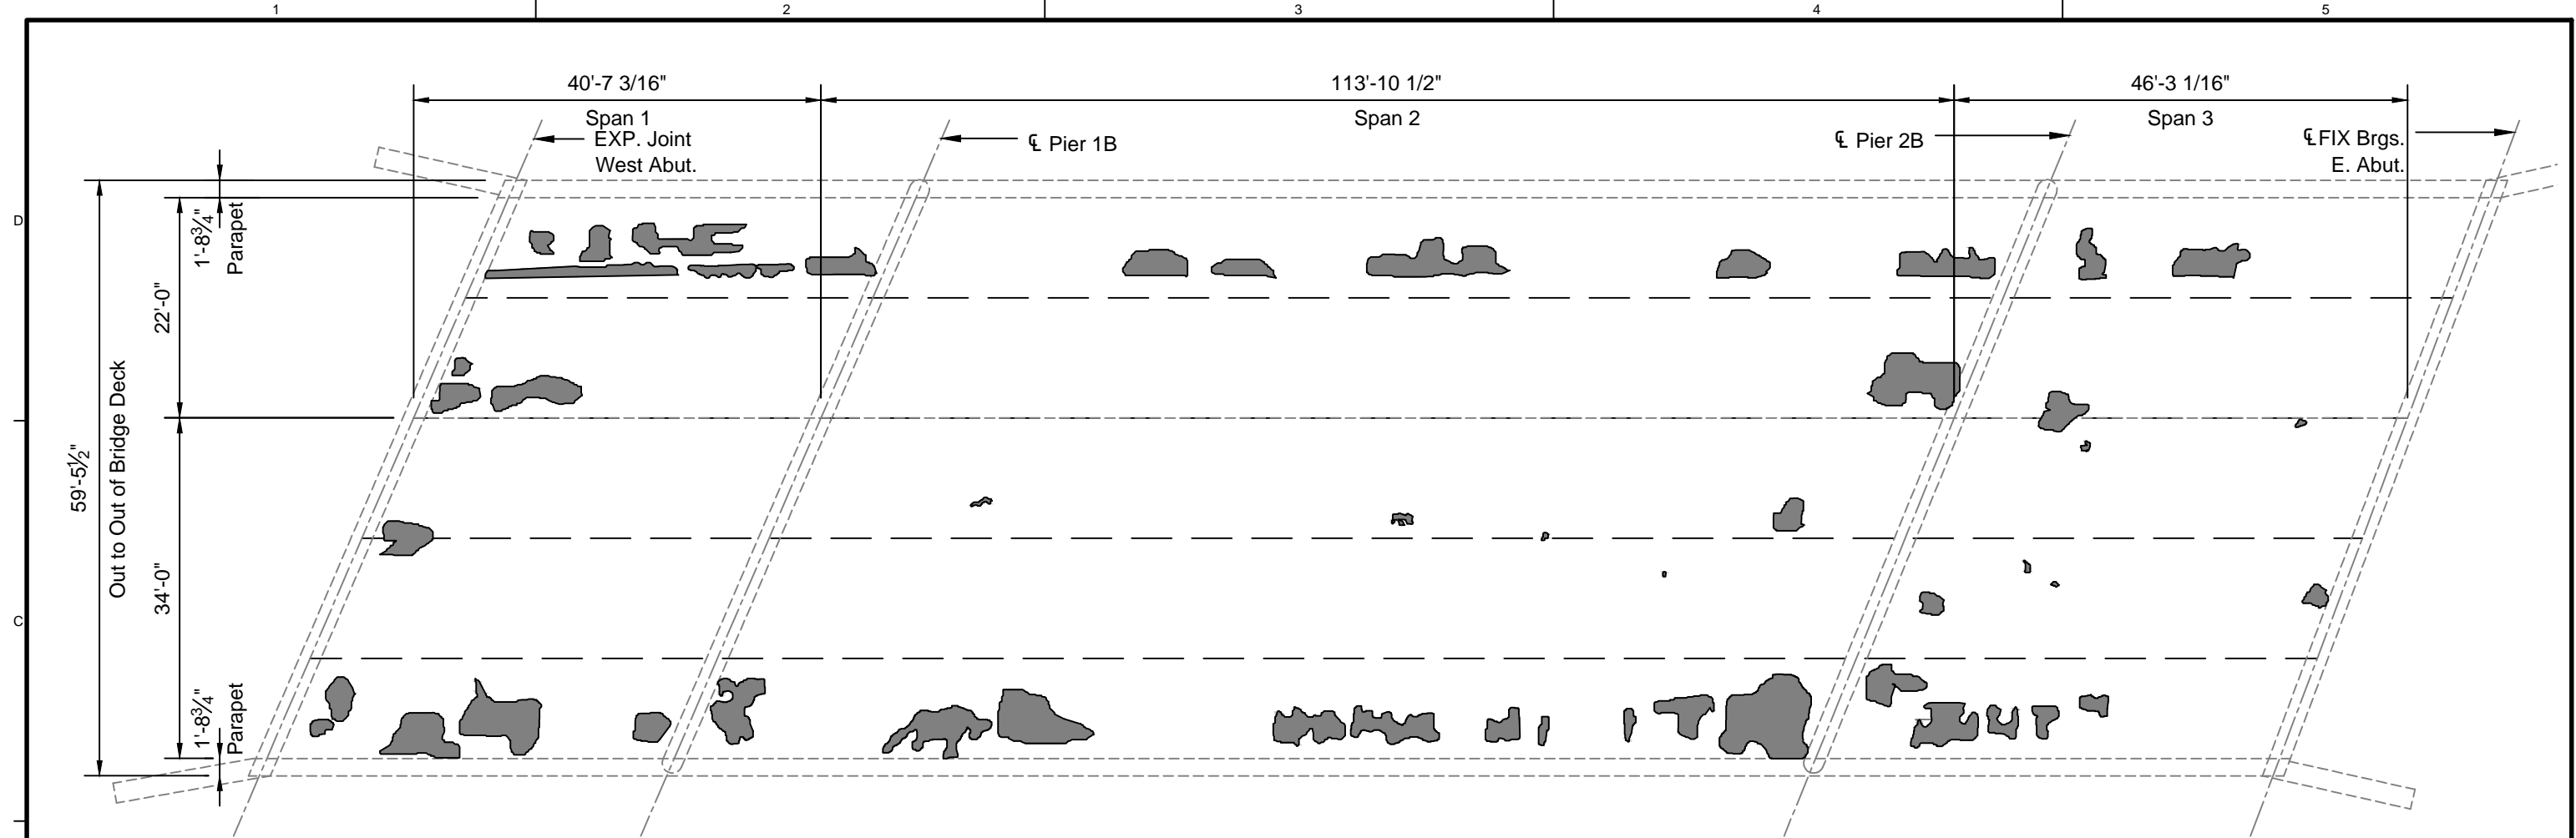
FIELD OBSERVATION SUMMARY		STRUCTURE # 016-0016		LEGEND	
ITEM	UNIT	QUANT.	%	DELAMINATION	
TOTAL AREA	Ac	10,900	100	SPALL	
DELAMINATION	Ac	615	5.6	CRACK	
SPALL	Ac	0	0		
CRACKS	ft	-	-

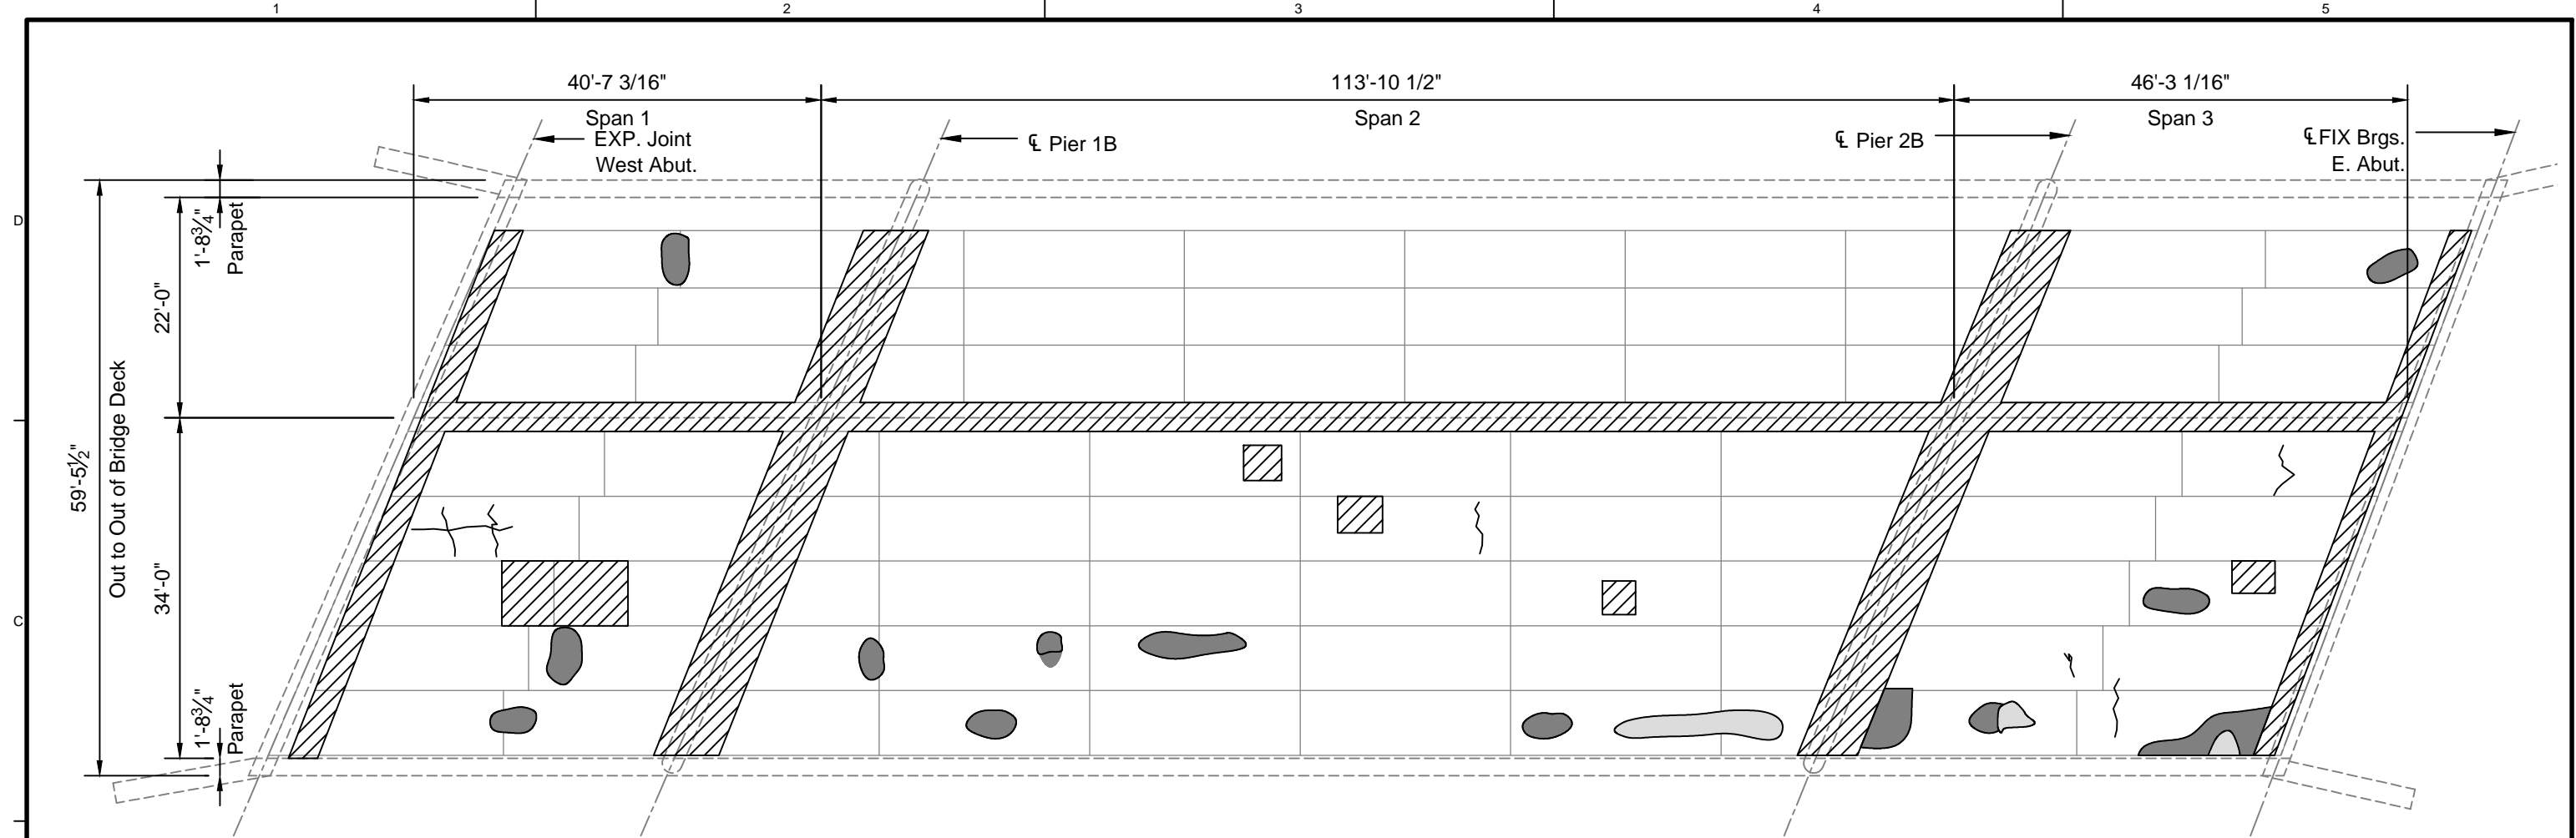
FIELD OBSERVATION SUMMARY		STRUCTURE # 016-0016		LEGEND	
ITEM	UNIT	QUANT.	%		
TOTAL AREA	Ac	10900	100	DELAMINATION	
DELAMINATION	Ac	180	1.7	SPALL	
SPALL	Ac	50	0.5	PREV. REPAIR	
PREVIOUS REPAIRS	Ac	1575	14.4	CRACK	
CRACKS	ft	-	-

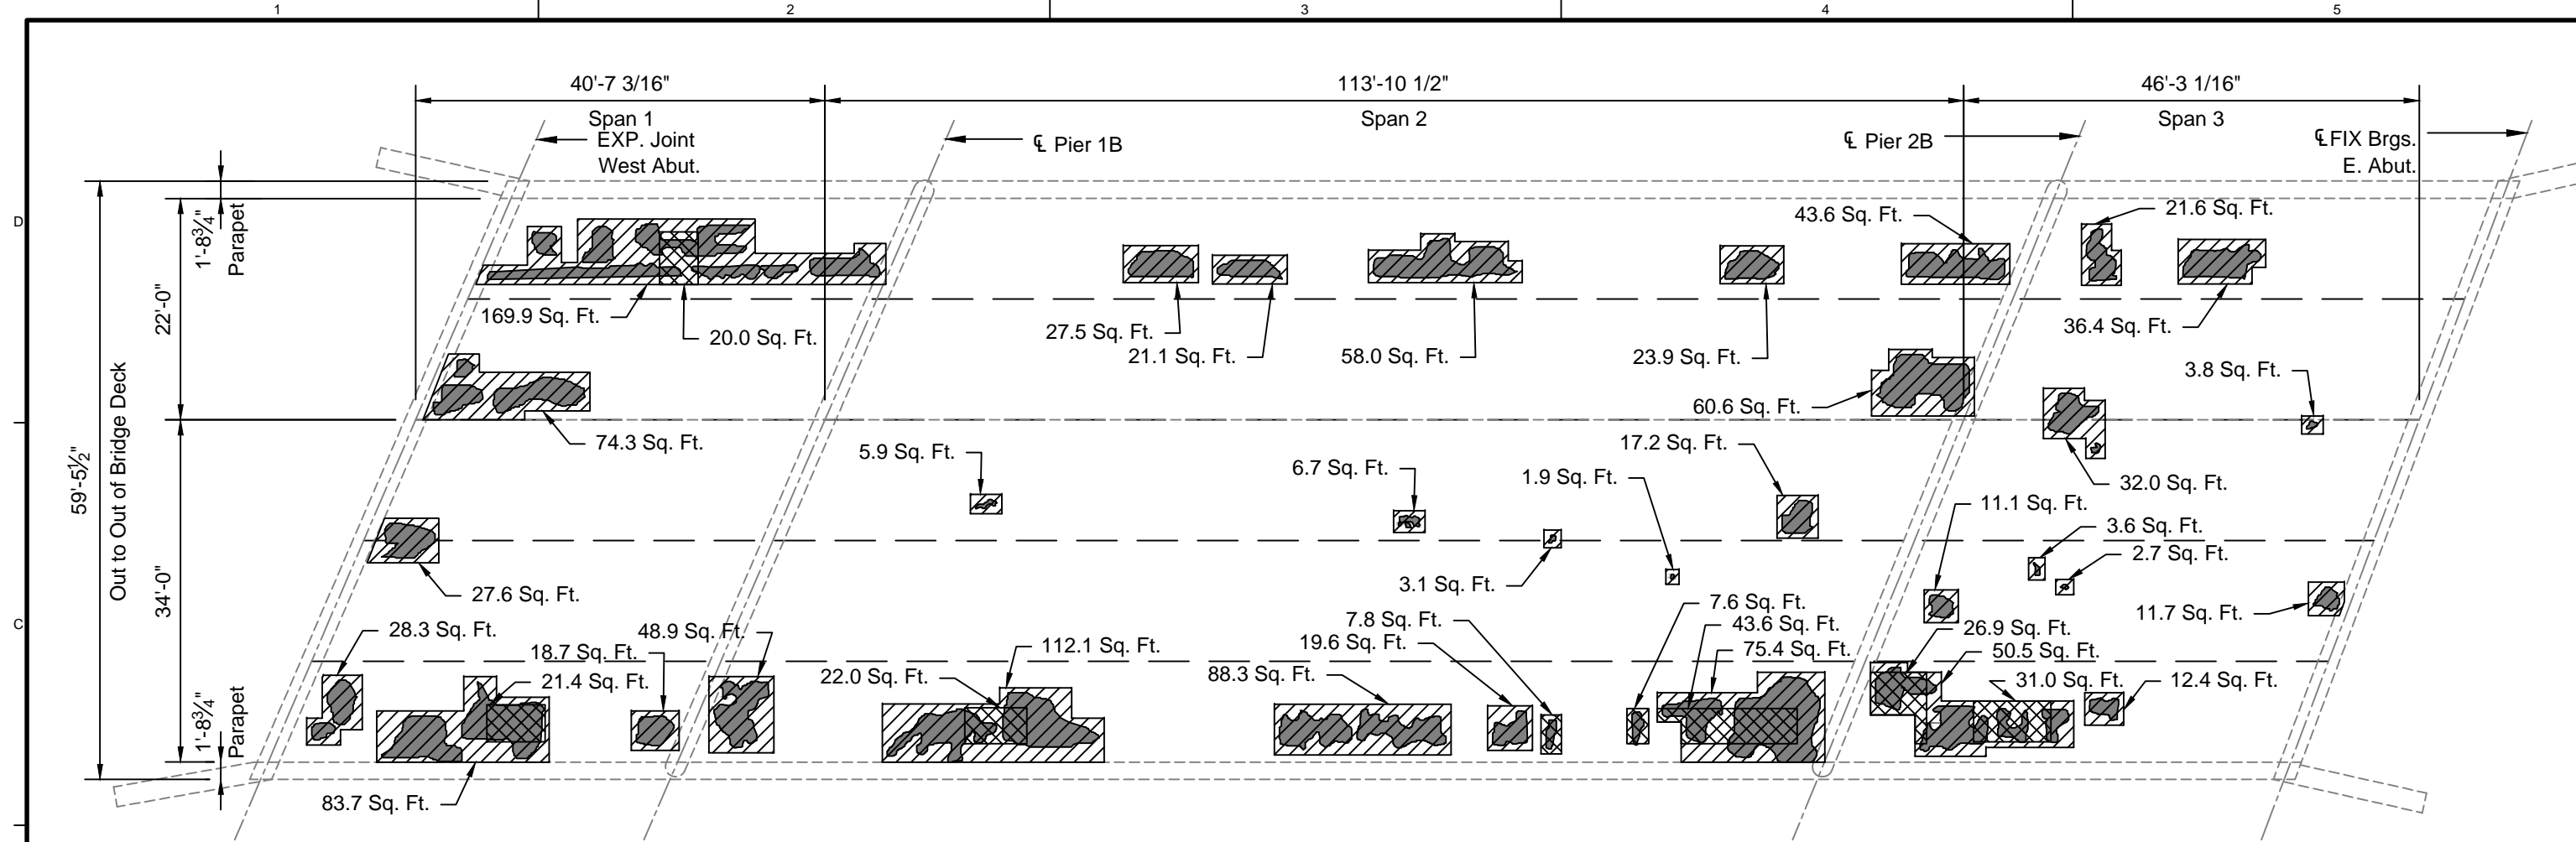
FIELD OBSERVATION SUMMARY		STRUCTURE # 016-0016		LEGEND	
ITEM	UNIT	QUANT.	%		
TOTAL AREA	Ac	10900	100	PARTIAL DEPTH REPAIR	
PARTIAL DEPTH REPAIR	Ac	1202	11.0	FULL DEPTH REPAIR	
FULL DEPTH REPAIR	Ac	180	1.7	DELAMINATION	
DELAMINATION	Ac	615	5.6	SPALL	
SPALL	Ac	0	0	CRACK	
CRACKS	ft	-	-

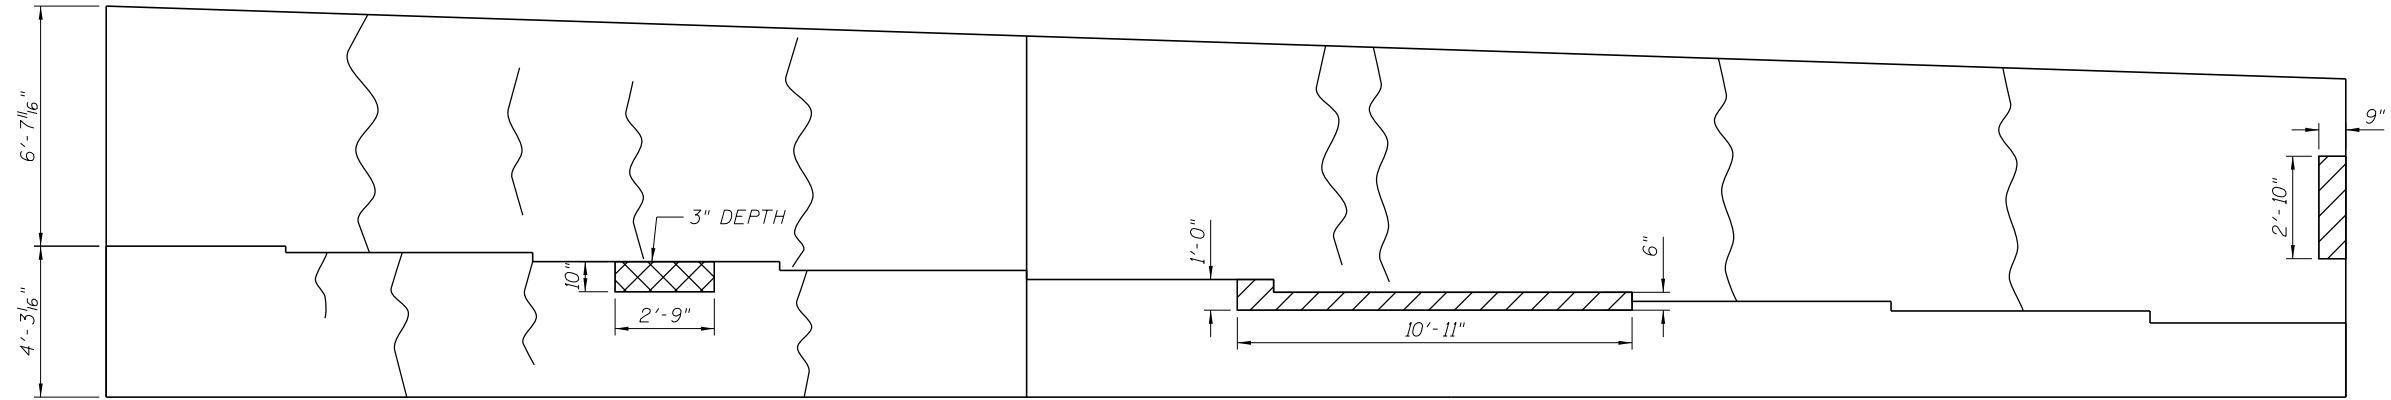
EAST ABUTMENT
LOOKING EAST

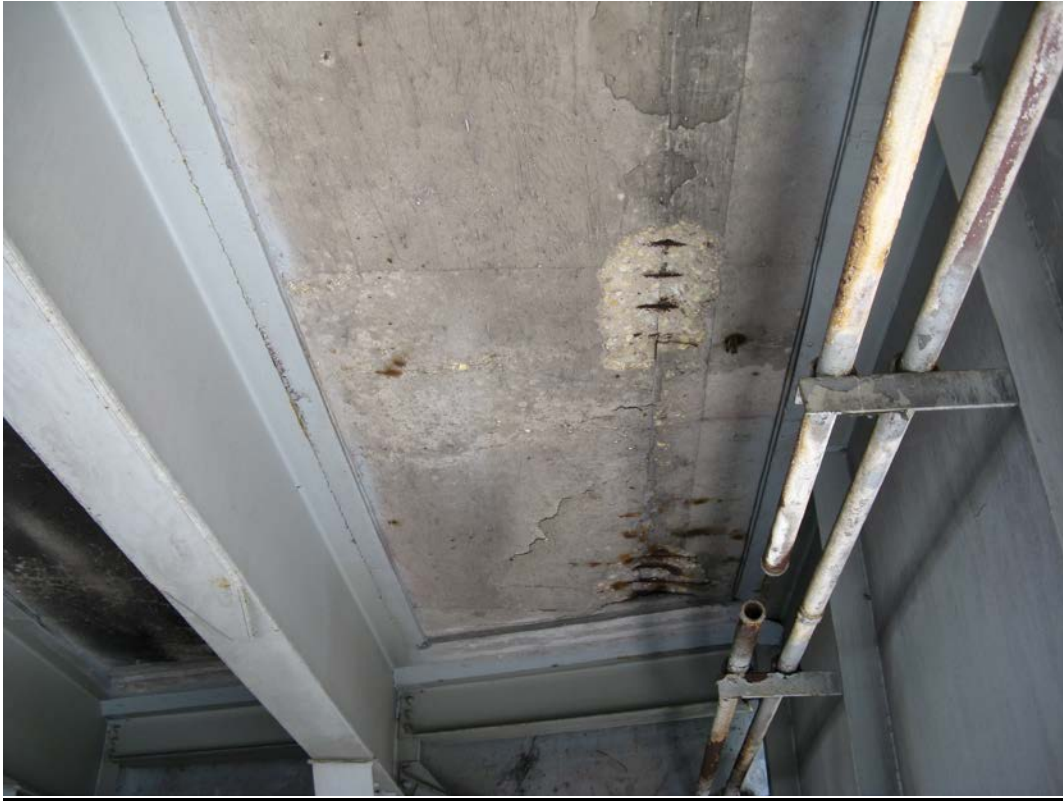
Photo 1 - Spalls on underside of deck in Span 3 between Beams 9-10 from north, east end, looking east

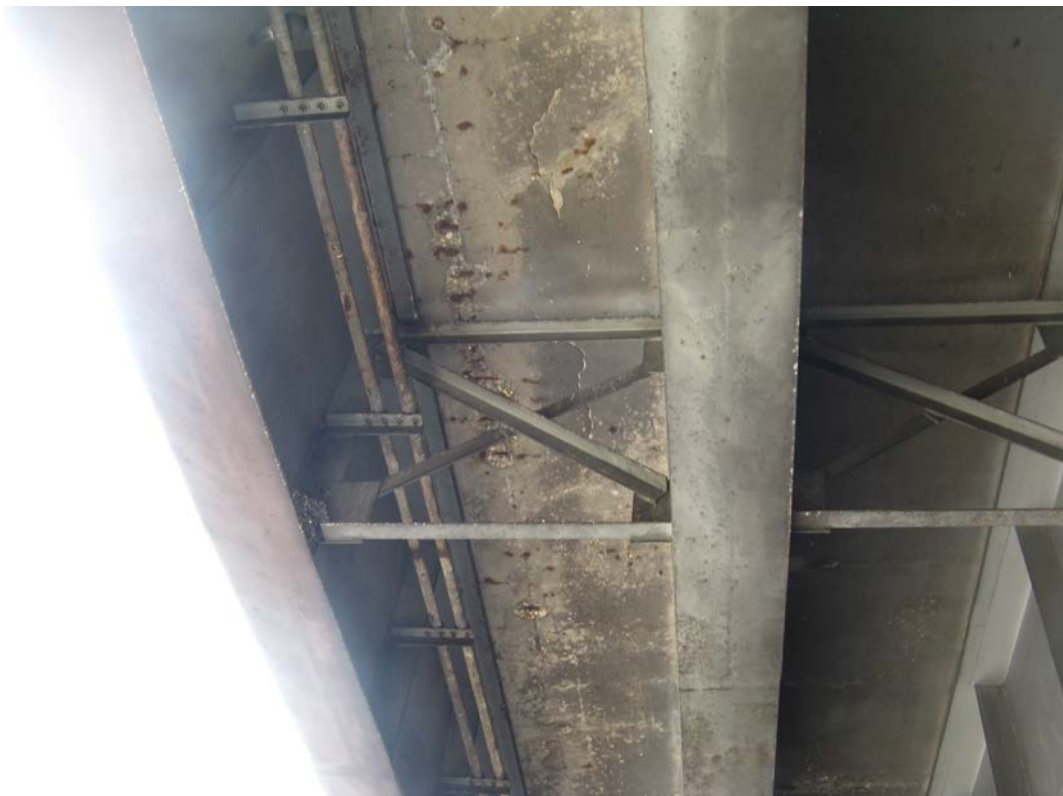
Photo 2 - Spalls on underside of deck in Span 2 between Beams 9-10 from north, east end, looking west

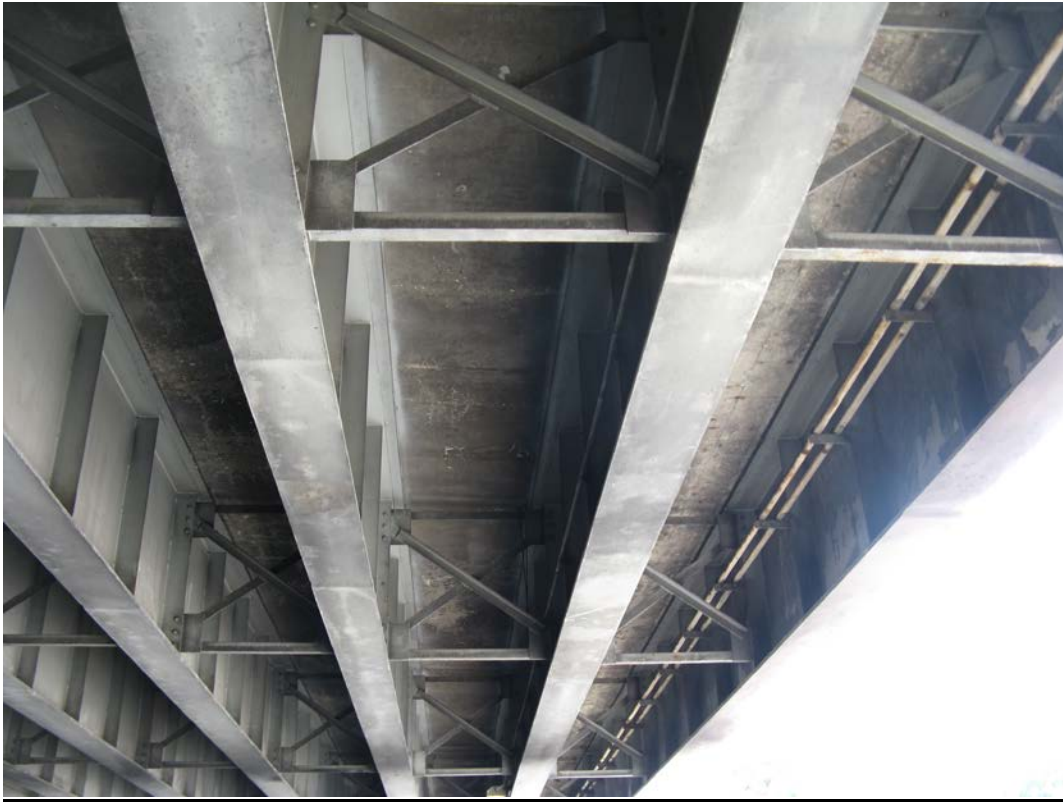
Photo 3 - Underside of Span 2, south end, looking east

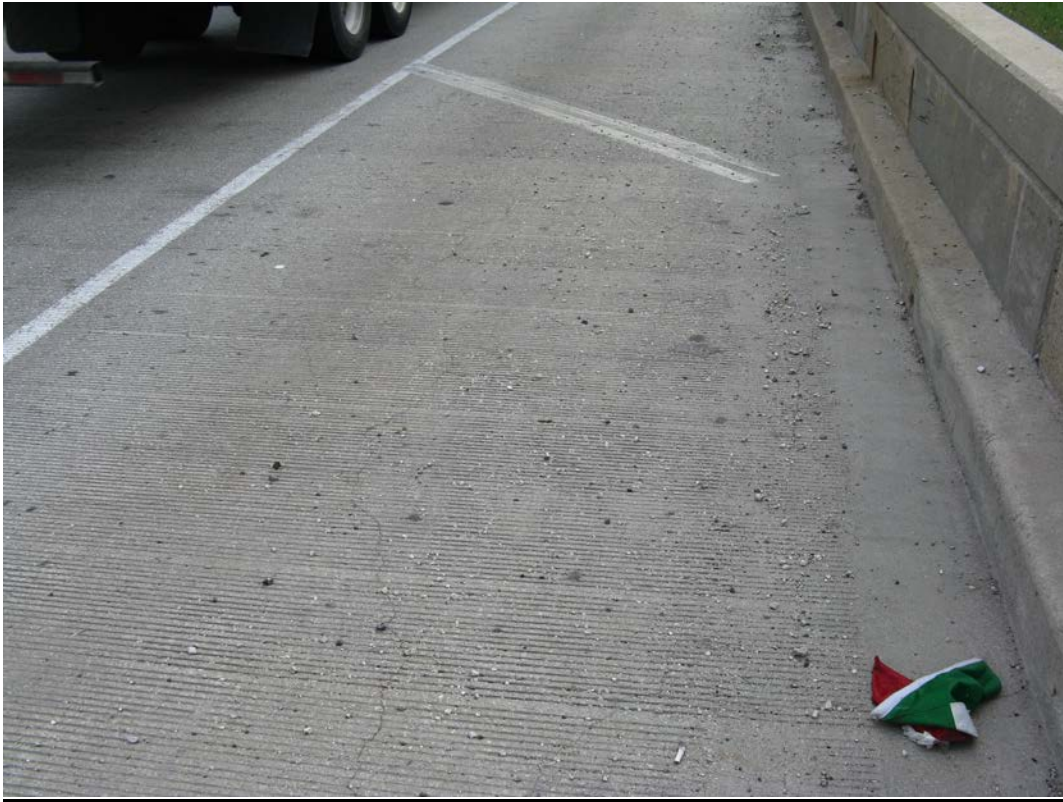
Photo 7 - Cracking in shoulder, Span 3, looking east

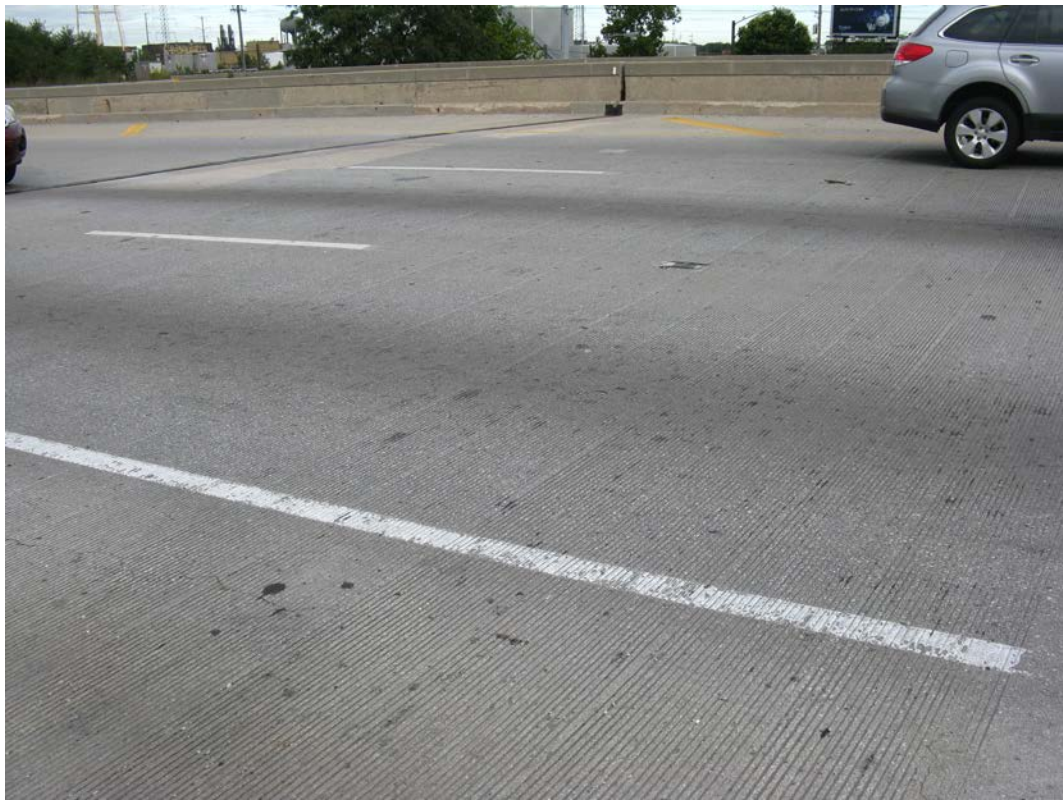
Photo 8 Span 3, looking northwest

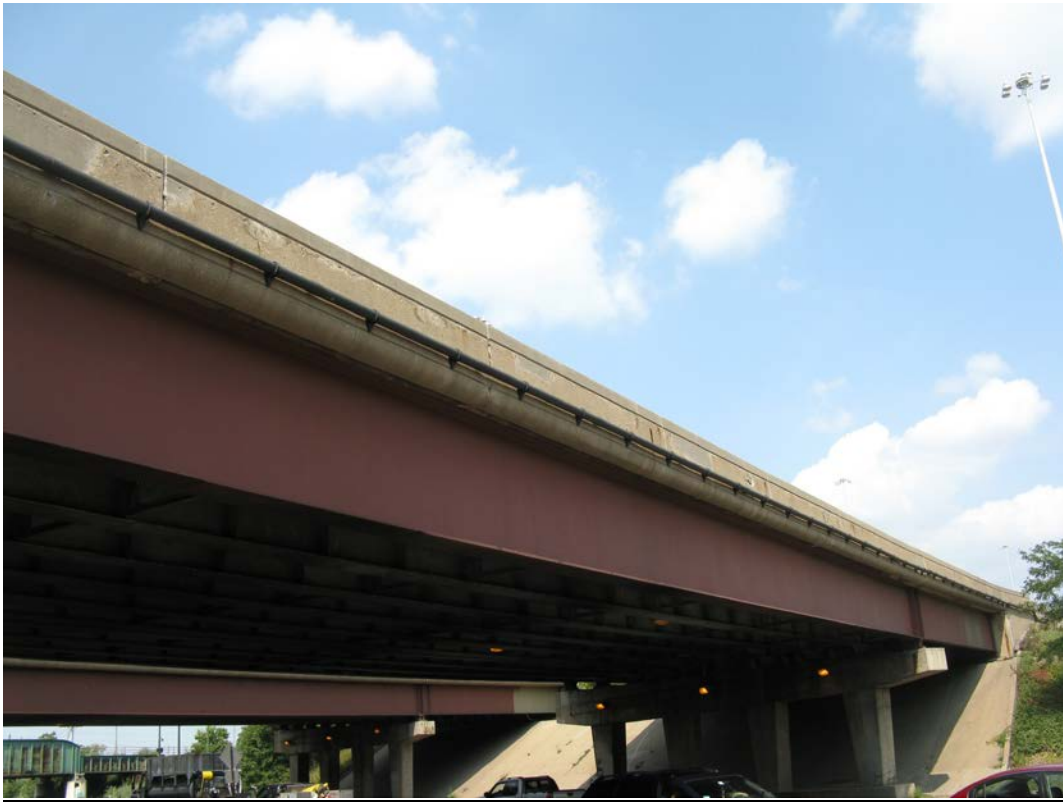
Photo 9 - Outside of South Parapet with minor rust stains, cracking, and minor spalling, looking northeast

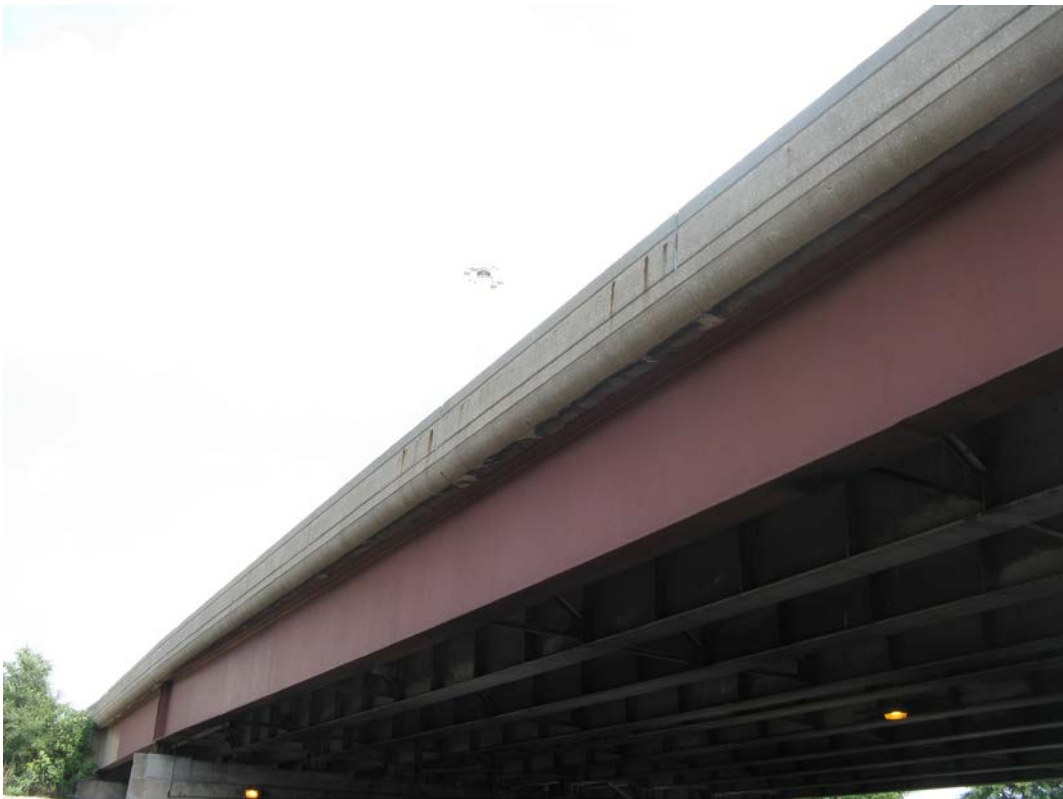
Photo 10 - Outside of North Parapet with minor rust stains and cracking, looking southeast

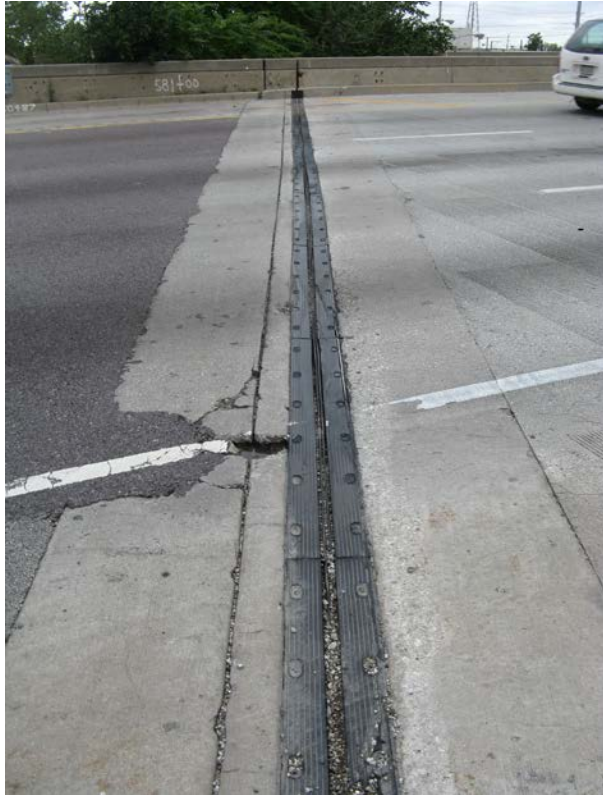
Photo 11 - West Abutment joint, looking north

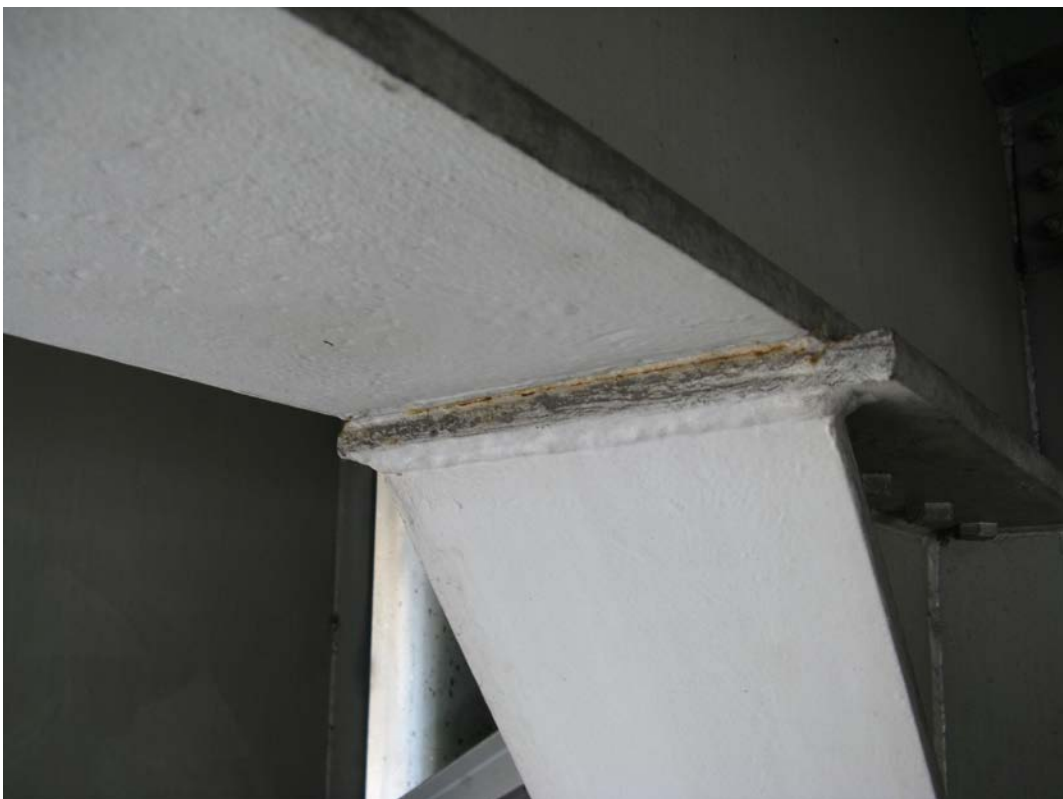
Photo 16 - Typical cracked weld between bottom flange of beam in east span and built up steel bolster, looking northeast (Beam 2 from north at East Abutment)

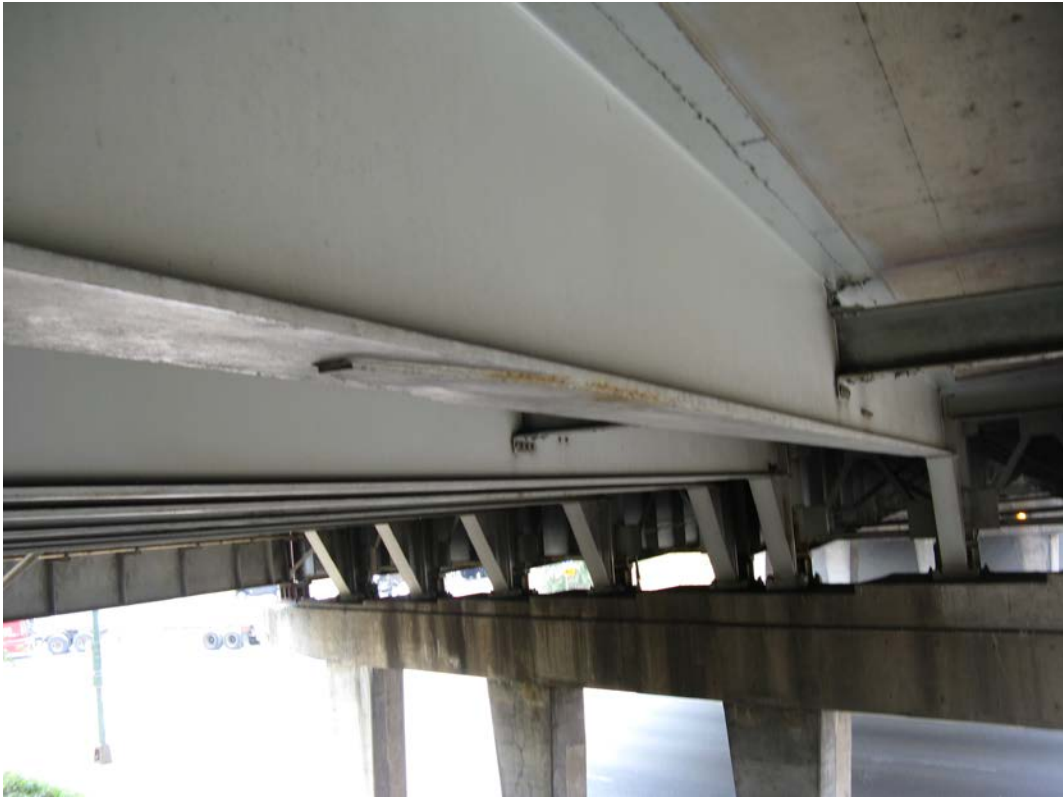
Photo 17 - Typical cover plates on bottom on beams in east span, looking southwest (Beam 3 from north, Span 3)

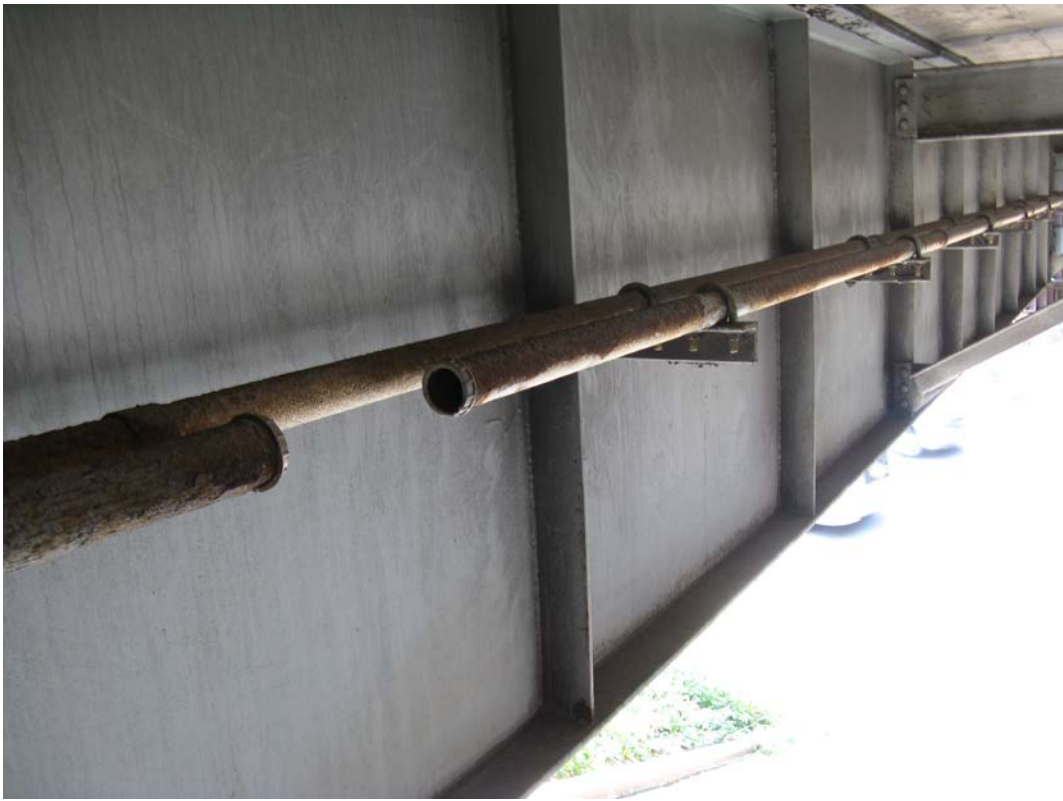
Photo 20 - Broken conduit along South Fascia Beam, Span 3, 8' from East Abutment, looking west

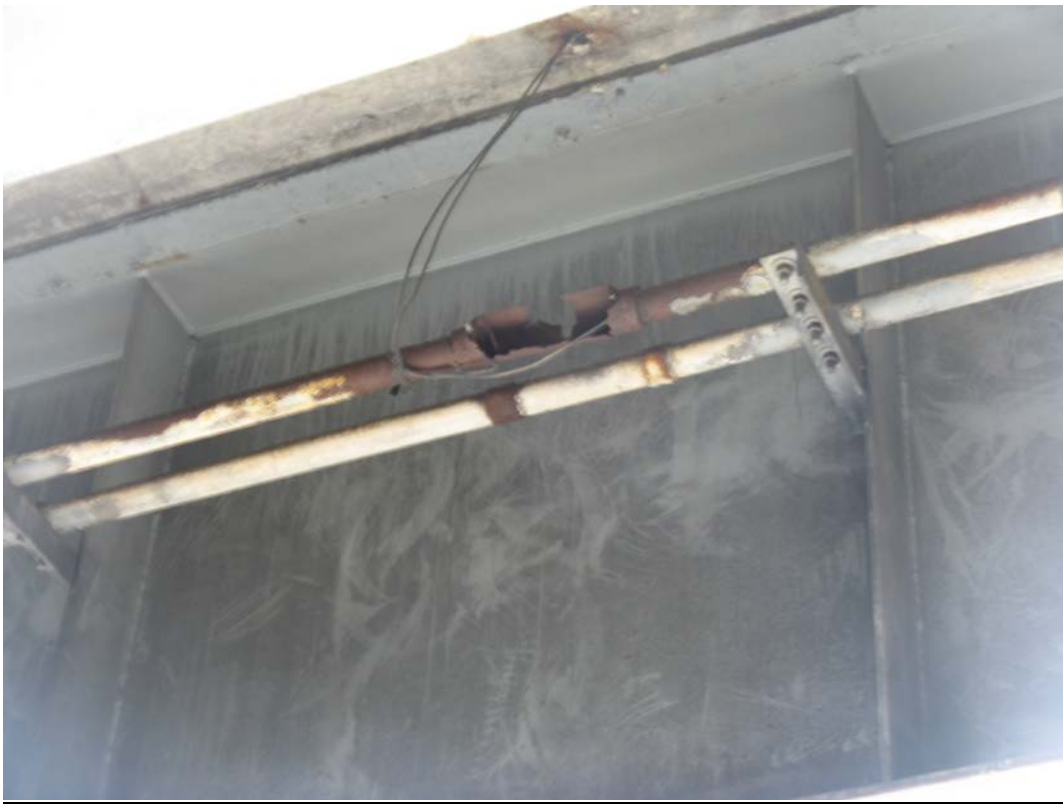
Photo 21 - Broken conduit in Span 2 along south fascia beam, 6' from West Pier, looking southeast

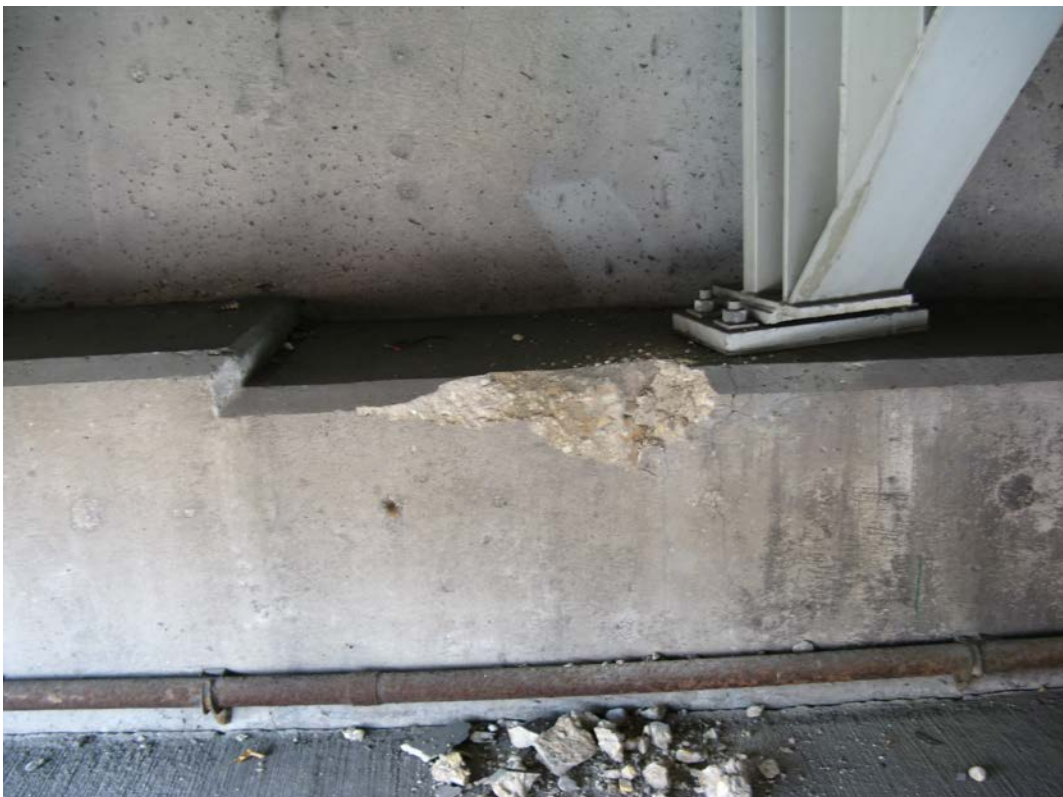
Photo 22 - Spall on East Abutment seat between beams 2-3, looking east

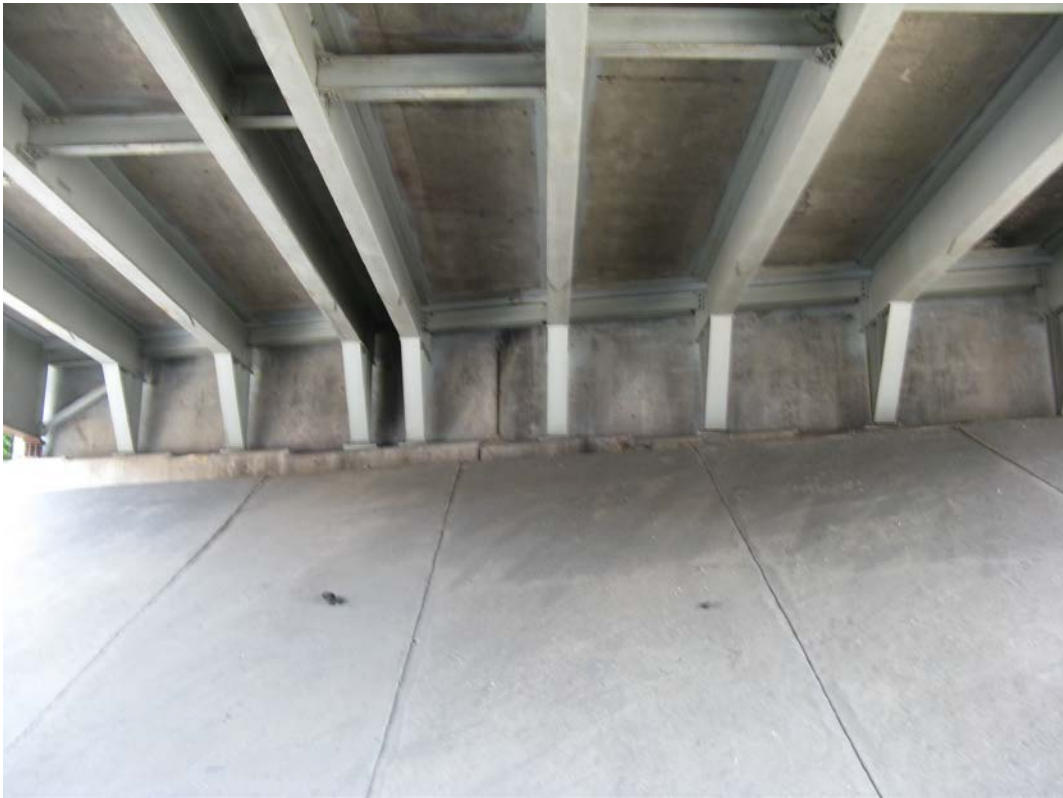
Photo 23 - East Abutment, looking east

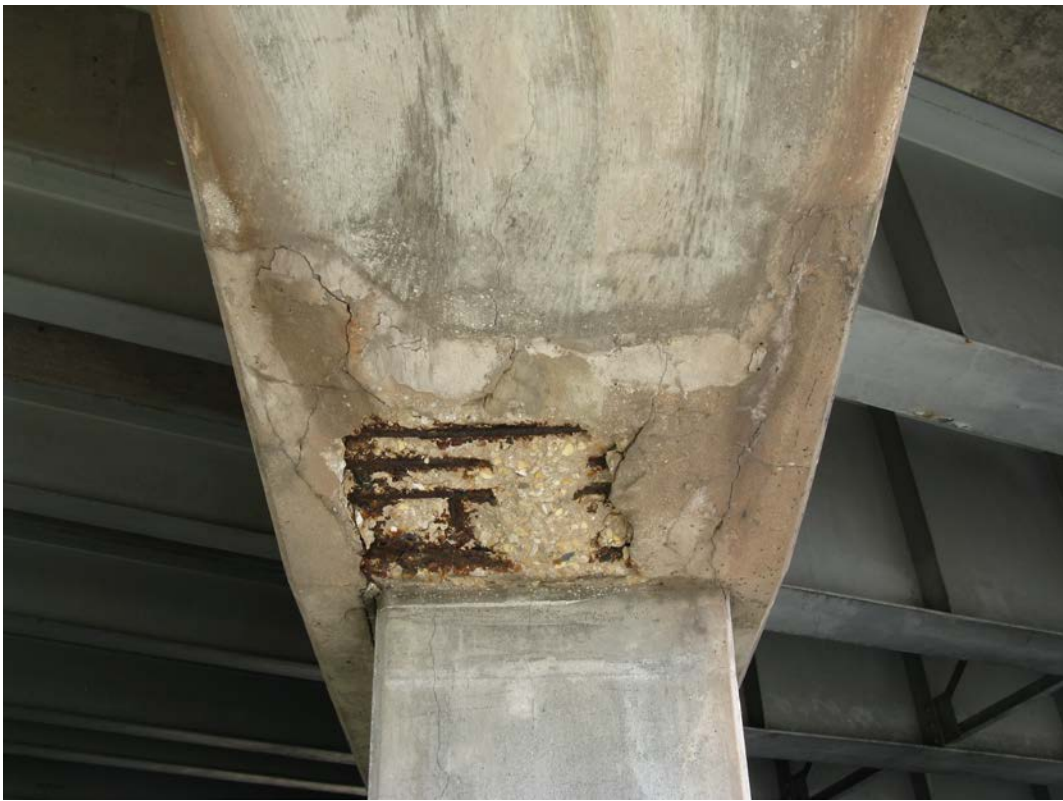
Photo 30 - Spall on underside of West Pier cap, south end, looking north
