I-55 Managed Lanes Combined Design Report

Appendix A.3 – Structures

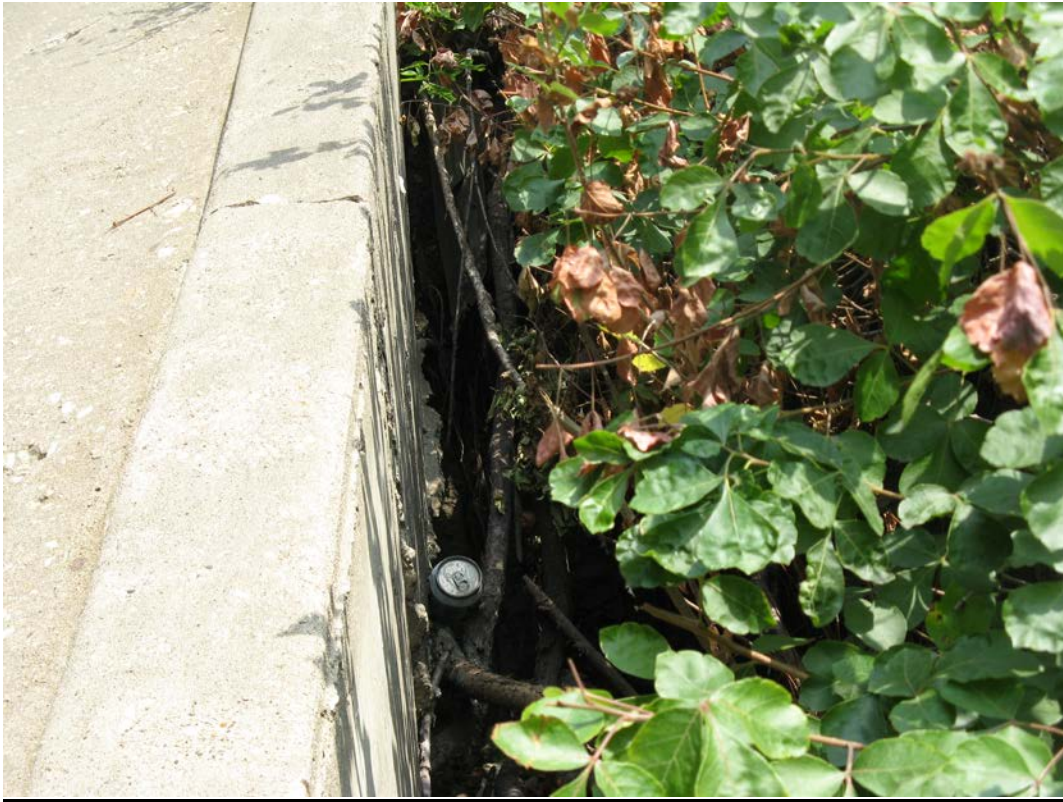
Photo 31 - Undermining of east sloped wall at south end, looking east

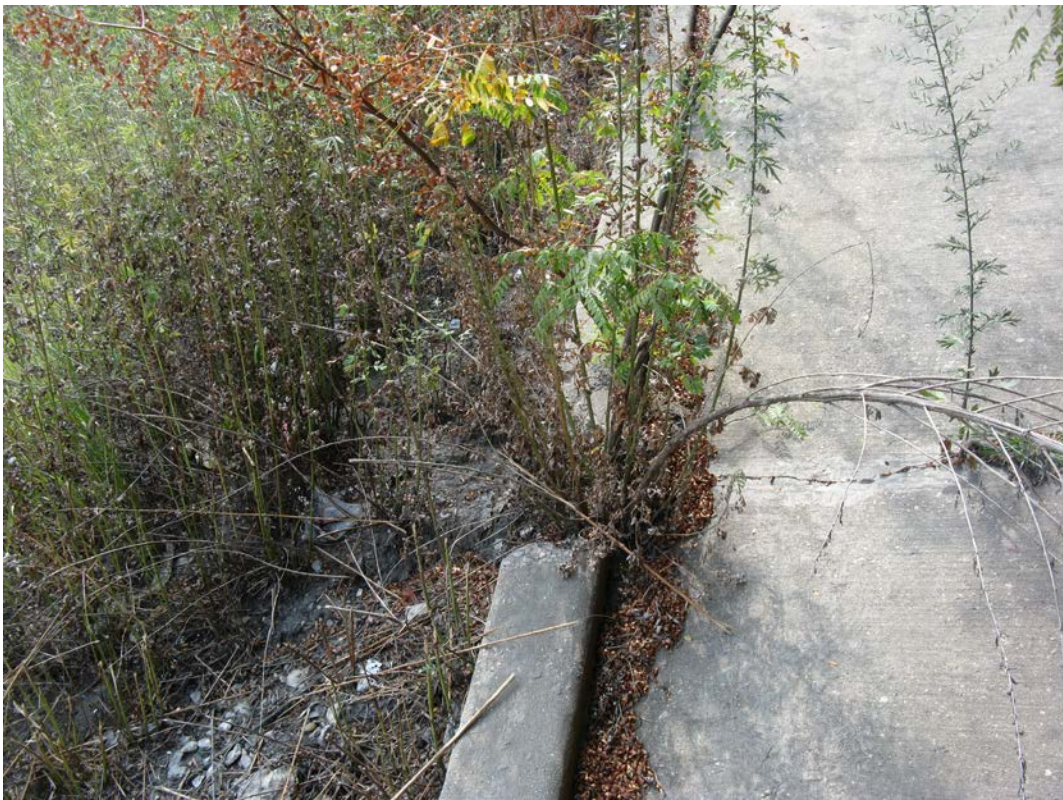
Photo 34 - Broken section of west slopewall curb with vegetation growing in it, approx half way up, looking west

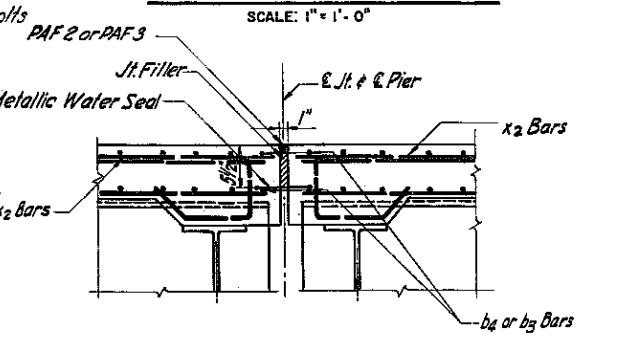
SECTION AT FIXED JOINT
SCALE: 1" = 1'-0"

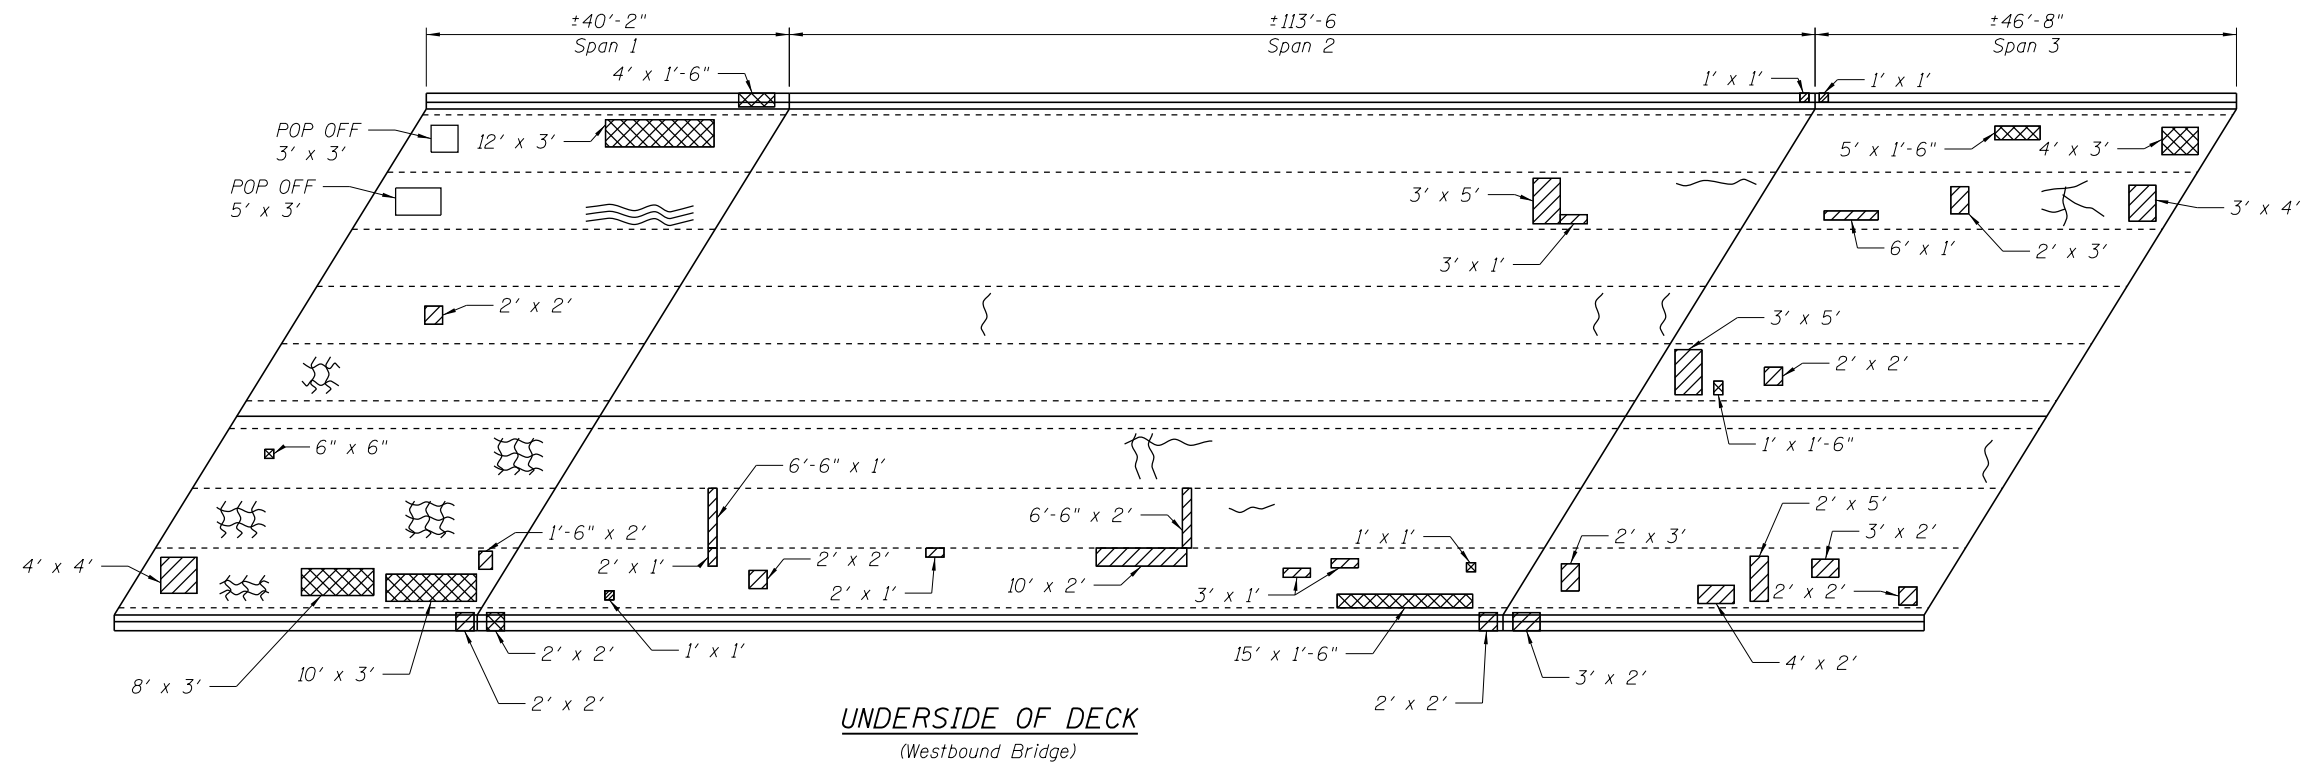
UNDERSIDE OF DECK
(Westbound Bridge)

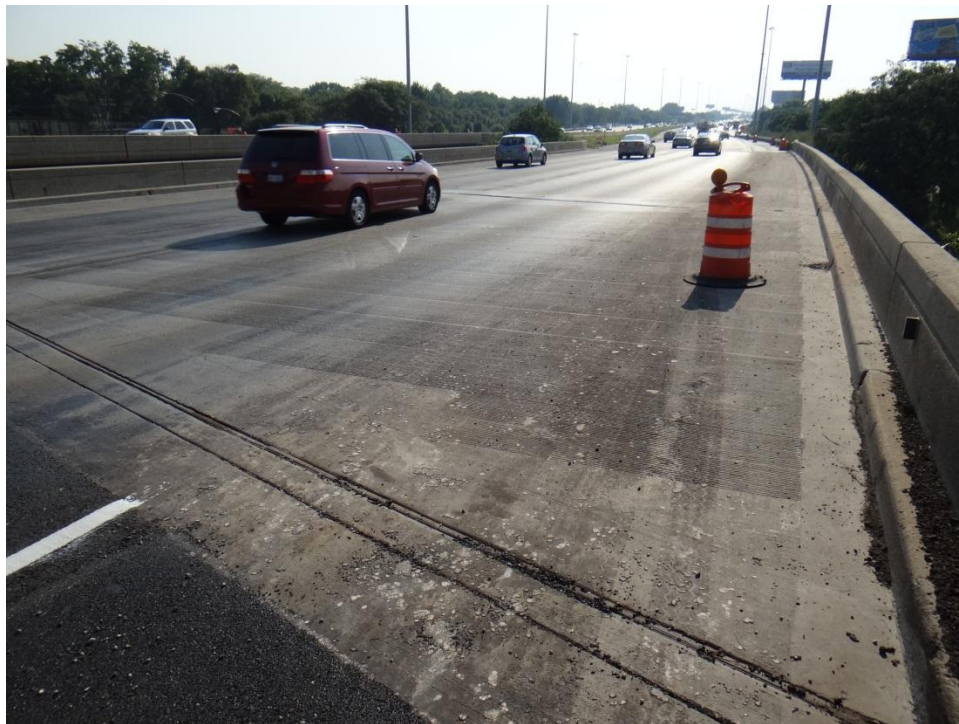
Figure 4. Typical view, deck top surface, looking southwest

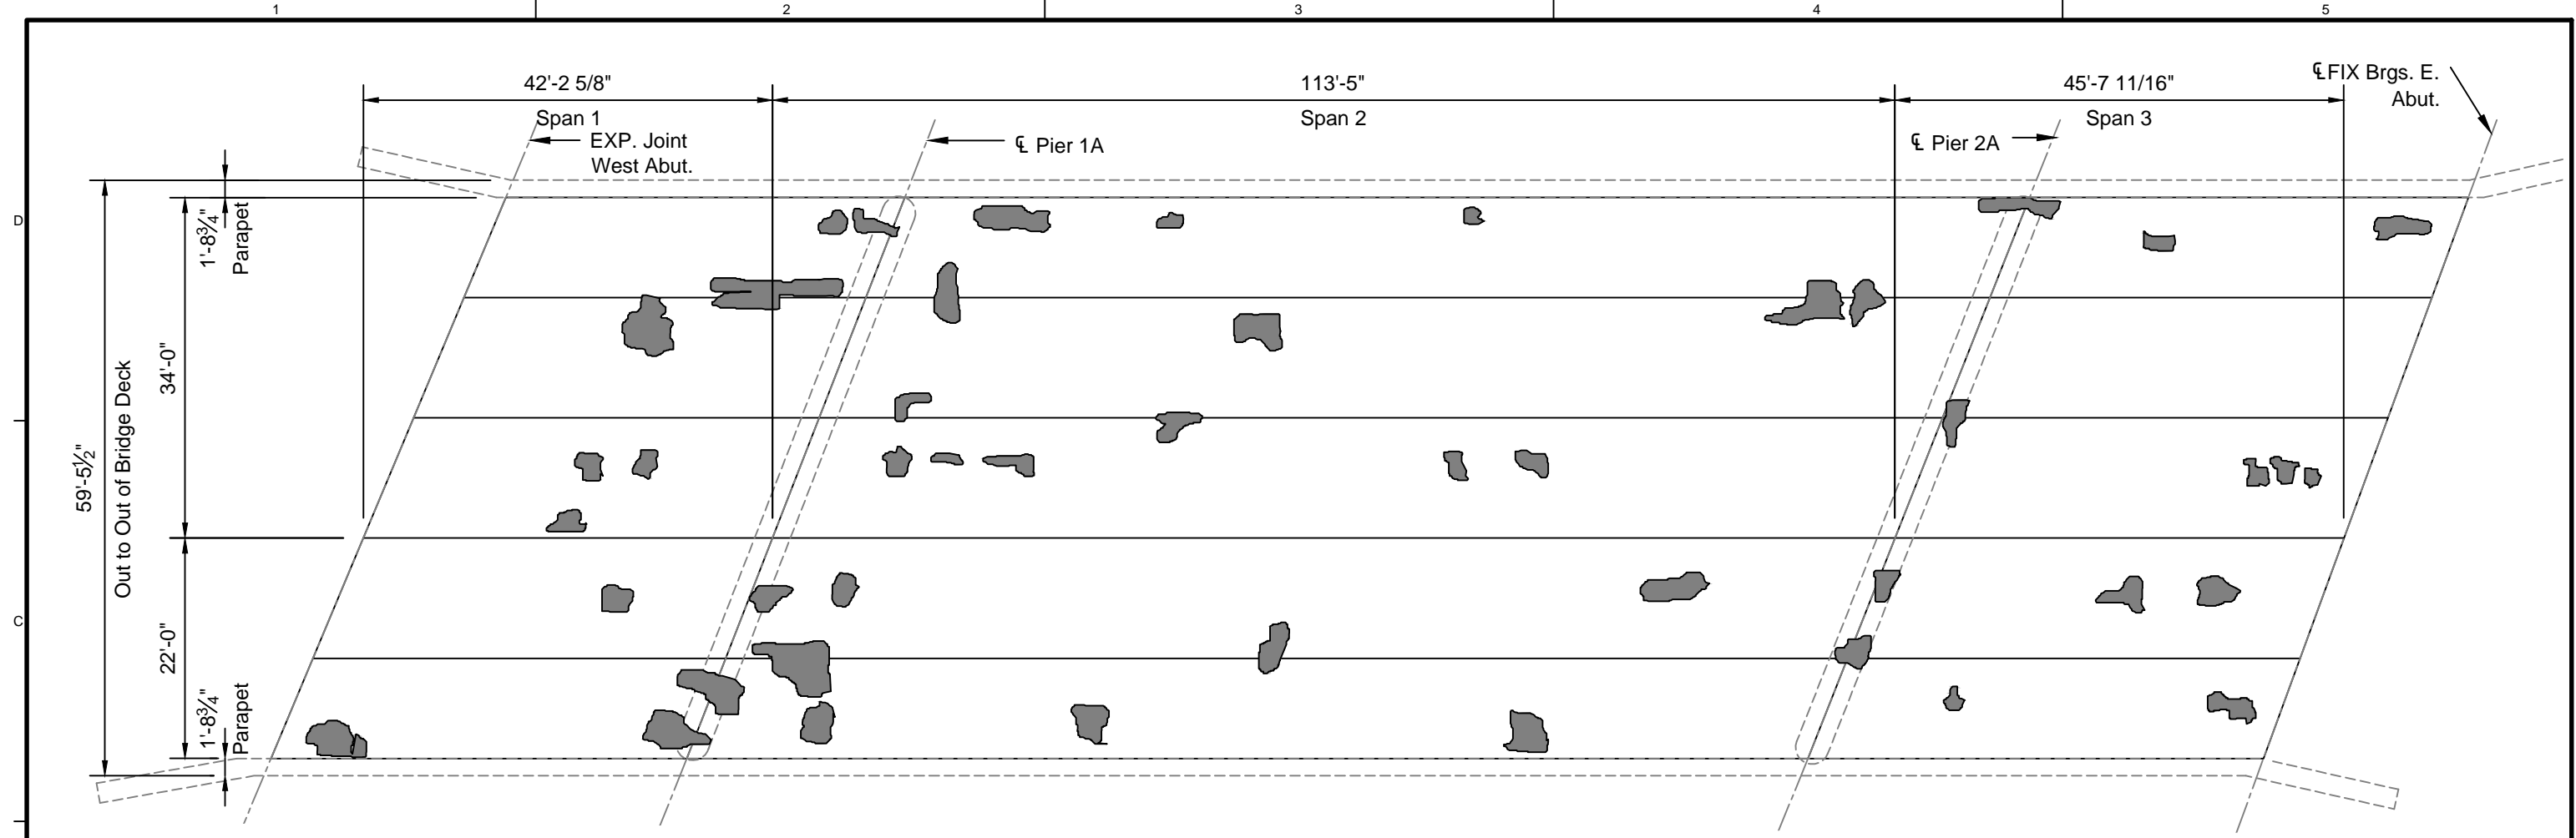
FIELD OBSERVATION SUMMARY		STRUCTURE # 016-0017		LEGEND	
ITEM	UNIT	QUANT.	%	DELAMINATION	SPALL
TOTAL AREA	Ac	11055	100		
DELAMINATION	Ac	430	3.9		
SPALL	Ac	0	0		
CRACKS	ft	-	-

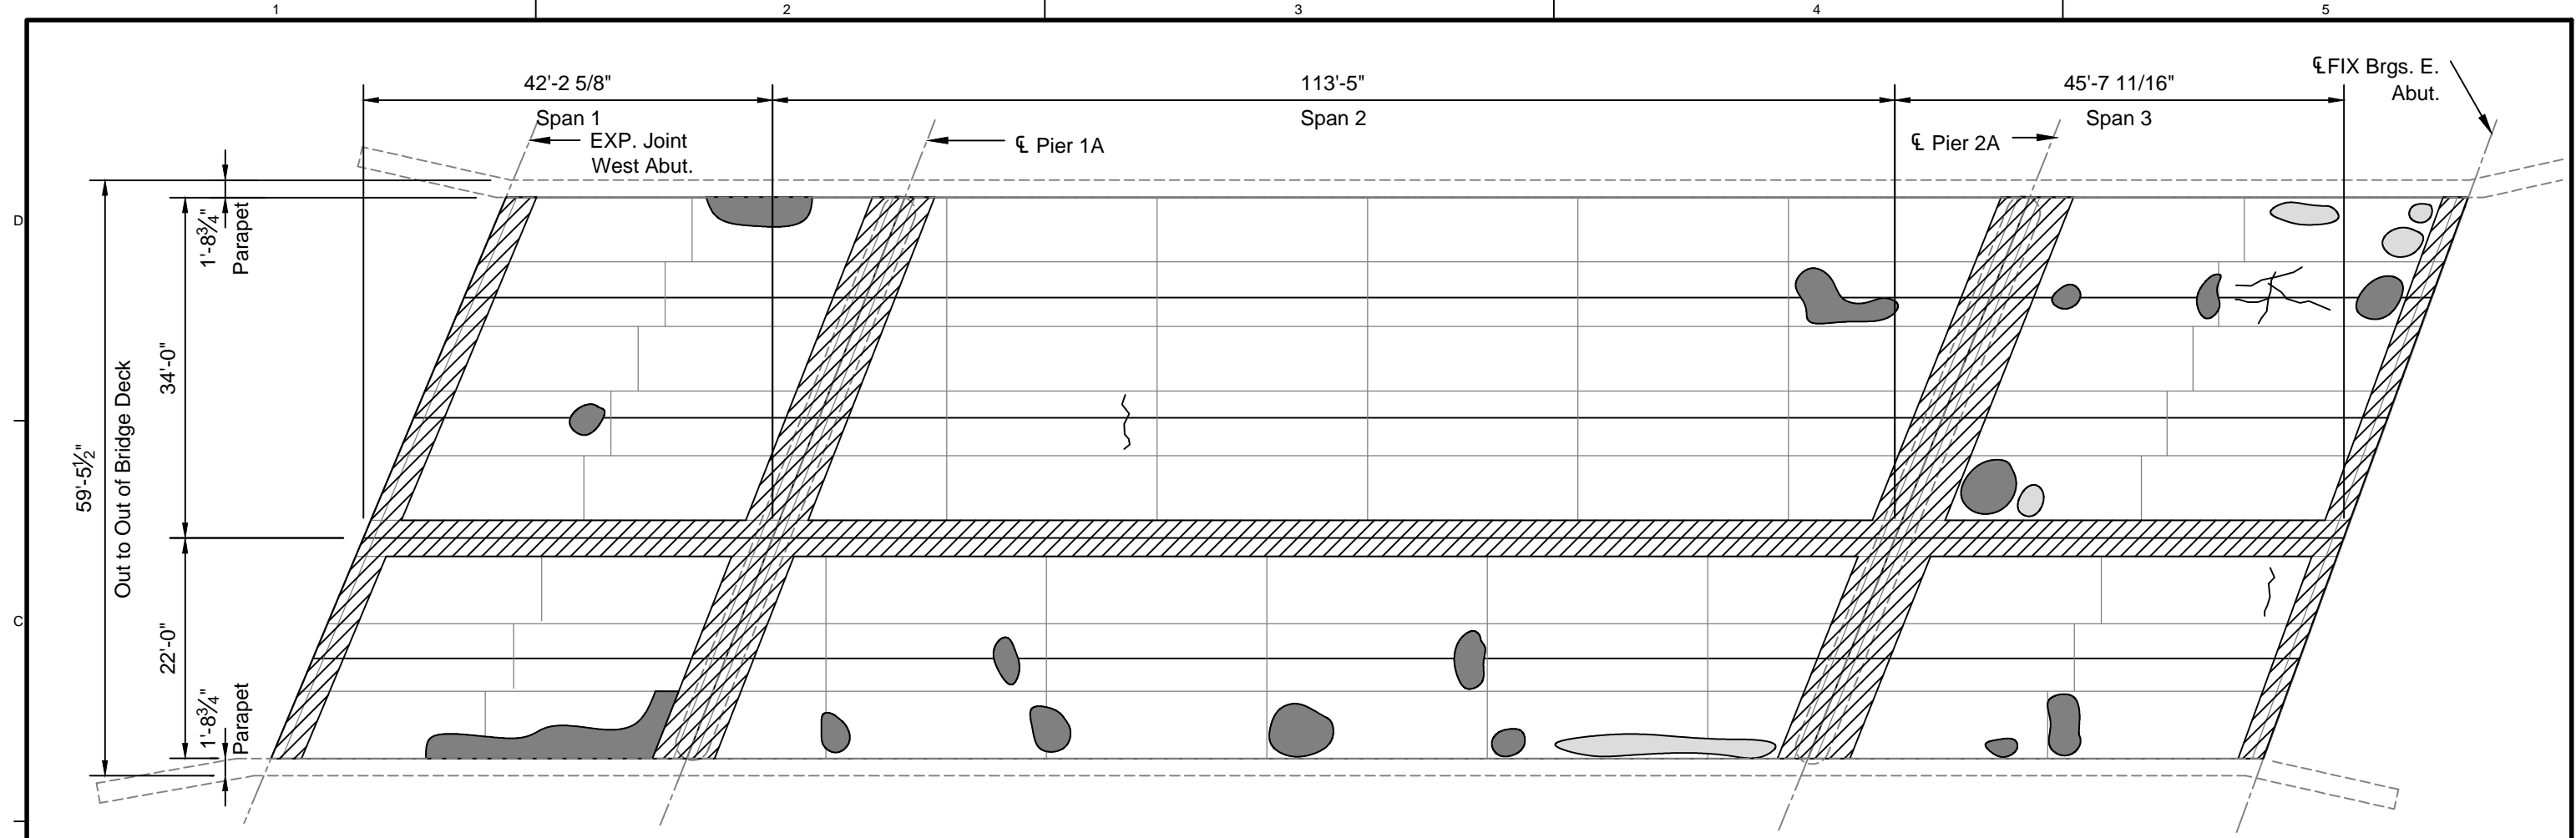
FIELD OBSERVATION SUMMARY		STRUCTURE # 016-0017		LEGEND	
ITEM	UNIT	QUANT.	%		
TOTAL AREA	Ac	11055	100	DELAMINATION	
DELAMINATION	Ac	285	2.6	SPALL	
SPALL	Ac	70	0.6	PREV. REPAIR	
PREVIOUS REPAIRS	Ac	1705	15.4	CRACK	
CRACKS	ft	-	-

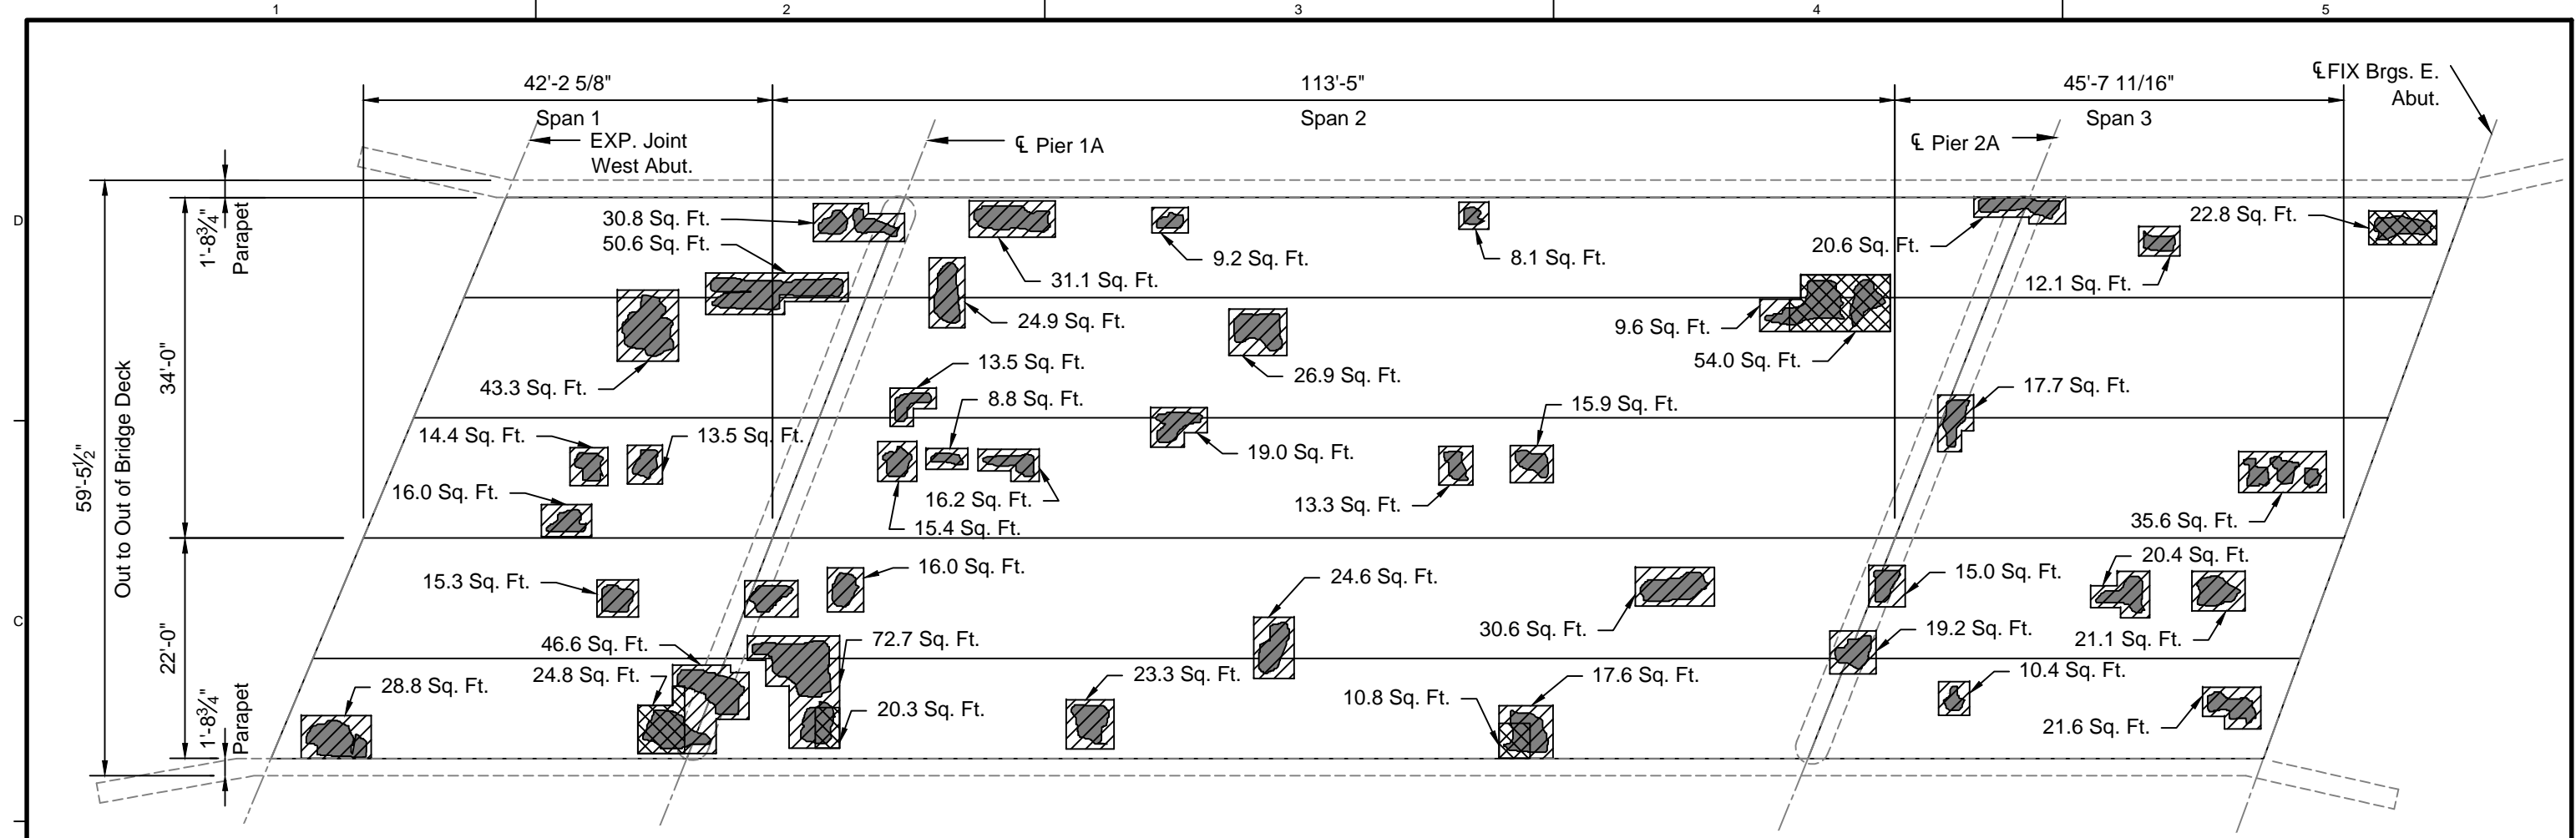
FIELD OBSERVATION SUMMARY		STRUCTURE # 016-0017		LEGEND	
ITEM	UNIT	QUANT.	%		
TOTAL AREA	Ac	11055	100	PARTIAL DEPTH REPAIR	
PARTIAL DEPTH REPAIR	Ac	861	7.8	FULL DEPTH REPAIR	
FULL DEPTH REPAIR	Ac	122	1.1	DELAMINATION	
DELAMINATION	Ac	430	3.9	SPALL	
SPALL	Ac	0	0	CRACK	
CRACKS	ft	-	-

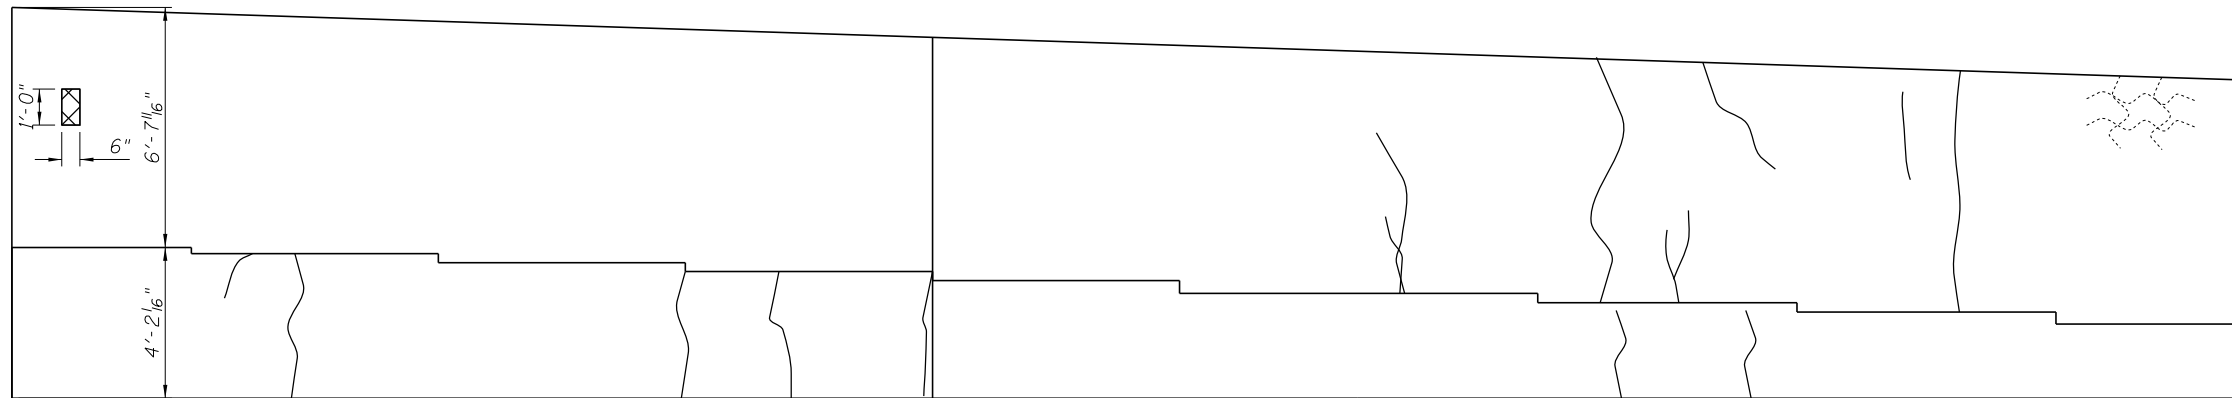
EAST ABUTMENT
LOOKING EAST

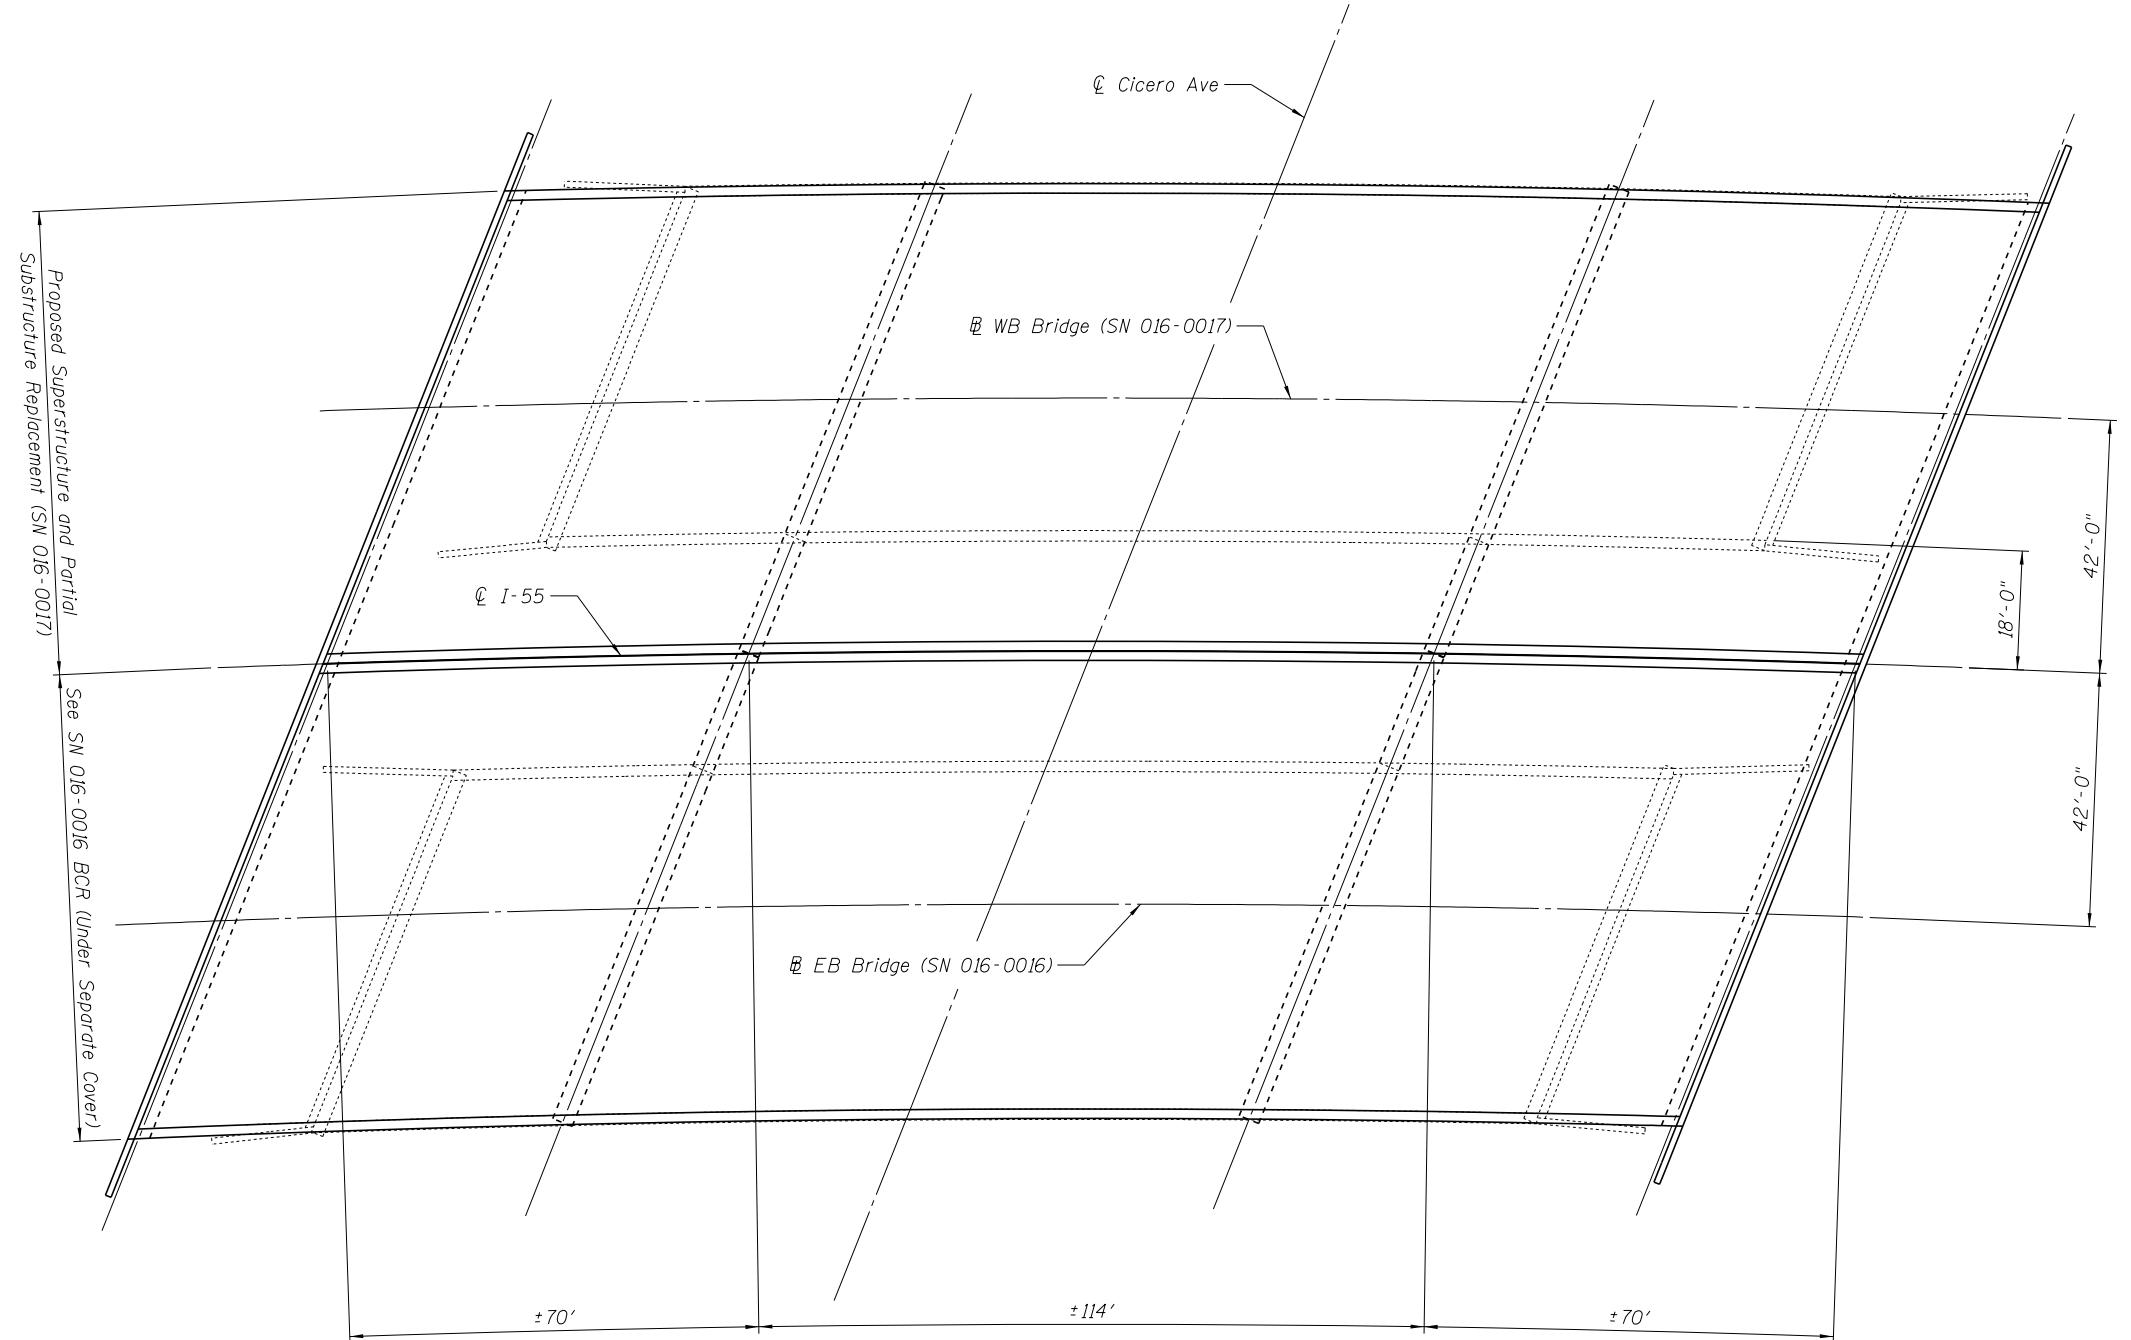
Proposed Superstructure and Partial Substructure Replacement (SN 016-0017)
 See SN 016-0016 BCR (Under Separate Cover)

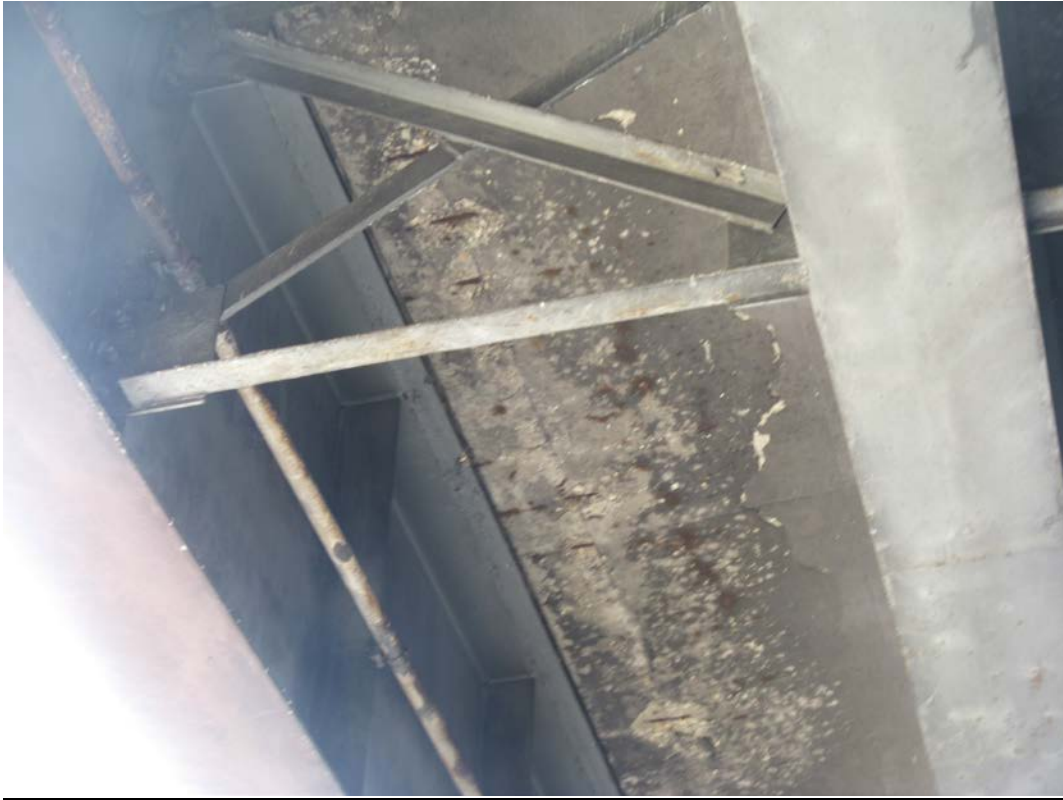
Photo 1 - Spalling in bay 9, Span 2 , east end, looking west

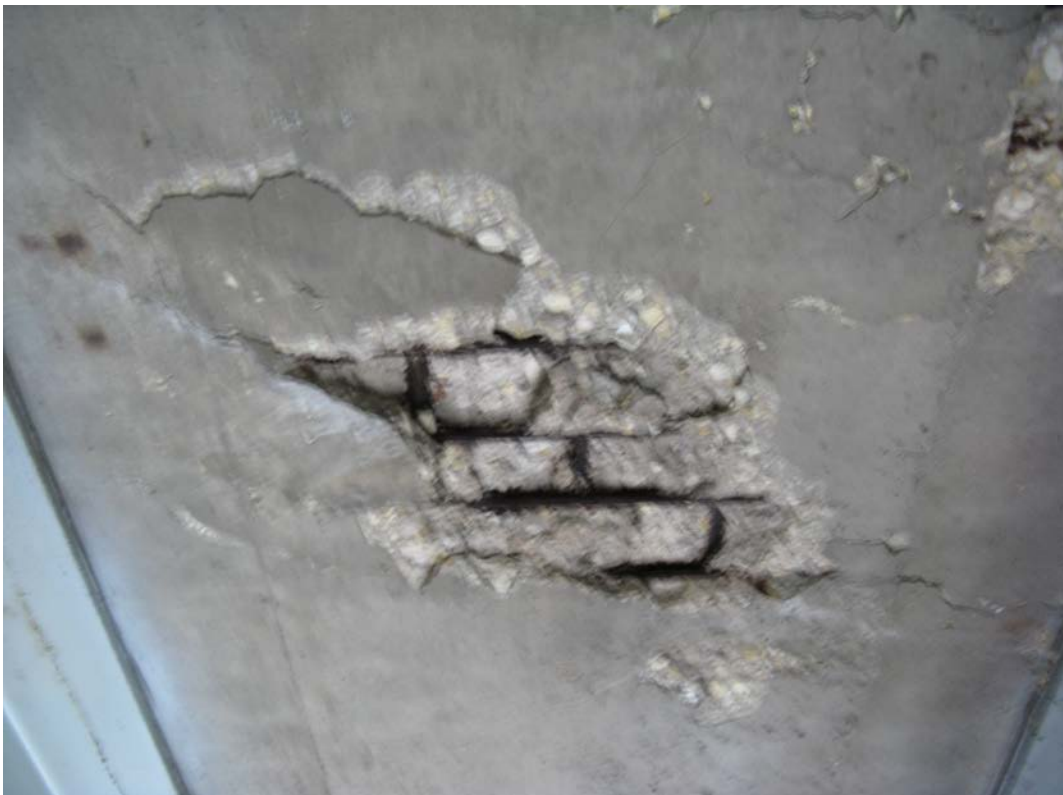
Photo 2 - Spall underside of deck in Span 3, east end, between beams 1-2 from north, looking west

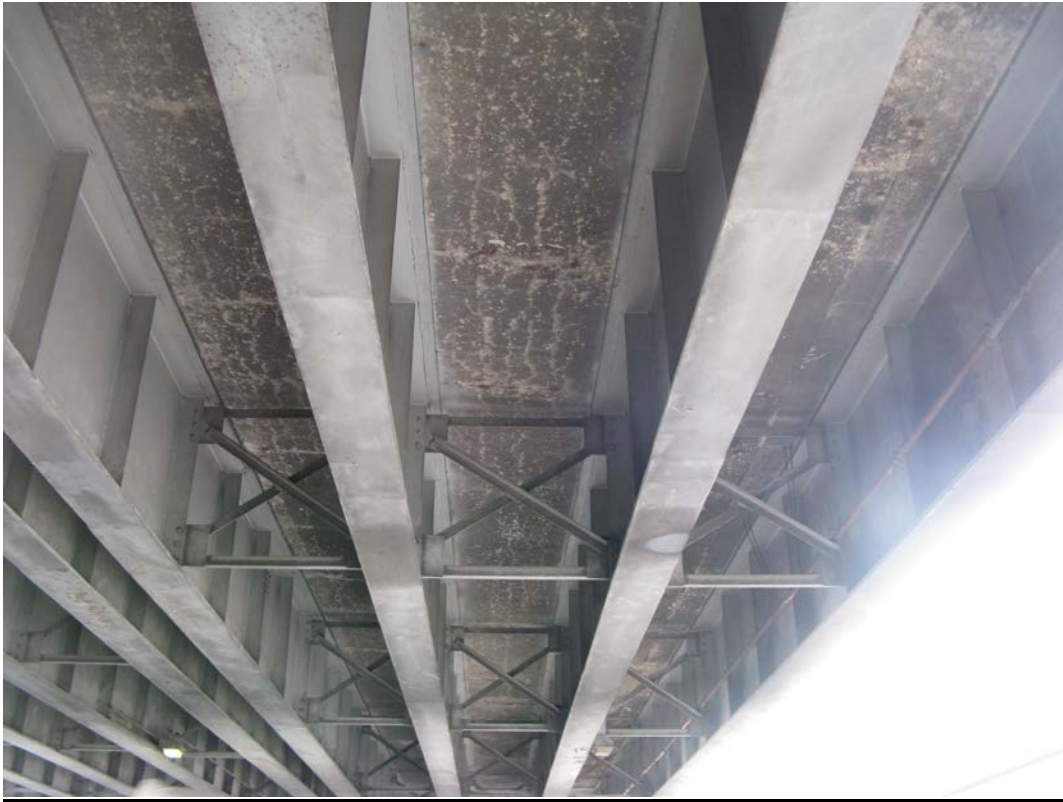
Photo 3 - Underside of Deck, Span 2, south end, looking east

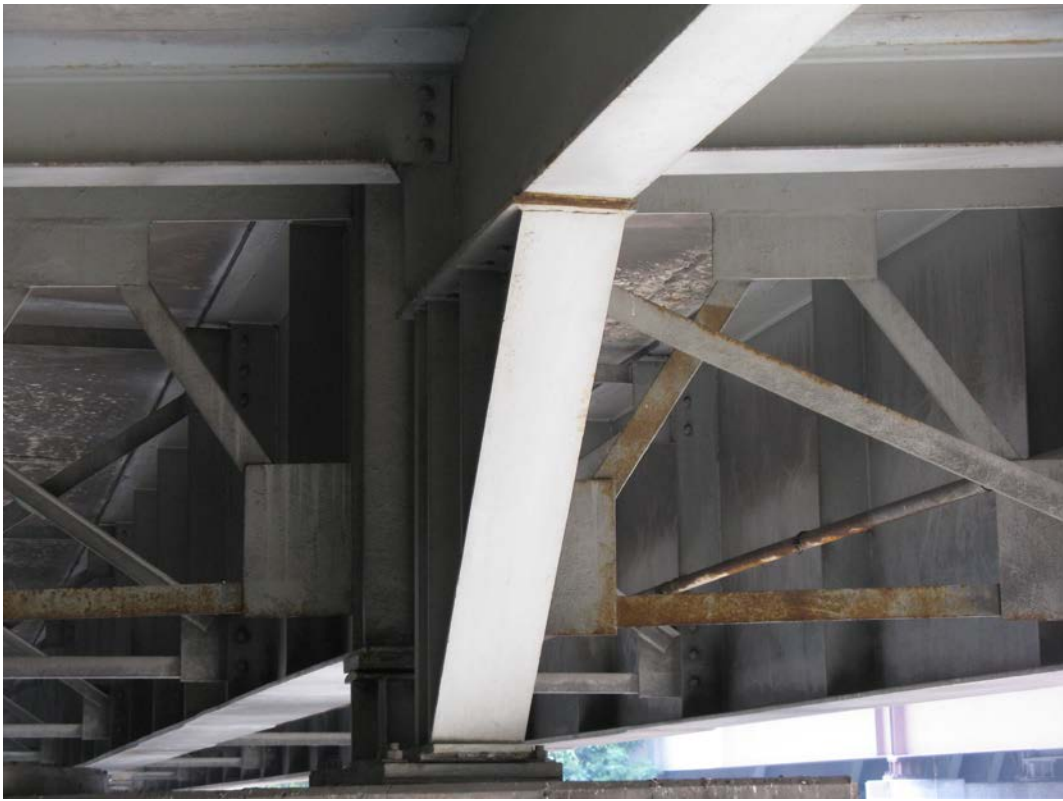
Photo 12 - Crack in built up pedestal on beam 9 from north at West Pier, west span, looking east

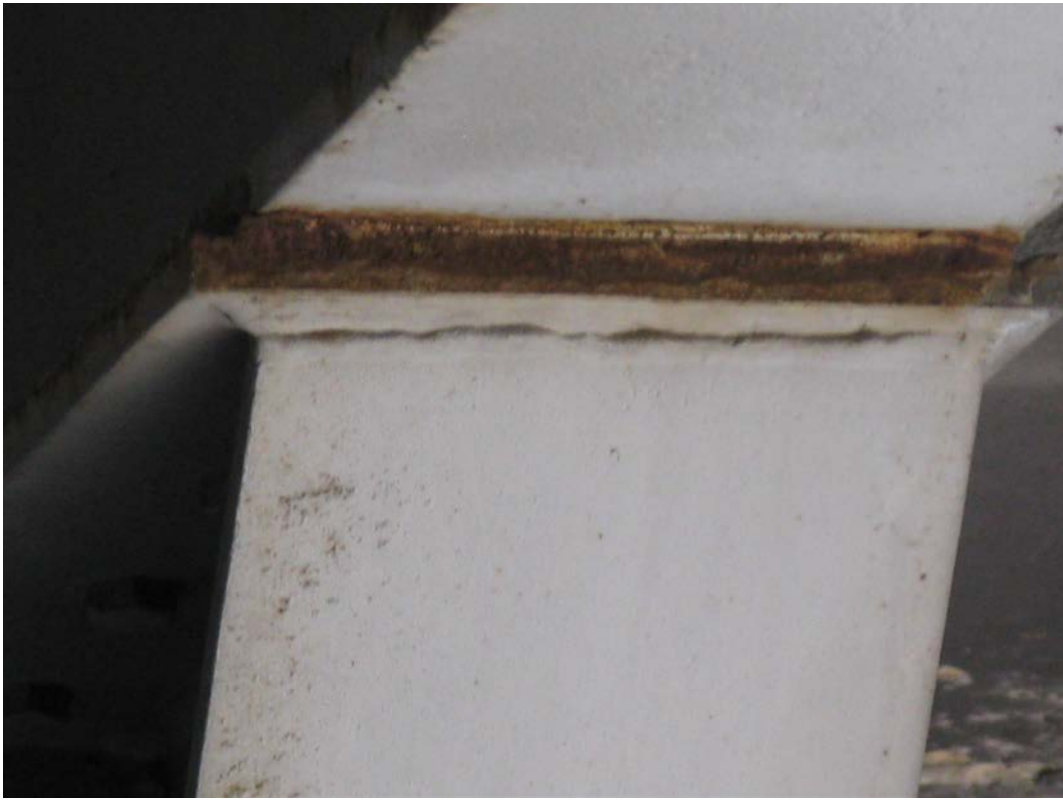
Photo 13 - Close up of photo 12

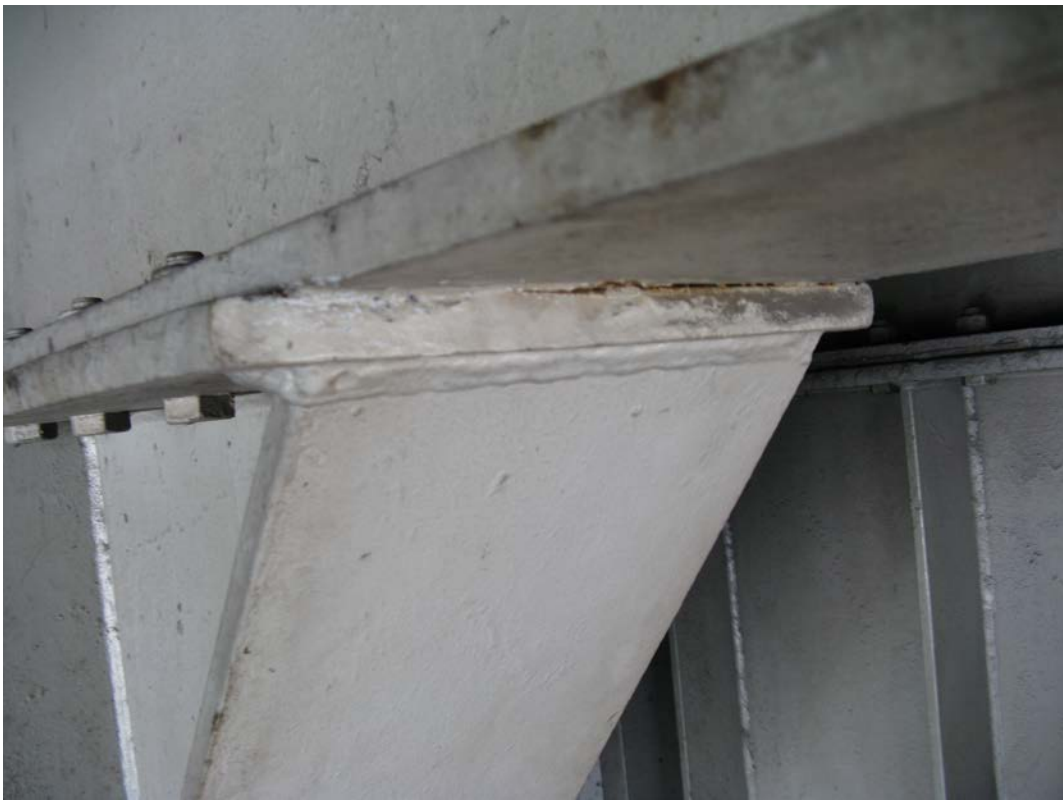
Photo 14 - Typical cracked weld between bottom flange of beam and built up steel pedestal, Beam 6 at East Abutment, looking southeast

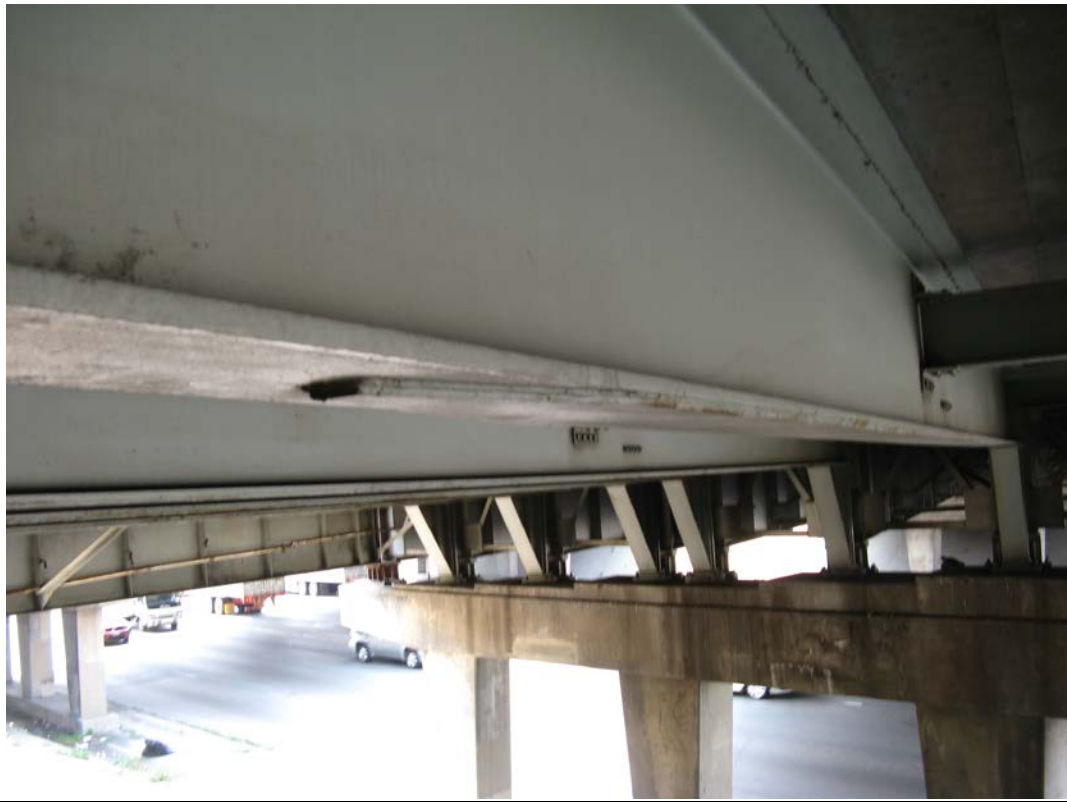
Photo 15 - Typical beam with cover plate in Span 1, Beam 4, looking southwest

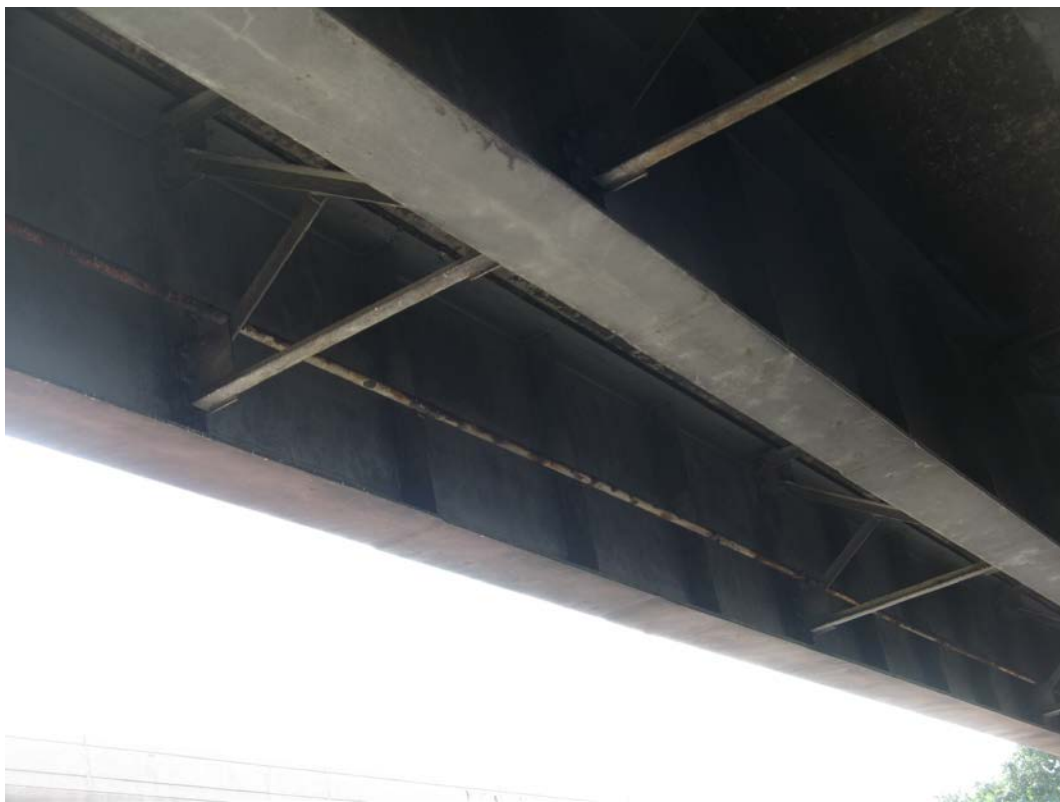
Photo 19 - Failed conduit connections, looking southwest

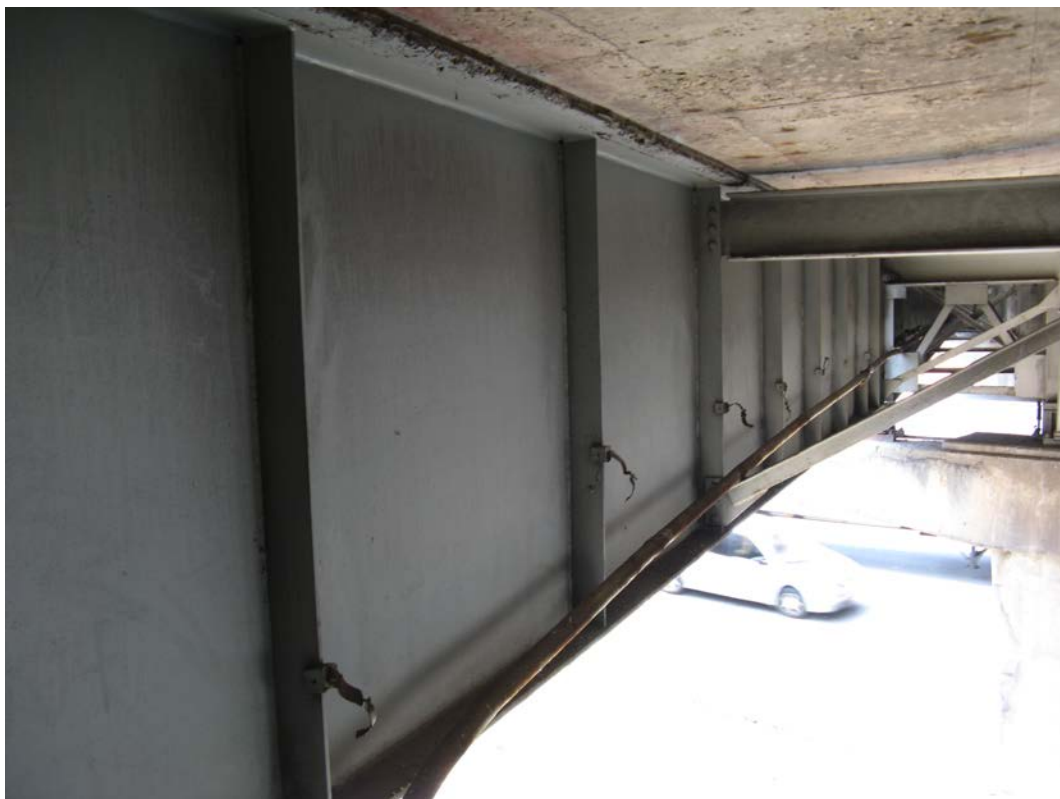
Photo 20 - Broken conduit from brackets along south fascia beam in Span 1, looking southwest
