I-55 Managed Lanes Combined Design Report

Appendix A.3 – Structures

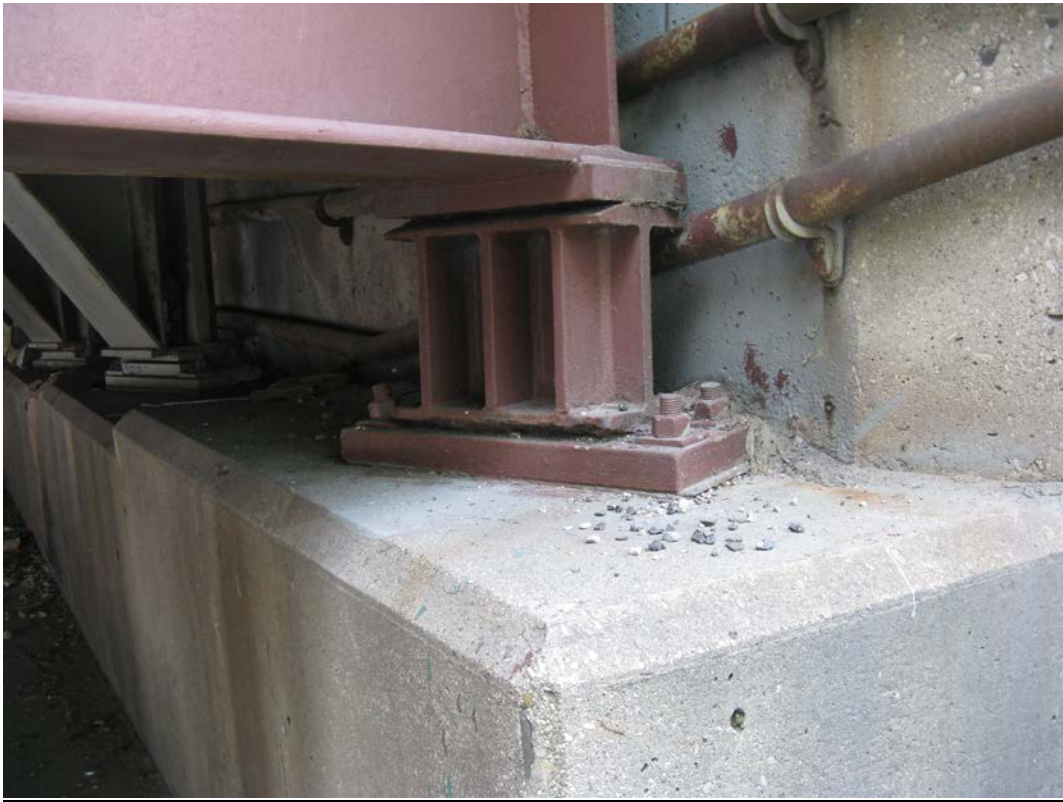
Photo 21 - Typical end beam bearing, beam 1 from north, West Abutment, looking southwest

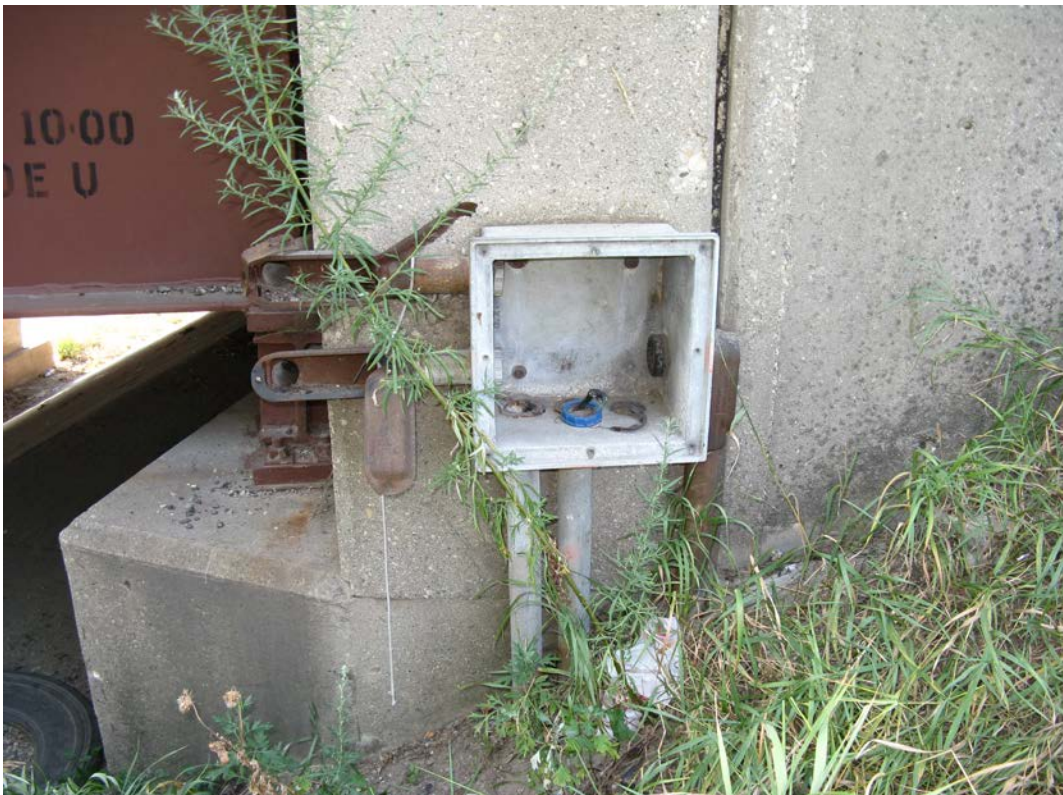
Photo 24 - Broken and open conduit on north end of West Abutment, looking south

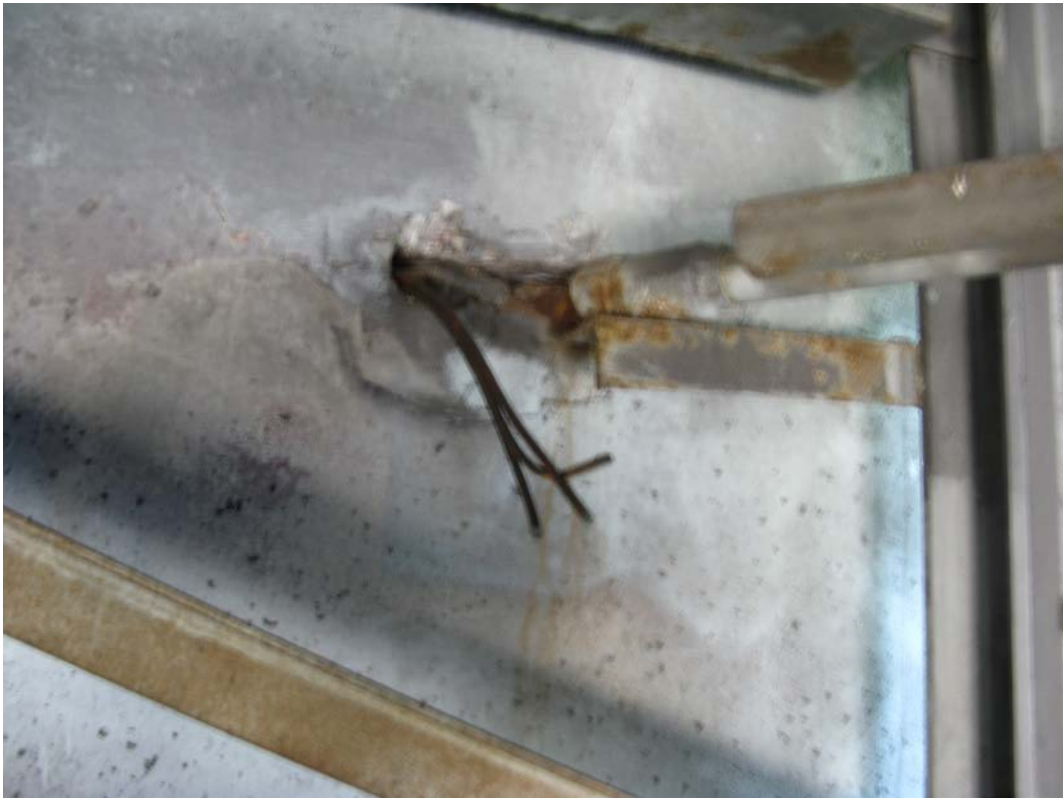
Photo 25 - Broken conduit at West Abutment backwall in bay 1 from north, looking west

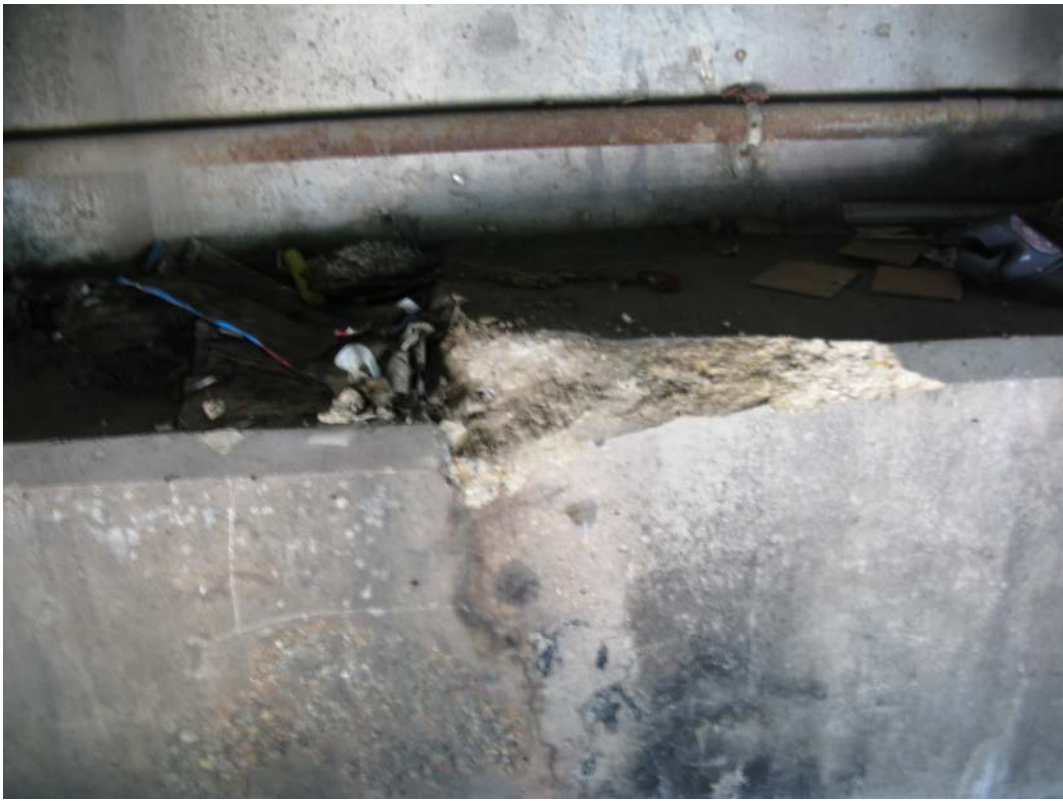
Photo 26 - Spall on West Abutment seat in bay 2 from north, looking east

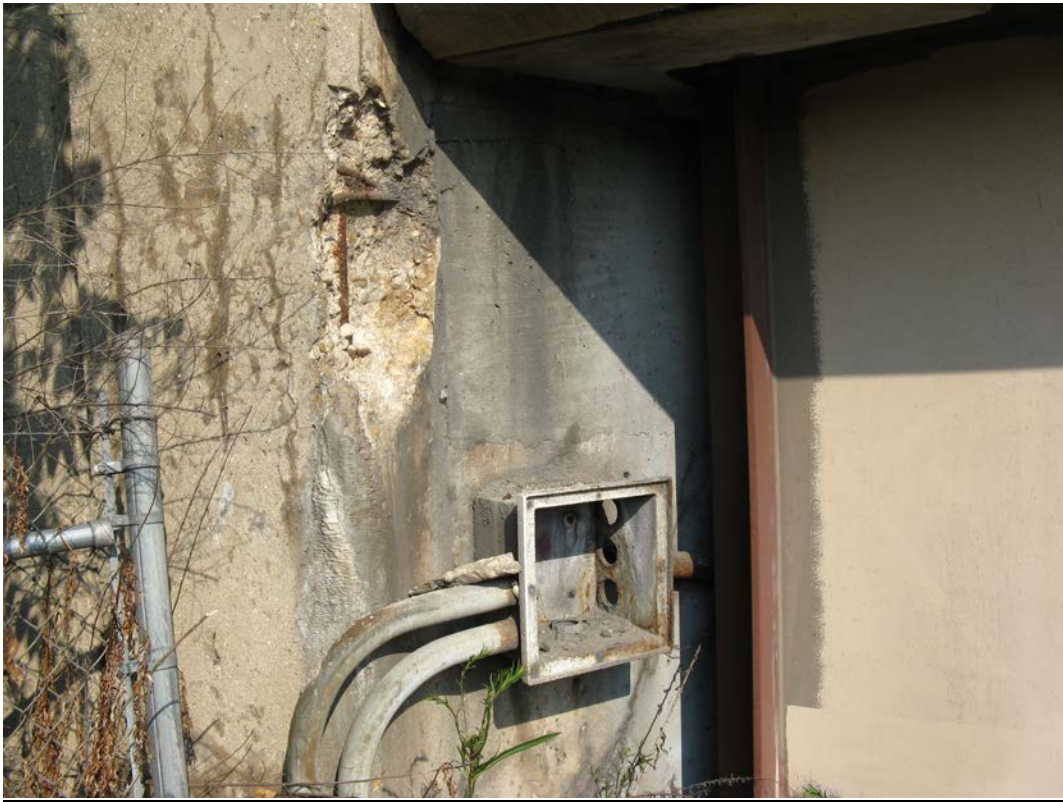
Photo 27 - Spall on front face of West Abutment backwall at south end and open conduit junction box, looking north

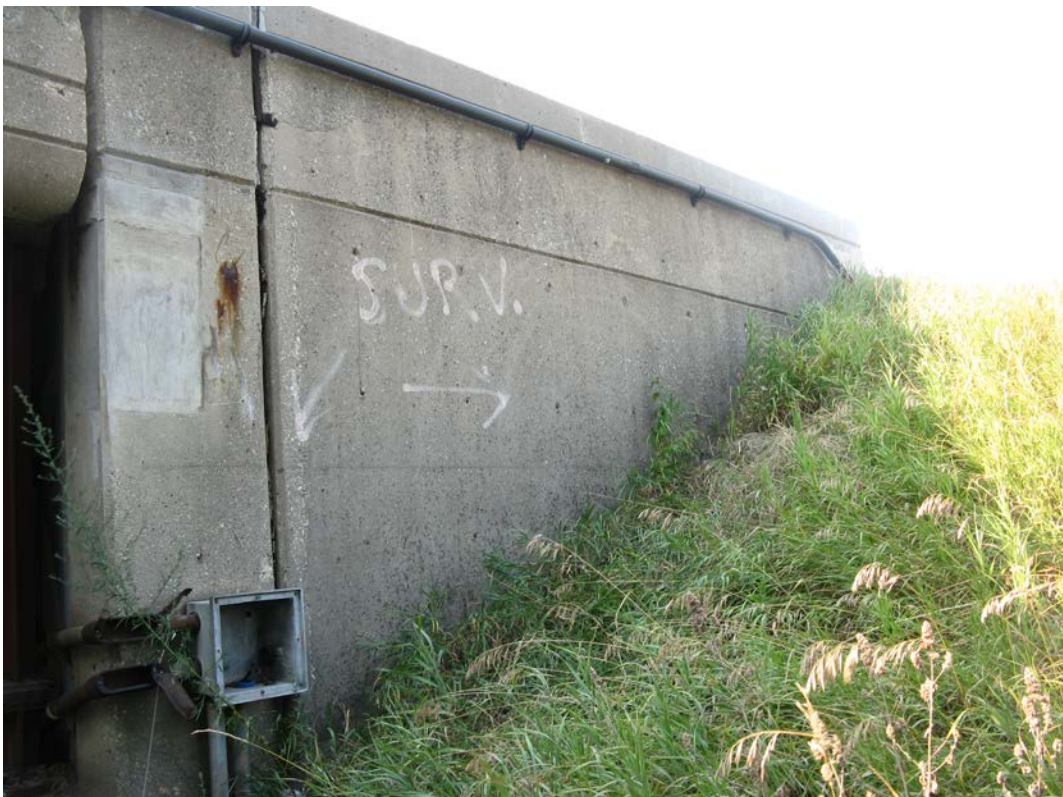
Photo 28 - Northwest Wingwall, looking southwest

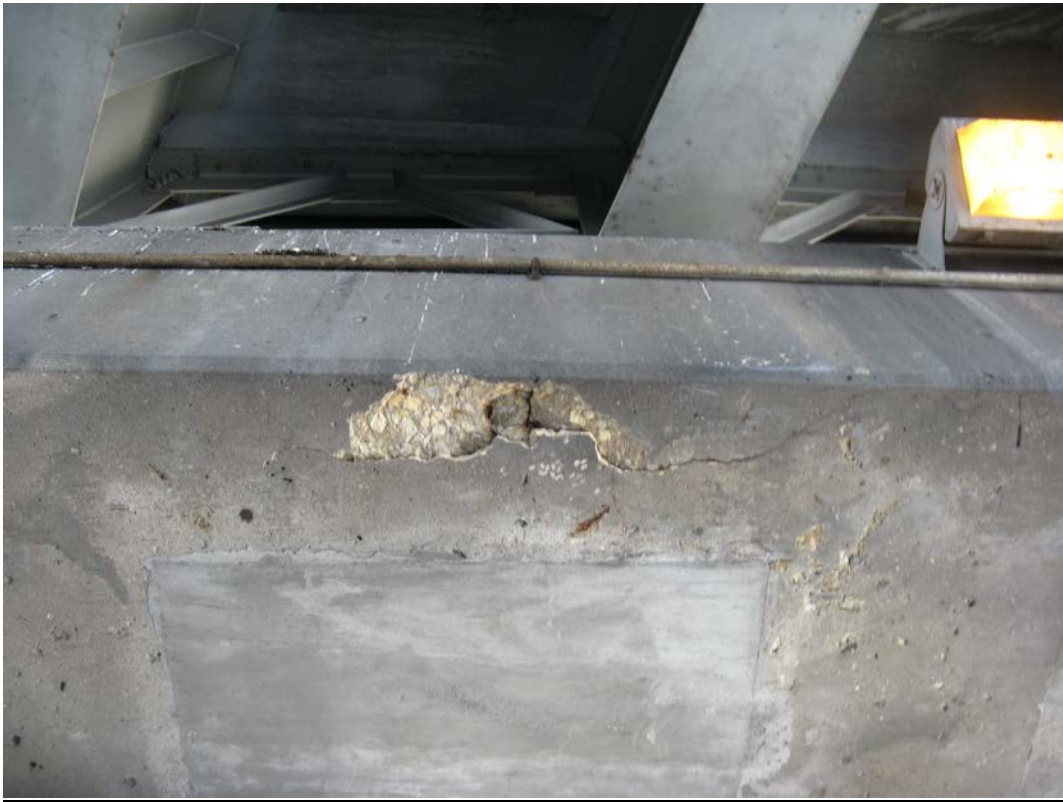
Photo 33 - East Pier, spall on underside of cap in between columns 3-4 from north, looking up and east

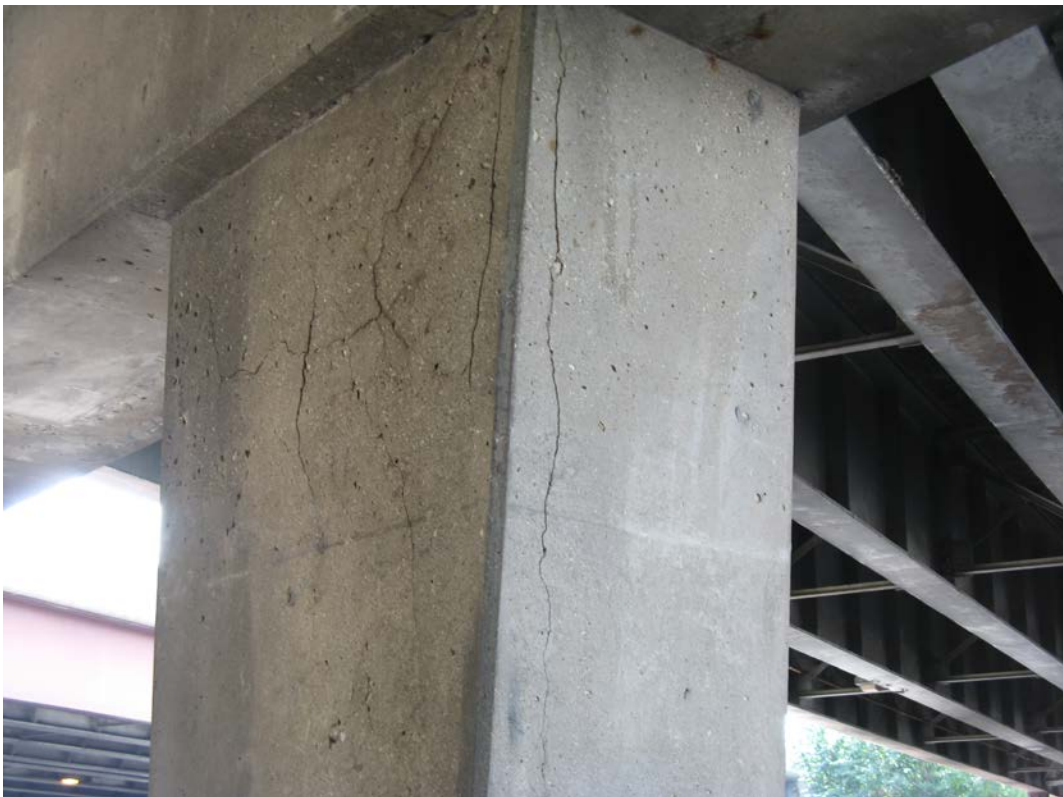
Photo 34 – East Pier, delam on northeast corner, looking southwest

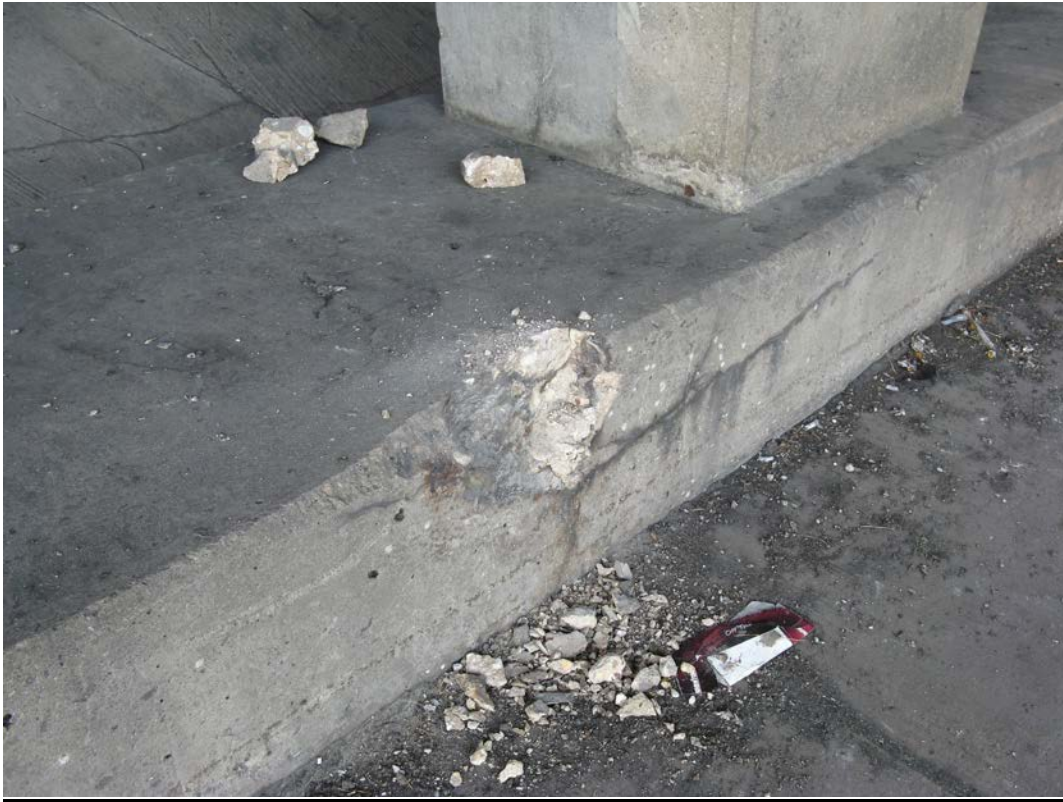
Photo 35 - Spall in East Pier crashwall, north of second column from north, west face, looking southeast

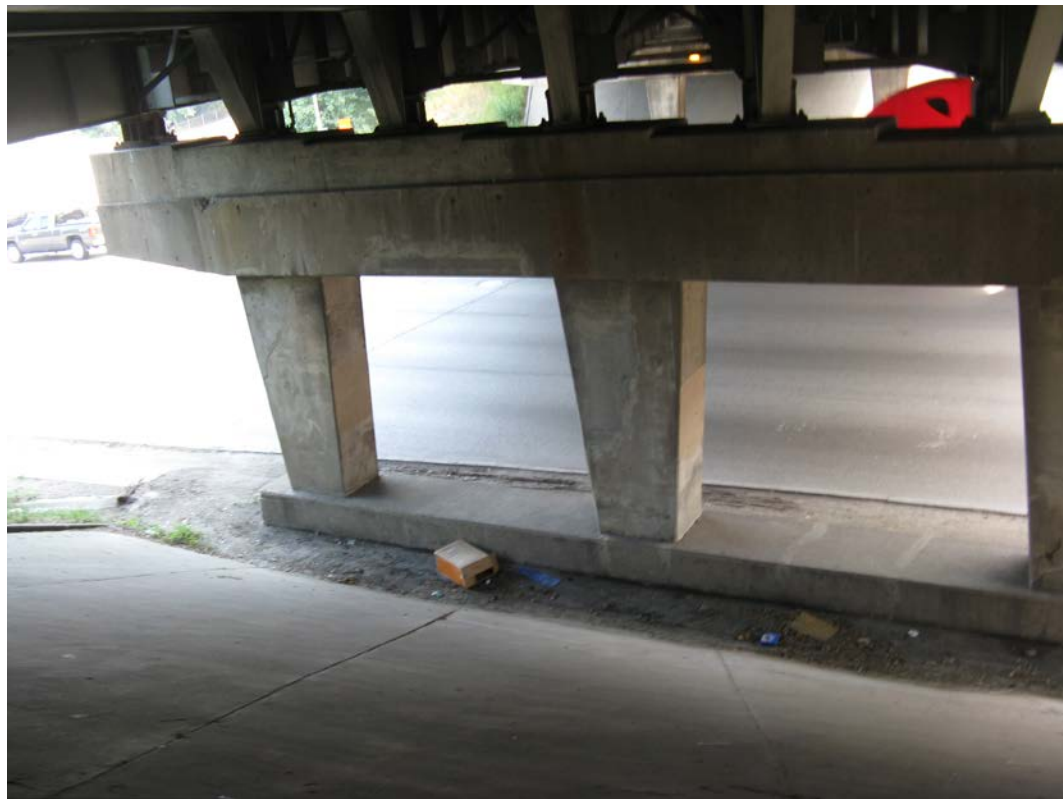
Photo 36 - West Pier, west face, north end, looking northeast

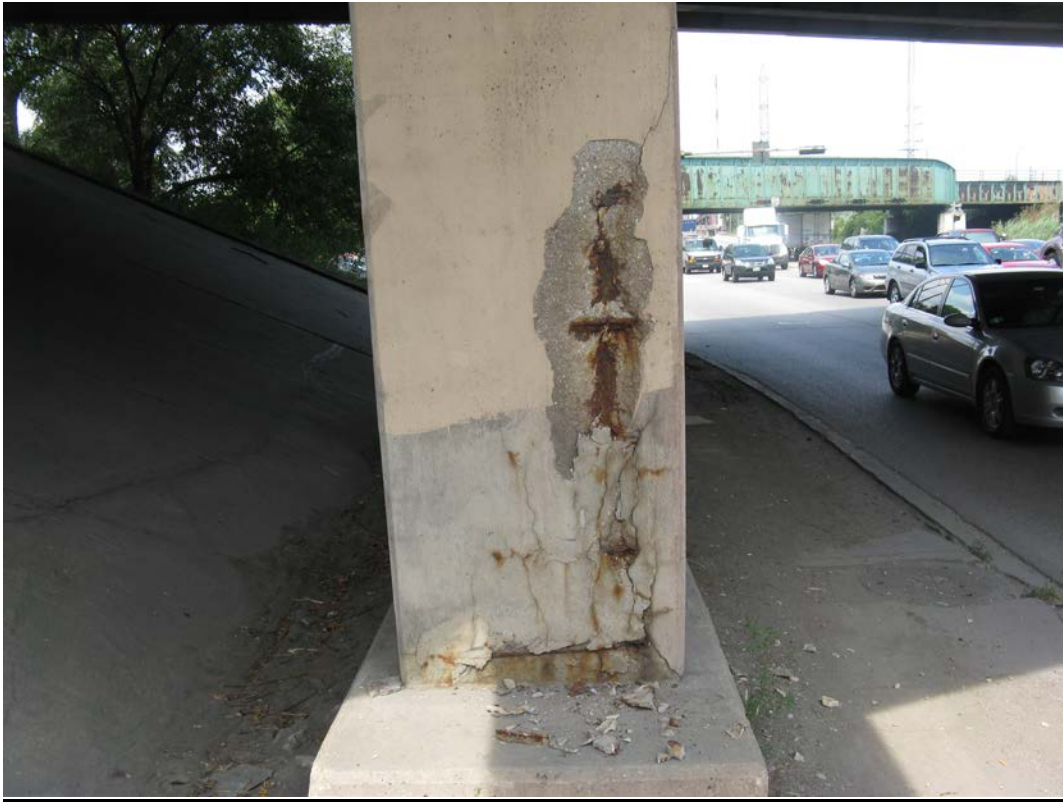
Photo 37 - Spall on West Pier, south face, bottom of fourth column from north, looking north

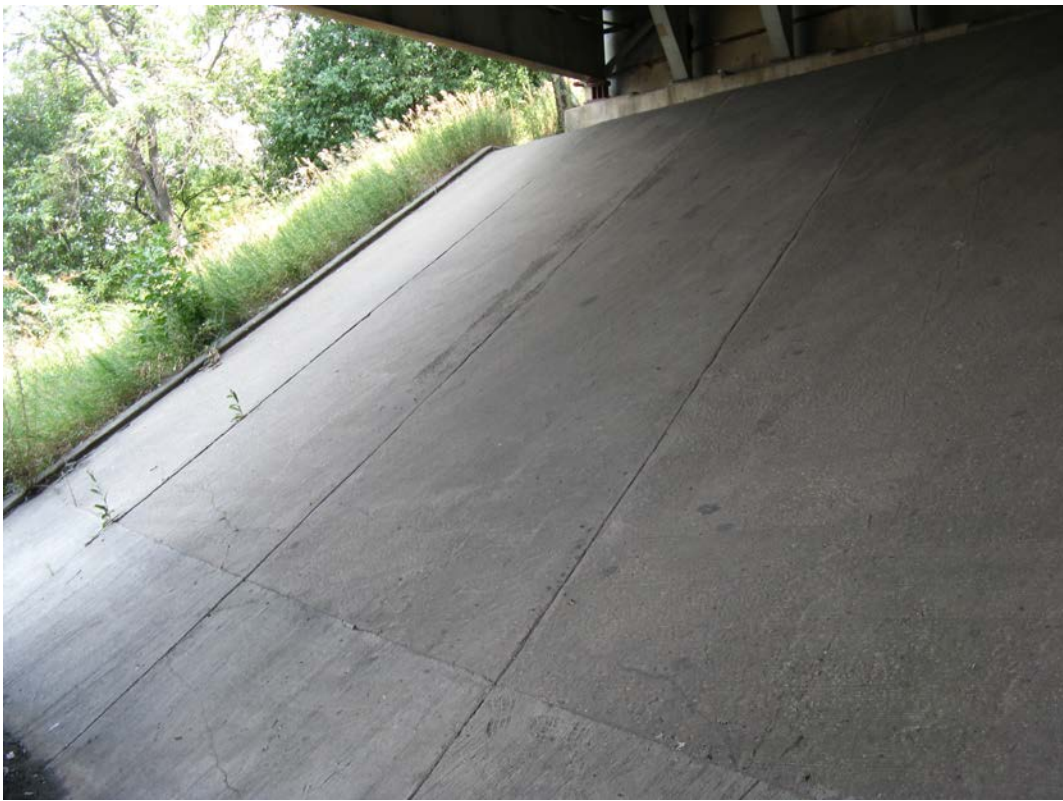
Photo 38 - North half of east slopewall, looking northeast

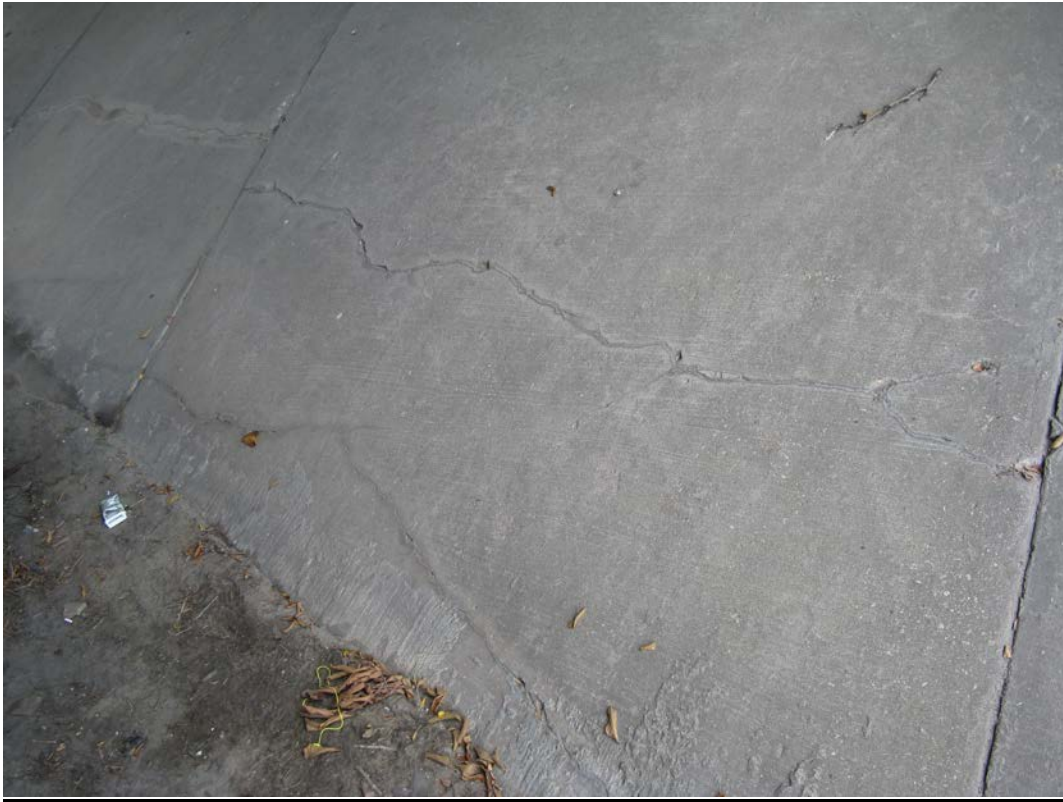
Photo 39 – Cracks in north end of west sloped wall, looking southwest

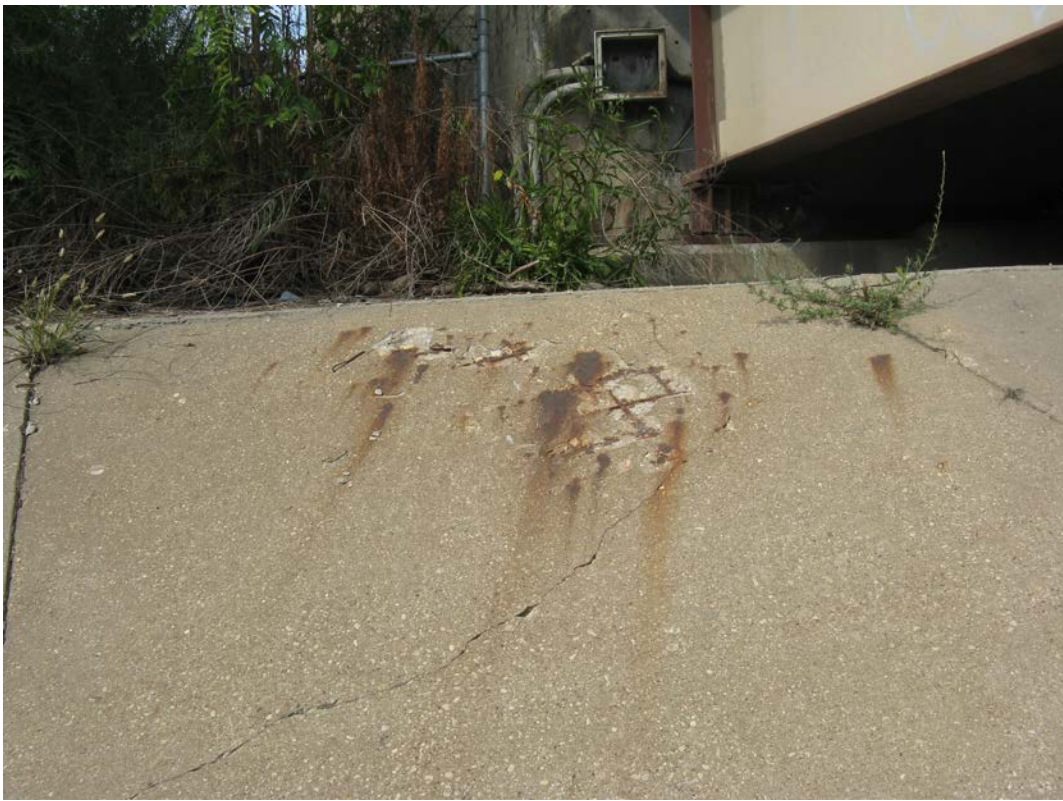
Photo 40 - Spall in west sloped wall, looking west

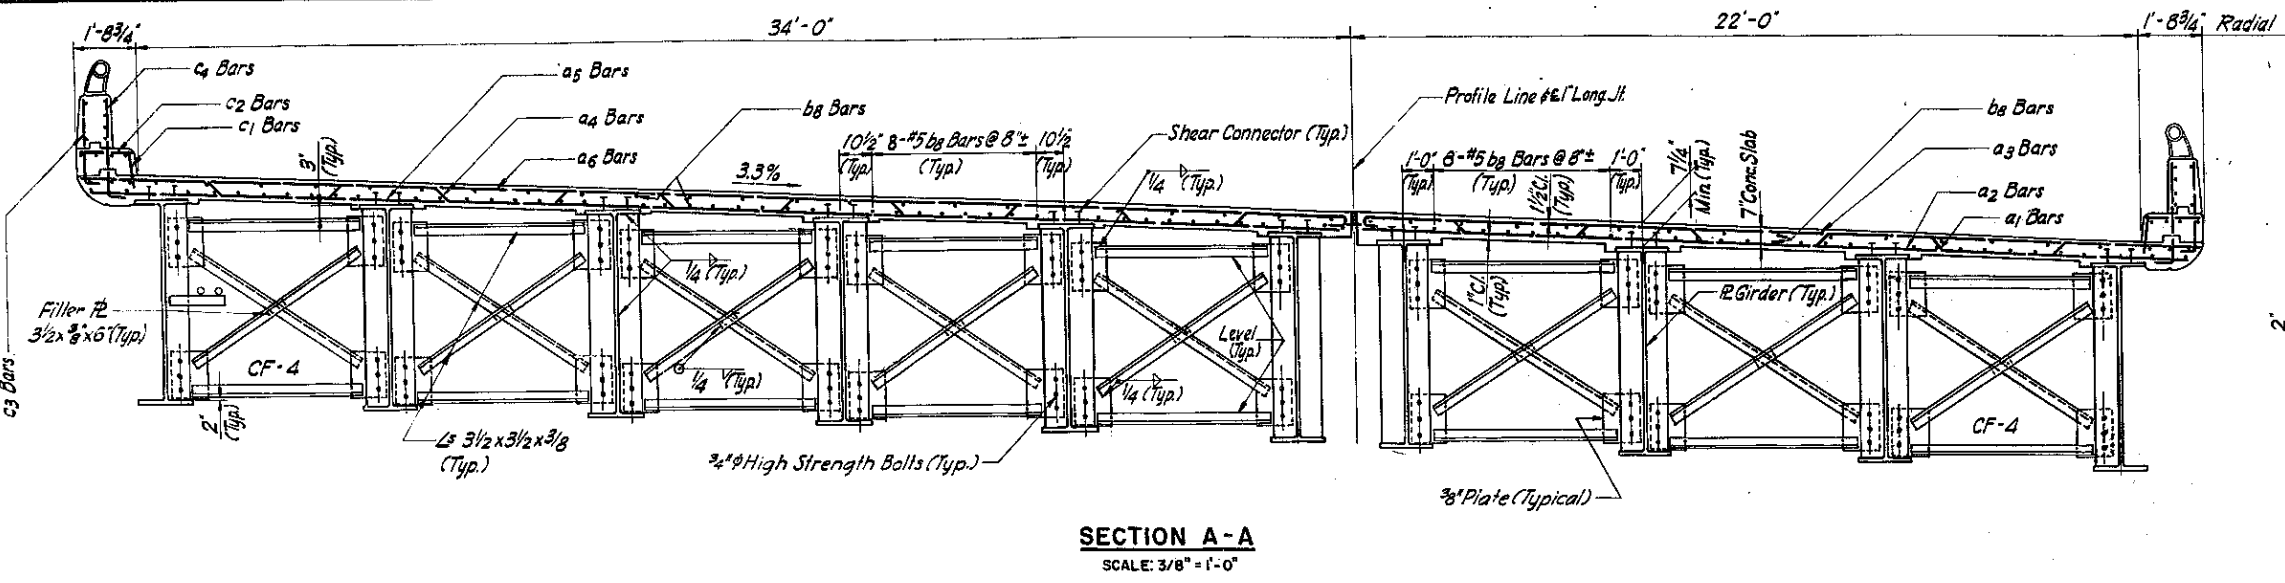
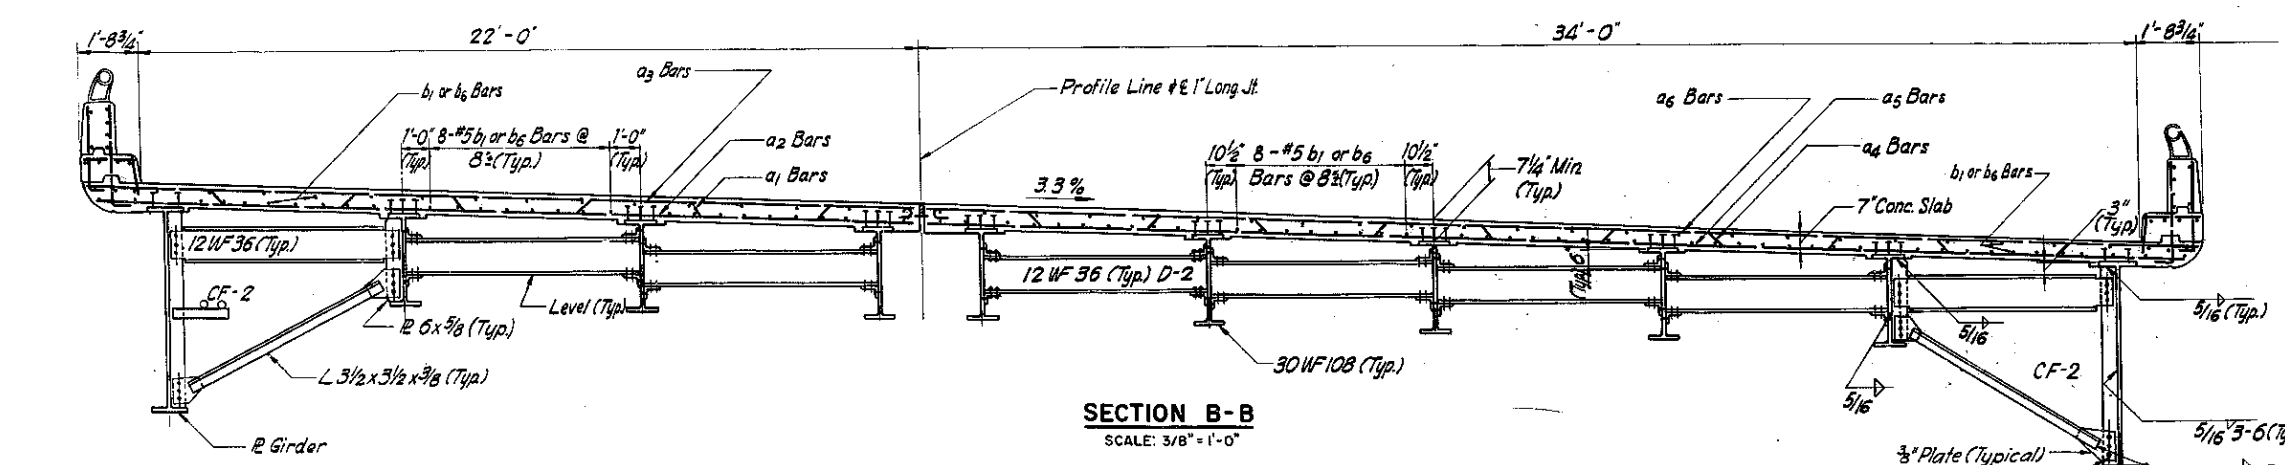
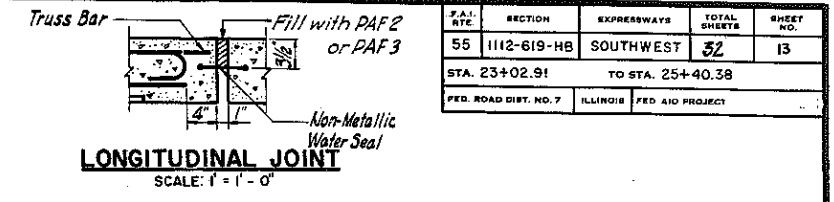
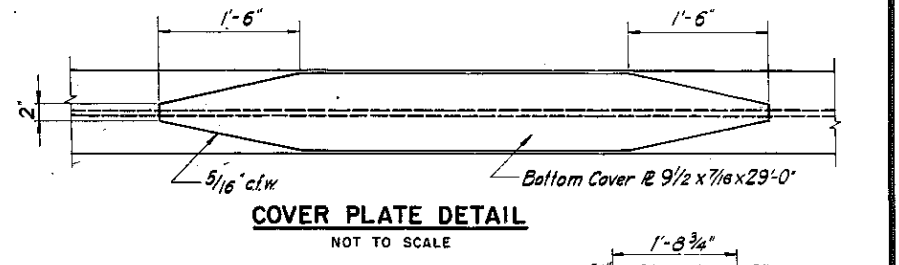
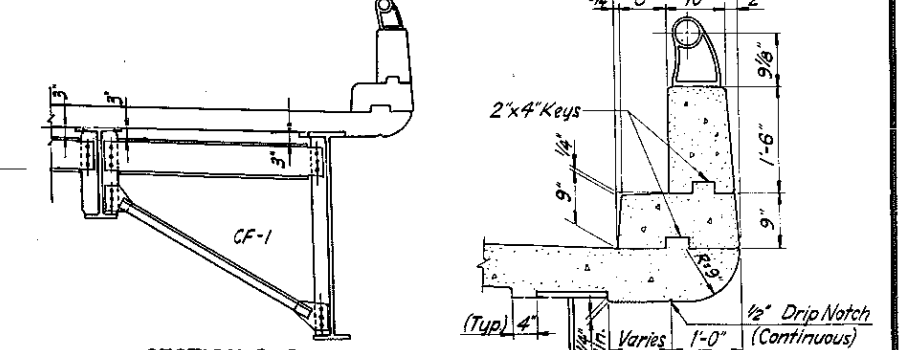
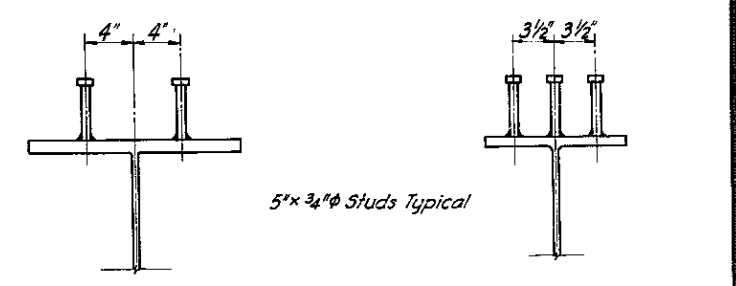
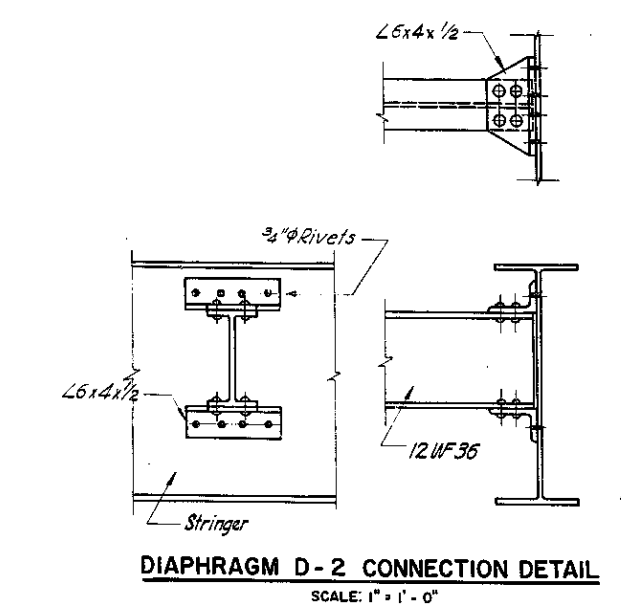
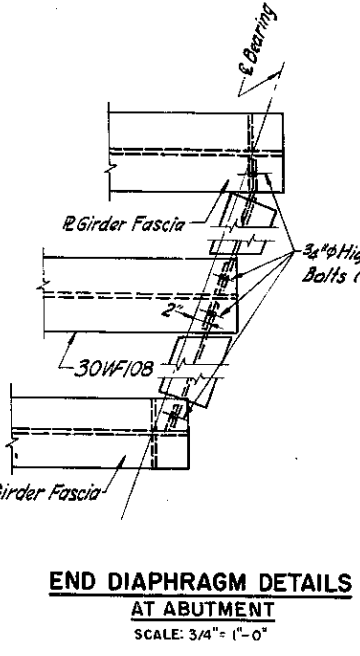
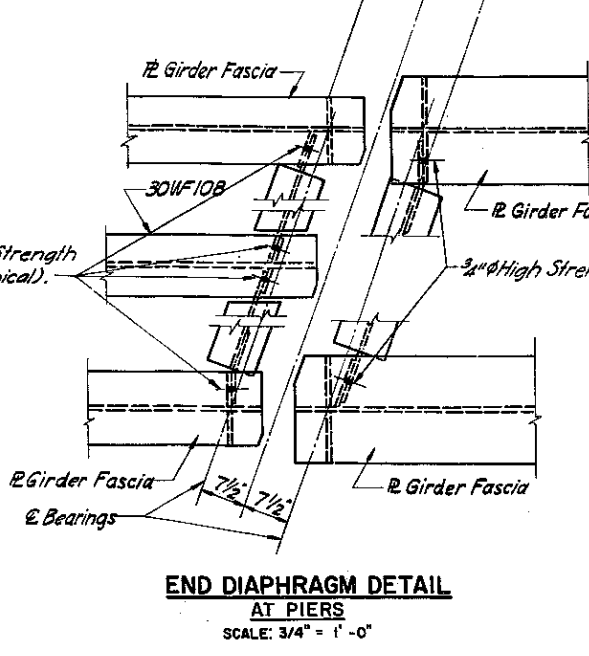
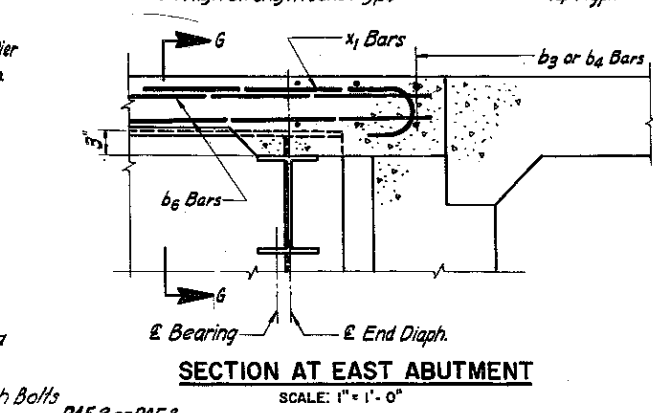
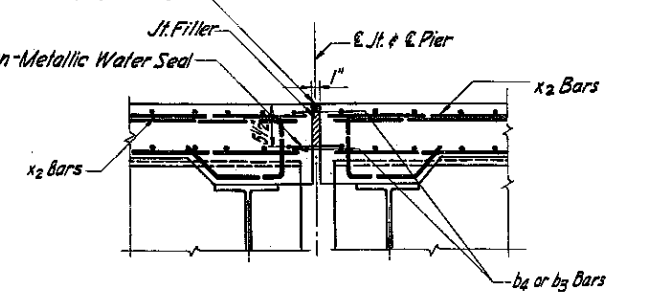
- NOTES:**
1. For location of sections A-A & B-B, see sheet 12.
 2. Section A-A shown for Bridge A, Bridge B similar except for stringer layout and spacing.
 3. Section B-B shown for Bridge B, Bridge A similar except for stringer layout and spacing.
 4. Use 3/4" rivets, except as otherwise noted.

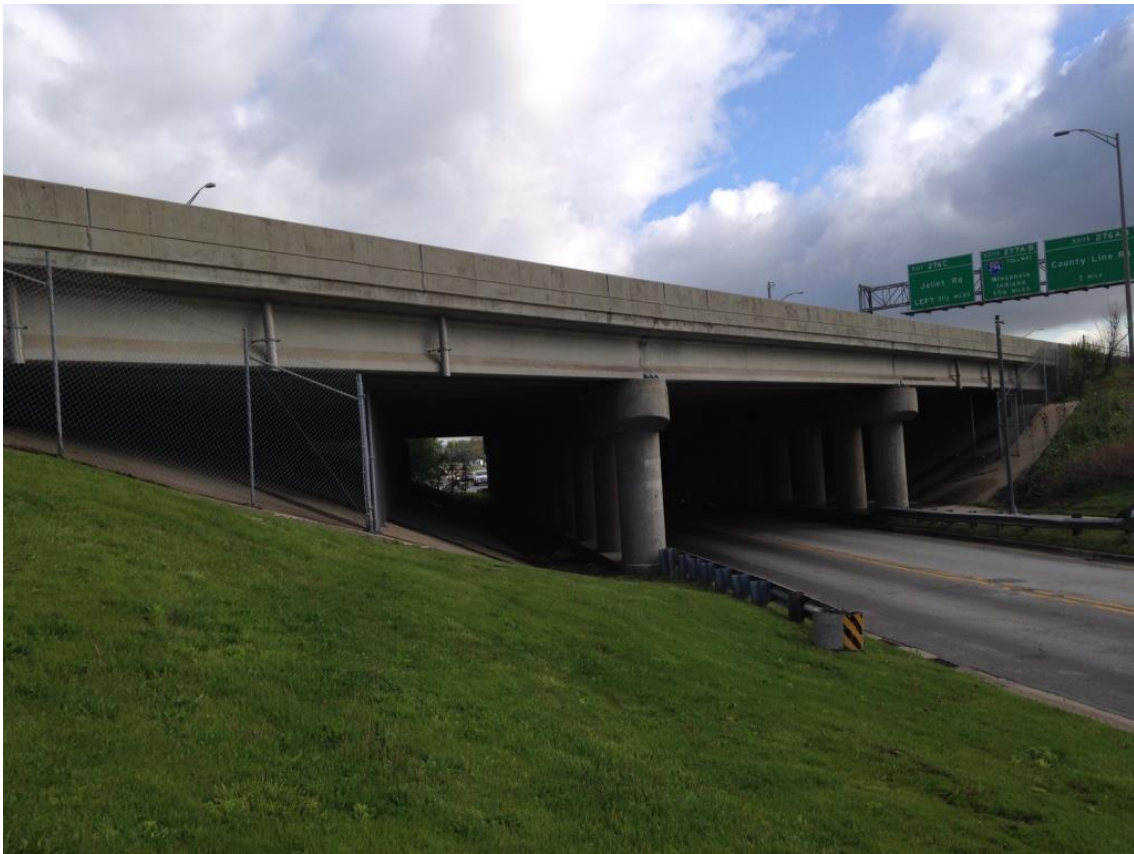
LOCATION: I-55 over S Madison St. in Burr Ridge, IL

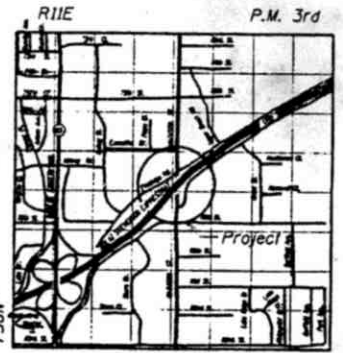
STATE OF ILLINOIS
DEPARTMENT OF TRANSPORTATION

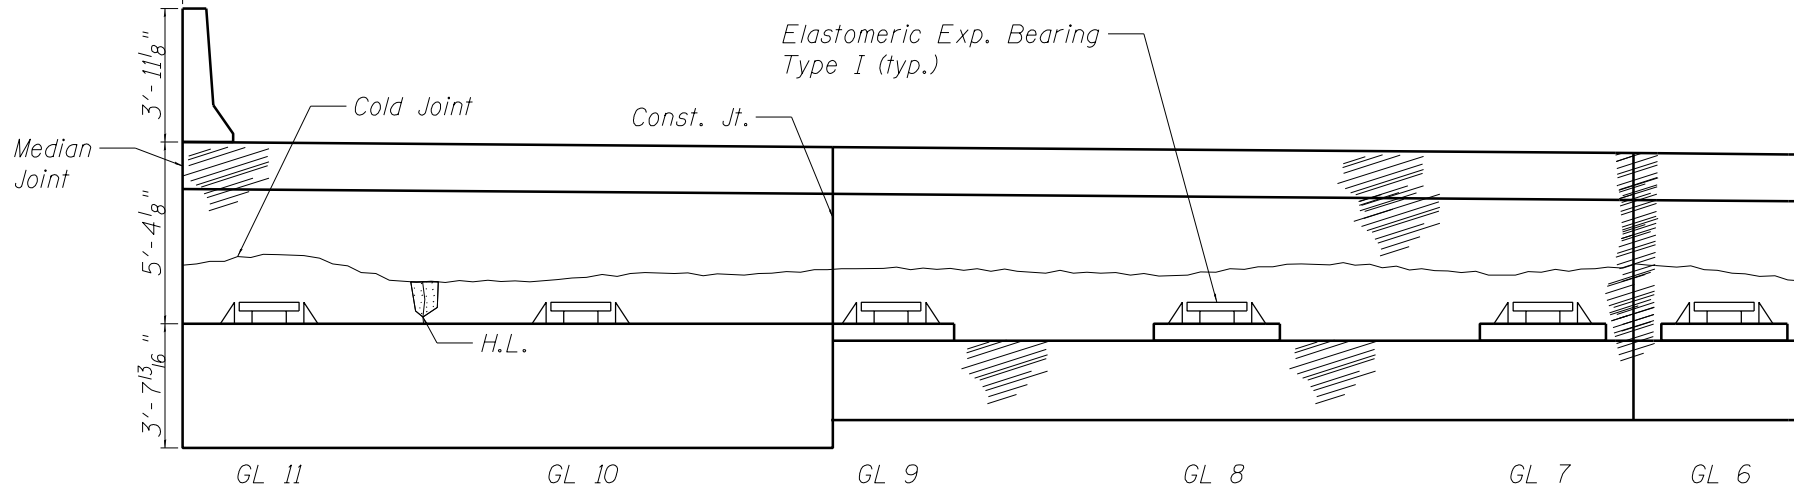
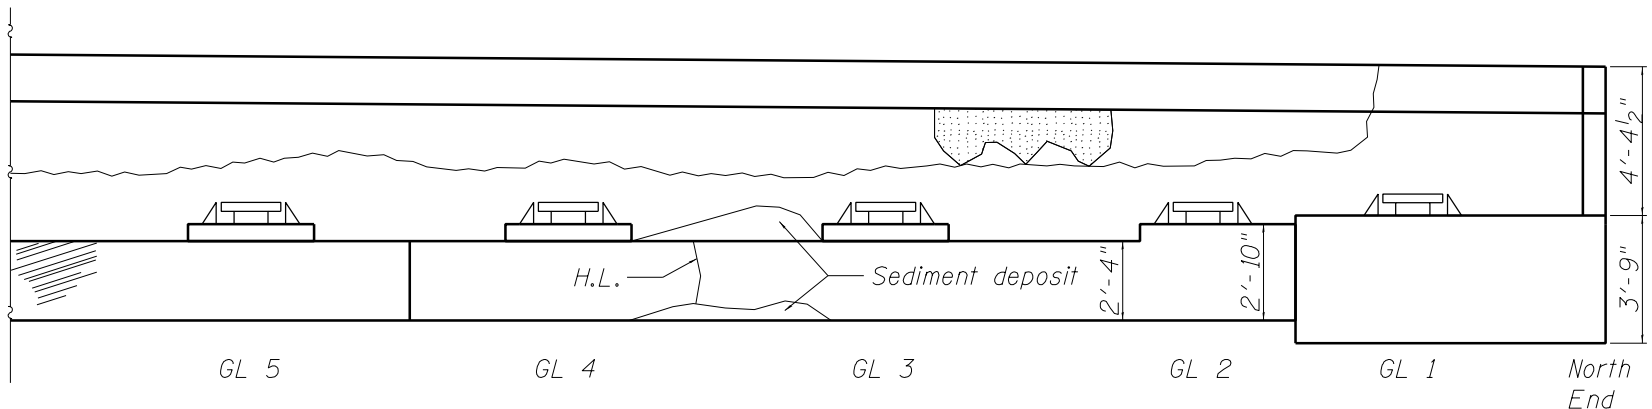
**WEST ABUTMENT
NORTH END ELEVATION**

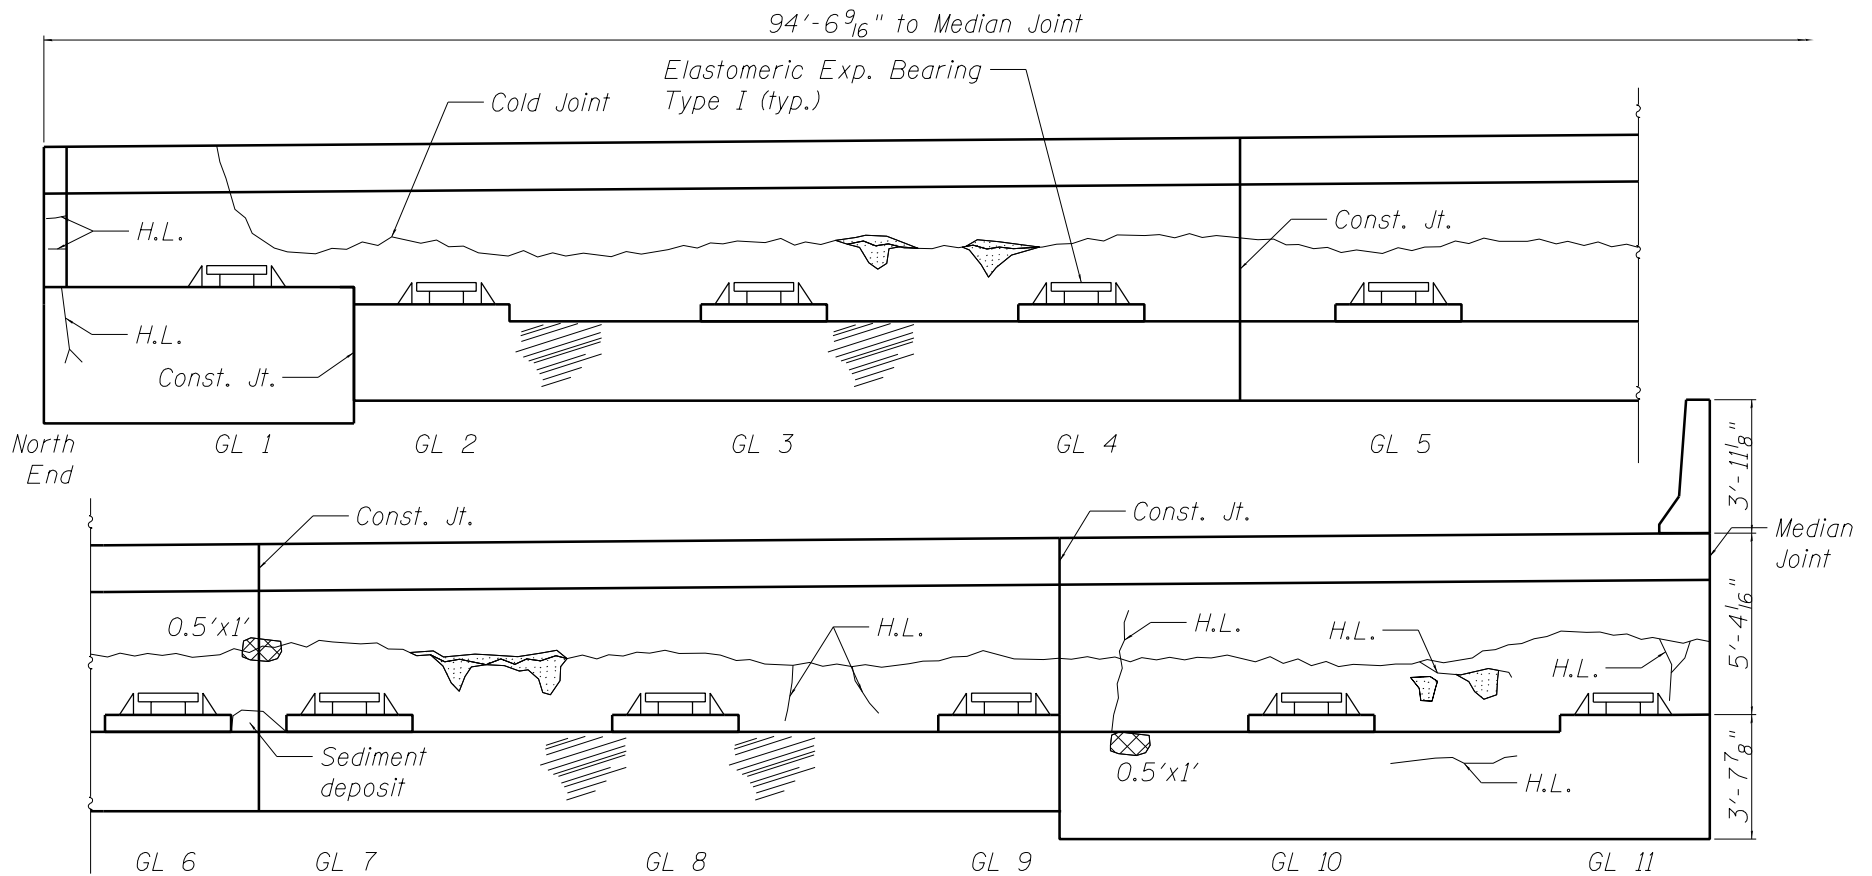
EAST ABUTMENT
NORTH END ELEVATION

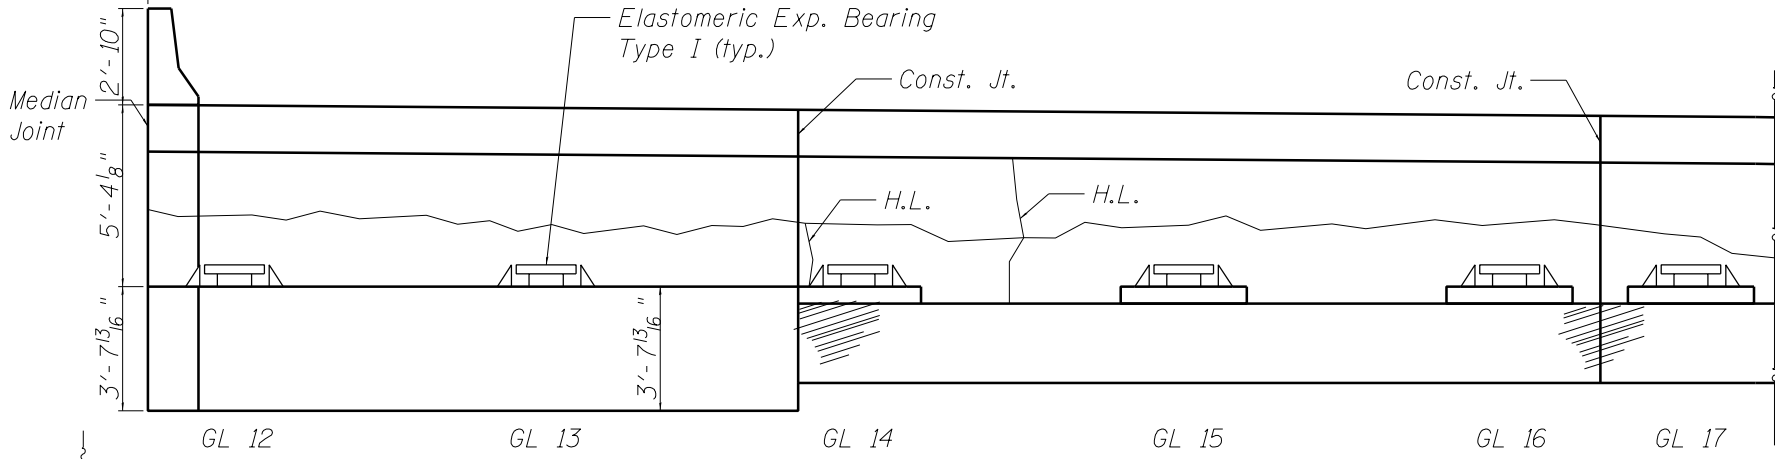
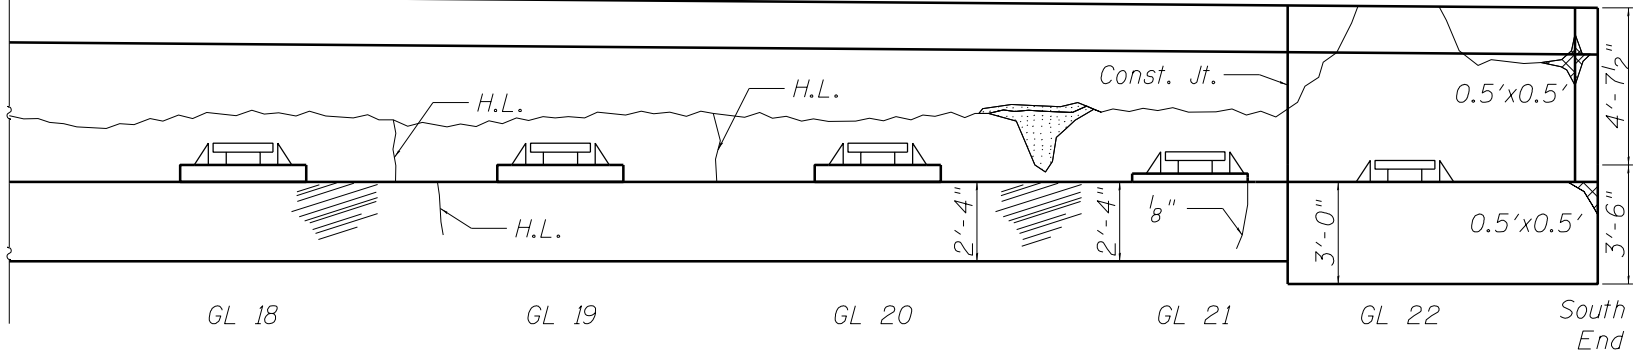
EAST ABUTMENT
SOUTH END ELEVATION
