I-55 Managed Lanes Combined Design Report

Appendix A.3 – Structures

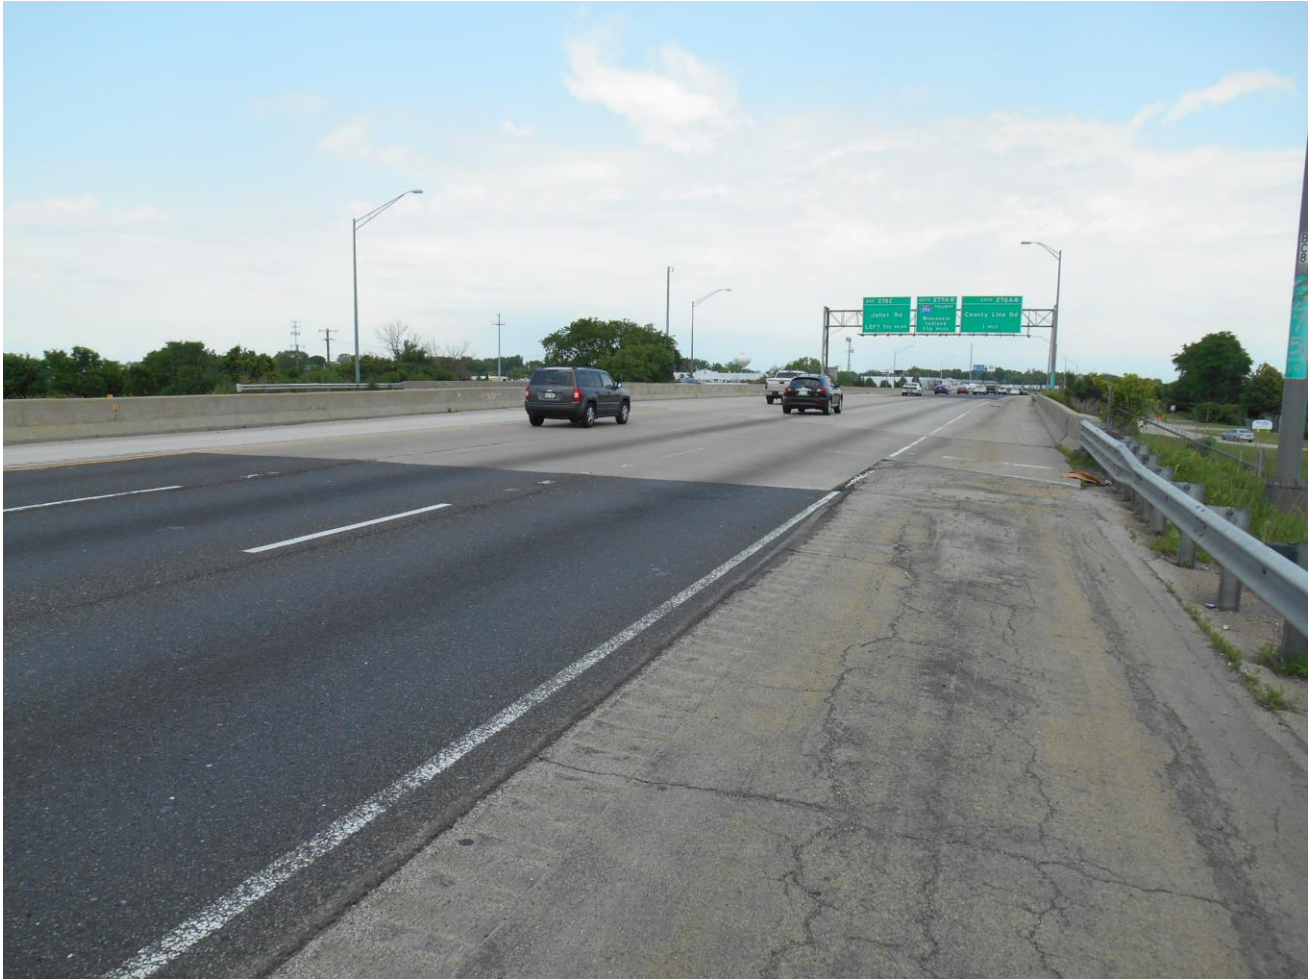
FIGURE 2
GENERAL VIEW - LOOKING SOUTH

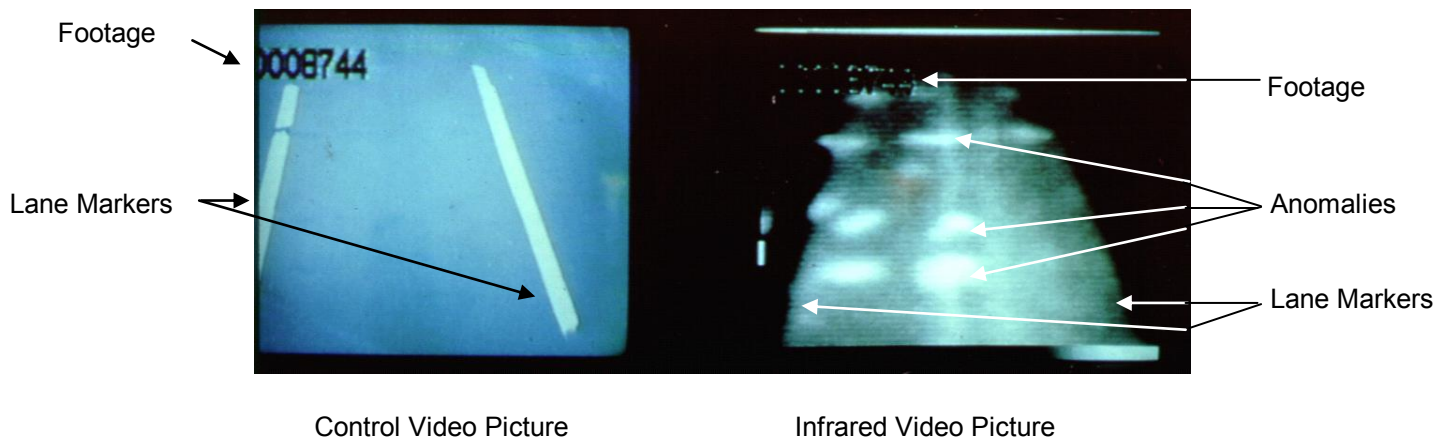
Anomalies can be separated into two basic categories; 1) delaminated concrete and 2) debonding between the overlay and the concrete deck. The separation of anomalies into these categories is accomplished by coring a representative sample of each type of anomaly detected on the bridge deck and comparing the results with the visual interpretation of the anomaly. These coring results, along with results from past projects are then used to categorize the remaining anomalies.

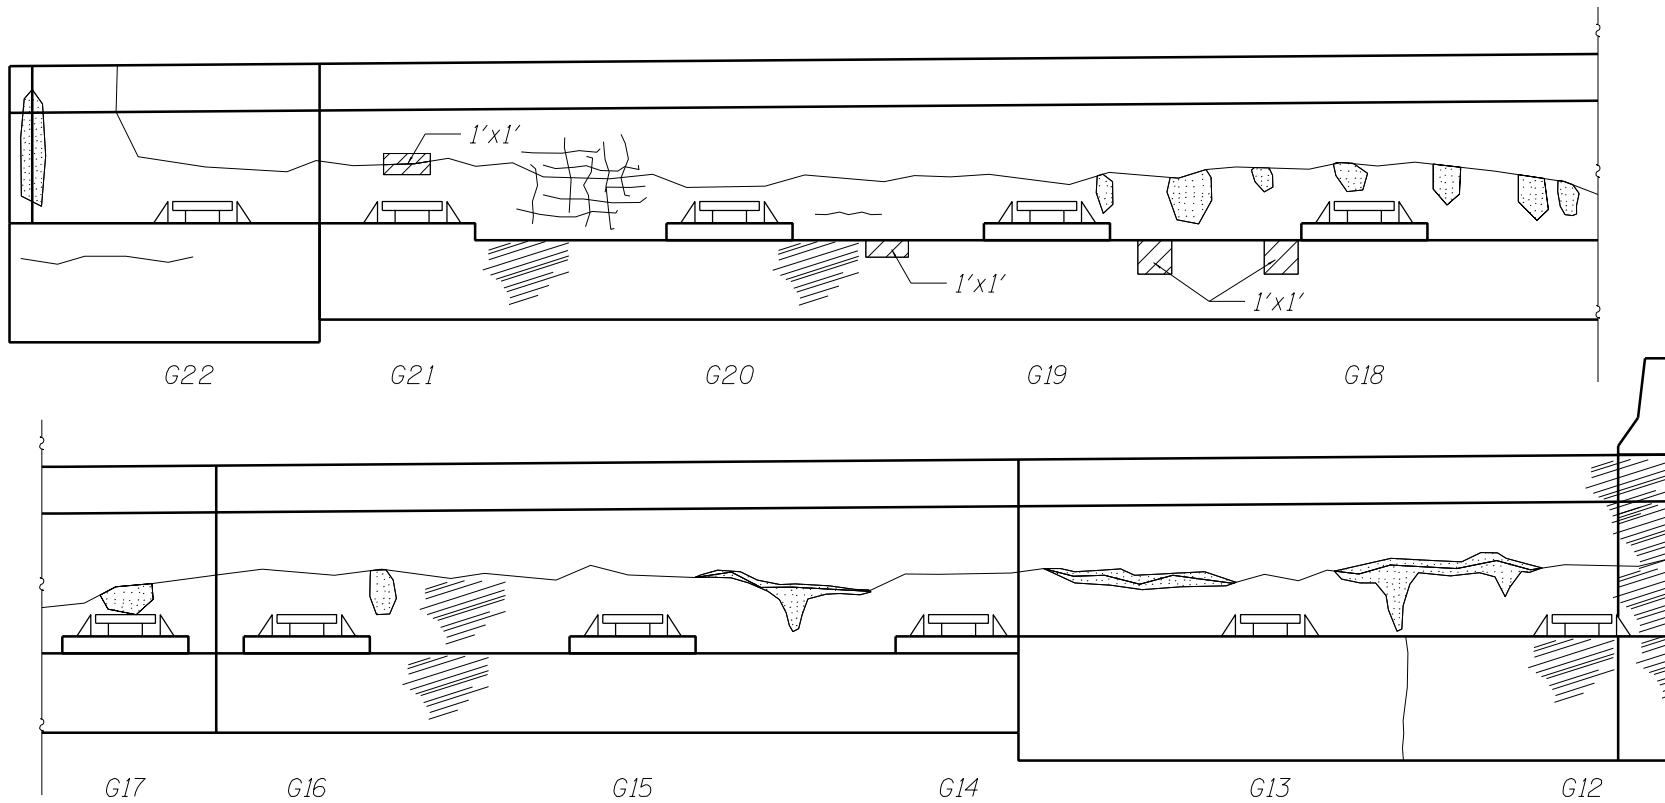
WEST ABUTMENT
SOUTH END ELEVATION

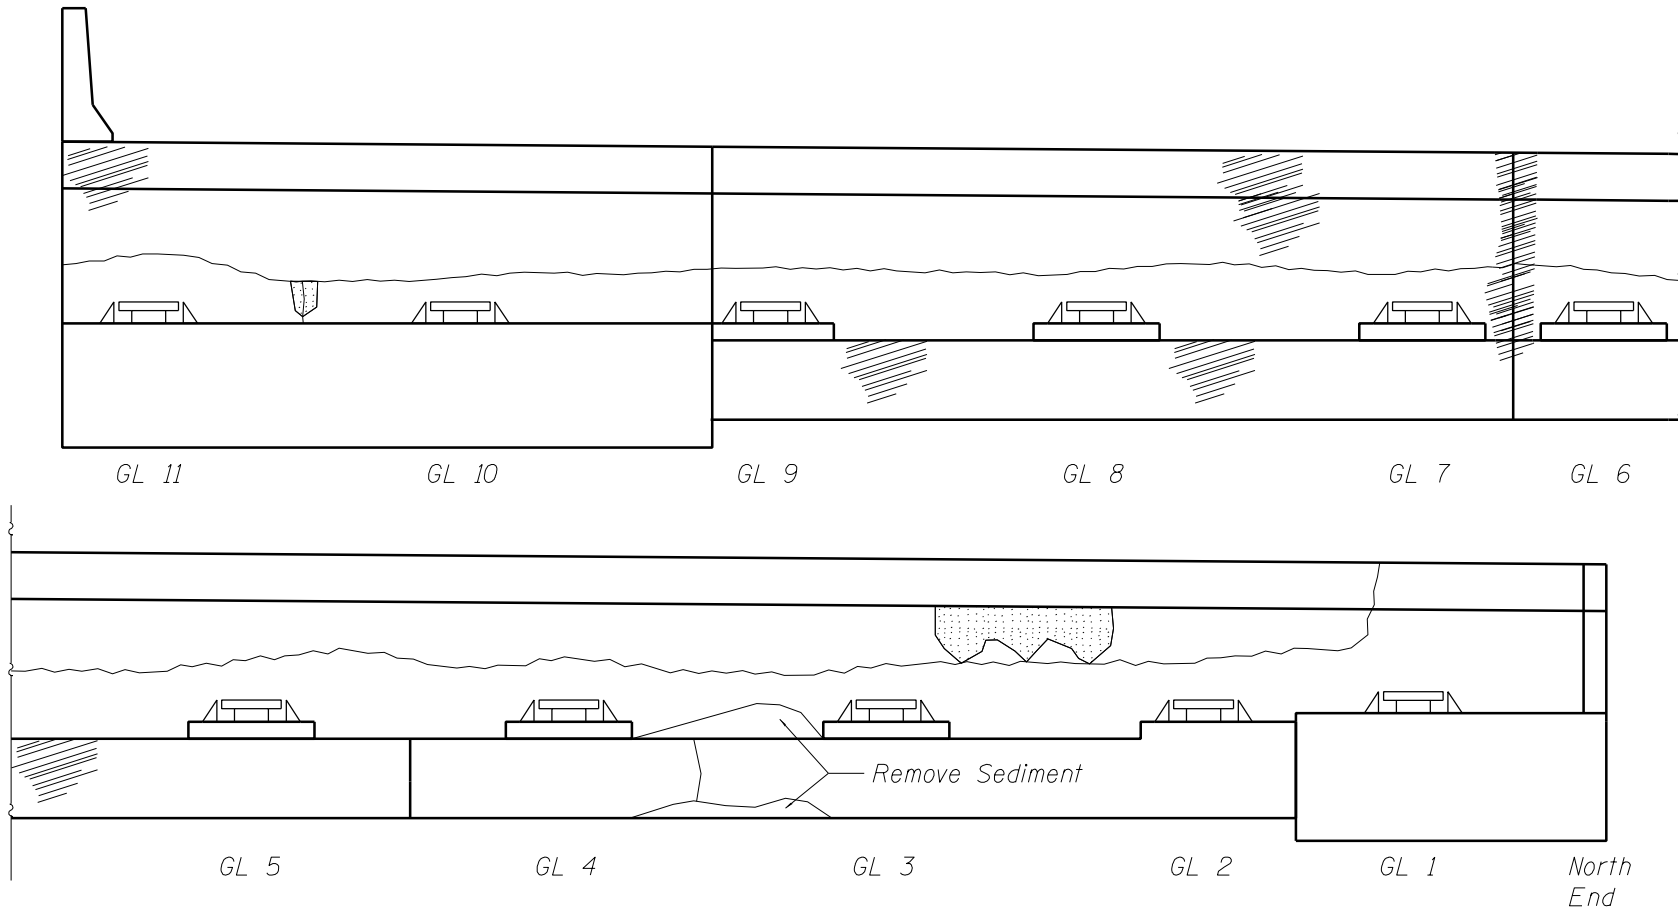
WEST ABUTMENT
NORTH END ELEVATION

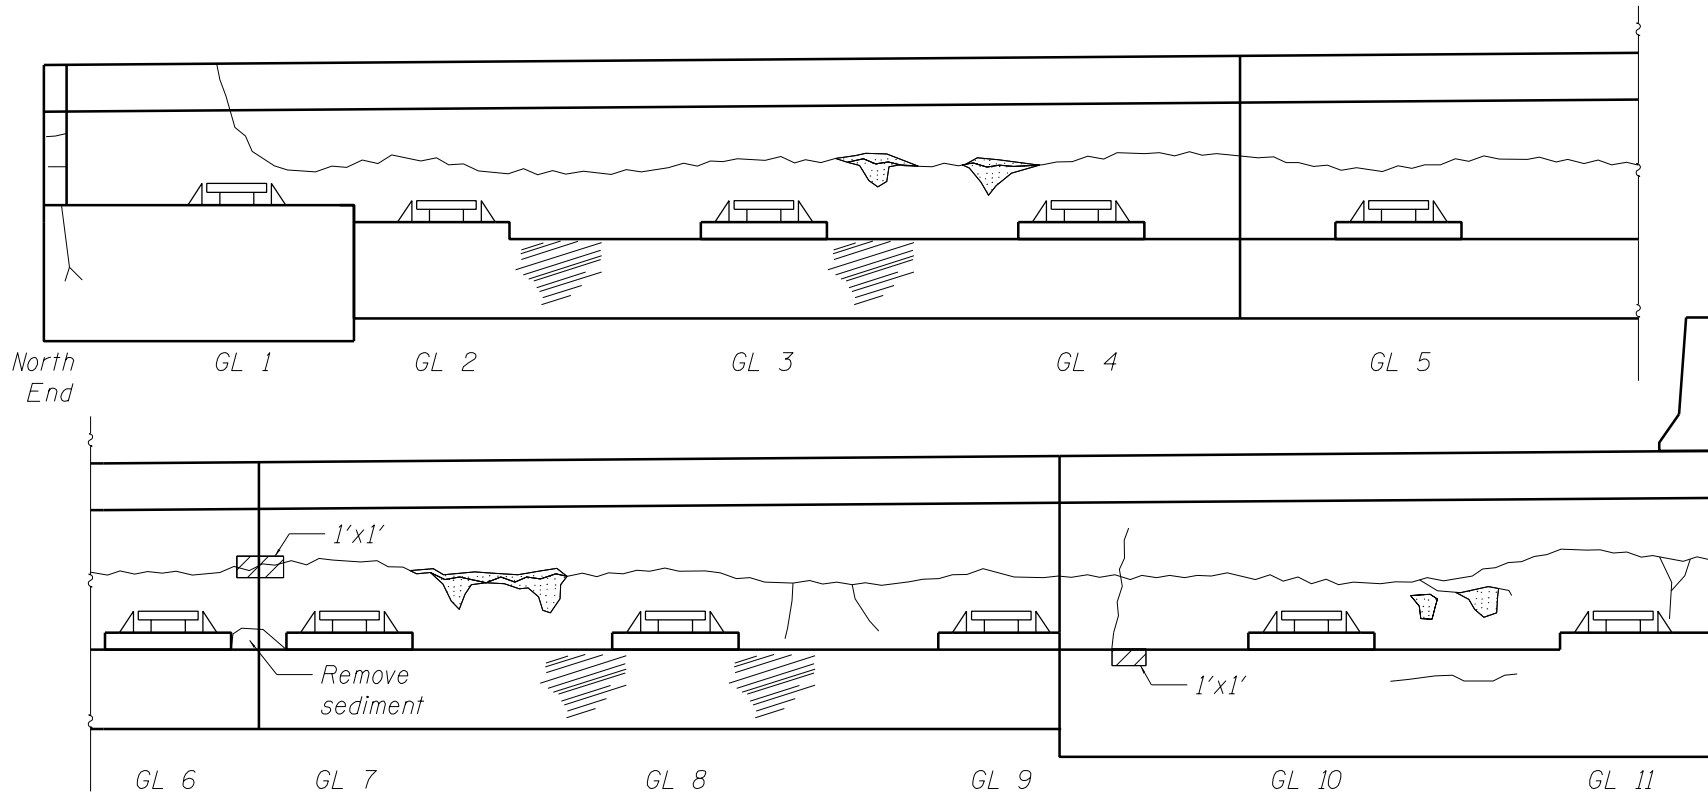
EAST ABUTMENT
NORTH END ELEVATION

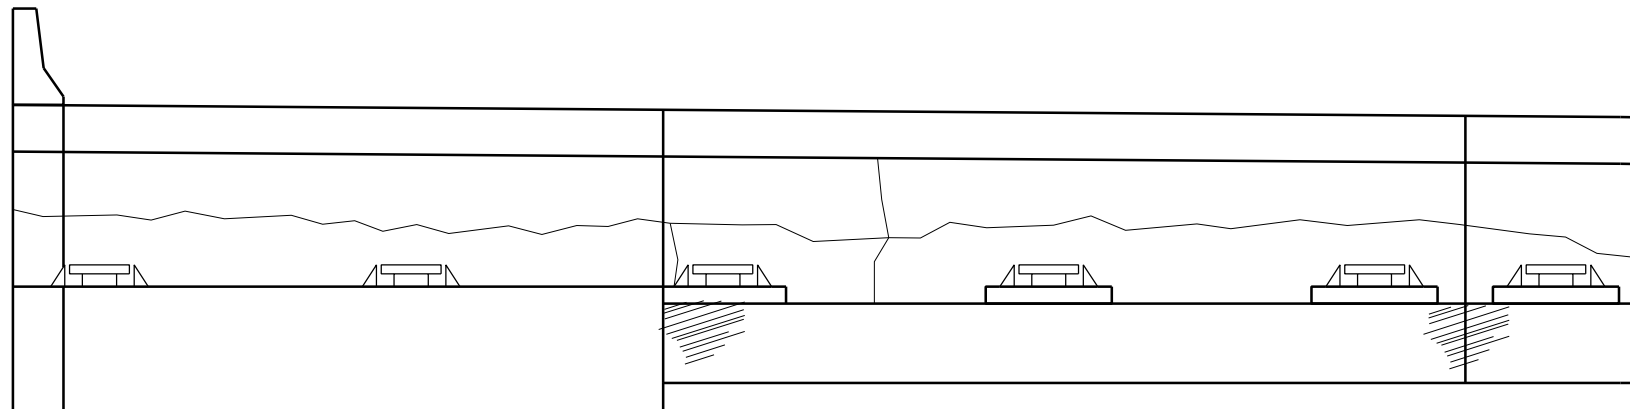
GL 12 GL 13 GL 14 GL 15 GL 16 GL 17

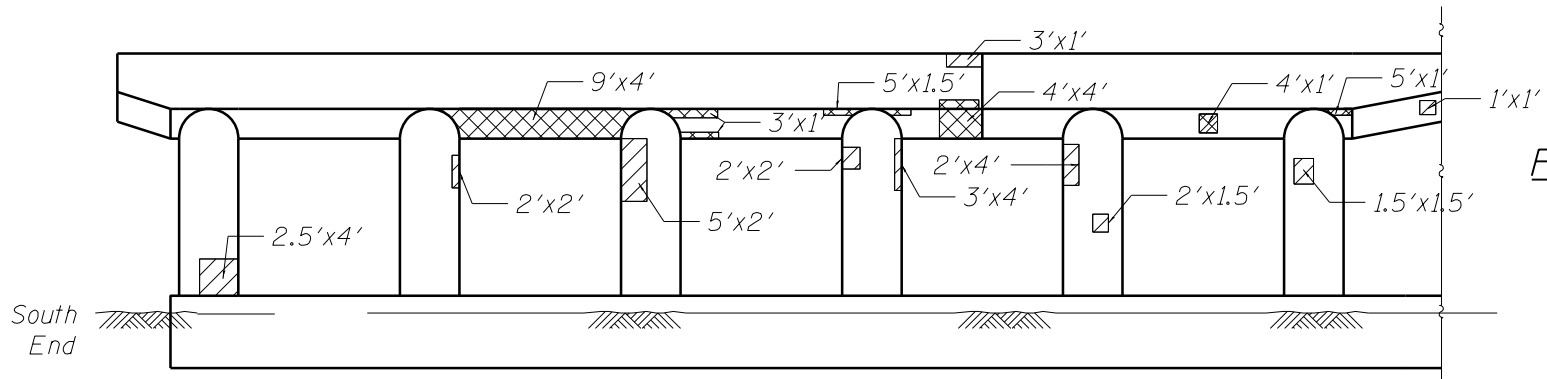
PIER 1: EAST FACE
ELEVATION
& UNDERSIDE

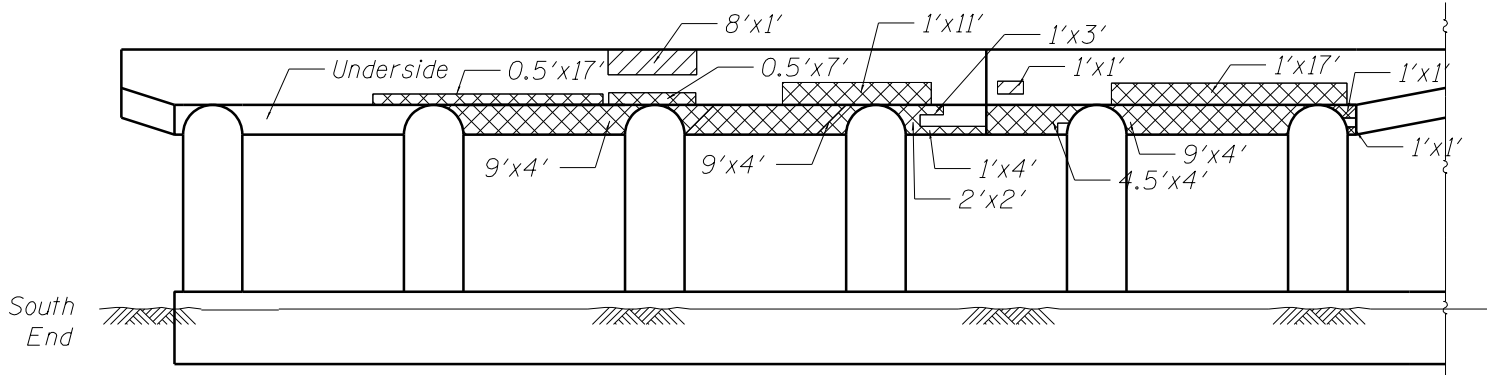
PIER 2: EAST FACE
ELEVATION
& UNDERSIDE

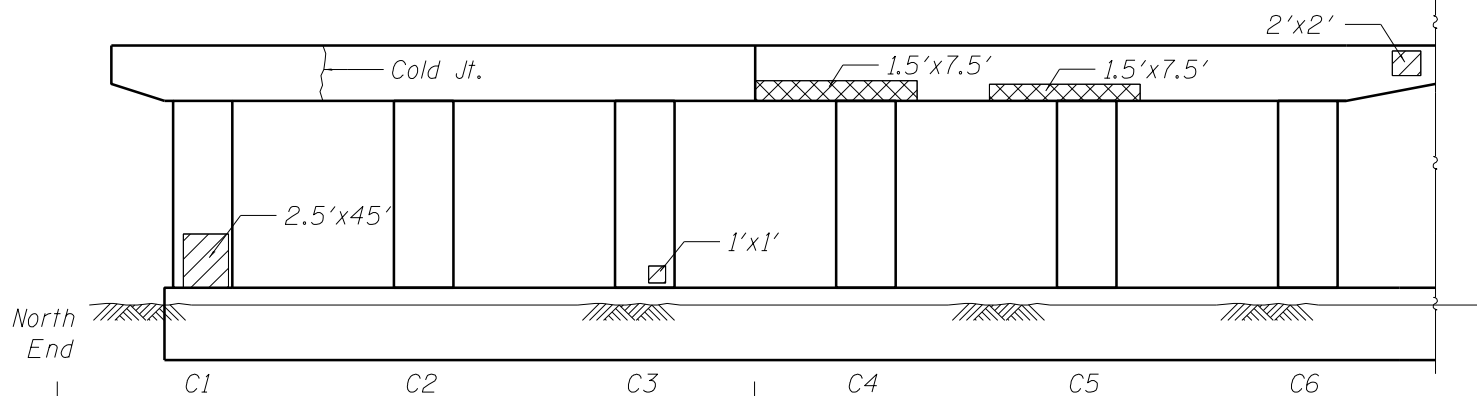
PIER 2: WEST FACE
ELEVATION

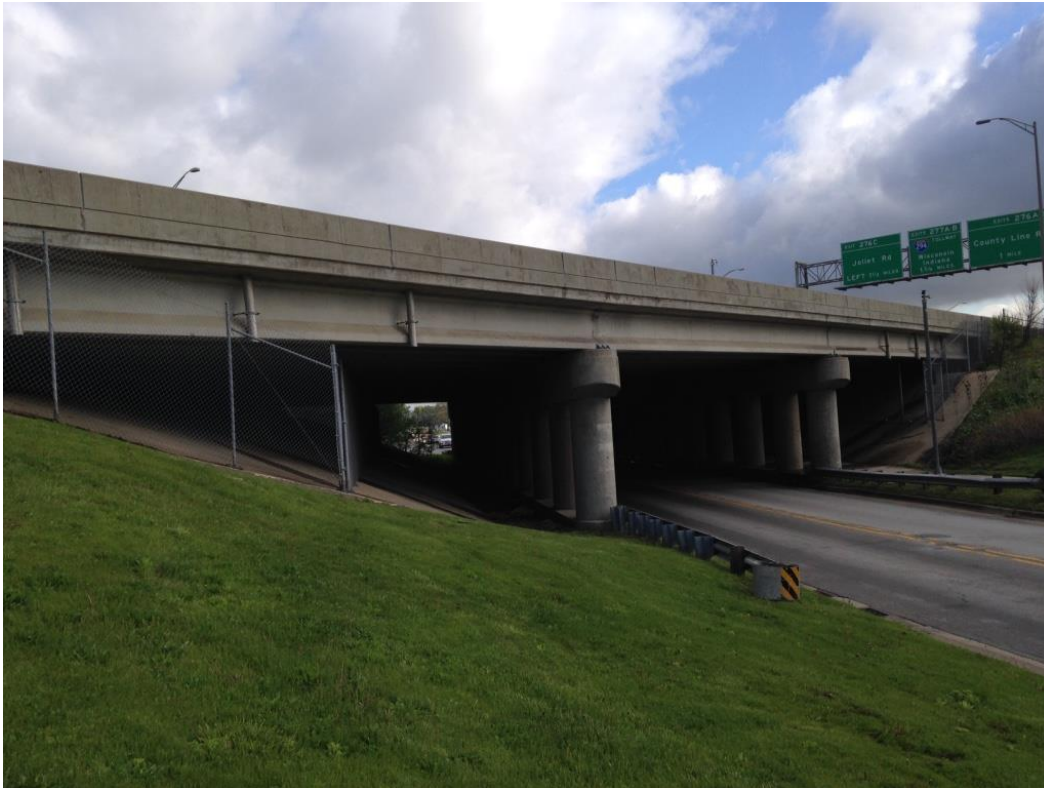
Photo 1: Structure overall, looking north east.

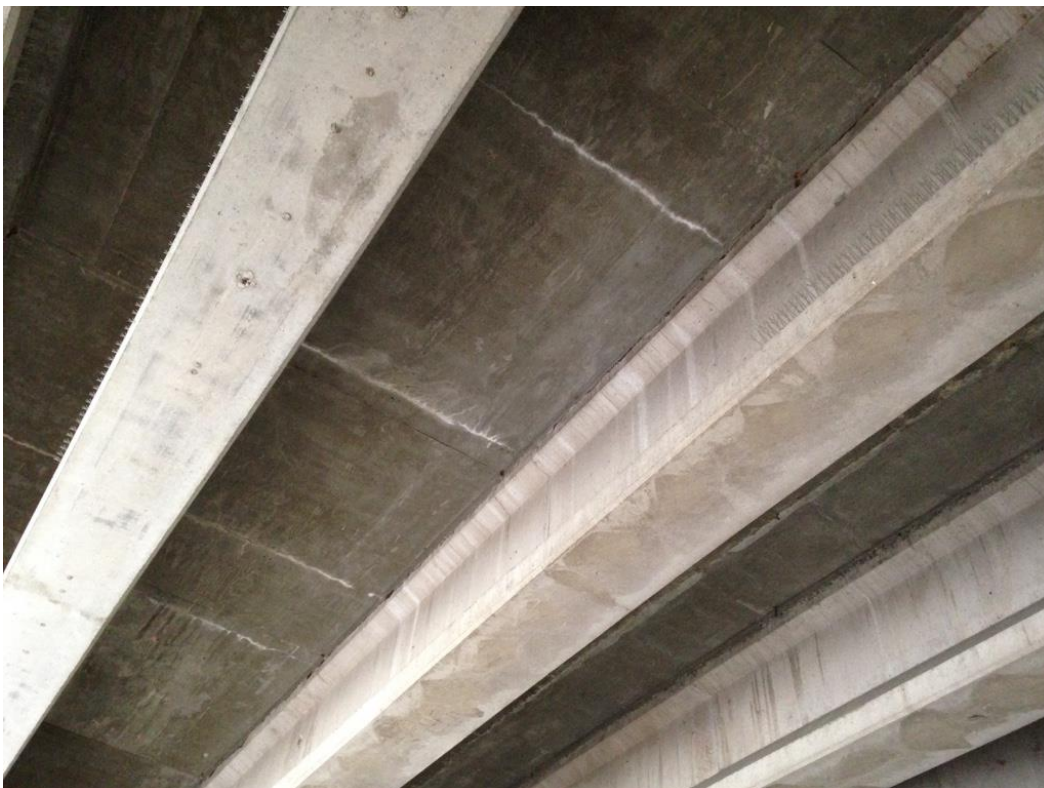
Photo 6: Span 3, bay 5 showing transverse hairline cracks with efflorescence.

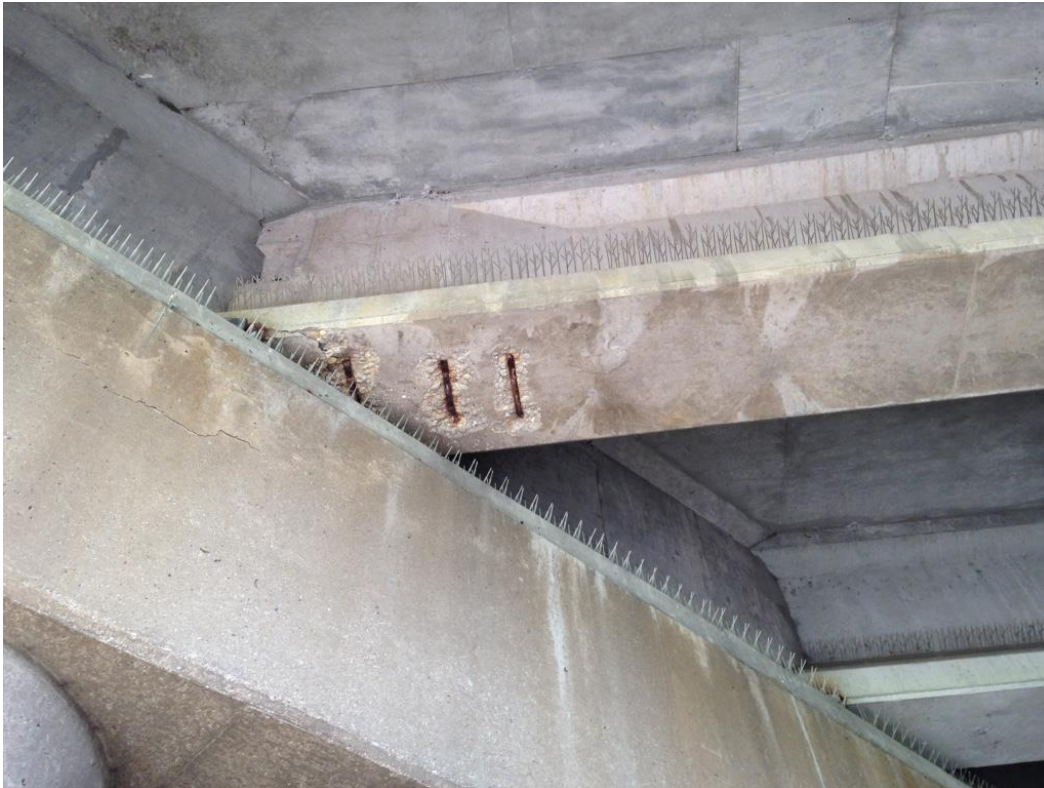
Photo 7: Span 3, underside of girder 19 at pier 2 showing spalling with exposed and corroded stirrups.

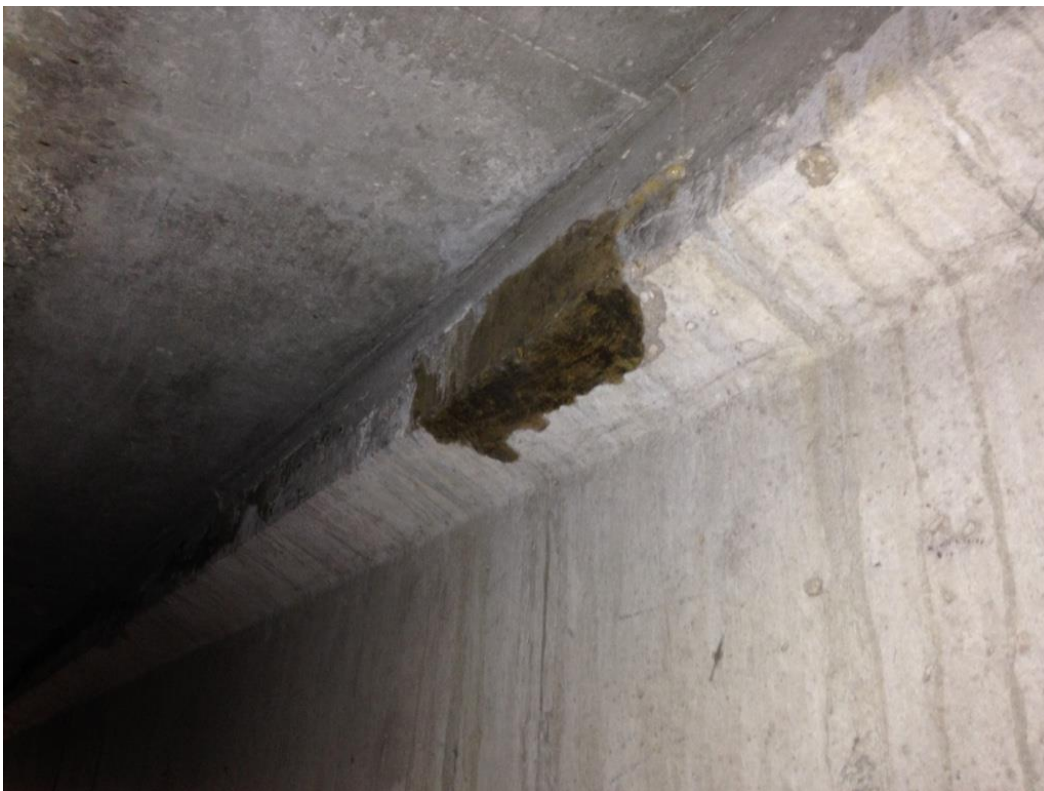
Photo 8: South face of girder 16 in span 3 showing previously patched area intact.

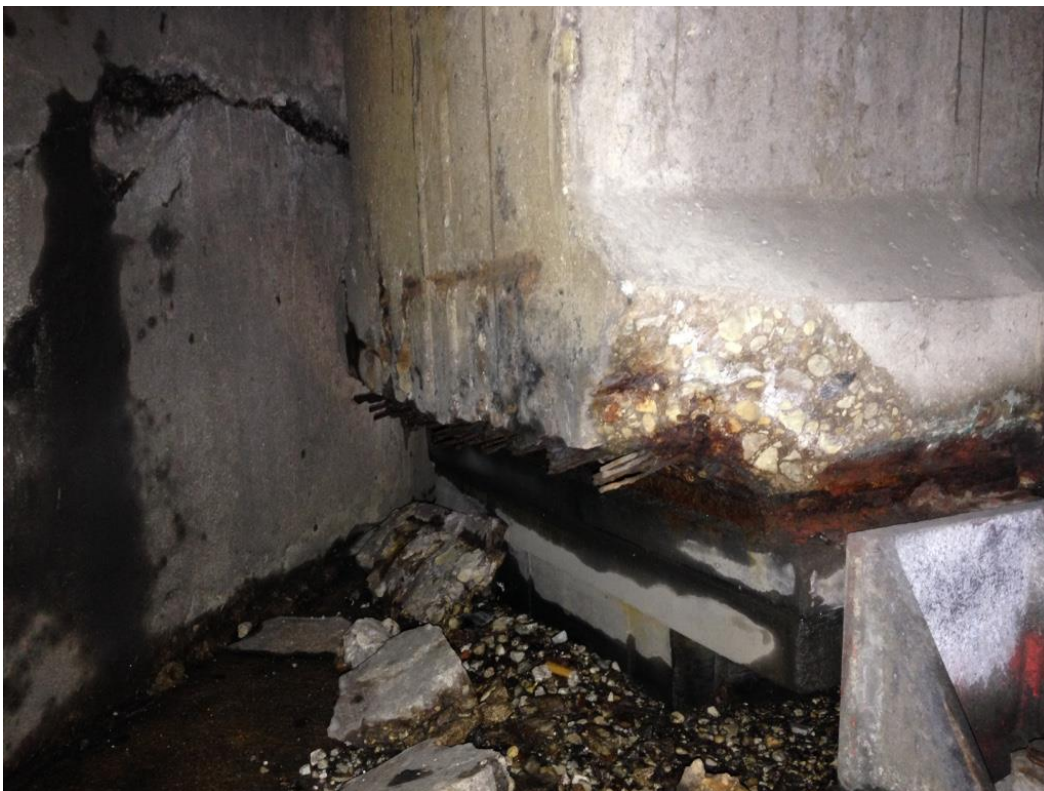
Photo 10: East end of girder 19 showing spalled bottom cover with exposed and corroded bottom row of prestressing strands.

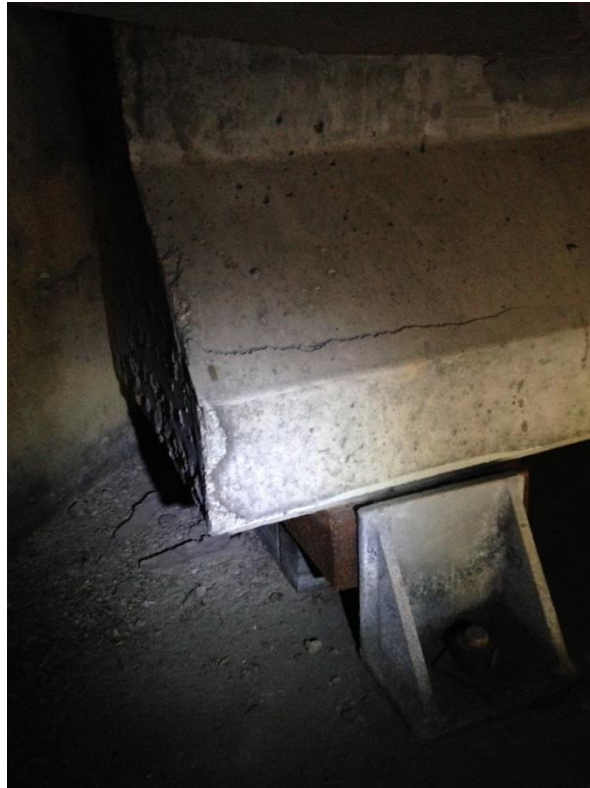
Photo 11: North face of girder 13 over east abutment showing area of delamination above bearing.

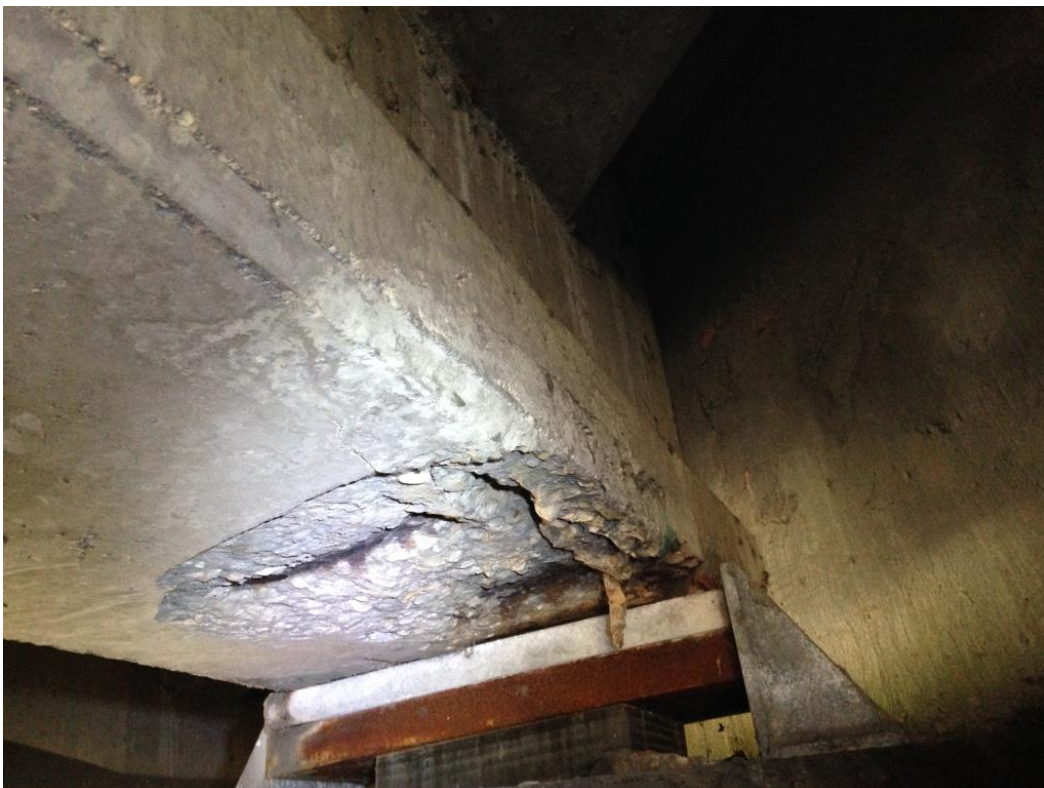
Photo 12: Underside of girder 6 over west abutment showing spalling with exposed and corroded reinforcement.

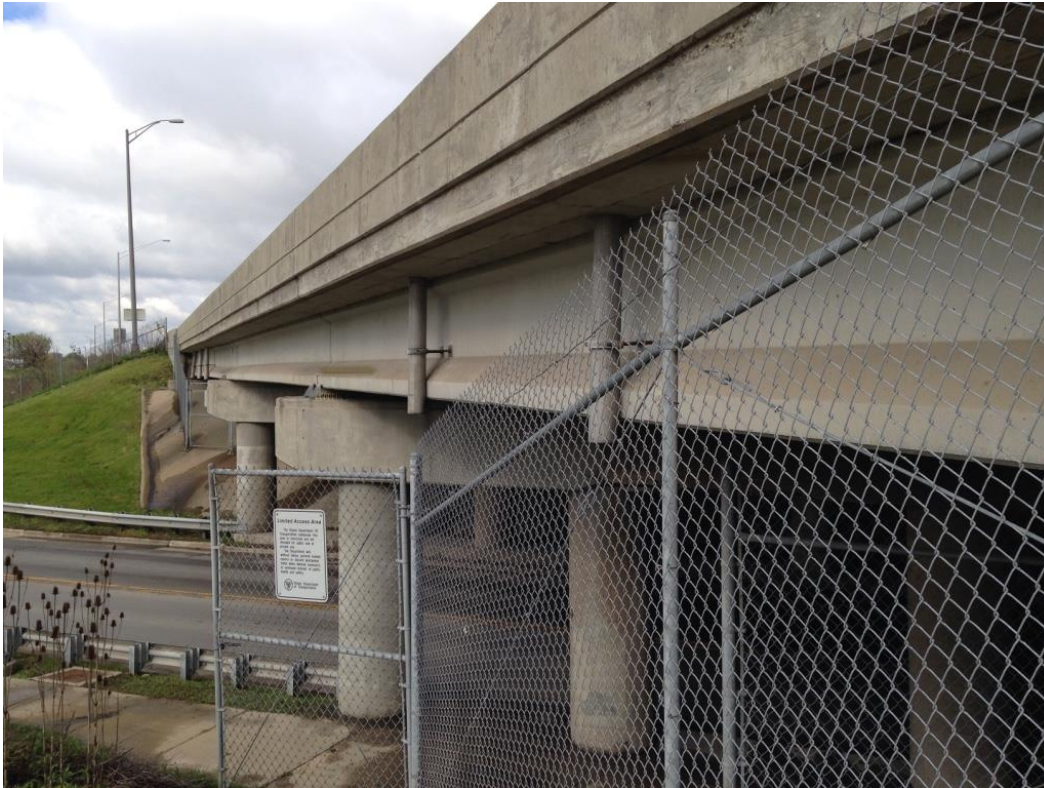
Photo13: South side of structure looking southwest along fascia showing deck drain down spouts.

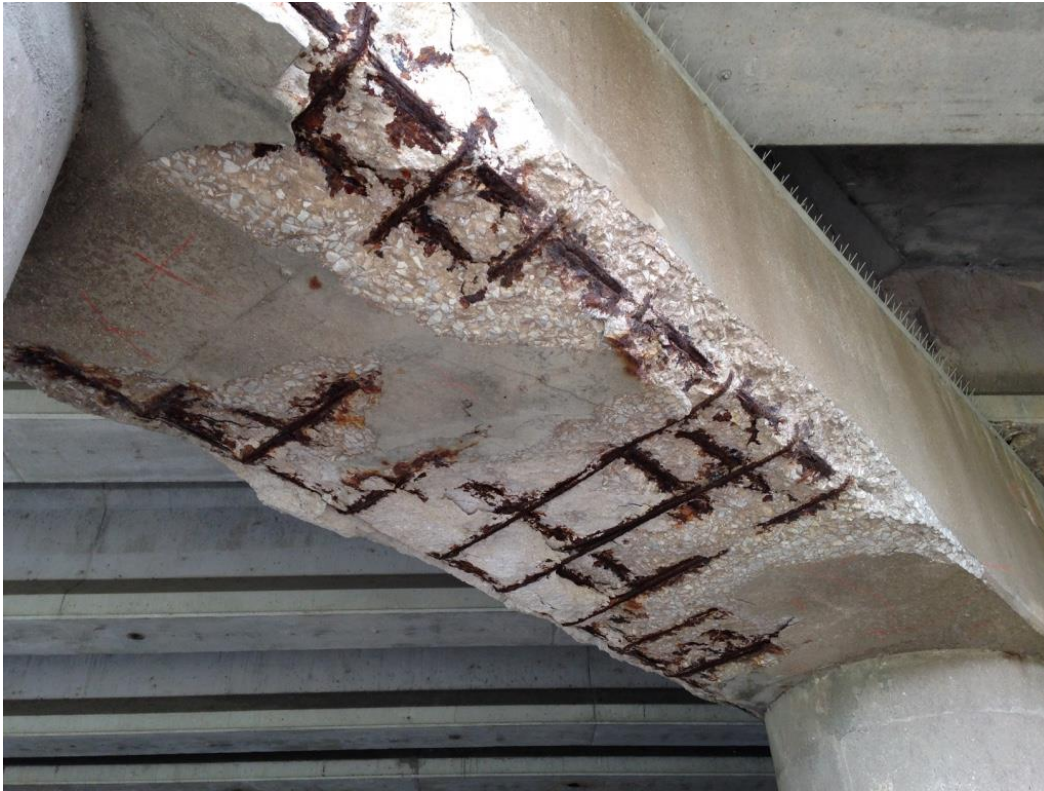
Photo 17: Pier 2, underside of pier cap between columns 13 & 14 showing spalling with exposed and corroded reinforcement.

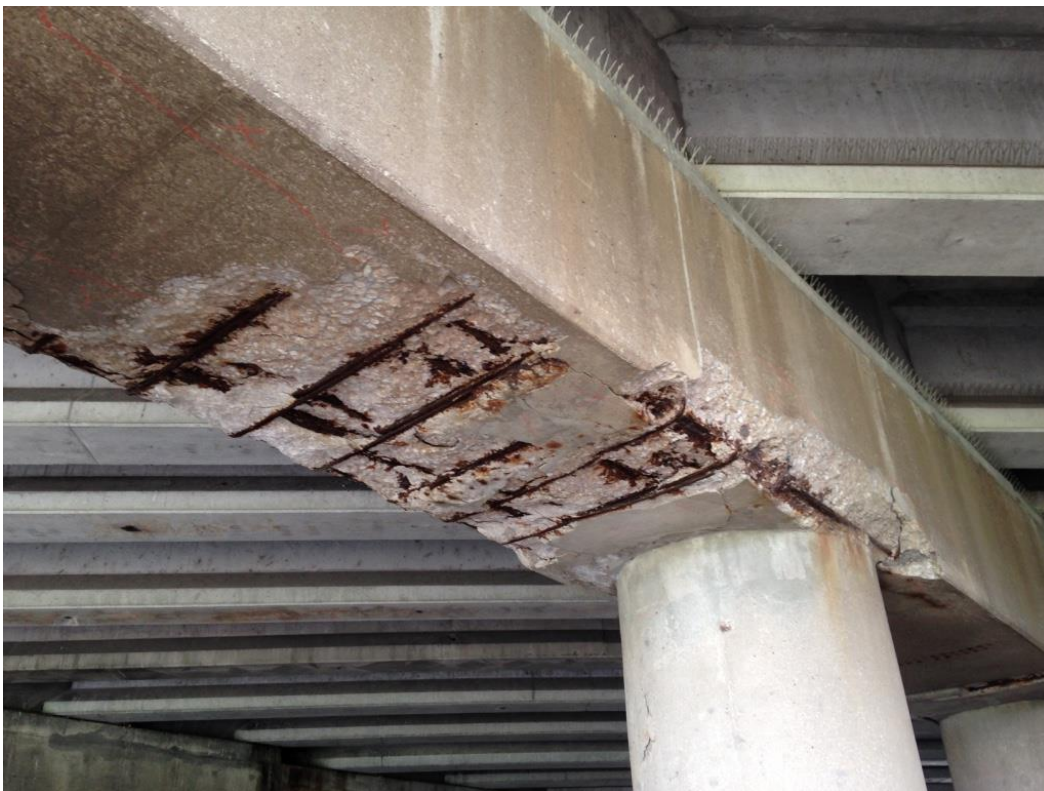
Photo 18; Pier 2, underside of pier cap between girders 12 & 13 showing spalling with exposed and corroded reinforcement.

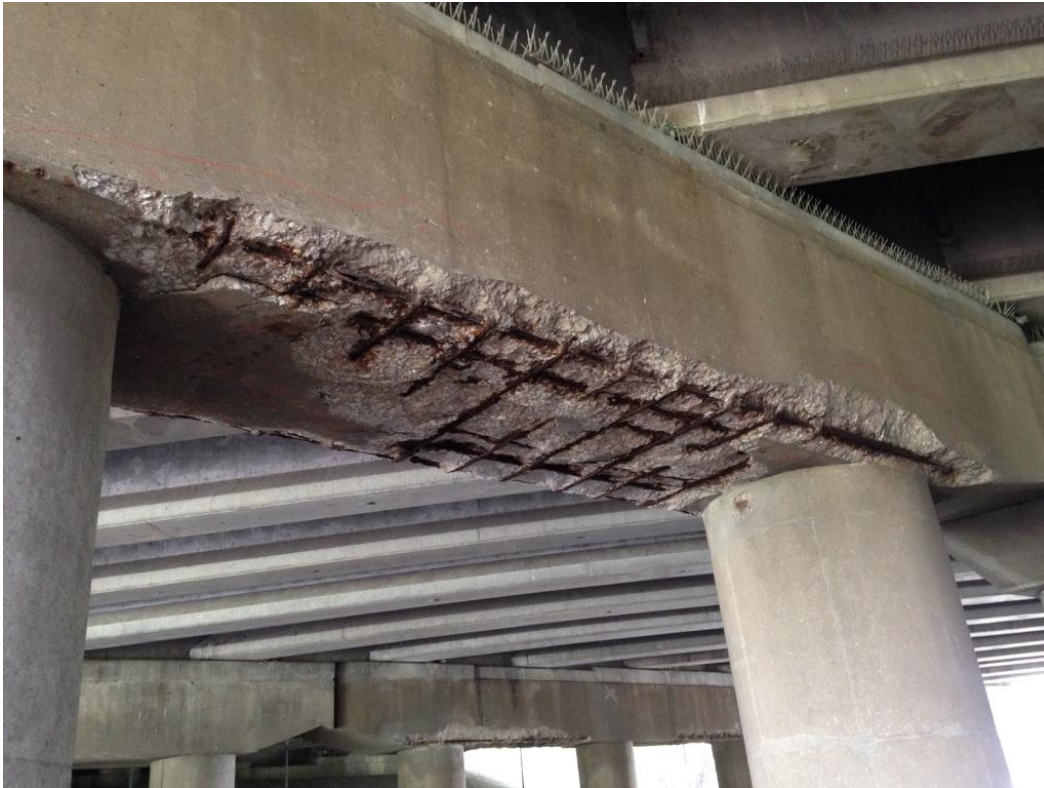
Photo 19: Pier 2, underside of pier cap between columns 10 & 11 showing spalling with exposed and corroded reinforcement.

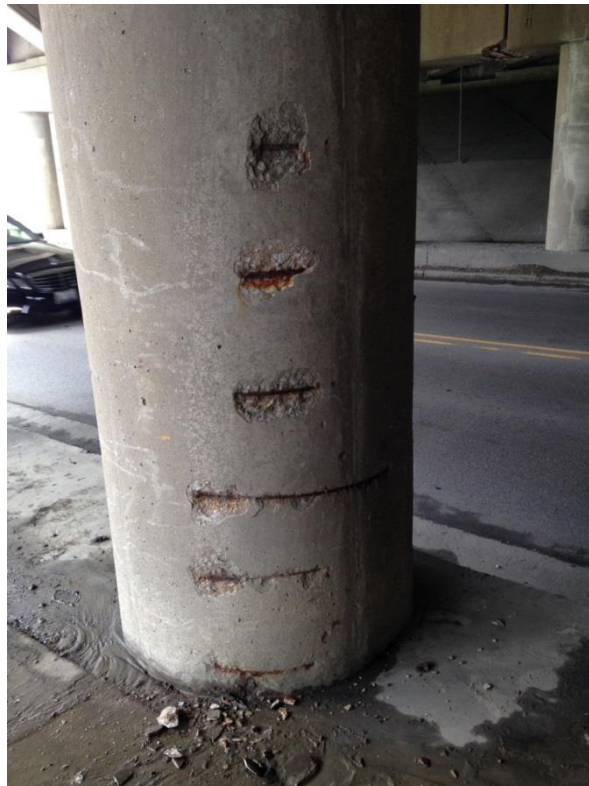
Photo 20: Pier 2, north east face of column 14 showing exposed and corroded spiral reinforcement.

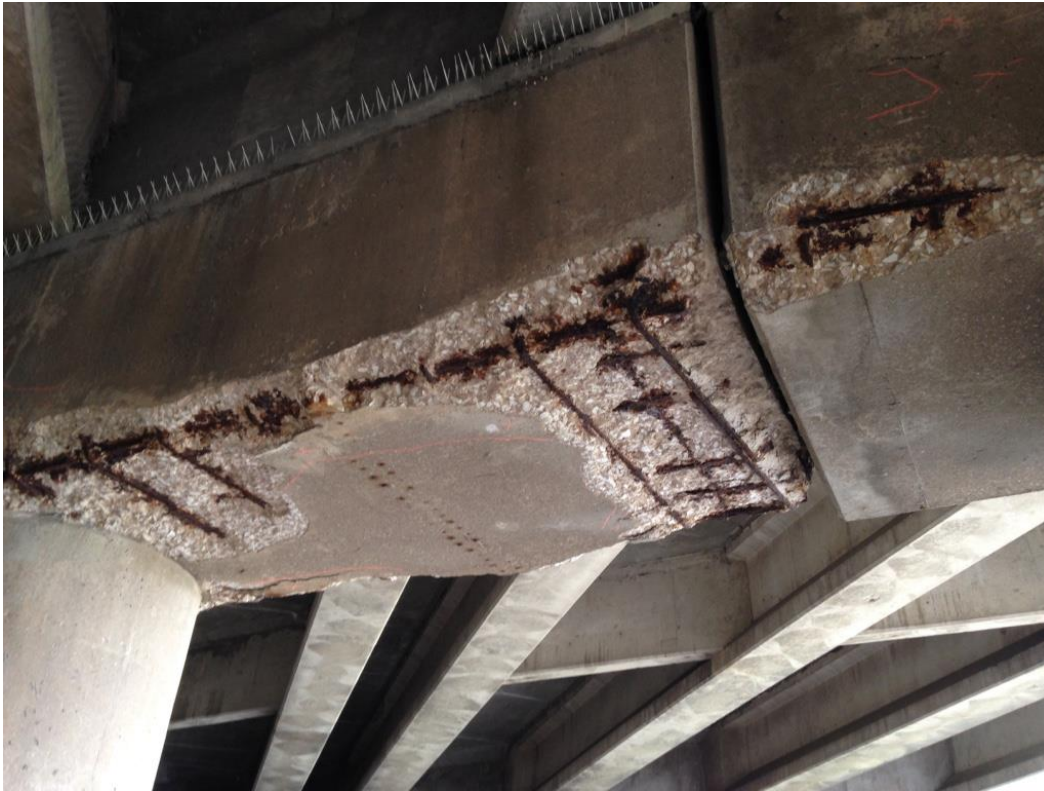
Photo 21: Pier 2, underside of pier cap between columns 3 & 4 showing spalling with exposed and corroded reinforcement on both sides of joint.

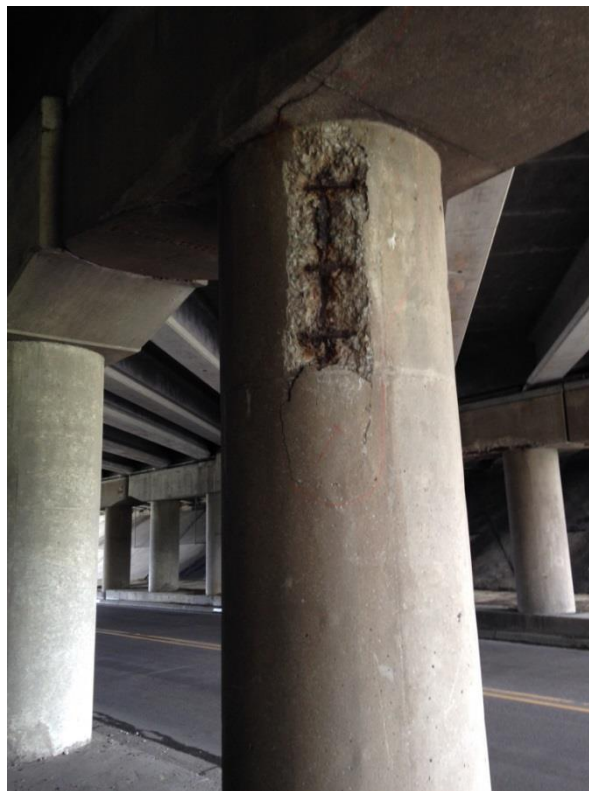
Photo 22: Pier 1, southwest face of column 10 showing spalling with exposed and corroded reinforcement near the pier cap.

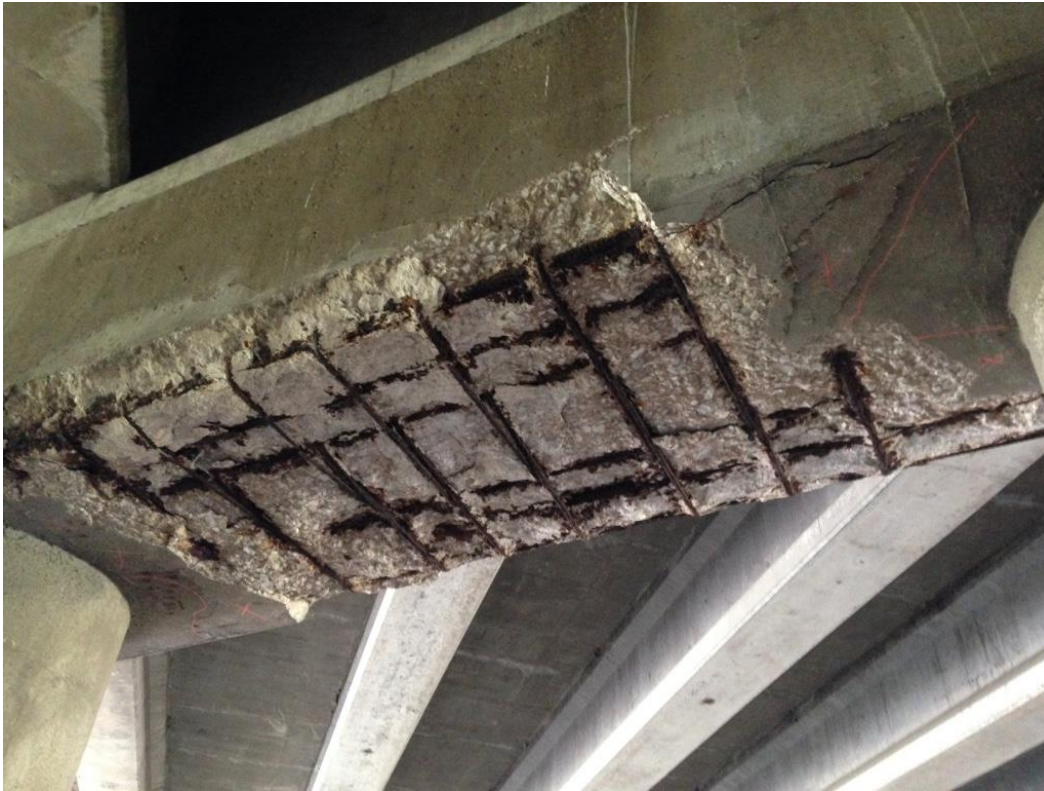
Photo 23: Pier 1, underside of pier cap between columns 5 & 6 showing spalling with exposed and corroded reinforcement.

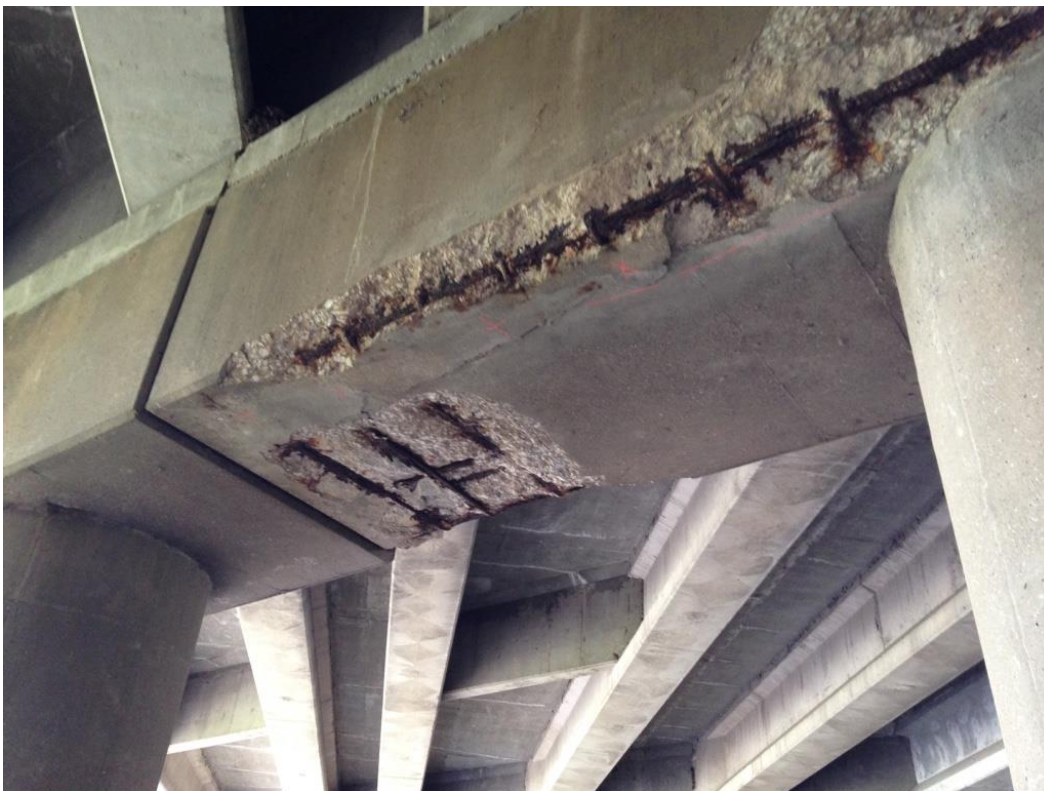
Photo 24: Pier 1, underside of pier cap between columns 3 & 4 showing spalling with exposed reinforcement on underside and bottom west corner of pier cap.

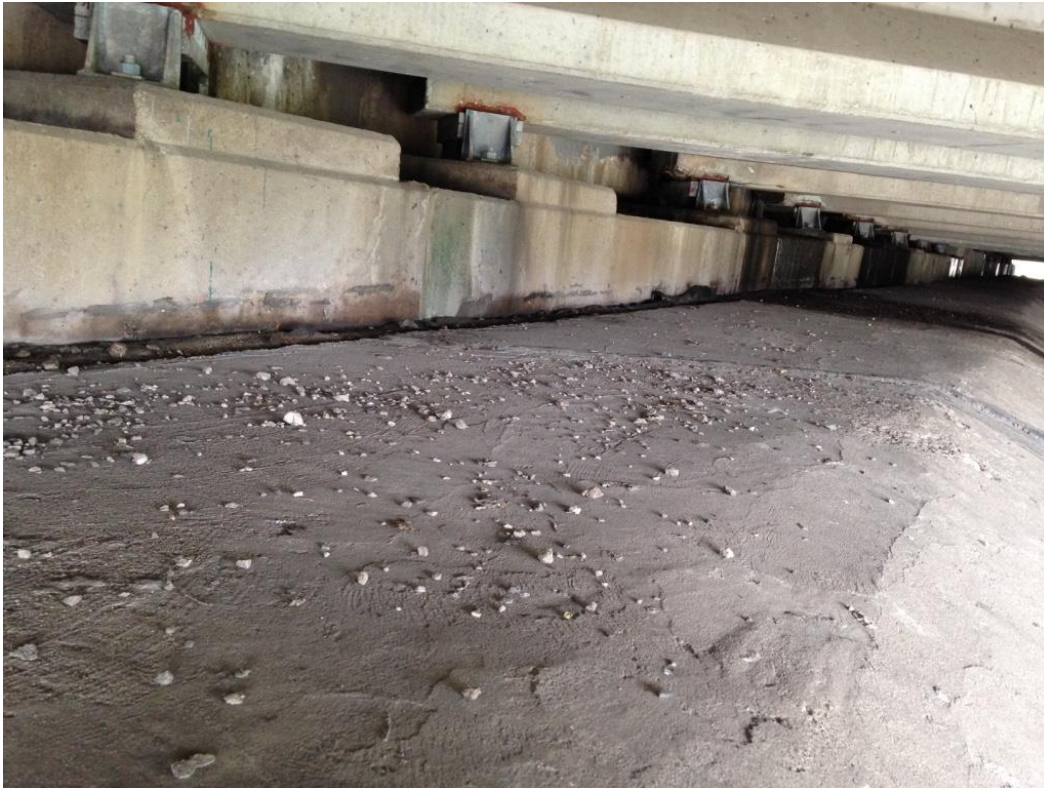
Photo 25; East abutment overall looking south along abutment from north end.

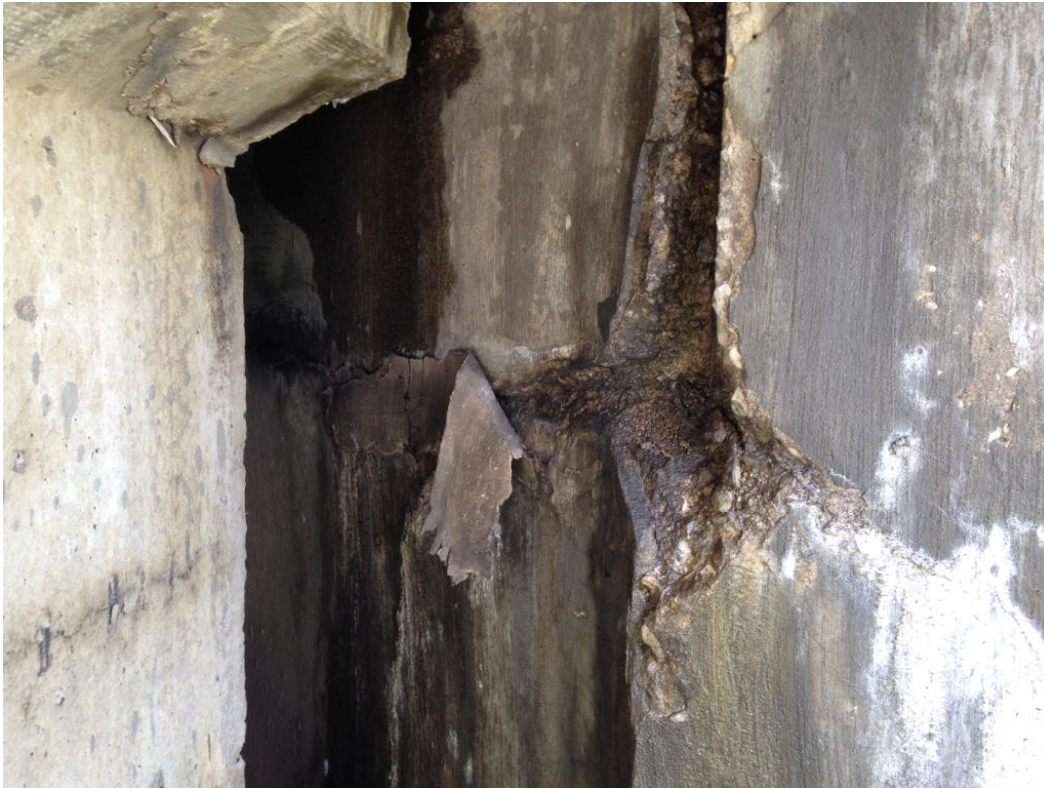
Photo 27: East abutment back wall south of girder 22 showing spall with loose crack seal and efflorescence.
