I-55 Managed Lanes Combined Design Report

Appendix A.3 – Structures

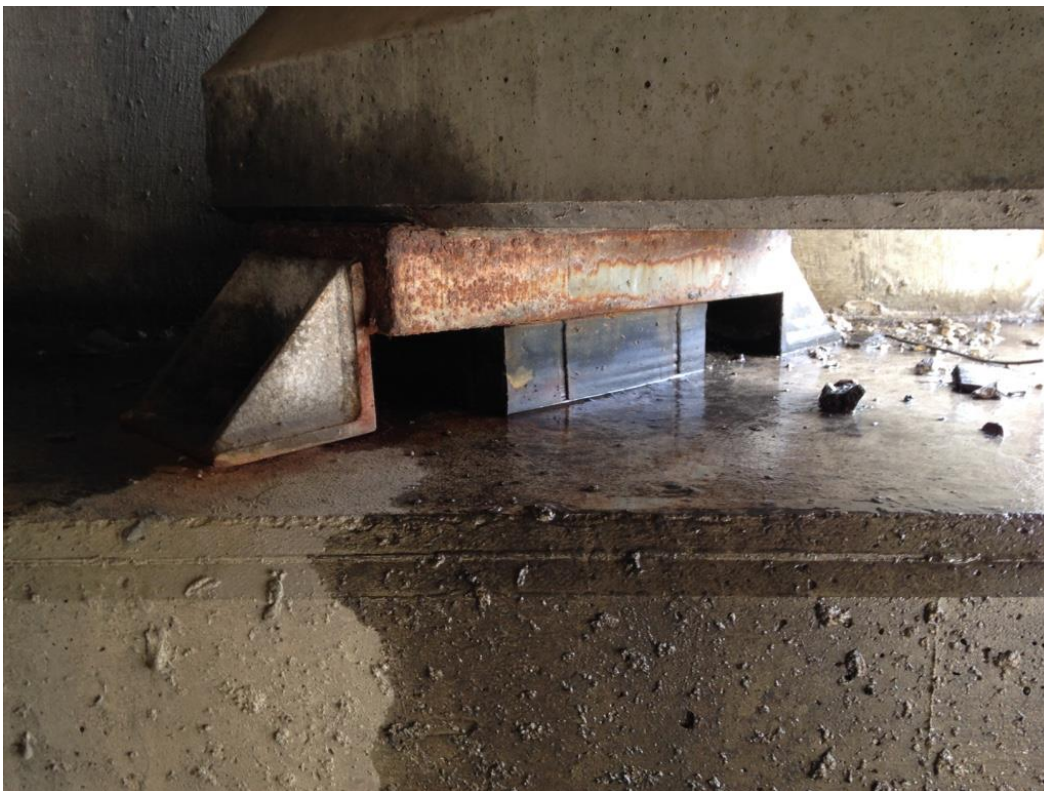
Photo 28: East bearing under girder 22 (typ.) showing standing water near backwall and corrosion of bearing top plate.

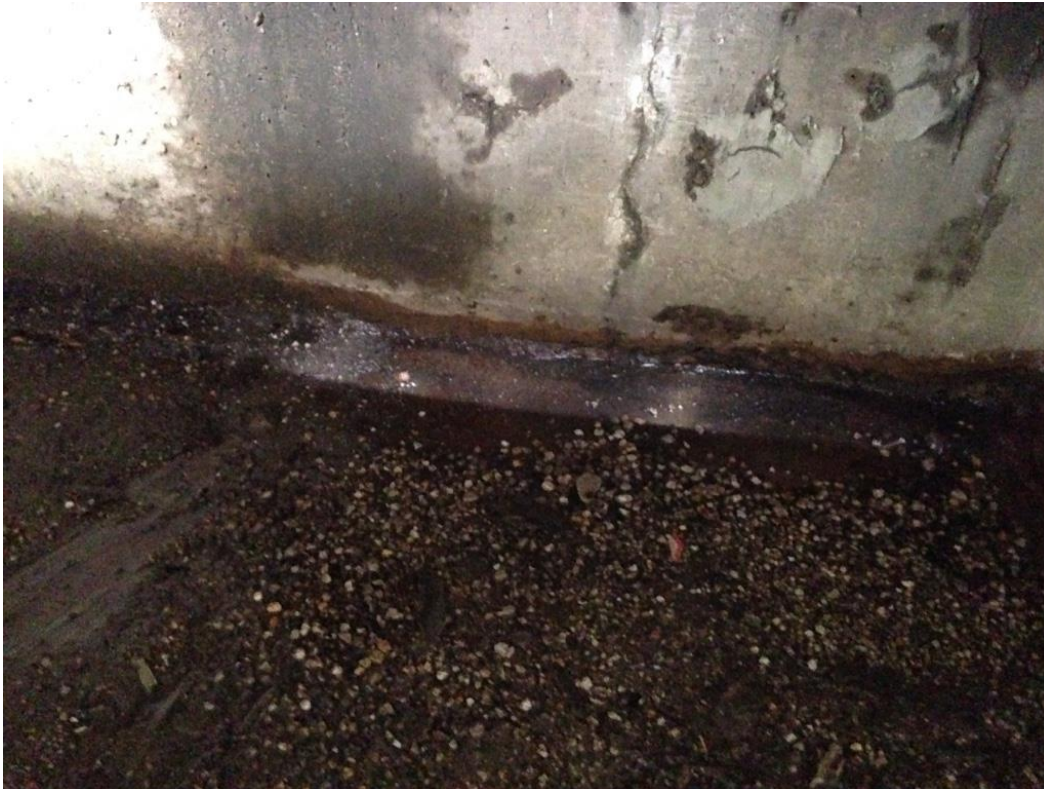
Photo 29: East abutment between girders 19 & 20 showing sediment deposit on abutment seat and light coming through from the top of deck due to missing joint section above.

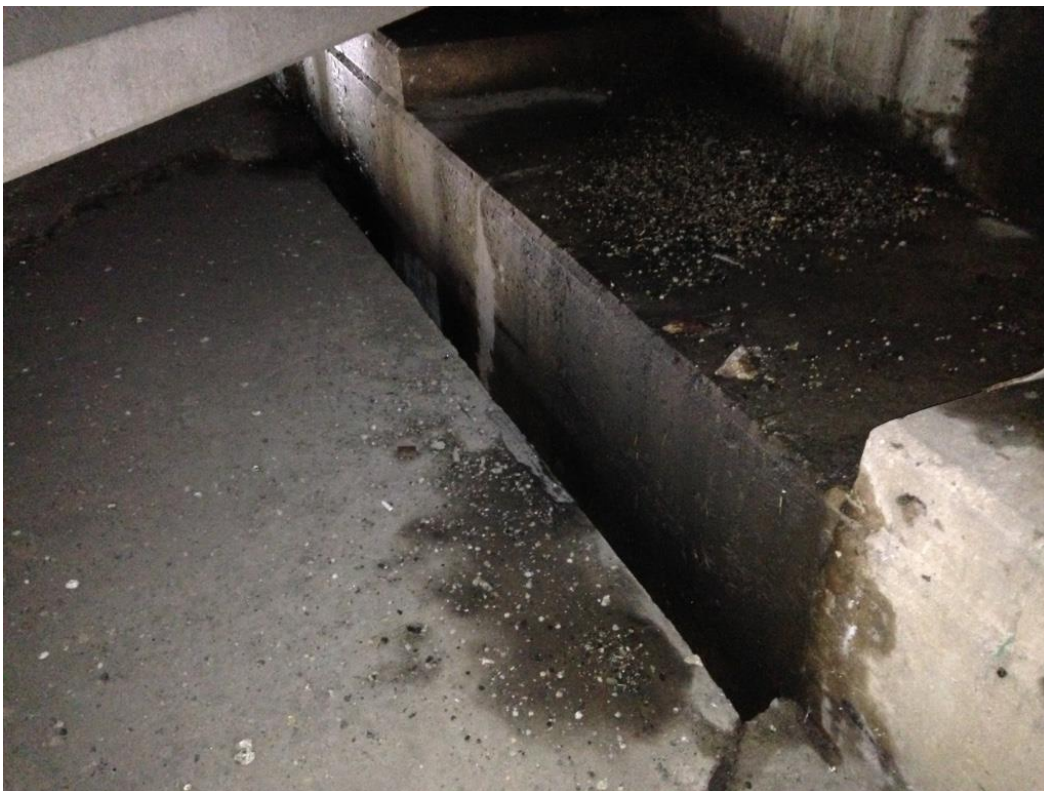
Photo 30: East abutment between girders 14 & 15 showing approximately 3.5 inch separation of slopewall from abutment seat.

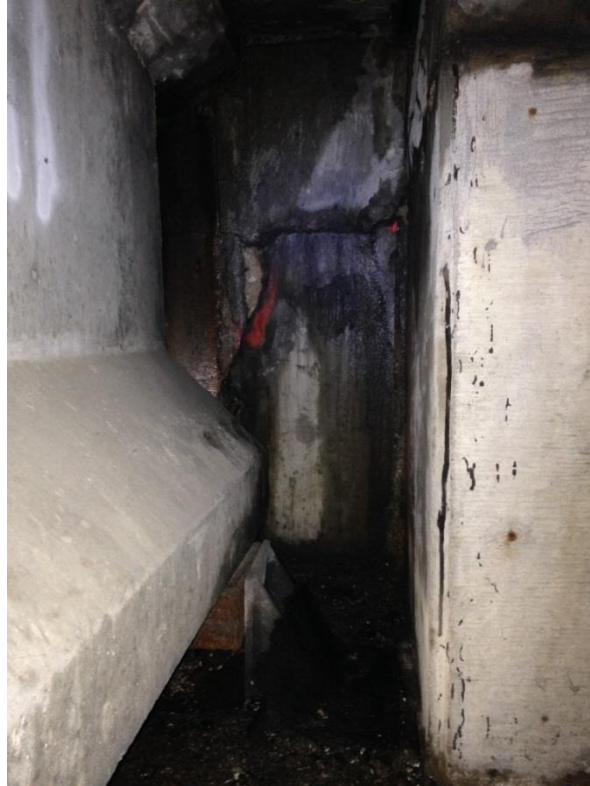
Photo 31: East abutment backwall at median joint showing water staining.

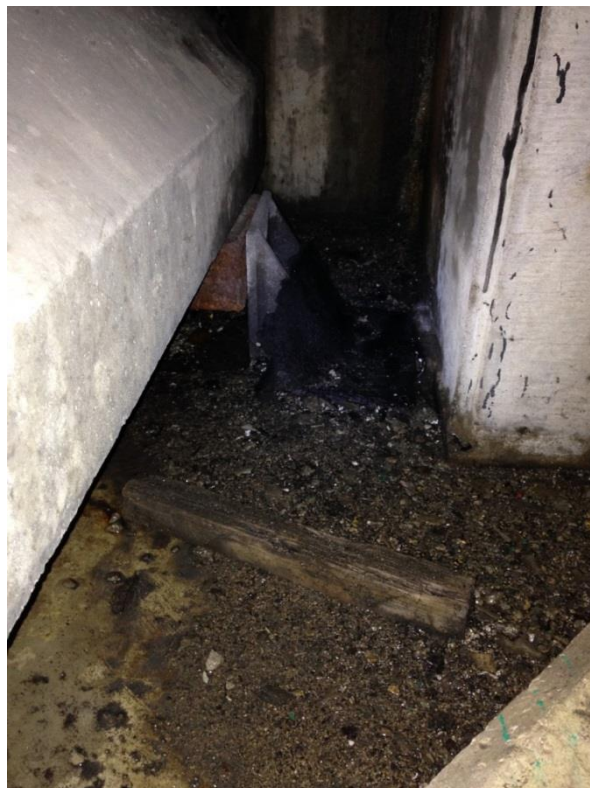
Photo 32: East abutment seat at median joint showing sediment build-up.

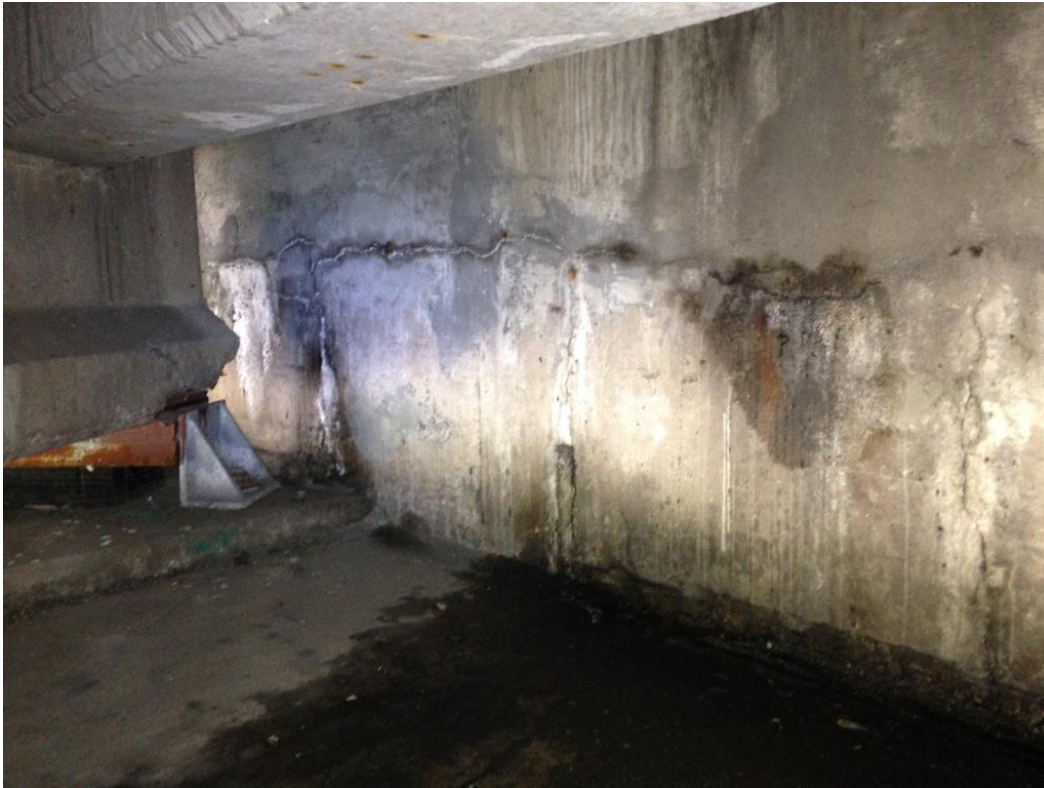
Photo 33: East abutment between girders 7 & 8 showing cold joint with efflorescence on backwall and water staining on abutment seat.

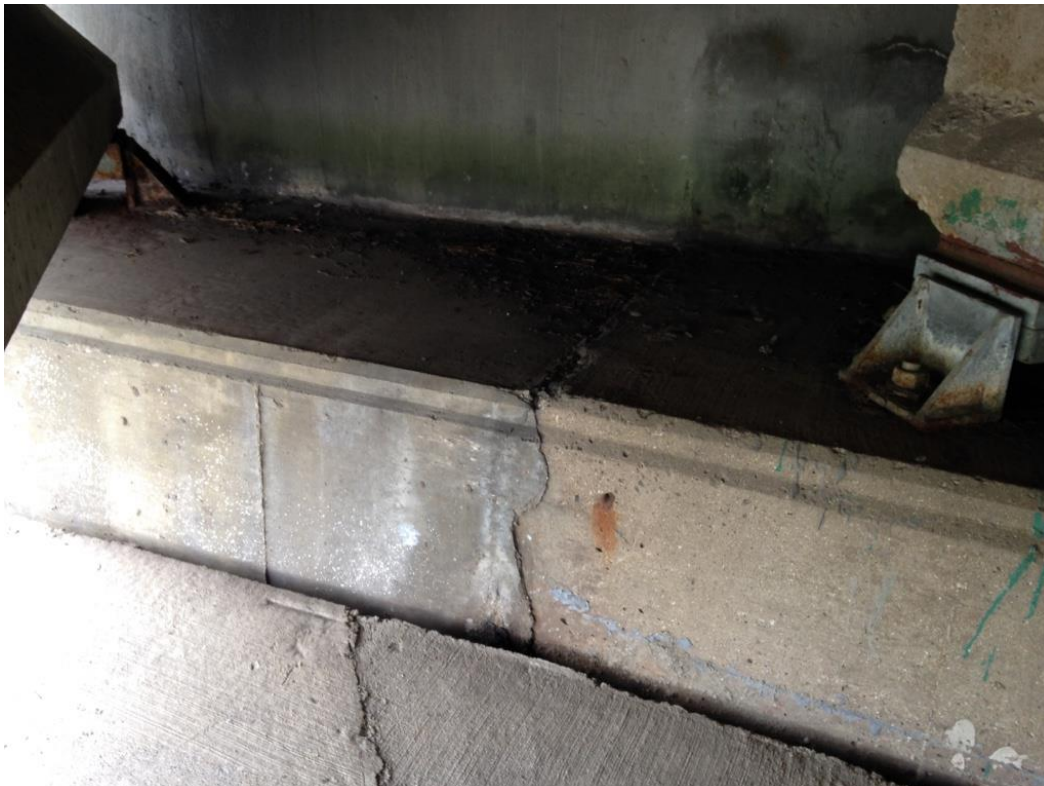
Photo 34: West abutment between girders 22 & 21 showing start of addition to abutment for widening.

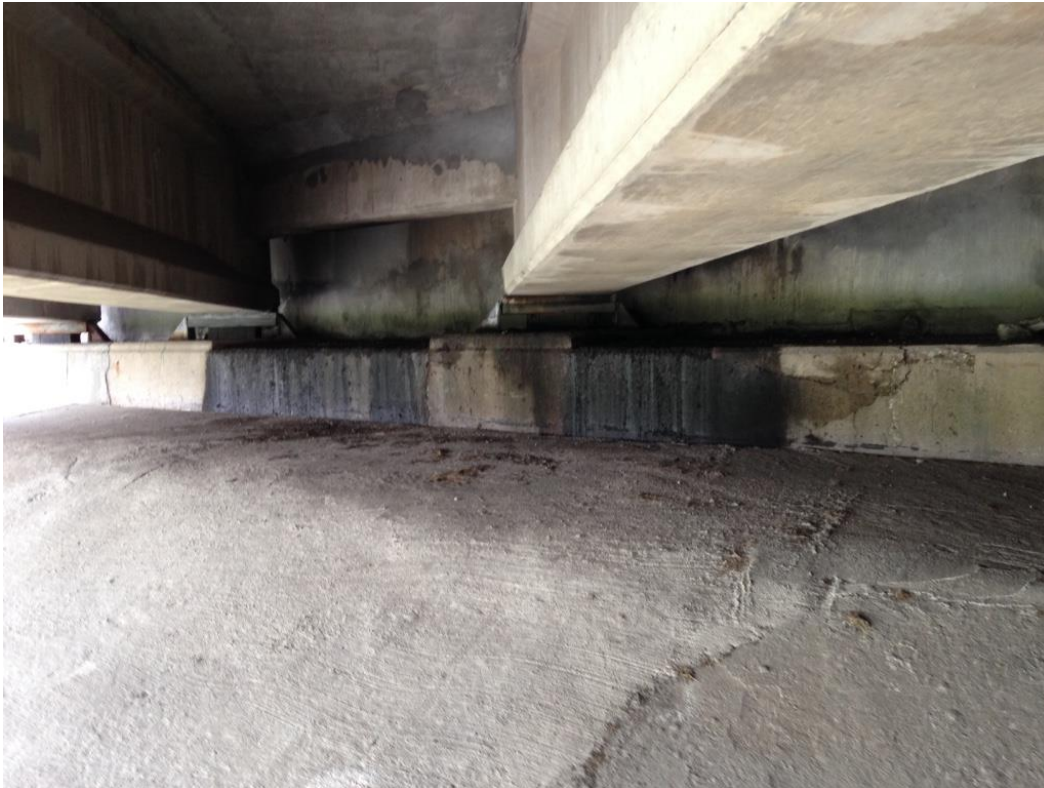
Photo 35: West abutment between girders 20 & 21 showing water staining on abutment seat.

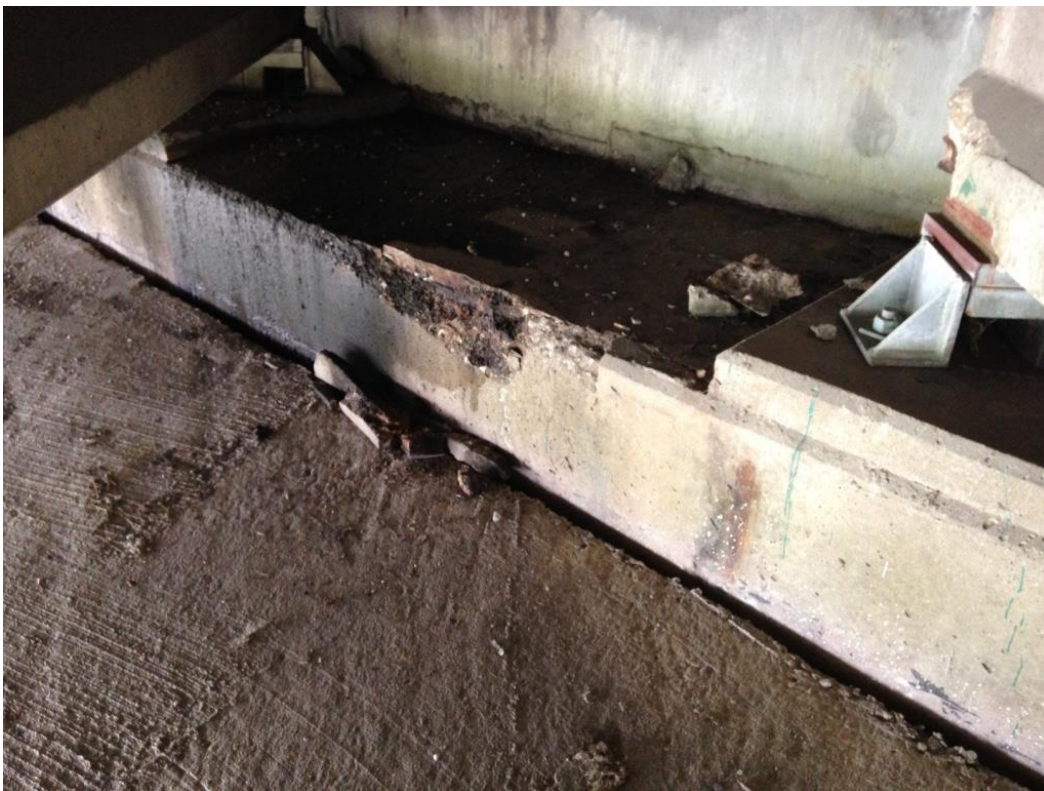
Photo 36: West abutment between 19 & 20 showing spalling with exposed and corroded reinforcement on abutment seat.

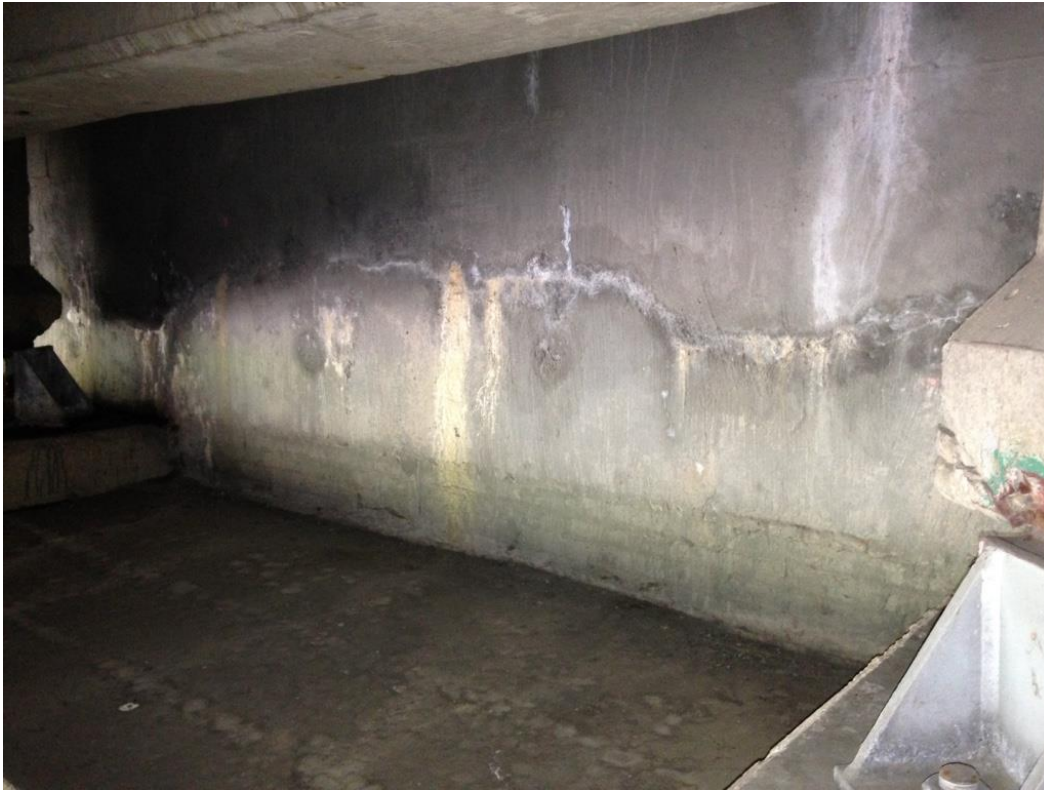
Photo 37: West abutment between girders 14 & 15 showing cold joint with efflorescence on backwall.

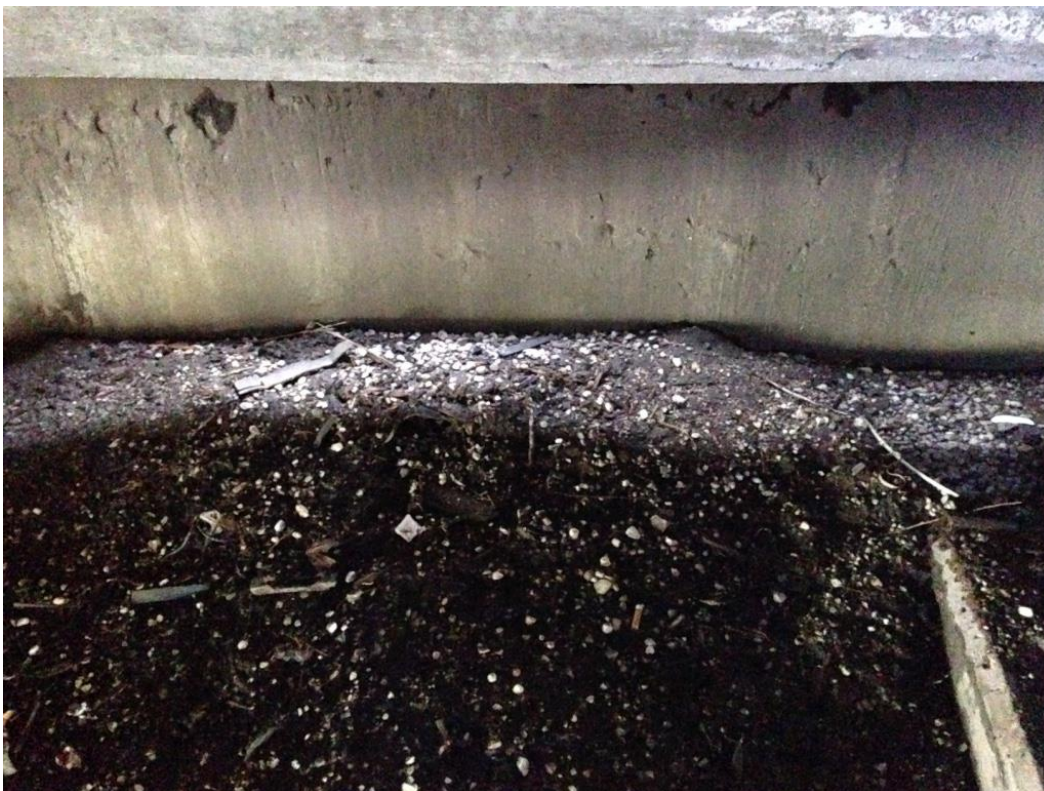
Photo 40: West abutment between girders 3 & 4 showing deposit of sediment and light coming through from top of deck due to missing joint section above.

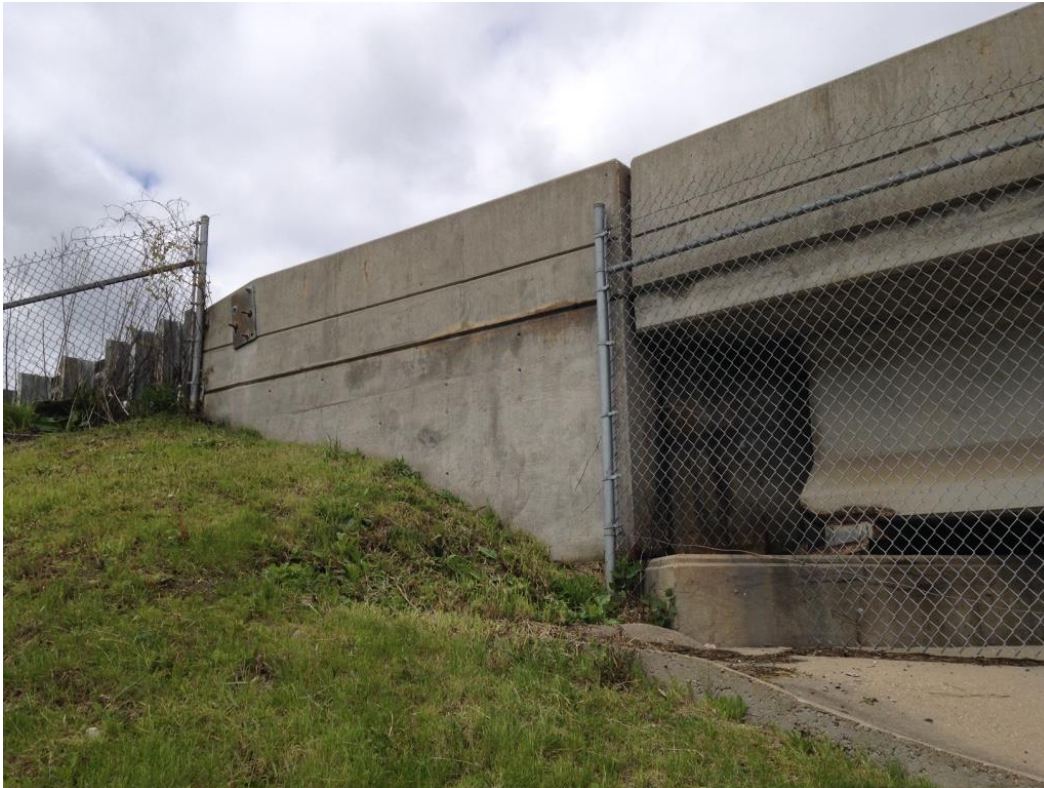
Photo 41: Southwest wingwall overall (typ.).

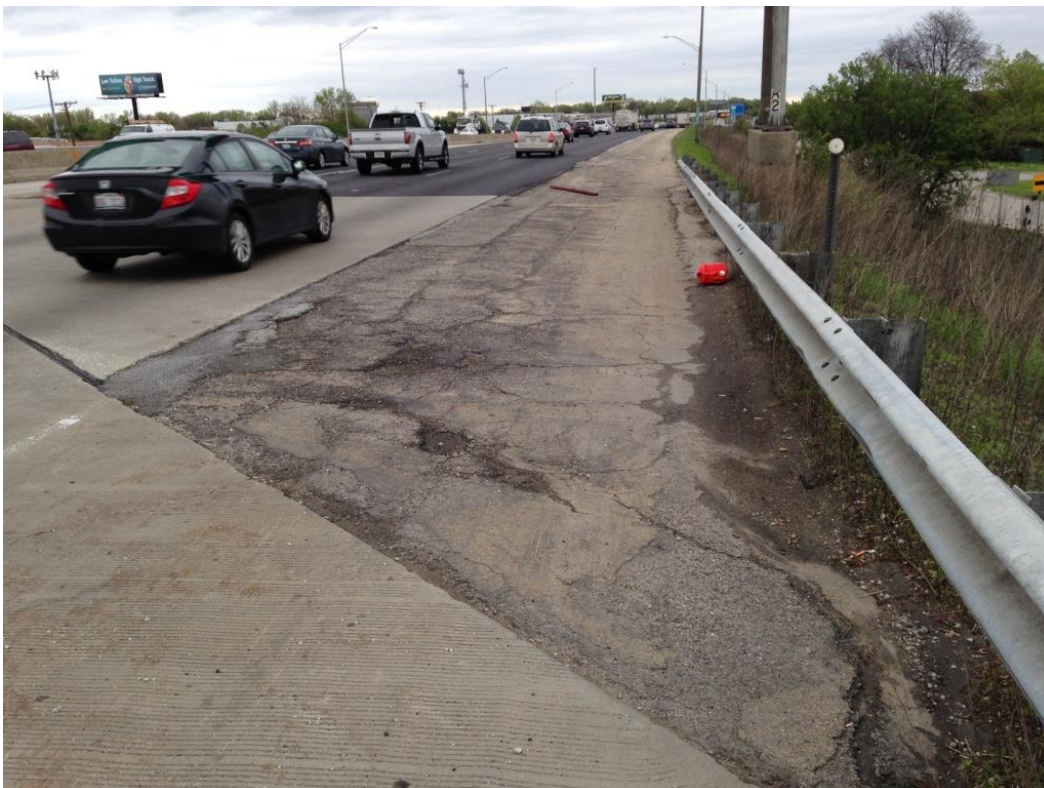
Photo 48: Top of deck looking east showing shoulder just beyond east approach slab showing significant cracking and potholes.

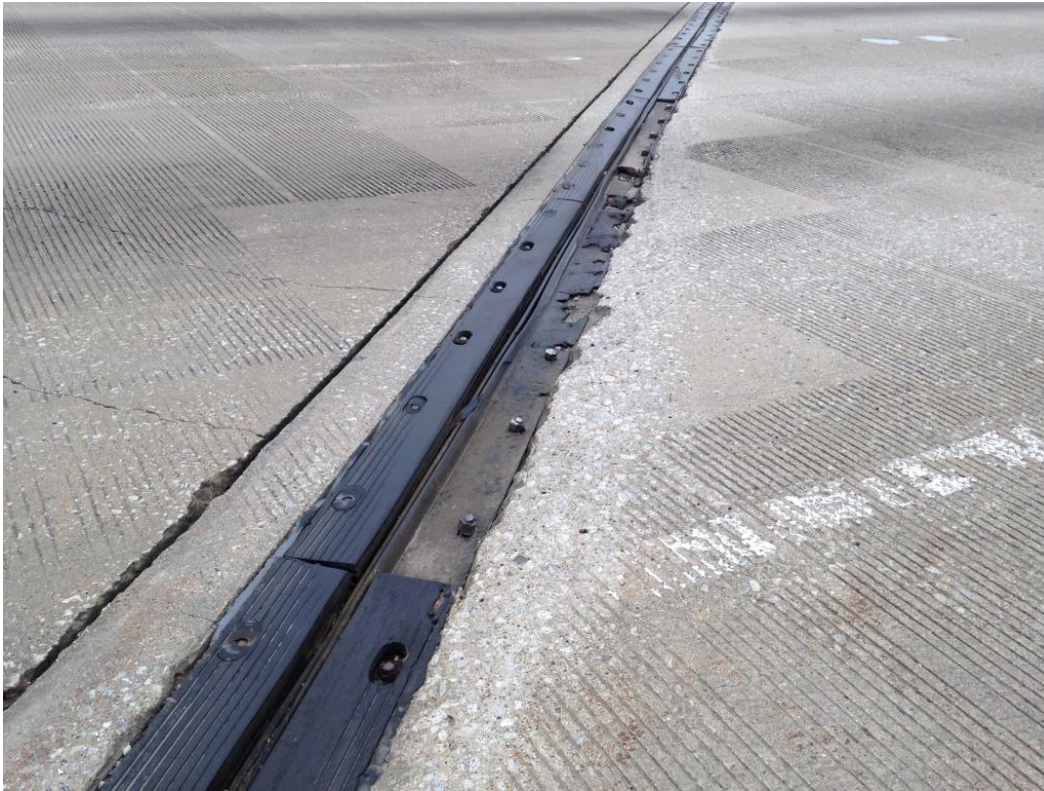
Photo 49: Transverse joint on the south west end of the bridge, looking north showing missing sections, exposed steel bolts, abrasion damage on bridge deck concrete and hairline cracking on approach slab.

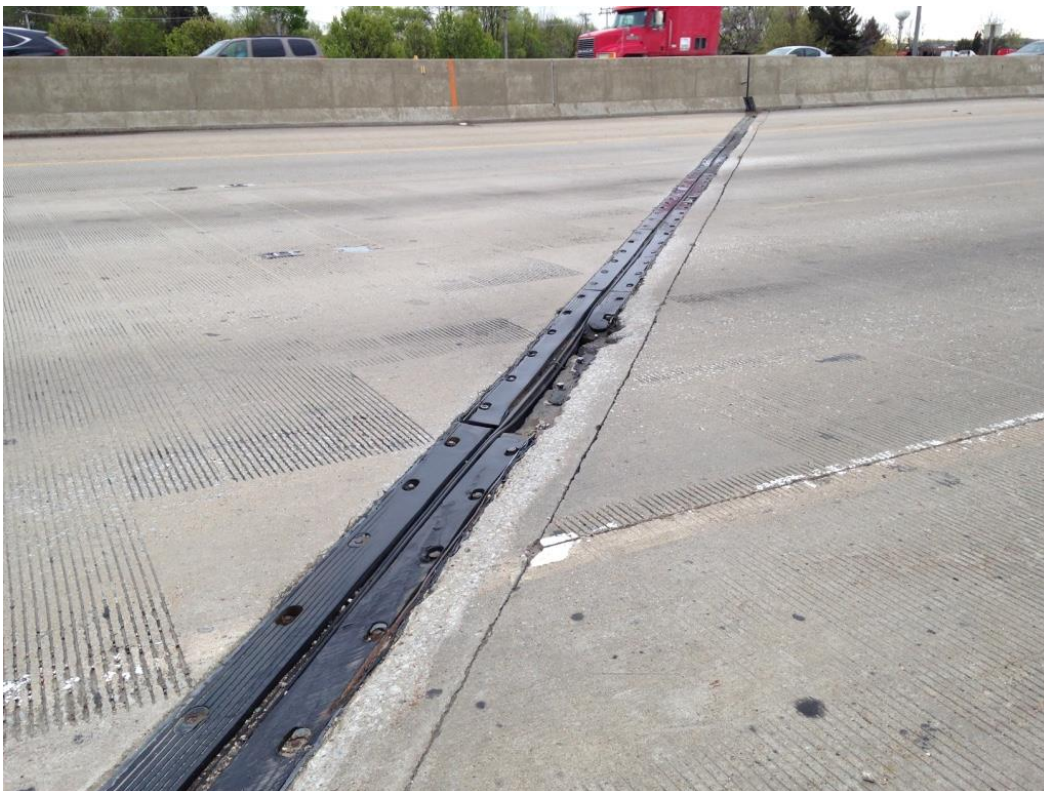
Photo 50: Transverse joint on north west end of bridge, looking south showing missing sections, exposed steel bolts, and abrasion damage to approach slab concrete.

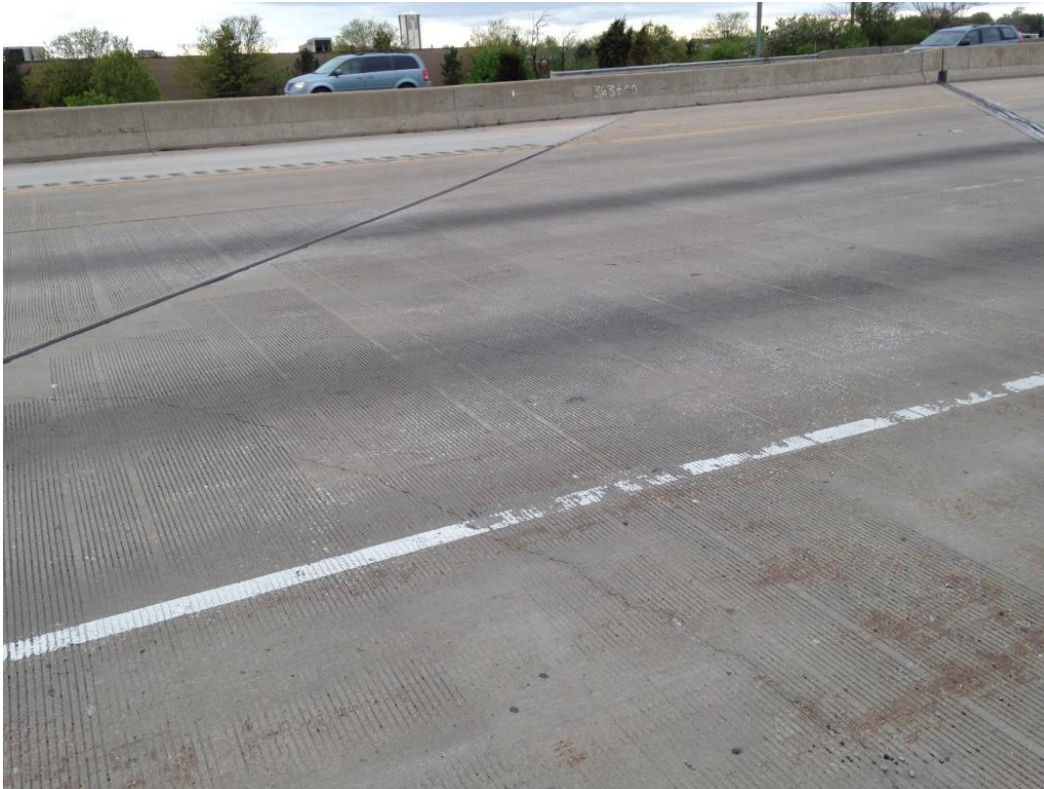
Photo 51: North west approach slab looking south showing hairline cracking.

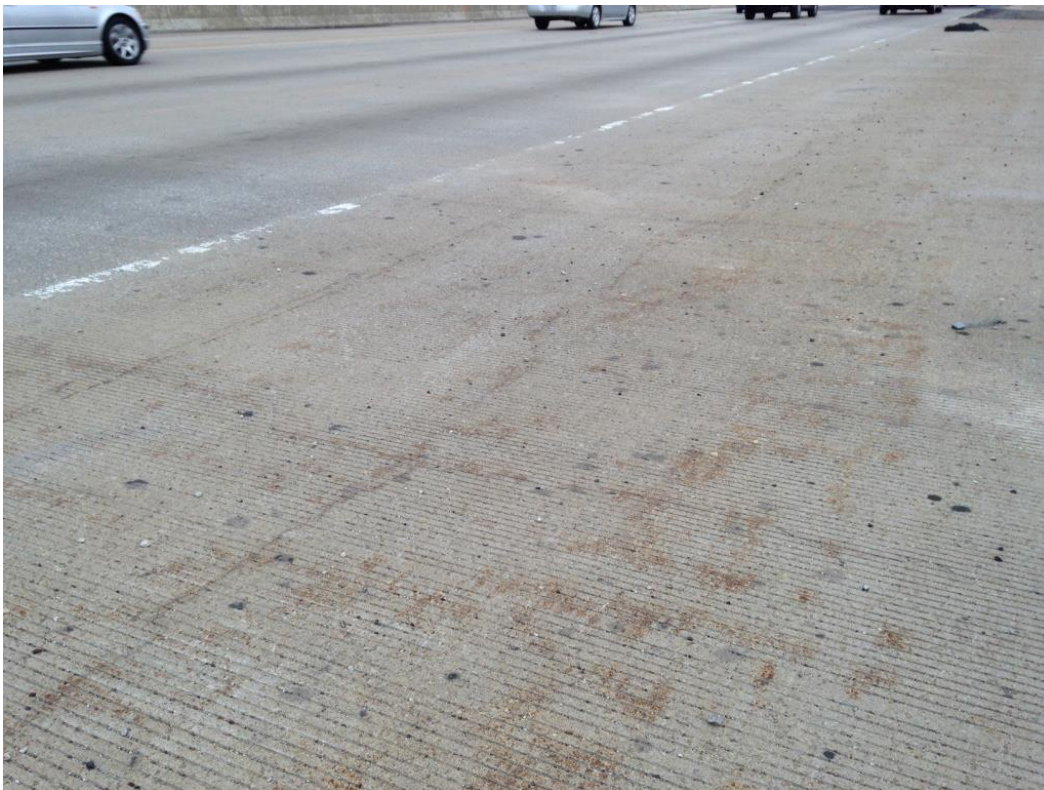
Photo 52: Top of deck on north end of bridge, looking west showing hairline longitudinal and transverse cracks on shoulder.

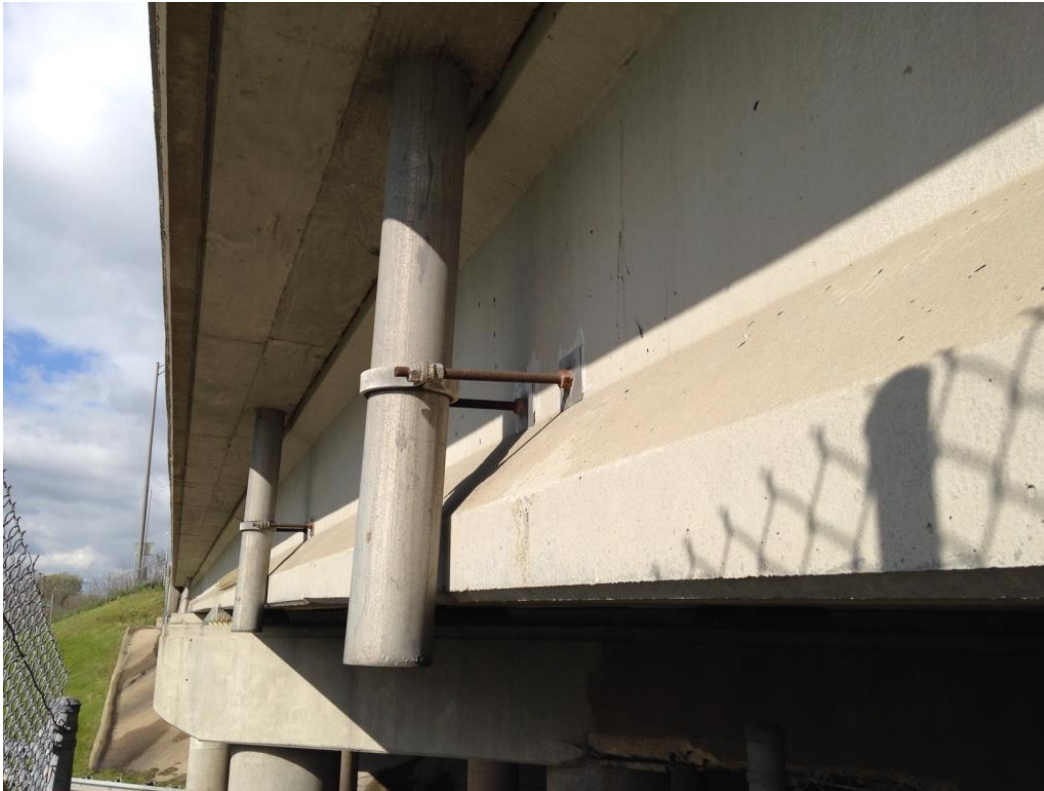
Photo 53: South end of bridge looking west showing deck drain down spouts.

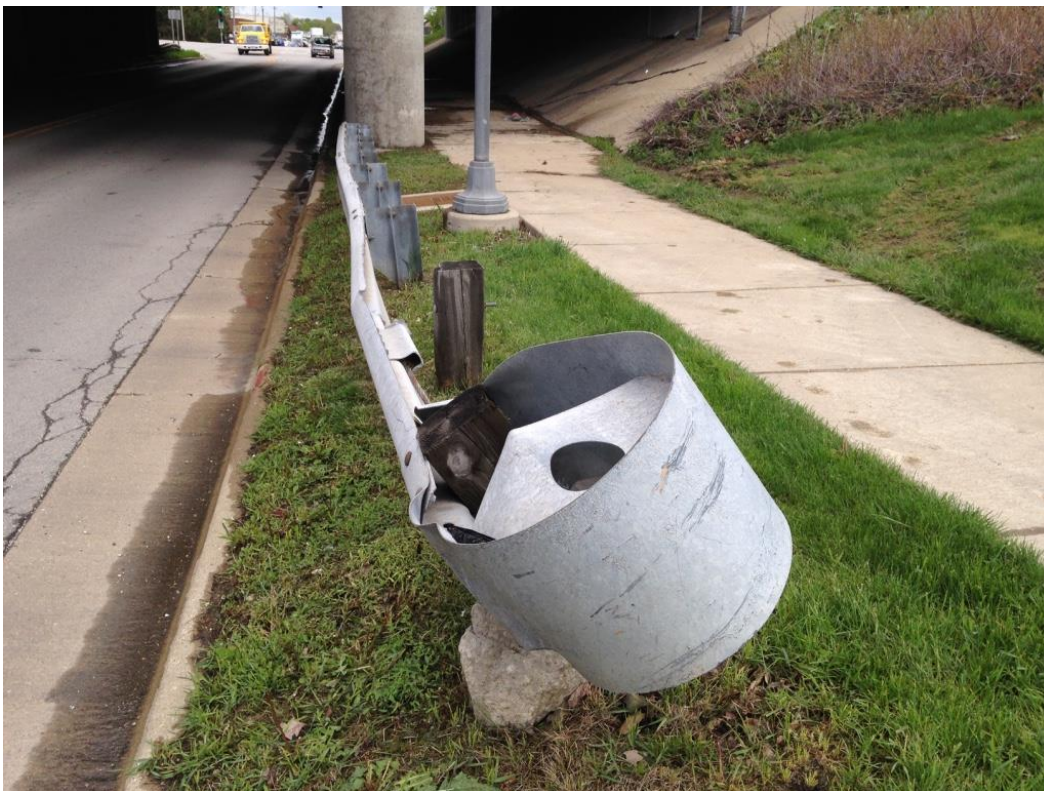
Photo 56: East approach guardrail on S Madison St. showing impact damage including detachment from first two wood posts.

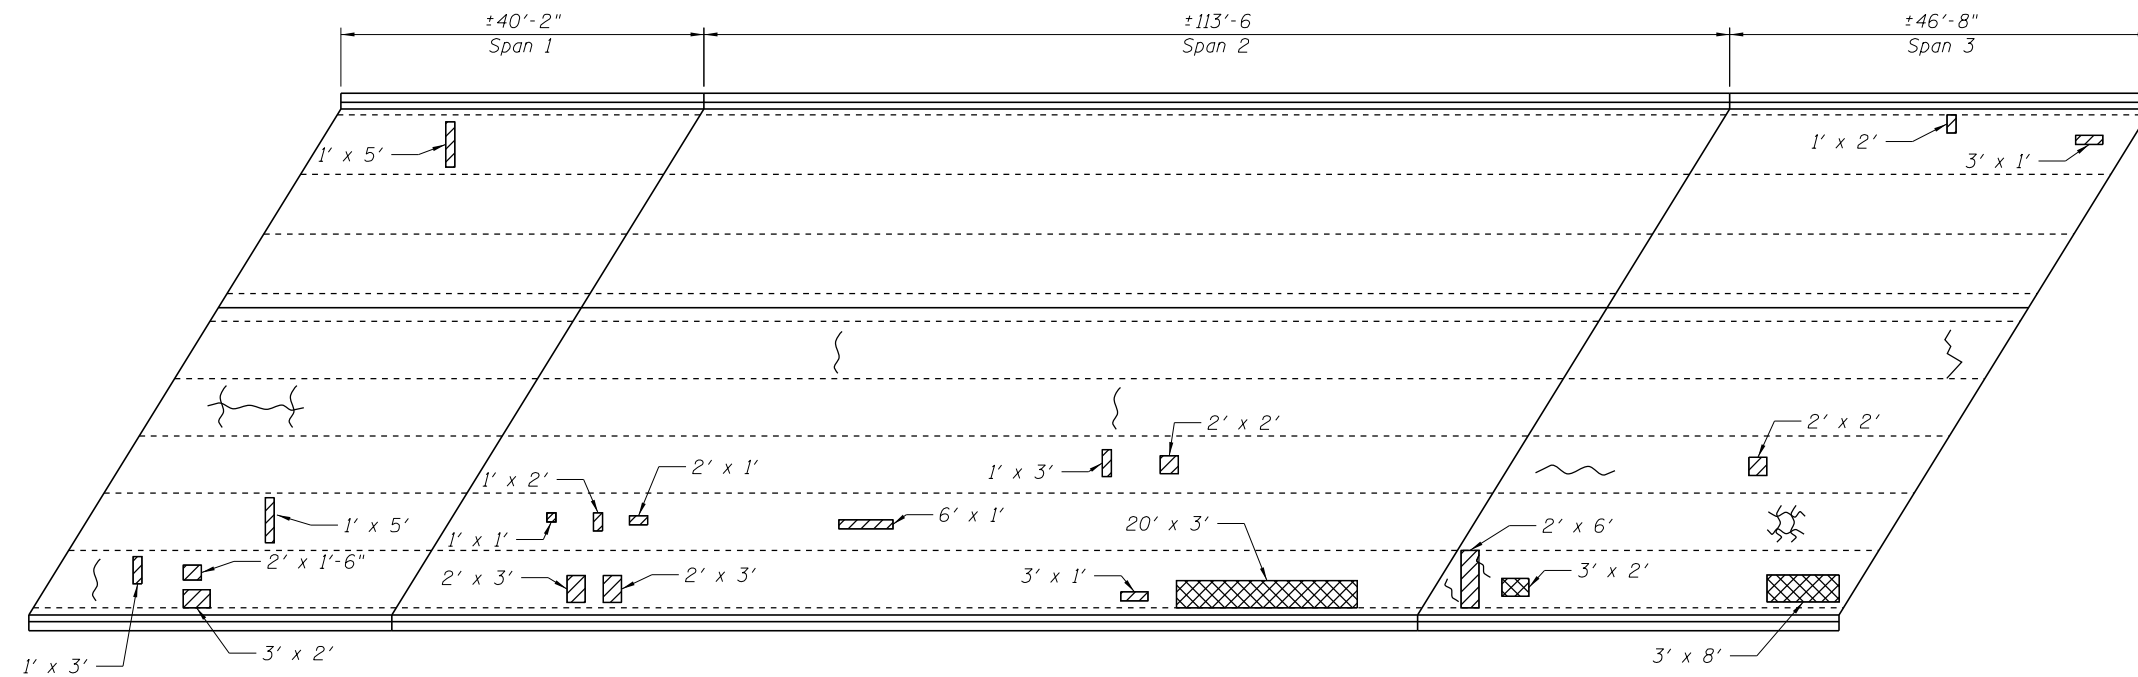
UNDERSIDE OF DECK
(Eastbound Bridge)

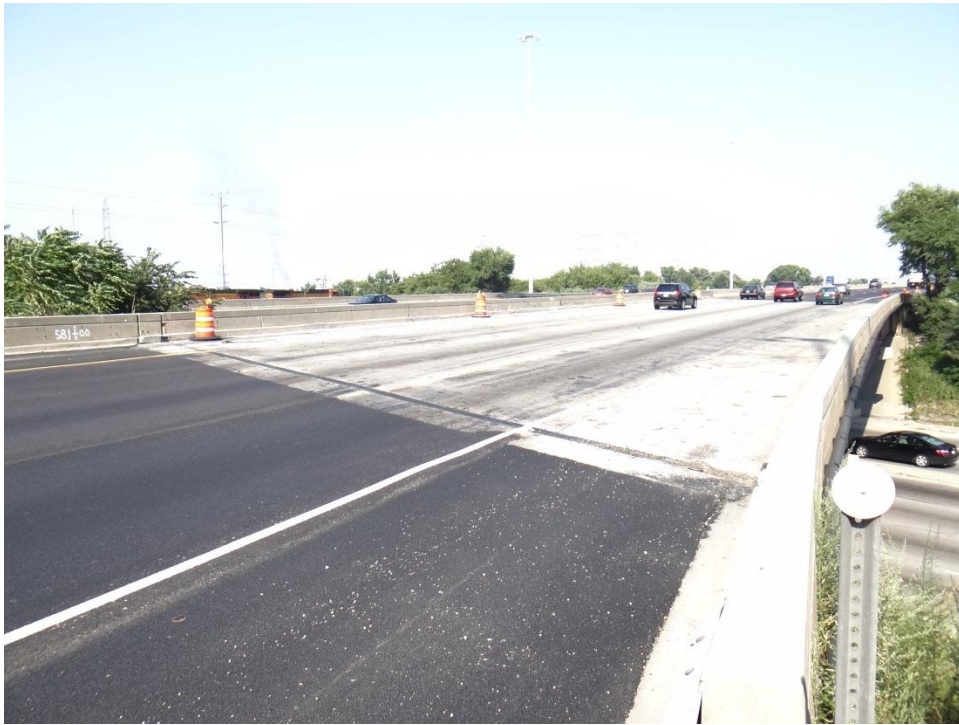
Figure 4. Typical view, deck top surface, looking northeast

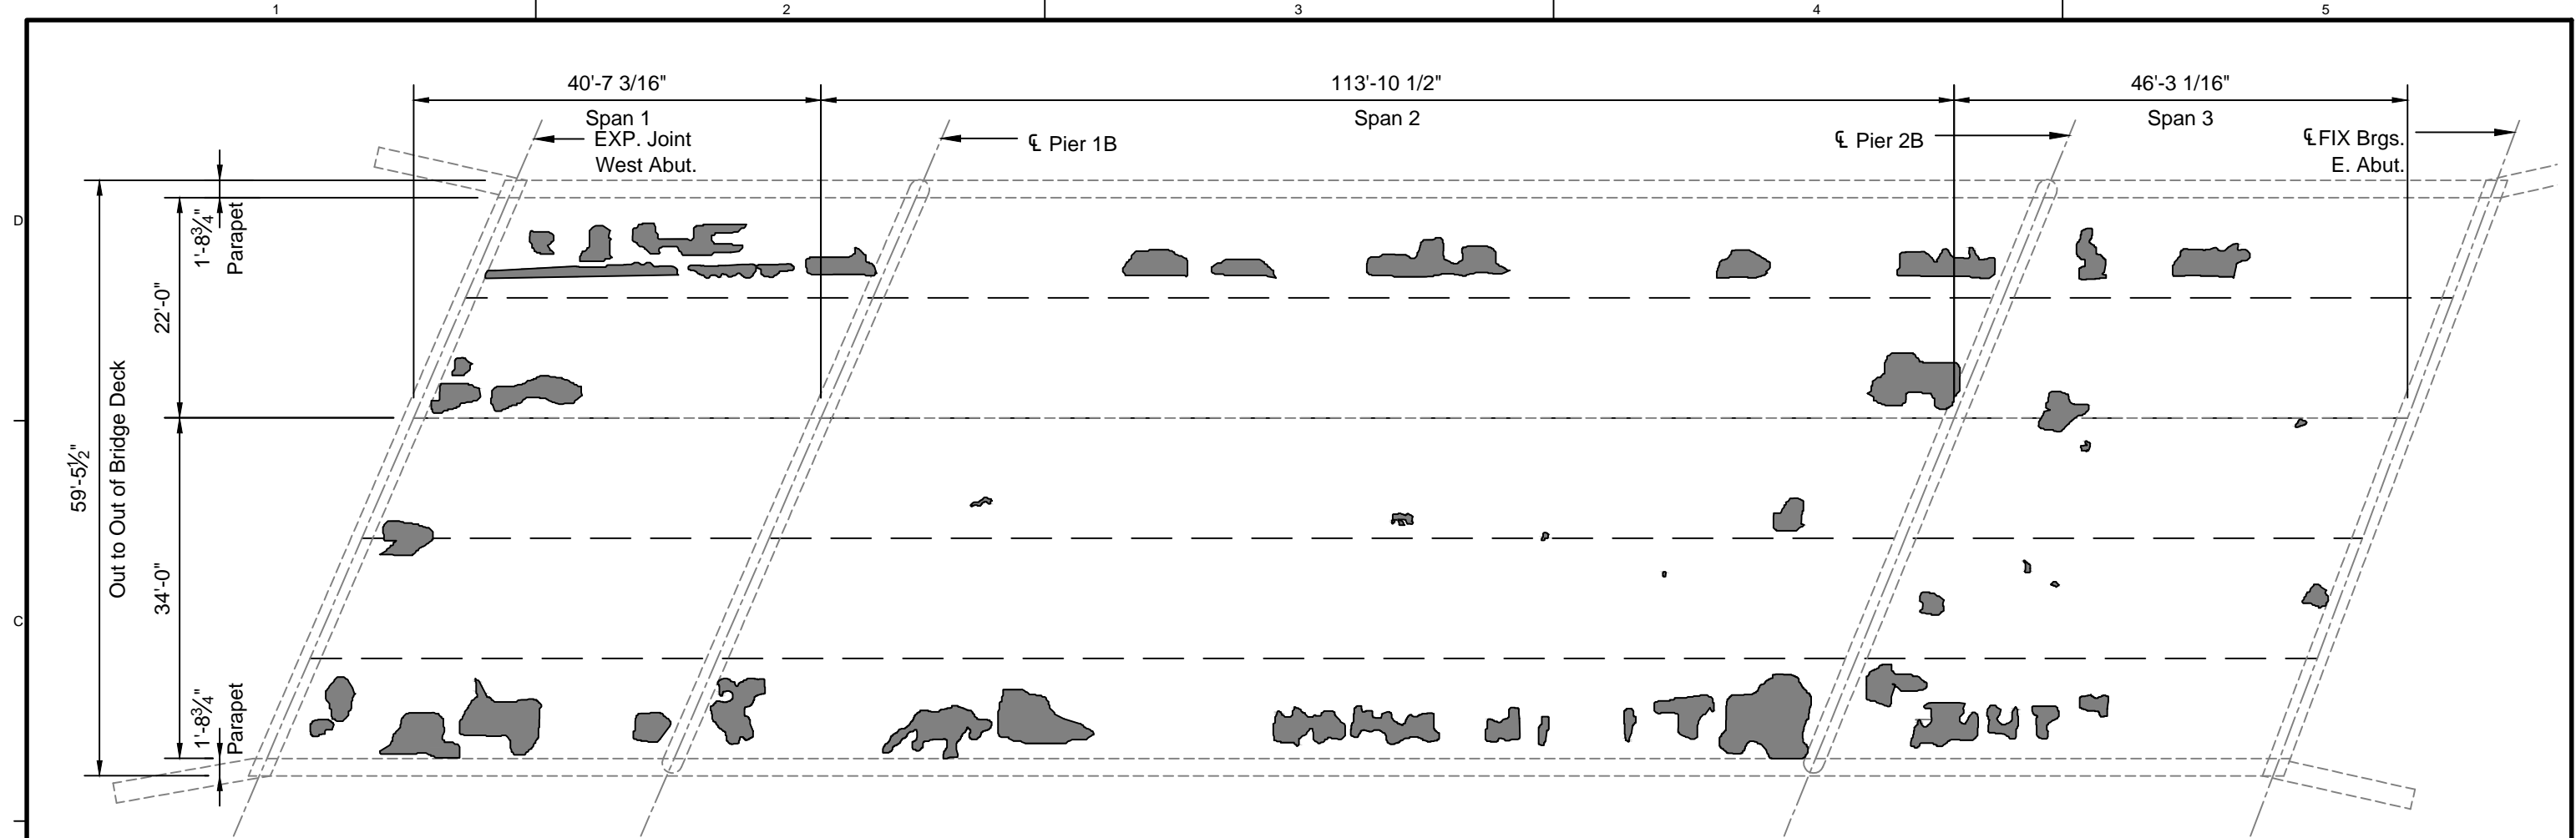
FIELD OBSERVATION SUMMARY		STRUCTURE # 016-0016		LEGEND	
ITEM	UNIT	QUANT.	%	DELAMINATION	
TOTAL AREA	Ac	10,900	100	SPALL	
DELAMINATION	Ac	615	5.6	CRACK	
SPALL	Ac	0	0		
CRACKS	ft	-	-

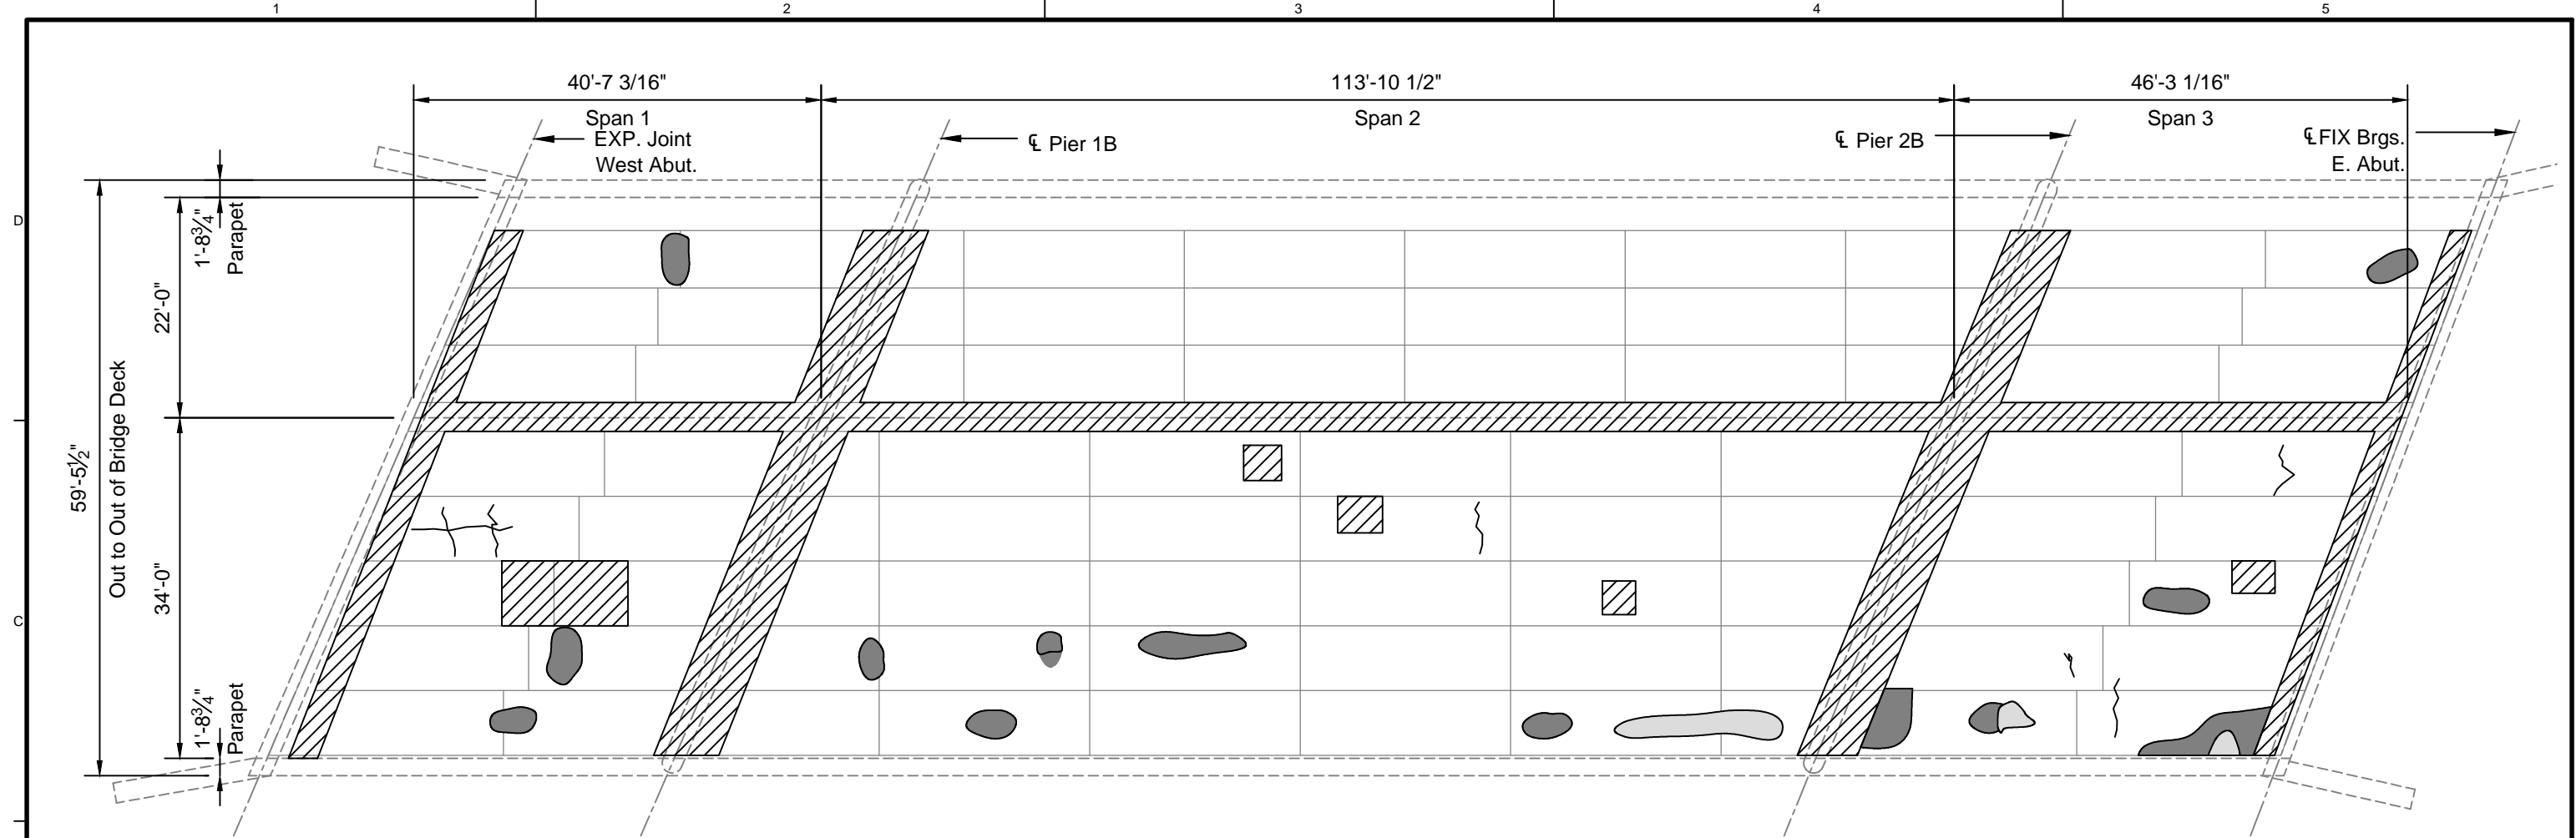
FIELD OBSERVATION SUMMARY		STRUCTURE # 016-0016		LEGEND	
ITEM	UNIT	QUANT.	%		
TOTAL AREA	Ac	10900	100	DELAMINATION	
DELAMINATION	Ac	180	1.7	SPALL	
SPALL	Ac	50	0.5	PREV. REPAIR	
PREVIOUS REPAIRS	Ac	1575	14.4	CRACK	
CRACKS	ft	-	-
