I-55 Managed Lanes Combined Design Report

Appendix A.3 – Structures

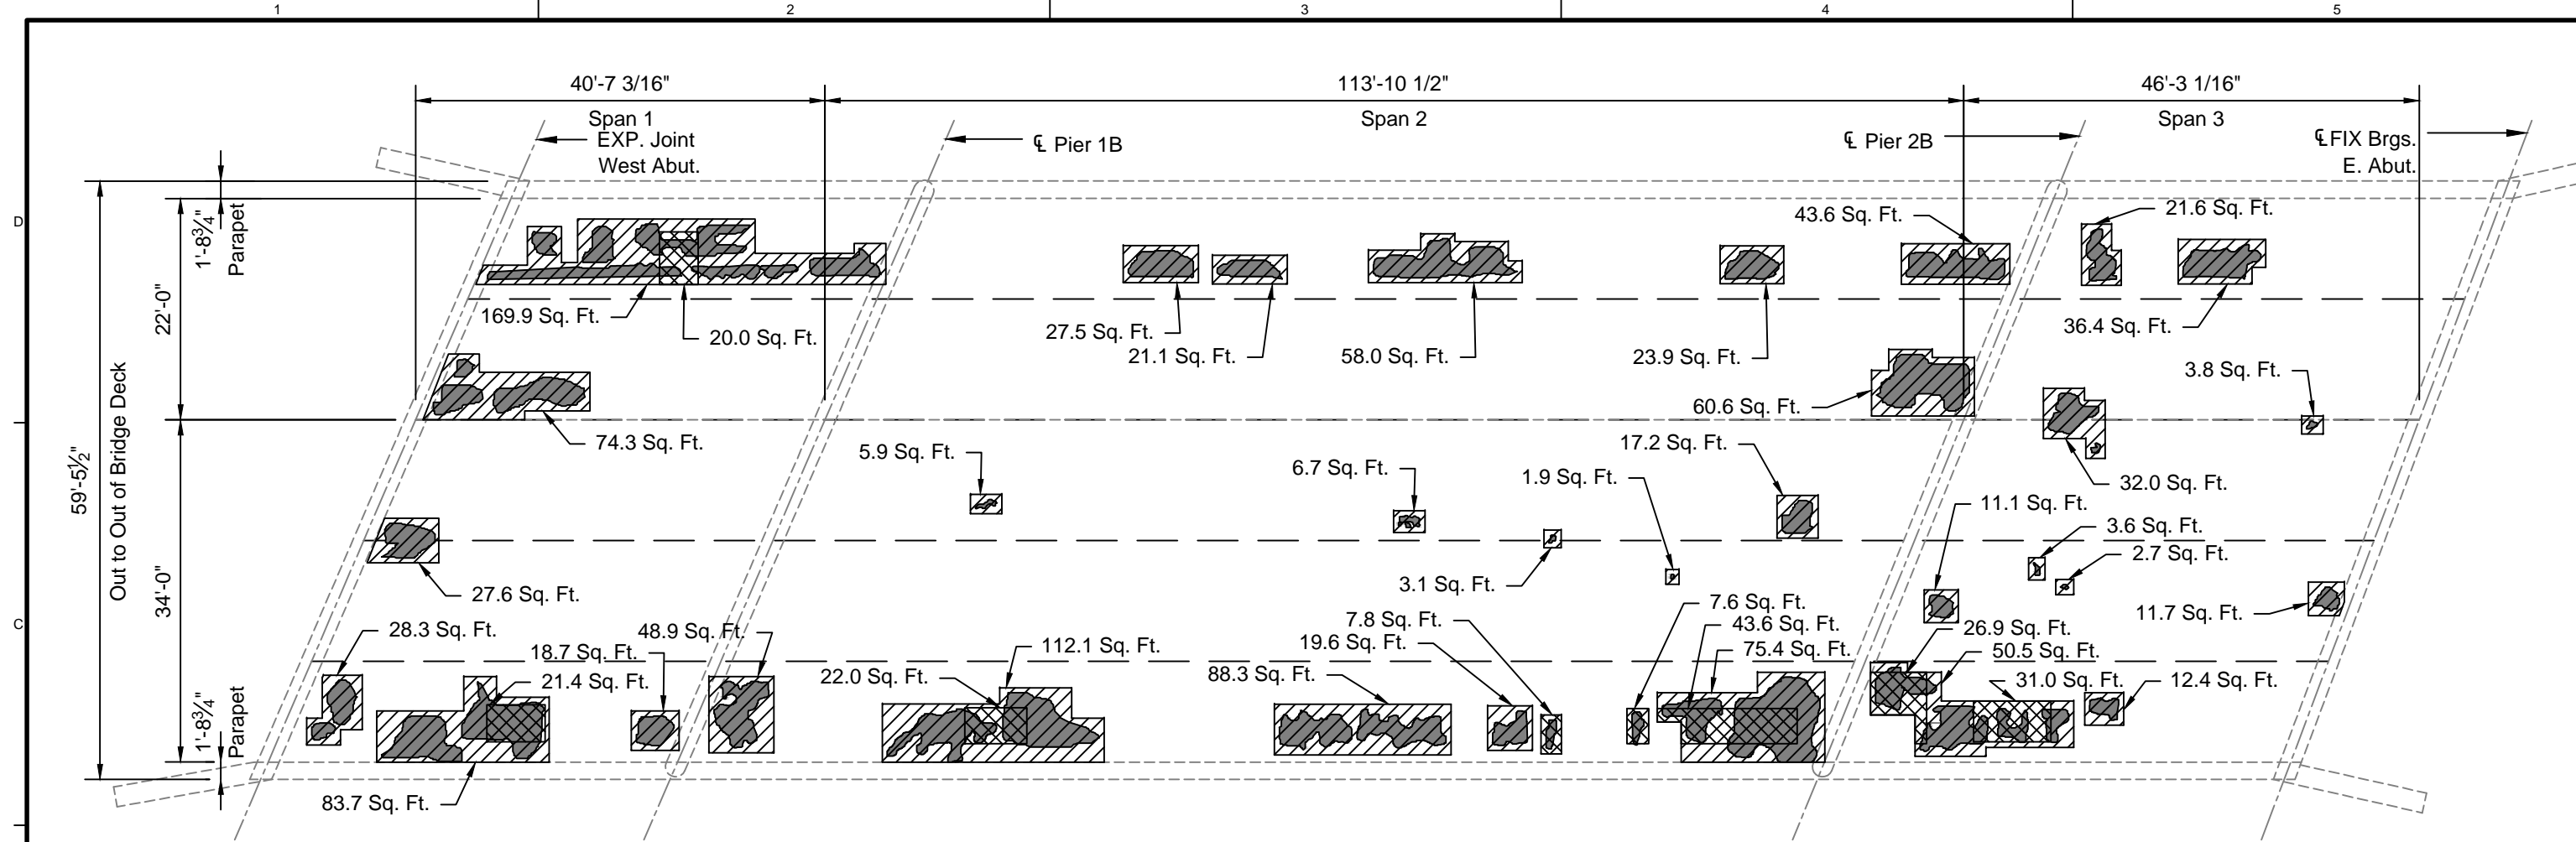
FIELD OBSERVATION SUMMARY		STRUCTURE # 016-0016		LEGEND	
ITEM	UNIT	QUANT.	%		
TOTAL AREA	Ac	10900	100	PARTIAL DEPTH REPAIR	
PARTIAL DEPTH REPAIR	Ac	1202	11.0	FULL DEPTH REPAIR	
FULL DEPTH REPAIR	Ac	180	1.7	DELAMINATION	
DELAMINATION	Ac	615	5.6	SPALL	
SPALL	Ac	0	0	CRACK	
CRACKS	ft	-	-

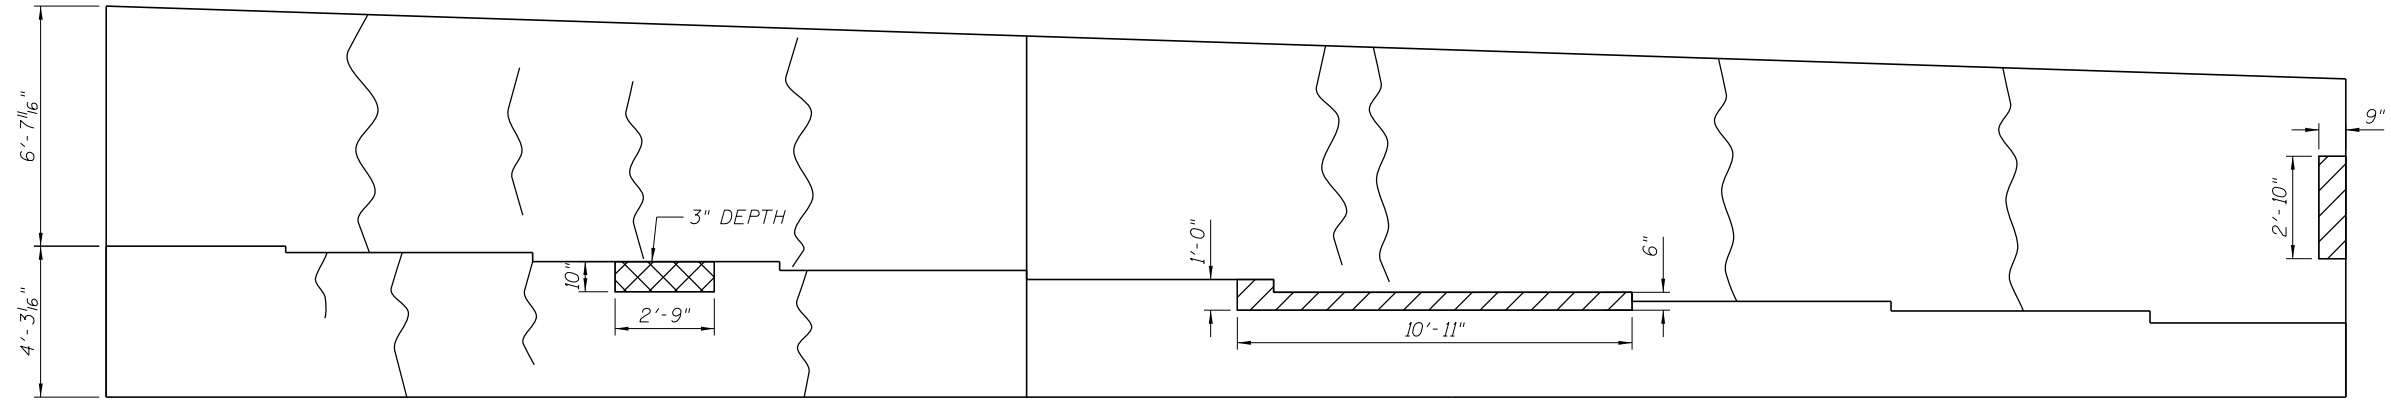
EAST ABUTMENT
LOOKING EAST

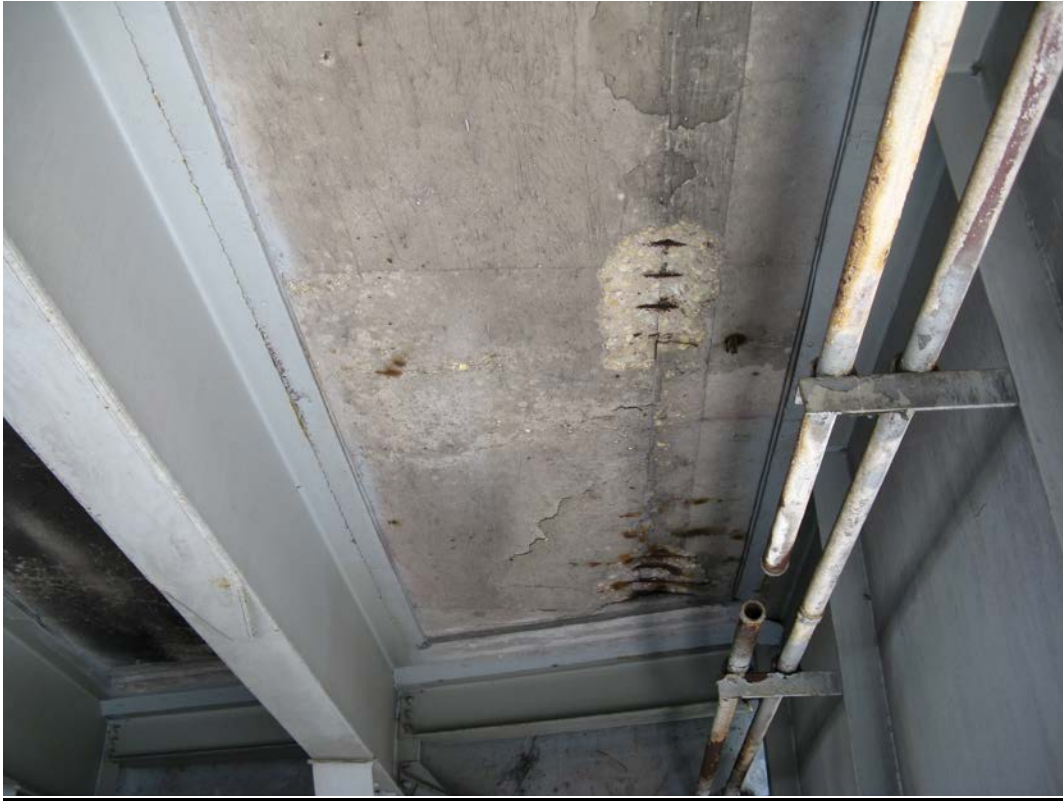
Photo 1 - Spalls on underside of deck in Span 3 between Beams 9-10 from north, east end, looking east

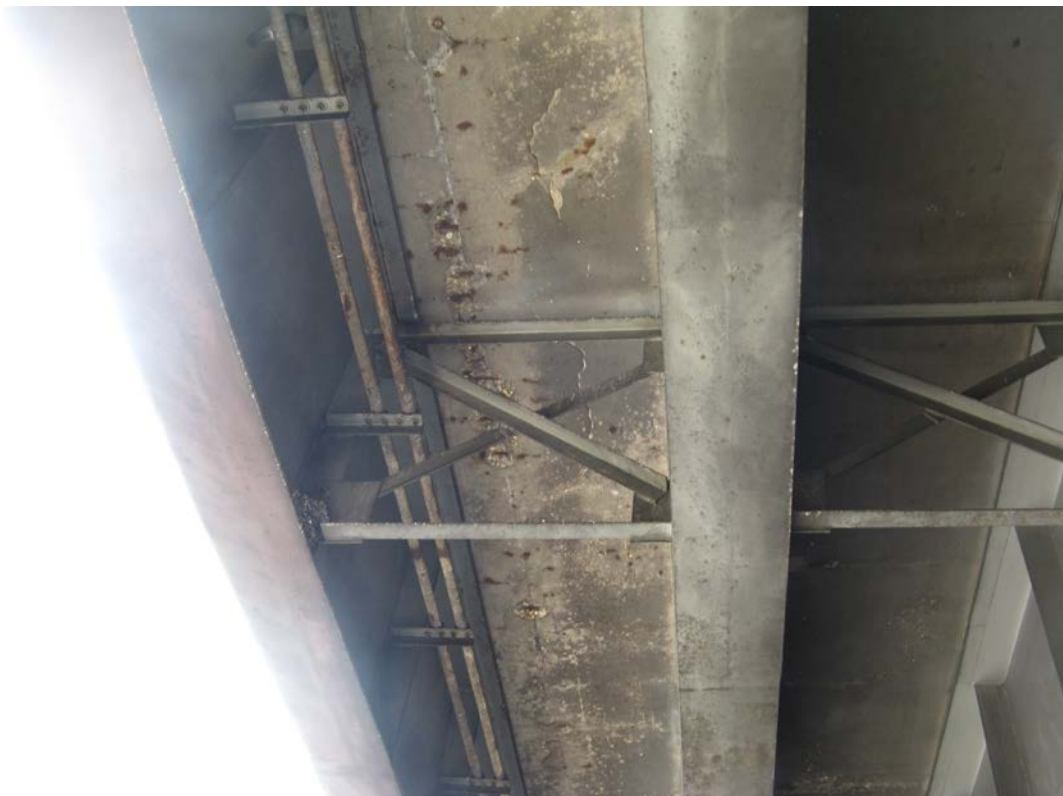
Photo 2 - Spalls on underside of deck in Span 2 between Beams 9-10 from north, east end, looking west

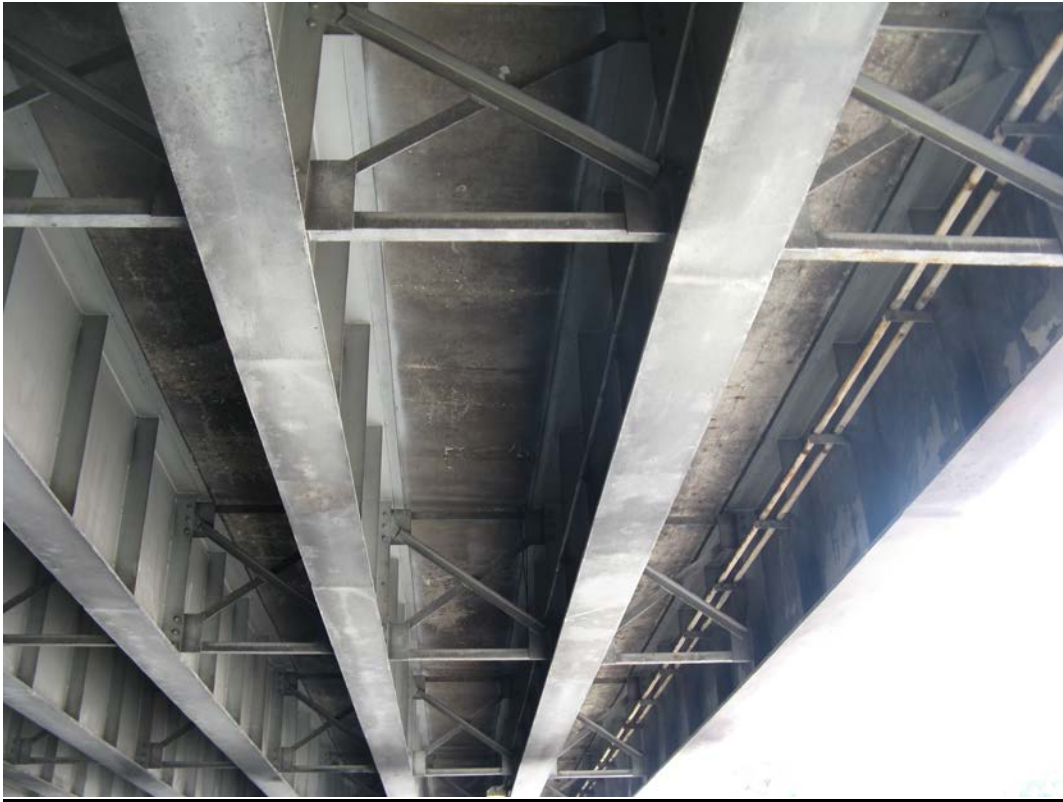
Photo 3 - Underside of Span 2, south end, looking east

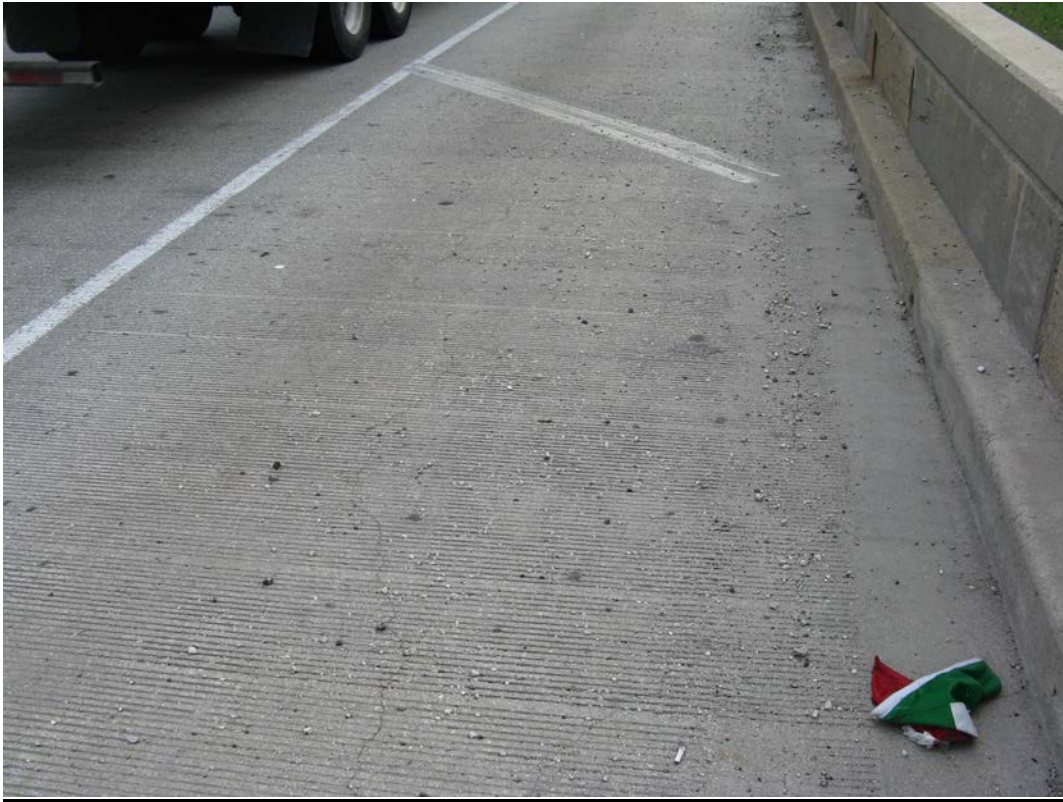
Photo 7 - Cracking in shoulder, Span 3, looking east

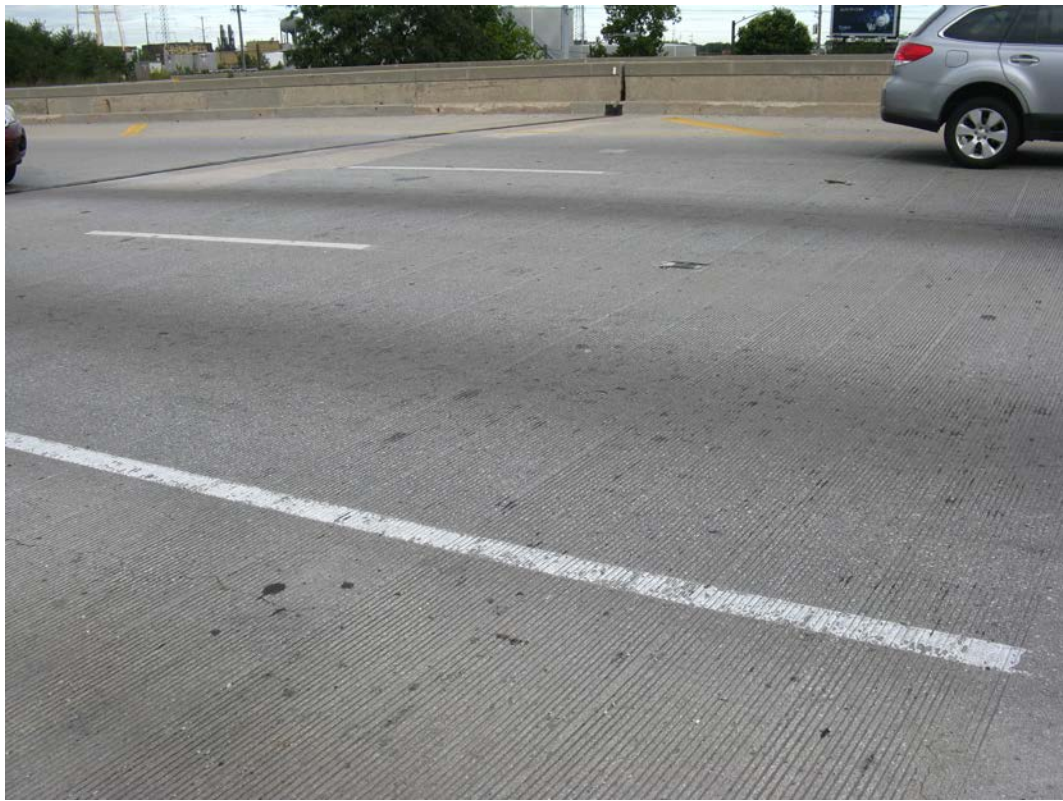
Photo 8 Span 3, looking northwest

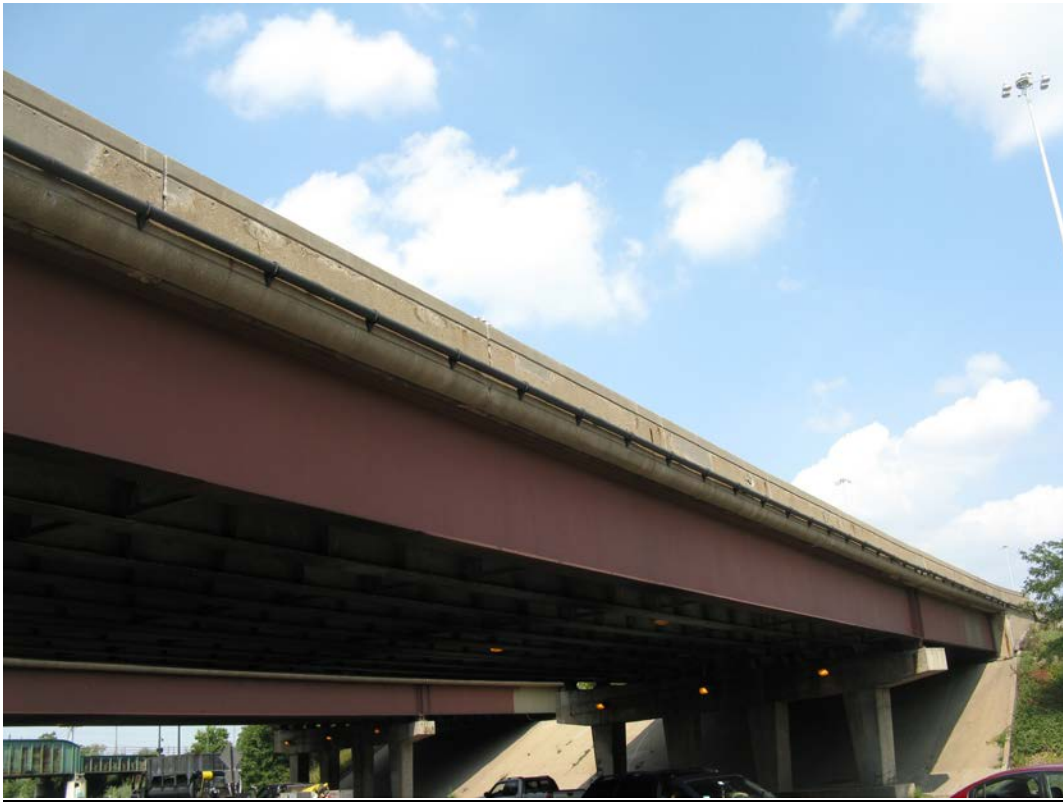
Photo 9 - Outside of South Parapet with minor rust stains, cracking, and minor spalling, looking northeast

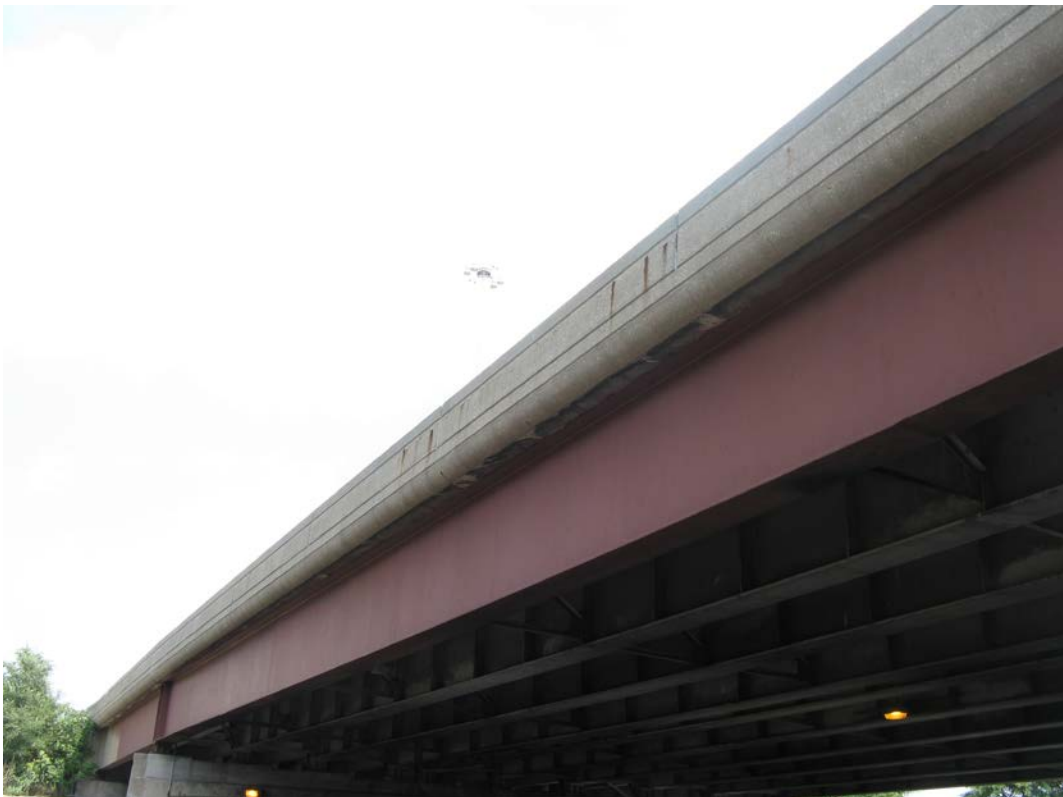
Photo 10 - Outside of North Parapet with minor rust stains and cracking, looking southeast

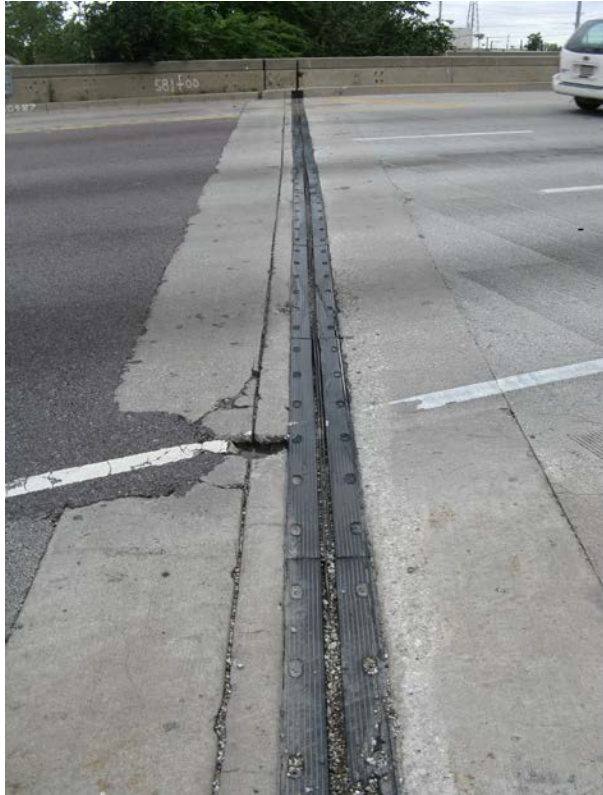
Photo 11 - West Abutment joint, looking north

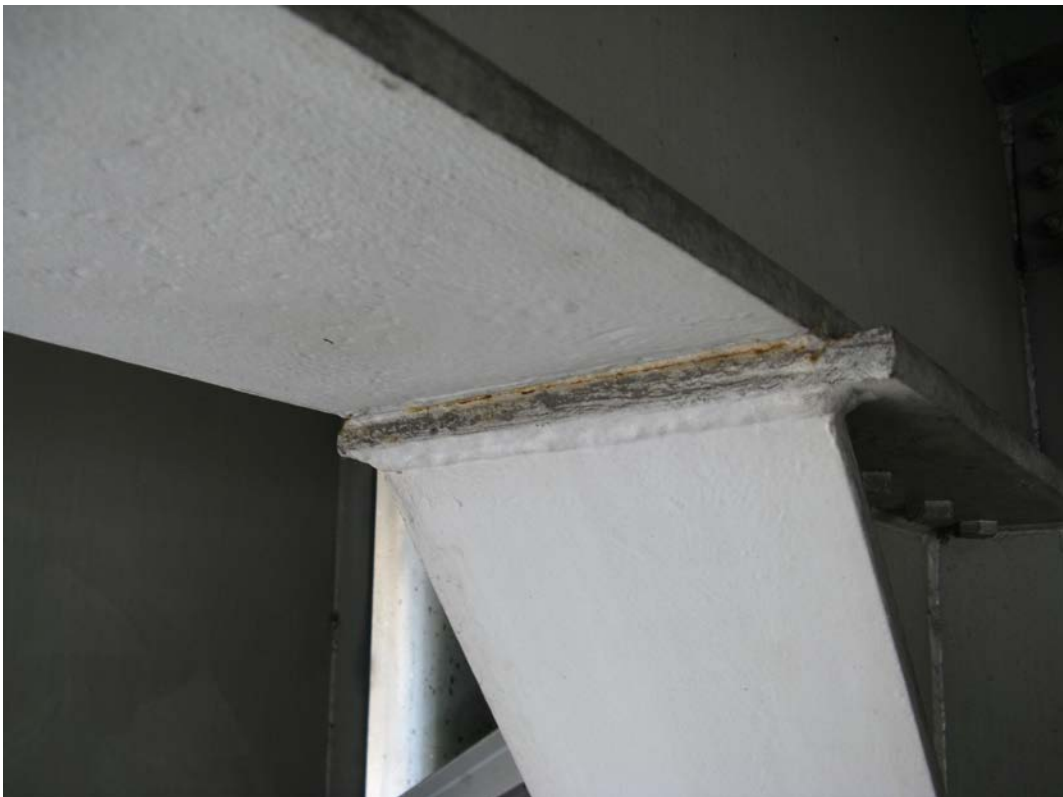
Photo 16 - Typical cracked weld between bottom flange of beam in east span and built up steel bolster, looking northeast (Beam 2 from north at East Abutment)

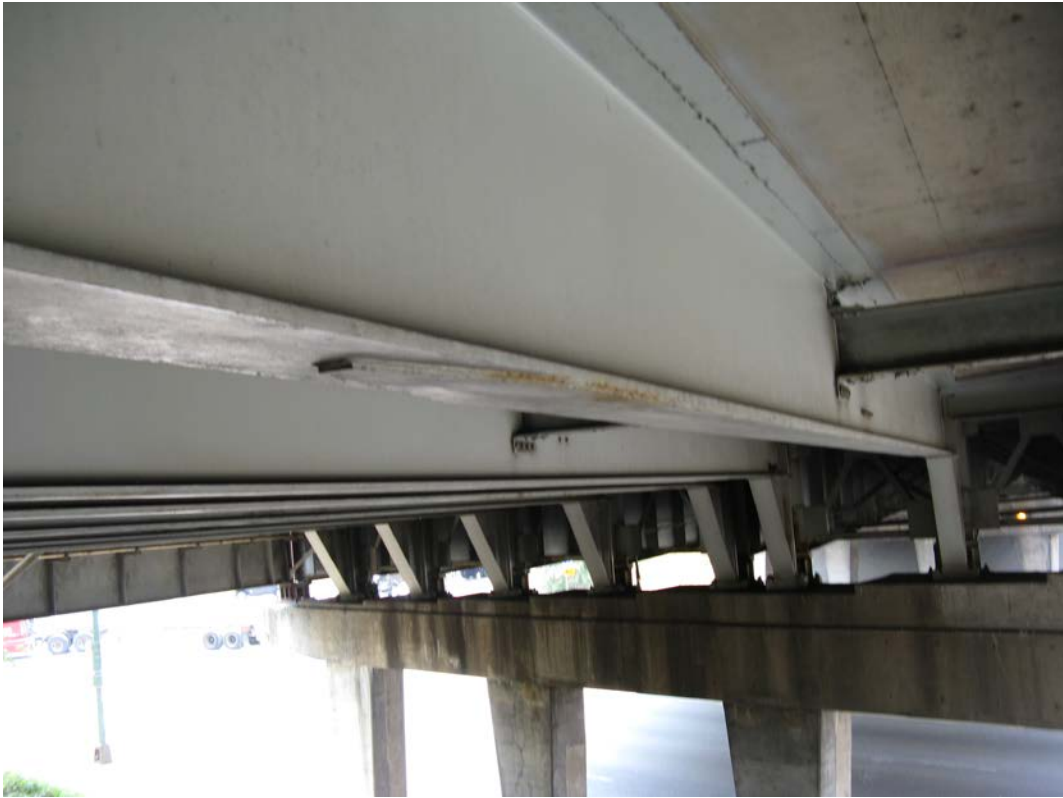
Photo 17 - Typical cover plates on bottom on beams in east span, looking southwest (Beam 3 from north, Span 3)

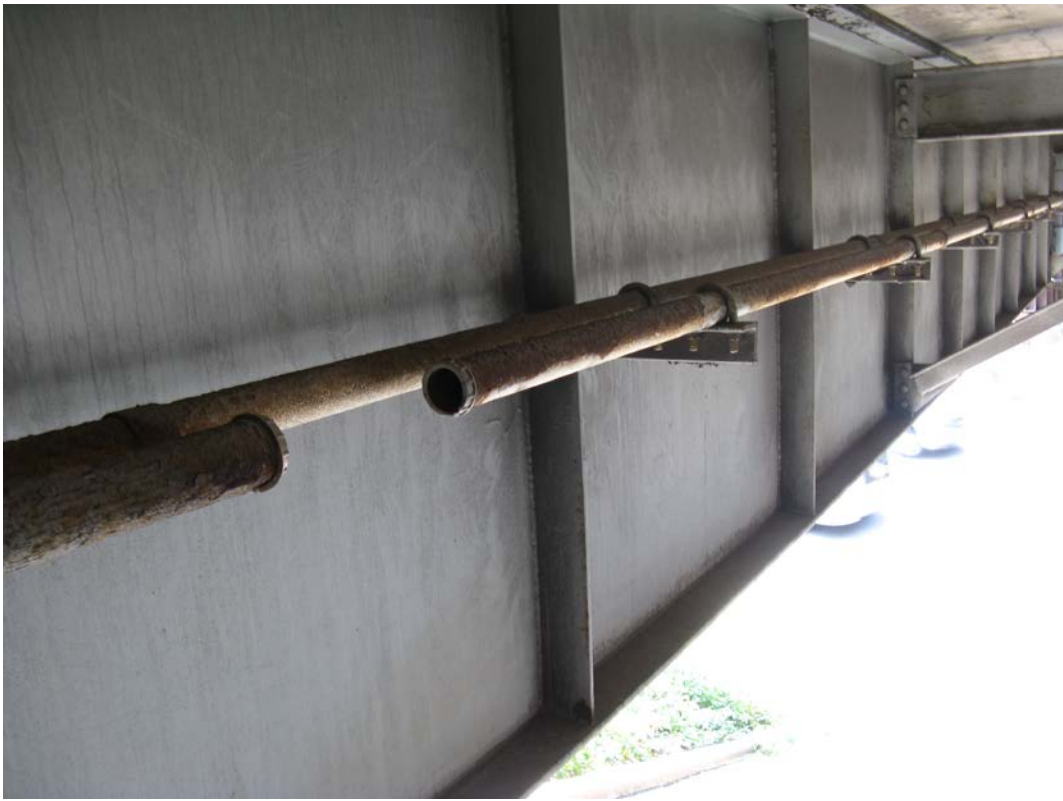
Photo 20 - Broken conduit along South Fascia Beam, Span 3, 8' from East Abutment, looking west

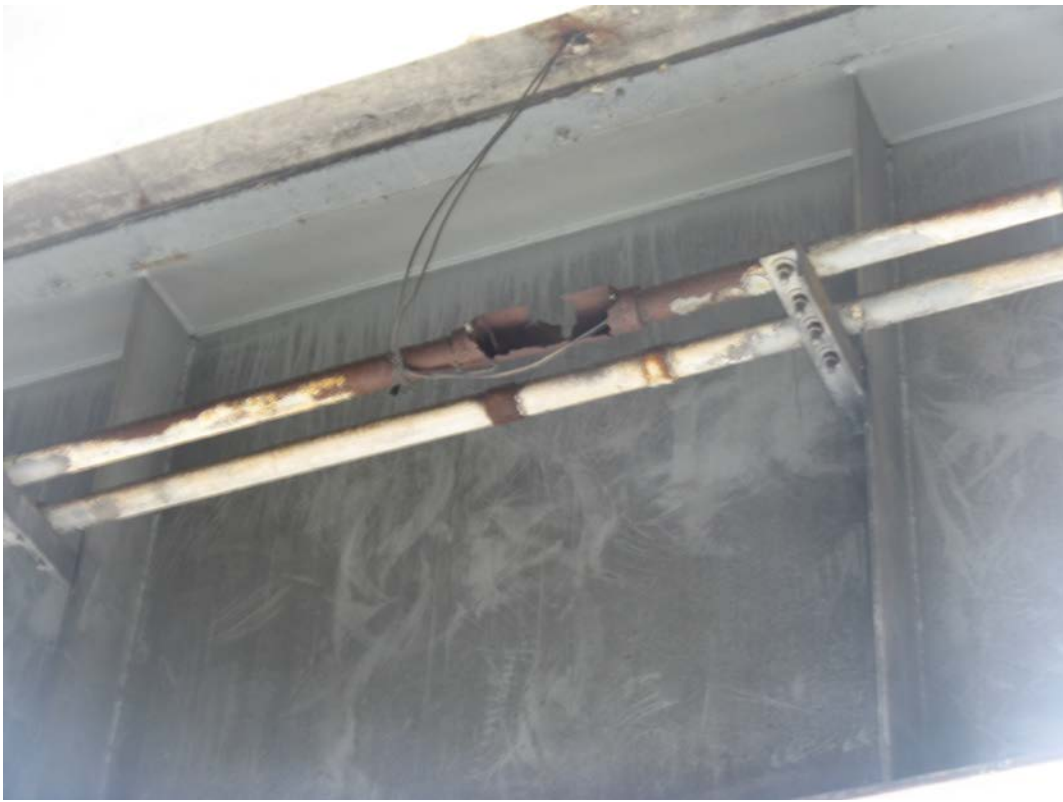
Photo 21 - Broken conduit in Span 2 along south fascia beam, 6' from West Pier, looking southeast

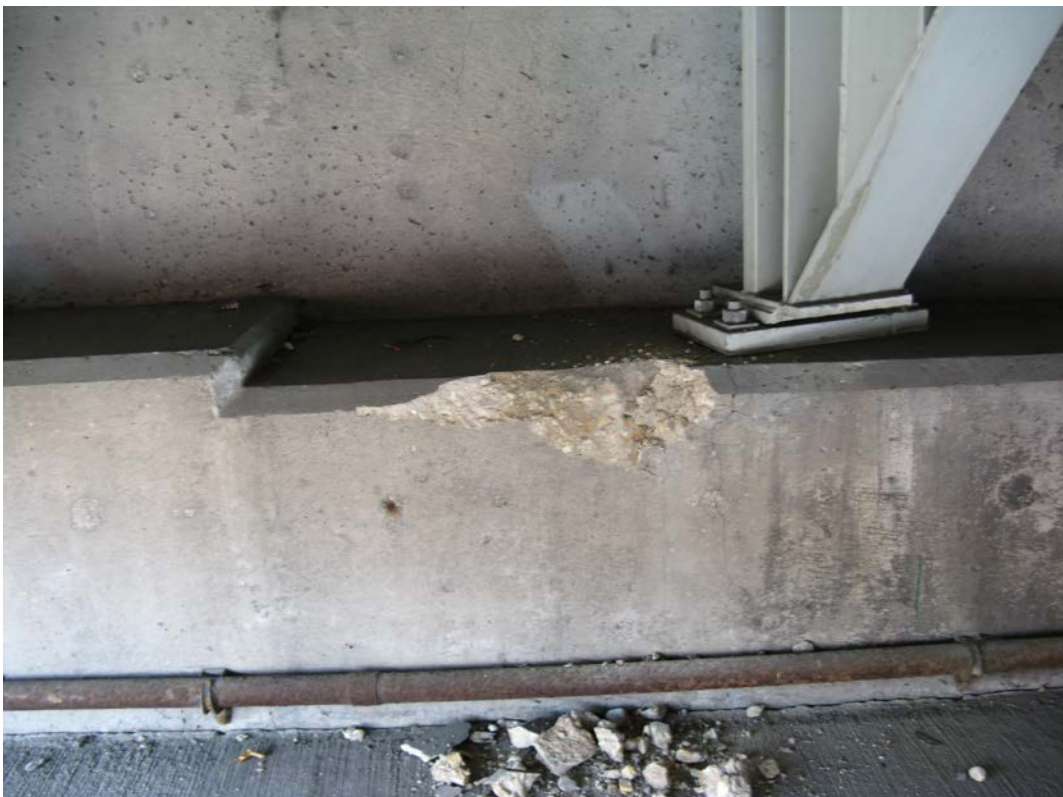
Photo 22 - Spall on East Abutment seat between beams 2-3, looking east

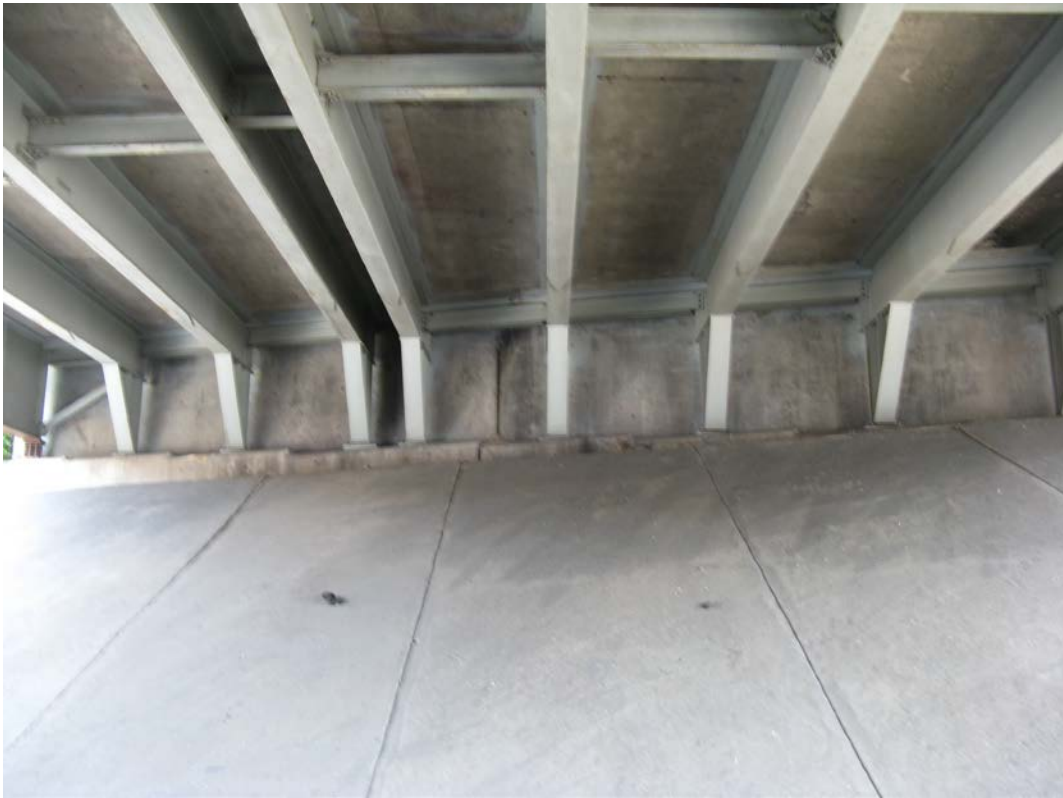
Photo 23 - East Abutment, looking east

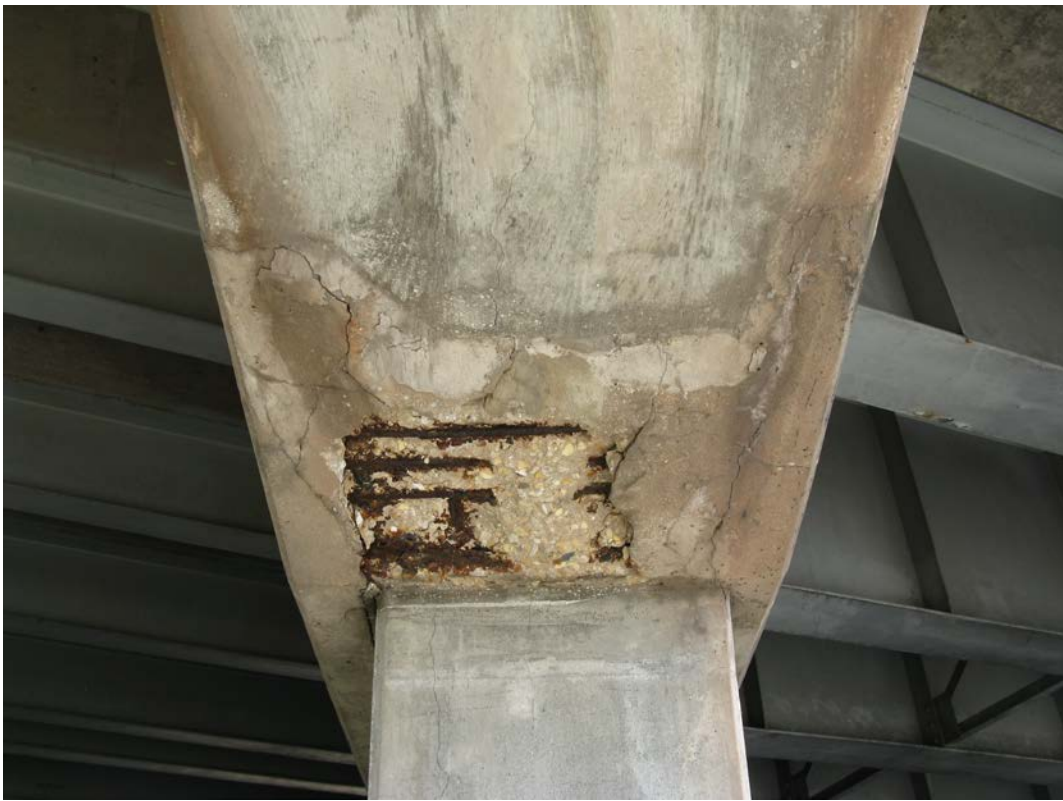
Photo 30 - Spall on underside of West Pier cap, south end, looking north

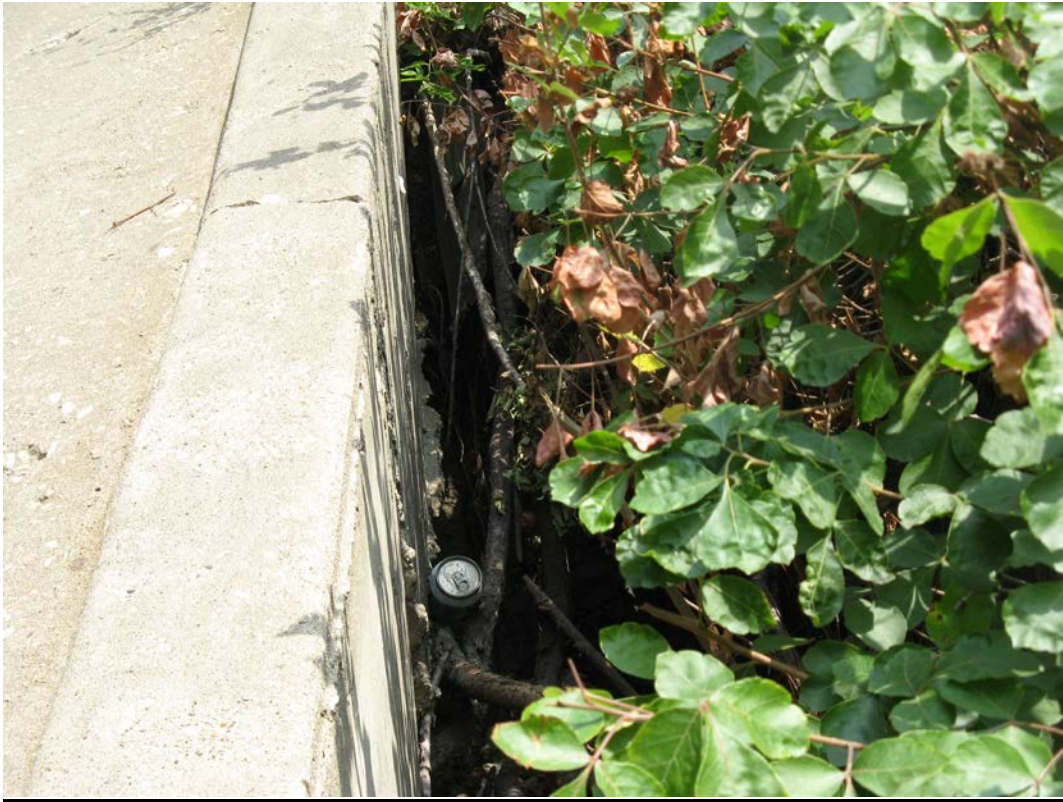
Photo 31 - Undermining of east slopewall at south end, looking east

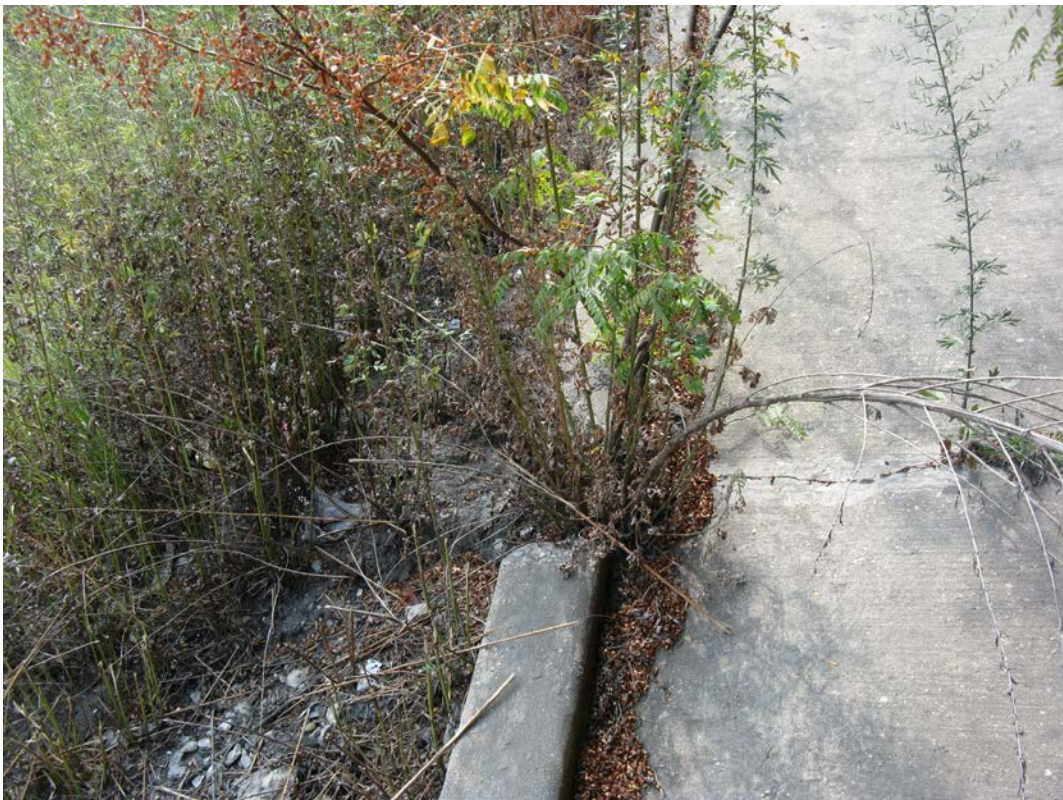
Photo 34 - Broken section of west slopewall curb with vegetation growing in it, approx half way up, looking west

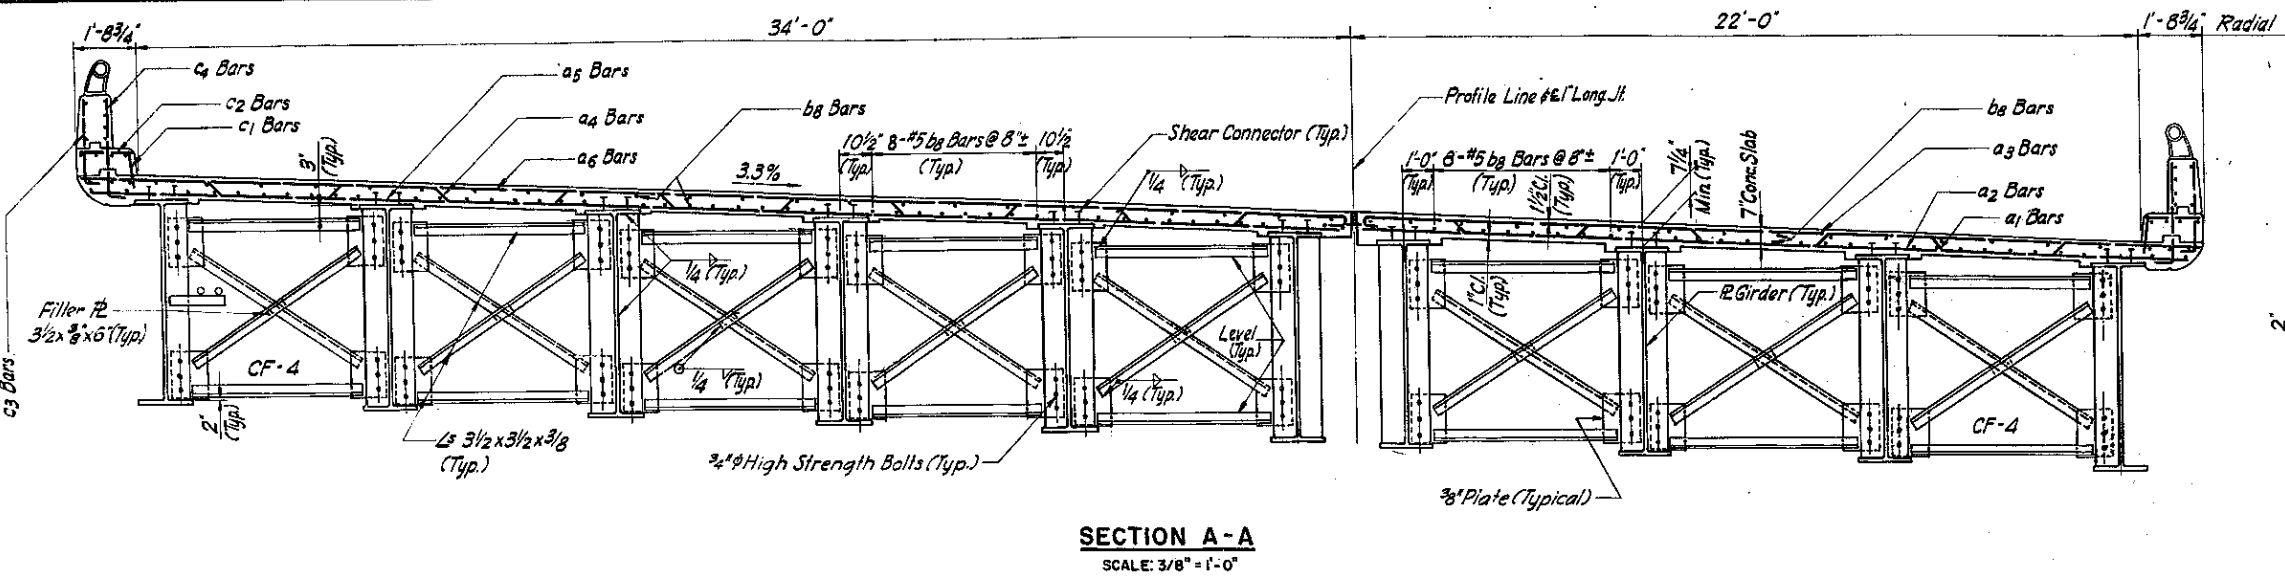
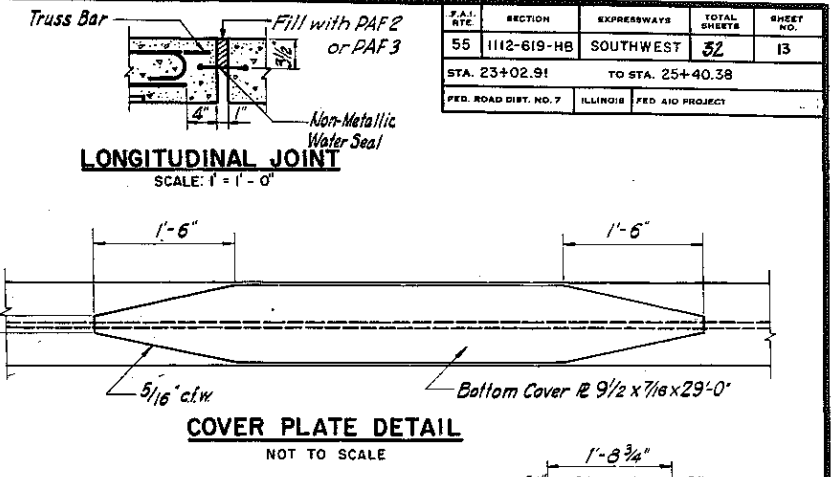
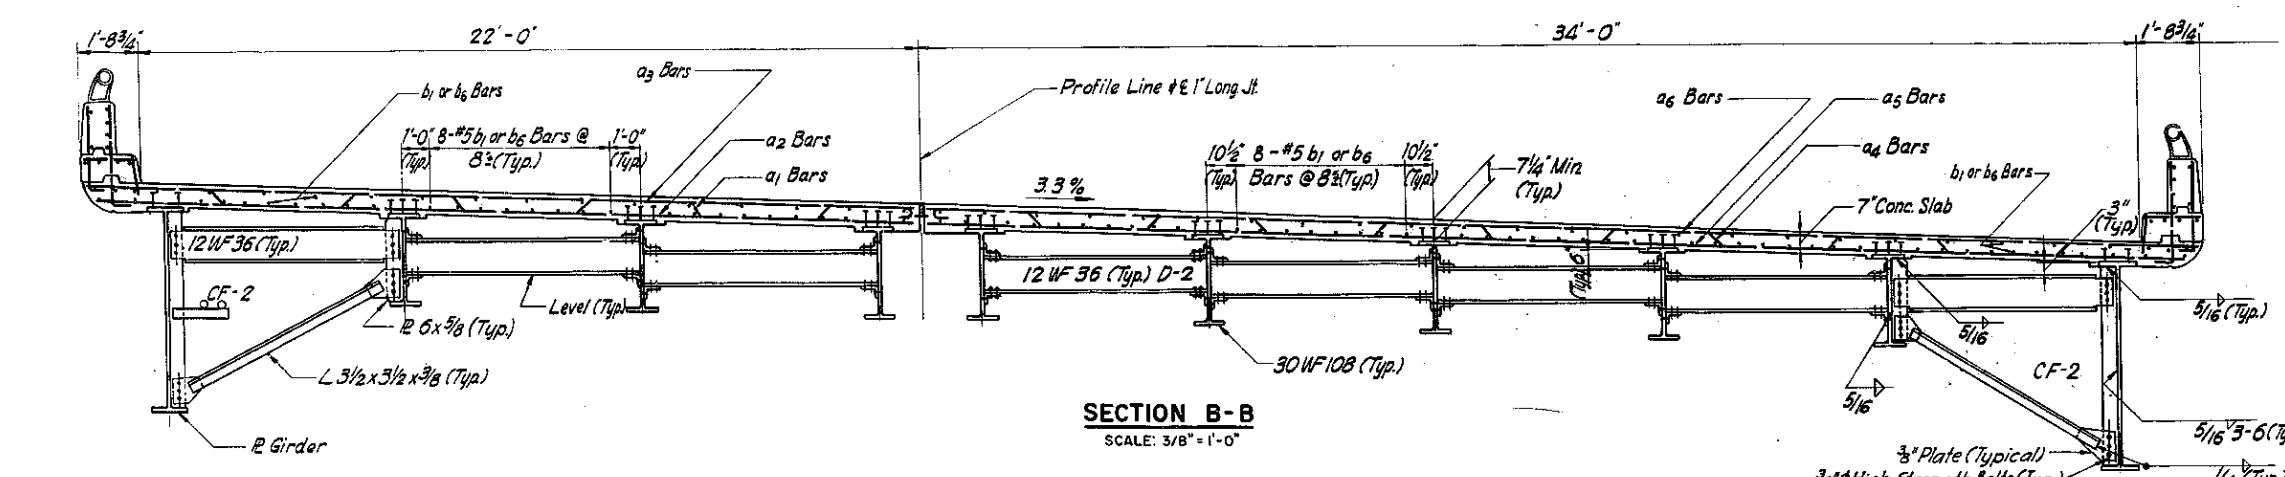
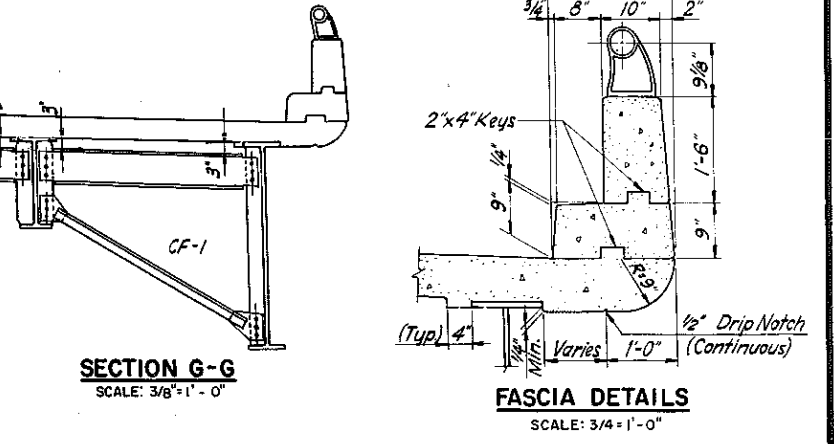
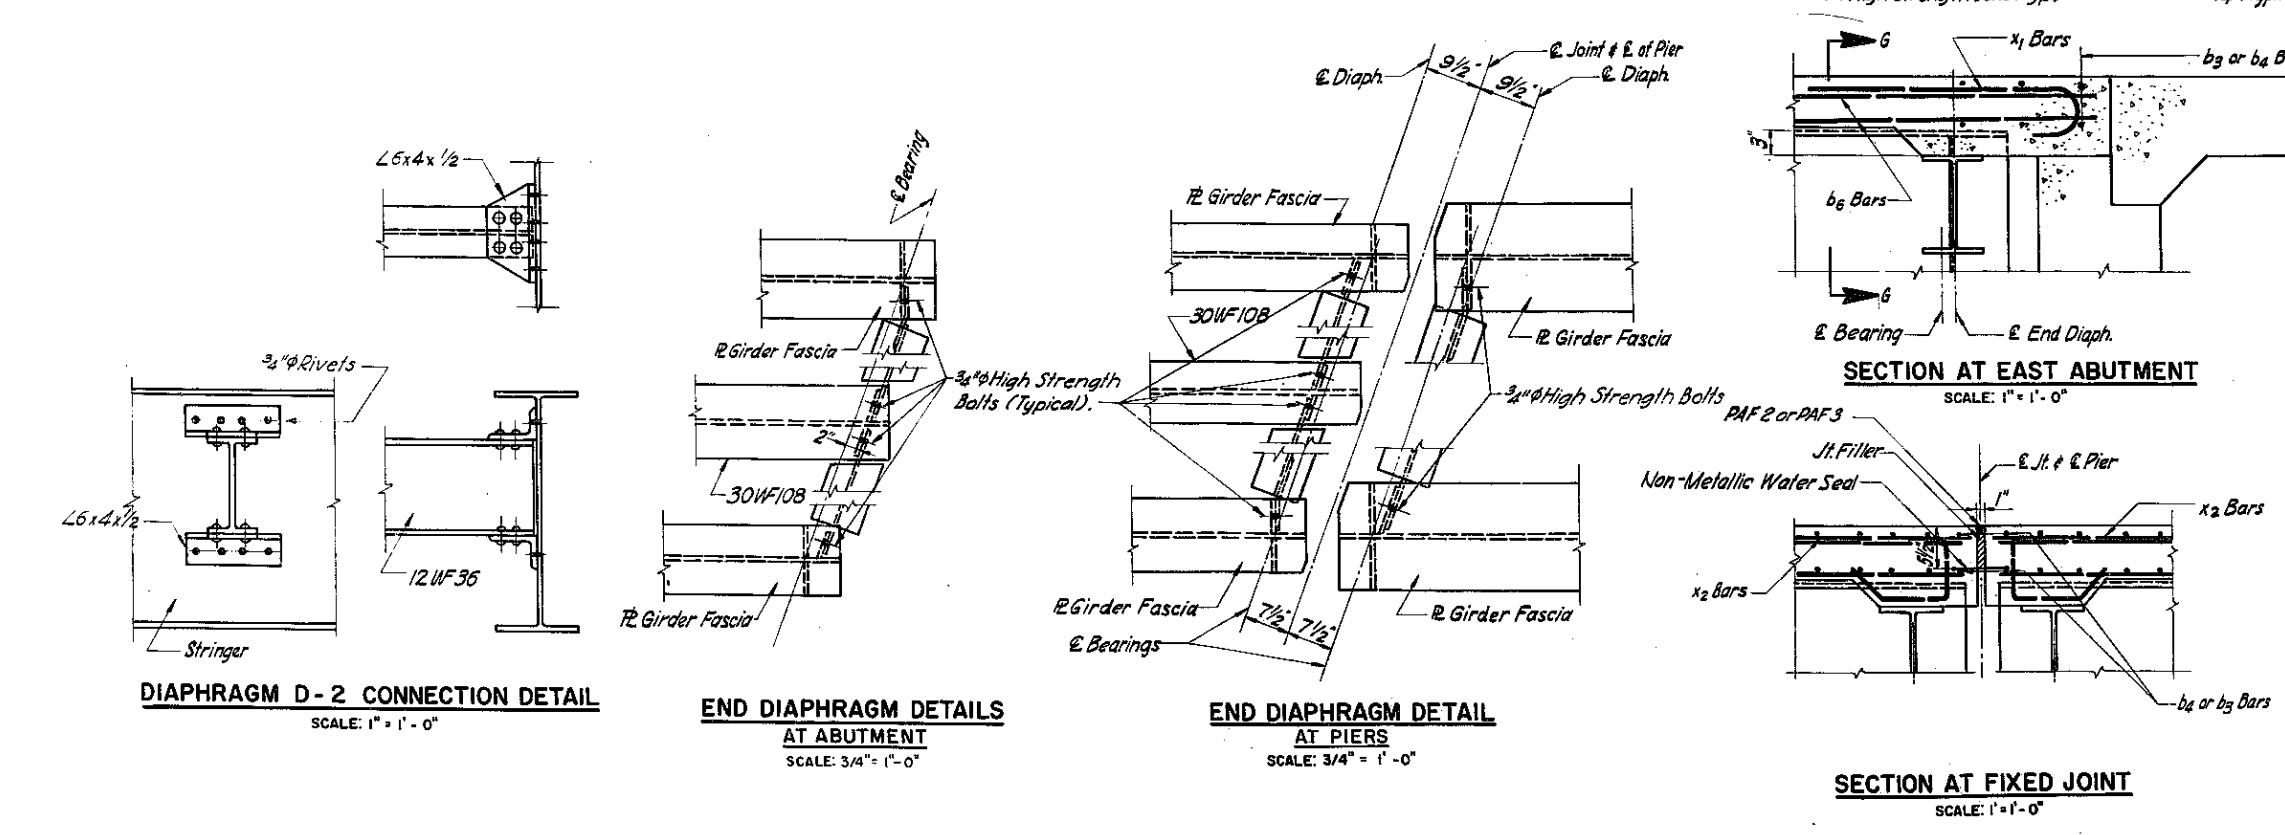
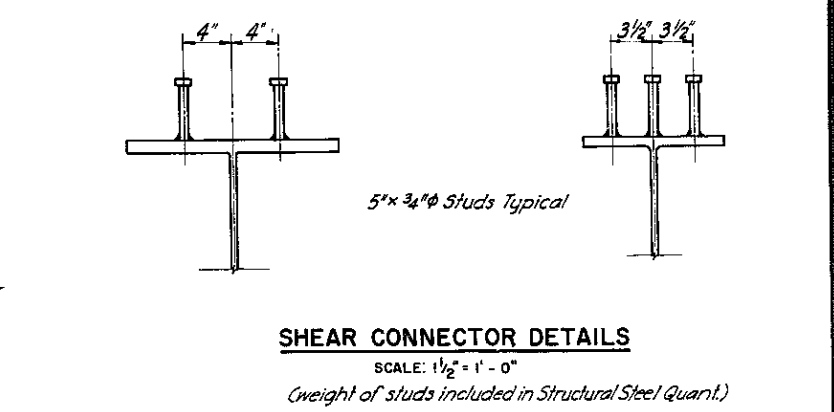
- NOTES:**
1. For location of sections A-A & B-B, see sheet 12.
 2. Section A-A shown for Bridge A, Bridge B similar except for stringer layout and spacing.
 3. Section B-B shown for Bridge B, Bridge A similar except for stringer layout and spacing.
 4. Use 3/4" rivets, except as otherwise noted.
