I-55 Managed Lanes Combined Design Report

Appendix A.3 – Structures

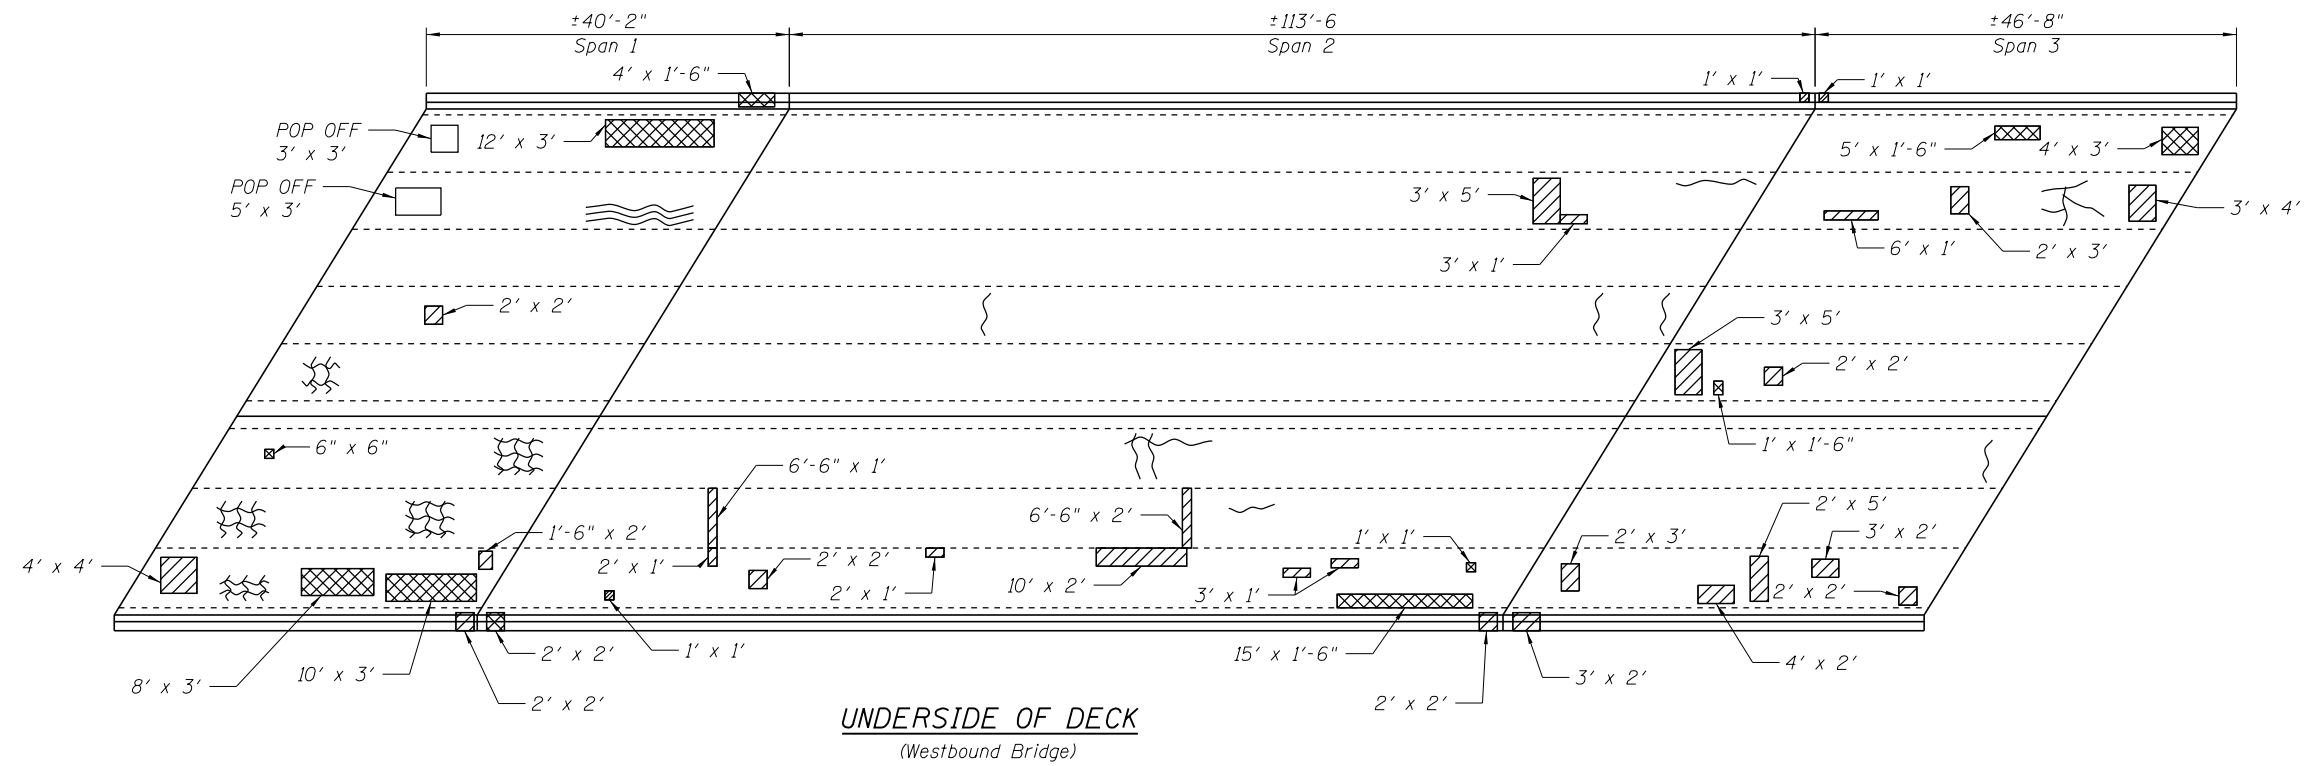
UNDERSIDE OF DECK
(Westbound Bridge)

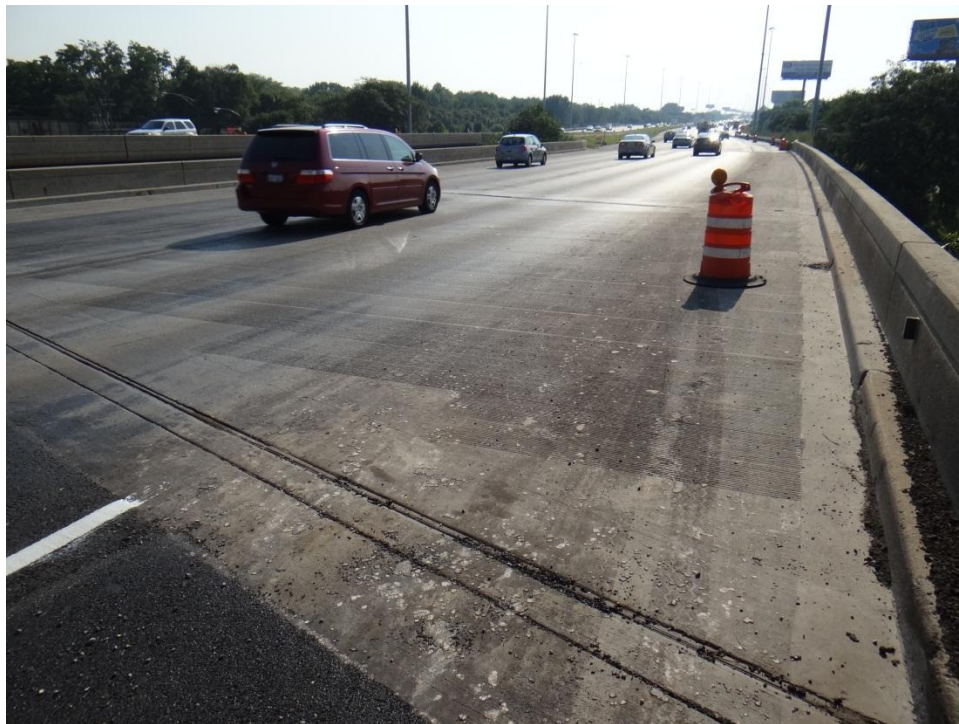
Figure 4. Typical view, deck top surface, looking southwest

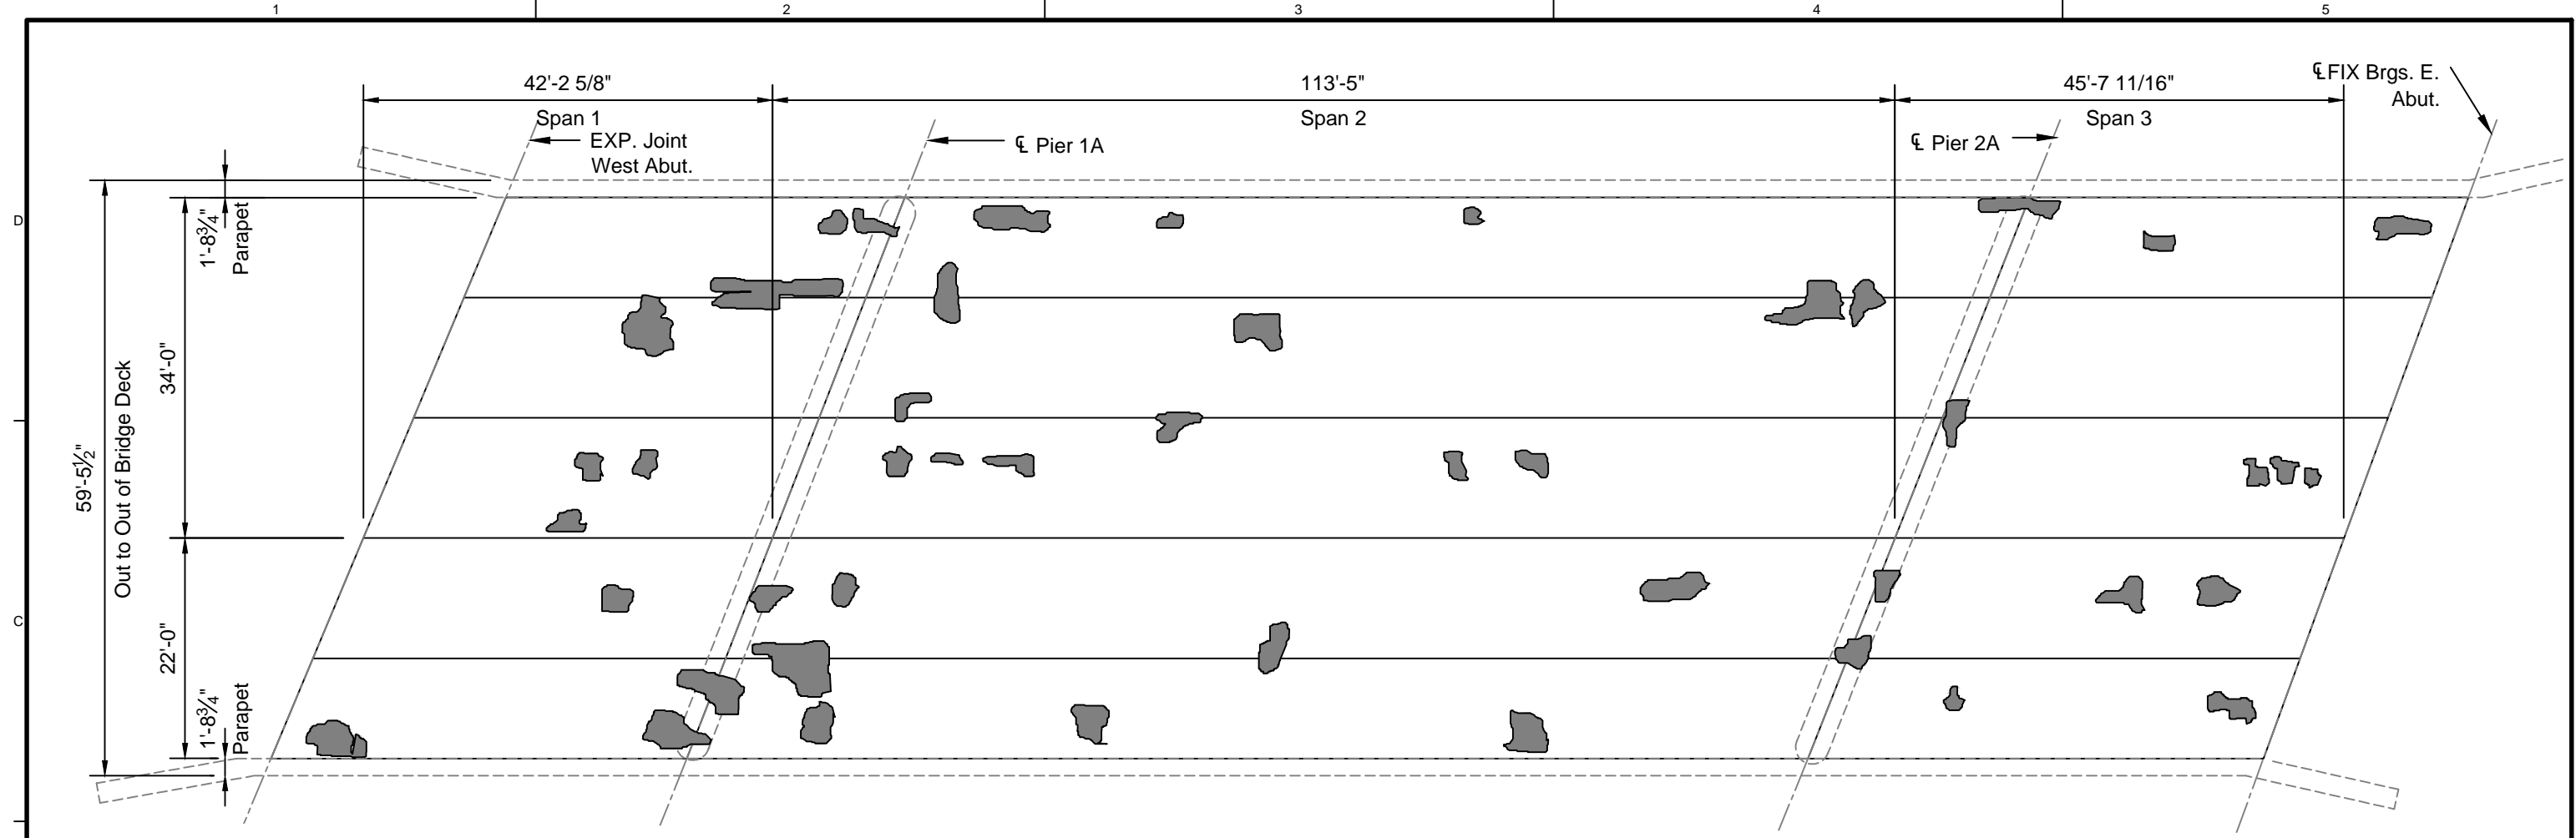
FIELD OBSERVATION SUMMARY		STRUCTURE # 016-0017		LEGEND	
ITEM	UNIT	QUANT.	%	DELAMINATION	SPALL
TOTAL AREA	Ac	11055	100		
DELAMINATION	Ac	430	3.9		
SPALL	Ac	0	0		
CRACKS	ft	-	-

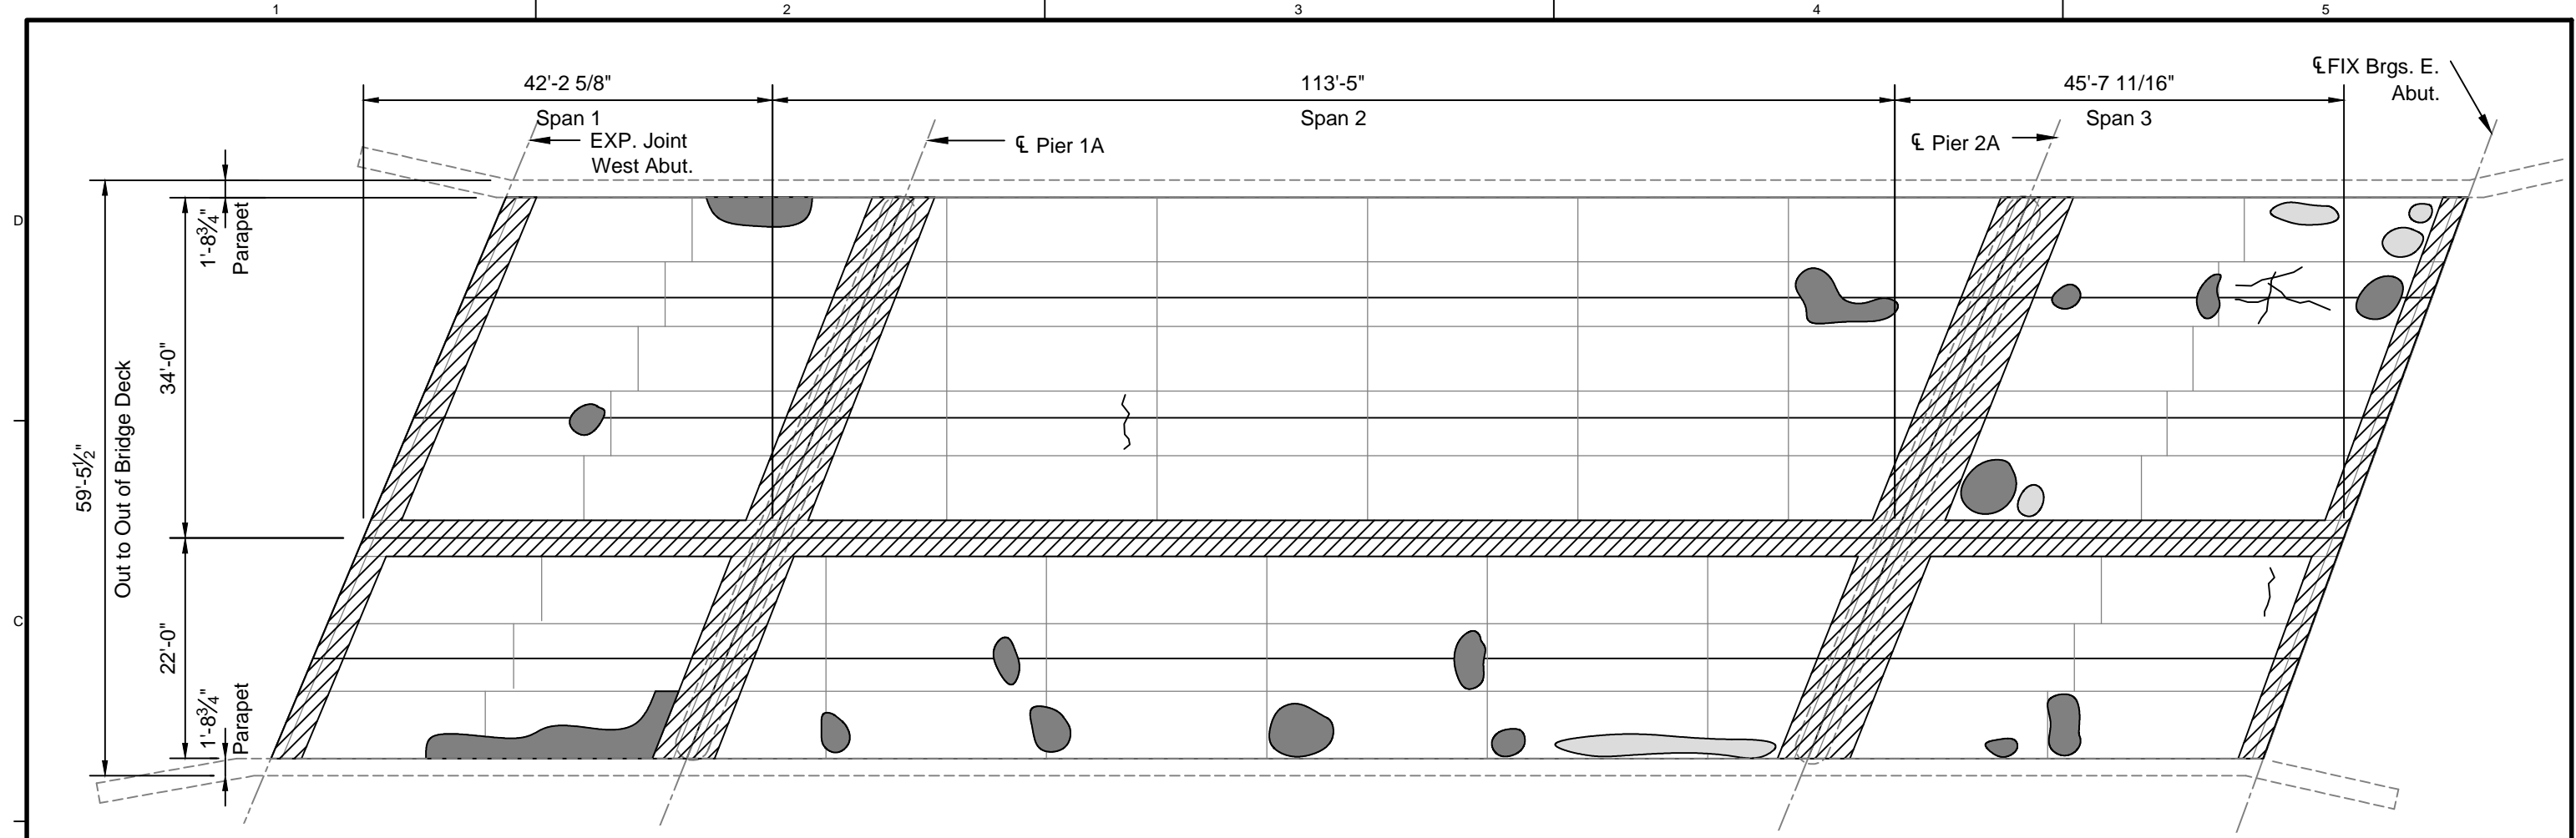
FIELD OBSERVATION SUMMARY		STRUCTURE # 016-0017		LEGEND	
ITEM	UNIT	QUANT.	%		
TOTAL AREA	Ac	11055	100	DELAMINATION	
DELAMINATION	Ac	285	2.6	SPALL	
SPALL	Ac	70	0.6	PREV. REPAIR	
PREVIOUS REPAIRS	Ac	1705	15.4	CRACK	
CRACKS	ft	-	-

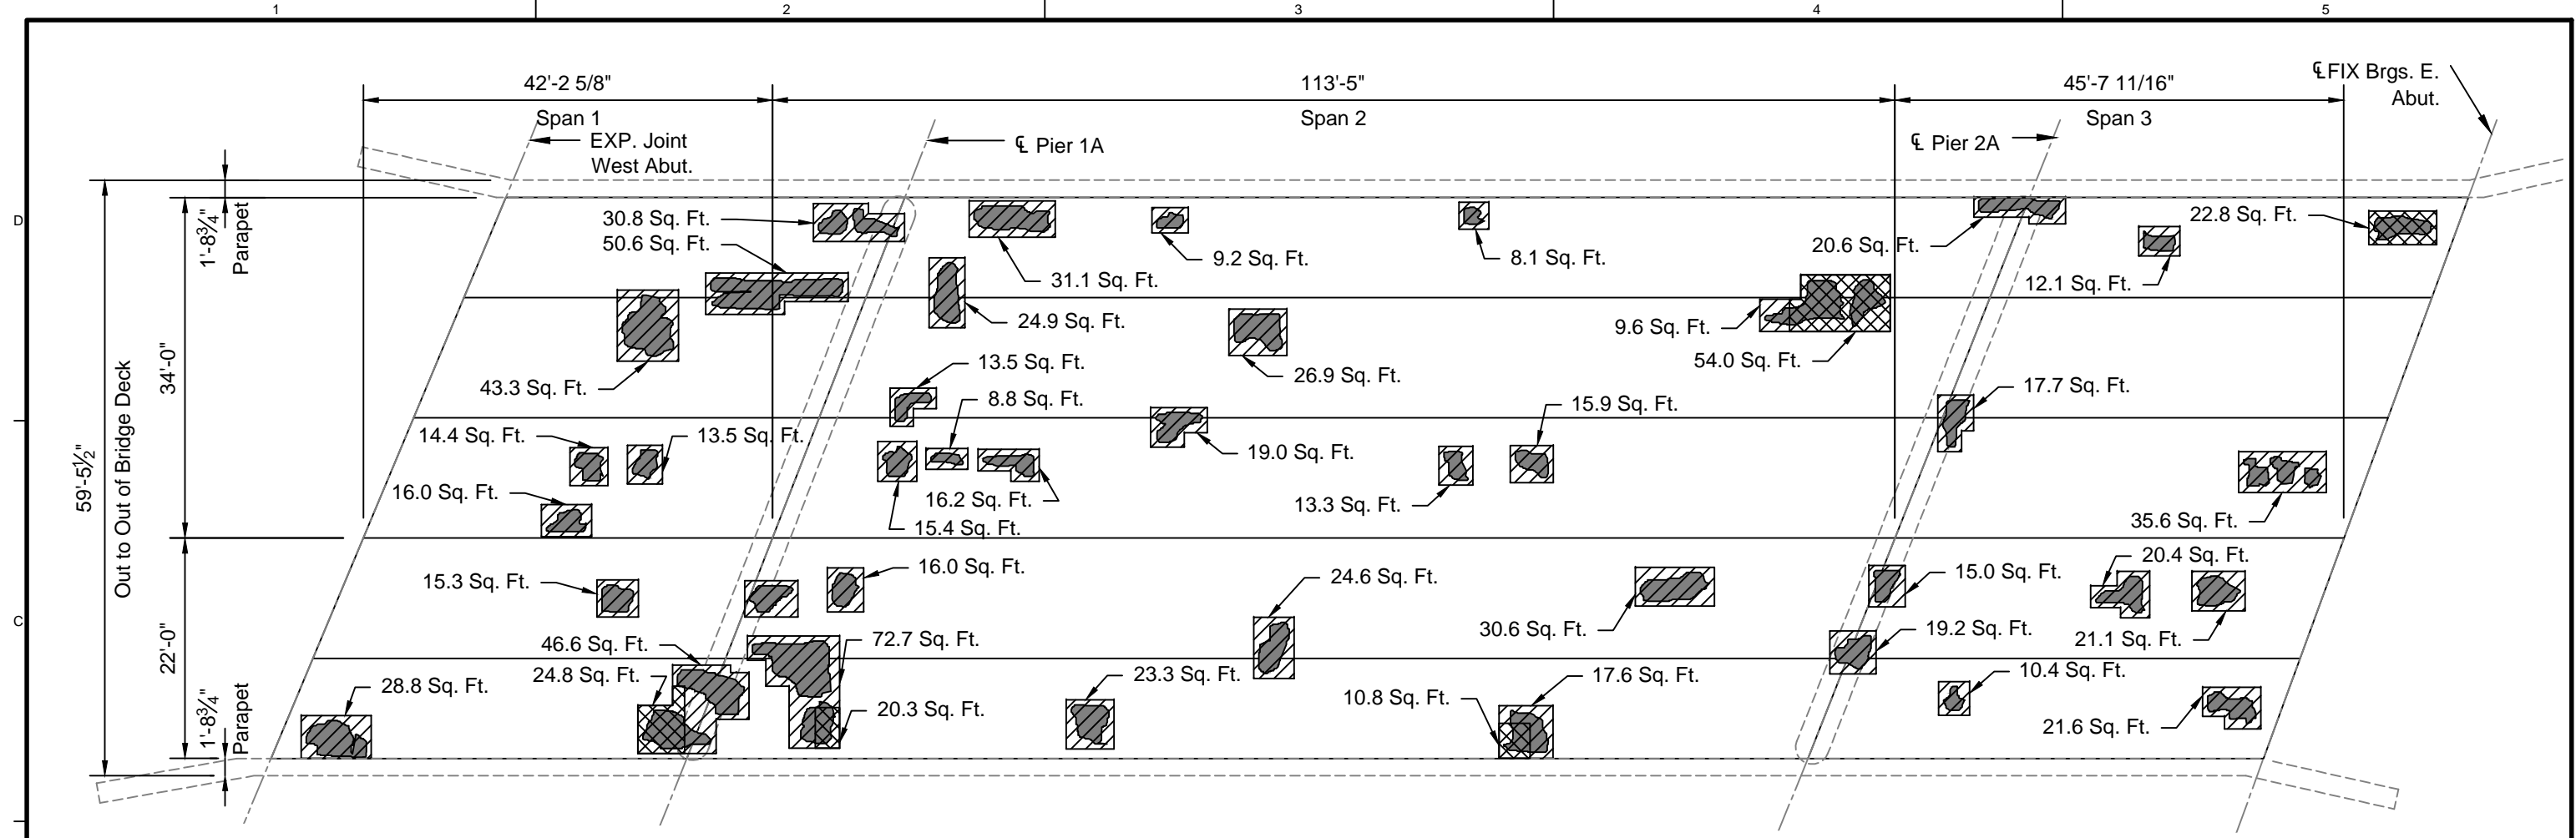
FIELD OBSERVATION SUMMARY		STRUCTURE # 016-0017		LEGEND	
ITEM	UNIT	QUANT.	%		
TOTAL AREA	Ac	11055	100	PARTIAL DEPTH REPAIR	
PARTIAL DEPTH REPAIR	Ac	861	7.8	FULL DEPTH REPAIR	
FULL DEPTH REPAIR	Ac	122	1.1	DELAMINATION	
DELAMINATION	Ac	430	3.9	SPALL	
SPALL	Ac	0	0	CRACK	
CRACKS	ft	-	-

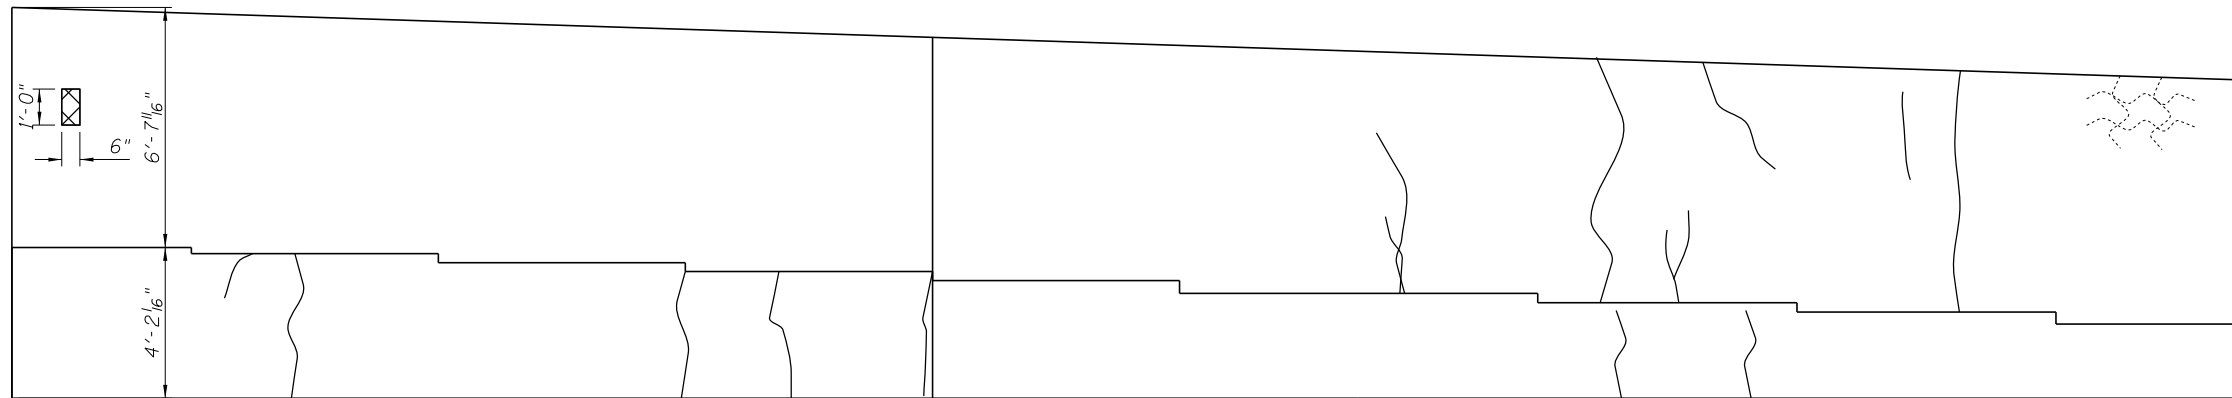
EAST ABUTMENT
LOOKING EAST

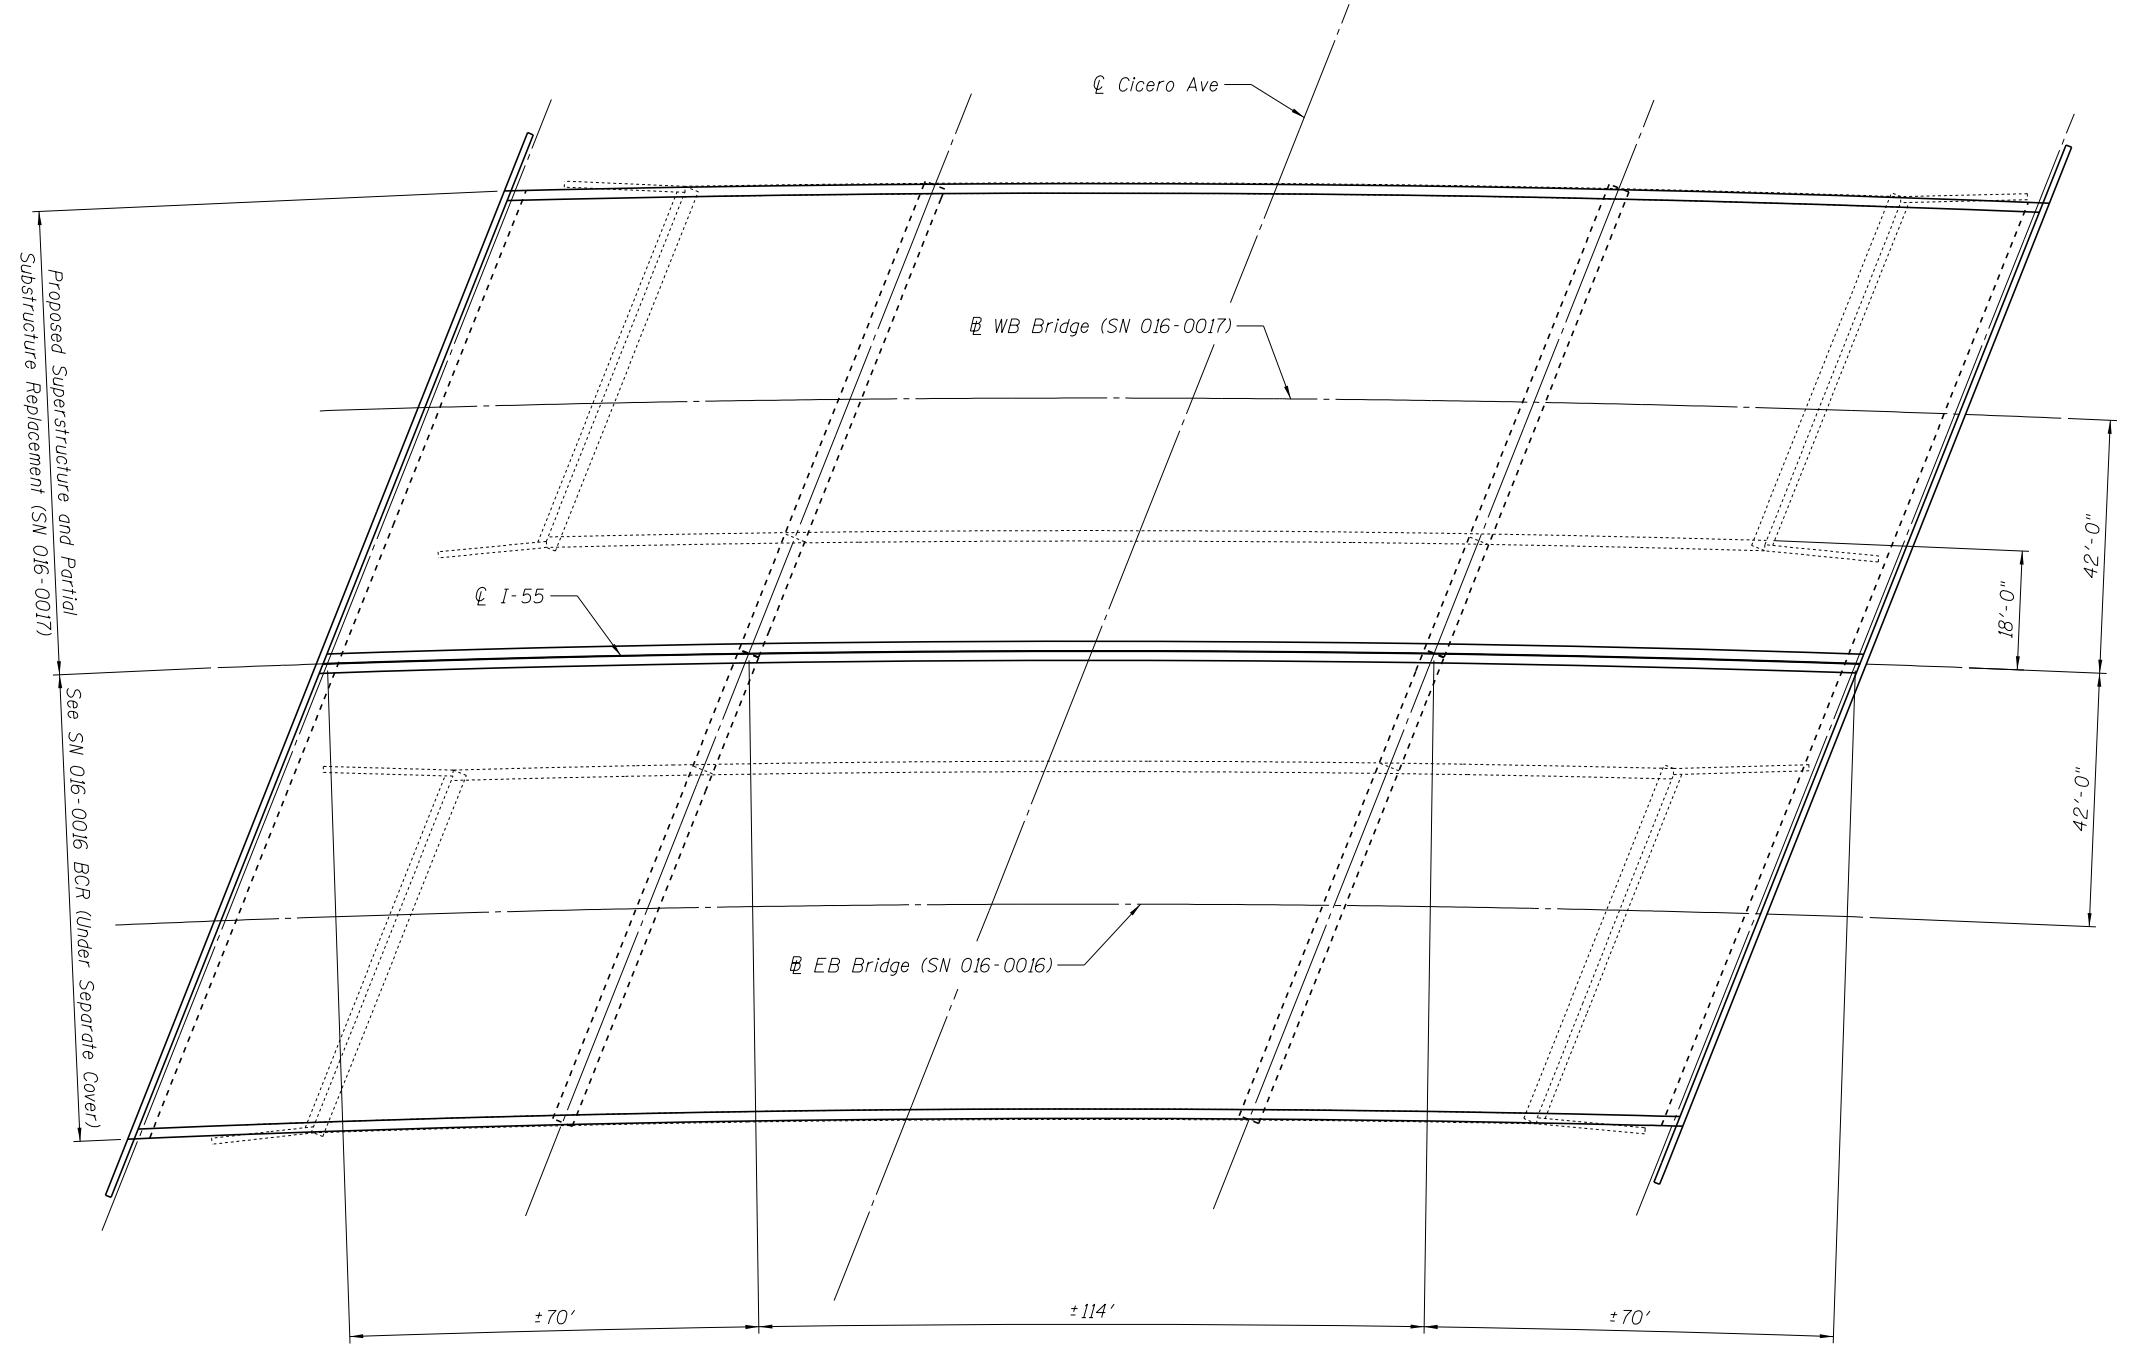
Proposed Superstructure and Partial Substructure Replacement (SN 016-0017)
 See SN 016-0016 BCR (Under Separate Cover)

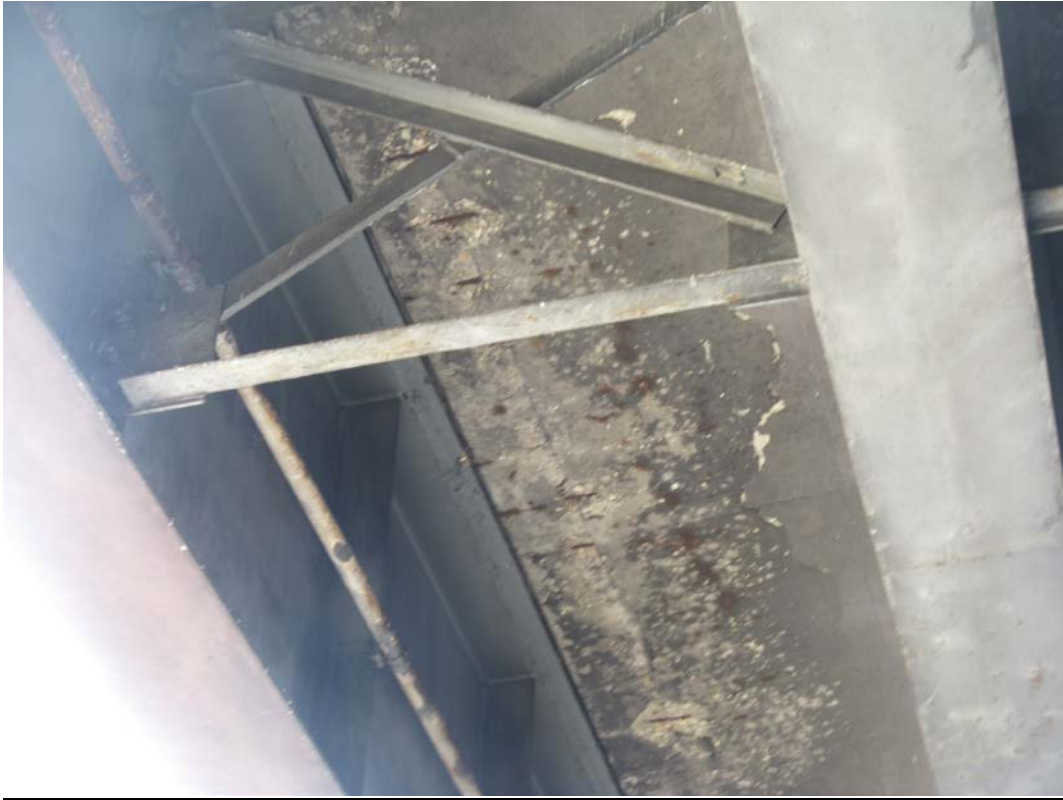
Photo 1 - Spalling in bay 9, Span 2 , east end, looking west

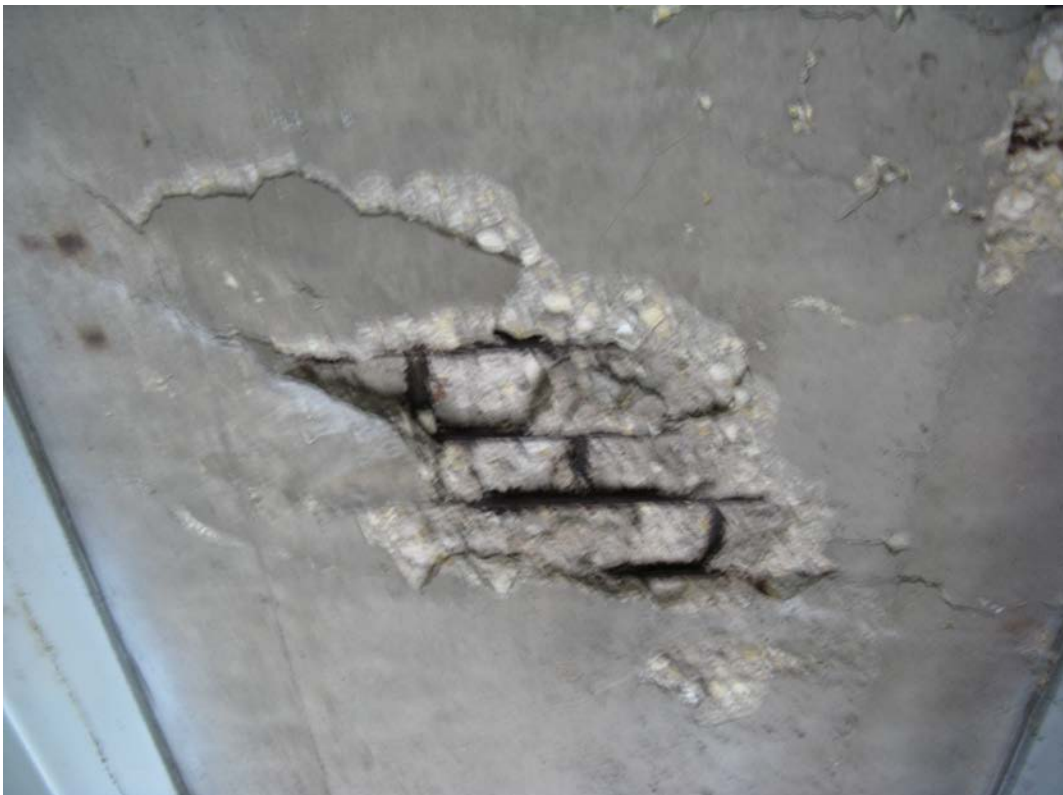
Photo 2 - Spall underside of deck in Span 3, east end, between beams 1-2 from north, looking west

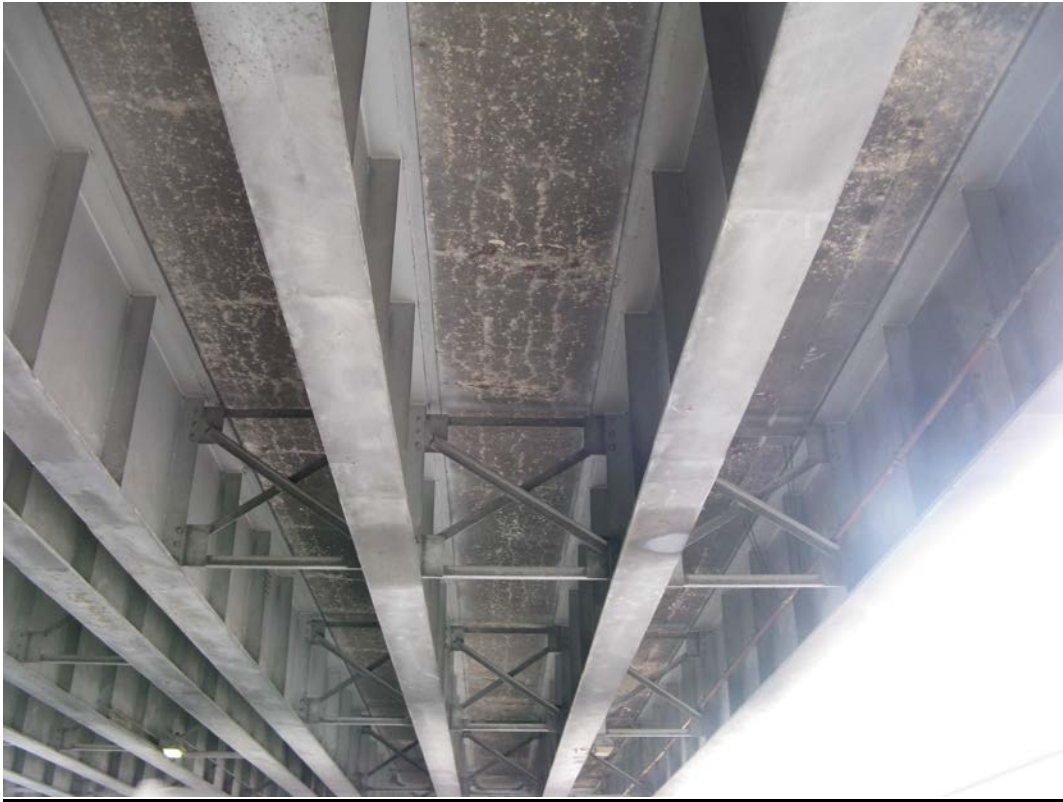
Photo 3 - Underside of Deck, Span 2, south end, looking east

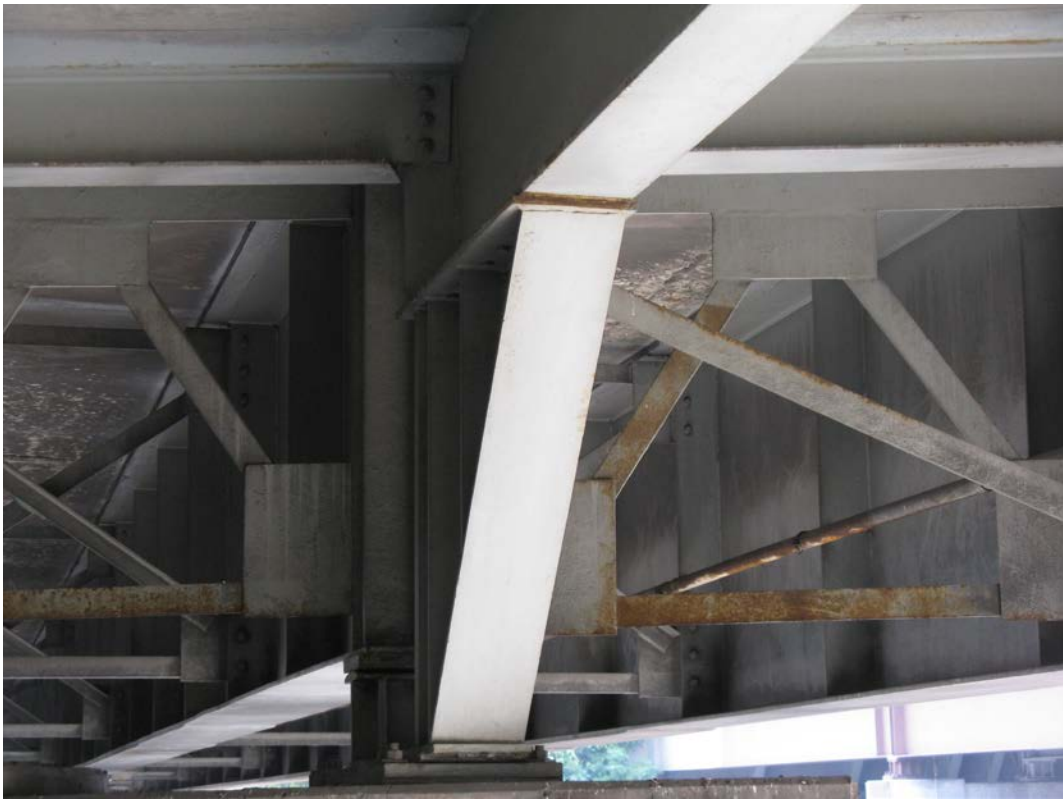
Photo 12 - Crack in built up pedestal on beam 9 from north at West Pier, west span, looking east

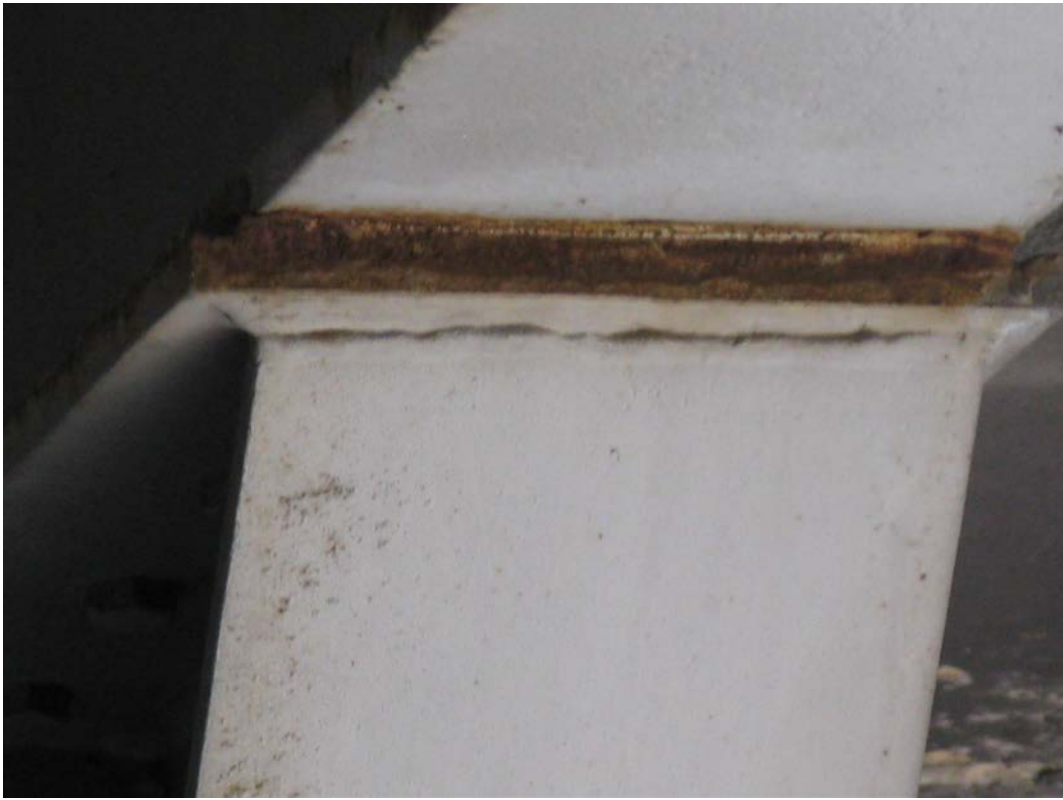
Photo 13 - Close up of photo 12

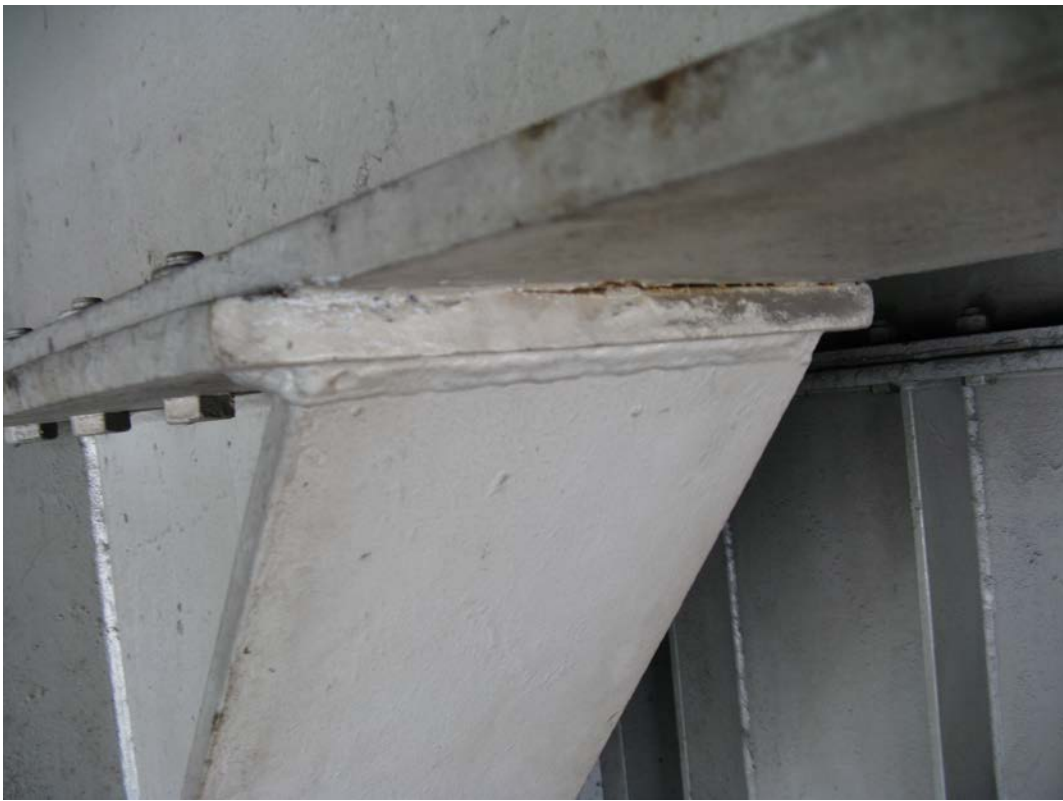
Photo 14 - Typical cracked weld between bottom flange of beam and built up steel pedestal, Beam 6 at East Abutment, looking southeast

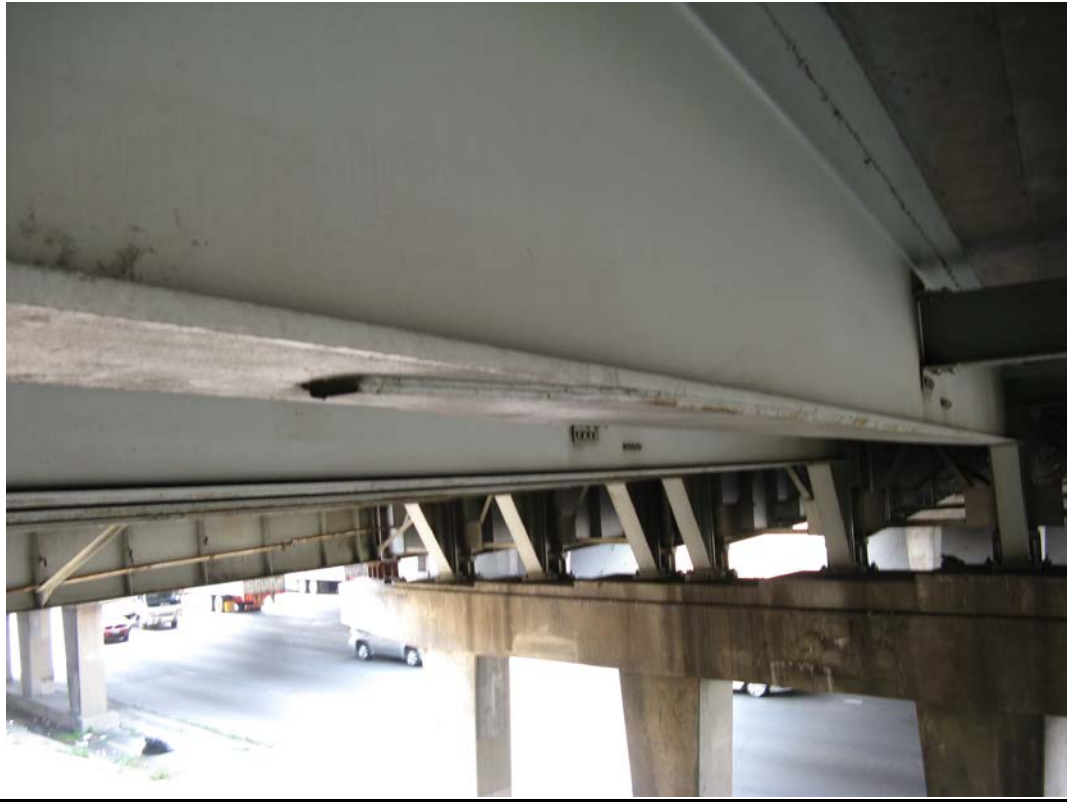
Photo 15 - Typical beam with cover plate in Span 1, Beam 4, looking southwest

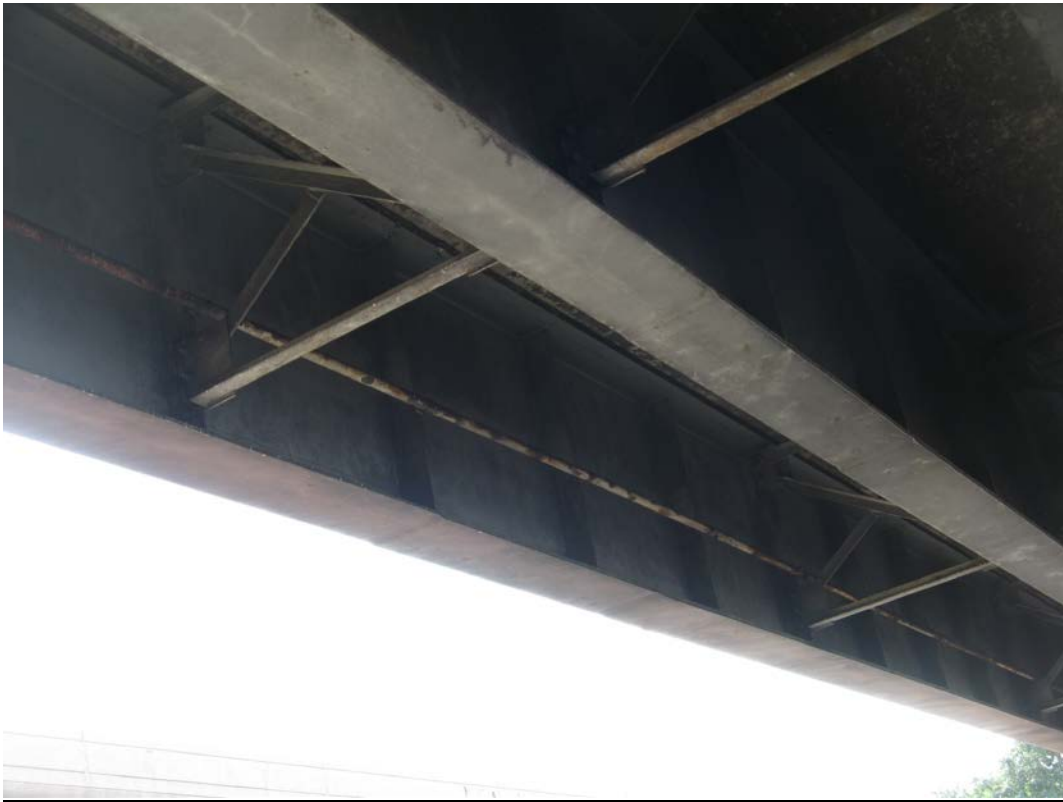
Photo 19 - Failed conduit connections, looking southwest

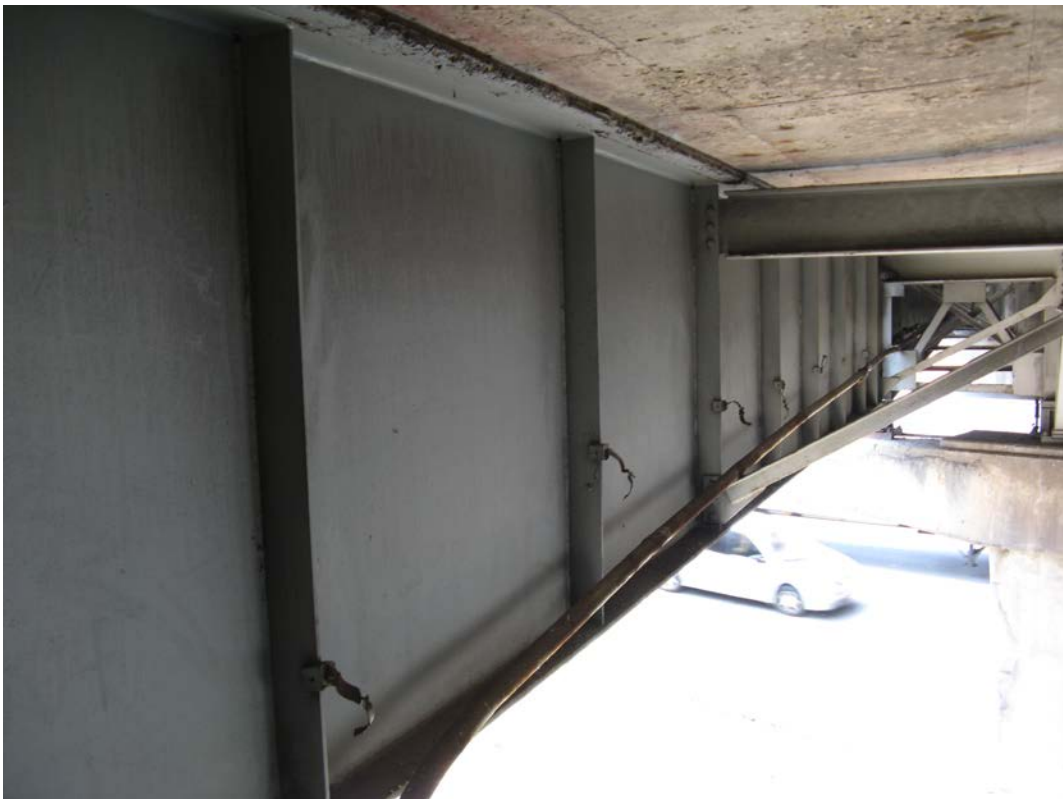
Photo 20 - Broken conduit from brackets along south fascia beam in Span 1, looking southwest

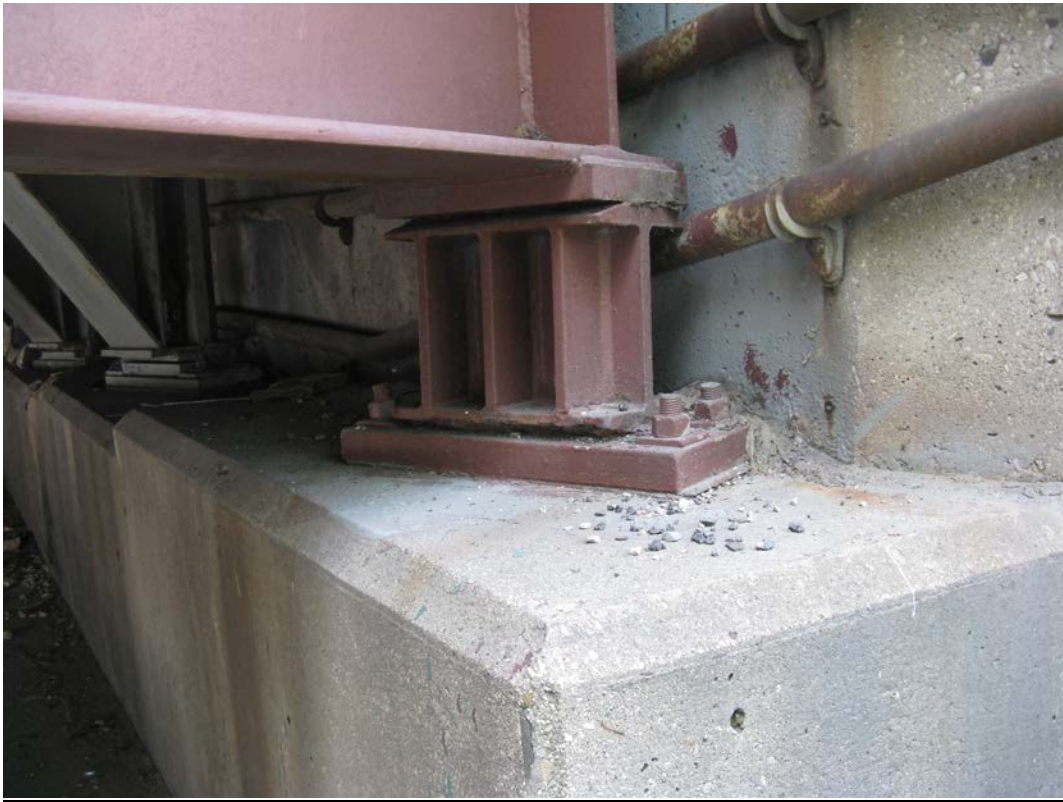
Photo 21 - Typical end beam bearing, beam 1 from north, West Abutment, looking southwest

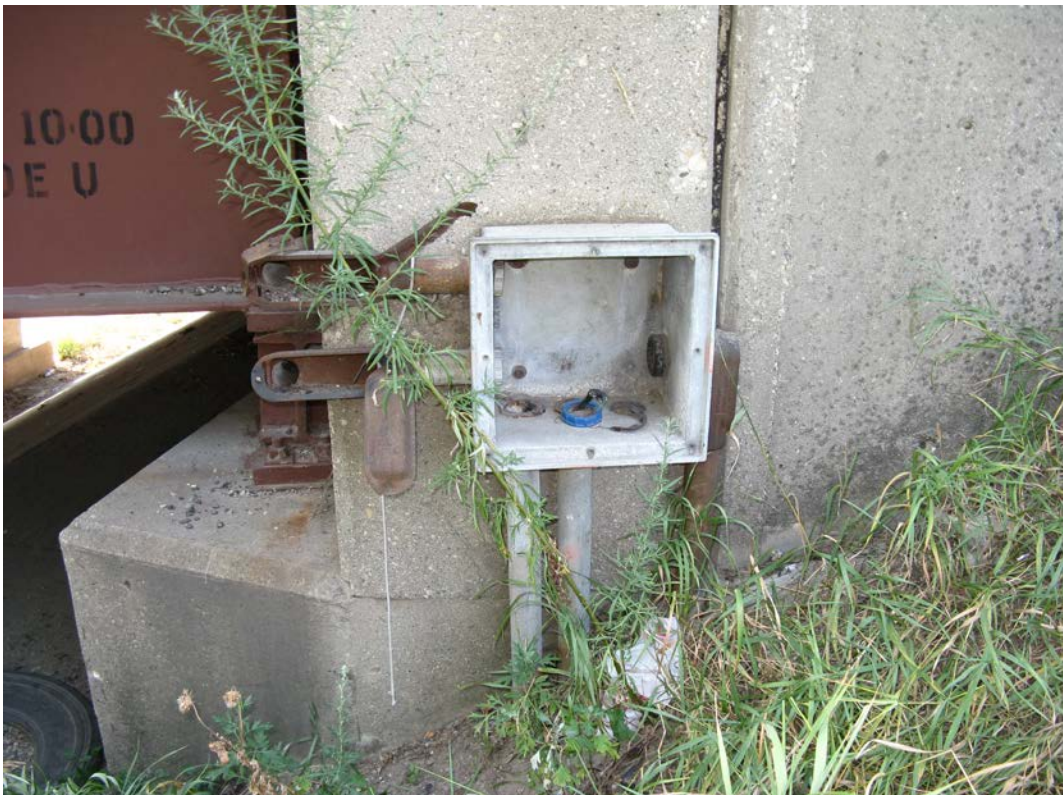
Photo 24 - Broken and open conduit on north end of West Abutment, looking south
