I-55 Managed Lanes Combined Design Report

Appendix A.3 – Structures

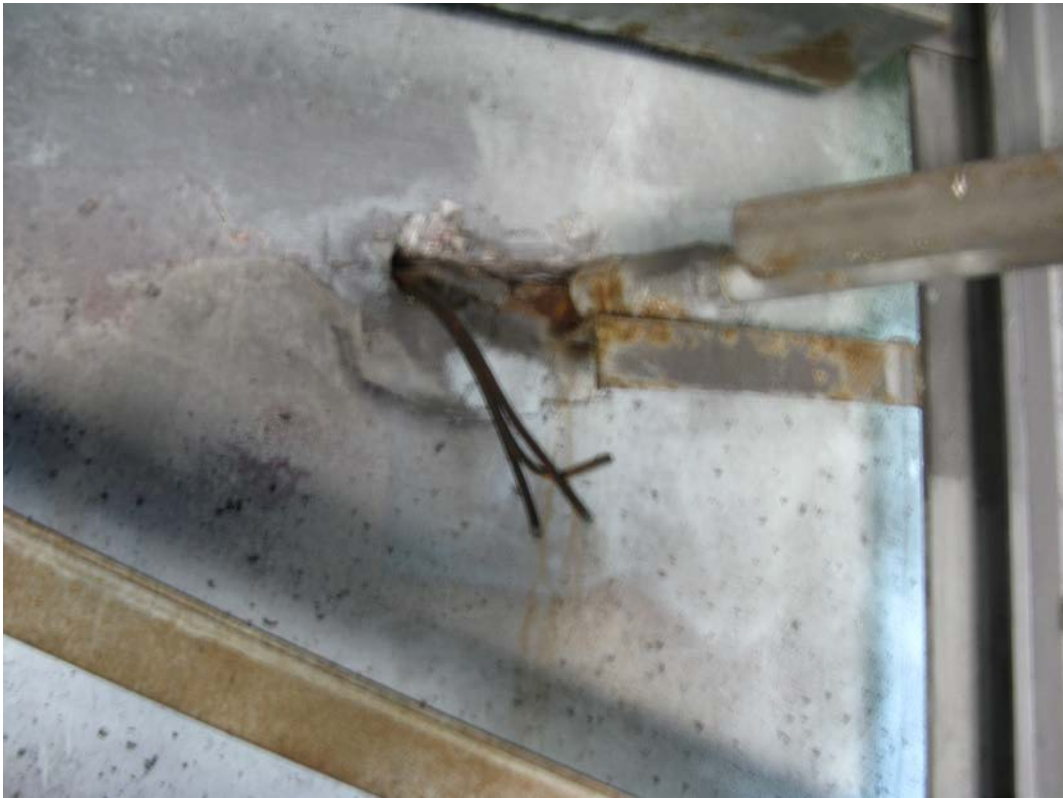
Photo 25 - Broken conduit at West Abutment backwall in bay 1 from north, looking west

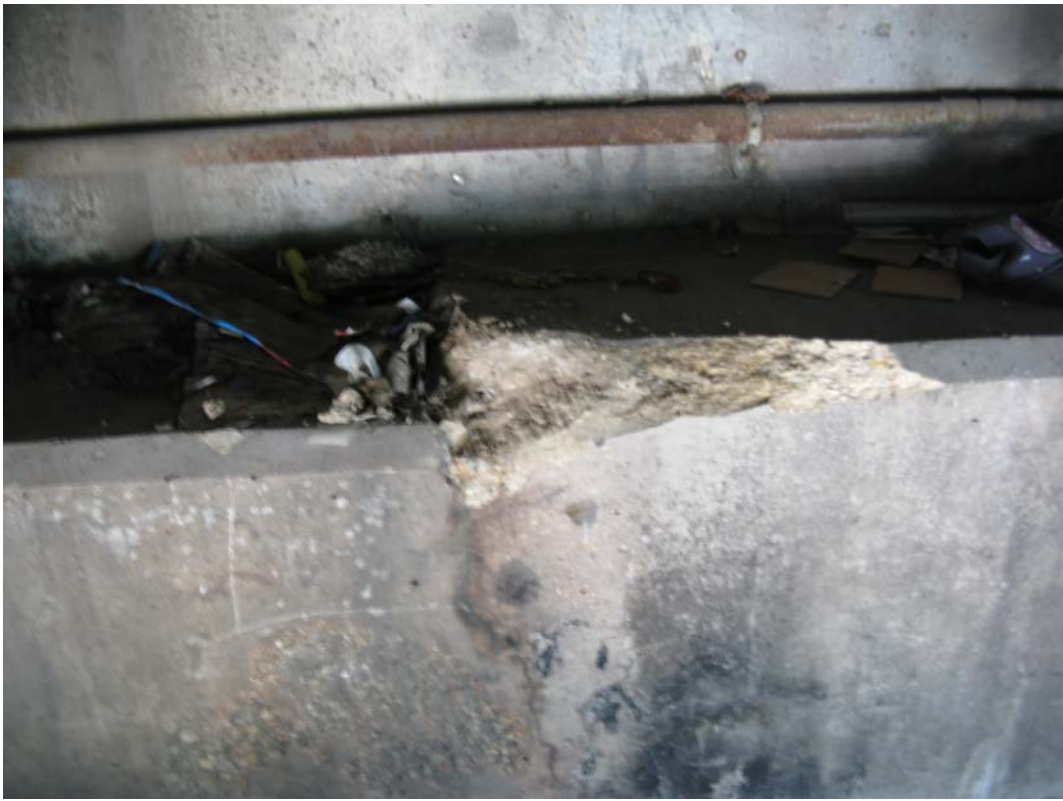
Photo 26 - Spall on West Abutment seat in bay 2 from north, looking east

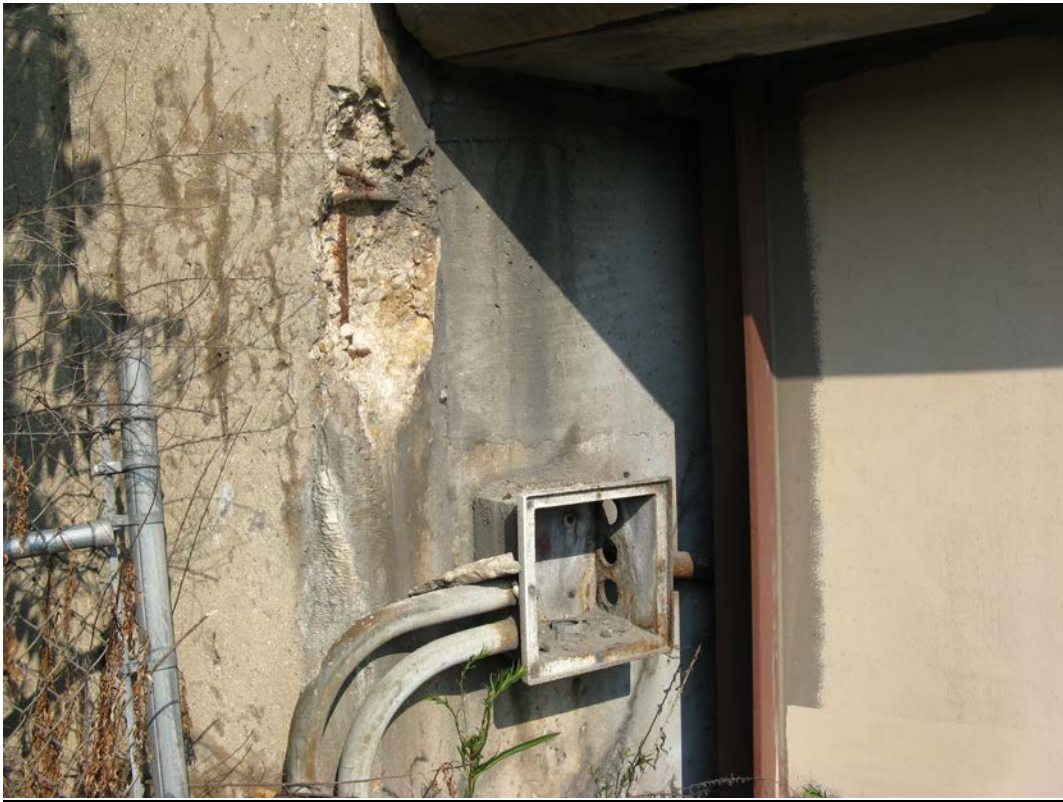
Photo 27 - Spall on front face of West Abutment backwall at south end and open conduit junction box, looking north

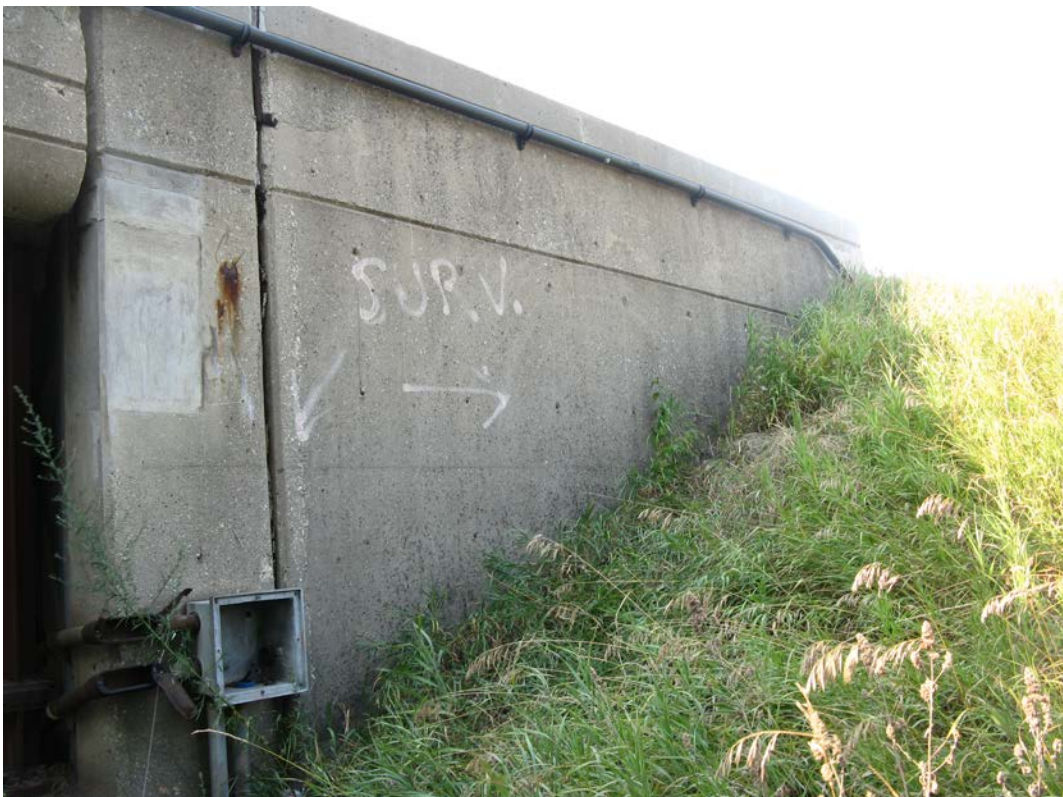
Photo 28 - Northwest Wingwall, looking southwest

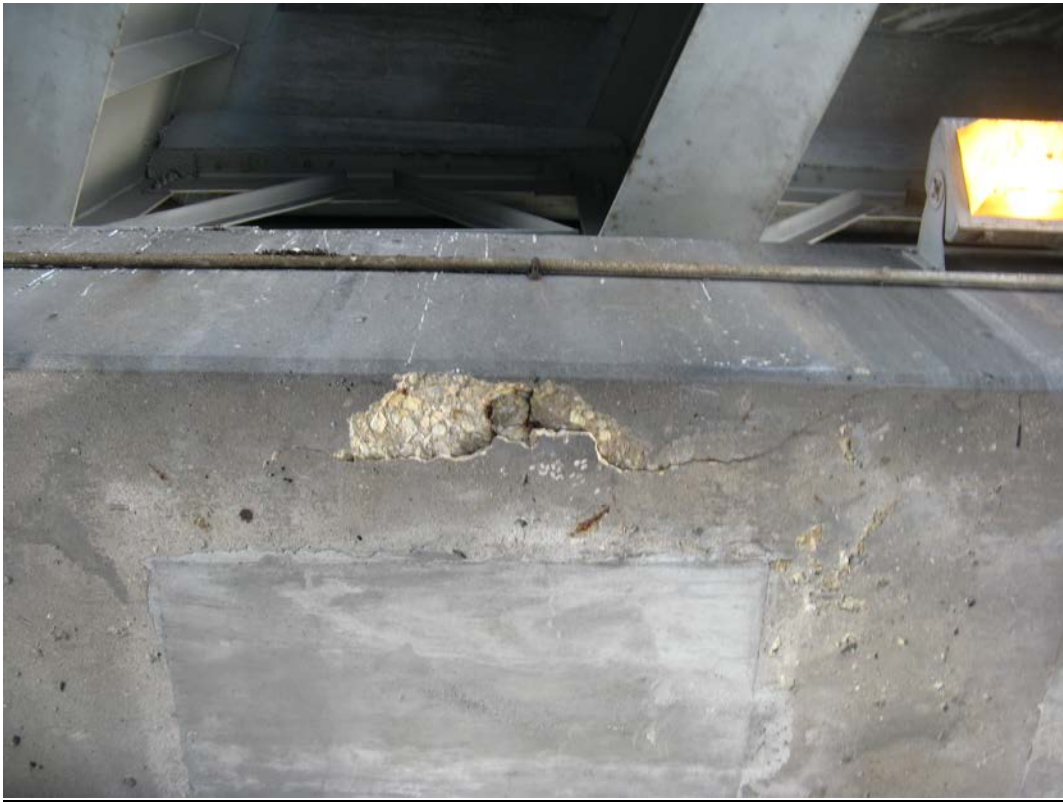
Photo 33 - East Pier, spall on underside of cap in between columns 3-4 from north, looking up and east

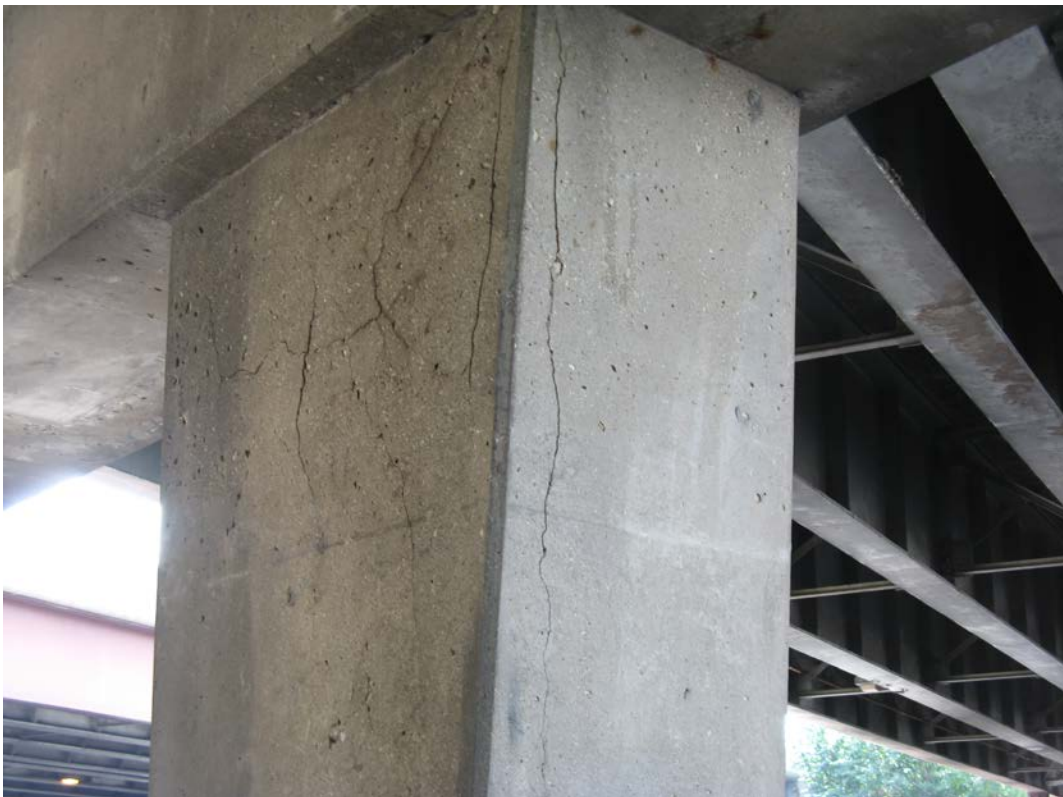
Photo 34 – East Pier, delam on northeast corner, looking southwest

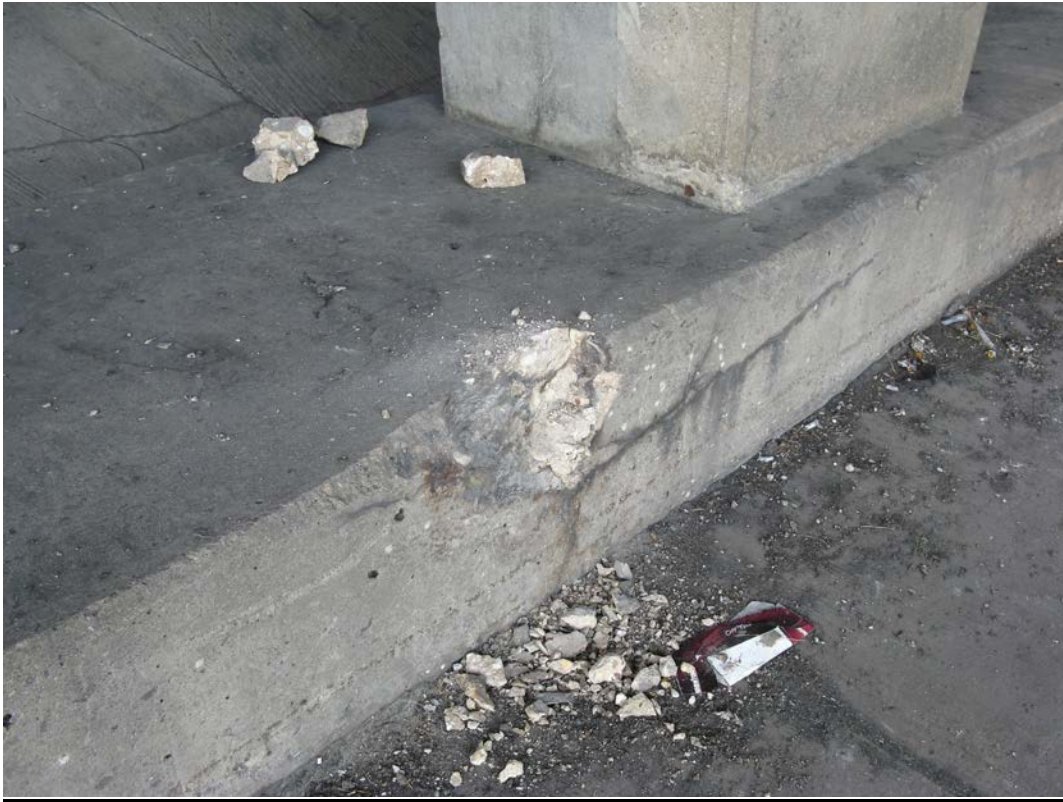
Photo 35 - Spall in East Pier crashwall, north of second column from north, west face, looking southeast

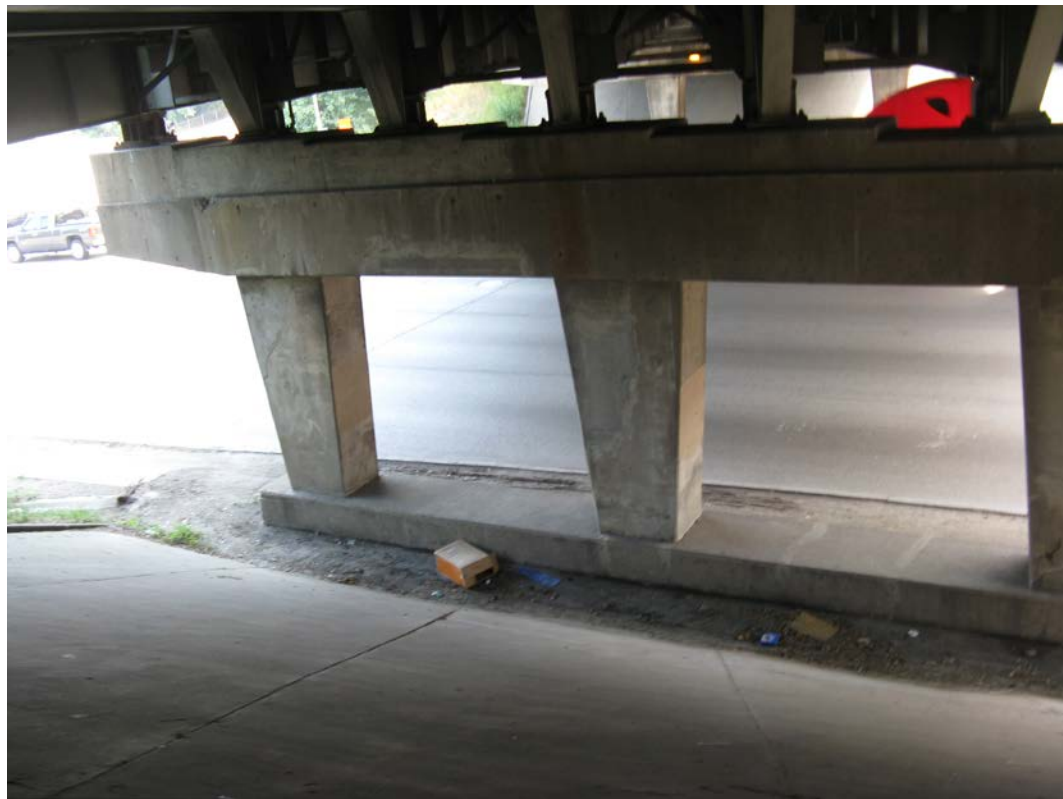
Photo 36 - West Pier, west face, north end, looking northeast

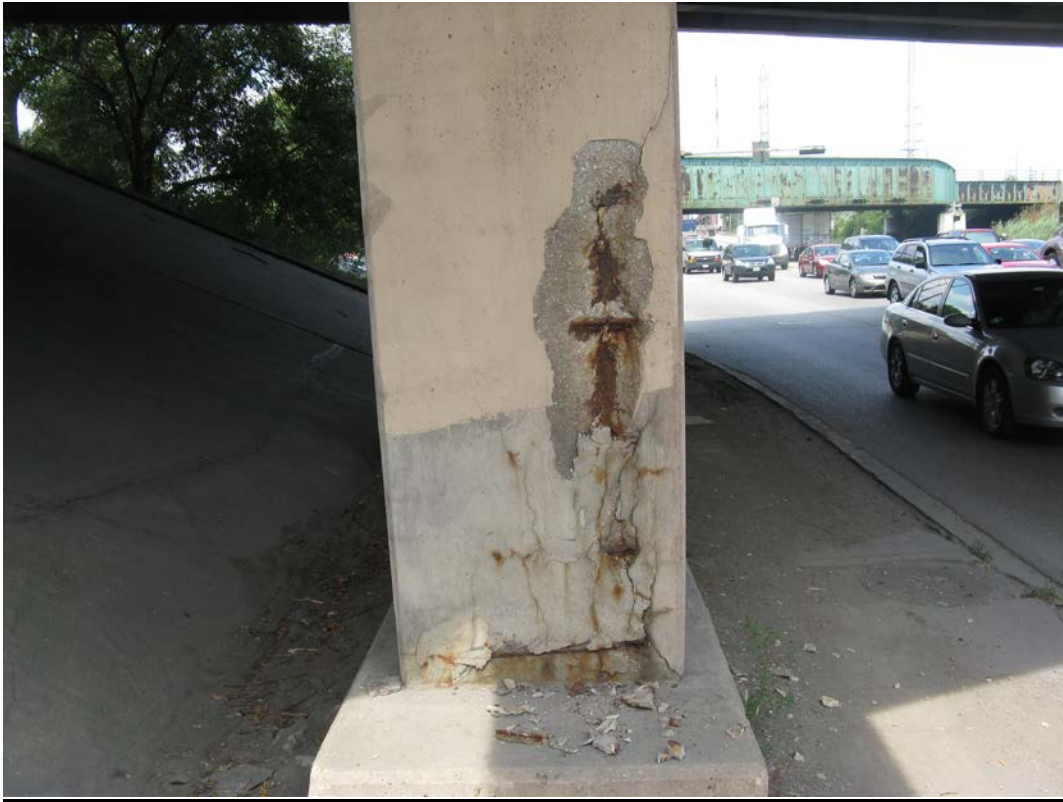
Photo 37 - Spall on West Pier, south face, bottom of fourth column from north, looking north

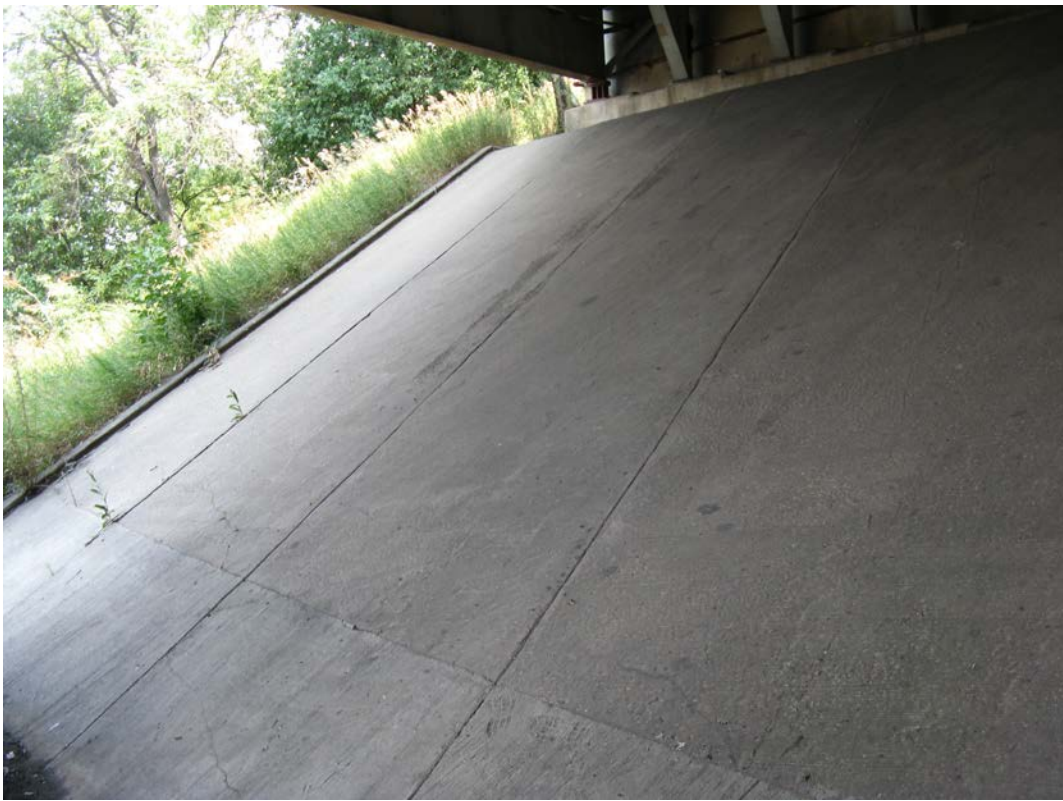
Photo 38 - North half of east slopewall, looking northeast

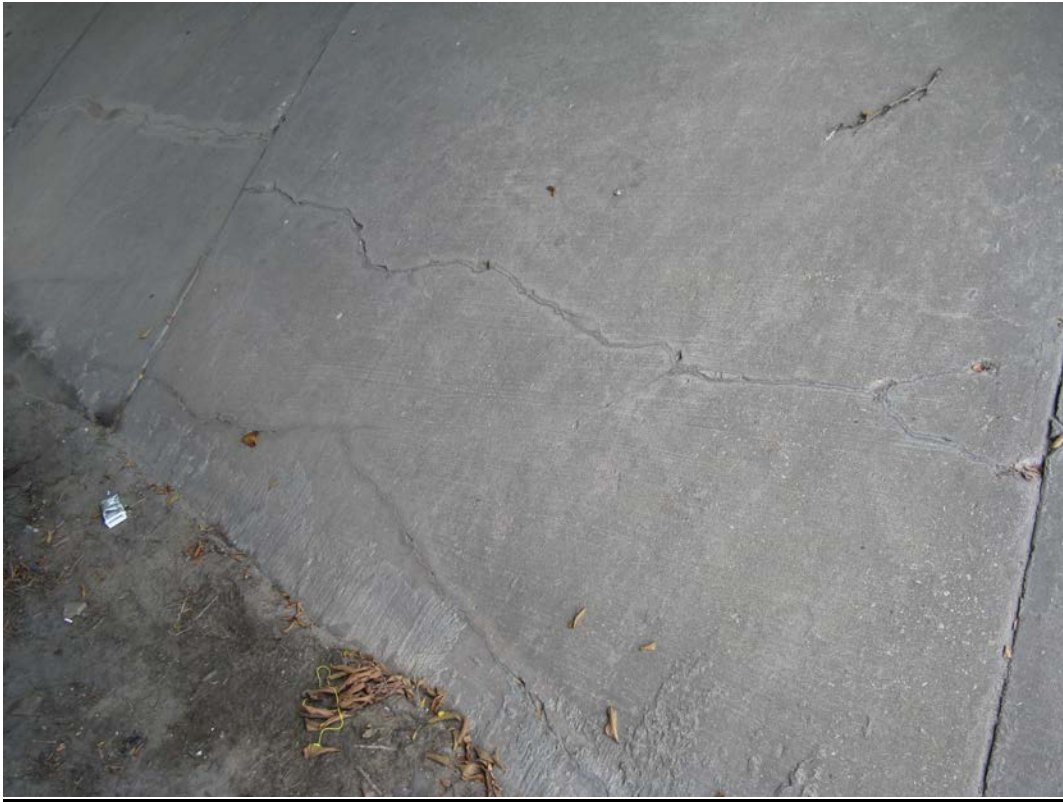
Photo 39 – Cracks in north end of west sloped wall, looking southwest

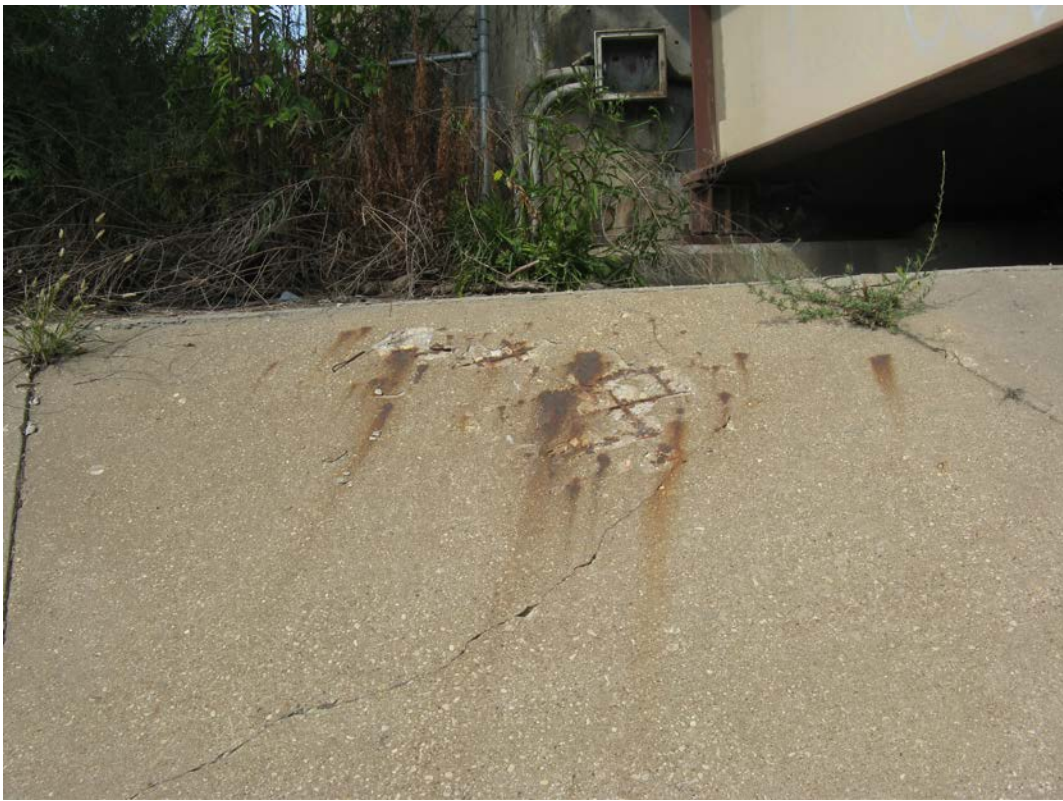
Photo 40 - Spall in west sloped wall, looking west

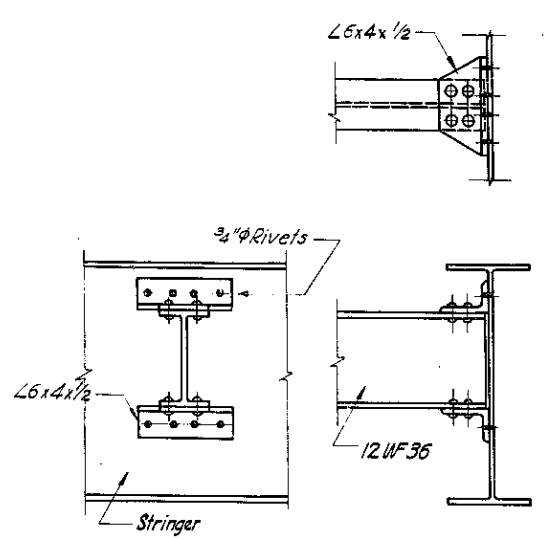
DIAPHRAGM D-2 CONNECTION DETAIL
SCALE: 1" = 1'-0"

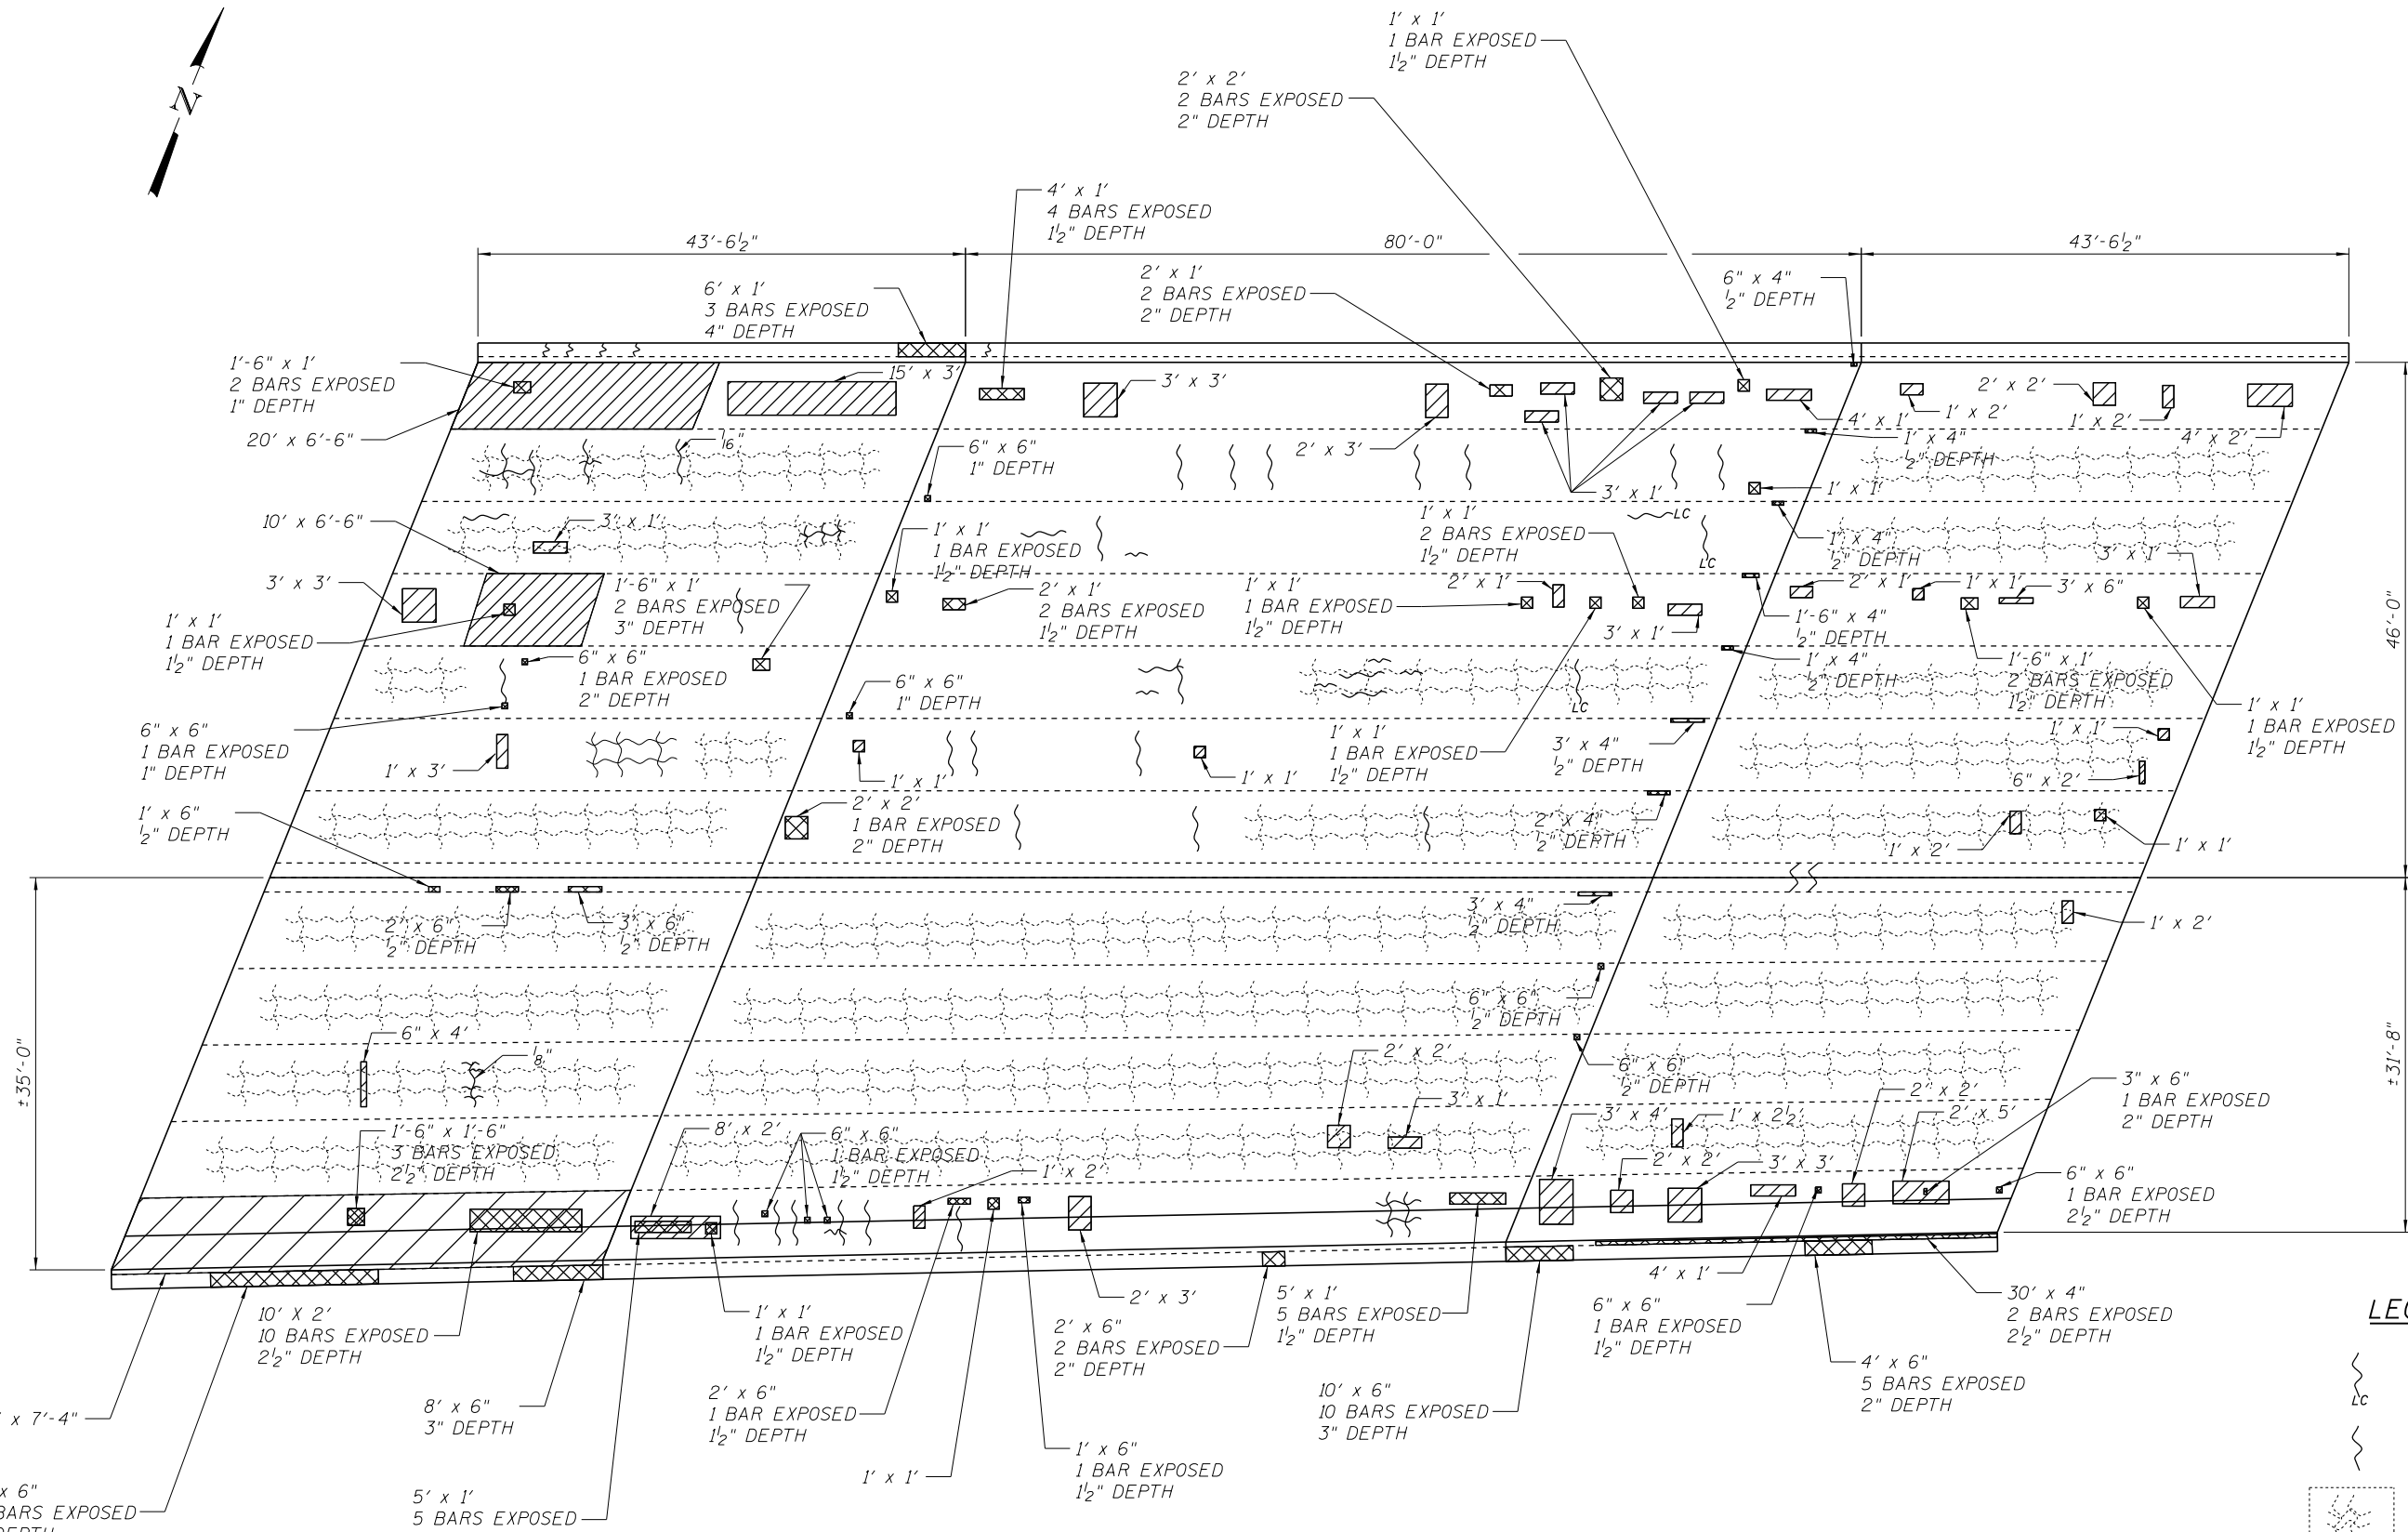
UNDERSIDE OF DECK
(EASTBOUND BRIDGE)

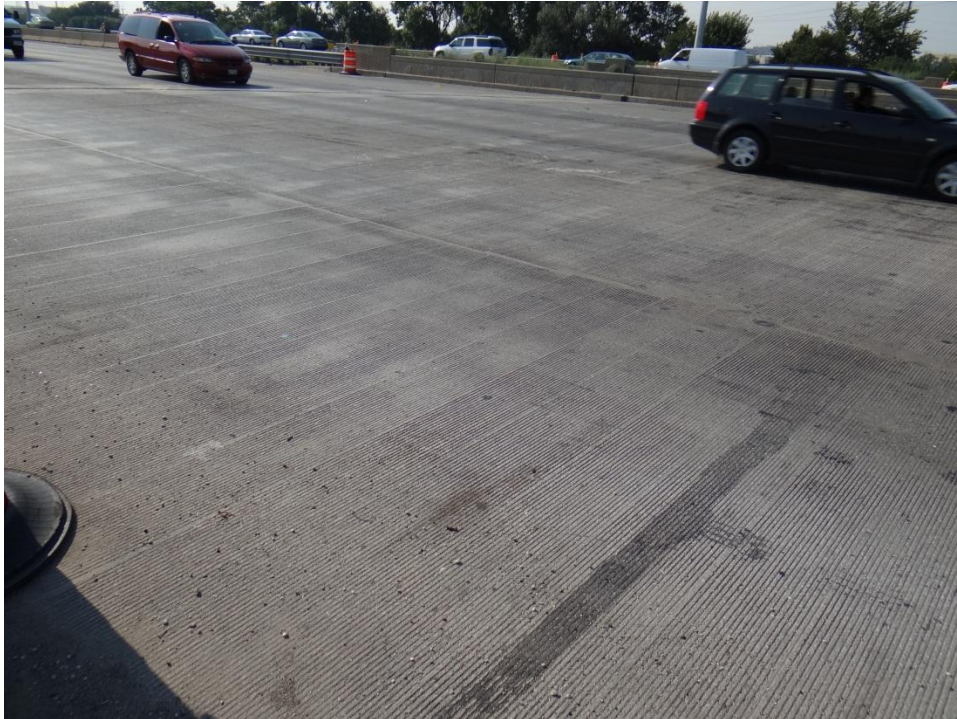
Figure 4. Typical view, deck top surface, looking northwest

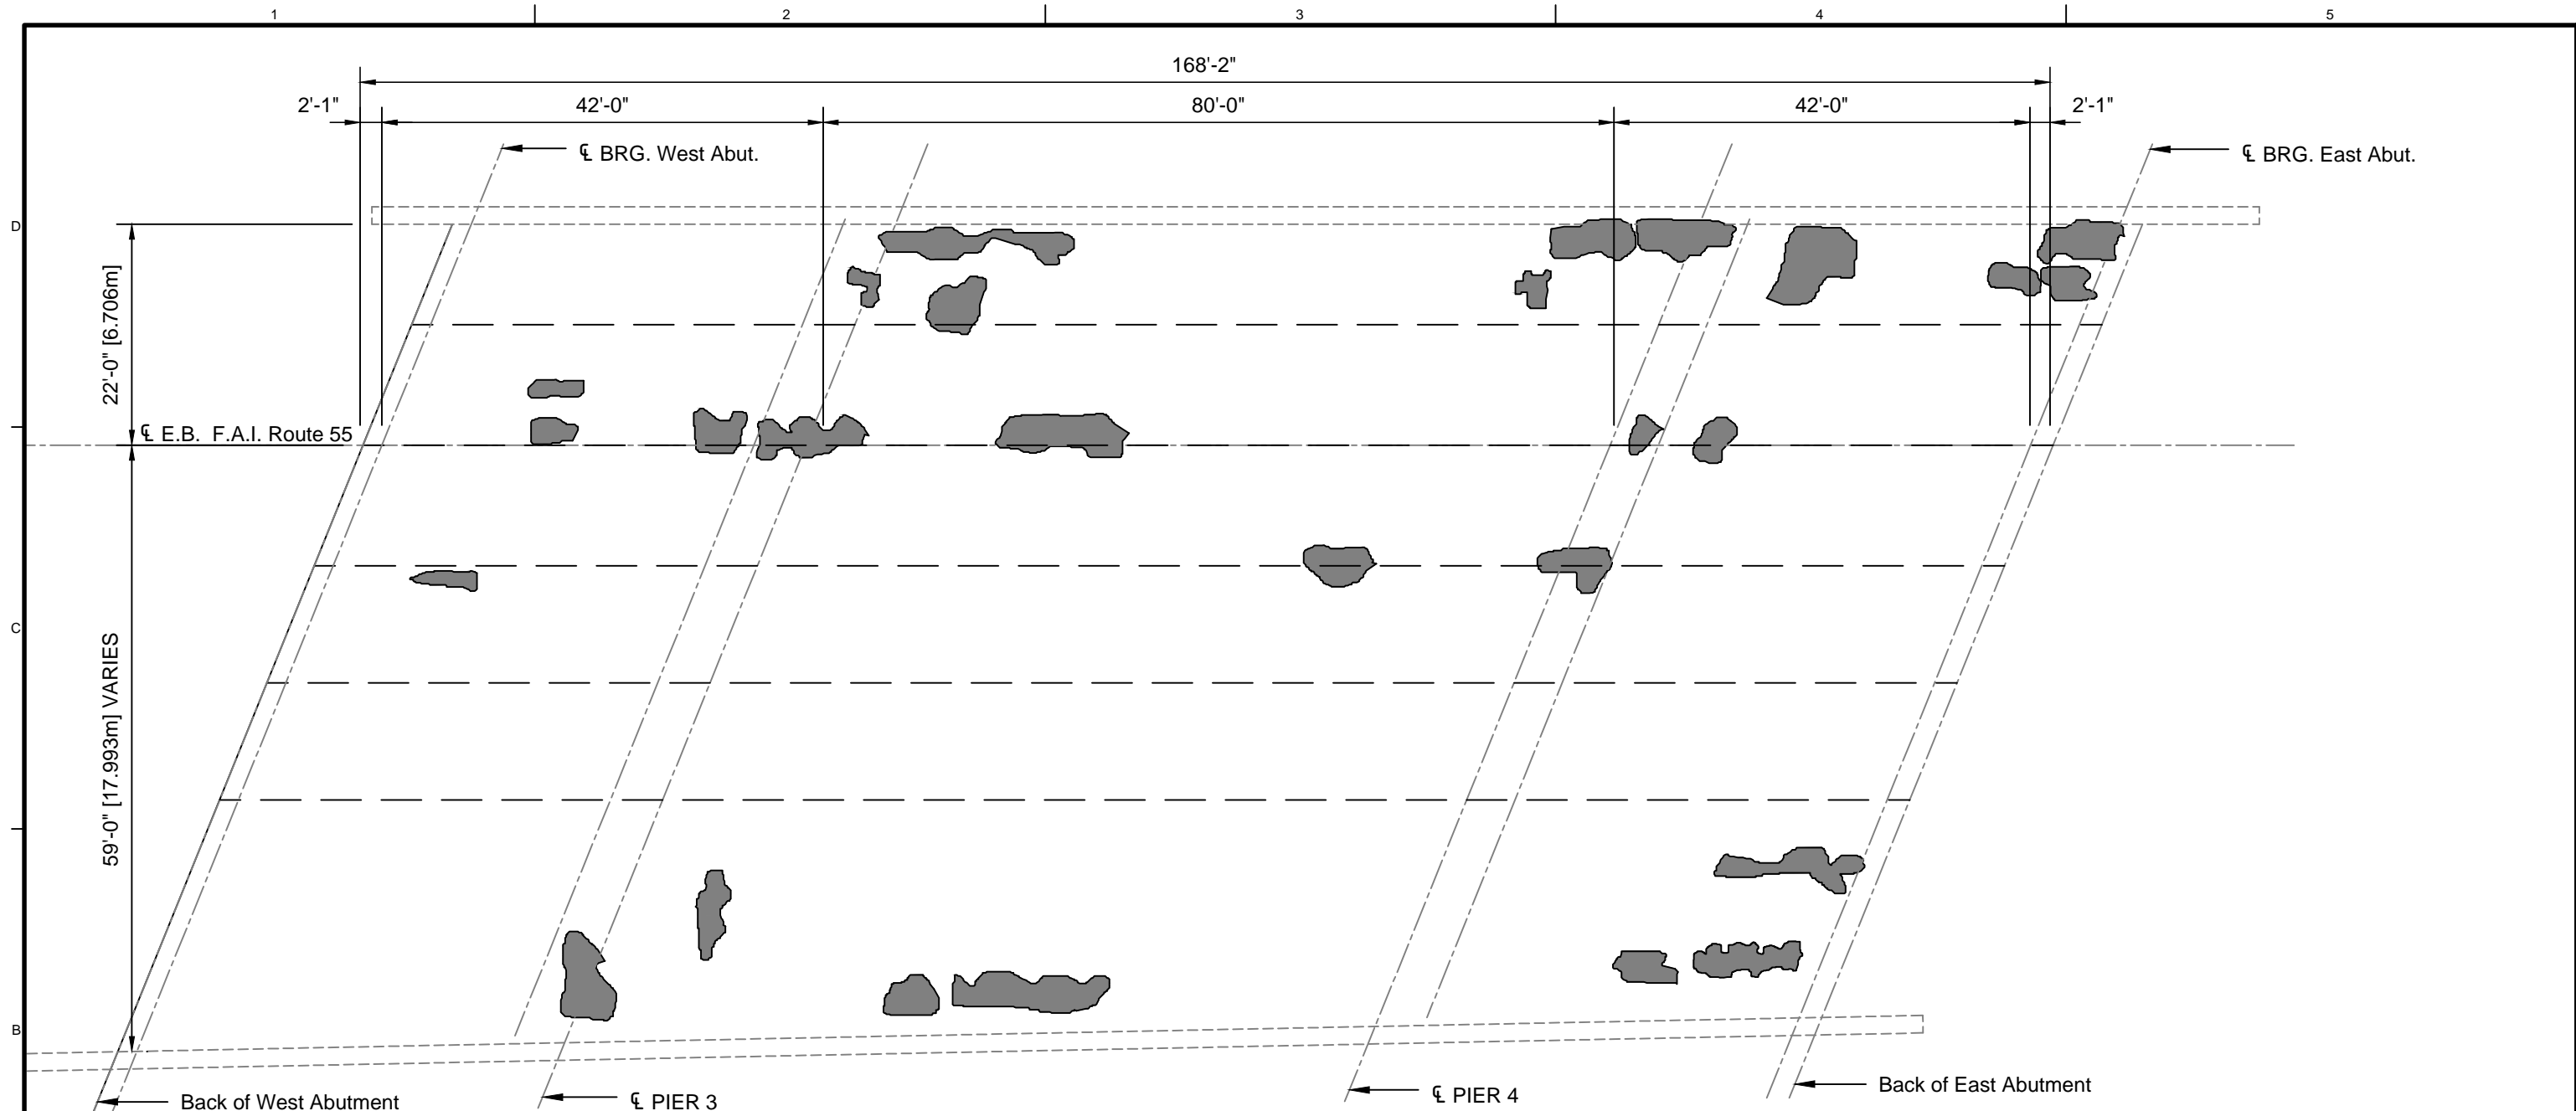
FIELD OBSERVATION SUMMARY		STRUCTURE # 016-0018		LEGEND	
ITEM	UNIT	QUANT.	%	DELAMINATION	SPALL
TOTAL AREA	Ac	13260	100		
DELAMINATION	Ac	605	4.6		
SPALL	Ac	0	0		
CRACKS	ft	-	-

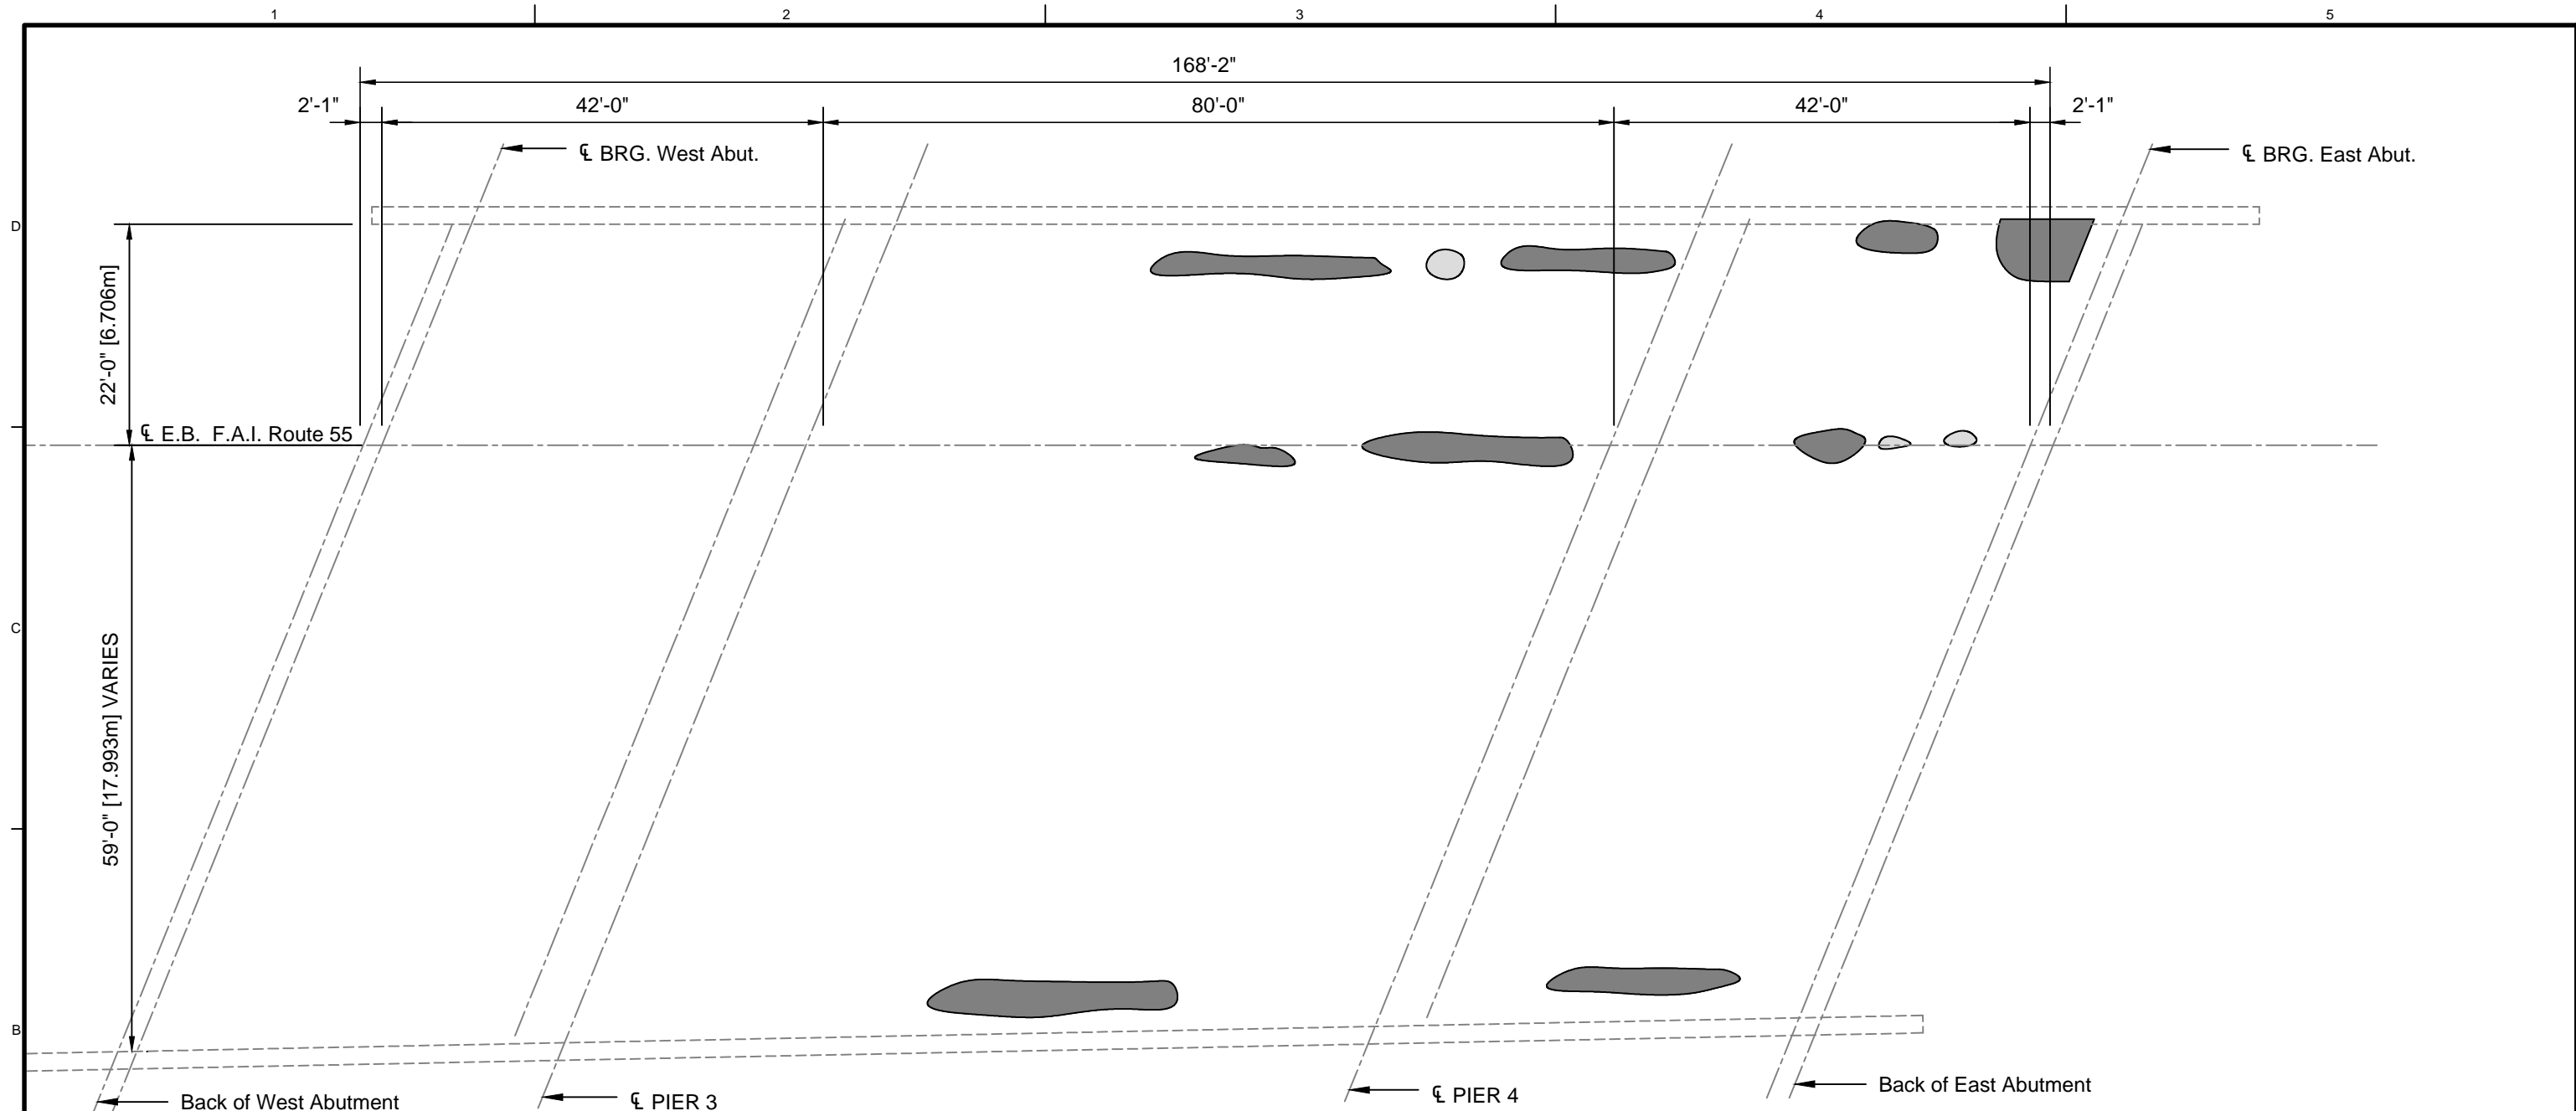
FIELD OBSERVATION SUMMARY		STRUCTURE # 016-0018		LEGEND	
ITEM	UNIT	QUANT.	%		
TOTAL AREA	Ac	13260	100	DELAMINATION	
DELAMINATION	Ac	355	2.7	SPALL	
SPALL	Ac	20	0.2	PREV. REPAIR	
PREVIOUS REPAIRS	Ac	2130	16.1	CRACK	
CRACKS	ft	-	-
