I-55 Managed Lanes Combined Design Report

Appendix A.3 – Structures

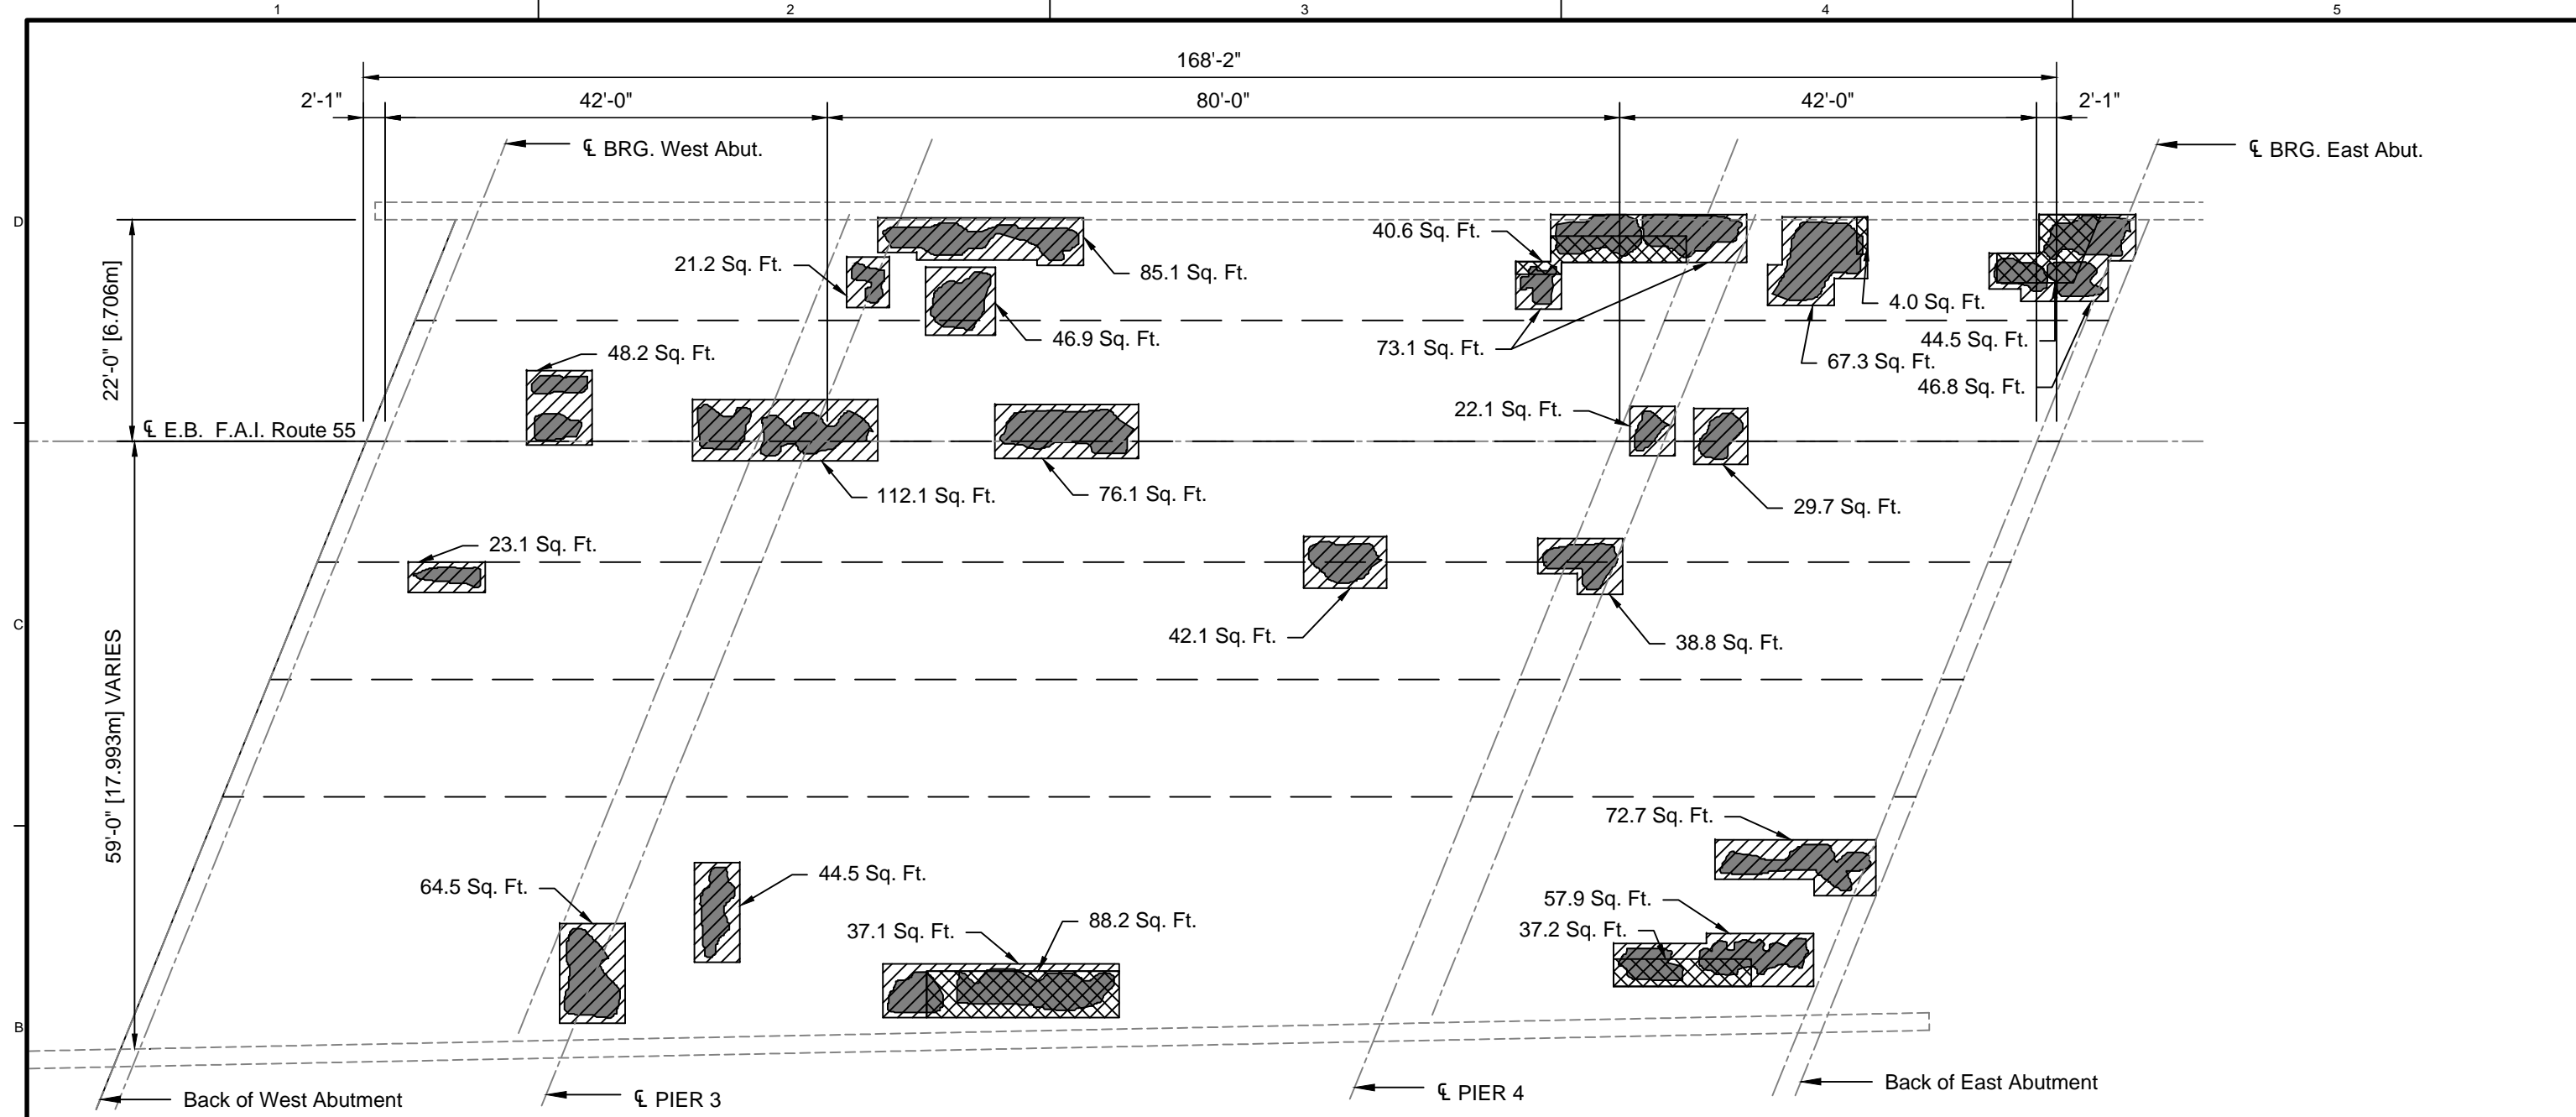
FIELD OBSERVATION SUMMARY		STRUCTURE # 016-0018		LEGEND	
ITEM	UNIT	QUANT.	%		
TOTAL AREA	Ac	13260	100	PARTIAL DEPTH REPAIR	
PARTIAL DEPTH REPAIR	Ac	1009	7.6	FULL DEPTH REPAIR	
FULL DEPTH REPAIR	Ac	214	1.6	DELAMINATION	
DELAMINATION	Ac	605	4.6	SPALL	
SPALL	Ac	0	0	CRACK	
CRACKS	ft	-	-

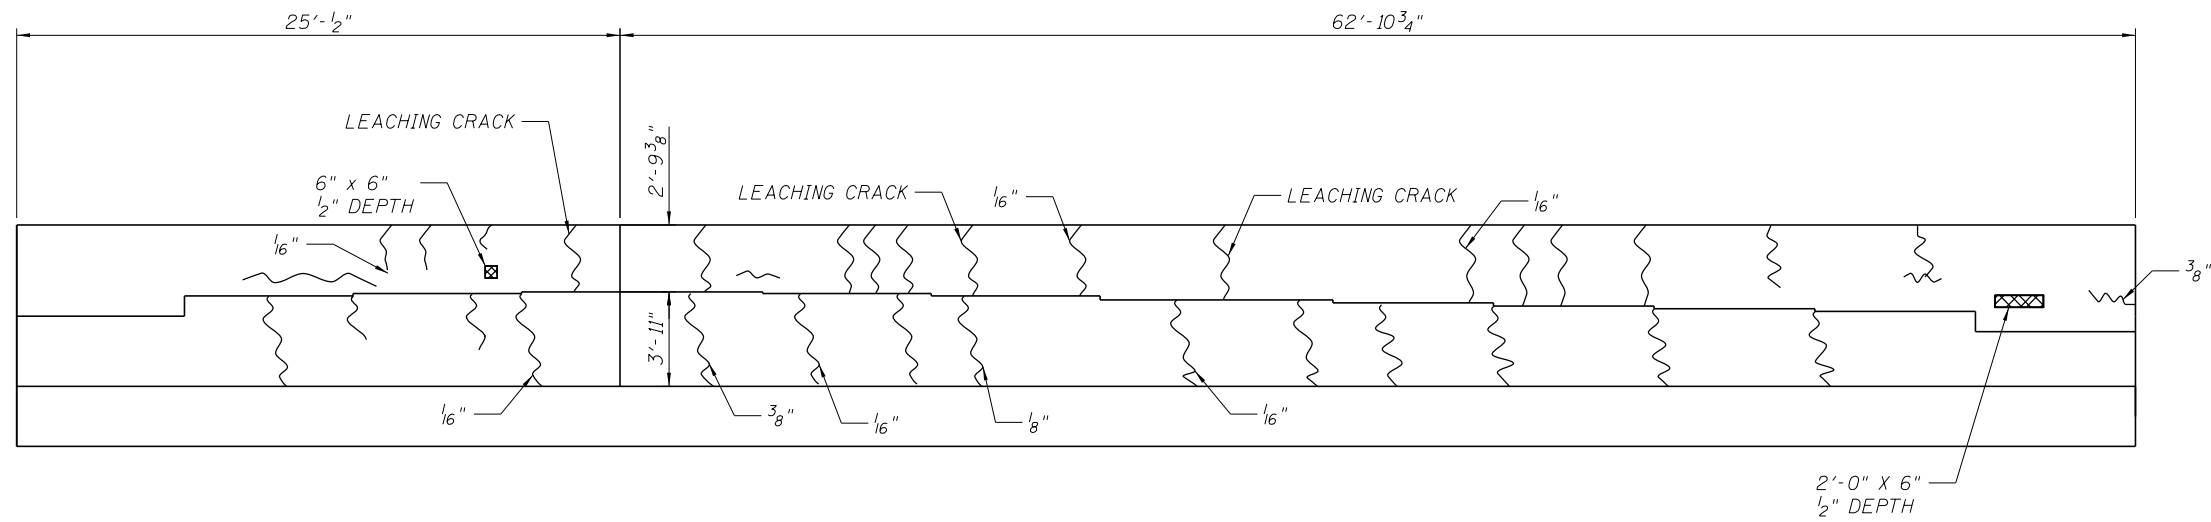
EAST ABUTMENT LOOKING EAST

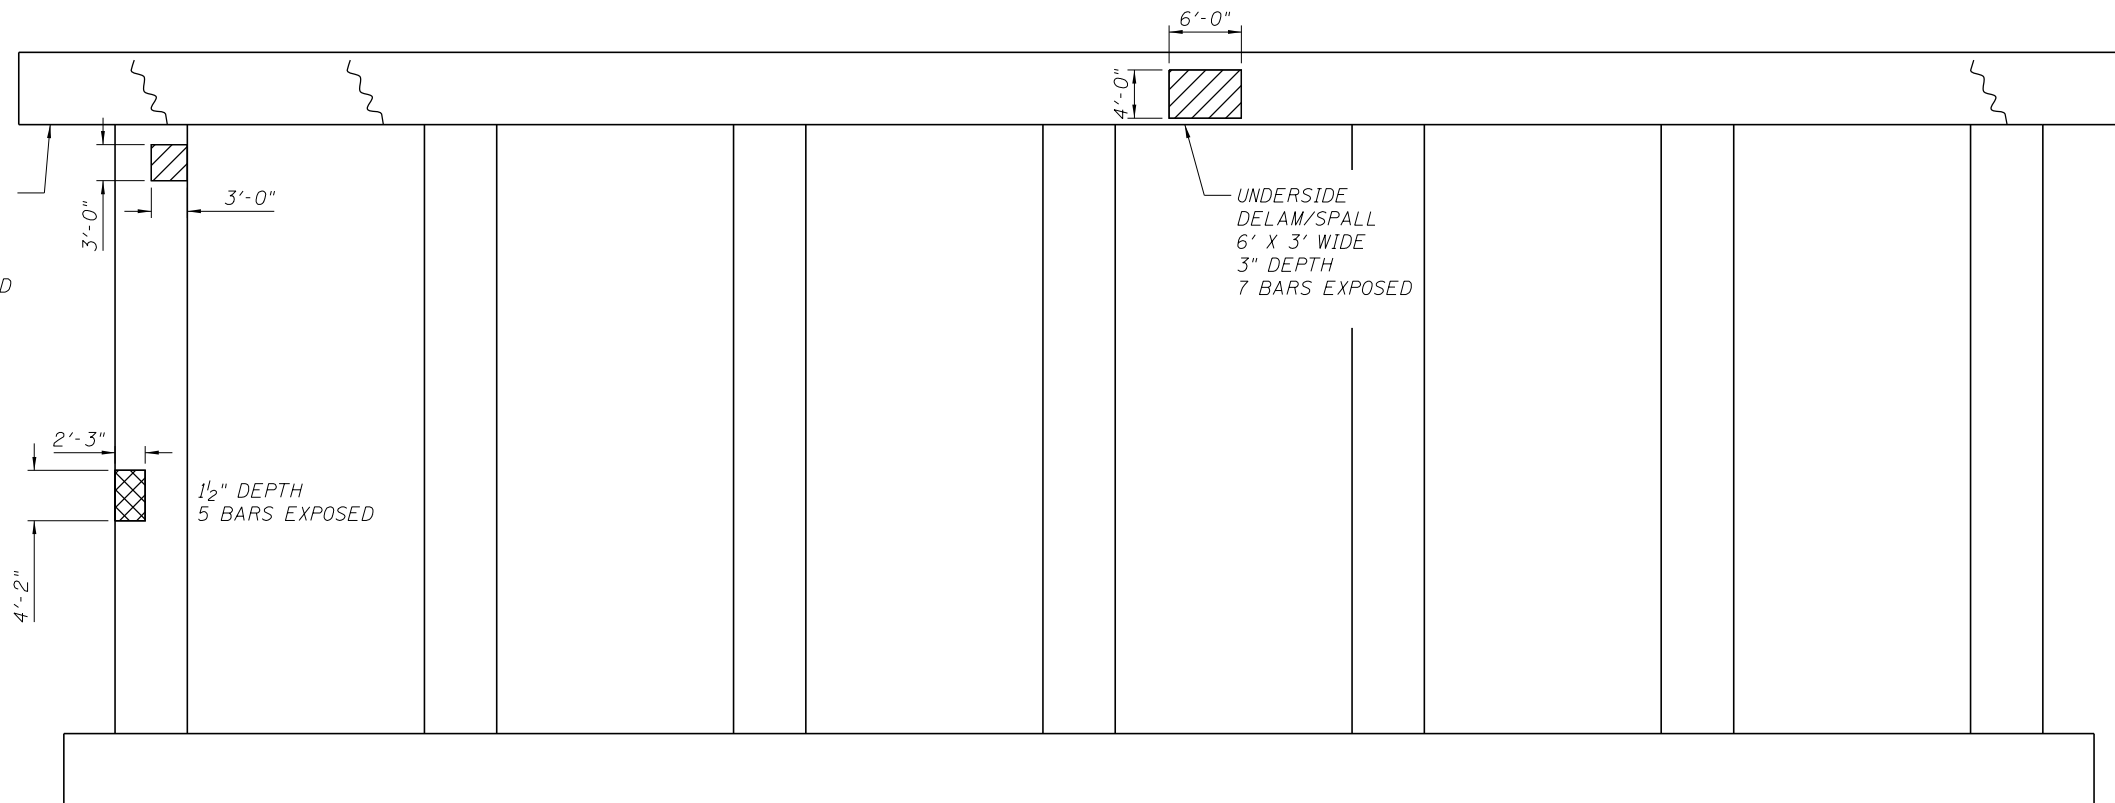
UNDERSIDE
SPALL
1' 6" X 3' WIDE
1 1/2" DEPTH
3 BARS EXPOSED

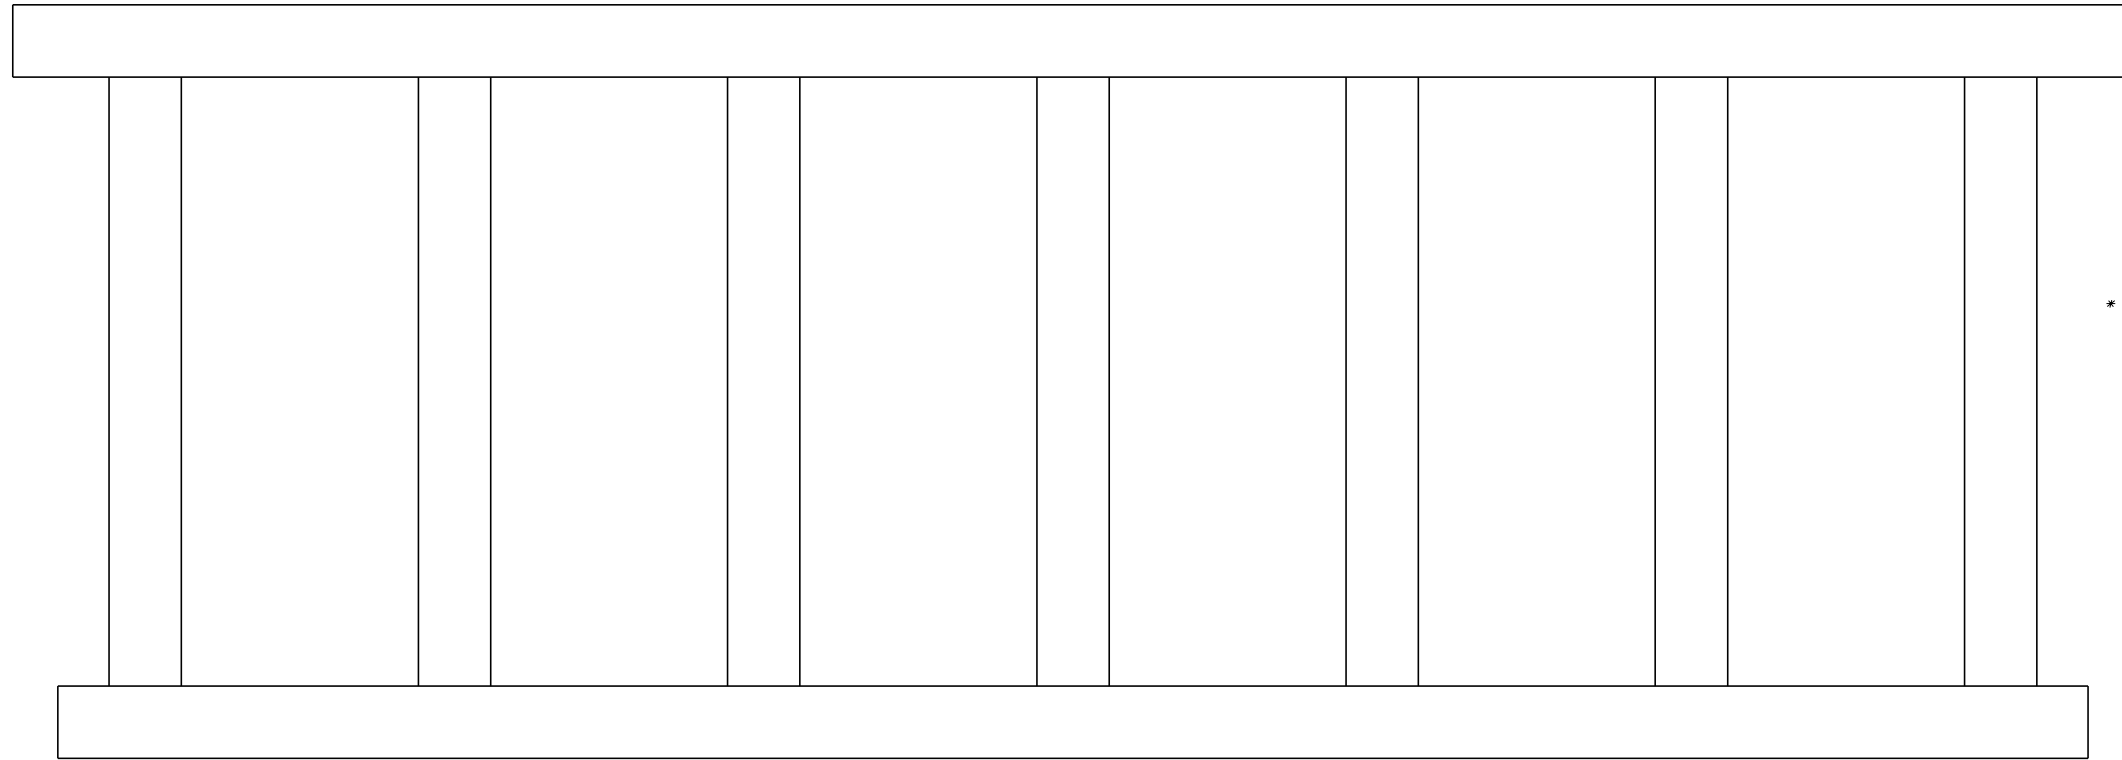
F.A.I. RTE.	SECTION	COUNTY	TOTAL SHEETS	SHEET NO.
55	1212-620-VB	COOK		
CONTRACT NO.				
FED. ROAD DIST. NO. 1 ILLINOIS FED. AID PROJECT

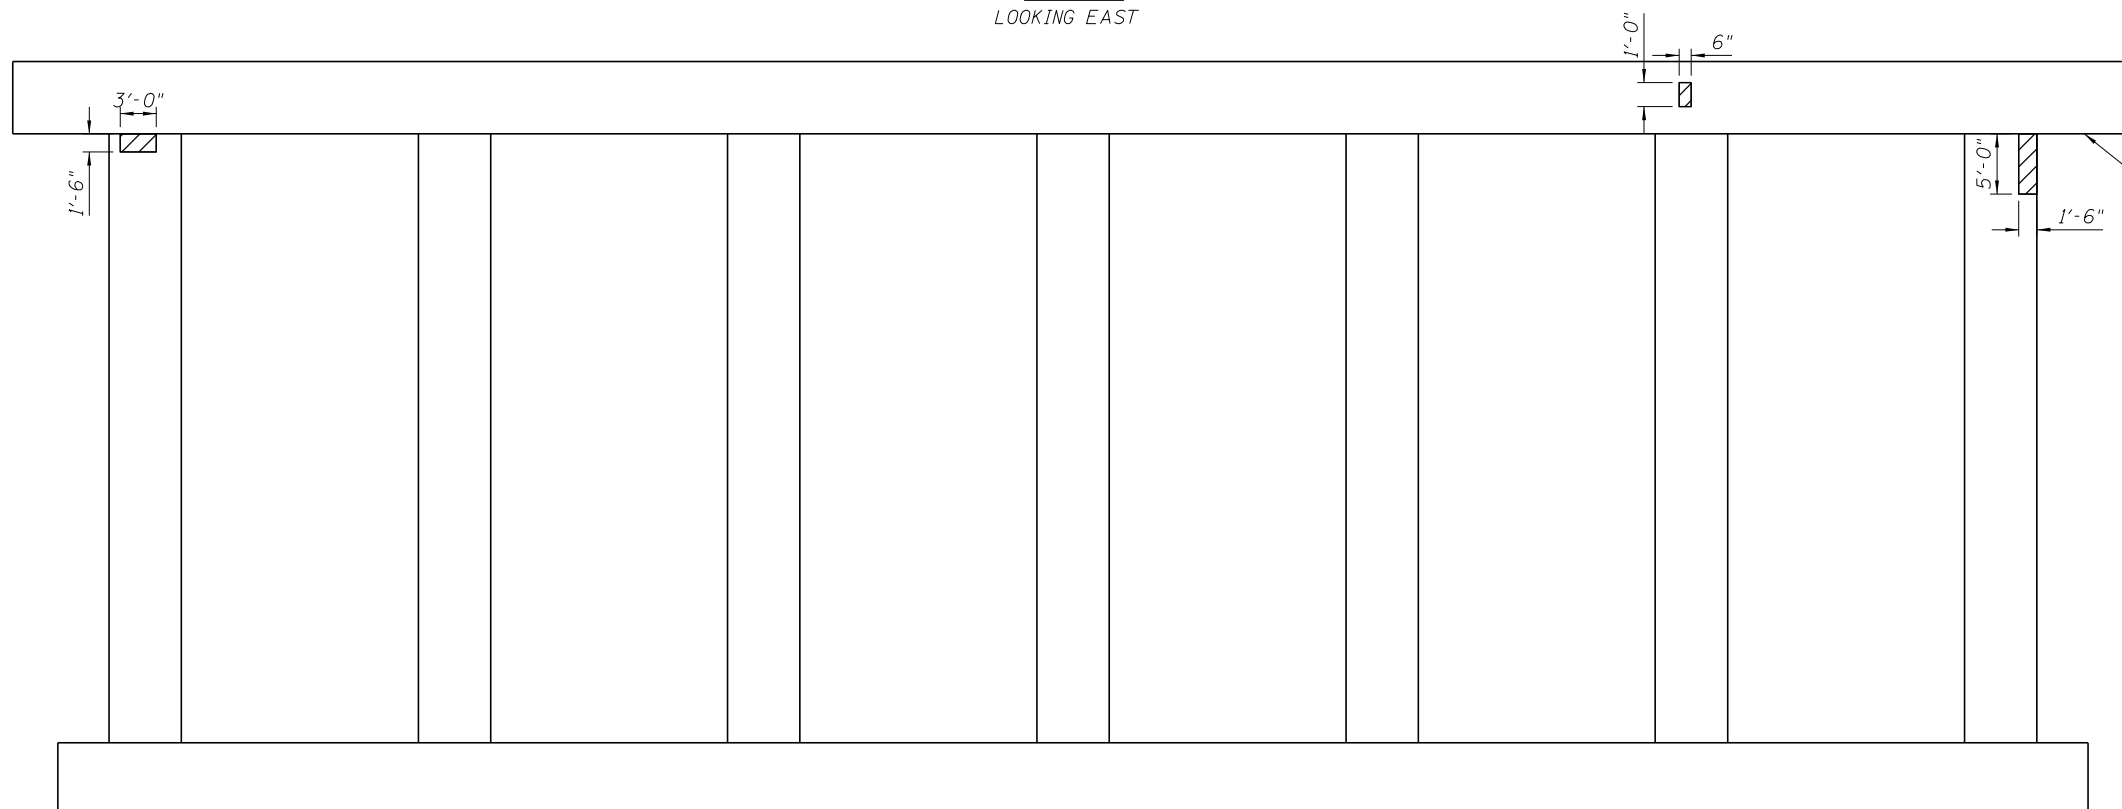
UNDERSIDE
DELAM/SPALL
1'-6" X 3'-0" WIDE
3" DEPTH
2 BARS EXPOSED

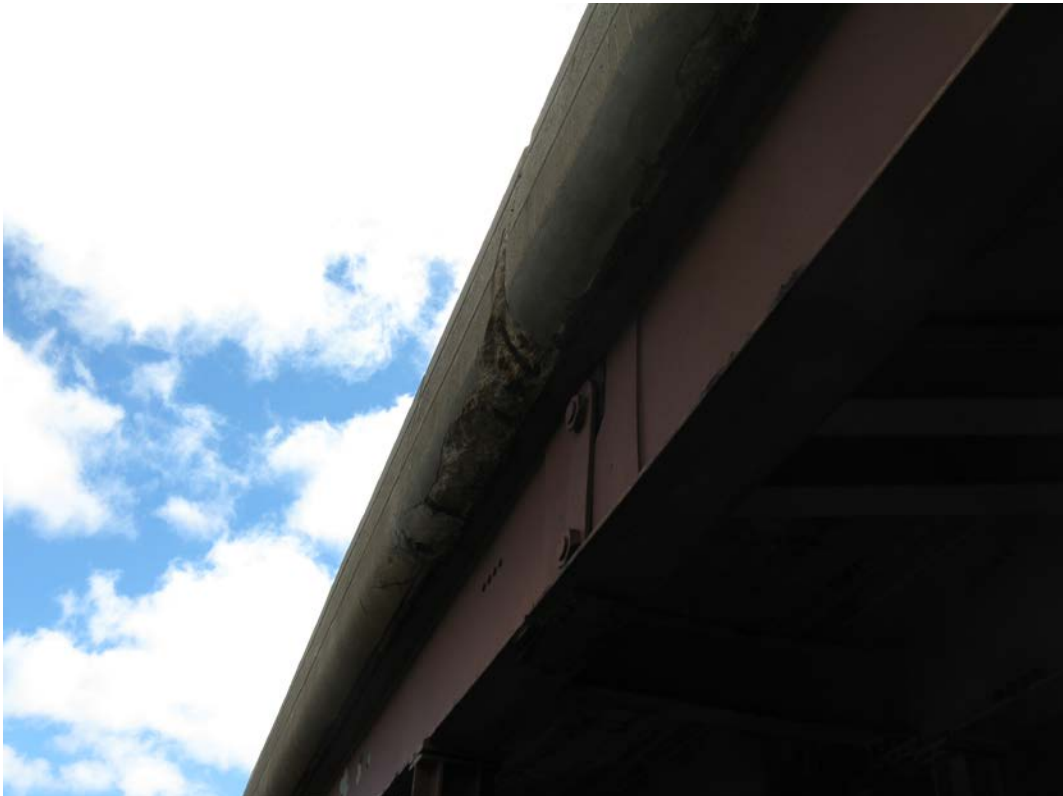
Photo 8 - Spalled parapet at north side at Span 1, looking southeast

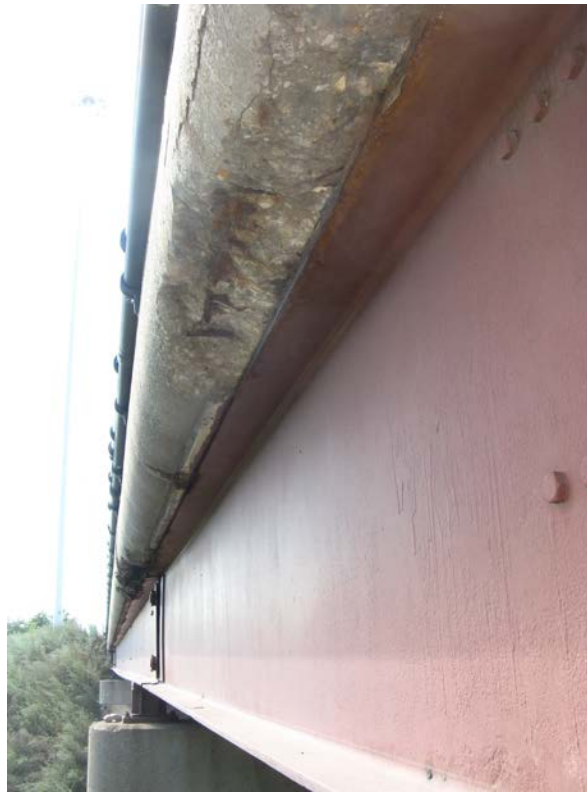
Photo 9 - Spalled parapet on south side of Span 3, looking west

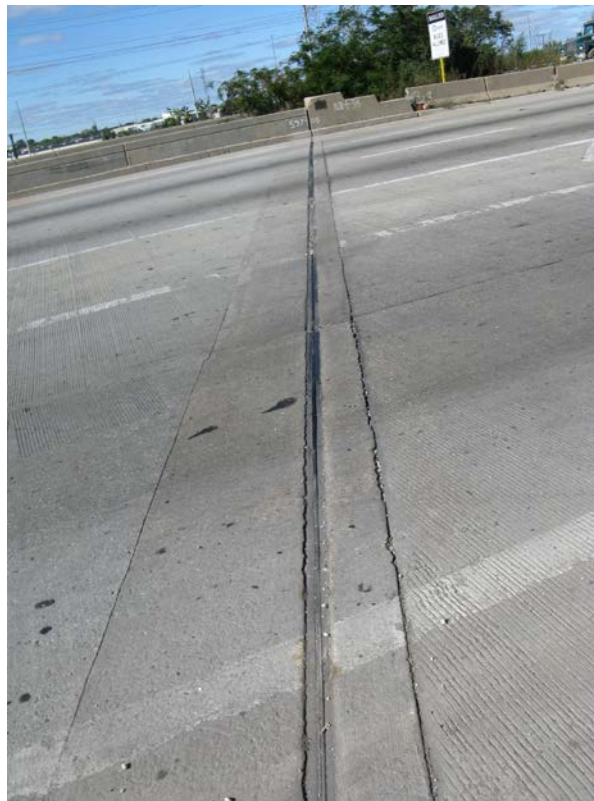
Photo 10 - East Abutment joint, looking north

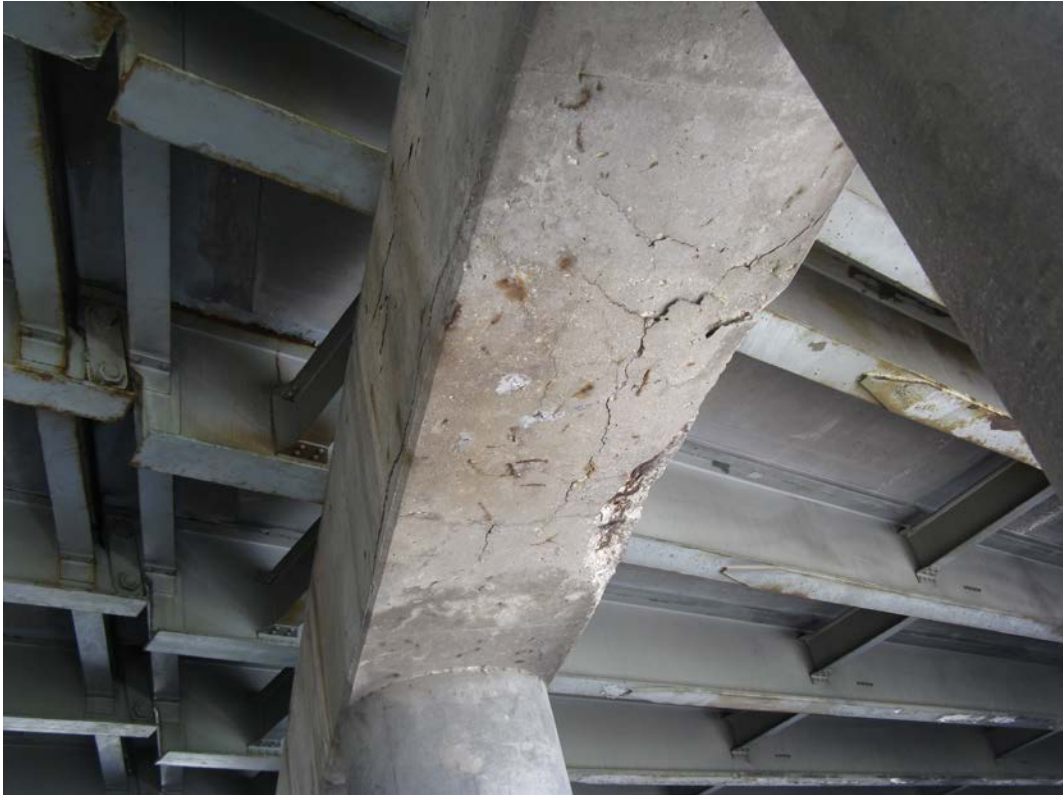
Photo 23 - Delaminated and spalled underside of Pier 1, looking northeast

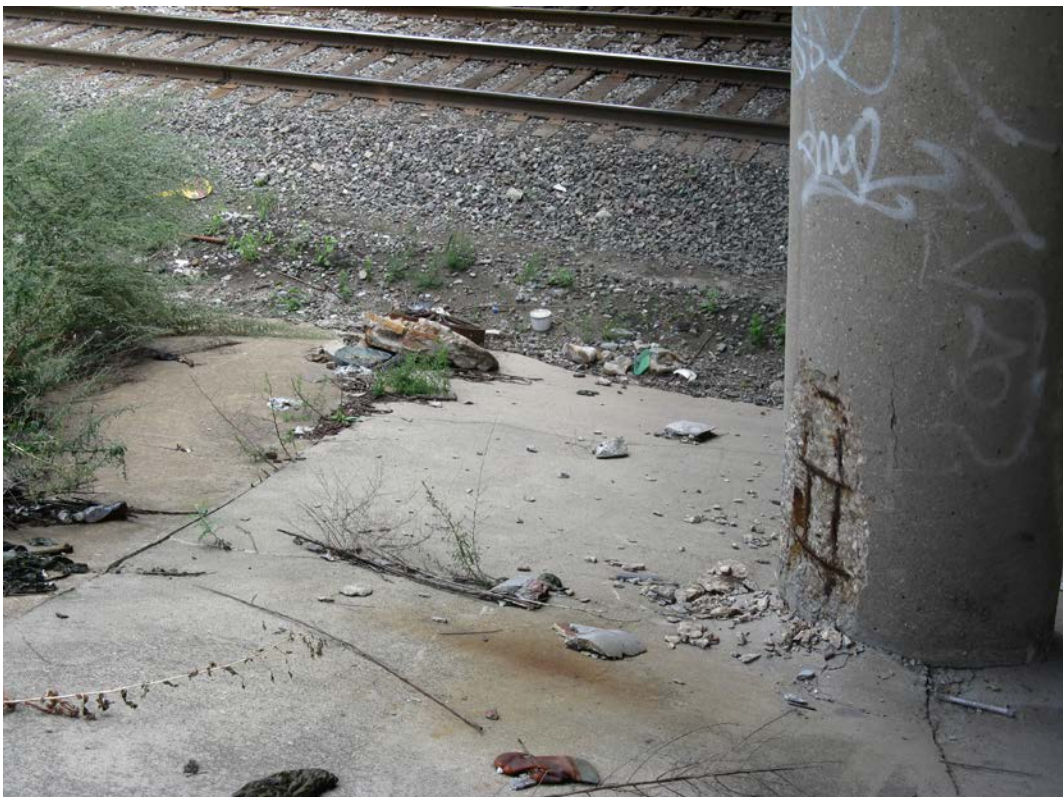
Photo 24 - Spalled column at Pier 1

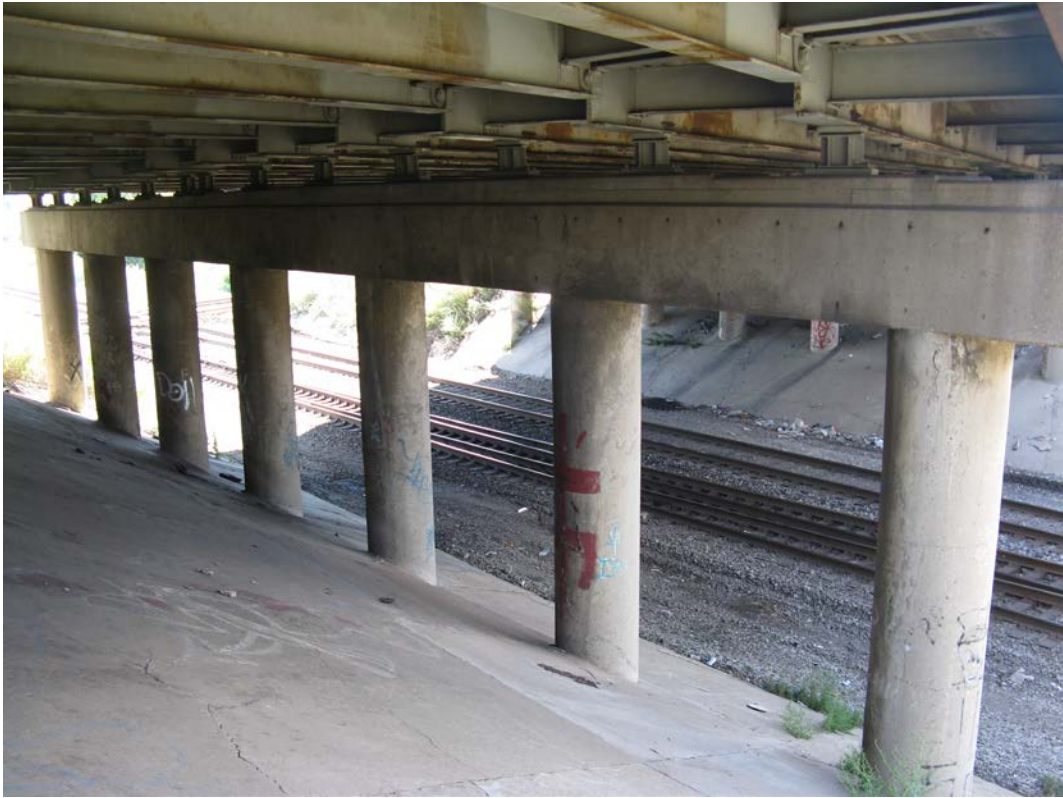
Photo 25 – Pier 2, looking southwest

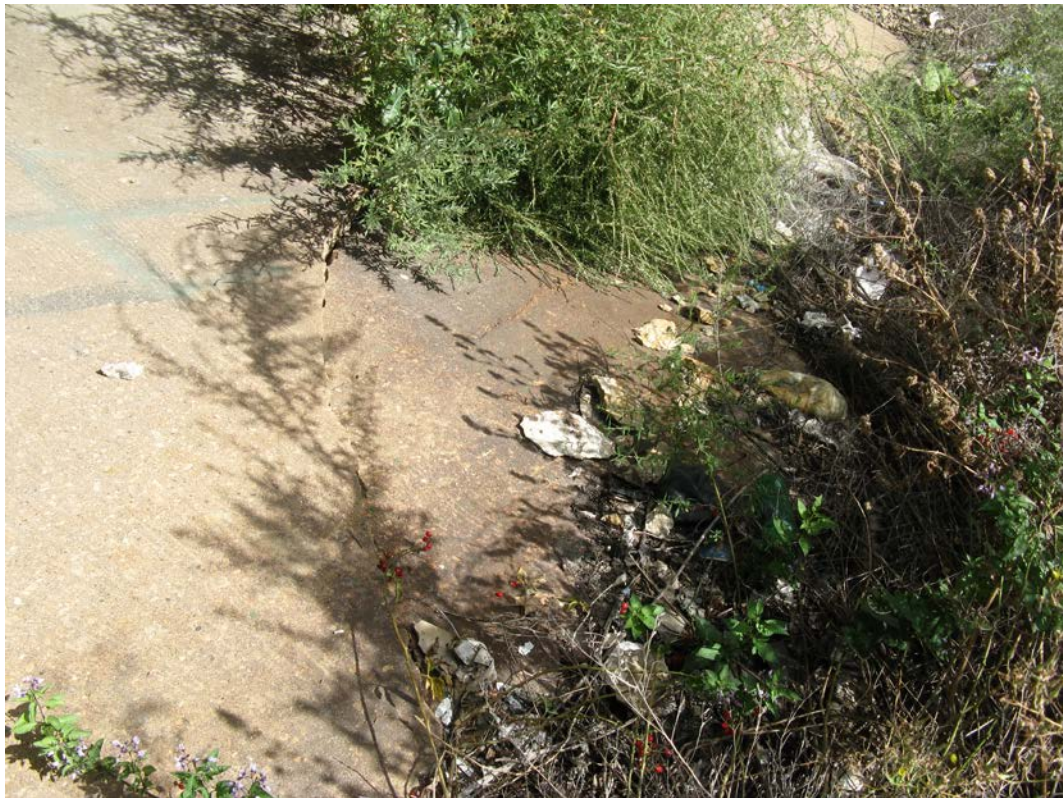
Photo 26 - Cracked west slopewall at southeast corner, looking east

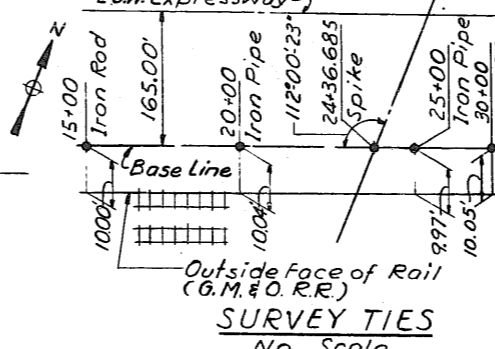
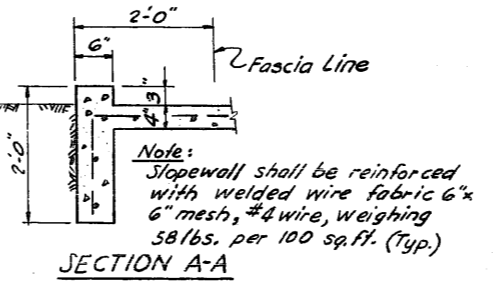
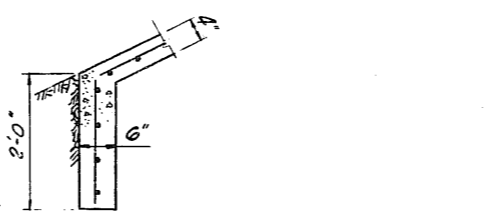
- REINFORCING STEEL:**
f_s = 20,000 psi
- STRUCTURAL STEEL: (ASTM A-36)**
f_s = 20,000 psi
- PILE LOADS:**
ABUTMENTS 25 TONS (REINFORCED CONCRETE PILES)
PIERS 20 TONS (CREOSOTED TIMBER)
APPROACH PILES = 15 TONS (CREOSOTED TIMBER)
EQUIVALENT FLUID PRESSURE = 4u pcf

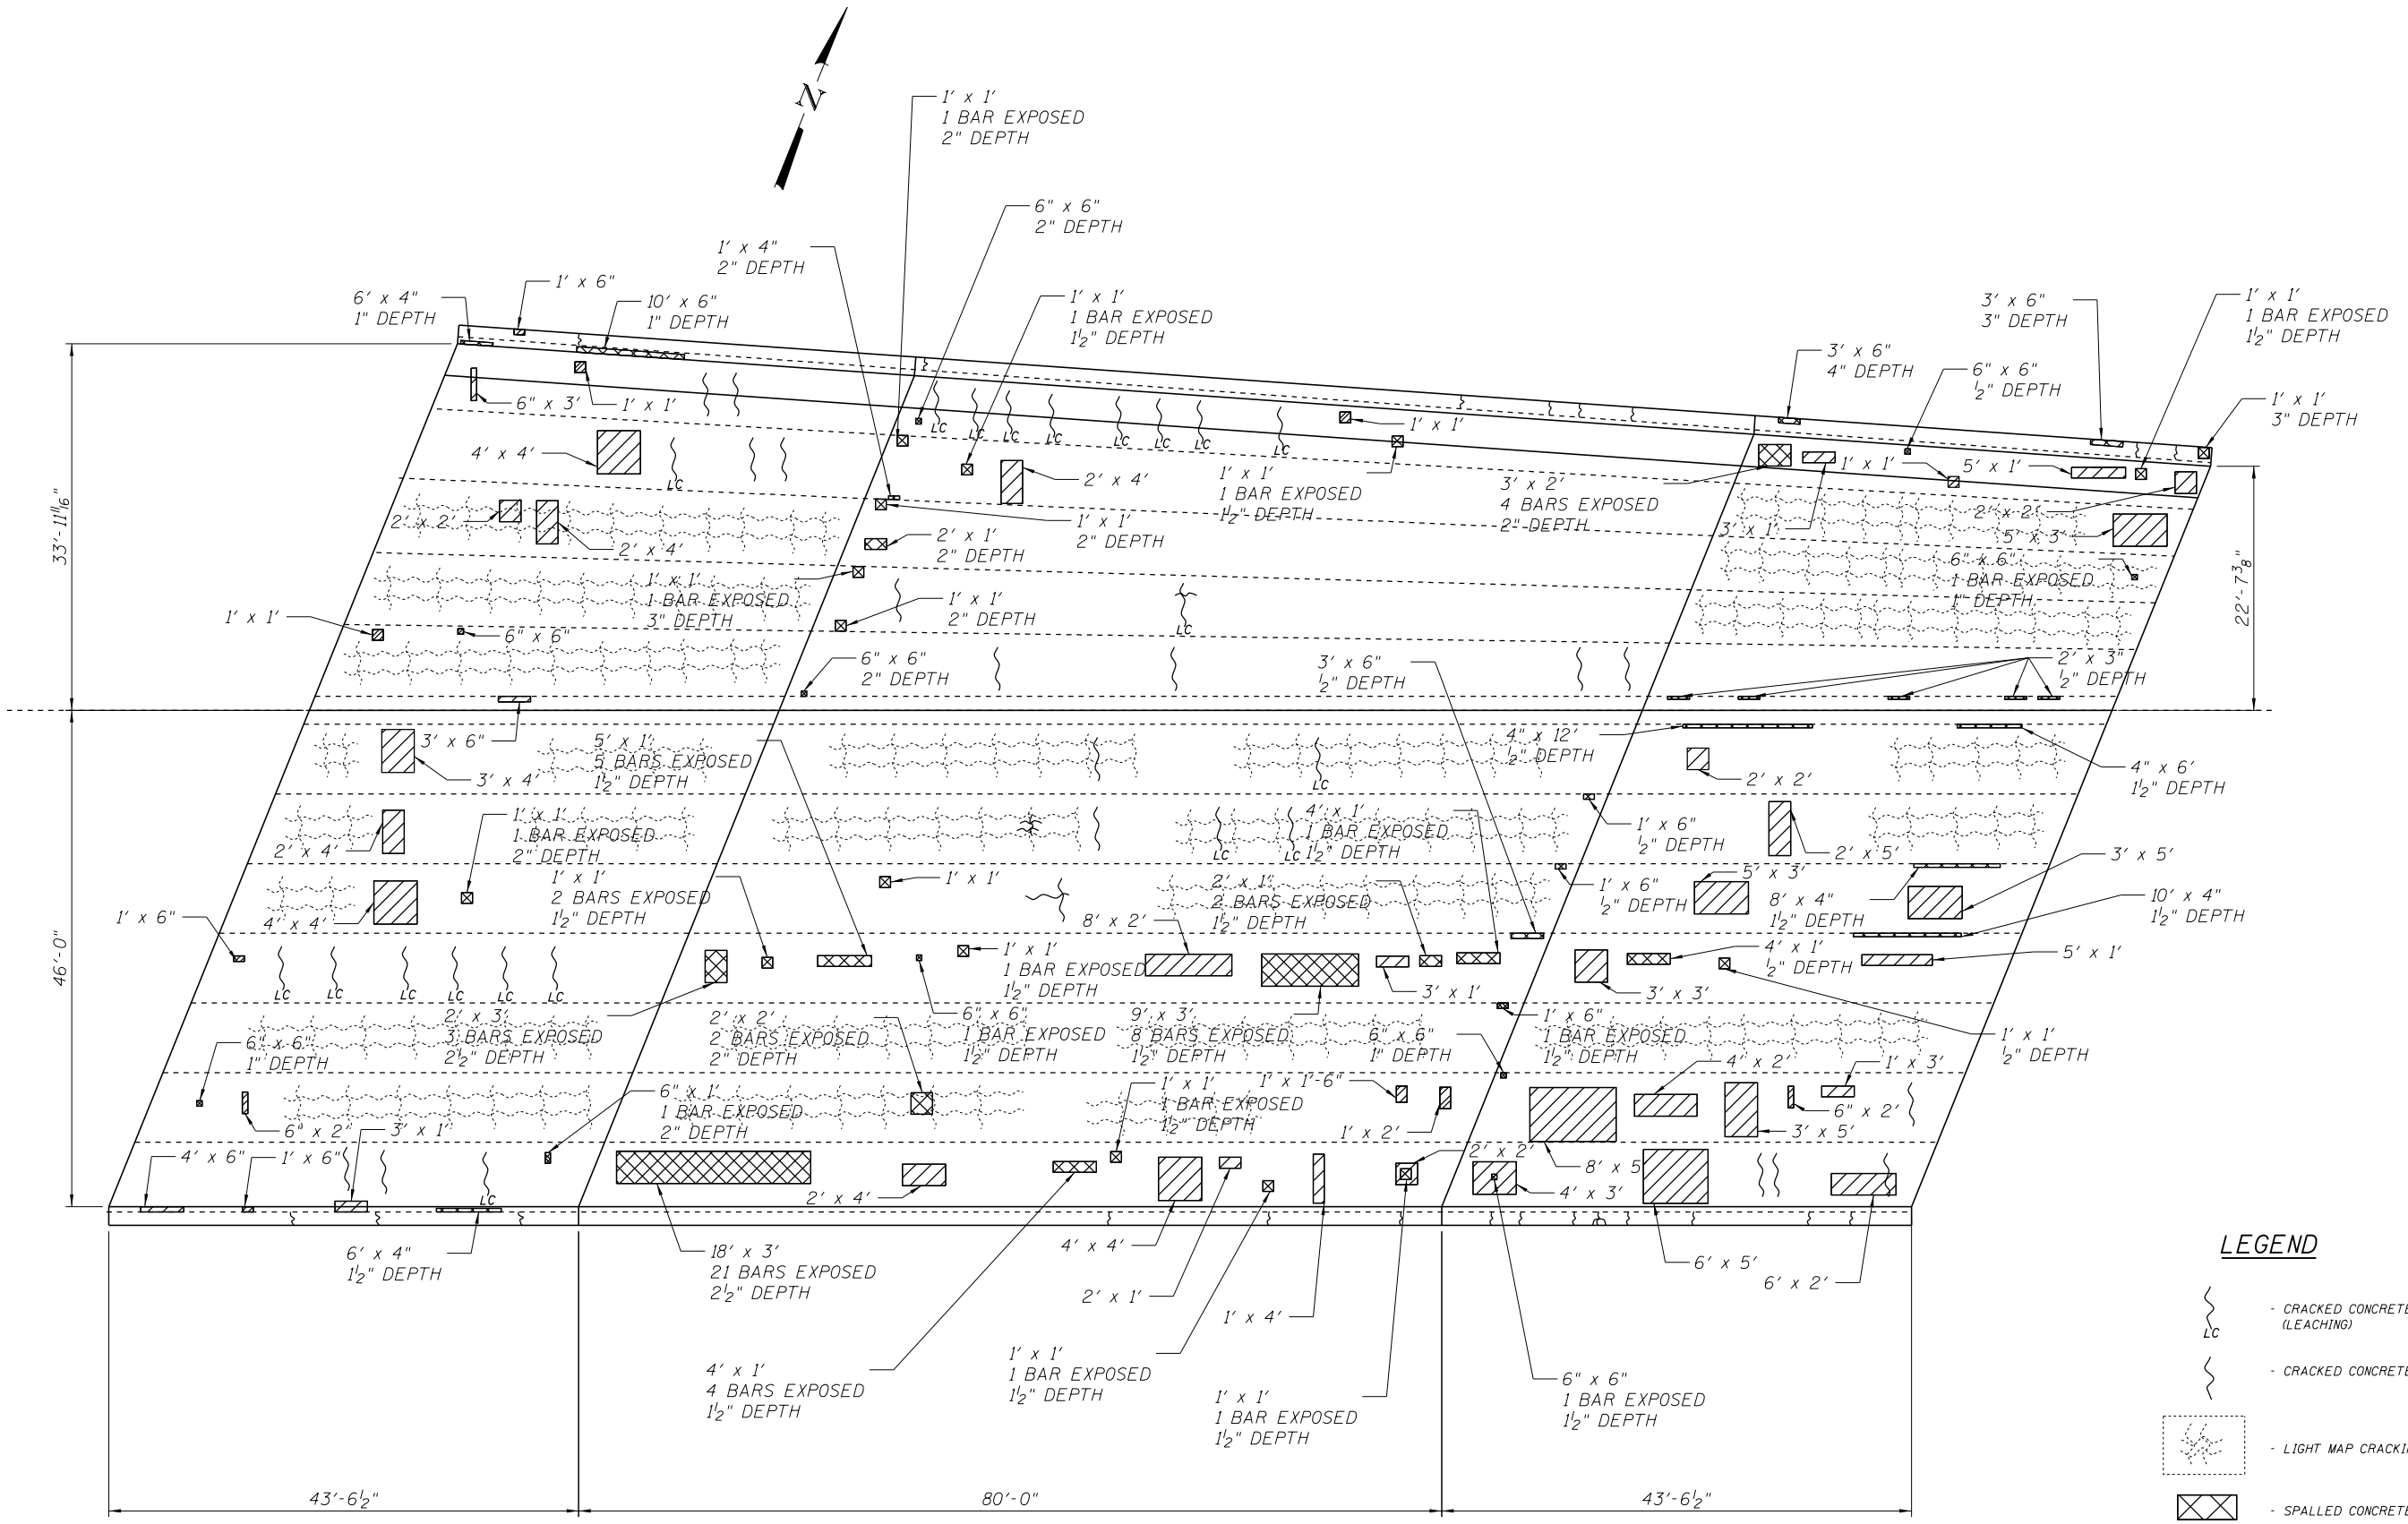
UNDERSIDE OF DECK
(WESTBOUND BRIDGE)

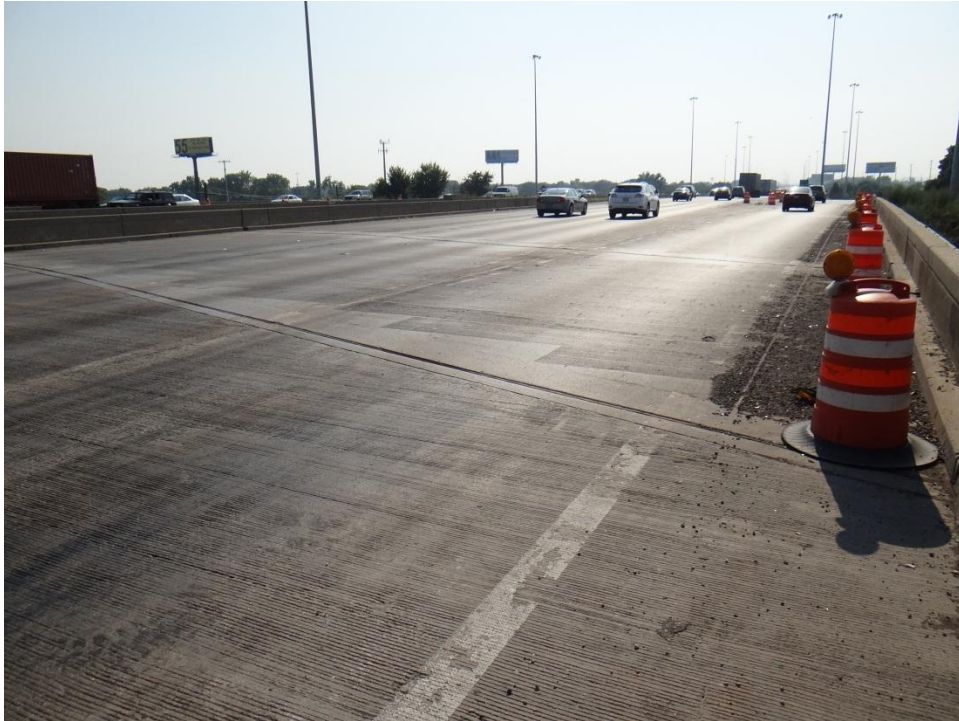
Figure 4. Typical view, deck top surface, looking southwest

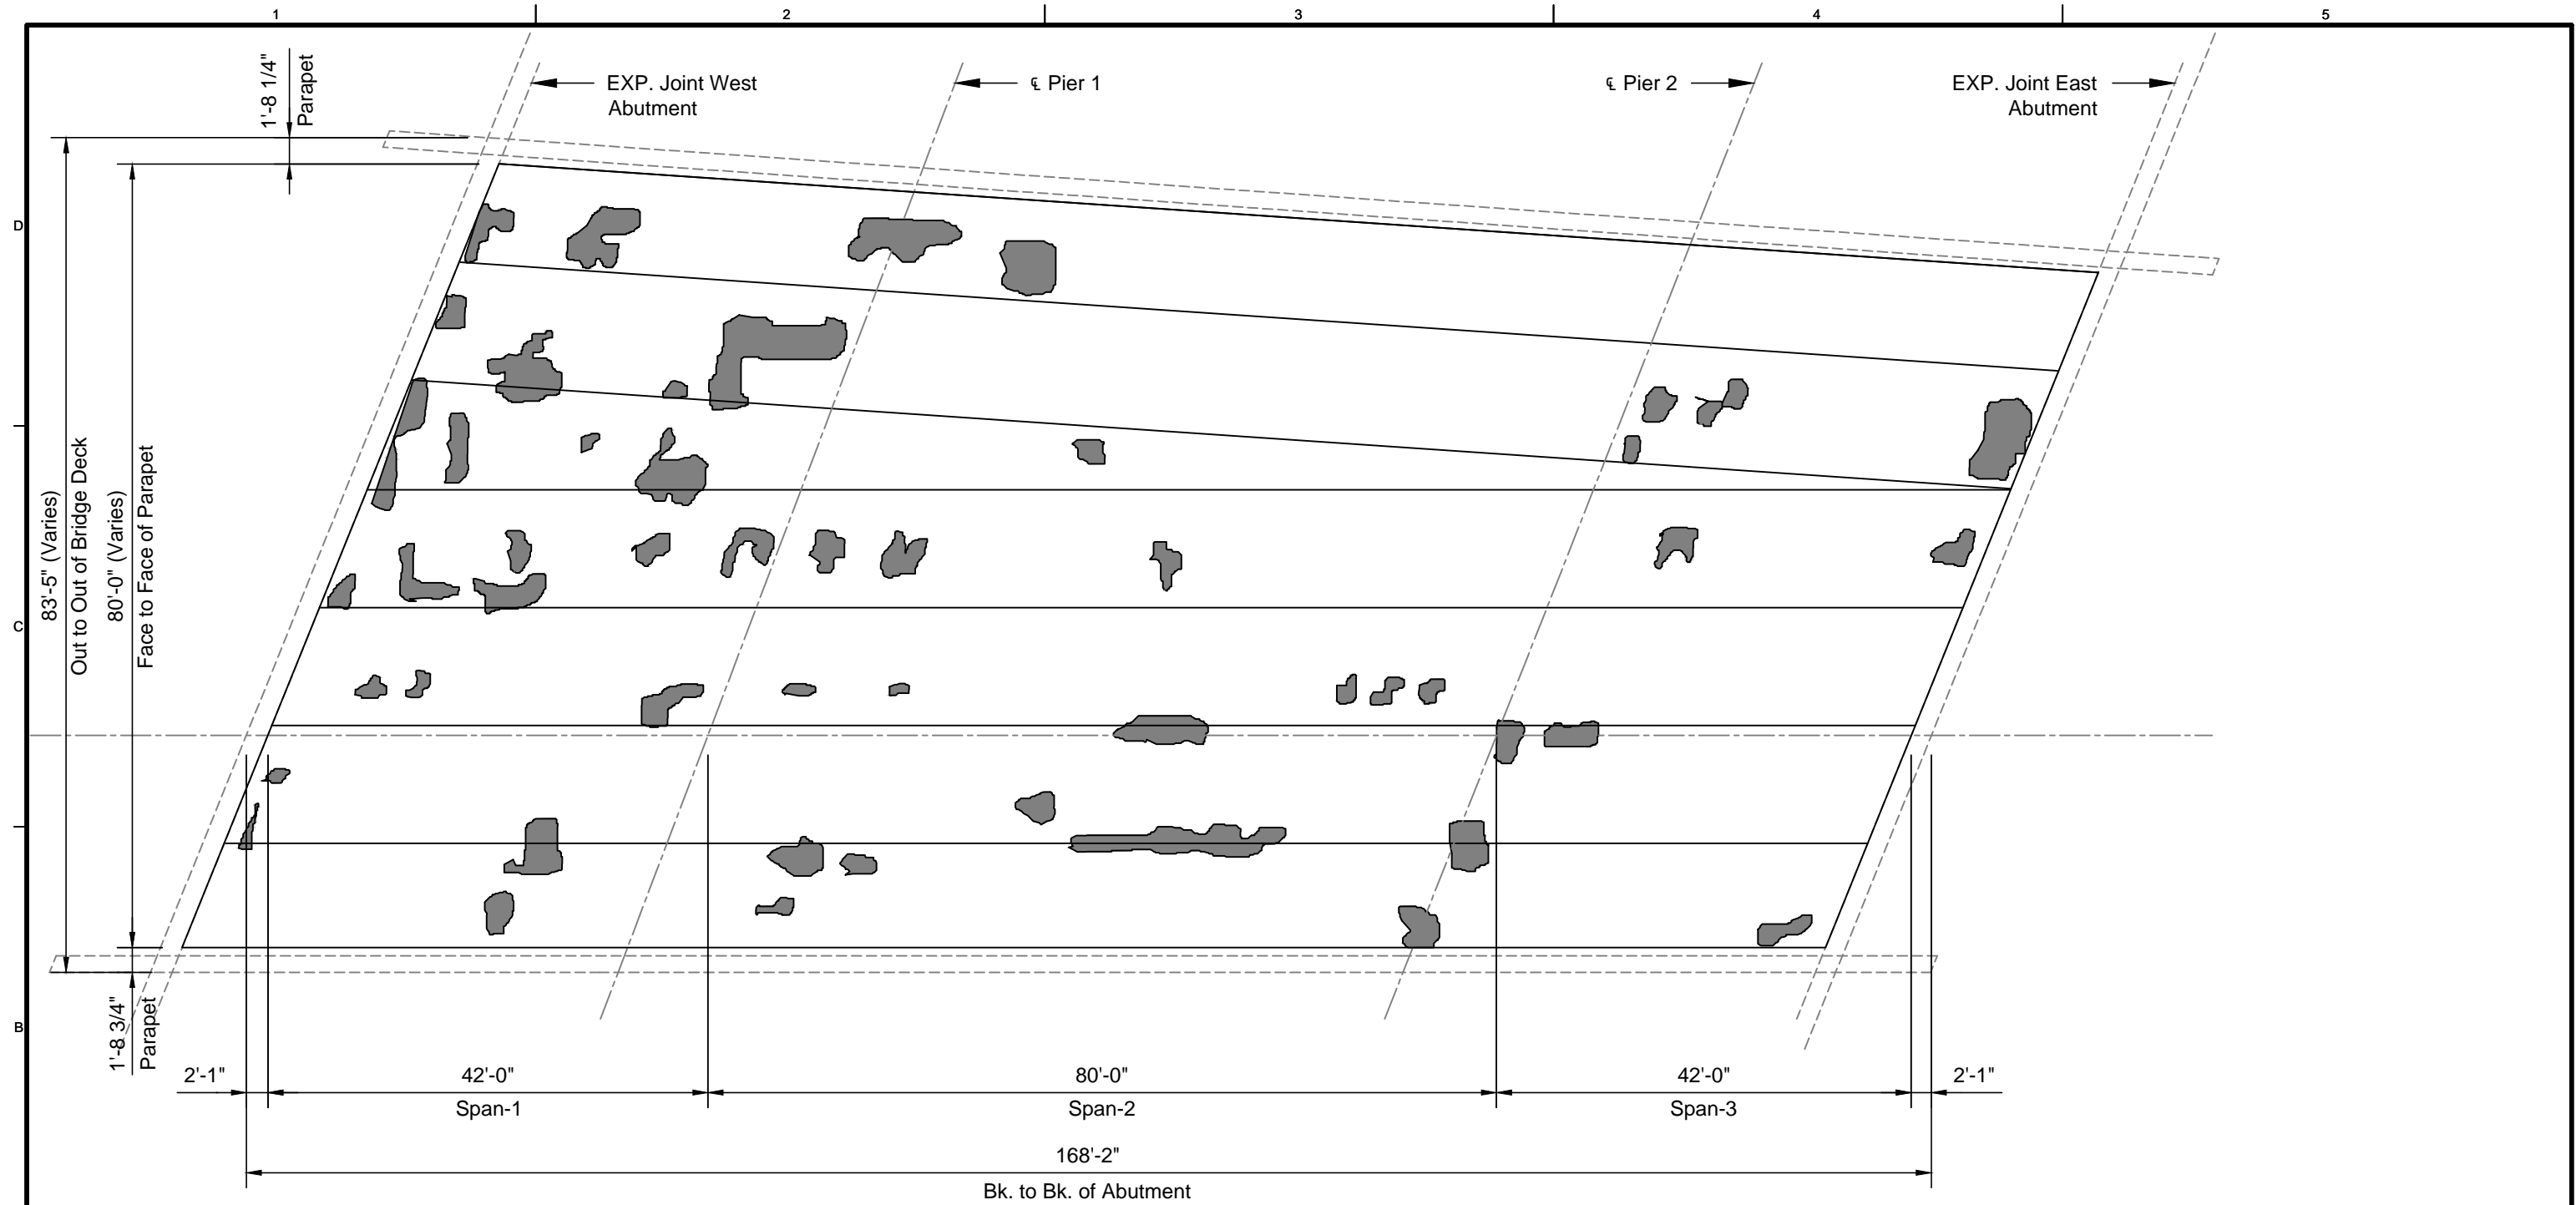
FIELD OBSERVATION SUMMARY		STRUCTURE # 016-0019		LEGEND	
ITEM	UNIT	QUANT.	%	DELAMINATION	
TOTAL AREA	Ac	12415	100	SPALL	
DELAMINATION	Ac	665	5.4	CRACK	
SPALL	Ac	0	0		
CRACKS	ft	-	-
