I-55 Managed Lanes Combined Design Report

Appendix A.3 – Structures

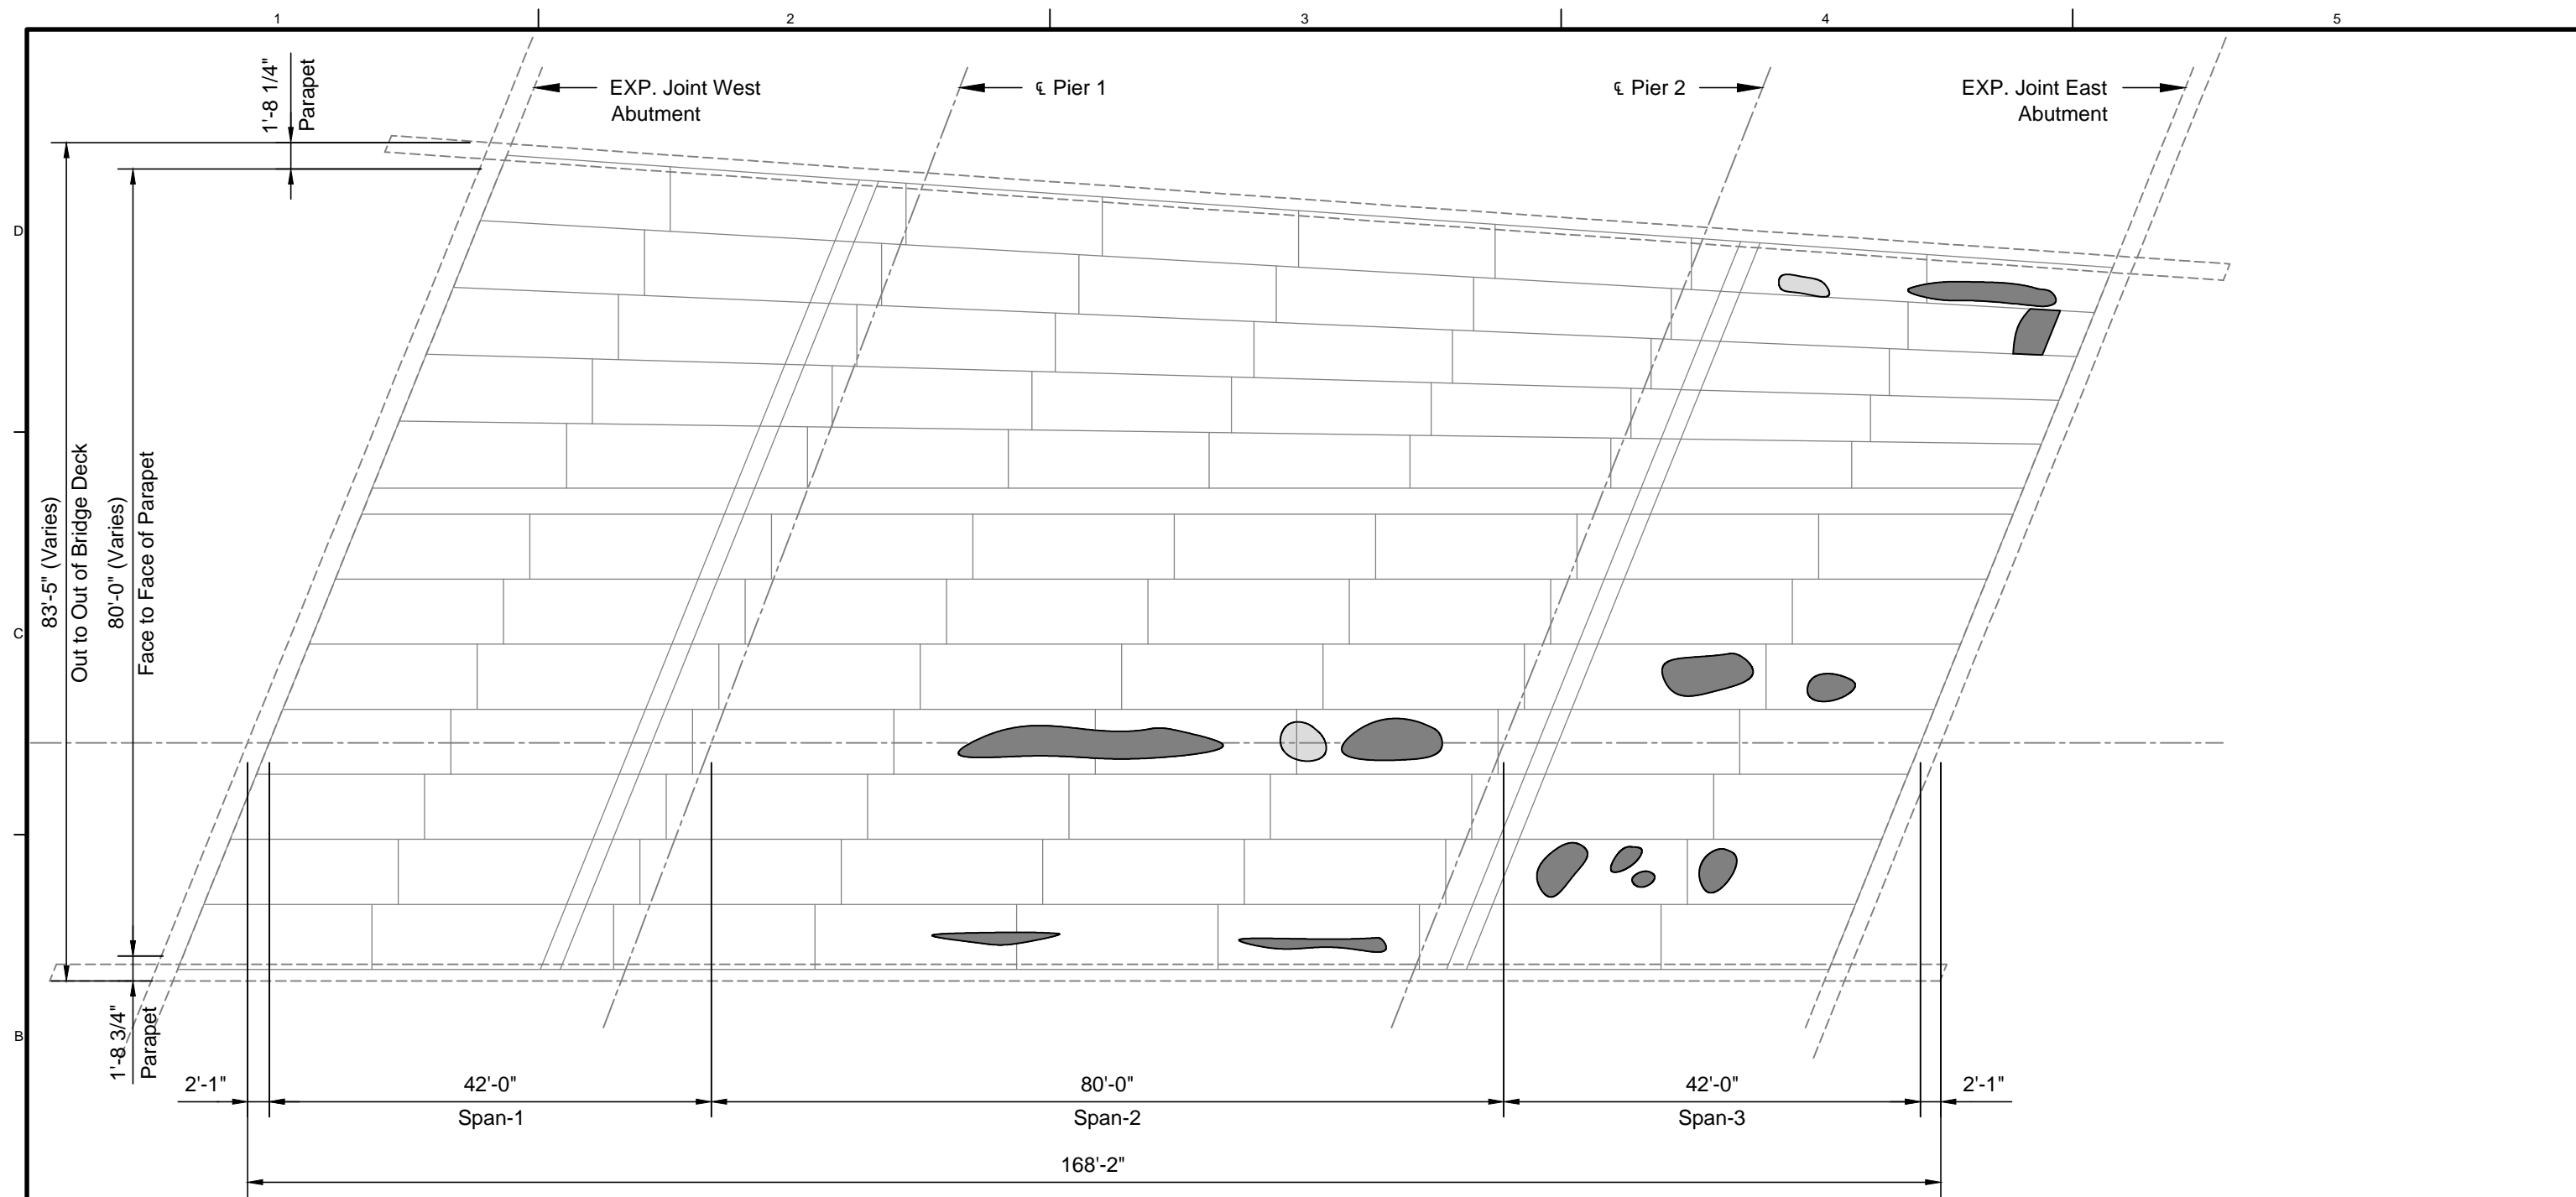
FIELD OBSERVATION SUMMARY		STRUCTURE # 016-0019		LEGEND	
ITEM	UNIT	QUANT.	%		
TOTAL AREA	Ac	12415	100	DELAMINATION	
DELAMINATION	Ac	235	1.9	SPALL	
SPALL	Ac	25	0.2	PREV. REPAIR	
PREVIOUS REPAIRS	Ac	2155	17.4	CRACK	
CRACKS	ft	-	-

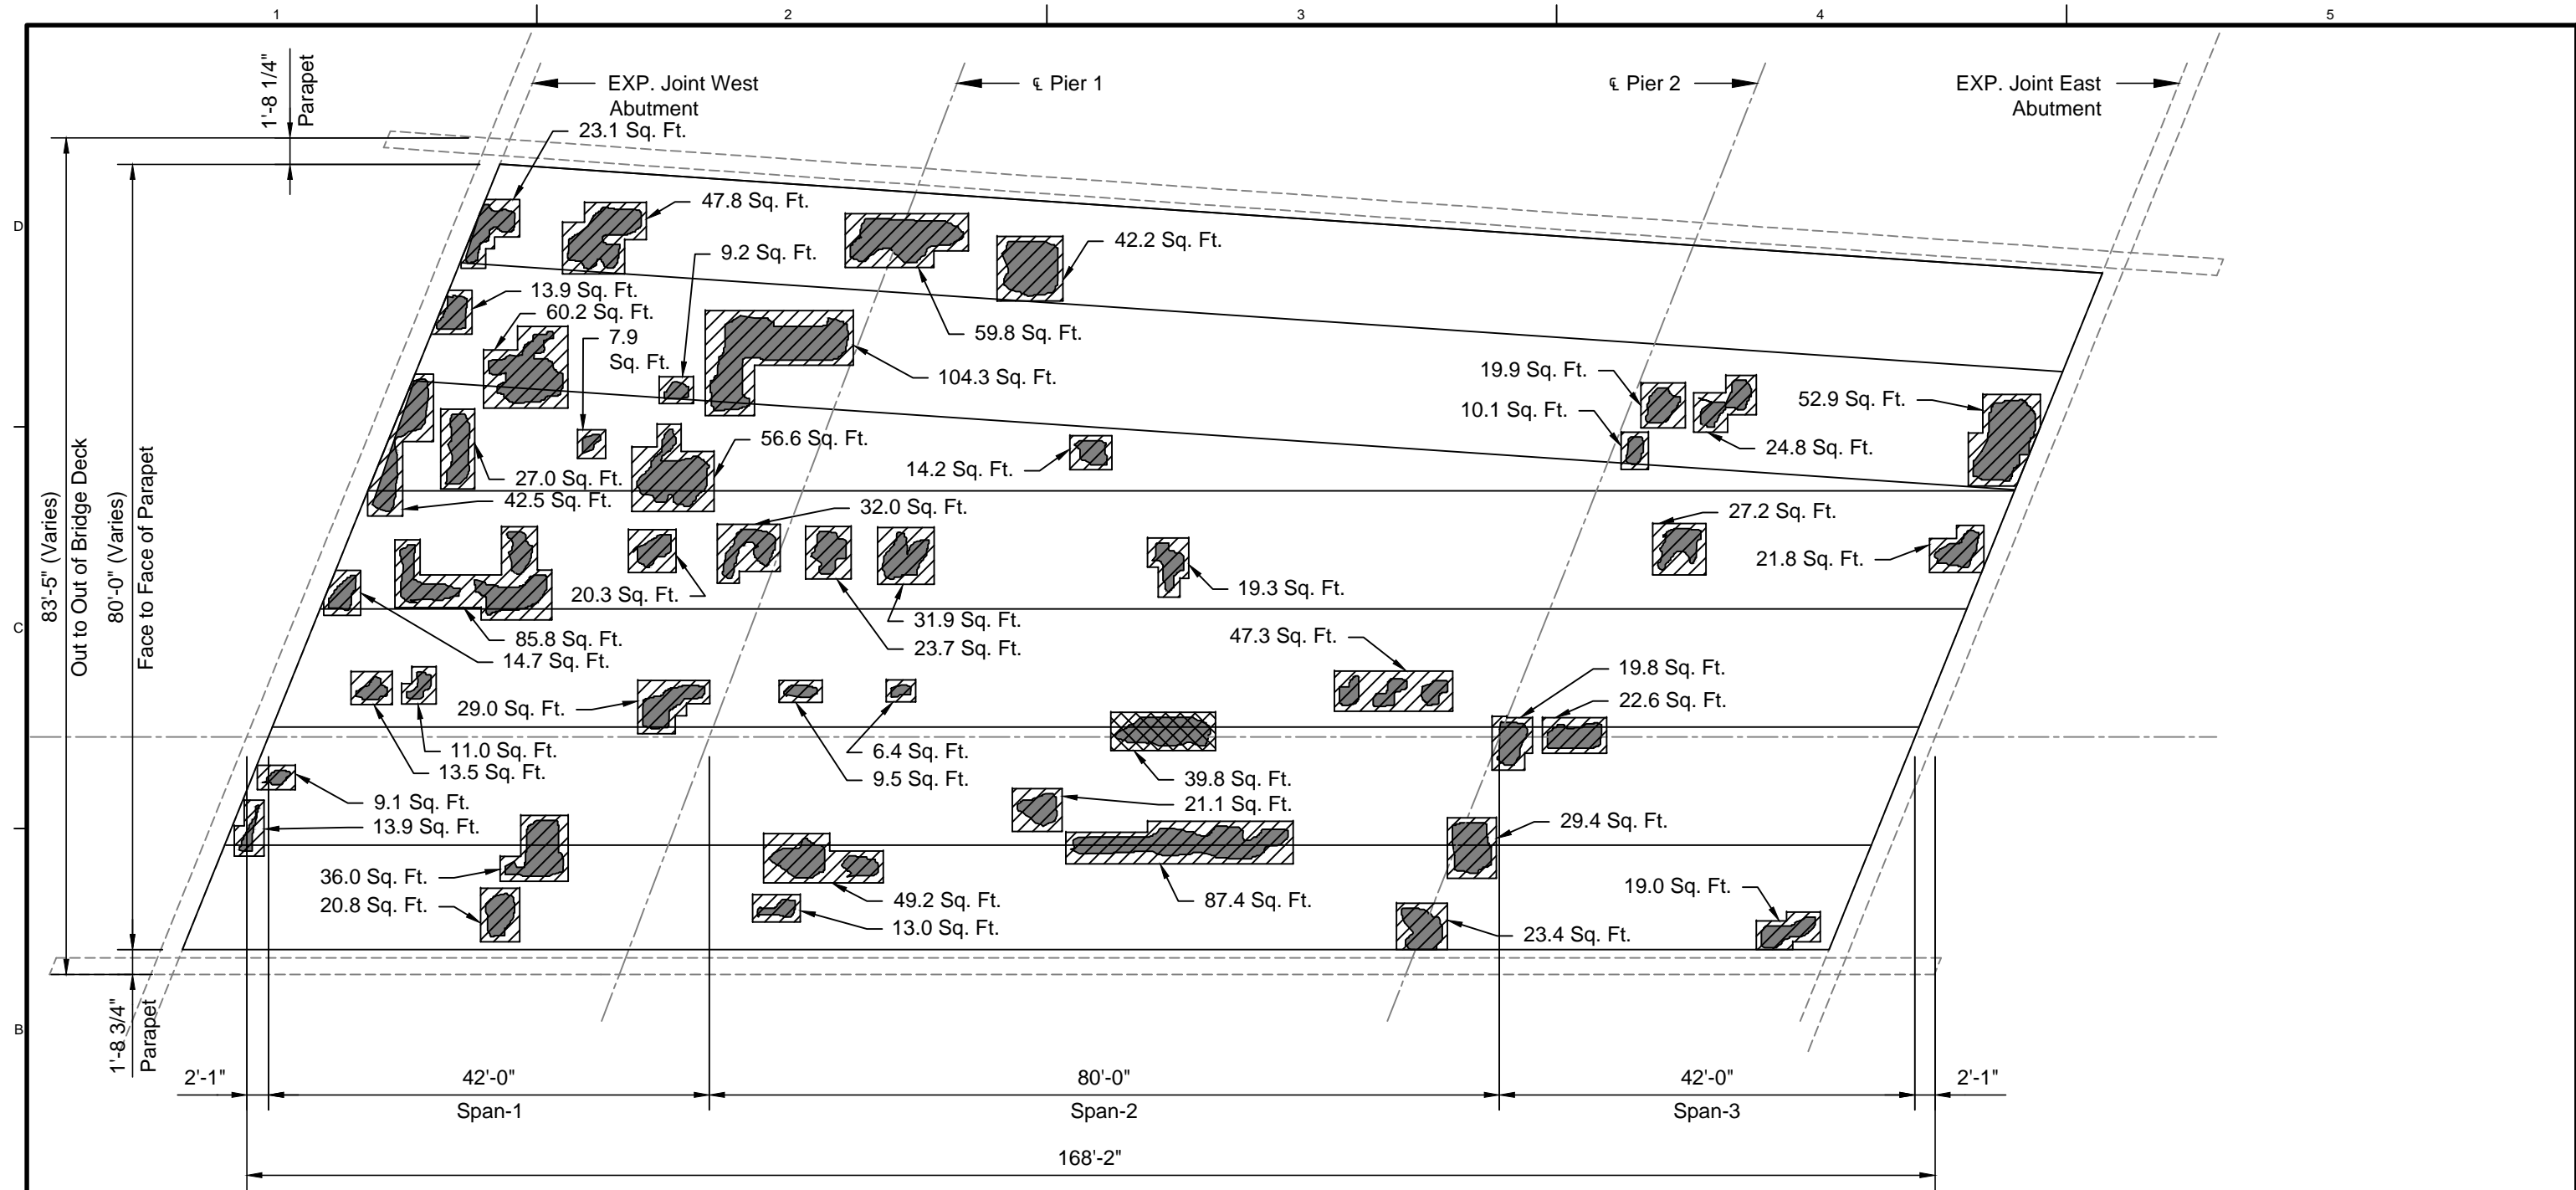
FIELD OBSERVATION SUMMARY		STRUCTURE # 016-0019		LEGEND	
ITEM	UNIT	QUANT.	%		
TOTAL AREA	Ac	12415	100	PARTIAL DEPTH REPAIR	
PARTIAL DEPTH REPAIR	Ac	1374	11.1	FULL DEPTH REPAIR	
FULL DEPTH REPAIR	Ac	40	0.3	DELAMINATION	
DELAMINATION	Ac	665	5.4	SPALL	
SPALL	Ac	0	0	CRACK	
CRACKS	ft	-	-

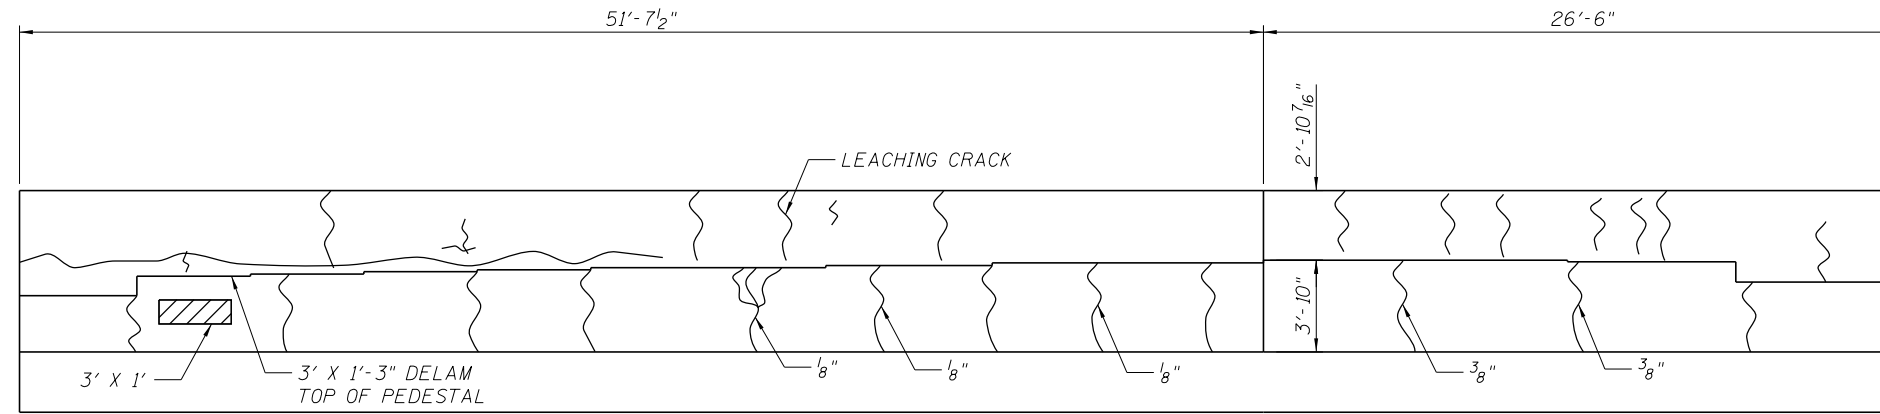
EAST ABUTMENT LOOKING EAST

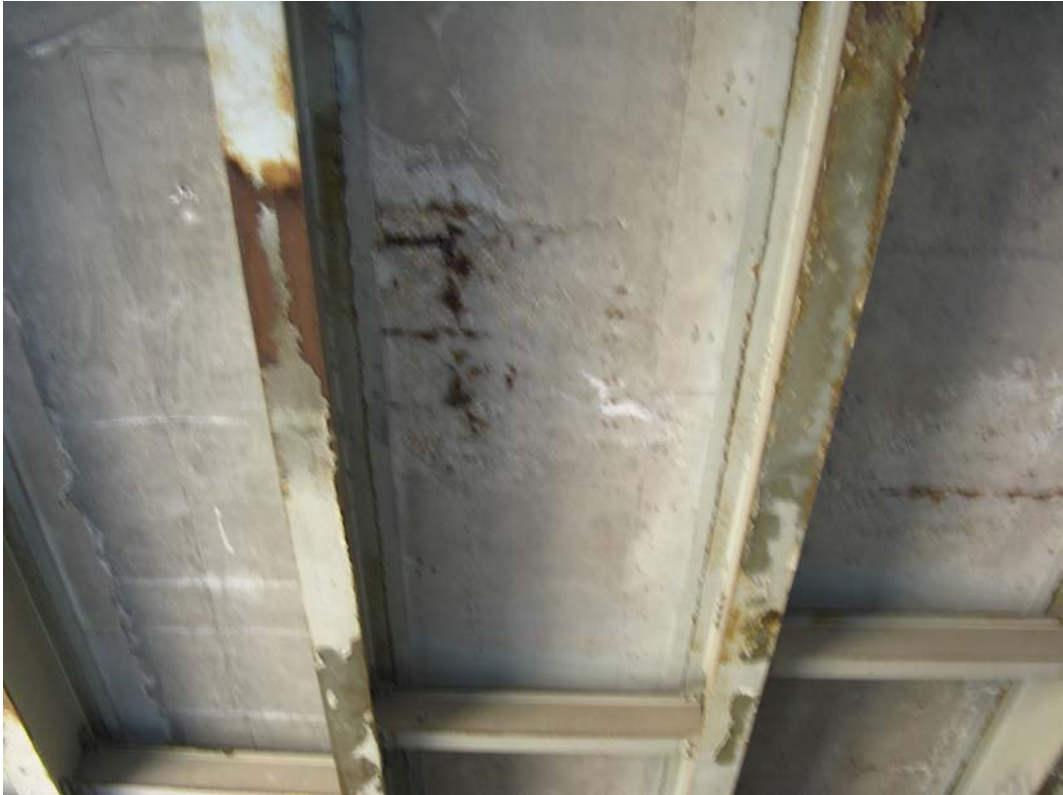
Photo 3 - Deteriorated concrete in Span 1, looking west

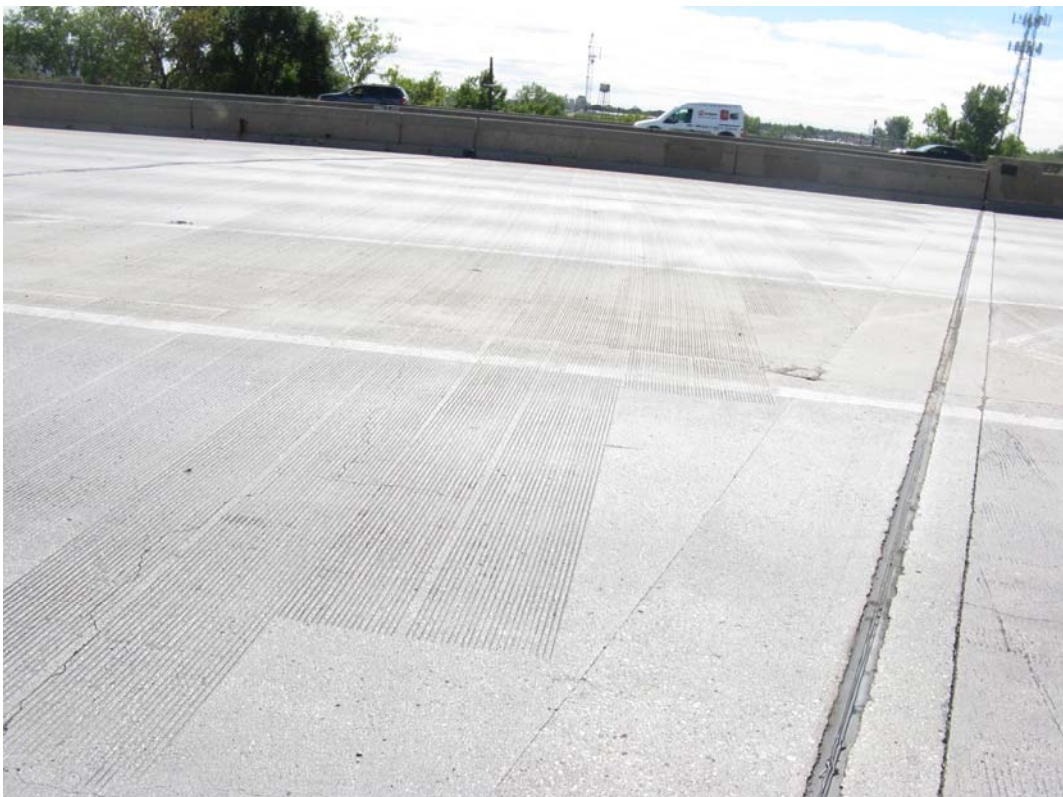
Photo 4 – Top of Deck in Span 1, looking south

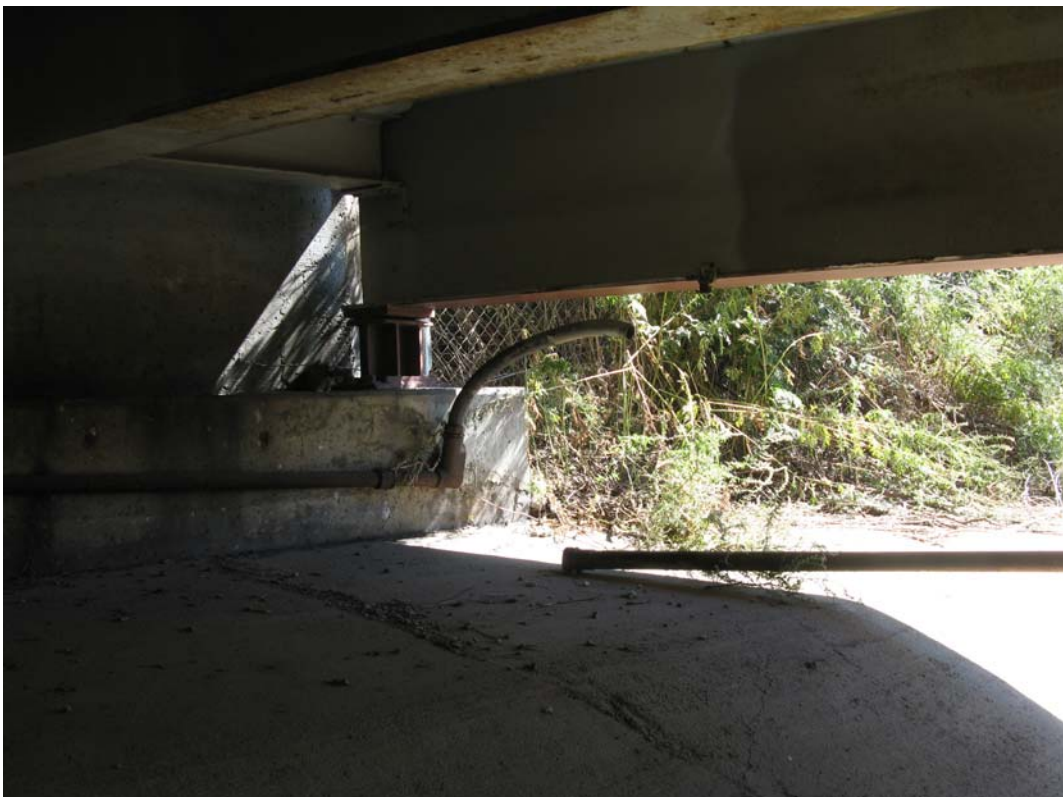
Photo 20 - Broken conduit on south side of Span 3, looking south

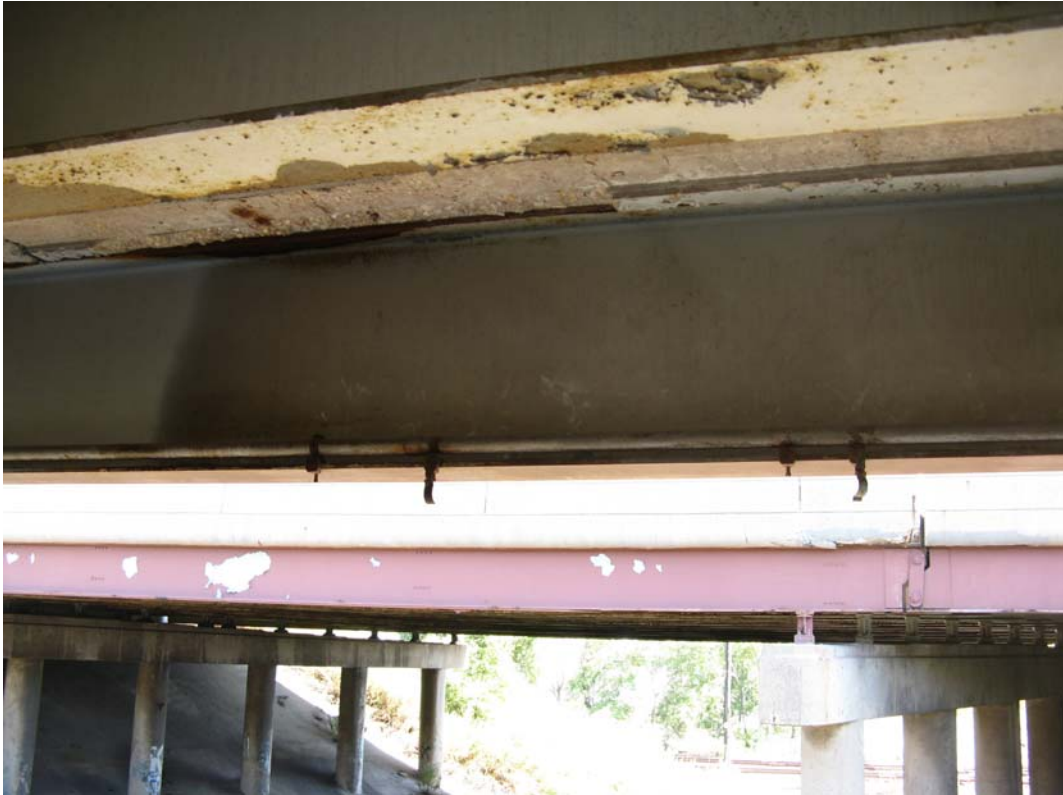
Photo 21 - Broken brackets on conduit, looking south

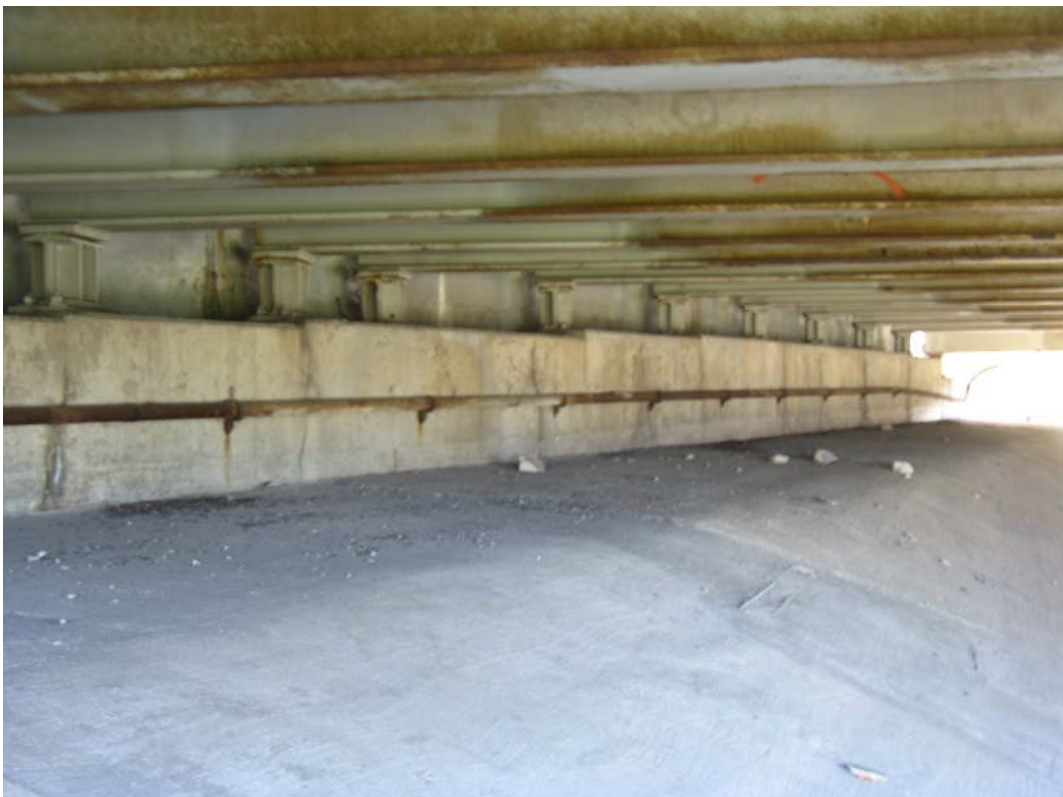
Photo 22 - East Abutment, looking southeast

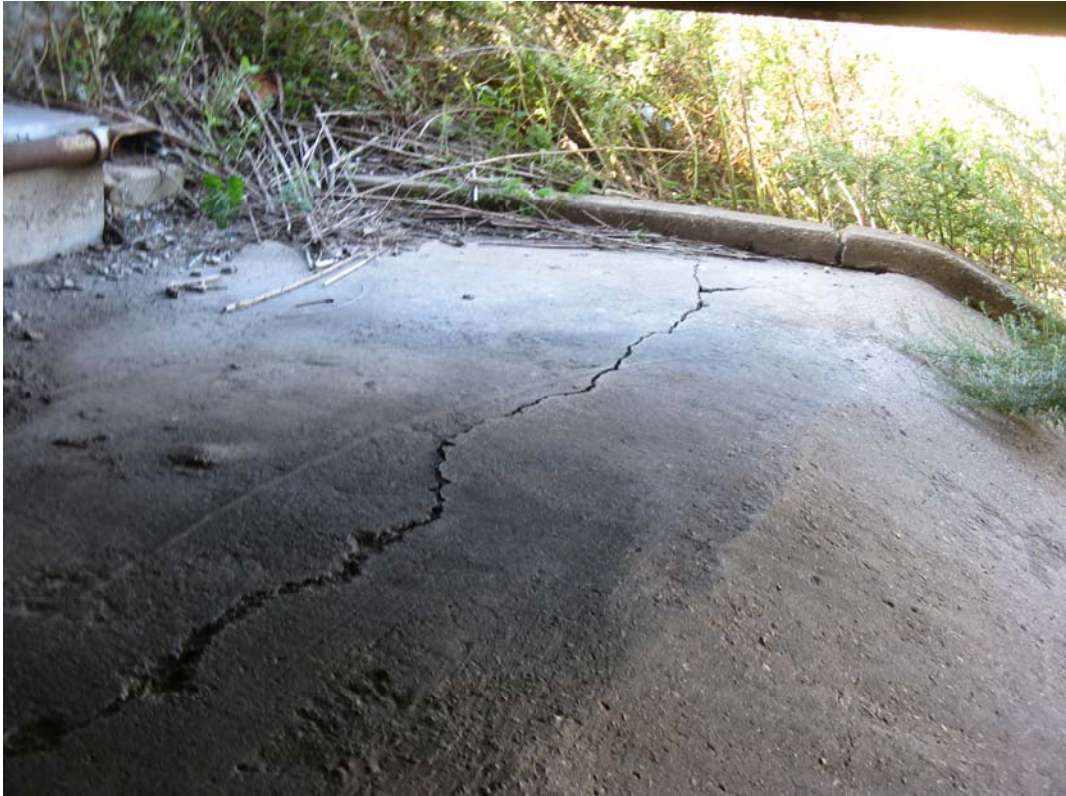
Photo 27 - Crack at Span 1 sloped wall, looking northwest
