# Metra Clybourn Station Feasibility Study

Stakeholder Advisory Group

Site Visit

Friday, August 28, 2026

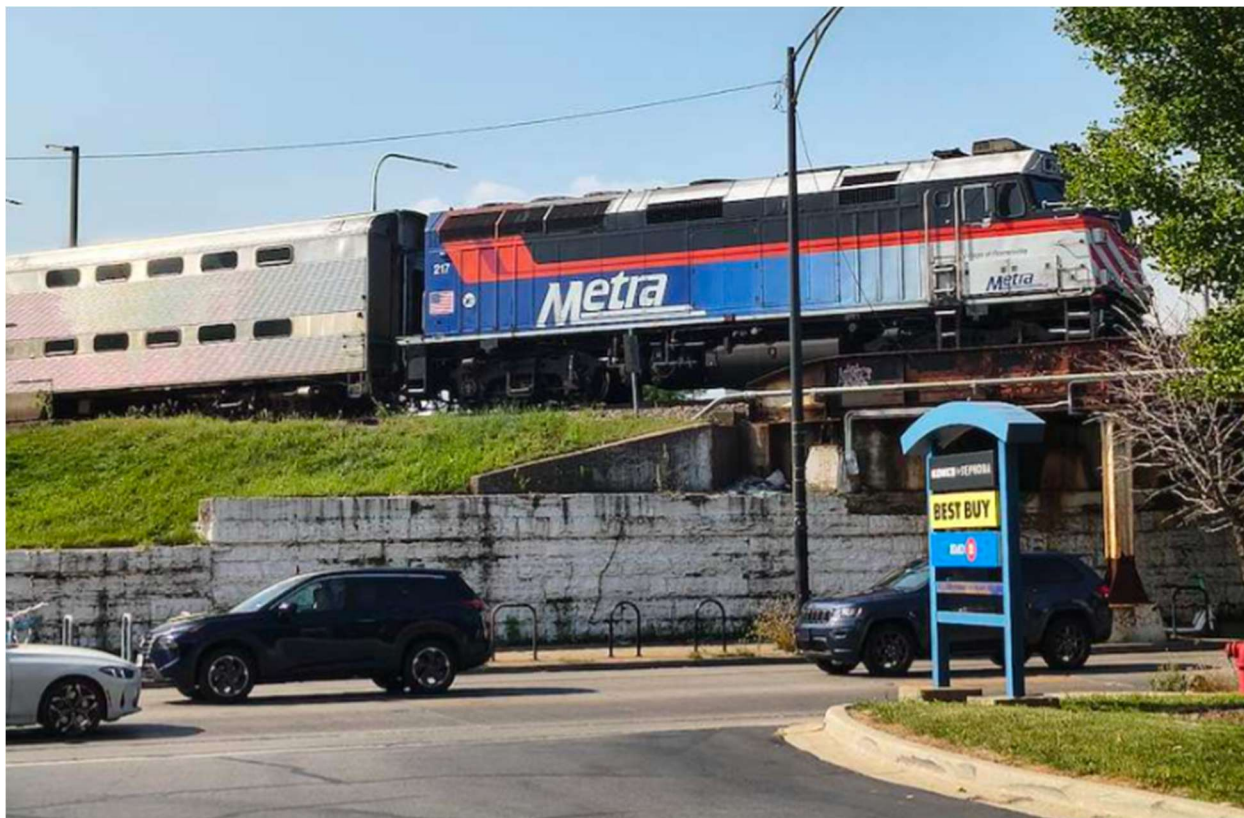
##### Stop 1 – North Armitage/Best Buy Lot

A key physical condition highlighted at this location was the lack of a direct marked crosswalk between the Best Buy area and the station parking lot – which meant the group had to walk back towards the Armitage and Ashland intersection in order to safely cross onto the side of the street where the station is located. The planned route deliberately required the group to cross at the intersection and return to the station lot so participants could experience the additional circulation required to make this connection. The discussion also focused on the overlap of multiple arrival modes within a constrained area, including bus drop-off, pedestrians, bicycles, and vehicles.

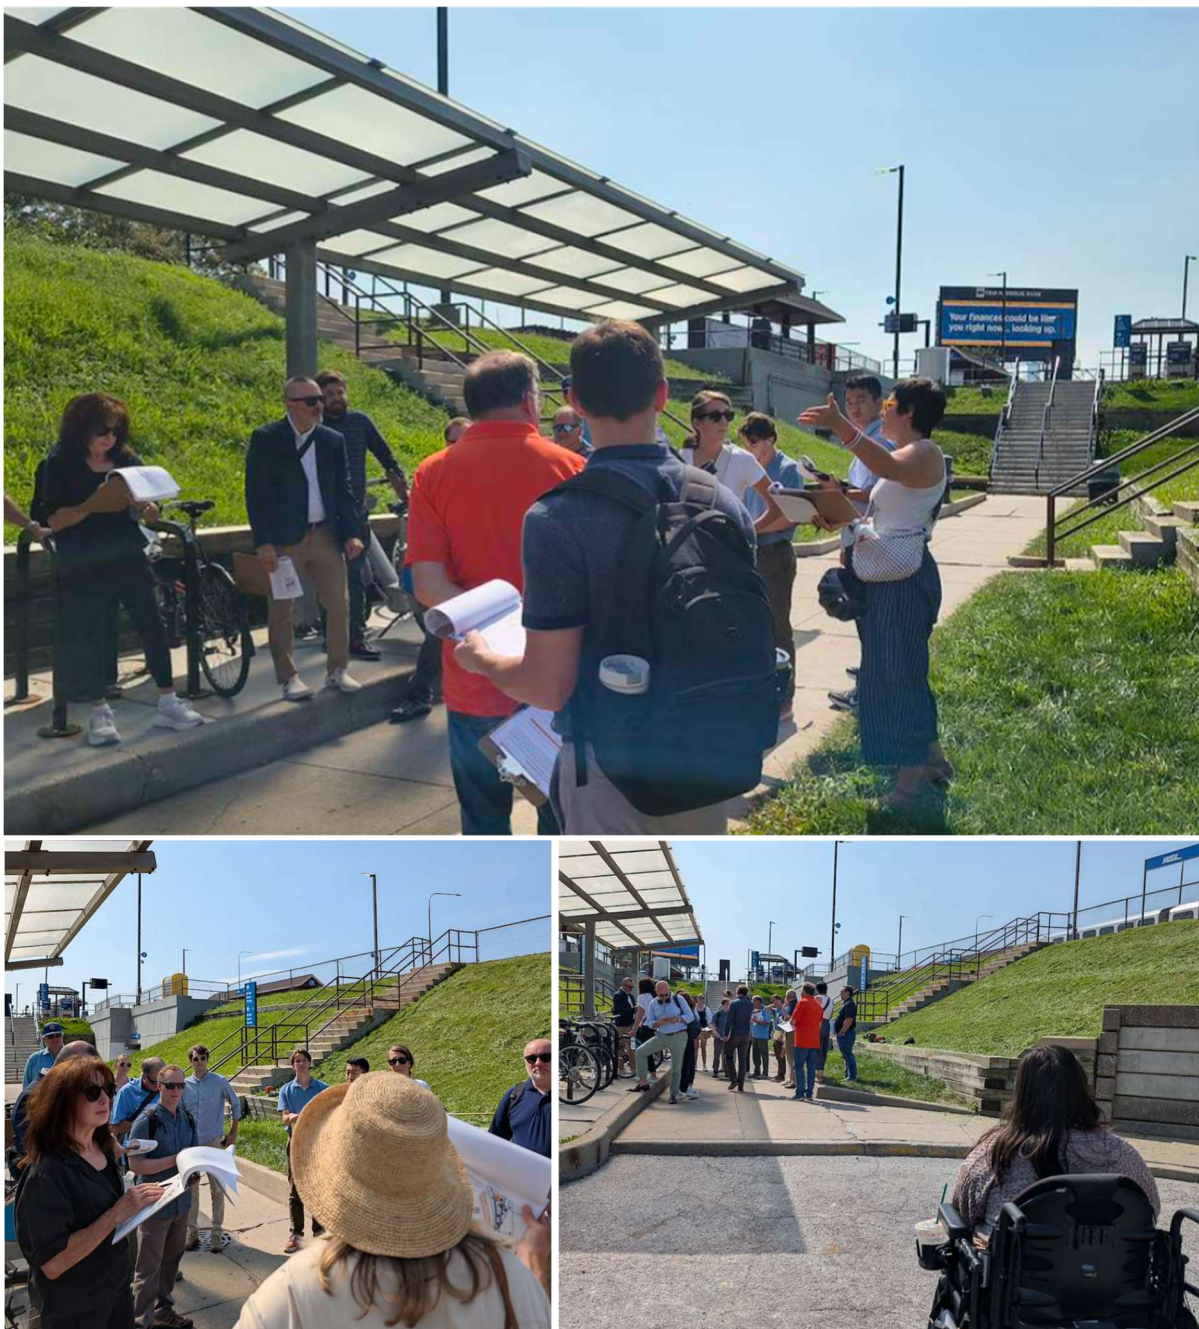
### Stop 3 – Stairs and Platforms

Participants expressed difficulty locating the in and outbound trains, discussing how the station layout is unclear for new users and near impossible for those needing ADA accommodation. One participant requiring ADA accommodation was unable to join the group for this portion of the tour, as the only way up the platforms is via stairs. While there is some signage, it is unclear, and participants had trouble determining which platform was for which Metra line going in each direction. One participant recommended the addition of “spoken signage”, like that which currently exists at Union Station (for instance, an announcement indicating a train is approaching on “Track number 15”).

Much of the participant feedback for this stop surrounded the platform itself, which is primarily a gravel pit with minimal seating and shelter and no restrooms. Additionally, participants expressed feeling unsafe due to the lack of cameras and emergency phones, with one noting they would not want to return. Participants discussed the unkempt appearance of the platform, noting weeds, graffiti, and excessive sun exposure due to a lack

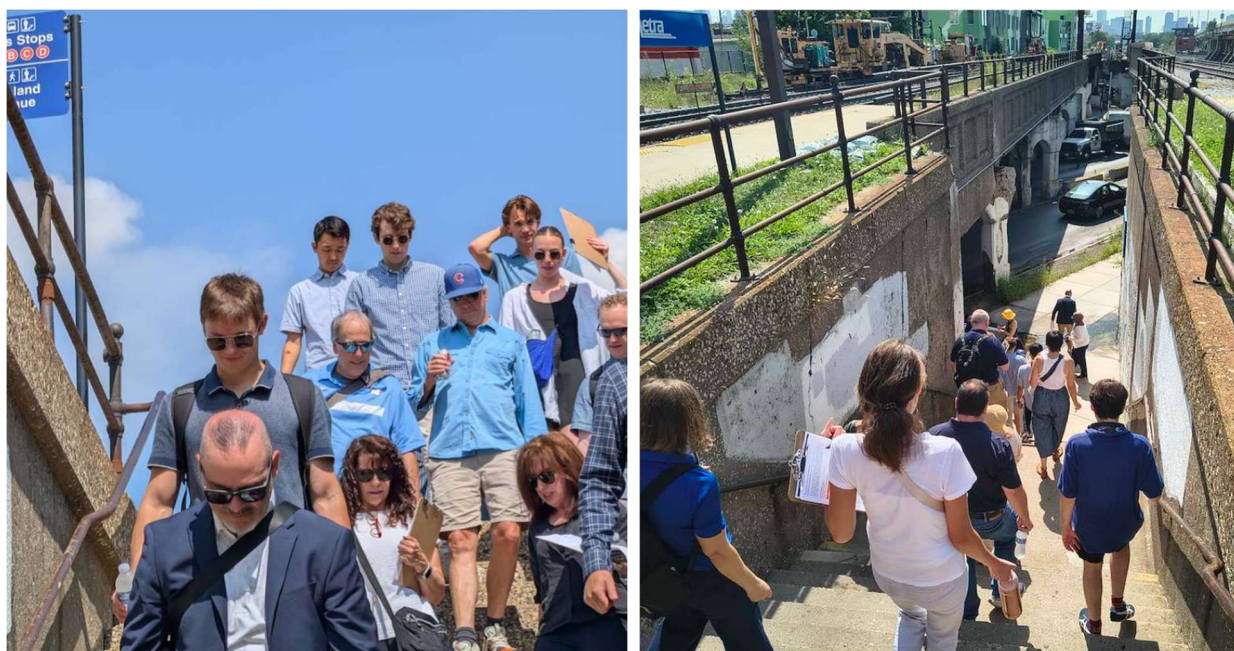
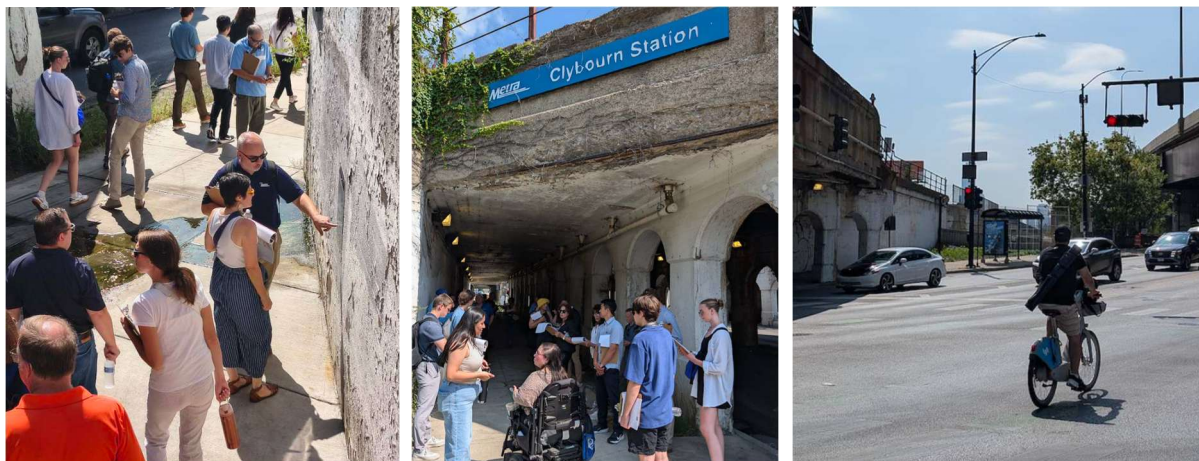
#### Stop 4 – Cortland Street and the Viaducts

- Station approaches;
- Deteriorating walls;
- Flood-prone stair landings;
- Sidewalk conditions;
- Lighting under rail viaducts;
- Neighborhood pedestrian connections; and bicycle infrastructure.

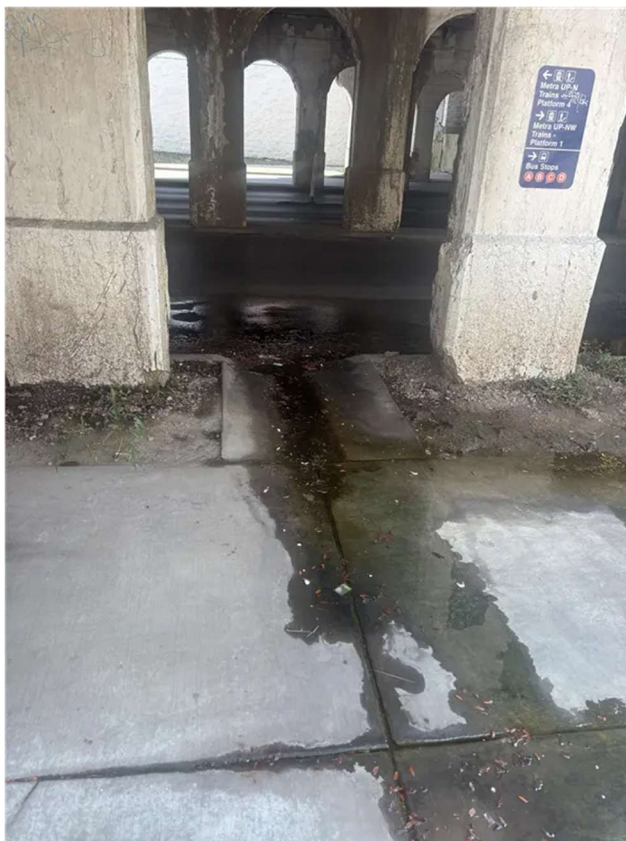
Photo taken and shared by **Liliana Schiller**,  
Program Manager, Mayor's Office for People with Disabilities

The primary concerns shared between most participants regarding this stop were safety, visual appeal, and maintenance. Participants noticed overgrown weeds, crumbling viaducts, and significant amounts of leaking/pooling water—which some noted can be a major safety hazard in the winter. Additionally, participants generally viewed this portion of the station as dirty, poorly lit, difficult to navigate, and unsafe for pedestrians and bicyclists, referring to the site as “desolate” and expressing concern regarding using the station at night. Like the gravel pit on the platform level, attendees expressed the desire to beautify the space with murals or other art installations, like other viaducts around the city.

1. Beautification
2. Better signage
3. Improved lighting
4. Installing a railing between the pier and roadway in viaduct area to better close it away from roadway traffic
