# **BRIDGE CONDITION REPORT**

**STRUCTURE NUMBER: 050-0058**

**LOCATION: US Route 52 over the Fox River in  
LaSalle County**

**DATE INSPECTED: November 28, 2016**

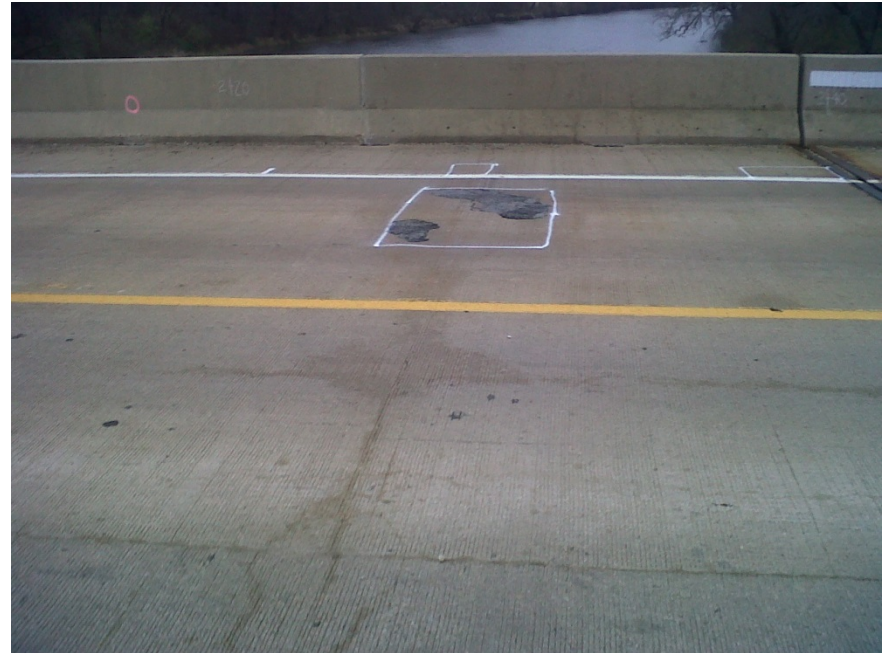
**Deck:** The top surface of the deck is generally in good condition. The deck exhibits some hairline cracks in the transverse and longitudinal directions. During the inspection the entire deck was sounded for delamination using the chain drag method. Approximately 1.5% (23 sq. yds.) of the top surface was found to be delaminated. Chloride concentration levels were tested and found that the corrosion initiation level has been exceeded at least 5" below the surface of the deck. The section loss threshold has been exceeded 3" below the deck surface. The deck underside had deterioration including delamination and spalls with exposed reinforcement at the deck drains (70 sq. yd. total) and adjacent to the deck expansion joints (44 sq. yds. total) equaling approximately 8% of the deck. Much of the remaining deck underside was in good condition. The parapets were generally in good condition with some vertical hairline cracks.

General Condition of Deck

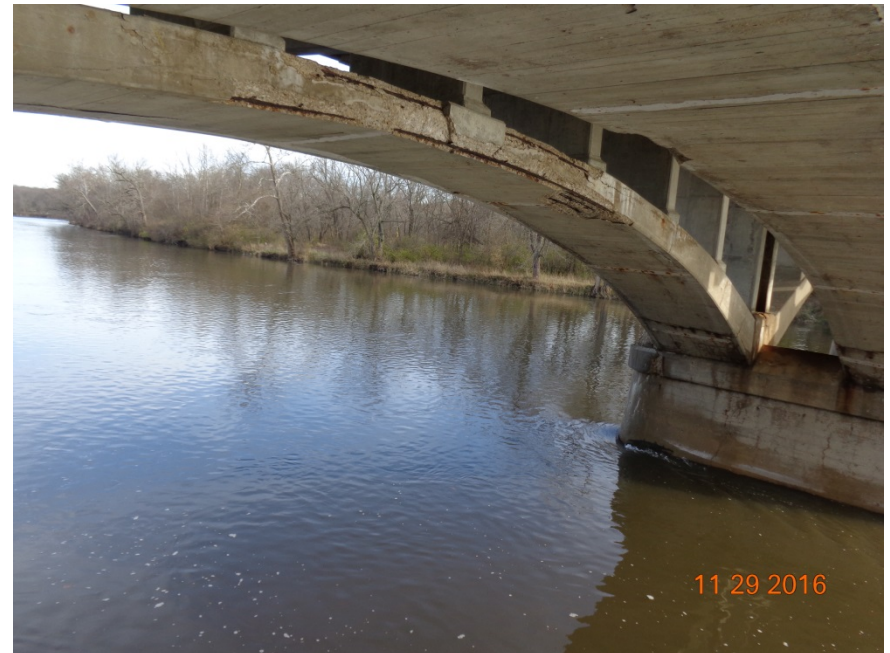
The north arch in Span 2 is in the worst condition at a bar lap location about 25' from pier 2. The outside face is a delaminated concrete patch. The inside face is completely spalled with a top and bottom bar debonded. The bottom of the arch is spalled 30% across with 5 reinforcement bars exposed. Two (2) of the bars have up to 25% section loss. Total loss of steel is approximately 15%. Loss of concrete is approximately 20% of the gross area.

Arch Deterioration (Span 2)

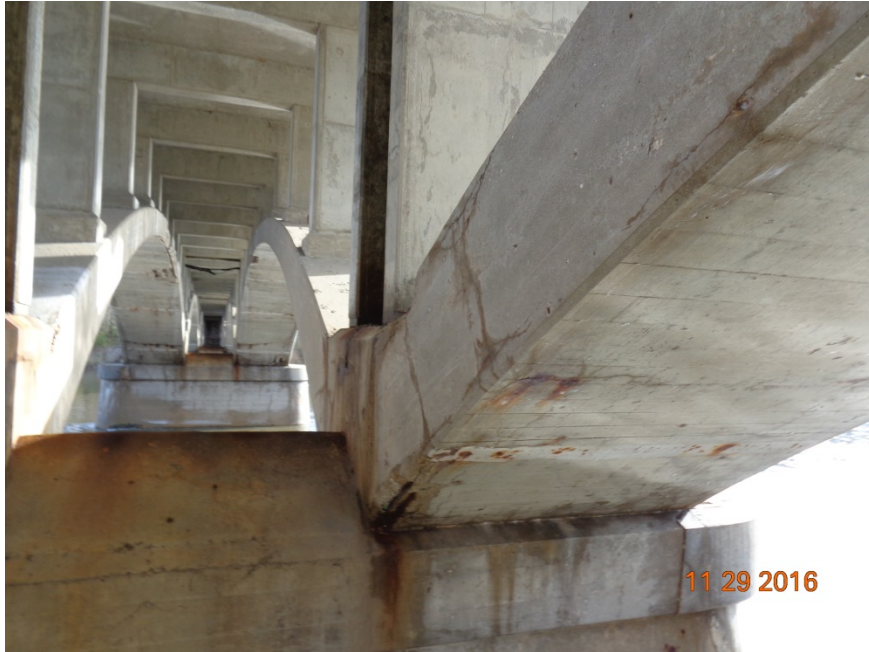
Hairline Cracks in Arch near Pier 1

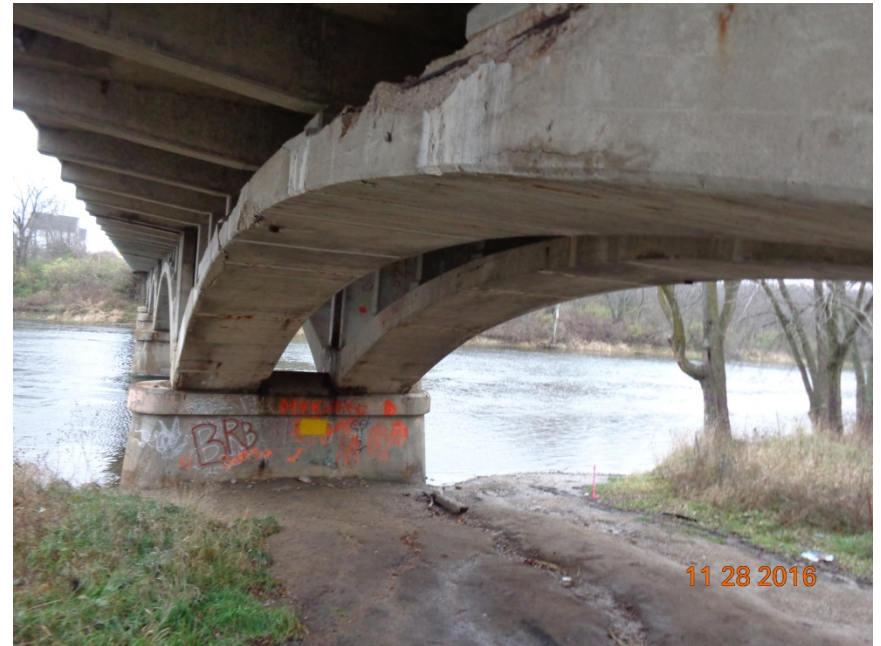
Arch Deterioration (Span 5)

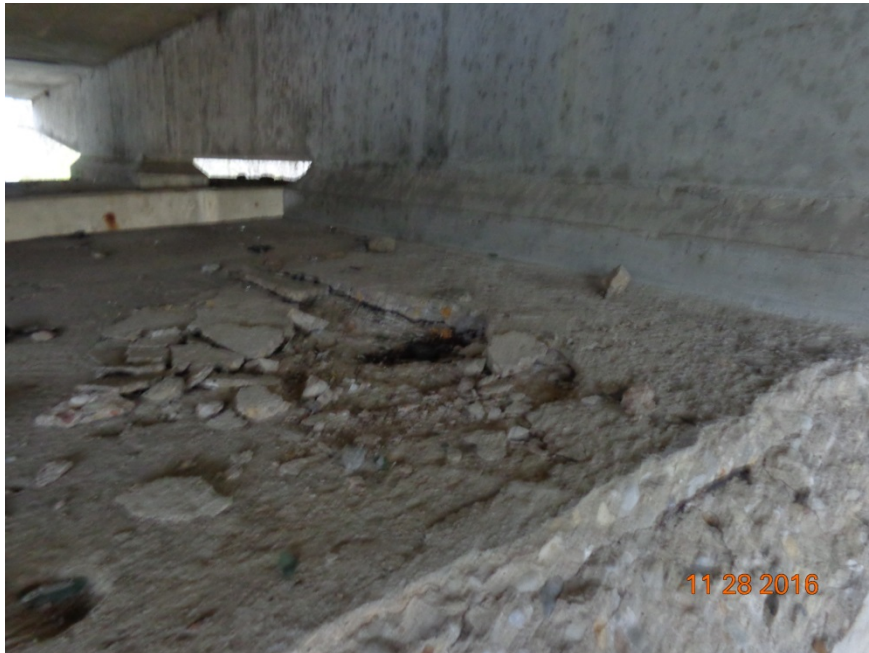
Top of Arch Delamination & Spall

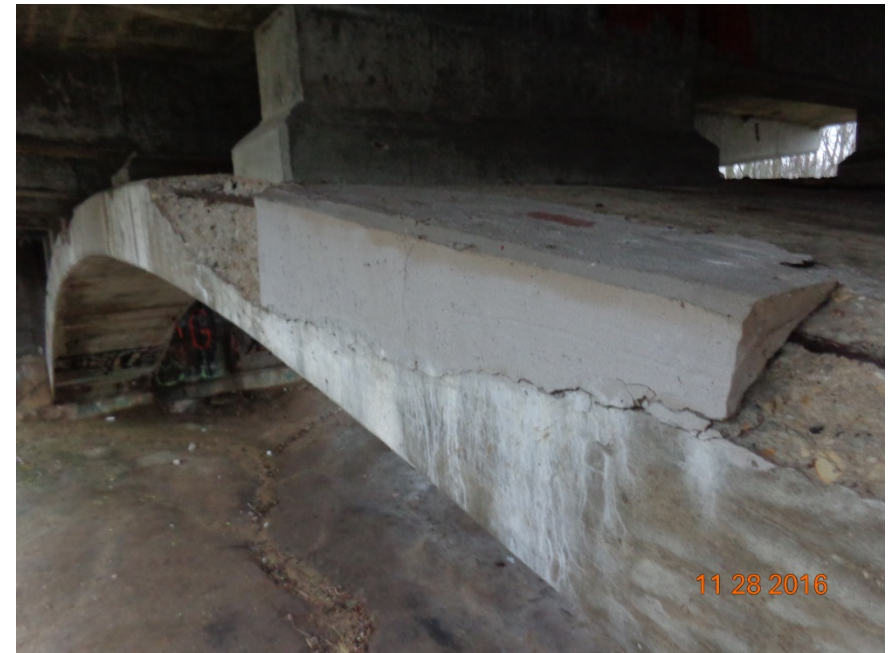
Failed Patch on Arch

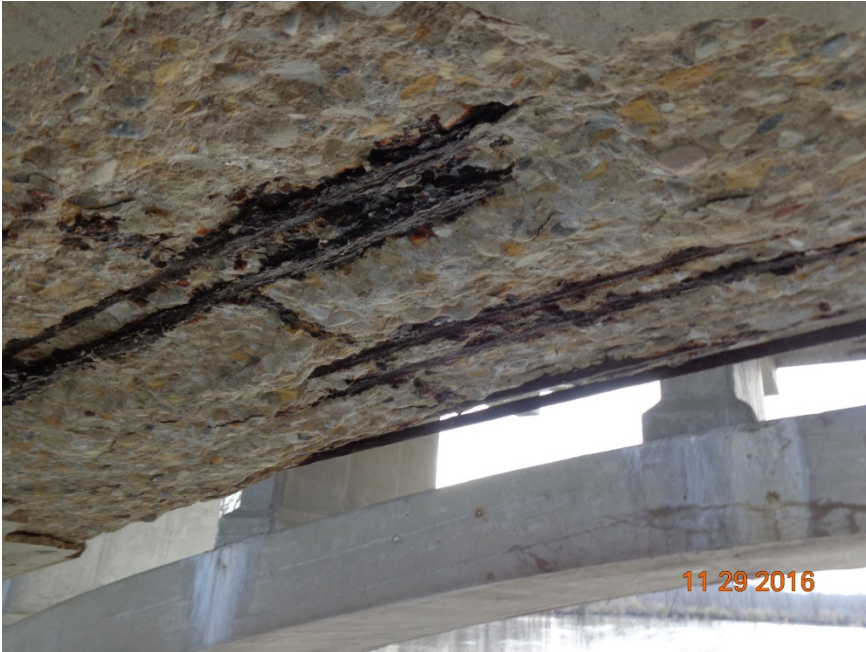
Spall on Underside of Arch

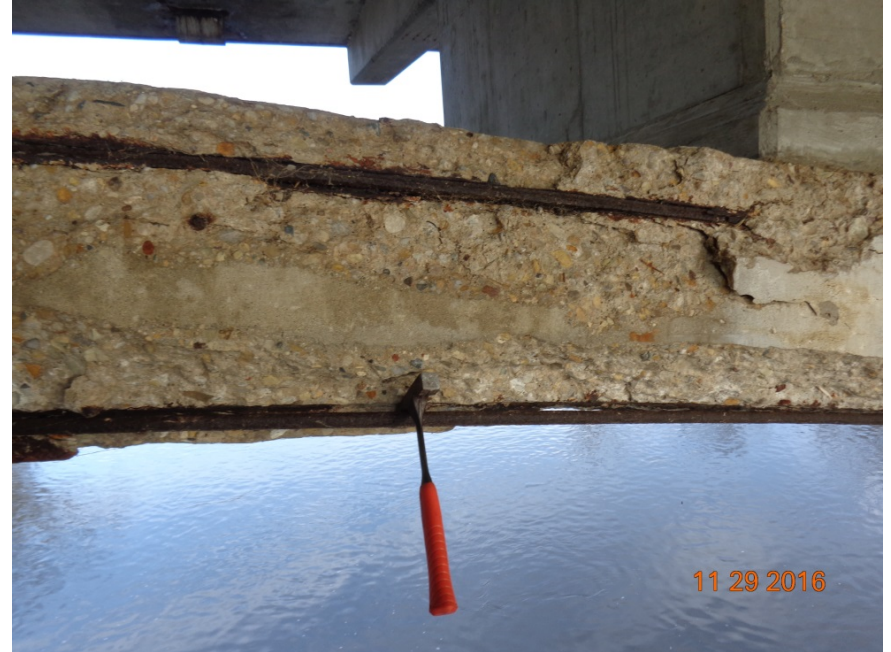
Debonded Arch Reinforcement

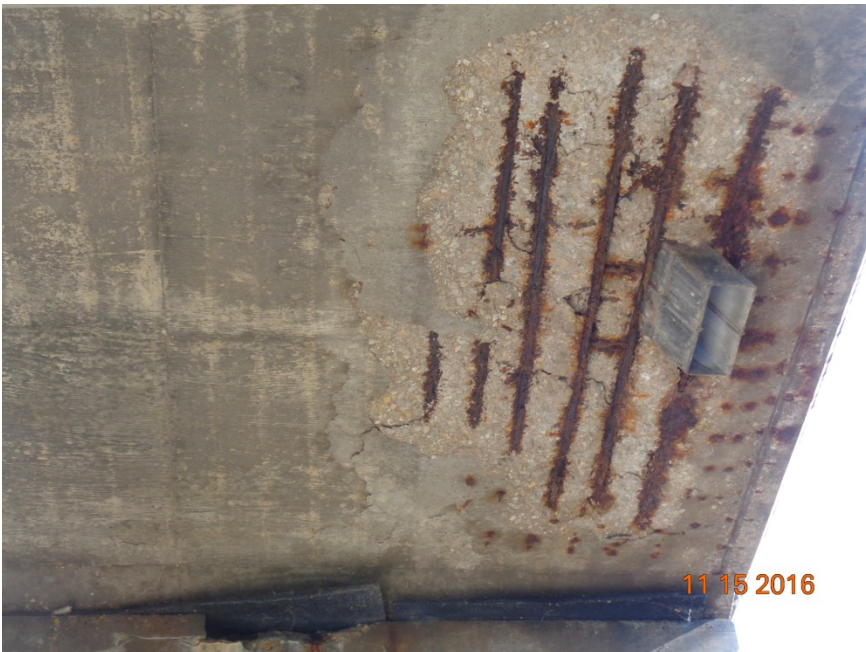
Spall at Deck Drain and Bearing Pad Movement at East Abutment

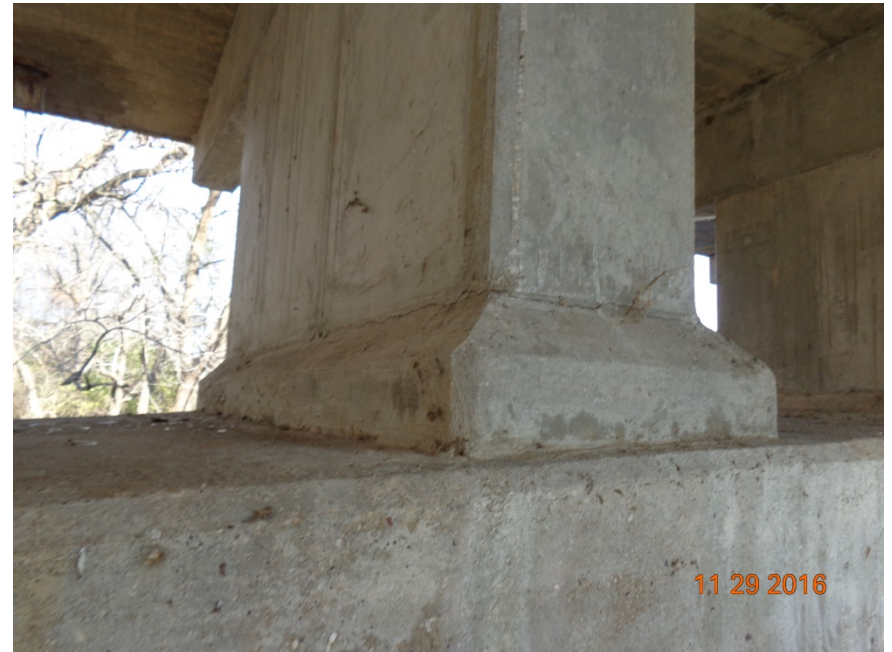
Crack in Column at Base

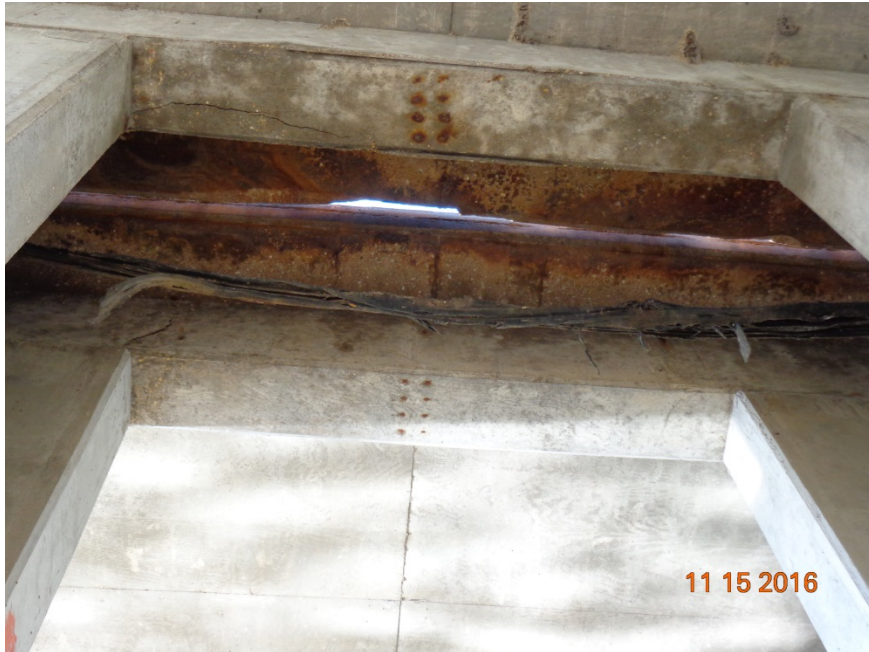
Deterioration Under Joint

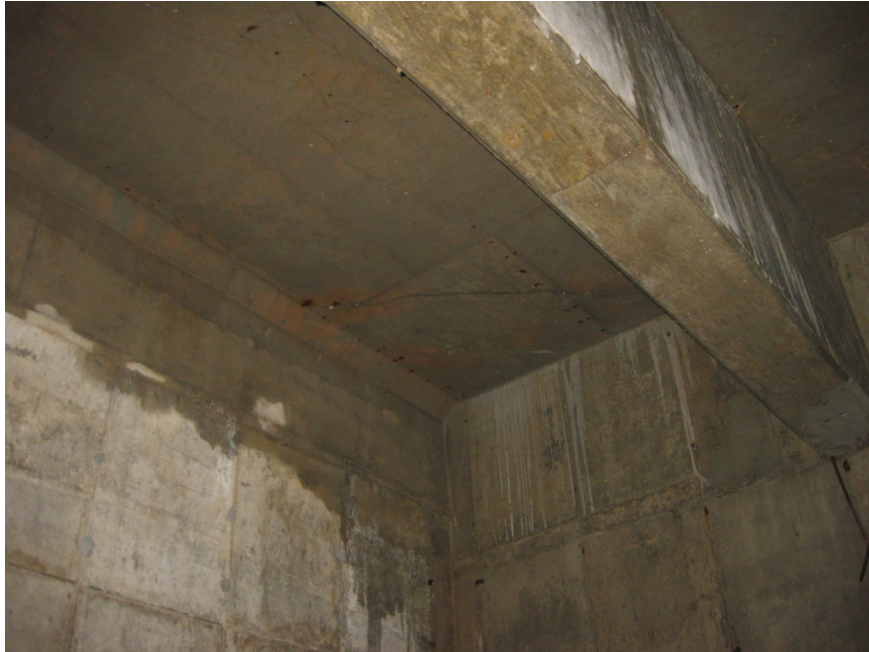
Typical Crack in Deck and Leakage inside Vaulted Abutment

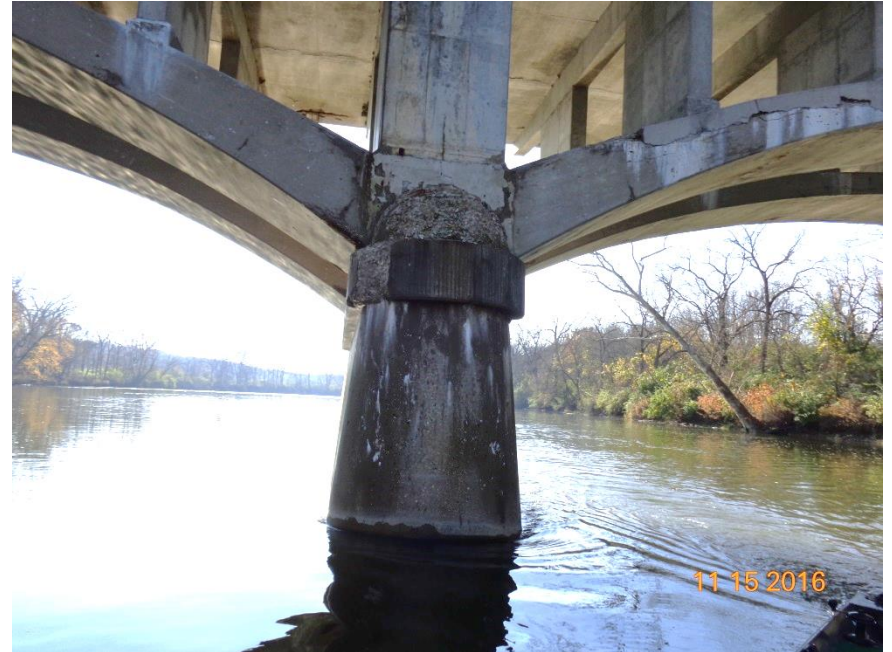
Typical Pier Nose Deterioration

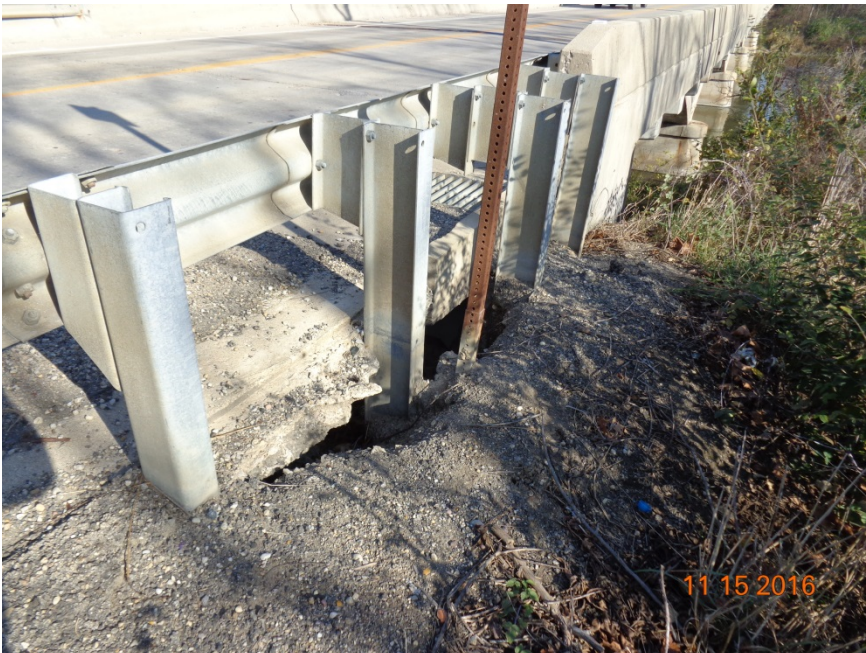
Void under South Side of West Approach Shoulder

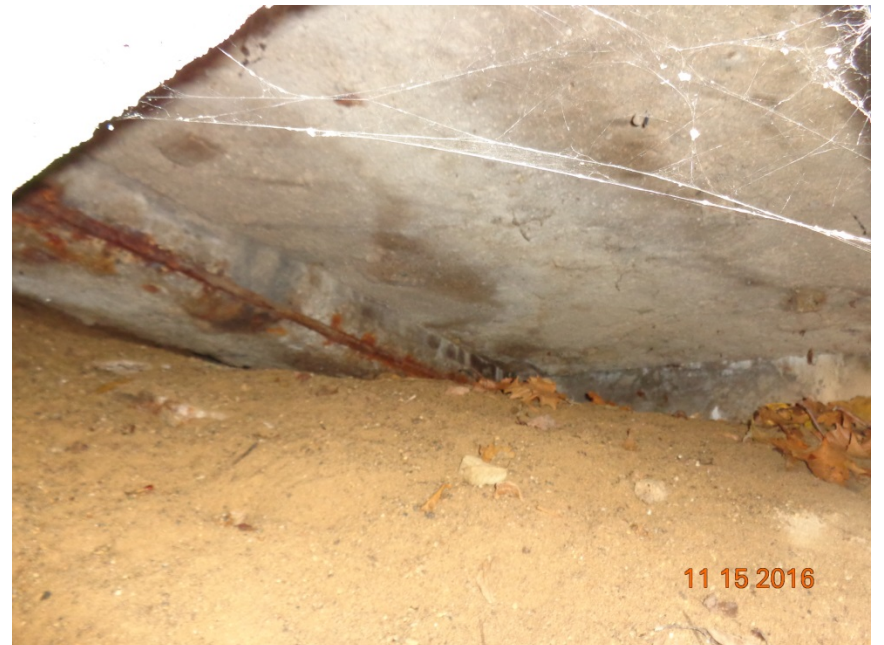
Void Under West Approach Slab
