# **Investigation of Rack and Pinion**

## **Alignment of the Cass Street**

### **Movable Bridge in Joliet, Illinois**

**Physical Research Report No.129**

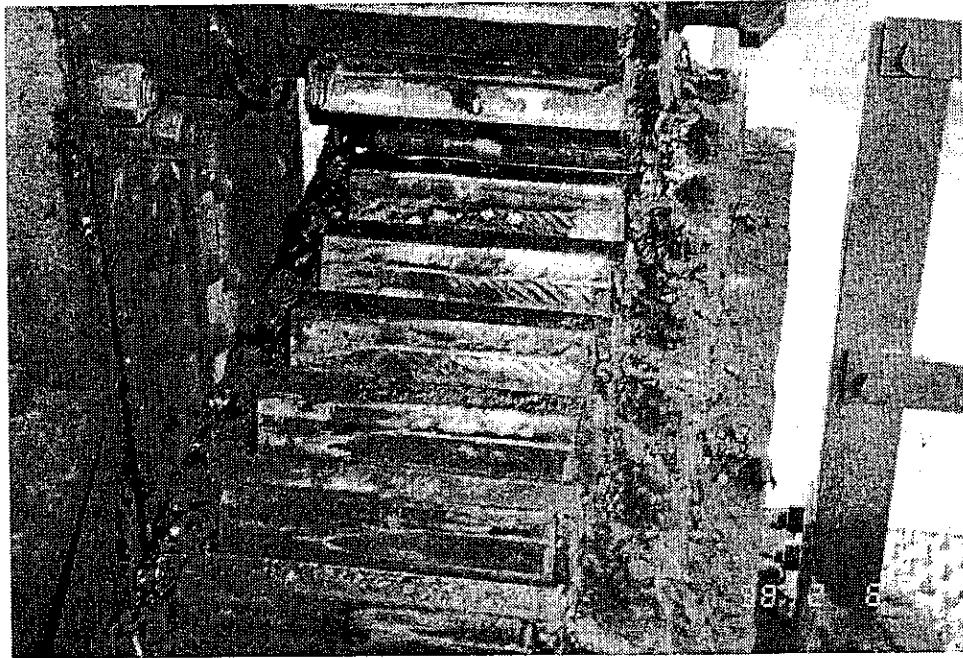
Based on the wear pattern as shown in *Figure 4*, the pinion is not correctly aligned with respect to the rack. Pinion orientation changed after the shims used in the retrofit of 1985-6 had fallen out, because the bolt holes had enlarged and bolt preload had dissipated. The steel shims were C-shaped, and were not passively captured by use of any epoxy or silicone rubber sealants. The collar was bolted to a series of rough, hot-rolled structural plates. These plates were not machined flat, nor were they spot-faced (made flat only in area of contact), nor was the bearing collar apparently reworked during the 1986 retrofit. Coincident with the 1997 rack and pinion problems were center lock misfit problems. Subsequent work in late 1997 apparently corrected the center lock interference problem, but the rack wear problem still remains.

**a. Abnormal Wear on Rack Teeth.** The racks, particularly in the northeast corner of the bridge, have experienced abnormal wear after the pinion bushing collar bolts were replaced due to hole expansion and incidental bolt breakage in 1997. The west side collars were welded into place with capture plates. The west side racks have not experienced significant wear damage like the east side. Broken collar bolts on the east side were removed, replaced and tightened in late 1997. Afterwards, the northeast rack developed a grooved wear pattern developed on the forward rack elements within a few weeks, as shown in *Figure 4*.

**Figure 4.** Wear pattern on the northeast forward (river side) rack segment which sustained the greatest wear pattern. Pattern indicates poor tooth contact and pinion misalignment.

Exchange the essentially unused rearward 17-tooth rack segment with the worn forward (river side) rack segment. Place the forward rack segment to the rear, with worn teeth at the end of the rack.

a. The worn river side 17-tooth rack element should be exchanged with the virtually unused rearward rack element on the NE corner of the bridge.

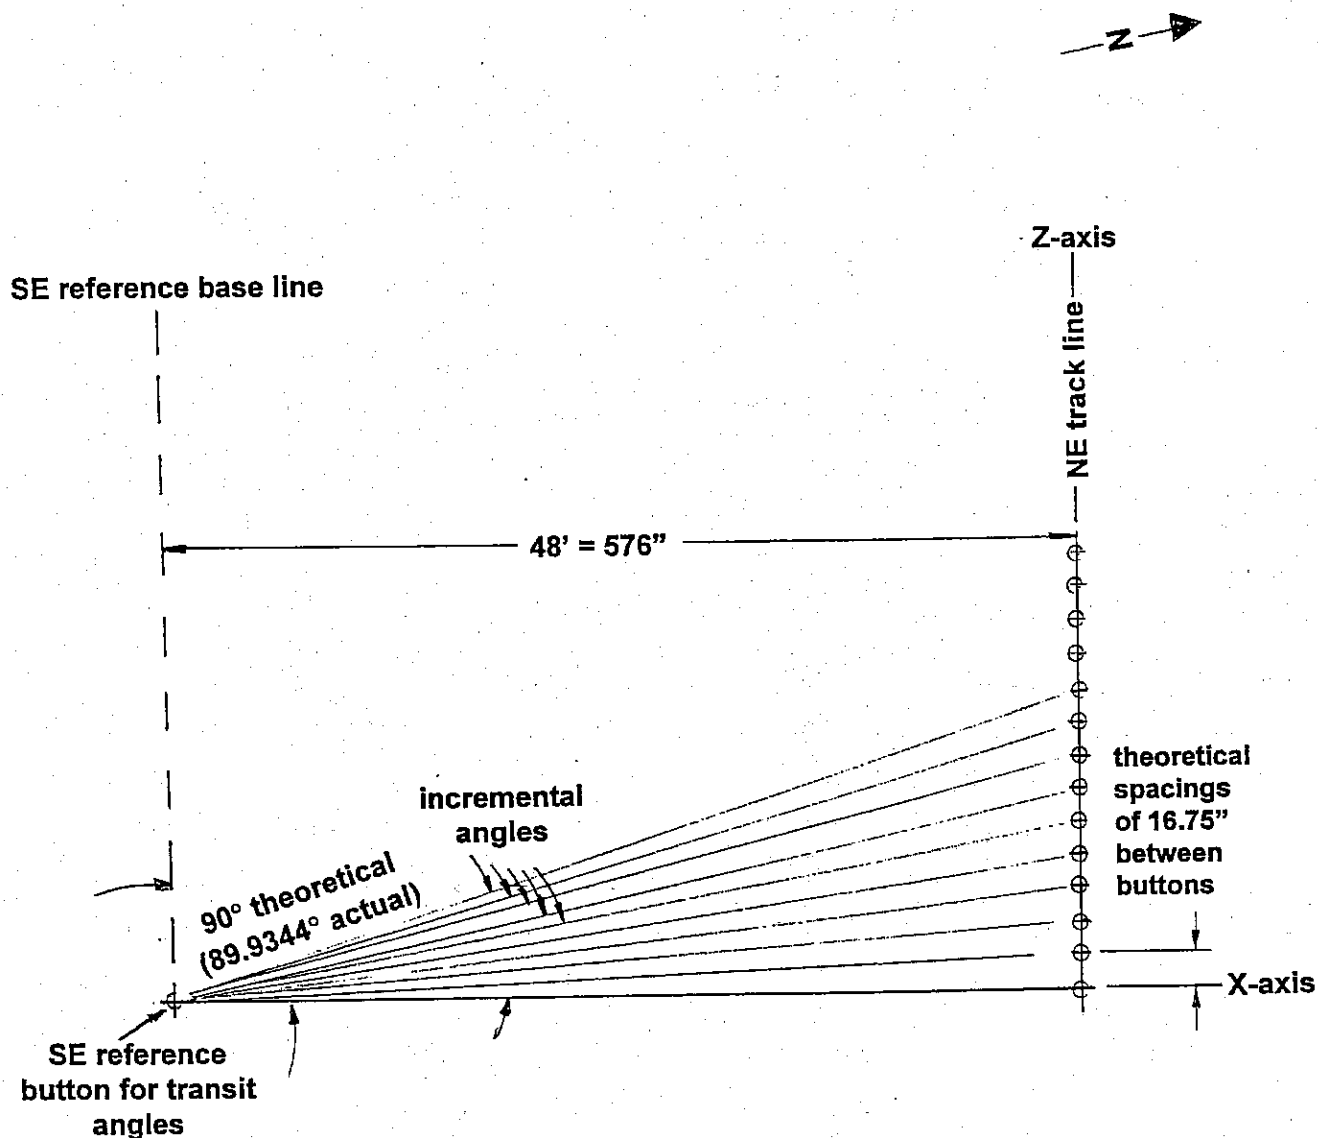
A second and more direct survey of the eastern tracks revealed several anomalies. The Geodimeter Model 600 instrument was placed on its tripod and centered directly over the center of the SE corner track bolt. Track button teeth are tapered cylinders set in bored holes and anchored down with a 1"-8UNC center bolt. From this corner position, the direct linearity and spacing of the track buttons could be measured, as well as SE and NE track parallelism. After measurements were made on the SE track, the transit was placed over the NE corner bolt where specific angles were measured for the SE track buttons. See *Figure 5* for transit placement on the bridge tracks and how angles were turned.

*Figure 5.* A Geodimeter Model 600 transit accurate to 1 second was centered over the SE corner button tooth bolt and angles turned for respective buttons on the opposite track. Procedure was reversed on the NE corner bolt. Linearity of SE and NE bolt lines was also measured. Average deviation from a straight line was approximately 2 mm.

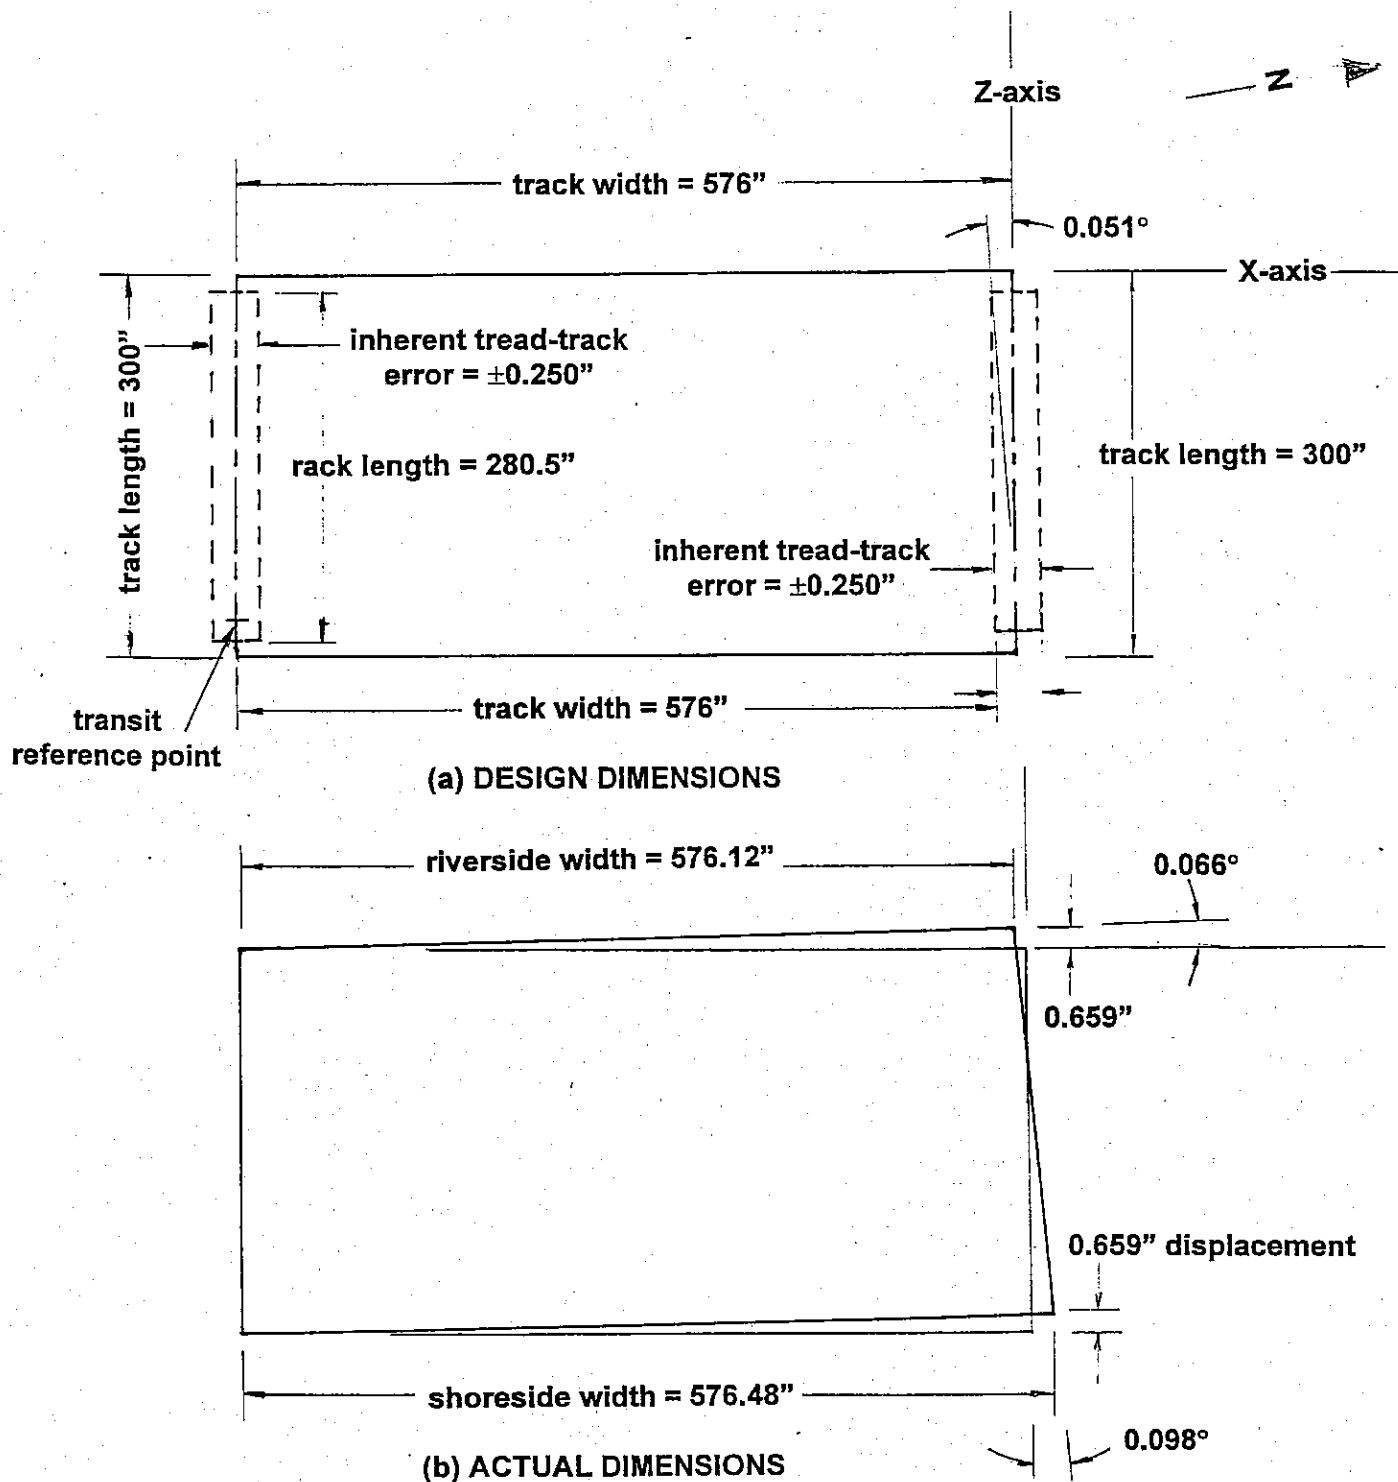
Although individual track linearity and button spacings were satisfactory, track lines were not parallel and buttons lacked proper correspondence. The NE button line was shifted toward the river by 0.659". This was confirmed by setting the SE track button line as a reference, and then turning the transit sight by  $90.000^\circ$ . It was found that the opposite button was not at  $90^\circ$ , but off by approximately  $0.06^\circ$ . Although  $0.06^\circ$  appears to be insignificant, this angle is over a distance of 576", resulting in a riverside displacement of 0.659", which exceeds the oversized socket hole accommodation of 0.250". Moreover, it skews the entire leaf span slightly, partially accounting for the center lock misfit.

*Figure 6.* Design dimensions for the track (a) are compared with actual dimensions as measured by direct survey (b). Scale of distortion in (b) is greatly magnified for effect. Because of the oversize of the tread sockets by 0.250", the tread can deviate from true linearity by  $\pm 0.250$ ".

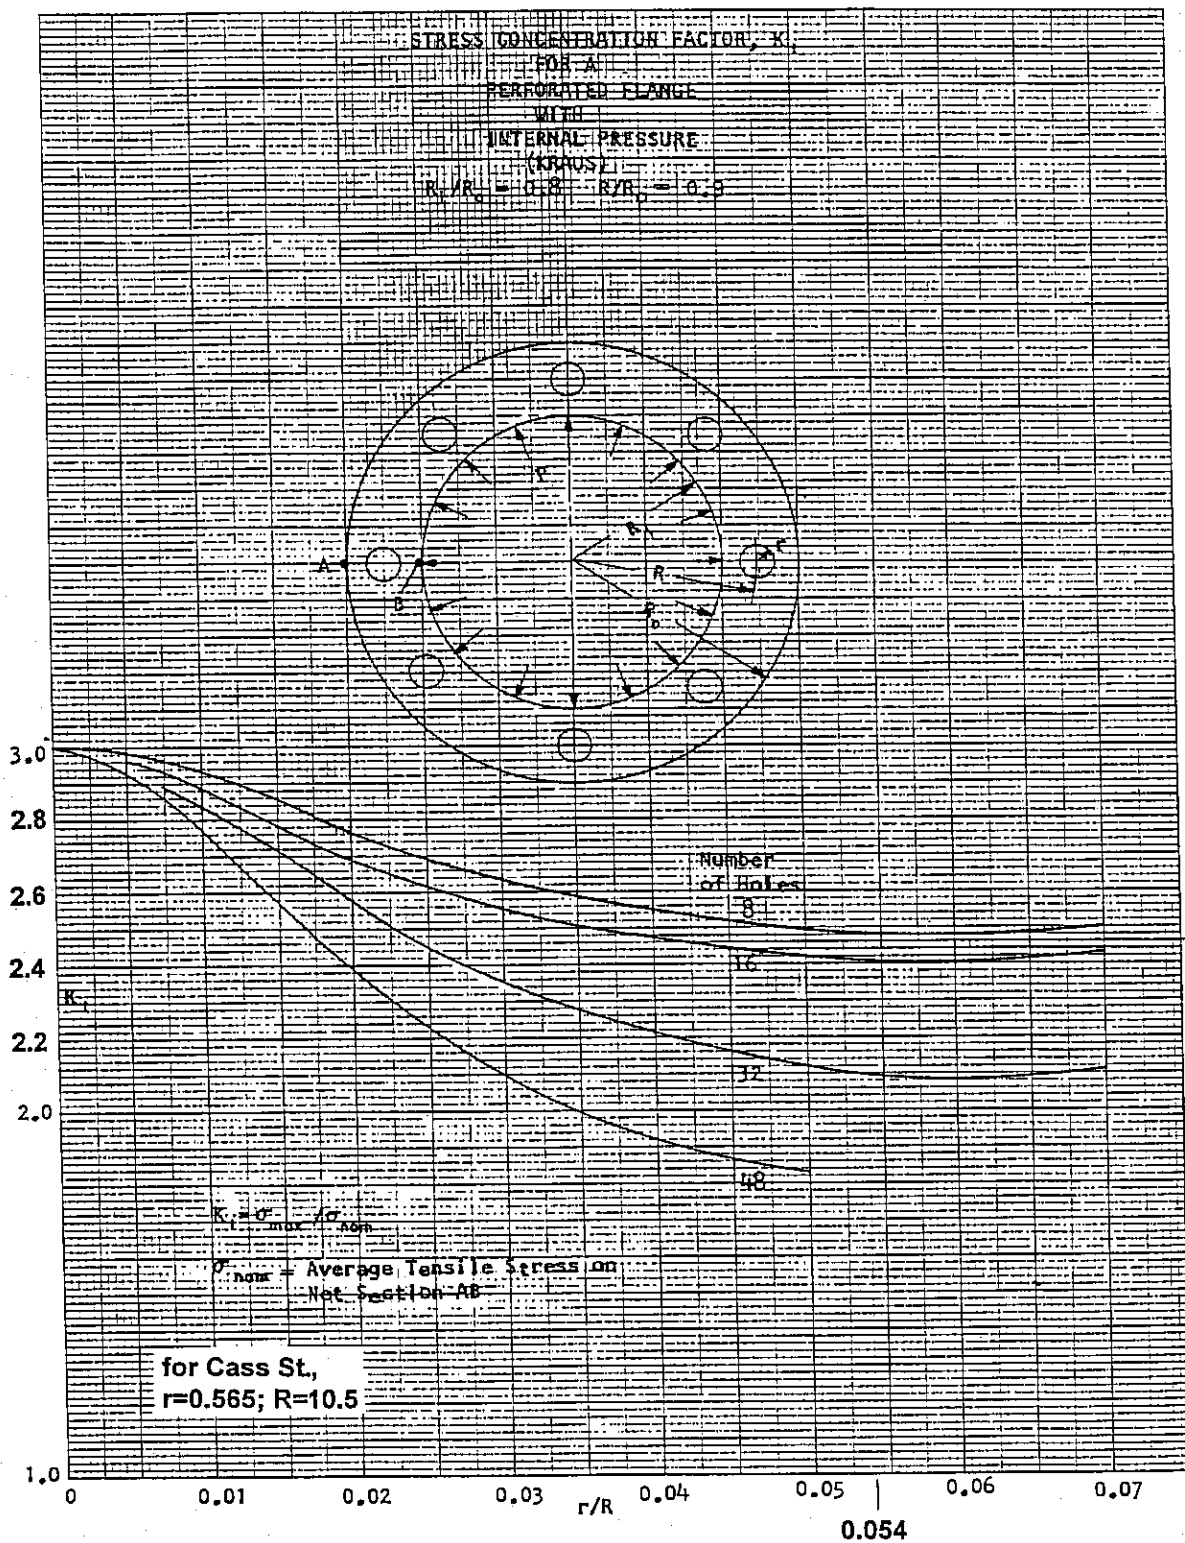
Stress concentrations in a perforated flange with internal pressure have been studied by Kraus (as summarized by Peterson) [Reference 6]. The graphical solution for the Cass St. Bridge conditions is shown in *Figure 8*. For the Cass St. Bridge, the bolt hole radius  $r$  is 0.565", and the bolt circle radius  $R$  is 10.50", resulting in an  $r/R$  ratio of 0.54. For six bolts, the stress concentration factor  $K_t$  is about 2.5 in the collar bolt holes.

Uniformly distributing 105,830 lbs of force among six bolt holes results in 17,638 lbs/hole. If this force exerts pressure on one side of a 1.125" diameter hole of 1.5" depth, 23,455 psi bearing pressure results. Because of stress concentrations, peak stresses can potentially rise to 58,600 psi, which exceeds the probable yield strength of 35,000 psi for the casting and plates. Holes on the castings and plates for both Cass St.

**Figure 8.** The graphical solution of Kraus for stress concentrations in a perforated flange with internal pressure. In the Cass St. Bridge pinion bearing, the shear and bending forces on the shaft provide the internal pressure. The  $K_t$  for 6 bolt holes was estimated as 2.5; and for 11 bolt holes,  $K_t \approx 2.4$ . Source: R. Petersen, *Stress Concentration Factors*, Wiley-Interscience, New York, 1974, p 192.

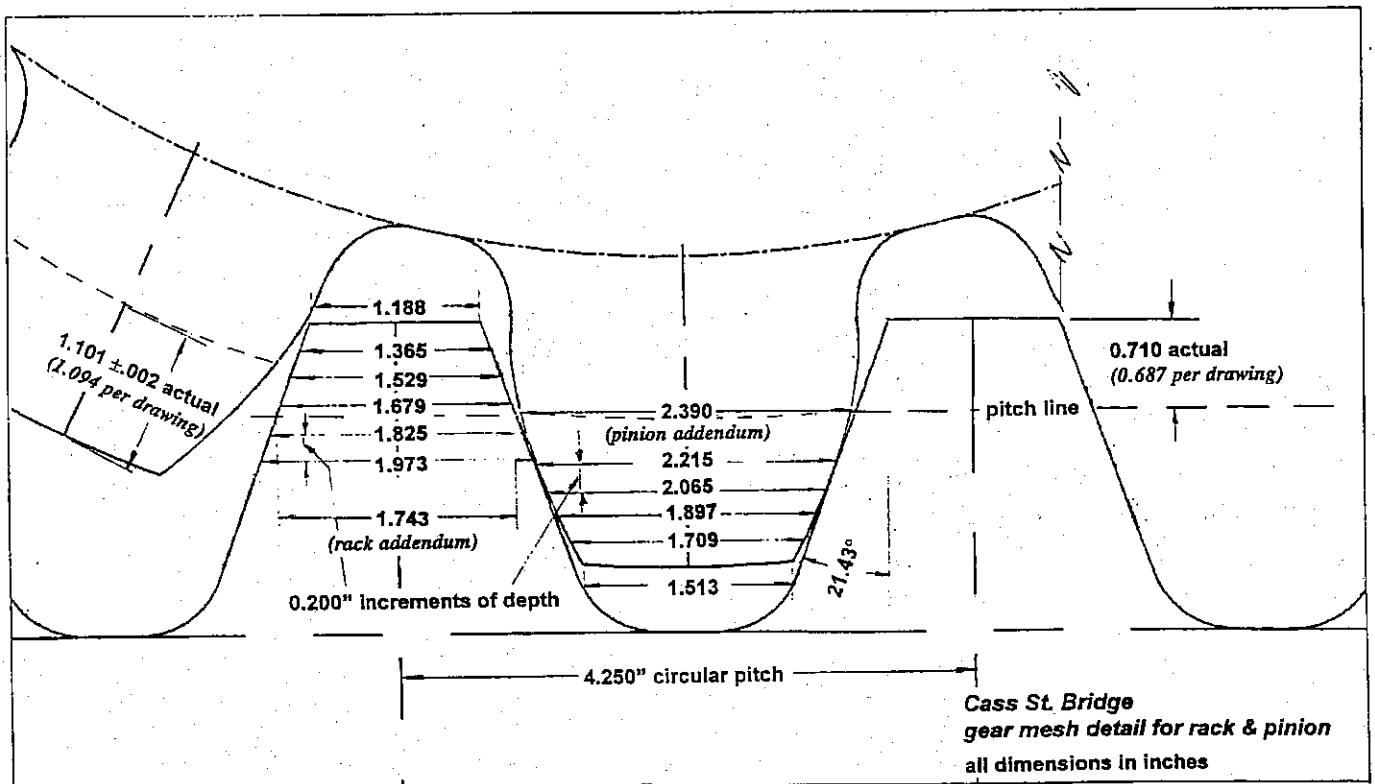
**Figure 10.** Actual gear mesh at the original design pitch line, showing actual dimensions taken by a tooth thickness vernier of the racks and pinions retrofitted in 1986 at various depths.

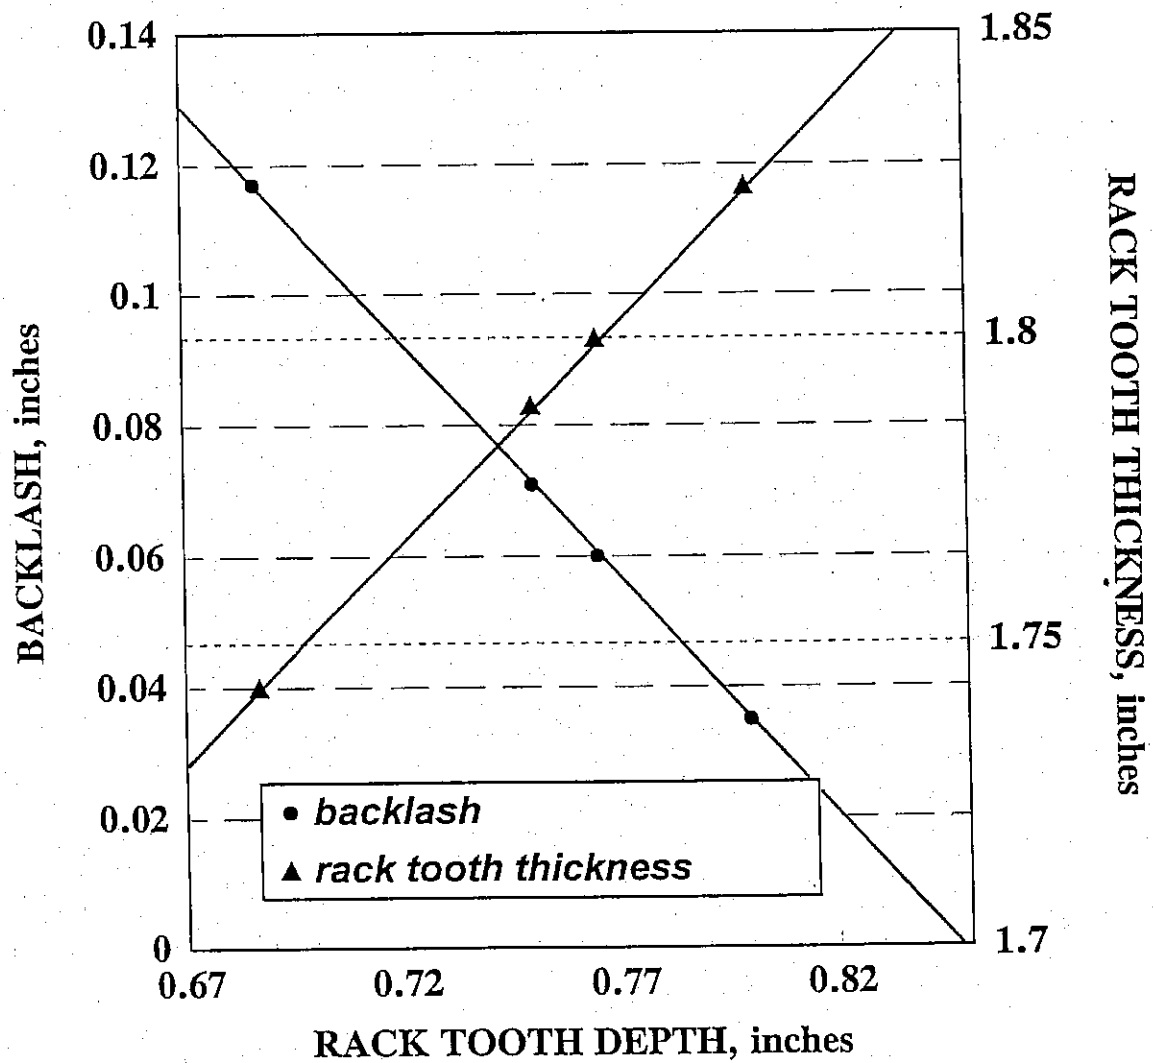
Figure 11. Plot of the amount of backlash available as the pinion addendum progressively moves downward below the rack pitch line. This graph assumes that the thickness of the pinion addendum is 2.390", the actual mean dimension obtained from field measurements with a gear tooth thickness vernier.

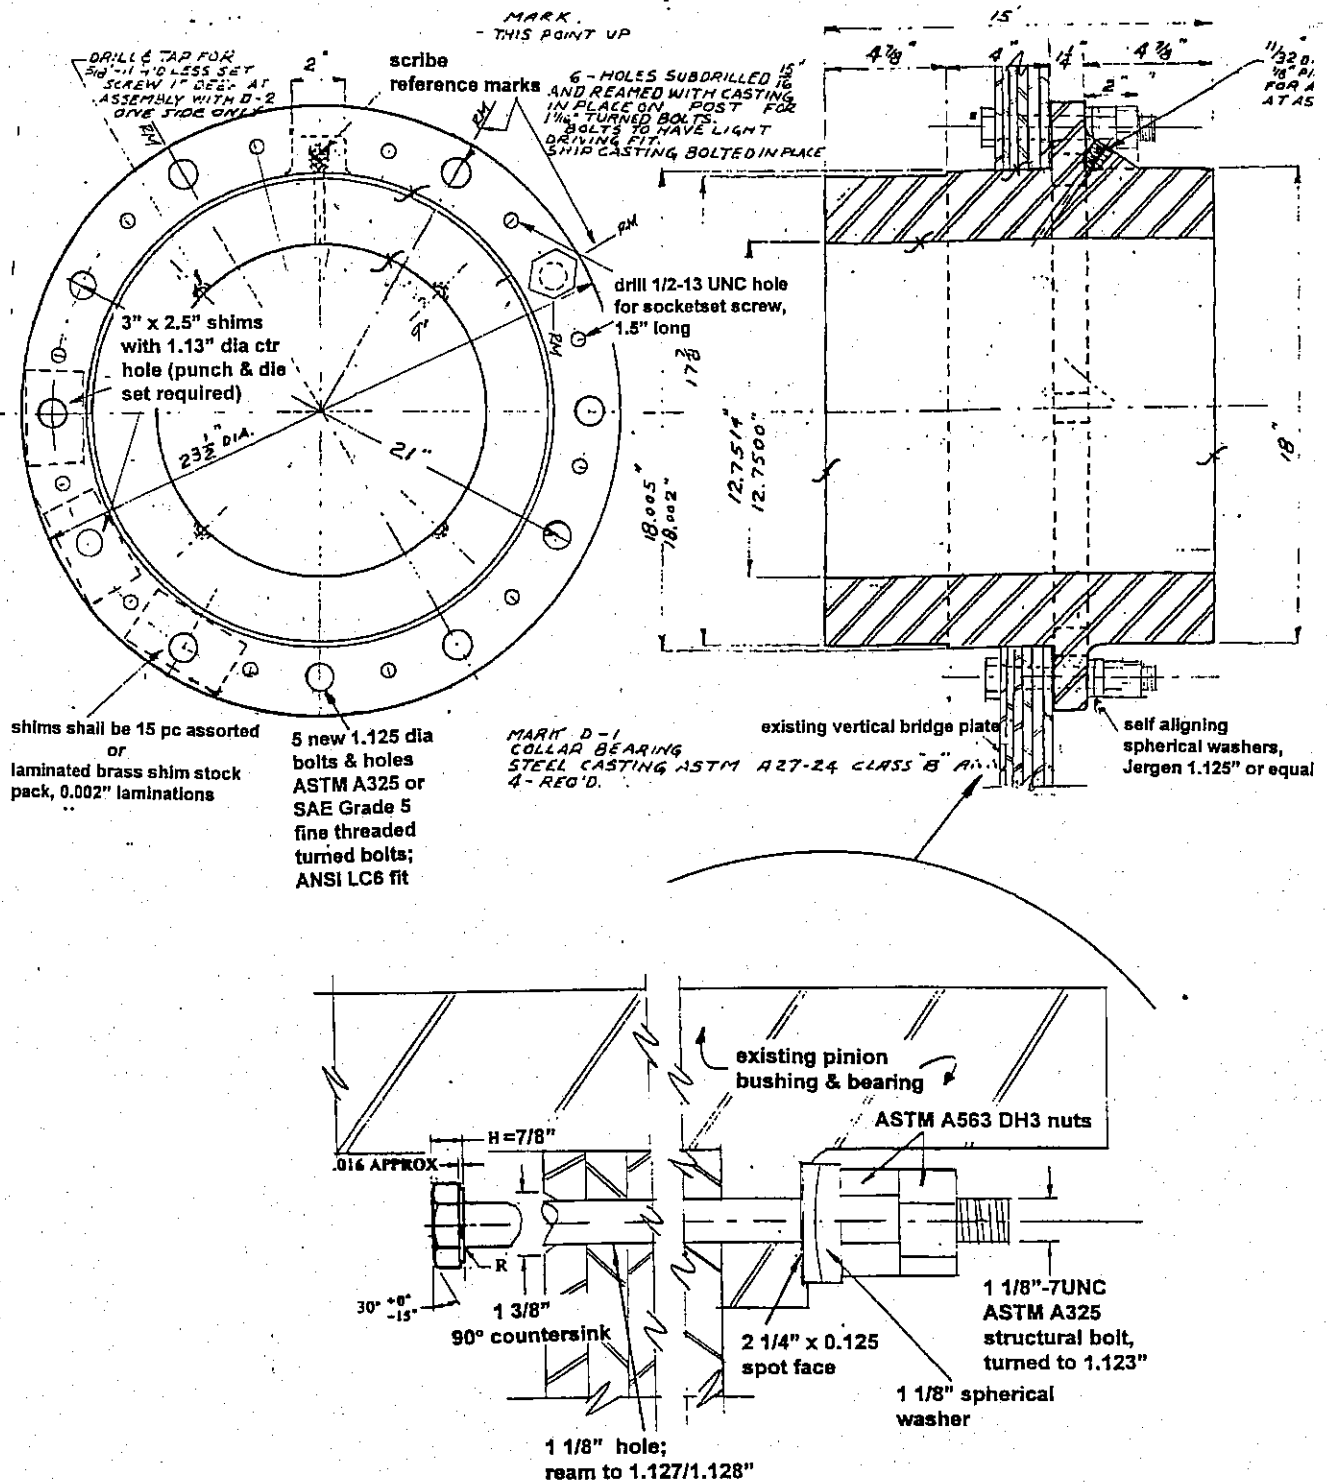
Figure 12. Modification of the original (existing) pinion bearing collar for alignment, showing set screws for alignment, insertion of center-hole brass or stainless steel shims, spherical washers, and five (5) additional bolts.

(a) Drill set screw tap holes and tap threads into the pinion bearing collar per *Figure 12*. Loosen the pinion collar bolts to permit gear adjustment. Position the bearing collar with the set screws until the pinion gear is properly aligned with rack in the X, Y and Z axes.

(b) Remove the bearing collar bolts one by one, spot face the collar holes, and insert new bolts with spherical washers. Insert shims at each position as required. Drill five (5) new 1.125" diameter holes per *Figure 12*. Permanent shims should be 3" x 1.38" brass or stainless steel sheet with a center hole, with sheet thicknesses varying from 0.002" to 0.010". Do not use C-shaped shims, except for temporary adjustment.
