**EVALUATION OF HIGH PERFORMANCE  
CONCRETE BRIDGE DECKS  
AND  
OTHER EXPERIMENTAL BRIDGE  
DECKS THROUGHOUT ILLINOIS**

**PHYSICAL RESEARCH REPORT NO. 166  
December 2017**

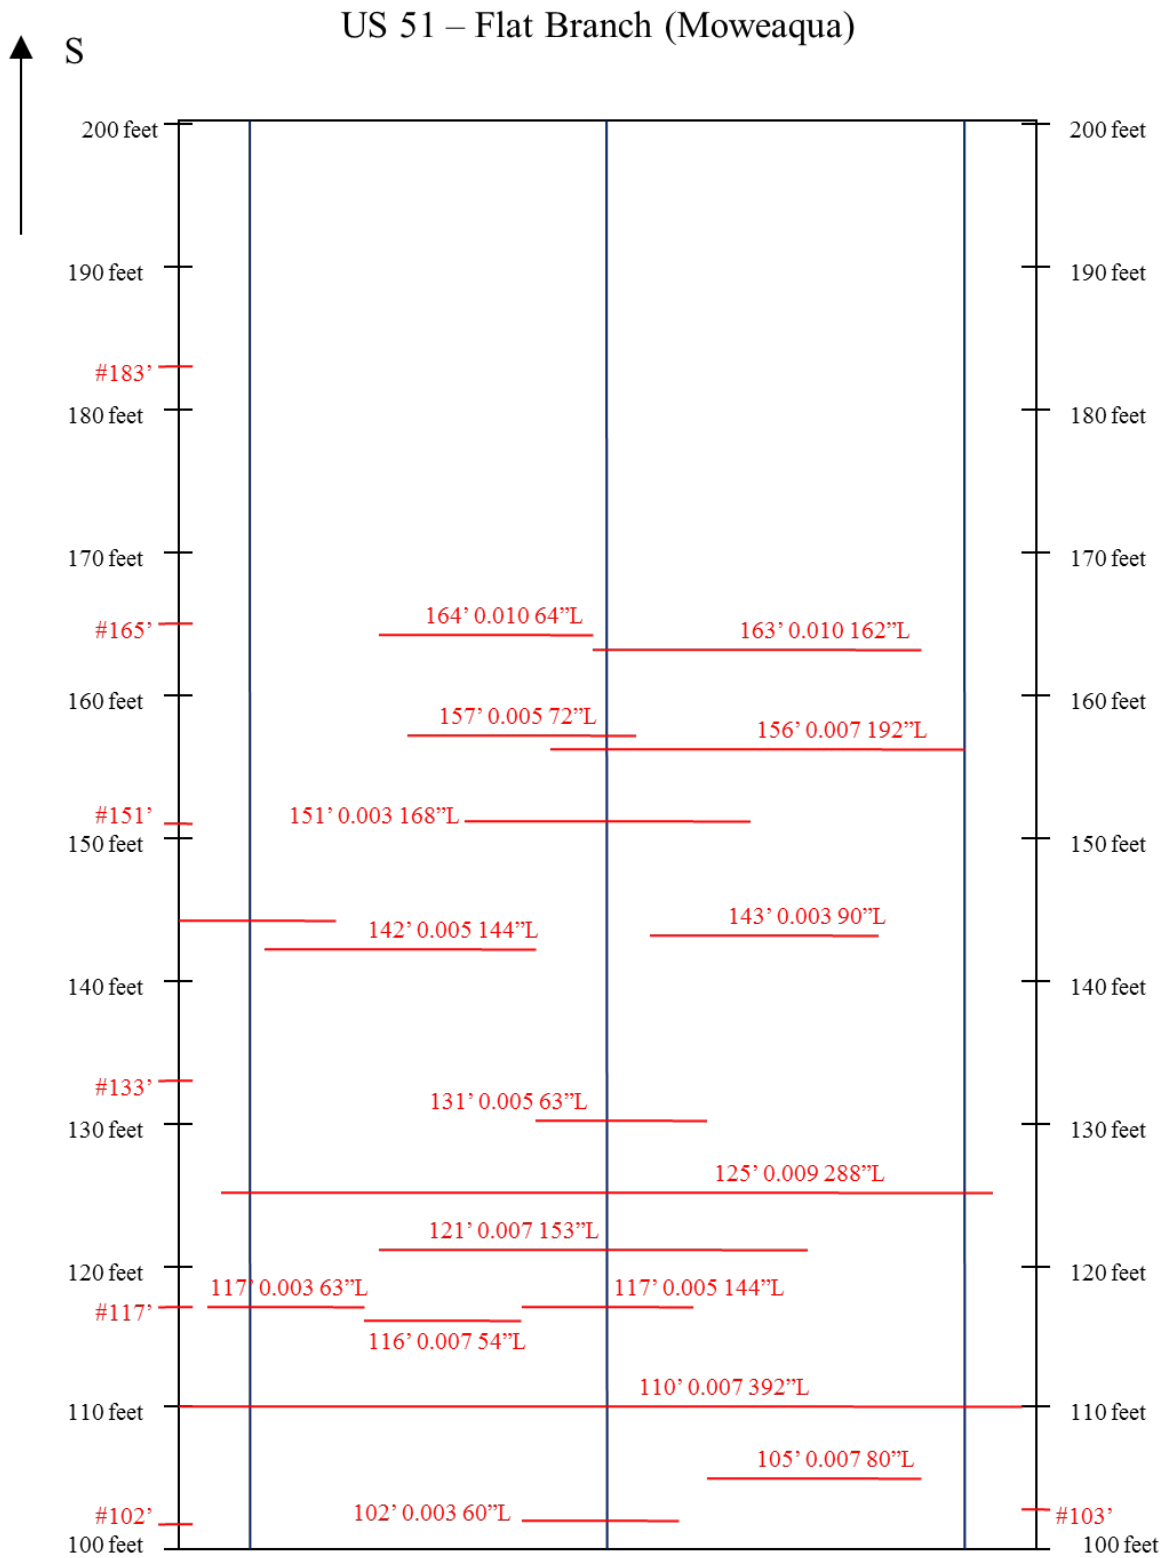
Figure 2.1-2

Christian County – SN#011-0036 – surveyed 9/19/2003  
 The “#” symbol represents cracks in the parapet only.

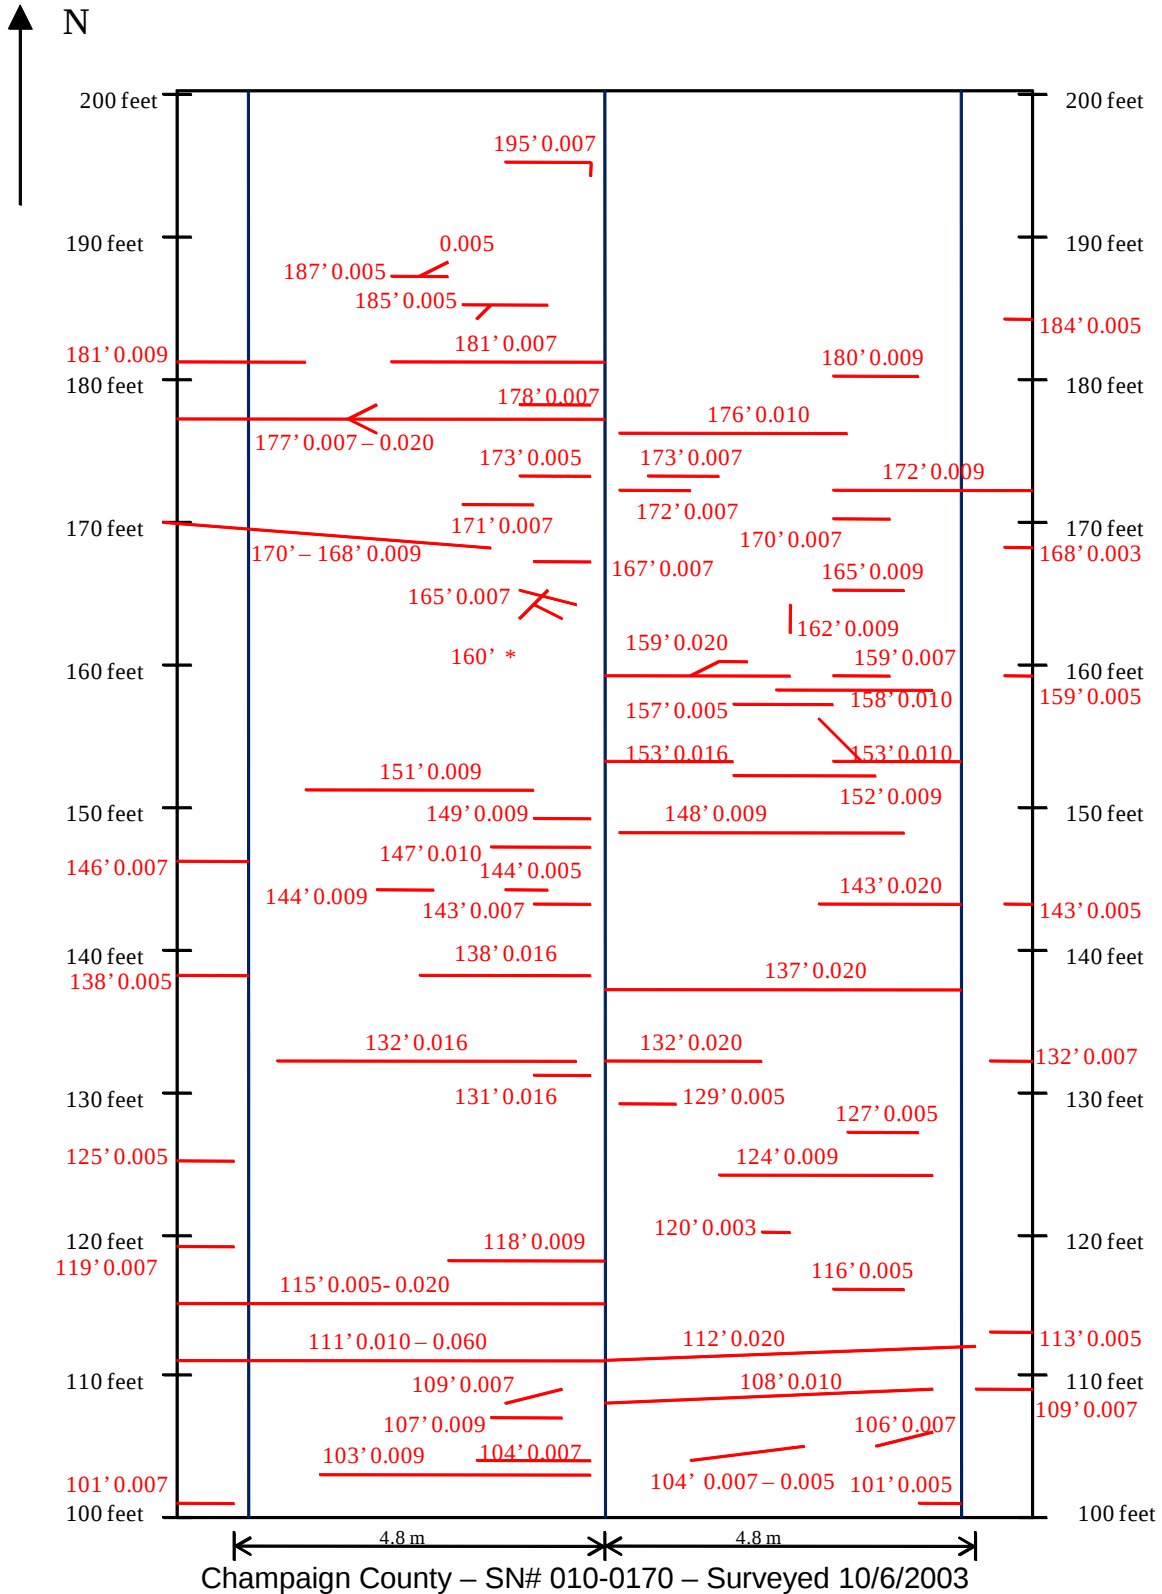
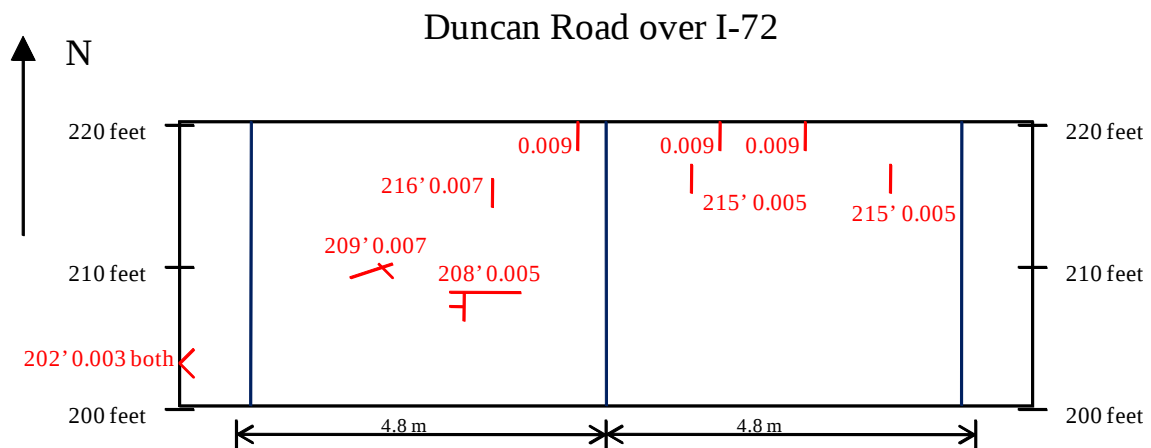
# Duncan Road over I-72

\* Denotes areas showing map cracking.  
Also, several cracks extended into the sidewalk.

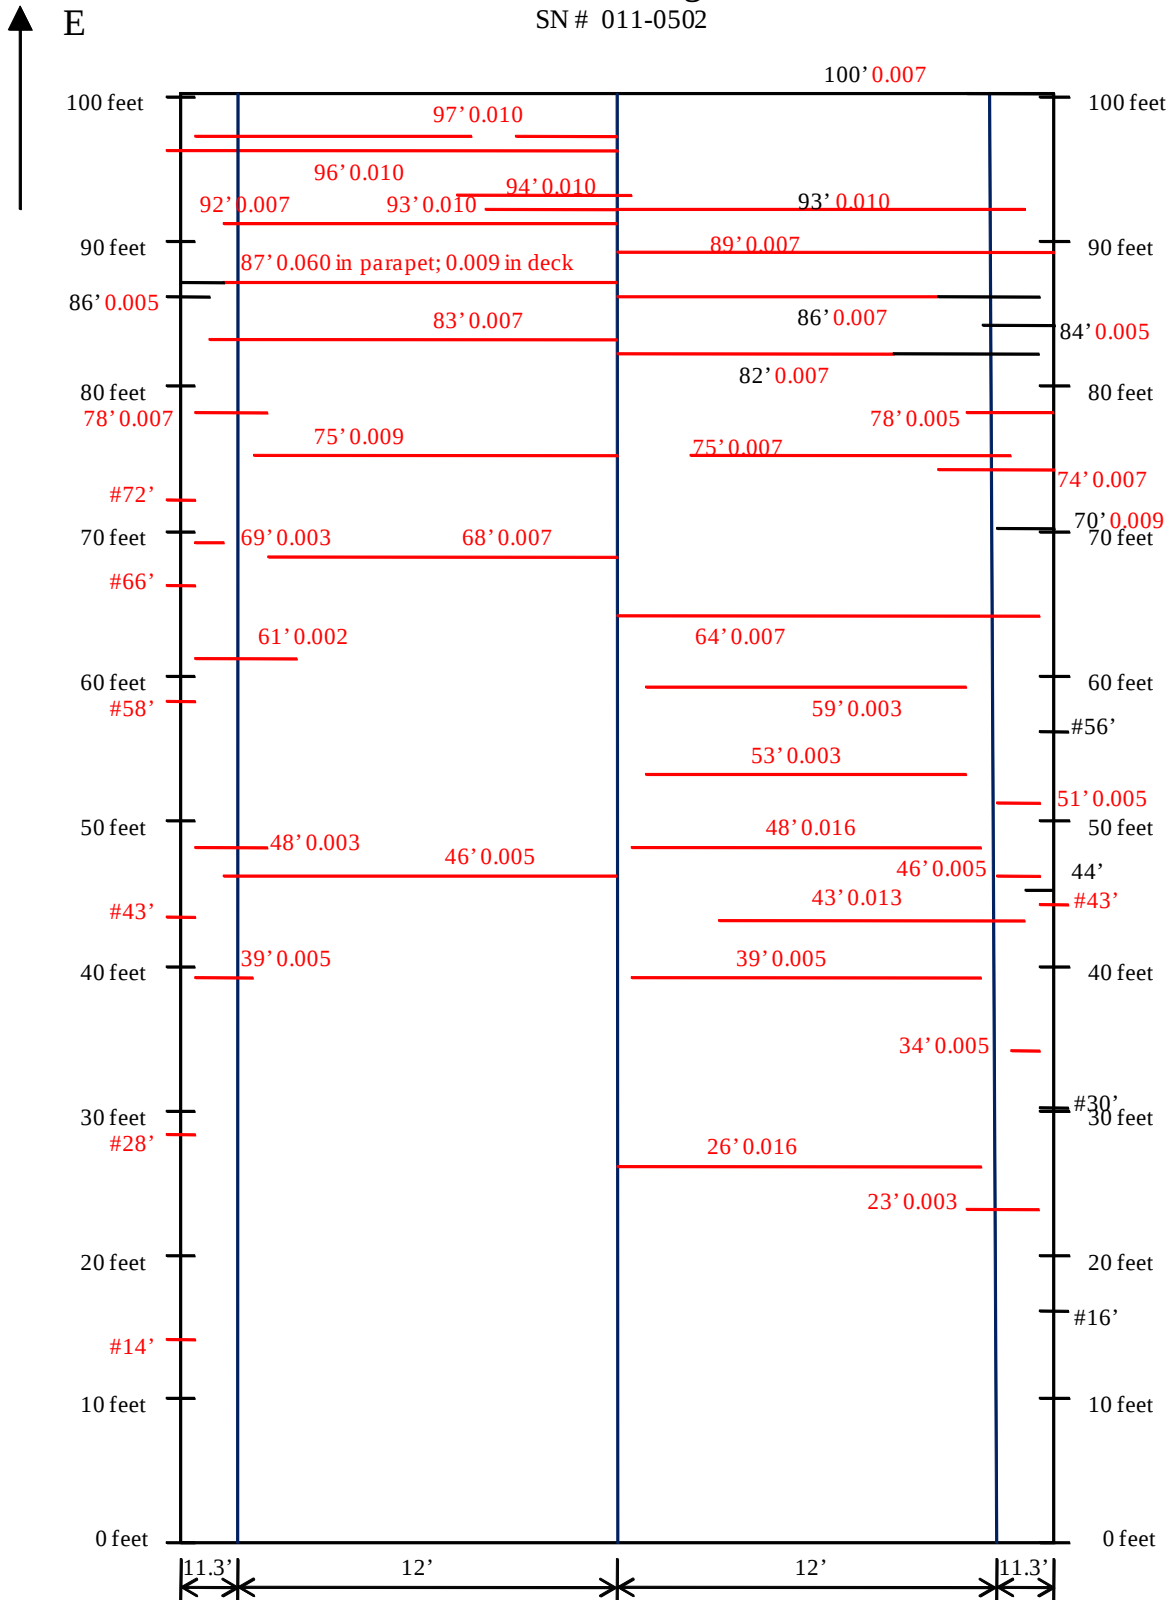
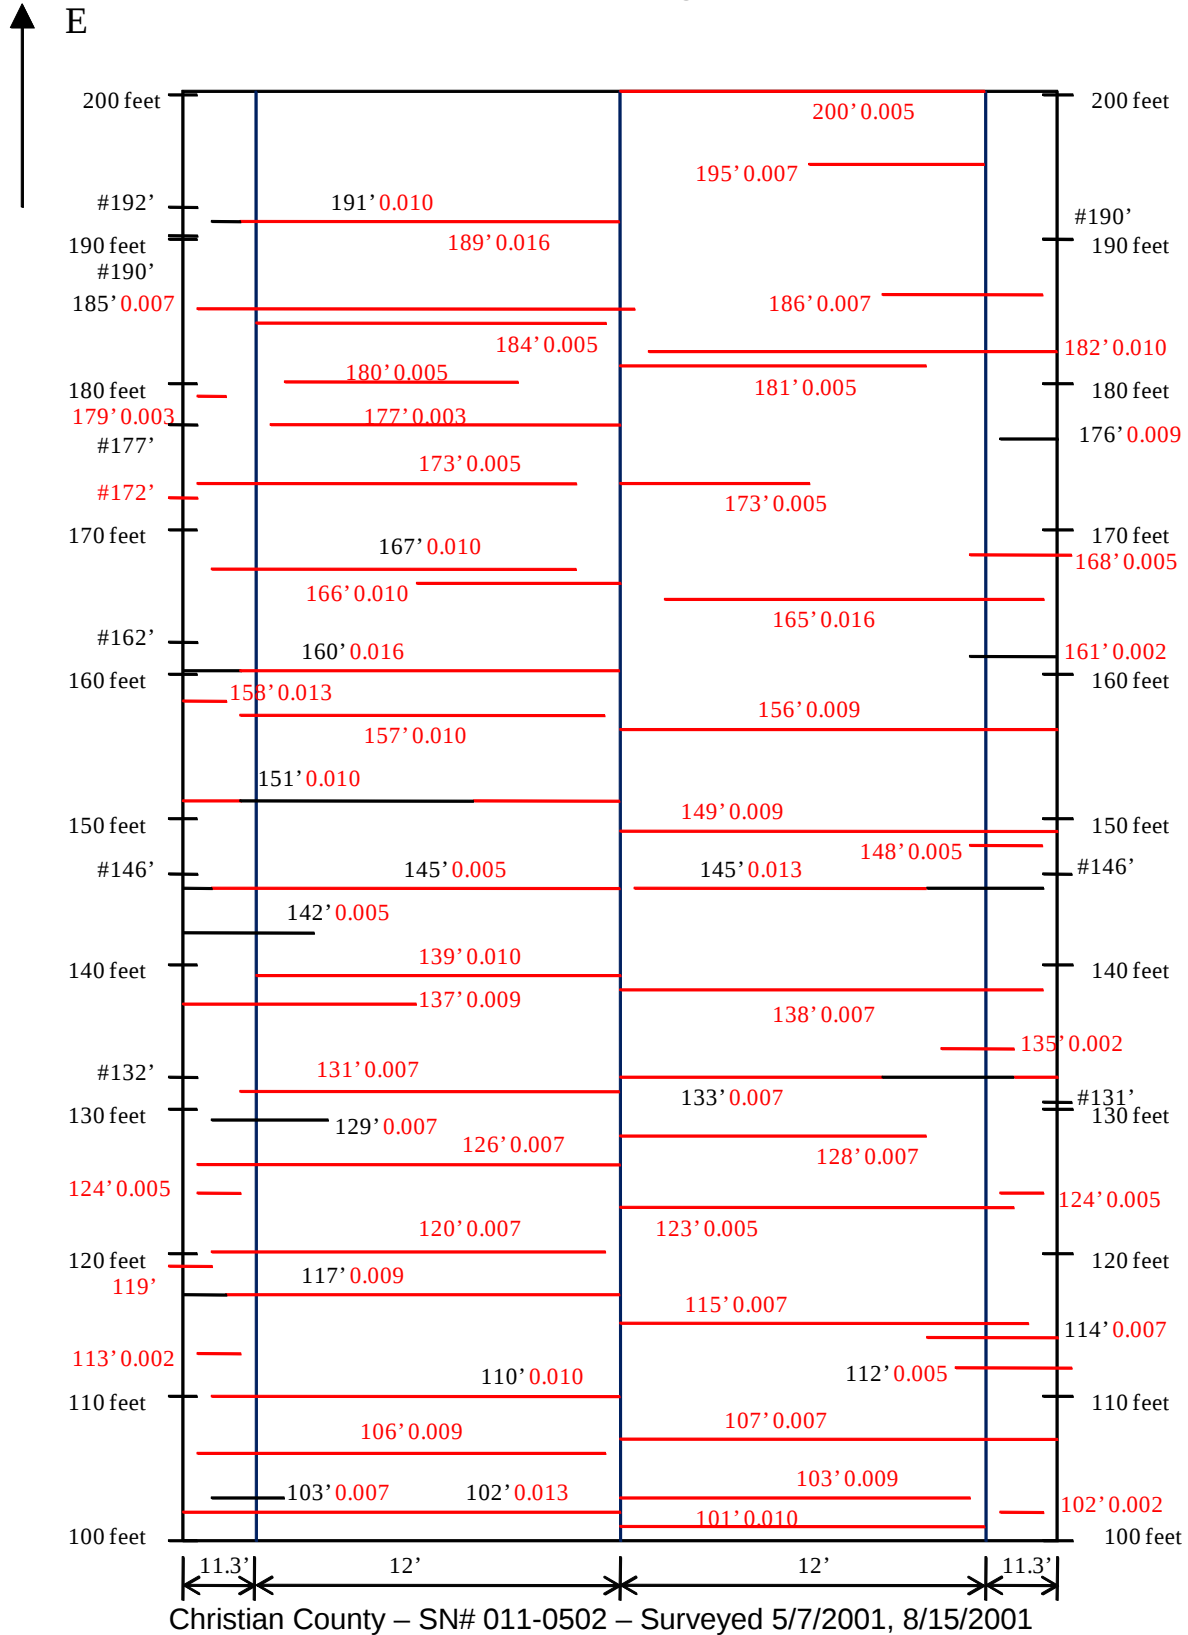
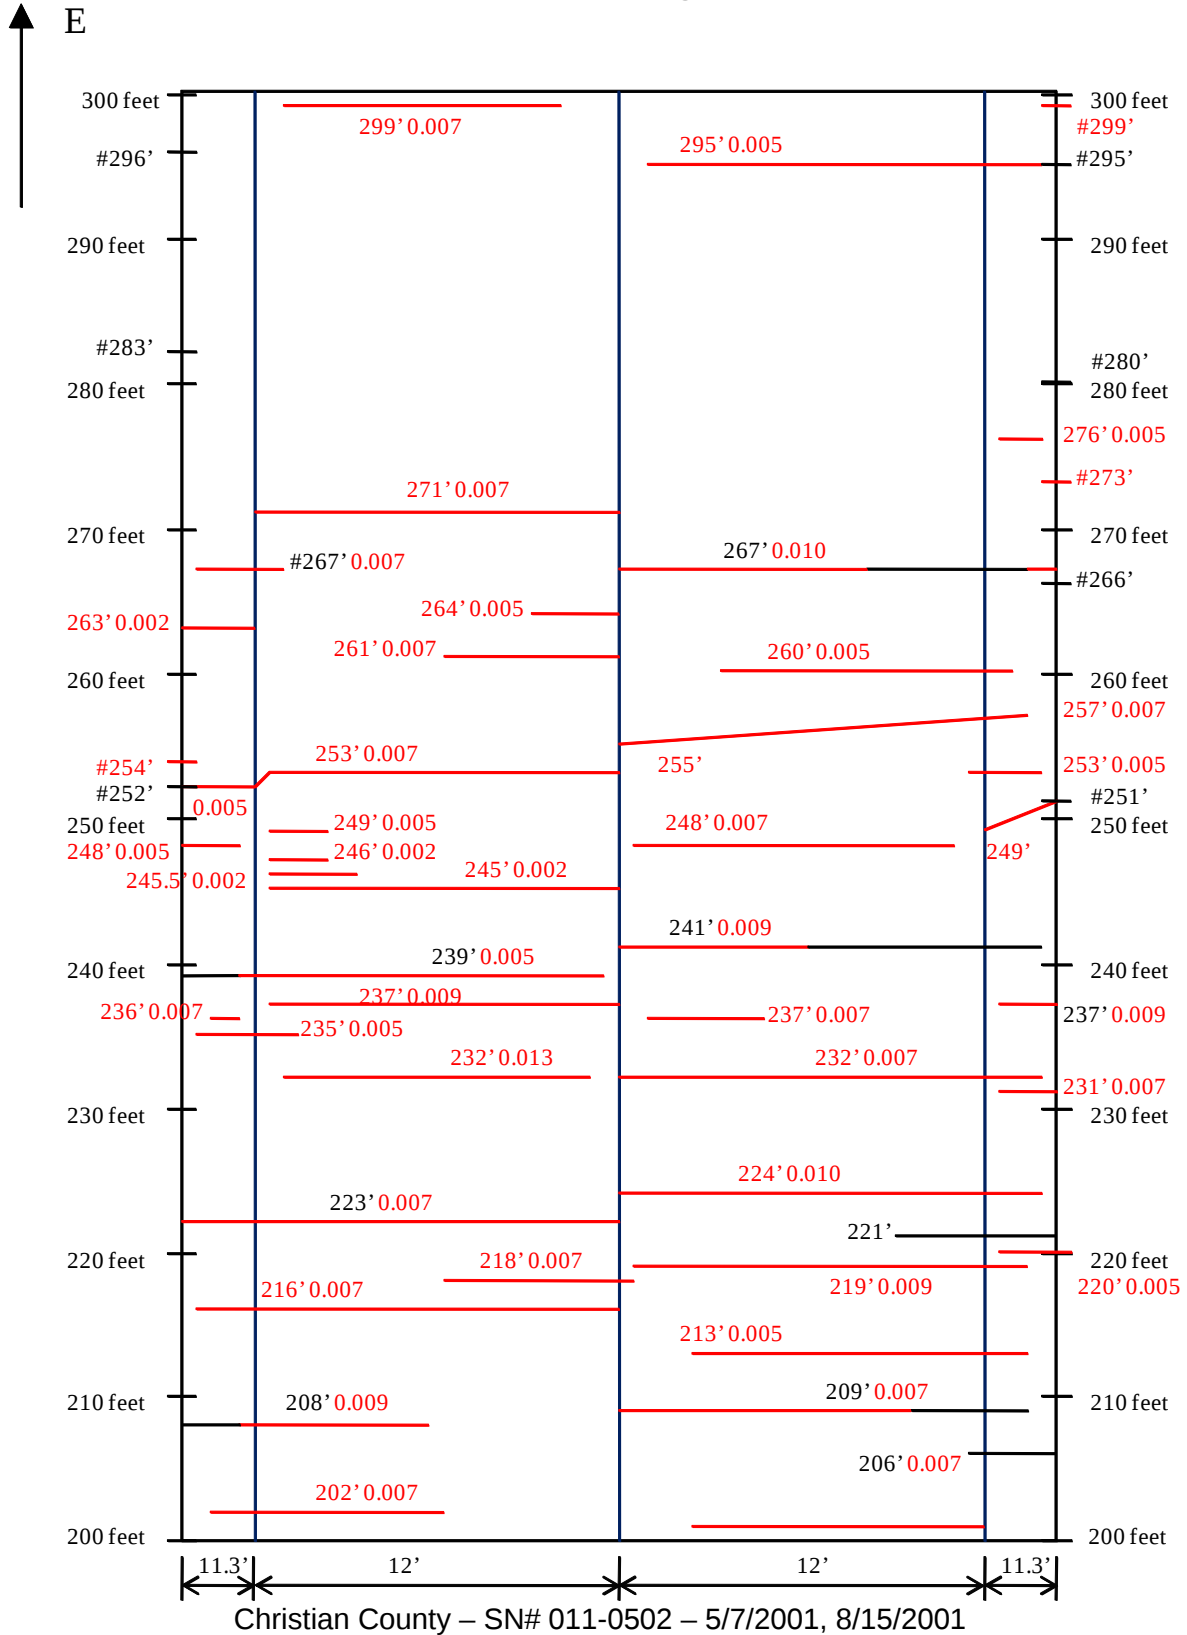
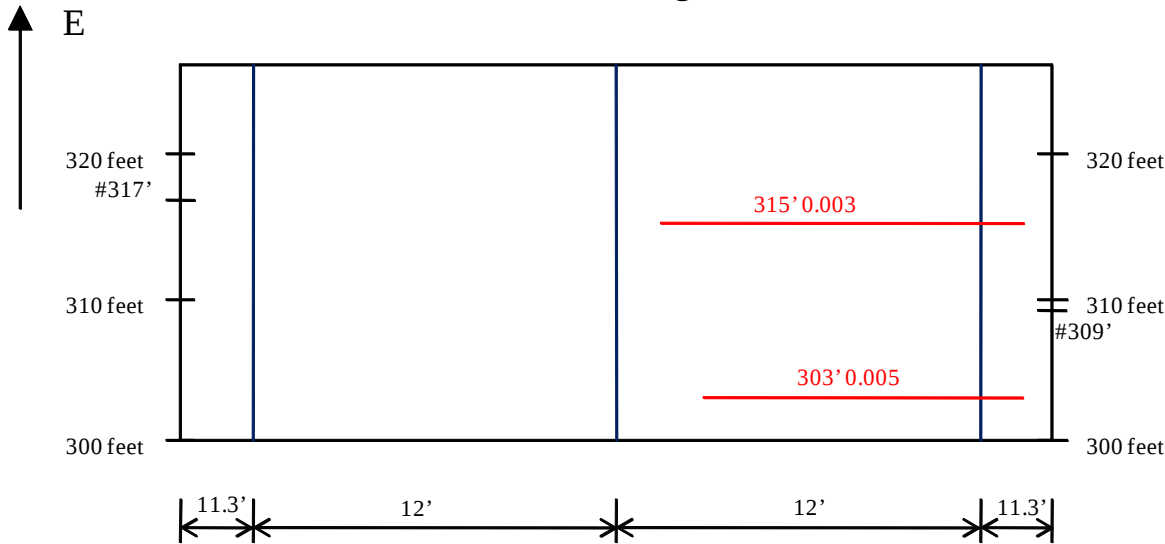
SN # 011-0502

Christian County – SN# 011-0502 – Surveyed 5/7/2001, 8/15/2001  
SN# 011-0502 was poured 10/12/2000 and the initial survey showed three hairline cracks.  
The “#” symbol represents cracks in the parapet only.

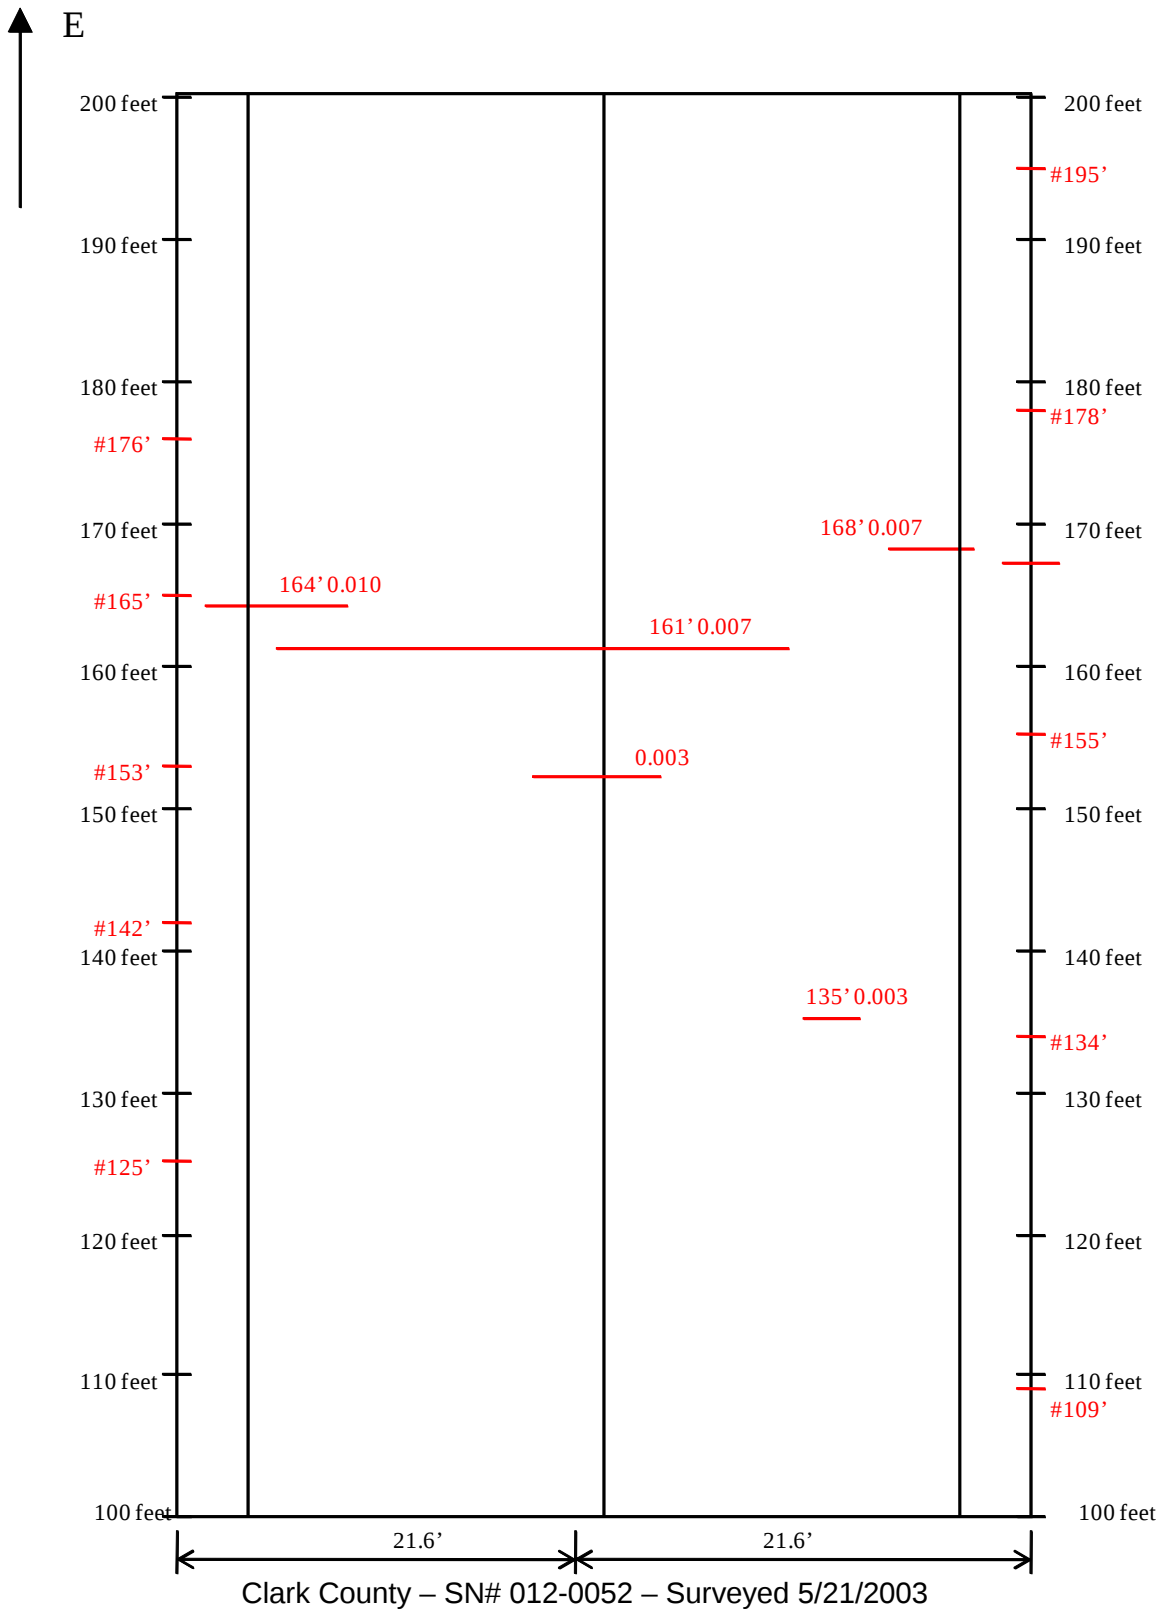
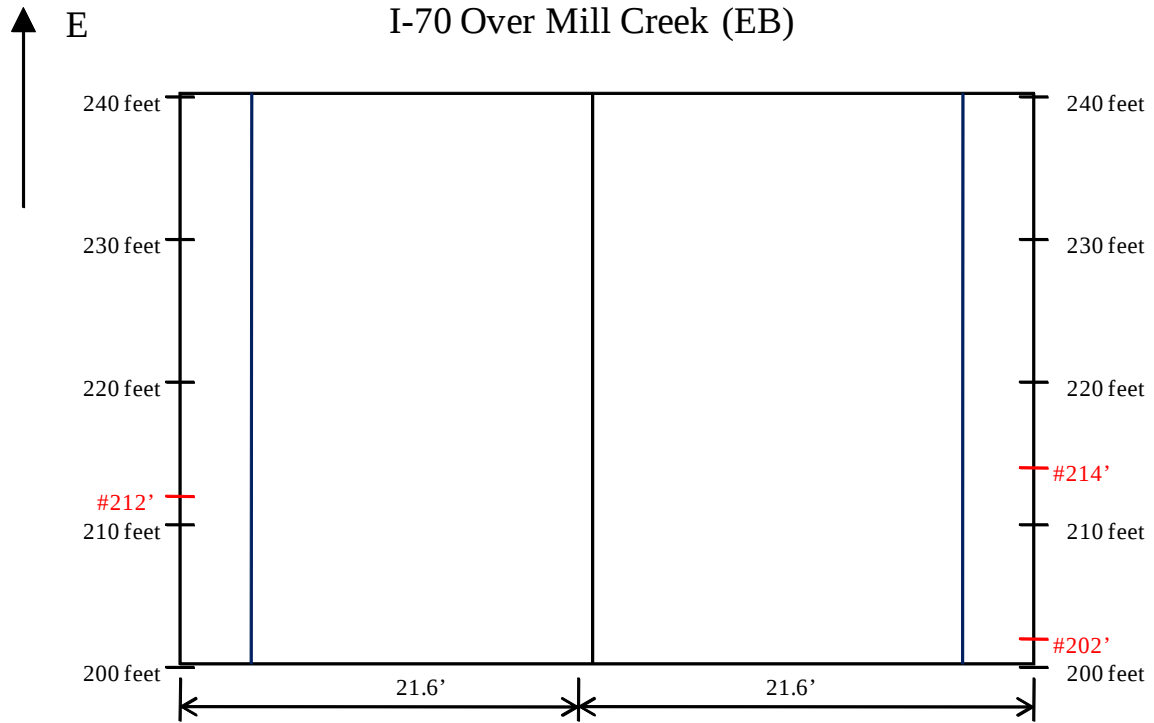
# I-70 Over Mill Creek (EB)

Clark County – SN# 012-0052 – Surveyed 5/21/2003  
The “#” symbol represents cracks in the parapet only.

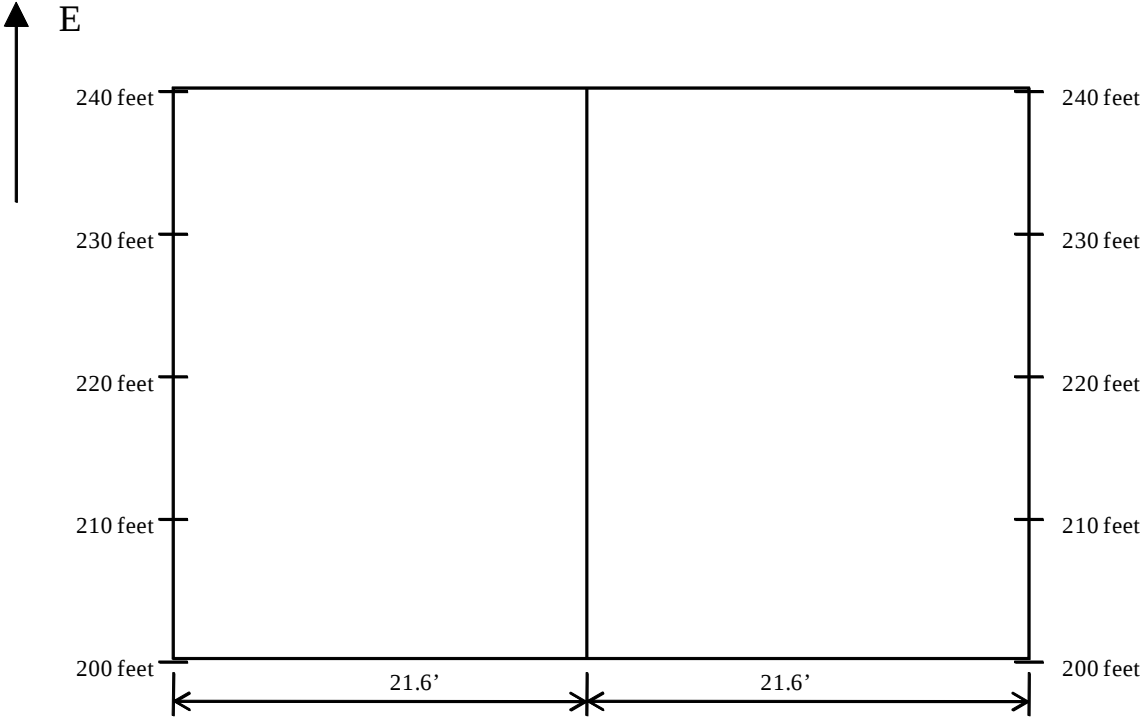
I-70 Over Mill Creek (WB)

\* Crack traversed through deck drain.

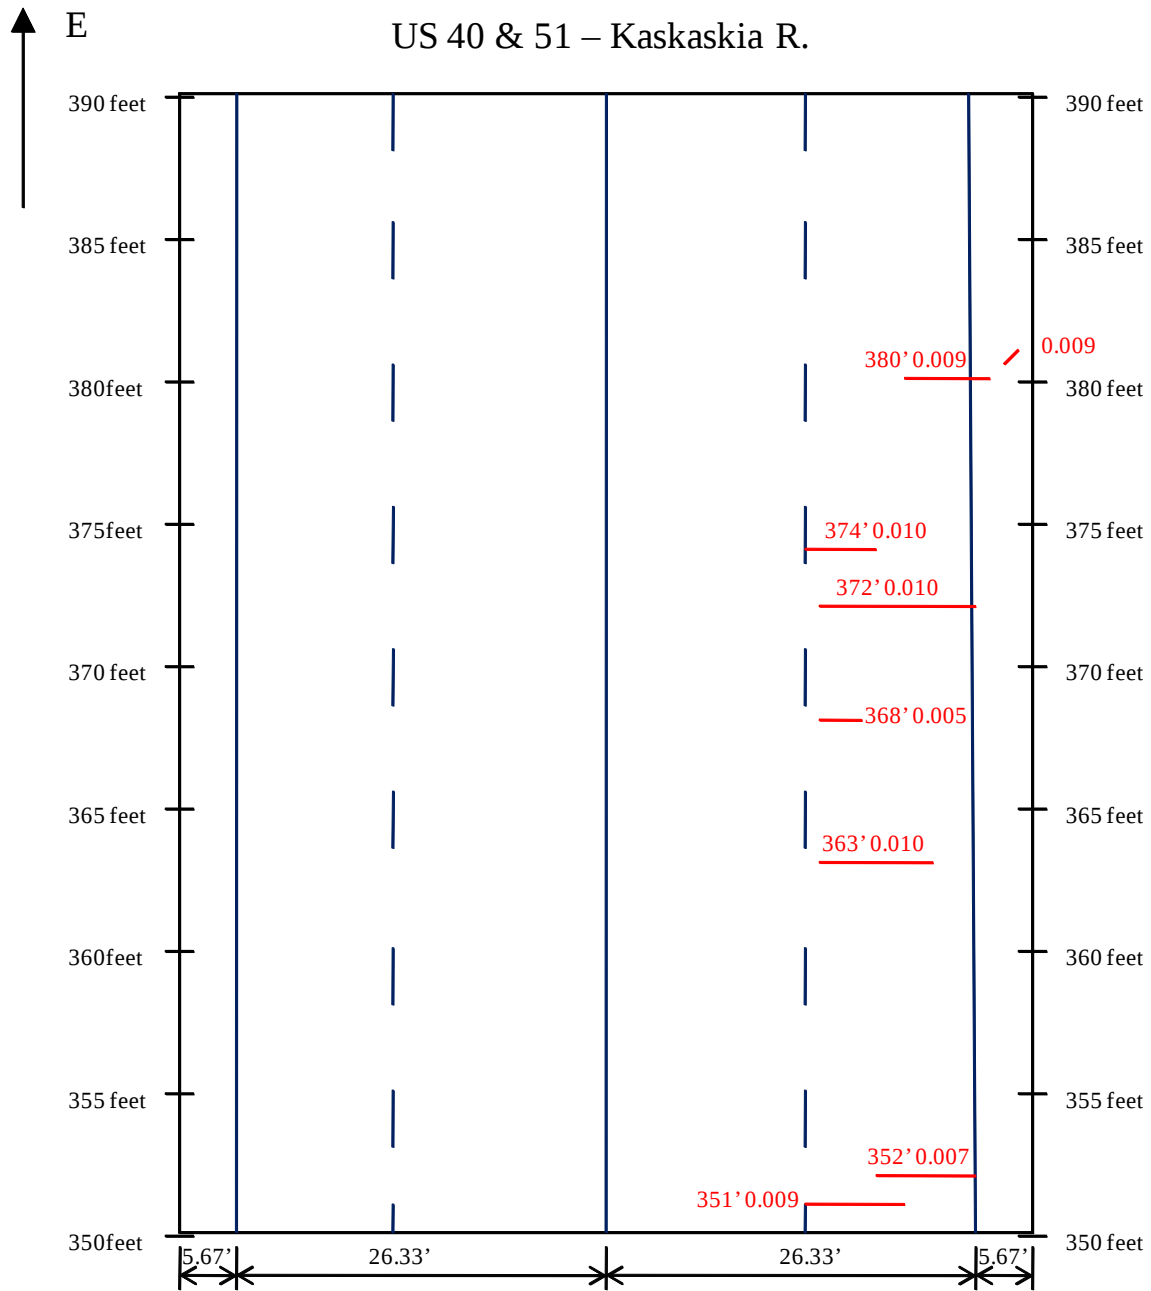
# US 40 & 51 – Kaskaskia R.

Only the driving lanes of this bridge deck were surveyed because of time constraints and traffic safety concerns. Numerous cracks extended from the driving lanes into the passing lanes.

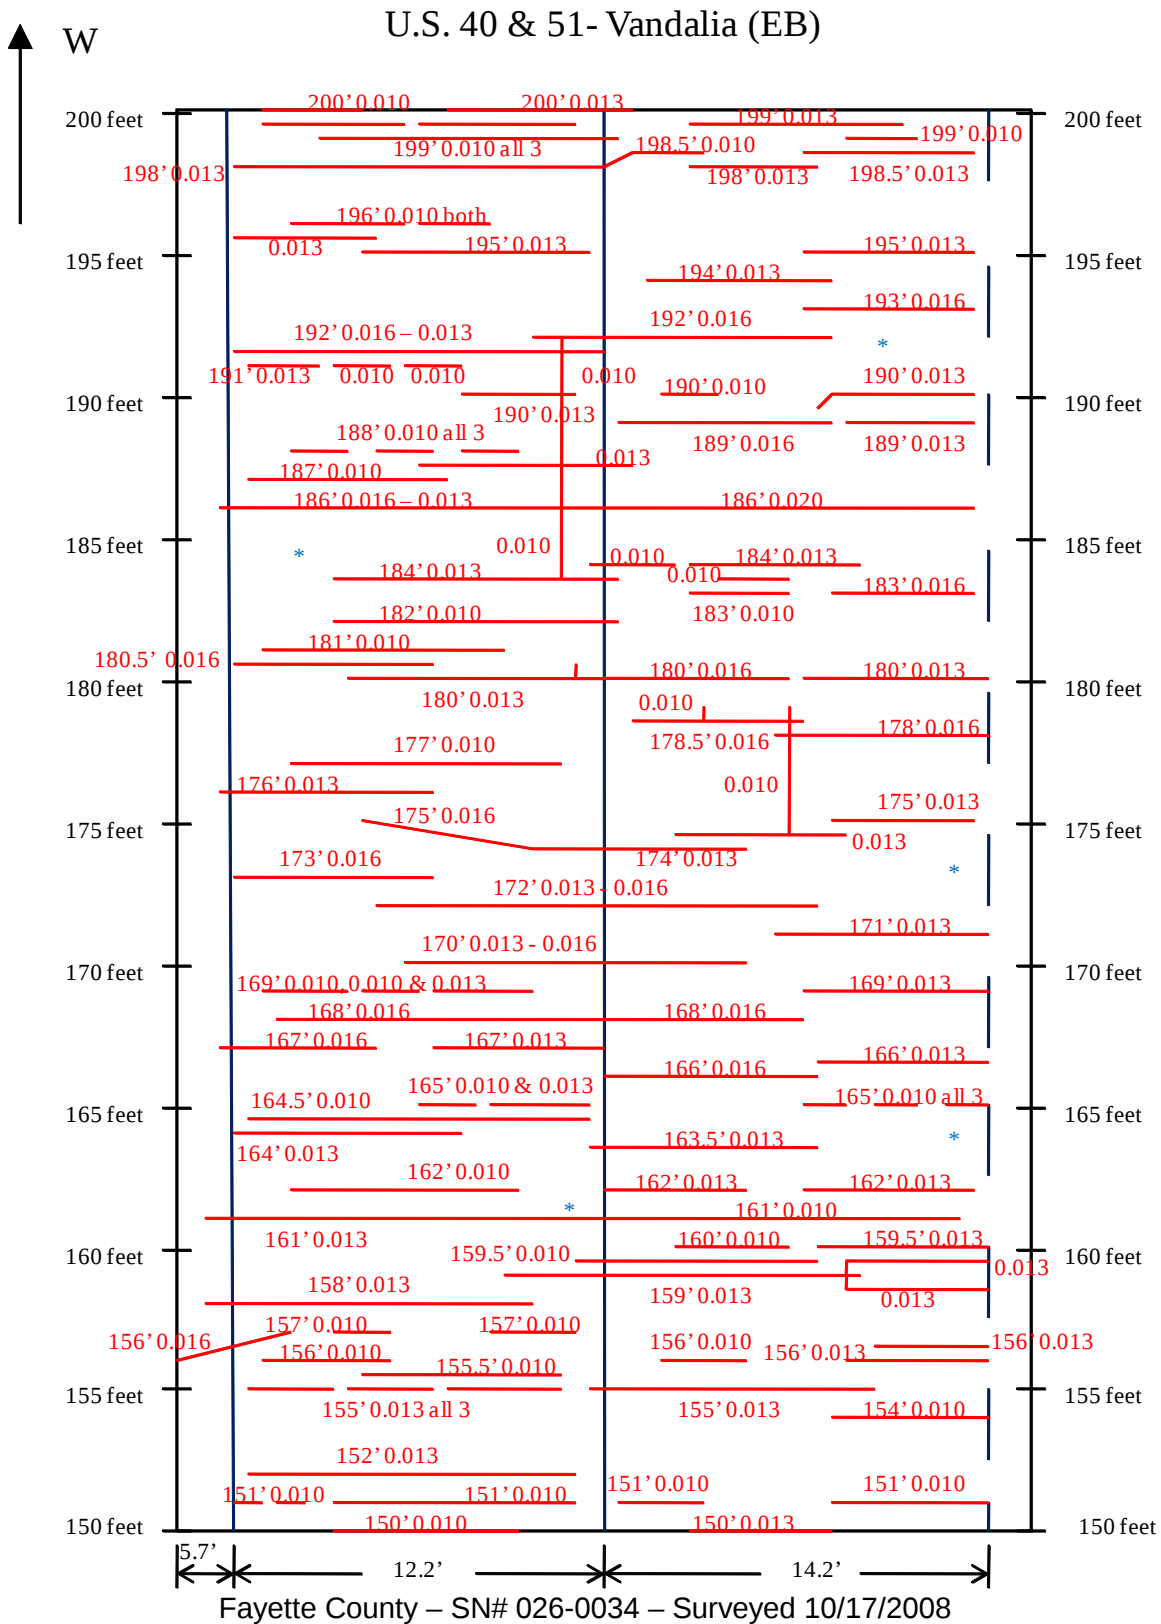
Areas of longitudinal cracking: a= 49'- 59' 0.010, b= 48' – 55' 0.010, c= 46' – 48' 0.010, d= 43' – 48.5' 0.010, e= 42.5' - 45' 0.010, f= 42.5' – 43.5' 0.010

\* This symbol denotes areas of numerous hairline cracks located very close together. The measurements of the cracks were 0.010.

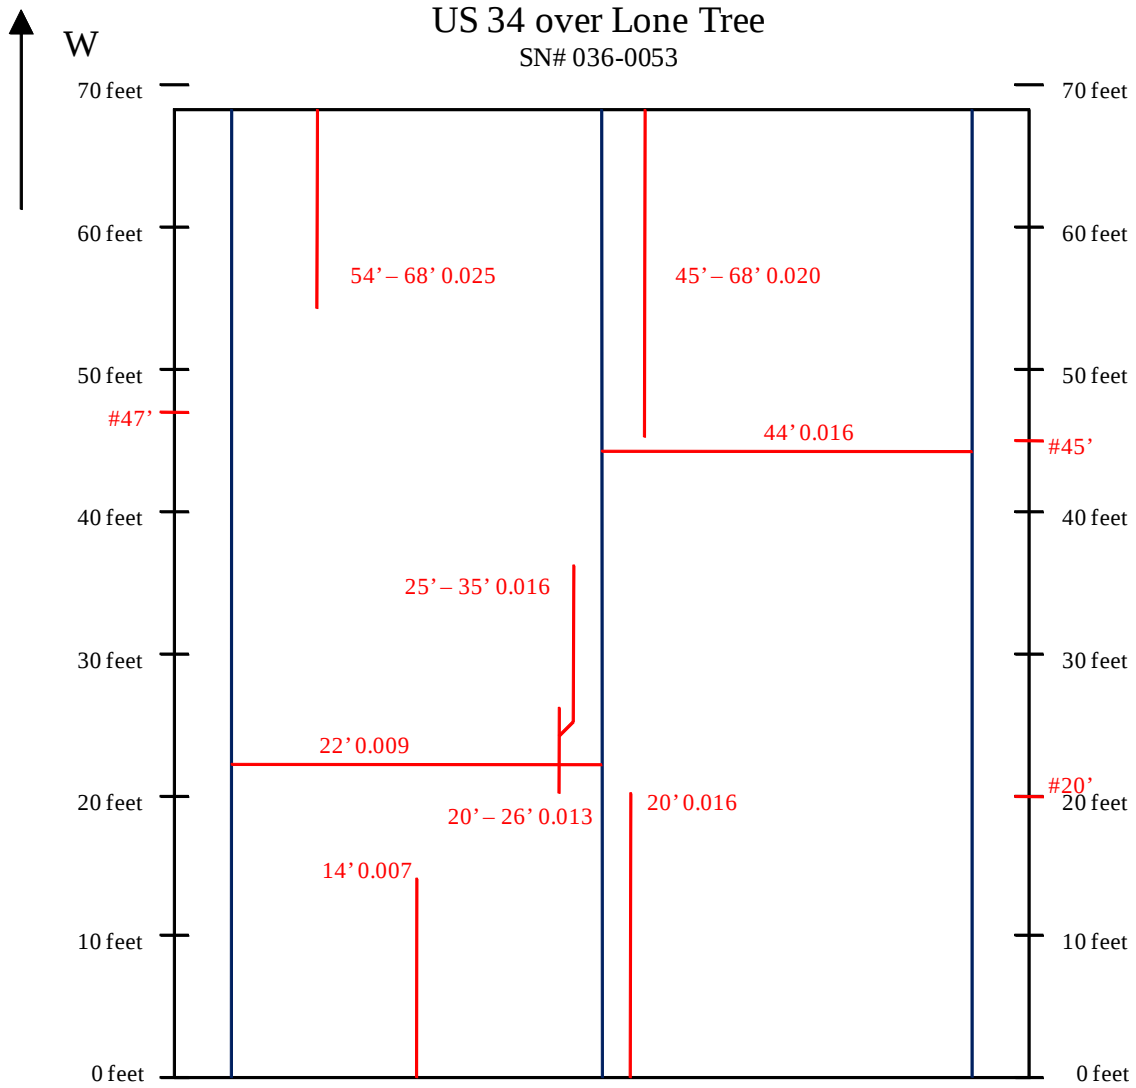
Henderson County – SN# 036-0053 – Surveyed 10/20/2003  
The “#” symbol represents cracks in the parapet only.

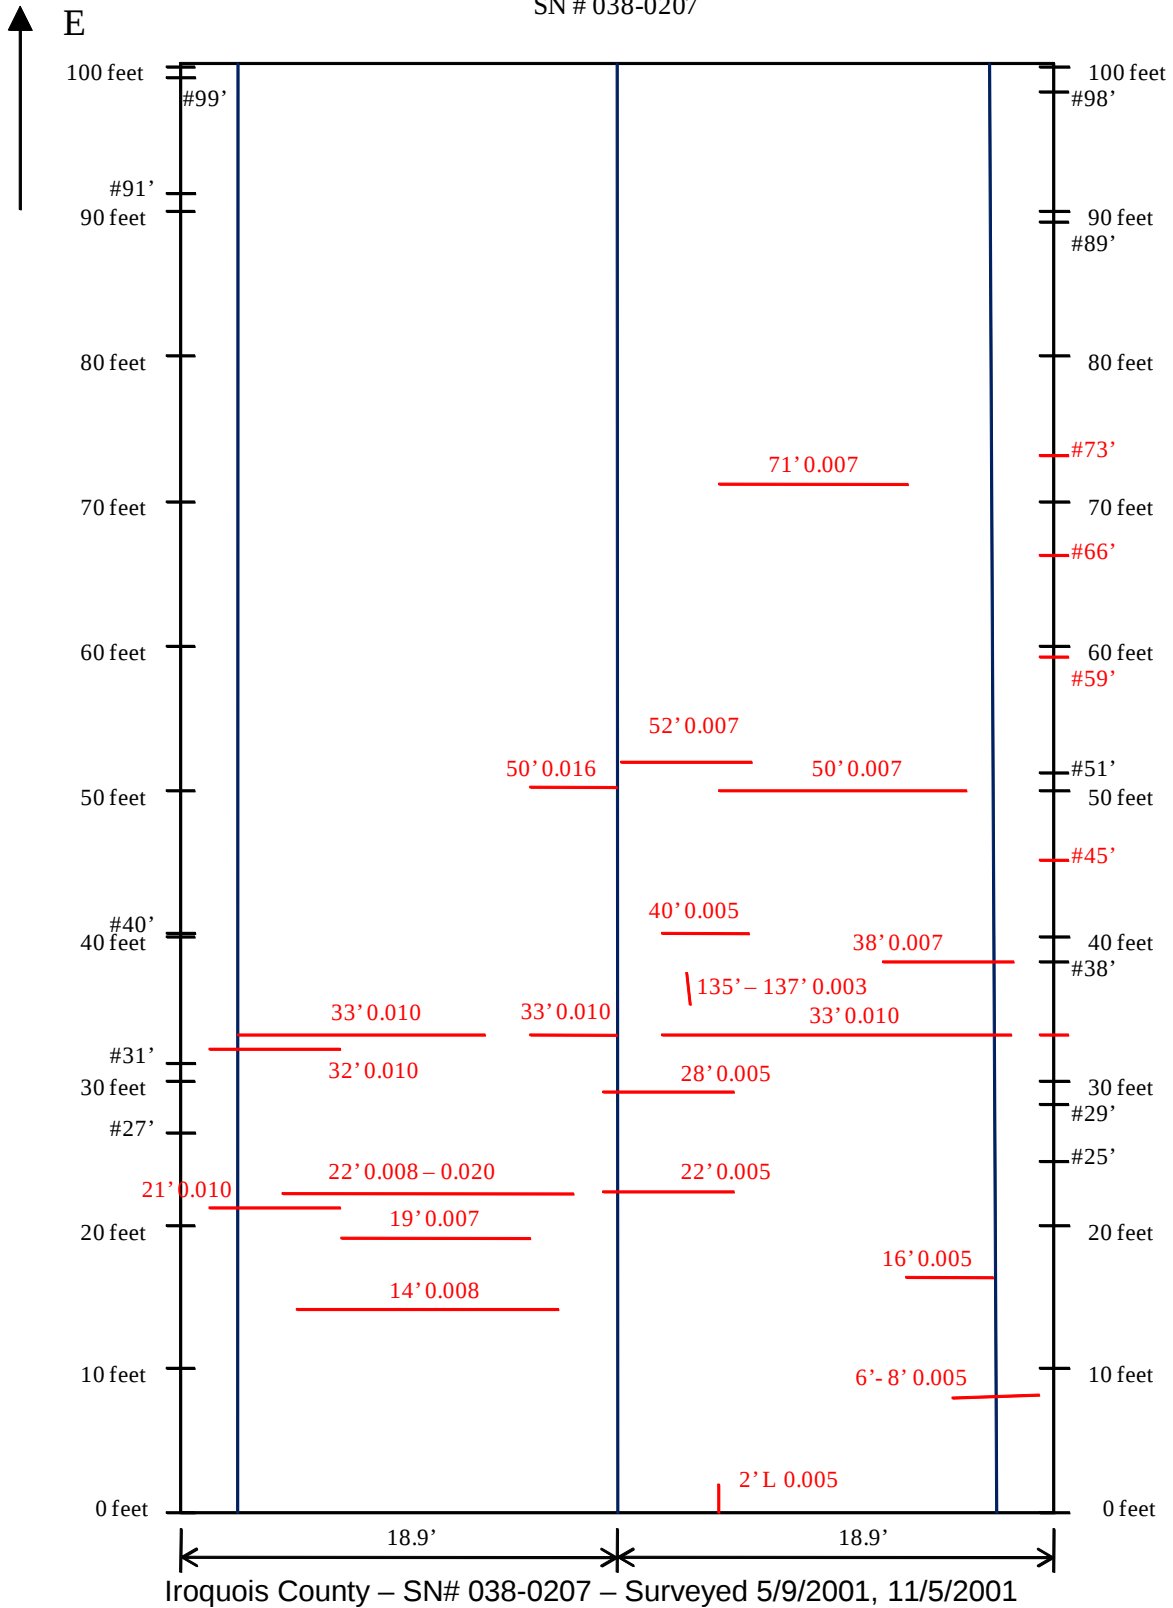
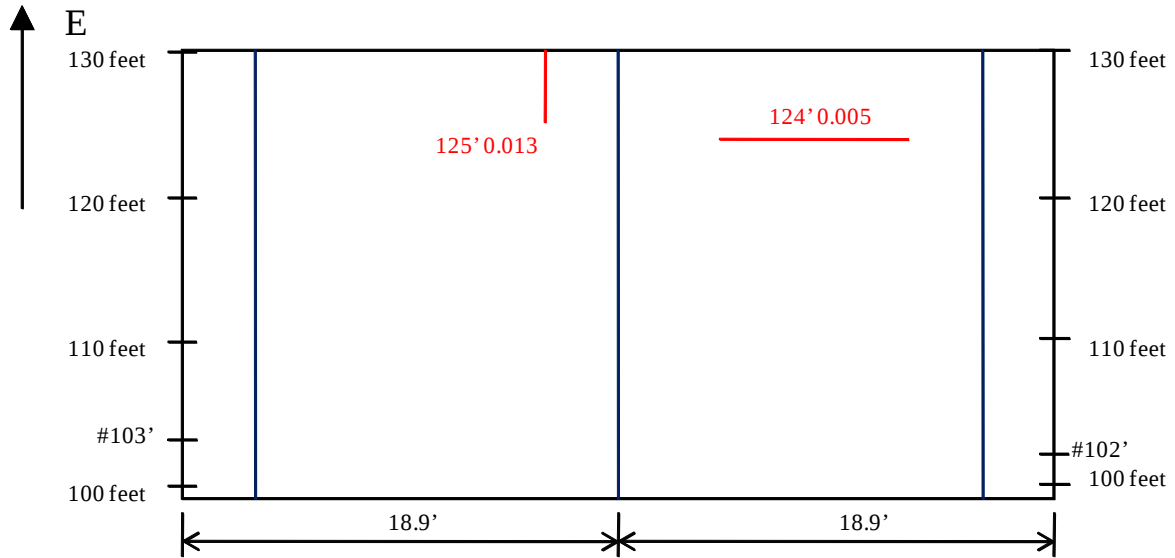
SN # 038-0207

Deck poured on November 03, 2000. The initial survey of this structure showed little to no cracking.

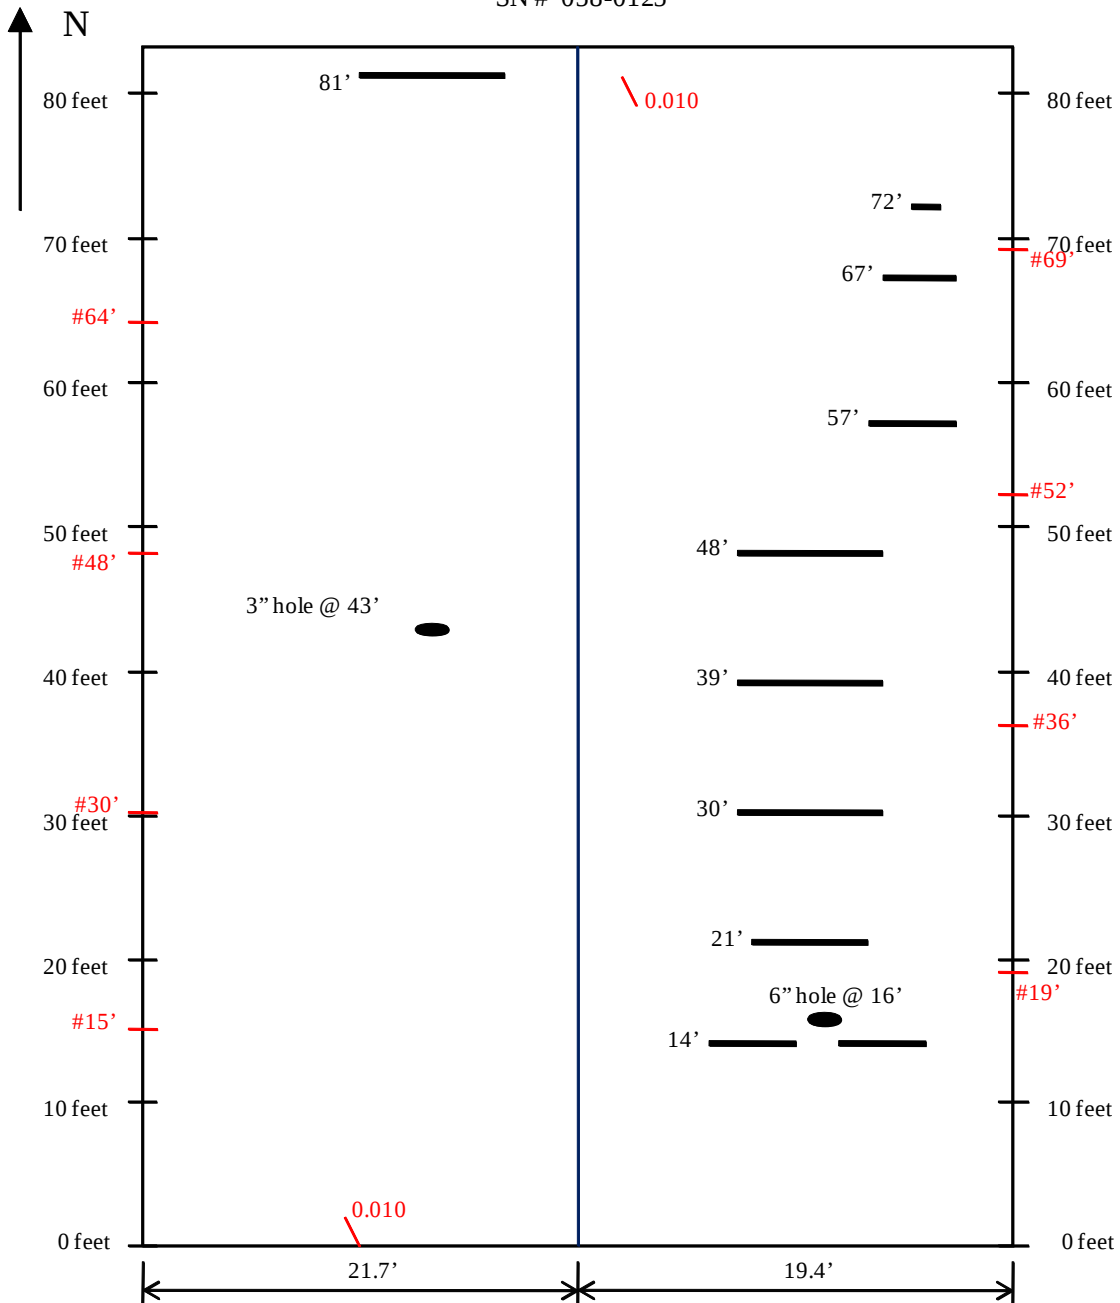
Macon U. S. 51 – NB  
SN # 058-0125

The structure numbered 058-0125 exhibited cracking on the bottom of the deck at 4' - 6' spacing. The structure numbered 058-0126 showed less cracking than the structure numbered 058-0125. From Tables 4.3-3 and 4.3-4, the structure numbered 058-0125 experienced a larger temperature fluctuation in the first 72 hours after the pour than the structure numbered 058-0126. These structures are a dual structure.

This bridge deck was poured on October 12, 2000. The initial survey showed no cracking. The thicker lines represent areas of popped out aggregate. The “#” symbol represents cracks in the parapet only.
