**EVALUATION OF HIGH PERFORMANCE  
CONCRETE BRIDGE DECKS  
AND  
OTHER EXPERIMENTAL BRIDGE  
DECKS THROUGHOUT ILLINOIS**

**PHYSICAL RESEARCH REPORT NO. 166  
December 2017**

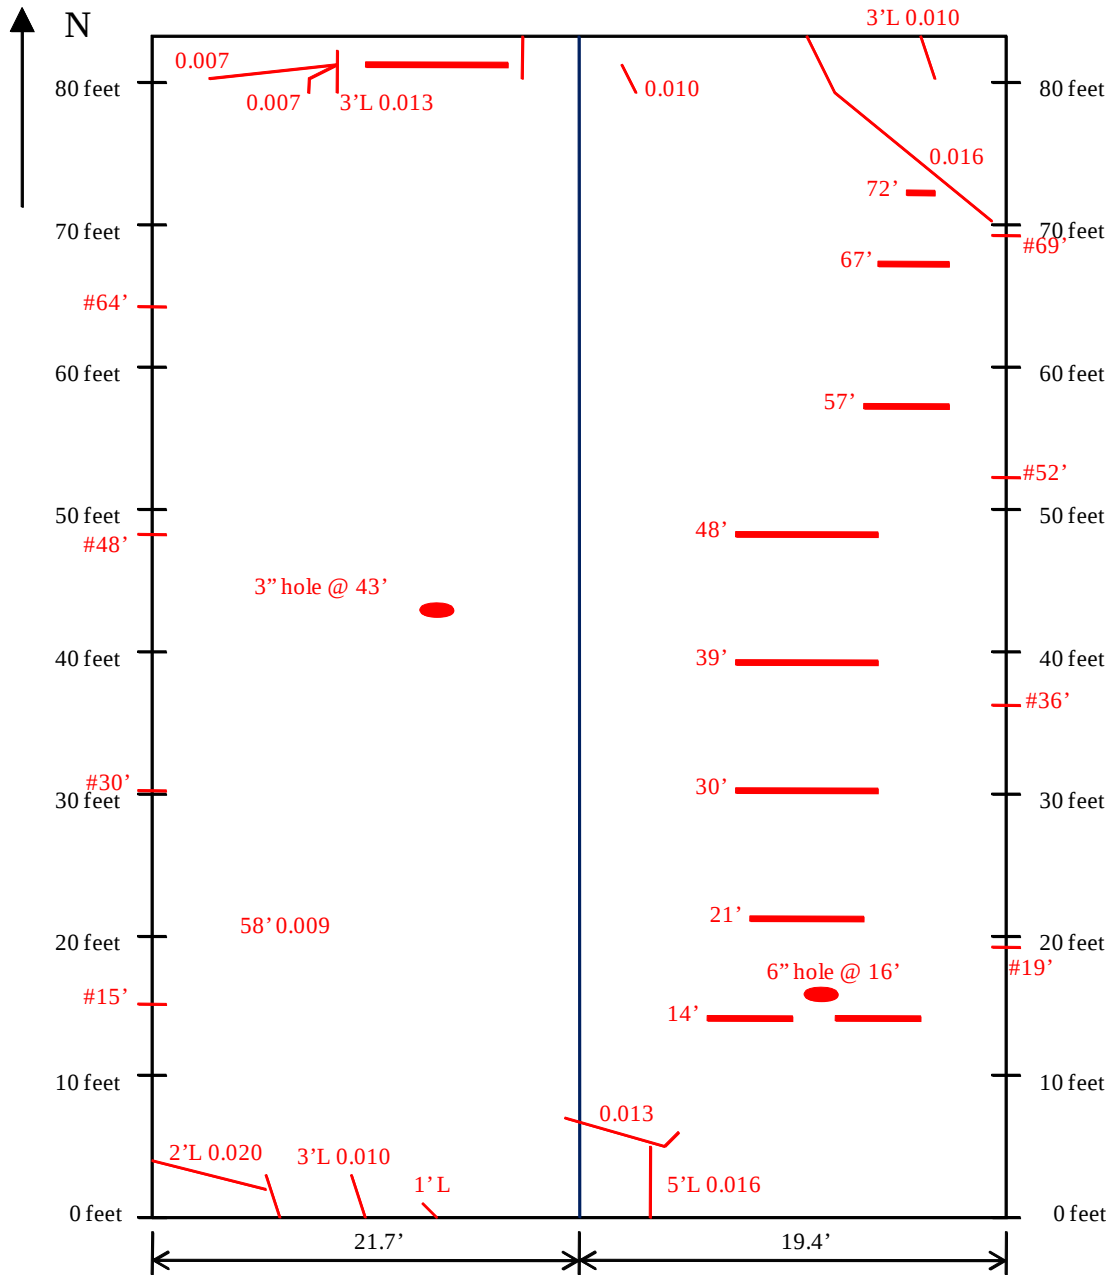
Macon U. S. 51 – NB  
SN # 058-0125

The “#” symbol represents cracks in the parapet only. The thicker lines represent areas of popped out aggregate.

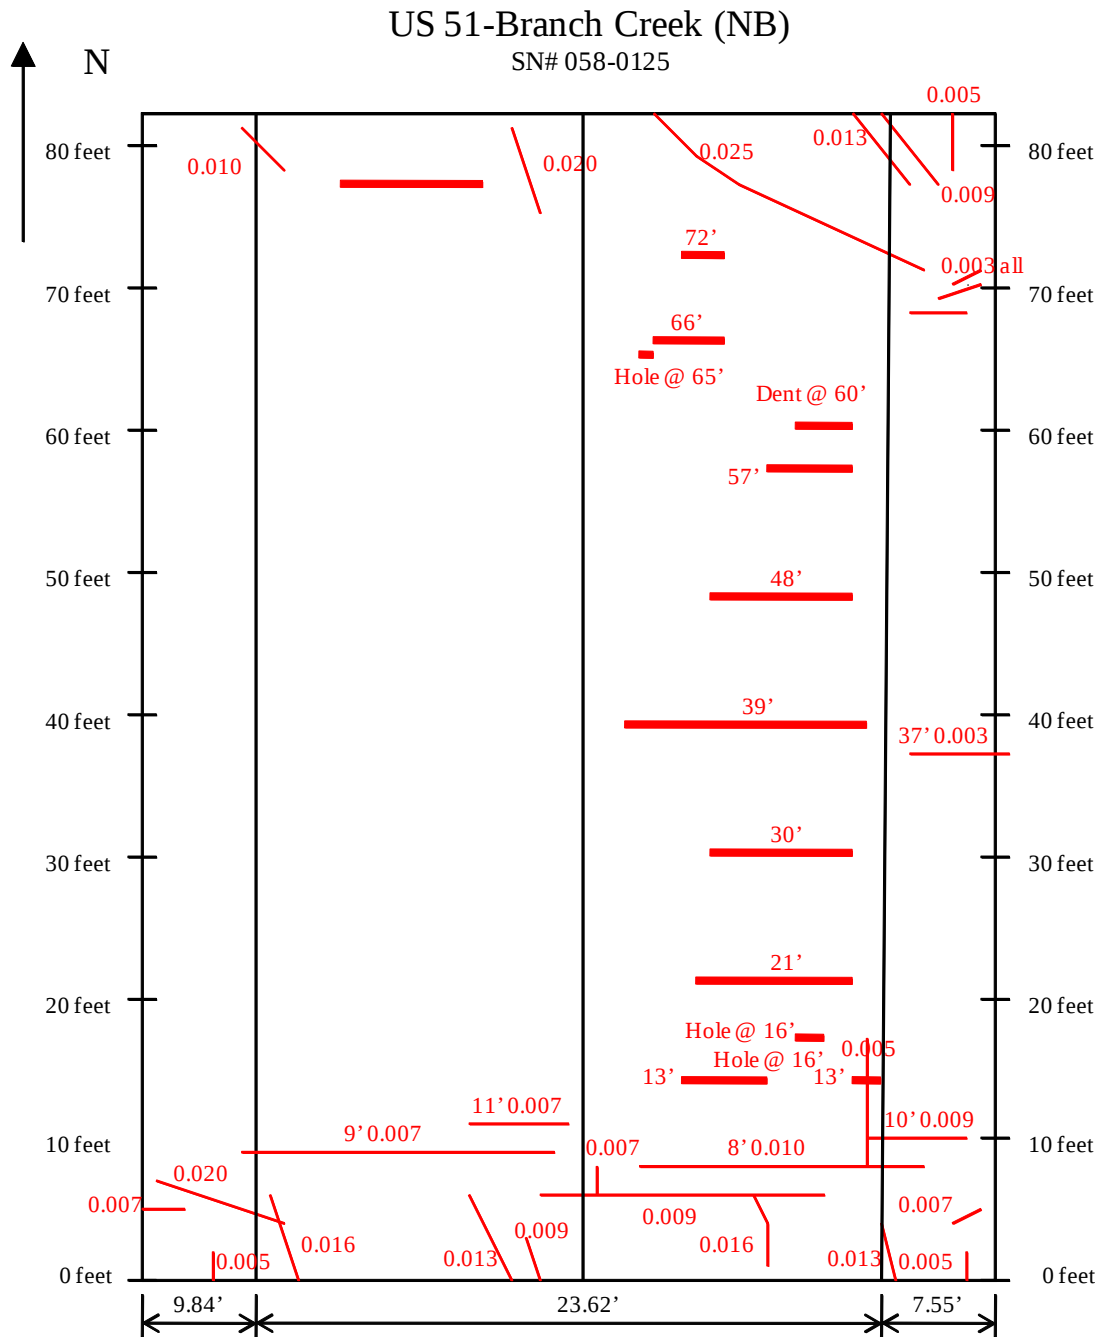
Macon County – SN# 058-0125 – Surveyed 10/7/2003  
The thick red lines represent portions popped out unless otherwise noted.

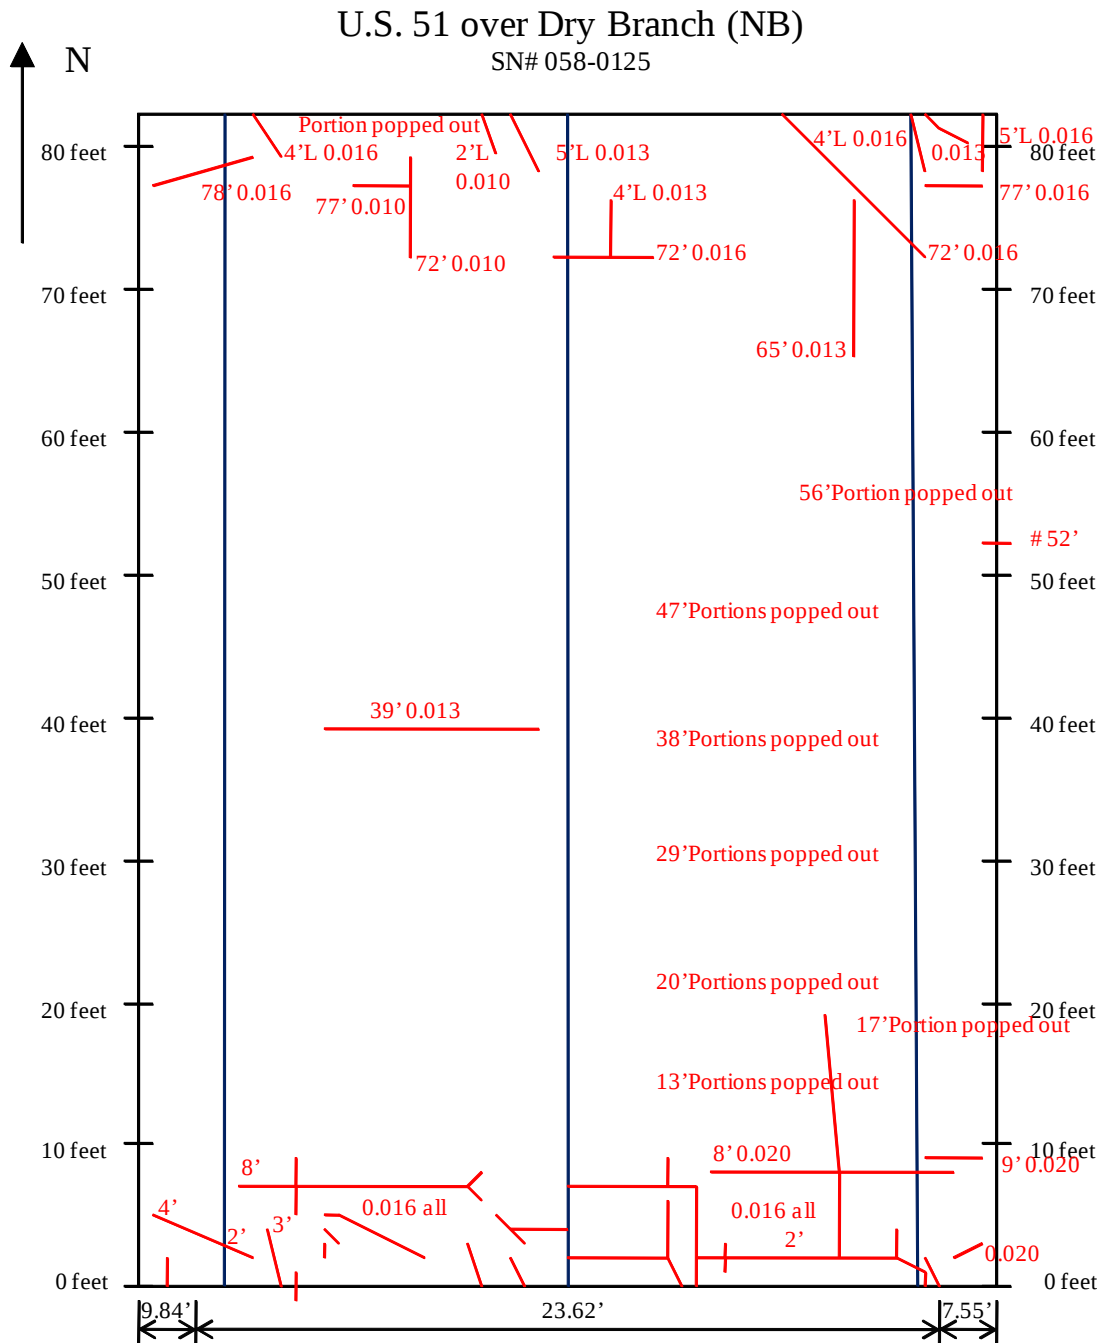
Macon County – SN# 058-0125 – Surveyed 10/25/2005  
Some portions of the bridge deck in the driving lane were popped out.  
The “#” means parapet only.

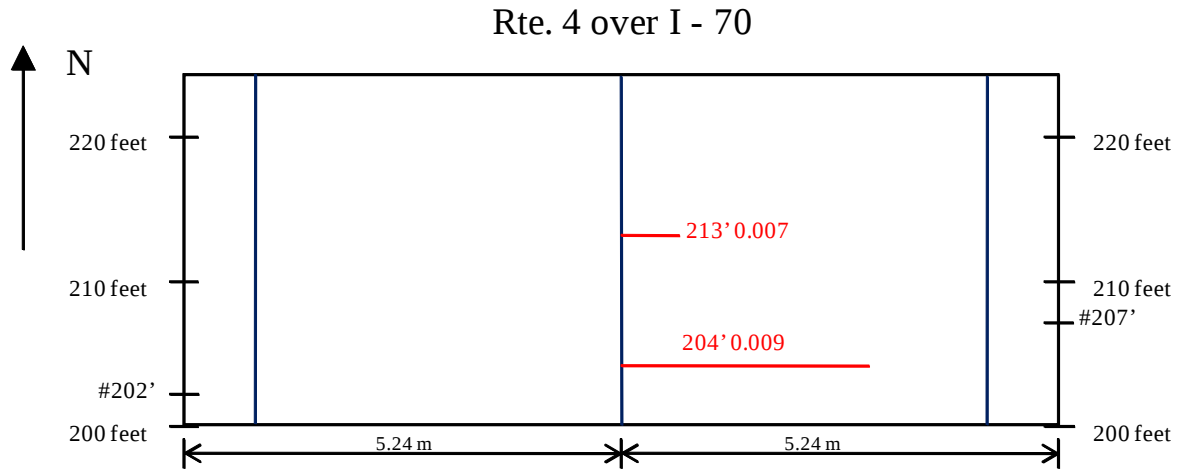
# Rte. 4 over I - 70

The initial survey of the southbound lane showed only one transverse crack.  
 The initial survey of the northbound lane showed five hairline transverse cracks.  
 The “#” symbol represents cracks in the parapet only.

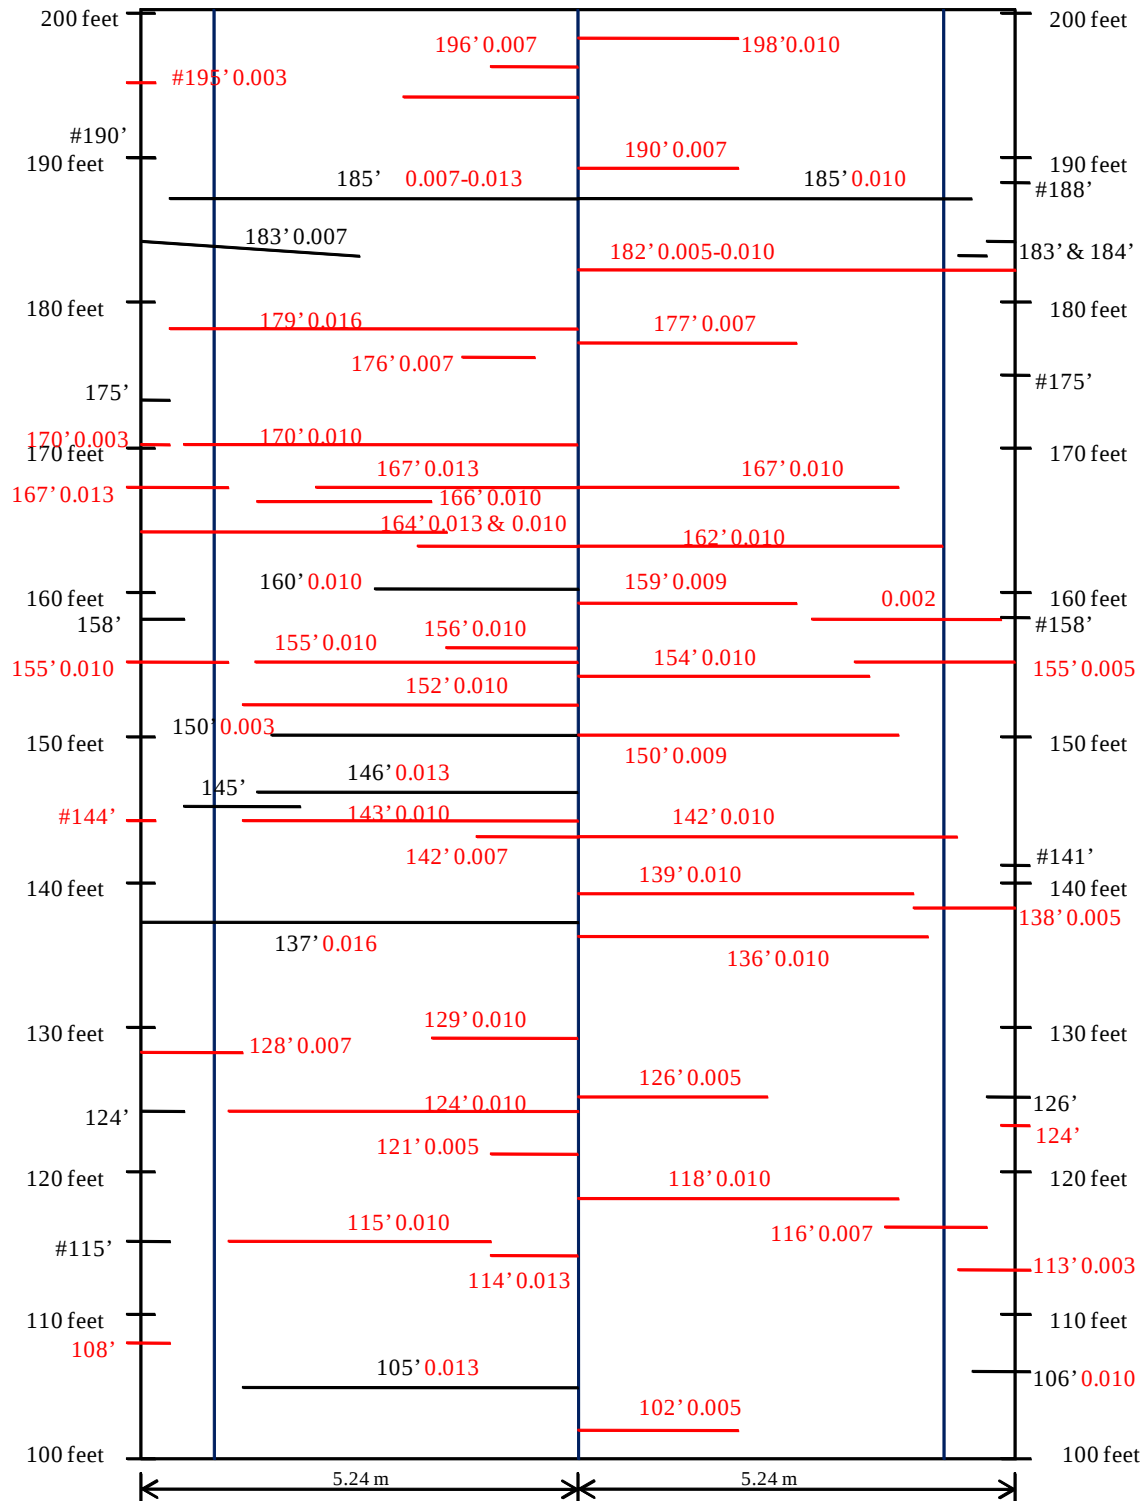
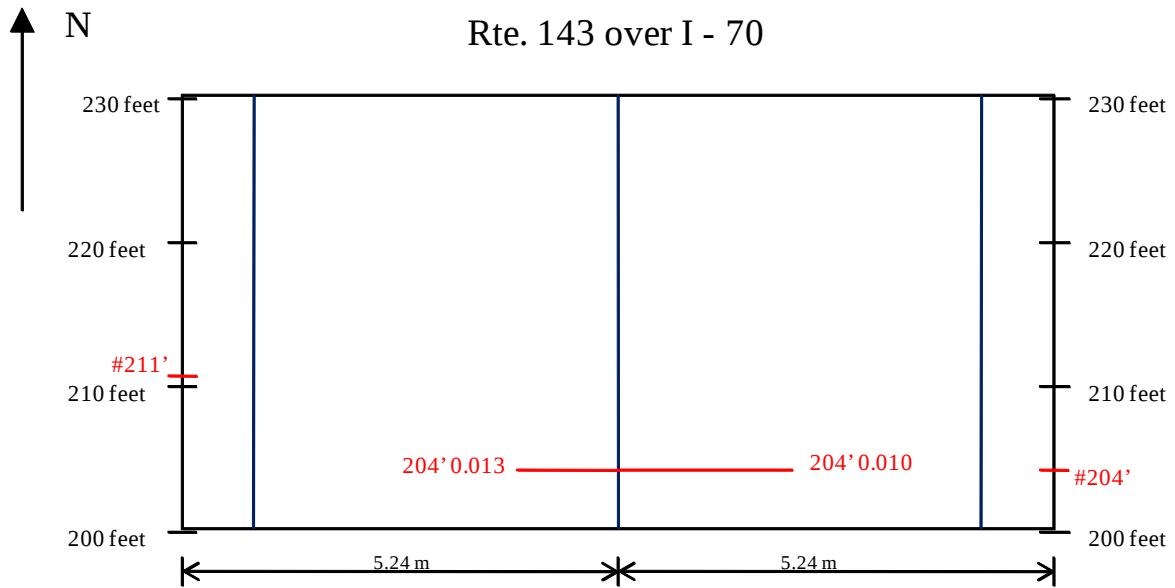
# Rte. 143 over I - 70

Madison County – SN# 060-0151 – Surveyed 5/8/2001, 8/2/2001  
 The initial bridge deck survey showed five hairline transverse cracks.  
 The “#” symbol represents cracks in the parapet only.

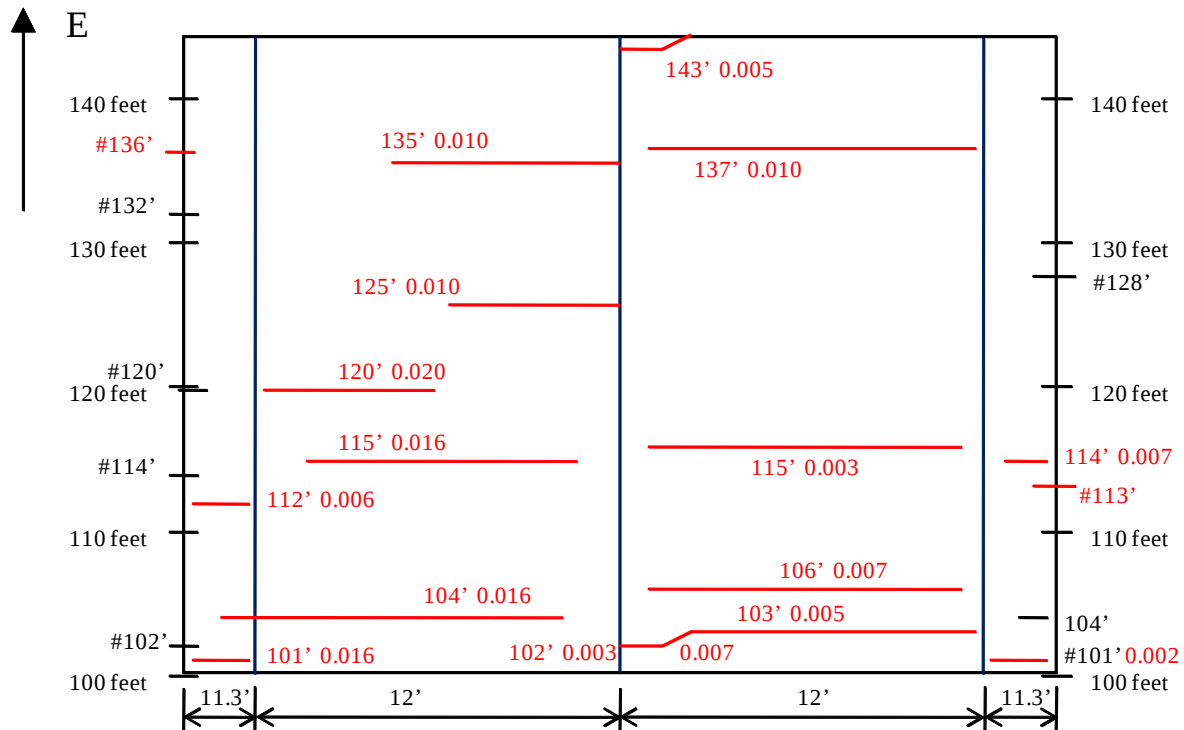
# IL 104 over Brush Creek

The initial survey of the westbound lane showed 33 hairline transverse cracks.

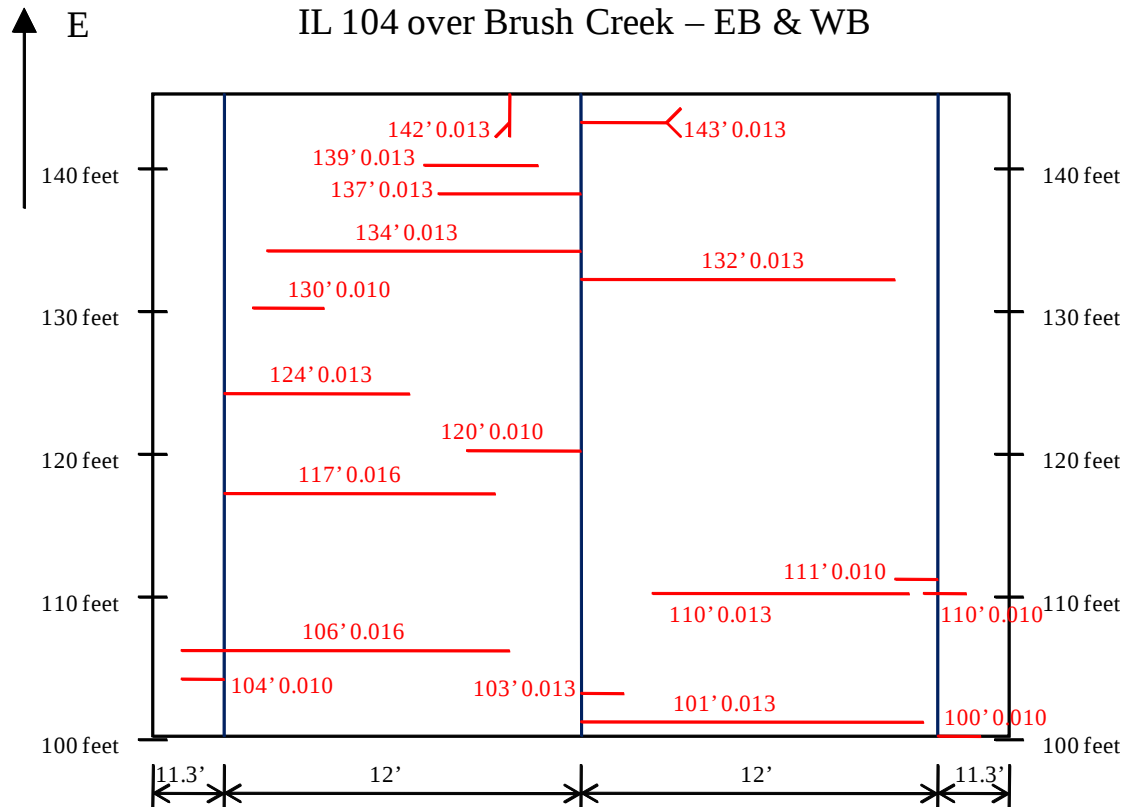
\* Denotes areas of interconnected hairline cracks, sometimes resembling a spider web.

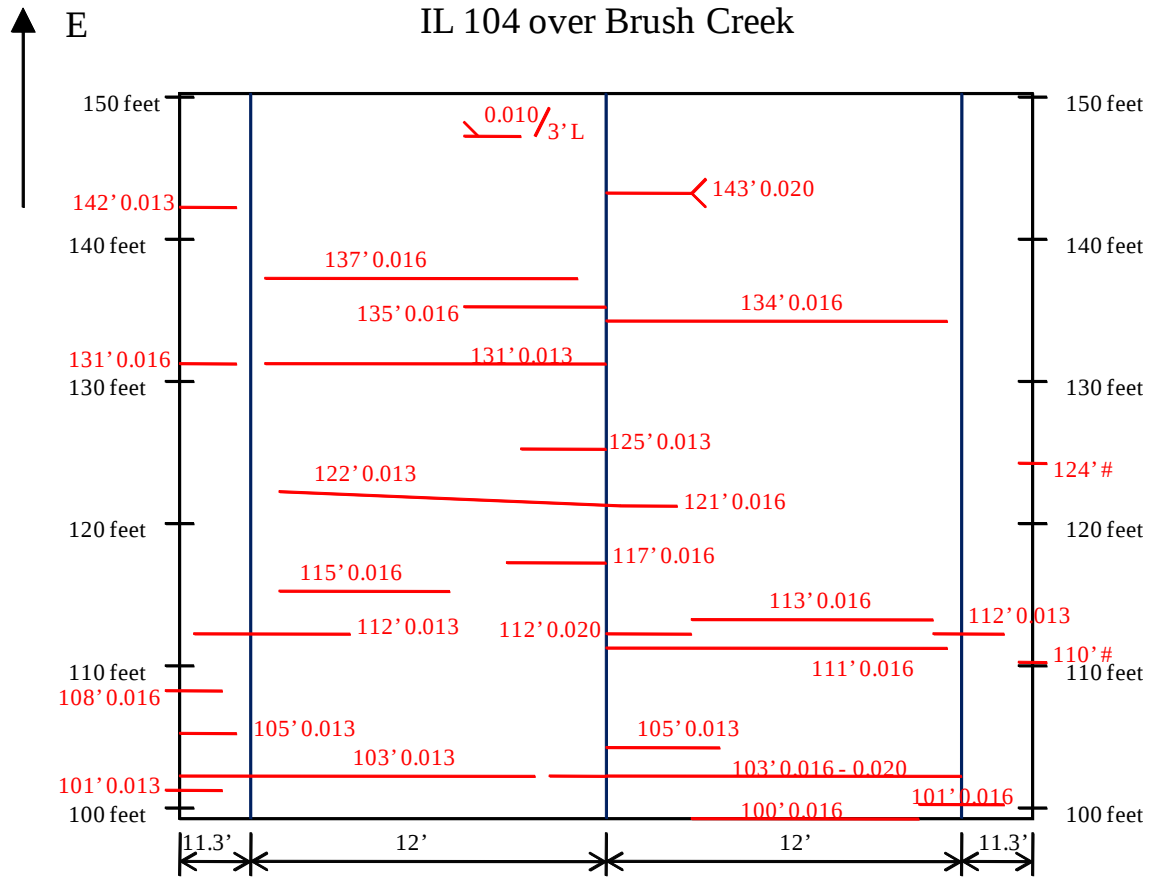
Sangamon County - SN# 084-0065 - Surveyed 9/26/2005

Sangamon County – SN# 084-0065 – Surveyed 9/26/2005  
 Map cracking was observed in the eastbound lane near the centerline from 9' to 89'.  
 The “#” symbol represents cracks in the parapet only.
