# Experimental Joint Sealants for Hot Mix Asphalt Pavements and Overlays

**CONSTRUCTION REPORT**  
**PHYSICAL RESEARCH REPORT NO. 169**  
**April 2019**

**Illinois Department of Transportation**

# Construction Report

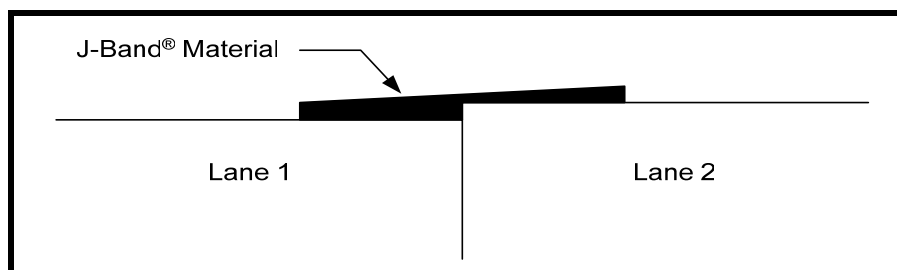
Figure 5  
Lane to Lane Elevation Difference With J-Band® Placement

The placement of the J-Band® material presented a couple of problems. Even with sweeping the pavement surface at the joint, sand sized rocks remained that caught the strike-off plate and left a track mark in the material. More critical, however, was the difference in elevation between the two lanes of leveling binder on either side of the longitudinal joint. This difference in elevation resulted in thick and thin areas of material placement depending on the location of the strike-off plate with relation to the joint. Figure 5 illustrates the elevation difference and the resultant problems with the sealant material placement.

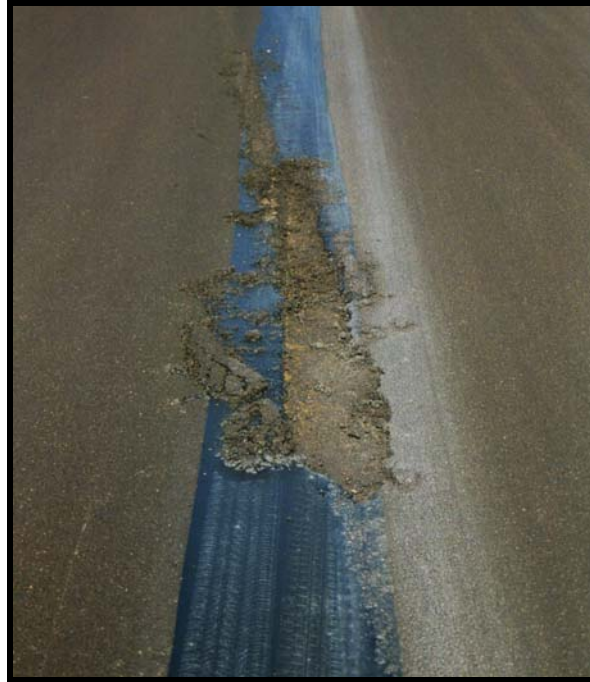
Figure 8  
Tracking of J-Band<sup>®</sup> material

The J-Band<sup>®</sup> material was placed at approximately 300° Fahrenheit and required about 10 to 15 minutes to cool. Flagmen were used to control traffic and prevent vehicles from crossing the material before it was solidified. However, at a couple of locations a vehicle did manage to cross the material before it cooled, and the material did track onto the vehicle tires. Figure 8 illustrates the amount and condition of the material when it tracks onto a vehicle tire. A thin layer of lime dust was spread over the material at all cross roads and driveway entrances to prevent tracking when vehicles did cross the material. Figure 9 illustrates the application of lime dust at a crossroad intersection to prevent tracking.

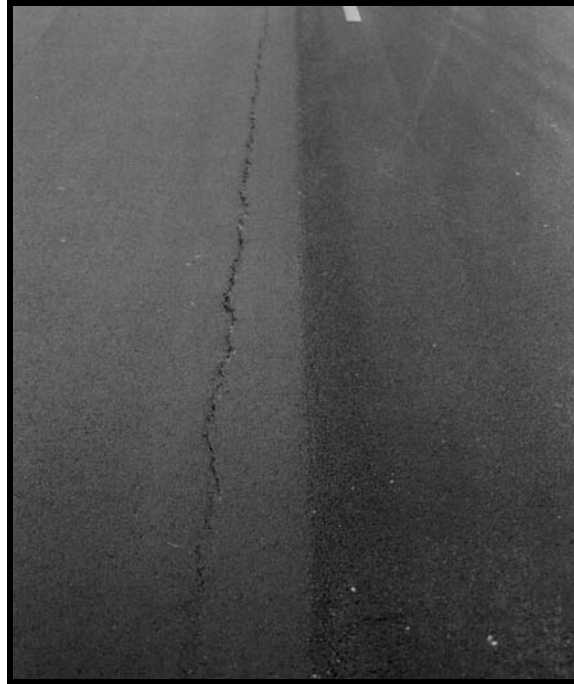
Figure 10  
J-Band® Boundary Cracking

The first problem noted occurred at the start of paving in the area of a butt joint to a mainline bridge. The existing pavement was milled down to bare concrete, and the J-Band<sup>®</sup> material was placed directly on the concrete. The first few loads of surface HMA material arrived at the project around 310° Fahrenheit. The elevated temperature of the HMA, and the impermeable concrete below, forced the sealant material to migrate through to the surface of the pavement. The action of the vibratory break down roller caused the vertical edge of the centerline joint to slough and flow under the roller. Once the rolling patterns were completed and the extra rich material at the centerline joint sloughed, a crack developed in the surface of the pavement at the outside edge of the J-Band<sup>®</sup> material.

Additional cracks of this nature were noted throughout the length of the J-Band<sup>®</sup> experimental section. However, it is believed that these cracks were introduced more by the rolling pattern of the vibratory roller, as these cracks developed in areas where a leveling binder was placed below the surface lift. In these areas, the sealant material did not migrate to the surface. The cracks were believed to be created by a distinct boundary line between asphalt cement contents within the surface lift. The surface lift material placed directly over the J-Band<sup>®</sup> material absorbed the sealant material and changed physical properties in relation to the surface material adjacent to it. The two materials responded differently to the action of the vibratory roller. Another contributing factor is the relatively low “N” design number of 50 (less stable mixture) for the overlay. Cracks also developed along the confined edge at the boundary between the J-Band<sup>®</sup> material and regular surface HMA. An example of this boundary cracking may be found in Figure 10.

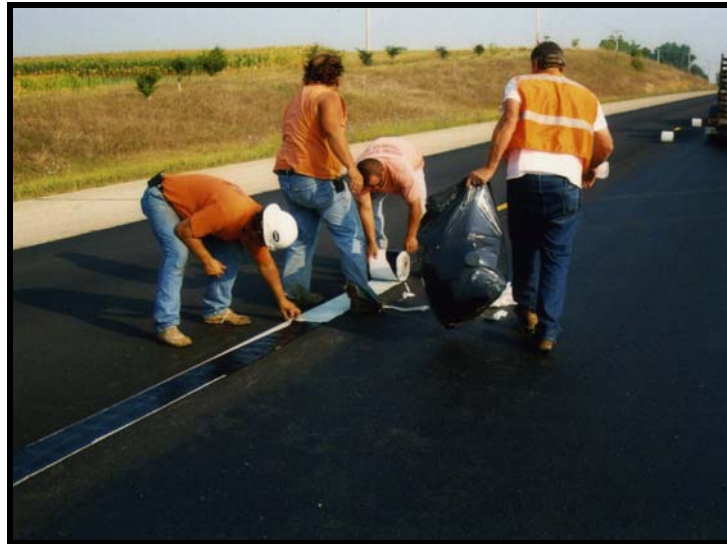
Figure 11  
Removal of QuickSeam<sup>®</sup> plastic backing

pieces of wax paper was extremely tedious and time consuming, however, necessary to prevent impurities and the creation of a slippage plane for the overlay materials. Once the wax paper was removed and the material was positioned along the centerline joint, the plastic backing material was removed from the top of the material. Again, this material ripped and left small fragments behind that had to be cleaned off. The tedious, time consuming, effort to remove the small fragments of plastic may be seen in Figure 11.

A trial and error process was used to establish a better method for removing the plastic backing once the material was placed on the pavement. Eventually, a utility knife was used to cut the plastic backing into two separate halves. The halves were then easily peeled off the material from the center towards the outer edges. This process eliminated the small fragments of plastic that were left on the material at the material edges. This process also increased the placement rate for the QuickSeam<sup>®</sup> material. The average placement rate for the first pass of the material was approximately 800 linear feet per hour. The entire first pass took approximately six hours to place.

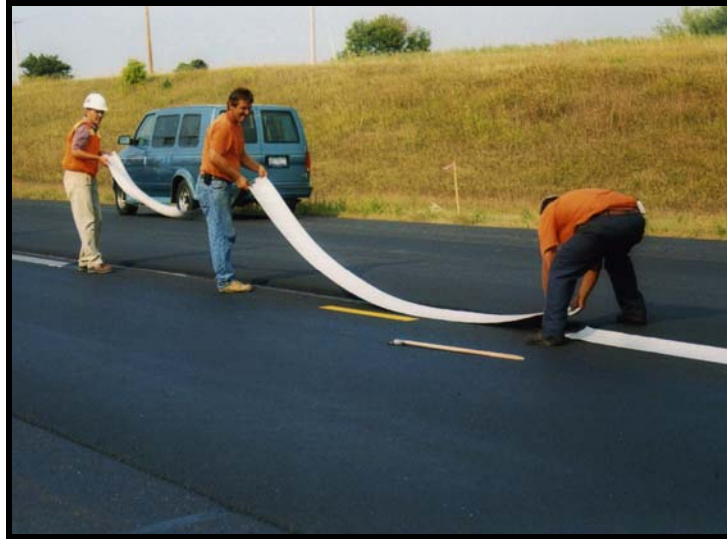
The problem still remained of peeling the wax paper backing off the material before placing it onto the pavement. Eventually, it was determined that the material could be completely unrolled upside down and the wax paper backing cut into halves with the utility knife. Once cut, the two halves of wax paper were peeled off from the center towards the outer edges. Three to four people were then used to flip the material right side up and place it along the centerline joint all at once. This process dramatically improved the placement rate. Placement of the second pass of the sealant material was done at a rate of approximately 1,500 feet per hour. The second pass of the material was placed in approximately three hours. Illustrations of this placement method may be found in Figures 12 and 13.
