# **IDNR – Office of Mines and Minerals Abandoned Mine Land Reclamation Division**

## **Emergency Unit**

# **Mine Grouting Emergency Projects**

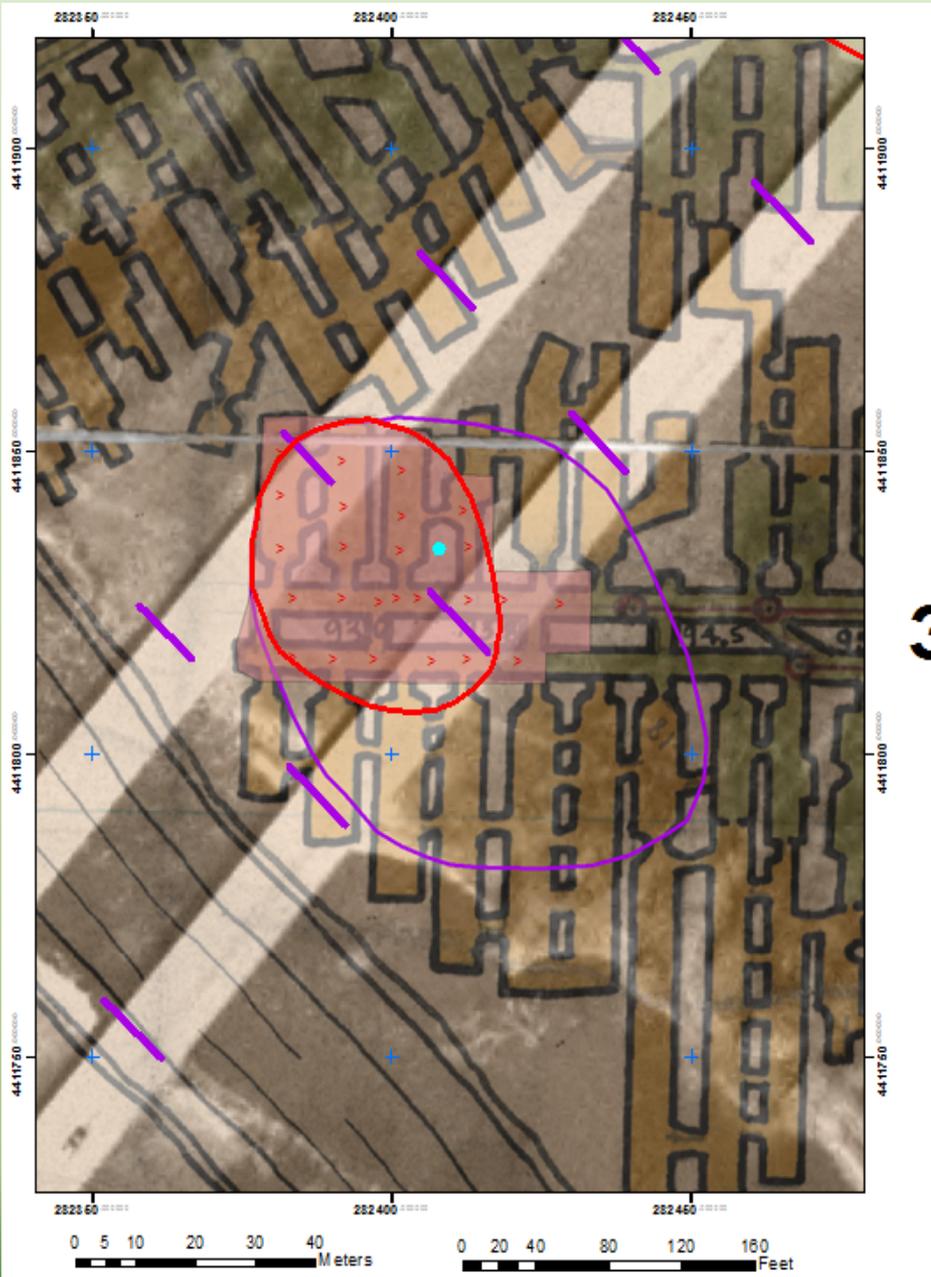
Existing Subsidence Boundary,  
 Anticipated Intermediate Sag  
 Expansion Boundary, Grout  
 Boreholes and Corehole Locations,  
 Grout Infill Area and Bridge Piers  
 Plotted Relative to Mine Workings  
 and 2005 DOQ.

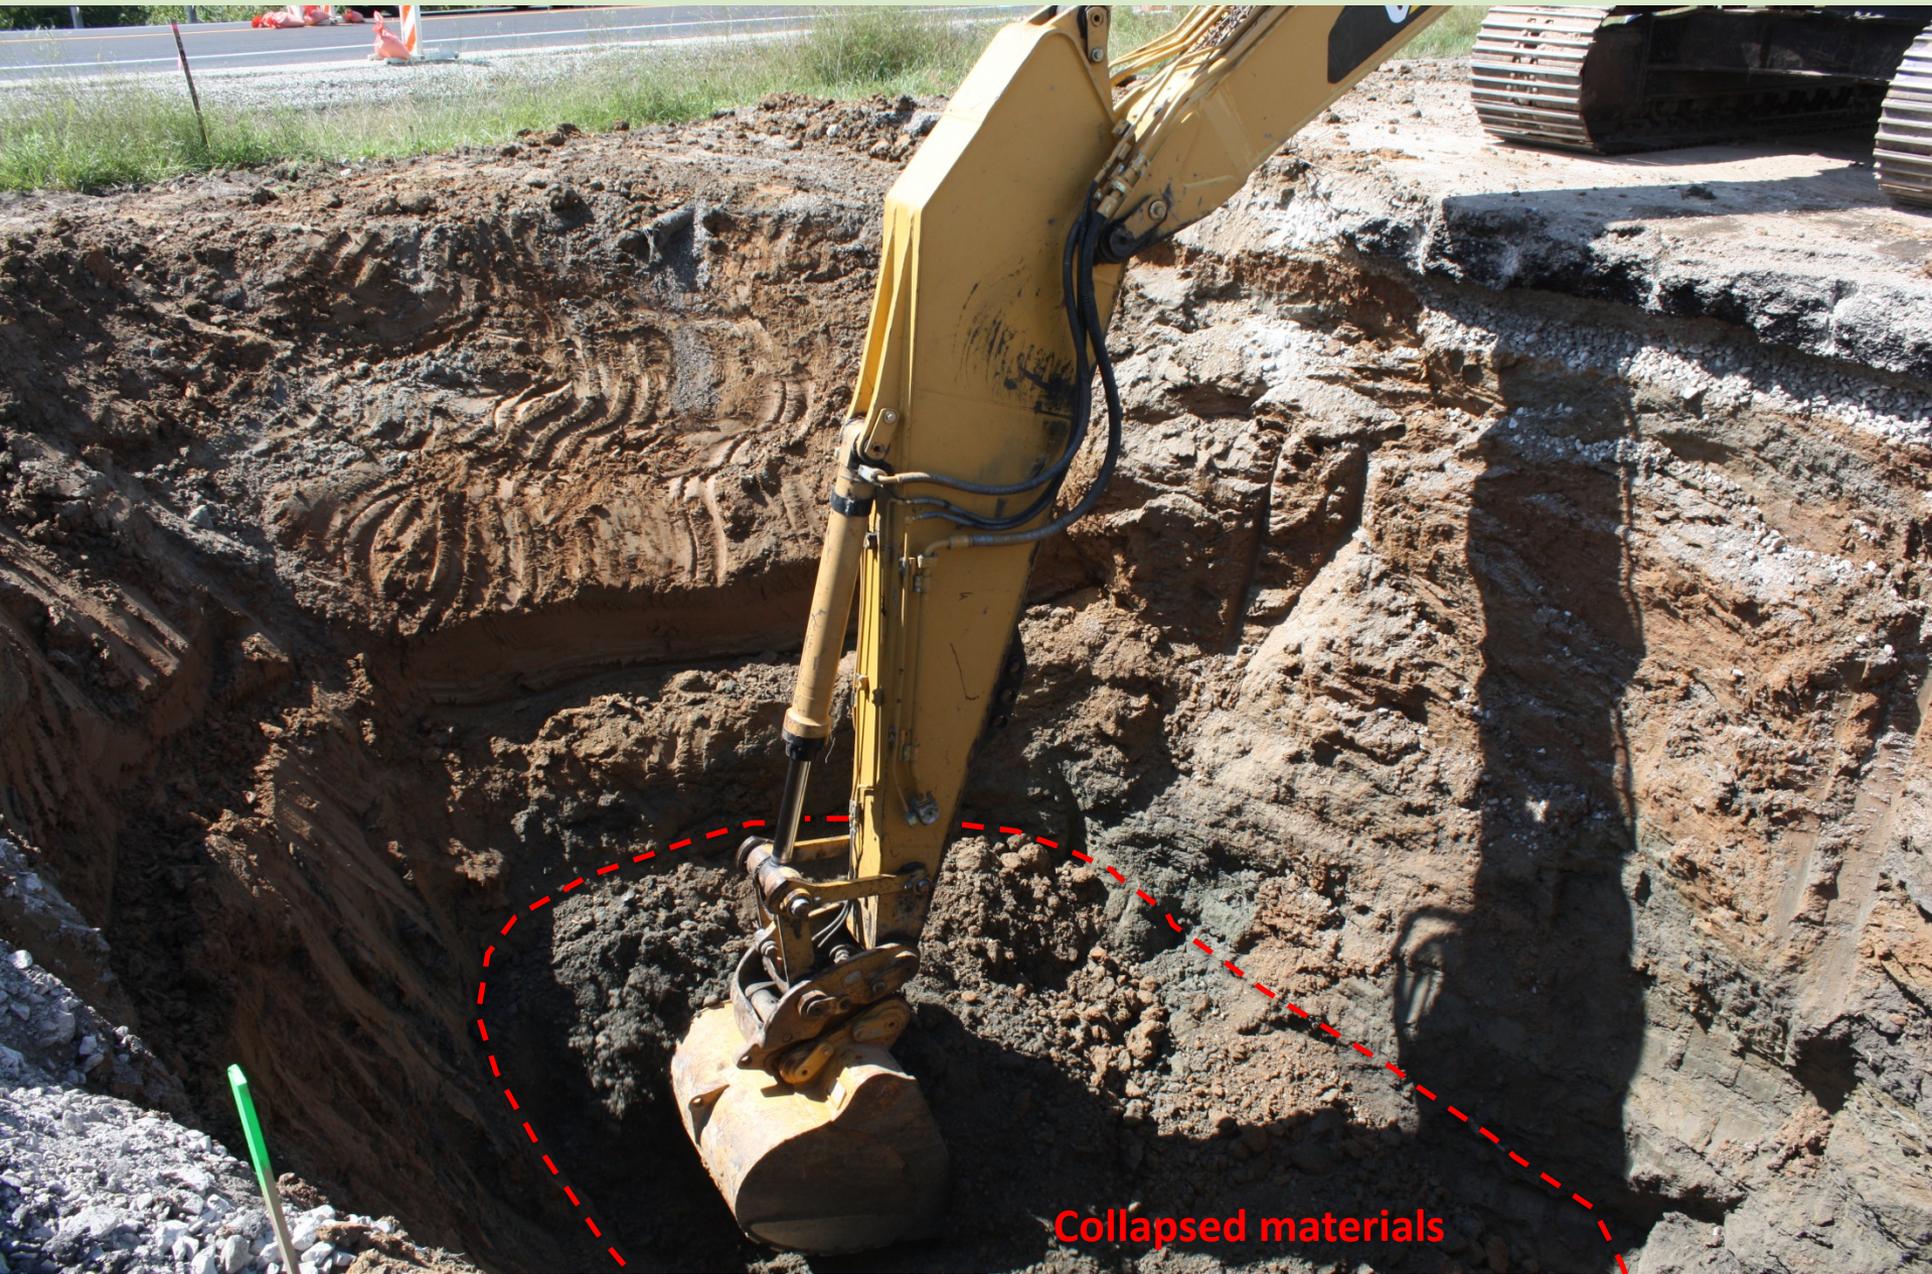
**Collapsed materials**

September 15, 2014

330 cubic yards of flowable fill

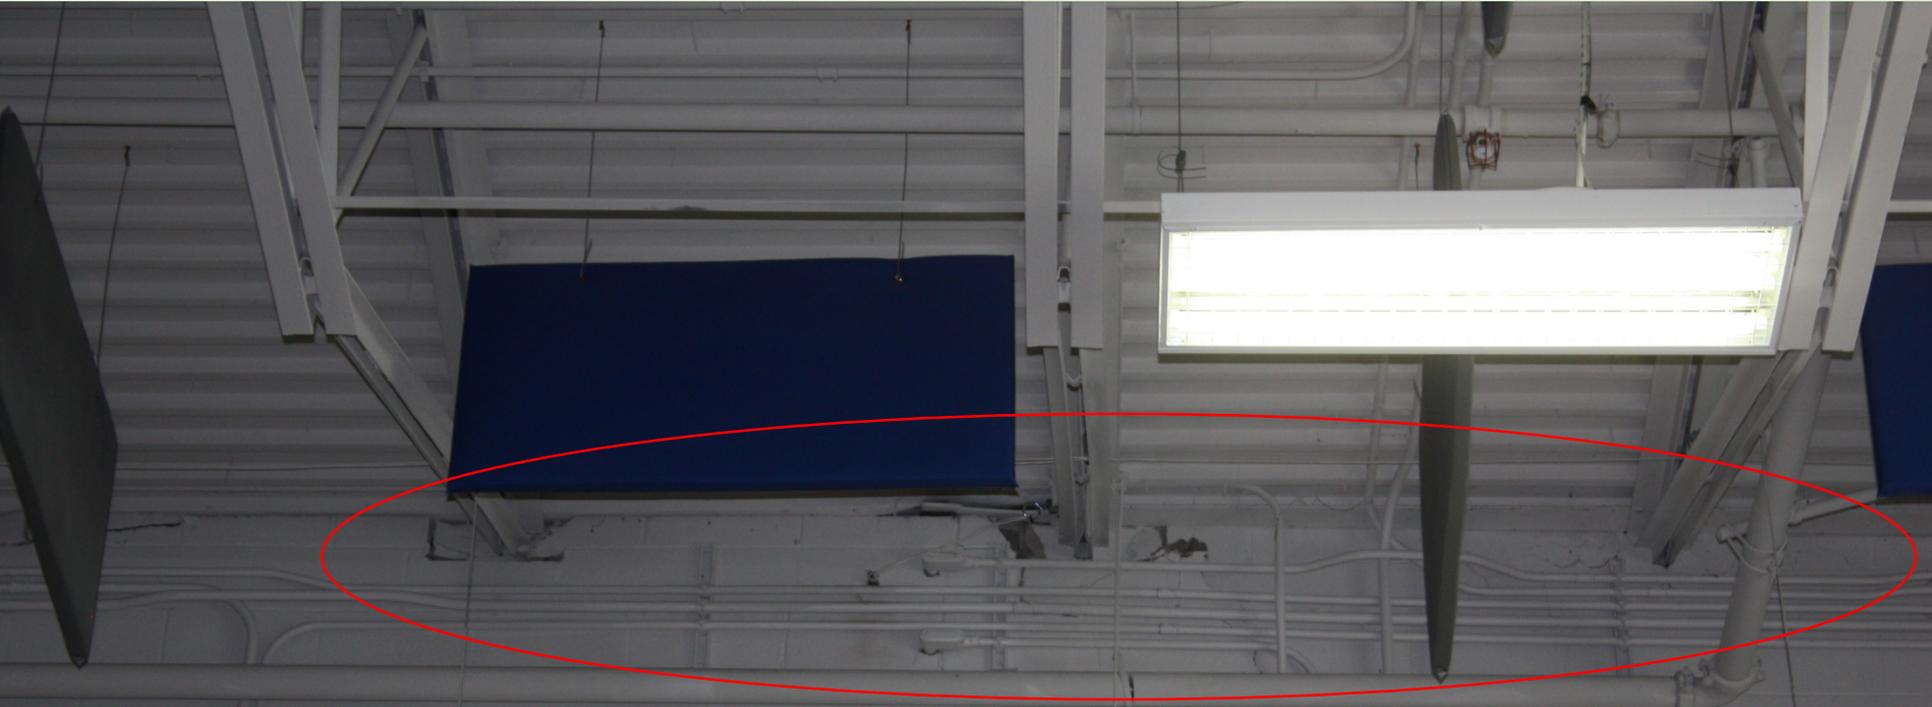
**North Gymnasium Wall  
- Roof Trusses Punching Through Load Bearing CMU**

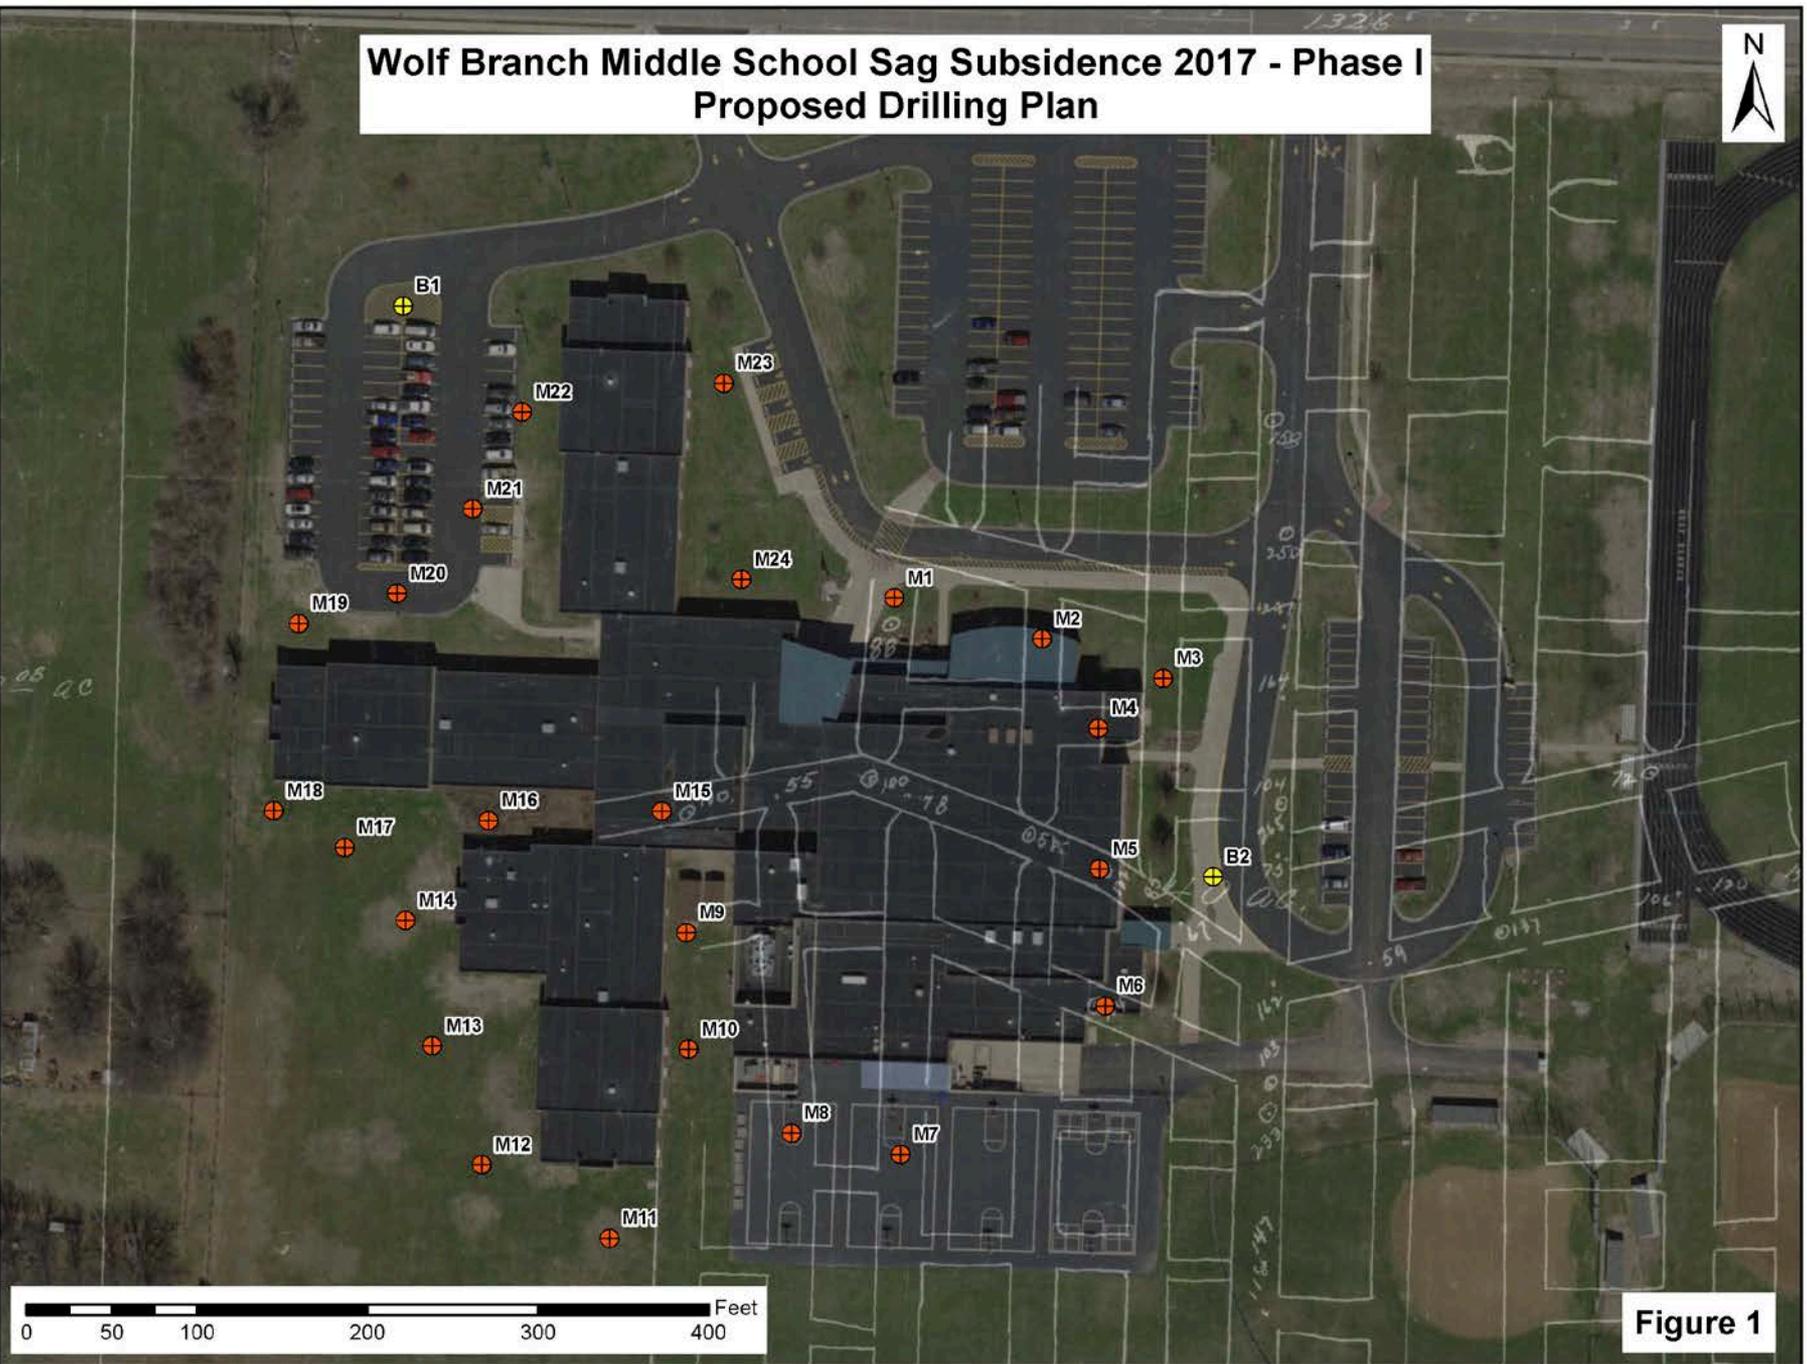
Figure 1

# Wolf Branch Middle School Sag Subsidence 2017 - Phase I Proposed Drilling Plan

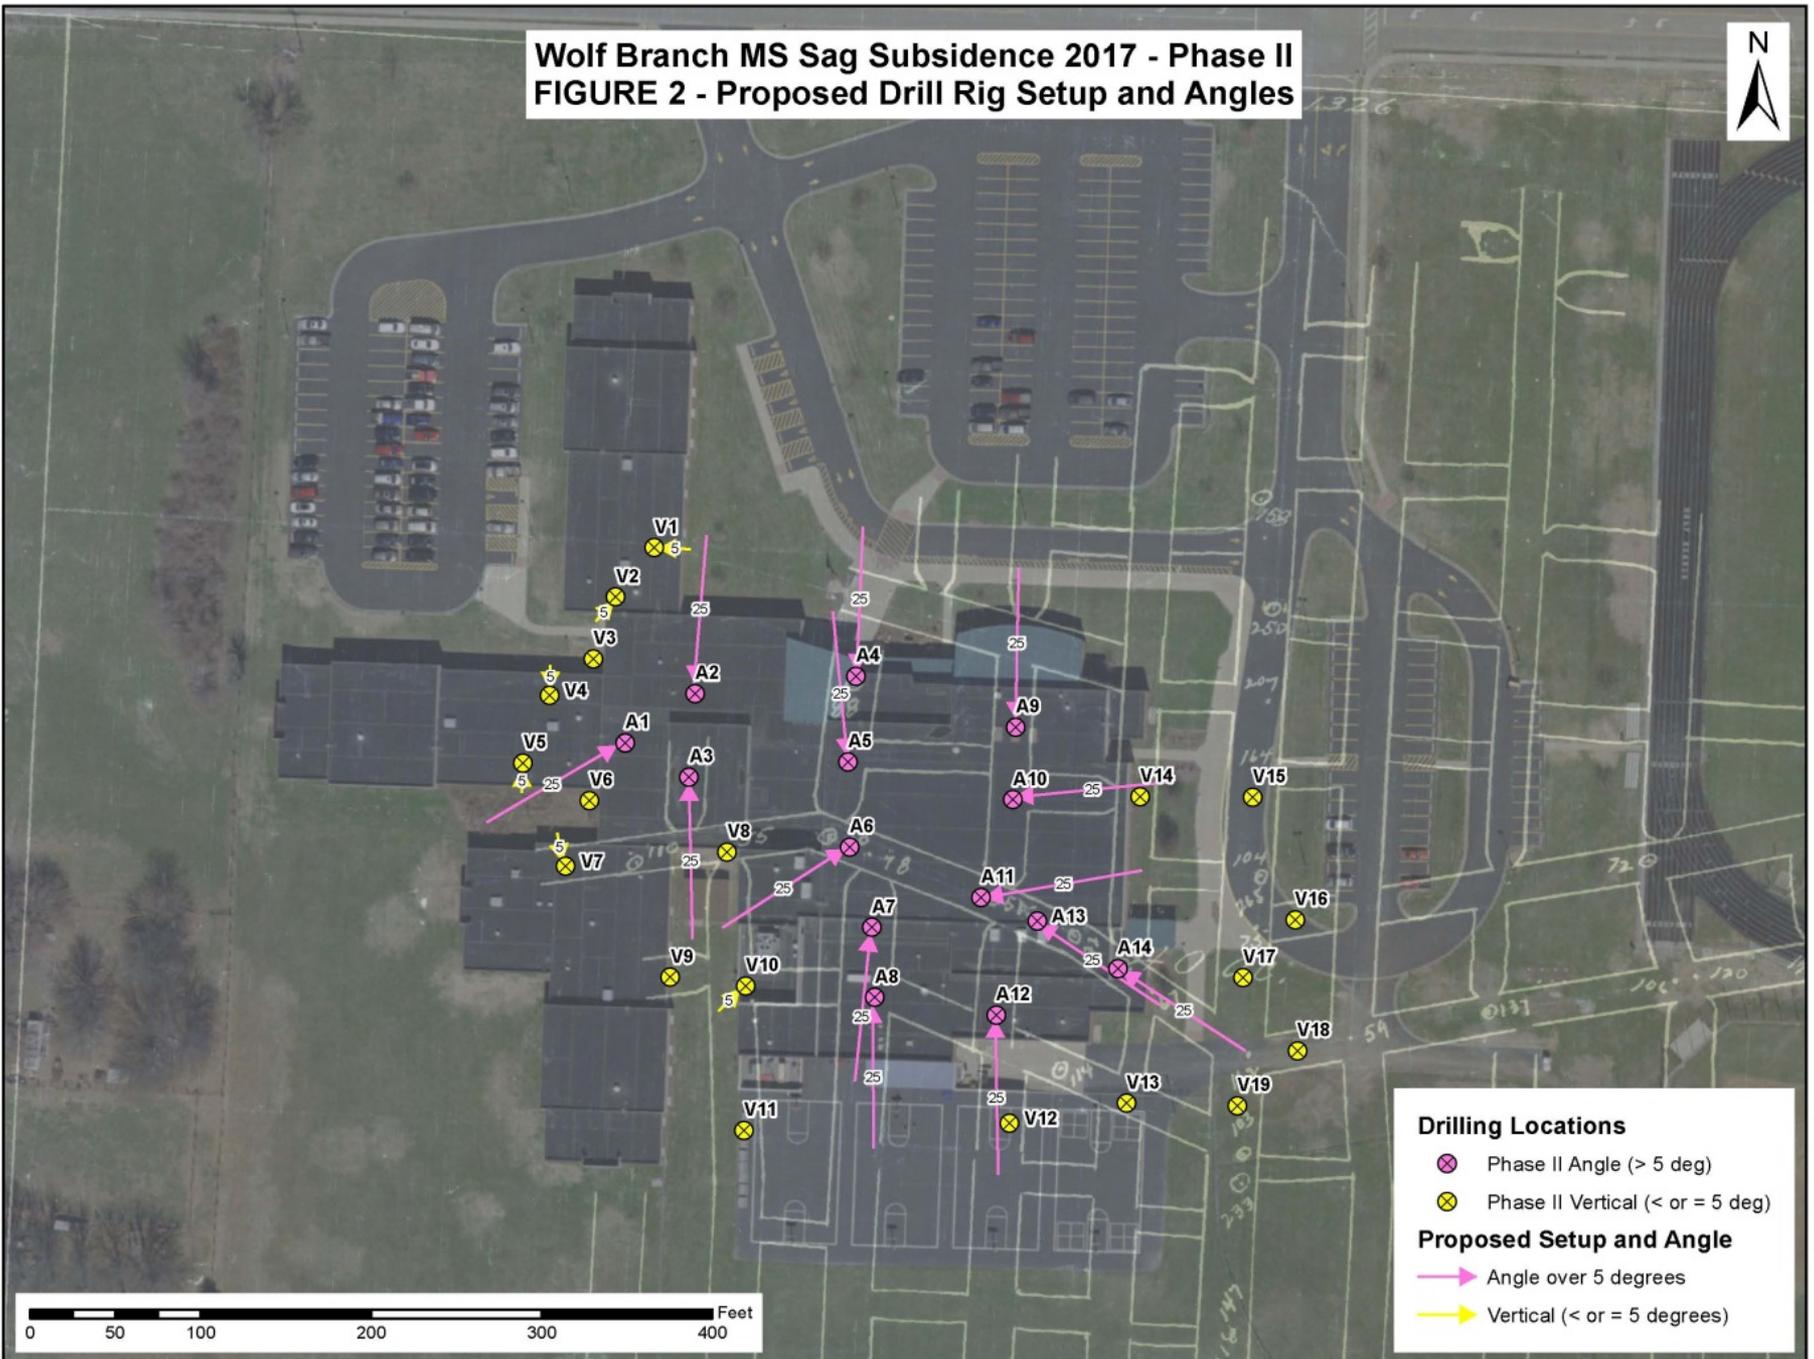
**Wolf Branch MS Sag Subsidence 2017 - Phase II**  
**FIGURE 2 - Proposed Drill Rig Setup and Angles**

- Containment (Mix A) – 6 to 8 inch slump
  - Infill (Mix B) – 30 to 60 second flow
- Strength requirements: 7 day = 400 psi, 28 day = 700 psi

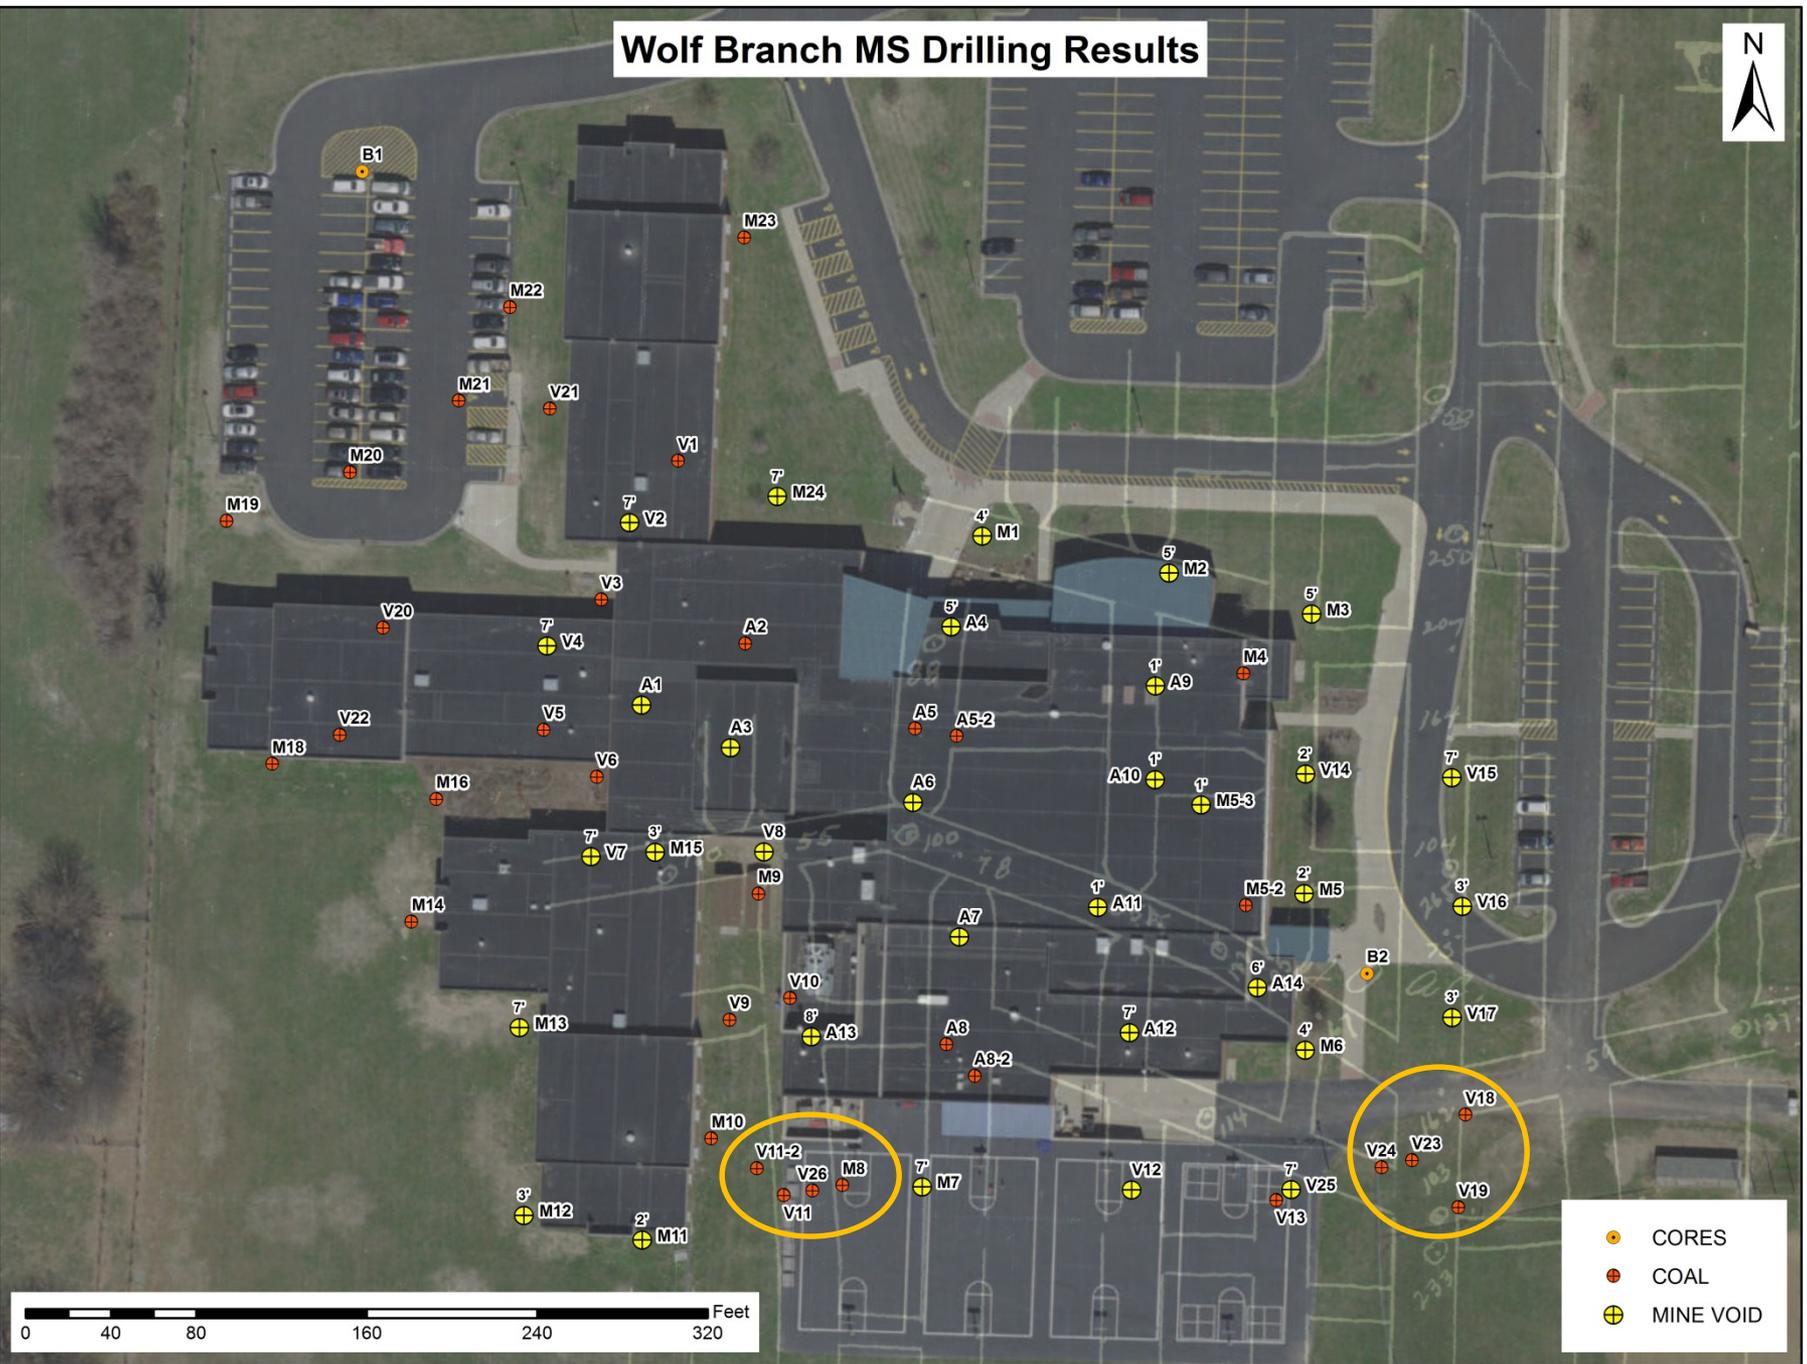
# Wolf Branch MS Drilling Results

- Depth to mine approximately 30 feet deeper than anticipated (185 - 190 feet)
- Mine works partially to completely inundated
- Coal seam thickness varies from 6 feet to 10 feet
- Voids heights range from 7 foot to less than 1 foot
- Mine map is both a blessing and a curse...
