SHRP-H-353

Innovative Materials Development and Testing Volume 2: Pothole Repair

Thomas P. Wilson
A. Russell Romine
ERES Consultants, Inc.
Savoy, Illinois

Strategic Highway Research Program
National Research Council
Washington, DC 1993

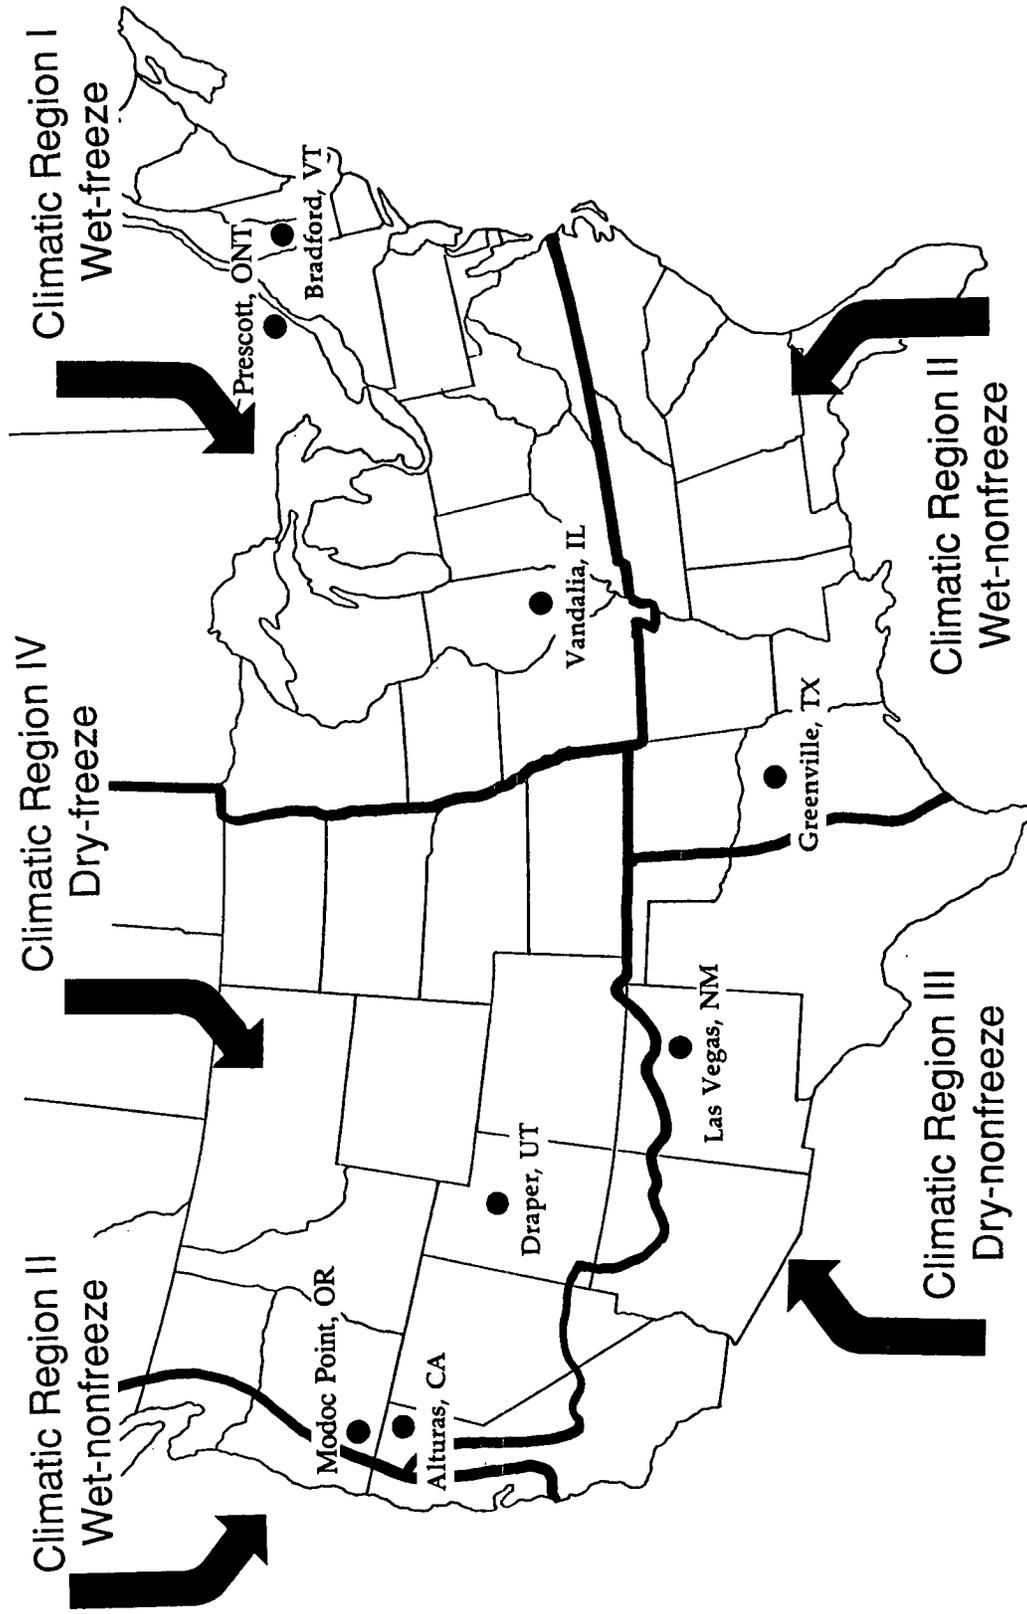
Shaded areas represent sets of repairs installed

Figure 1. Pothole repair test site locations and climatic regions.

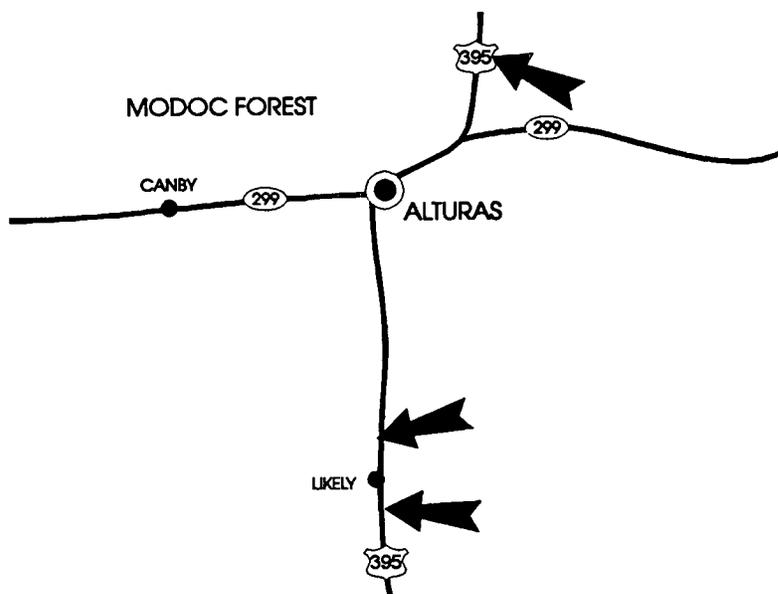
The cross section of this pavement is 4 in (102 mm) of asphalt concrete over 10 in (254 mm) of granular material. The shoulders consist of a strip of asphalt concrete approximately 1 ft (305 mm) wide beyond the edge stripe, and a section of gravel approximately 6 ft (1.83 m) wide.

Figure 2. Alturas, California pothole repair test site

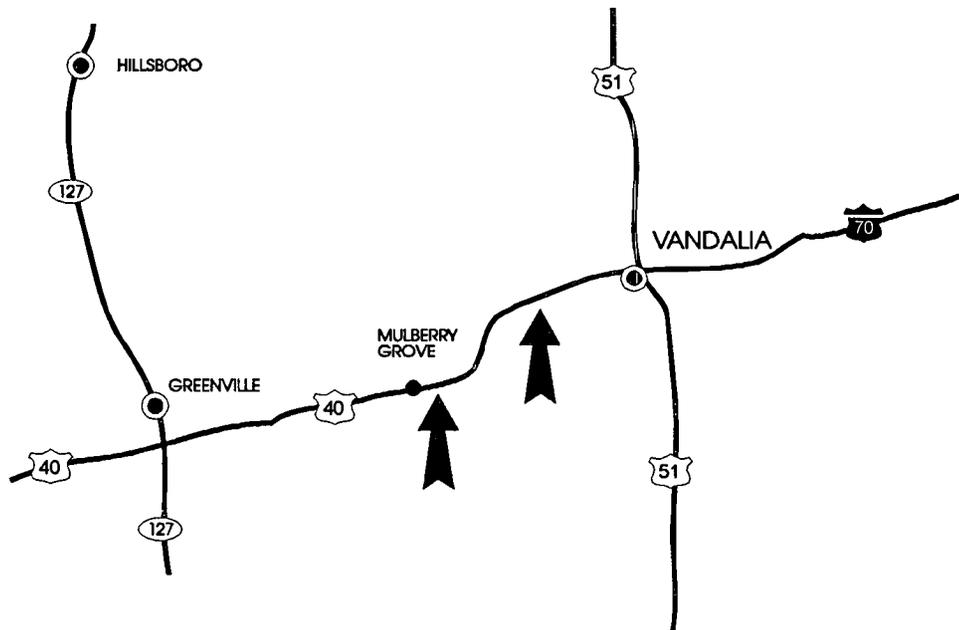
The cross section of this pavement is 4 in (102 mm) of asphalt concrete over 10 in (254 mm) of CRCP pavement. The shoulders are asphalt concrete on both the inside and outside lanes; the inside shoulder is 4 ft (1.22 m) wide and the outside is 10 ft (3.05 m) wide.

Figure 3. Vandalia, Illinois pothole repair test site

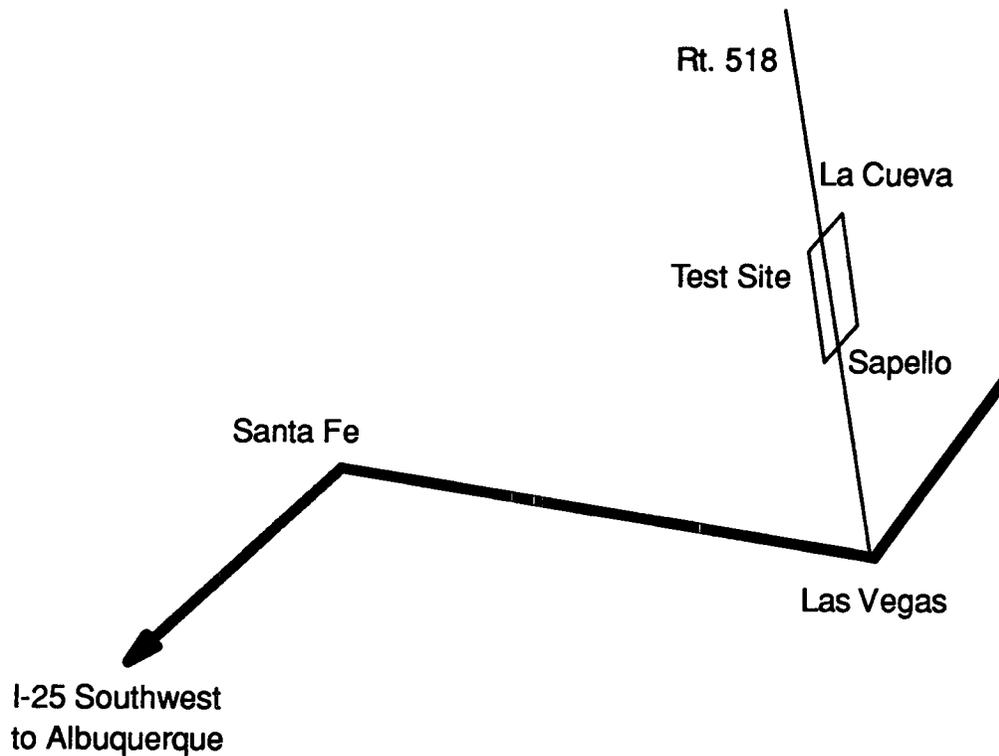
This test site is north of Las Vegas, in the southbound lane of Route 518 in Mora County, between M.P. 22 and M.P. 16, ending just north of the Mora/San Miguel county line (figure 4).

Figure 4, Las Vegas, New Mexico pothole repair test site

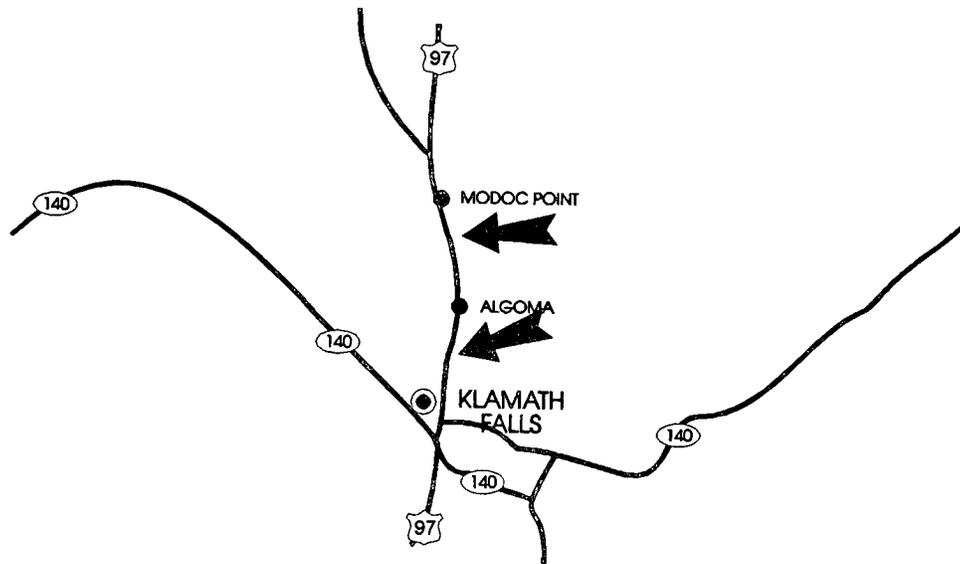
Figure 5. Modoc Point, Oregon pothole repair test site

The cross section of this pavement is 4 in (102 mm) of asphalt concrete surface over 10 in (254 mm) of granular material. The shoulders are approximately 1 ft (305 mm) of asphalt concrete and 5 ft (1.52 m) of gravel.

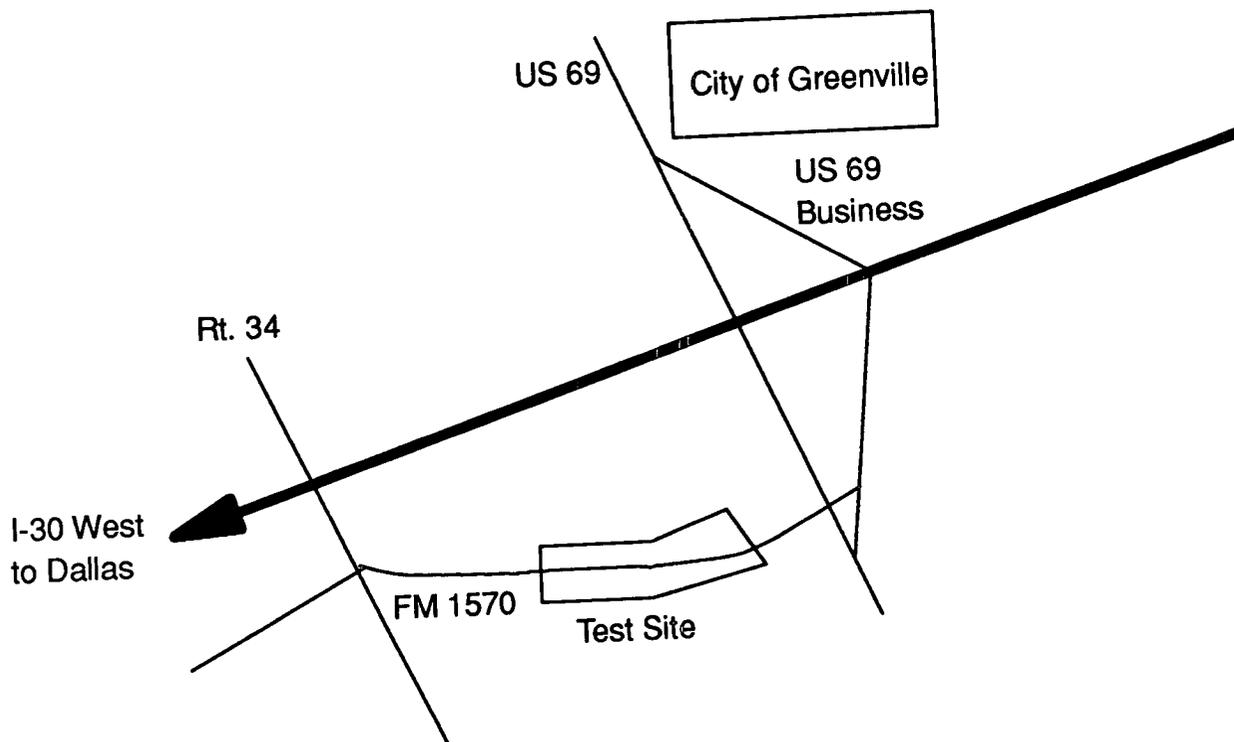
Figure 6. Greenville, Texas pothole repair test site

The cross section of this pavement is 4 in (102 mm) of asphalt concrete over 8 in (205 mm) of gravel. The shoulders consist of a strip of asphalt concrete approximately 2 ft (610 mm) wide and a width of turf that is 6 ft (1.83 mm).

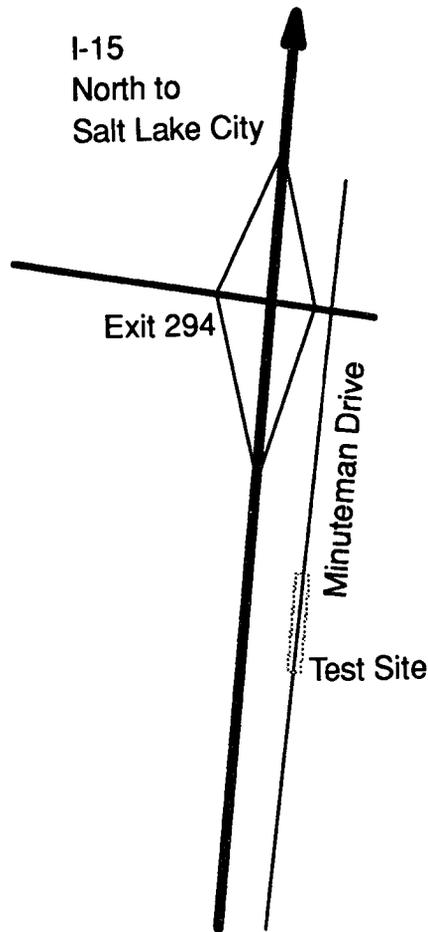
Figure 7. Draper, Utah pothole repair test site

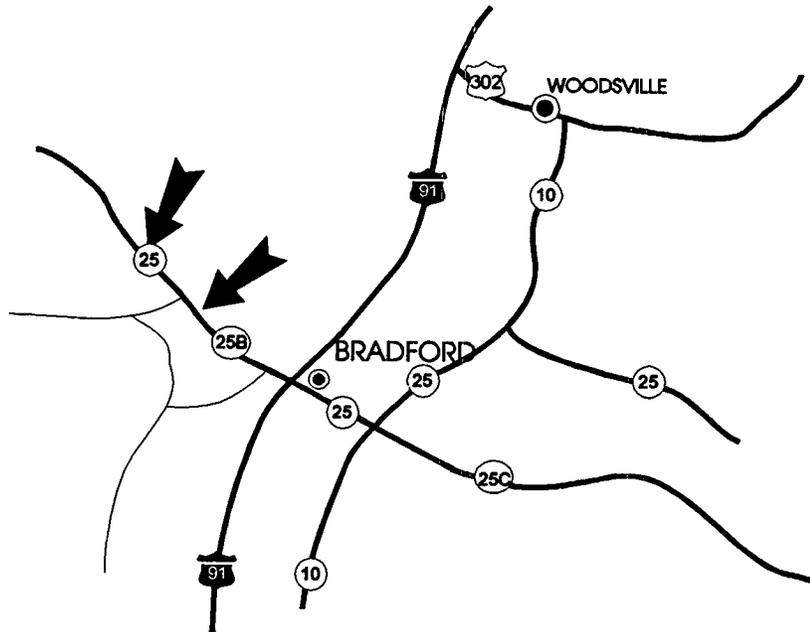
Figure 8. Bradford, Vermont pothole repair test site

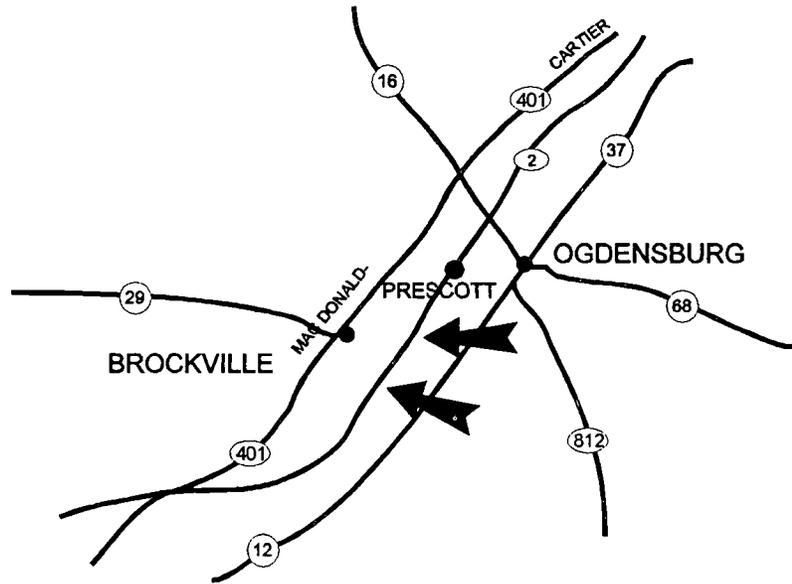
Figure 9. Prescott, Ontario pothole repair test site

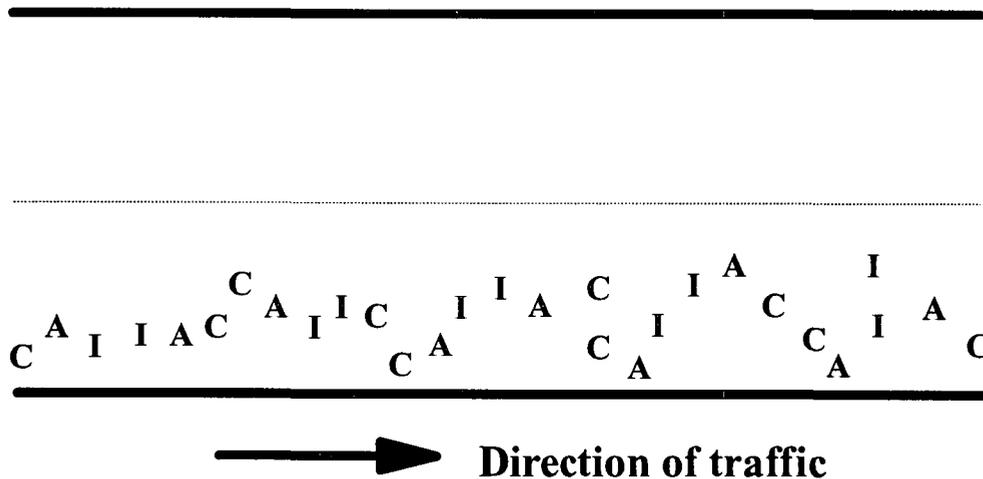
Figure 11. Example of 30-patch placement order.

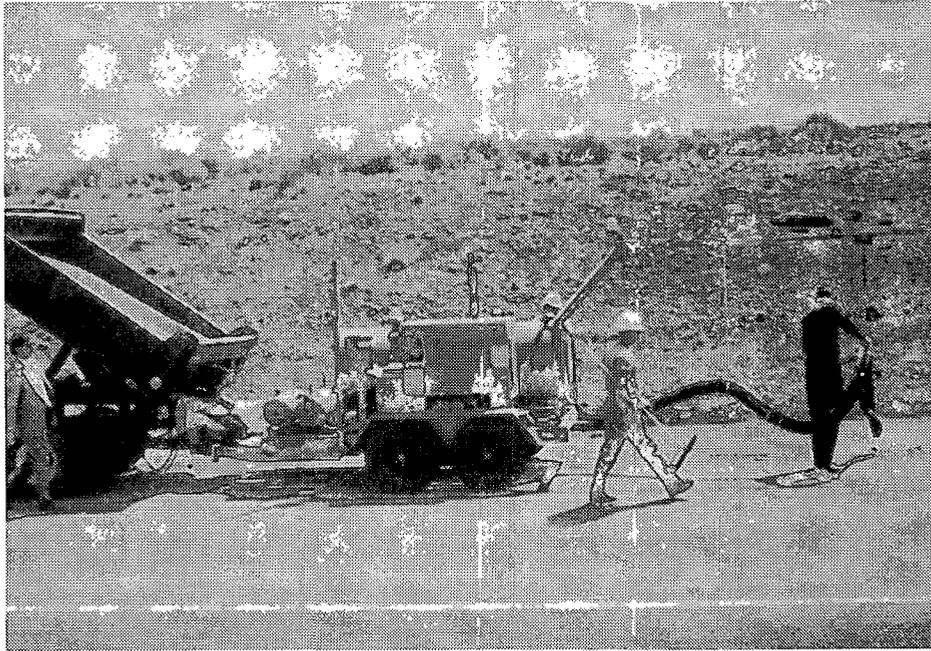
Figure 12. Durapatcher spray-injection device

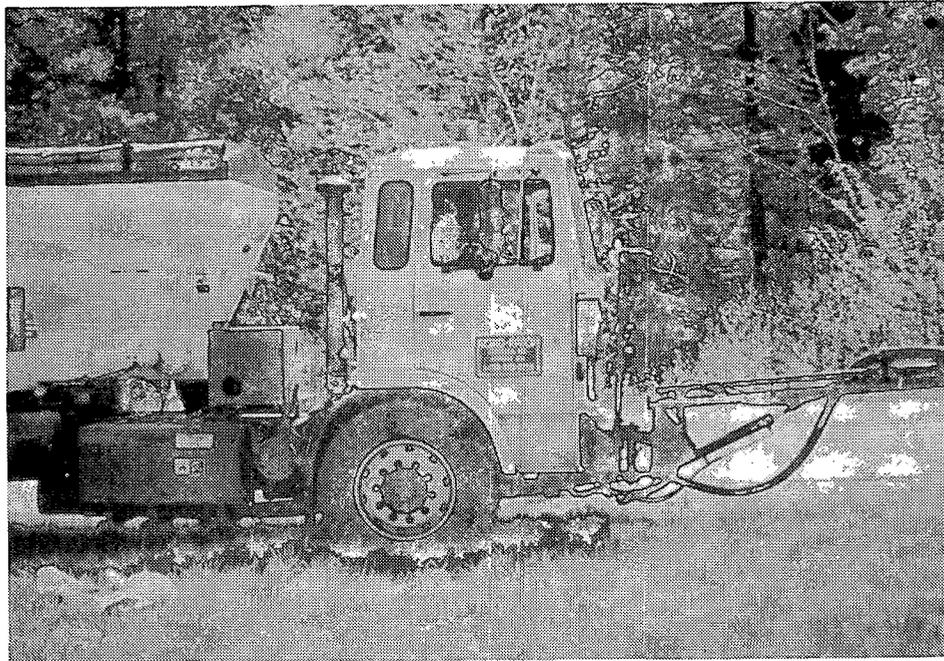
The second type of device combines storage for binder and aggregate with delivery systems on a single chassis. The nozzle for this device is generally controlled by the driver of the vehicle, so that no workers are actually on the roadway. The Wildcat Roadpatcher, which was used in Ontario and Vermont, is an example of this type of equipment (figure 13).

Figure 13. Wildcat Roadpatcher spray-injection device

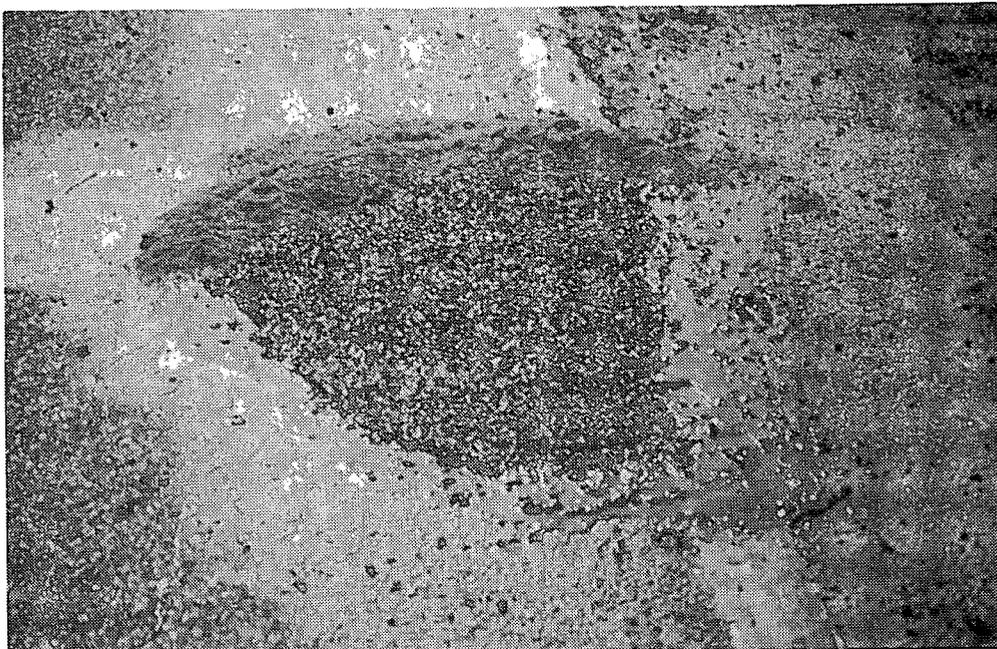
Figure 14. Asphaltic material placed as edge seal around patch

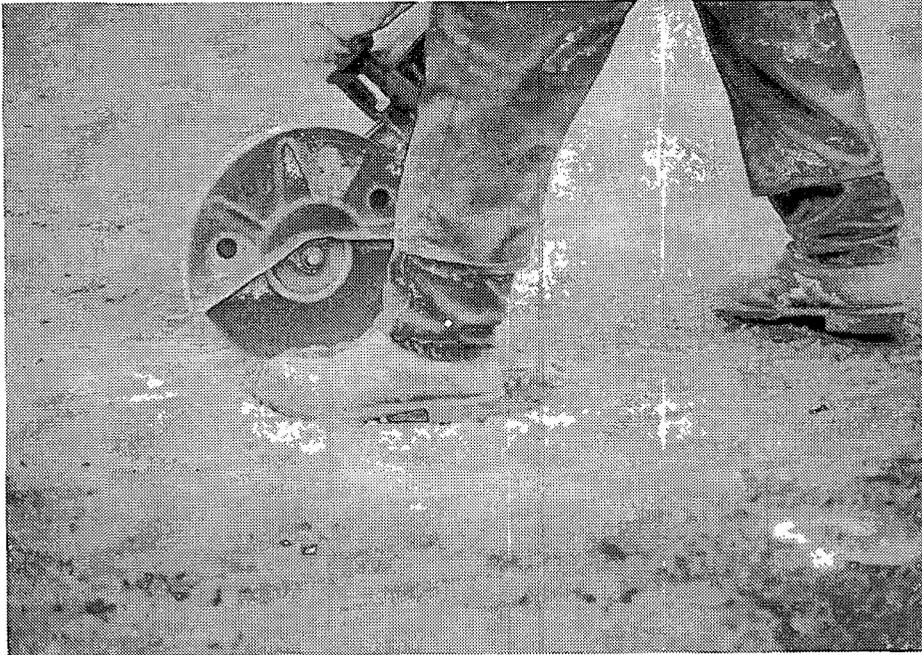
Figure 15. Straightening sides using pavement saw

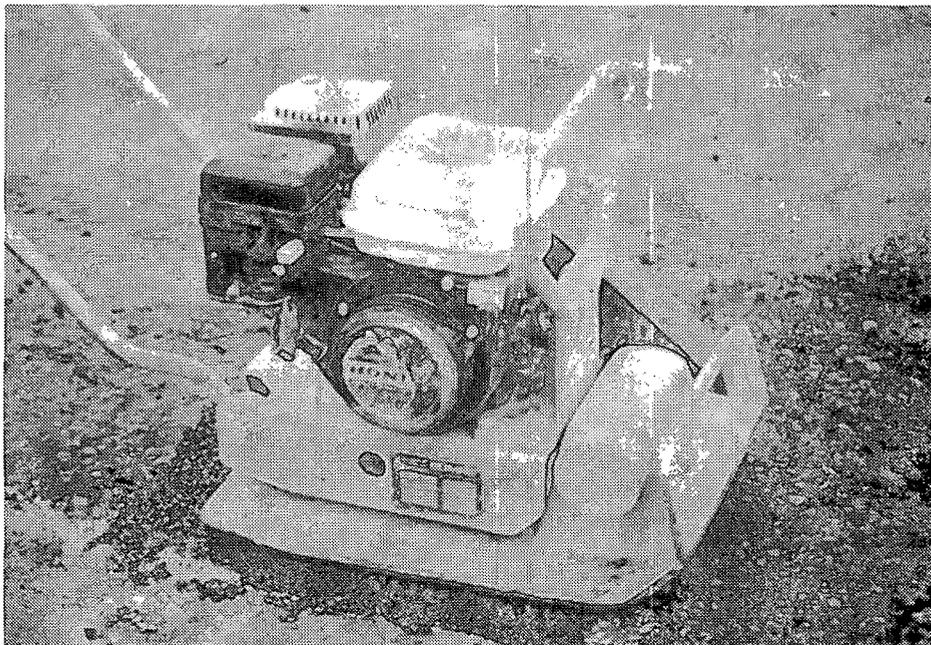
Figure 16. Compaction using vibratory plate compactor

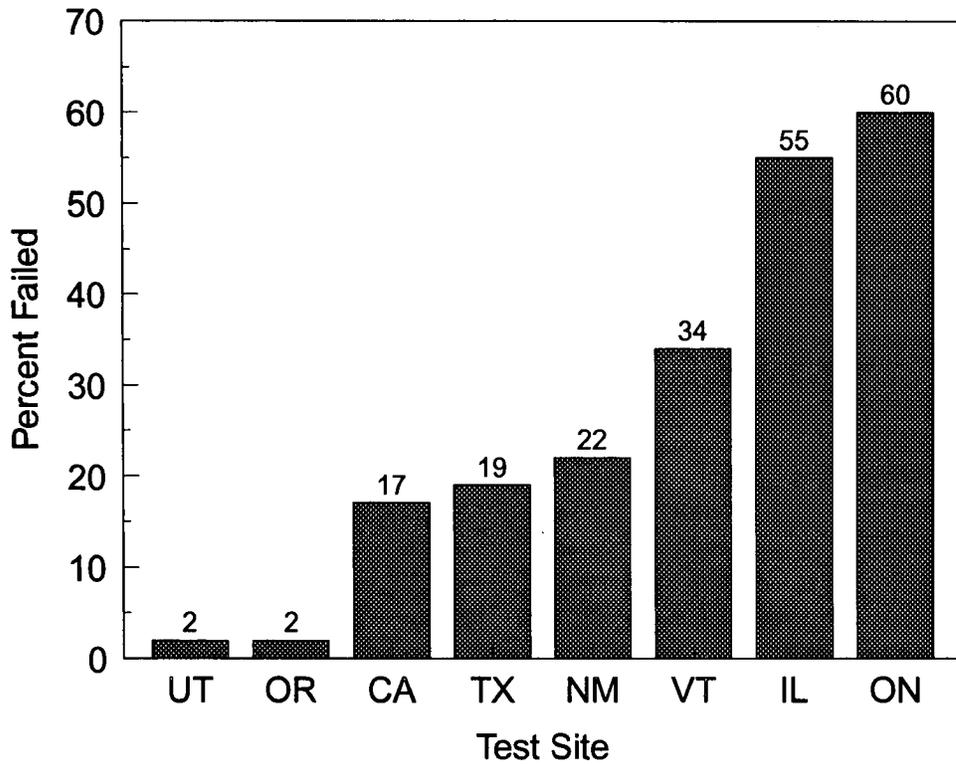
Values from last observations

Figure 18. Patches failed by site

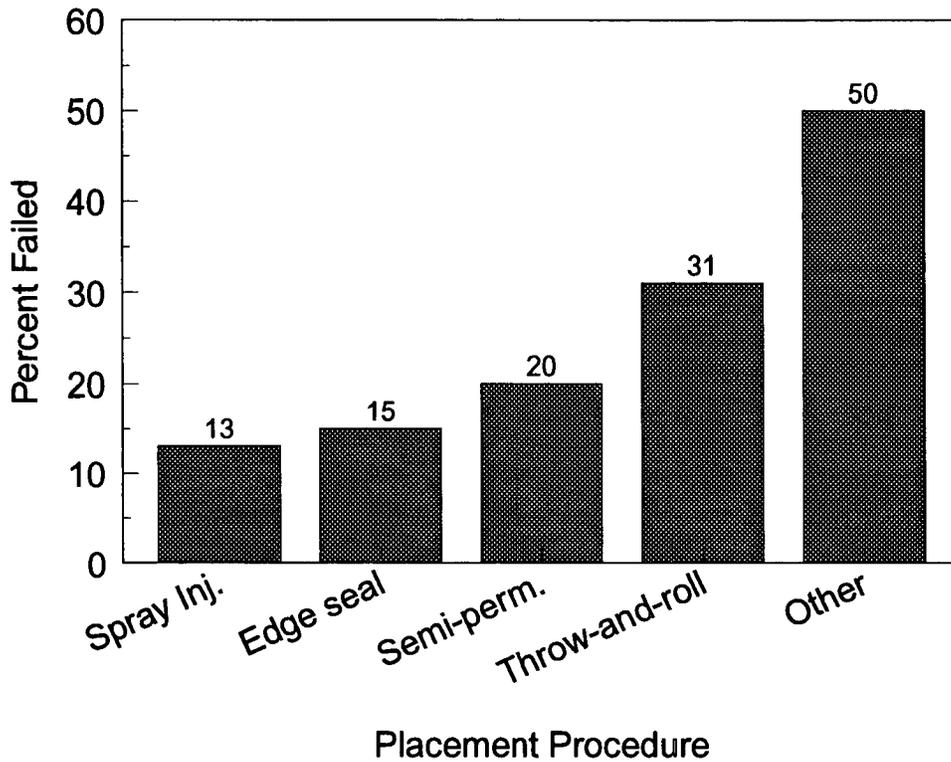
Values from last observations

Figure 19. Patches failed by procedure

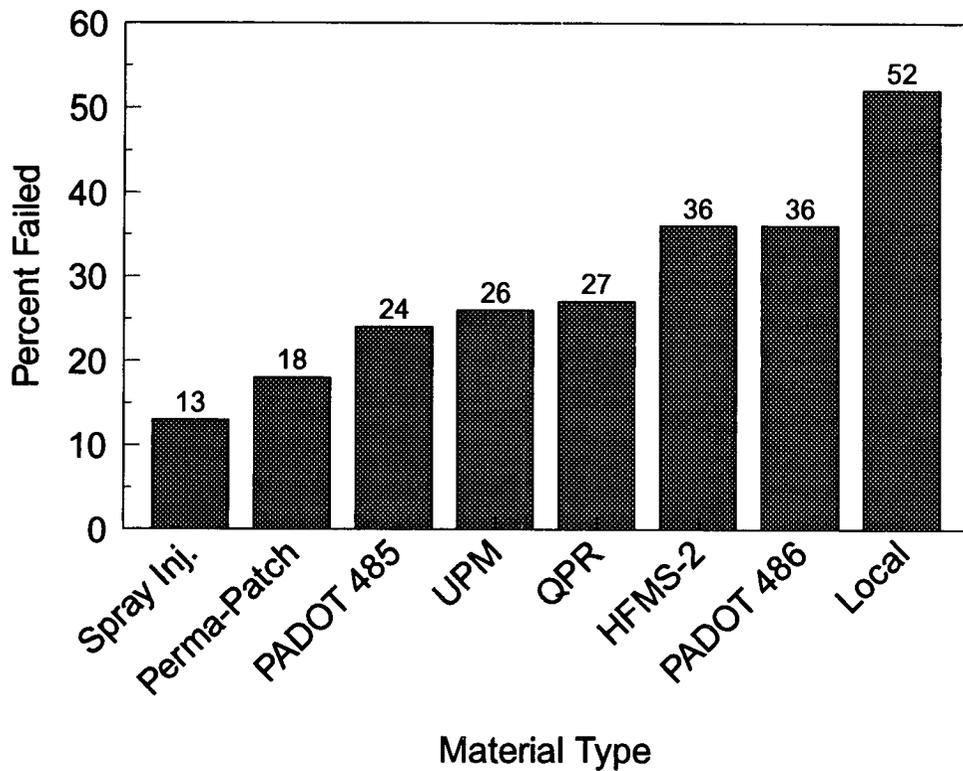
Values from last observations

Figure 20. Patches failed by material

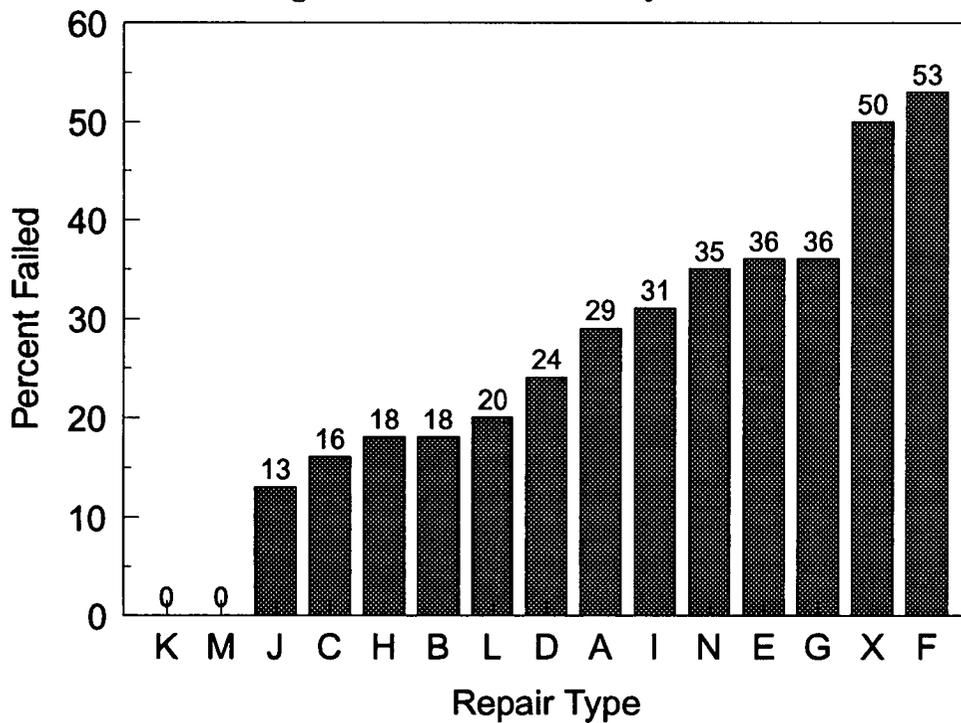
Values from last observations

Figure 21. Patches failed by repair type

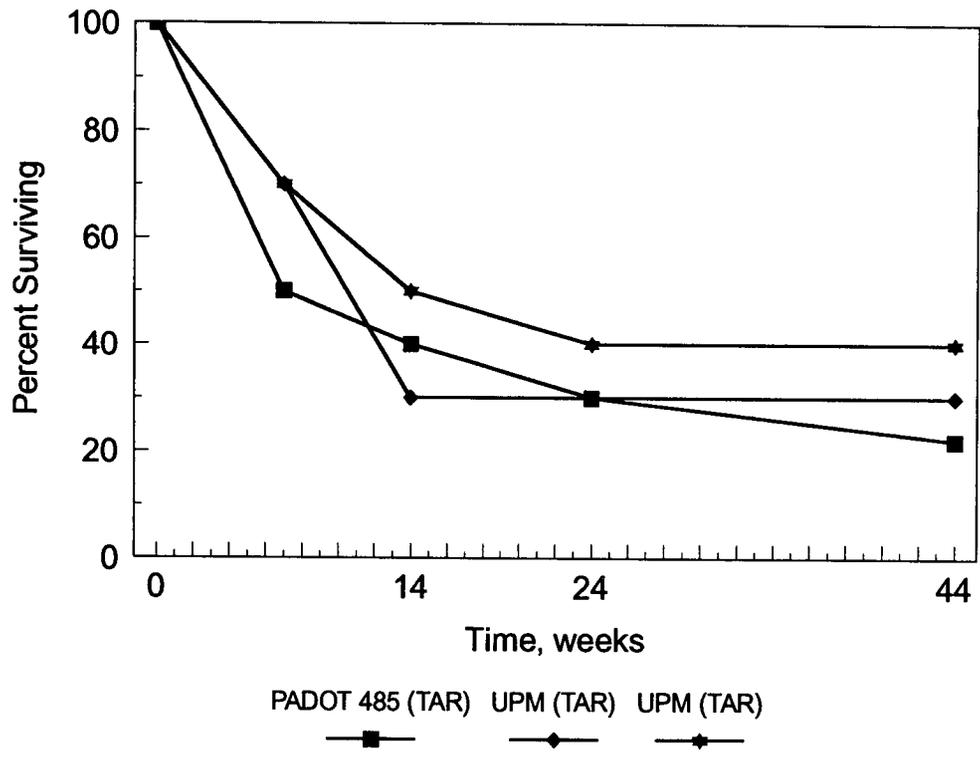
Figure 22. Survival plots for Ontario test site-set 1

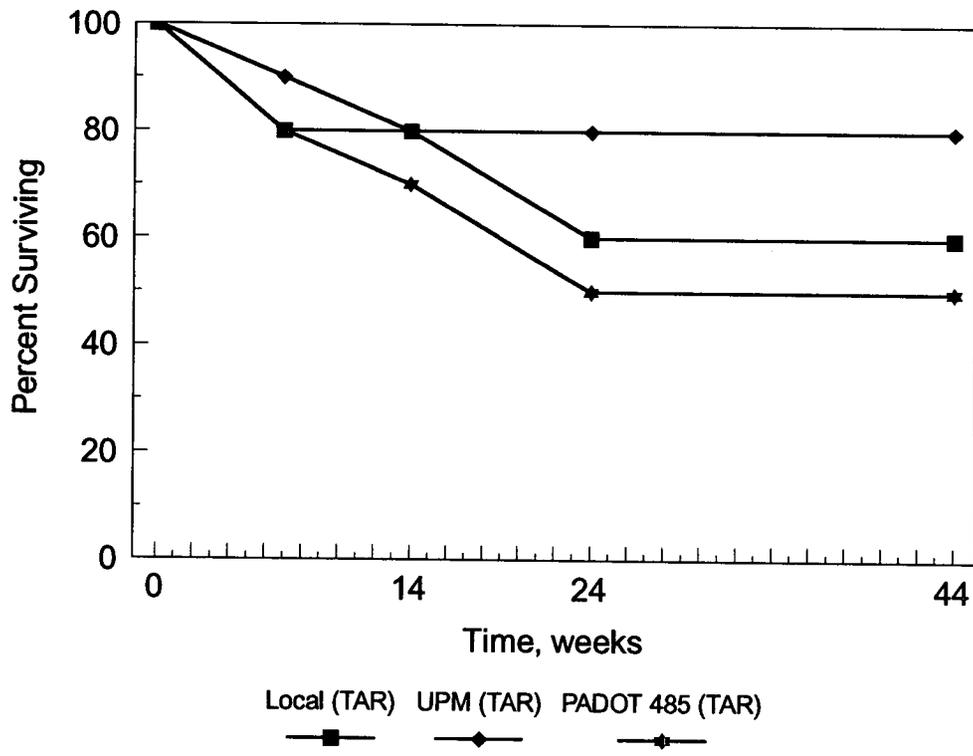
Figure 23. Survival plots for Ontario test site-set 2

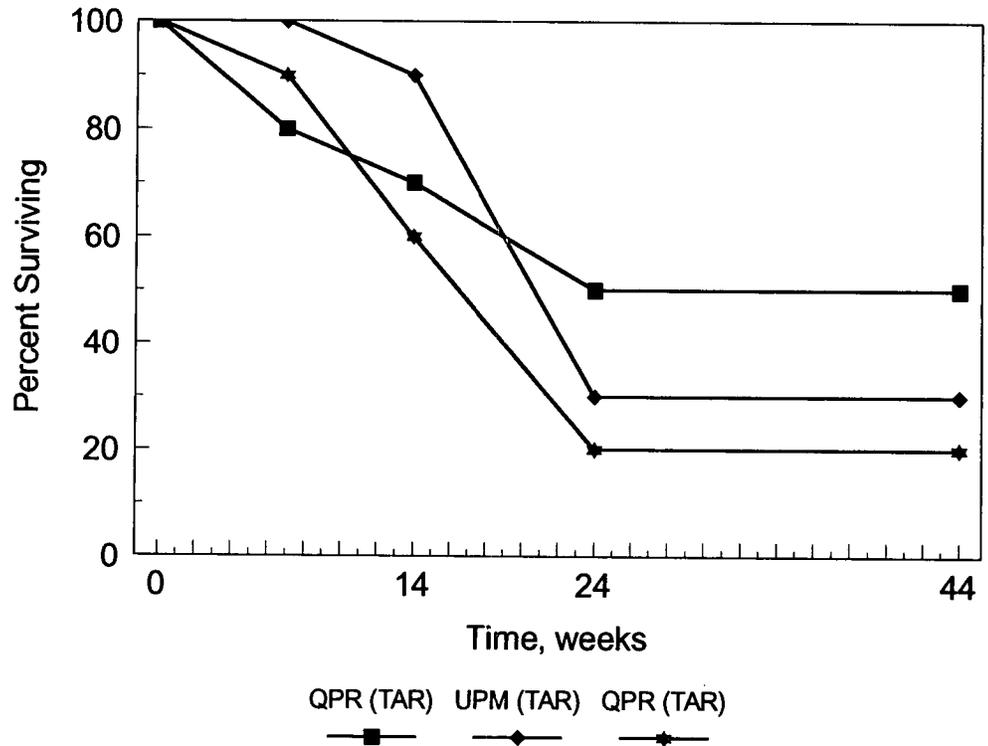
Figure 24. Survival plots for Ontario test site-set 3

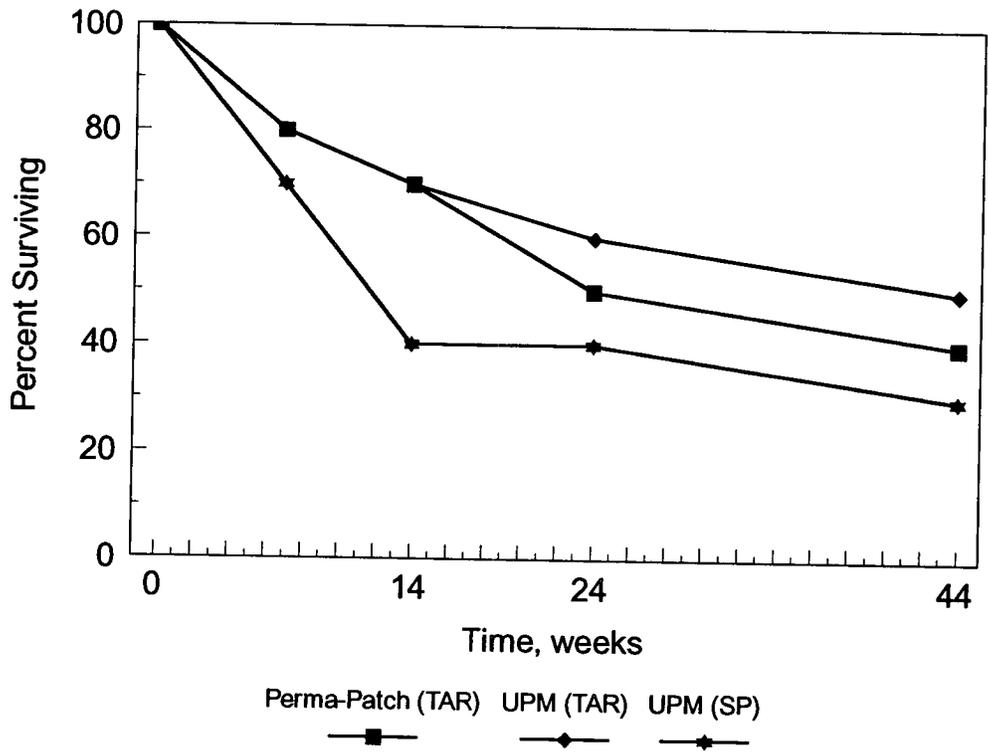
Figure 25. Survival plots for Ontario test site-set 4

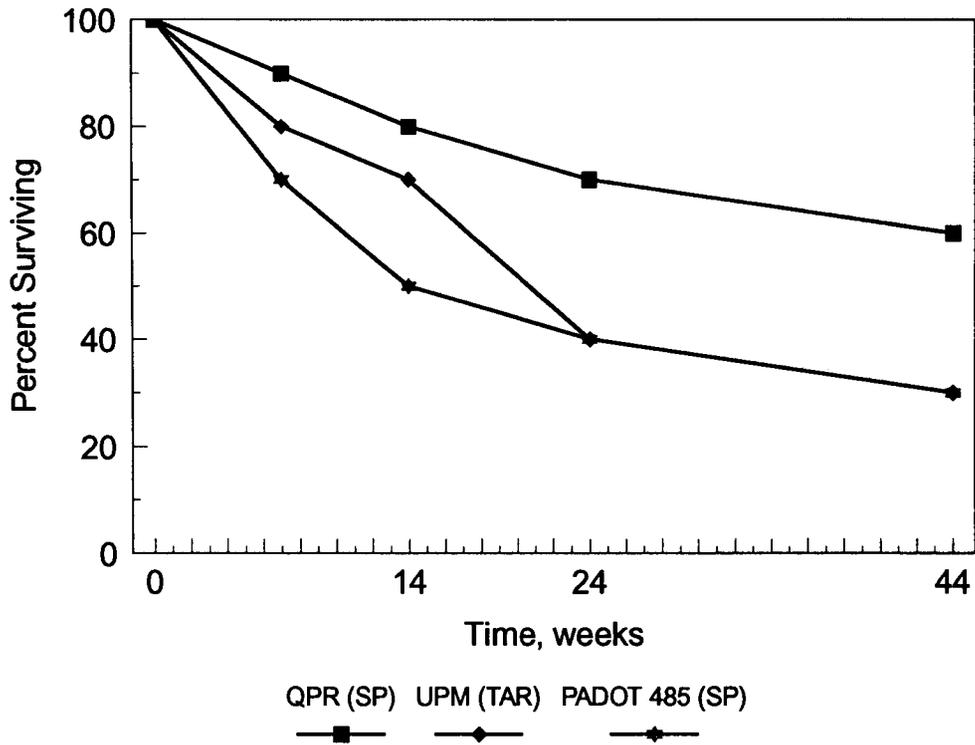
Figure 26. Survival plots for Ontario test site-set 5

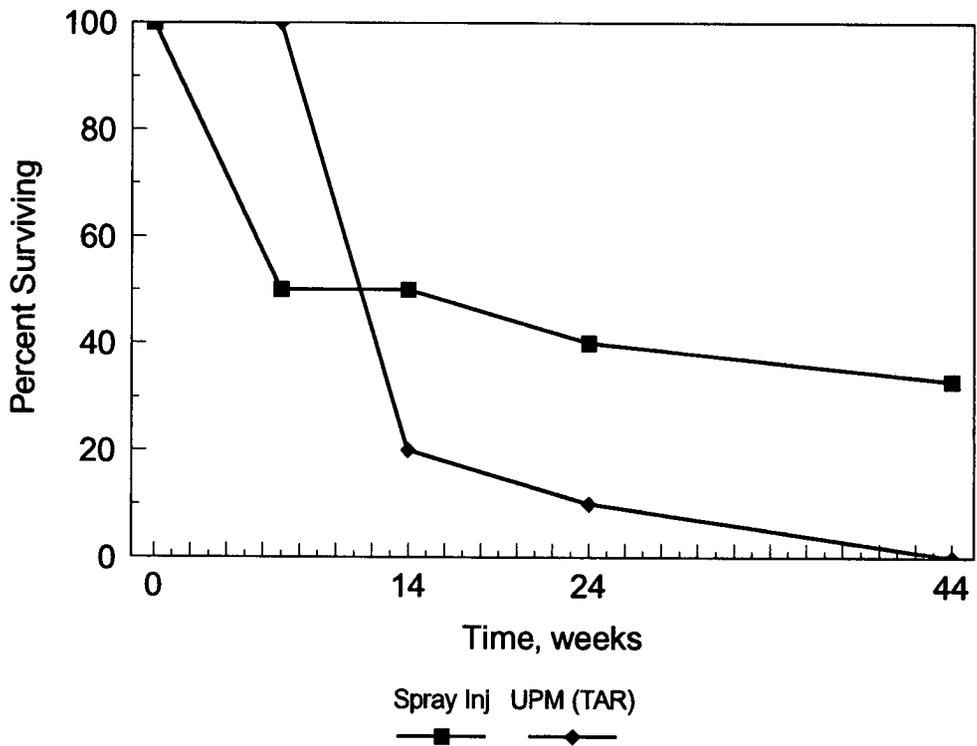
Figure 27. Survival plots for Ontario test site-set 6

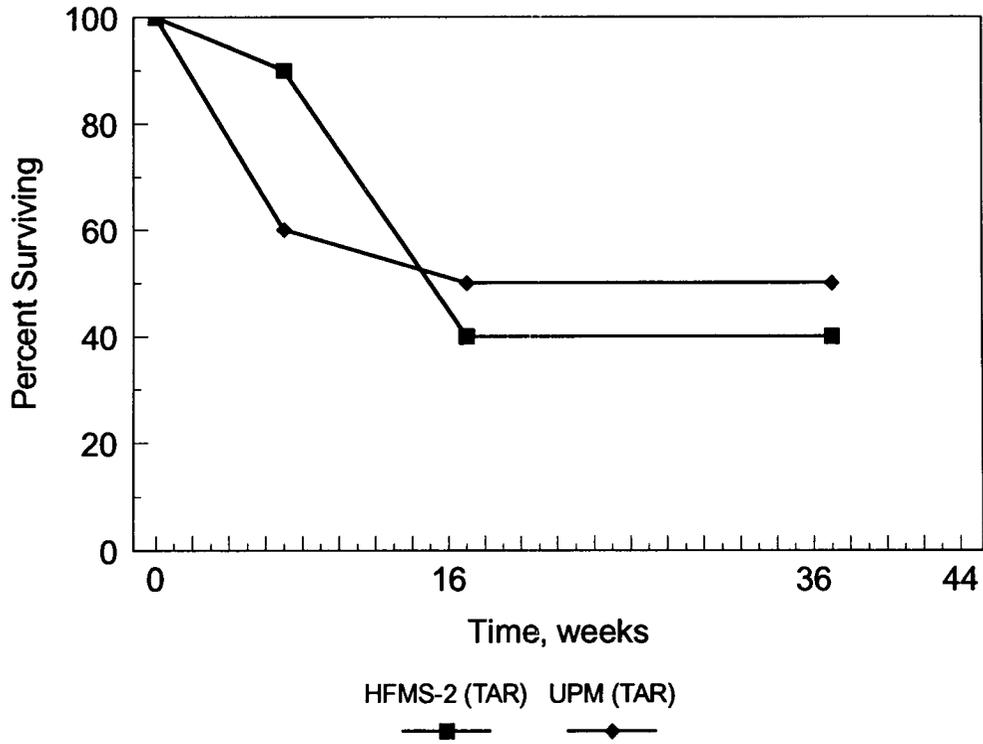
Figure 28. Survival plots for Ontario test site-set 7

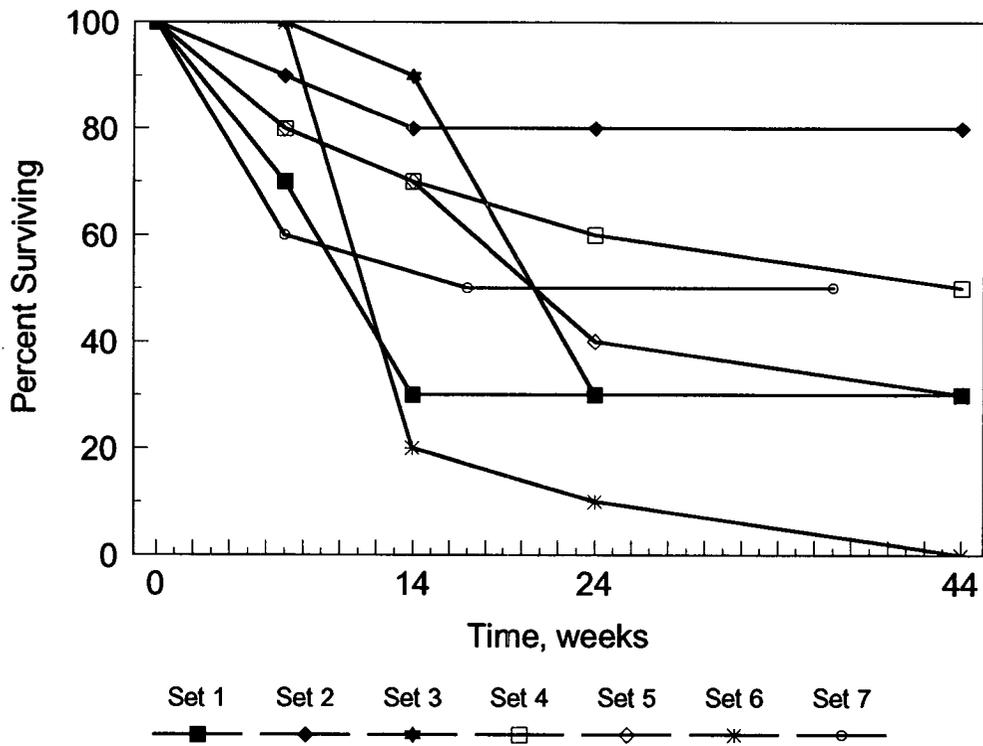
Figure 29. Survival plots for control patches-Ontario test site

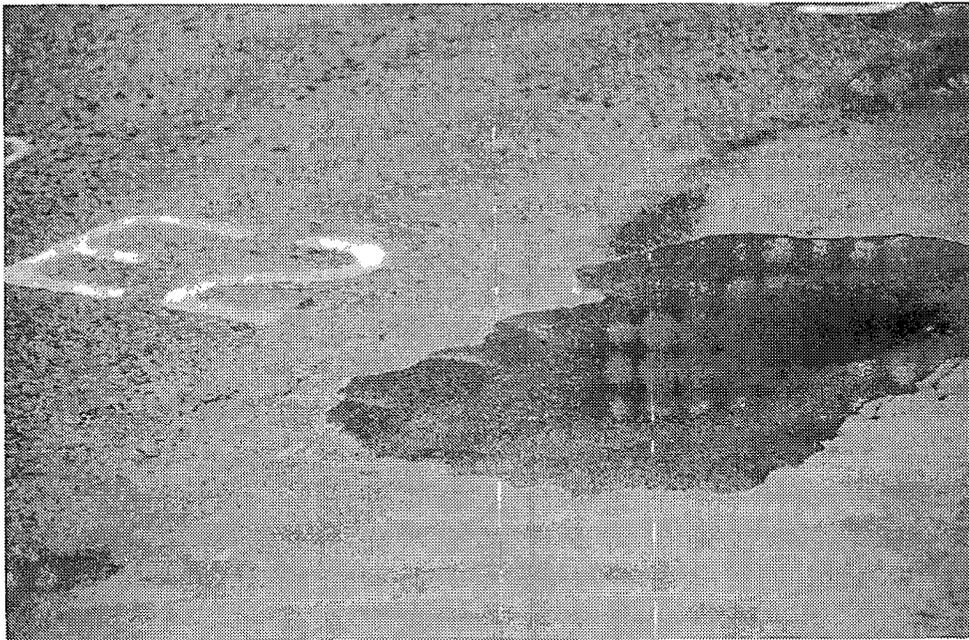
Figure 30. Example of bleeding distress

See figures 30 through 34 for examples of the distress types noted in the field.

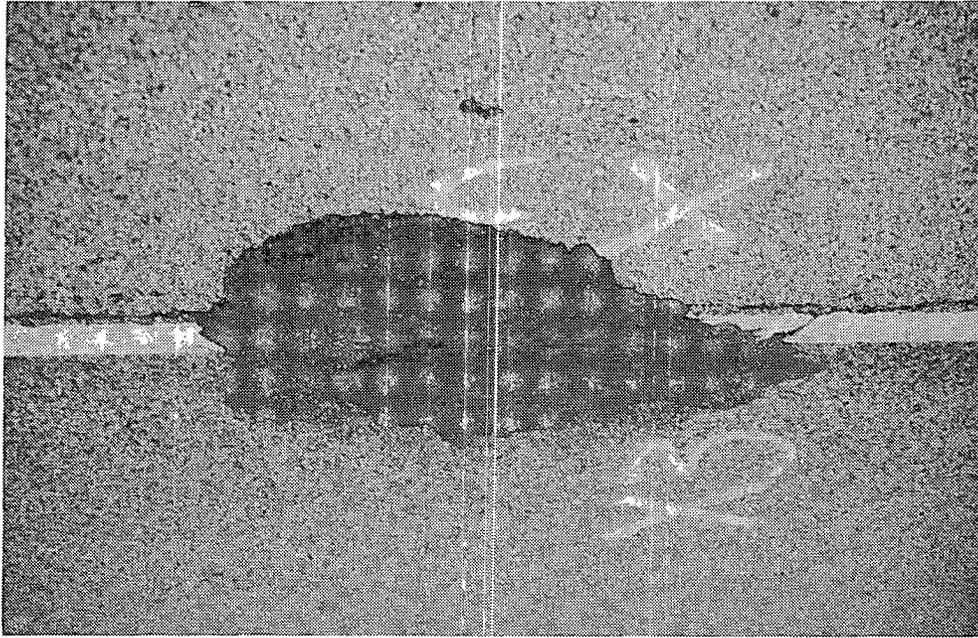
Figure 31. Example of shoving distress

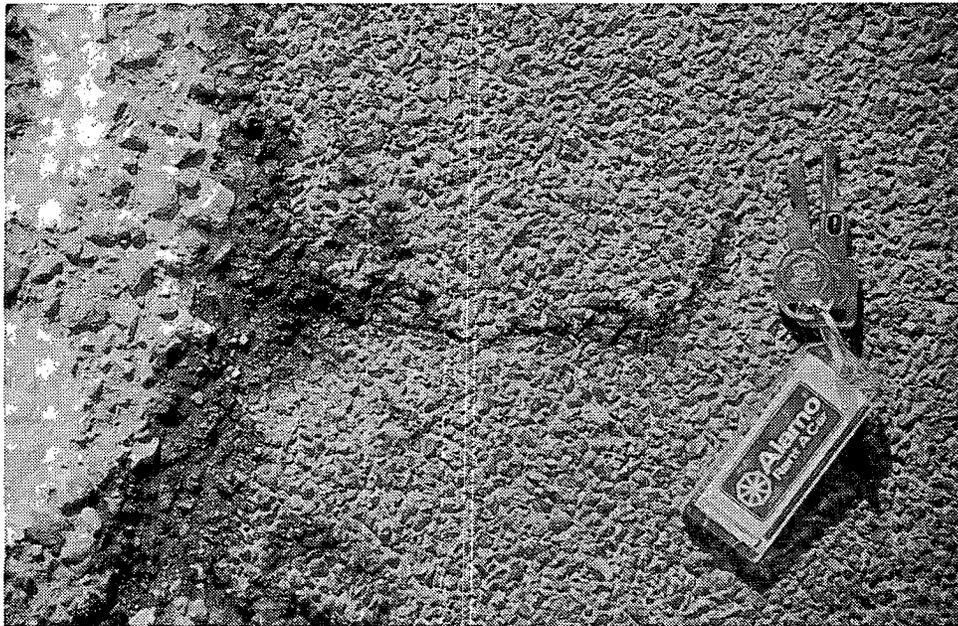
Figure 32. Example of cracking distress

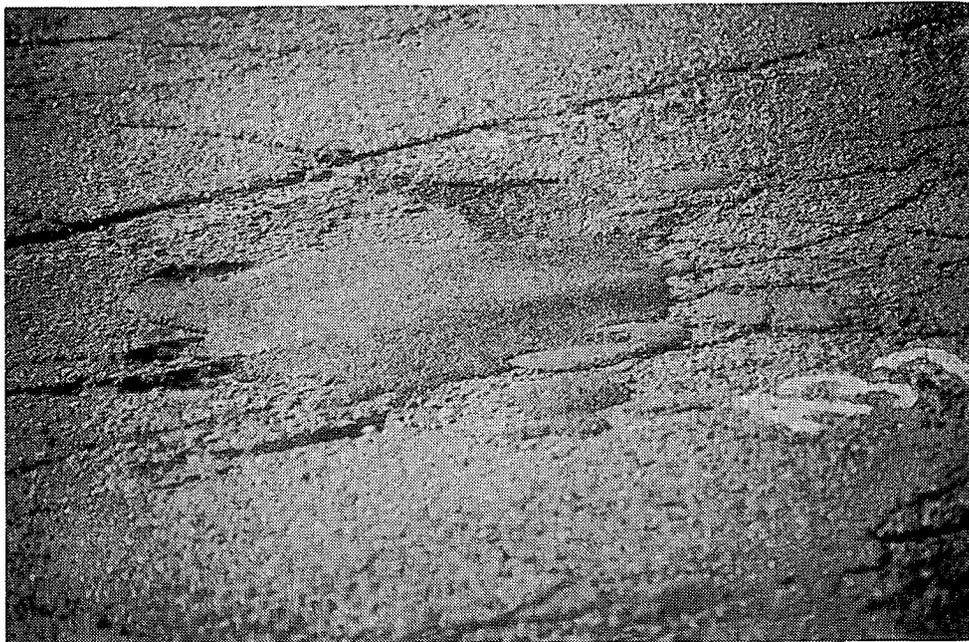
Figure 34. Example of edge disintegration distress

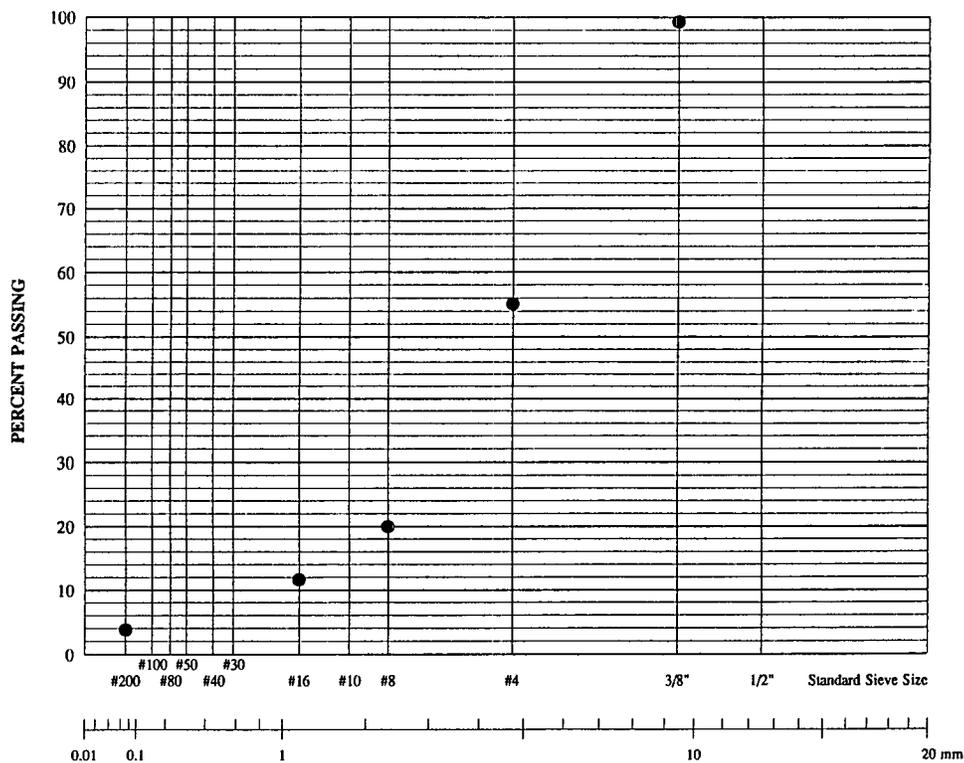
Figure C-1. Gradation for HFMS-2-Texas
