SHRP-H-353

Innovative Materials Development and Testing Volume 2: Pothole Repair

Thomas P. Wilson
A. Russell Romine
ERES Consultants, Inc.
Savoy, Illinois

Strategic Highway Research Program
National Research Council
Washington, DC 1993

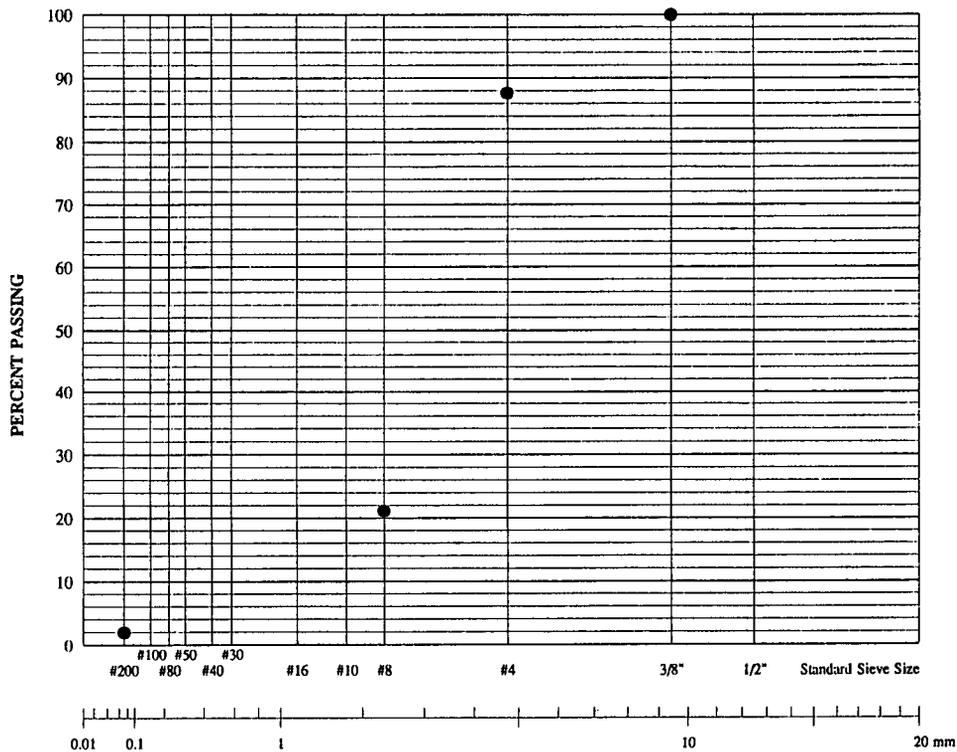
Figure C-2. Gradation for Perma-Patch-Texas

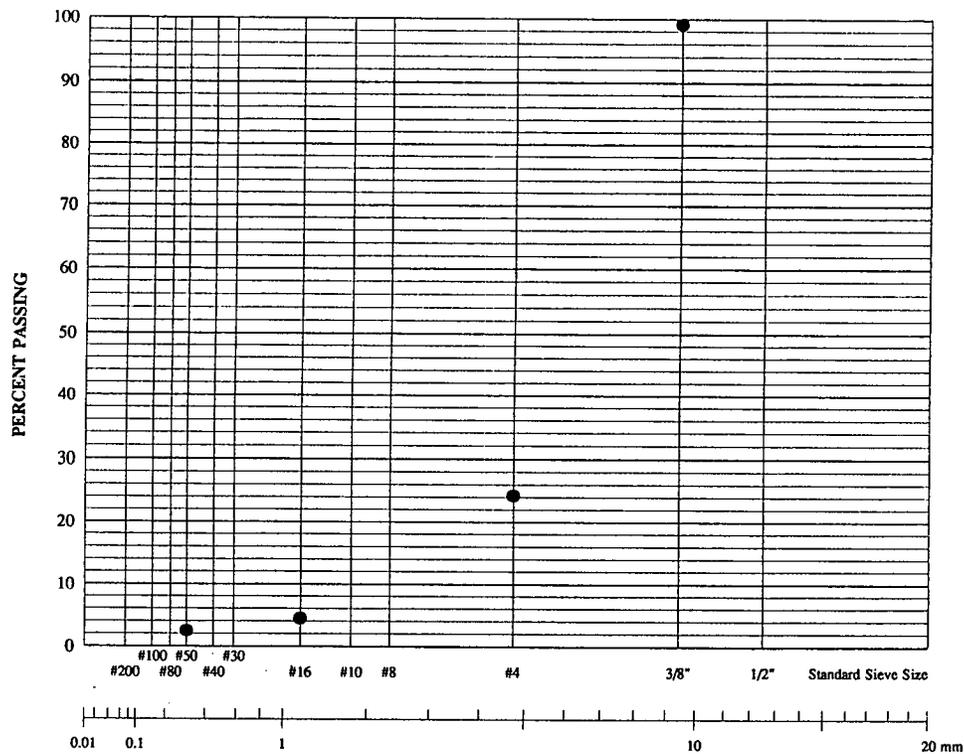
Figure C-3. Gradation for UPM-Texas

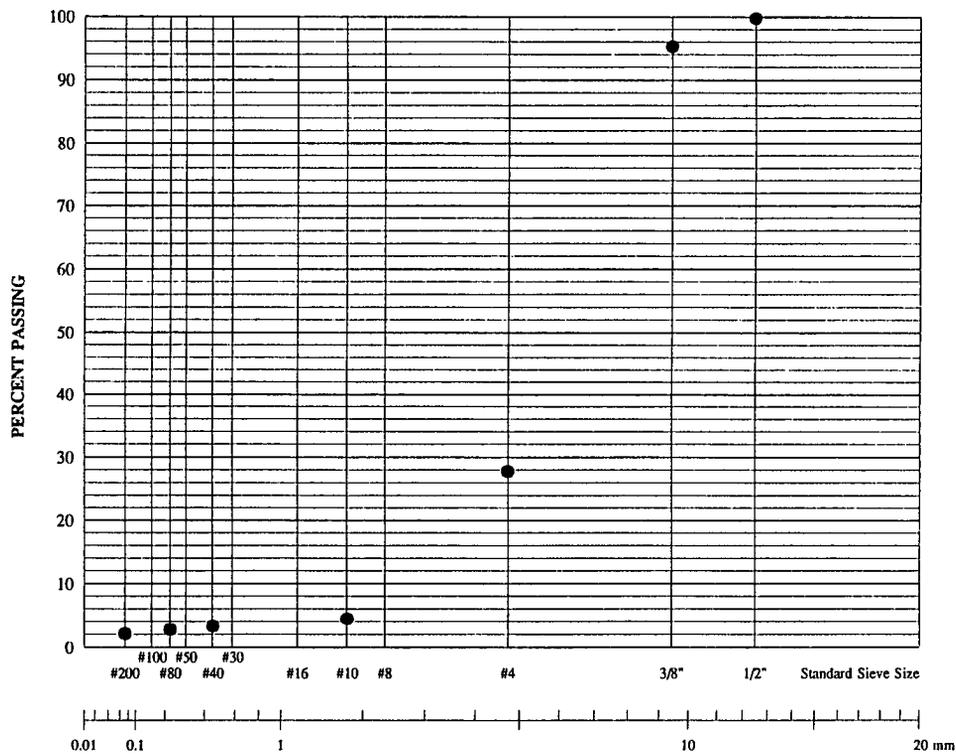
Figure C-4. Gradation for local material–Texas

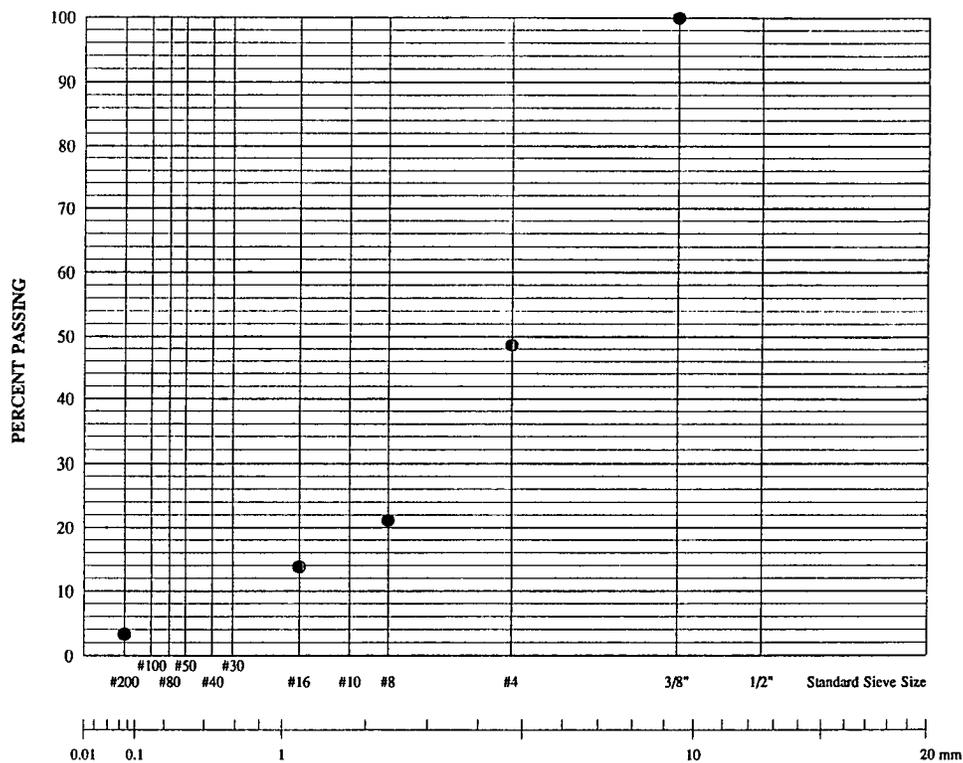
Figure C-5. Gradation for PennDOT 485-Texas

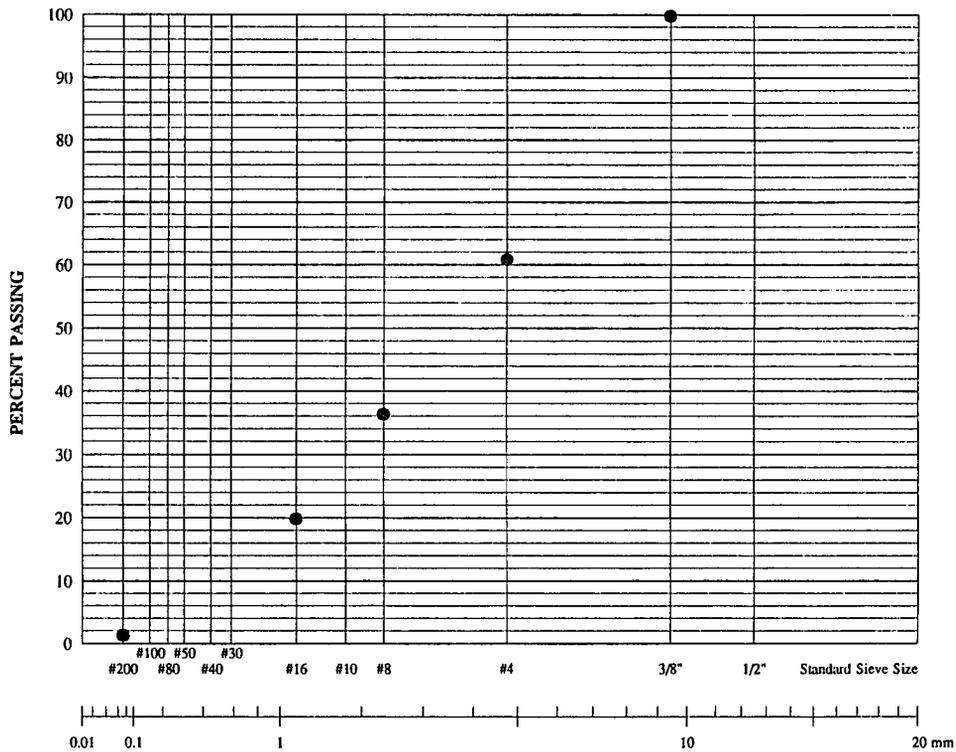
Figure C-6. Gradation for PennDOT 486–Texas

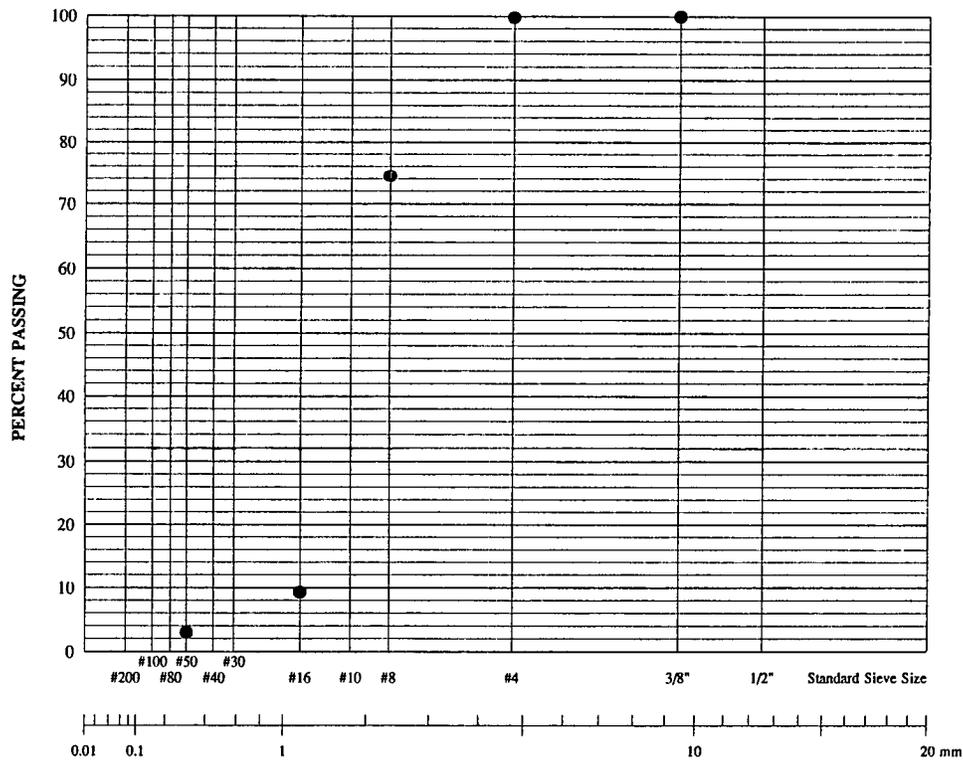
Figure C-7. Gradation for QPR 2000–Texas

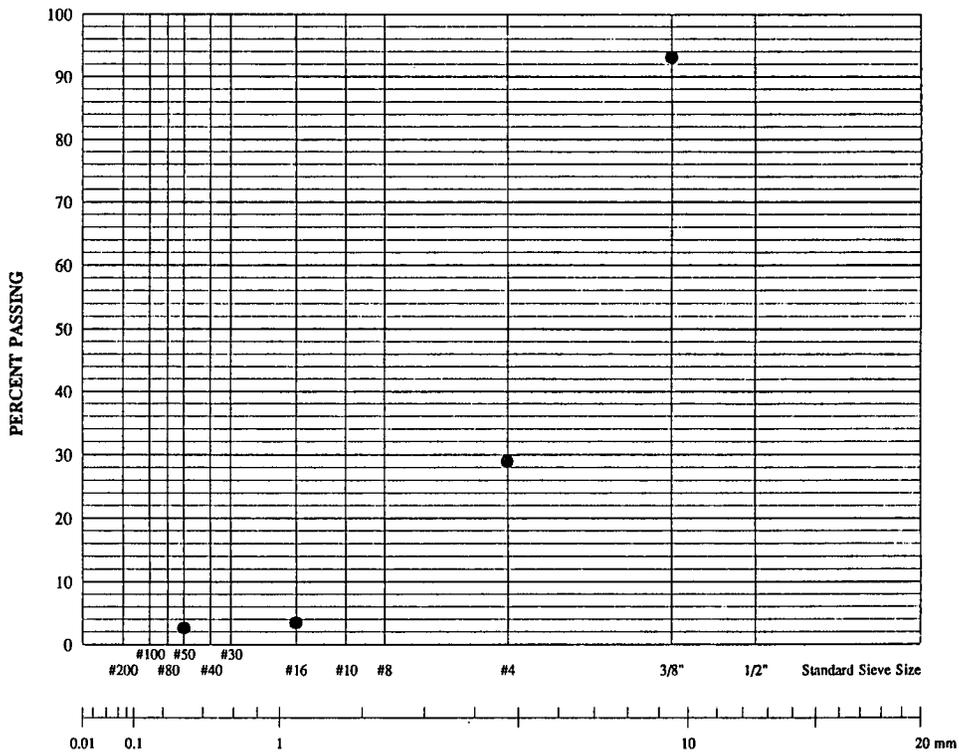
Figure C-8. Gradation for UPM-Illinois

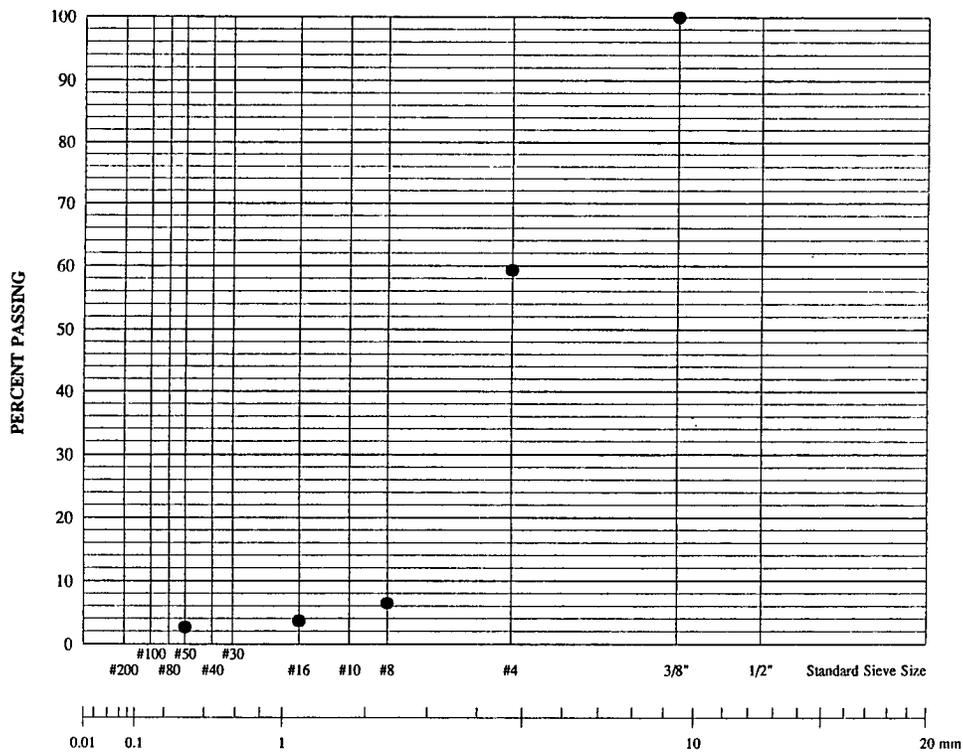
Figure C-9. Gradation for QPR 2000–Illinois

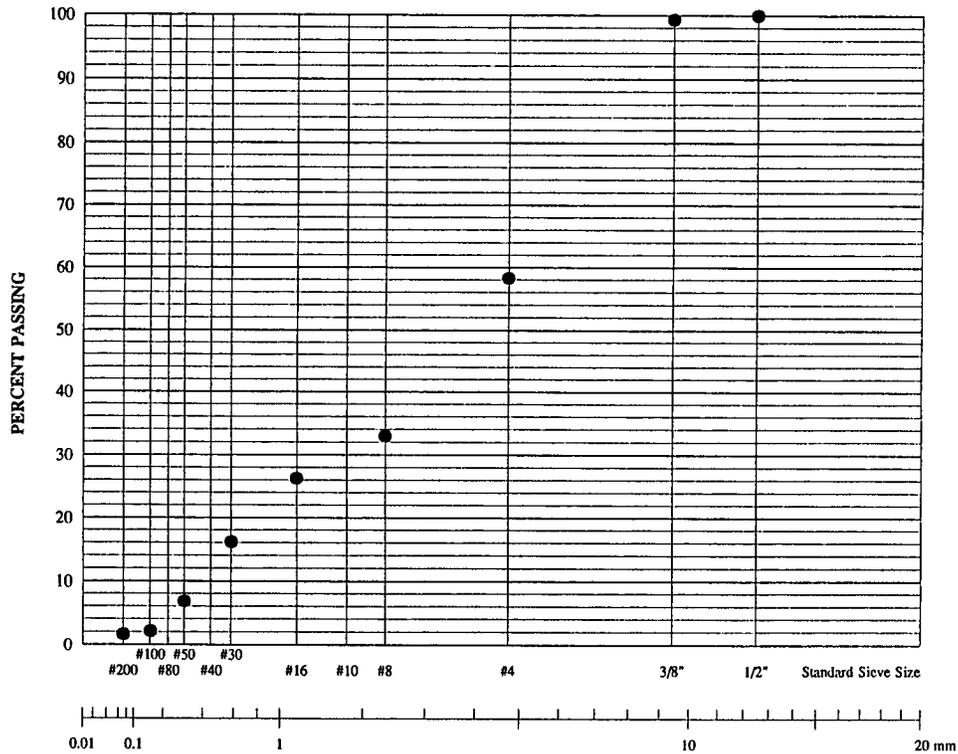
Figure C-10. Gradation for local material–Illinois

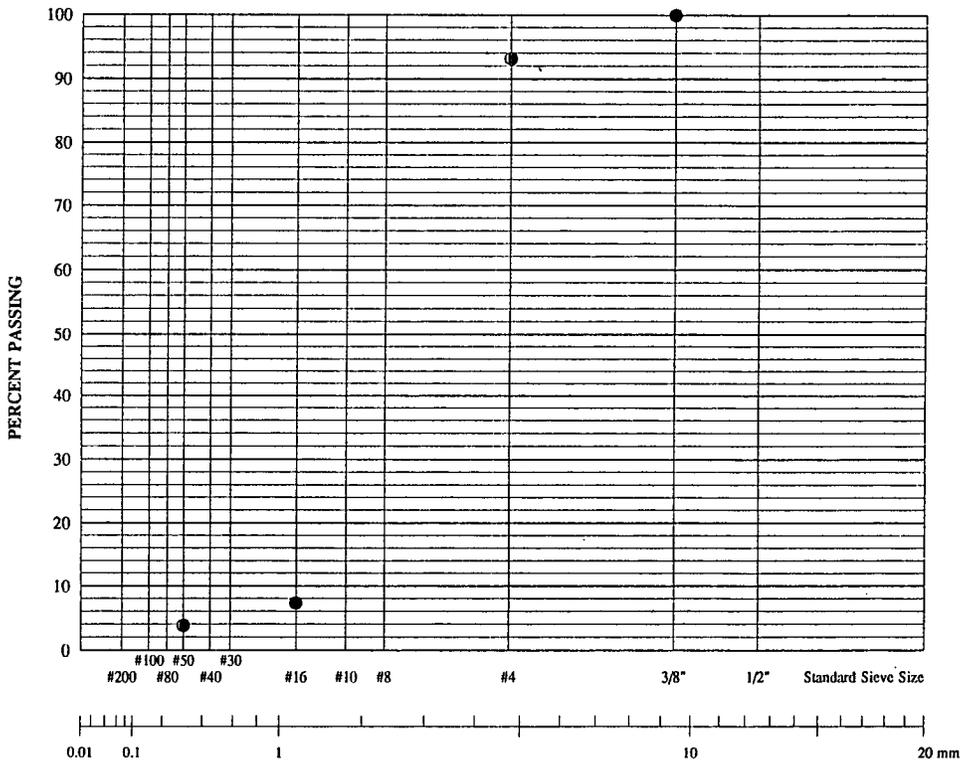
Figure C-11. Gradation for UPM-Utah

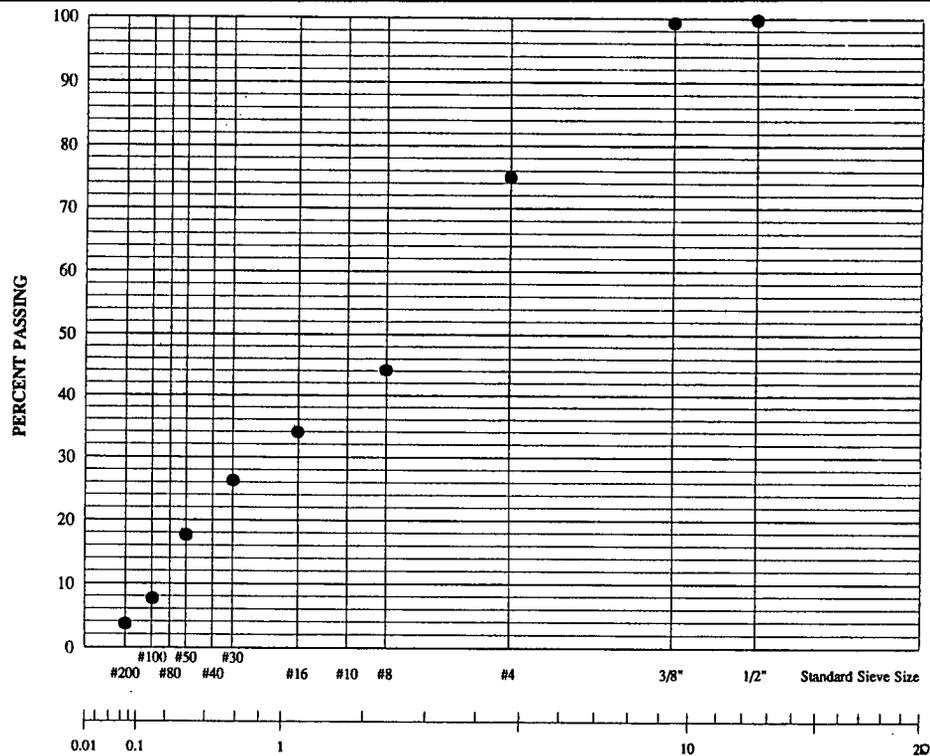
Figure C-12. Gradation for local material–Utah

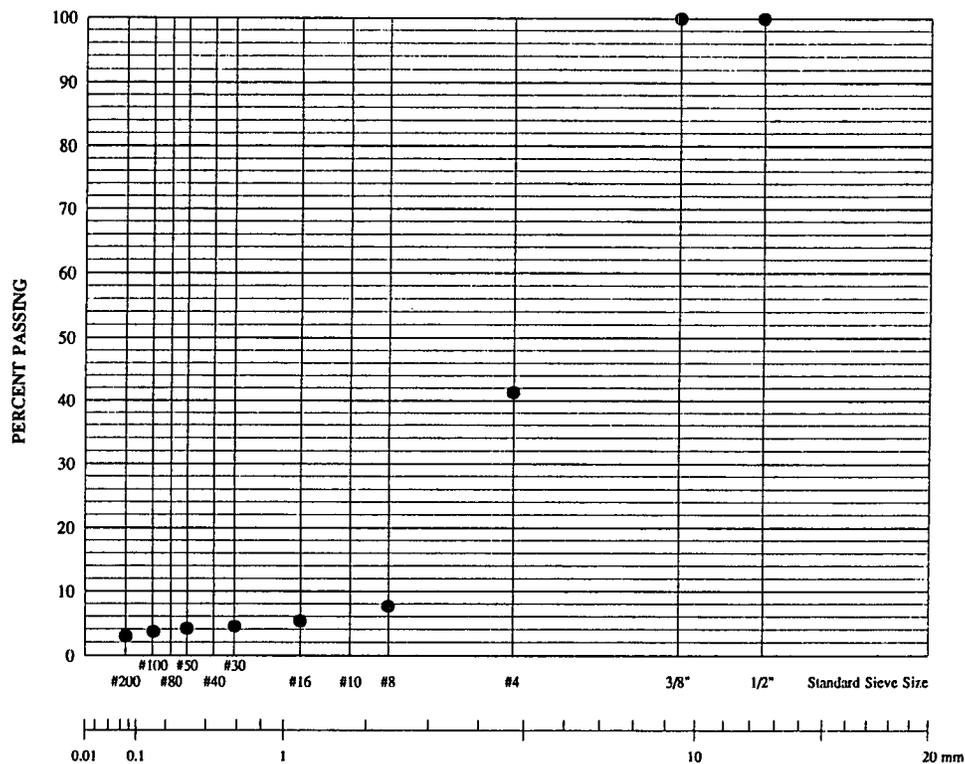
Figure C-13. Gradation for QPR 2000–Oregon

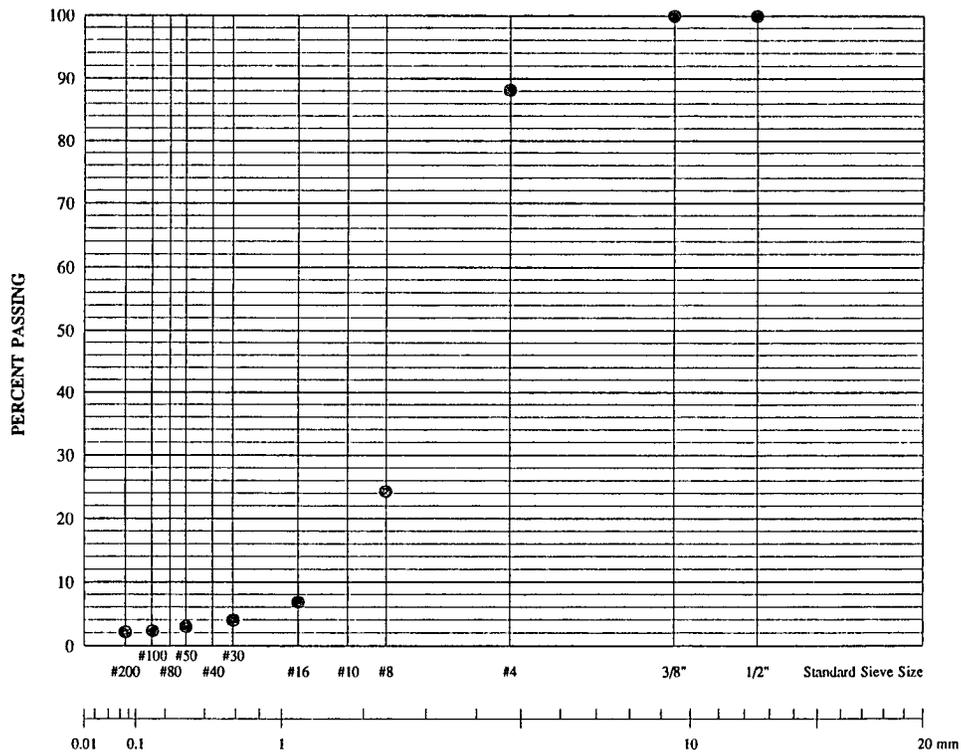
Figure C-14. Gradation for Perma-Patch-Oregon

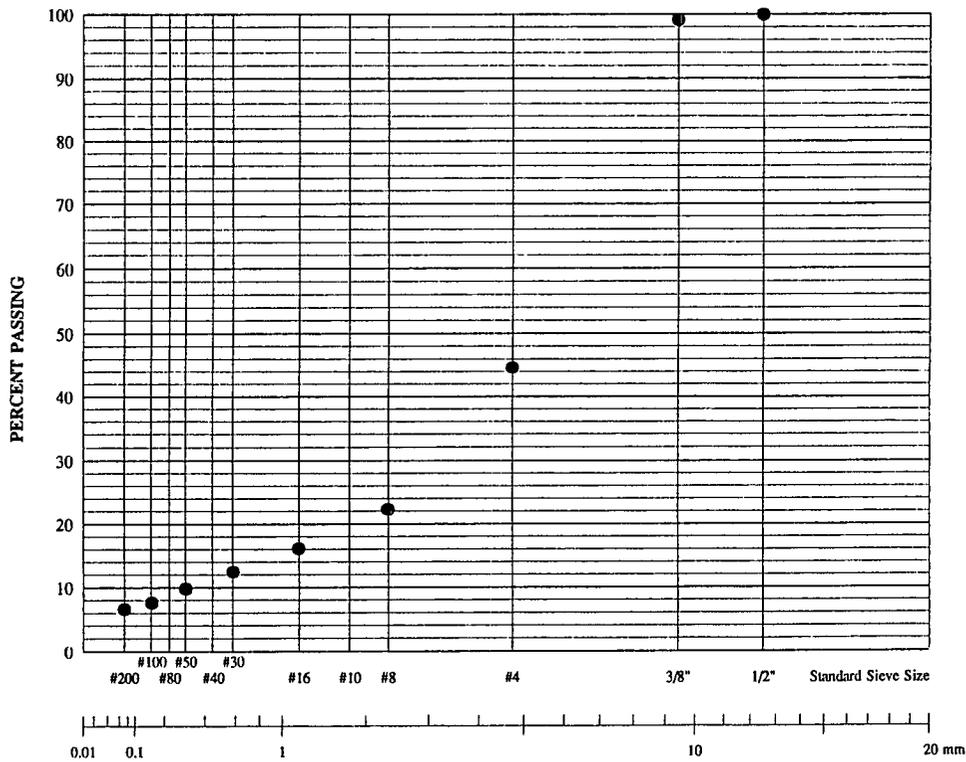
Figure C-15. Gradation for HFMS-2–Oregon

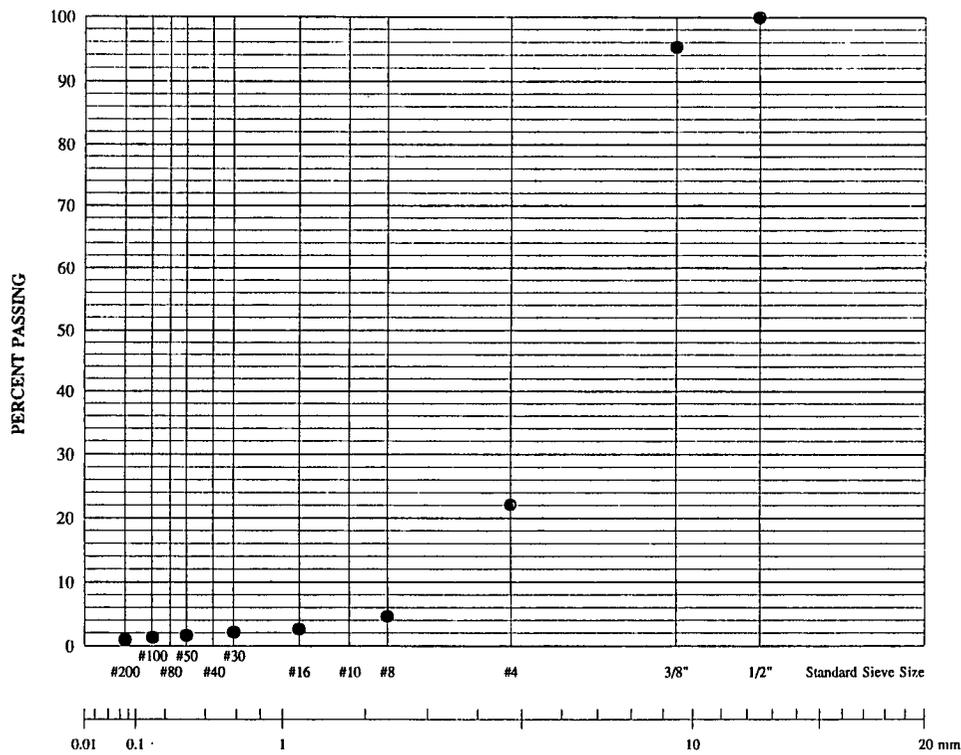
Figure C-16. Gradation for local material–Oregon

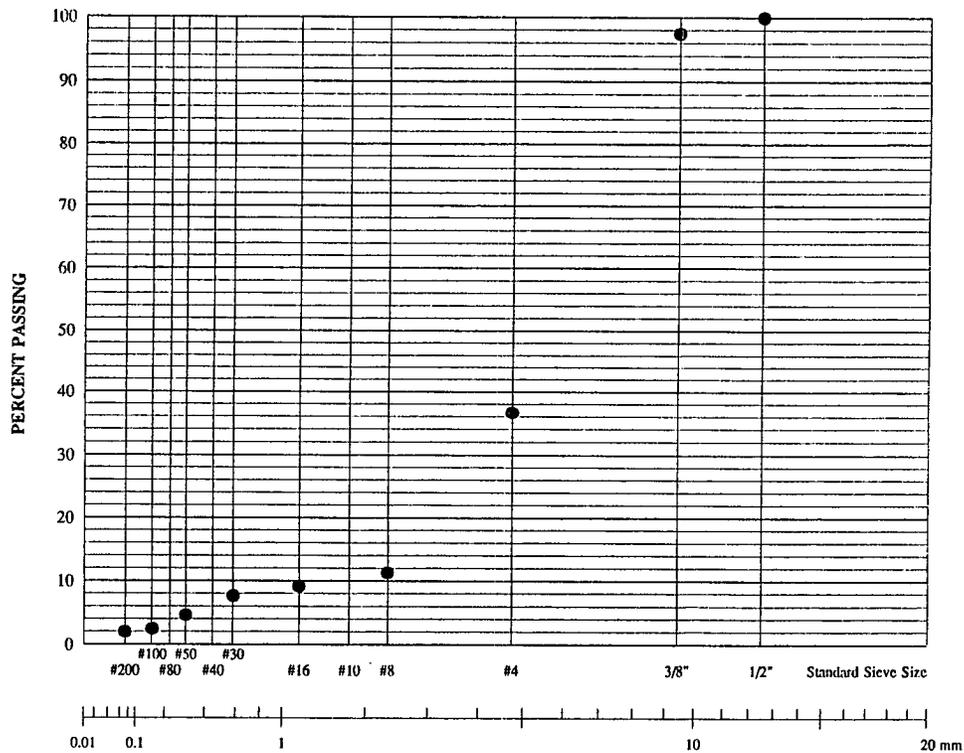
Figure C-17. Gradation for UPM-Oregon

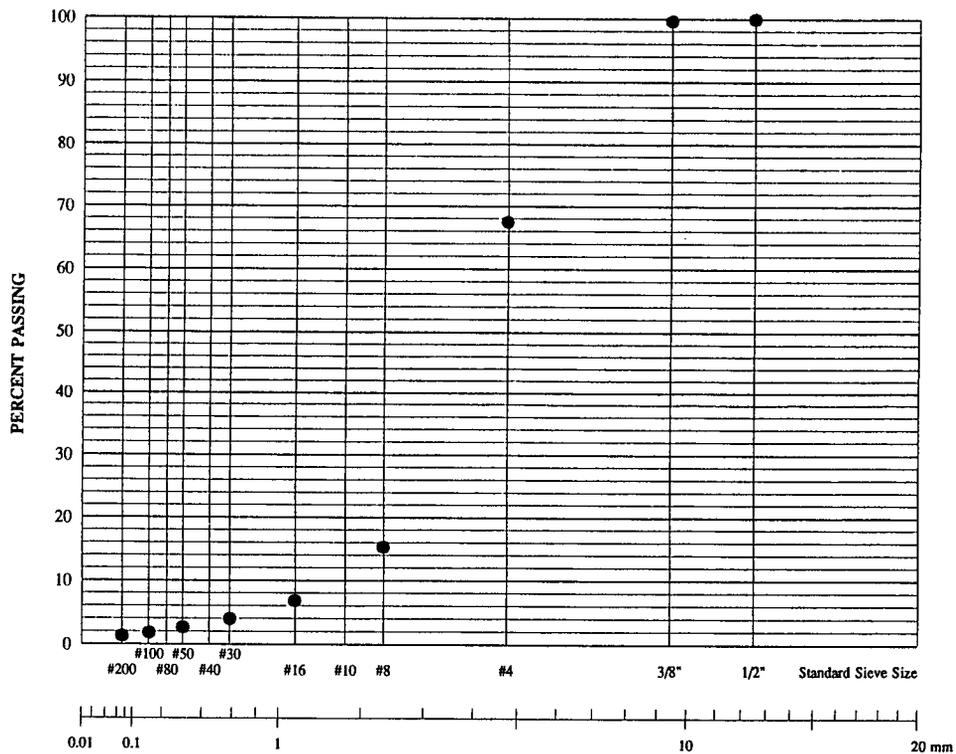
Figure C-18. Gradation for local material–Ontario

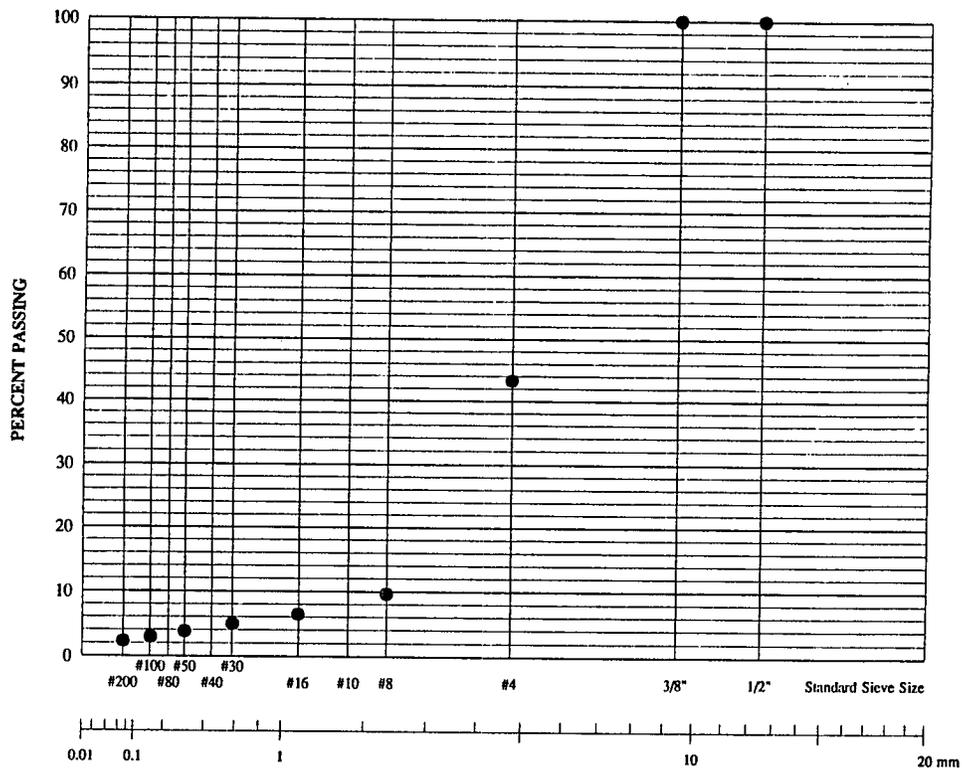
Figure C-19. Gradation for UPM-Ontario
