FINAL REPORT

Stream Channel Migration Effects on Bridge Approaches and Conveyance

Report No. ITRC FR 94-4

Department of Civil Engineering

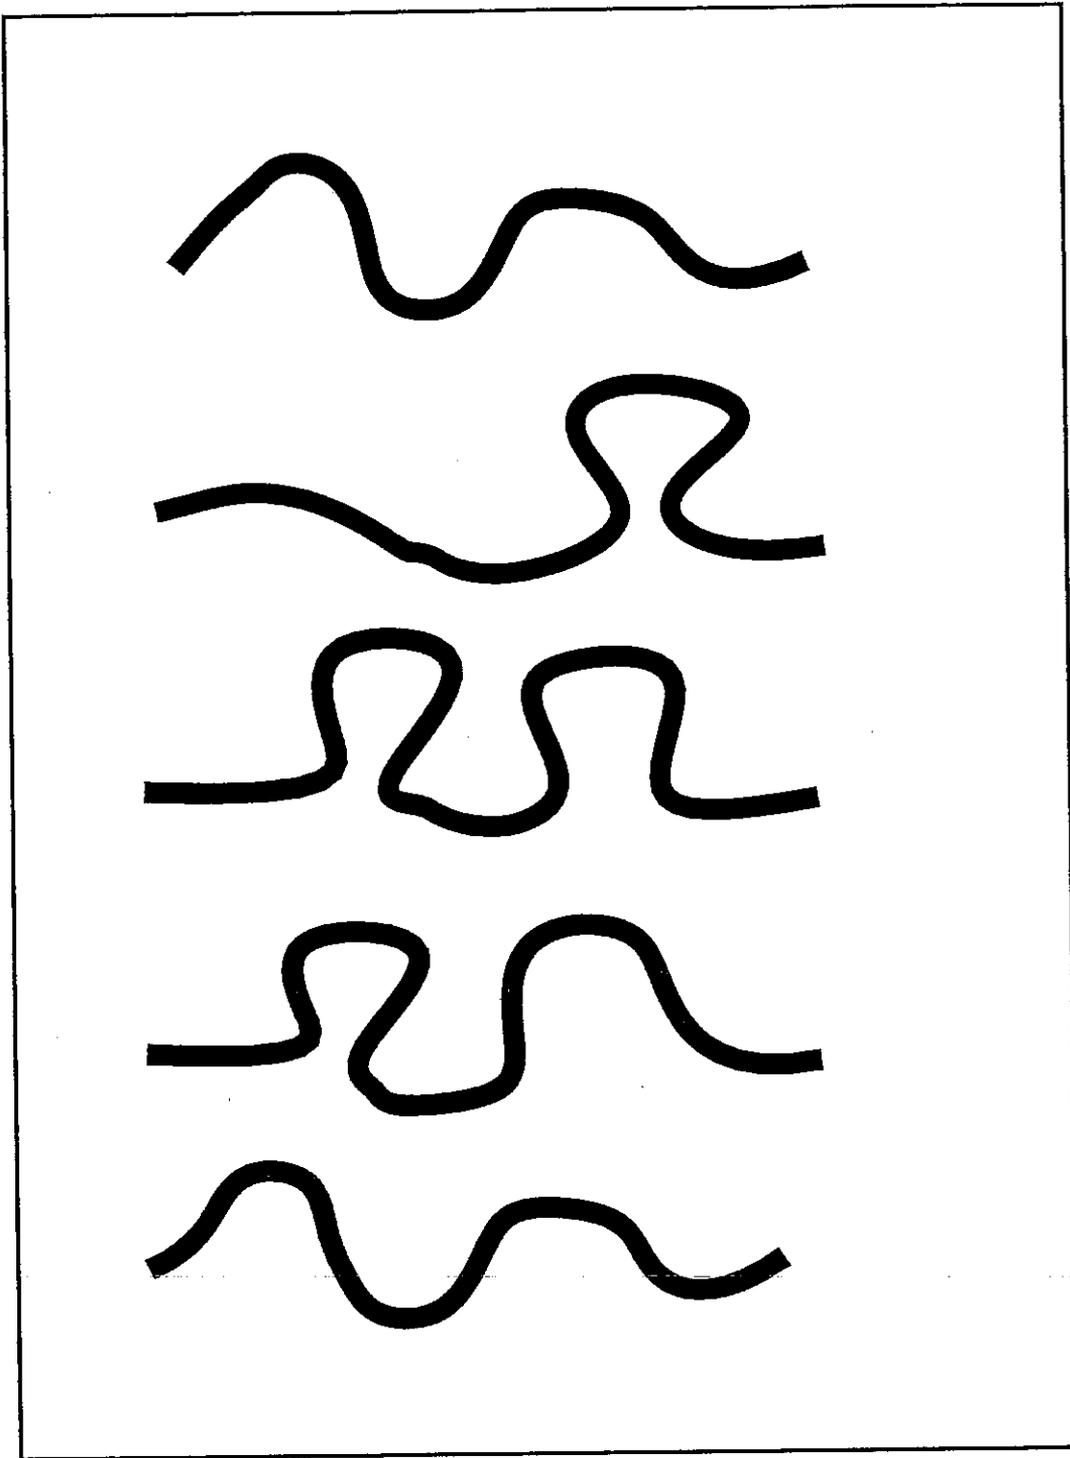
Figure 1-1. Meander migration with time-changing loop geometry.

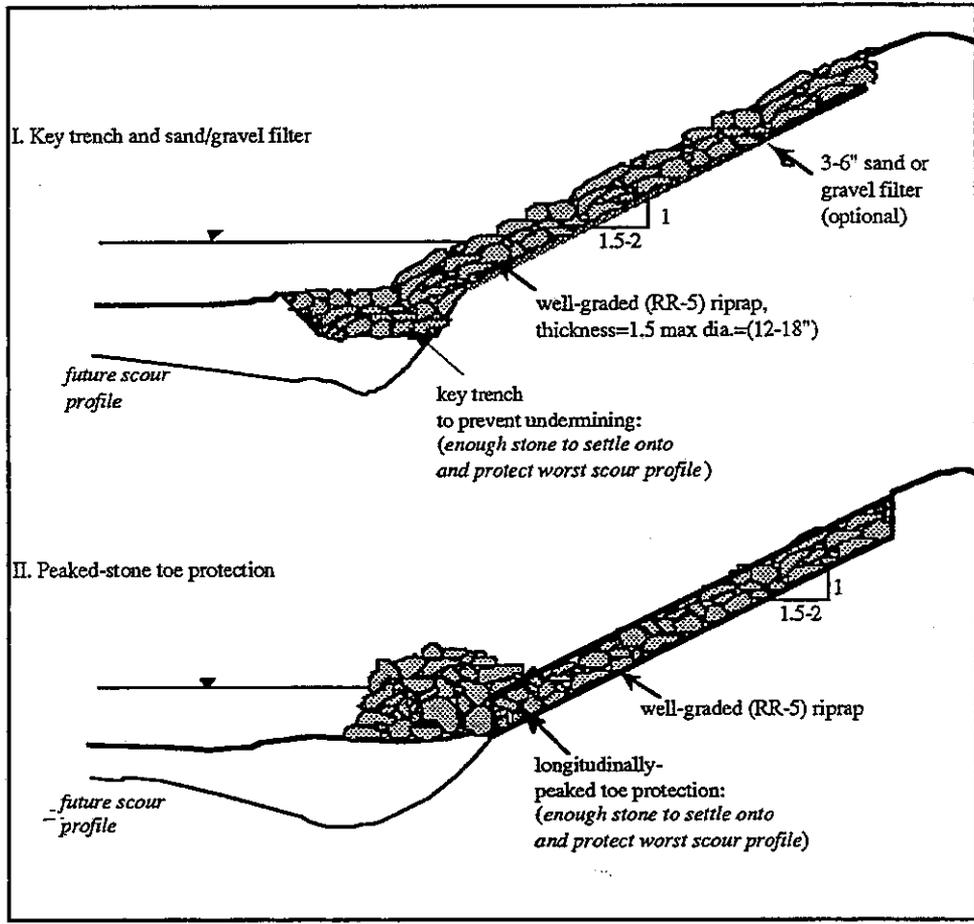
Figure 2-1. Traditional riprap stream bank protection design. (After: U.S. Army Corp of Engineers, 1983)

Guidelines by Gray and Leiser (1982) summarize important points in riprap stone selection, giving specifications for stone size based on the average stream velocity and bank slope; Jansen et al. (1979) gives a similar design relation based on the Shields diagram for sediment transport. The U.S. Army Corps of Engineers (1983) gives more general design criteria for stone size, recommending a well-graded mix of stones weighing from 20 to 200 lbs for streams with maximum velocities less than 10 ft/sec. The (1981) U.S. Army Corps of Engineers literature summary recommends blocked stones and discourages the use of stones with length-to-width ratios greater than 3. Grading specifications for riprap can be found in Hemphill and Bramley (1989), and all sources agree that a well-graded mixture is desirable. In Illinois, the most common riprap grading used in stream bank protection is RR-5 gradation (See Appendix I).

The U.S. Army Corps of Engineers (1981) recommends a maximum uniform bank slope of 1V:2H for dumped stone and 1V:1.5H for hand-placed stone; Hemphill and Bradley (1989) give the angle of repose of riprap as being between 35° and 42°. The method of toe stabilization used traditionally is a key trench or riprap apron (U.S. Army Corps of Engineers, 1983). The method of "longitudinal peaked stone toe protection" has been successful in providing toe protection to streams with degrading beds. The riprap blanket should be keyed in to the stream bank at its upstream and downstream ends to prevent the riprap blanket from being unraveled at its ends. The recommended thickness of the riprap blanket is 1-1.5 times the diameter of the largest-sized stone in the riprap

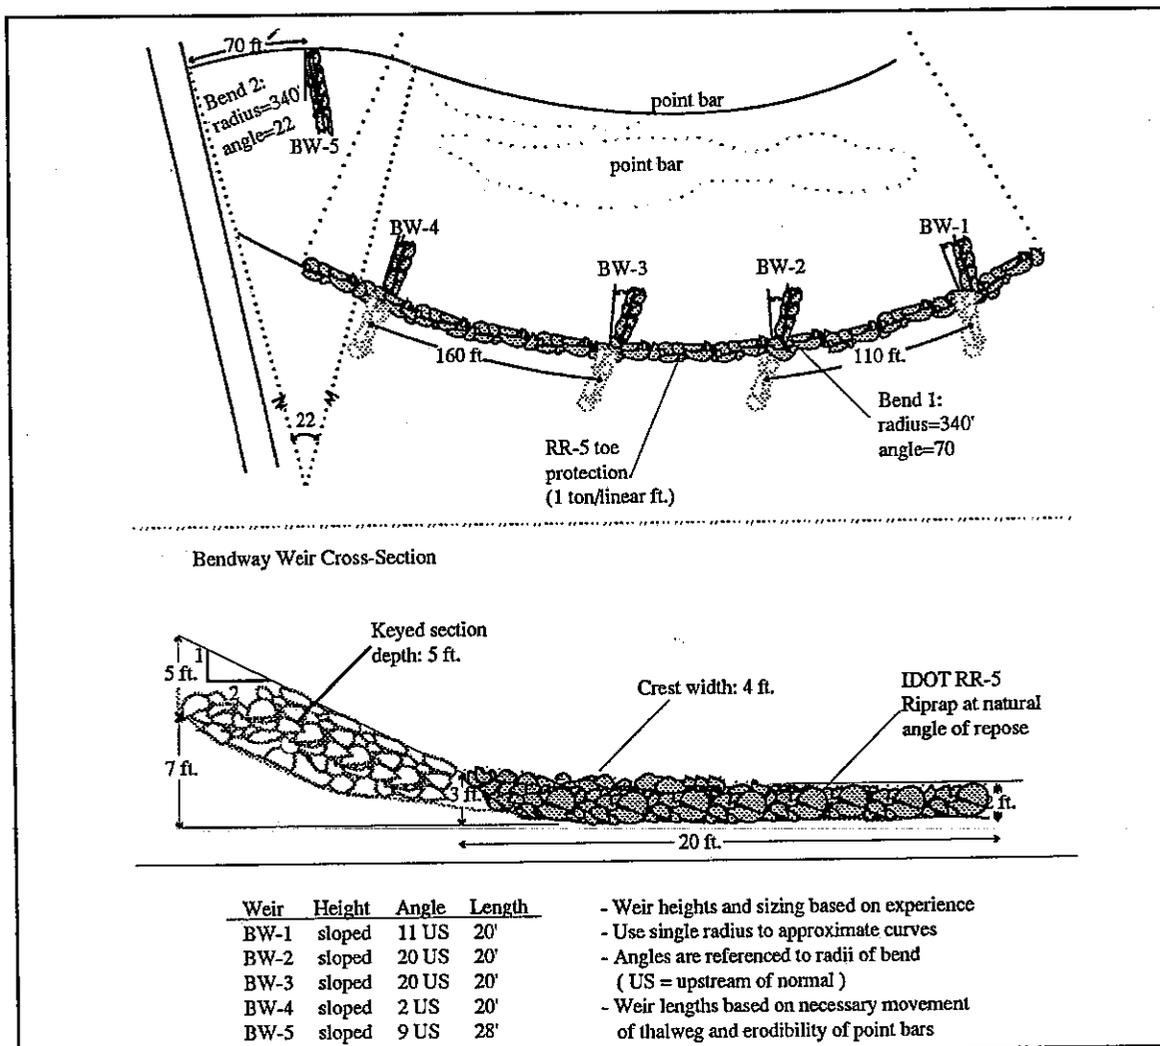
Figure 2-2. Bendway Weir design example - Wood River Creek design. (After: Derrick and Kinney, 1995)

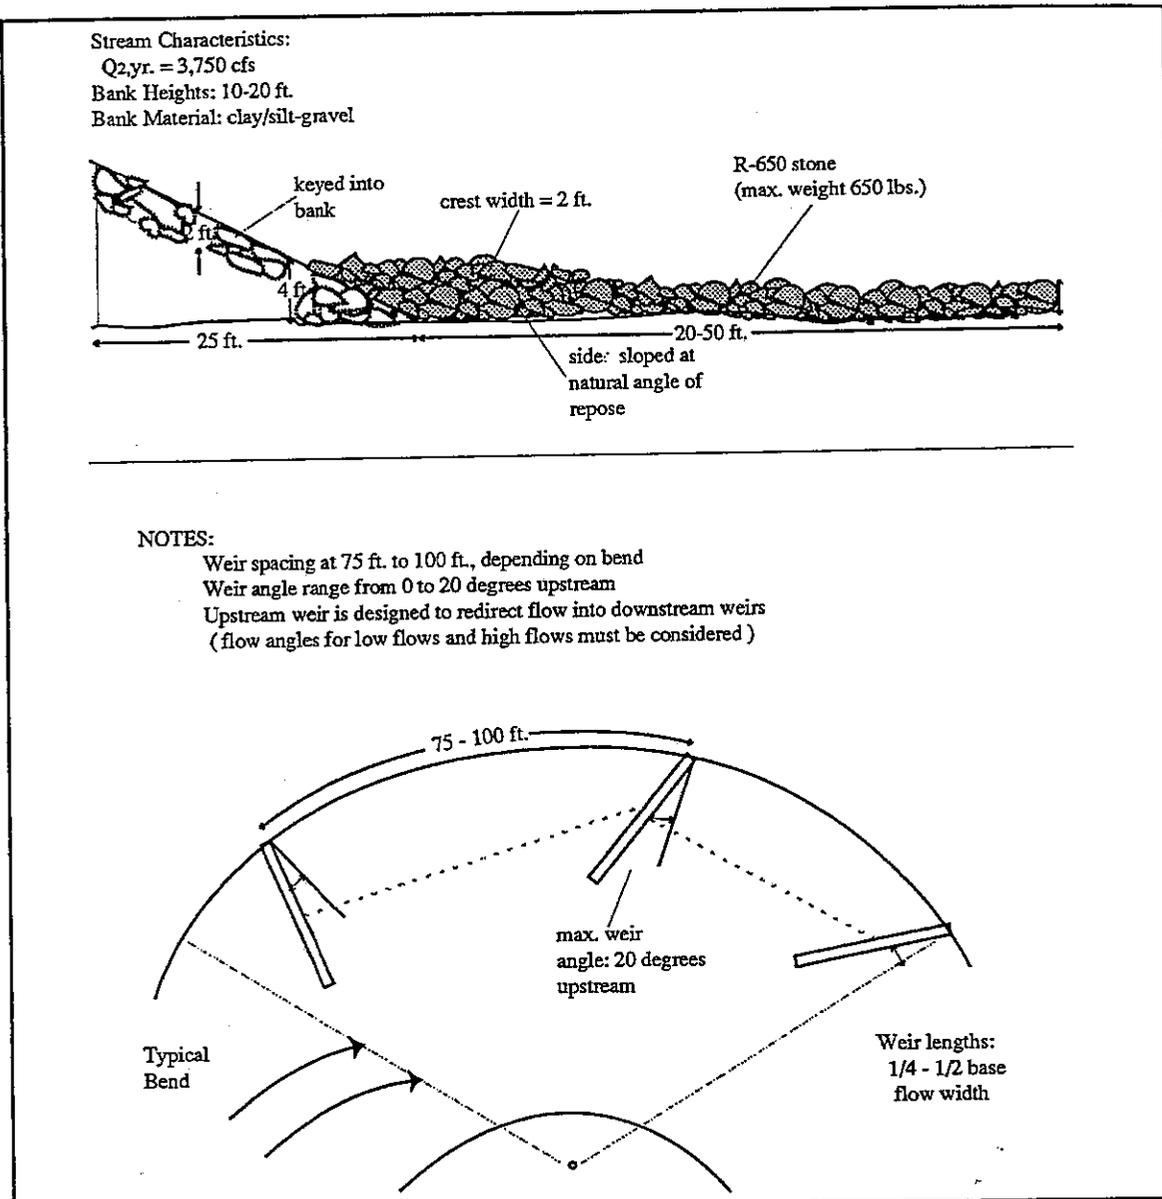
Figure 2-3. Bendway weir design example- Harland Creek design.
 (After: Derrick, 1995)

Derrick (1995b) describes the "theory" and application of bendway weirs in both navigable rivers and in smaller rivers and streams. The informal report also outlines work done on Harland Creek in Mississippi to protect fourteen stream bends with bendway weirs. Several design points are stressed: the need to correctly design the upstream weir to align the flow toward the remaining weirs, the need to design all of the weirs for both low flow and high flow conditions, and the frequent need for toe protection in conjunction with the bendway weirs. Another stream bank stabilization project used tree trunks and hand-placed stone as low bendway weirs on the East Fork of Wood River Creek. Five trees were placed as weirs on one bend by anchoring the trees to the stream bed with various materials. Stone was placed manually for weirs on another bend, and both projects are being monitored. Figure 2-3 provides a schematic representation of the Harland Creek Demonstration project.

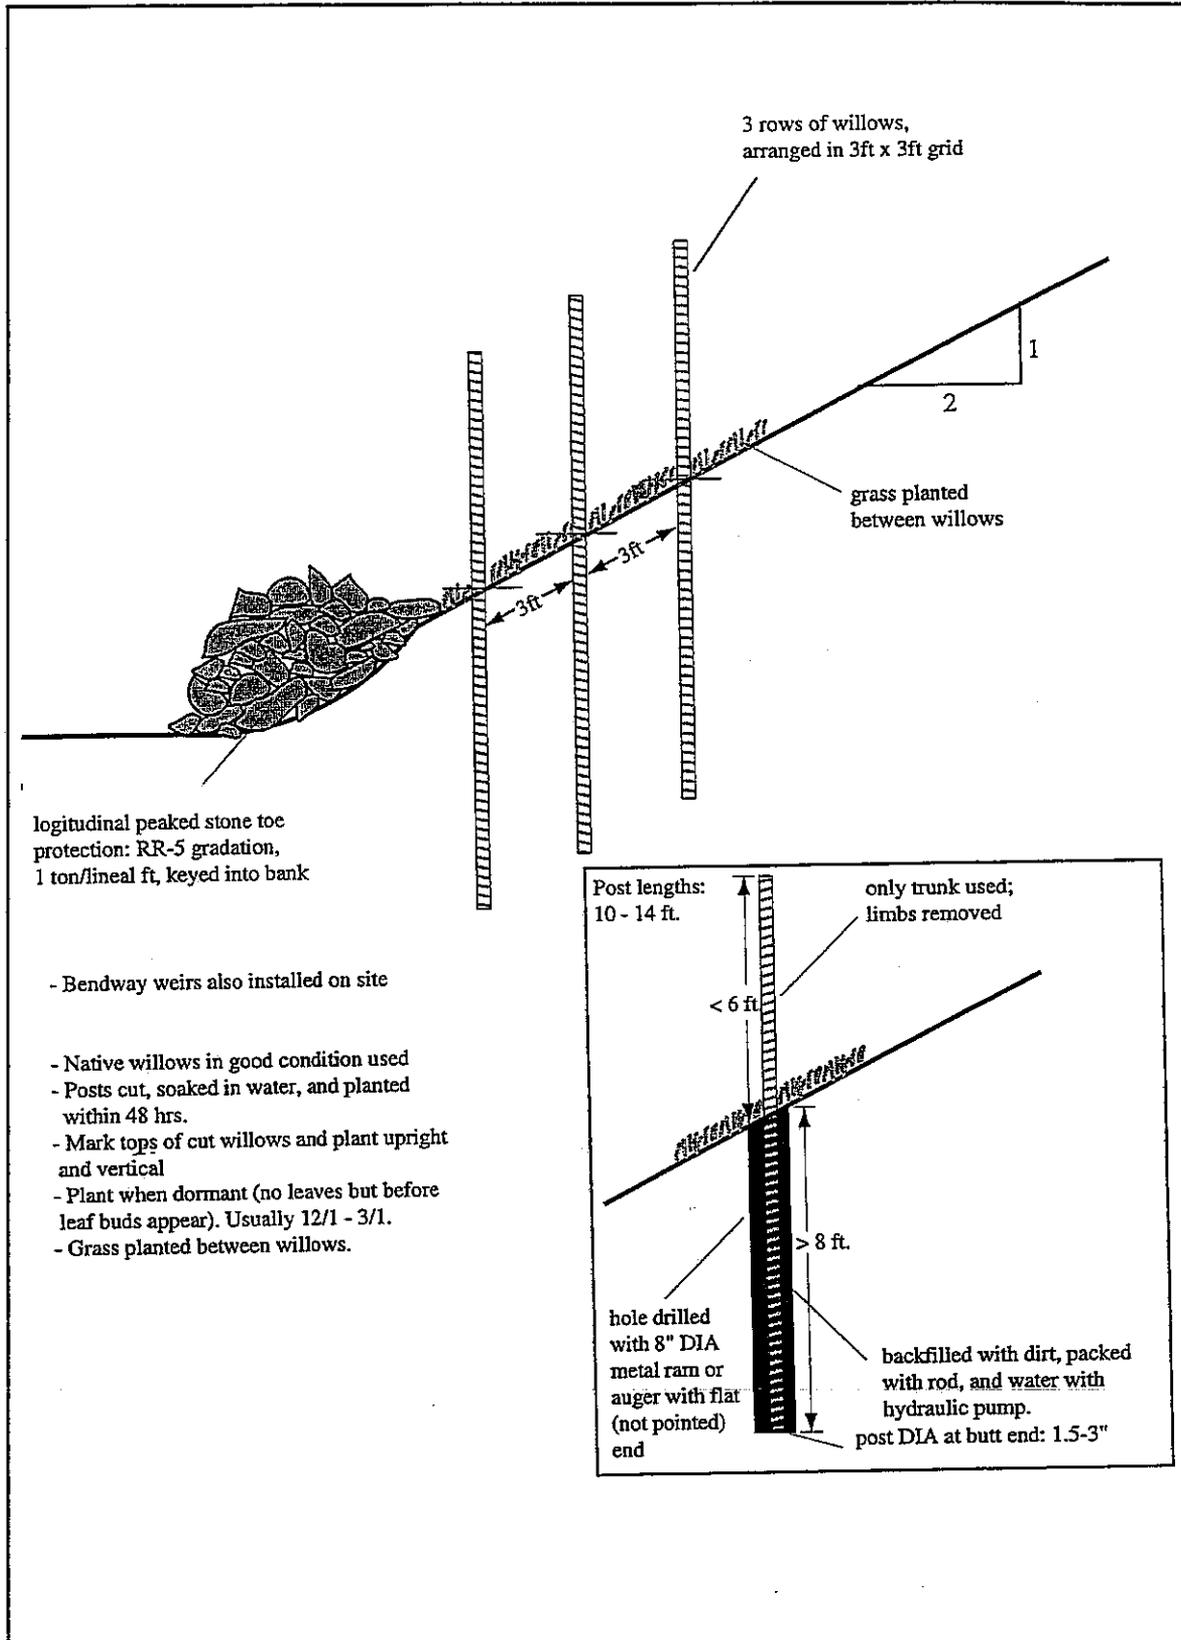
Figure 2-4. Willow post design example - Wood River Creek, Madison Co., Illinois. (After: Derrick and Kinney, 1995)

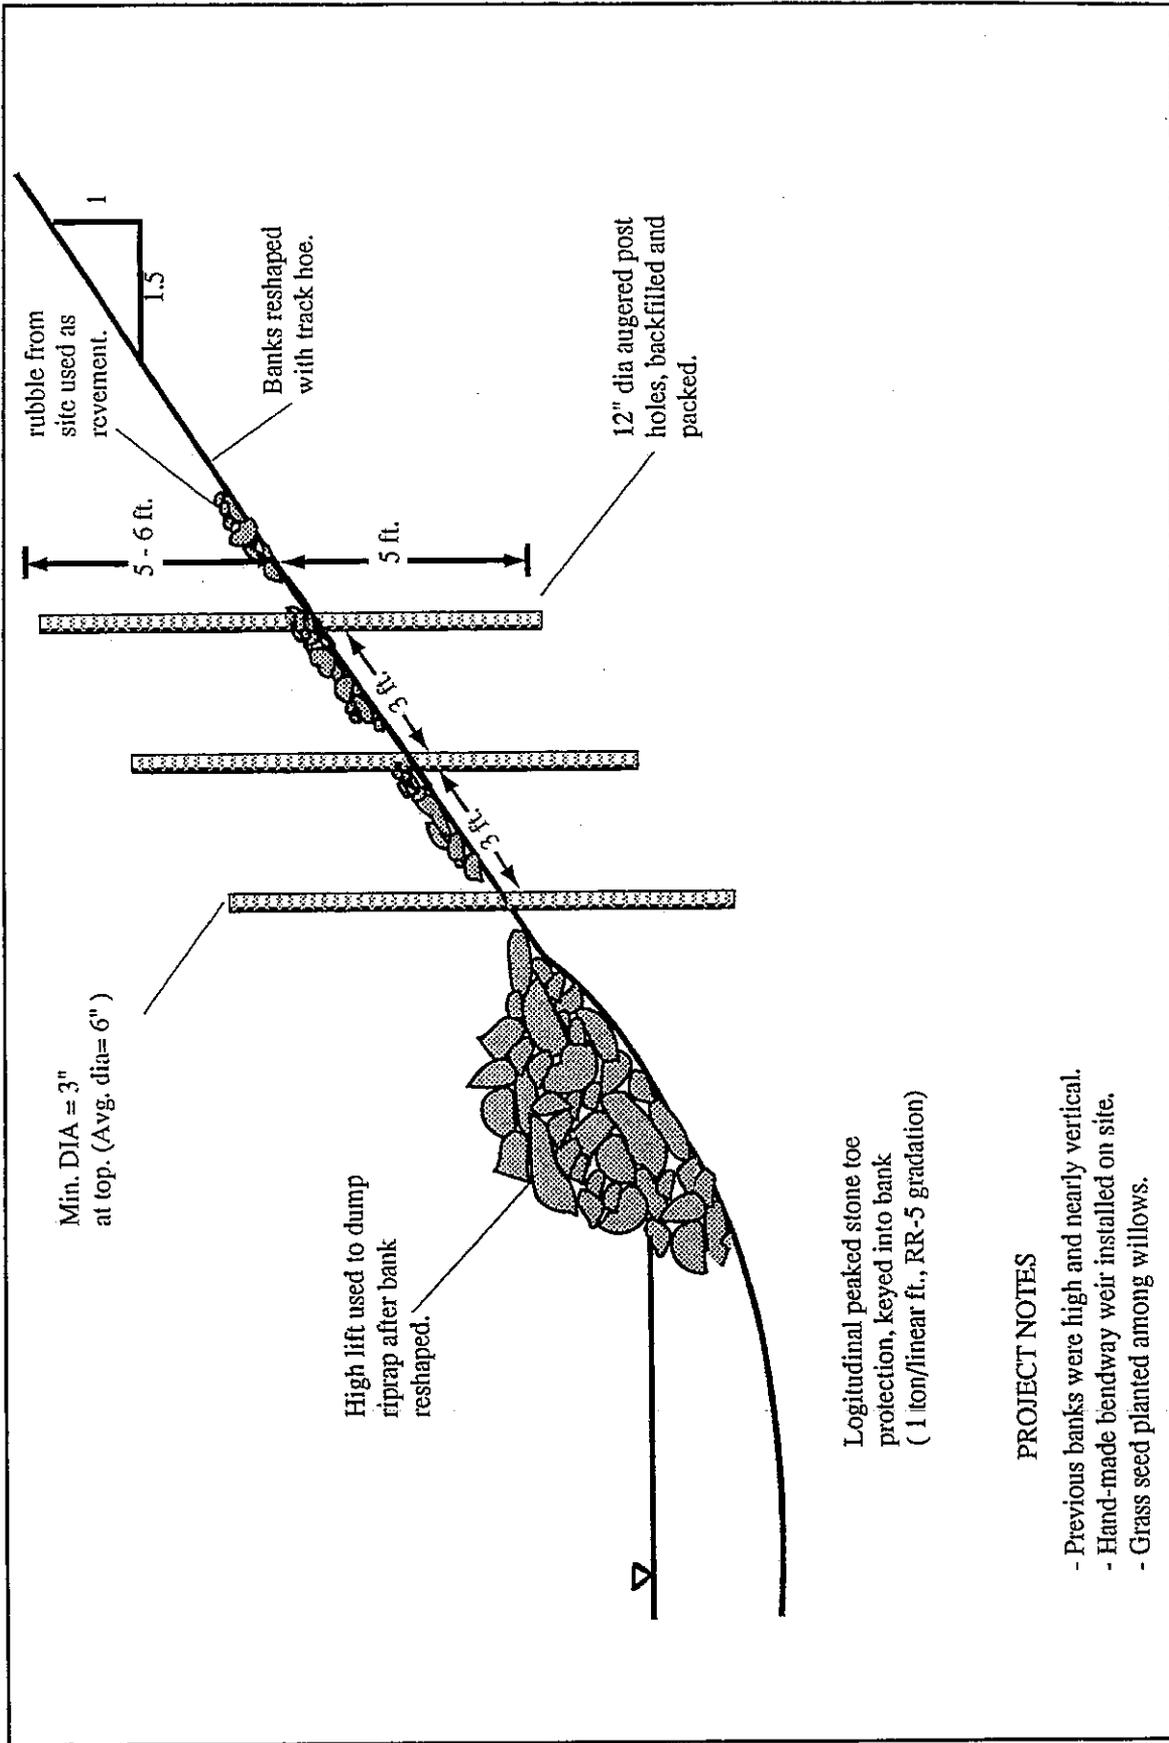
Logitudinal peaked stone toe protection, keyed into bank (1 ton/linear ft., RR-5 gradation)

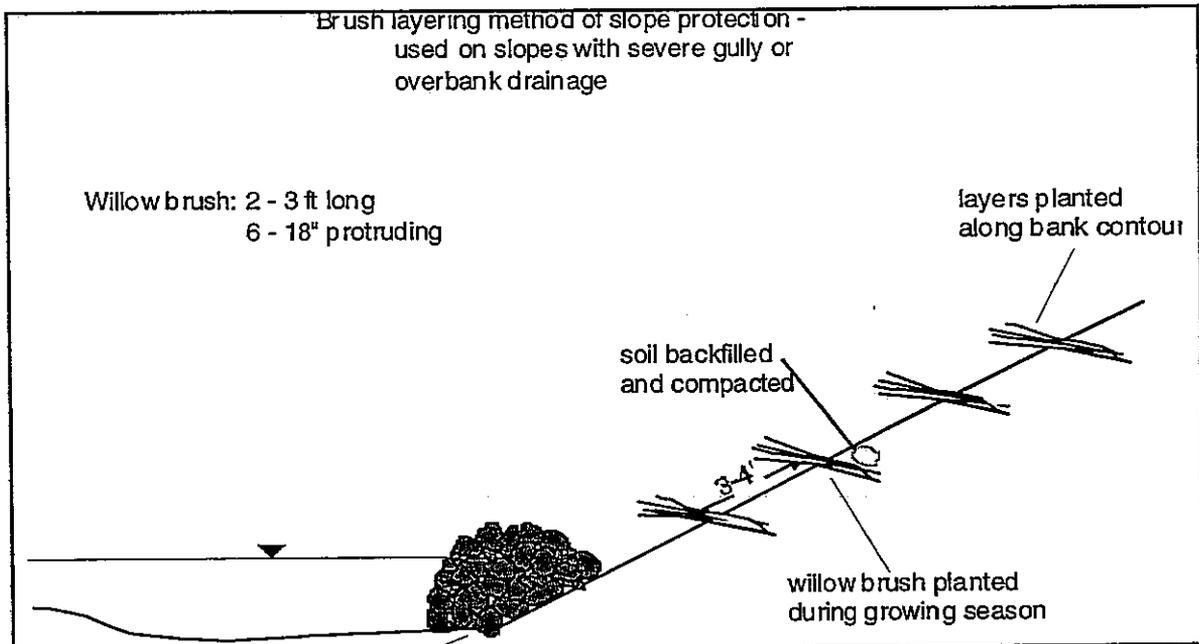
Figure 2-6. Brush layering method. (After: Gray and Leiser, 1982)

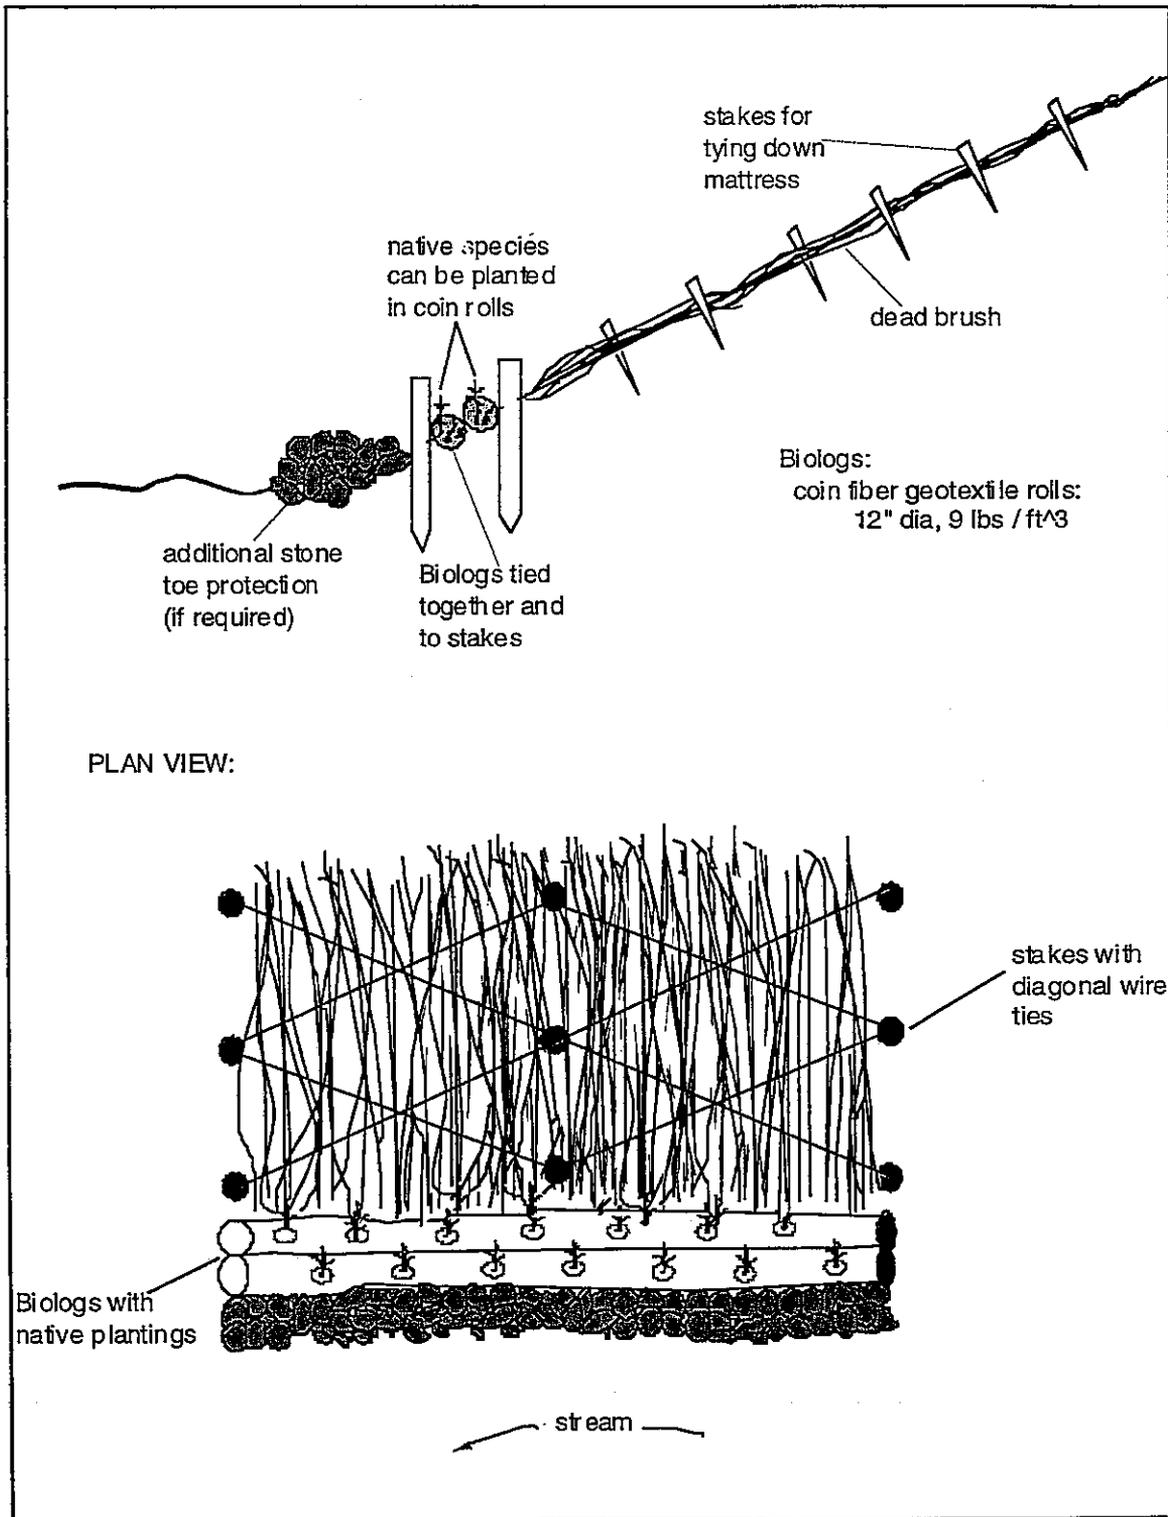
Figure 2-7. Brush matting with biolog toe protection. (After: Gray and Leiser, 1982)

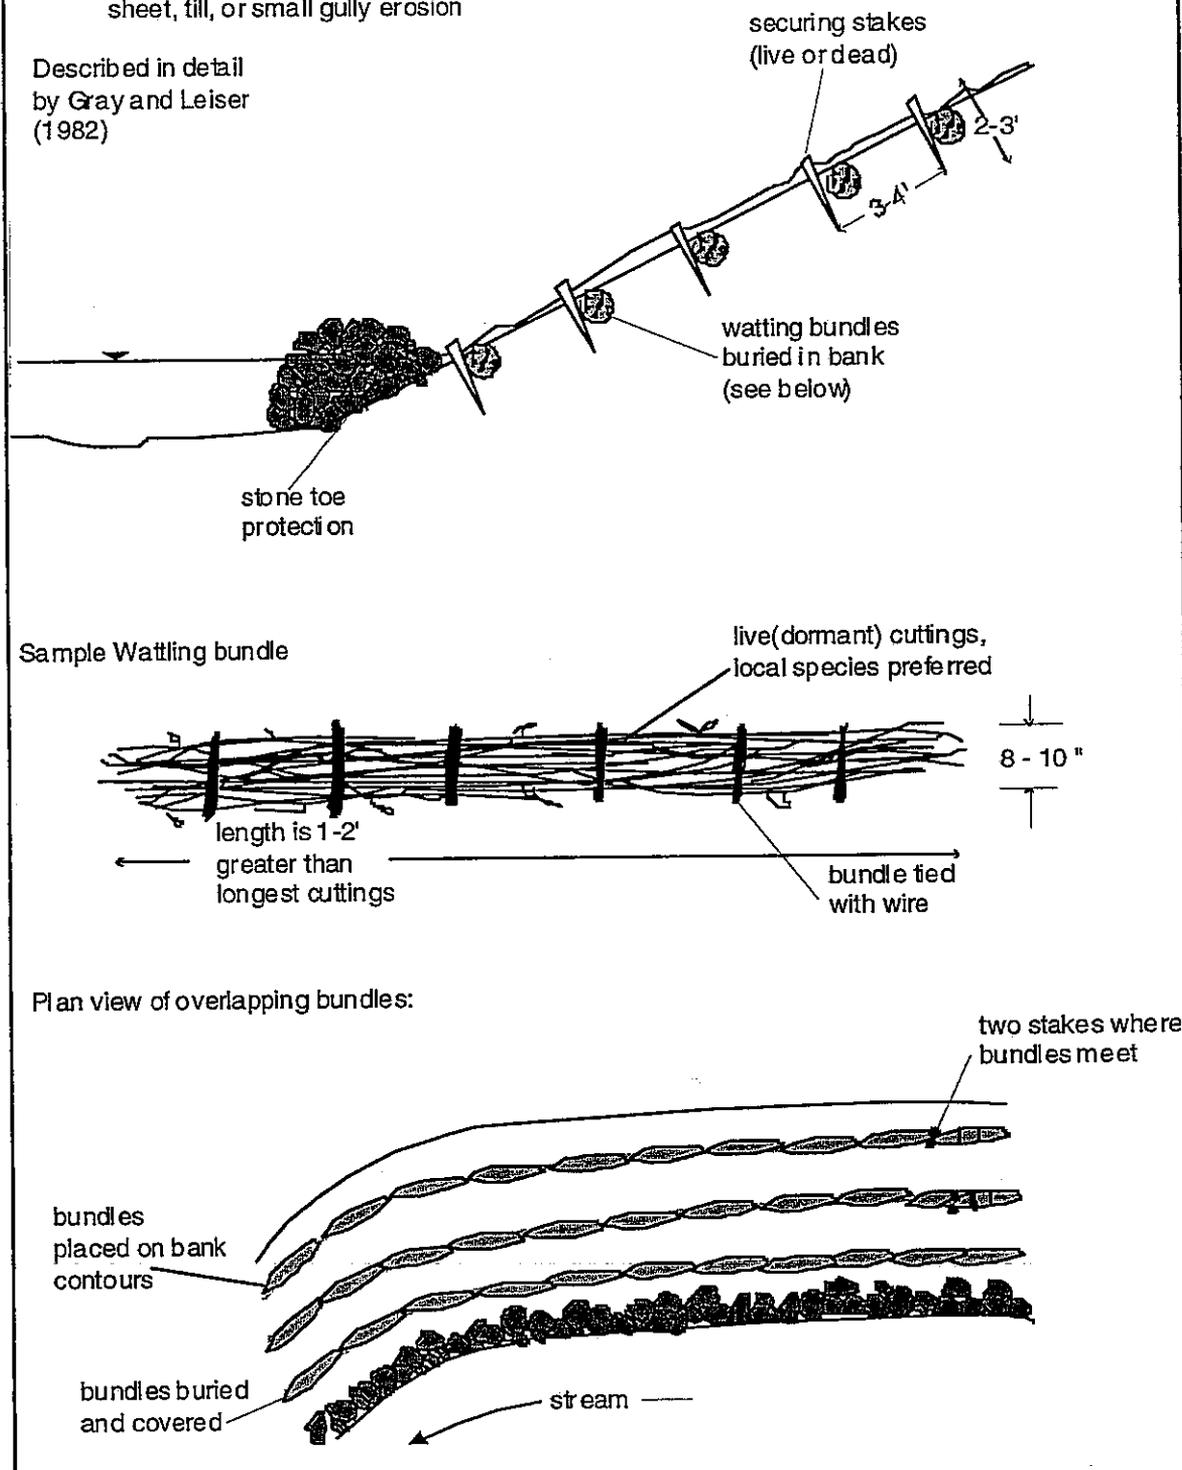
Bioengineering Example: Contour "Live" Wattling
 Recommended for loose surface soils with
 sheet, till, or small gully erosion

Figure 2-8. Contour "live" wattling. (After: Gray and Leiser, 1982)

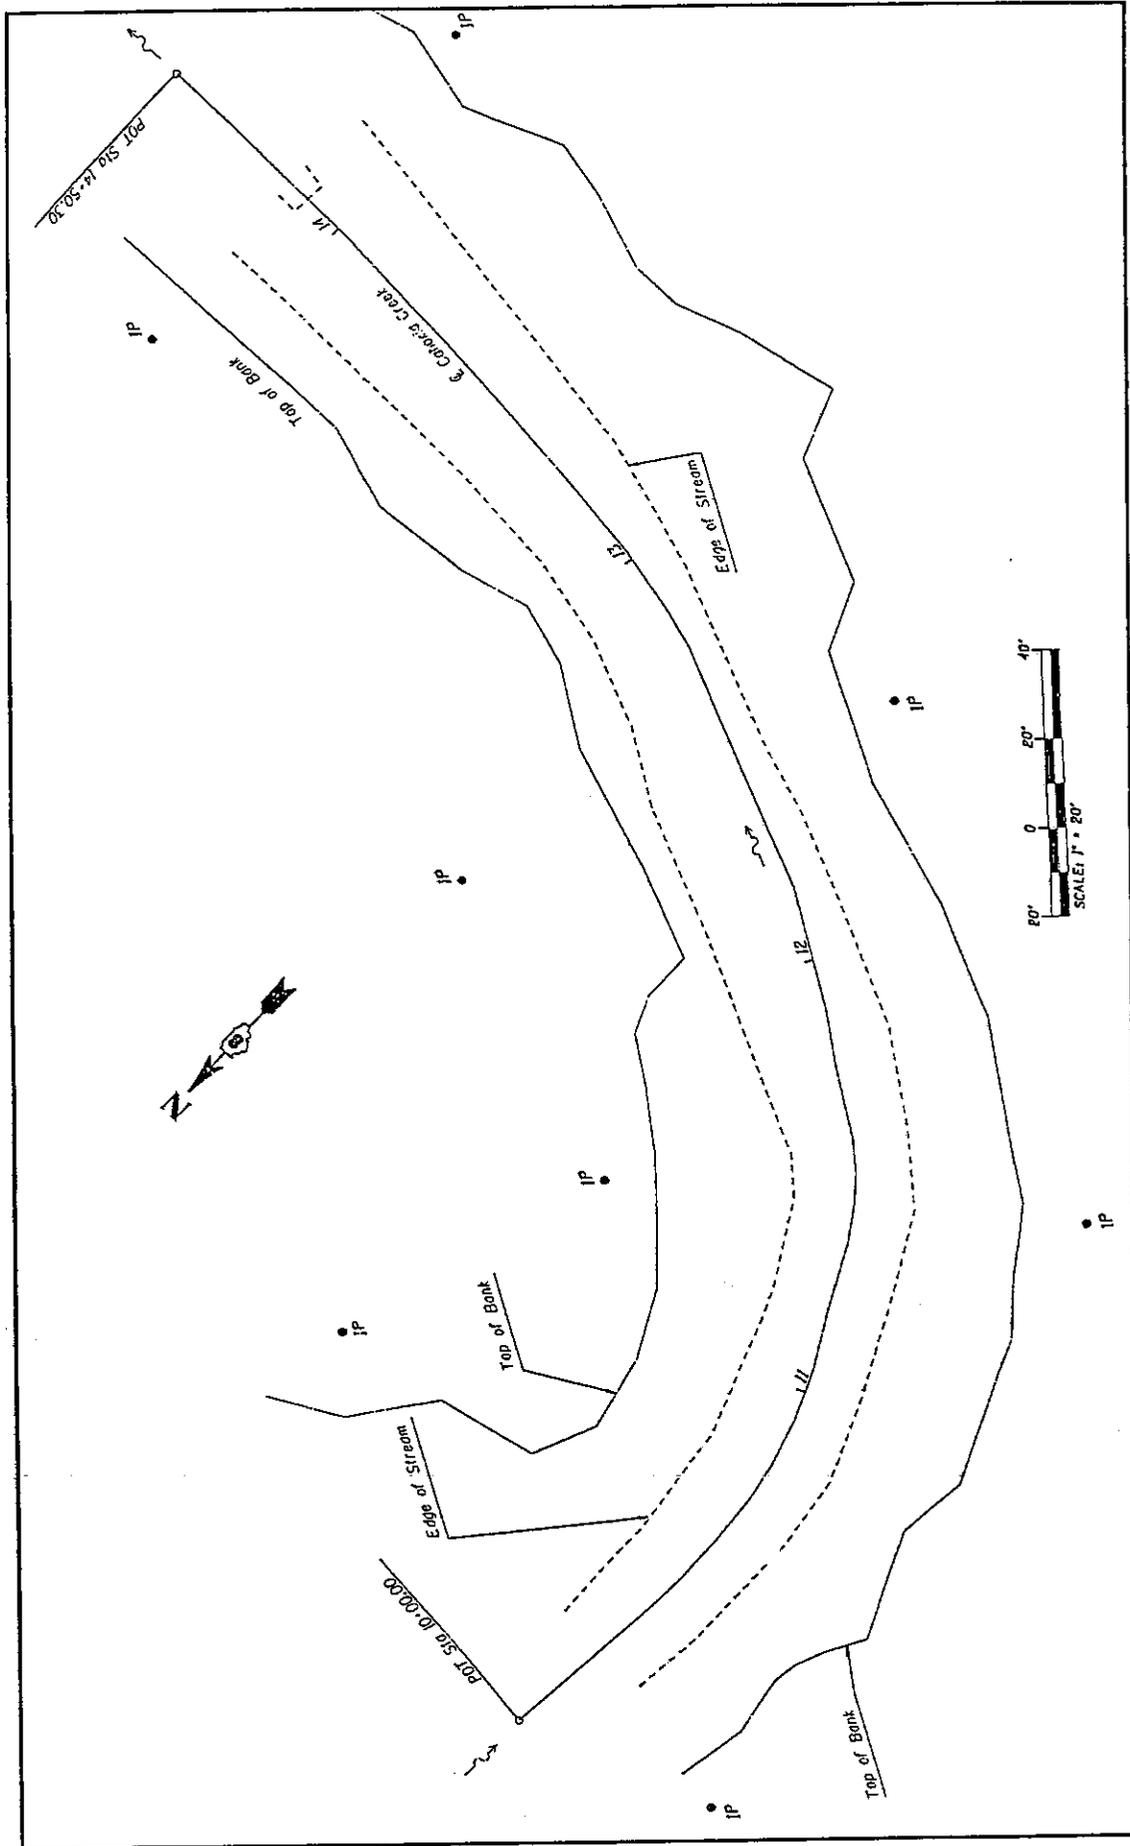
Figure 4-8. Plan survey of Cahokia Creek, July 1996. (Source: IDOT)

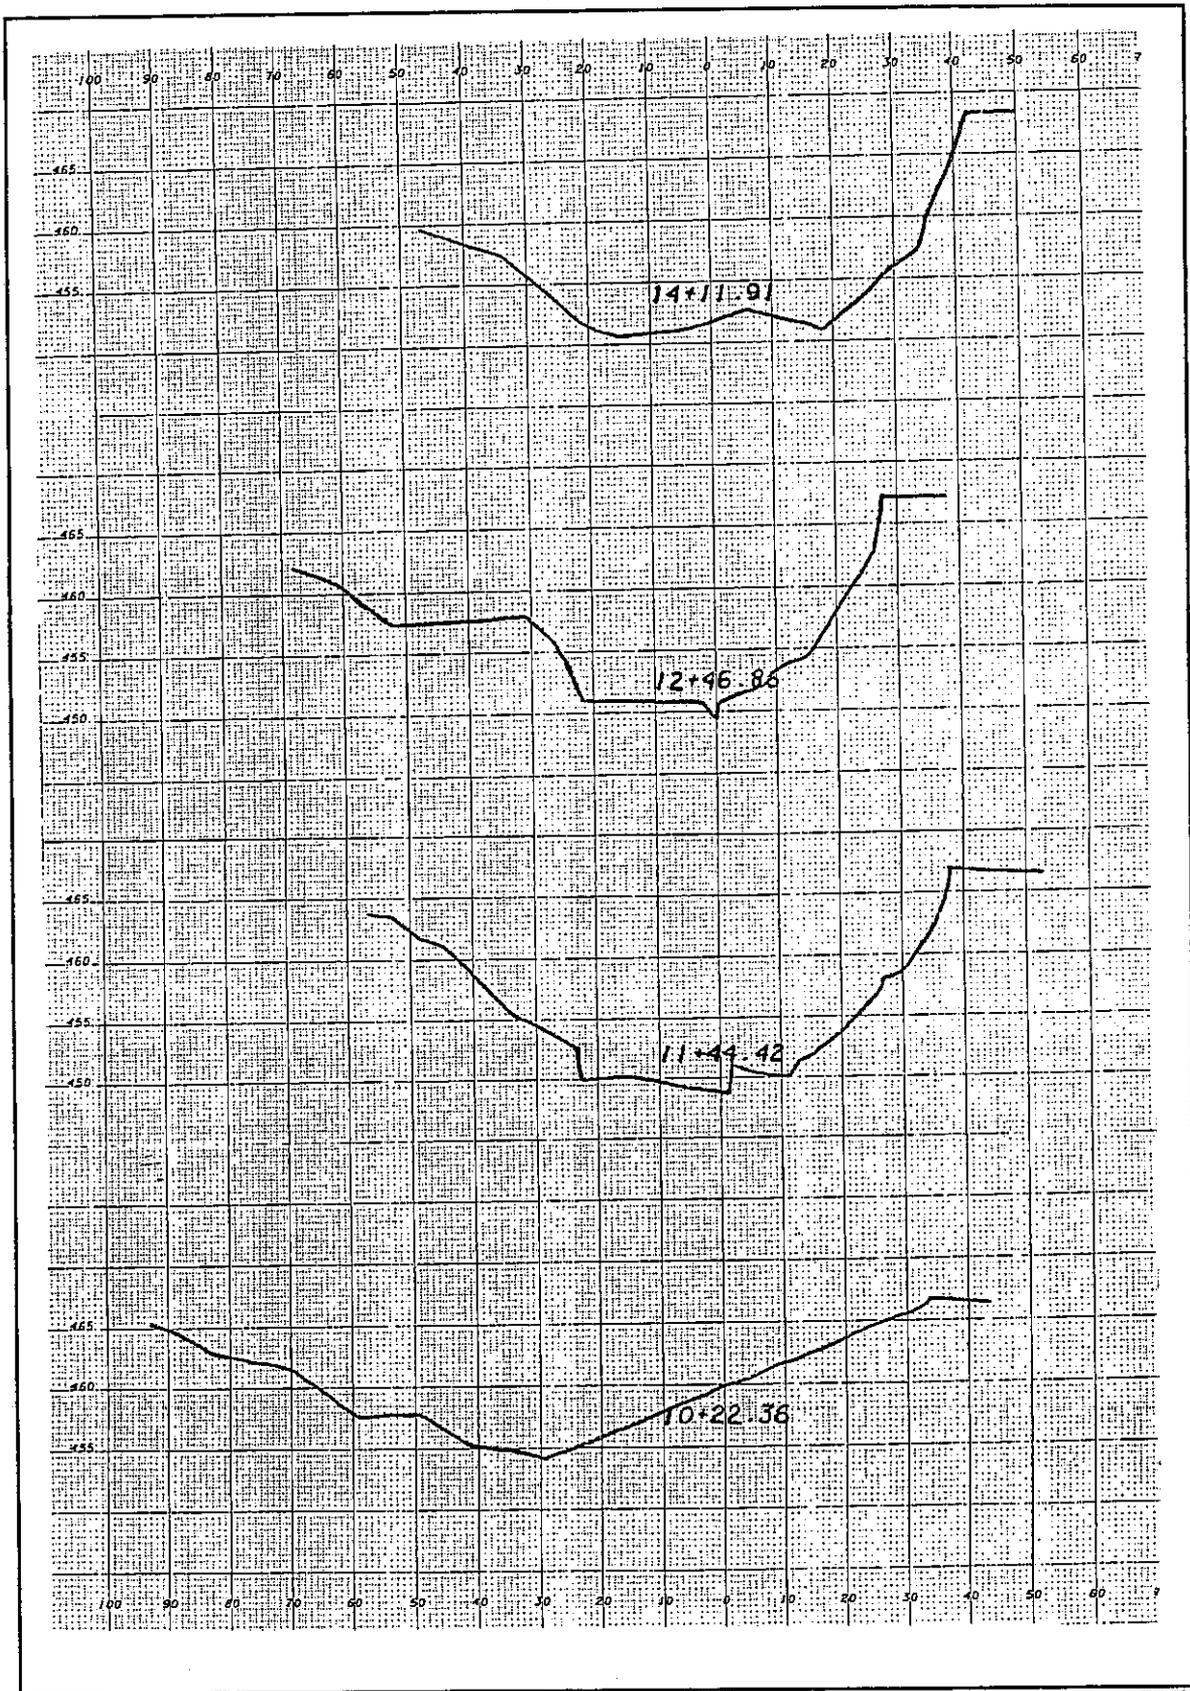
Figure 4-9. Cross-sectional survey of Cahokia Creek, July 1996. (Source: IDOT)

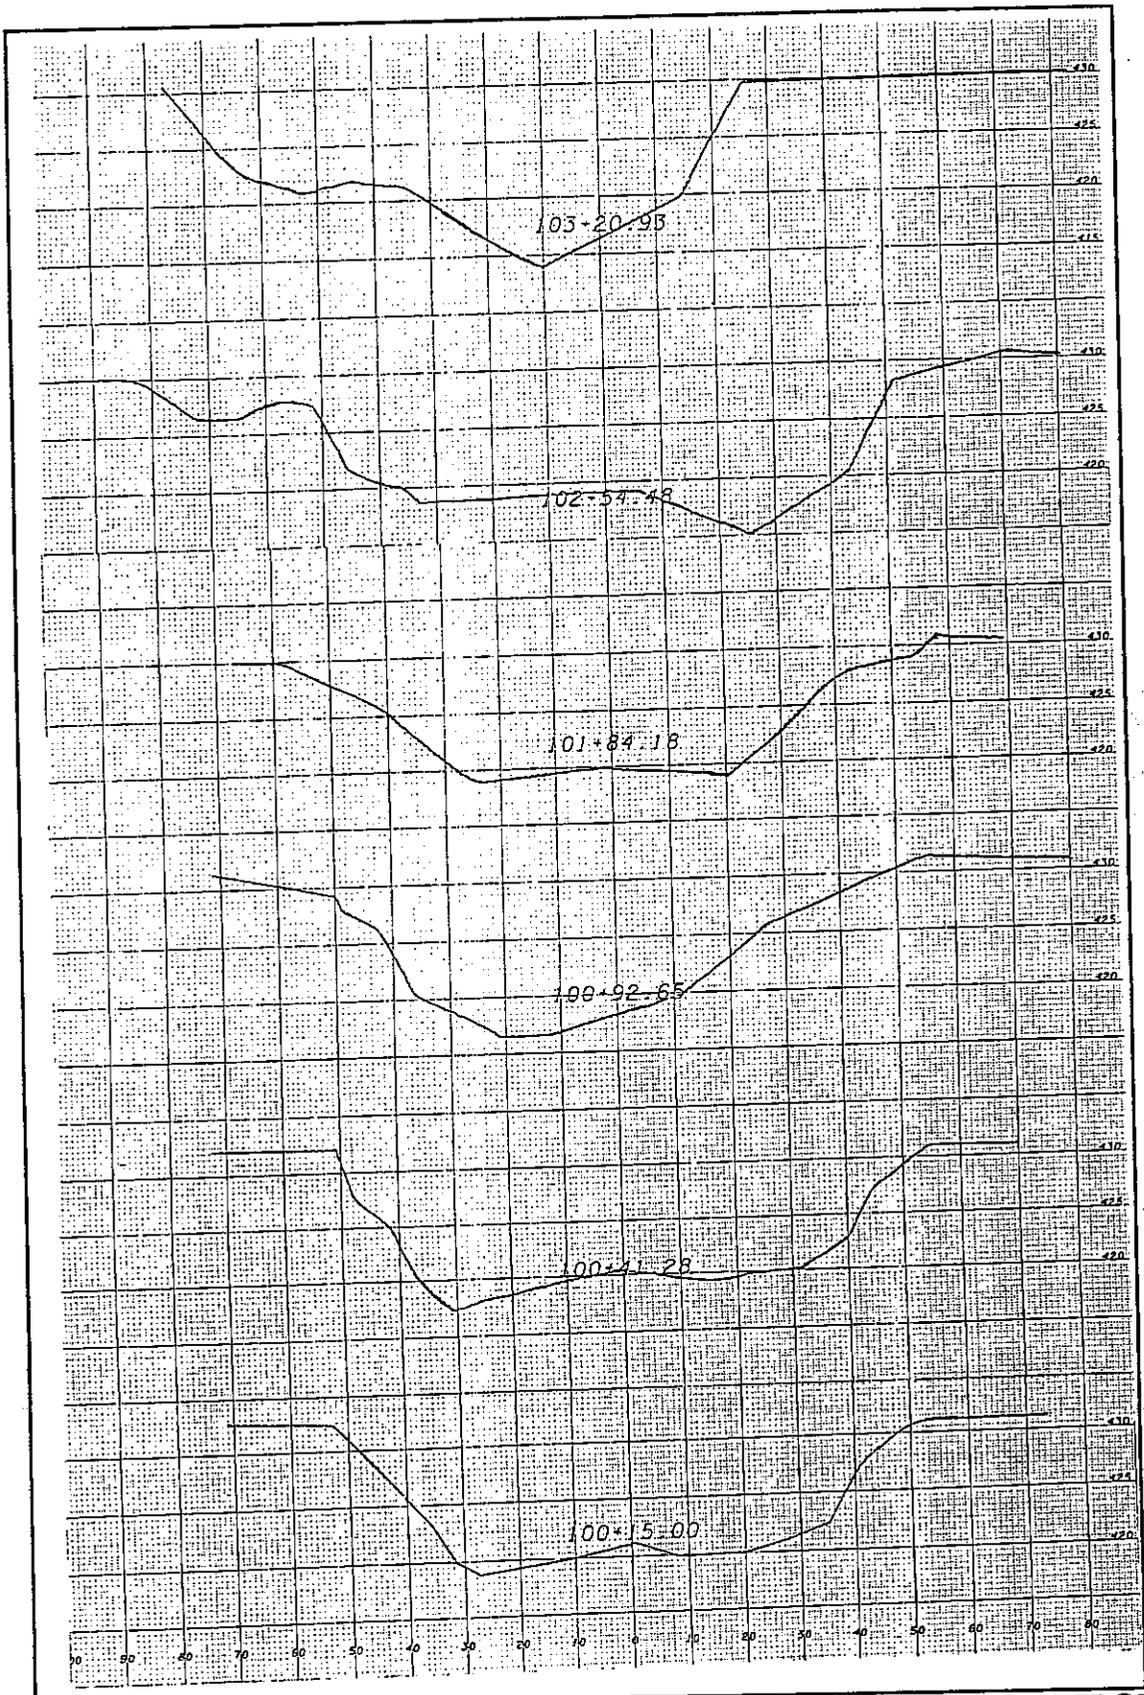
Figure 4-18. Cross-sectional survey of Piasa Creek, July 1996. (Source: IDOT)

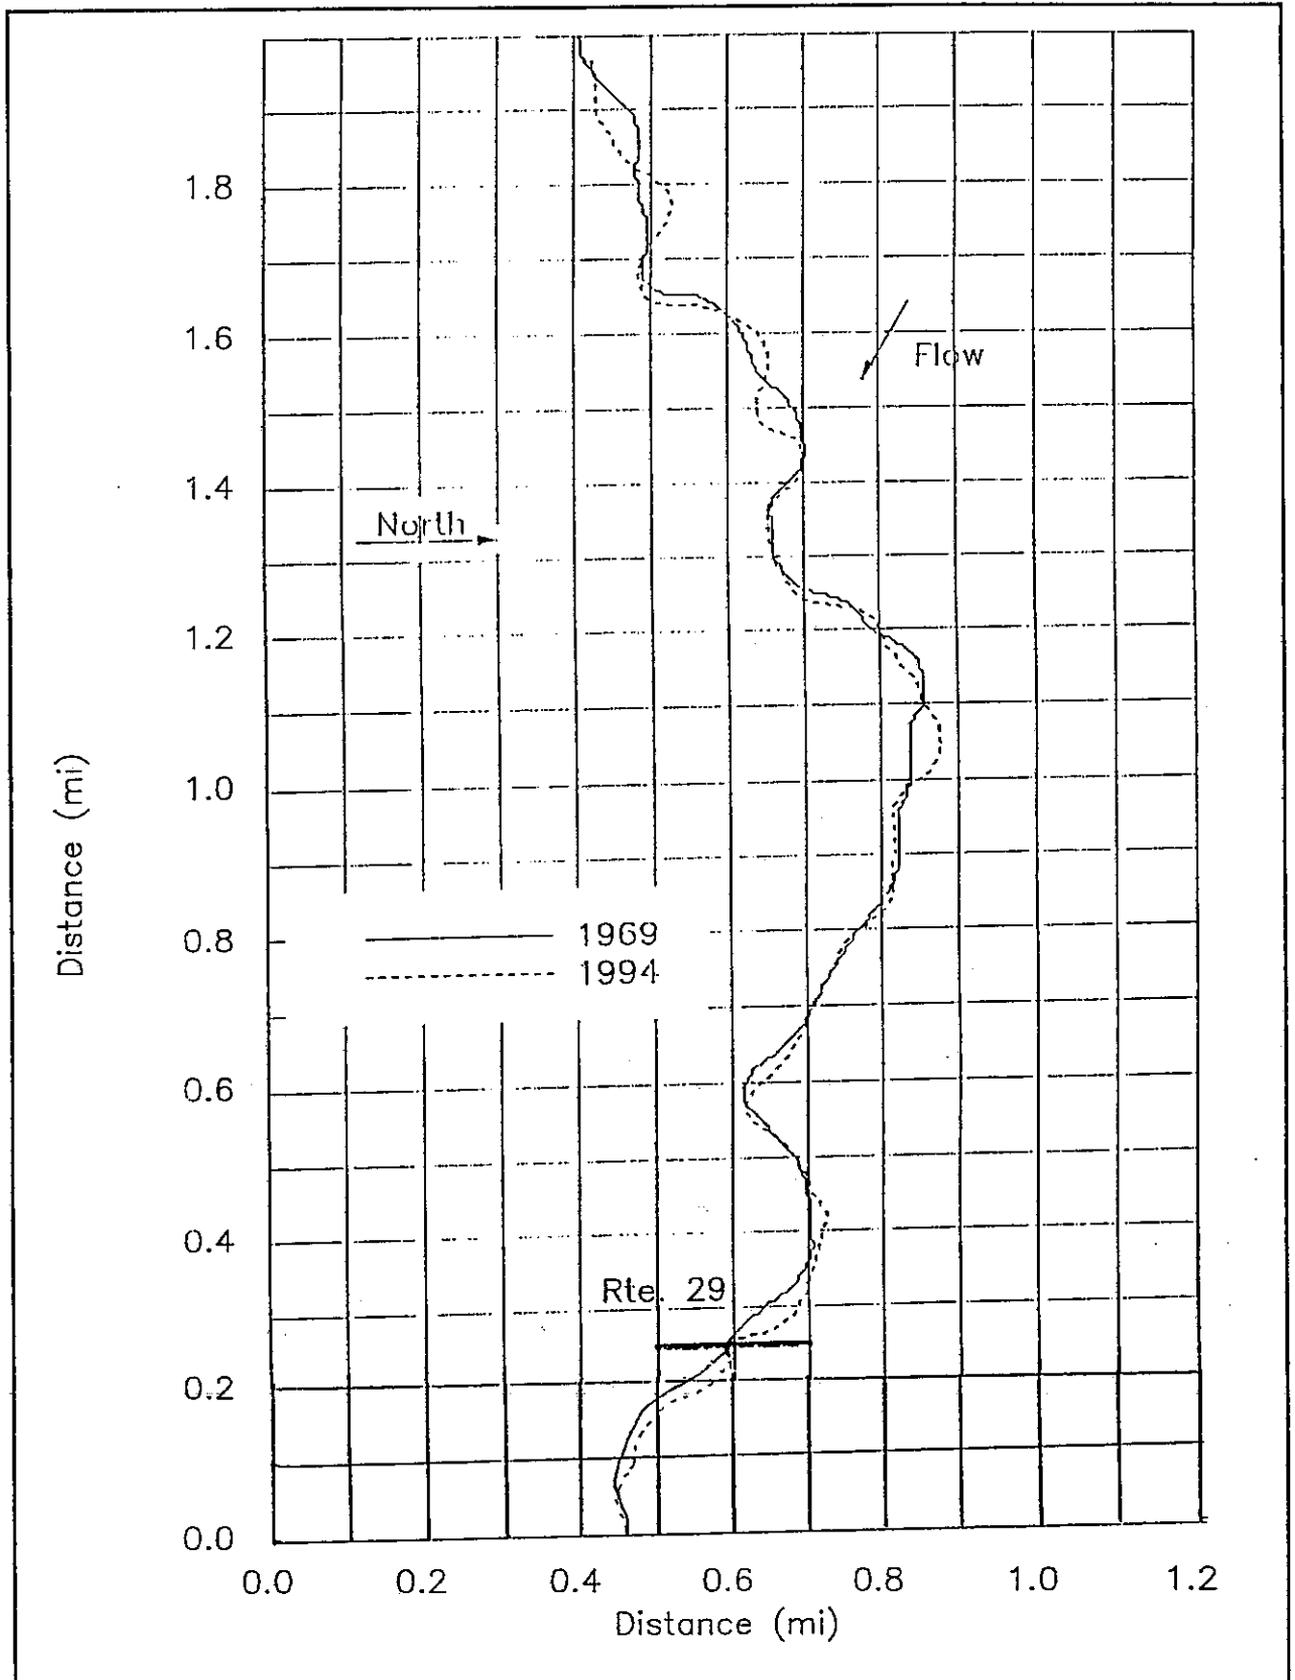
Figure 4-21. Orientation of Senachwine Creek in vicinity of study area.

The creek meander just upstream of the Route 29 bridge is threatening both the bridge and power line tower. Figure 4-21 shows that this meander has become very pronounced during the last 35 years. Bank failure and scour is occurring where the river is forced to turn at a right angle toward the bridge. The bend meander is very active and littered with fallen trees. More trees are in immediate danger of being undercut and will undoubtedly fall soon, complicating any erosion control efforts. The creek has experienced some extreme flood events, evident by the woody debris deposited on the high parts of the banks. A large point bar exists immediately upstream of the site, and the outer parts of the channel have been scoured deeply. The difficulties presented by this site will test the limits and success of low-cost stream bank protection methods. At this site, any low-cost effort should be viewed as temporary until it is proven successful, and more extensive measures may be necessary.
