FINAL REPORT

Stream Channel Migration Effects on Bridge Approaches and Conveyance

Report No. ITRC FR 94-4

Department of Civil Engineering

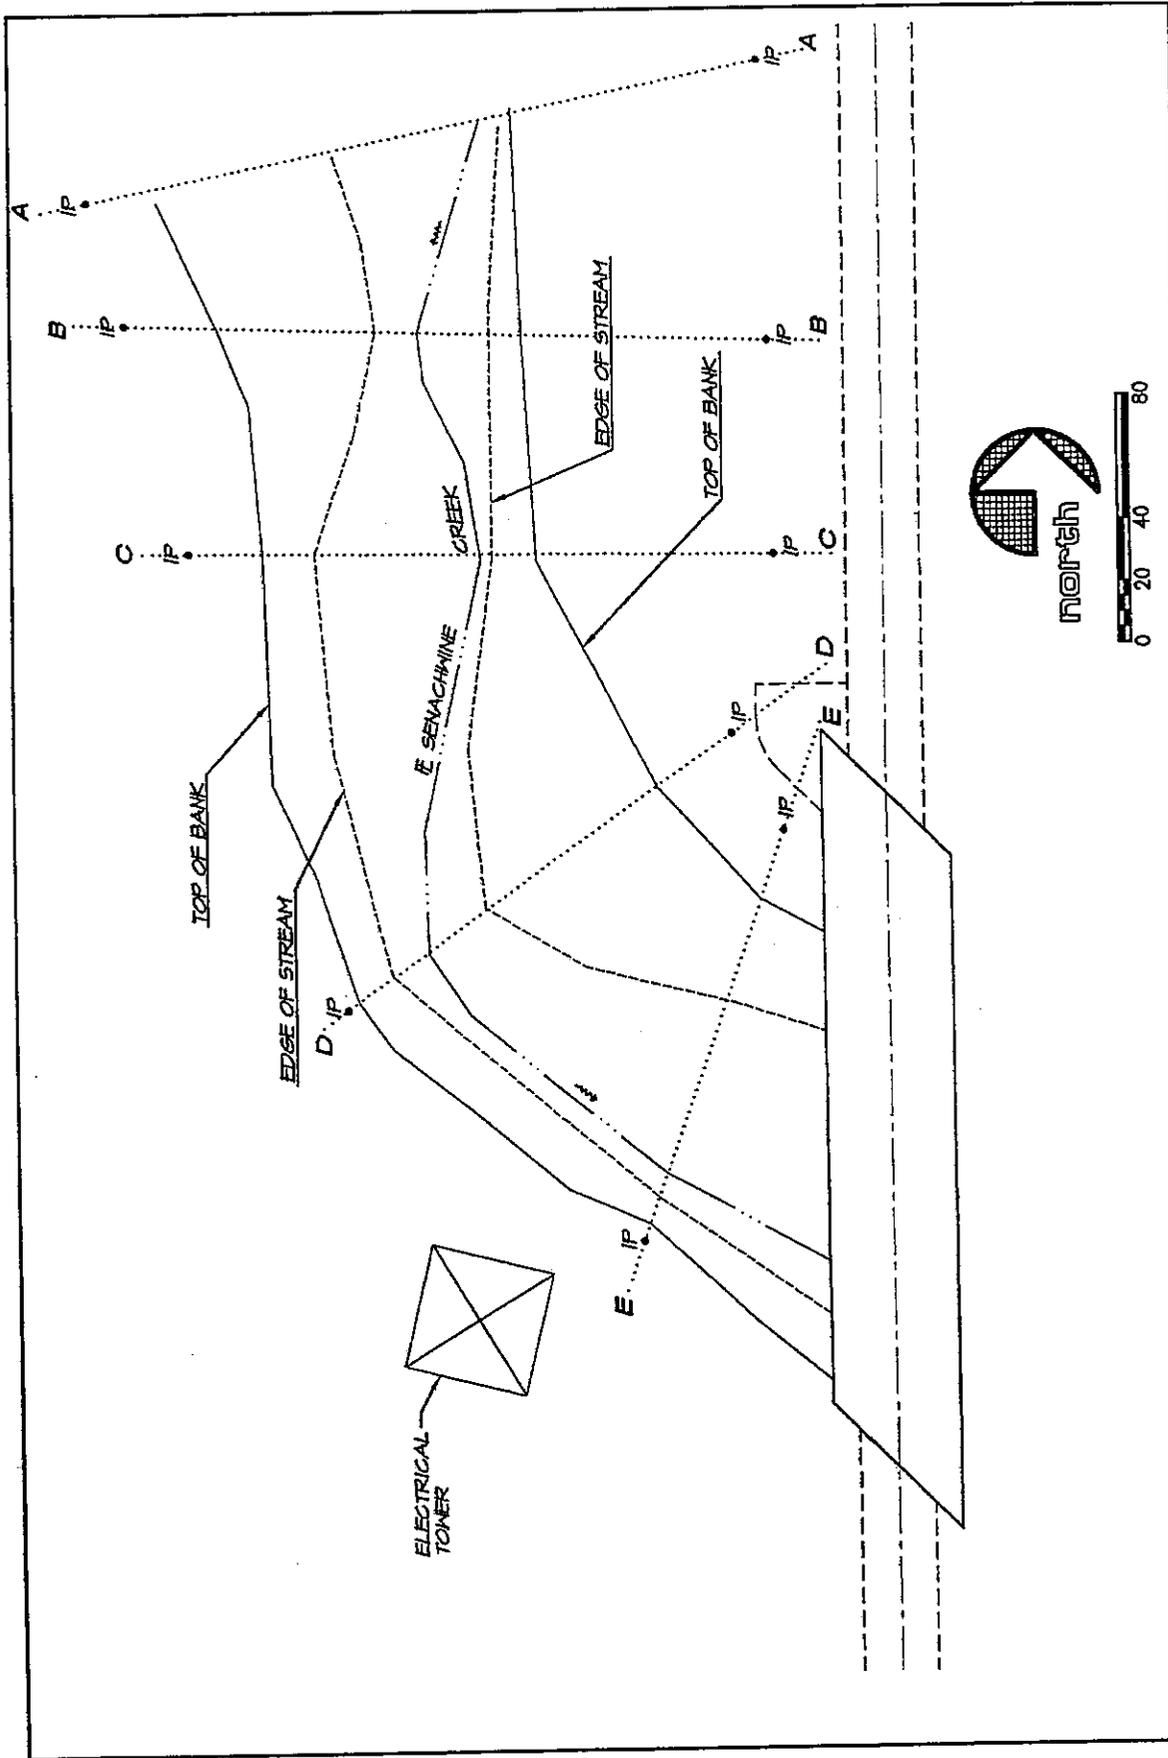
Figure 4-26. Plan survey of Senachwine Creek, July 1996. (Source: Upchurch and Associates)

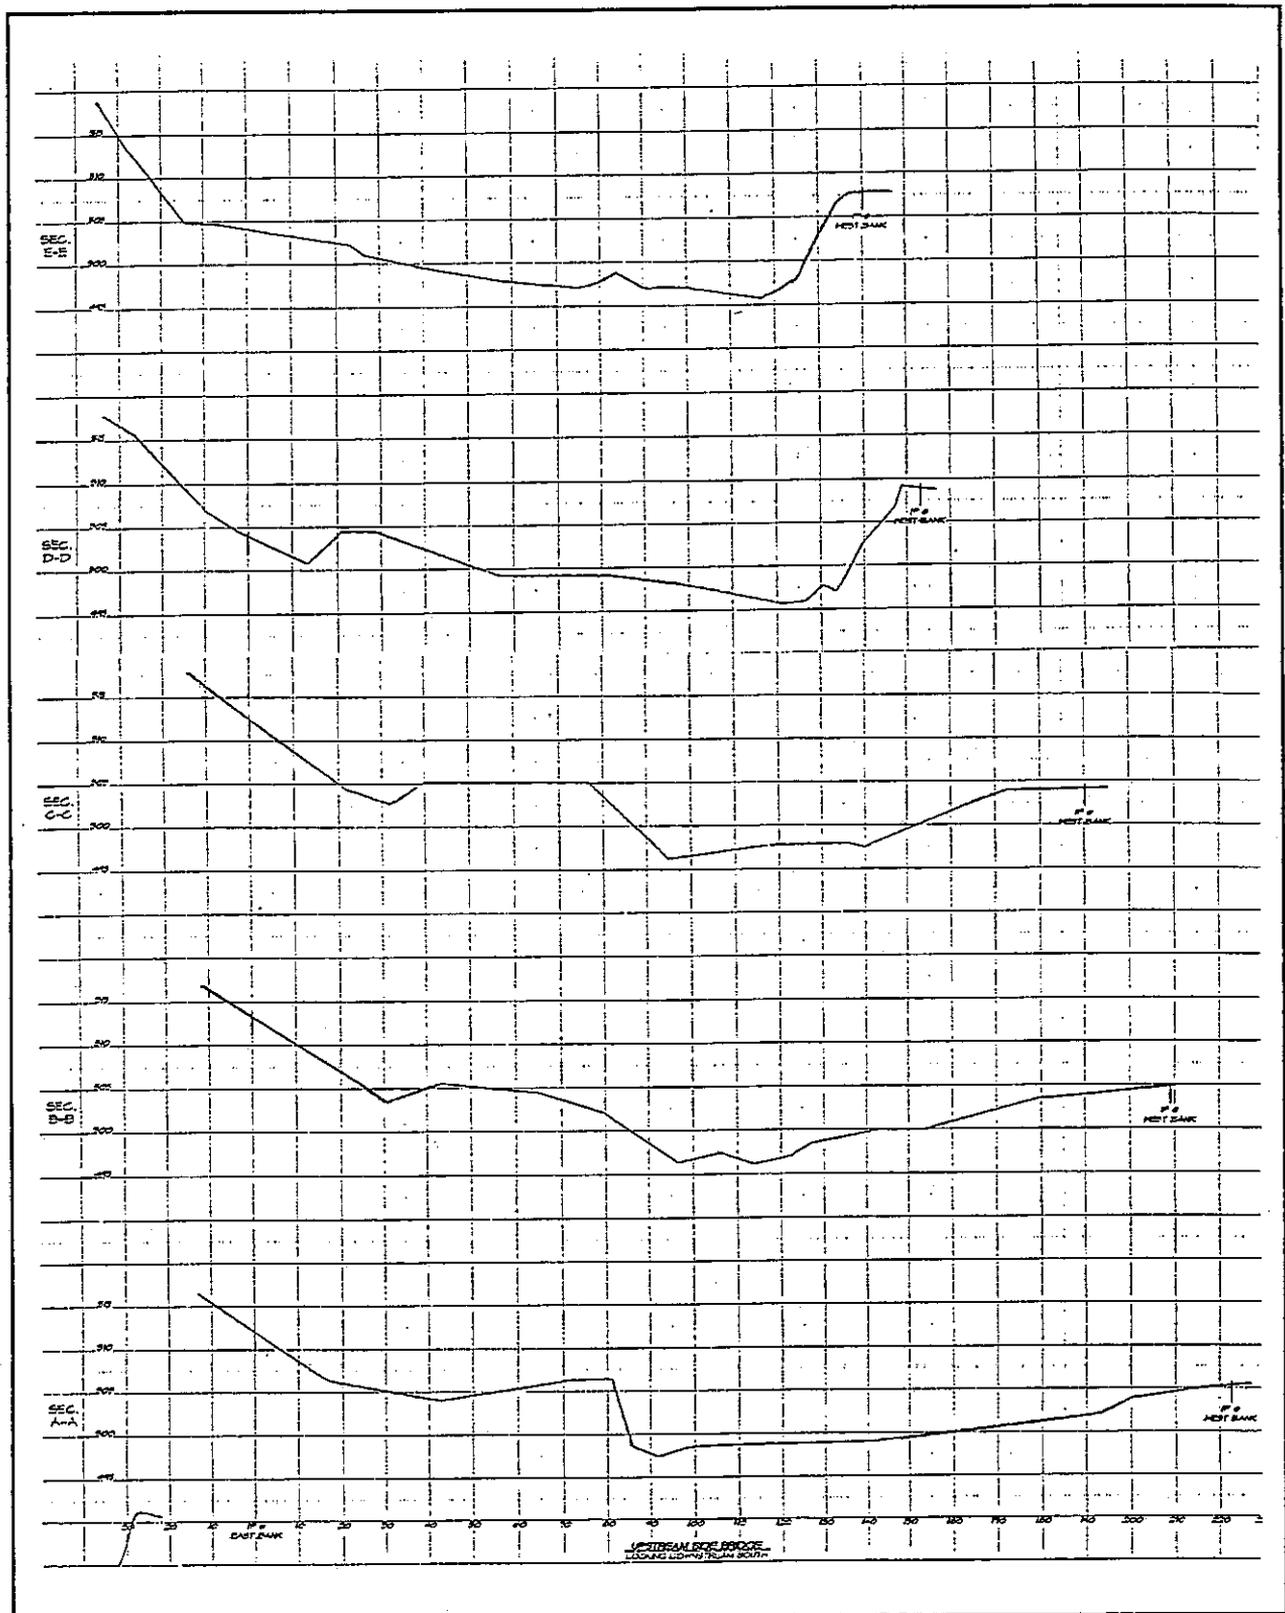
Figure 4-27. Cross-sectional survey of Senachwine Creek, July 1996. (Source: Upchurch Associates)

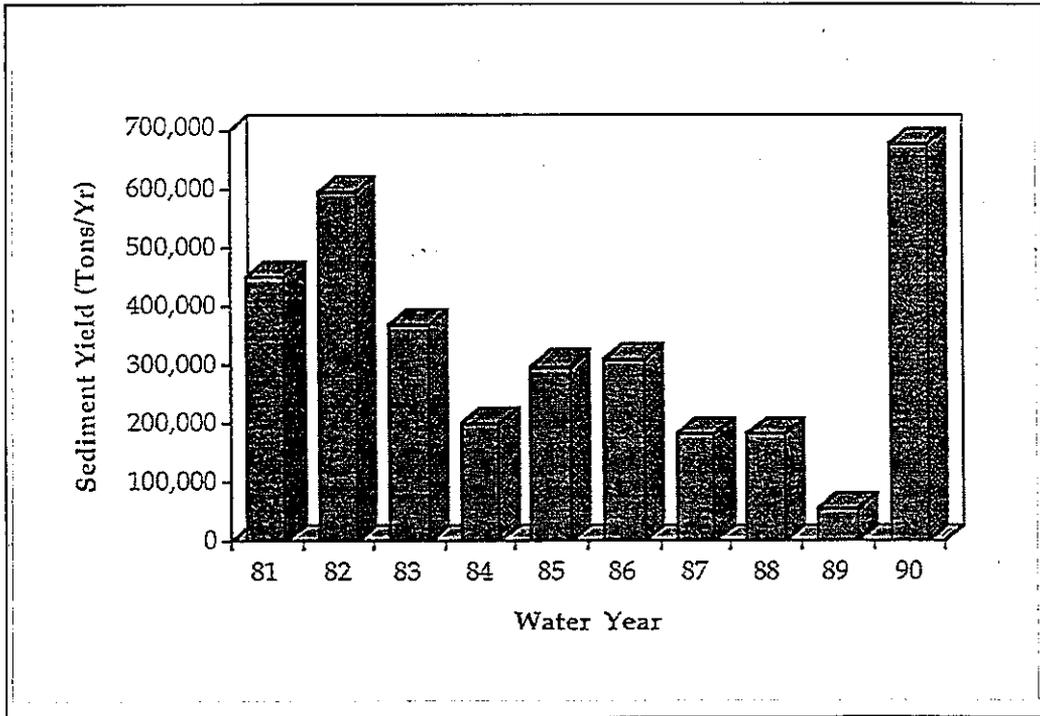
Figure 4-33. Estimated annual sediment yield at Spoon River site.

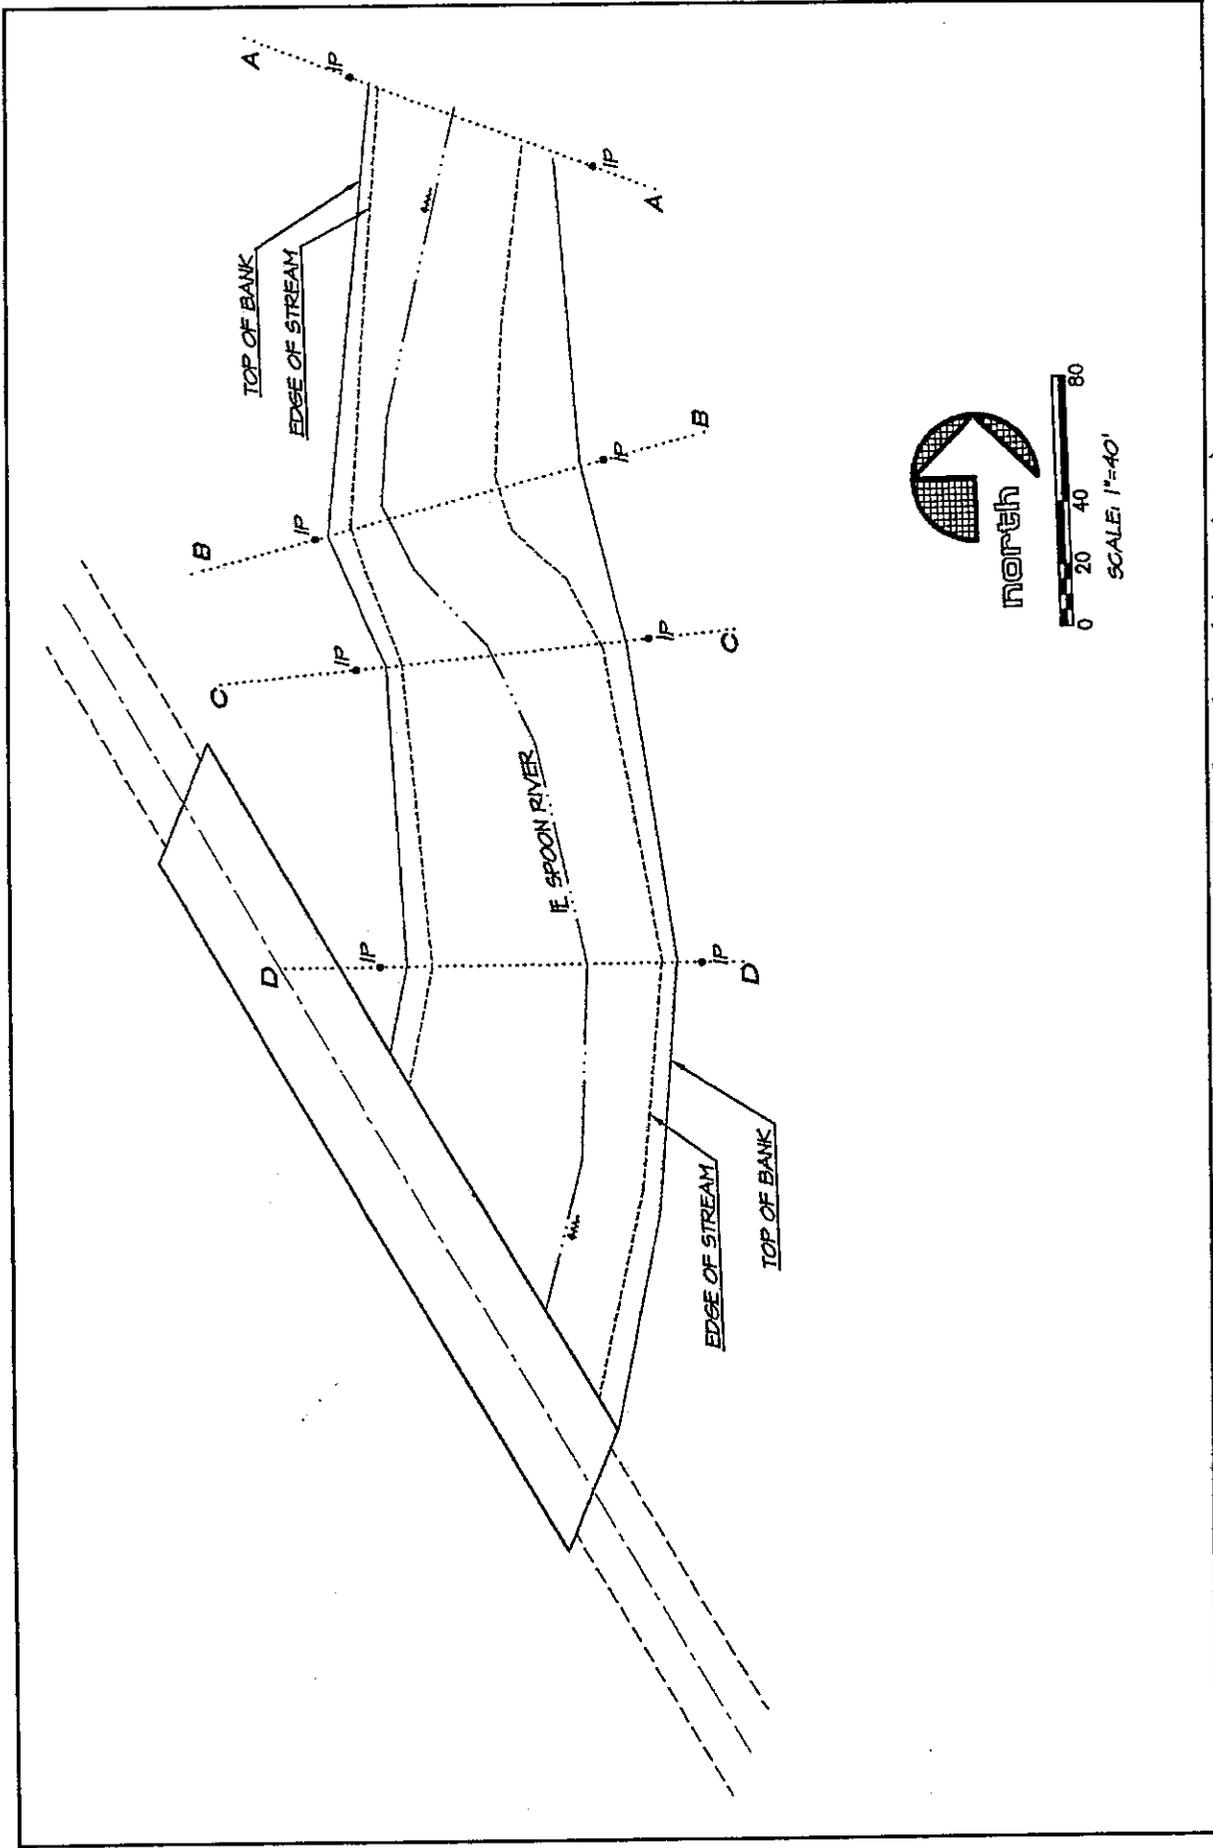
Figure 4-35. Plan survey of Spoon River, July 1996. (Source: Upchurch and Associates)

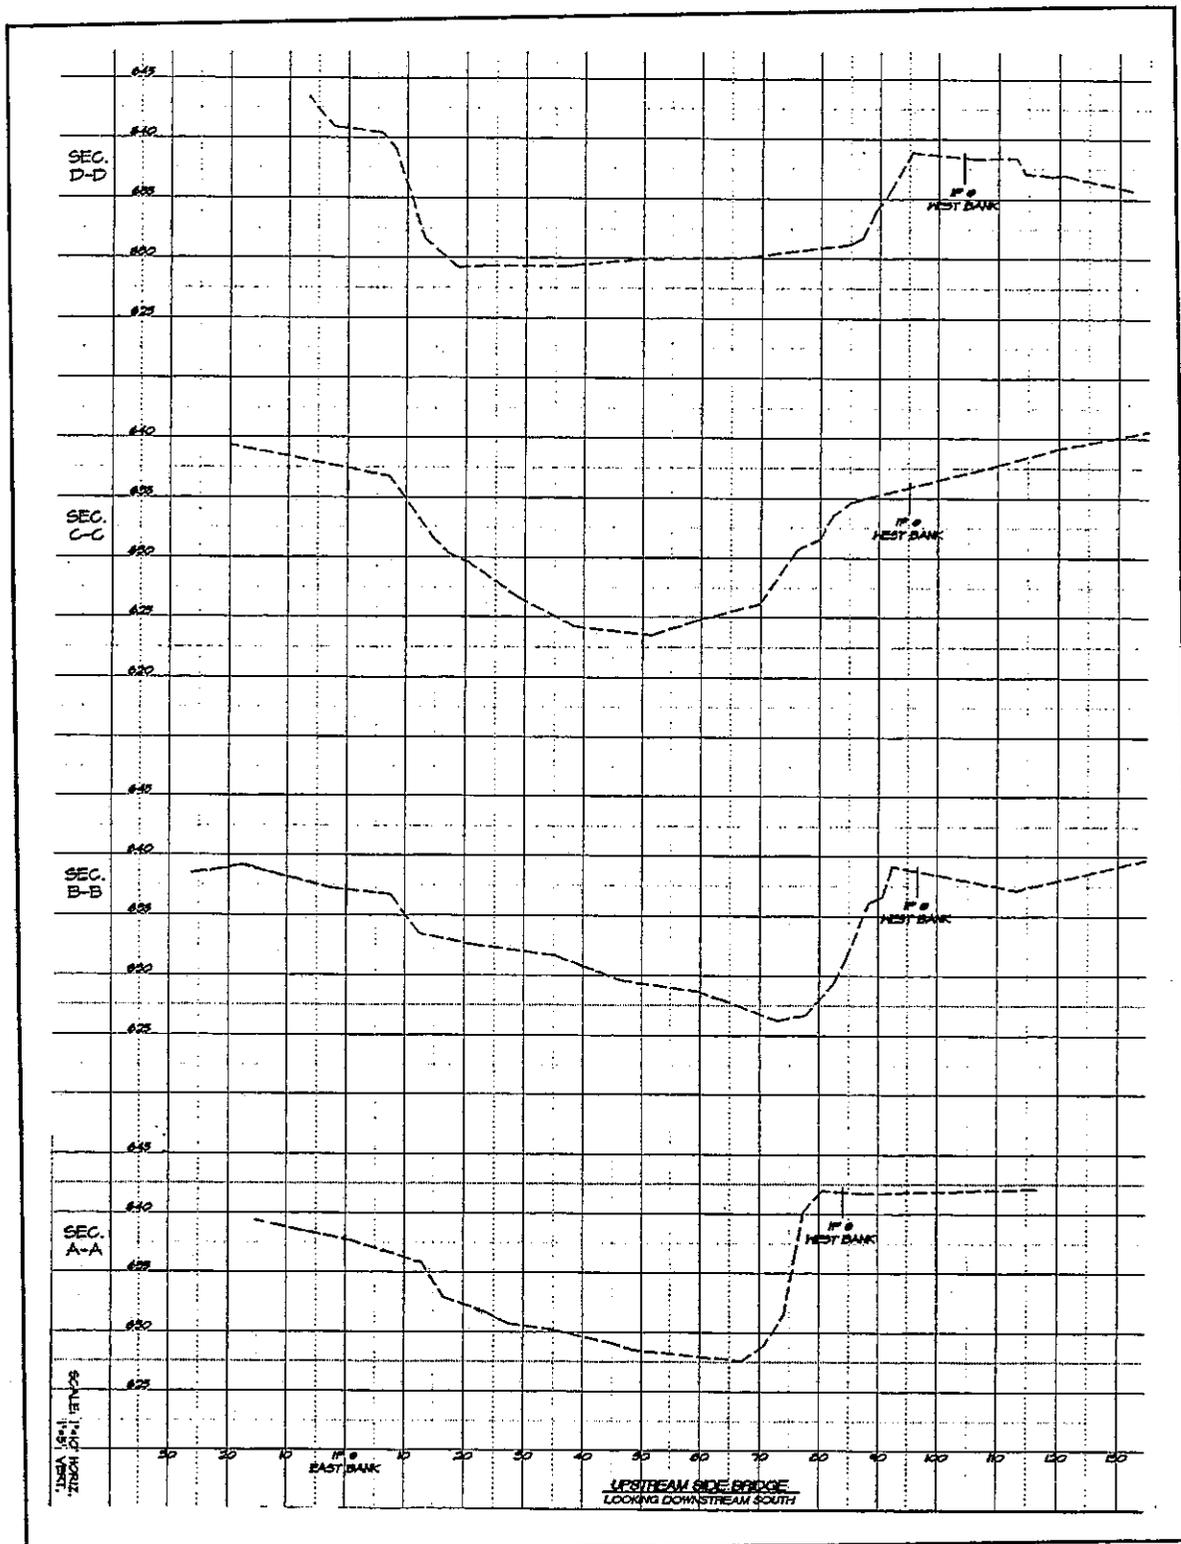
Figure 4-36. Cross-Sectional survey of Spoon River, July 1996. (Source: Upchurch and Associates)

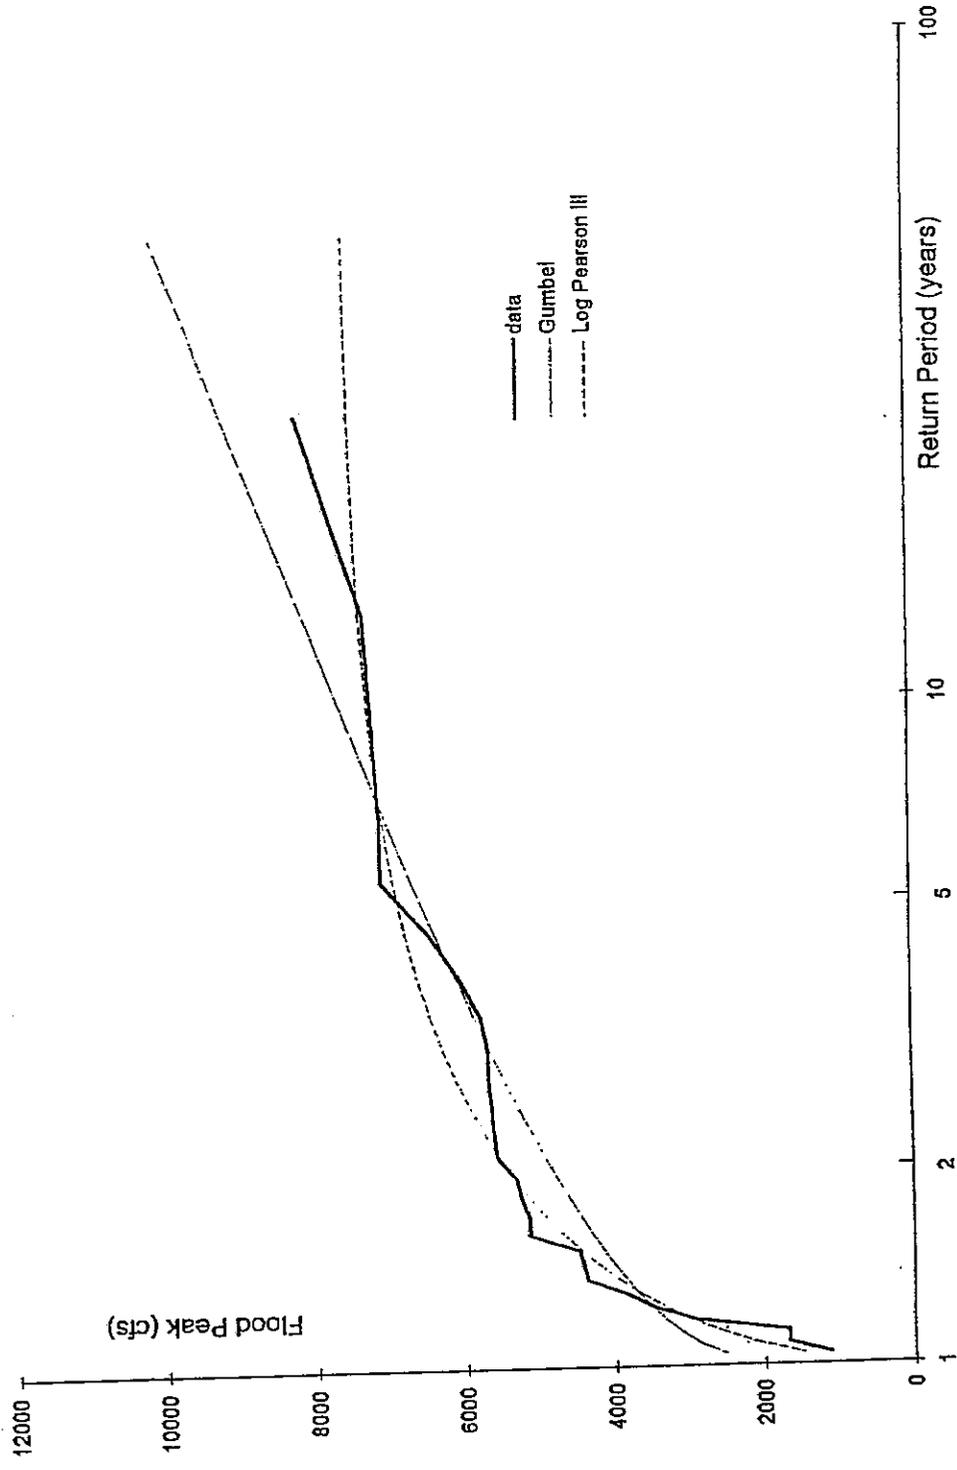
Figure 5-1. Example flood frequency curve for Cahokia Creek at Edwardsville, Illinois.

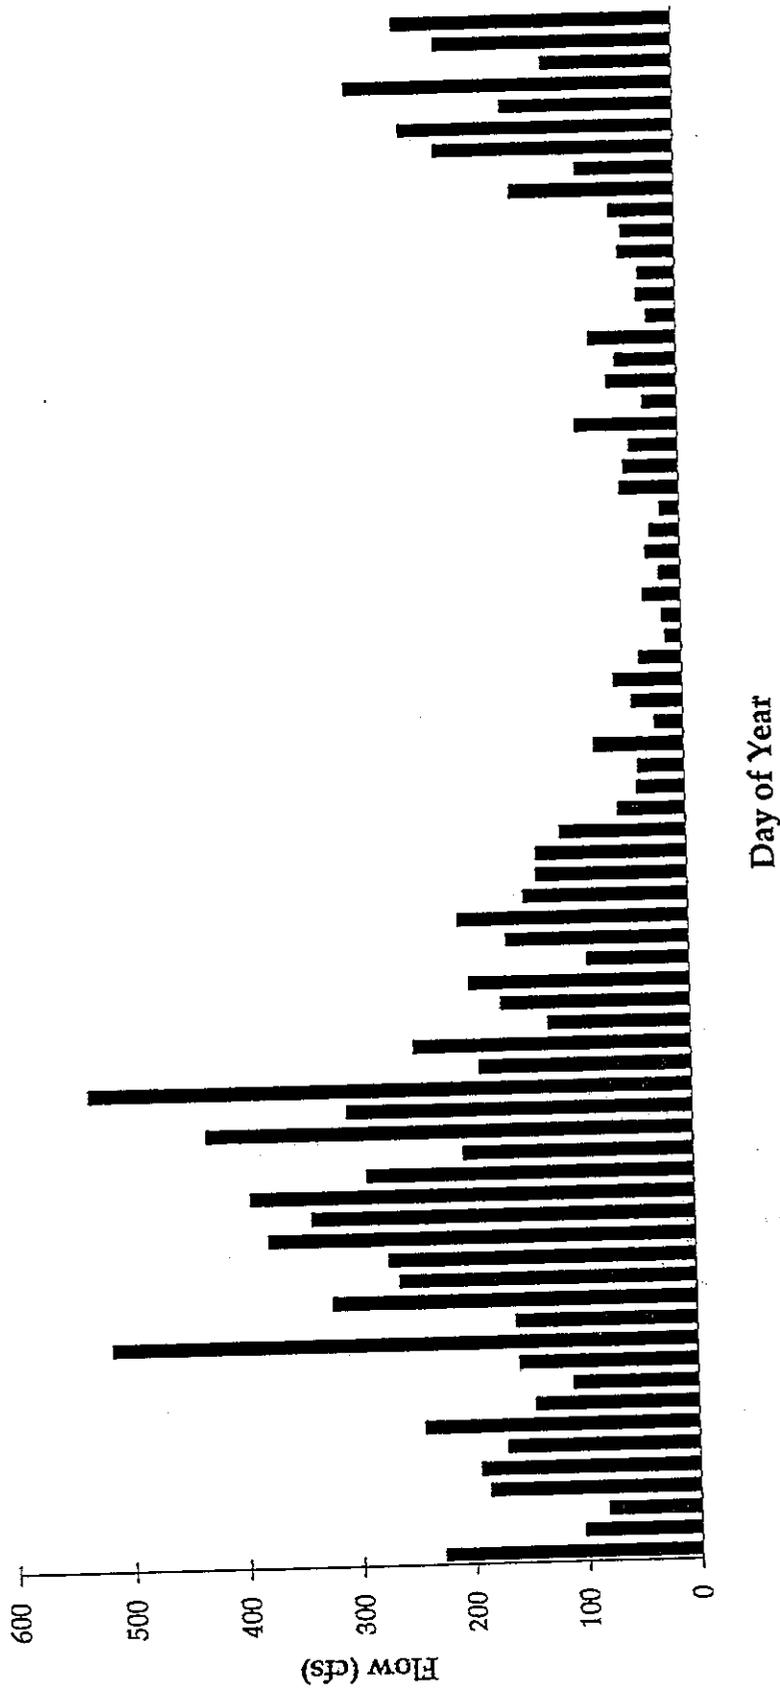
Figure 5-2. Expected annual variation of 5-day average flow for Cahokia Creek at Edwardsville, Illinois.

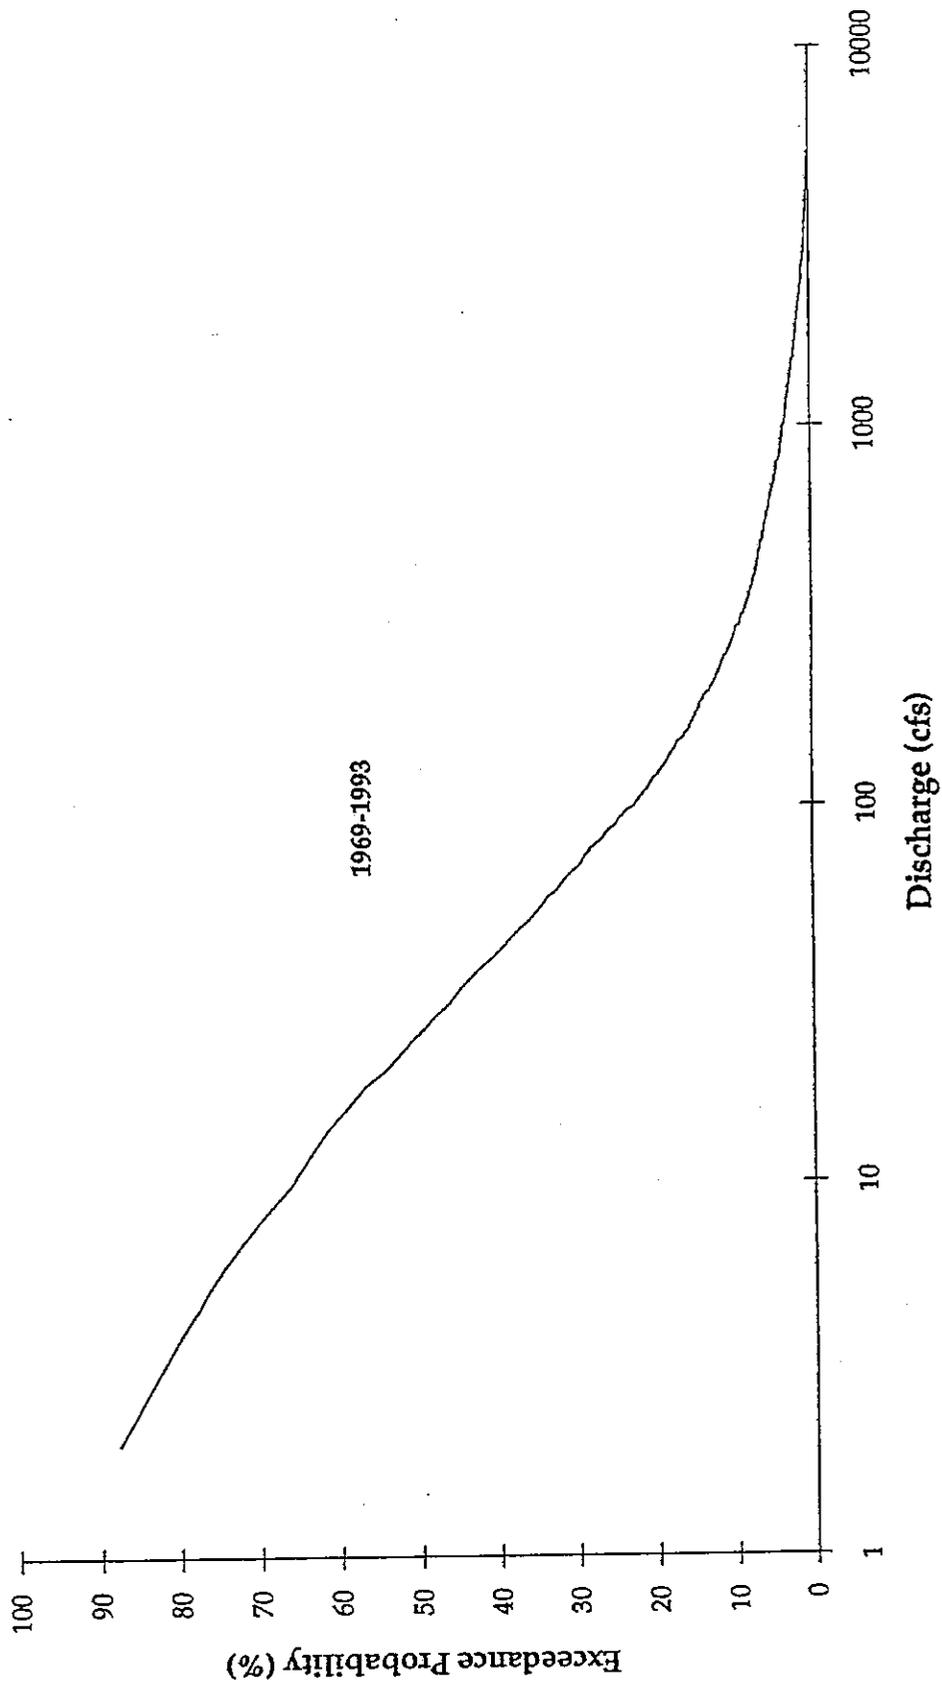
Figure 5-3. Flow duration curve for Cahokia Creek at Edwardsville, Illinois.

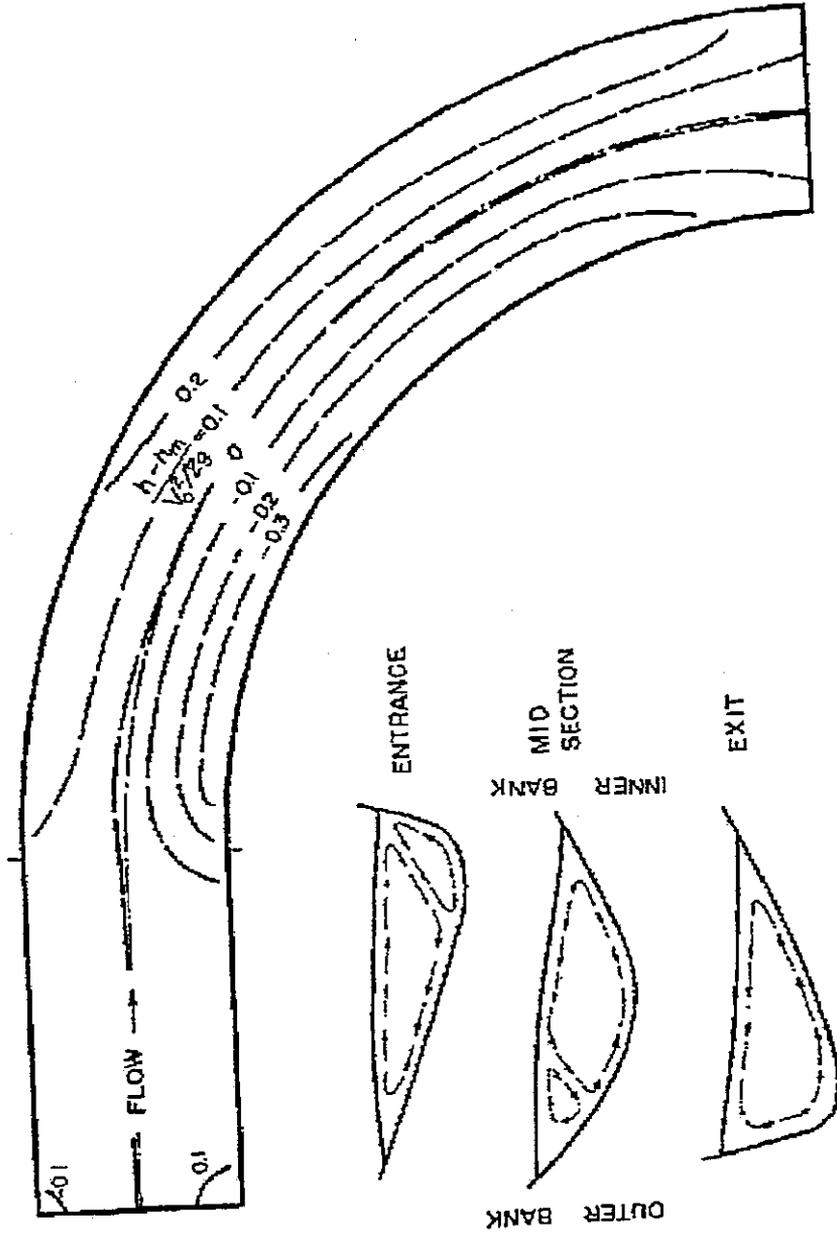
Figure 5-4. Example drawing of spiral motion in three cross sections of a bend and relative water surface configuration.

Compared with flow in a straight channel, flow in a channel bend has four major characteristics (Rozovskii, 1962; Yen, 1965,1967): (a) superelevation of water surface towards outer bank; (b) existence of spiral trajectory of the flow in the bend; (c) lateral discharge moving water towards outer bank with the bend; and (d) steep bank slopes and deep pools along the outer bank in the downstream part of the bend. Characteristic (b) and (d) are particularly important in controlling meander migration (Yen, 1975). As shown in Figure 5-4, the spiral motion enhances erosion along the outer bank and sediment deposition and sand bar formation on the inner bank. Some counter measures such as bendway weirs and Iowa vanes are constructed to modify or inhibit the occurrence of spiral motion near the outer bank. Understanding the strength of spiral motion and the angle of attack of the flow near the bank is important for effective control of channel migration. The erosion rate and speed of meander migration is also affected by the ability of the flow to move the eroded sediment from the outbank to the opposite bank.

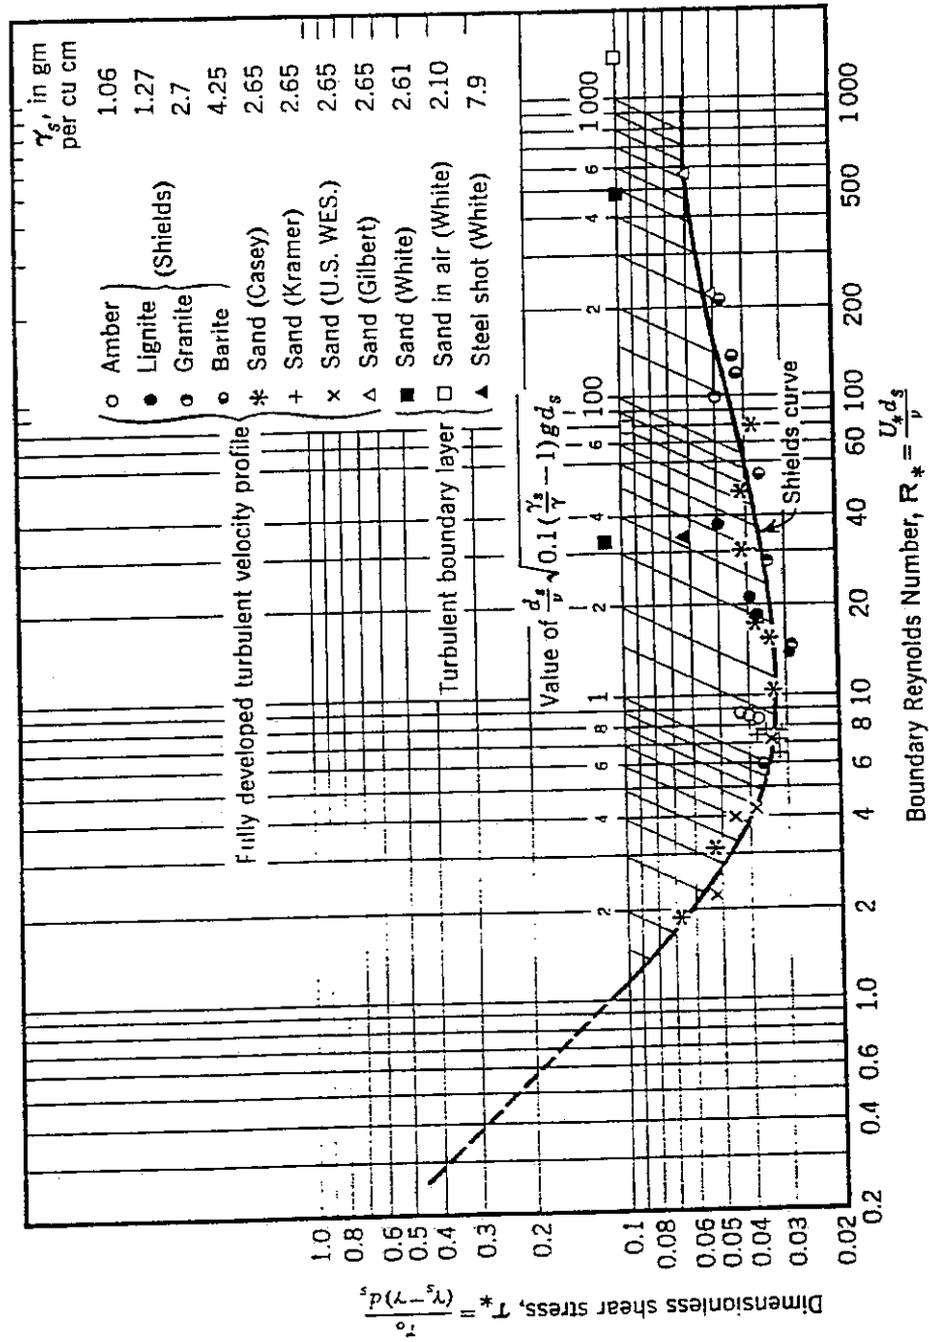
Figure 5-5. Shields diagram. (Source: ASCE, 1975)

Diagram's like Shields' is useful in evaluating the erodibility of soil or riprap on a flat bed. For a meandering channel, bank erosion is also a function of bank slope and the spiral motion shown in Figure 5-4. Along the outer (concave) banks, near the exit of a bend, the shear stress is high and the downward direction of the spiral motion assists the bank soil to move, enhancing the erosion (Yen, 1995). The strength of the spiral motion is a function of the curvature of the bend and the discharge in the channel. Along the inner (convex) bank, around the entrance to the bend, the depth is small and the spiral motion is weak. Sediment eroded from upstream is carried to this region and deposited in this region, and the point bar grows. Small floods may not be able to transport the majority of the eroded sediment at the outer bank near the bend exit and move it across the channel to the outside of the opposite bank; hence, for such floods, bends tend to grow sharper and bigger. For large floods, eroded sediment are mostly carried across the channel and move downstream. For such floods, there tends to be more migration downstream than growth in bend. Figure 4-3 shows a typical growth and migration of a meander. For bridge protection, it is important to control the meander at the bridge site, and understanding of this hydro-geomorphologic factor is important.

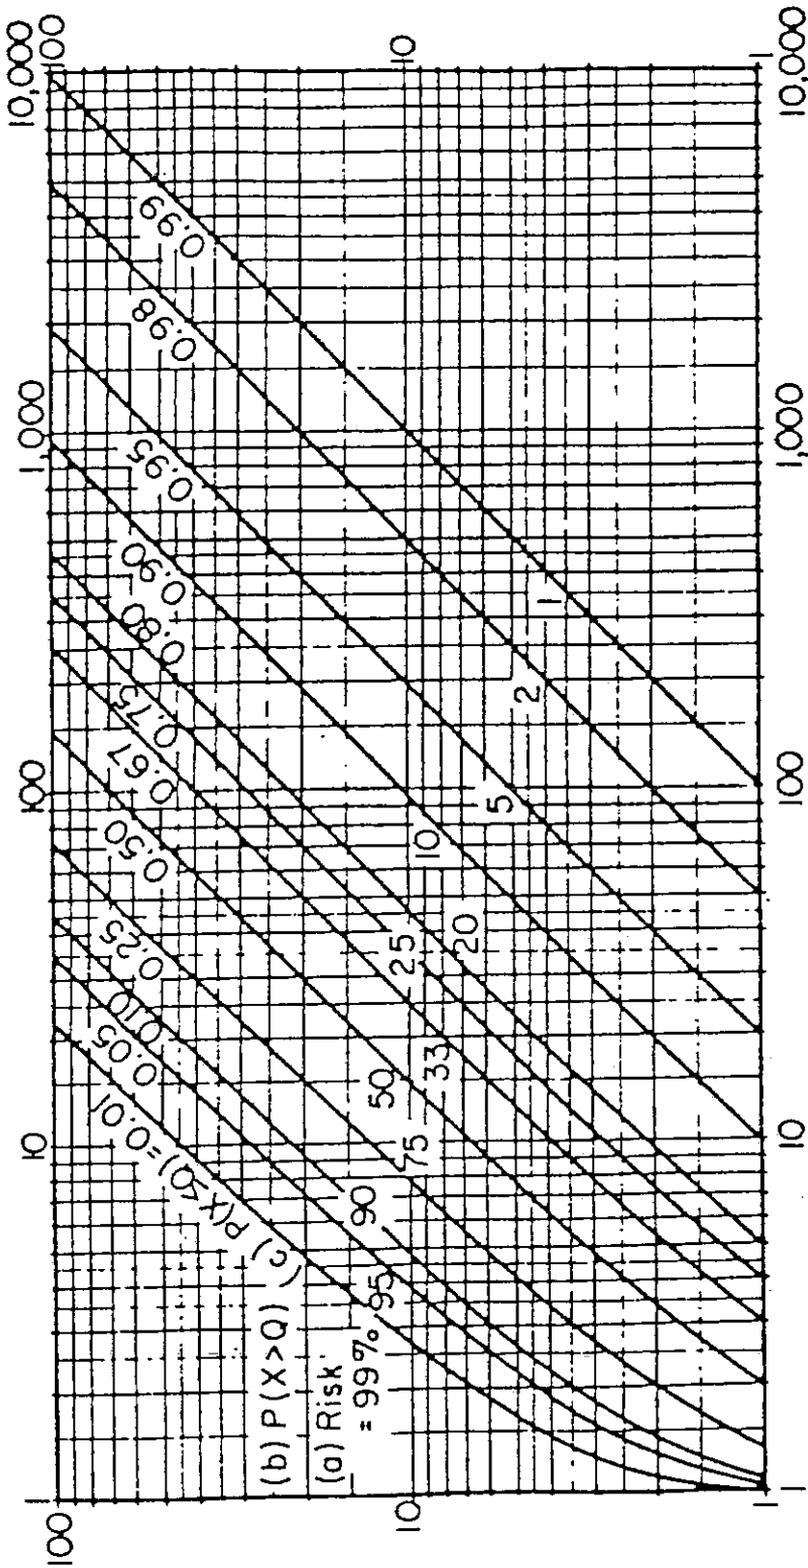
Figure 5-6. Relationship between return period, project life and risk (Yen, 1970)

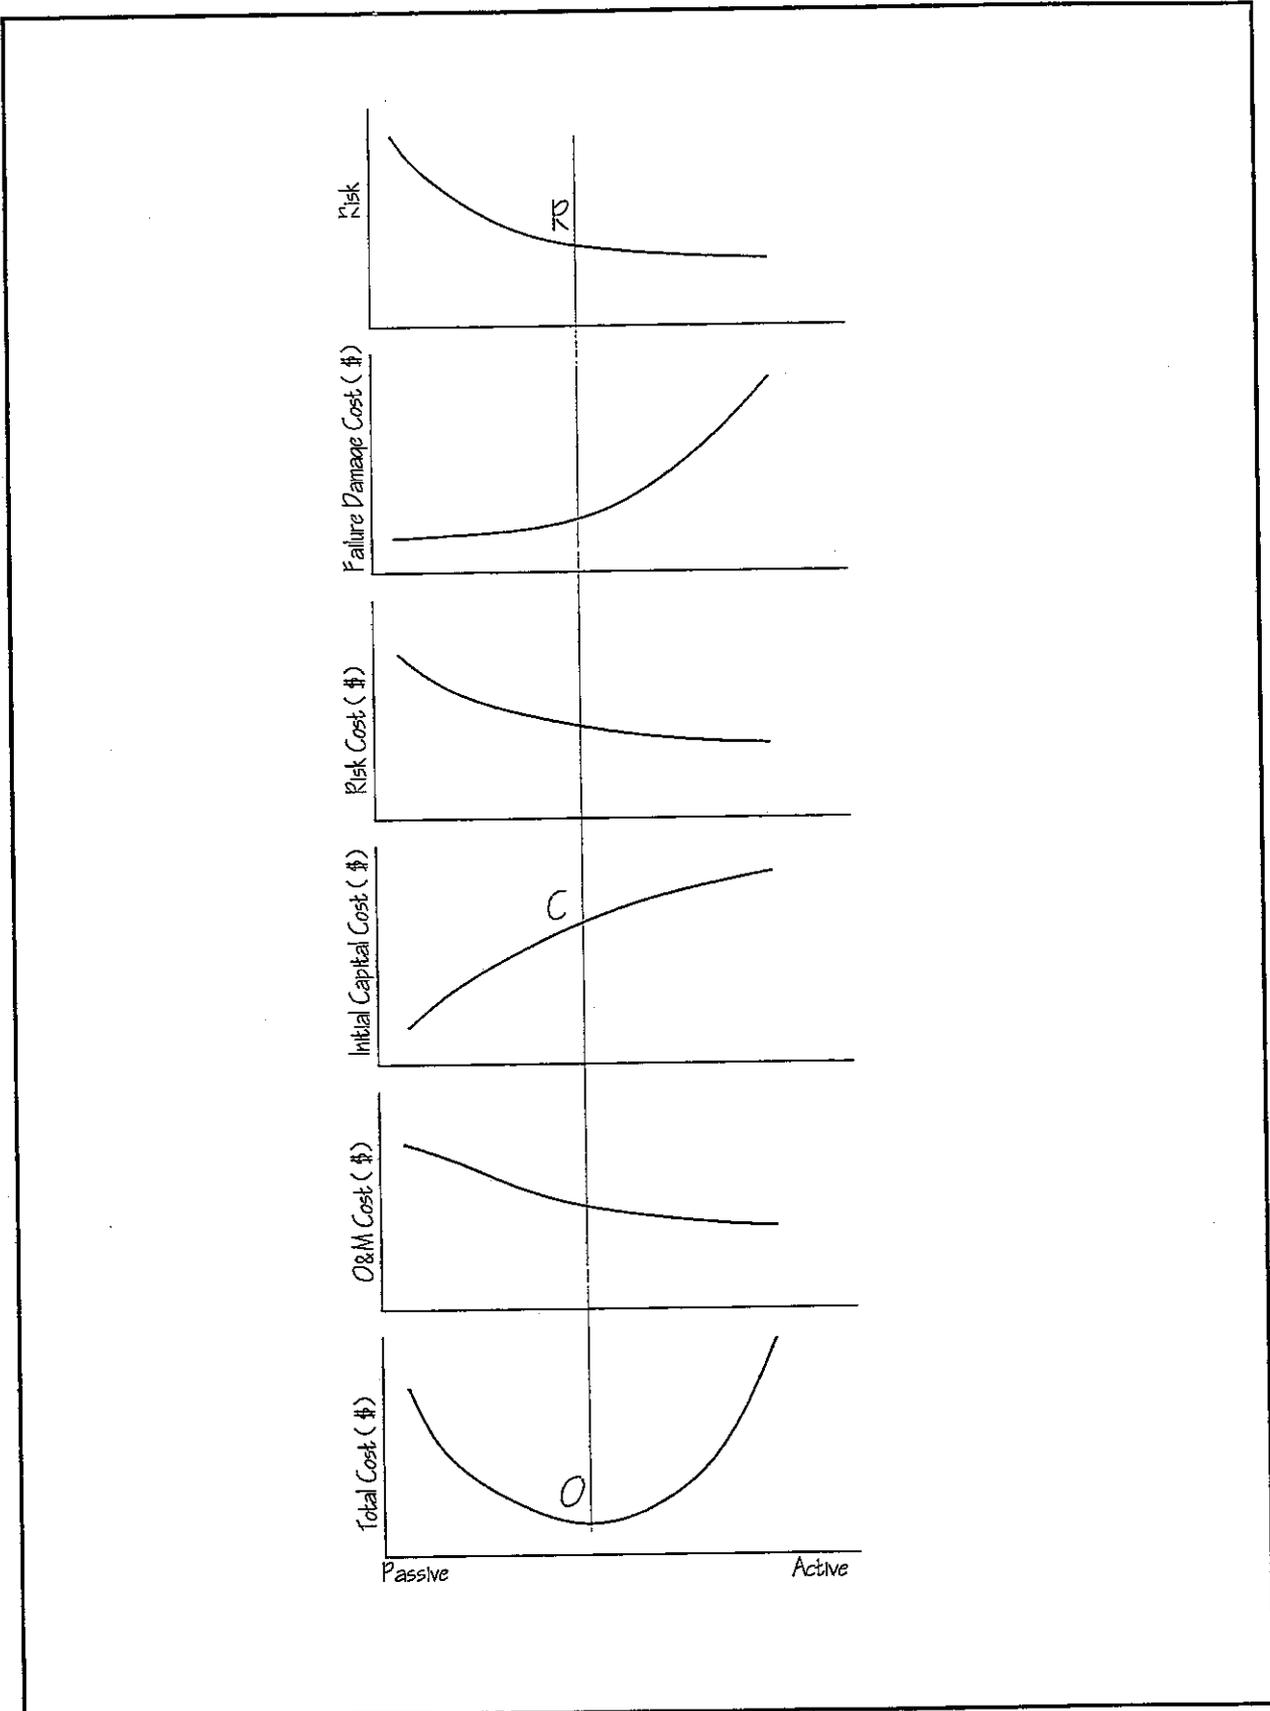
Figure 5-7. Risk based optimum design among alternatives. (After: Yen,1990)

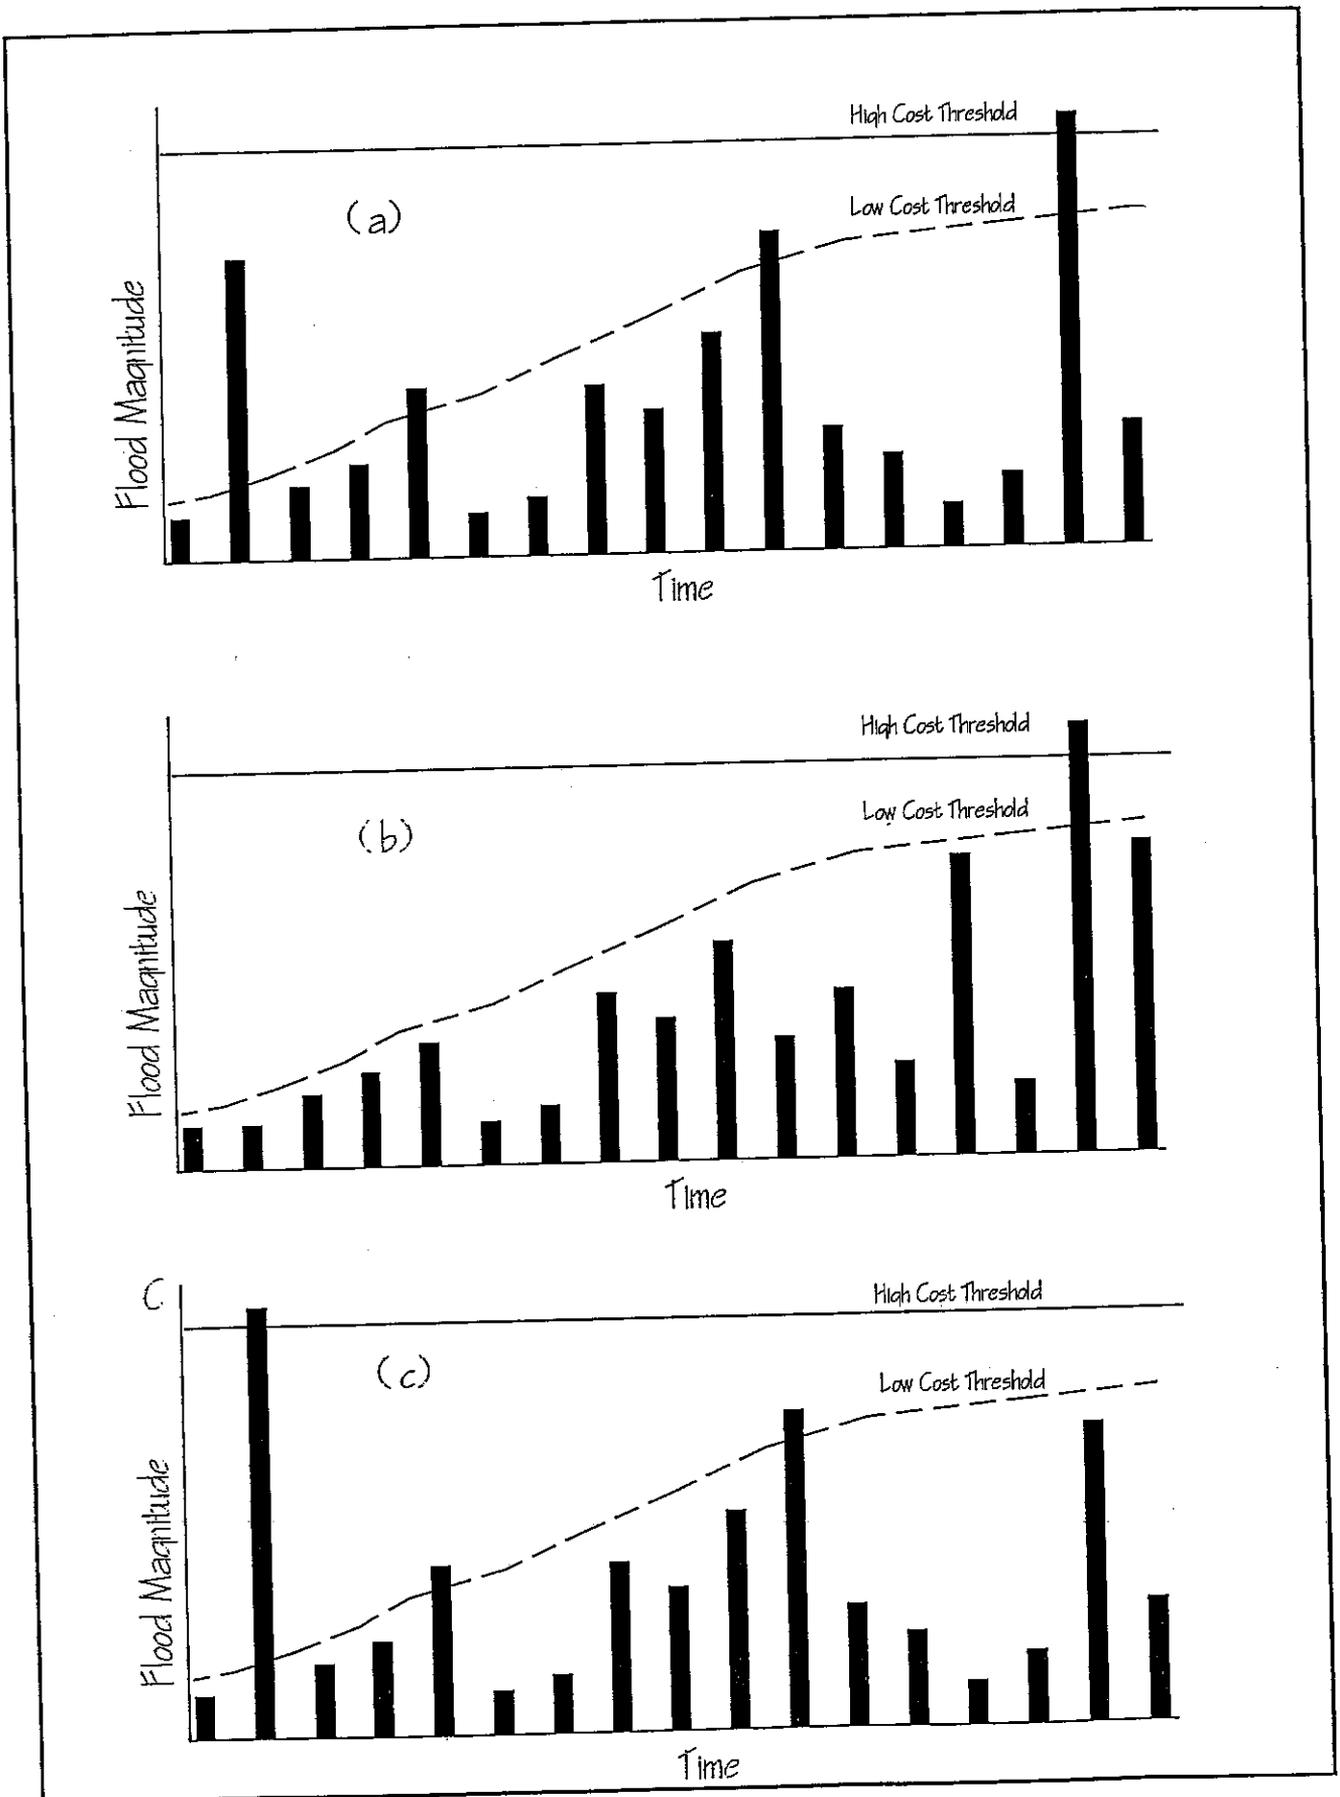
Figure 5-8. High and low cost risk thresholds and dependency of failure with flood sequence.
