FINAL REPORT

Stream Channel Migration Effects on Bridge Approaches and Conveyance

Report No. ITRC FR 94-4

Department of Civil Engineering

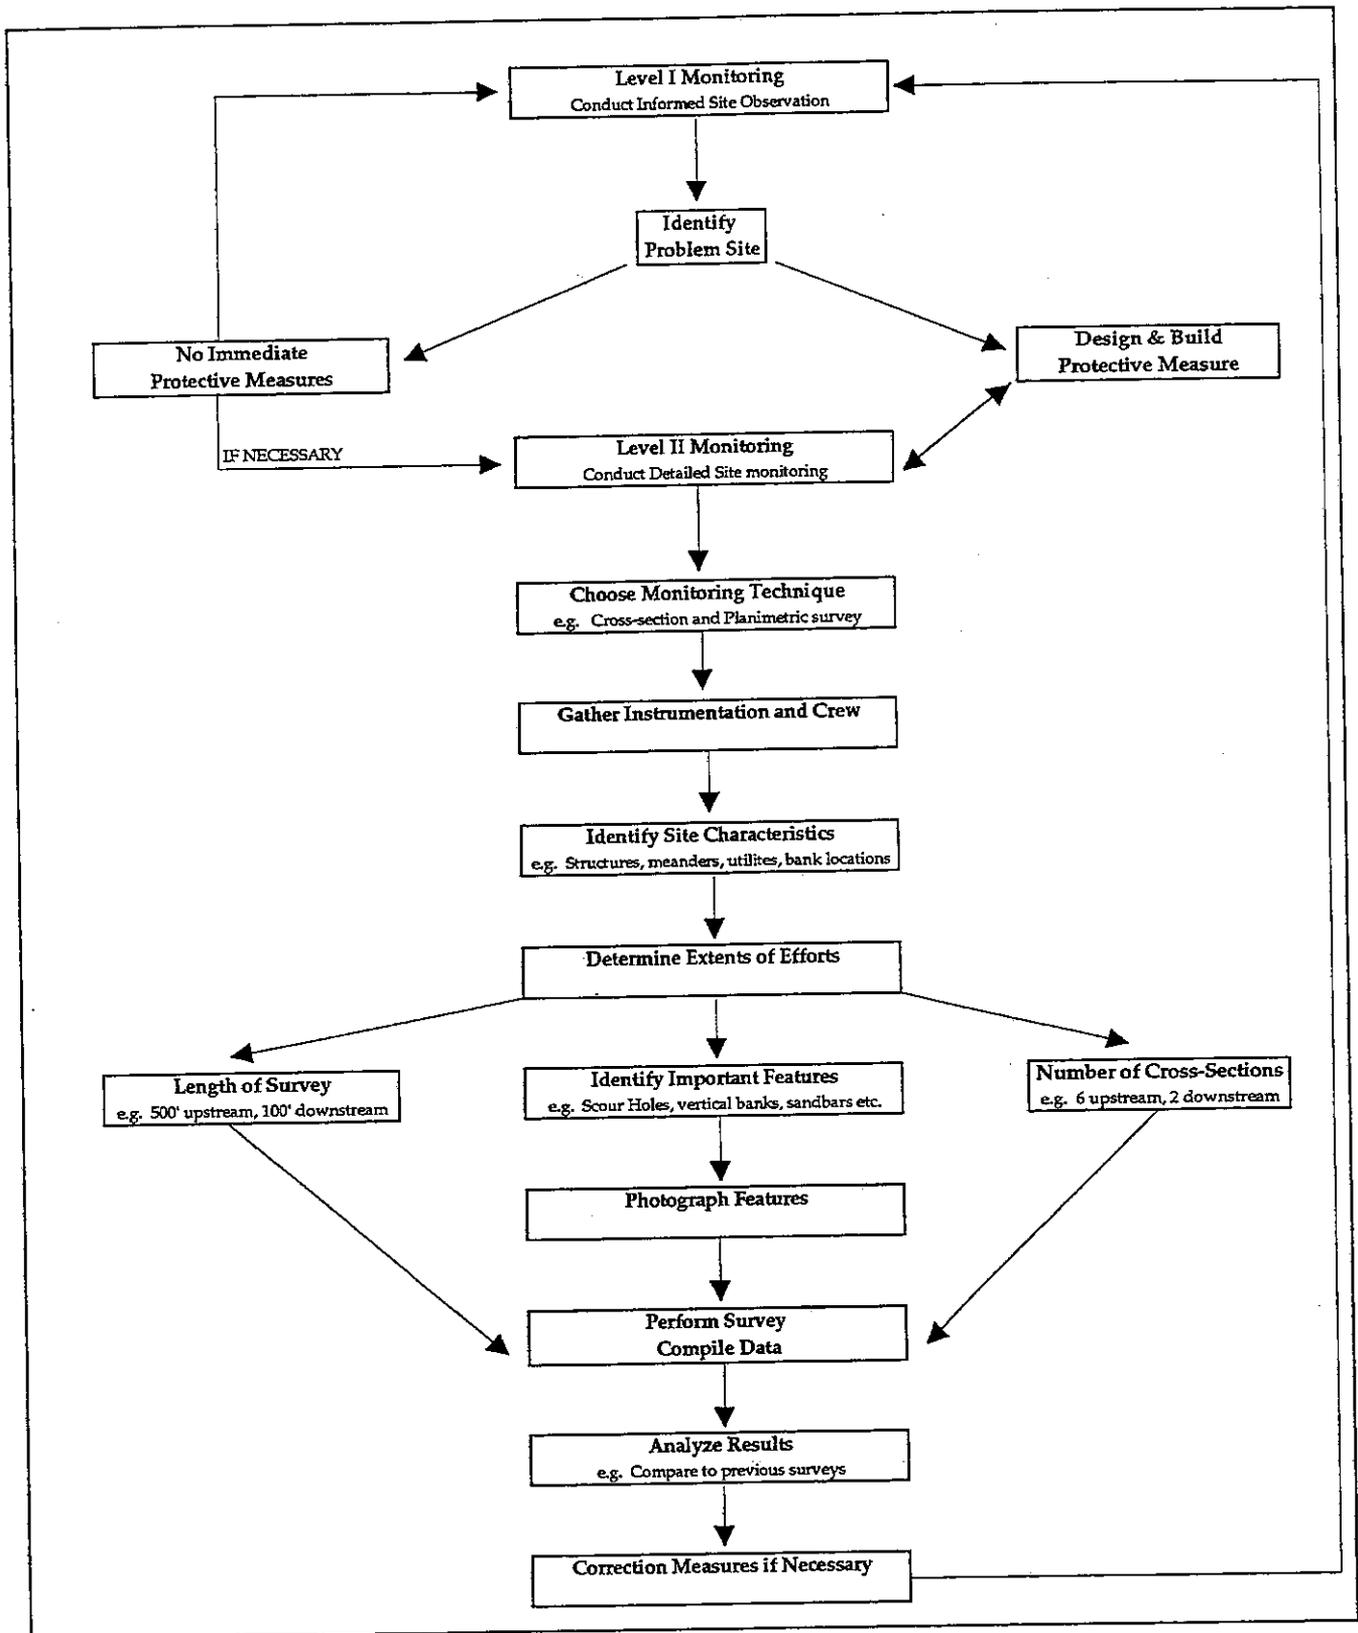
Figure 6-1. Sample monitoring plan flow-chart. (Examples developed for Spoon River site)

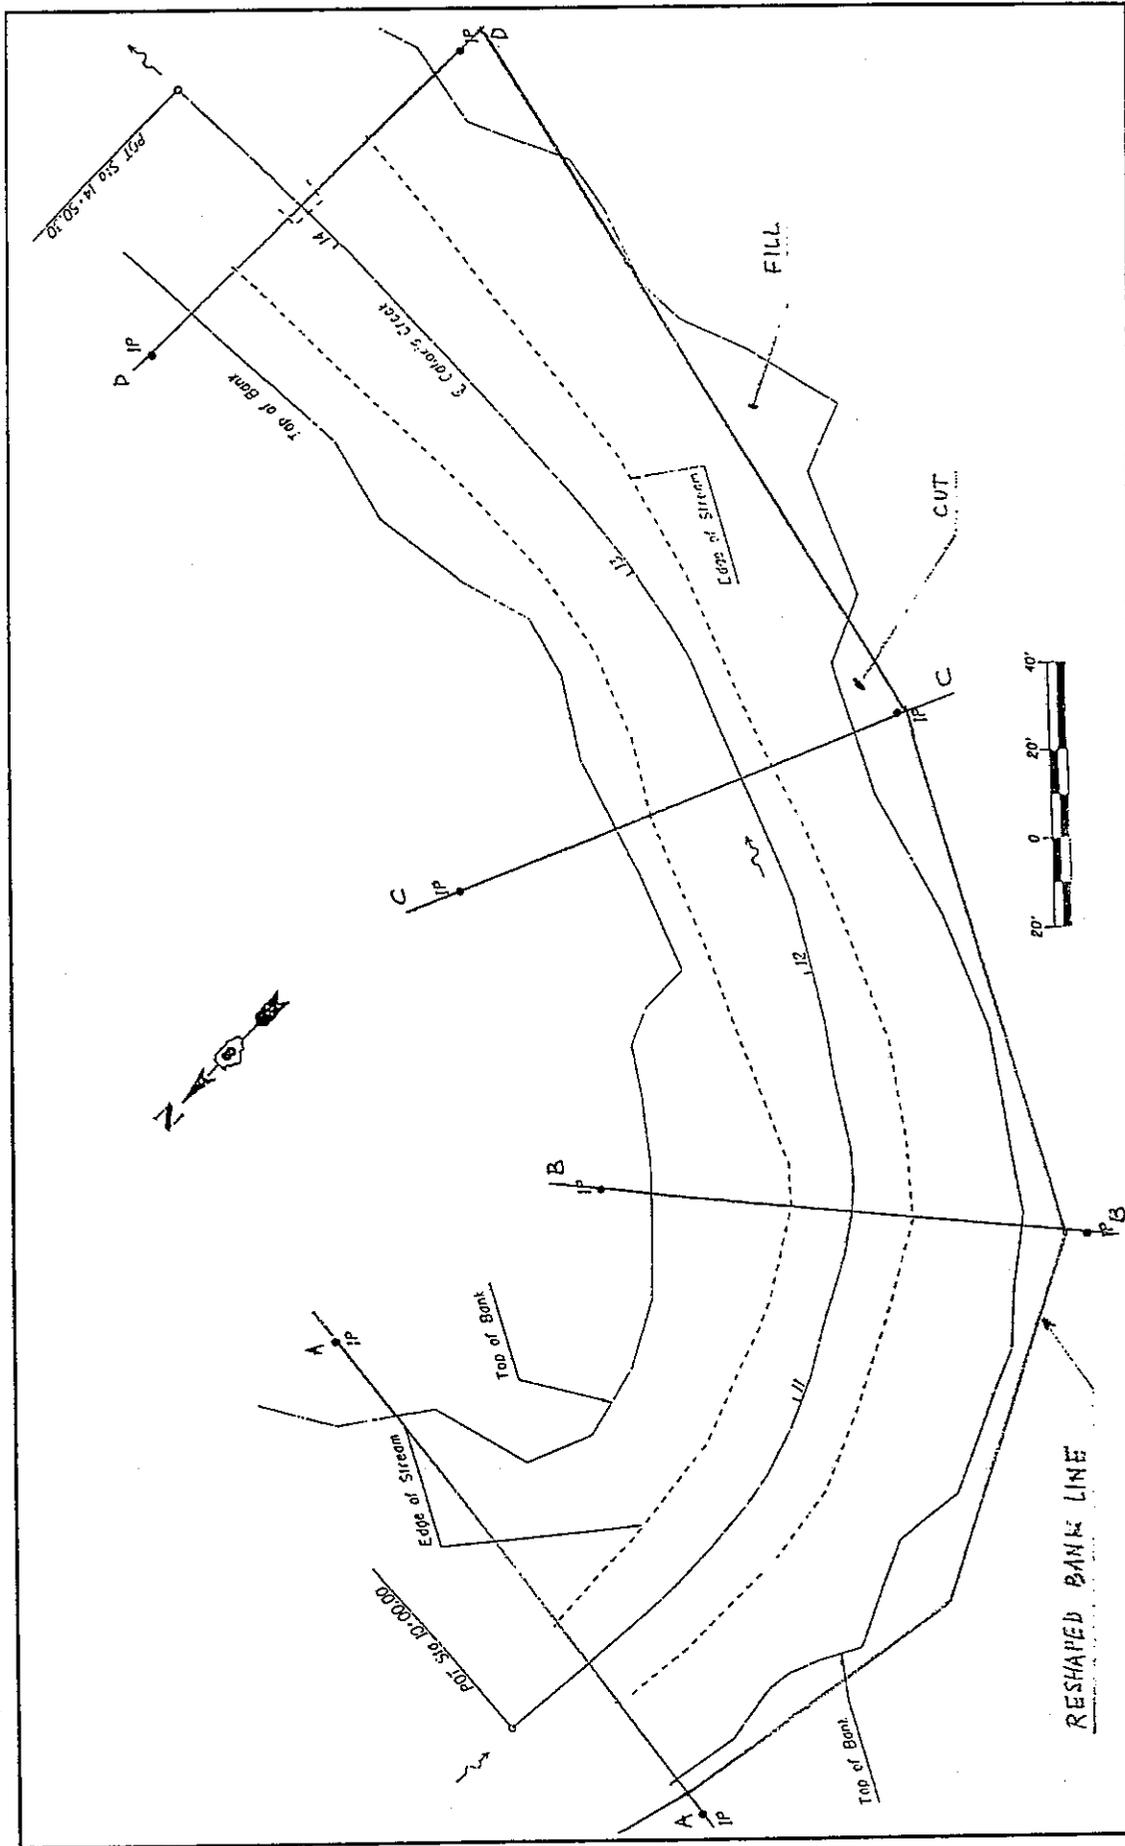
Figure 7-1. Cahokia Creek site alternative 1 design schematic (plan view).

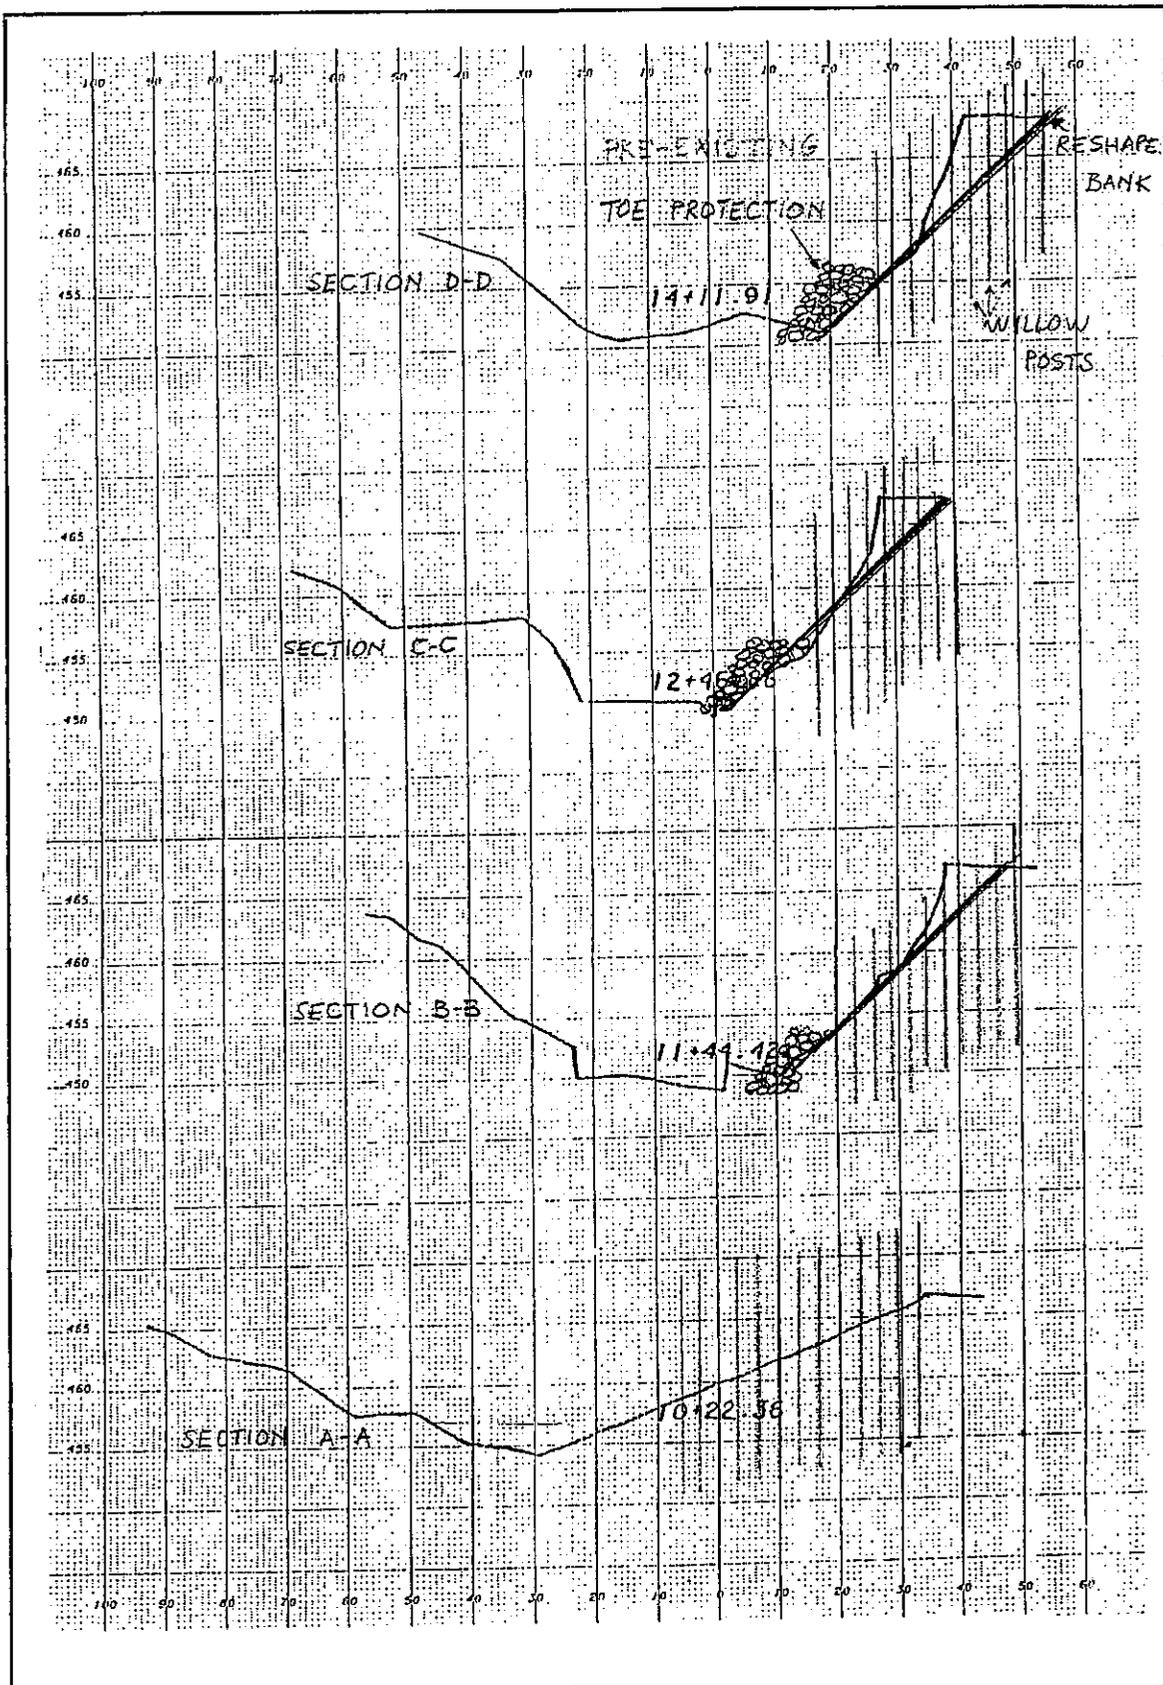
Figure 7-2. Cahokia Creek site alternative 1 design schematic (cross-section view).

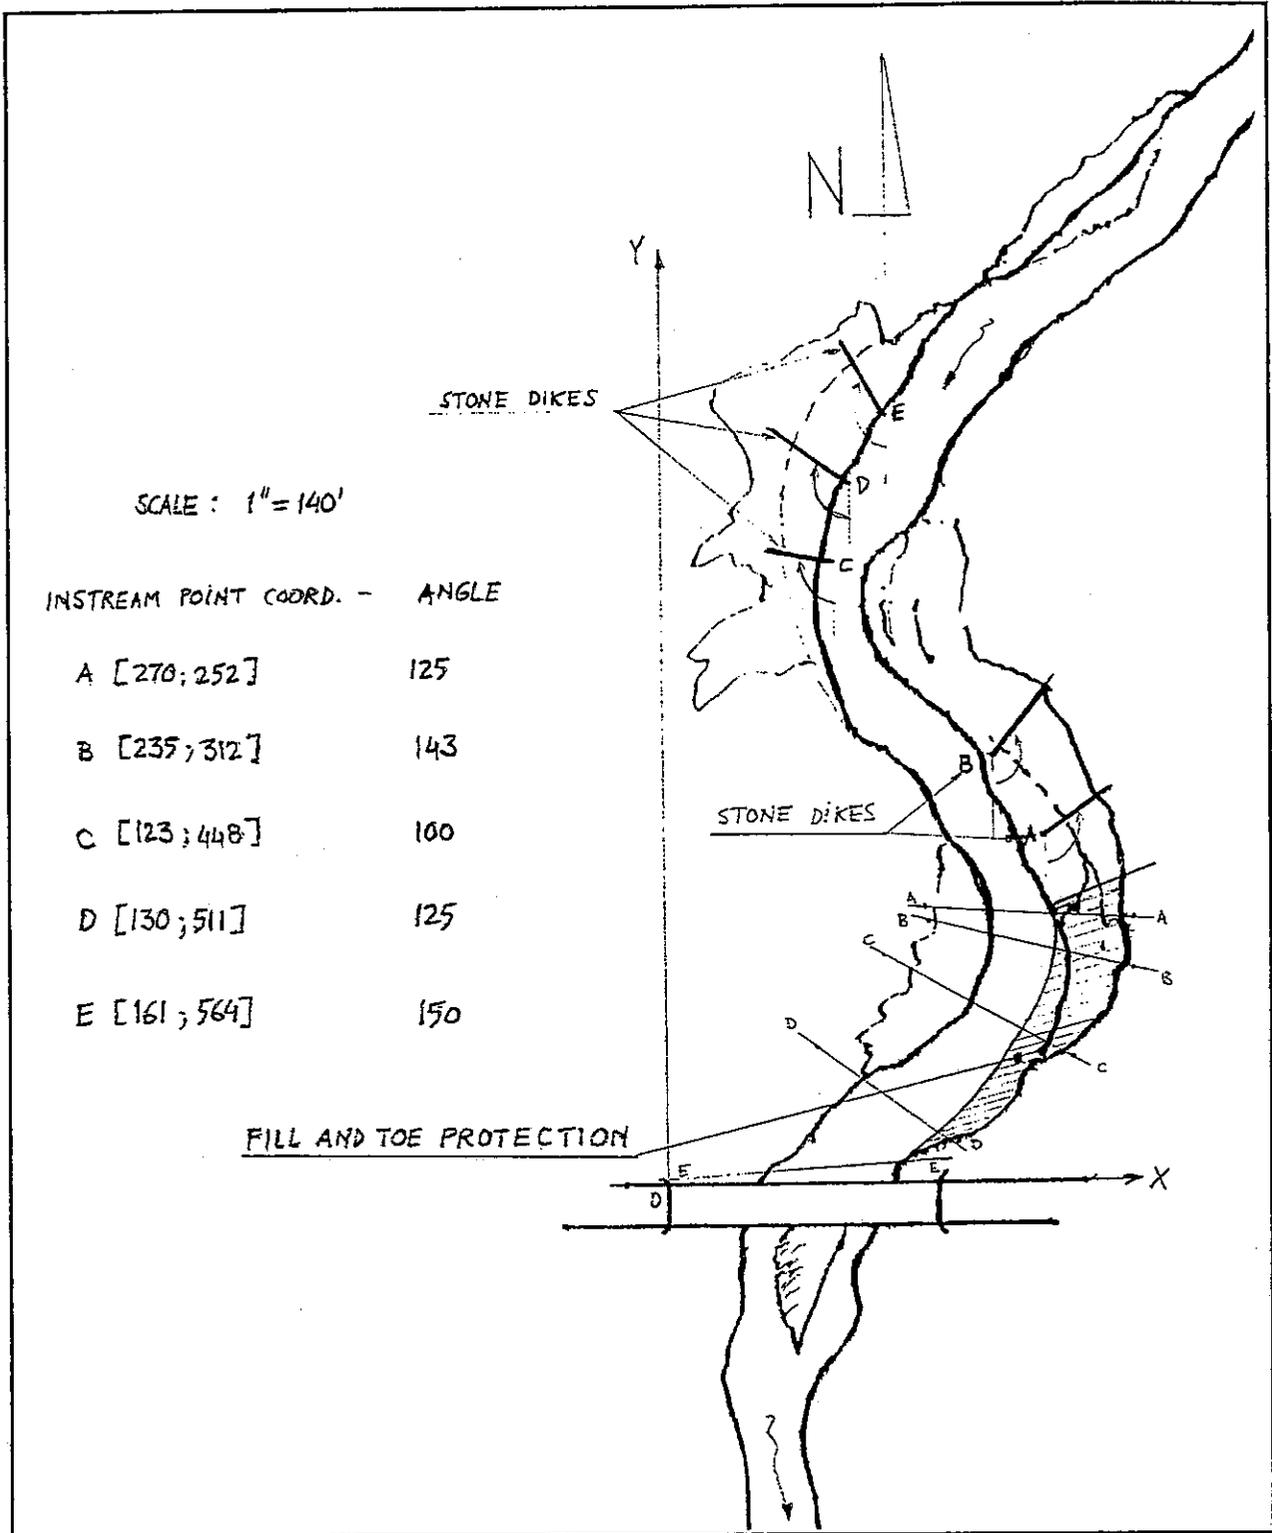
Figure 7-3. Piasa Creek alternative 1 design overview (aerial photo trace - 1994).

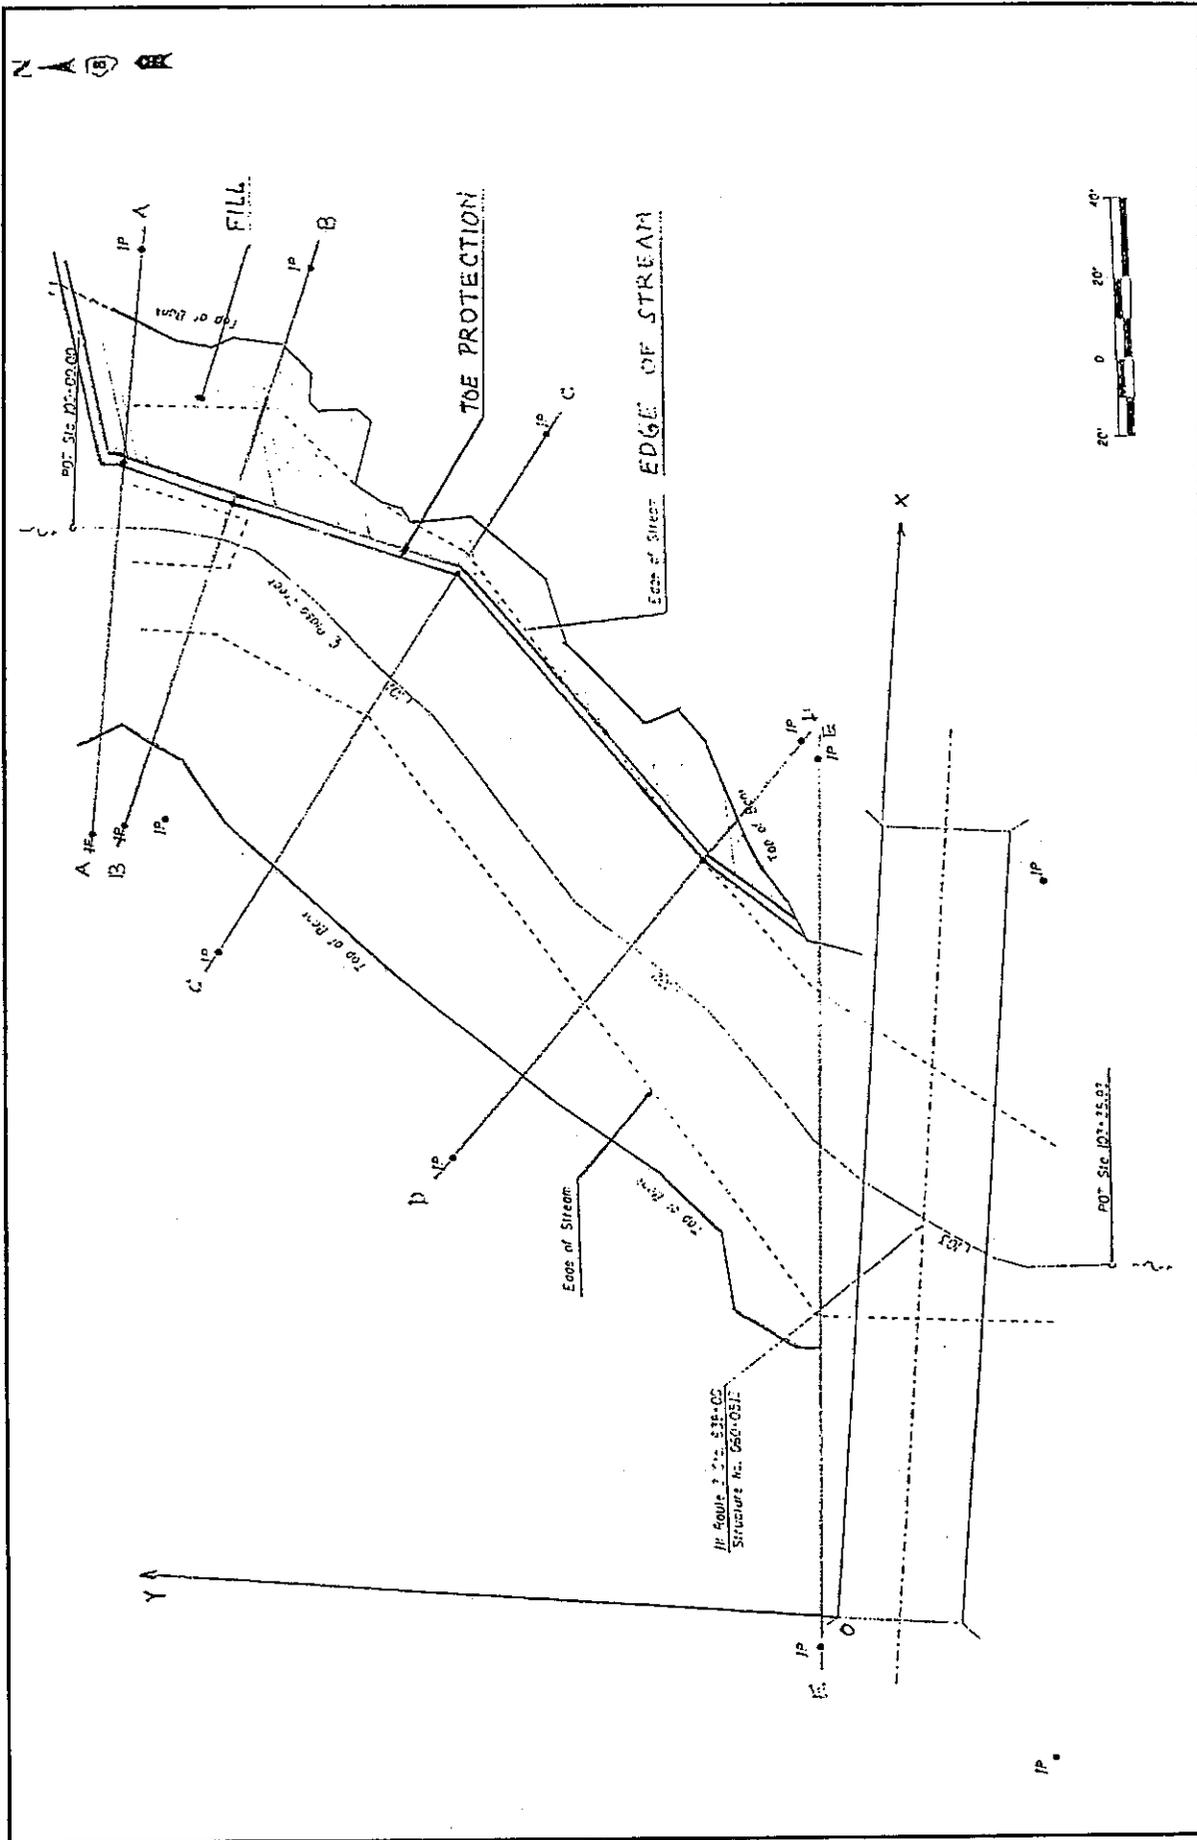
Figure 7-4. Piassa Creek site alternative 1 design schematic (plan view).

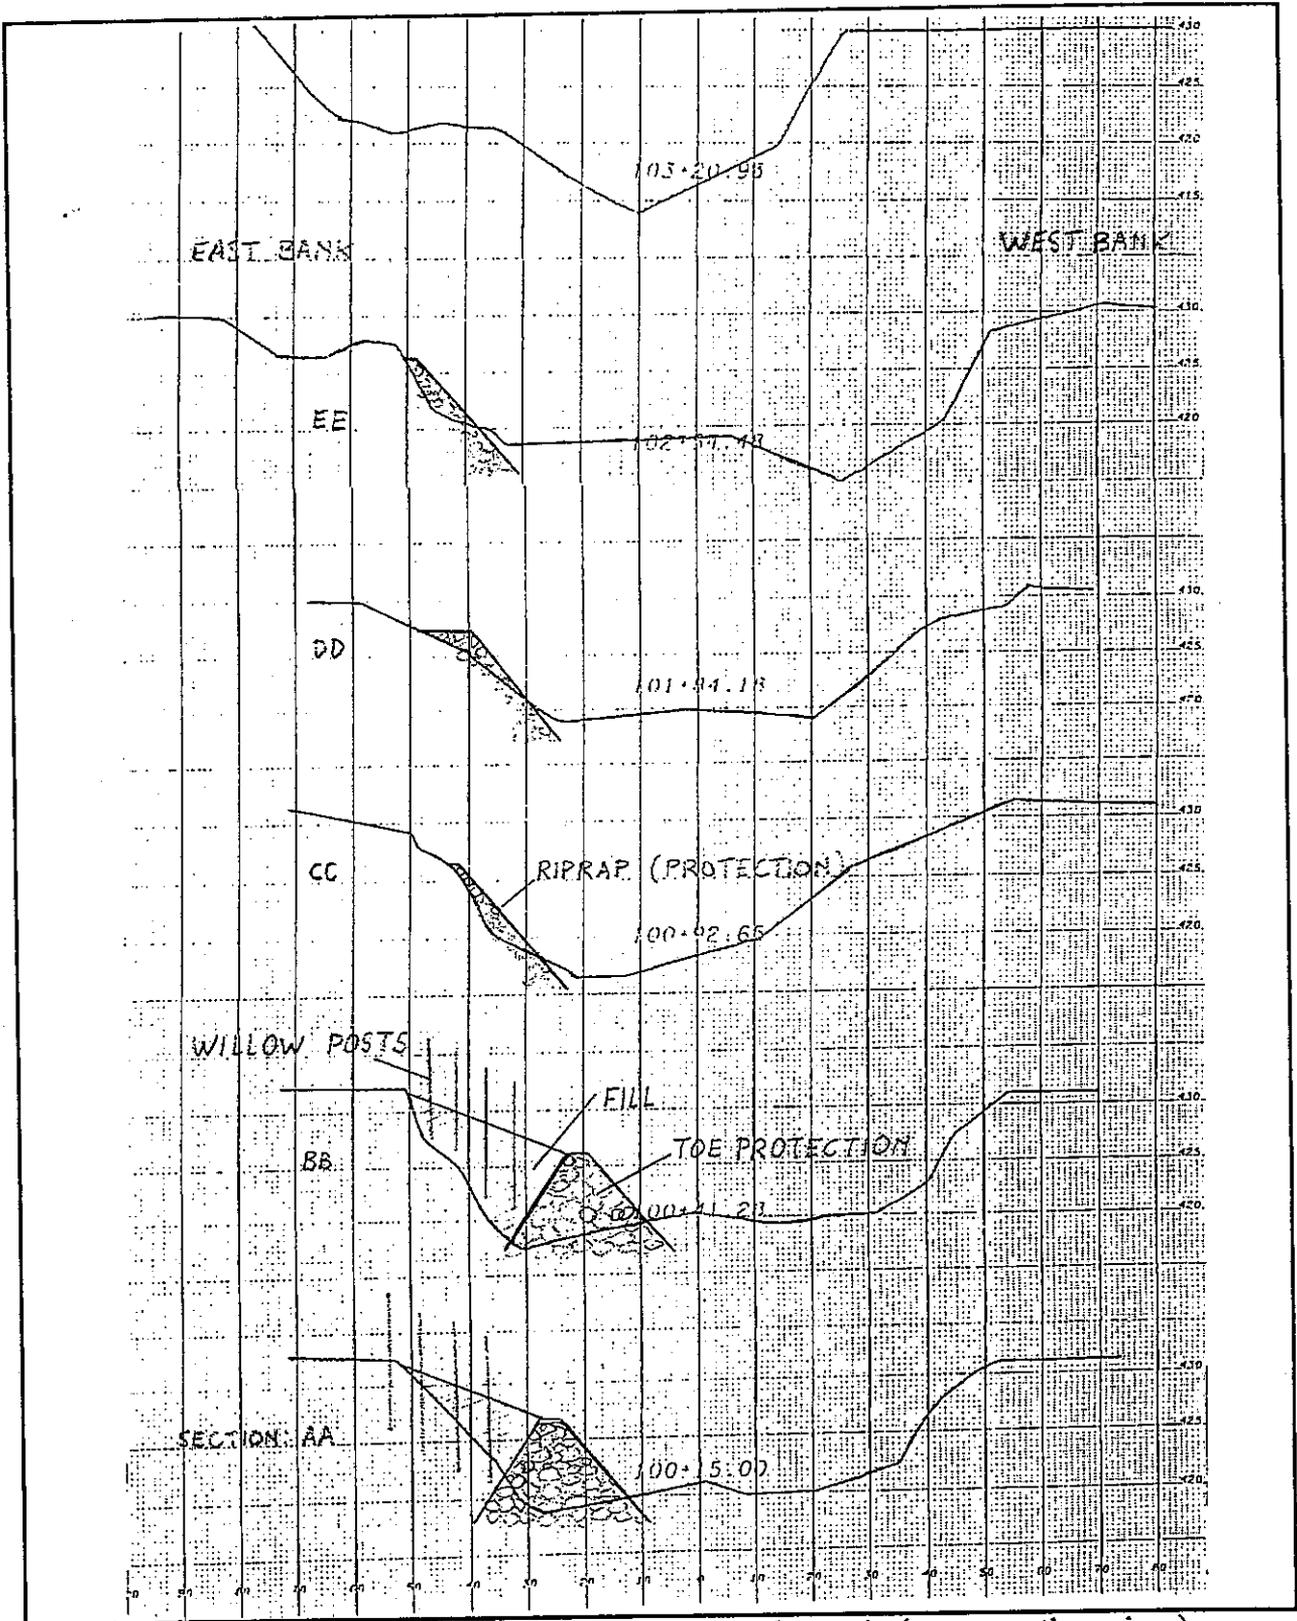
Figure 7-5. Piasa Creek site alternative 1 design schematic (cross-section view).

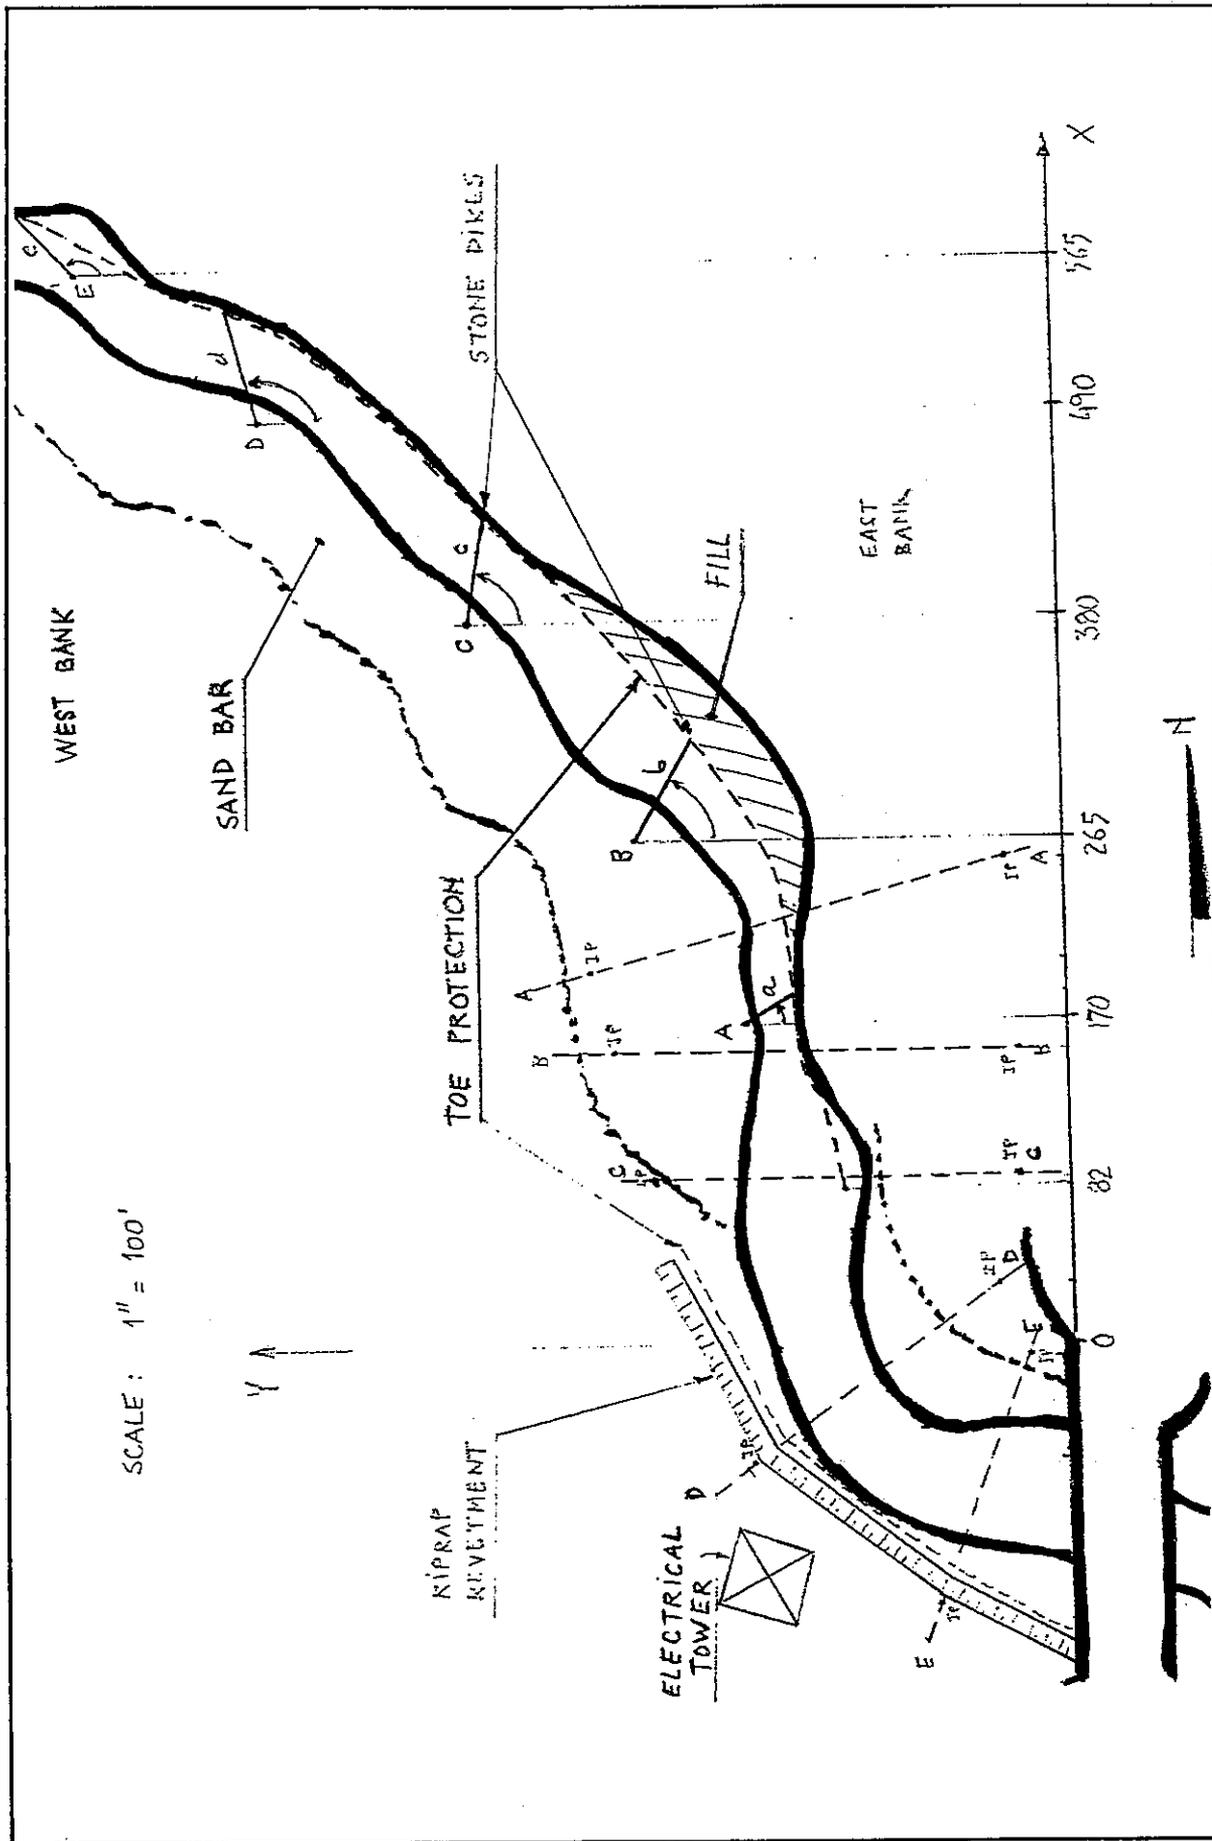
Figure 7-6. Senachwine Creek alternative 1 design overview (aerial photo trace - 1994).

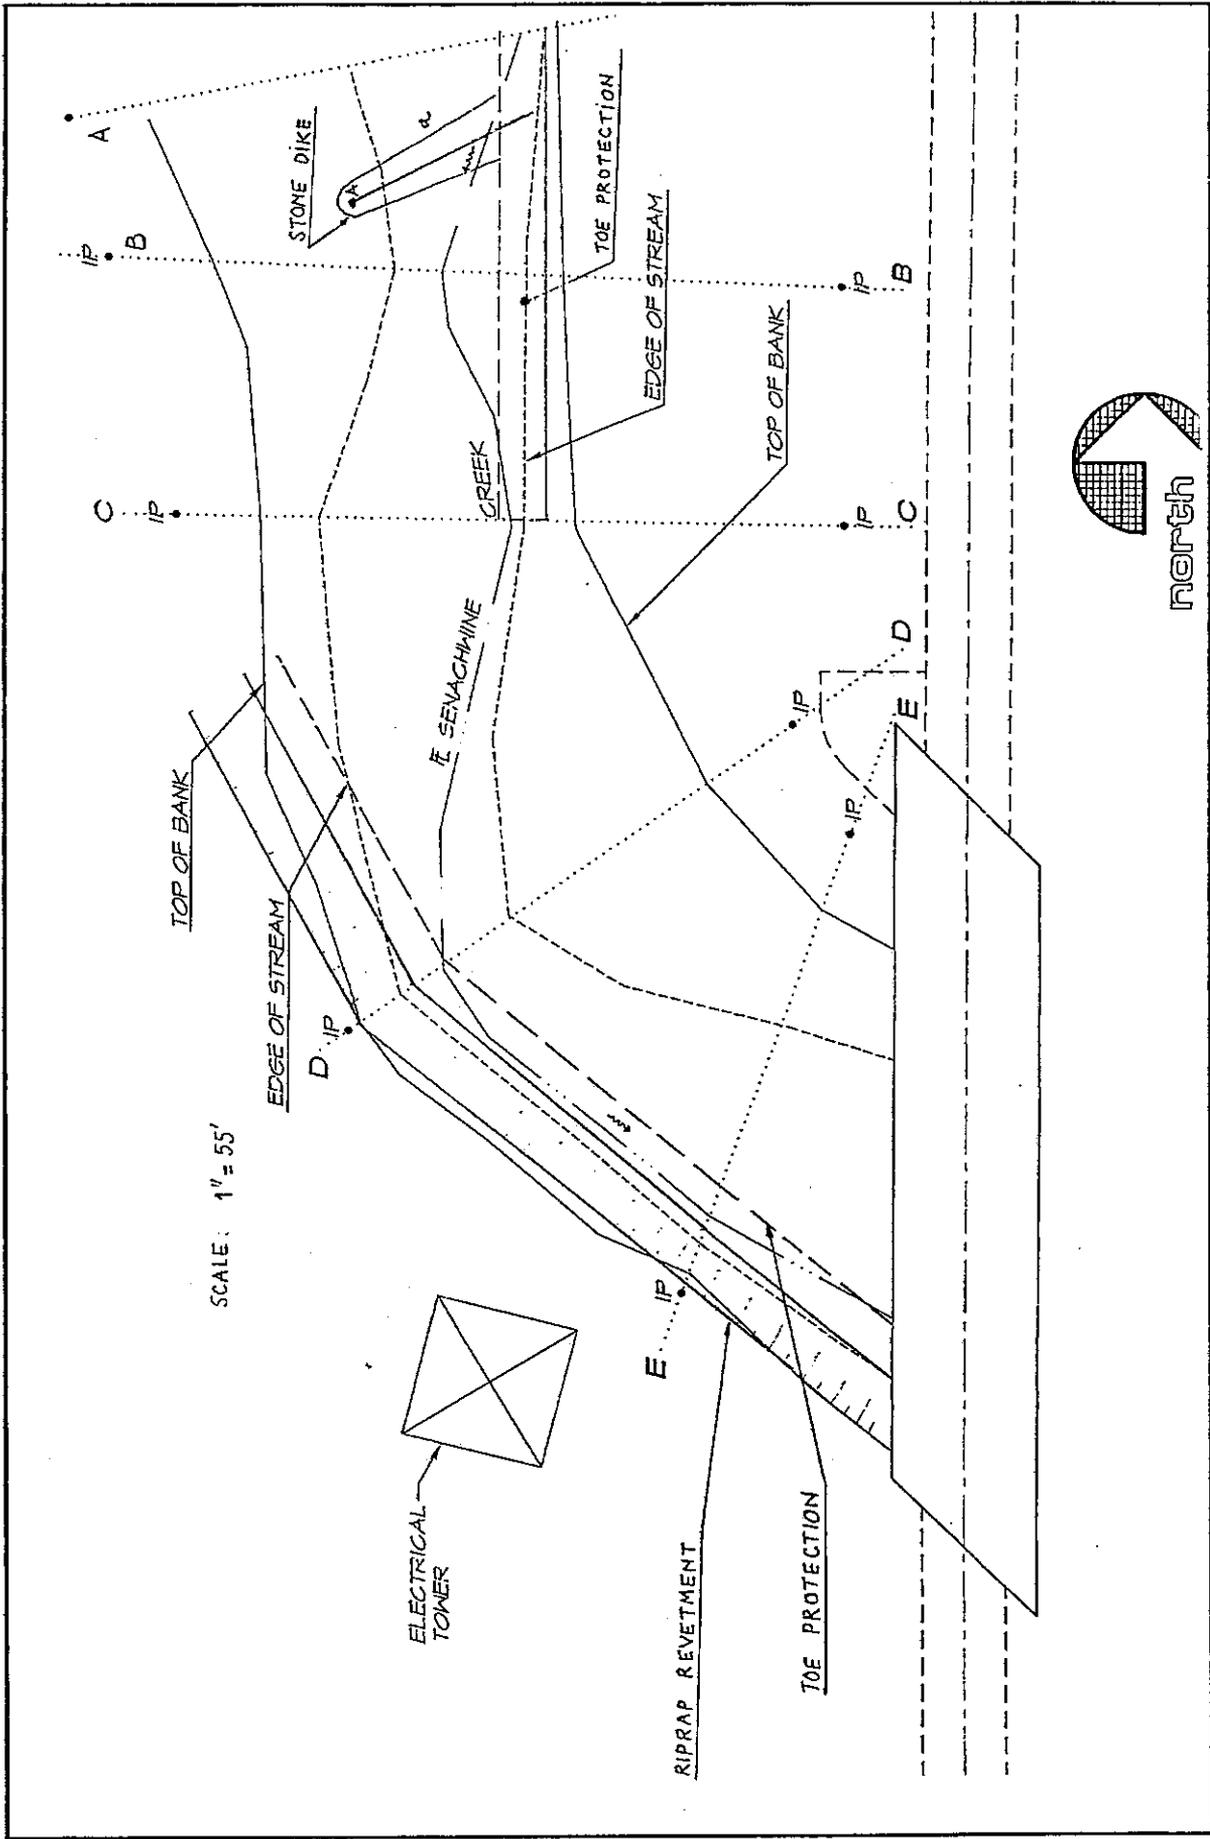
Figure 7-7. Senachwine Creek site alternative 1 design schematic (plan view).

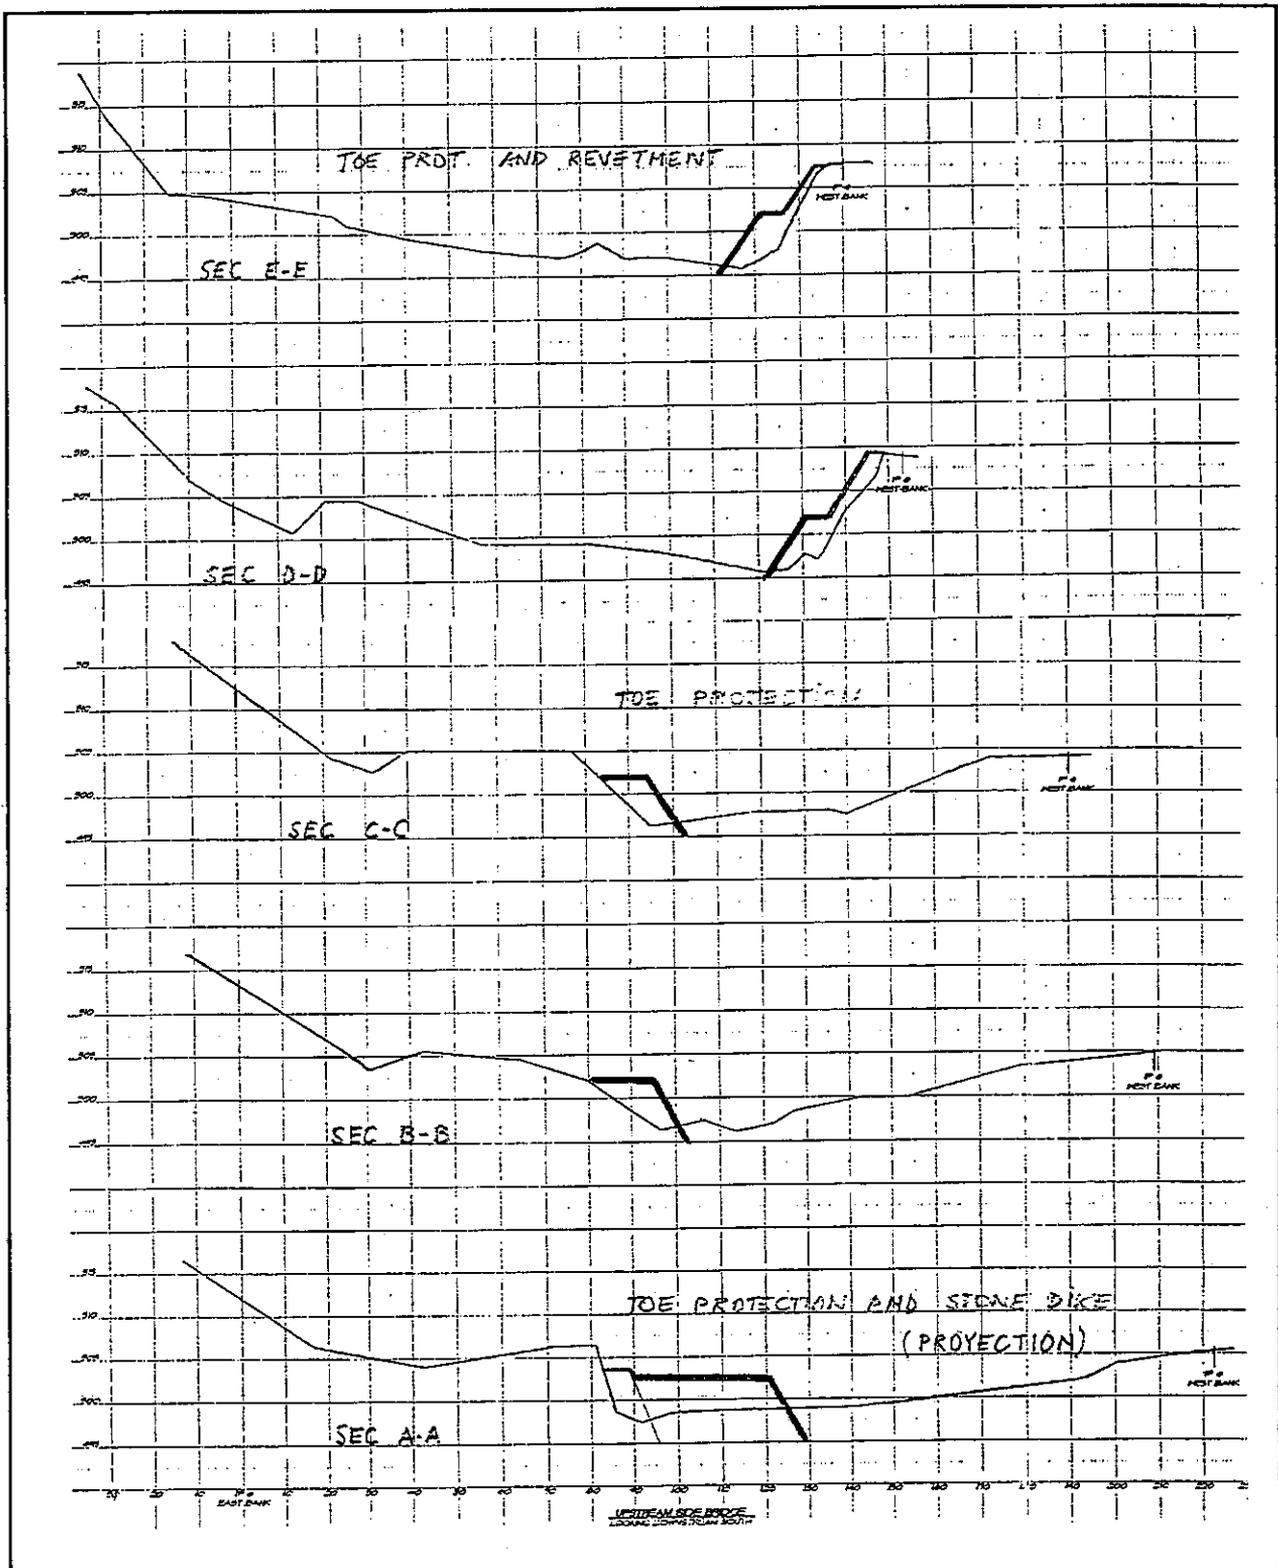
Figure 7-8. Senachwine Creek site alternative 1 design schematic (cross-section view).

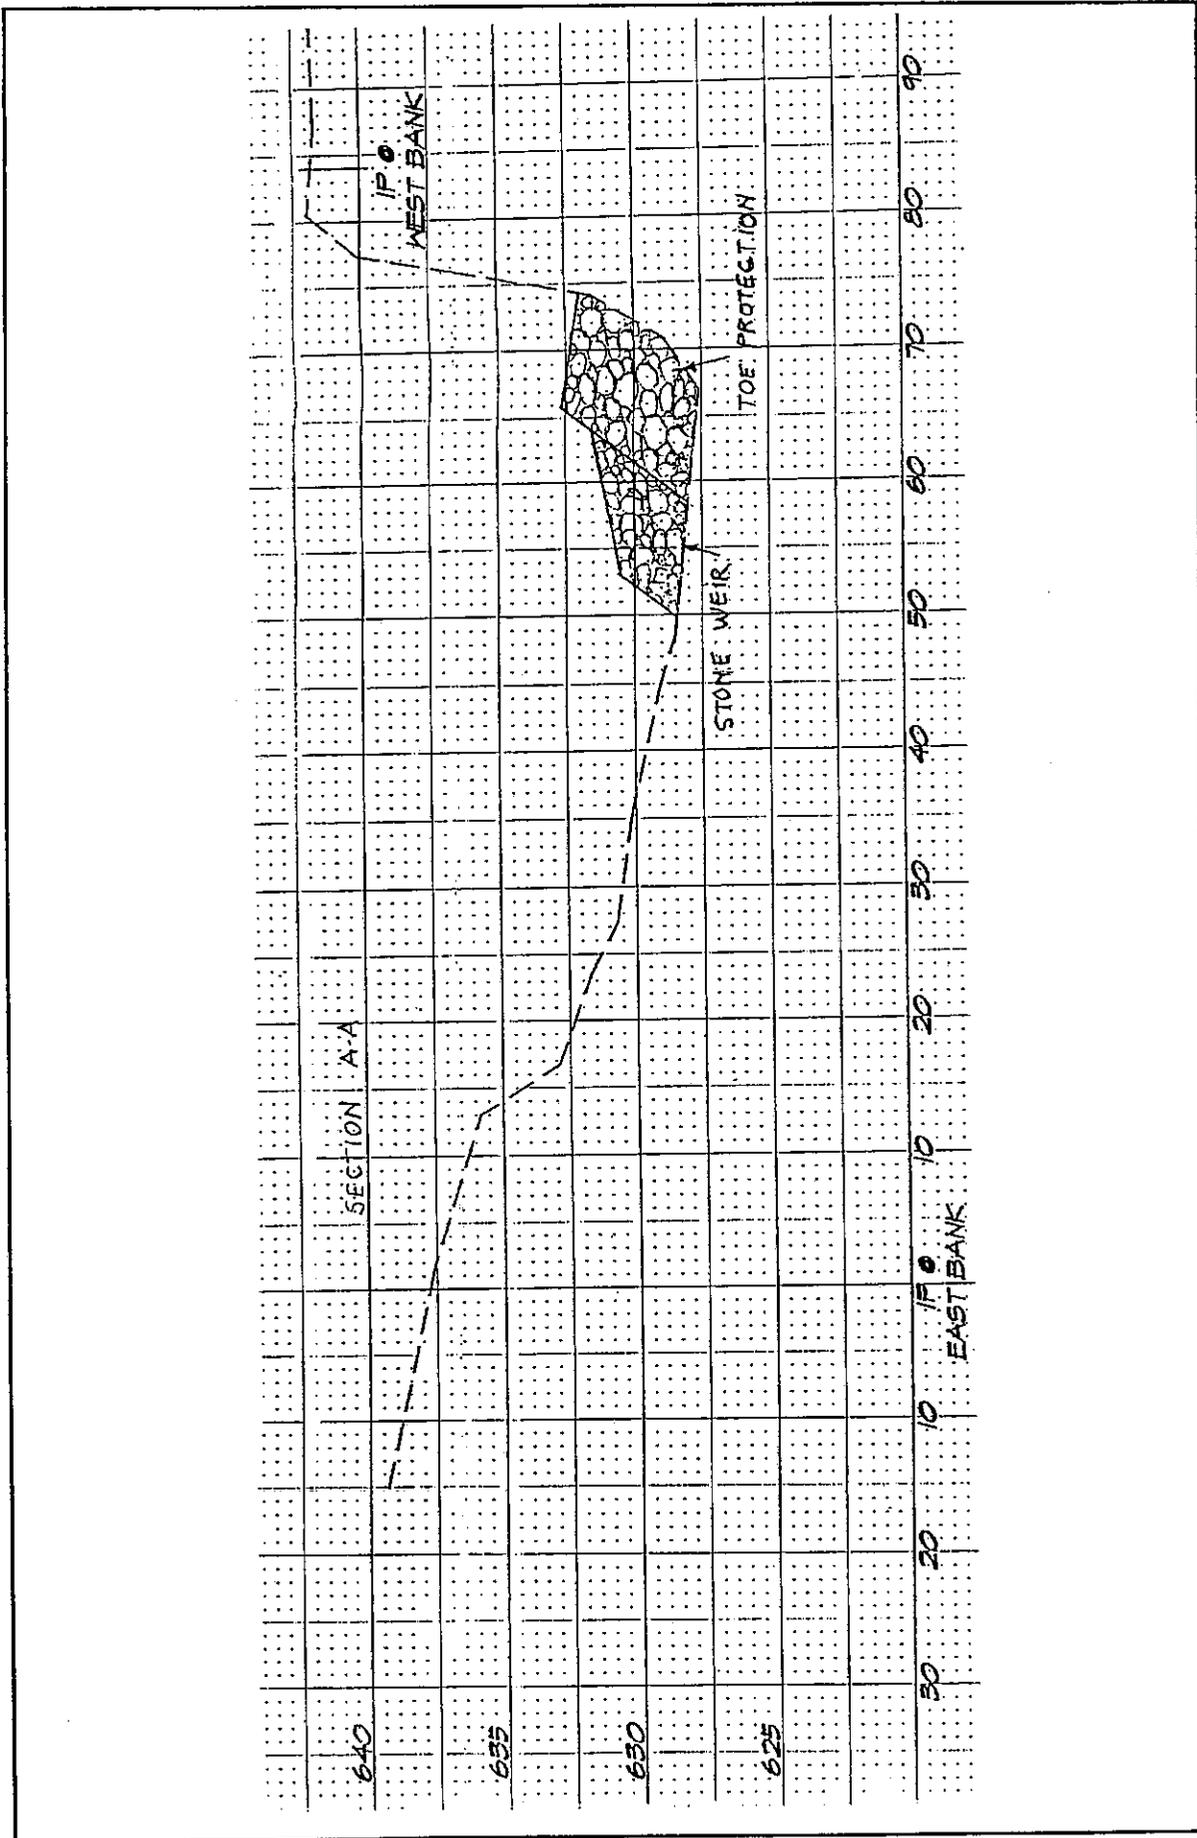
Figure 7-10. Spoon River alternative 1 protection design - typical cross-section (Section AA).

* Alternative 3 - Either riprap OR willow post toe protection.

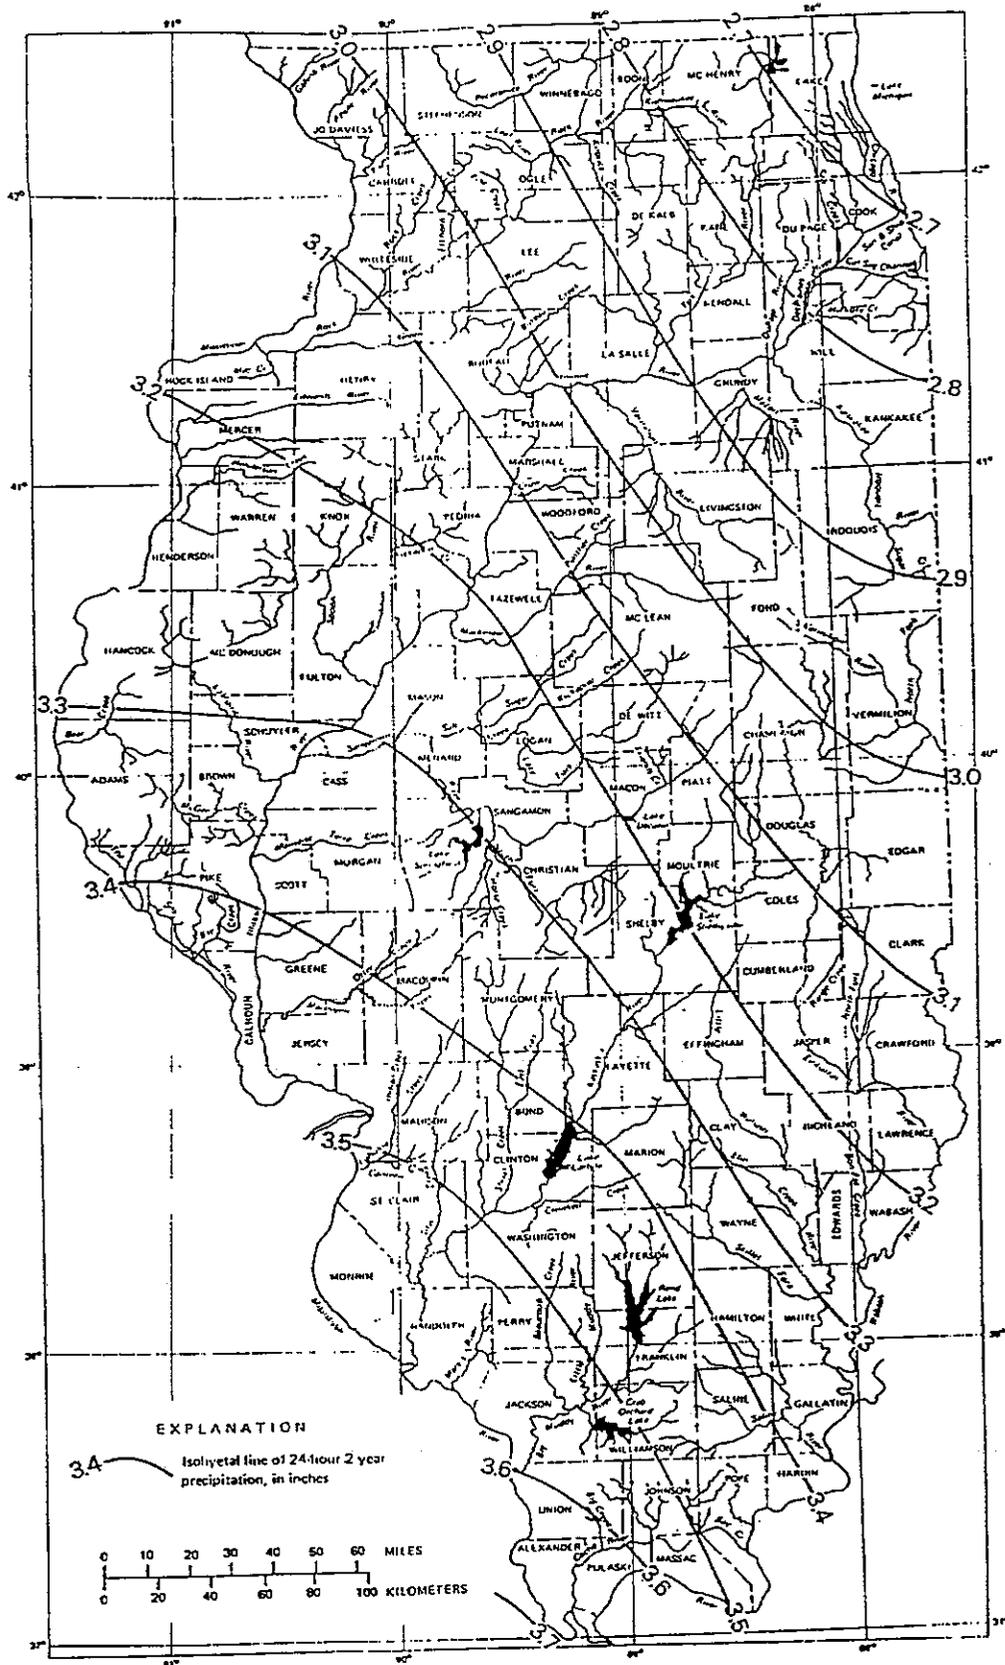
Figure 3.--Distribution of rainfall intensity (24-hour 2-year) I, in inches, in Illinois (modified from Hershfield, 1961).
