Evaluation of Reflective Crack Control Policy

Project IA-H1, FY95/96

Report No. ITRC FR 95/96-4

Illinois Transportation Research Center

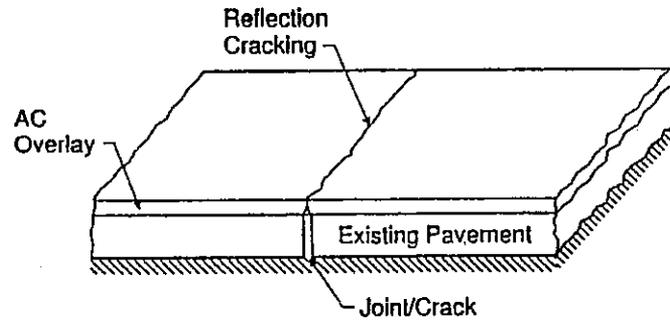
Figure 1.1. Reflection Cracking in Asphalt Overlays (After Mukhtar and Dempsey, 12)

When an overlay is placed on existing pavement, physical tearing of the overlay takes place as a result of movement at the joints and cracks in the underlying pavement layer (Figure 1.1). Reflection cracking has occurred in nearly all types of overlays. When an asphalt concrete overlay is placed over an existing pavement surface, the former is fully bonded with the latter. Any movement taking place in the underlying pavement at its joint/crack will produce stresses in the overlay and can cause physical tearing if the stresses in the overlay exceed its tensile strength. There are three common modes of failure associated with joint/crack movements. These three movements at the crack interface are shown in Figure 1.2. Horizontal movement of the slab is the most common mode of reflection cracking. It is usually temperature associated and causes tensile stresses to develop in the overlay. Vertical movement is primarily load induced and leads to shear stresses in the overlay. Parallel movement is less common and occurs only under laterally unstable conditions.

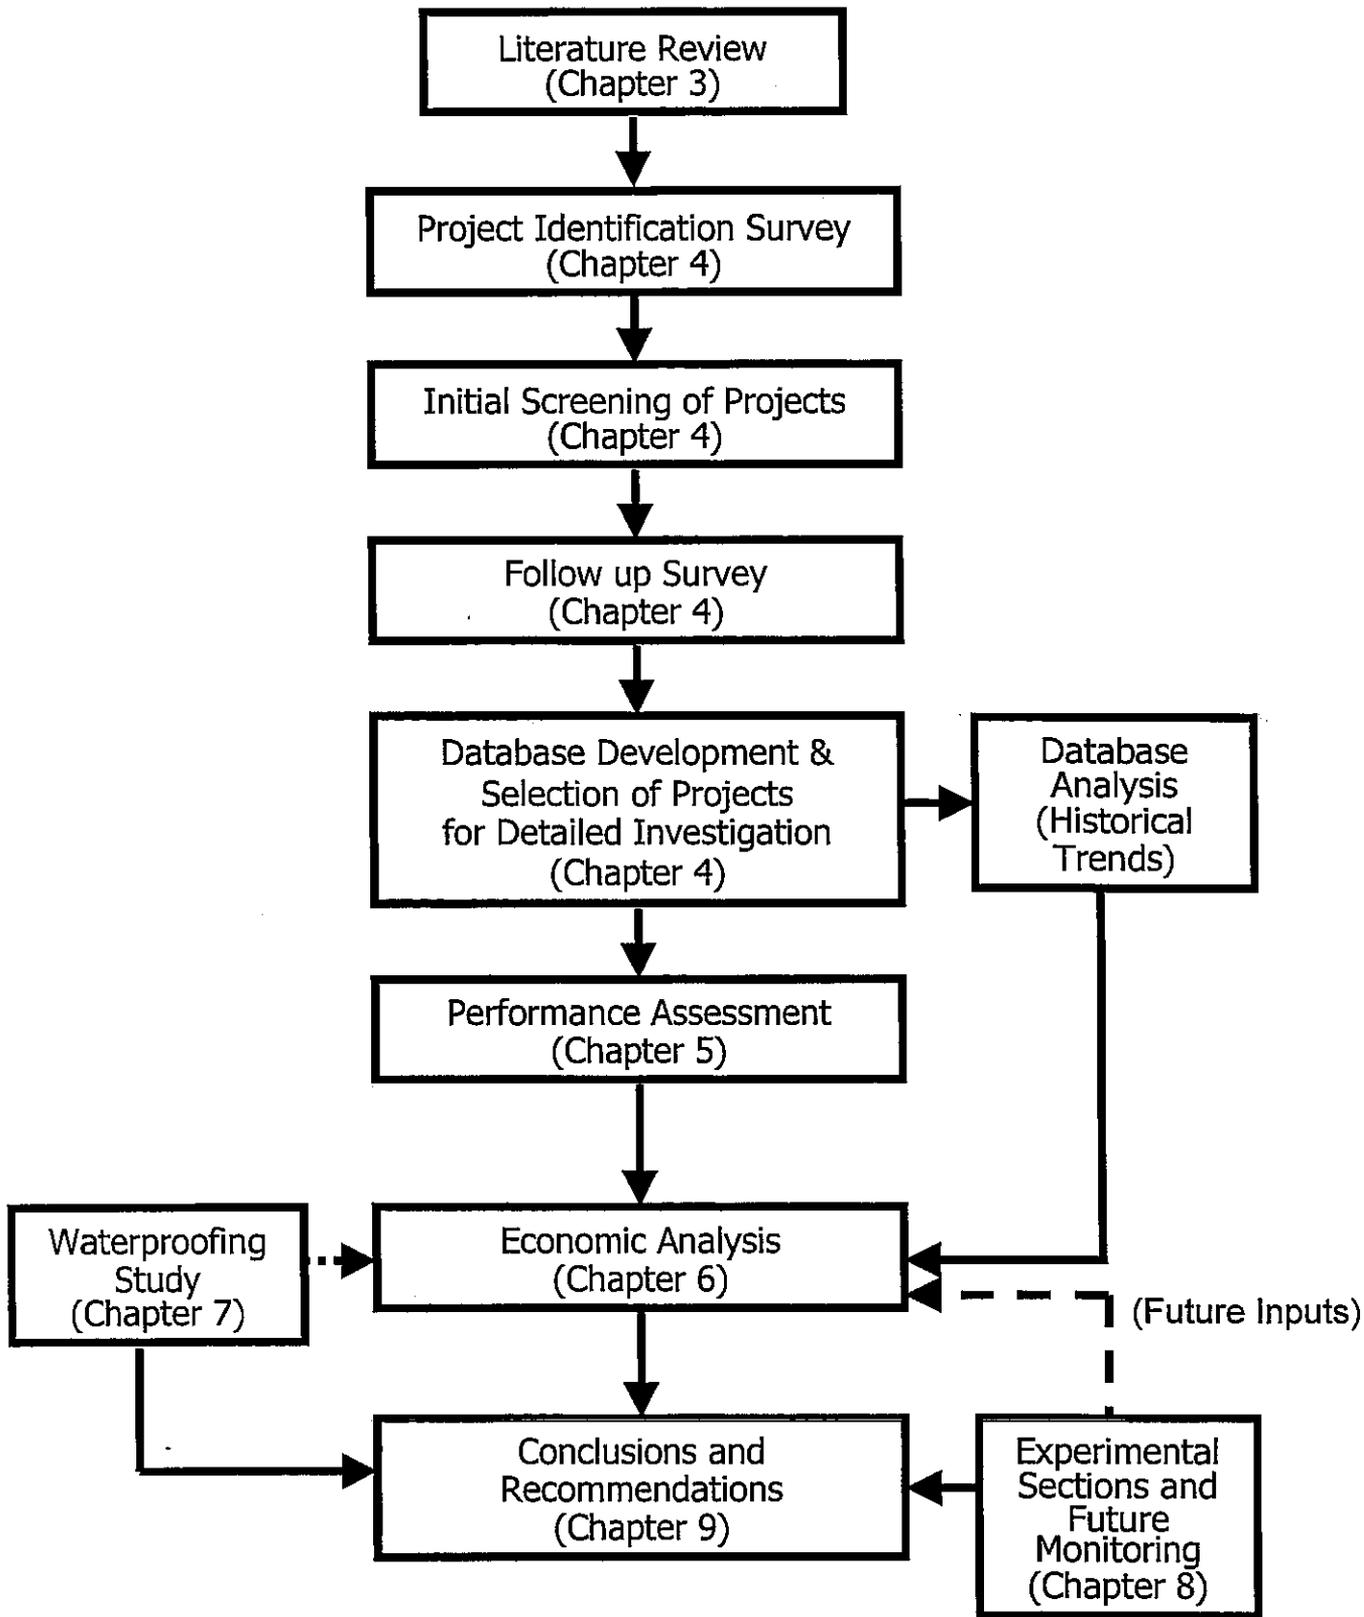
Figure 2.1. Research Approach

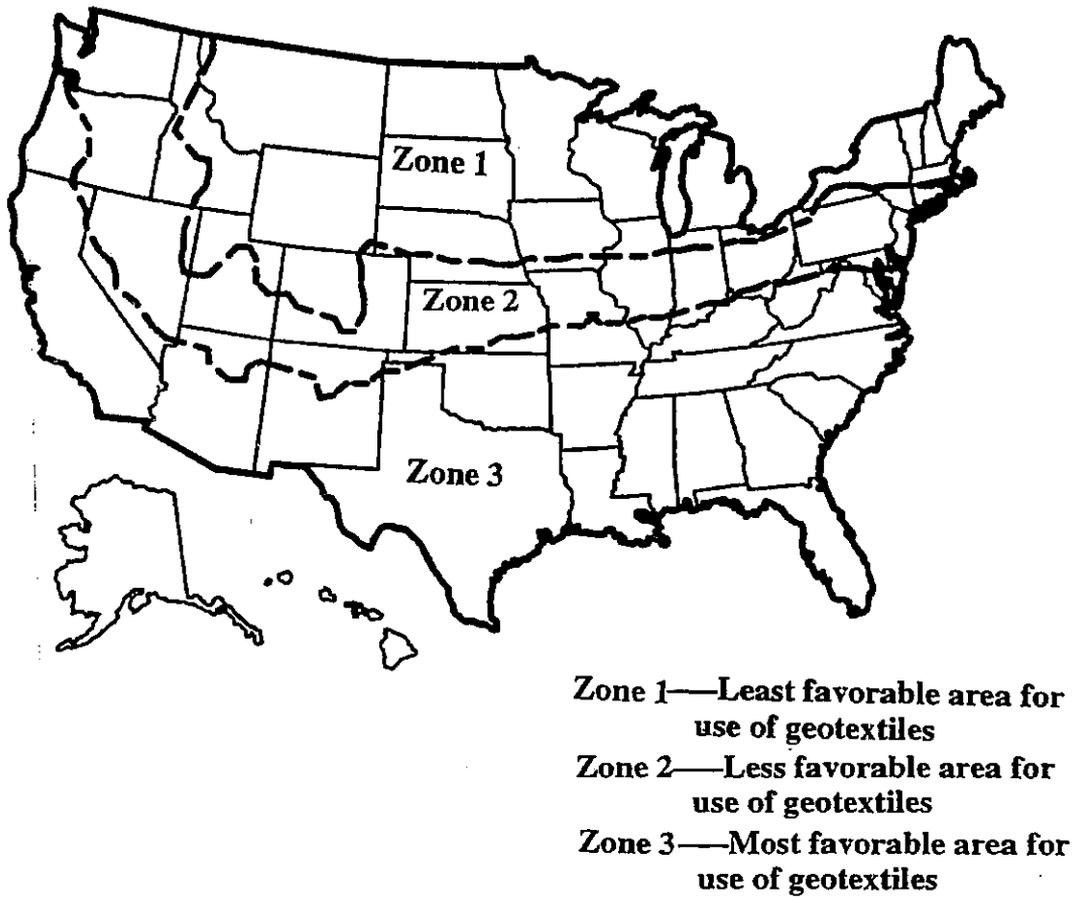
Figure 3.1. Climatic Zones and Expected Benefit of Reflective Crack Control Treatments (After Tyner et al., 19)

In cold climates, pavements tend to contract, causing thermal openings in rigid pavement slabs at joints and cracks. When horizontal joint movements are less than 0.03 inches (0.76 mm), Lytton (4) determined that reflective crack control is not required. This condition would occur, for instance, in the case of a continuously reinforced concrete pavement with closely-spaced, tight cracks. For horizontal joint movements in the range of 0.03 inches (0.76 mm) to 0.07 inches (1.78 mm), paving fabrics will potentially reduce reflective cracking, according to Lytton. For horizontal movements larger than 0.07 inches (1.78 mm), or when vertical movements are present, fabrics are not effective in preventing reflection cracks from occurring. The latter conditions are akin to most of the rigid pavements in Illinois' state road system, many of which are approaching or have exceeded their design lives. Paving fabrics placed over these pavements should therefore not be expected to reduce the appearance of reflective cracking. However, other benefits, such as waterproofing, might prevail after reflective crack appearance. Thus, it is necessary to monitor the performance and to determine the life-cycle costs of these systems to evaluate their true benefits.

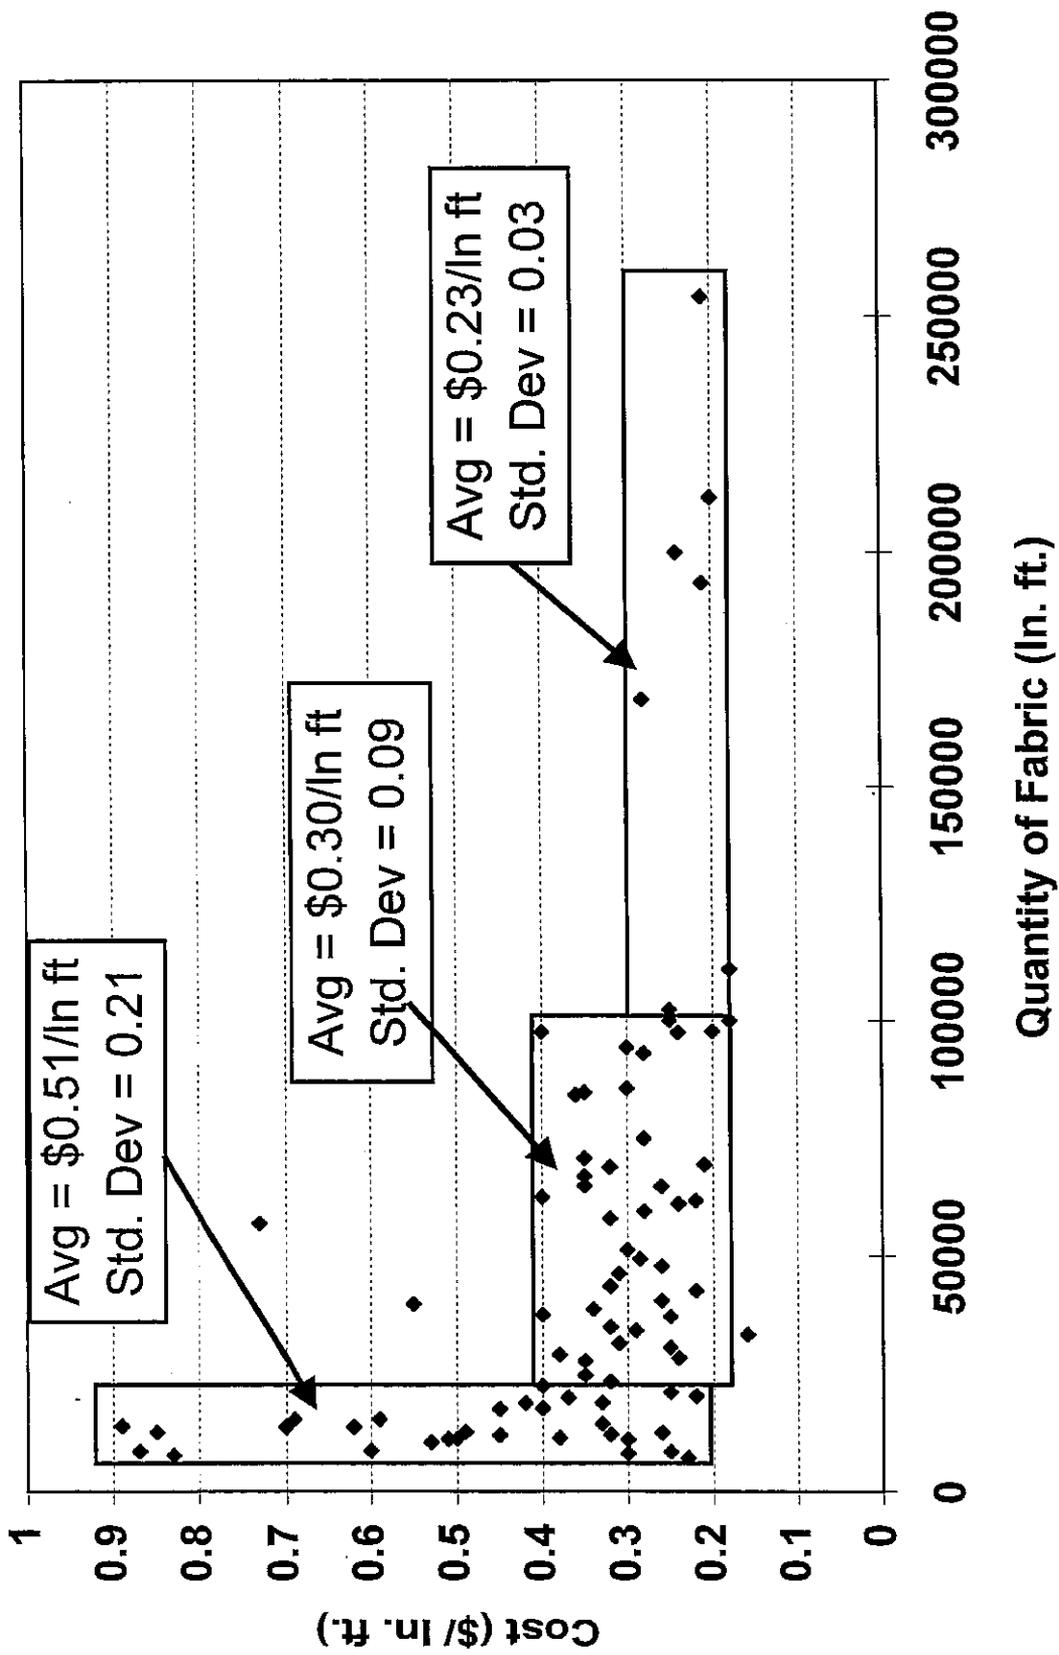
Figure 4.2. Average Installed Cost of Strip Reflective Crack Control Treatment Versus Quantity

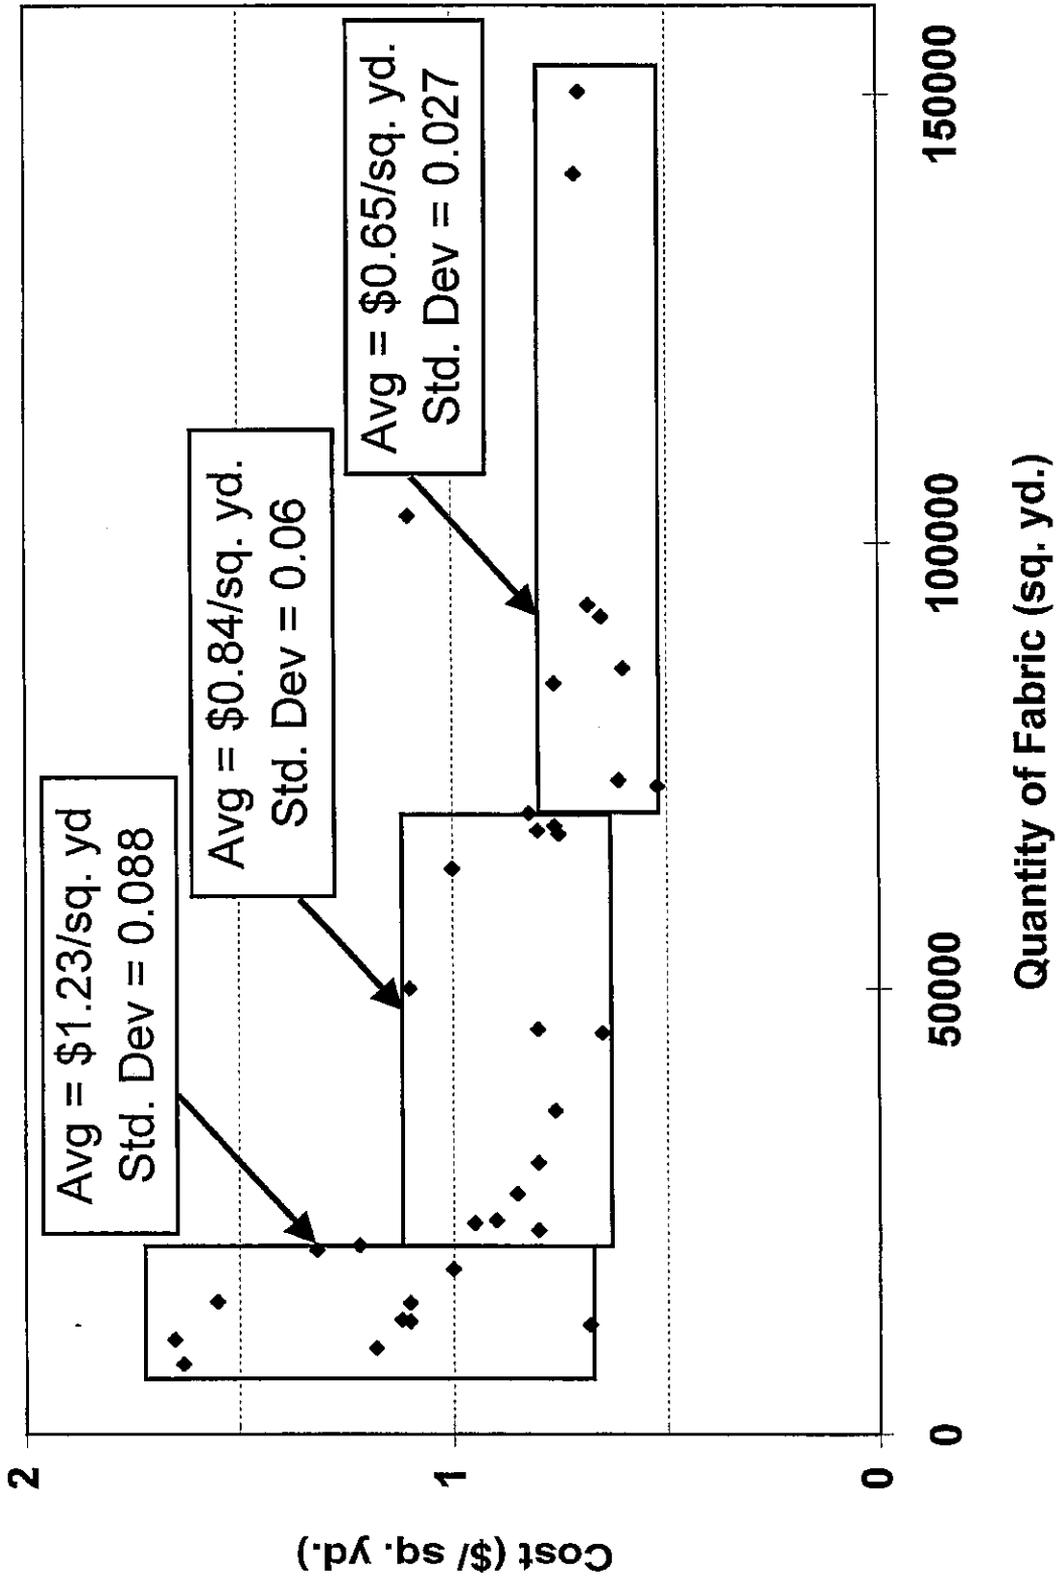
Figure 4.3. Average Installed Cost of Area Reflective Crack Control Treatment Versus Quantity

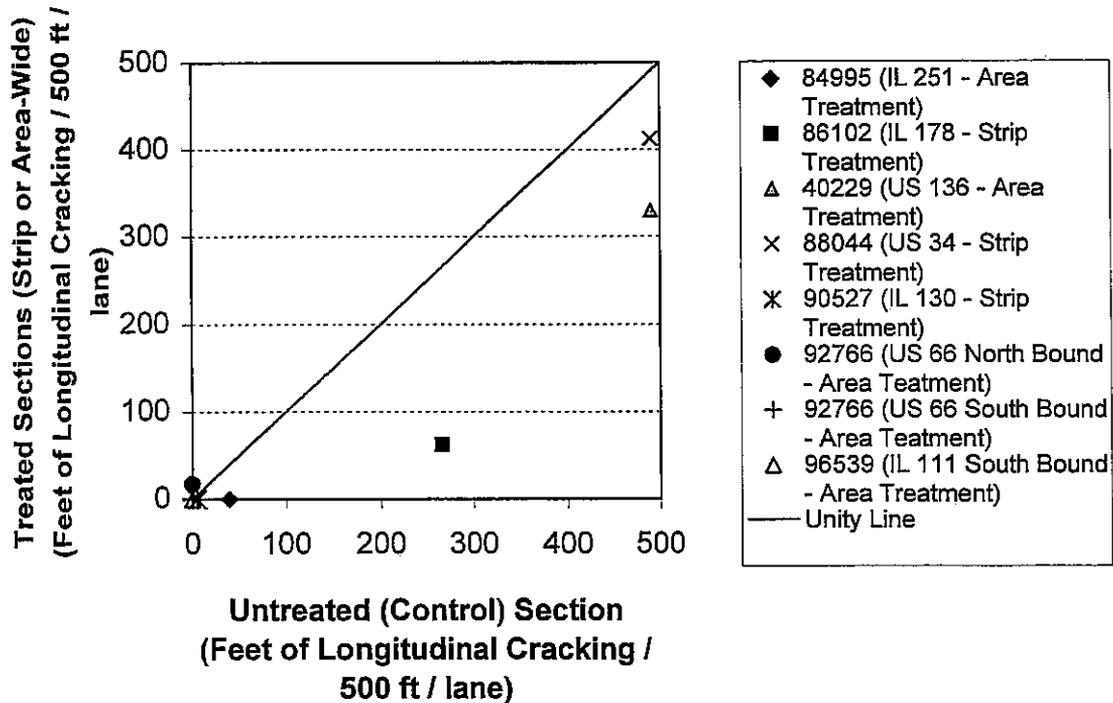
Figure 5.1. Comparison of Reflective Widening Crack Development: Treated Versus Untreated Sections

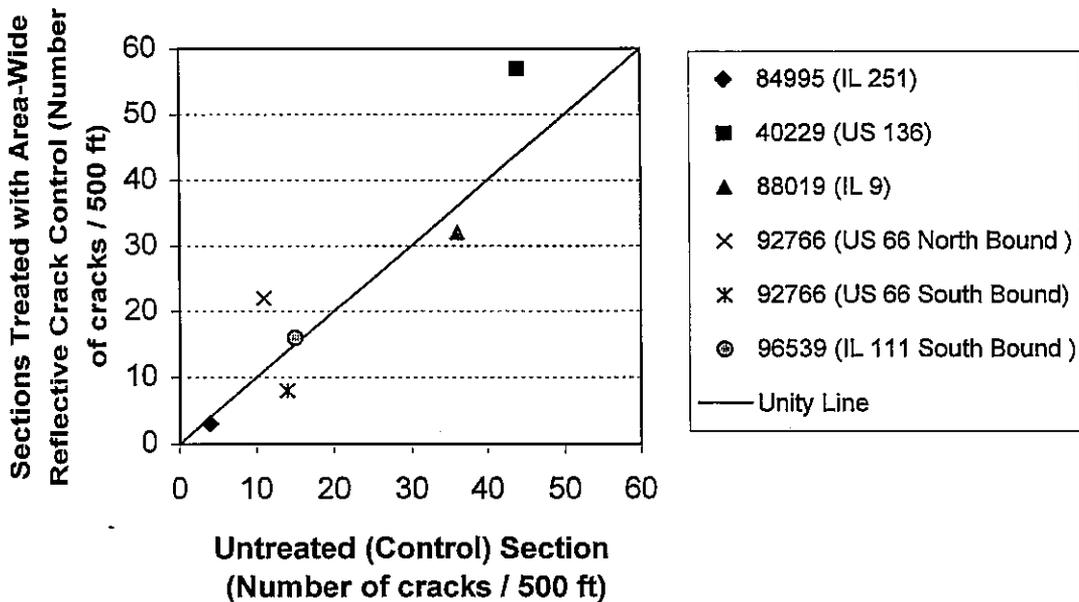
Figure 5.2. Comparison of Transverse Crack Development: Treated Versus Untreated Sections

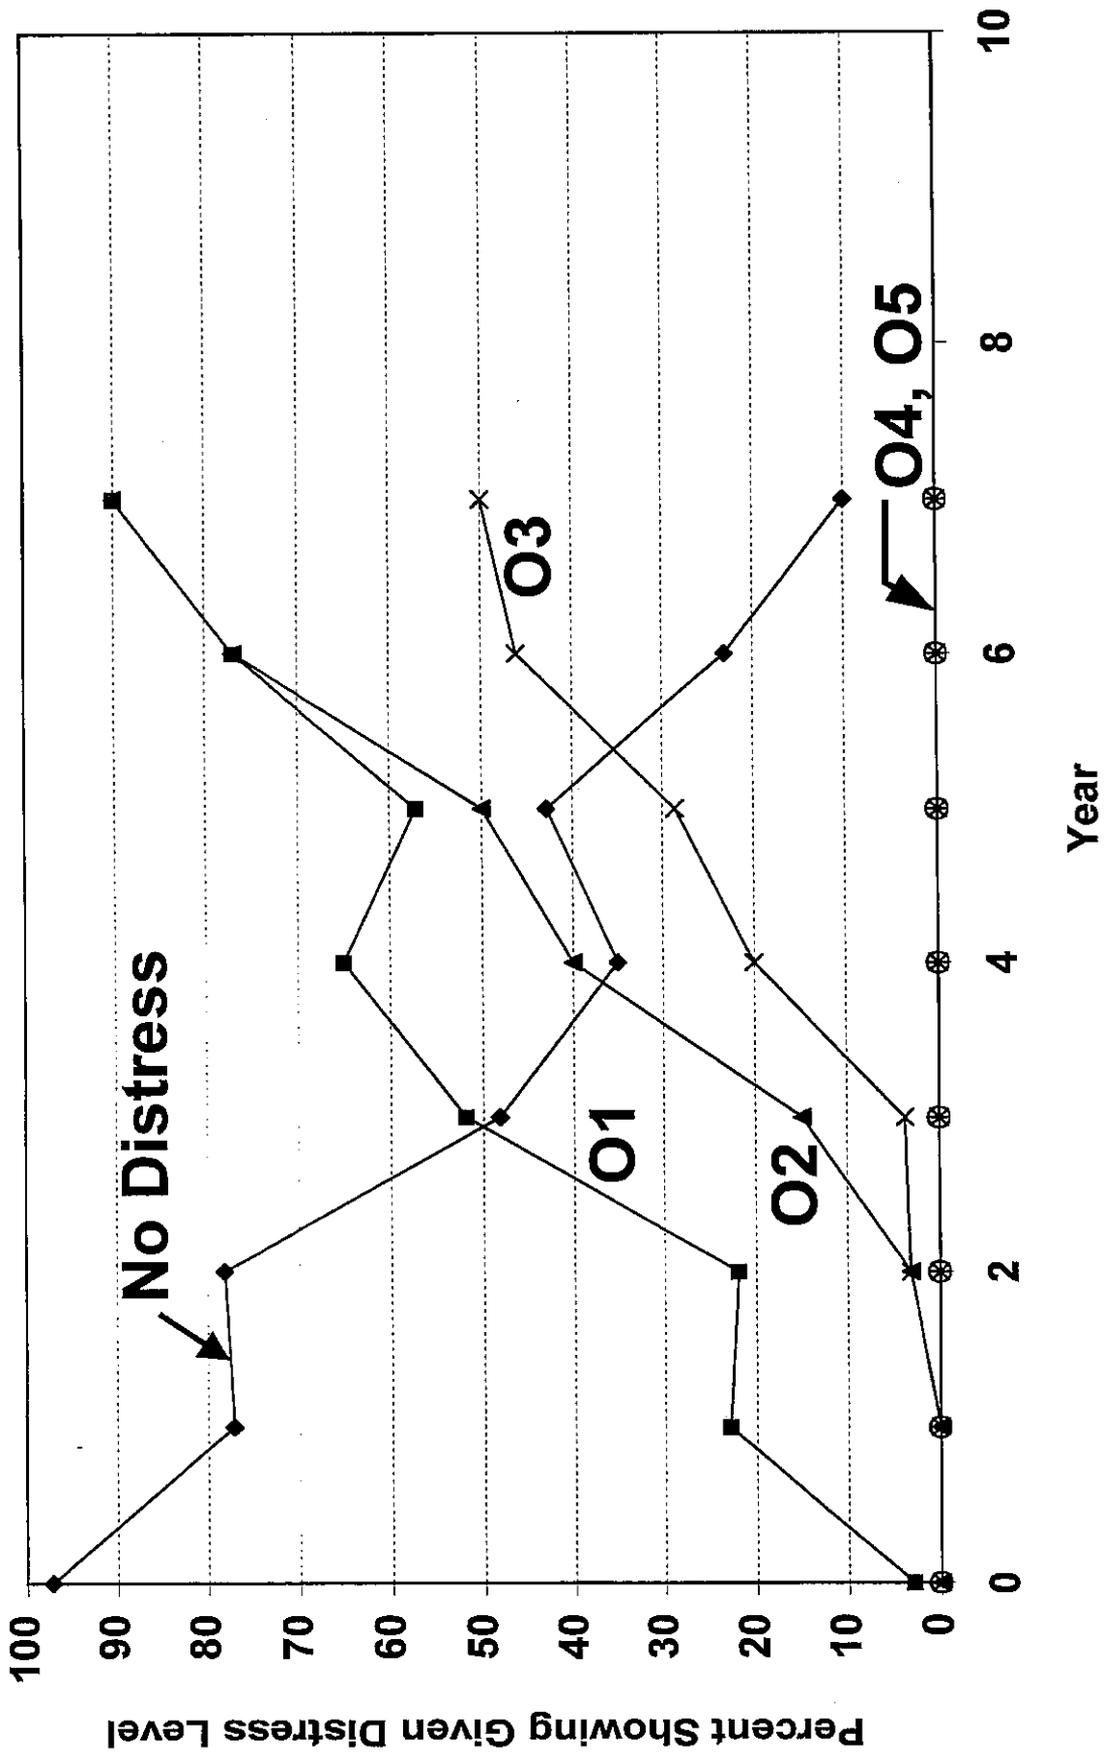
Figure 5.3. Performance Curve for Transverse Reflective Cracking, Original Raw Data

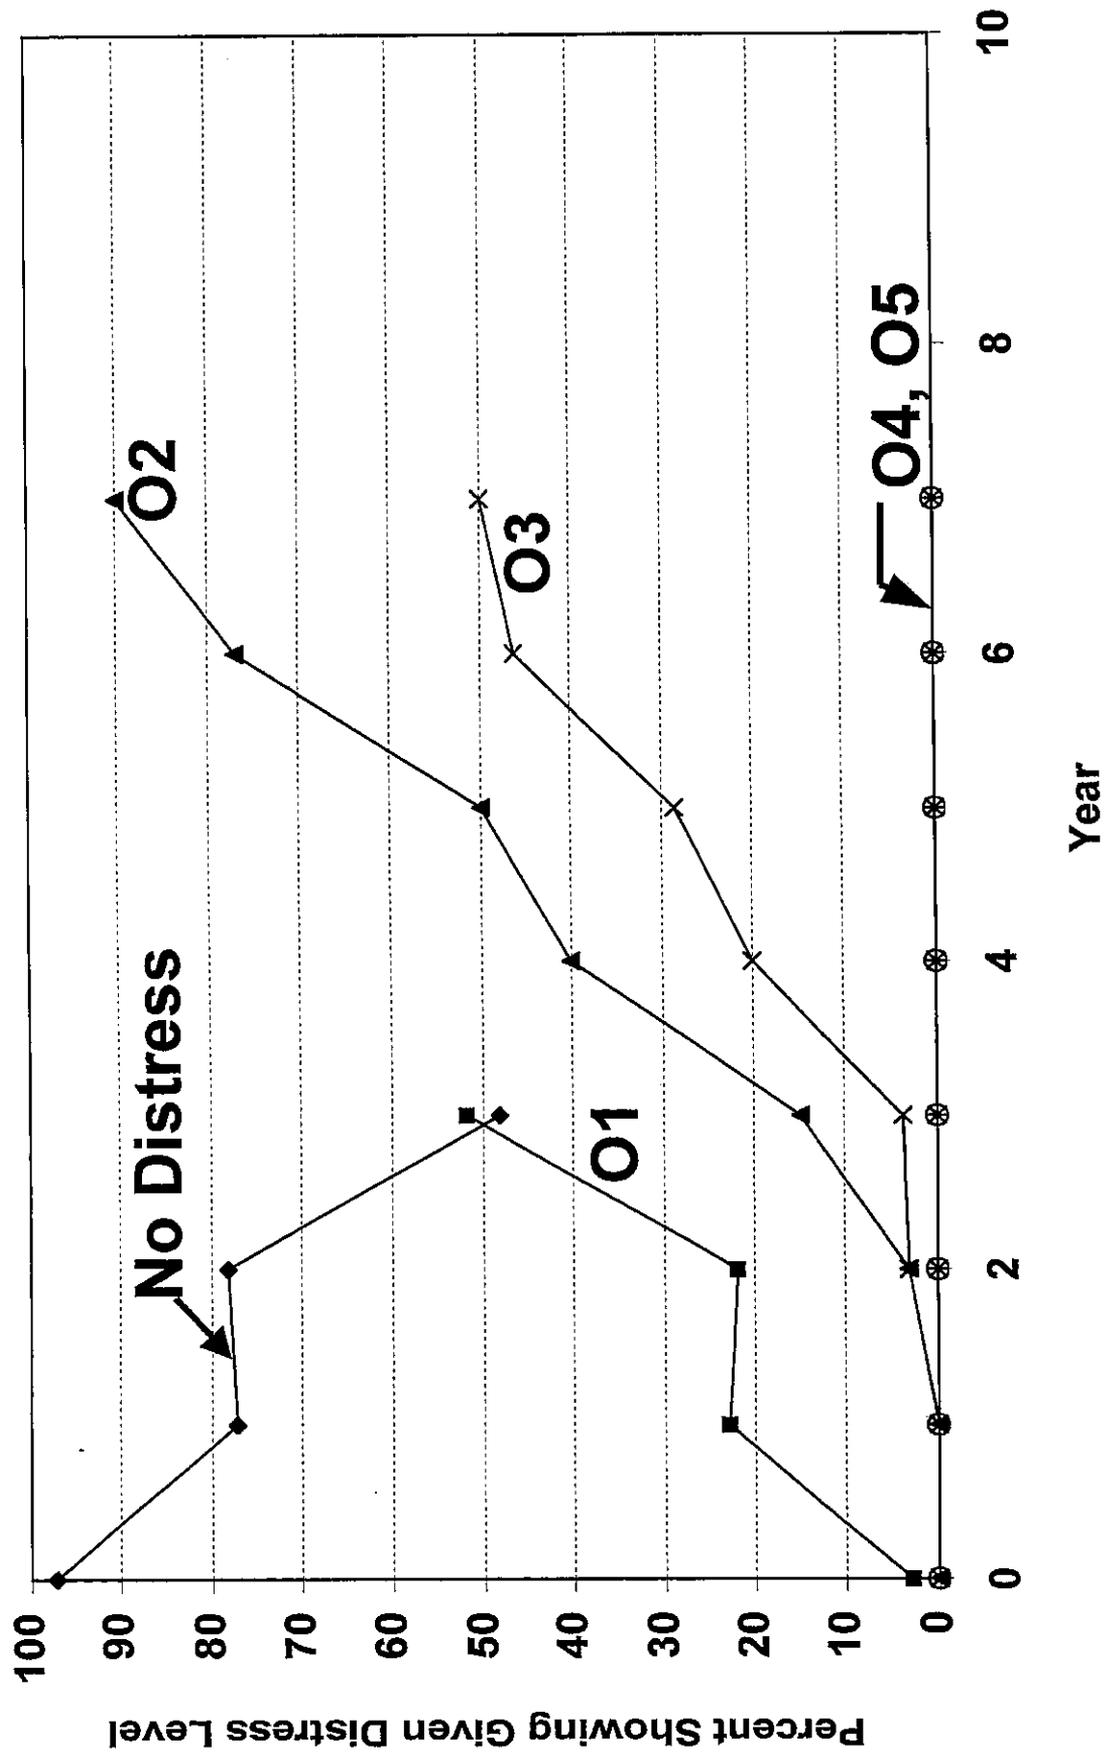
Figure 5.4. Performance Curve for Transverse Reflective Cracking, After Truncating

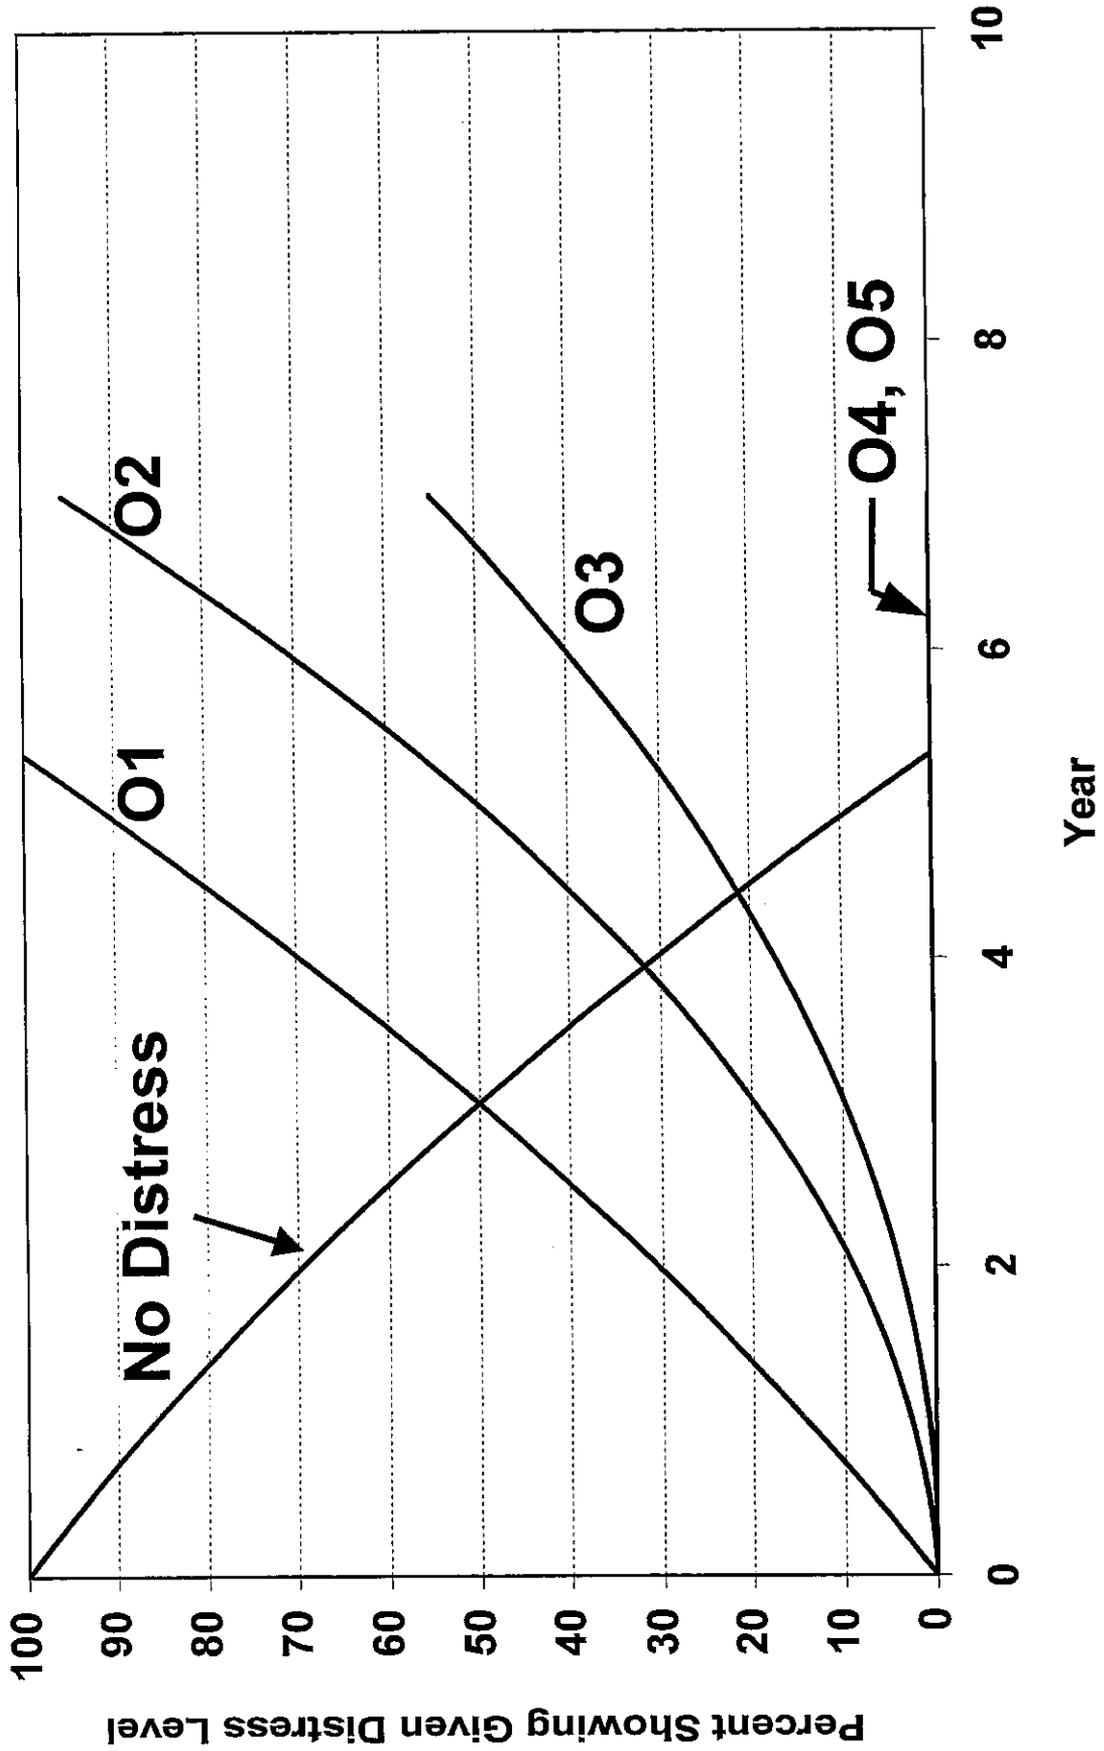
Figure 5.5. Performance Curve for Transverse Reflective Cracking, Showing Fitted Polynomial Trend Lines

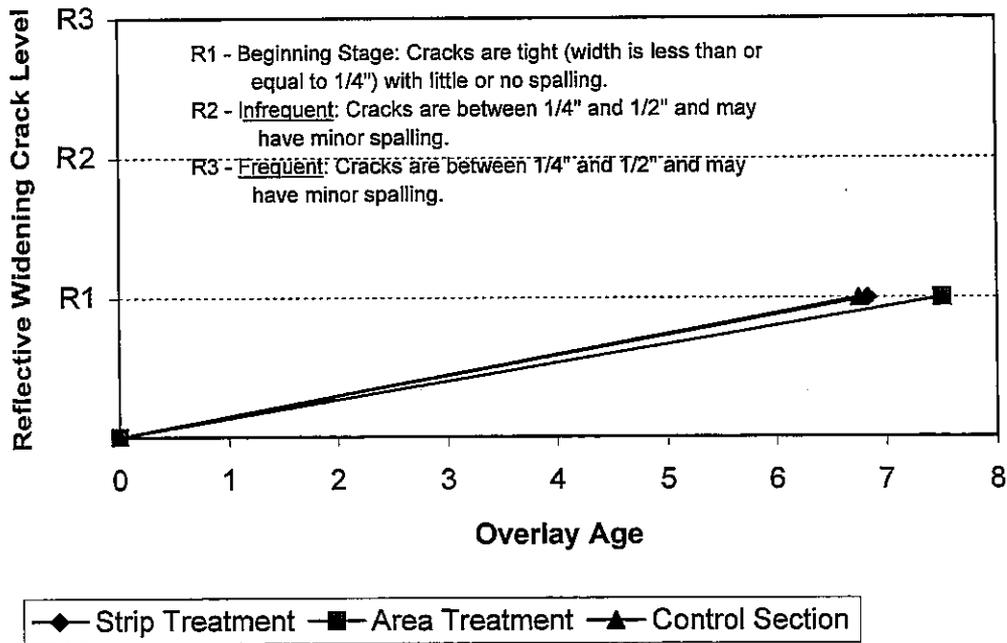
Figure 5.6. Median Overlay Age to Reach Various CRS - Based Distress Levels: Reflective Widening Crack

Figures 5.6 and 5.7 present a concise and useful summary of the data presented in Appendix E. These figures indicate that very little difference in transverse and longitudinal reflective cracking is found to exist between treated and untreated sections, based upon CRS results. In terms of transverse cracking (Figure 5.7), this finding is in agreement with crack mapping results (Figure 5.2). Strip reflective crack control treatment placed over longitudinal joints is not intended or expected to retard transverse joint reflective cracking to an appreciable extent, so it would be unfair to compare the performance of strip treatment versus the control sections. Instead, the strip treated projects were conservatively considered as additional "control sections" for the evaluation of area treated projects, as indicated on Figure 5.7. Another useful piece of information that can be derived from this plot is that the median overlay ages for the development of O1, O2, and O3 distress levels is approximately 3, 5, and 7 years, respectively.

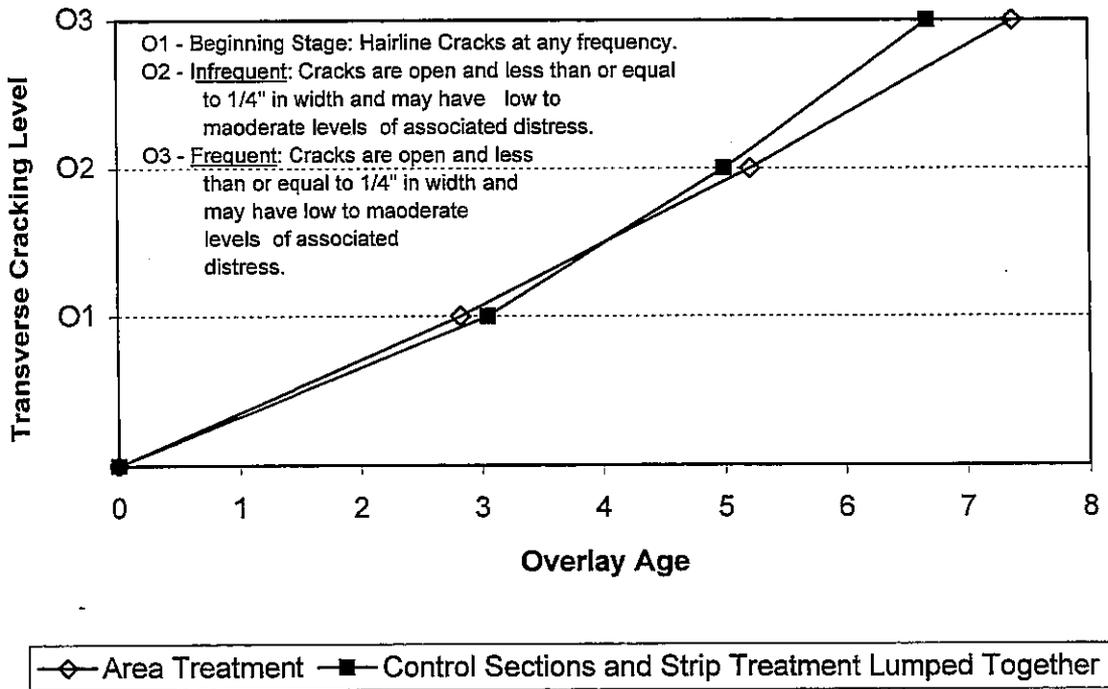
Figure 5.7. Median Overlay Age to Reach Various CRS - Based Distress Levels: Transverse Cracking

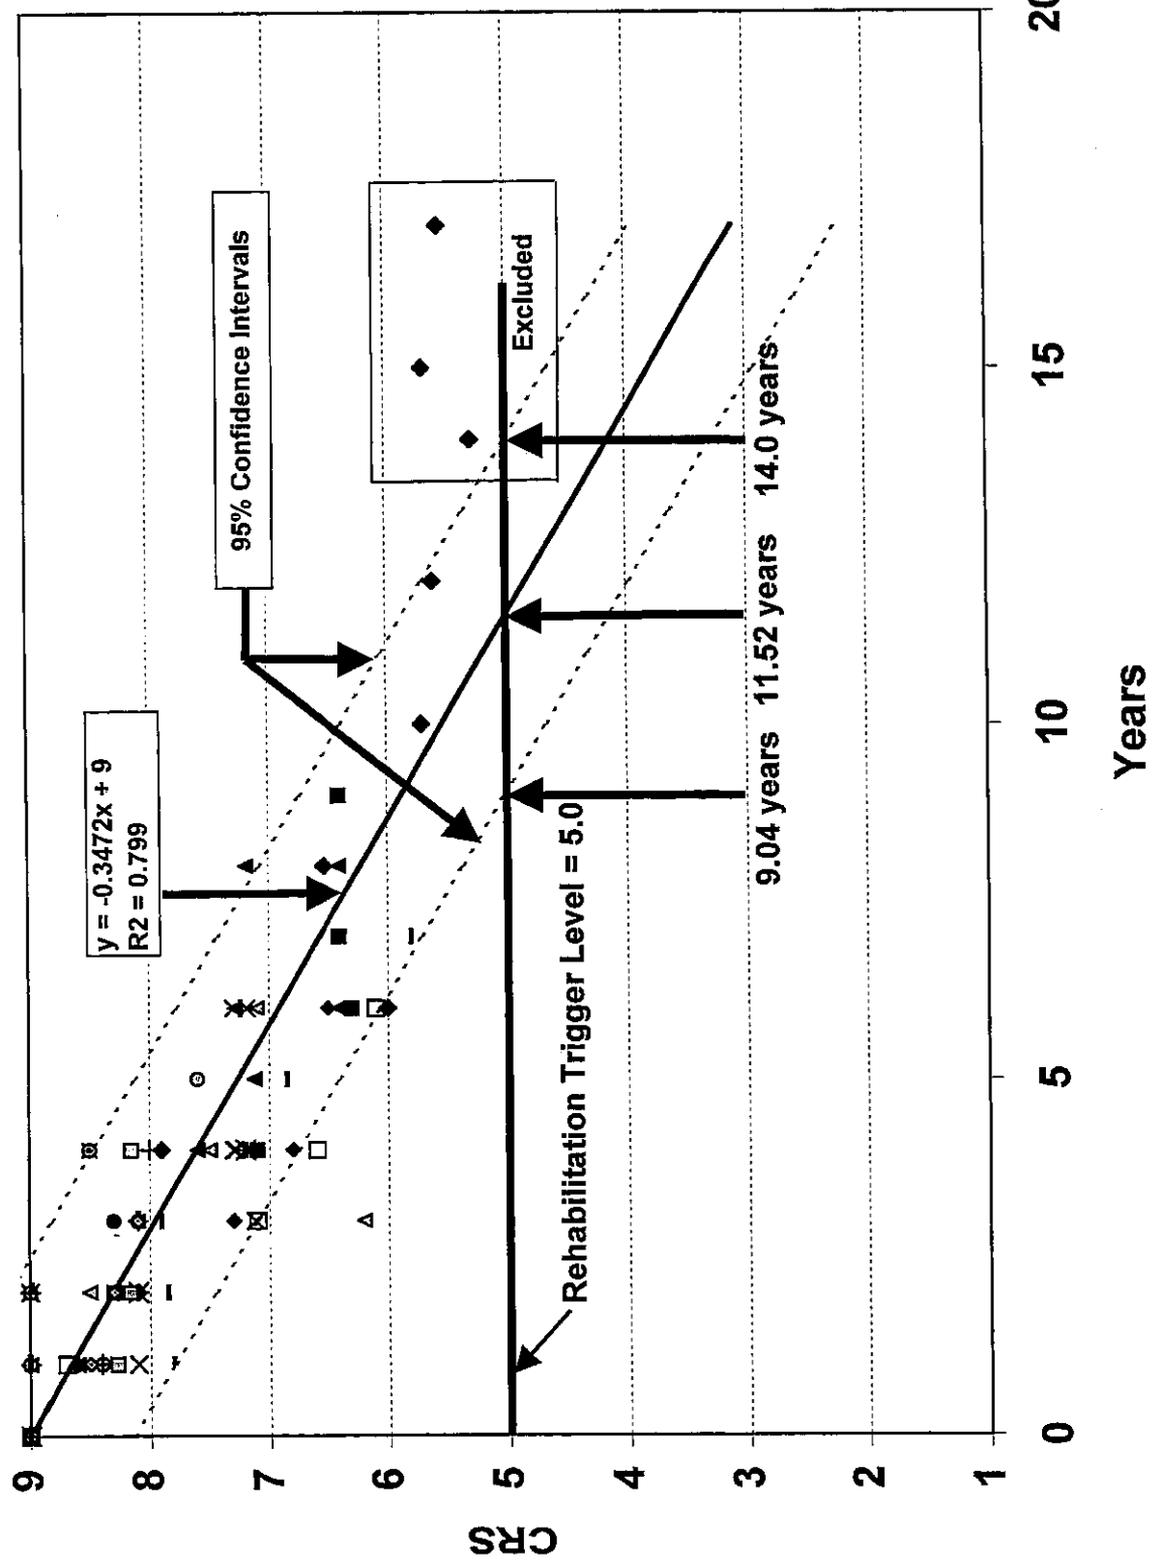
Figure 5.8. Regression Method to Determine Number of Years to Rehabilitation (CRS = 5.0); Strip Treatment

Figures 5.8 through 5.10 present the overall CRS serviceability level versus overlay age for strip-treated, area-treated, and control sections. Best-fit straight lines were generated through data using least squares linear regression techniques, along with 95% confidence intervals. These relations were extrapolated to predict the overlay age where a CRS level of 5 would have been reached. For this study, a CRS level of 5 was considered the *rehabilitation trigger level*. In Illinois, a CRS of 6.0 is the transition from a rating of good to fair, and a CRS of 4.5 is the transition from fair to poor. A CRS rating of 5.0 allows for rehabilitation prior to a pavement

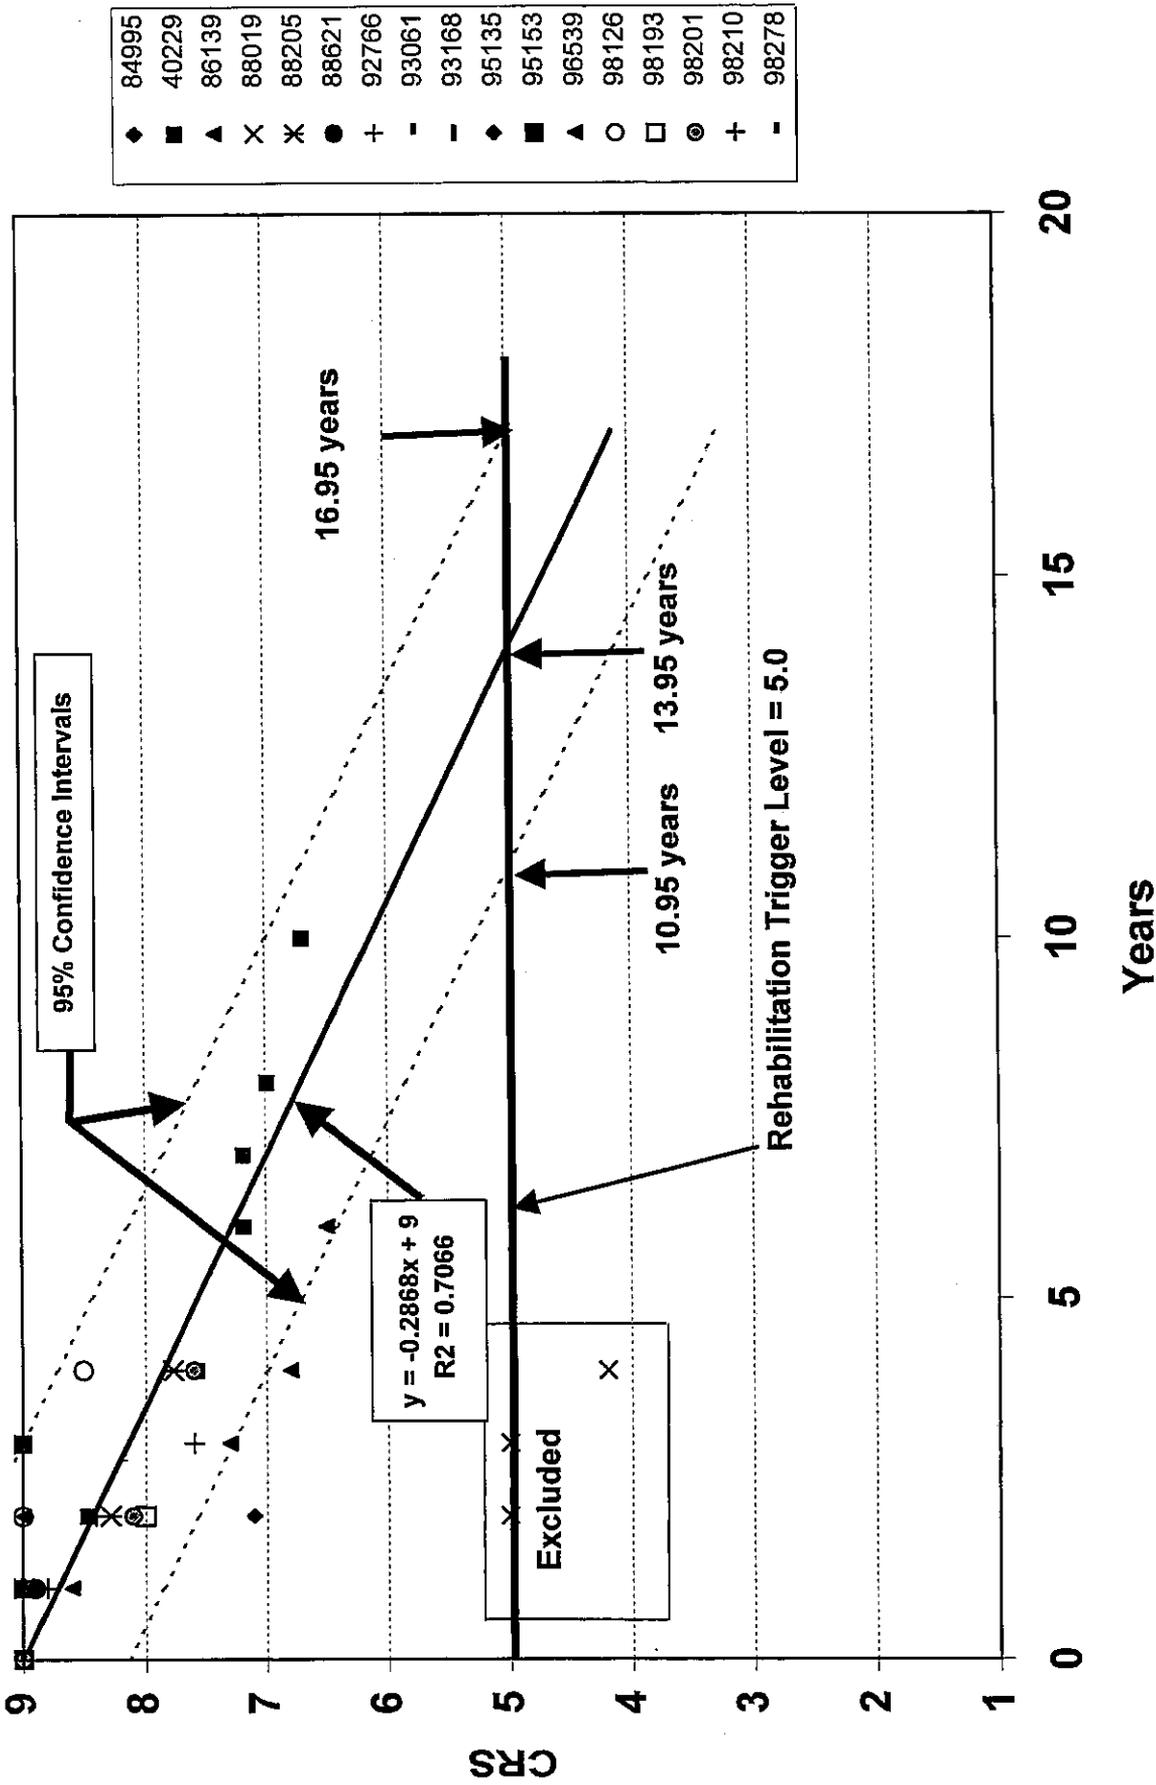
Figure 5.9. Regression Method to Determine Number of Years to Rehabilitation (CRS = 5.0); Area Treatment

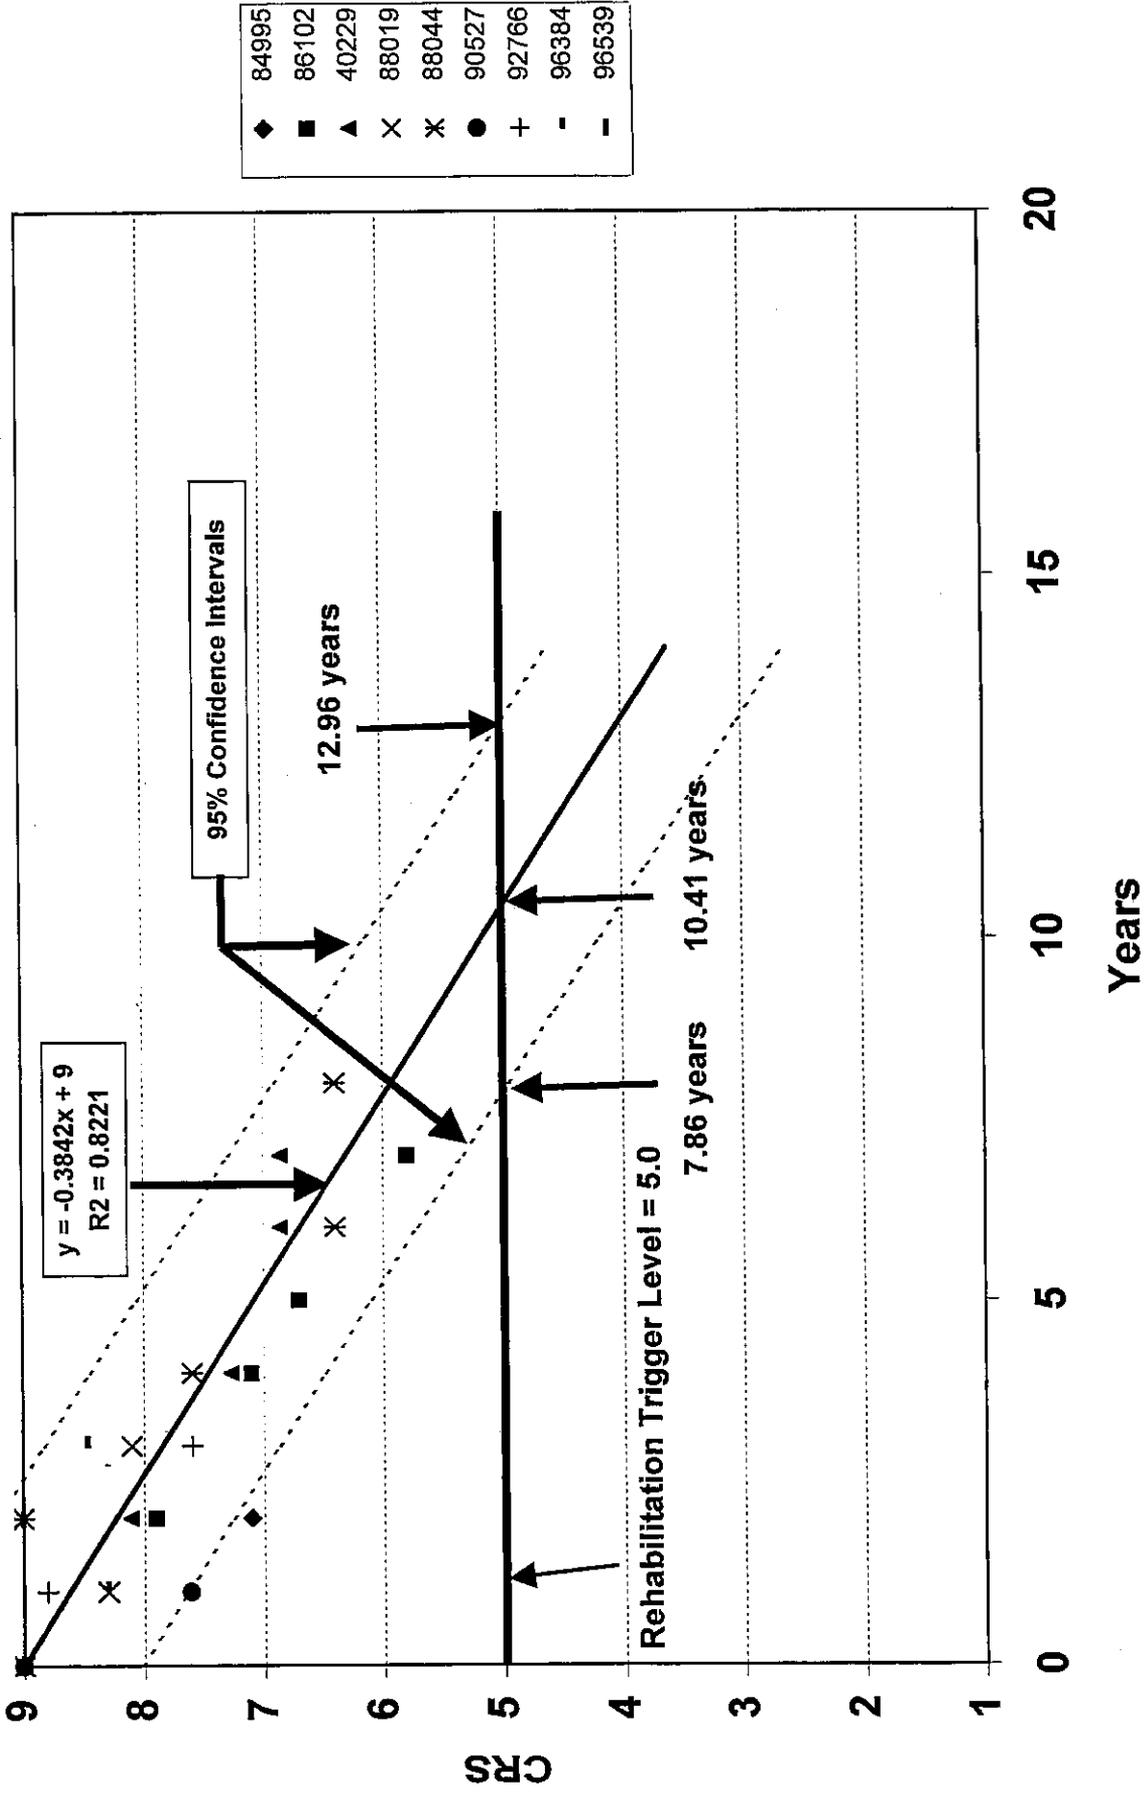
Figure 5.10. Regression Method to Determine Number of Years to Rehabilitation (CRS = 5.0); Control Section
