Evaluation of Reflective Crack Control Policy

Project IA-H1, FY95/96

Report No. ITRC FR 95/96-4

Illinois Transportation Research Center

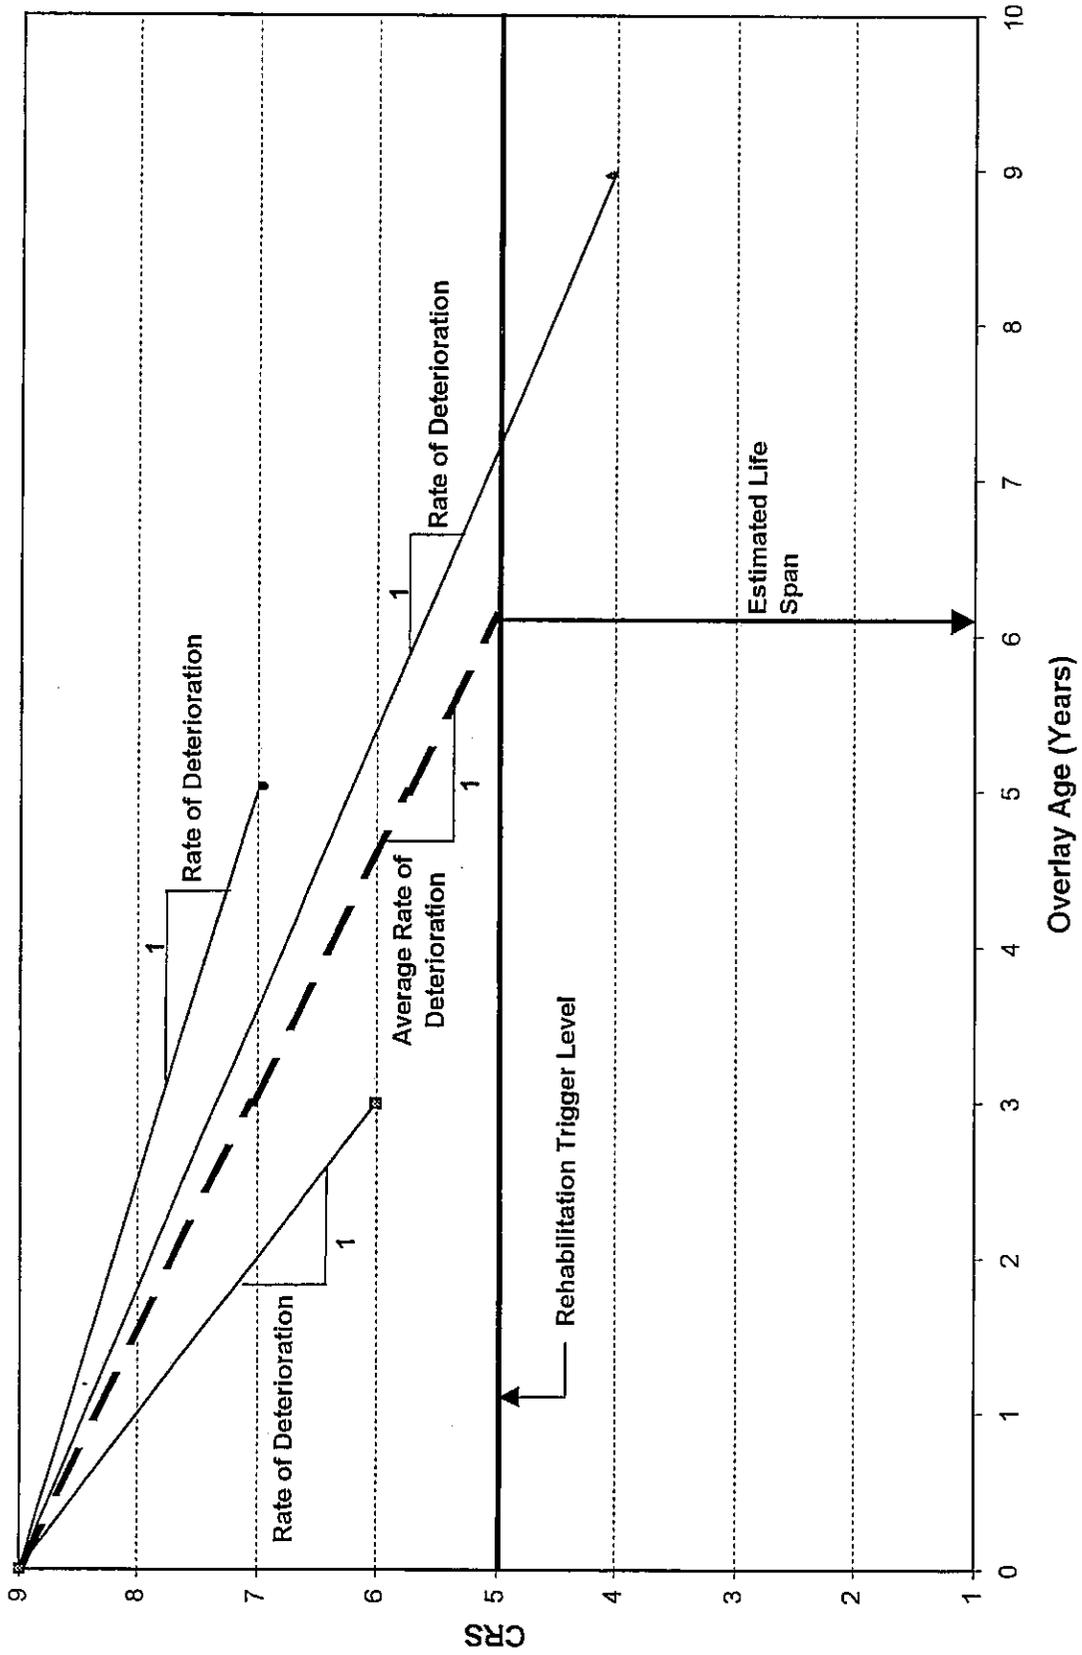
Figure 6.1. Conceptual Illustration of Average Rate of Deterioration Method

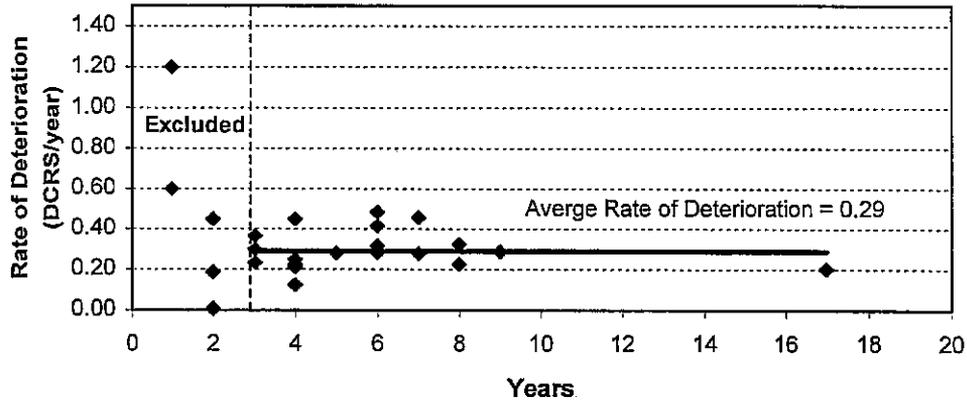
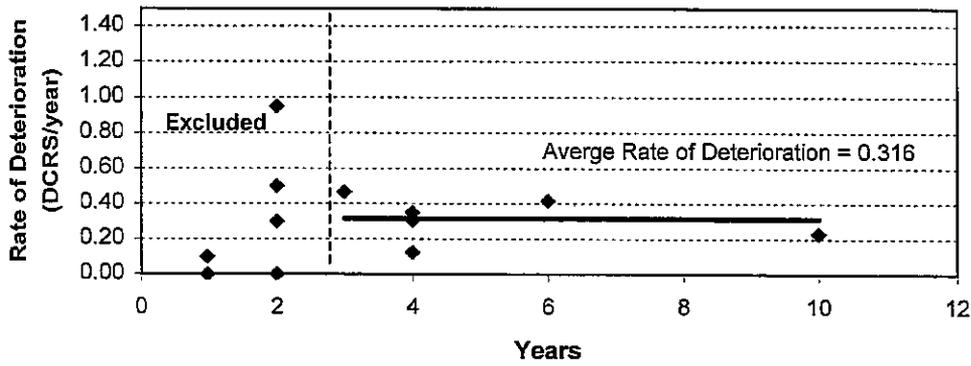
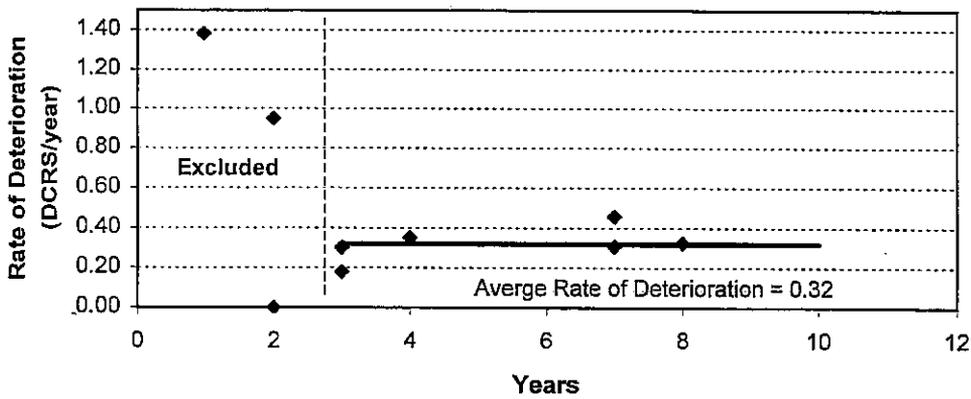
Figure 6.2. Determination of Average Rate of Deterioration

the relatively small number of data points used to determine average deterioration rate after truncation (Figure 6.2), it was concluded that the regression method yielded more reliable life span prediction for the given data set. Nevertheless, both methods were used and compared in the subsequent LCCA.

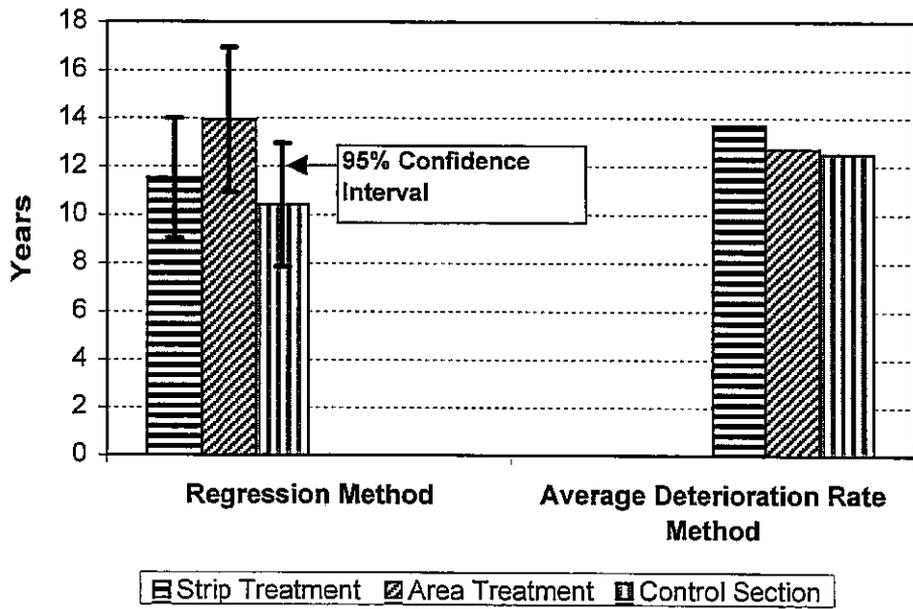
Figure 6.3. Estimated Life Span Based Upon CRS Rehabilitation Trigger Level of Five

The resulting life spans are given in Table 6.2. Figure 6.3 presents a comparison of life spans of strip-treated, area-treated, and untreated projects using each of the estimation methods. Given

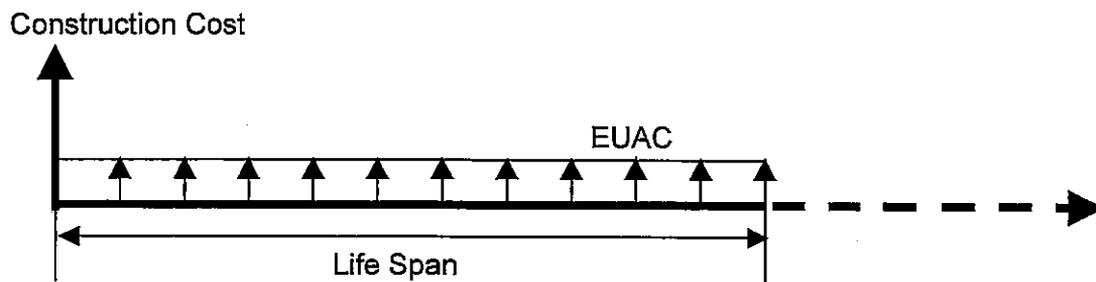
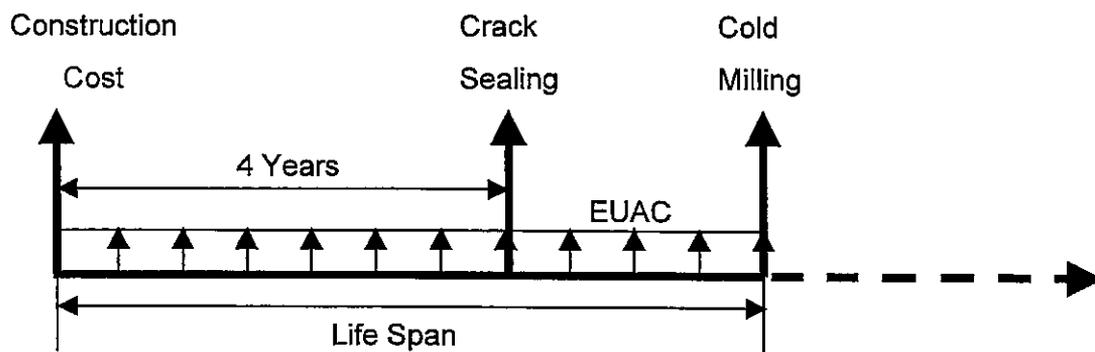
Figure 6.4. Expenditure Stream Diagram for Life Cycle Cost Analysis

The LCCA modeling structures used in this study are graphically represented using expenditure stream diagrams, as shown in Figure 6.4. As illustrated, the equivalent uniform annual cost (EUAC) method was selected for translating economic elements to a common time period, accounting for the time effect of money. As the name suggests, the EUAC method equates life cycle costs to an equivalent annual cost that would be incurred over the analysis period to pay for the given rehabilitation.

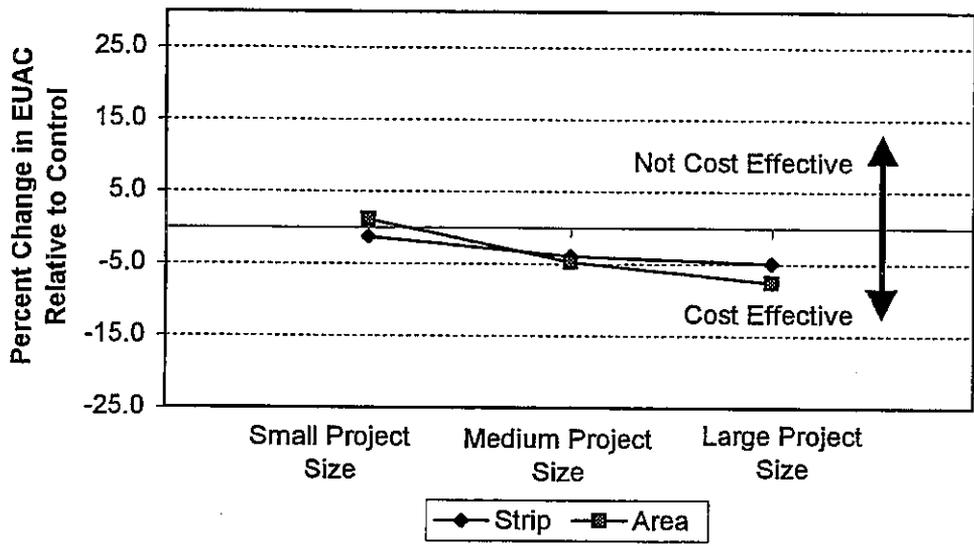
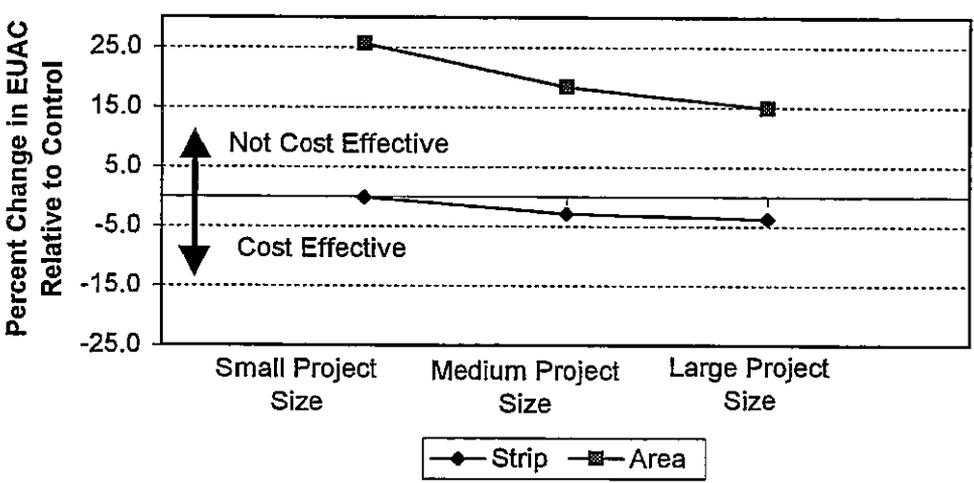
Figure 6.6. EUAC Comparisons Relative to Untreated Projects, Including Maintenance and Cold Milling Costs

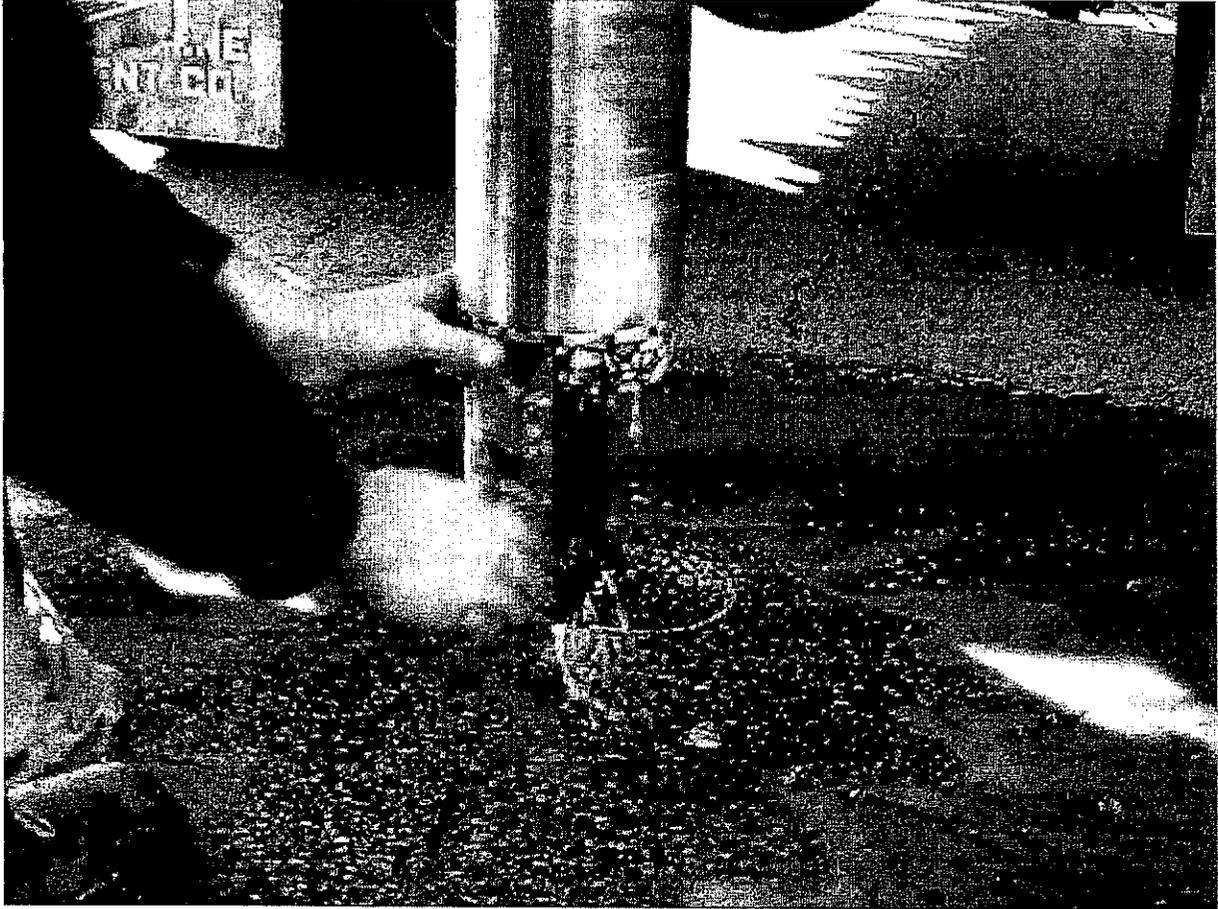
Figure 7.1 Field Coring to Obtain Specimens for Permeability Test

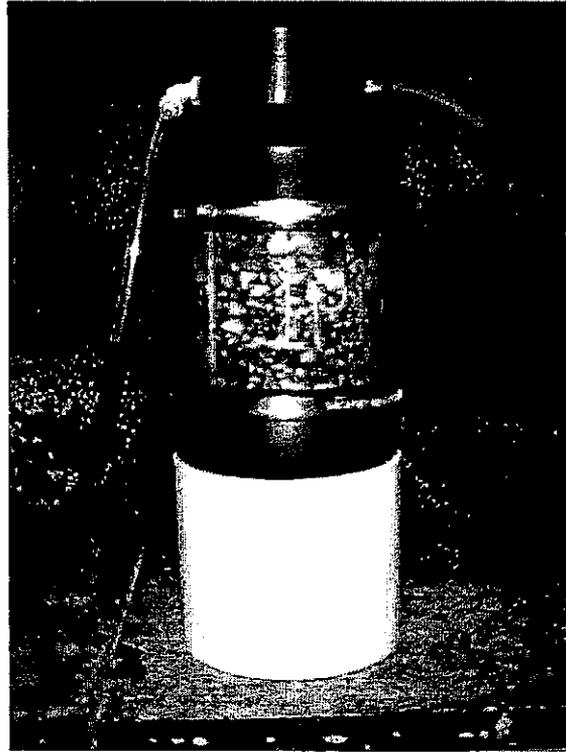
Figure 7.2 Constant Head Permeability Test

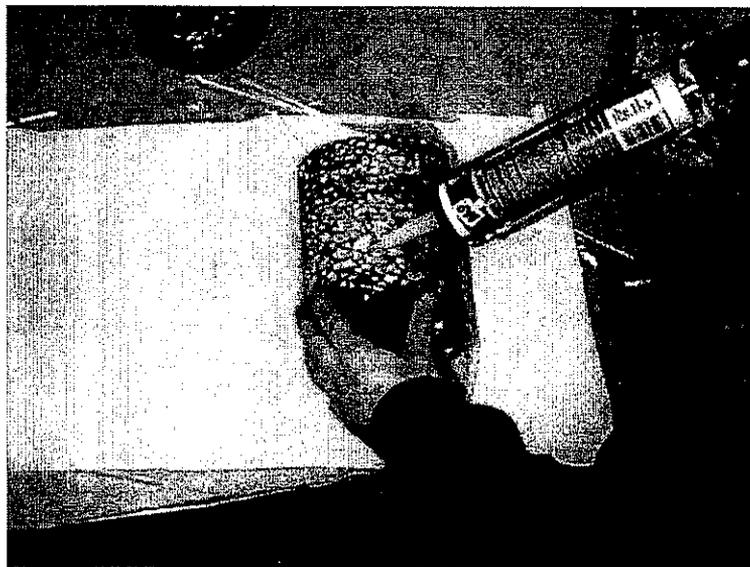
Figure 7.3 Specimen Preparation for Permeability Test

A clear silicone rubber sealant was applied with a caulking gun to close any vertical cracks on the core surface (Figure 7.3). The sealant was also spread evenly with a brush around the entire side of the core. Clear vinyl sheeting was wrapped around the specimen to assist in working with the silicone sealant and to prevent leakage along the sides of the core (Figure 7.3). Caulking tape was used to prevent leakage of water from the water reservoir. Later it was

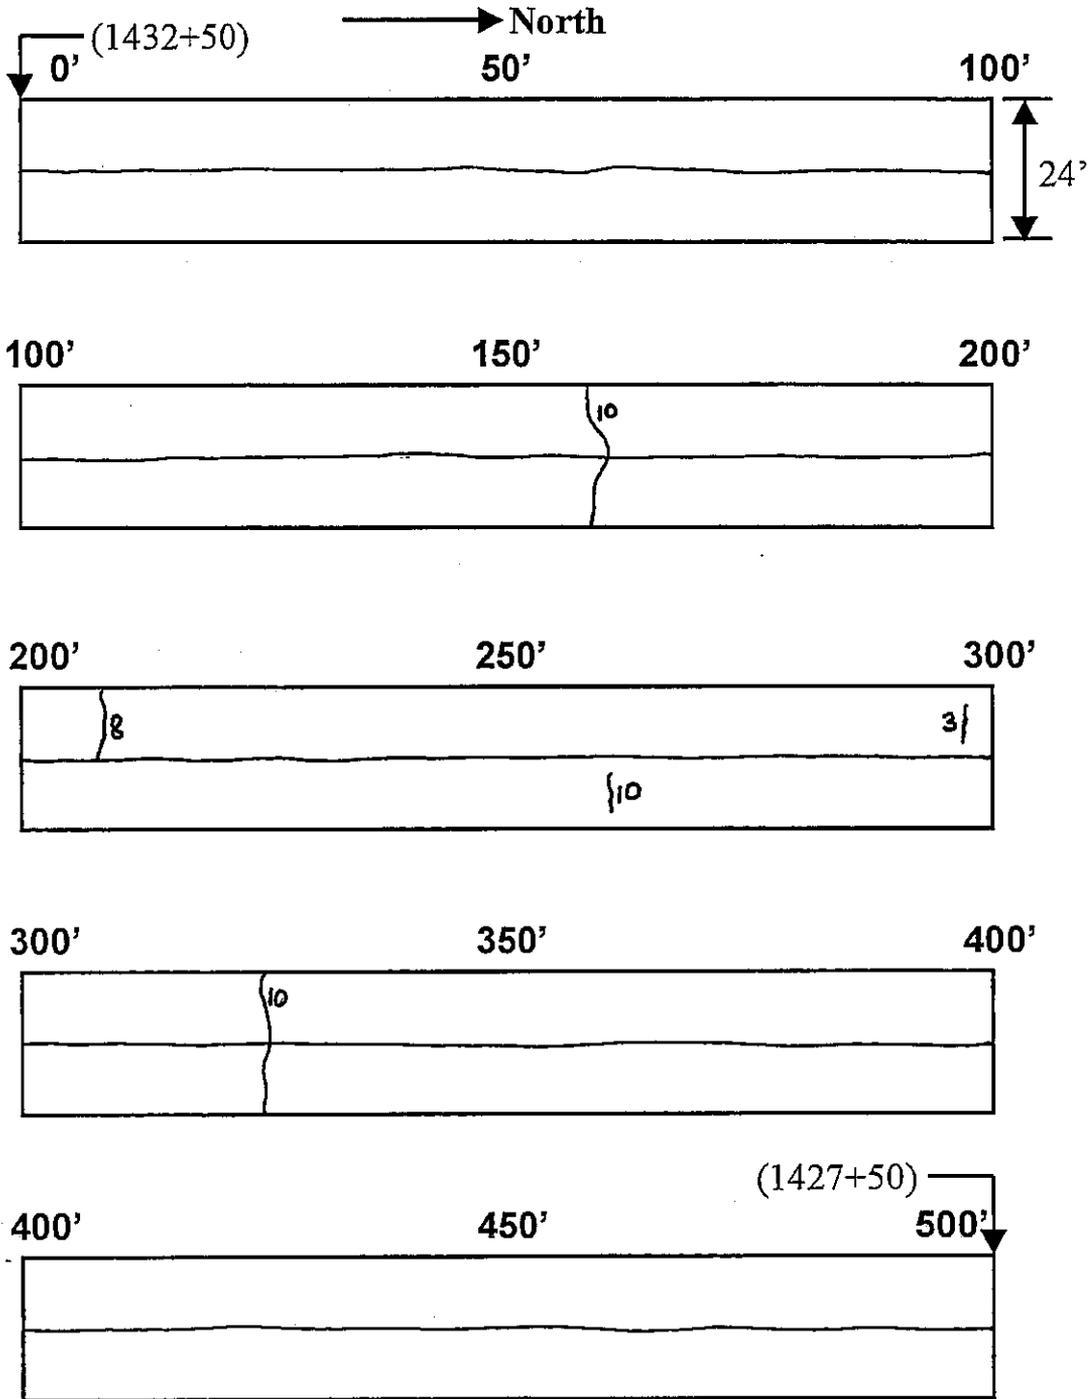
Figure D1. Crack Survey for IL 251

Date: 6/25/98 (Note: Crack widths indicated on survey are given in mm.)

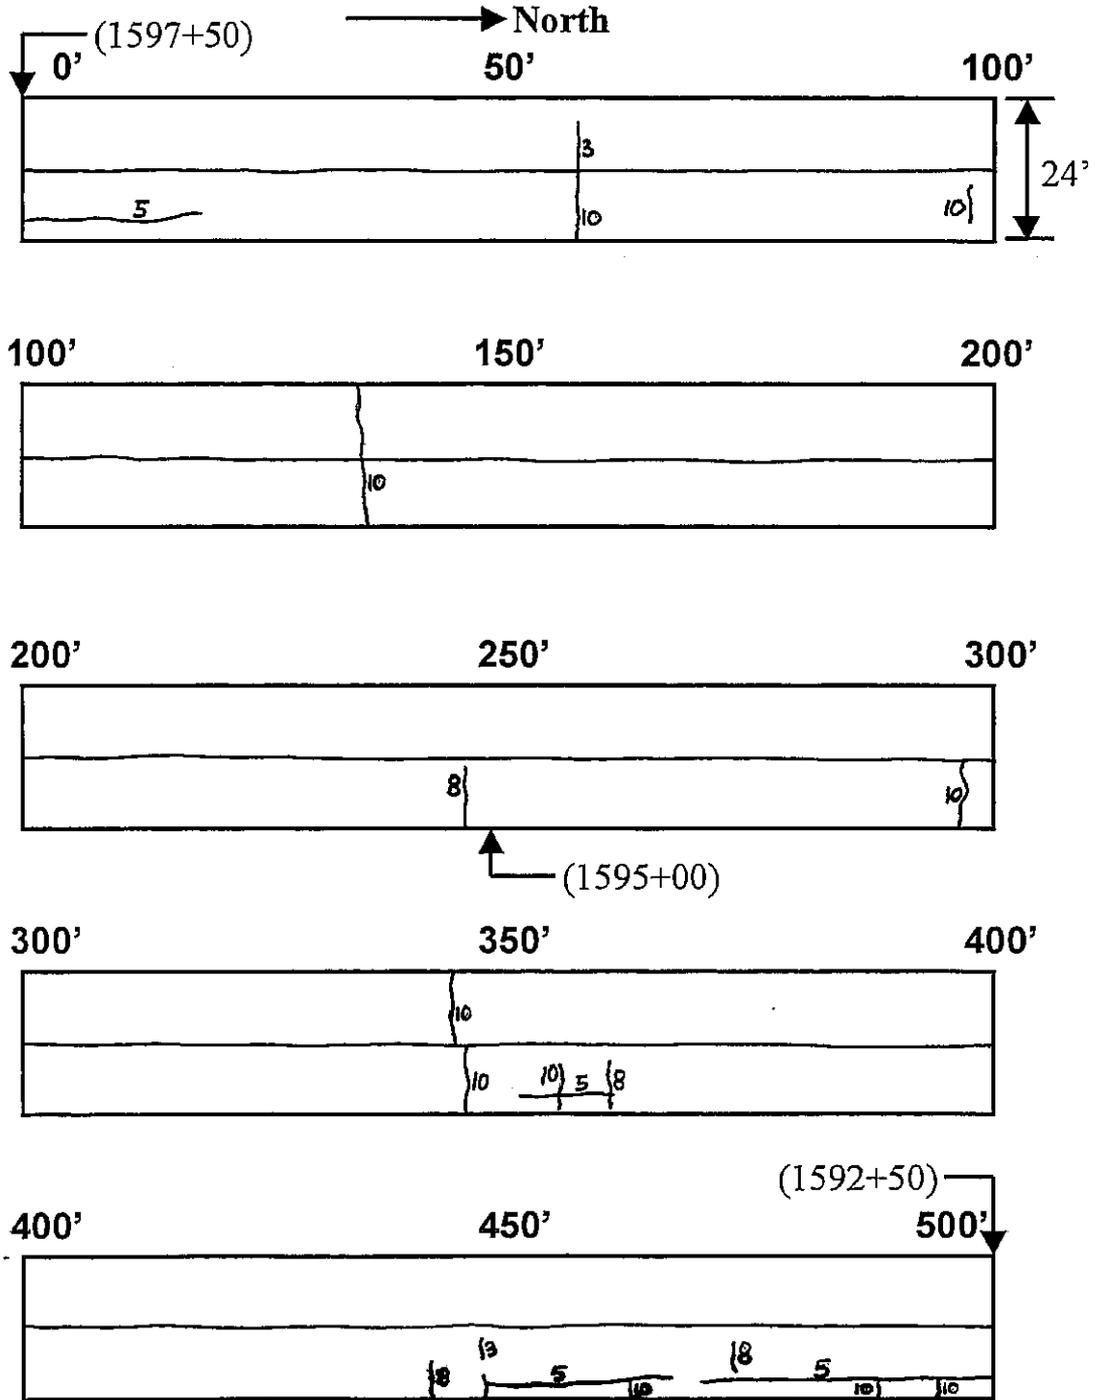
Figure D2. Crack Survey for IL 251

Location/Description: IL 251 South of US 30 (Control Section)

Date: 6/25/98 (Note: Crack widths indicated on survey are given in mm.)

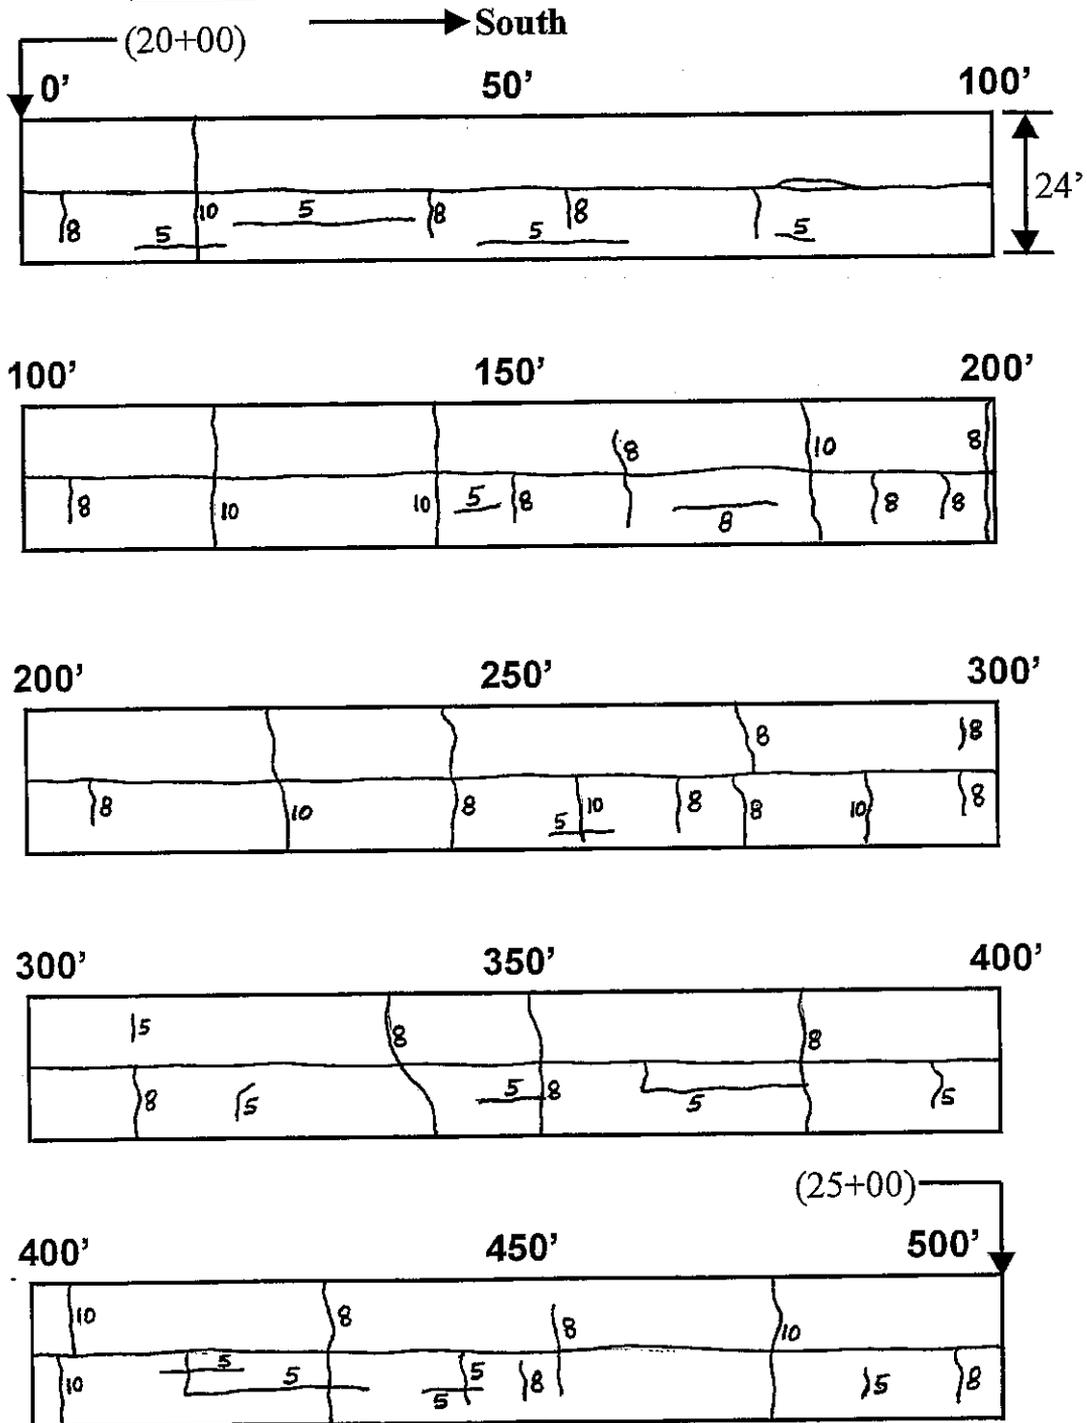
Figure D3. Crack Survey for IL 178

Location/Description: IL178 (Strip Treated Section)

Date: 6/25/98 (Note: Crack widths indicated on survey are given in mm.)

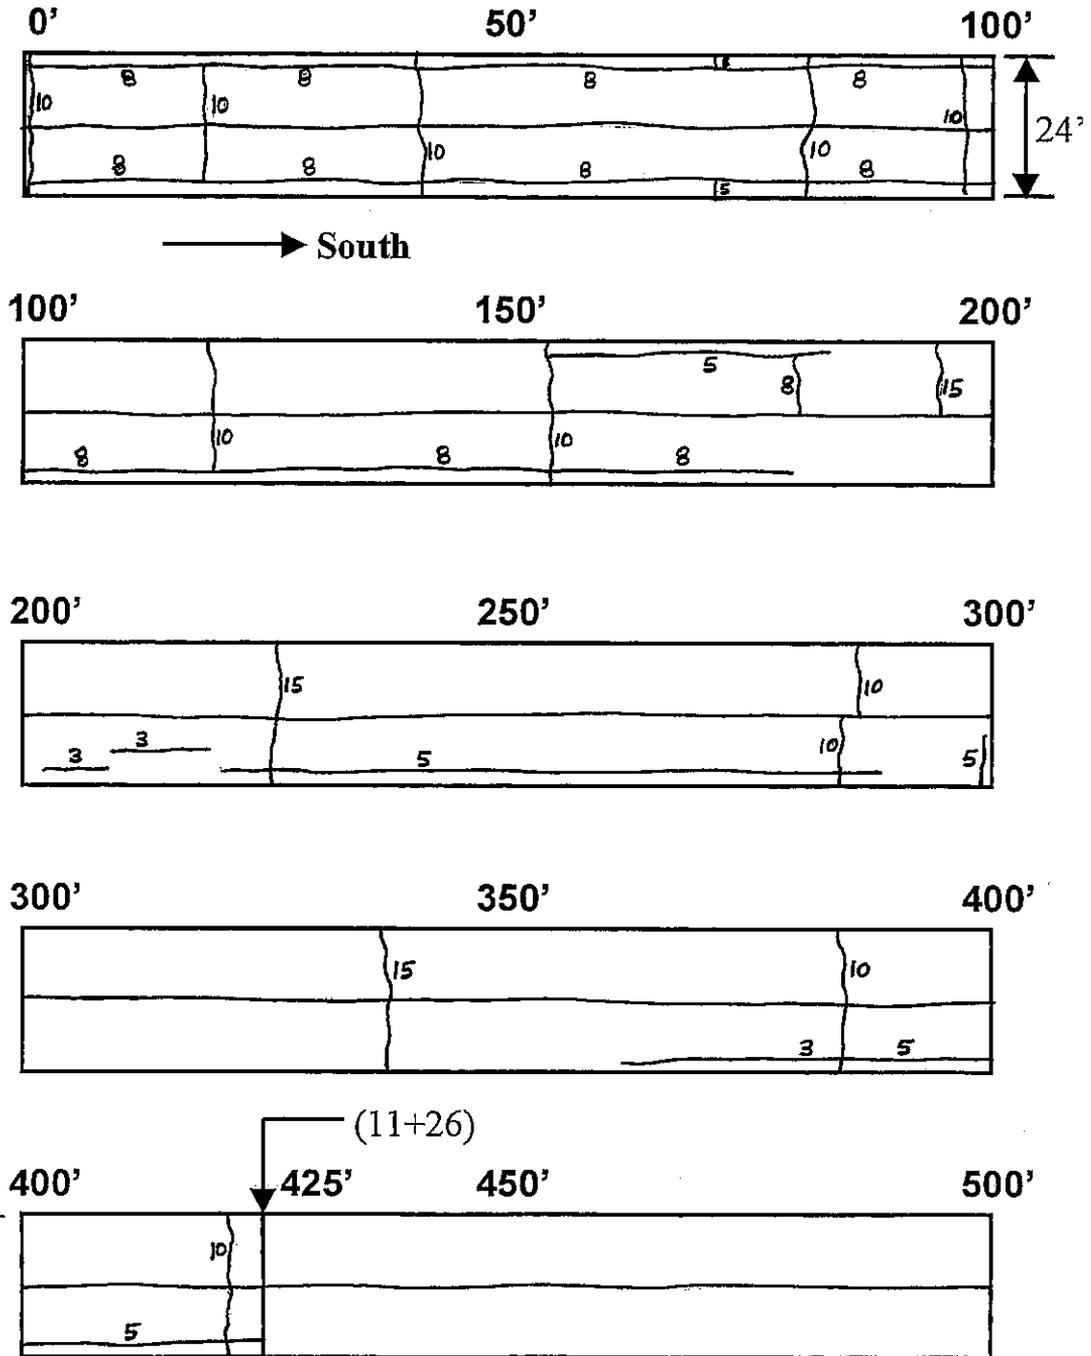
Figure D4. Crack Survey for IL 178

Location/Description: IL 178 South of IL 71 Junction

(Note: Crack widths indicated on survey are given in mm.)

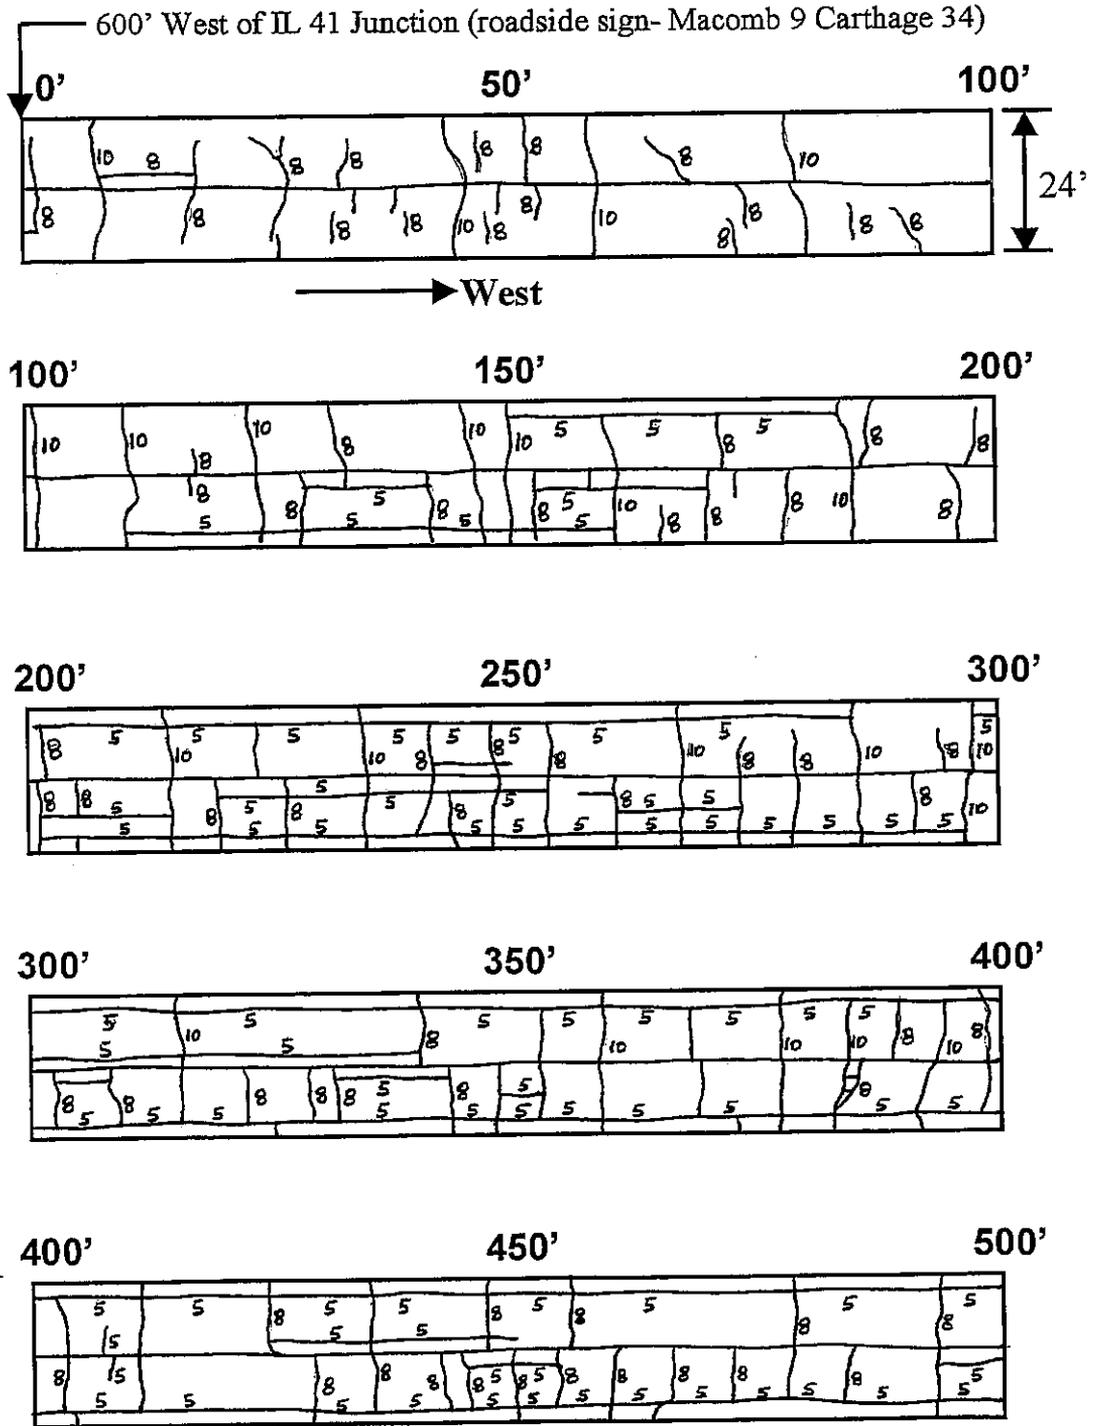
Figure D5. Crack Survey for US 136

Location/Description: US 136 from US 67 to IL 41 (Strip Treated Section)

Date: 6/23/98 (Note: Crack widths indicated on survey are given in mm.)

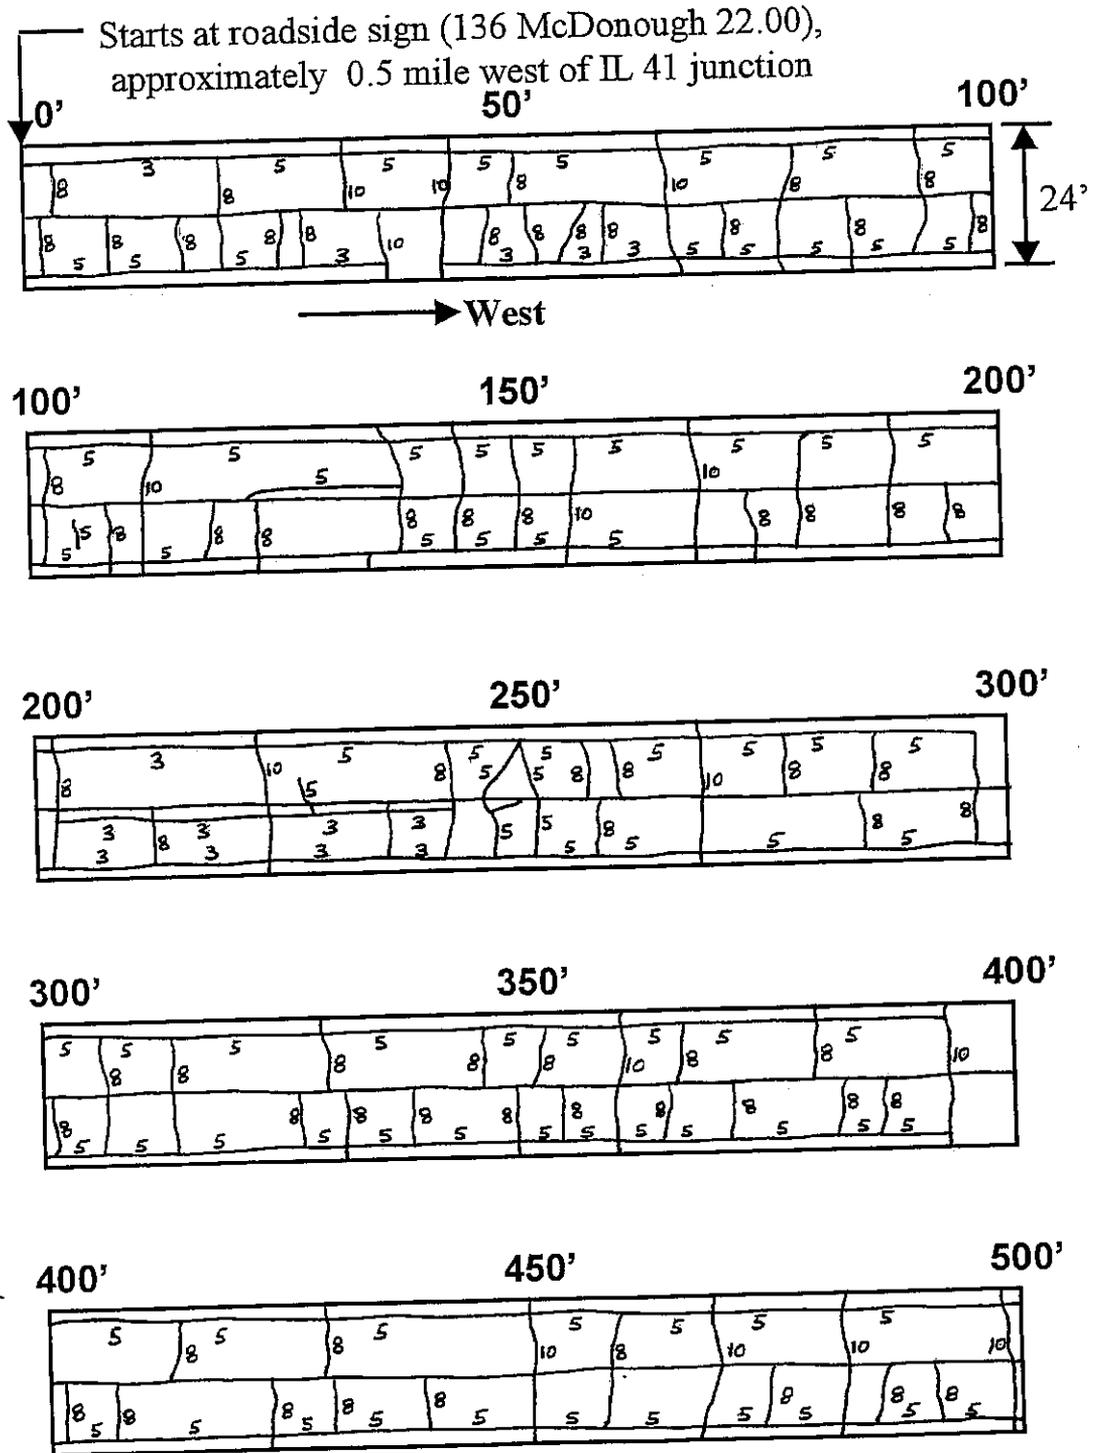
Figure D6. Crack Survey for US 136

Location/Description: US 136 from US 67 to IL 41 (Control Section)

Date: 6/23/98 (Note: Crack widths indicated on survey are given in mm.)

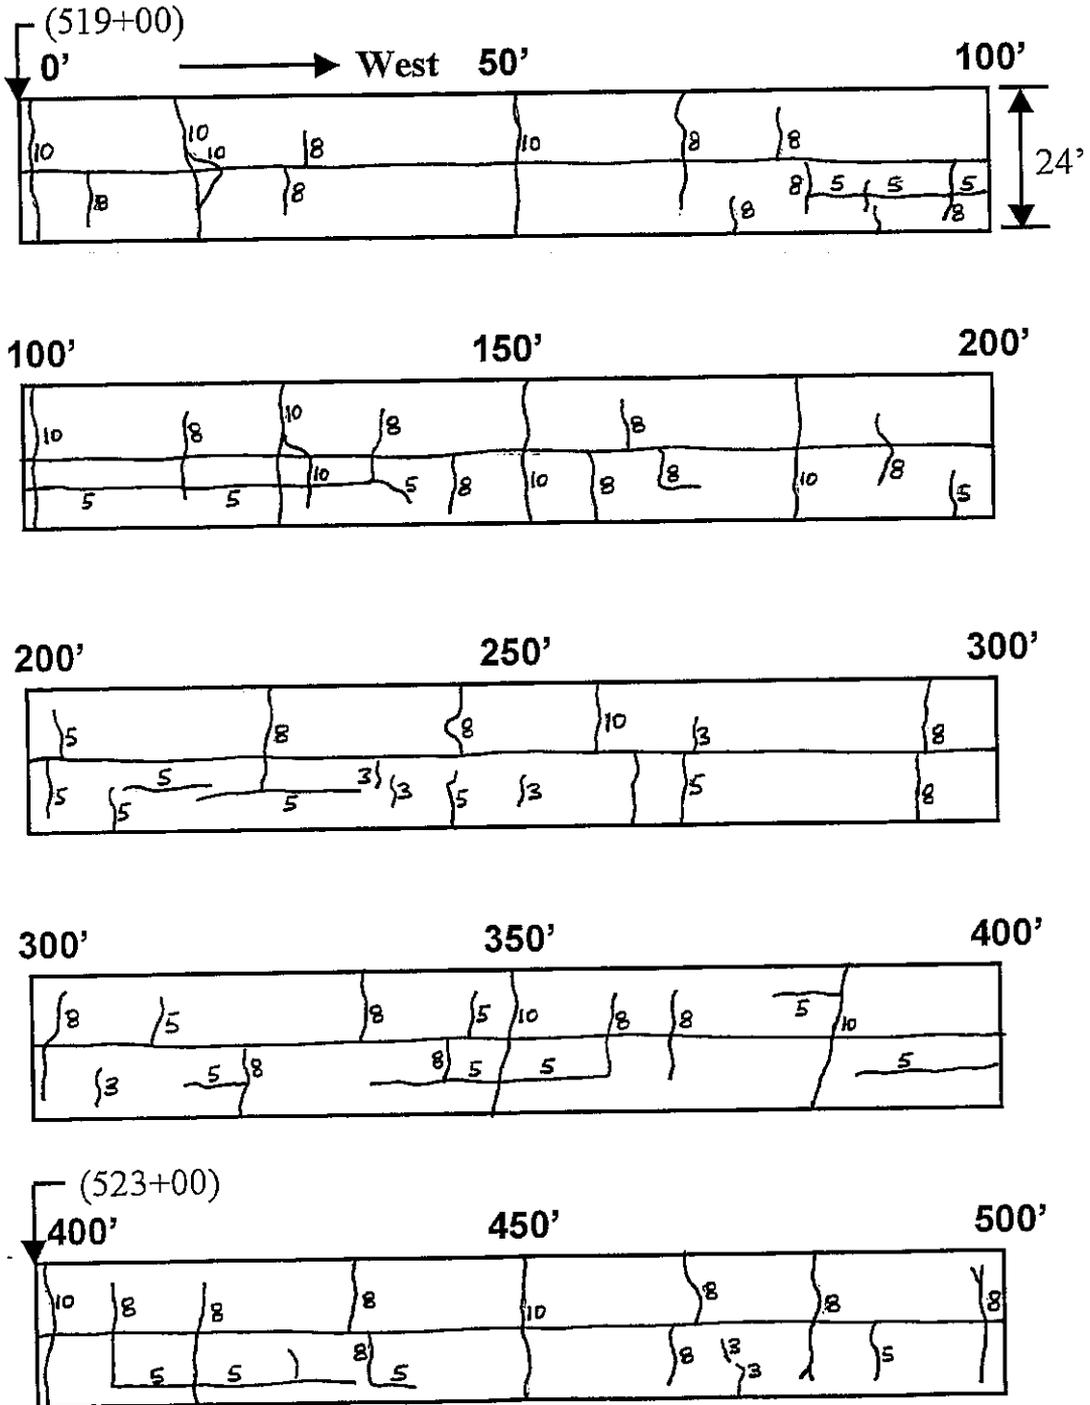
Figure D8. Crack Survey for IL 9

Location/Description: IL 9 1 to 2 miles east of IL 41,
South of Prairie City (Control Section) Date:6/22/98

(Note: Crack widths indicated on survey are given in mm.)

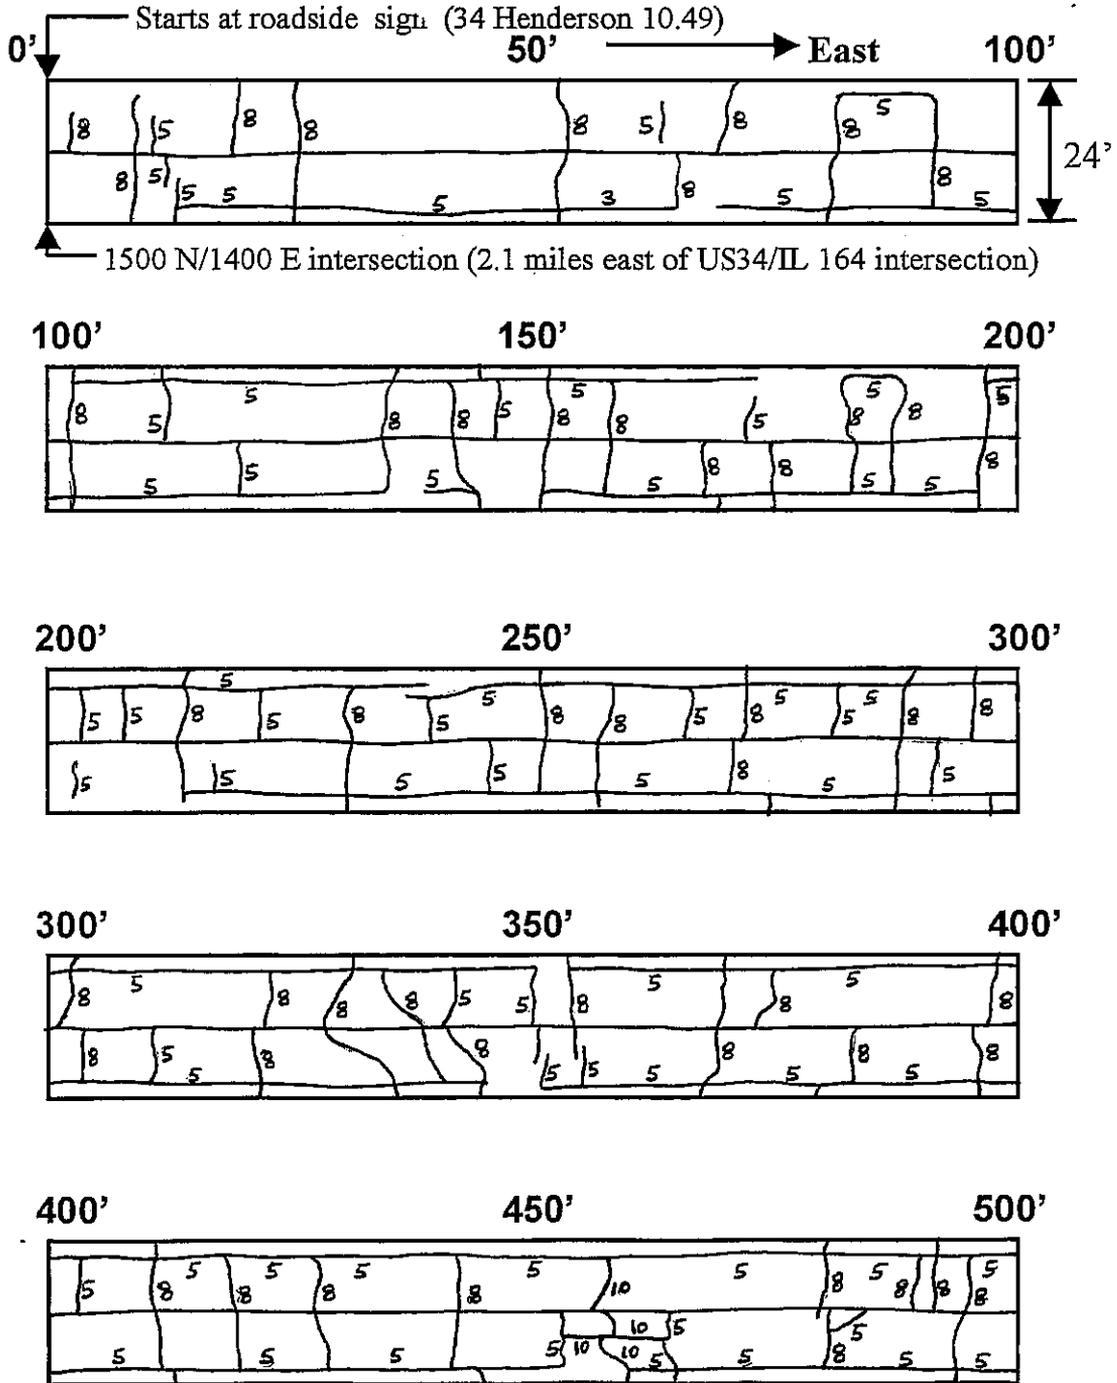
Figure D9. Crack Survey for US 34

Location/Description: US 34 South of Gladstone to South of Kirkwood (Strip Treated Section) Date: 6/22/98

(Note: Crack widths indicated on survey are given in mm.)

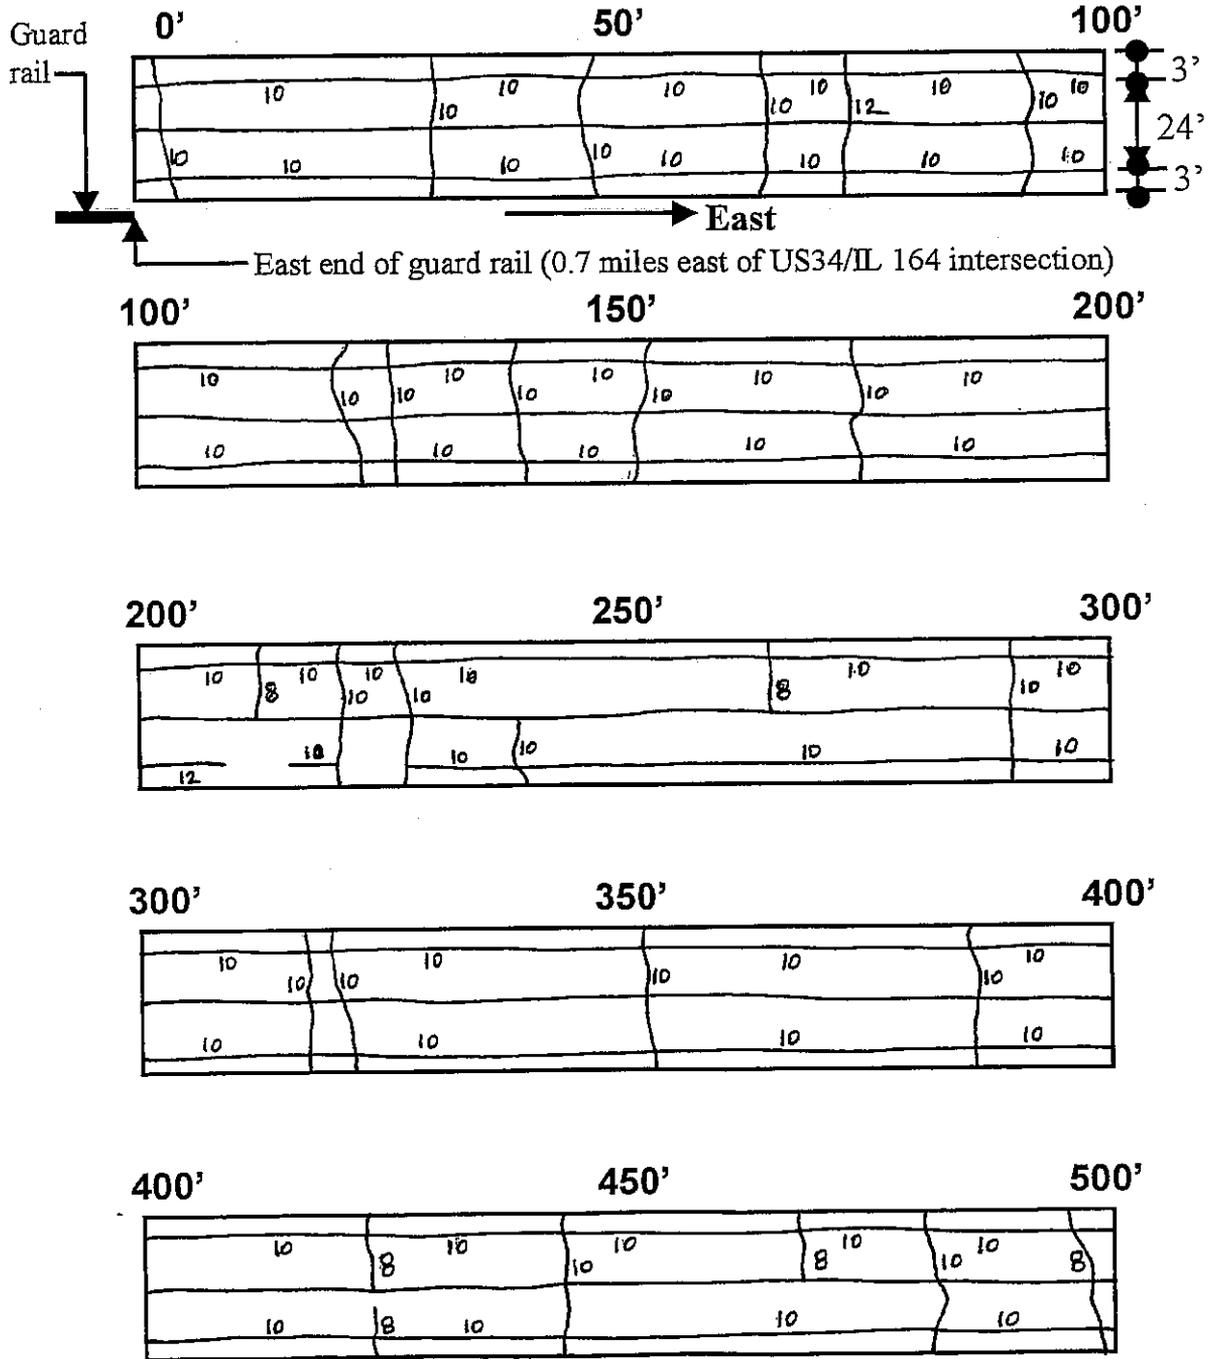
Figure D10. Crack Survey for US 34

Location/Description: US 34 South of Gladstone to South of Kirkwood (Control Section) - 24' wide existing PCC

(Note: Crack widths indicated on survey are given in mm.)
