Evaluation of Reflective Crack Control Policy

Project IA-H1, FY95/96

Report No. ITRC FR 95/96-4

Illinois Transportation Research Center

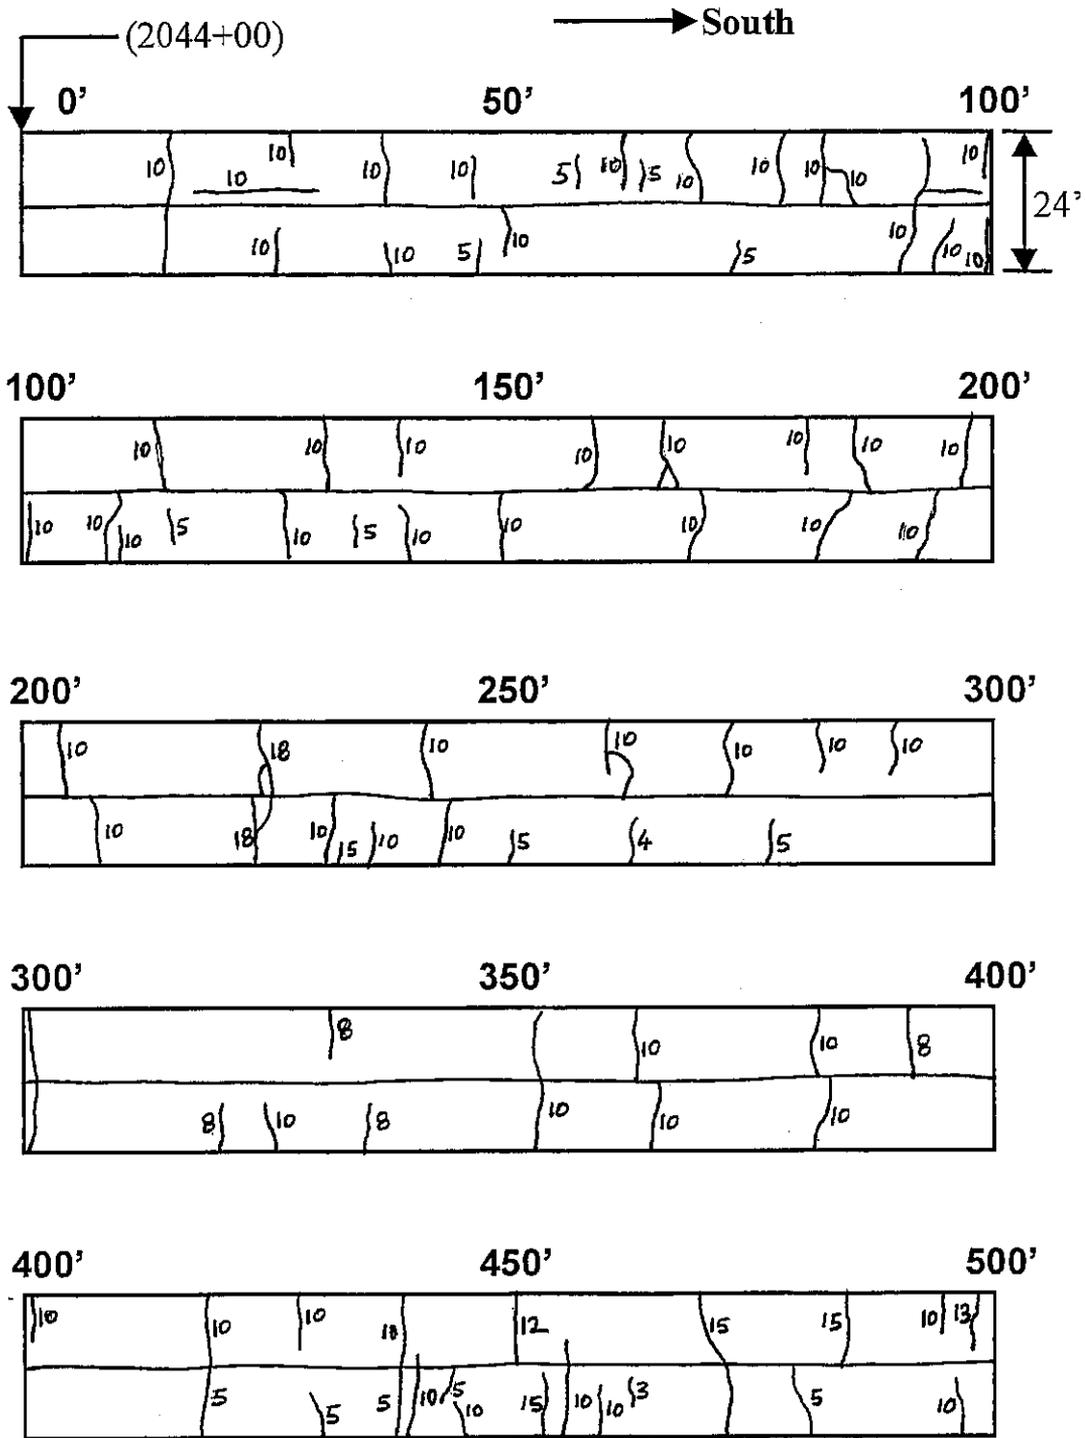
Figure D11. Crack Survey for IL 130

Location/Description: IL 130 Philo to Villa Grove (Strip Treated Section) Date: 6/19/98 (Note: Crack widths indicated on survey are given in mm.)

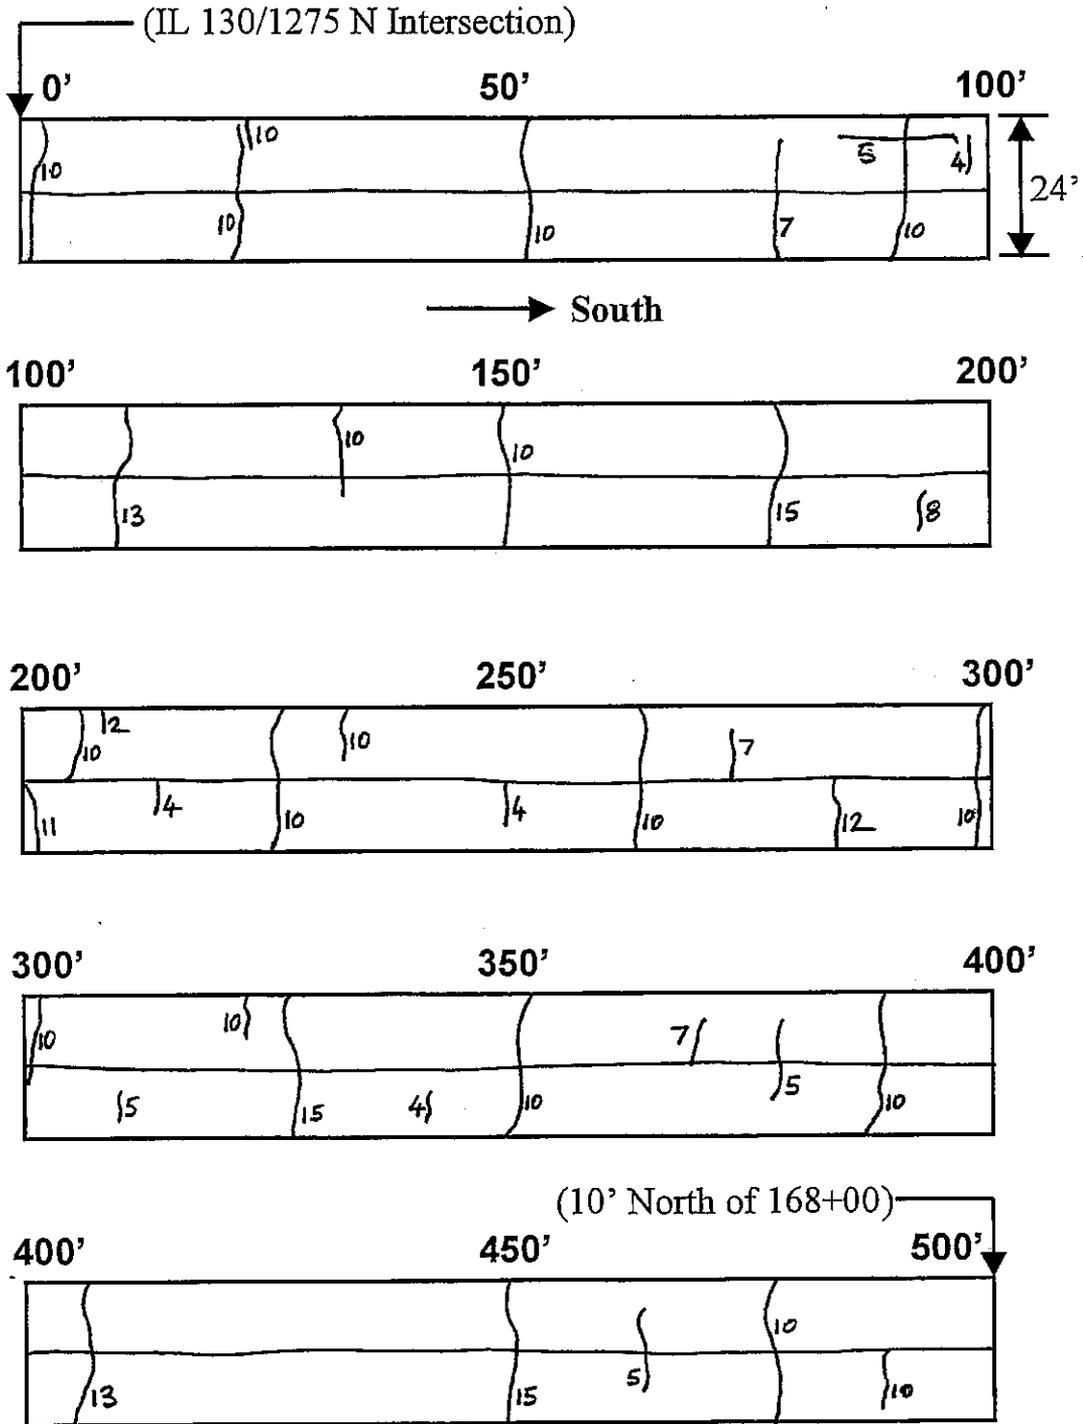
Figure D12. Crack Survey for IL 130

Location/Description: IL 130 Villa Grove to Camargo (Control

Section) Date: 6/19/98 (Note: Crack widths indicated on survey are given in mm.)

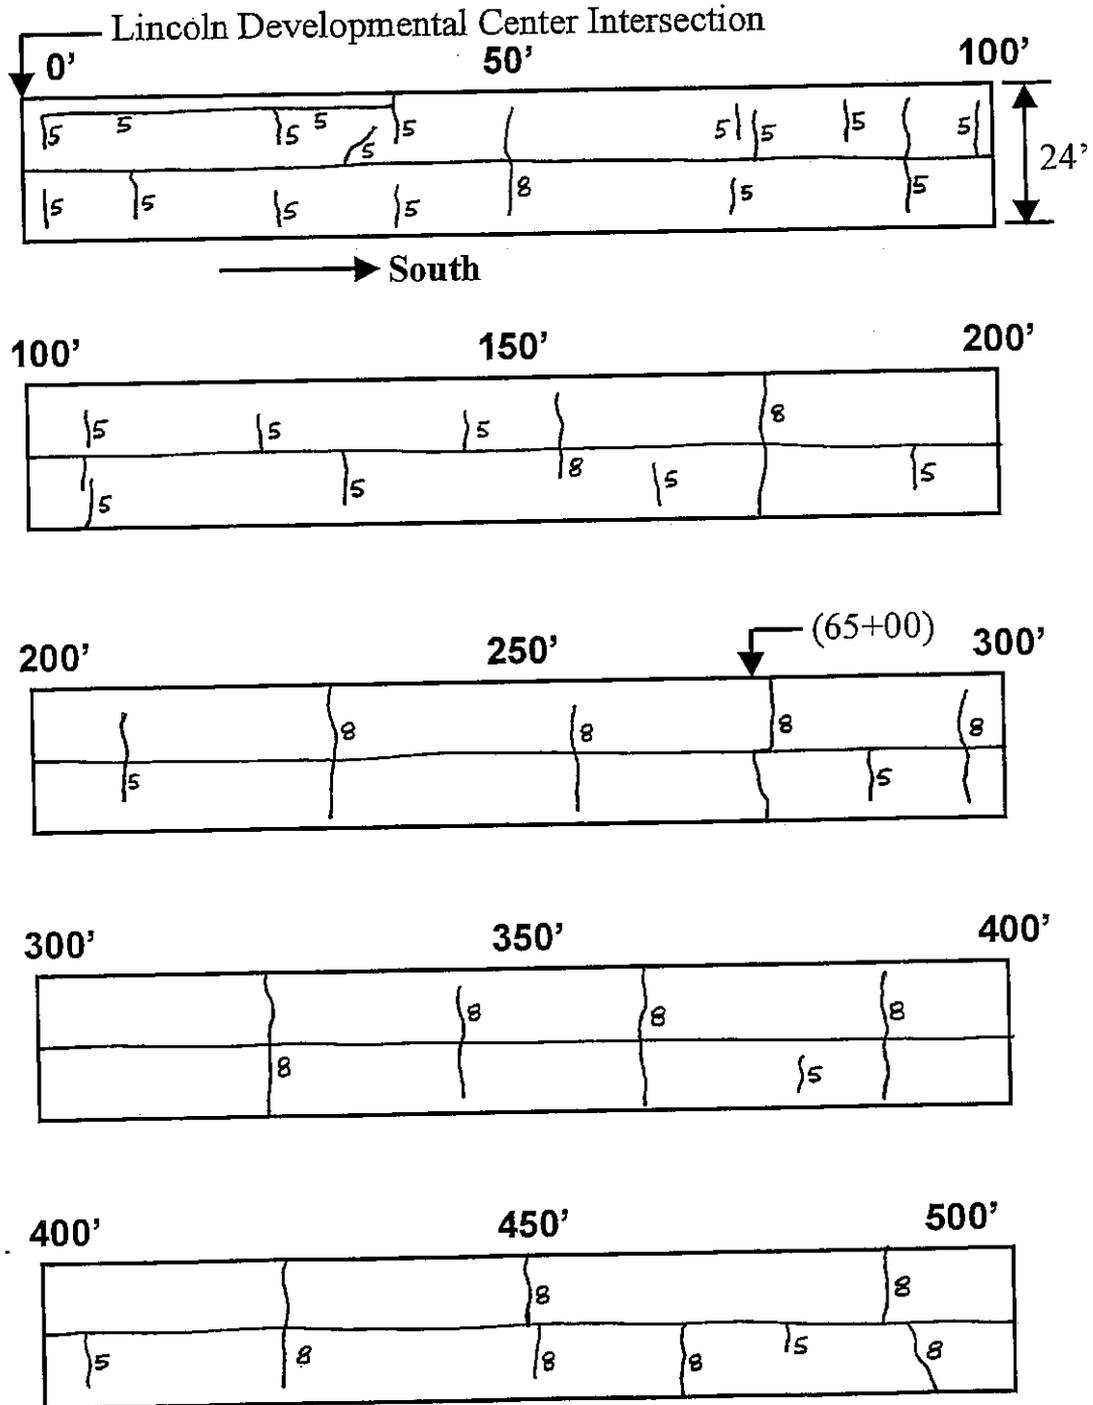
Figure D13. Crack Survey for US 66 – North Bound

Location/Description: US 66 from IL 10 intersection to Salt Creek (Area Treated Section) - North Bound Date: 6/23/98

(Note: Crack widths indicated on survey are given in mm.)

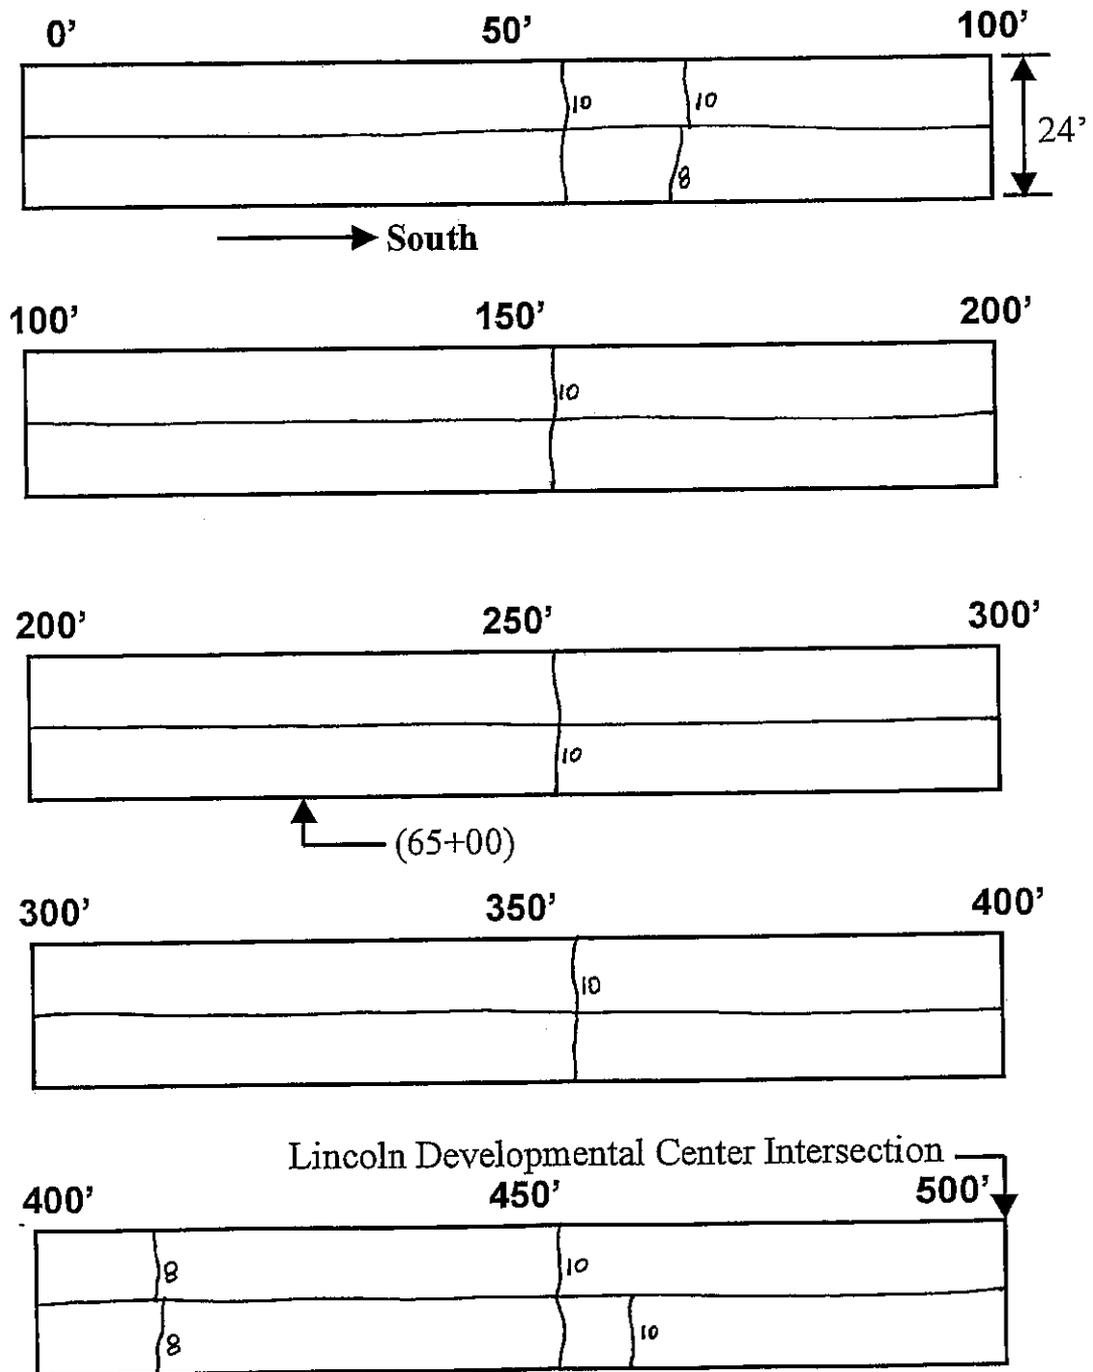
Figure D14. Crack Survey for US 66 – South Bound

Location/Description: US 66 from IL 10 intersection to Salt Creek (Area Treated Section) - South Bound Date: 6/23/98

(Note: Crack widths indicated on survey are given in mm.)

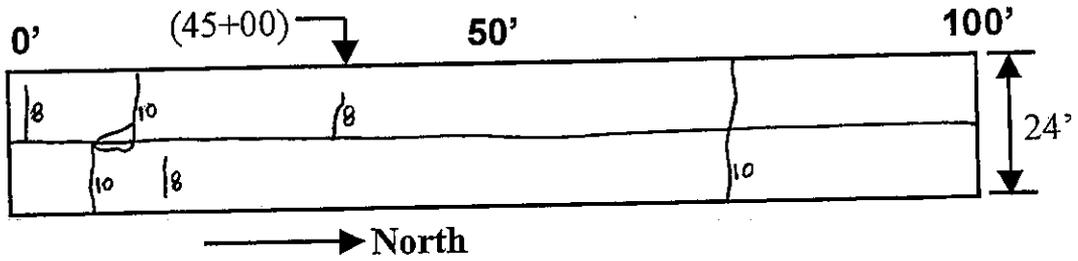
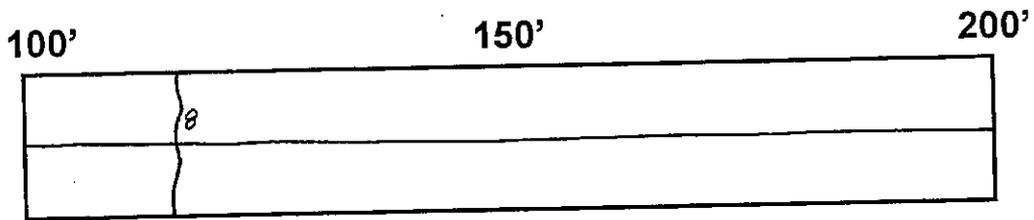
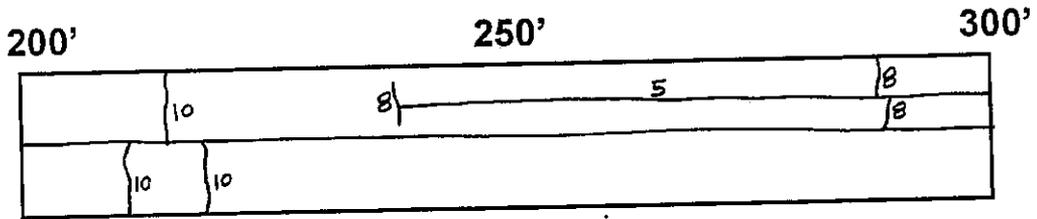
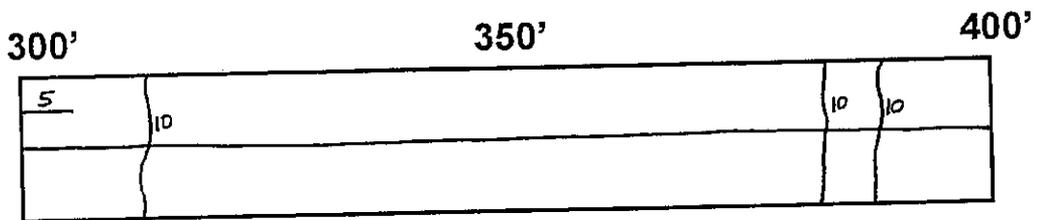
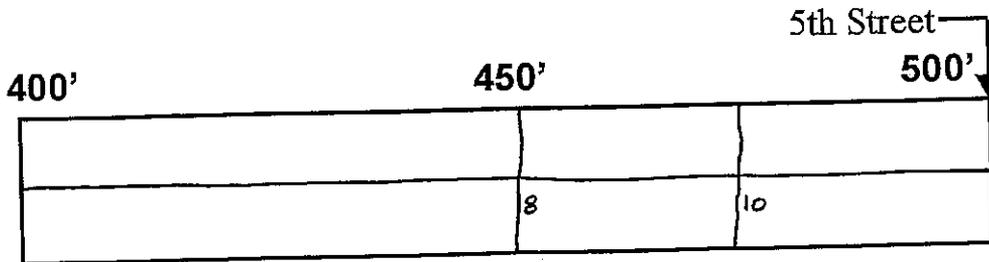
Figure D15. Crack Survey for US 66 – North Bound

Location/Description: US 66 from IL 10 intersection to Salt Creek (Control Section) - North Bound Date: 6/23/98

(Note: Crack widths indicated on survey are given in mm.)

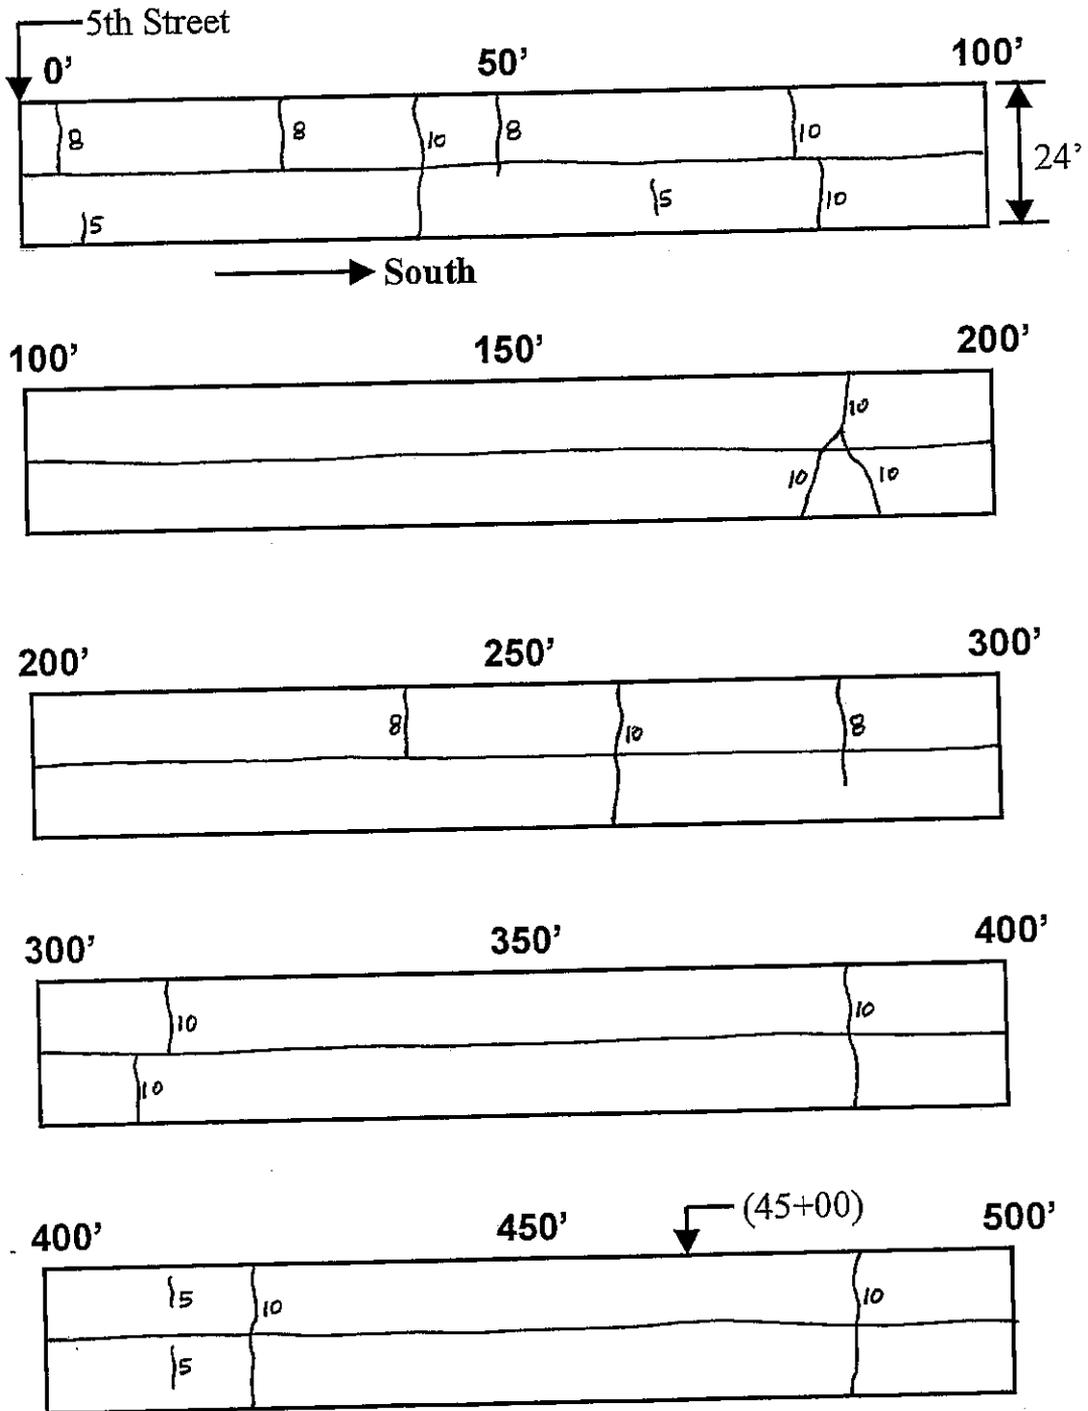
Figure D16. Crack Survey for US 66 – South Bound

Location/Description: US 66 from IL 10 intersection to Salt Creek (Control Section) - South Bound Date: 6/23/98

(Note: Crack widths indicated on survey are given in mm.)

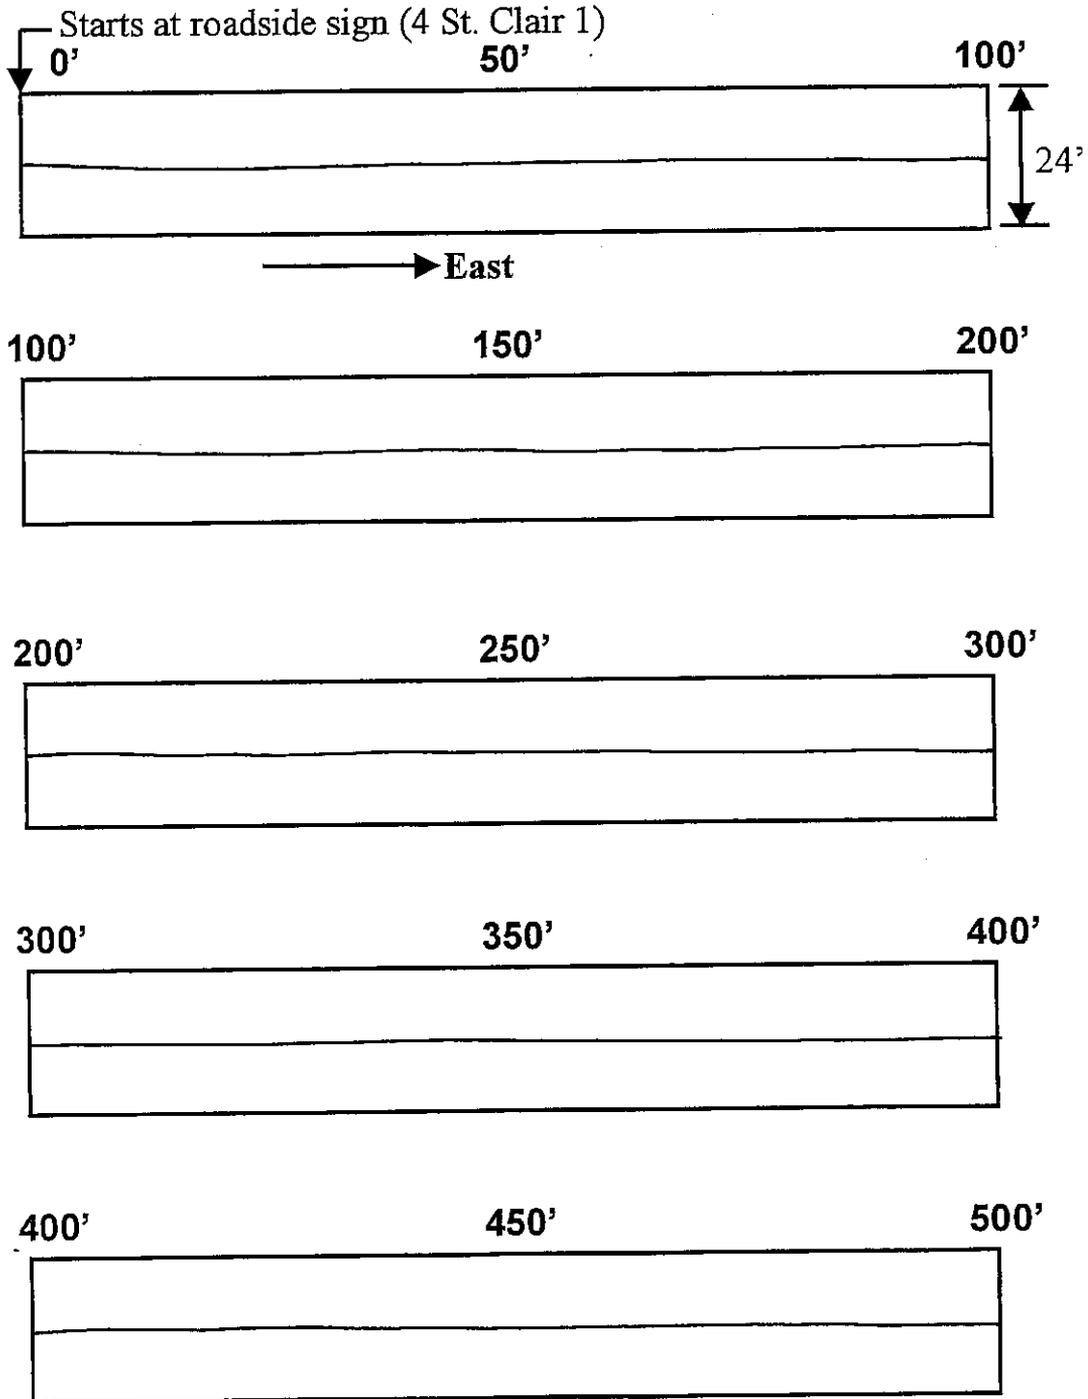
Figure D17. Crack Survey for IL 4/13

Location/Description: IL 4/13 from Marissa to Tilden

(Note: Crack widths indicated on survey are given in mm.)

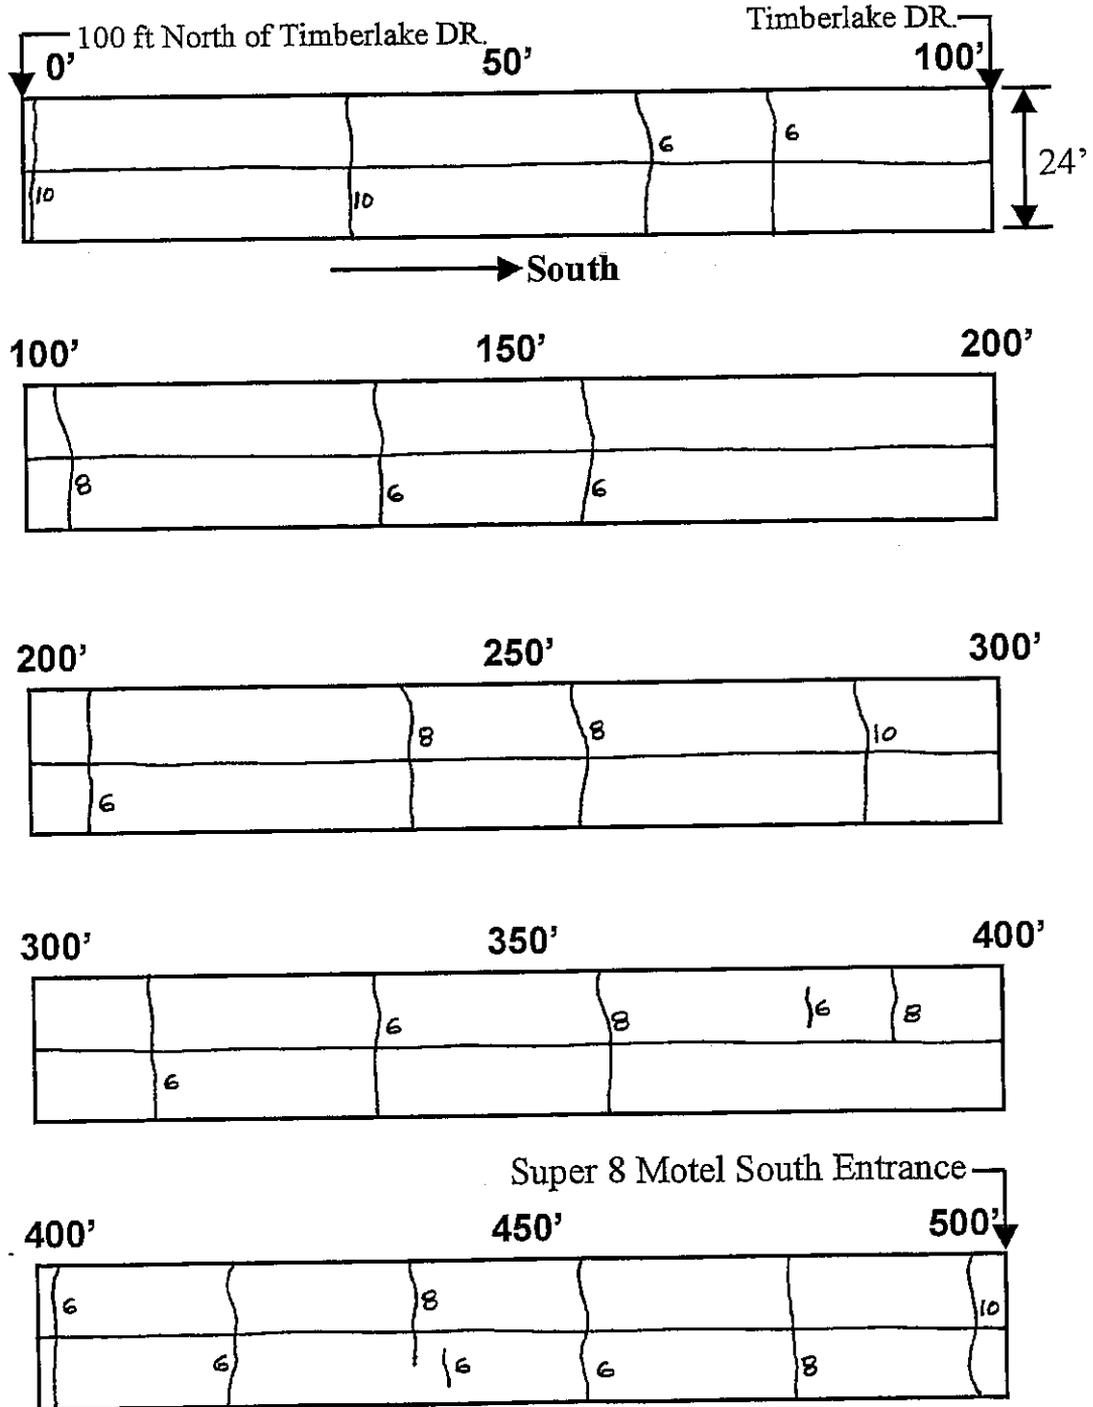
Figure D18. Crack Survey for IL 111 – South Bound

Location/Description: IL 111 in Pontoon Beach
(Area Treated Section) - South Bound Date: 6/24/98

(Note: Crack widths indicated on survey are given in mm.)

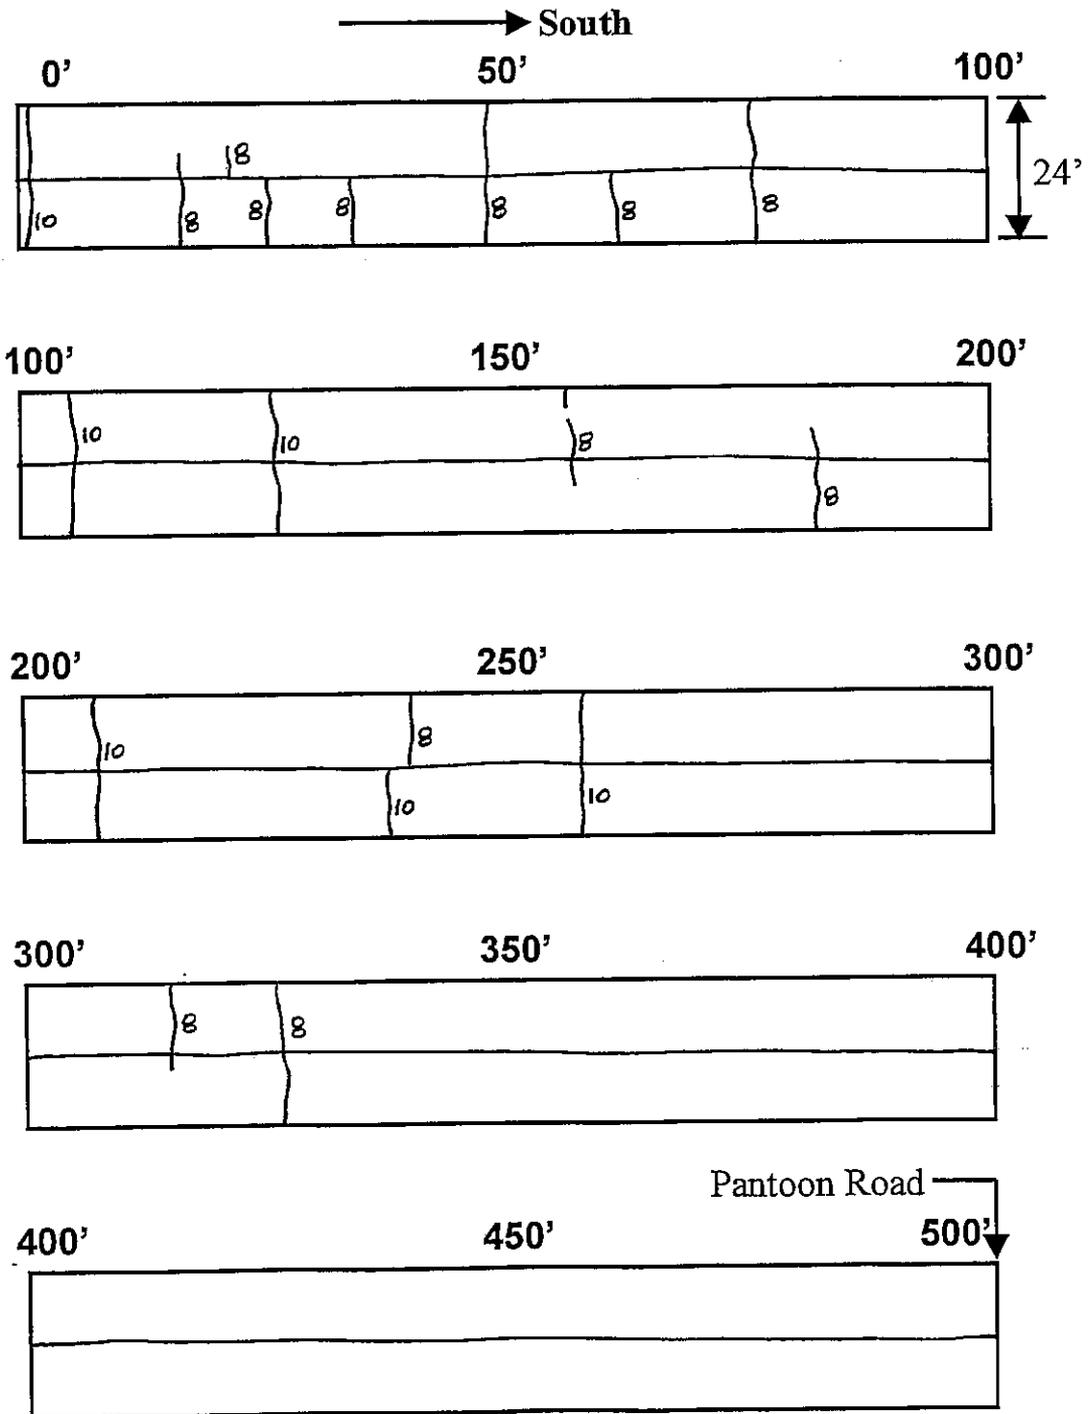
Figure D19. Crack Survey for IL 111 – South Bound

Location/Description: IL 111 in Pontoon Beach
(Control Section) - South Bound Date: 6/24/98

(Note: Crack widths indicated on survey are given in mm.)

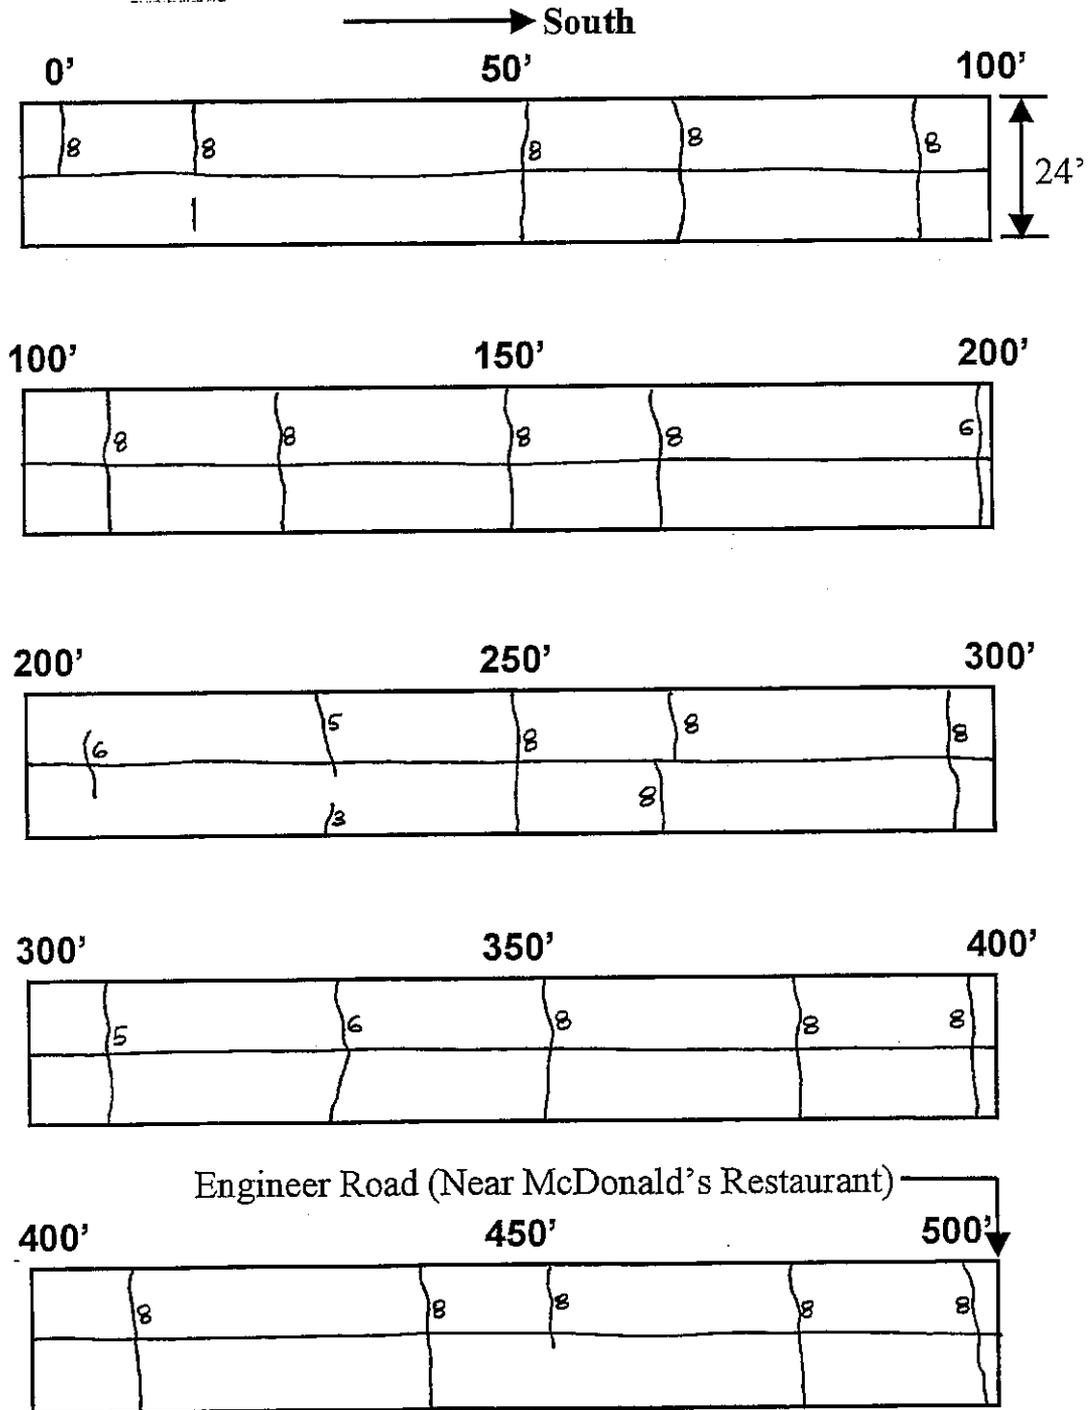
Figure D20. Crack Survey for IL 111 – South Bound

Location/Description: IL 111 in Pontoon Beach

(Note: Crack widths indicated on survey are given in mm.)

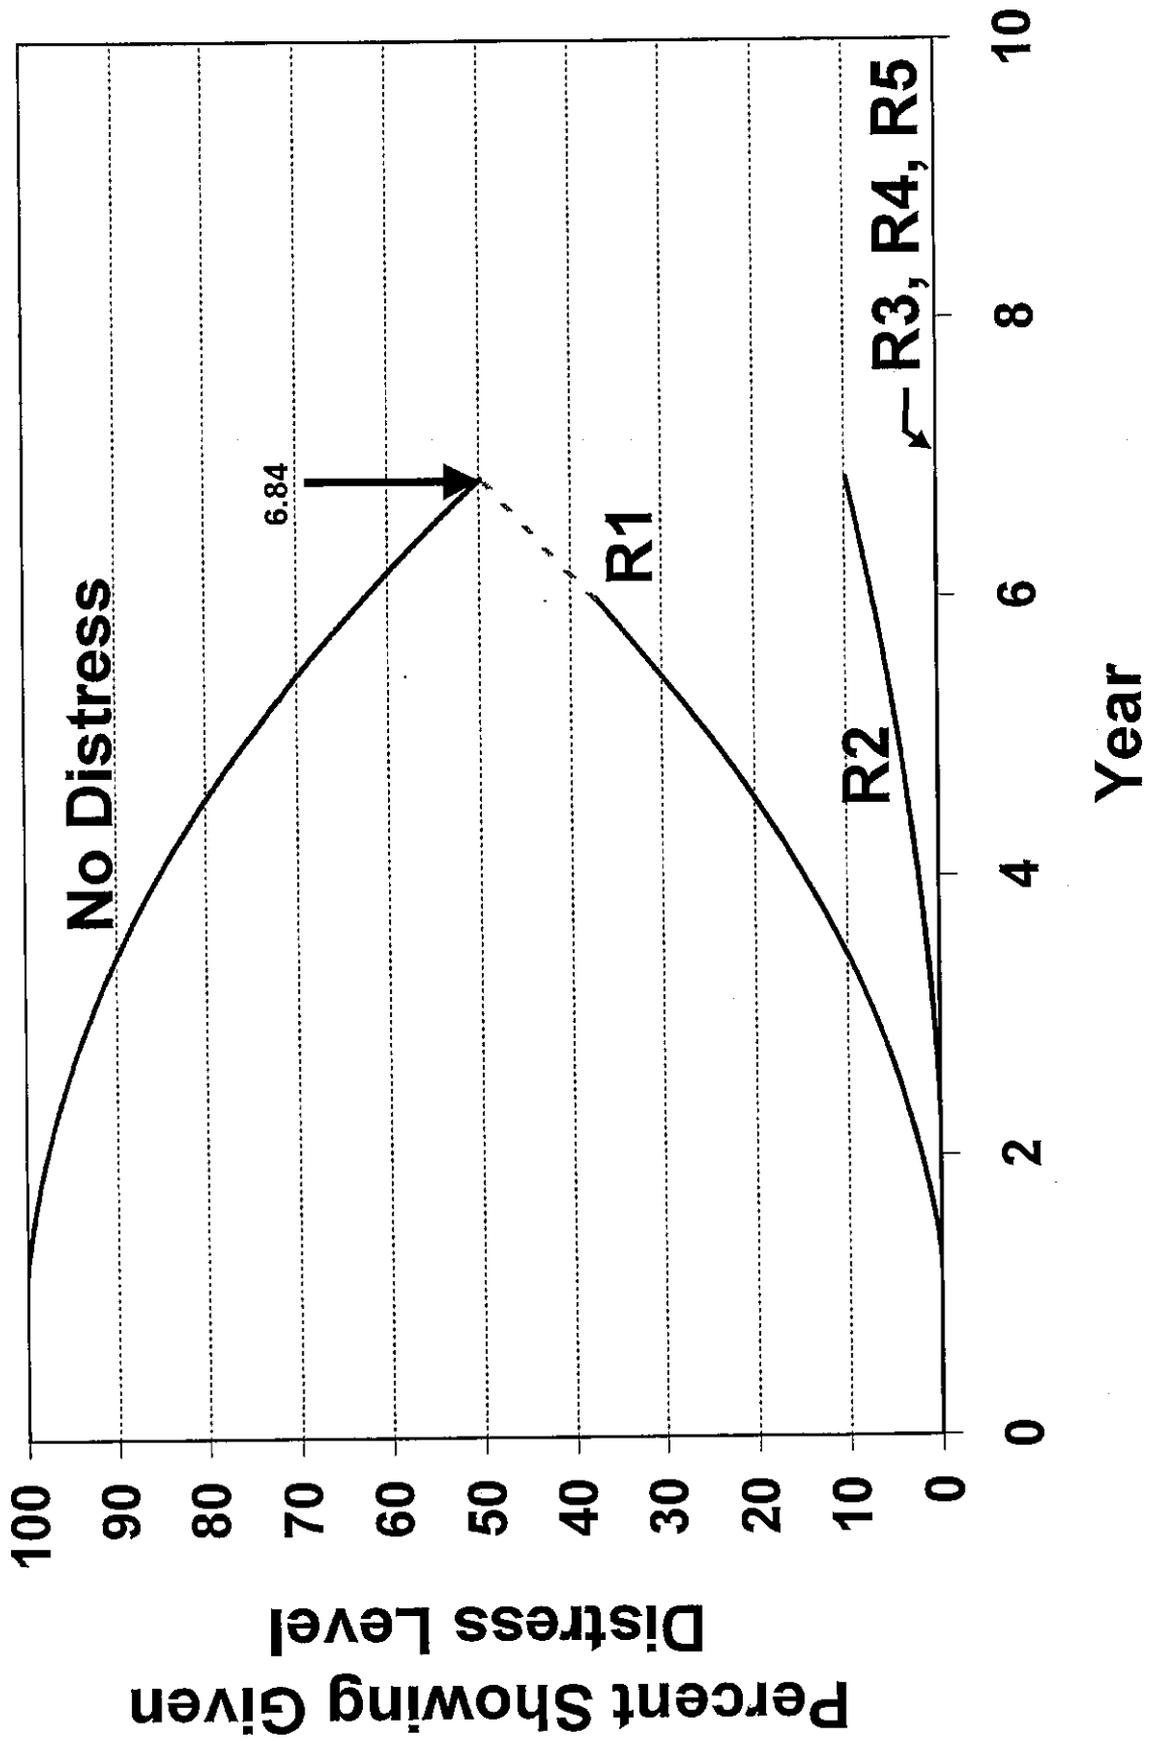
Figure E1. Performance Curve for Reflective Widening Crack, All Projects with Strip Treatment

A complete set of performance curves can be found in Appendix E. Annotated on these figures is the overlay age where 50 percent of projects reach a given distress level. This age will hereafter be referred to as the *median overlay age* to reach a given distress level. There are two properties of the performance curves that are worth mentioning. First, the 'no distress' curve and level-one (or greater) distress curve are, by definition, mirror images. Thus, these curves intersect at the 50 percent mark on the ordinate axis. A second expected trend is that each of the distress level lines (one through five) should plot from left to right without crossing. It should be noted that "interactions" are assumed negligible, e.g., strip, area, and control sections are assumed to have a relatively equal number of projects of varied traffic, environmental, material, and structural parameters. Given the fact that the final 52 projects were selected to balance these factors (Table 4.1), this assumption is valid.

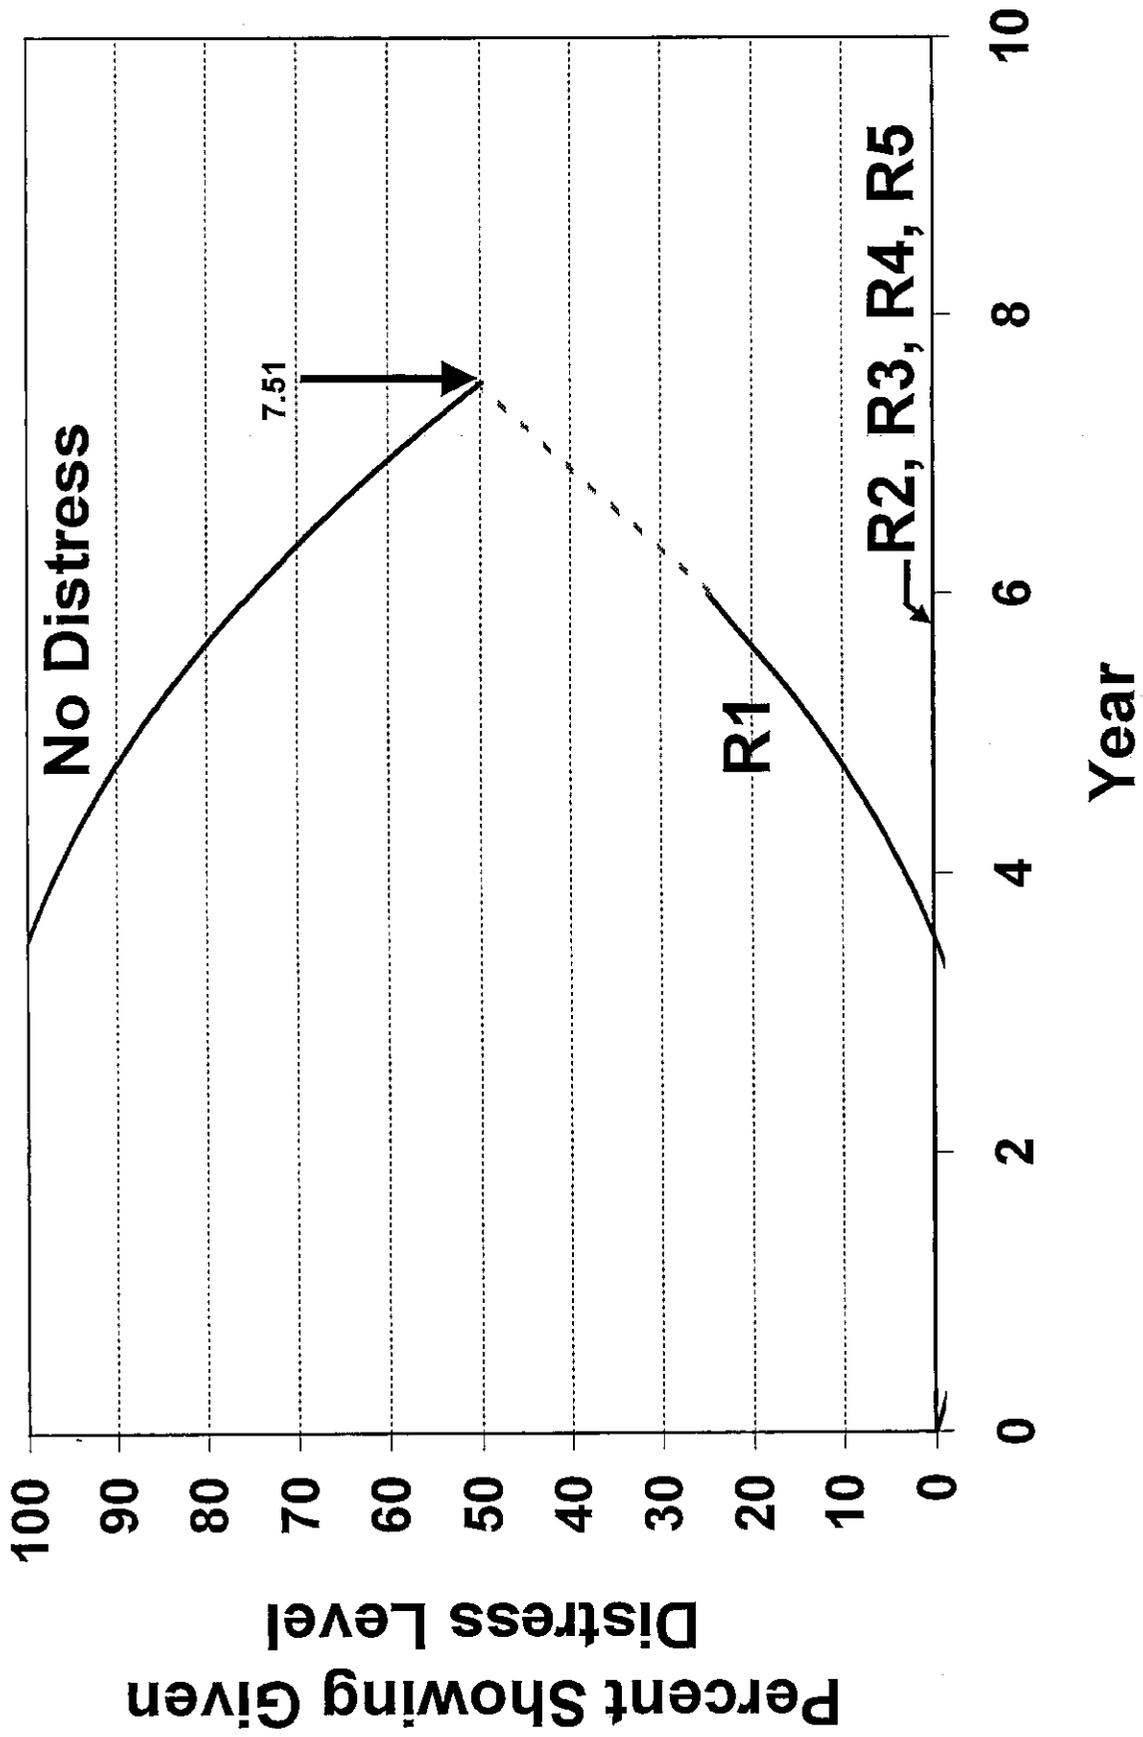
Figure E2. Performance Curve for Reflective Widening Crack, All Projects with Area Treatment

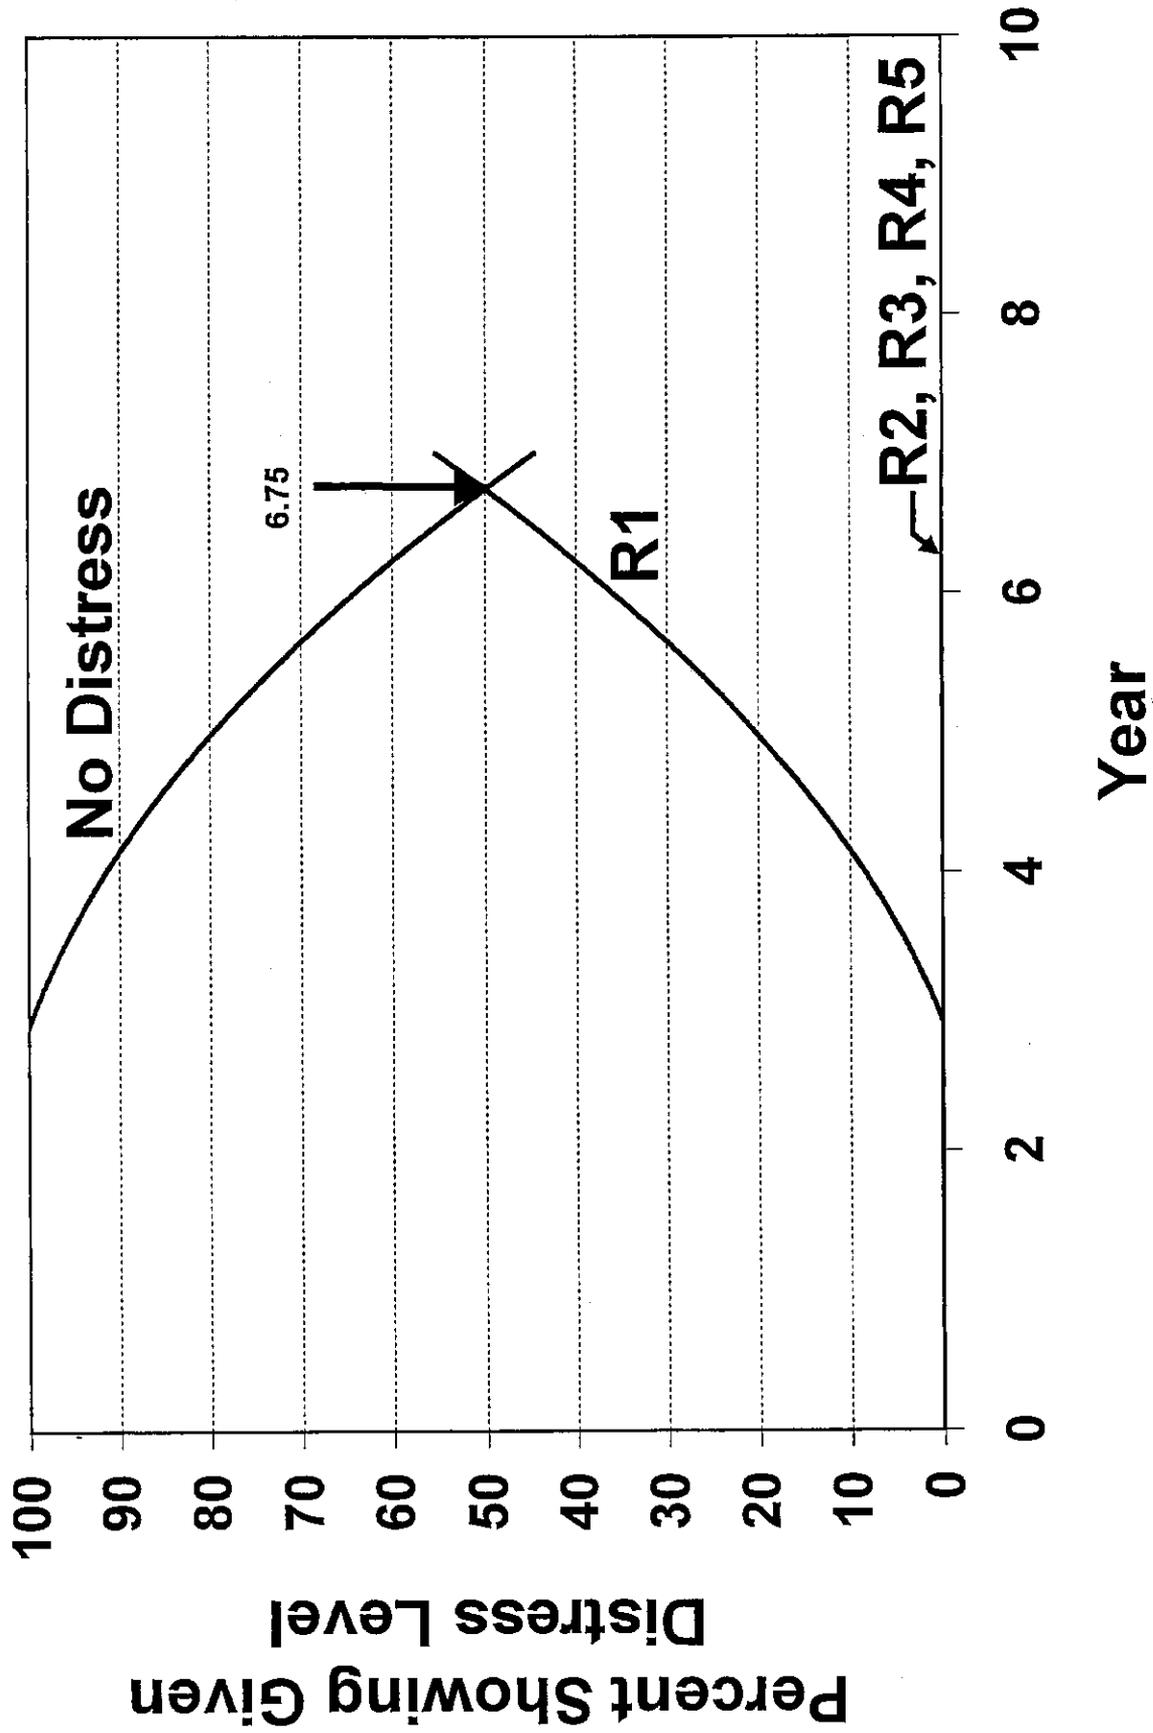
Figure E3. Performance Curve for Reflective Widening Crack, All Control Sections
