Evaluation of Reflective Crack Control Policy

Project IA-H1, FY95/96

Report No. ITRC FR 95/96-4

Illinois Transportation Research Center

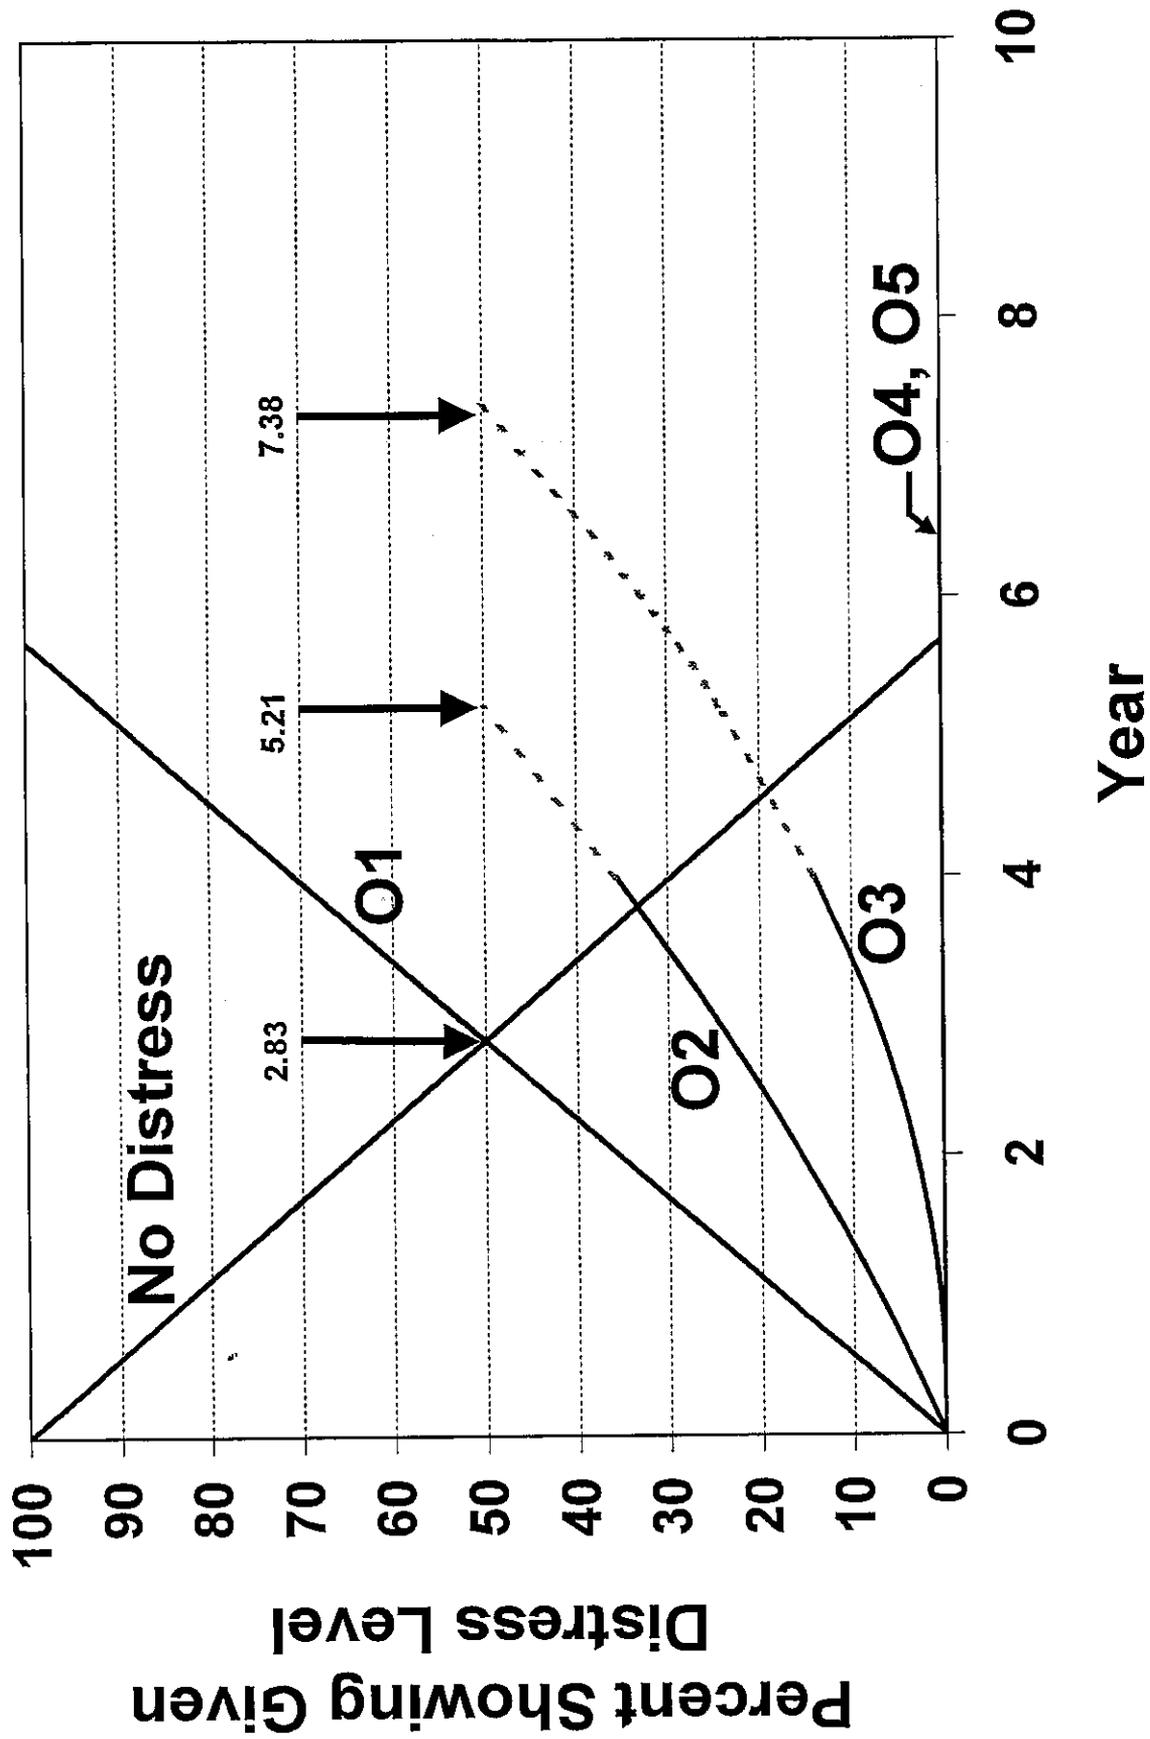
Figure E4. Performance Curve for Transverse Cracking/Joint Reflection Cracks, All Projects with Area Treatment

A complete set of performance curves can be found in Appendix E. Annotated on these figures is the overlay age where 50 percent of projects reach a given distress level. This age will hereafter be referred to as the *median overlay age* to reach a given distress level. There are two properties of the performance curves that are worth mentioning. First, the 'no distress' curve and level-one (or greater) distress curve are, by definition, mirror images. Thus, these curves intersect at the 50 percent mark on the ordinate axis. A second expected trend is that each of the distress level lines (one through five) should plot from left to right without crossing. It should be noted that "interactions" are assumed negligible, e.g., strip, area, and control sections are assumed to have a relatively equal number of projects of varied traffic, environmental, material, and structural parameters. Given the fact that the final 52 projects were selected to balance these factors (Table 4.1), this assumption is valid.

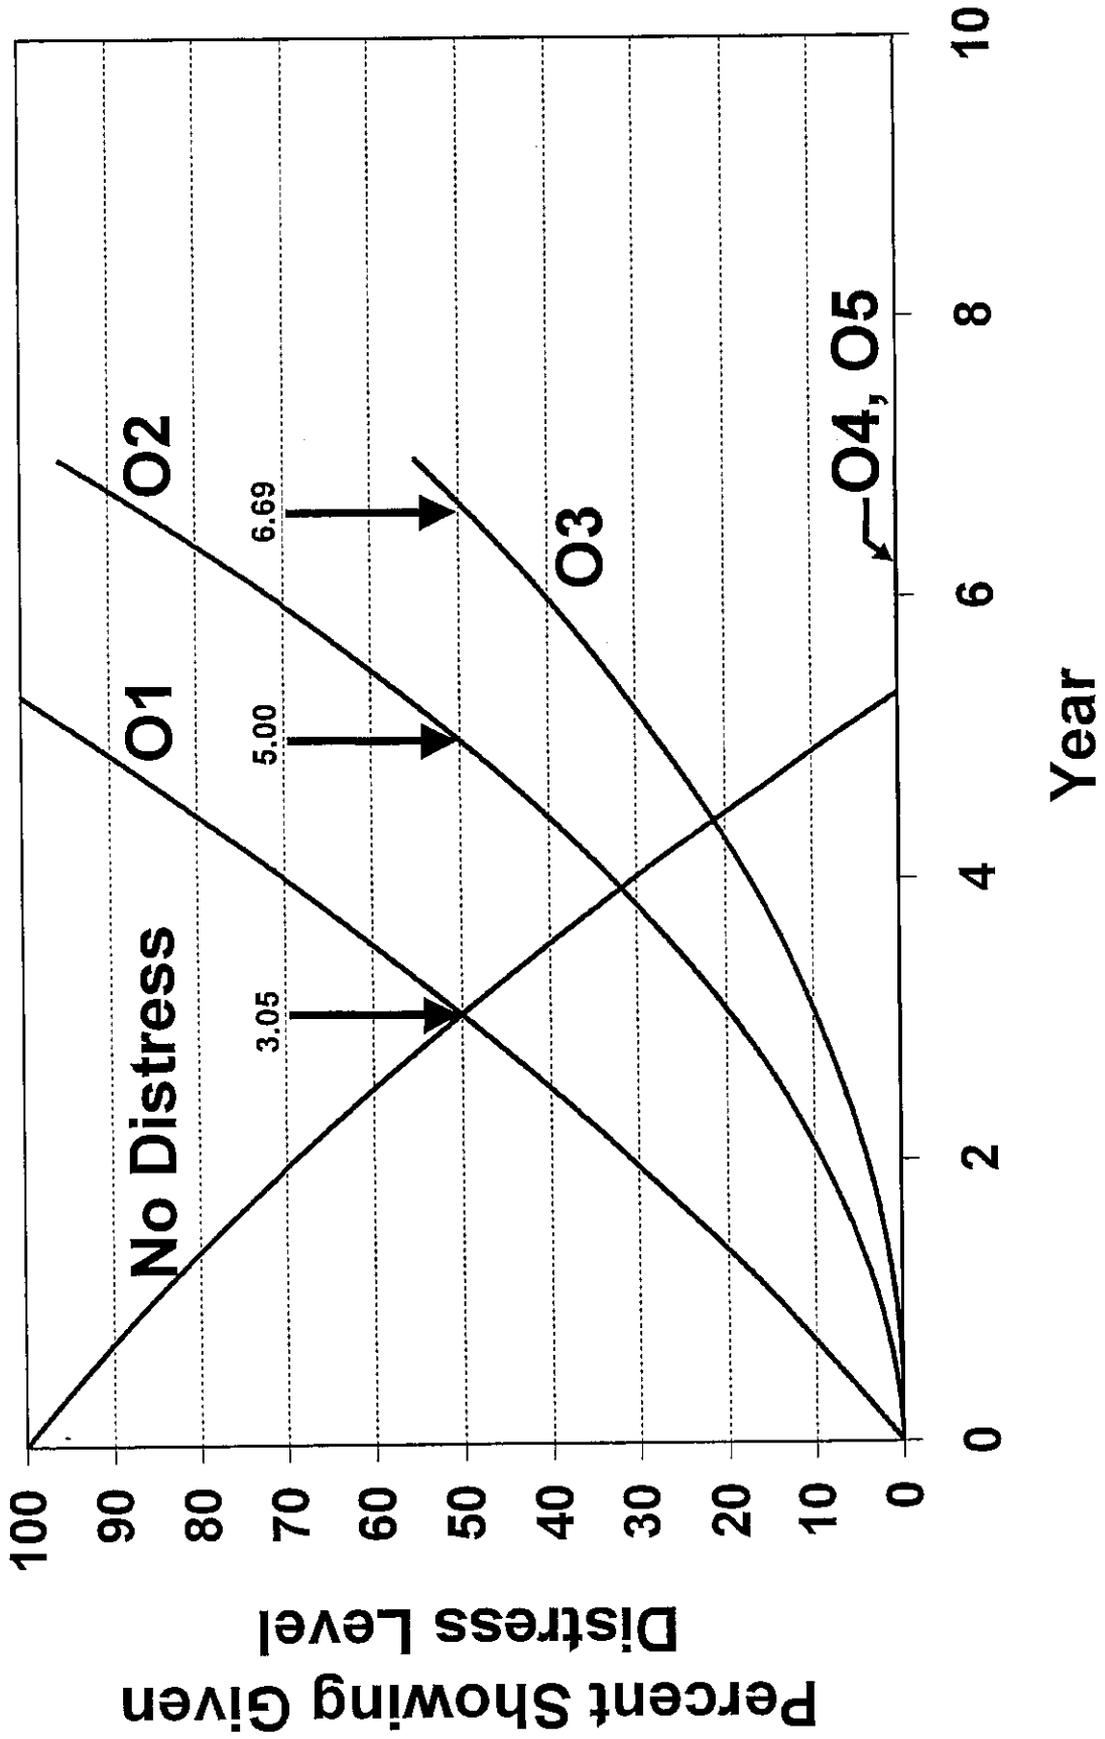
Figure E5. Performance Curve for Transverse Cracking/Joint Reflection Cracks, All Control Sections and Strip Treatments Lumped Together
