STATE OF ILLINOIS
DEPARTMENT OF TRANSPORTATION

FINAL REPORT
ON
LIME STABILIZATION OF BRIDGE CONES
IHR-98 - Item 3

May 1973

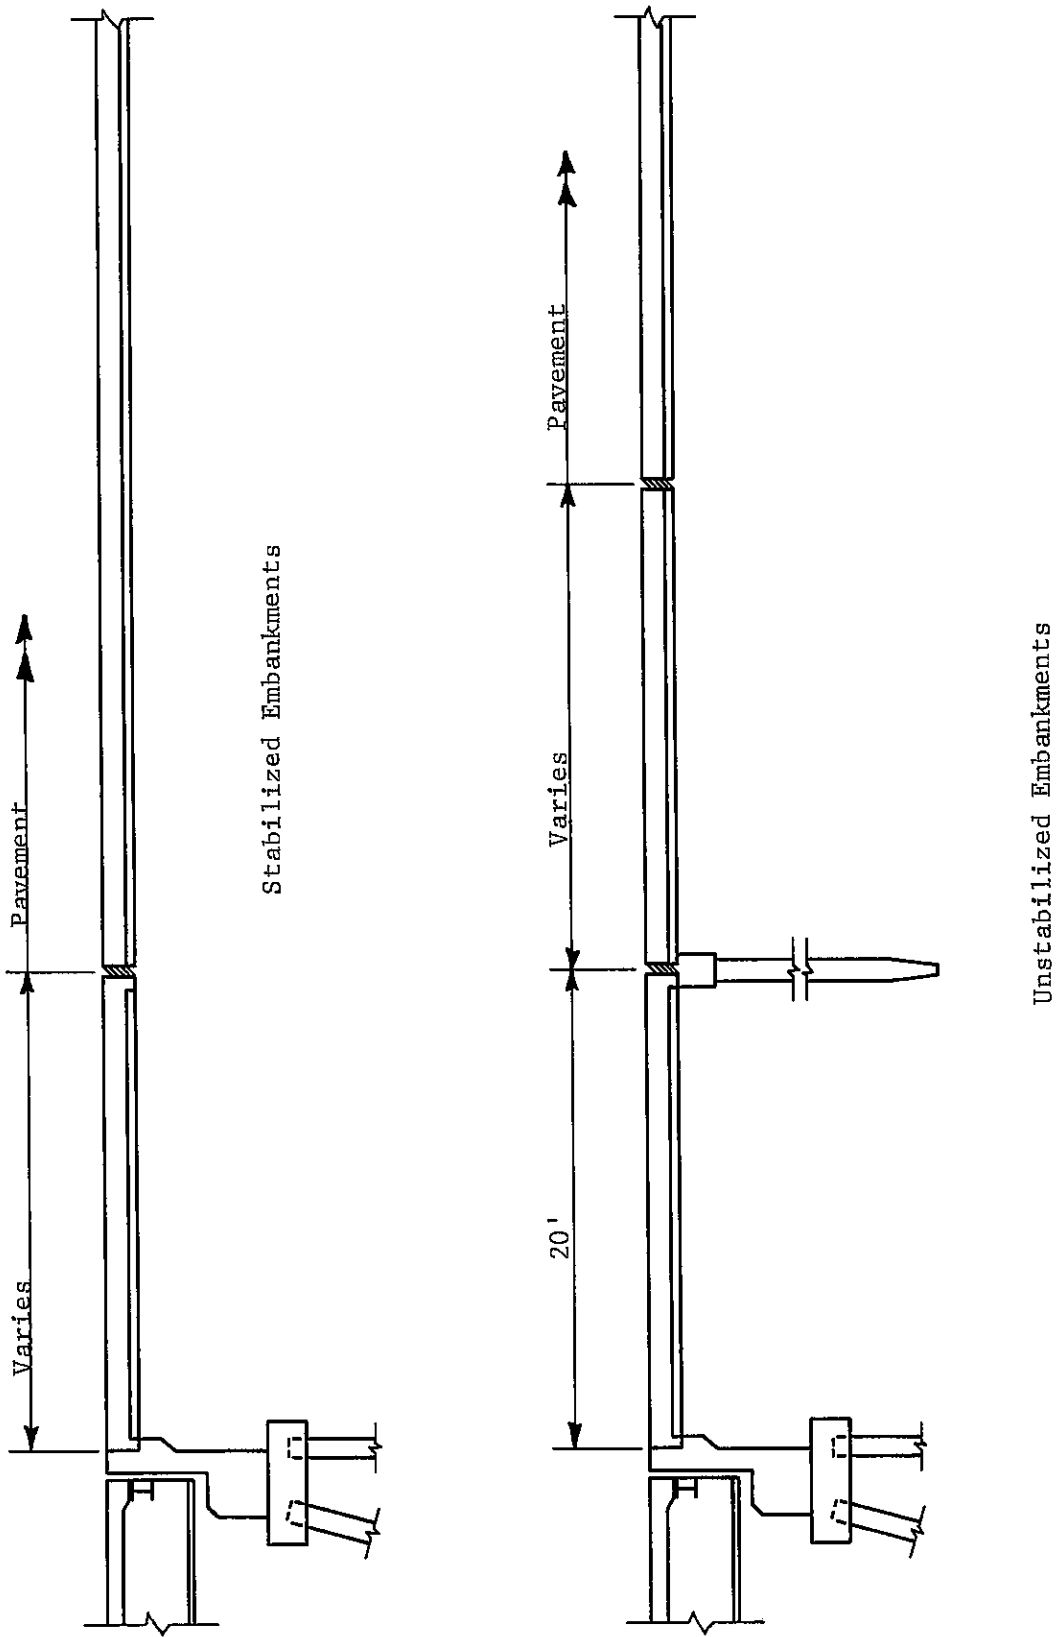
Figure 3. Section through approach slabs at Higgins Road.

The approach slabs on the south stabilized embankments at Higgins Road were constructed as conventional 20-ft slabs between the bridges and the pavements (Figure 3). No pile caps were used to support the adjoining ends of the approach slabs and pavements. The slabs were constructed on a 16° skew at the back of the abutments and at right angles to the centerline of the roadway at the end of the slab adjoining the pavement. Therefore, the length of the short side of the slabs is 20 ft, and the length of the long side is about 30 ft. The roadways at this location consist of three 12-ft lanes for a total roadway width of 36 ft.

The approach slabs on the north unstabilized embankments consist of a conventional 20-ft slab adjacent to the bridge and a 20-ft transition slab between the approach slab and the pavement (Figure 3). The adjoining ends of the approach slabs and the transition slabs are supported by pile caps. The transition slabs were constructed on a 16° skew at the pile caps and at right angles to the centerline of the pavements at the ends adjoining the pavements.

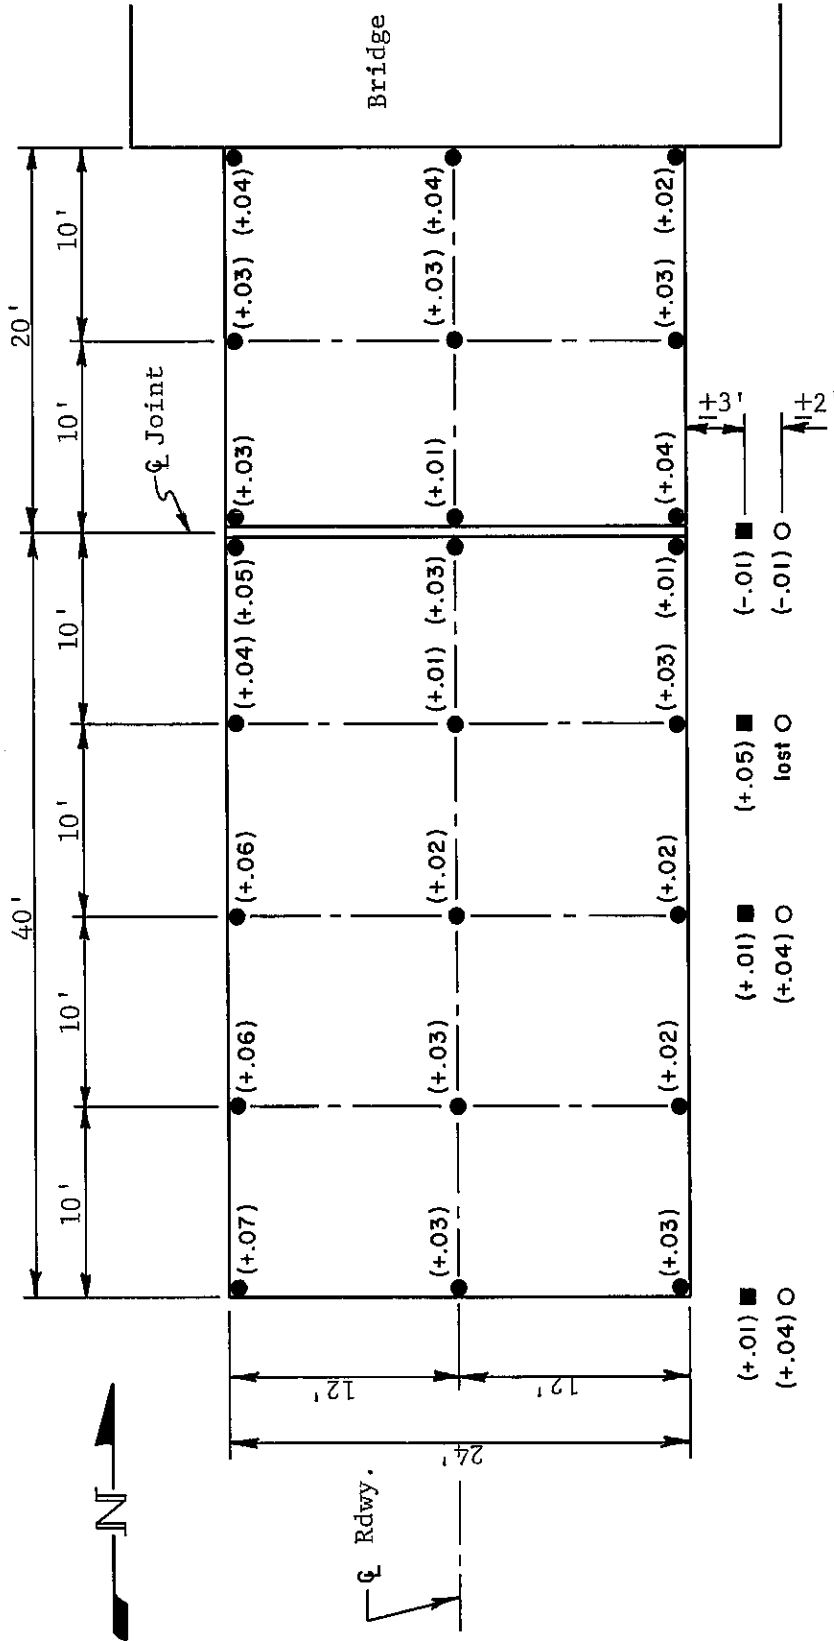
- Settlement plates on top of embankment
- Settlement platforms beneath embankment
- Elevation points on approach slabs
- (#.XX) Difference in elevation in feet from October 1969 to August 1972

Figure 4. Plan of Southeast approach slab at First Avenue (stabilized embankment).

Observations made on the approach slabs located on the stabilized southeast embankment show that the slight vertical movements of the slabs were in the upward direction (Figure 4). Shortly after the approach slabs were placed, the adjacent shoulders heaved with respect to the approach slabs. The upward displacement of the approach slabs and shoulders is not believed to be a result of the lime treatment.

The small settlement plates located on top of the stabilized embankment indicate that, since the approach slabs were placed, the top of the embankment rose approximately 1/2 in. except at the plate located 20 ft from the back of the abutment where a settlement of 1/8 in. was recorded. The water which was trapped within the subbase may have flowed beneath the plates and, upon freezing, forced the plates upward at some locations.

At the stabilized embankment the three buried platforms located on top of natural ground beneath the embankments at distances of 20, 40, and 60 ft from the back of the abutment show that a negligible amount of vertical movement occurred in the subsoils. The platform located 5 ft below natural ground appears unreasonably to have moved upward about 5/8 in. An increase in elevation at this location is considered unlikely because of the physical nature of the subsoil underlying the platform; therefore, the recorded increase in elevation is attributed to an error in measured elevations.

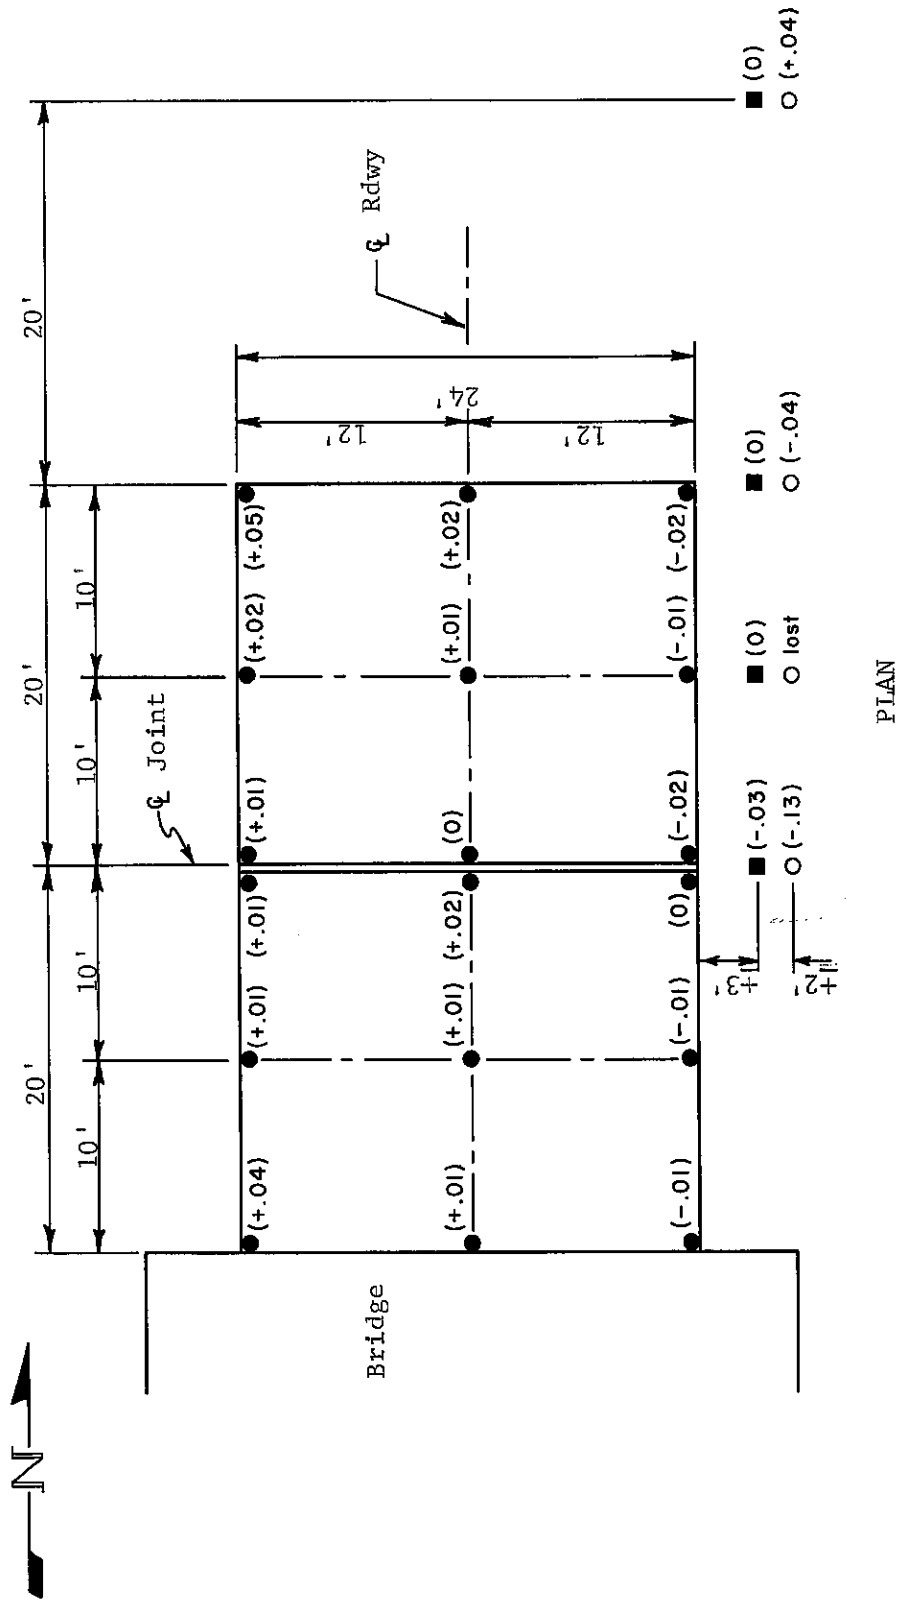
- Settlement plates on top of embankment
- Settlement plates beneath embankment
- Elevation points on approach slabs
- (±.XX) Difference in elevation in feet from October 1969 to August 1972

Figure 5. Plan of Northeast approach slabs at First Avenue (unstabilized embankment).

At the north unstabilized embankment the changes in elevations on the approach slabs from October 1969 to August 1972 were moderate as shown in Figure 5. At most locations the measurements indicate a slight rise in elevation with the largest increase in elevation (5/8-in.) occurring at the northwest corner. Elevation changes of this magnitude are not sufficient to materially affect the riding quality of the approaches.

The vertical movements within the northeast embankment as indicated by the small settlement plates located beneath the subbase show that the movements ranged from 0 to \pm 1/2 inch except at the plate located 20 ft from the back of the abutment. At this location a total settlement of about 1-5/8 in. was recorded. By deducting the settlement of 3/8 in. which occurred beneath the embankment at this location from the total settlement of the top of the embankment, a net settlement within the embankment of 1 1/4 in. is recorded. This settlement was not reflected in the movement of the approach slab at this location, possibly because the slab is supported by an approach pile cap which did not settle a corresponding amount. The variation in vertical movements within the embankments is evidence of localized settlements which can occur within an embankment constructed by standard methods.

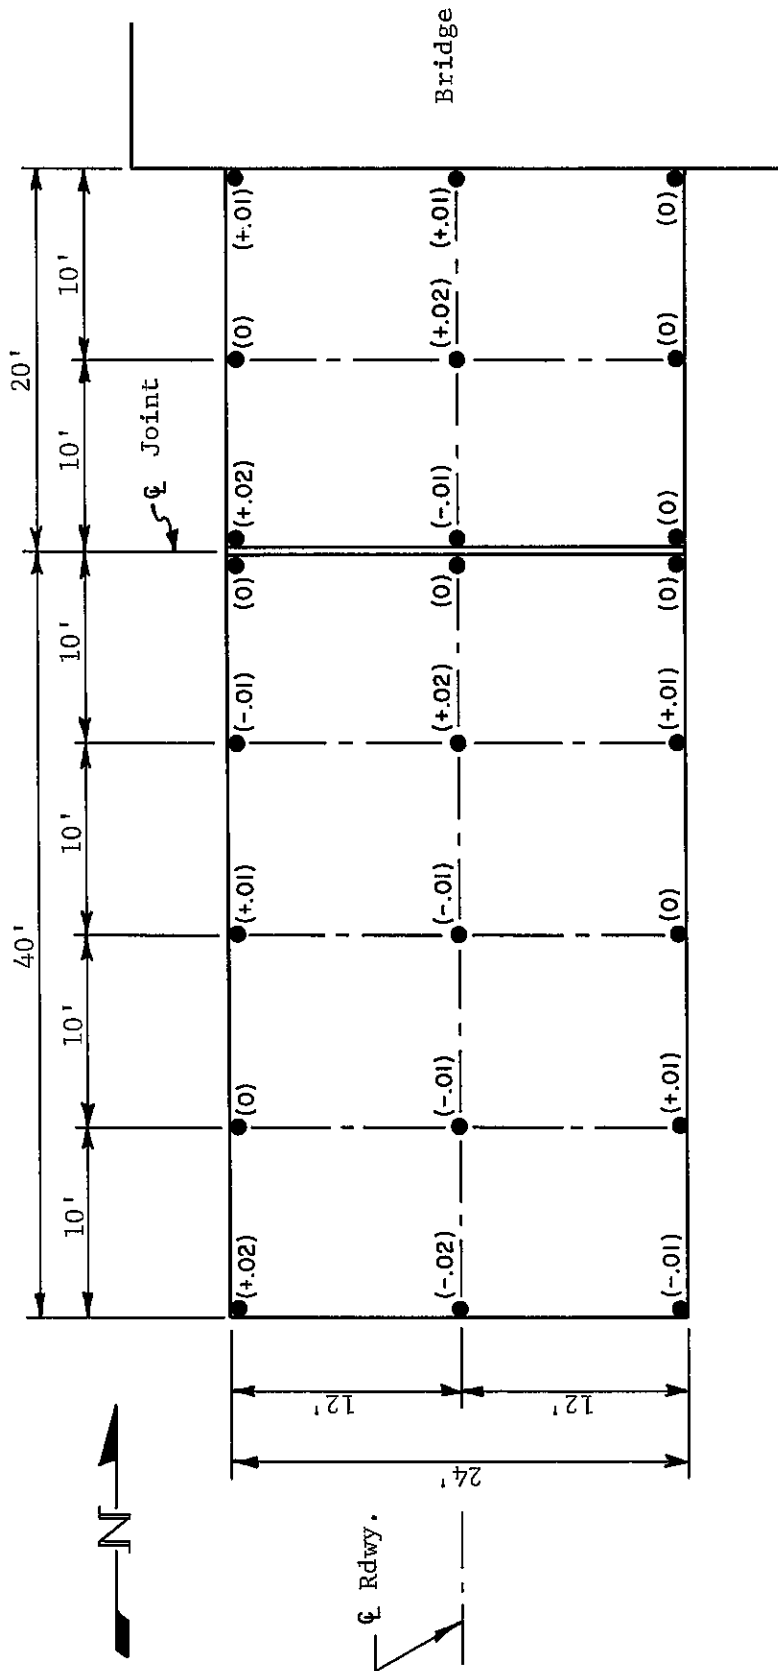
- Elevation points on approach slabs
- (±.XX) Difference in elevation from October 1969 to August 1972

Figure 7. Plan of Southwest approach slabs at First Avenue (unstabilized embankment).

The settlements of the approach slabs at the northwest and southwest embankments, which were both constructed by standard procedures, were slight as indicated in Figures 6 and 7. These small settlements would have little effect on the riding quality of the approach slabs and for all practical purposes can be considered negligible.

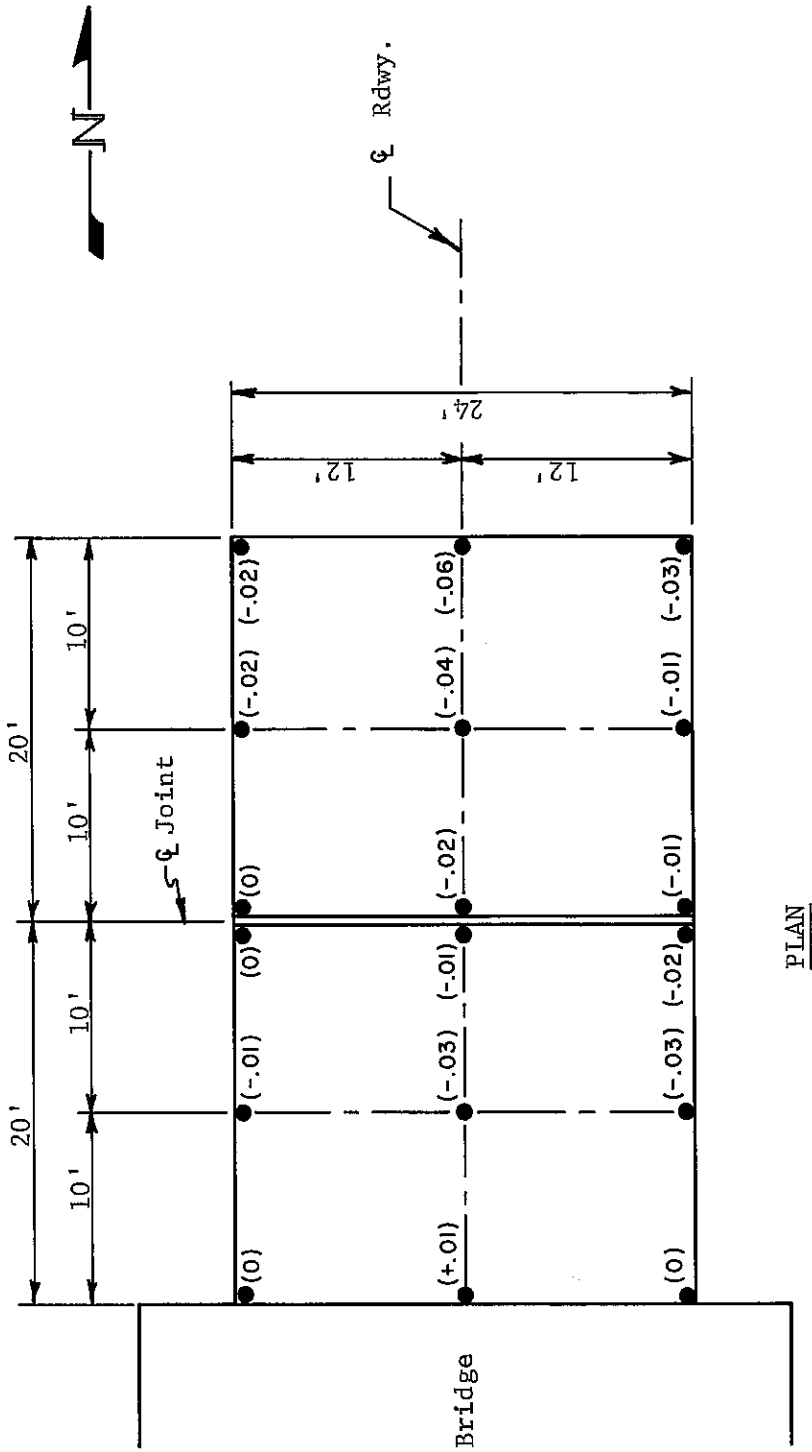
Legend
 ● Elevation points on approach slabs
 (±.XX) Difference in elevation from October 1969 to August 1972

Figure 6. Plan of Northwest approach slabs at First Avenue (unstabilized embankment).

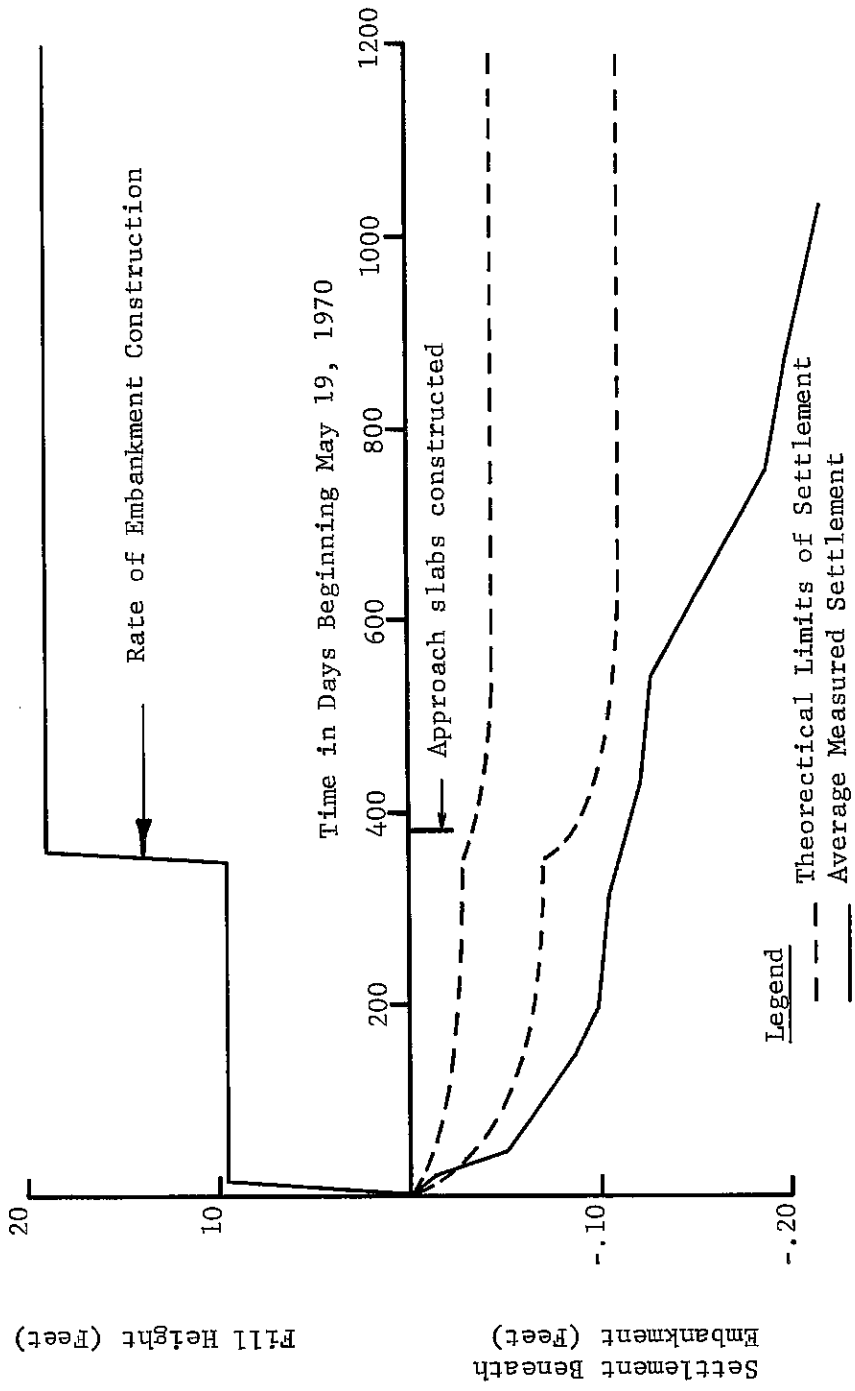
Figure 9. Theoretical and measured settlement of unstabilized embankment correlated to rate of embankment construction (Higgins Road Project).

A comparison of the total settlement which has occurred in the subsoils beneath the stabilized and unstabilized embankments as plotted in Figures 8 and 9 show that

more settlement has occurred beneath the north unstabilized embankment than has occurred beneath the south stabilized embankment. Since the stabilized embankment was completed about 200 days before the unstabilized embankment, more settlement theoretically should have occurred beneath the stabilized embankment during this time period than below the unstabilized embankment assuming all other factors to be equal.

At both embankments the amount of measured settlement which has occurred exceeds the theoretical limits for predicted settlement. The difference between measured and theoretical settlement is not regarded as significant since the dashed lines represent only a general approximation of the subsoil settlements.
