# AGGREGATE SUBGRADE THICKNESS DETERMINATION

**PHYSICAL RESEARCH REPORT NO. 154**  
**August 2009**

**Illinois Department of Transportation**

Experimental Features Project IL 03-01

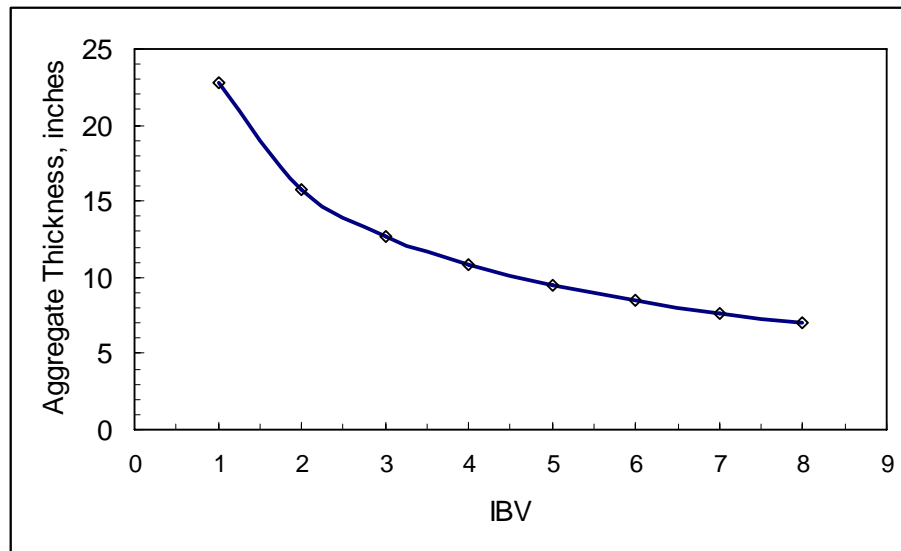
**Figure 1. Aggregate Thickness Recommendations Based on Thompson et al.**

Figure 1 has been used by IDOT since 1982 to determine appropriate improved subgrade thickness, and the most recent edition of the Subgrade Stability Manual (IDOT, 2005)

reaffirms this chart's use. The minimum 12-inch improved subgrade thickness requirement is based on the assumption that most Illinois soils have an in-situ moisture content wet of optimum resulting in an in-situ IBV around 3 (IDOT, 2002). Figure 1 indicates an IBV of 3 requires a thickness of 12 inches. Although aggregate properties are not directly input, both Thompson et al. and the Subgrade Stability Manual (IDOT, 1982/2005) discuss the importance of aggregate properties to performance. They recommended a minimum Illinois Bearing Ratio (IBR) of 15 to 20 and an aggregate with low moisture sensitivity. Low moisture sensitivity was characterized by having crushed materials with a lower fines content having a low Plasticity Index (PI).

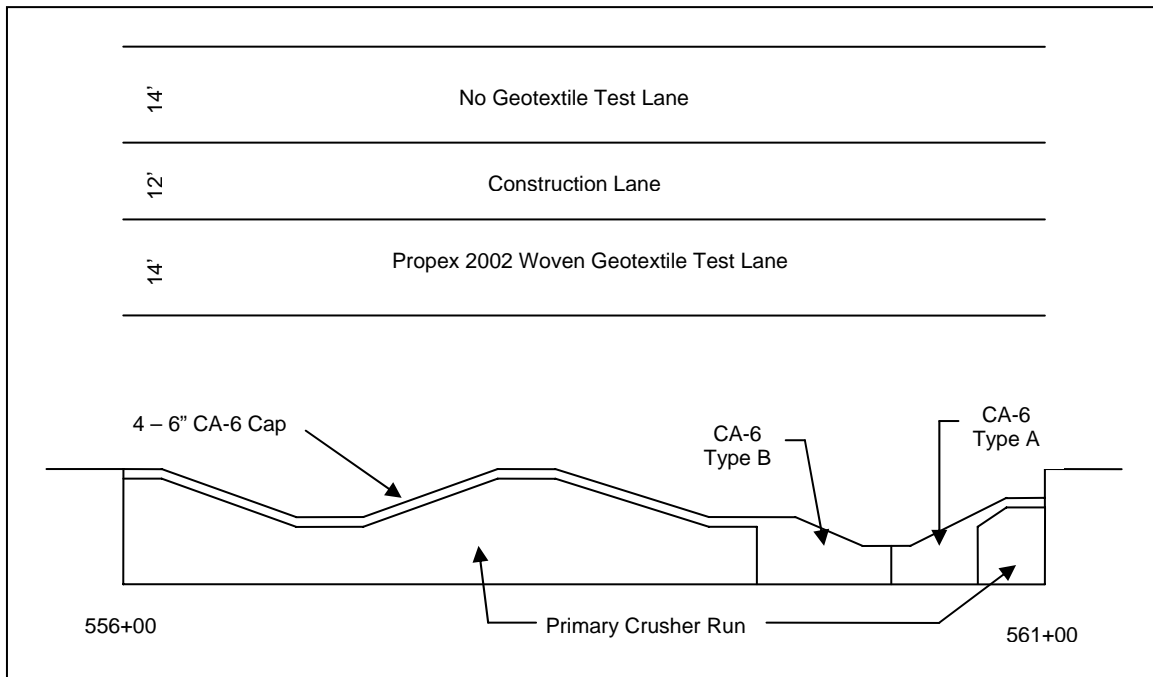
**Figure 2. Example Plan and Profile View from Northbound Lane**

Because of the difficulty involved with grading aggregate to a variable depth, actual test locations were determined based on comparing a detailed survey before and after placing aggregate. Because of the construction variability inherent with fine grading, some locations with a particular desired aggregate thickness could not be identified. Test locations were grouped according to the specific aggregate types being compared and similarity of soil conditions.

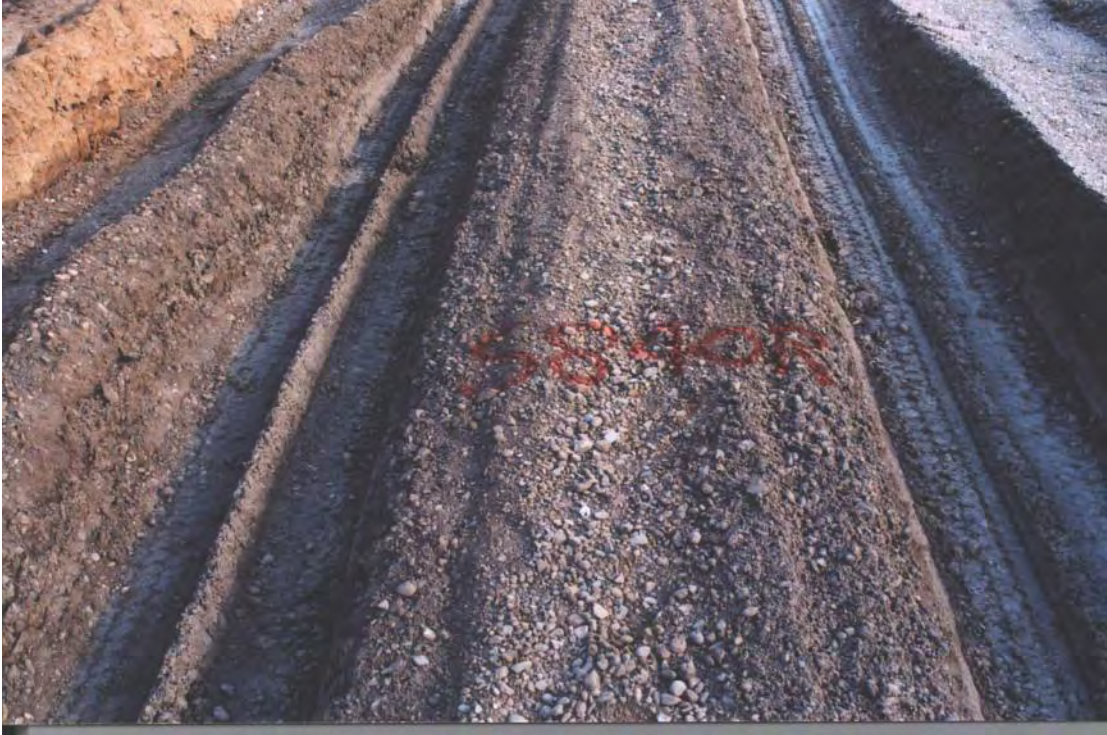
**Figure 3. Test Location S840R: 12” Gravel without Geotextile after 20 Load Passes**

Figure 3 visually shows the magnitude of rutting representative of these locations. Accurately measuring rut depth was difficult in these situations because there was a combination of rutting and shoving. As a result, no meaningful data was obtained following the 10 load pass measurements. Trucks were diverted to the construction lane after about 20 passes because of difficulty driving through the ruts.

The poor performance of this section may have been a direct result of inadequate compaction. The subgrade IBV was sufficient to support the aggregate thickness used, and the clay soil within the gravel test area was not prone to pumping. Therefore, most of the rutting occurred within the aggregate layer itself. If an area is compacted only to the “satisfaction of the Engineer,” the quality of compaction can vary depending on the Engineer’s bias and also material type. Both the gravel and CLS sections were compacted using the same compactive effort. The CLS was able to achieve a higher percent compaction perhaps due to a larger amount of fines.

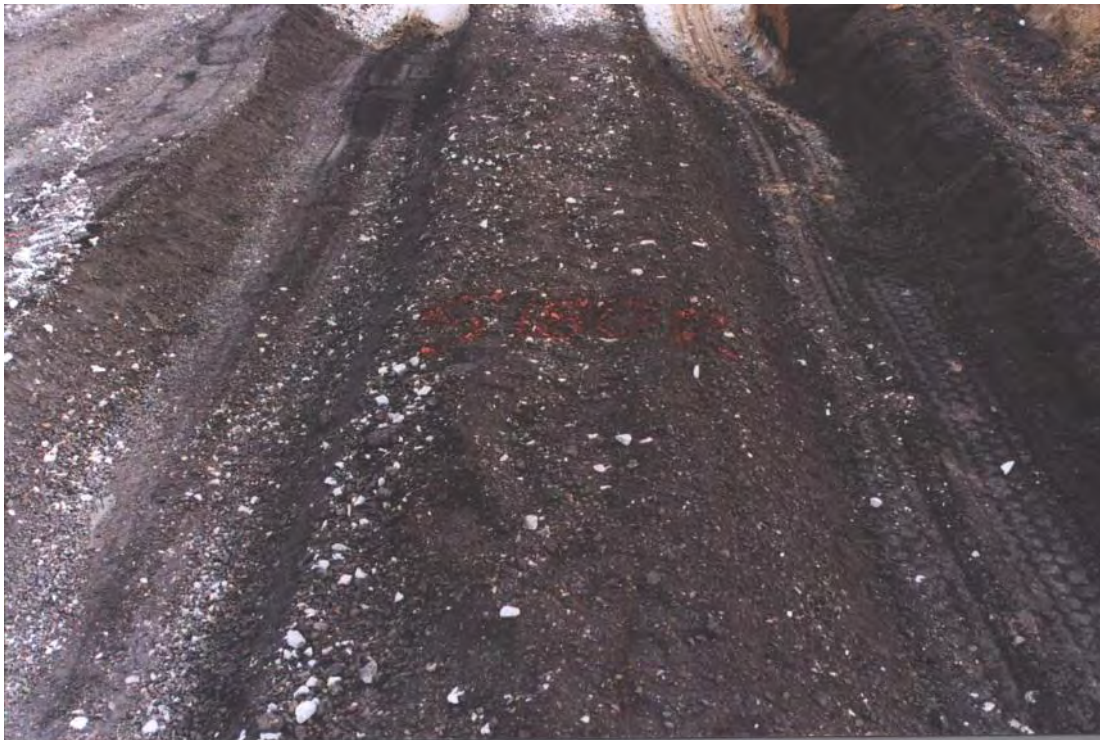
**Figure 4. Test Location S180R 12" of Surface Millings after 20± Load Passes**

The data in Table 3 shows that all test locations exhibited excessive rutting after a relatively small number of load passes. Like Figure 3, Figure 4 shows the difficulty in obtaining

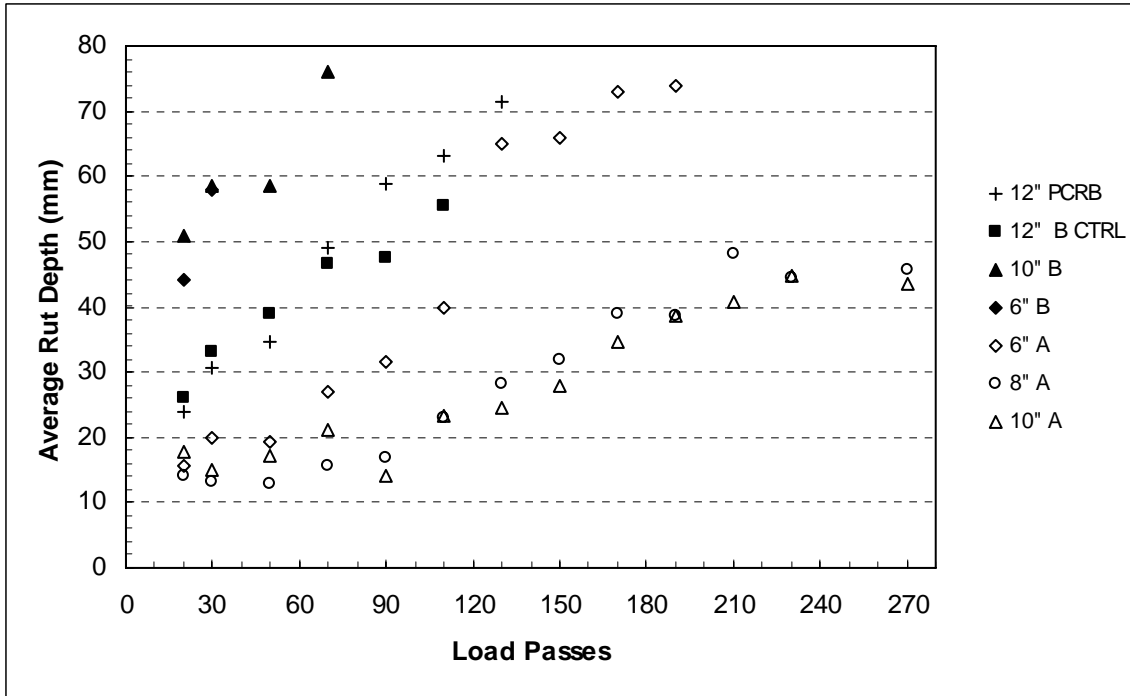
**Figure 5. Crushed Limestone CA-6 Rut Depth versus Load Passes with no Geotextile**

The data shown in Figure 5 indicates Type A materials outperform Type B materials. The rutting observed within the 12-inch Type B CLS control section was similar to that observed within the uncrushed gravel and RAP CLS control locations. However, the Type A material outperformed the control material at every thickness down to 6 inches. The oversize material capped with Type B material performed only slightly better than the control. With the exception of the 8-inch Type A CLS, all of the materials exceeded the maximum 0.5-inch (12.5 mm) rut depth allowed by IDOT policy (IDOT, 2005). Complete rutting data is shown in Appendix C.

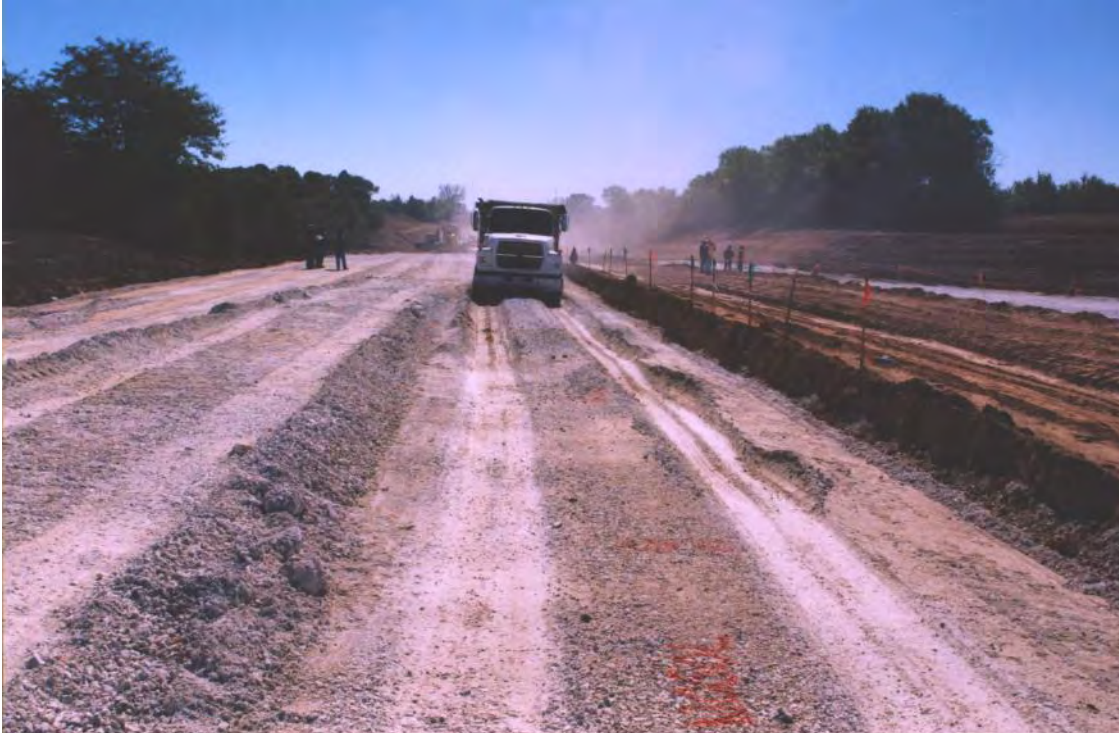
**Figure 6. Loading Transition area between Type A (foreground) and Type B (background) CLS CA-6. Note edge effects the right side of the photo corresponding to the left wheel path**

After approximately 20 load passes, the left most wheel path over the length of the Type B material showed approximately two times the rutting depth as the right wheel path as shown in Figure 6. The likely reason for these edge effects is inadequate compaction along the left edge. To compensate for this, the Type B data rutting data described in this section represents the average of the 2 rut depth measurements opposite the edge, with the largest two measurements along the edge discarded. The test location representing the 8-inch Type B material (N950L) has also been discarded because, even after compensating for edge effects, the rut measurement after 20 passes was 112 mm. This value is unrealistically high, especially given the measurements obtained at the 6-inch test location. A review of subgrade data indicates the high rut depth may have been due to a localized area with IBV less than 3.

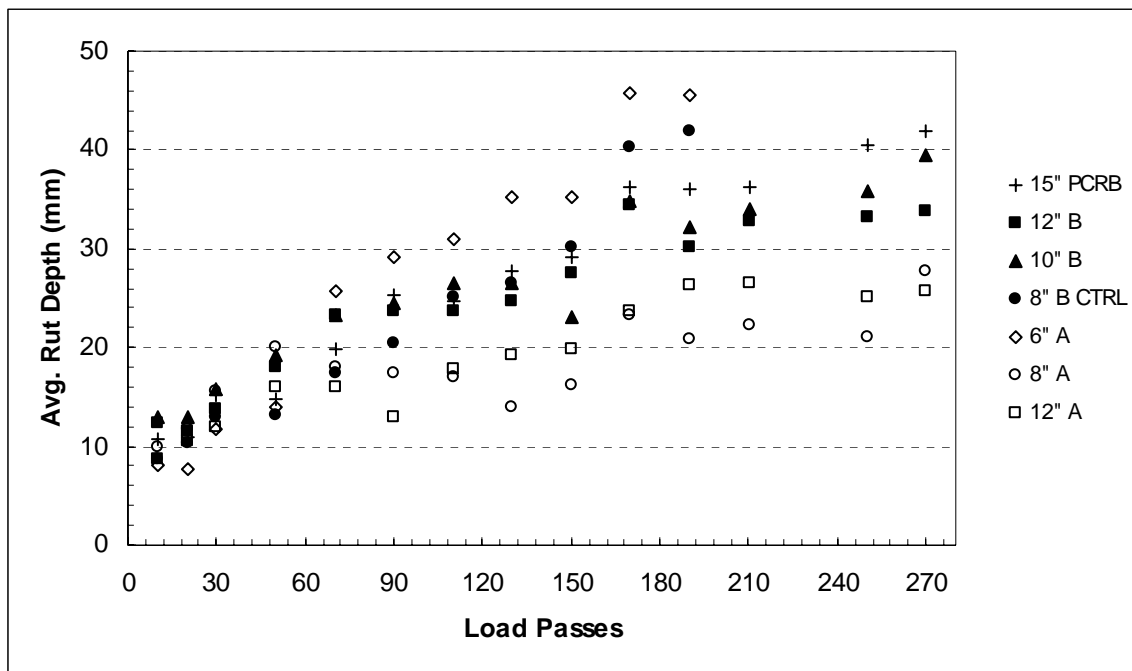
Figure 7. Average Rut Depth Versus Load Passes for CLS CA-6 over Geotextile

The data shown in Figure 7 show a significant improvement in Type B CLS performance as load passes increase when compared with the no-geotextile data shown in Figure 5. When a geotextile is used, the Subgrade Stability Manual allows a one-third reduction in aggregate thickness (IDOT, 1982/2005). As a result, the control location consisted of 8 inches of Type B materials rather than the 12 inches used in the no-geotextile sections. The data indicates the sections with geotextile limited rutting to the required 0.5-inch (12.5 mm) maximum for less than 30 load passes.

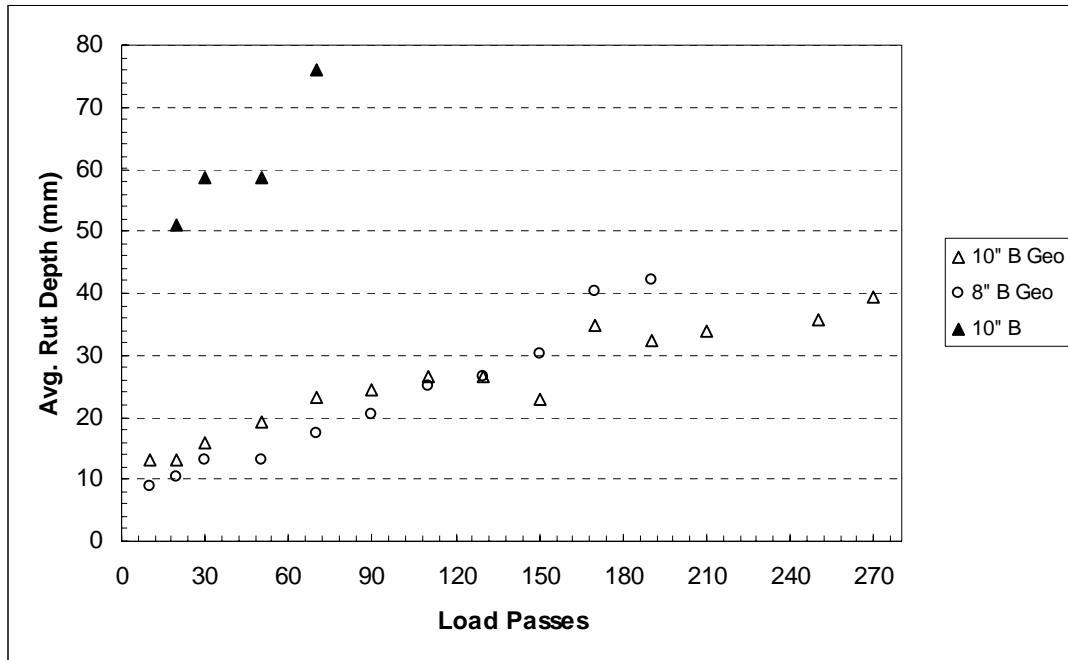
**Figure 8. Type B CLS With and Without Geotextile Rut Depth vs. Load Passes**

The data in Figure 8 shows the geotextile significantly improved the performance of Type B CLS. However, the data may be misleading. One reason the rutting data with geotextile is significantly lower than without geotextile is the lack of any observed edge effects within the geotextile test section. The lack of edge effects may be a result of better edge compaction within the geotextile section. However, it cannot be determined whether this is a result of construction variability or a benefit of using geotextile. The data for Type A materials in Figure 9 may provide a more accurate representation of the effect of geotextile.

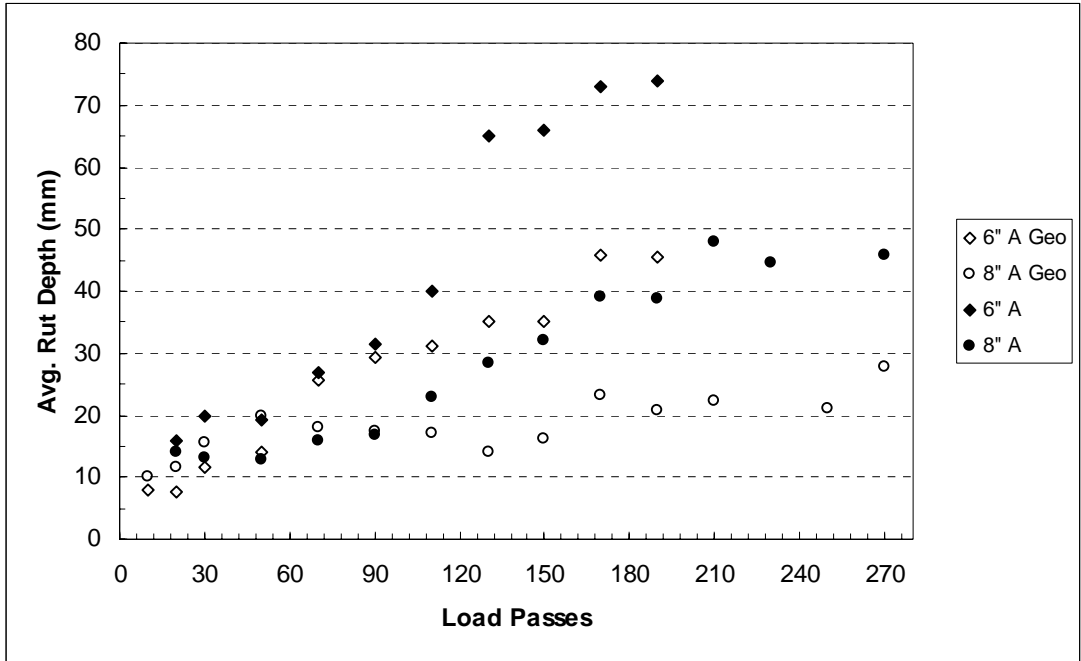
**Figure 9. Type A CLS With and Without Geotextile Rut Depth vs. Load Passes**

Figure 9 indicates there was no real benefit to using geotextile when the number of load passes was less than 90. Because there was no significant difference in rut depth at fewer than 90 passes, reinforcement was likely not the mechanism by which the geotextile was functioning. Given the relatively high IBV of 4.9, it is unlikely there was sufficient deflection to mobilize significant strength of the woven fabric material. After 90 passes, the fabric may have helped to prevent intrusion of the aggregate into the underlying subgrade.

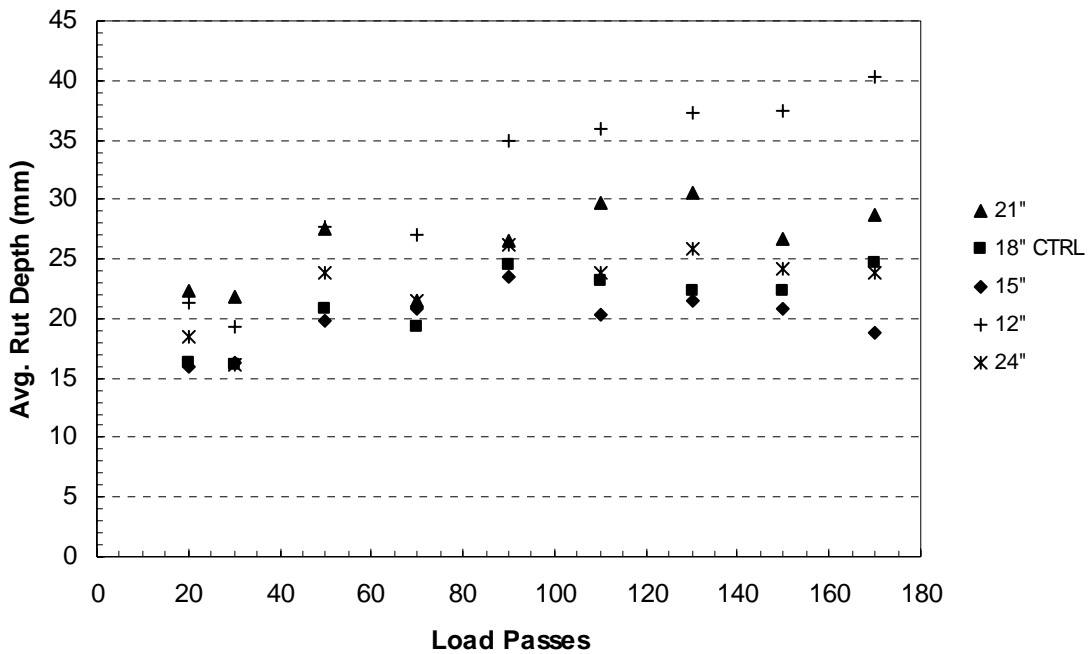
**Figure 10. Rut Depth vs. Load Passes for CLS Oversize Materials Capped with CA-6**

The number of load passes shown in Figure 10 was limited to 170. At loadings greater than 170, the rut width began to increase because of truck tracking variability. This increase in rut width began to interfere with measurements because it exceeded the straightedge width. This resulted in an apparent reduction in rut depth with increasing loading, which is not possible. Complete rutting data is shown in Appendix C.

The data in Figure 10 shows the rutting after 20 passes already exceeded the minimum 12.5 mm requirement. This result was similar to all the previously discussed test segments. Because of the relatively high IBV in relation to aggregate thickness, a majority of the rutting deformation is likely to have occurred within the aggregate layers themselves. The data shows some unexpected trends. One would expect rutting to increase with decreasing aggregate thickness. This was obvious with the 12-inch thick test location, but with the thicker test locations, there seemed to be no correlation between aggregate thickness and rutting. For example, the 21-inch thick test location consistently performed worse than the 15-inch, 18-inch and 24-inch locations, and the 15-inch test location outperformed the 24-inch location. This reinforced the hypothesis that the rutting was more a function of aggregate properties and uniformity of construction.

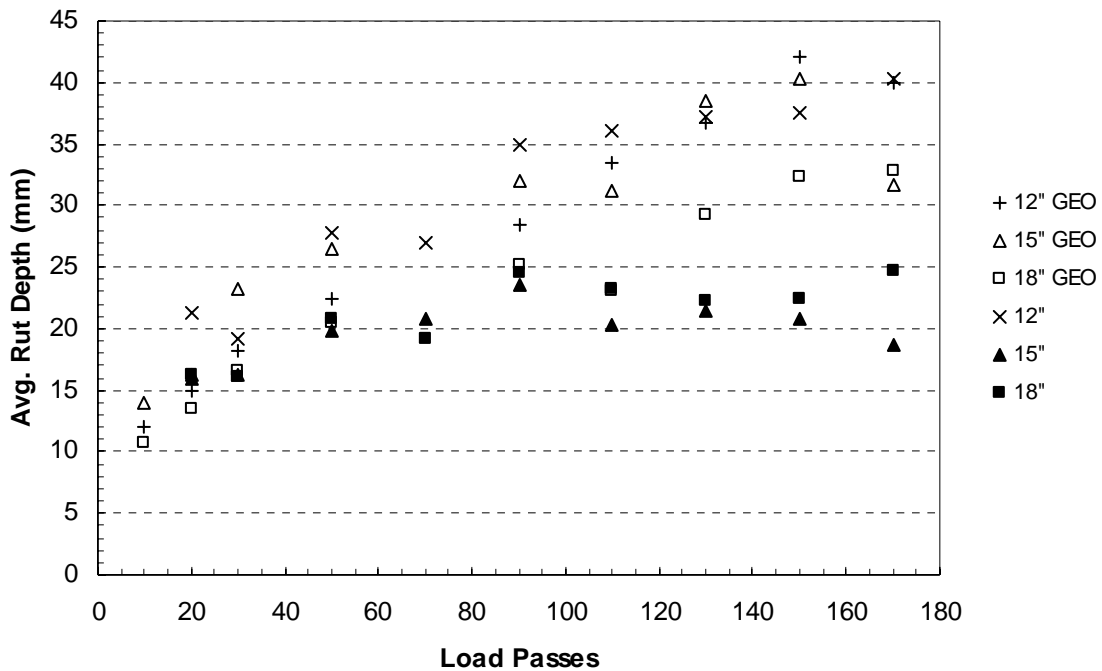
**Figure 11. Oversize CLS Capped with CLS CA-6 With and Without Geotextile Rut Depth vs. Load Passes**

The data in Figure 11 shows there was no benefit to using a geotextile in this case. The IBV was not low enough to allow the geotextile to act as reinforcement. The variation in rut depth between the geotextile and no geotextile locations was probably due to variations in construction.

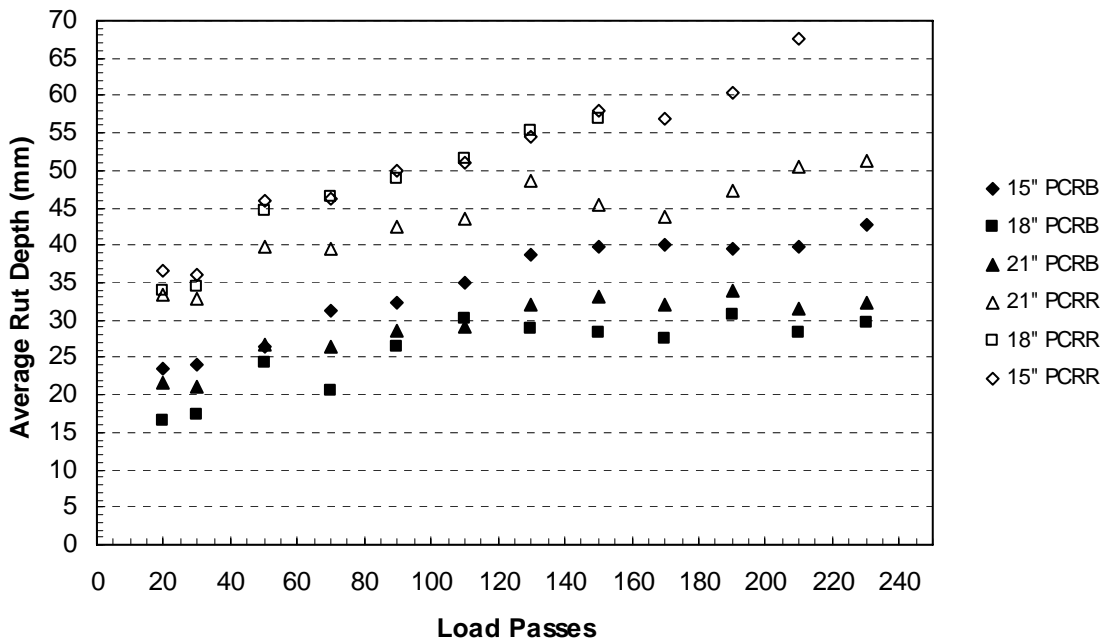
Figure 12. Rut Depth versus Load Passes for RAP and CLS CA-6 Capping Materials

The data in Figure 12 shows the CLS CA-6 outperformed RAP as a capping material. Unfortunately, no field measurements of cap density or moisture content were obtained. Compaction was to the satisfaction of the Engineer. Again the CA-6 gradation may perform better because of the additional fines content as discussed in Section 2.4.2.

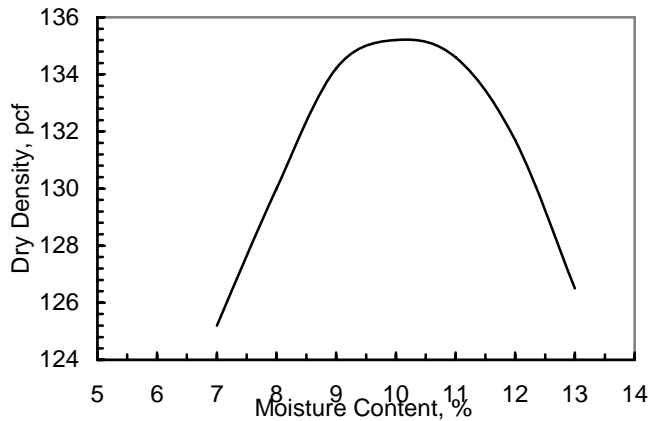
**Moisture-Density Relationship**  
**Subbase Granular Material, Type A**  
**SDD = 135.2 pcf @ 9.6% OMC**

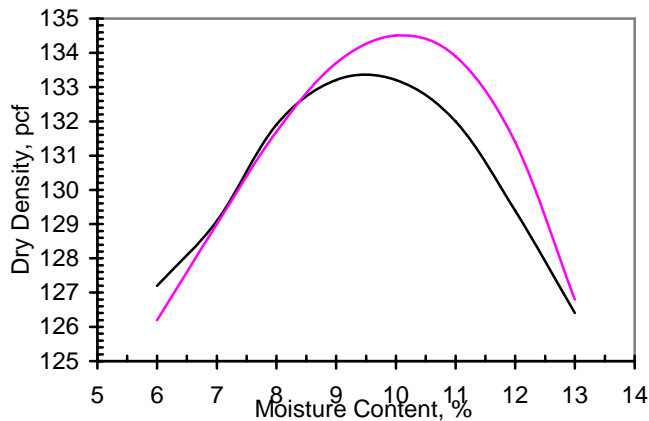
**Moisture-Density Relationship**  
**Subbase Granular Material, Type B (CLS)**  
 NBL SDD = 133.3 pcf @ 9.3% OMC  
 SBL SDD = 134.5 pcf @ 10.0% OMC

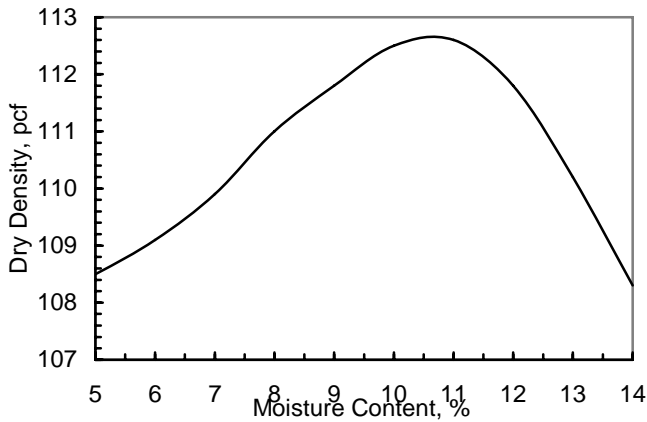
Moisture-Density Relationship  
Subbase Granular Material, Type B (CLS)  
#1 SDD = 112.7 pcf @ 10.5% OMC

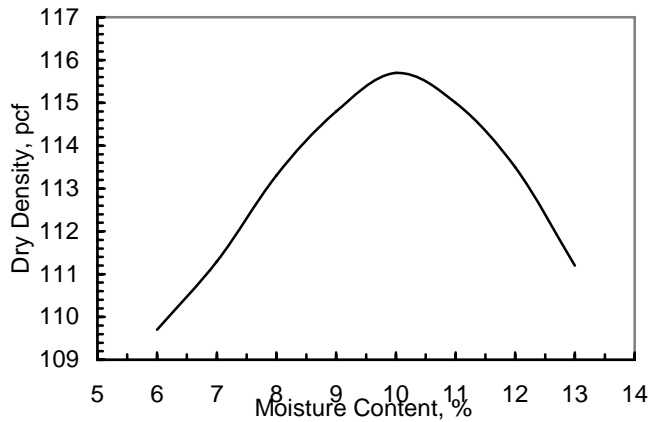
Moisture-Density Relationship  
Subbase Granular Material, Type B (CLS)  
#1 SDD = 115.8 pcf @ 10.1% OMC
