From May 5, 2016 Exposed Steel Pile Inspections

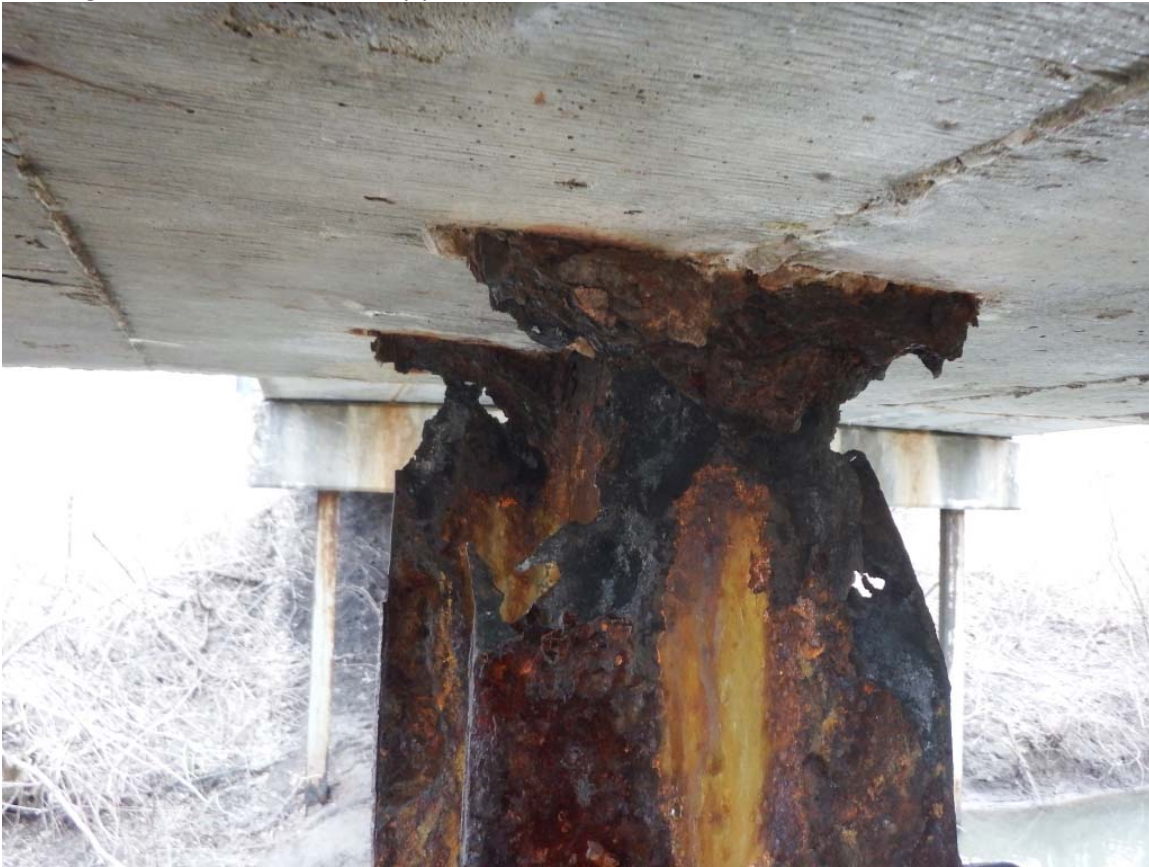
Recently the Bureau of Bridges and Structures has closed two structures due to severe deterioration of exposed steel piles directly under the concrete pier cap and not near the water surface elevation. Our office has not seen this phenomenon before. The Department will be working with the FHWA to identify possible causes for this corrosion.

The Department urges all inspectors to sound exposed steel piling for signs of deterioration during Routine NBIS Inspections. Visual inspection of all surfaces of exposed piling should continue. If a Local Agency has concerns about exposed piling, the Local Agency may institute a special inspection to monitor steel pile deterioration on a more frequent basis.

As stated in Circular Letter 2014-15, "all new structures with proposed individual steel H-piles or metal shell piles shall provide for concrete encasement of the piling".
