Construction Experience with CRC Pavements in Illinois

Physical Research Report No. 55

| 4. Title and Subtitle CONSTRUCTION EXPERIENCE WITH CRC PAVEMENTS IN ILLINOIS | | 5. Report Date March 1977 | |
| 7. Author(s) Jagat S. Dhamrait, Floyd K. Jacobsen, and Philip G. Dierstein | | 8. Performing Organization Report No. Physical Research No. 55 | |

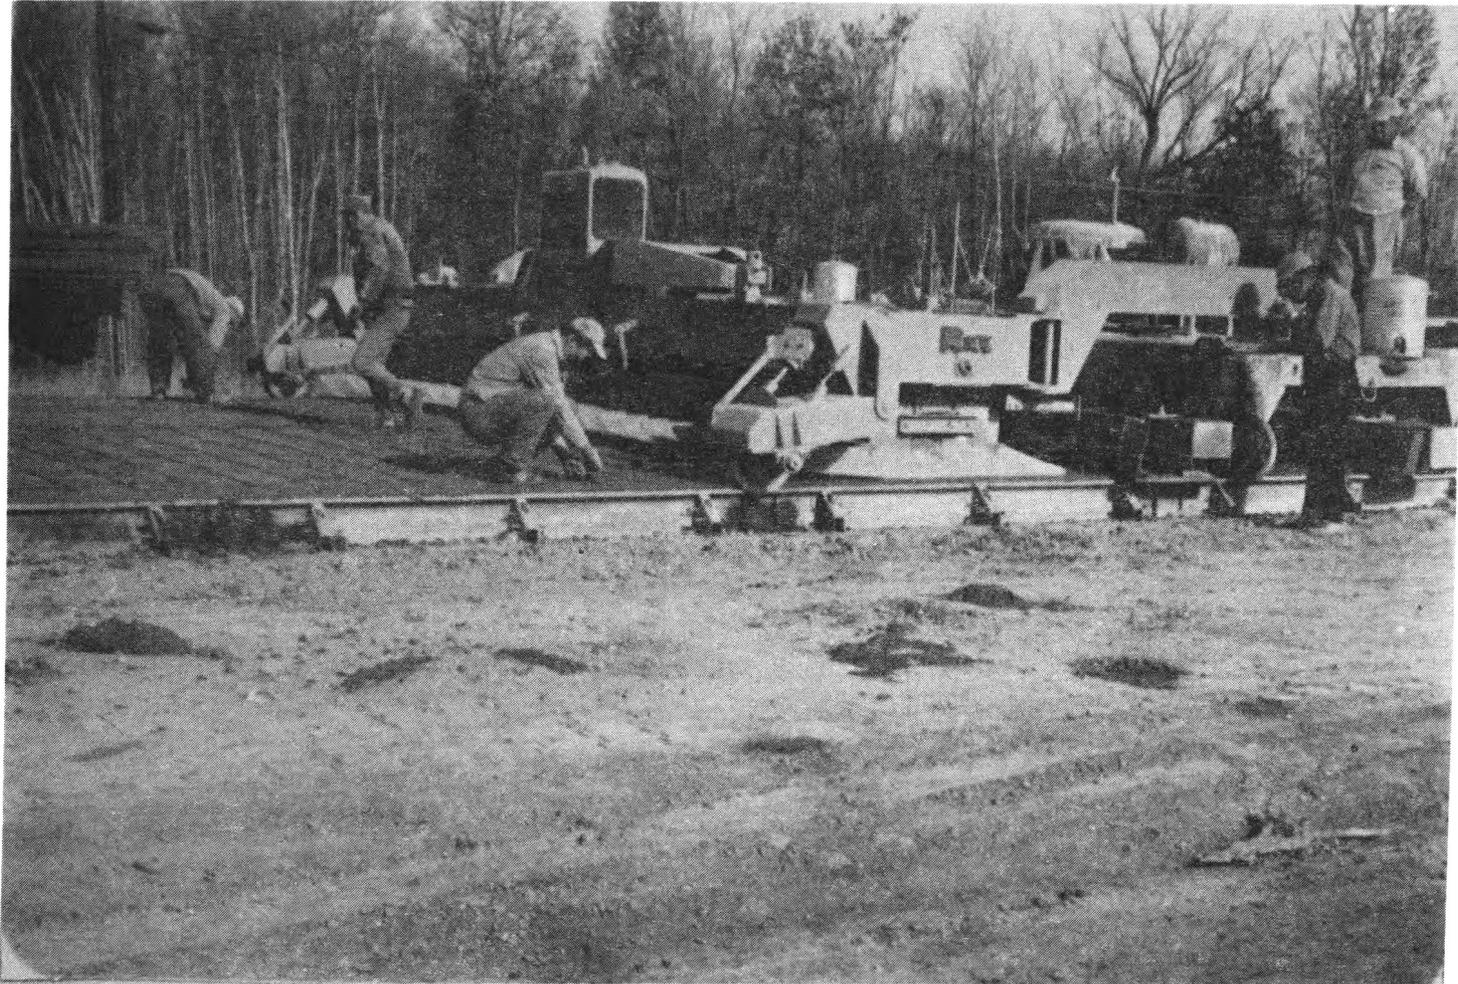
Figure 12. Mechanical depressor attached to finishing machine.

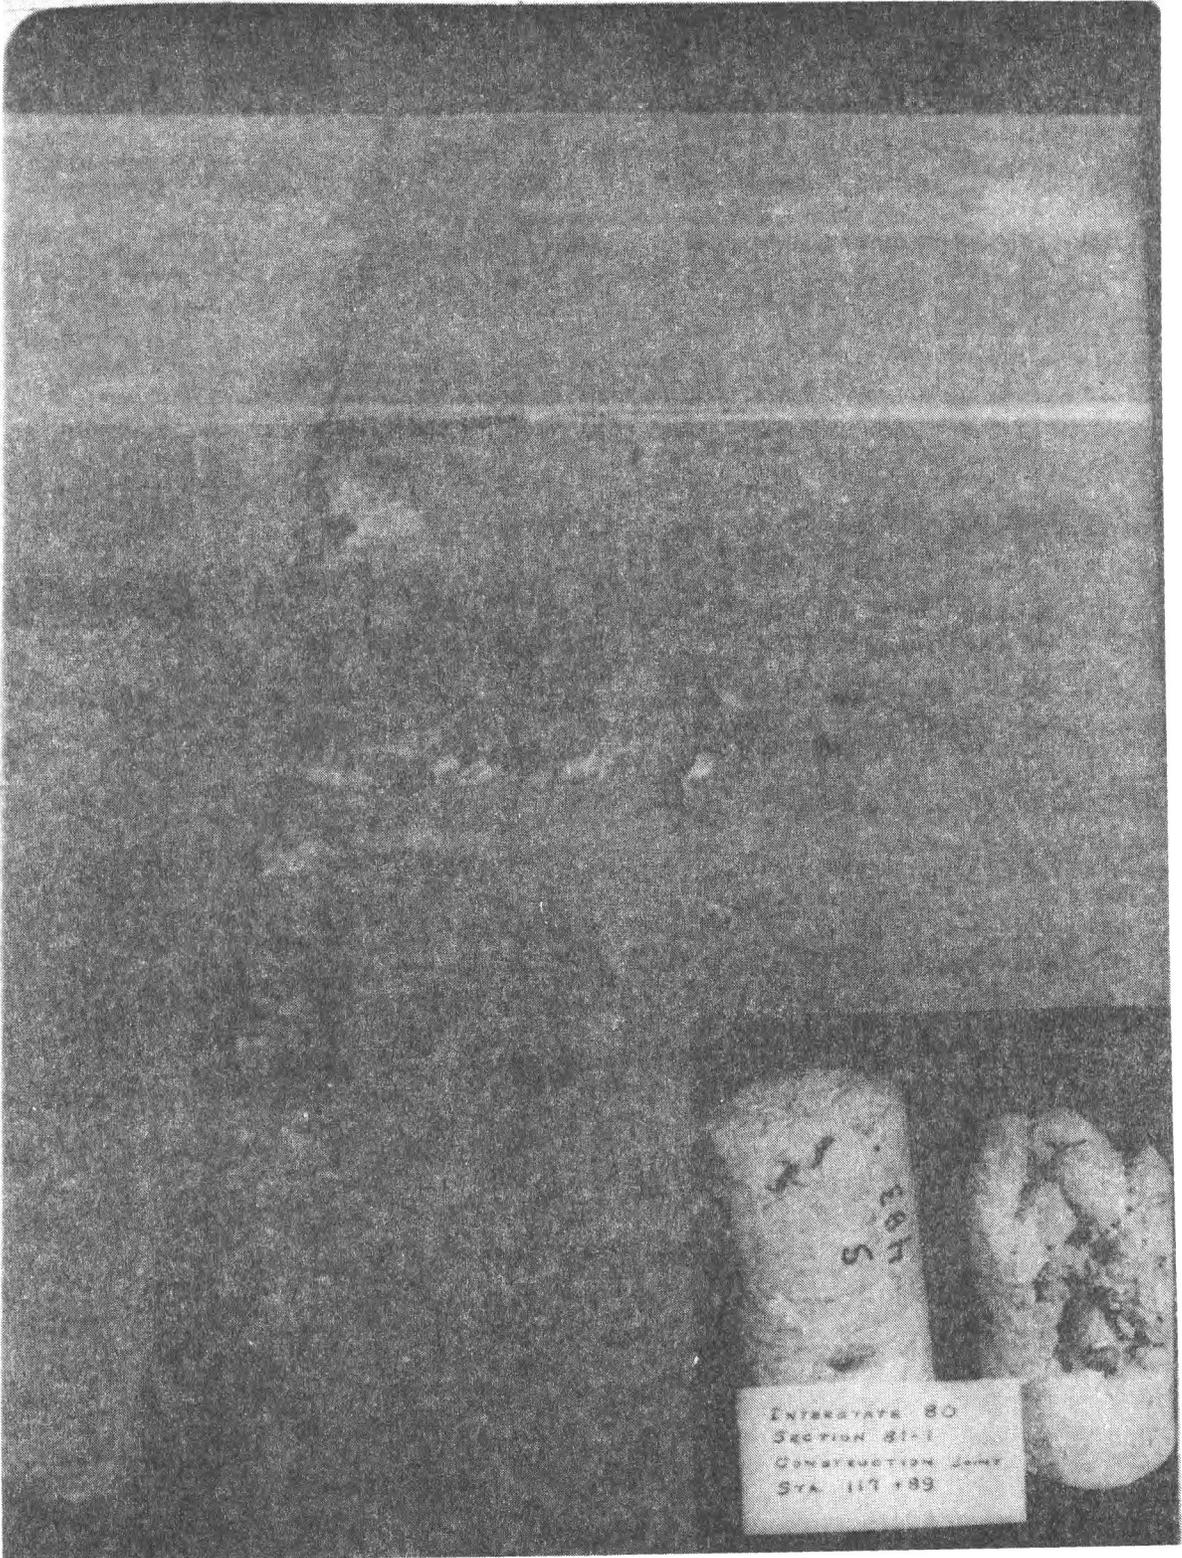
Figure 19. Failure at construction joint.

A typical failure resulting from inadequate consolidation of the concrete at construction joints is shown in Figure 19. Cores removed from the failed area are shown in the insert of the figure. The core shown on the right, which was taken at the face of the joint, shows a lack of consolidation around and below the longitudinal bar, but the core to the left, which was taken two feet ahead of the right core in the direction of paving, shows that the concrete two feet away from the construction joint was reasonably well consolidated except for a small void at the bottom of the pavement.

A majority of the failures in CRC pavements have been occurring at construction joints. These failures at the joints can be primarily attributed to inadequate consolidation of the concrete adjacent to the joints. Problems of this nature became even more pronounced with the adoption of the slipform paver because of difficulties encountered in attaining adequate consolidation during the start and end of daily paving operations. To correct this situation, the specifications were revised to call for hand vibration to extend for 10 feet on each side of the joint for the full width of the pavement. Prior to this revision, the specifications required that hand vibration extend only along the length of the joint.

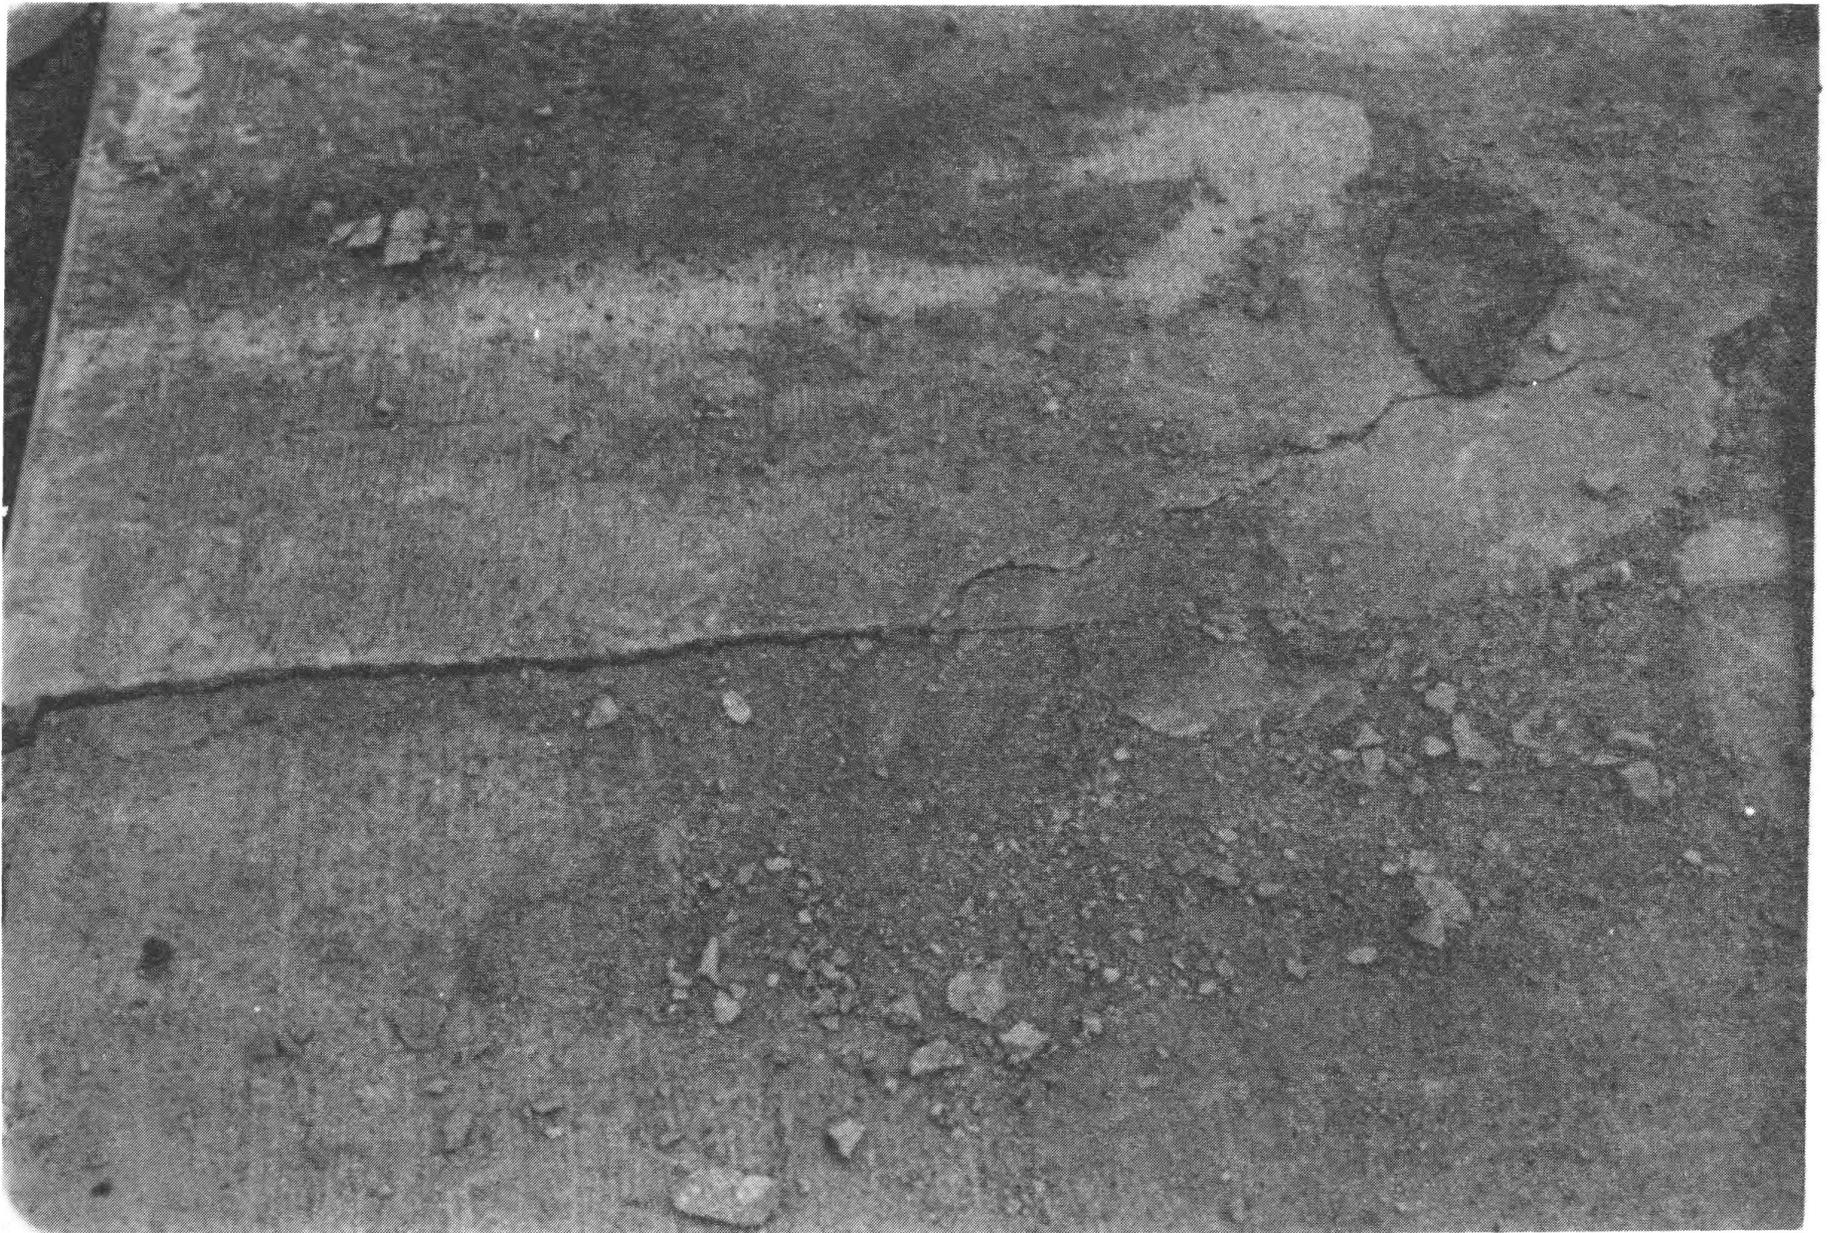
Figure 22. Construction joint failure due to bend in the reinforcement.

A similar failure also has occurred at a construction joint between a new and an old pavement as shown in Figure 22. During this investigation, it was found that the steel on the raised side (new concrete) of the construction joint had a sharp downward bend. It is believed that the bend in the reinforcement did not maintain the stress axis in the same horizontal plane during expansion and contraction of the slab, and therefore ruptured the concrete along the reinforcement path.
