# Performance Monitoring of Mechanistically-Designed Pavements

## 2010 Data Collection

PHYSICAL RESEARCH REPORT NO. 159  
MARCH 2011

**Illinois Department of Transportation**

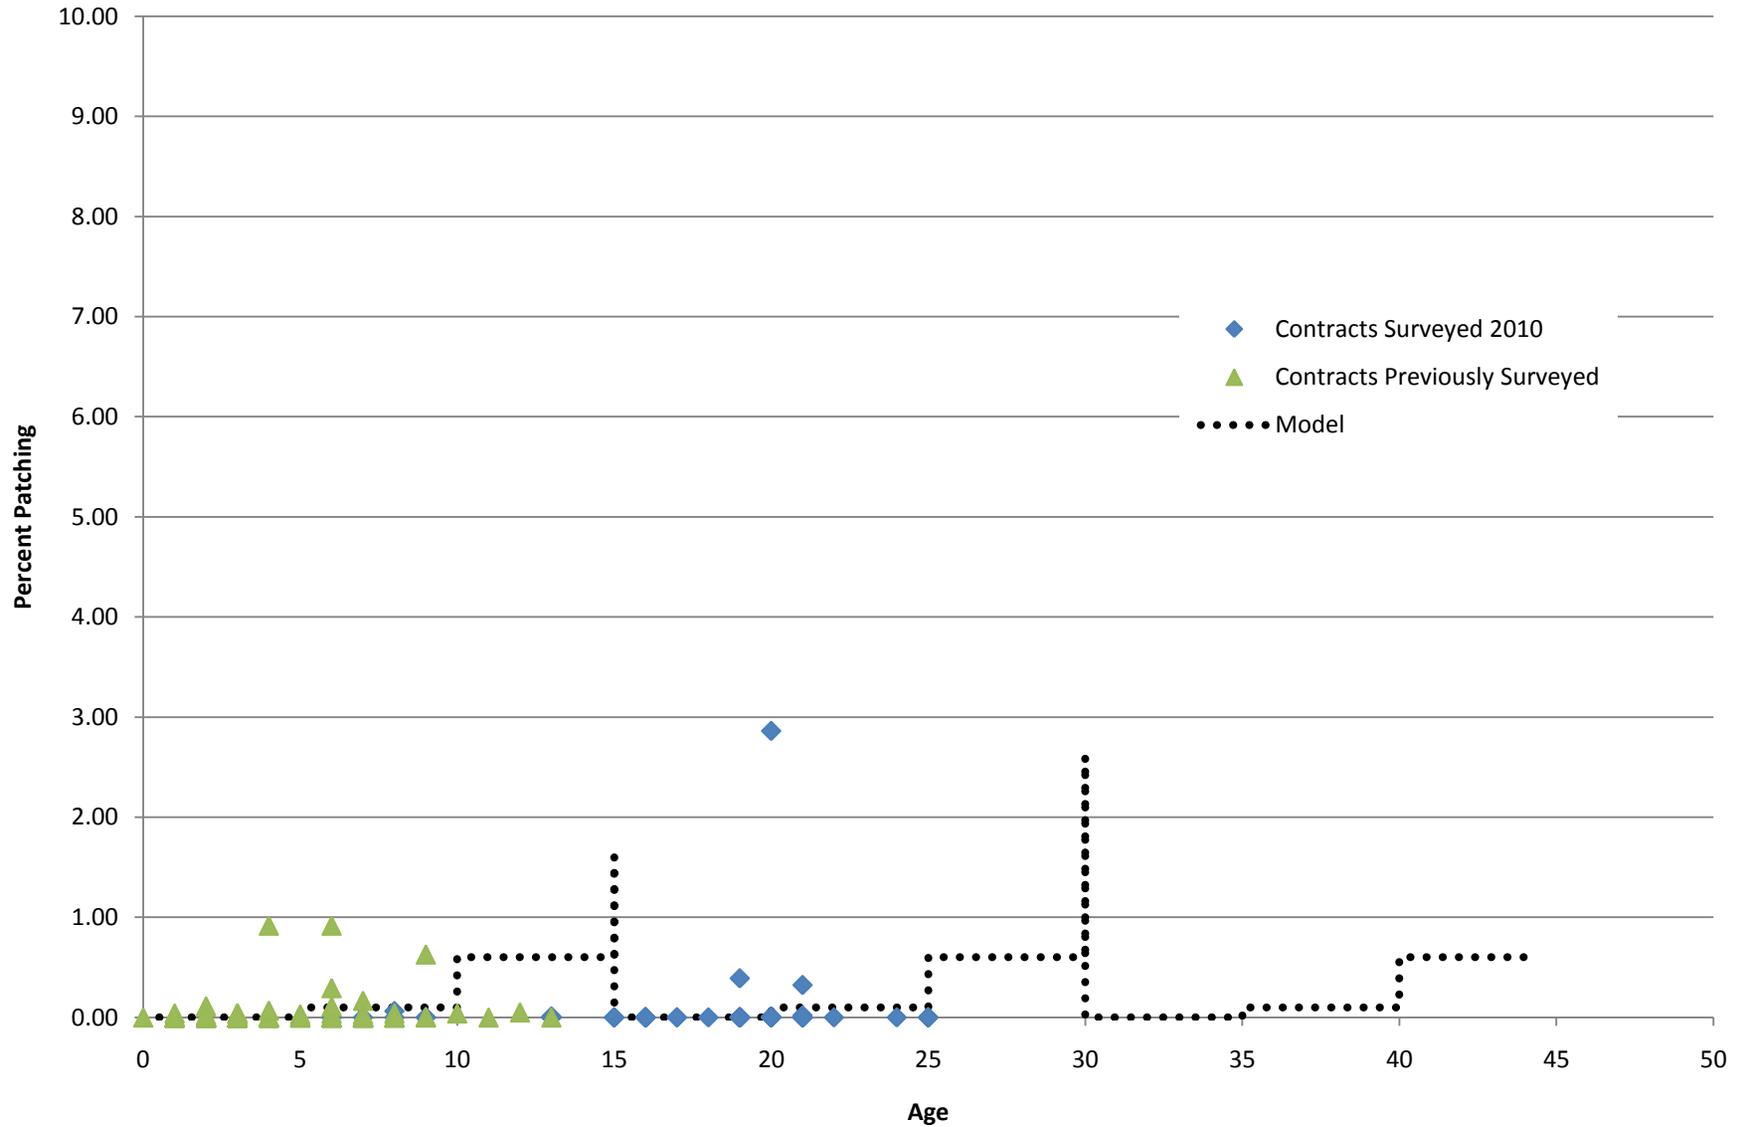
**Figure 1: Patching Quantities as a Function of Age: Full-Depth HMA Pavements  
Complete Life-Cycle Analysis Period**

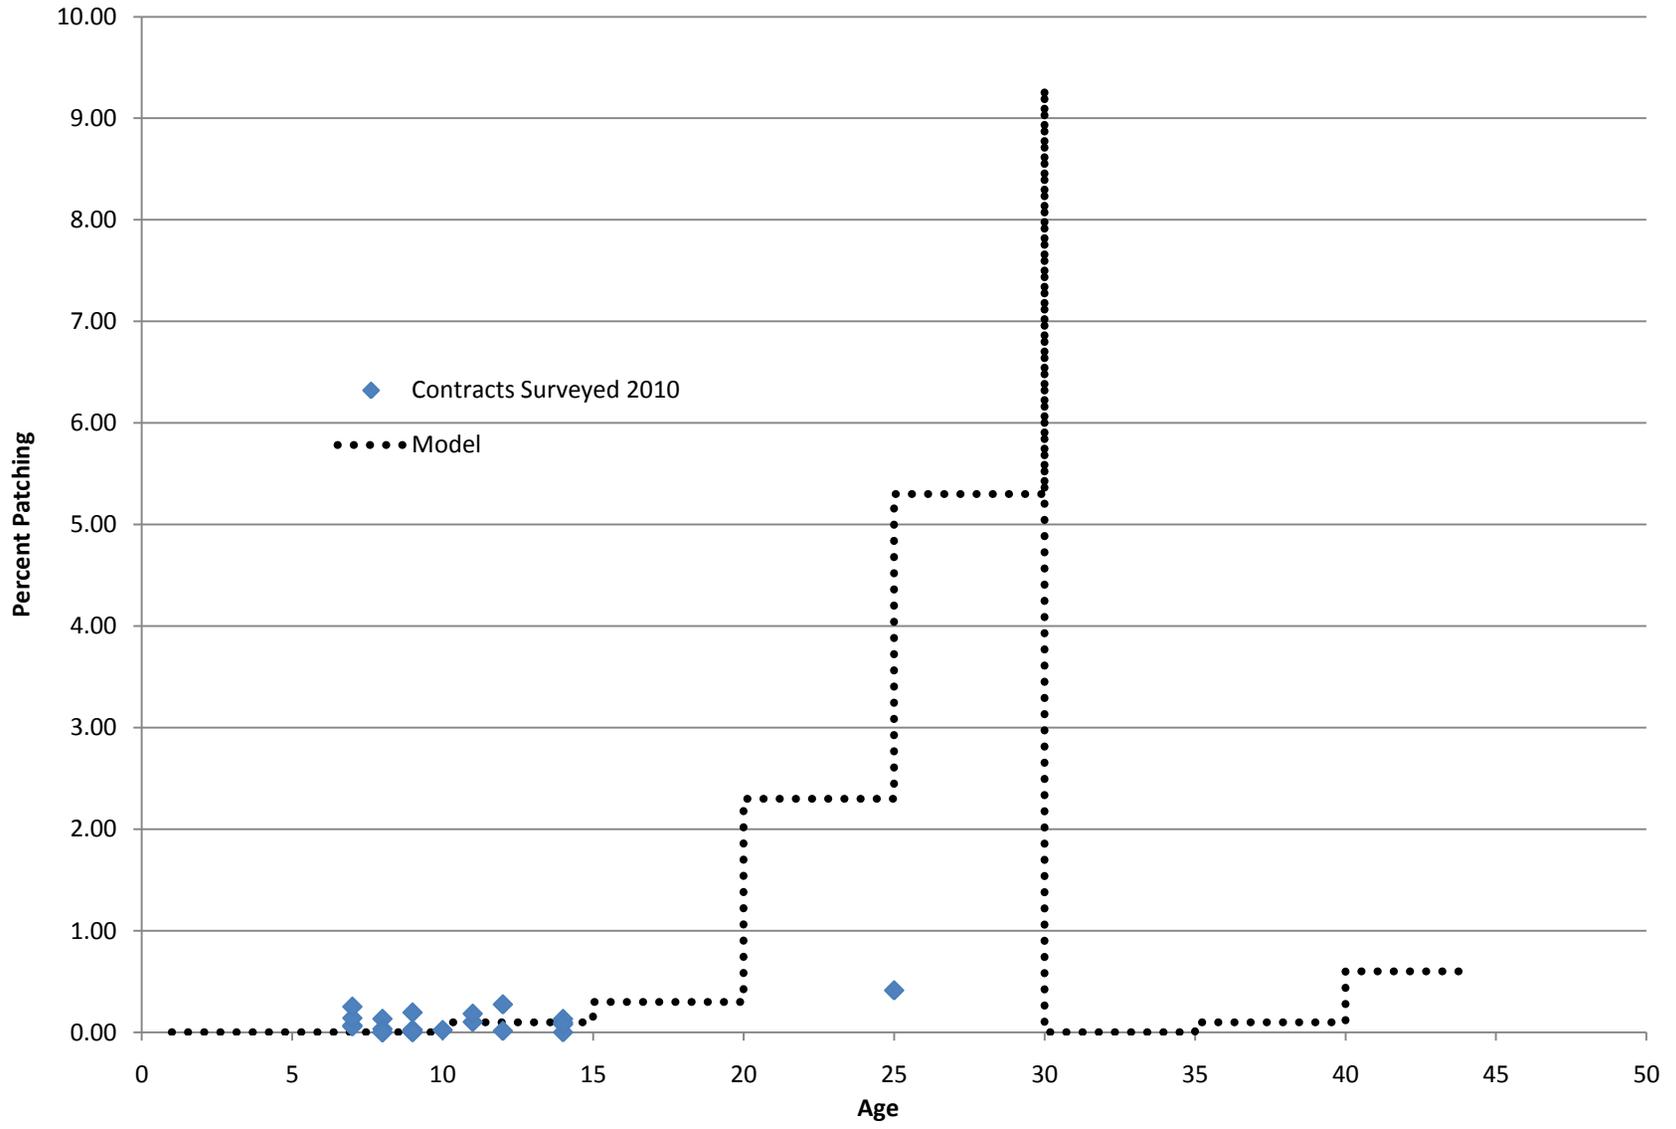
**Figure 2: Patching Quantities as a Function of Age: JPCP  
Complete Life-Cycle Analysis Period**

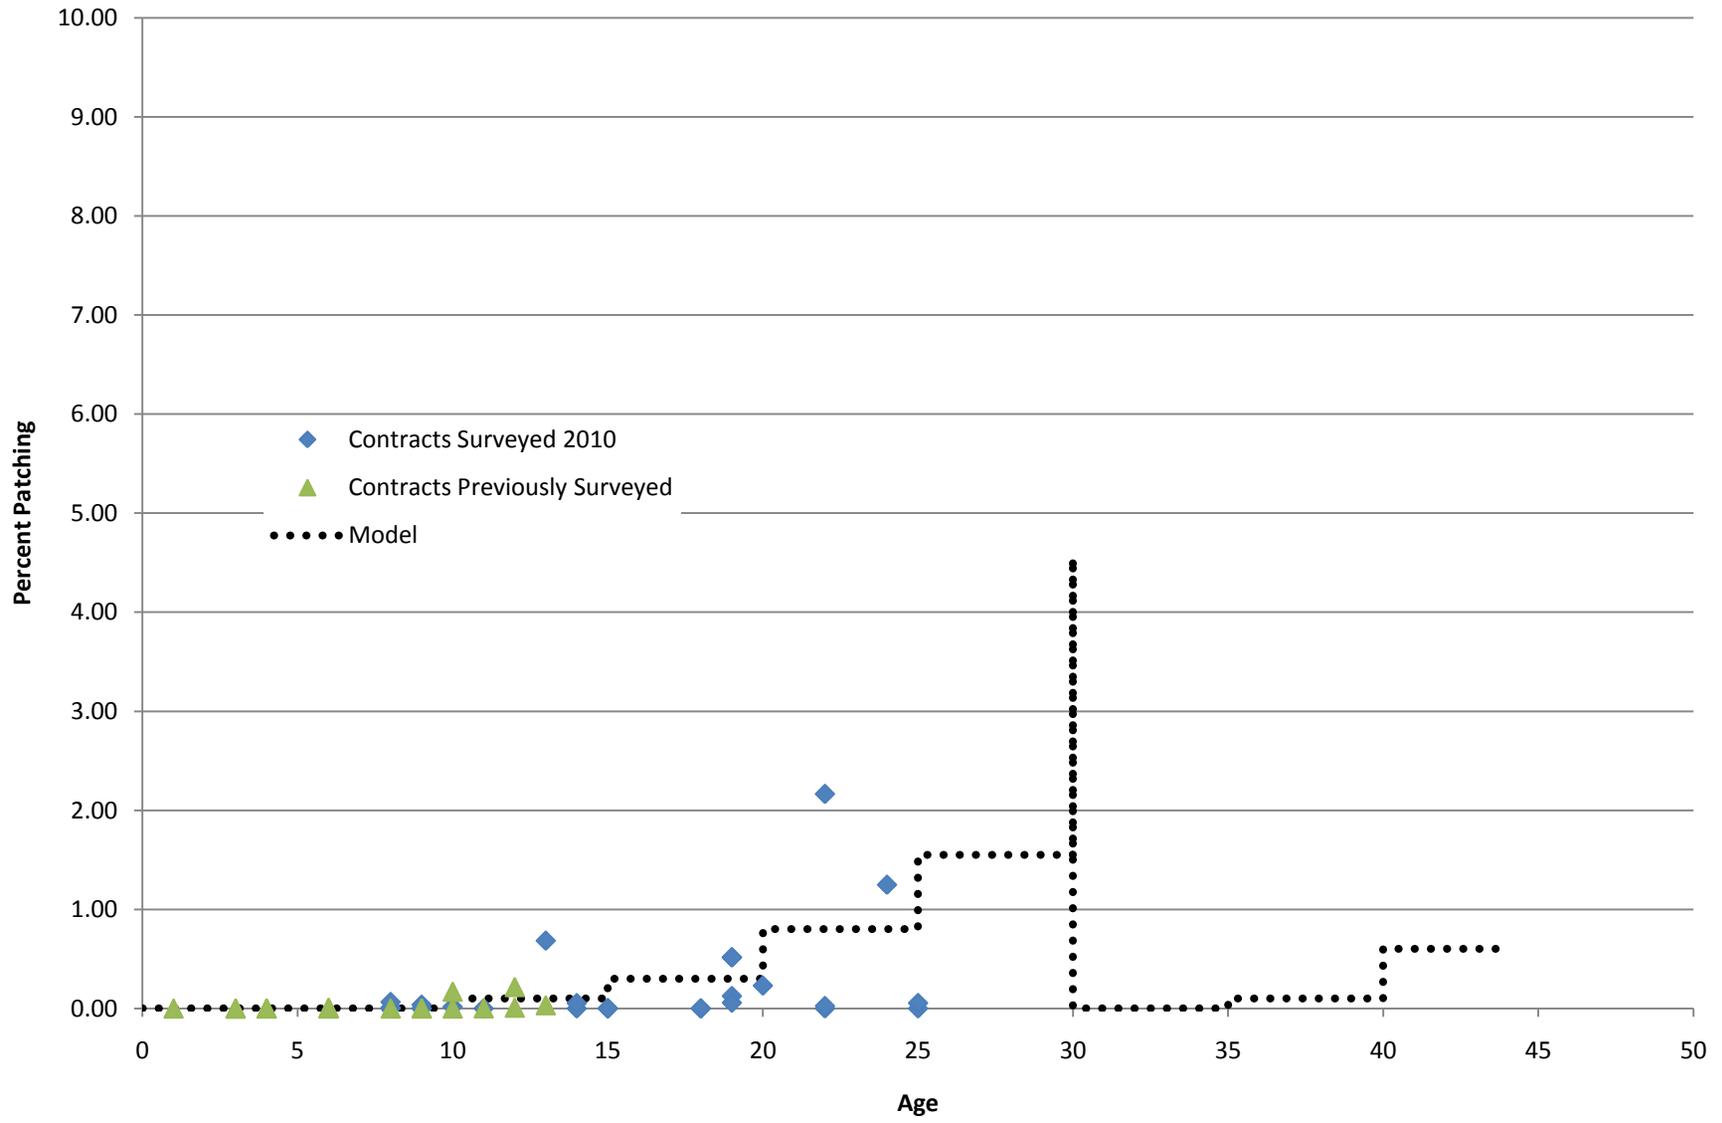
**Figure 3: Patching Quantities as a Function of Age: CRCP  
Complete Life-Cycle Analysis Period**

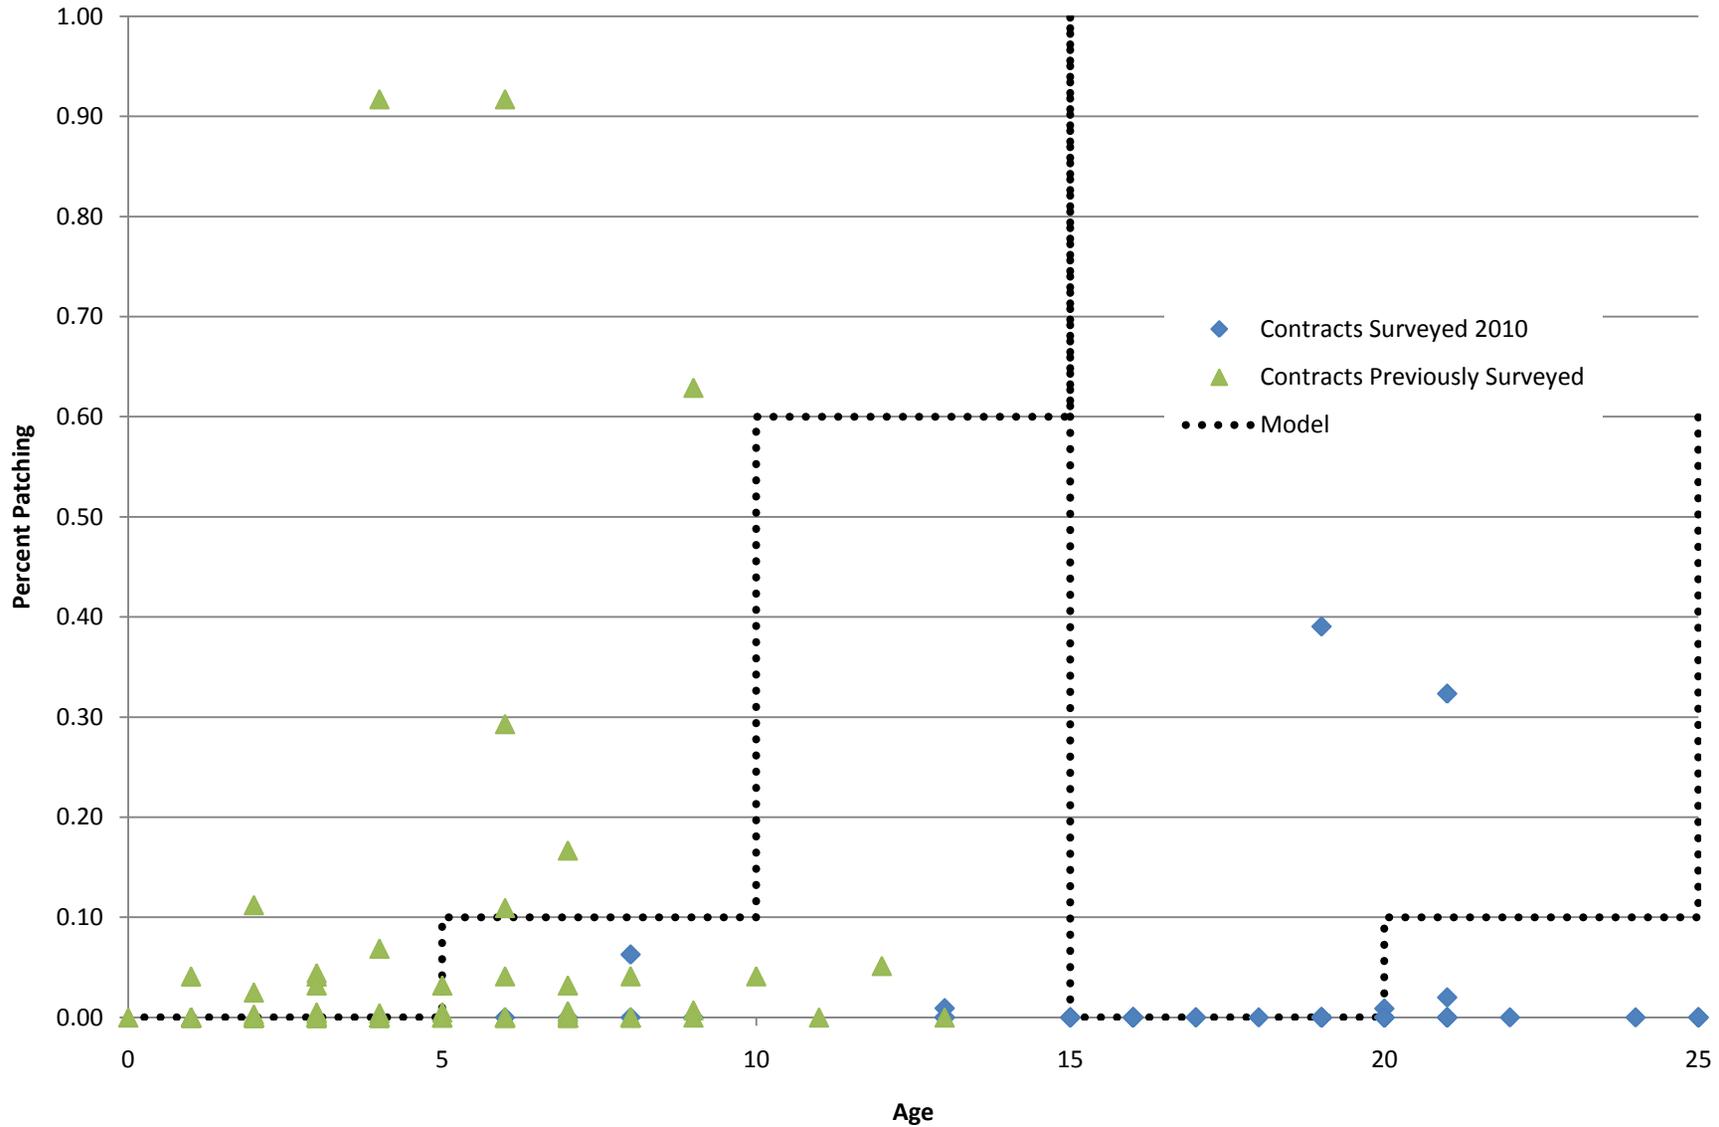
**Figure 4: Patching Quantities as a Function of Age: Full-Depth HMA Pavements  
First 25 Years of Life-Cycle Analysis Period**

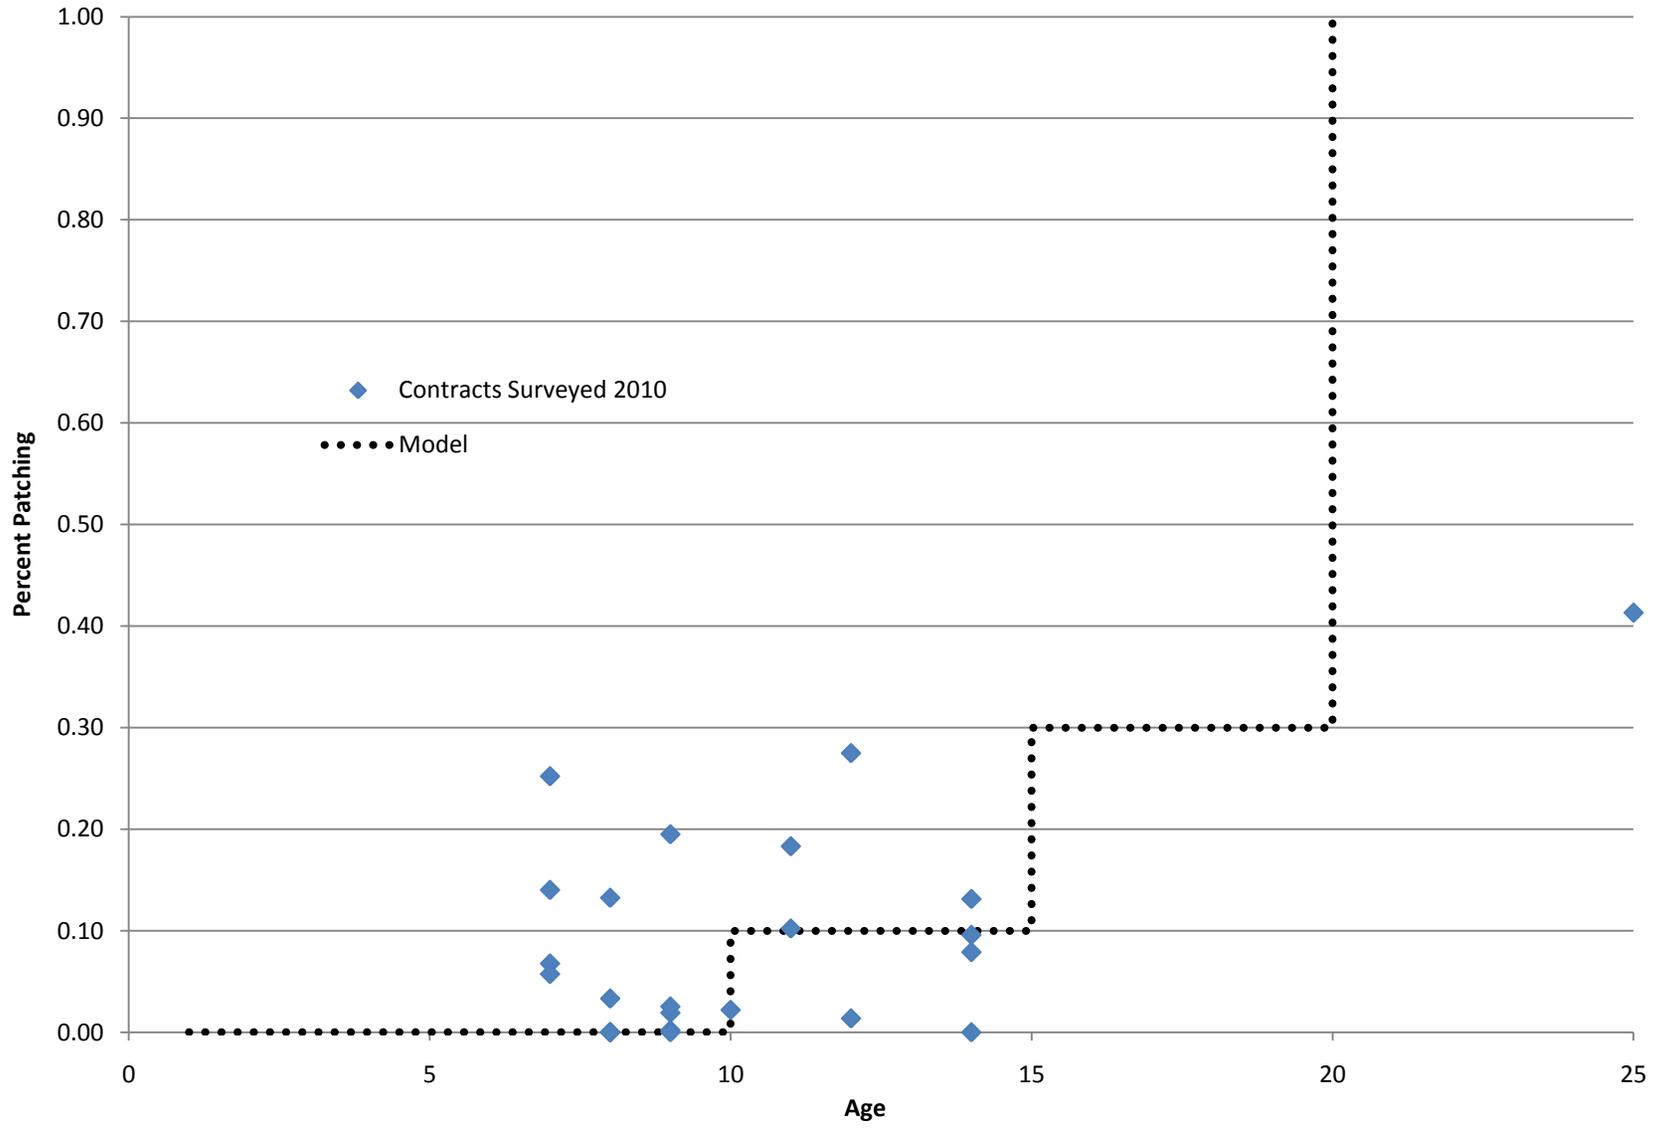
**Figure 5: Patching Quantities as a Function of Age: JPCP**  
**First 25 Years of Life-Cycle Analysis Period**

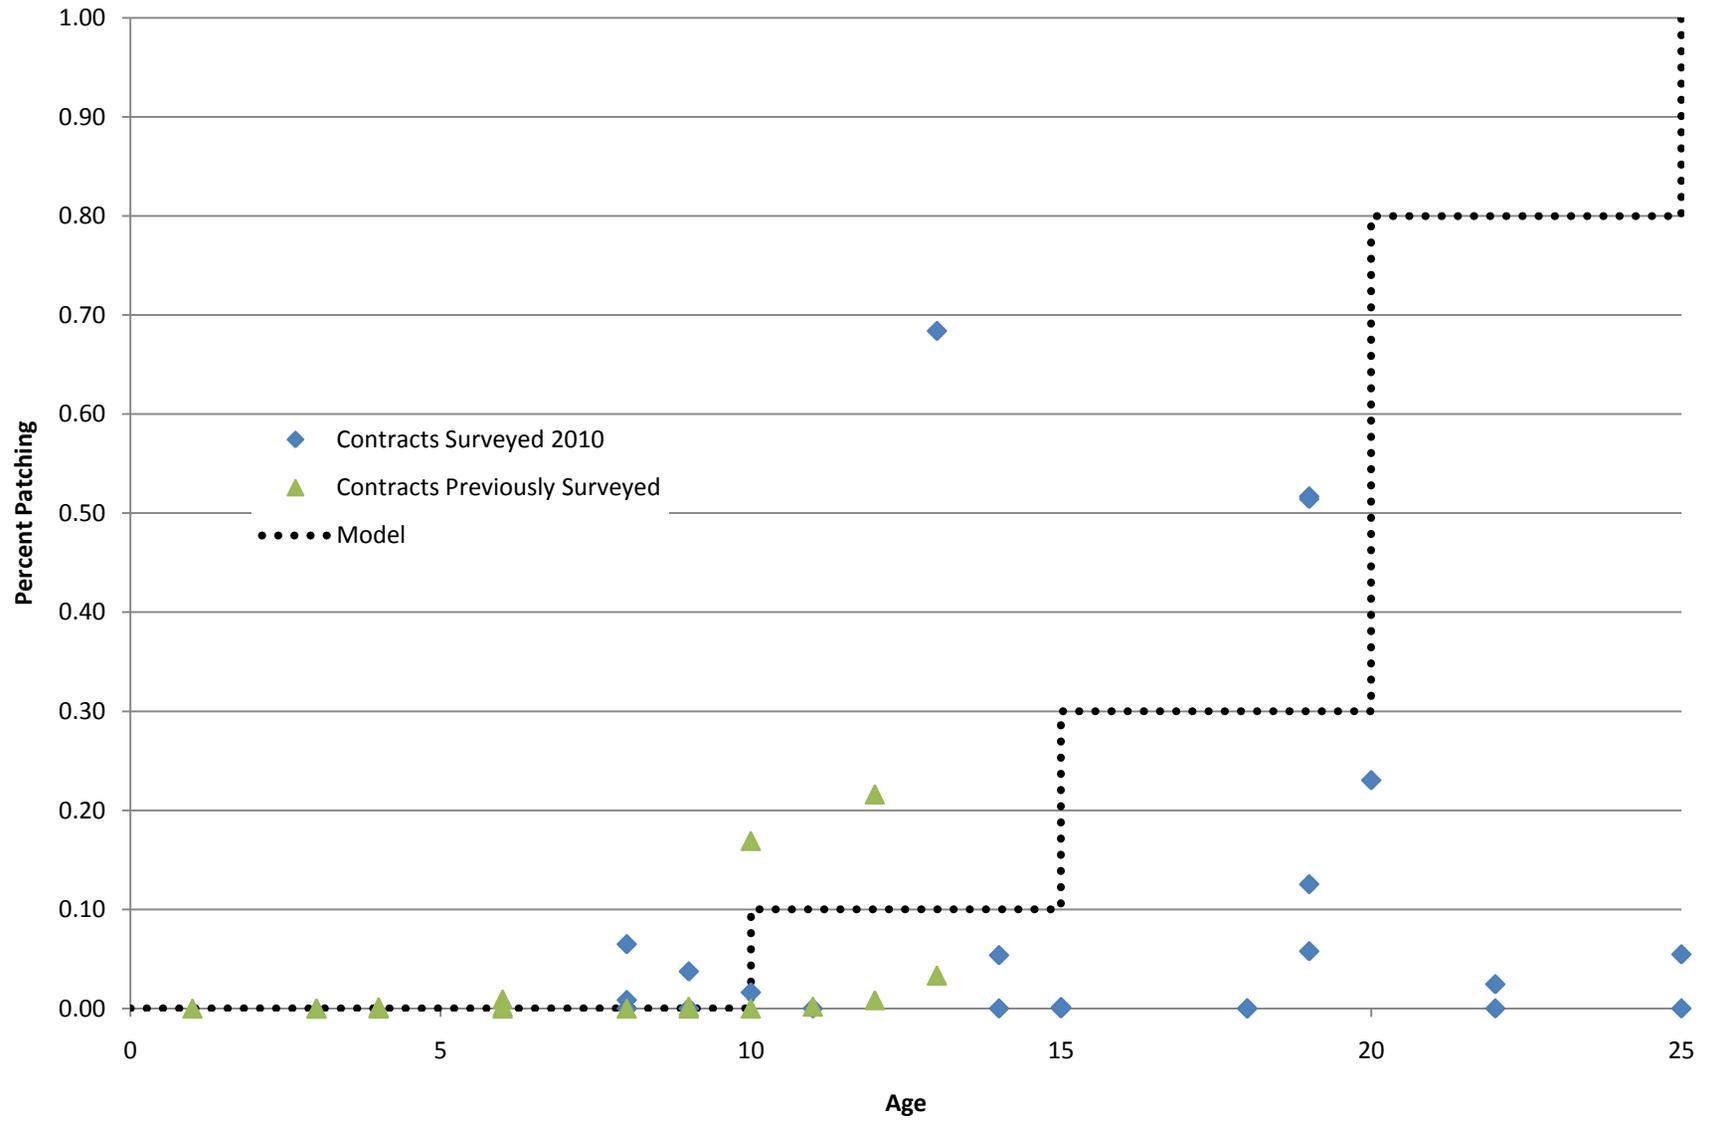
**Figure 6: Patching Quantities as a Function of Age: CRCP  
First 25 Years of Life-Cycle Analysis Period**

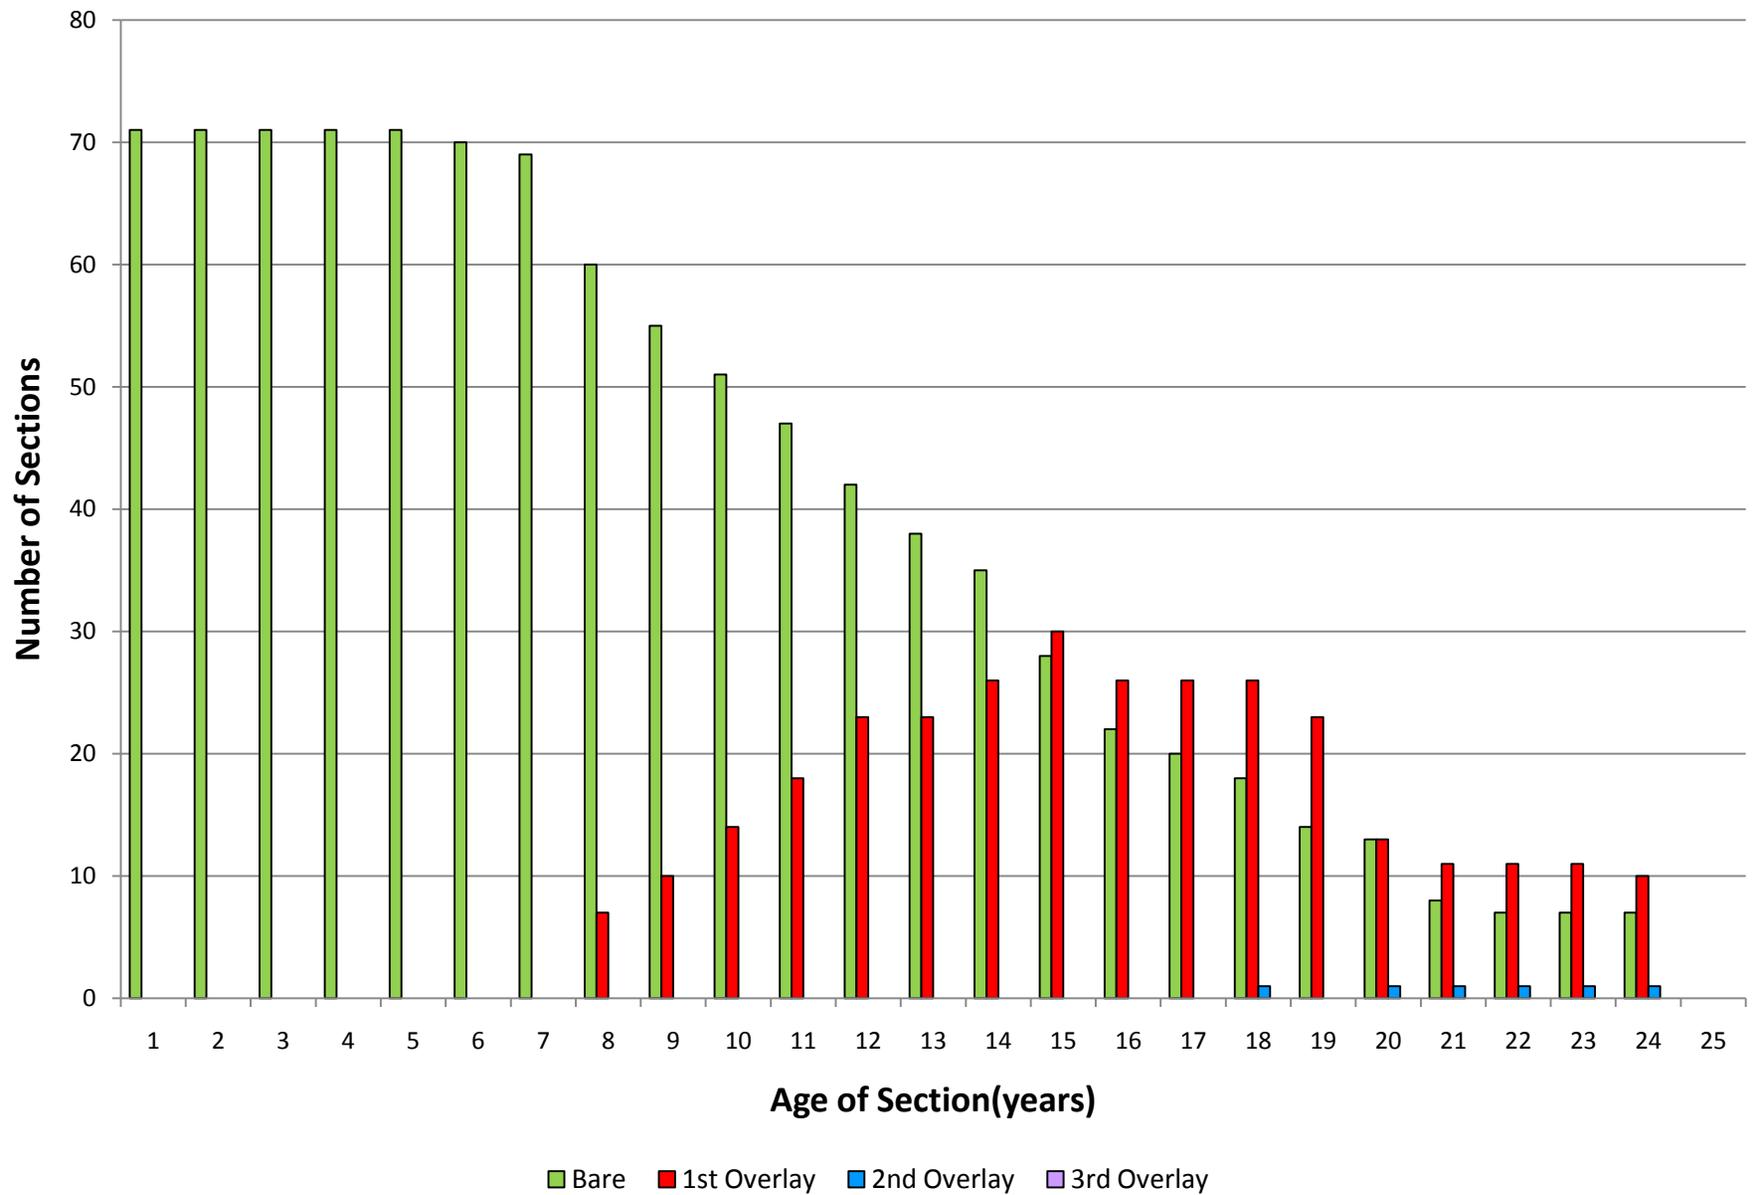
**Figure 7: Overlays as a Function of Age: Full-Depth HMA Pavements**

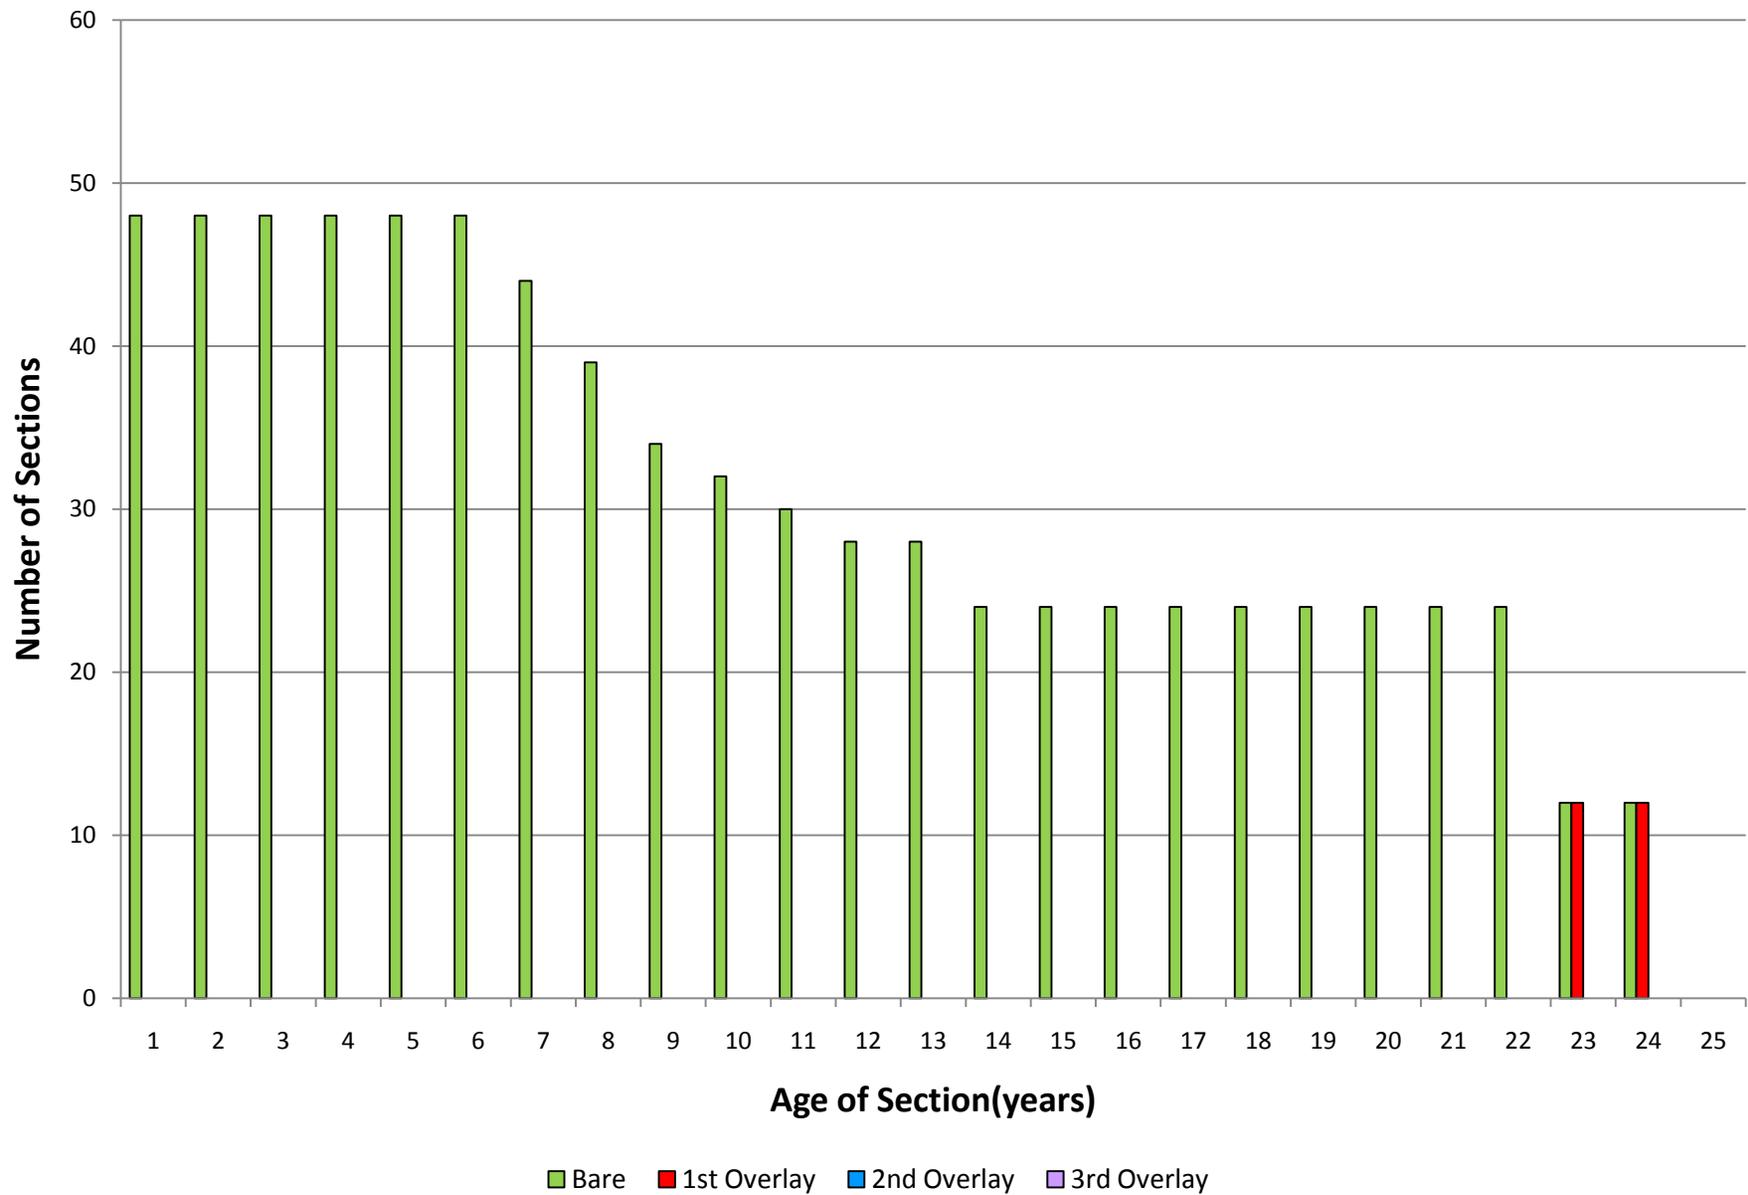
**Figure 8: Overlays as a Function of Age: JPCP**

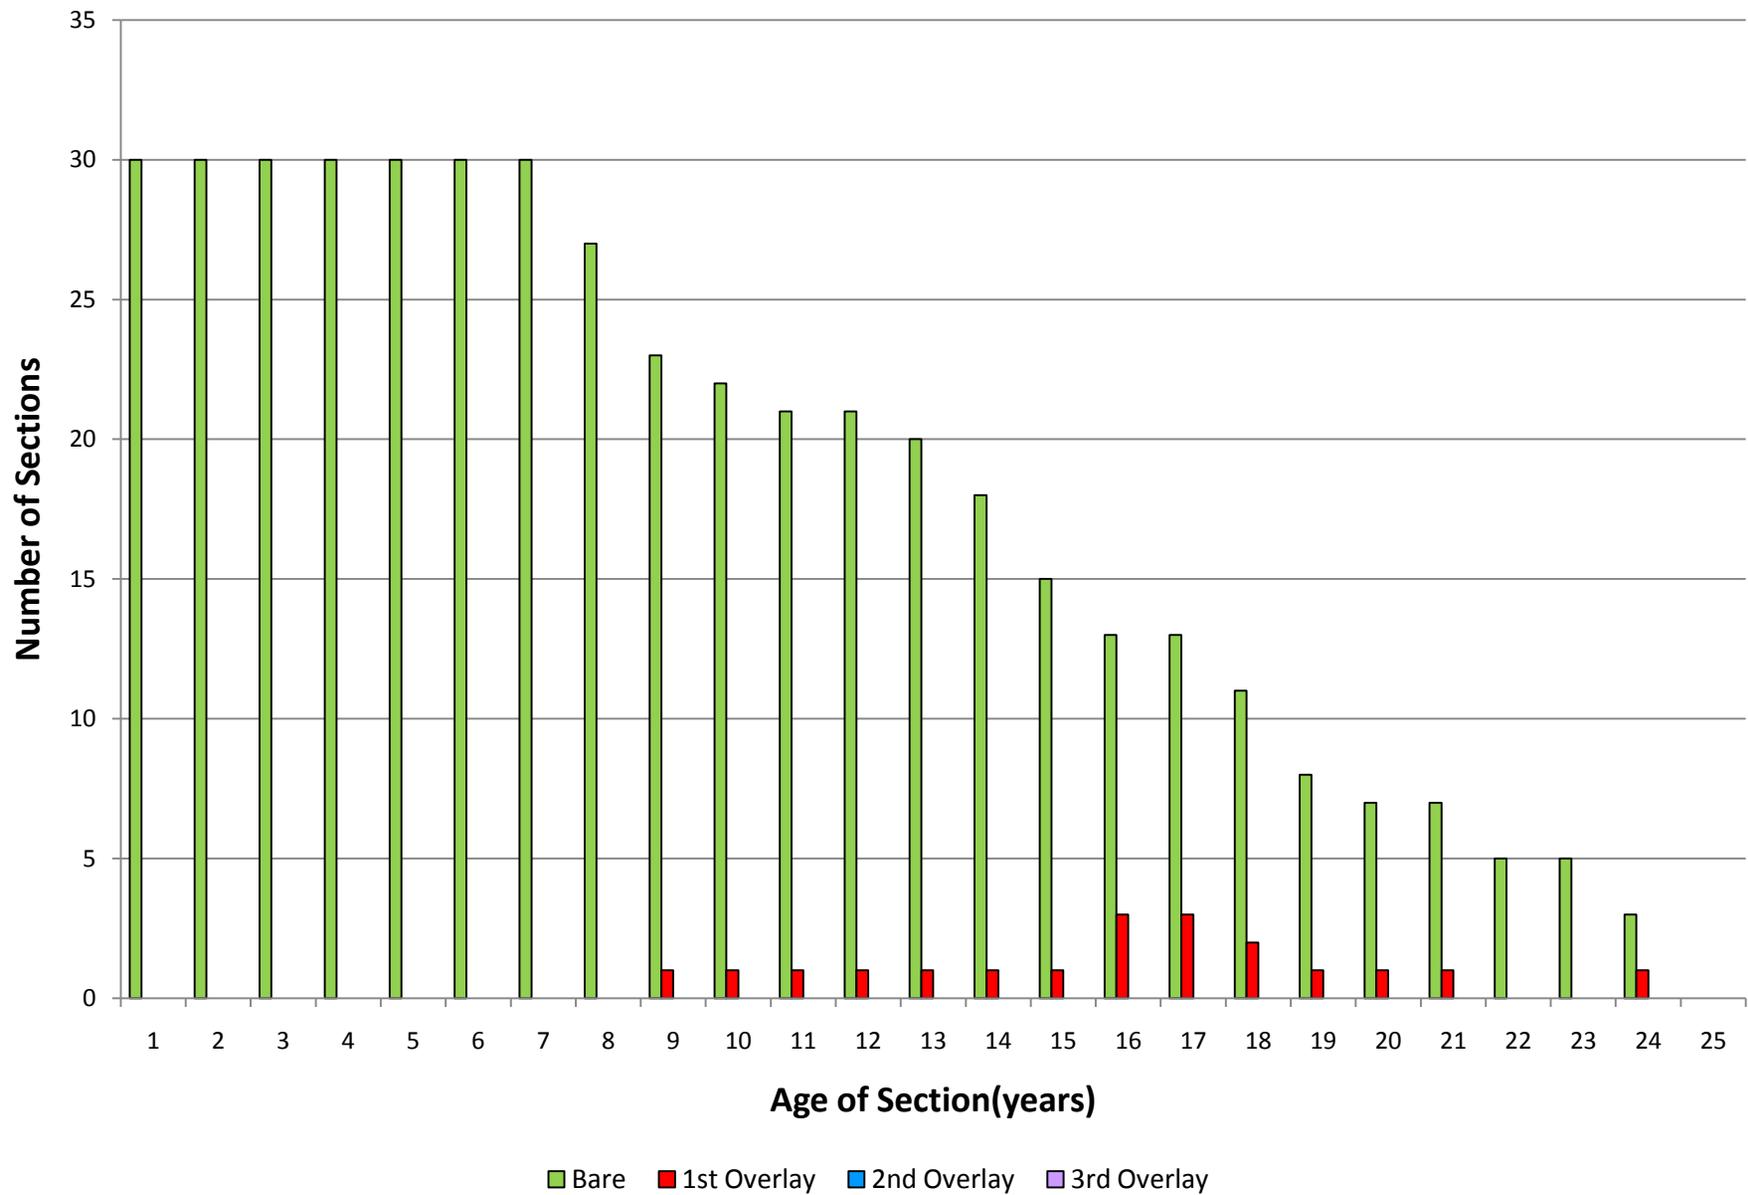
**Figure 9: Overlays as a Function of Age: CRCP**

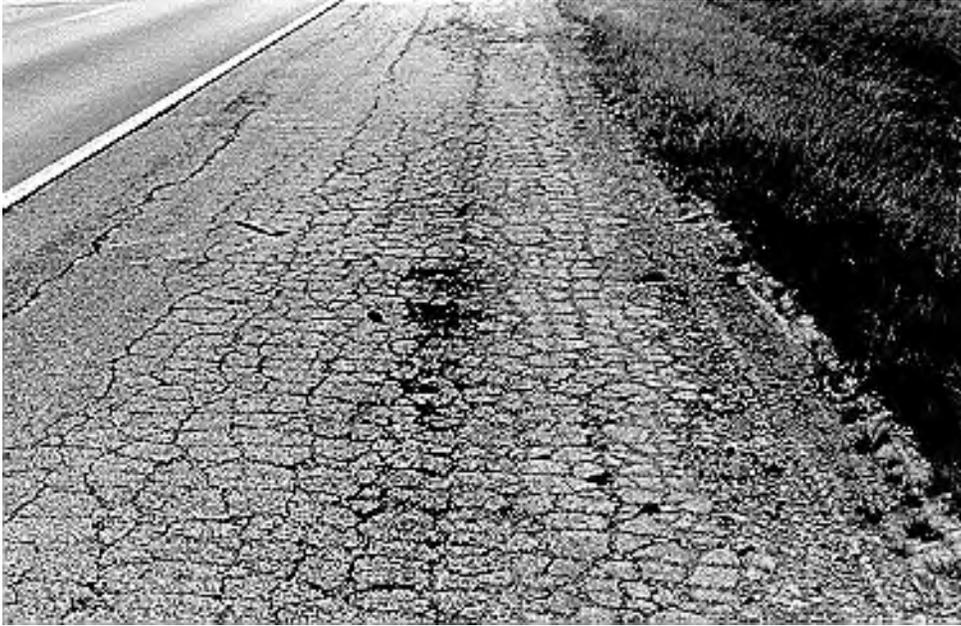
Alligator or fatigue cracking is a series of interconnecting cracks forming many-sided, sharp-edged pieces. The cracks develop a pattern resembling chicken wire or the skin of an alligator. The longest side of the pieces is usually less than one-foot in length. Fatigue or alligator cracking is a load associated distress. Pattern-type cracking occurring over an area not subjected to traffic load is rated as "Block Cracking".

- L - Longitudinal disconnected hairline cracks running parallel to each other. The cracks are not spalled. Initially there may only be a single crack in the wheel path. Defined as Class 1 cracking at AASHO Road Test.
- M - Further development of low severity fatigue cracking into a pattern of pieces formed by cracks that may be sealed. Defined as Class 2 cracking at AASHO Road Test.
- H - Medium fatigue cracking has progressed so that pieces are more severely spalled at the edges and loosened until the cells rock under traffic. Pumping may exist. Defined as Class 3 cracking at AASHO Road Test.

High Severity Alligator Cracking

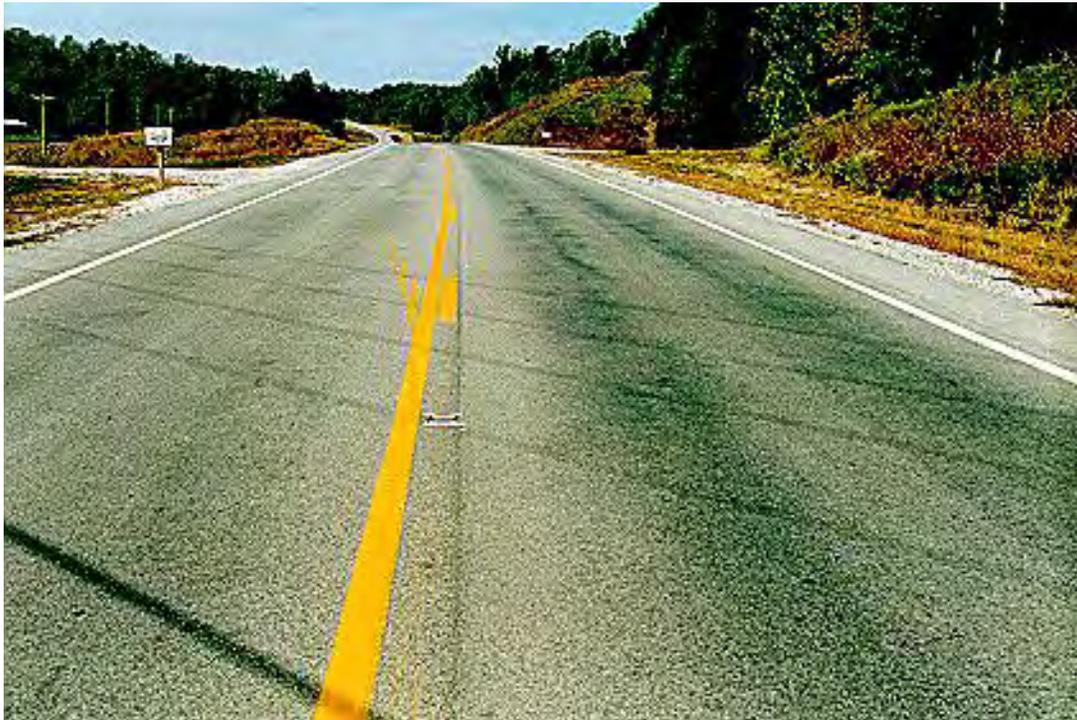
Asphalt Bleeding in Wheelpaths

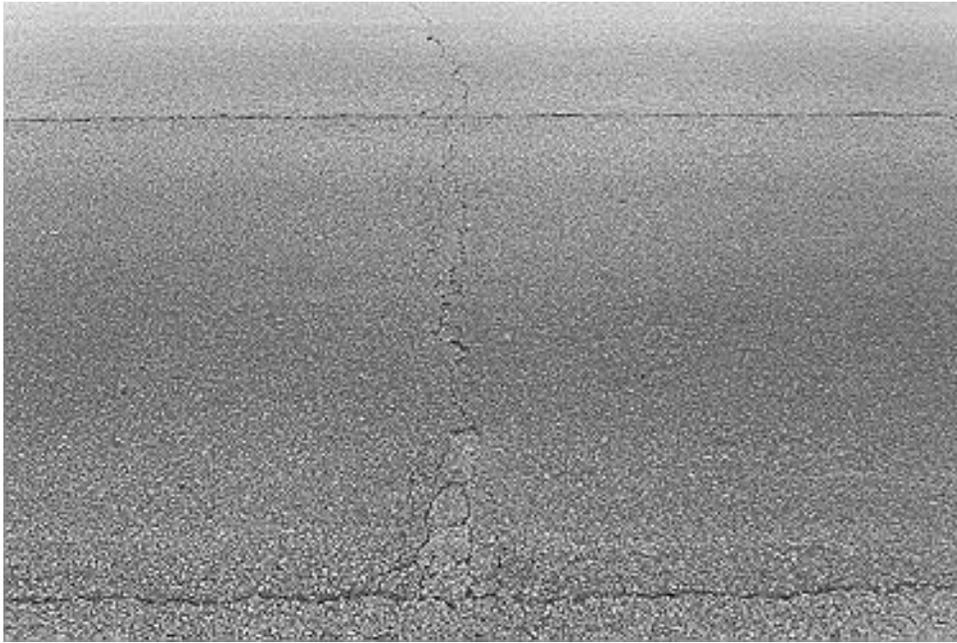
- L - One or both parallel cracks are very tight and barely visible to the eye, or one crack is definitely wider than the other.
- M - Both cracks have the same crack width. The area between the parallel cracks may be slightly depressed (less than or equal to .10"), but is in good overall condition.
- H - The following conditions may exist alone or in combination: (1) the area between the parallel cracks is depressed noticeably, (2) the area between cracks is severely distressed and material may be loose or missing, (3) maintenance has been performed.

Medium Severity Belt Cracking

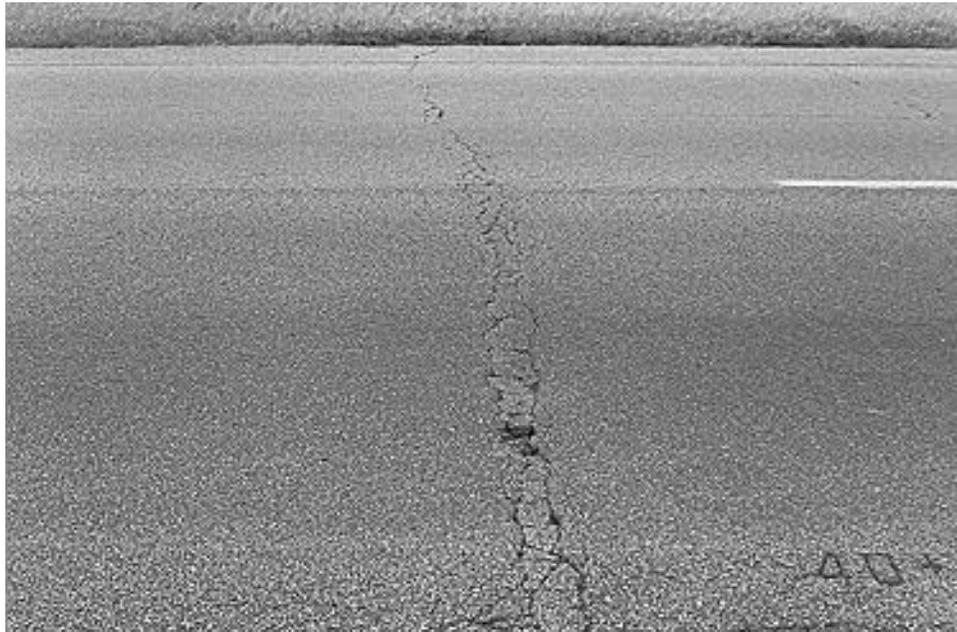
High Severity Belt Cracking

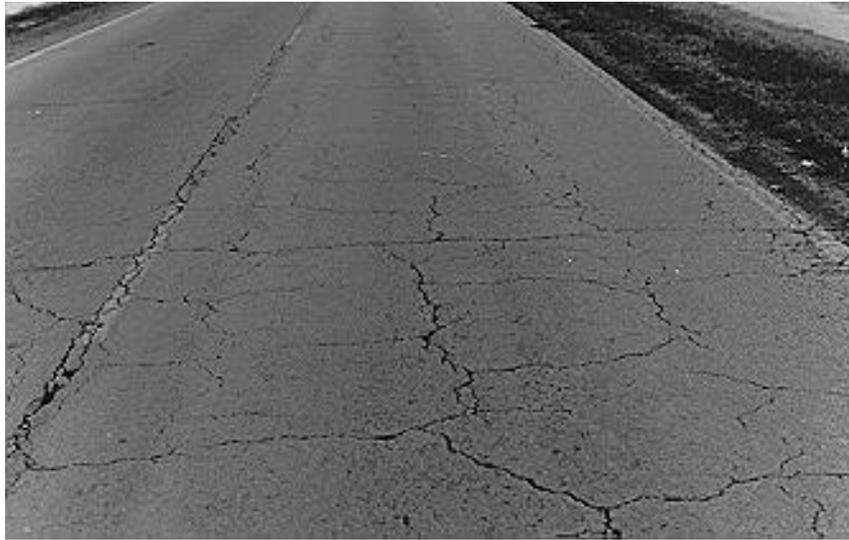
- L - Cracks are tight (mean width less than or equal to 1/4") with minor or no spalling present.
- M - Crack width is between 1/4" and 1/2". Cracks may be moderately spalled. Low severity random parallel cracking may exist near the crack or at the intersection of cracks.
- H - One or more of the following conditions exist: (1) crack width is greater than 1/2", (2) crack is severely spalled, (3) medium or severe random parallel cracking exists near the crack or at the intersection of the cracks, (4) major sealing or other major maintenance activity has been performed.

Medium Severity Block Cracking

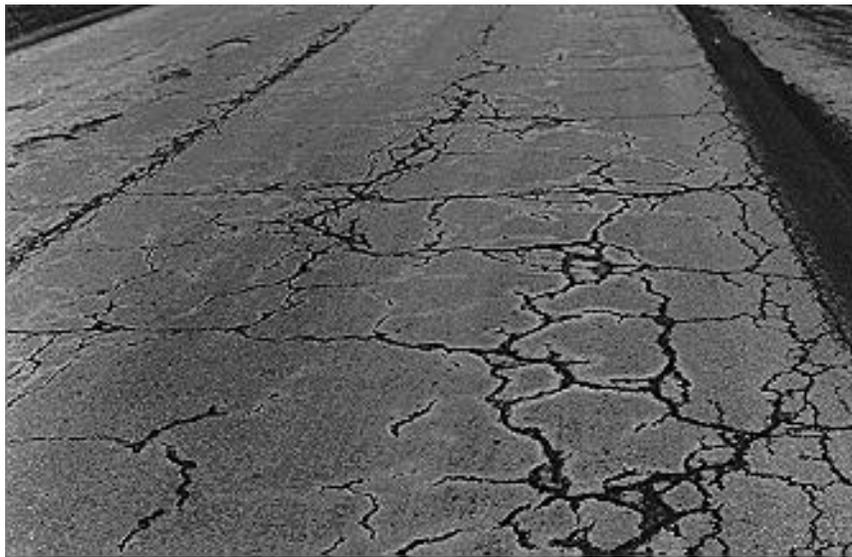
High Severity Block Cracking

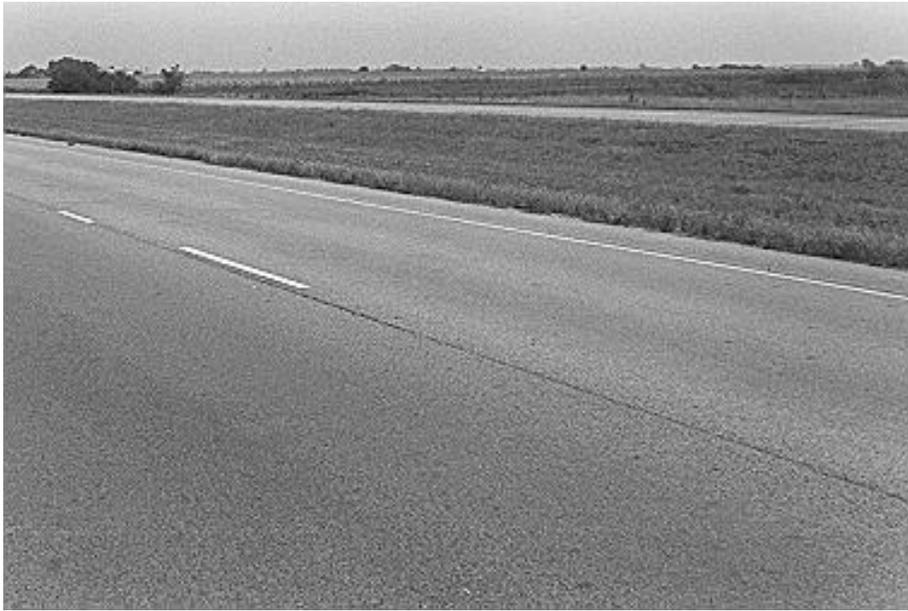
- L - Cracks are tight (mean width less than or equal to 1/4") with minor or no spalling present.
- M - Crack width is between 1/4" and 1/2". Cracks may be moderately spalled. Low severity random parallel cracking may exist near the crack or at the intersection of cracks.
- H - One or more of the following conditions exist: (1) crack width is greater than 1/2", (2) crack is severely spalled, (3) medium or severe random parallel cracking exists near the crack or at the intersection of cracks, (4) major sealing or other major maintenance activity has been performed.

Low Severity Centerline Cracking
